## Chapter 4:

# The CCC Years, 1933-1940

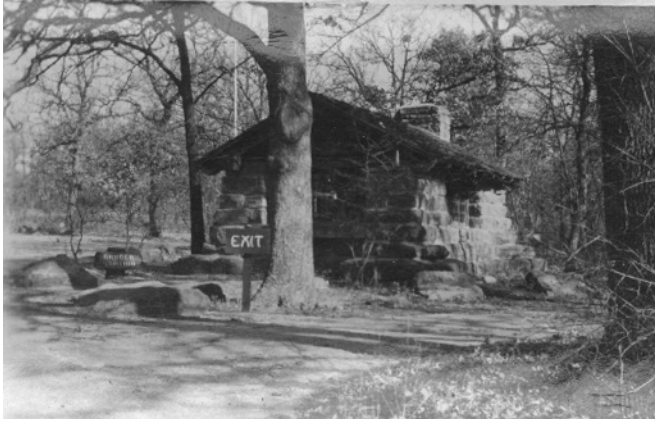
Figure 4-82. Cold Spring Checking Station, circa 1949.

of 1936.<sup>211</sup> However, construction does not appear to have begun until a year later, with the building more or less complete in March, 1938.<sup>212</sup> The small NPS Rustic building, approximately twenty-seven by twenty-one feet, was constructed of materials similar to those of the two comfort stations: Large boulder masonry formed the walls and rough sawn timbers were used to frame the gable roof. The design called for the roof to be surfaced with thirty-inch wood shakes laid nine and one-half inches to the weather on a 12:7 pitch. However, historic photos show that the reveal was somewhat less—closer to six and one-half inches to the weather. The building also sported a stone fireplace and chimney, and window shutters with leather hinges.<sup>213</sup> Constructed after the comfort stations, it apparently exceeded the picturesque nature of even the Cold Springs comfort stations: A landscape architect reported that “[t]he appearance of this structure is unusually pleasing.”<sup>214</sup>

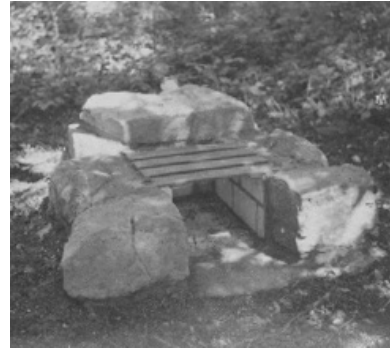
The smaller features in the campground were designed to complement the larger structures in creating a rustic campground scene. Most of these were constructed in the summer of 1935. These included ten of the rectangular stone trash can containers that were also equipped with water hydrants for visitor use. Fireplaces were also constructed, one for each campsite (Figure 4-83). “[U]nobtrusive yet serviceable,” these were lined with firebrick and it was noted that “with proper planting, they will fit very well in the campsites.”<sup>215</sup> A picnic table of rough sawed dimension lumber was also designed for the campsites (Figure 4-84). The picnic table was promoted as model in *Park and Recreation Structures*, where it was described as “substantially braced and . . . [with] a center of gravity so low that it could only be overturned by intent and much effort.”<sup>216</sup> It was also lauded for its “sanitary” table top, which was constructed

Figure 4-83. Stone masonry fireplace at Cold Springs Campground, circa 1935.

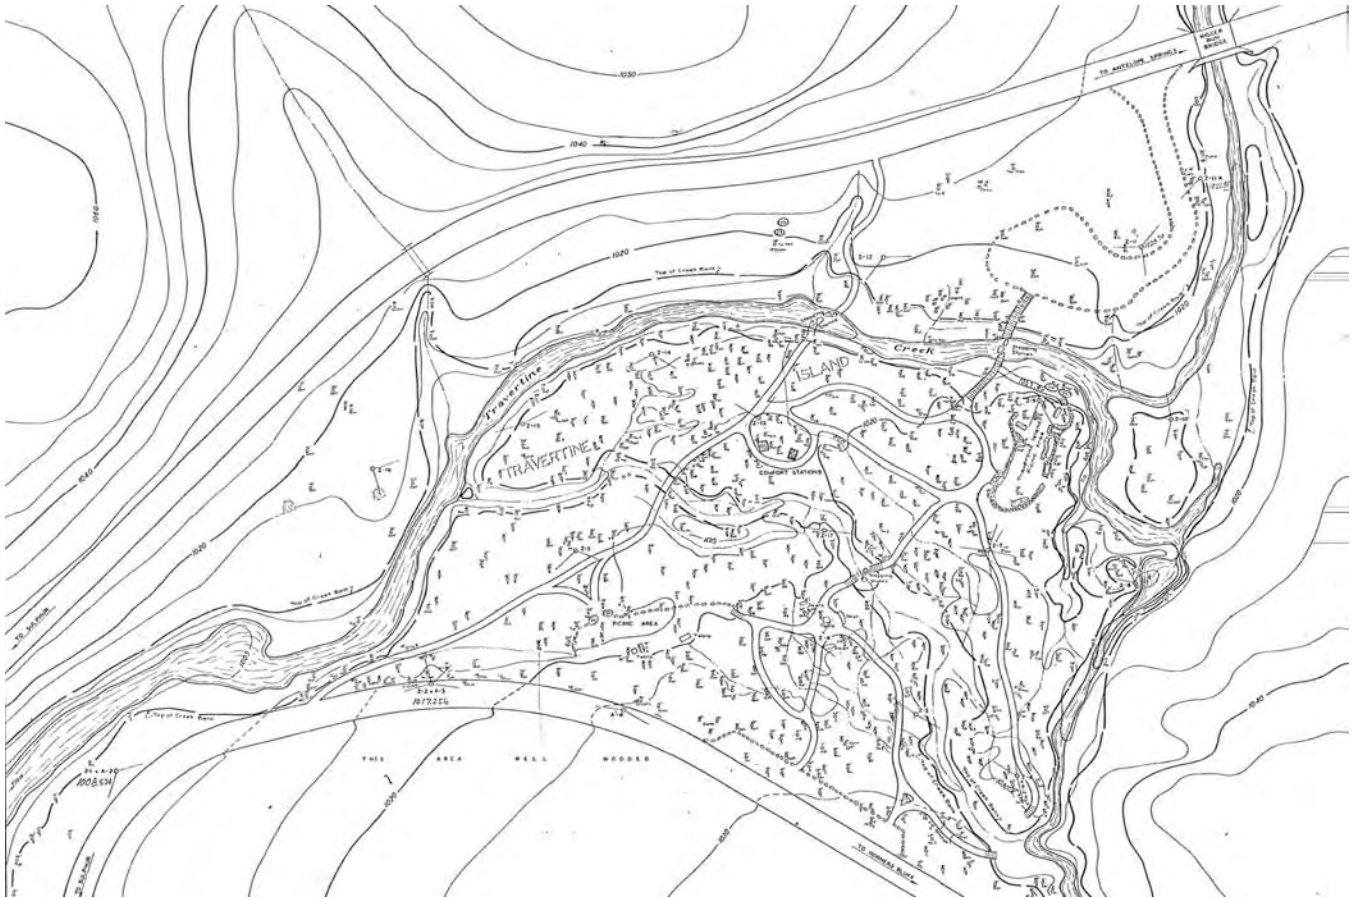
Figure 4-86. "Topographic Map, Travertine Island Area," Drawing NP-PLA-5038, 1936.

These features are shown in greater detail on a topographic survey (NP-PLA-5038) dating to 1936 (Figure 4-86). Though the survey post-dates plans made in 1935 for alterations that eventually created the extant swimming pool at Little Niagara, the 1936 drawing still shows the area prior to these changes.

Three distinct areas of activity appear on the 1936 survey. The area described by Richey and Miller, above, as being for “large parties” is shown as a curved, oblong area, ringed by a stone seatwall. Access is shown from the northern parking via steps and stepping stones across the creek. Within the walled area are two tables, one large and one small (Figure 4-87), as well as a barbecue fireplace with an adjacent wood storage area and “counter top” built into the nearby wall (Figure 4-88). A number of trees were located within the walled area and provided overhead canopy and shade (Figure 4-87). A small circular table appears in other historic photos (Figure 4-89), but is not shown on the 1936 survey.

The two parking areas are also shown on the 1936 survey (Figure 4-86) in their respective locations and defined by boulder guardrails. Wandering paths lead from the

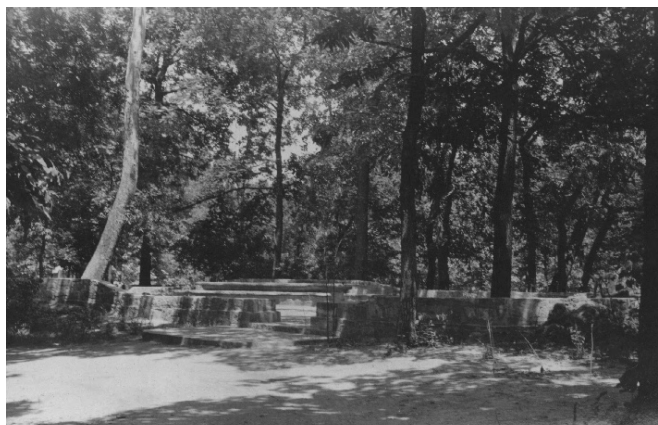
A number of minor areas have been developed for small parties. In some of these stone tables and seats, with near-by fireplaces, have been developed. In addition to these, Mr. Merrill has developed one area for large parties with a large table and seat, a smaller table nearby for children, and a fireplace. Attractive paths have been developed throughout the area. This development promises to be unusually popular with the park visitors. Because of the limited area available for parking cars, Travertine Island will be closed to automobile traffic and a parking area developed nearby at Little Niagara Falls. In his work here, Mr. Merrill has tried to take advantage of the Natural Travertine stone formations which characterize this area.<sup>230</sup>

Figure 4-87. Large picnic area on Travertine Island, 1935. The Large table is to the left.

might supply seats for an audience of three hundred people or more, whether this audience were enjoying a musical, a lecture, or some general entertainment. We feel however, that the main use of this area will be for large picnic lunches. The large paddle-shaped table will accommodate at least twenty-five people, whom we may conceive to be the officials or other dignitaries of some organization such as that of the American Legion. The bean-shaped table was designed primarily for the children

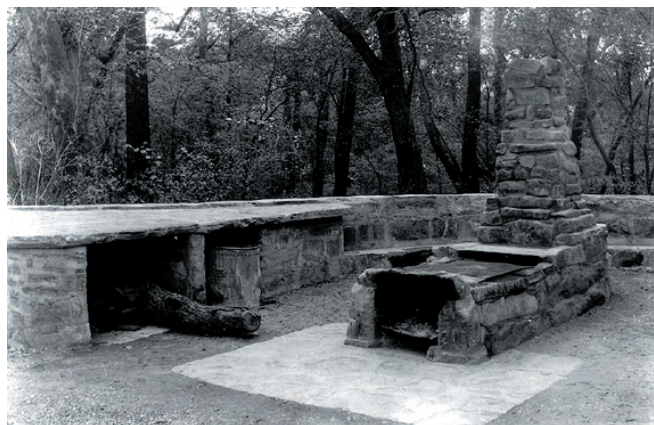
Figure 4-88. Barbecue, food preparation area and wood bin at large picnic area, no date.

who might be holding their own party, or who might be along with their parents in a general picnic party. The oven and wood-box-table combination are adequate to the obvious uses for which they are intended.<sup>231</sup>

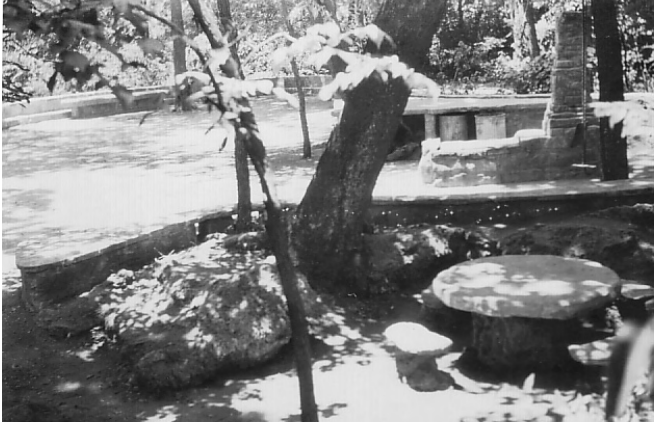
Figure 4-89. Small circular table in the large picnic area, 1935. The table, chairs and adjacent wall are not seen in Figure 4-86.

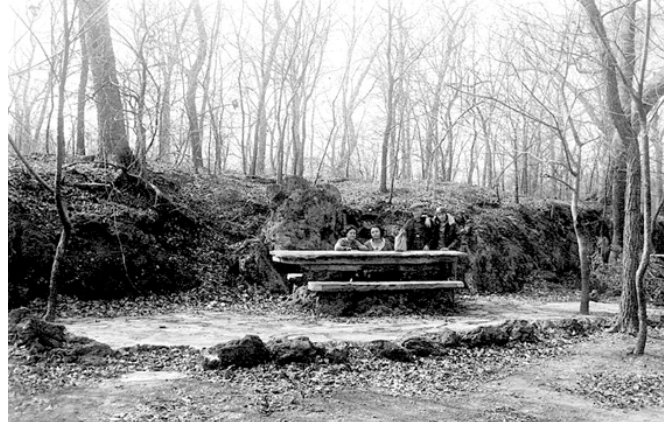
Figure 4-90. Square stone table at the “End of the World,” no date. Note paving and travertine edging around table.

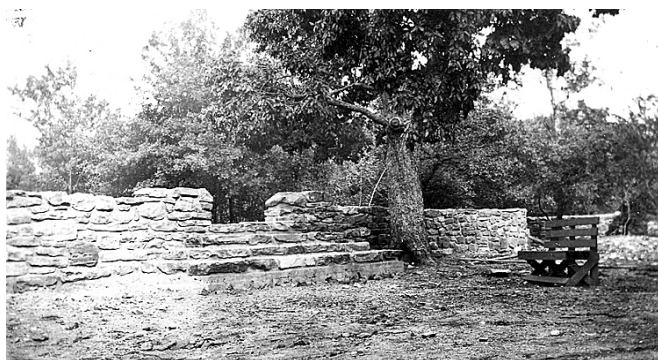
Figure 4-93. Retaining wall at Buffalo Spring parking area, circa 1933.

On the south side of the road, across from the parking area was a loading and unloading area for the picnic area. The road, parking and unloading areas were all filled about two feet above existing grade, and as a result, a stone retaining wall was built to accommodate the grade change and separate vehicular traffic from the picnic area. The retaining wall (Figure 4-93), was eighteen inches thick, and varied in height on the picnic side from fifteen to forty inches. The wall extended southeast along the

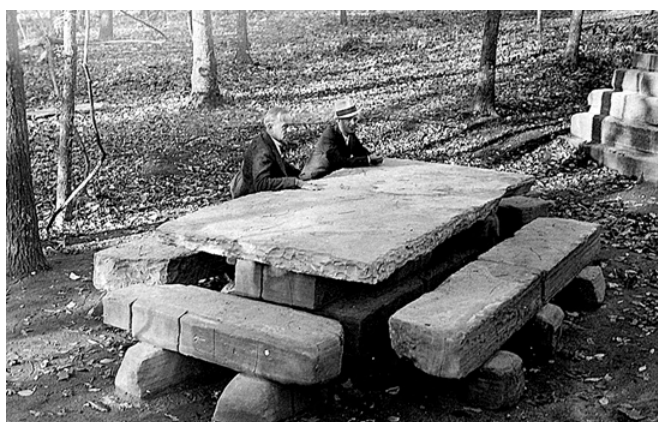
Figure 4-95. Large stone table at Buffalo Spring, circa 1934; note barbecue to the left.

barbecue. A large stone picnic table (Figure 4-95) similar to those at Travertine Island was also built in 1934, and traditional wooden picnic tables were also liberally sited around. Three additional stone fireplaces and another stone picnic table were planned to be built later, these were completed in the summer of 1934.<sup>242</sup> The 1934 survey (Figure 4-92) shows what appear to be a total of three stone tables, two large stoves, and an additional symbol likely indicating additional tables.

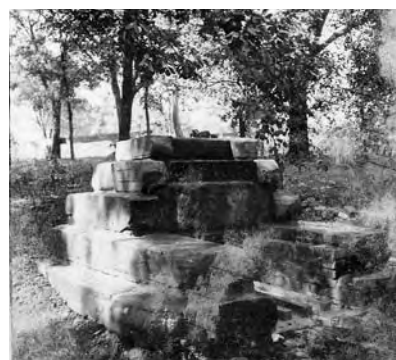
Figure 4-94. Barbecue pit located in picnic area near Buffalo Spring, circa 1935.

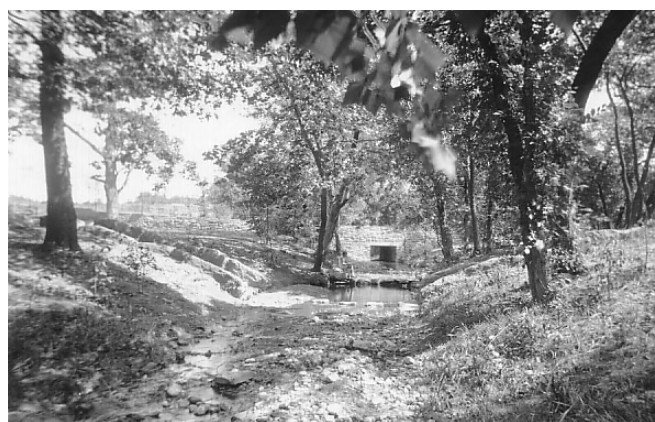
Figure 4-96. Steps and stepping stones at Buffalo Spring, no date. Note bridge in background.

The picnic area was connected to the spring area by steep steps and a set of stepping stones. The stone stairs were four feet wide and were located on both sides of the creek bank. Large, fifteen-inch-high stones flanked the steps, and were meant to act as both seat and railing. On each side of the creek, the lowest two steps were set in concrete (eighteen inches deep) while the others were simply set on clay and had mortar joints. Four large stepping stones bridged the creek, and a flagstone walk led between the top of the creek bank and the Buffalo Springs pool (Figure 4-96).

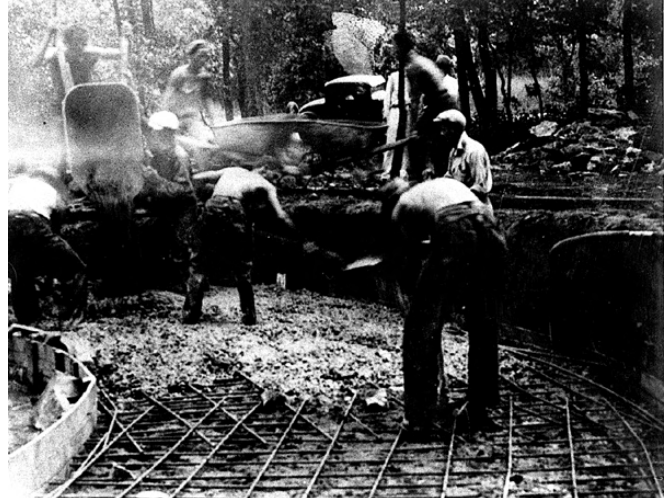
Figure 4-98. Buffalo Spring under construction, 1934, showing concrete reinforcing.

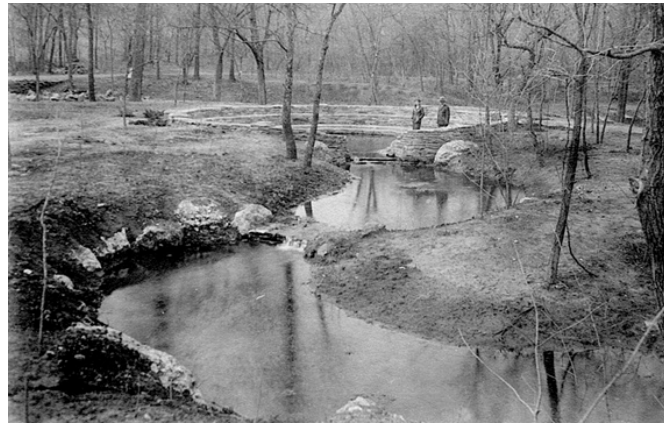
Figure 4-99. Finish grading at Buffalo Spring, 1934.

The finished area was smoothly graded (Figure 4-99). A panoramic view of the area (Figure 4-100) gives an idea of the grade changes and the overall landscape composition, as well as the skilled masonry at the spillway leading to the creek.

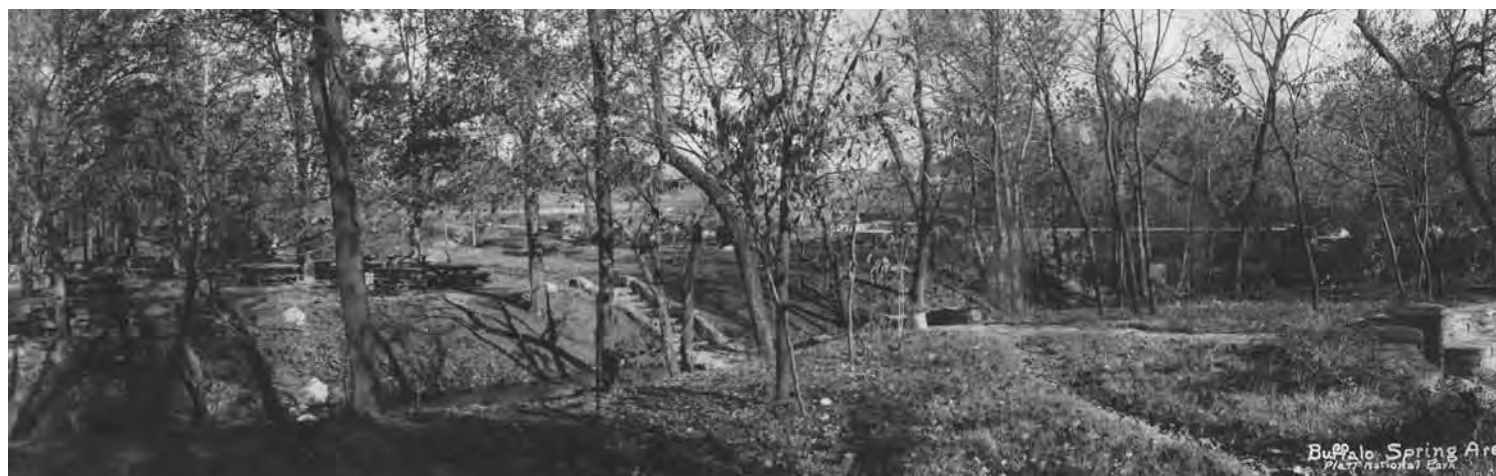
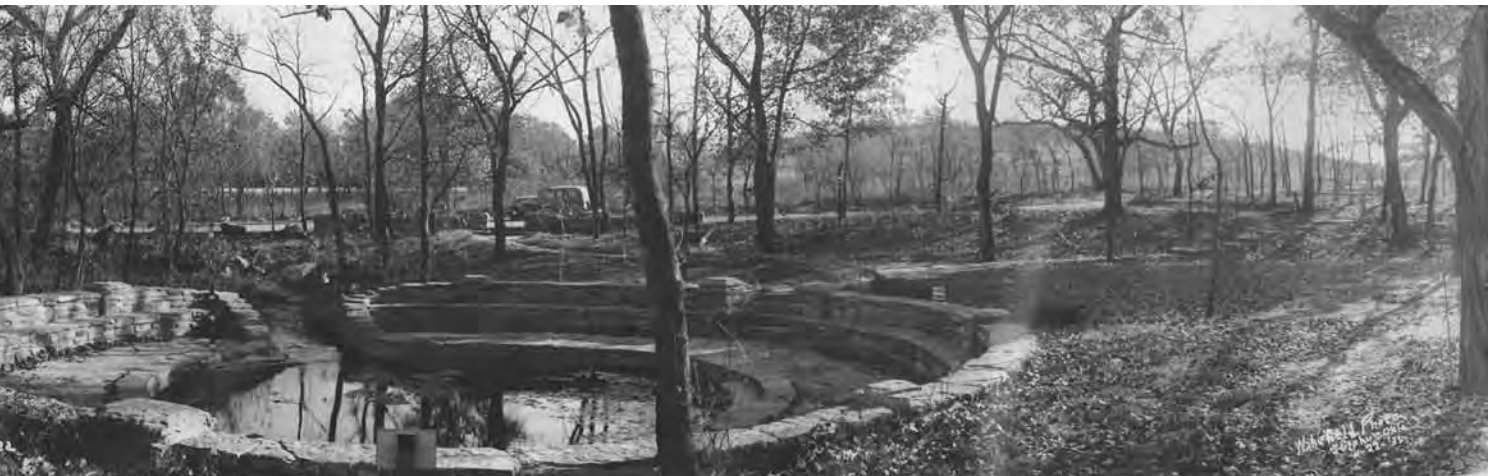
Figure 4-100. Panoramic view of Buffalo Spring, including spring enclosure (center), parking area (right), and steps and stepping stones leading to

the picnic area (left), circa 1935.

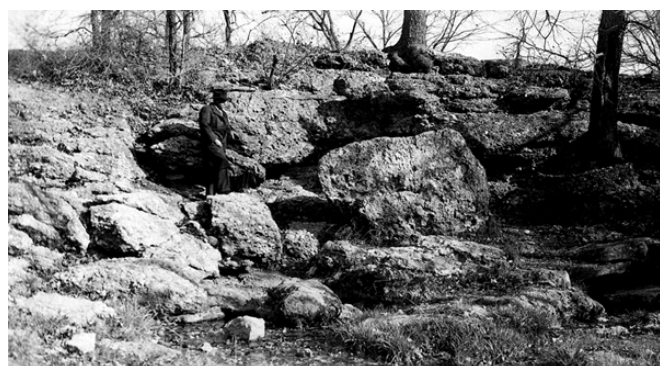
Figure 4-101. Rock formation from which Antelope Spring emanates, circa 1935.

on Pavilion Springs and Bromide Springs Pavilion, soil and rock was removed from the front of Antelope Springs to reveal the fresh water spring emerging from the solid rock formation below (Figure 4-101).<sup>250</sup> The flow was used to create two "lily ponds" by constructing a water fall and then two gravity dams, in sequence, along the stream emerging from the spring (Figure 4-102). Water flowed from one tranquil pond thus created into the next. Trails looped around the two ponds, with stepping stones crossings created at the waterfall at the top of the upper stream pool and the dam between the two (Figure 4-103). A comparison of Figure 4-101 with Figure 3-76 shows the extent of the changes made to the area by the CCC designers and crews.

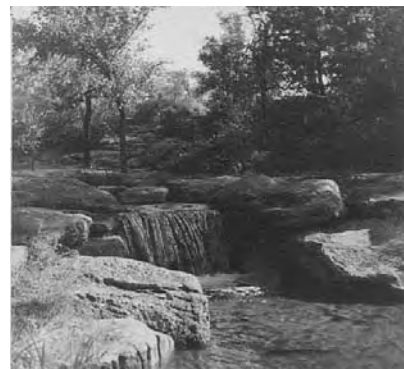
Figure 4-102. Falls flowing from Antelope Springs, with springs in background, circa 1937.

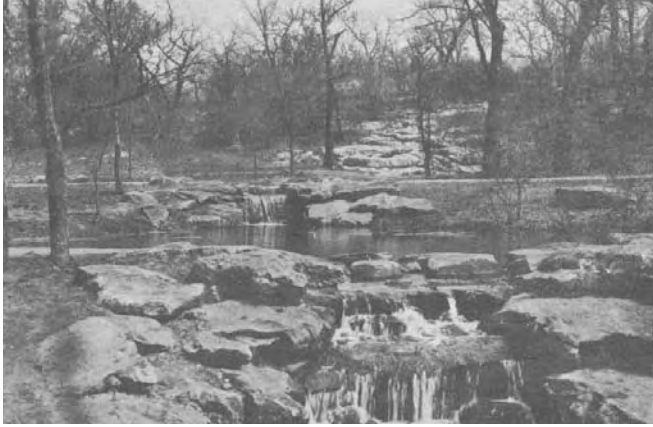
Figure 4-103. First and second falls at Antelope Spring, circa 1941.
