# Chapter 5:

## Maintenance and Change, 1940-2003

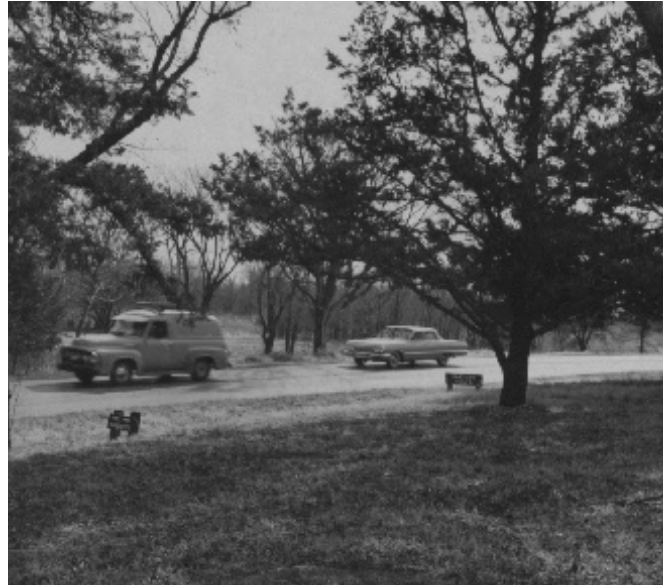
Figure 5-1. Typical low, wood directional signs on the northwest side of Buckhorn Road between Hillside Spring and the turn-off to the maintenance area, 1964.

The 1942 Master Plan provides a comprehensive, if general, statement of the existing conditions of the park and a few suggestions for development. These suggestions included a comprehensive signage plan, and minor additions and subtractions of campground or picnic area features. Little of this appears to have been accomplished, with the possible exception of the implementation of a comprehensive signage plan. By 1945, all old metal signs had been removed and replaced with carved wooden signs, including location and road and direction signs (Figure 5-1).<sup>3</sup>

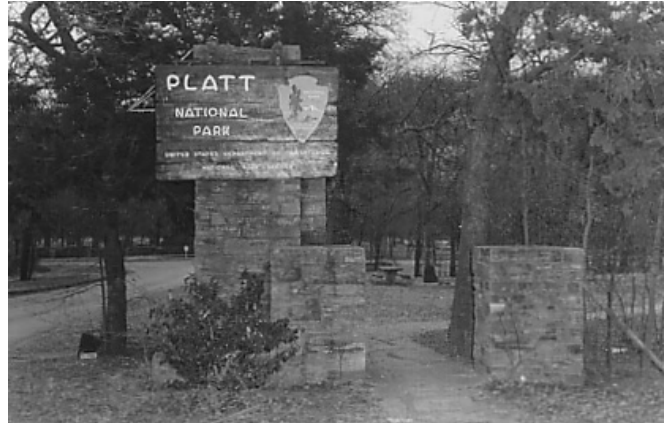
Figure 5-7. New entry sign at the 12th Street entry, 1963.

By 1950, most of the guard rail in the area had been removed, replaced by large conglomerate boulders, which were set along the roads about five feet apart.<sup>64</sup> In 1954, an NPS emblem was mounted at the 12th Street entrance.<sup>65</sup> The sign seems to have been revised again in 1963 resulting in a curious hanging sign located on the Bromide Piers (Figure 5-7).

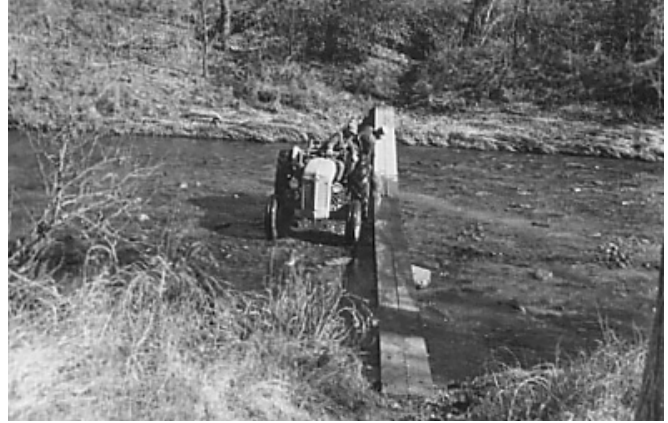
Figure 5-9. Wooden footbridge, located east of the Museum, 1963. This bridge was replaced by the Arbuckle Job Corps bridge in 1967.

Minor changes continued in the 1960s and 70s. In 1962, standing grills for use by picnickers were installed throughout the area.<sup>72</sup> In 1965, ten picnic tables were added.<sup>73</sup> In 1964, the porch on the museum was enclosed, and a new visitor entrance from the side street was added.<sup>74</sup> In 1967, the Arbuckle Job Corps built an arched stone bridge across Rock Creek in the eastern part of the area.<sup>75</sup> The bridge replaced a jerry-rigged wooden low water crossing, which had existed in that location for some time (Figure 5-9). The bridge's construction was difficult since heavy rainfall washed it out three times over the course of the spring and summer.<sup>76</sup> The bridge was constructed of concrete with a white and grey limestone veneer. Approximately sixty feet long and six feet wide, it had five corrugated galvanized steel openings, each ten feet wide.<sup>77</sup> The bridge also had four twenty-eight-foot-long wing walls, and a concrete approach on each end. It originally had a pipe railing, but this was broken off in its first flood.

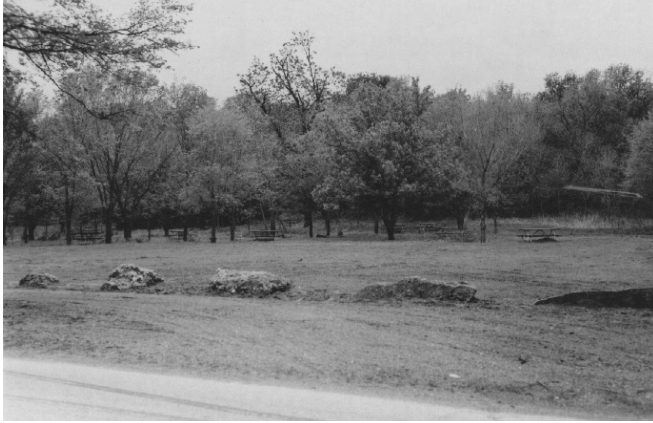
Figure 5-10. Walnut Grove, with boulder-bounded parking area and picnic tables, 1966.

area was likely well-used as a picnic area by this time. In 1964, the area was briefly reconsidered as a location for the Arbuckle Job Corps Camp to begin in 1966, but Regional Director Daniel Beard quashed that idea, noting “I would not like to reoccupy the old CCC site in Platt National Park that is now growing up nicely.”<sup>84</sup> By 1966, the area had a nice balance of both open and shaded turf (Figure 5-10)

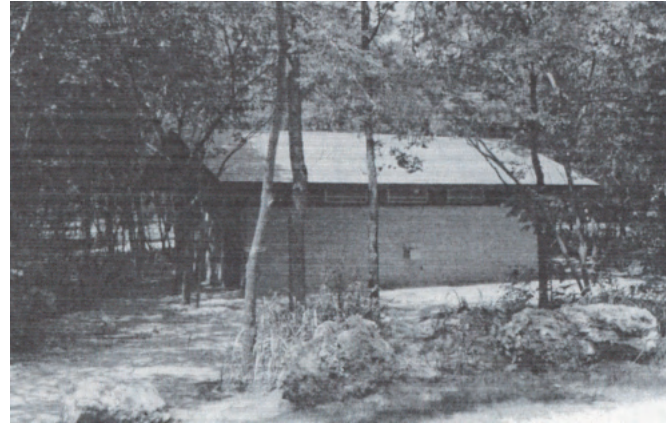
Figure 5-11. Walnut Grove comfort station, 1966.

The 1966 Master Plan also proposed a comfort station for Walnut Grove in the western half of the site. This comfort station was built in 1966, along with two others at Little Niagara Falls and Black Sulphur Springs. Constructed of concrete block on a concrete slab, with an asbestos shingle roof, the building was a simple, “form follows function” structure, not unlike the stucco comfort stations built in the 1920s. A small nose-in parking lot, separated from the perimeter road, was proposed in front of the comfort station, but it appears this was not built as planned. Instead, it seems that the comfort station was simply located near an existing parking area in somewhat wooded surroundings (Figure 5-11). Also notable in the photograph are the large travertine boulders lining the parking area in the foreground.

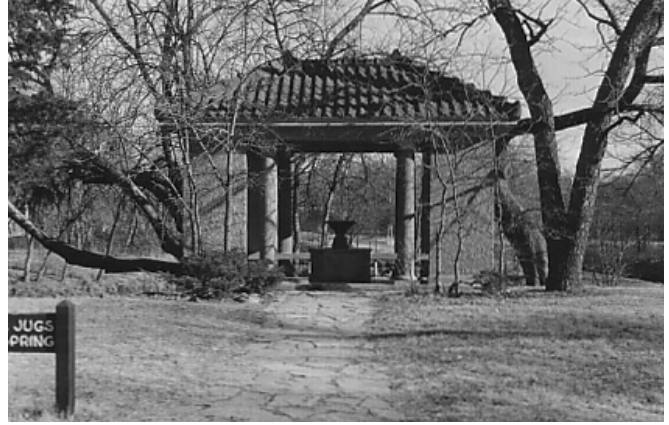
Figure 5-13. Black Sulphur Springs Pavilion, 1963.

Though plans for the new Black Sulphur Springs pavilion and an associated five-car parking area across the road from the extant neoclassical structure were approved in 1939, its construction remained an elusive goal throughout the 1940s.<sup>87</sup> The new pavilion appeared on the 1942 and the 1950 Master Plans, and the old pavilion was replaced by a comfort station on the 1950 plan. By the 1958 Master Plan, however, a new pavilion had been abandoned as a development idea, and the existing pavilion continued its existence in the landscape (Figure 5-13).

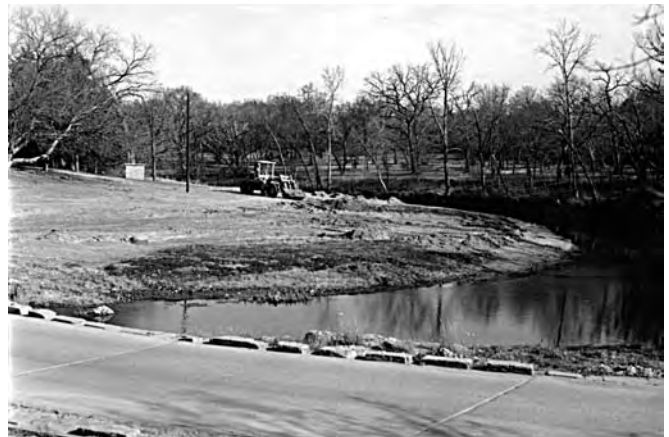
Figure 5-14. Regrading beach below Black Sulphur Springs after the flood of 1953.

drinking fountain,” and when the water receded, sand covered a third of the west side of the Black Sulphur Springs causeway and extended in a wide swath for 125 yards south of the structure.<sup>88</sup> Major regrading of the area was undertaken in the summer to restore the sandy beach between Rock Creek and the old pavilion (Figure 5-14).

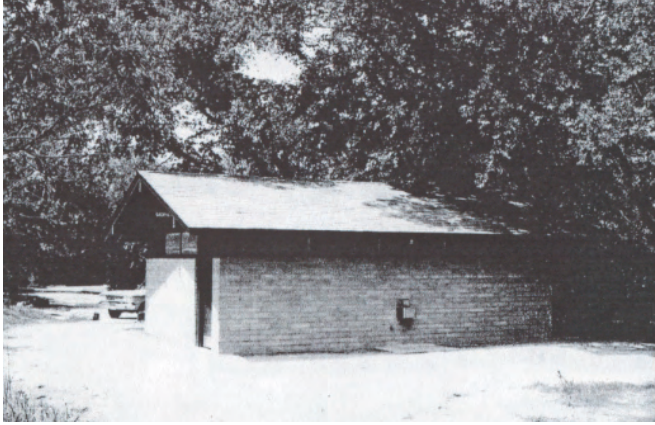
Figure 5-15. Mission 66 comfort station at Black Sulphur Springs, 1966.

In 1961, the park entrance at Tishomingo Avenue was closed, despite protests from the neighbors.<sup>89</sup> Trees were planted along the boundary the following year, to provide a greater separation between town and park.<sup>90</sup> By the early 1960s, then, the area west of the pavilion was well-established as a contained and popular picnic area.<sup>91</sup> The 1965 and 1966 Master Plans confirm this use, and further proposed that a comfort station be built somewhere in this area.<sup>92</sup> This Mission 66 comfort station (Figure 5-15) was built in 1966, though it was located in a slightly different site than shown on the original construction plan.<sup>93</sup> It was built of concrete block and matched the others at Walnut Grove and Little Niagara

Falls. The new comfort station may have precipitated installing fifty four new picnic tables, nineteen fireplaces, and eighteen refuse units in the area in 1967, a year when most picnic areas seem to have received new fixtures.<sup>94</sup> As of 1960, the sandy area was established as one of the most popular swimming areas in the park (Figure 5-16). Tradition has it that the area was regularly cleared of excess sand deposited on the beach after heavy rainfalls.

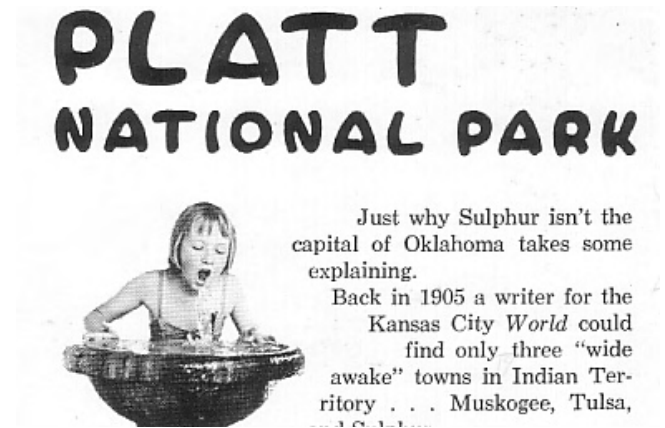
Figure 5-17. Fountain in the Black Sulphur Springs Pavilion, circa 1960.

of the spring to disinfect the water; this may have been later replaced by a chlorinating system.<sup>98</sup> The pavilion's fountain basin was filled with concrete, though it's not clear exactly when this happened. A circa 1960 brochure about Platt featured a child drinking from the basin (Figure 5-17). In 1966, the concrete block pump house for supplying the fountain was constructed and perhaps changes to the basin were made at this time.<sup>99</sup> Or perhaps the basin was filled in 1971, when five person days were spent replacing the chlorinator, installing a new frost-proof hydrant for visitor use, as well as a new cover and manhole over the cistern.<sup>100</sup>

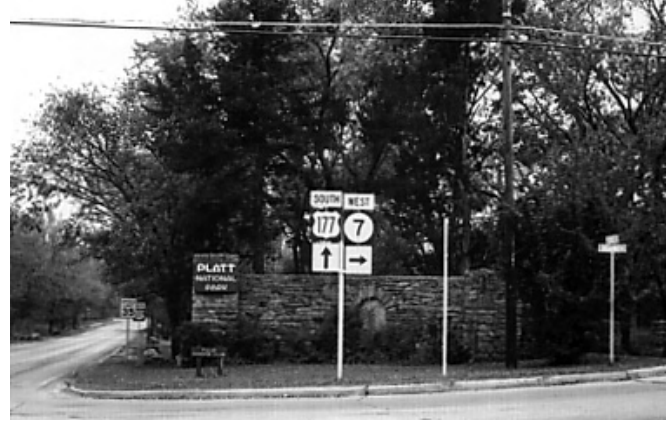
Figure 5-20. Wooden sign added to the Flower Park entry piers, 1970.

In the 1970s, the main entrance to the park was significantly changed after a series of vehicle collisions with the entry piers. The piers had already been hung with a variety of NPS emblem signs, one in 1954 (Figure 5-19) and one in 1963 (Figure 5-20). In 1971, a large truck crashed into the east entry pier, damaging a hanging wooden arrowhead that had been added as part of the 1963 signage.<sup>106</sup> Two years later, in February 1973, a second truck did even more damage, destroying the entire eastern pier and its attached curved wall. Instead

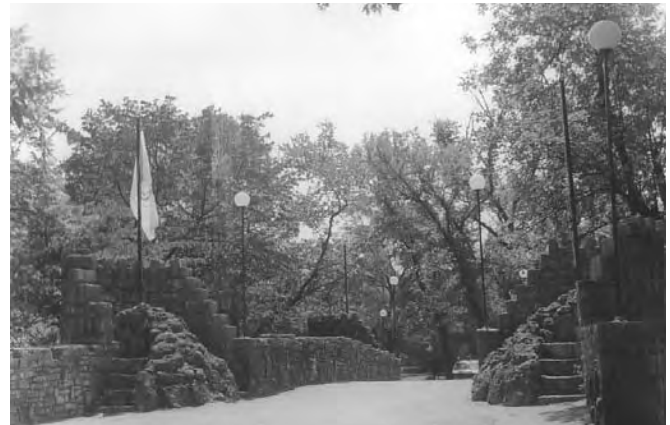
Figure 5-21. Lincoln Bridge with new flagpoles and original light posts.

In 1974, a small stone and log footbridge near Lincoln Bridge was replaced by the extant stone masonry arch footbridge. This small bridge was constructed by park maintenance worker and mason Lawrence Howell. In 1976 four flagpoles which had been removed from the Lincoln Bridge were replaced, although the new flagpoles were shorter than the original poles (Figure 5-21). Sometime between 1976 and the present, the light posts were also removed from the Lincoln Bridge.

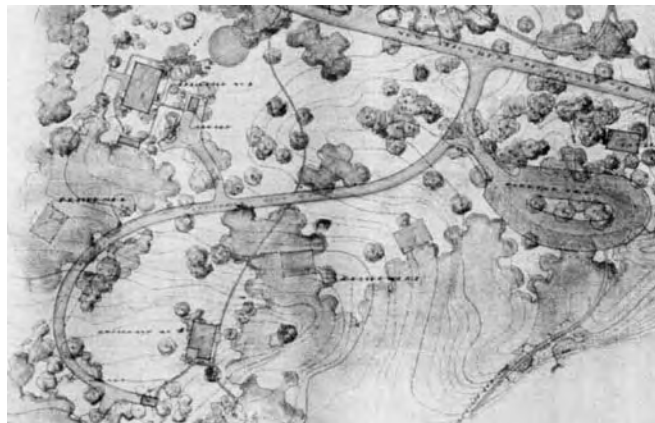
Figure 5-34. Portion of Drawing NP-PLA3045J, showing 1940 Master Plan design for the Residence Area, 1940.

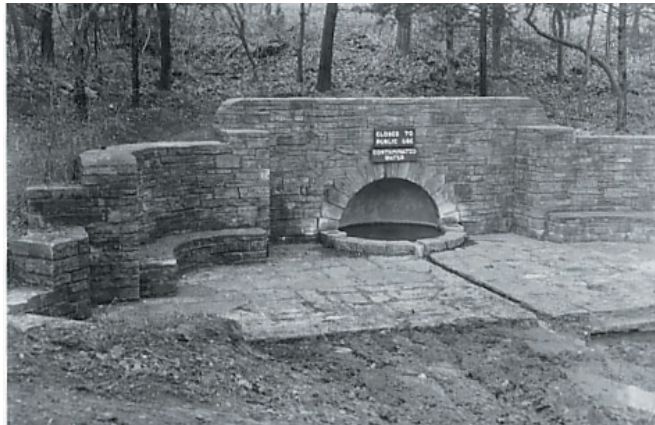
Figure 5-41. Hillside Springs, circa 1963. Note signs above spring enclosure.

As far as can be told, little planning or changes to Hillside Springs was recommended in the 1940s and 1950s.<sup>121</sup> Located in a semi-secluded locale, with a distinct function, the fountain probably required little beyond maintenance (Figure 5-40). In 1961, however, bacterial contamination was reported at Hillside Springs. In December, dye was placed in the area's sewers to determine the source of the contamination, though the results of this test have not been located.<sup>122</sup> In 1962, additional tests were made and water samples were sent to Oklahoma State University, which determined the water was still contaminated. As a result, signs indicating the contaminated water and prohibiting its use were mounted above the circular pool (Figure 5-41).<sup>123</sup>

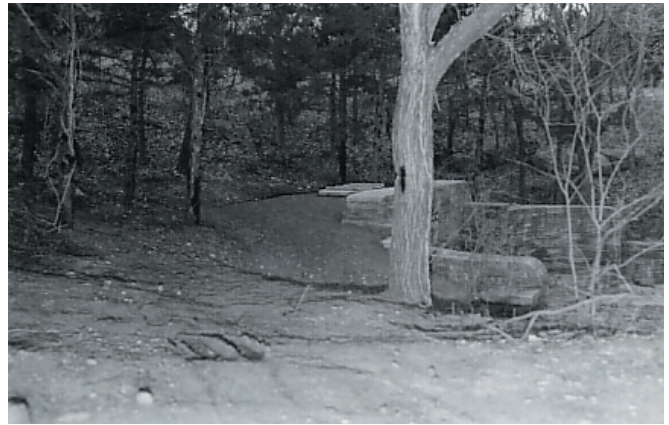
Figure 5-42. Backfilled area around repaired Hillside Springs, circa 1963.

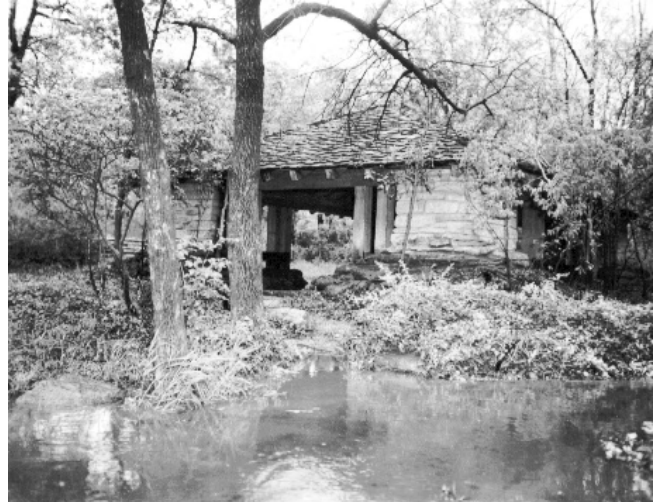
Figure 5-44. Pavilion Springs after the 1953 flood.

change also occurred at Pavilion Springs, especially in the 1950s. The area was badly flooded in 1953 (Figure 5-44). In 1965, the drainage of the seven springs underneath the building was altered a bit. A one-hundred foot ditch eighteen inches wide and twenty-four inches deep was dug along the south end and west side of the pavilion. Two lines of four-inch drain tile was laid side-by-side in the ditch, which was then filled with one-inch paving stone.<sup>130</sup> The new drainage way emptied into the spillway and trail passageway under Highway 177 and thence to Rock Creek. Maintenance on the spring in 1971 consisted of cleaning and replacing drain line and took a total of five person days over the course of the year.<sup>131</sup> In 2000, the roof was replaced with a new shake roof duplicating the original.

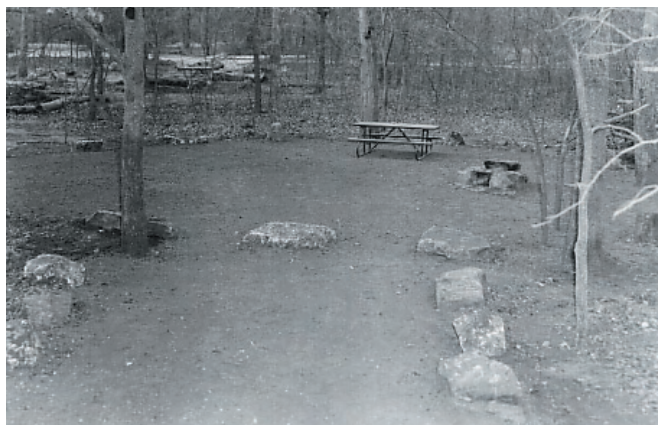
Figure 5-49. Finished repairs at Cold Springs Campground, 1963.

A first stab at campground improvement occurred in 1961, when trees were planted in all of the campgrounds and ten signs were placed at planting locations to notify the public.<sup>142</sup> In Cold Springs, Osage orange seeds were collected for planting between the campground and the perimeter road.<sup>143</sup> The loop road in the campground was also resurfaced with Troy Gravel.<sup>144</sup> In March of 1963, a more comprehensive treatment was undertaken in Cold Springs. The sites were overhauled; they were regraded and stones separating the parking areas from the campsites were either installed for the first time or rearranged (Figure 5-49 and Figure 5-50).<sup>145</sup>

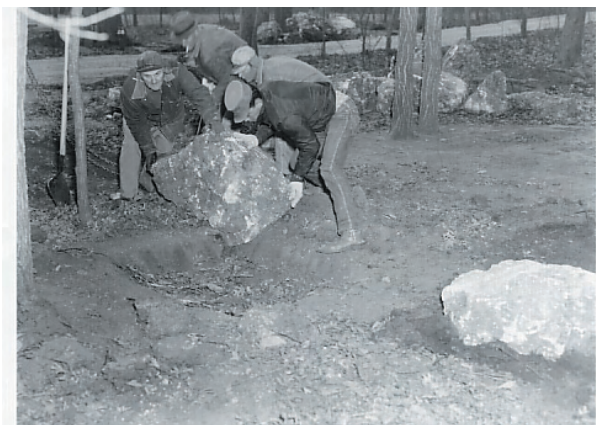
Figure 5-50. Campsite reorganization at Cold Springs Campground, 1963. Note how boulders are being embedded below grade.

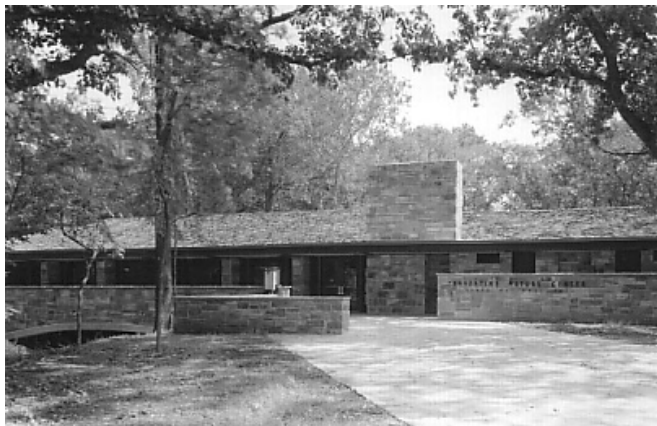
Figure 5-56. Travertine Island Nature Center, shortly after completion, 1969.

By the end of 1965, a plan had been made to develop a nature center within the park, and in 1966 the entry to the Buffalo and Antelope Springs was chosen as the best location for it. In February 1967, drawings for the new Travertine Nature Center were completed. The building was designed by the Houston architectural firm of McKee and Kamrath, and was styled after the work of Frank Lloyd Wright. The building was bridge-like. Long and low, with horizontal lines, it was built over Travertine Creek, displaying Steel's hoped-for architectural ingenuity (Figure 5-56).

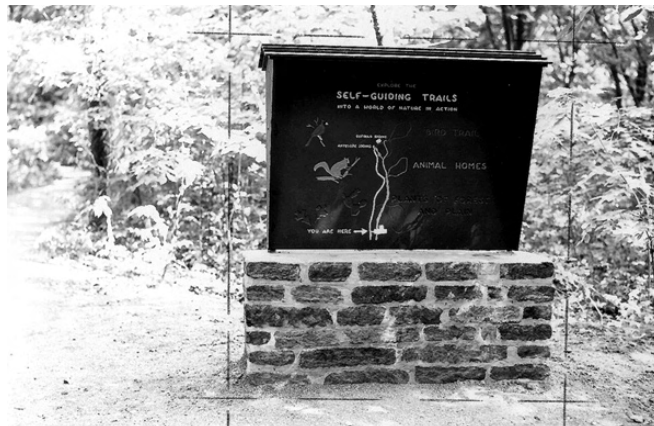
Figure 5-57. One of three kiosk-like interpretive signs along Buffalo Springs Trail, 1971.

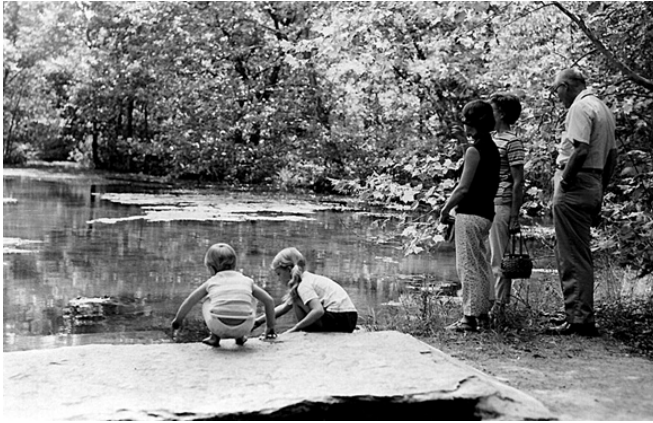
Figure 5-58. Lower pool, sometimes known as the lily pond, below Antelope Springs, circa 1970. Note stone bridge.

Small changes continued, primarily to stream crossings, which, after forty years, were beginning to deteriorate. The stepping stones at the lowest Antelope Springs crossing had already been replaced by a large stone slab, reputedly the table top of a former stone picnic table, sometime before 1971. Lawrence Howell recalls replacing the middle crossing at Antelope Springs in 1976, removing a set of stepping stones. In 1977, he constructed the plank bridge located on the return trail between Buffalo Springs and the lowest Antelope Springs crossing. The bridge was constructed, he says, because the stepping stones, located underneath the bridge, were slippery, and it was deemed easier to build the bridge than constantly clean the stones. In 1979, Howell constructed wing walls and the pipe rail bridge at Buffalo Spring, where there used to be stairs and stepping stones. As part of this work, he repaired the flagstone path to Buffalo Springs, and in 1981 constructed a new flagstone path between Buffalo Springs and the curved arch bridge. He also recalls doing masonry repairs on the stone arch bridge itself, using dirt and soil to age the new mortar so that repairs would not be so noticeable.<sup>168</sup> The mortar he used was three parts creek sand to one part grey cement.

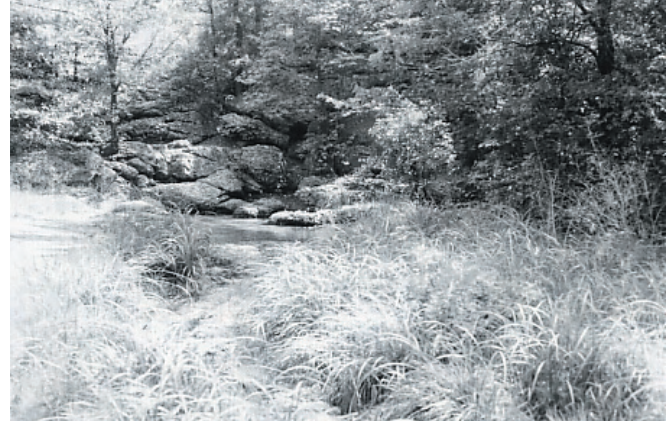
Figure 5-59. Antelope Springs rock outcropping, 1963. Note released nature of vegetation in the area.

Maintenance also continued, but to a lesser extent than previously, and primarily on the waterways and extant structures. In 1971, six person days were spent cleaning the channels and ponds at Buffalo and Antelope Springs of debris. In contrast, activities such as mowing and pruning were restricted in the new Environmental Study Area. As a result, the released landscape grew up. This was particularly noticeable at Antelope Springs (Figure 5-58 and Figure 5-59), but also true at Buffalo Springs (Figure 5-60). The park-like qualities of these areas receded into the background of the natural landscape.

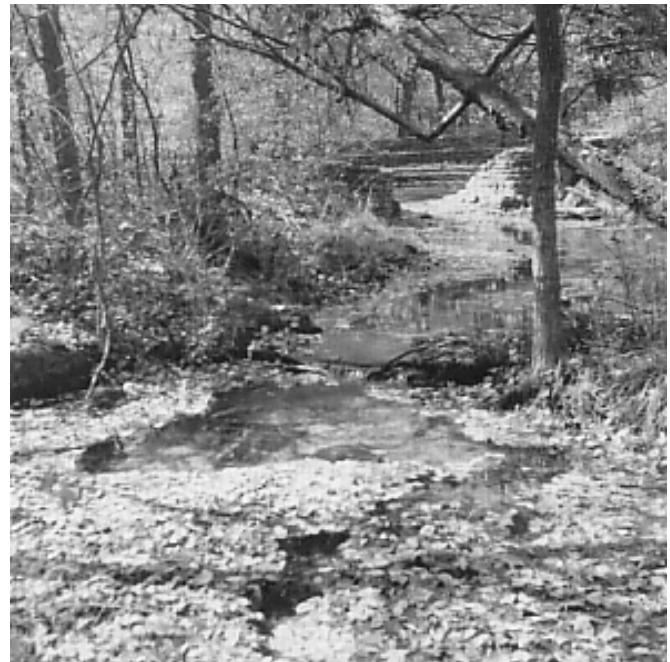
Figure 5-60. Buffalo Springs from east of enclosure, 1971. Again, note released nature of vegetation, especially in comparison to Figure 4-100.

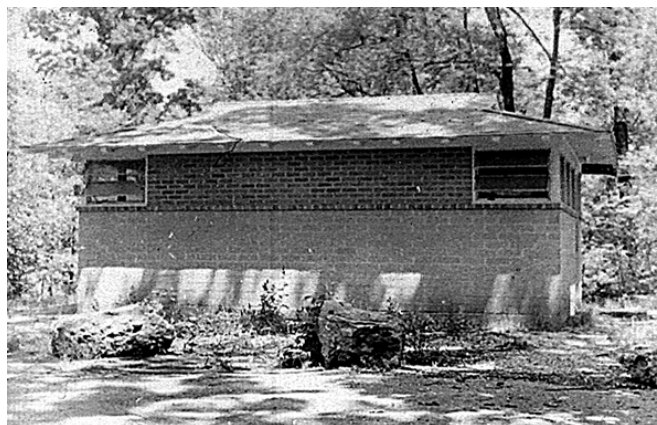
Figure 5-62. Comfort station in Rock Creek campground, circa 1950.

Work was delayed slightly due to the outbreak of the Korean War, but by June of 1950, two comfort stations of "tile construction" were underway in the campground.<sup>176</sup> Located on the second and fifth loops in the middle of the campground, the buildings were simply designed buildings (Figure 5-62). A band of more ornamental brick located underneath their wood-framed shingle roofs emphasized the horizontal line of the buildings. Built in a more Modern style, these buildings were something of a departure from the heavy stone construction of the Cold Springs comfort stations, but the overall scale, size, shape and hip-on-gable roofs mimicked the lines of the older structures. A set of narrow pedestrian paths along the curving axis of the loops linked the comfort stations to the road system.

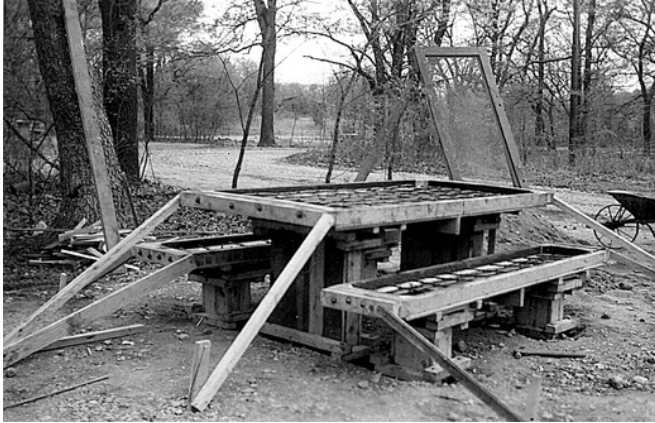
Figure 5-63. Picnic table under construction in Rock Creek Campground, 1951.

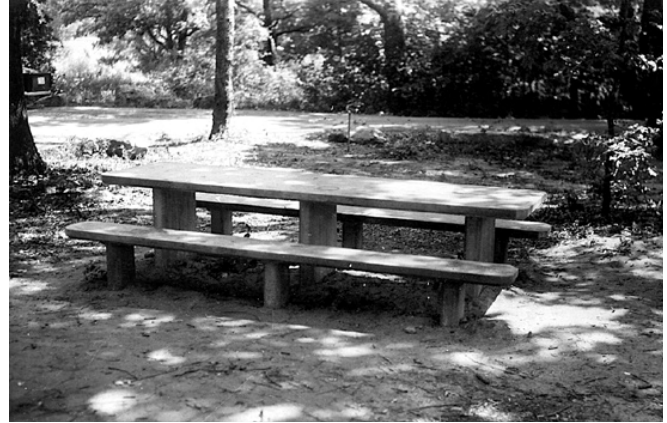
Figure 5-64. Long, ten-foot picnic table in Rock Creek Campground, shortly after construction, 1951.

Cornell proposed using a concrete picnic table, similar to ones he had seen in state parks in Texas.<sup>177</sup> Cornell felt the design not only met NPS objectives of “cleanliness, safety, and low cost maintenance,” but also demonstrated “the importance of stability” since “all unnecessary embellishment in design was eliminated with the dimensions of the structural members held to a minimum to reduce the conspicuousness of the structure as a whole.”<sup>178</sup> Though specified to be constructed in lengths of six, eight, and ten feet, it appears that only the six and eight foot tables were constructed (Figure 5-63, Figure 5-64 and Figure 5-65). More than forty were built by June 1950.<sup>179</sup> The fire pits were also built of poured concrete (Figure 5-66), not in rustic limestone masonry as had been the case fifteen years earlier at Cold Springs Campground. Each site was also equipped with an underground garbage can.<sup>180</sup> A small checking station was also constructed near the front of the campground in 1950 (Figure 5-67). A sign was also built at the entrance, but was reworked in 1954 (Figure 5-61).<sup>181</sup>

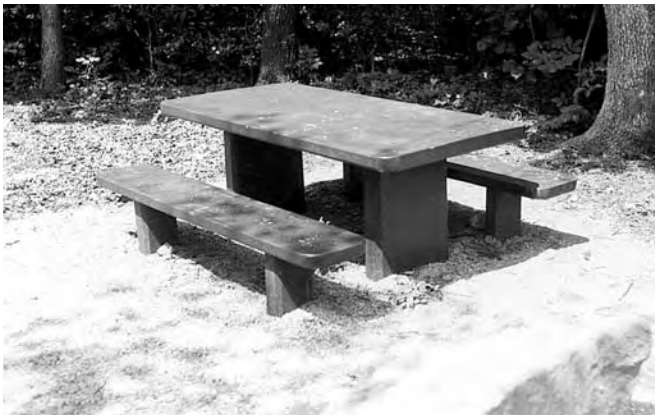
Figure 5-65. Six-foot picnic table in Rock Creek Campground, 1951.

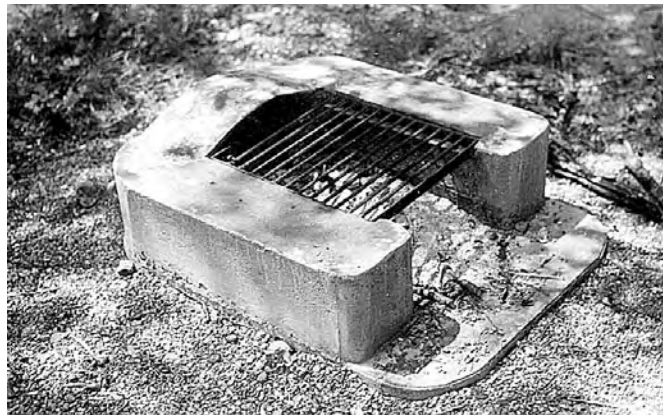
Figure 5-66. Concrete grill in Rock Creek Campground, 1951.

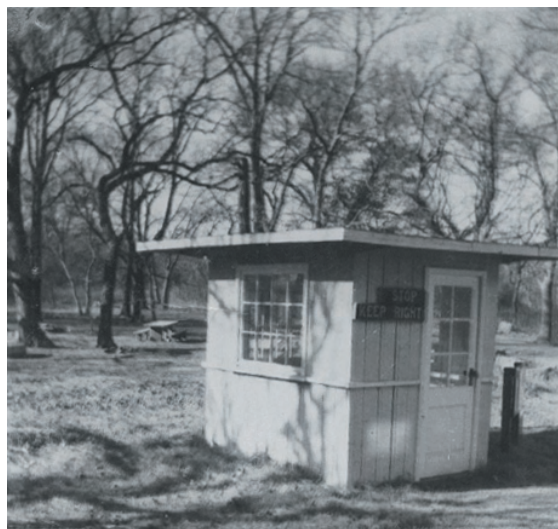
Figure 5-67. Checking Station at Rock Creek Campground, 1954.

Changes in Rock Creek Campground following 1967 appear to have been minimal. New metal directional signs were added. The checking station, surveyed on site in 1981, was later moved to Guy Sandy.

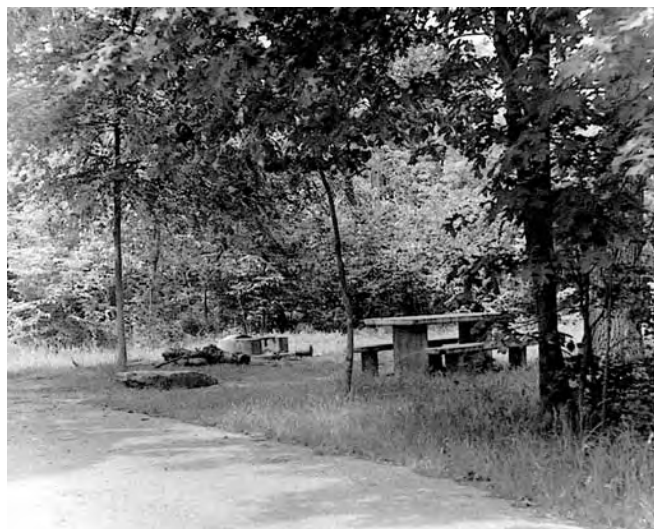
Figure 5-68. Campsite at Rock Creek Campground, circa 1950.

The campground opened for use in the summer of 1951. The new sites were initially more vegetated than the hard-used, compacted earth sites in Cold Springs (Figure 5-68). Park use continued to rise through the 1950s, and by 1962, summer attendance saw an average of 70,000 visitors per week.<sup>182</sup> The Bromide Springs area was continually called into use as an overflow campground, stressing the facilities and vegetation in the area. As a result of demand, and because of plans to eliminate campgrounds elsewhere in the park, Rock Creek was enlarged in the mid 1960s.

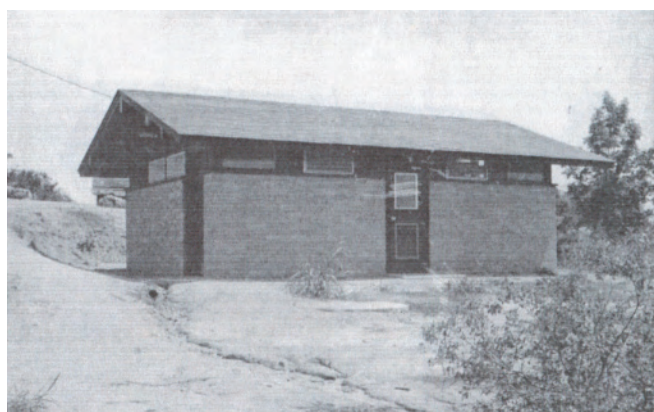
Figure 5-70. Mission 66 comfort station at Chigger Hill in Rock Creek Campground, 1966.

Hill. The two new concentric loops were predominantly pull through sites, but the Chigger Hill loop was a combination of pull through, pull in and back in sites as it accommodated the steeper topography. A total of 47 new sites were added, each with a moveable picnic table and fireplace. Five double trash can holders were installed in the new section, along with sixteen single can holders.<sup>183</sup> A comfort station (Figure 5-70) was

constructed at the top of the hill. The campground addition was completed in 1967.

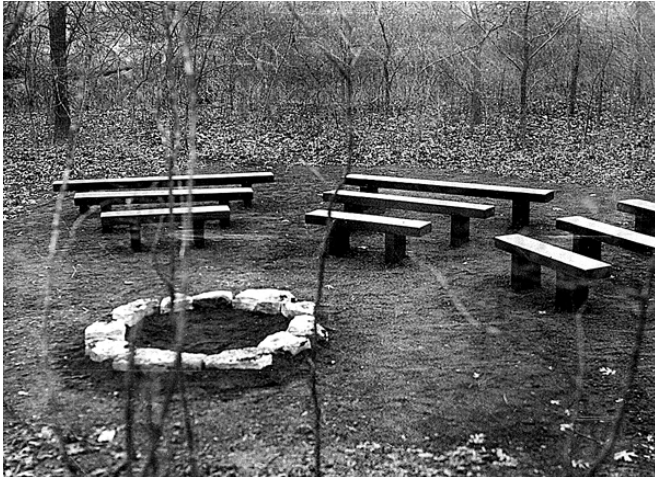
Figure 5-71. Lecture circle at Rock Creek Campground, 1967.

A campfire or “lecture circle” was also constructed at Rock Creek, at the same time as and identical to the one at Cold Springs. It was a half circle of plank seats on ten by ten-inch pillars around a stone-lined fire pit (Figure 5-71).<sup>184</sup> Its location within the overall campground is not known.
