Historic Furnishings Report

Lockhouse 44
Chesapeake & Ohio Canal National
Historical Park
Williamsport, Maryland

Planning and Research
Media Services
Harpers Ferry Center
National Park Service
March 2010

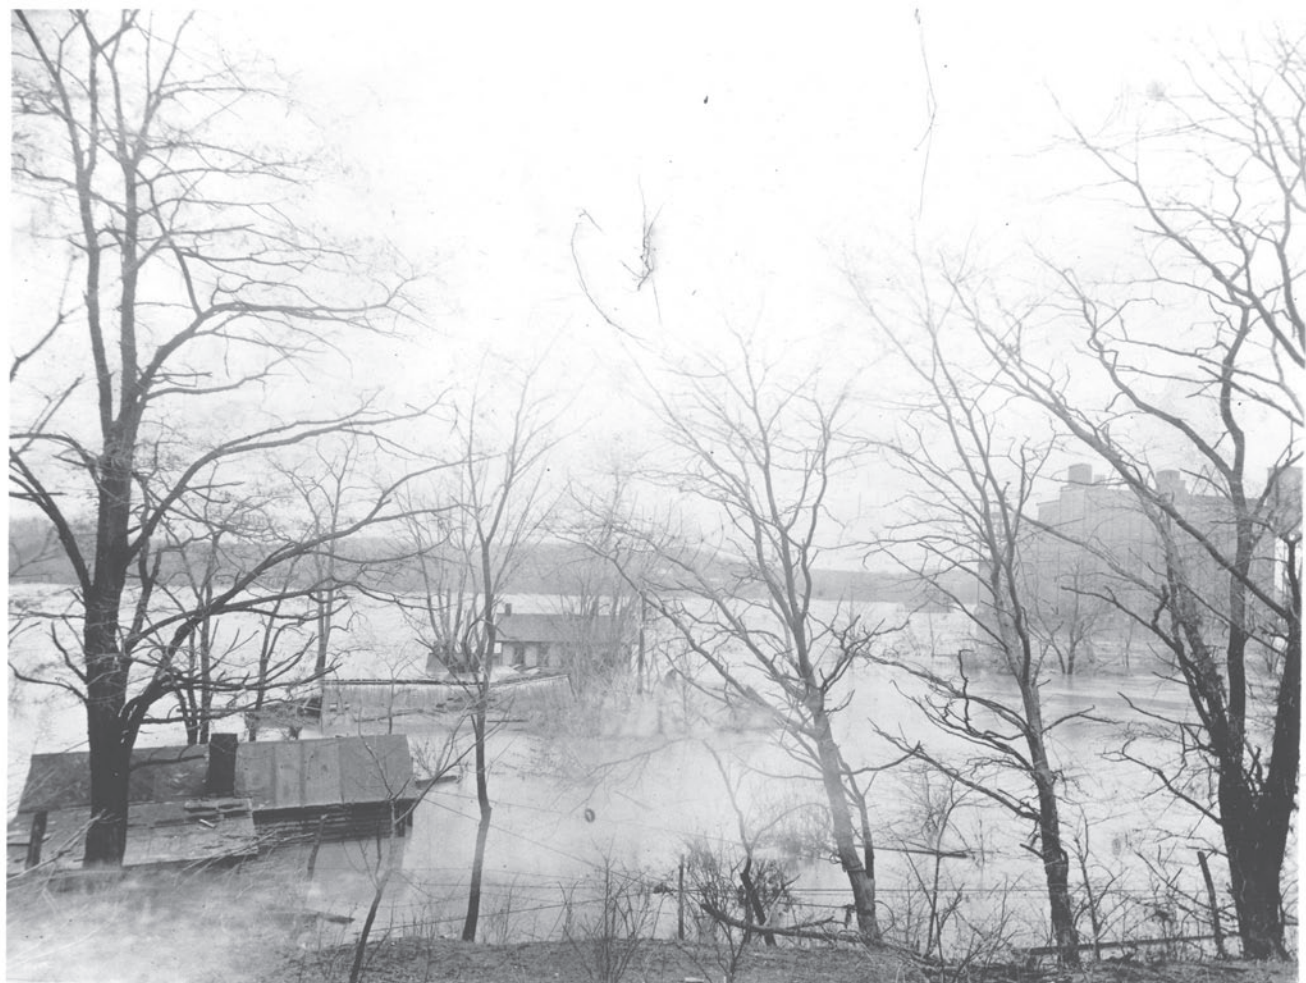
Figure 8. Lockhouse 44 and Lock 44 during the 1936 flood, C&O Canal NHP.

The lockhouse at Lock 44 was damaged by severe floods in the 20th century, but unlike most other canal company buildings in the area, it survived the high water. Lockkeeper Harvey Brant recalled that in 1924, the water was "about three foot deep in the house."²⁰ Flooding was a constant concern, and Lula Brant Harsh recalled: "Sometimes the floods would come up to just the first floor; sometimes it would come up to the window sills; sometimes it would get up in the second floor."²¹ During the flood of 1936, water rose to within three feet of the eaves, but the house remained standing (figure 8).²²

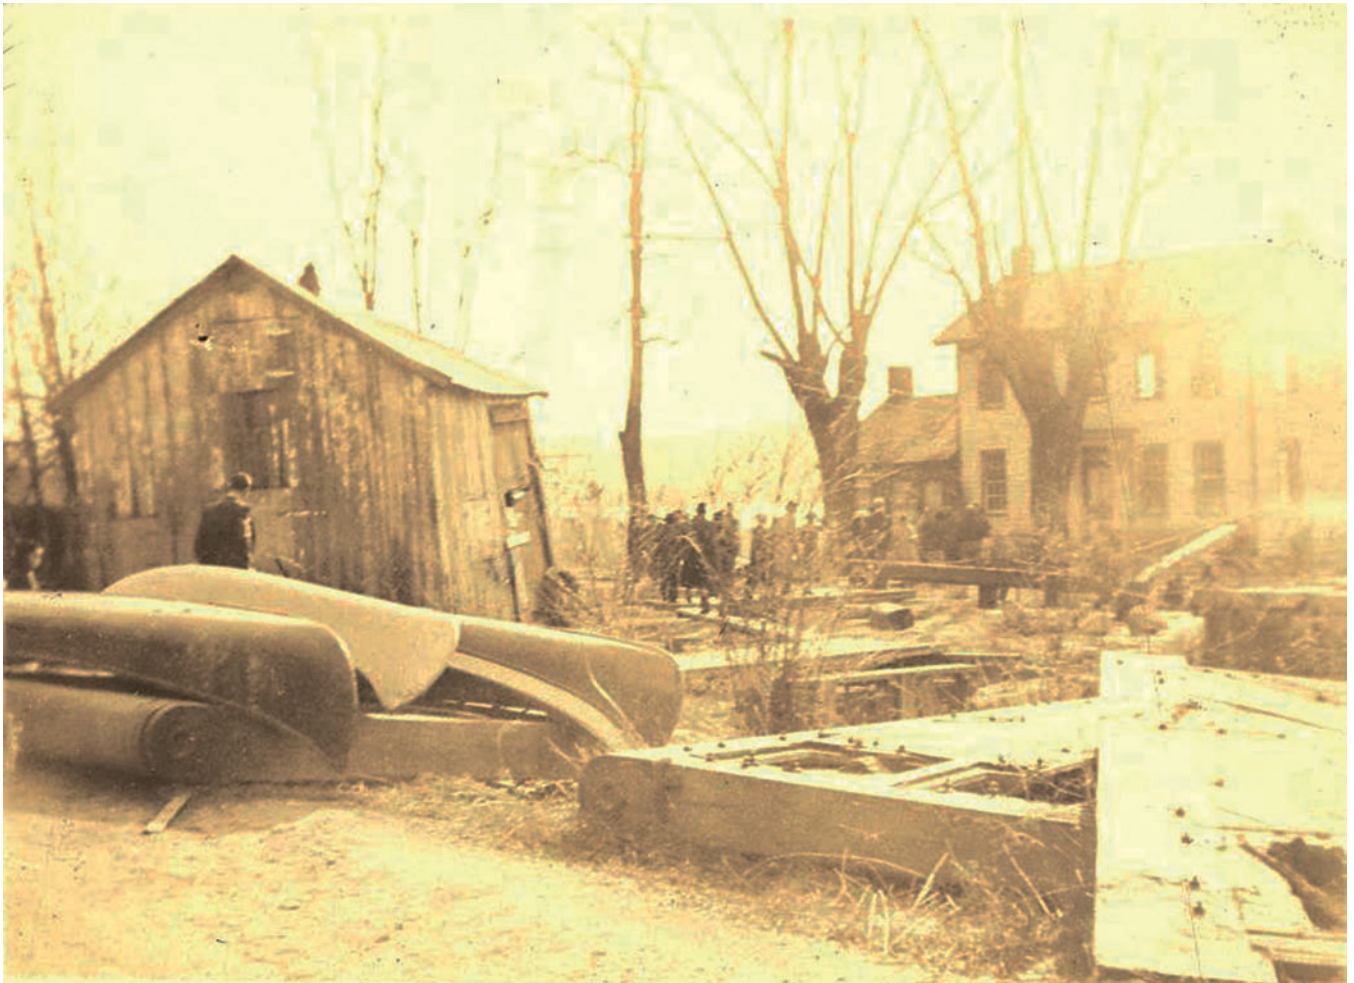
Figure 11. “Damage to Lock 44, Flood 1936.” Additional label. “Lock House after ’36 Flood, Wmsport, Md.,” L. B. Harsh Collection, CHOH 53663.15, C&O Canal NHP.

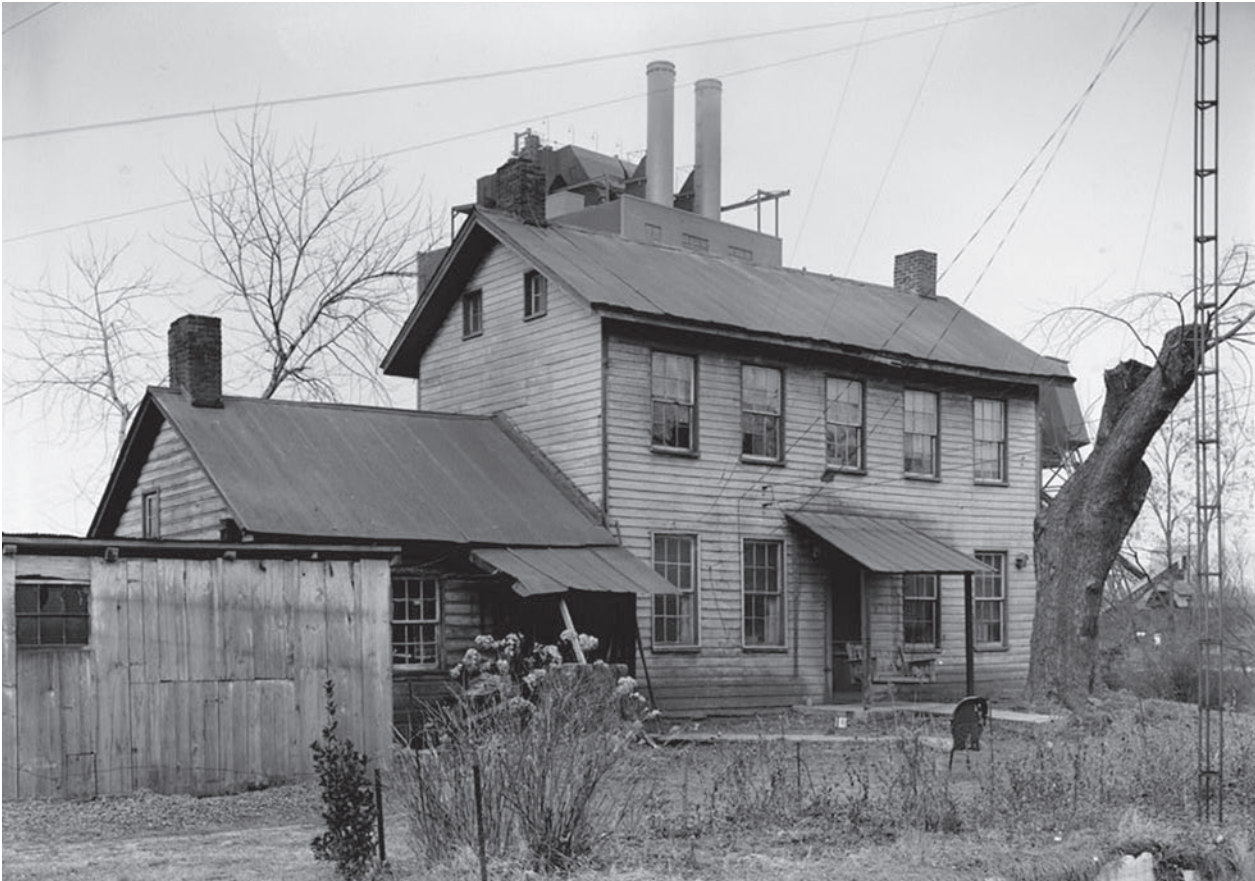
Figure 15. Lockhouse 44, “East (Main) and South Elevations,” 1960, Jack Boucher, photographer. HABS No. MD-786-1, Library of Congress. Note: North and east elevations. According to local and NPS convention, the canal runs west to east at Williamsport, so the front of the lockhouse faces north. The photographer who captioned the 1960 images based his captions on the canal running north to south.

The National Park Service documented the condition of Lockhouse 44 around the time the Brants moved out in 1961. As of 1960, condition was listed as “fair.” Figures 15, 16, and 17 are Historic American Buildings Survey (HABS) images recording the existing condition of the building. Figure 17 shows the enclosed porch the Brants used for household activities and storage, and figures 15 and 16 show porches at both doors on the north side of the house, fronting the canal. The images show a porch swing installed directly in front of the front door leading to the hallway, supporting Lula Brant Harsh’s statement that no one ever used the front door.²⁵

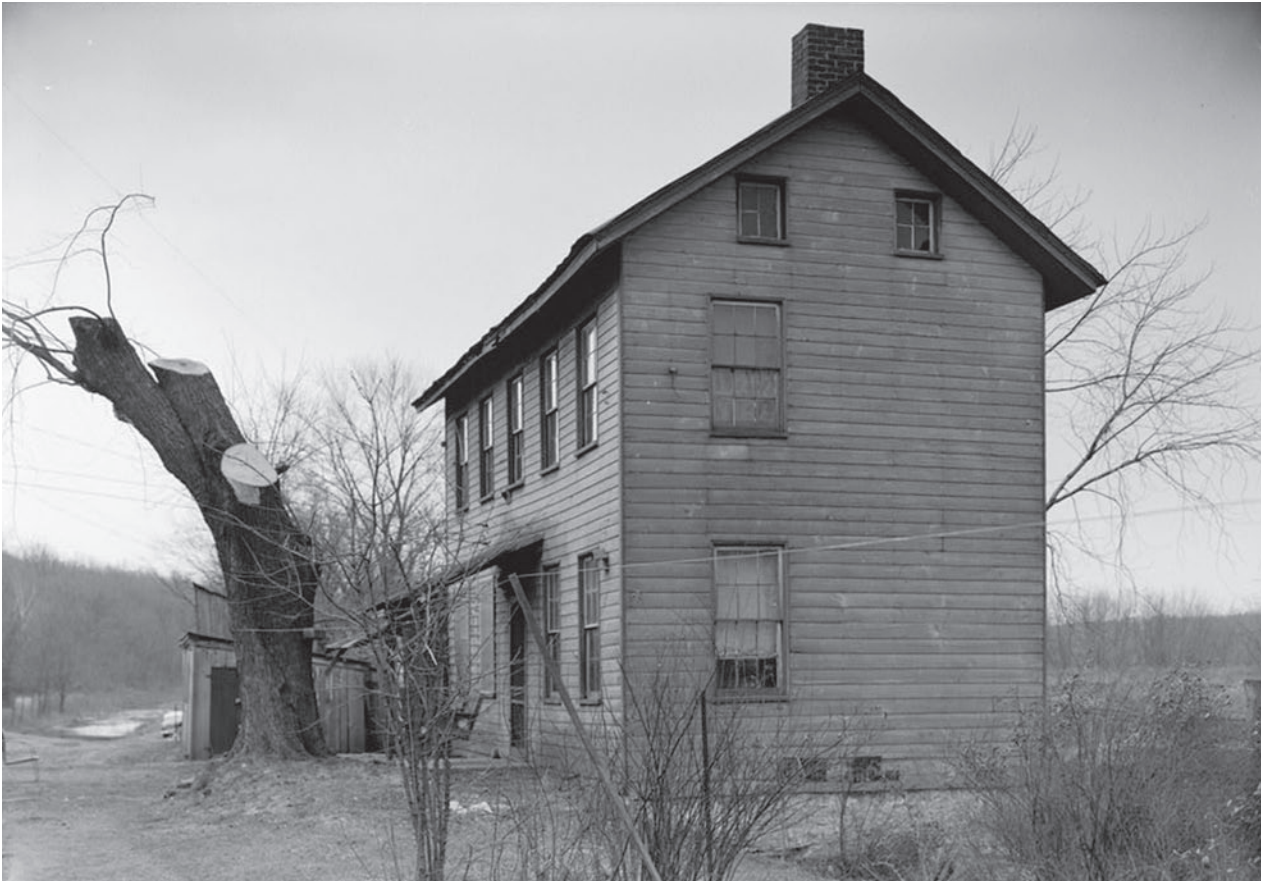
Figure 16. Lockhouse 44, “East (Main) and North Elevations,” 1960, Jack Boucher, photographer. HABS No. MD-786-2, Library of Congress. Note: West and north elevations.

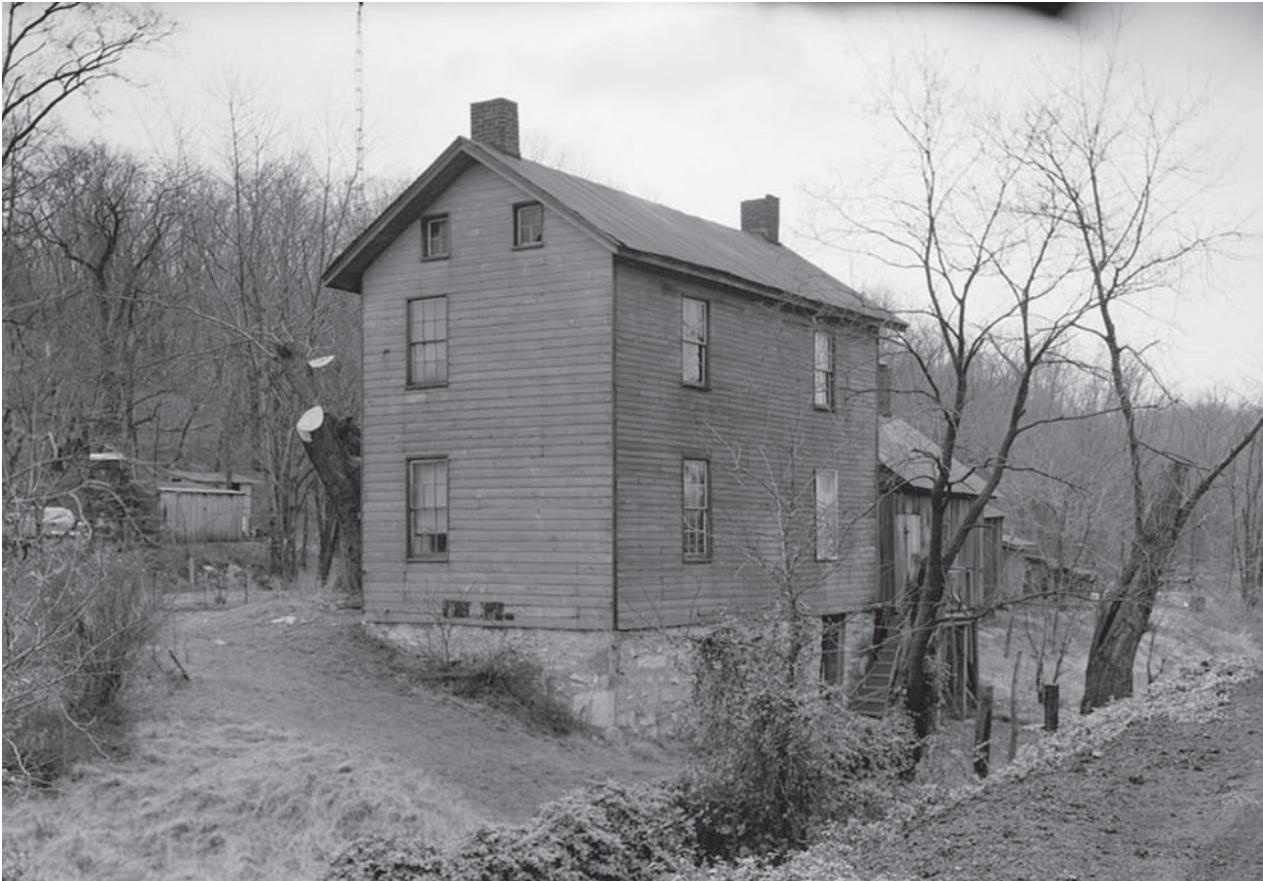
Figure 17. Lockhouse 44, “North and West (Rear) Elevations,” 1960, Jack Boucher, photographer. HABS No. MD-786-3, Library of Congress. Note: West and south elevations.

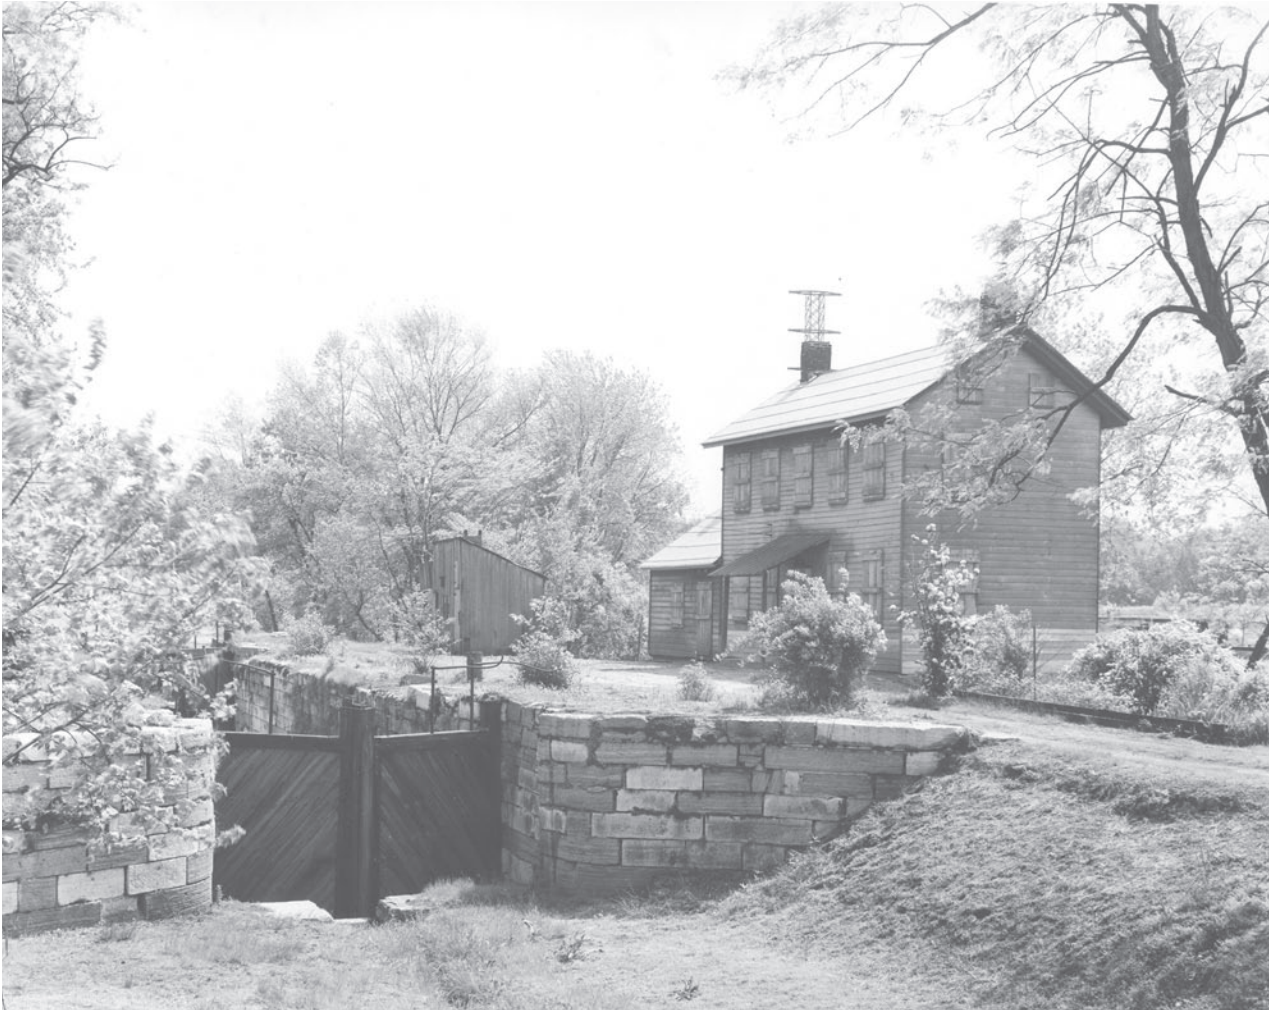
Figure 18. Lockhouse 44, northwest corner, during NPS ownership, C&O Canal NHP.

During the mid-1970s the house displayed many problems associated with frequent flooding—floors were warped, failing joists were propped, and interior plaster was crumbling in all rooms. The NPS replaced the tarpaper roof in kind in 1972, and painted gutters and down spouting in 1975 (figure 18).²⁶

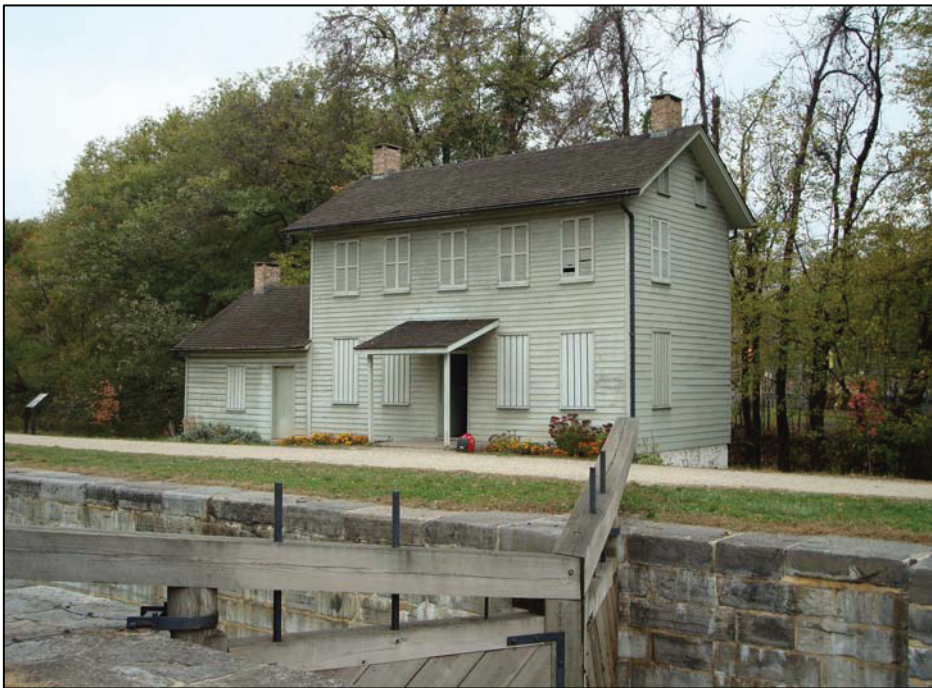
Lockhouse 44 –north and west elevations. Note Canal Lock 44 structure and granite retaining wall of canal in the foreground, October 2008.

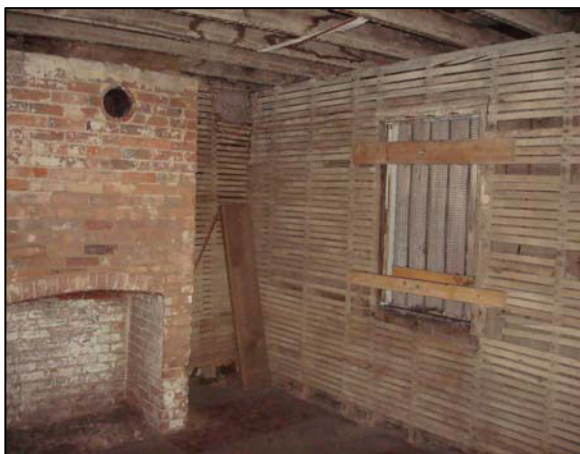
Room 101, kitchen, southeast corner featuring fireplace and W 1- 2.

Currently all that remains of the kitchen accouterments are a brick chimney on the east wall, exposed lath and the wood window trim on W 1- 1 (north wall). Missing from the room are the mantel, shelving, doors, window sash, window trim (W1- 2), all plaster (walls and ceiling), and flooring. The west wall of the kitchen is covered with the exposed exterior clapboards of the main block of the house suggesting that the kitchen may have been added after the construction of the main two- story structure. This west wall was never plastered. All exposed lath is circular sawn. A mix of round head wire nails and machine cut nails is evident in the kitchen.

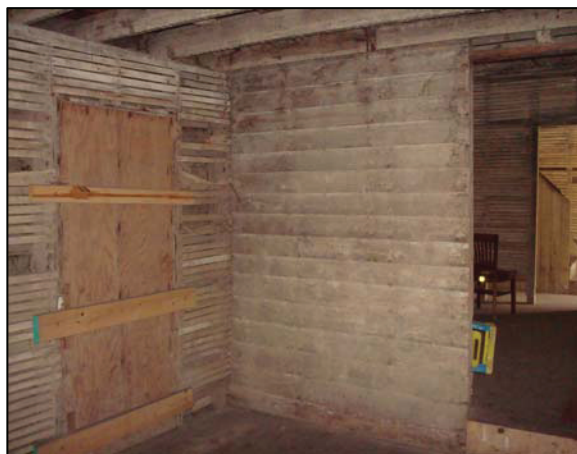
Room 101, kitchen, southwest corner. West wall featuring exterior clapboarding with exterior door (D1- 2) located to left.

Finish History. A brief examination of several paint samples revealed at least ten separate paint finishes applied over time in the kitchen. Although based on just samples removed from the trim of one window, examination under magnification suggests that the original trim color of the room was a **Rust Red** (*Munsell 10R 4/12*) over a white primer. A similar Rust Red paint was found on several elements in the hallway (Room 103). The Rust Red finish is not present on the window sill suggesting that the sill was damaged and replaced early in the history of the room. A distinct Dark Green paint over a Light Green primer was found following the Rust Red paint. The Dark Green layer of paint is present in all of the window trim samples. The remainder of the paint history of the kitchen is comprised of creams and whites. The south, east and north walls of the kitchen were plastered and may have been painted or papered. The west wall, covered in exposed exterior clapboards, appears to have remnants of a white wash finish. The

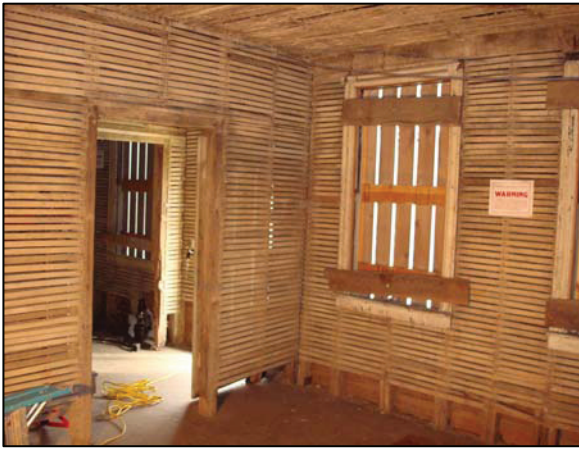
Room 102, dining room, northwest corner looking out through D 1- 4 into hallway. W1- 3 at right.

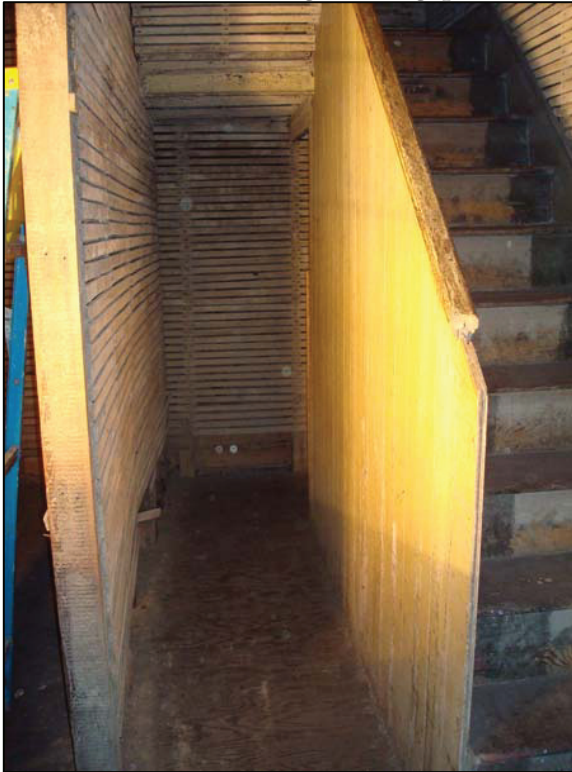
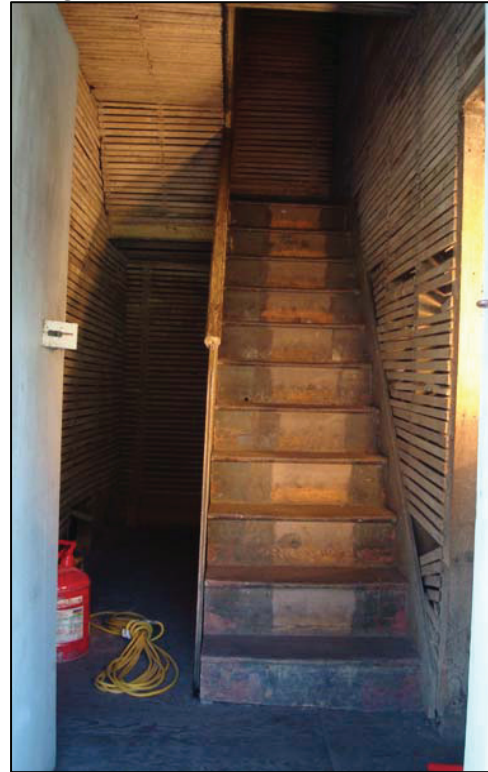
Room 103, hallway looking south towards rear of building. Note original bead board stair casing and stairs with clear ghost of former stair runner.

An early finish on the stair risers and treads is a rust red color, dull in finish; the stair casing and handrail were painted in a cream shade and varnished.³⁰ Appendix A, “Interior Paint

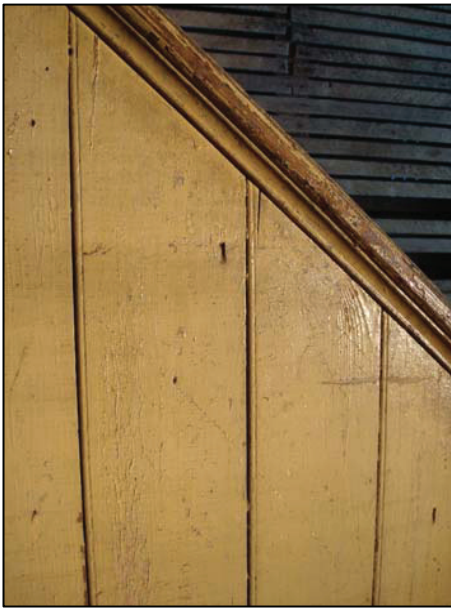
Room 103, hallway. Bead board stair casing and wood handrail viewed from first floor hall.

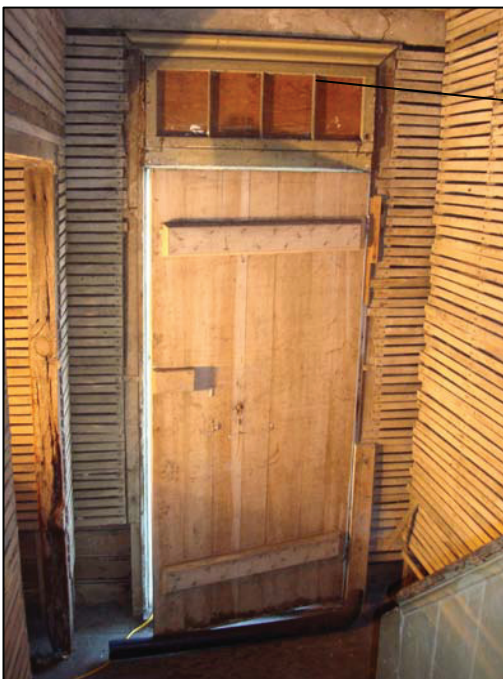
Room 103, hallway. Main entry door (D1- 5) and detail of four- light transom.

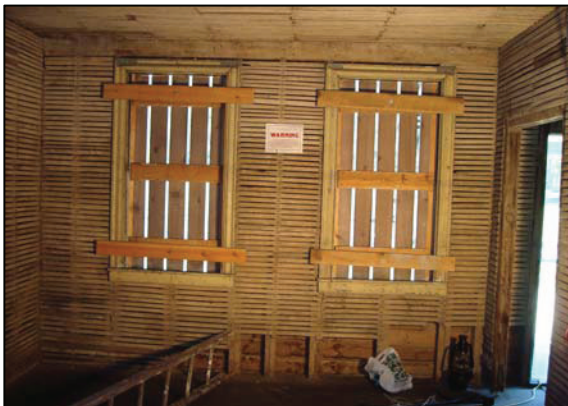
Room 104, parlor, north wall, W 1- 6 and W1- 7. Door to Hallway (D1- 7) visible at right.

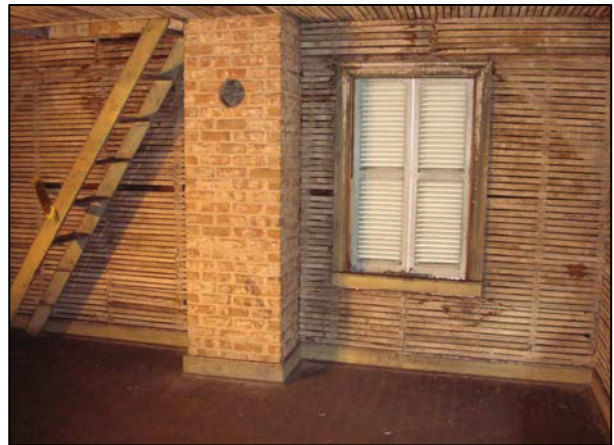
Room 202, bedroom, west wall. Note ladder to attic, chimney and baseboard.

Finish History. Paint is found on window trim, door trim, and baseboard, as well as on the ladder and trapdoor to the attic. Samples under magnification exhibit no more than five finish layers. The original finish on window and door trim appears to be White Cream (*Munsell 10YR 9/1*). This cream color is slightly lighter than the cream paint found in Rooms 102, 103, and 104 with none of the red orange pigments seen in the original cream finish on the first floor. The cream paint of Room 202 matches the original cream paint of Room 201. Baseboards represent

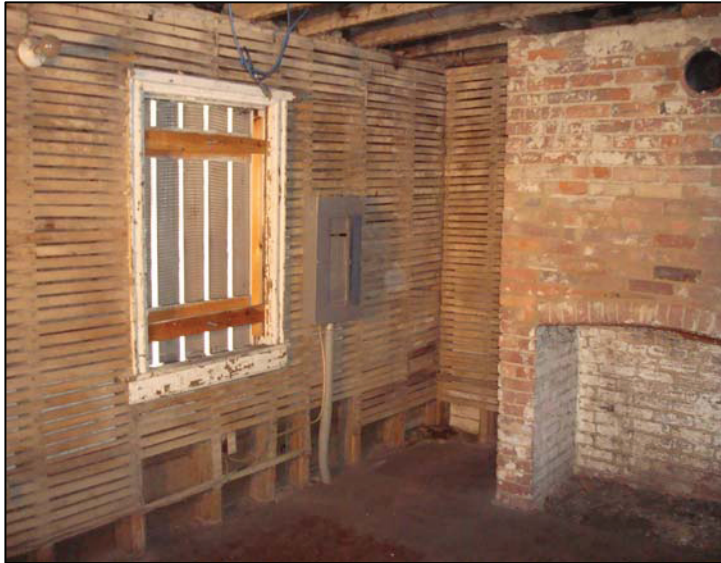
Room 101, kitchen, northeast corner, W 1- 1 and brick fireplace visible.

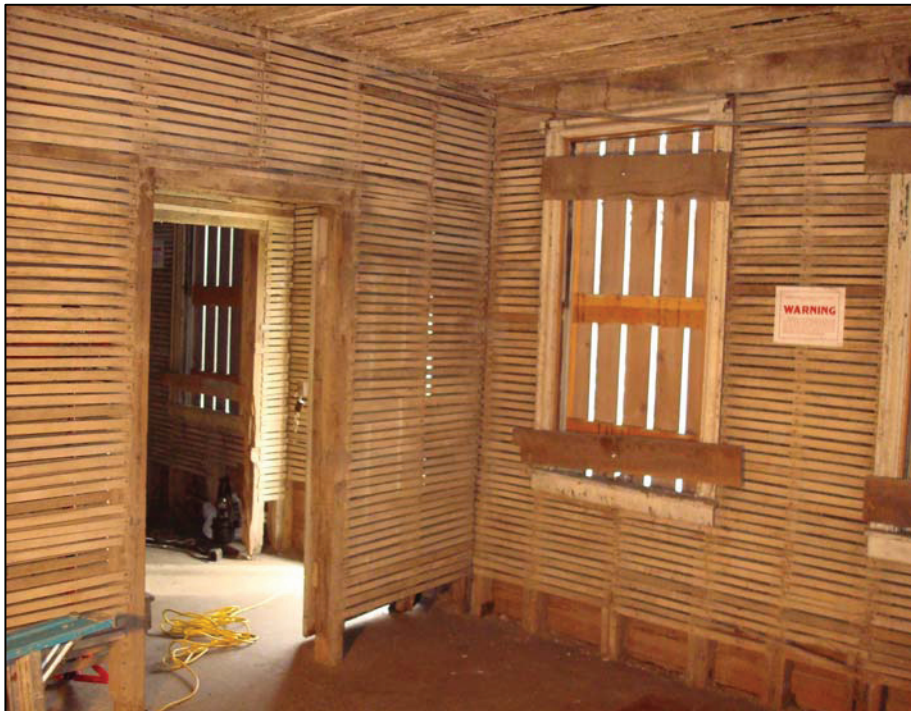
*Room 102, dining room,
northwest corner with D 1- 4 and
W 1- 4 visible.*

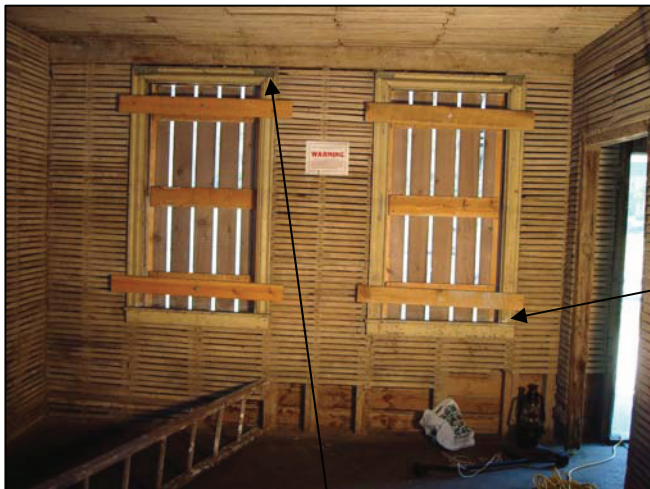
Room 104, parlor. Left- : North wall, W 1- 6 and W 1- 7 and D 1- 7 into hallway. Above right- detail of W1- 6 At left- Detail of W 1- 7.
