**CHAPTER 4:  
NPS MANAGEMENT AND EXISTING  
CONDITIONS, 1970–2005**

**SUMMARY OF LANDSCAPE CHANGES AND EXISTING CONDITIONS**

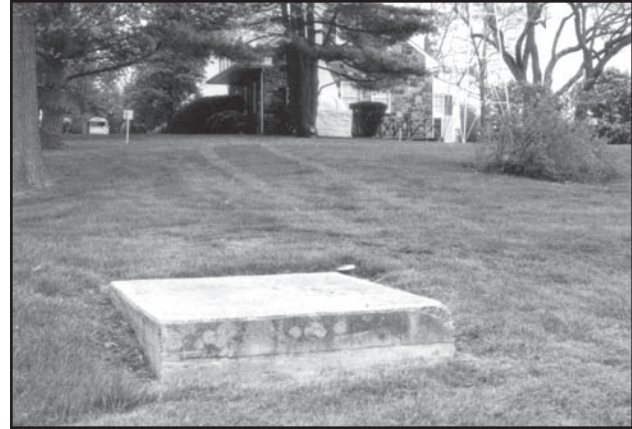
Figure 4.2. Detail of concrete pad where south guardhouse had been on Farm #1. (Photo by OCLP, 2002)

In the late 1980s, the south guardhouse built in the 1970s was removed. This guardhouse was significantly larger than the 1950s guardhouse located south of the house. A new larger foundation for the 1970s guardhouse was built incorporating the concrete pad of the 1950s guardhouse. When the 1970s guardhouse was removed, only the concrete pad of the 1950s guardhouse remained to mark the location of this structure. The 1970s guardhouse was not extant during the donation of the farm in 1967 and did not fit within the period of significance. (fig. 4.2)

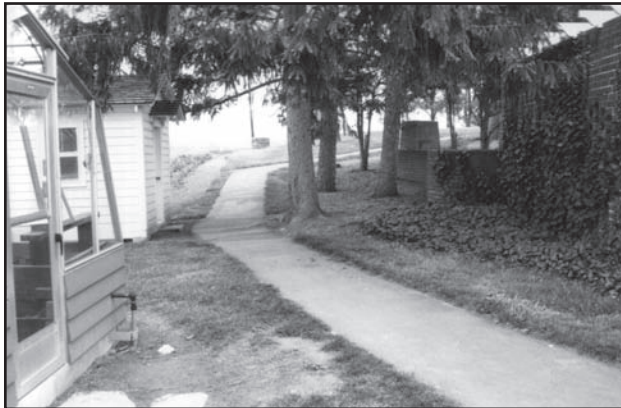
Figure 4.3. Detail of asphalt path from house to greenhouses on Farm #1. (Photo by OCLP, 2002)

Several walkways were added to Farm #1 in the 1970s and 1980s. A short asphalt path was installed between the driveway parking area, south of the house, and the greenhouses, providing easier access for visitors. A brick walkway installed by the NPS below the terrace surrounded the rose beds. In the early 1990s, the outside walk of this feature was removed and the slope was never regraded properly. The sand and brick walkway from the barbecue to the terrace was replaced with a concrete base and brick and mortar surface. Stairs were also added as the walk approached the terrace. A macadam path was installed in the northern lawn, just in front of the planted area between the barn and house. This was added to connect the driveway near the guesthouse to the pathway between the northern end of the rear terrace

and the barn, allowing visitor wheelchair access from the front to rear landscape of the house. An asphalt path was installed along the eastern side of the barn, next to the Adenauer Rose Garden. Additionally, most of the parking area north of the barn, which had previously been surfaced in gravel, was resurfaced with asphalt by the Secret Service in the 1970s and have been resurfaced several times since then. (figs. 4.3-4.6)

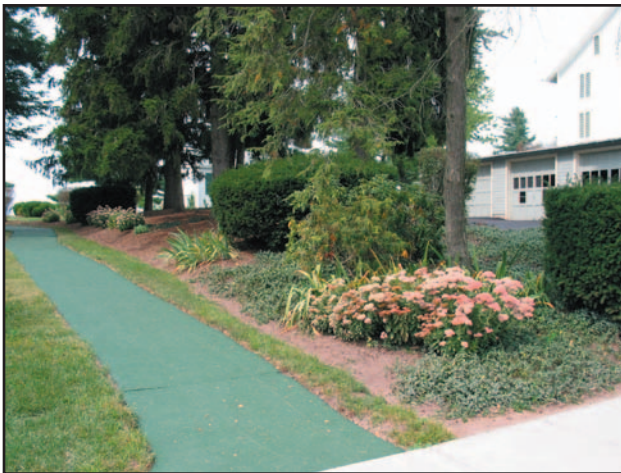
Figure 4.5. Detail of asphalt path north of house, (Photo by OCLP, 2005)

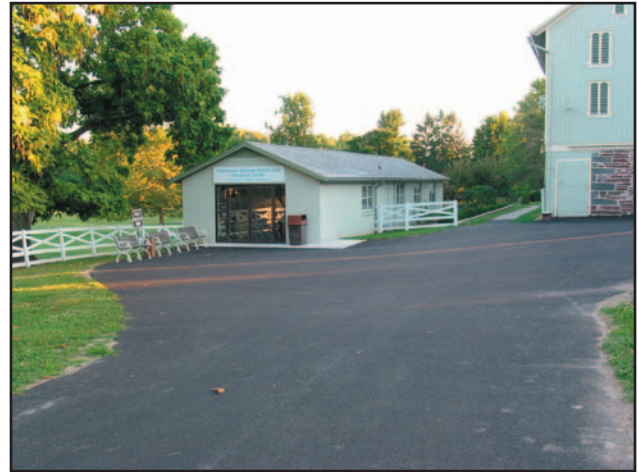
Figure 4.6. The former shale yard at Farm #1 north of the barn is now a paved parking area. (Photo by OCLP, 2005)

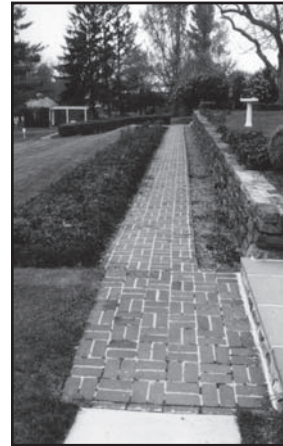
Figure 4.4. Detail brick path adjacent to rear terrace retaining wall on Farm #1. (Photo by OCLP, 2002)

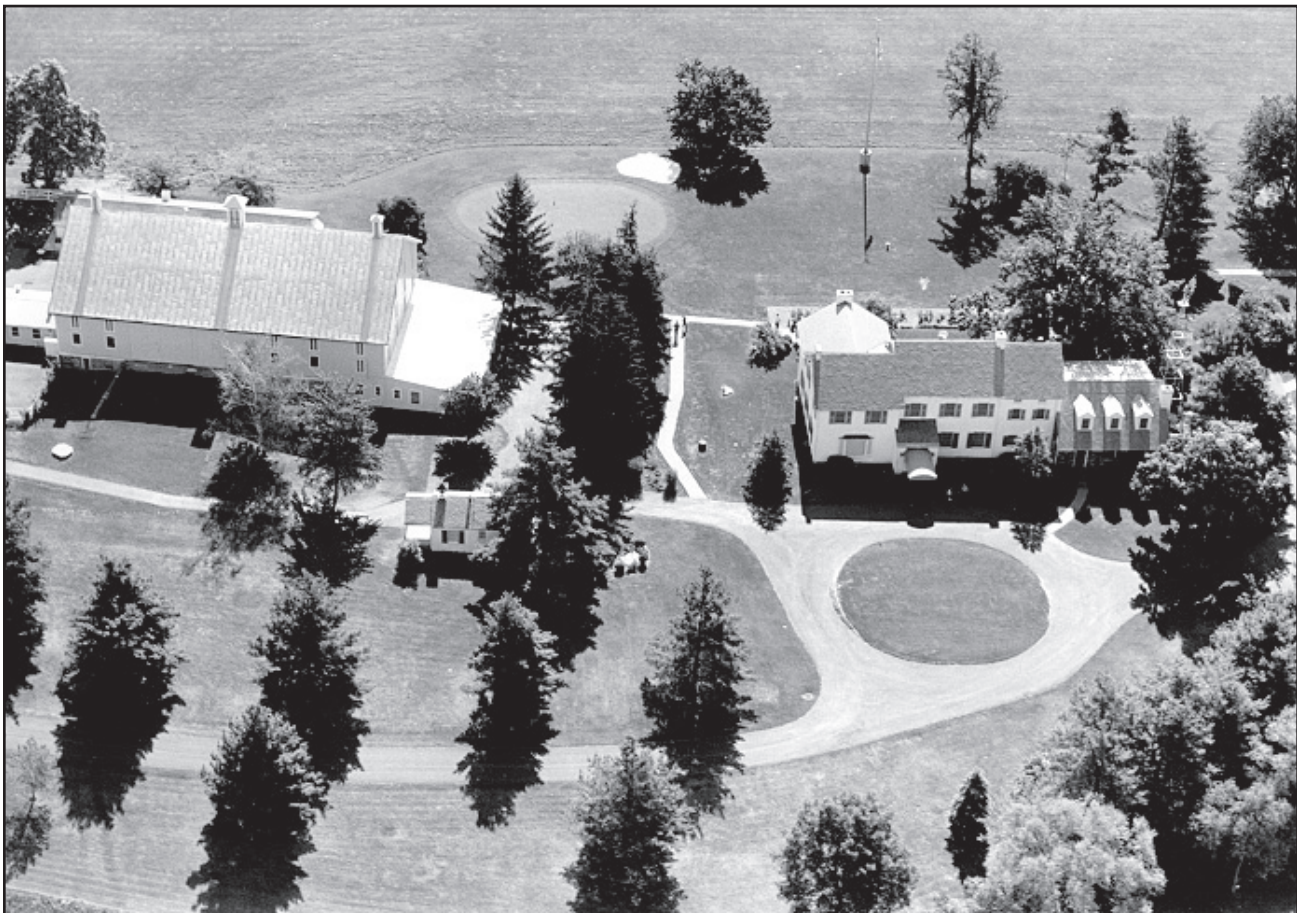
Figure 4.9. Aerial of Farm #1 from west, historic trees missing include black locusts from front lawn circle, elm in north lawn, and two green ash from rear terrace, ca. 1982. (EISE NHS files, #3590)

Several of these missing trees were some of the most historically important specimens on the site. Two of the three green ash trees to the rear of the home had been lost and were replaced in 1980. These trees were

especially important to Mrs. Eisenhower. They were mentioned as two of the features initially attracting her to the house and farm. Additionally, the two black locusts planted in the circle of lawn in front of the home had died and were replaced with trees from the battlefield in the 1980s. However only the south tree grew. In 1990, Scottish Heritage USA and the National Trust for Scotland replaced the north black locust as well as three cherry trees south of the home, and replanted the shrubs and flowers in the flower bed located between the house and barn. All of these trees had predated the Eisenhowers' and were associated with the early Redding years on Farm #1. The American elm north of the house was another important tree that was no longer extant by the early 1980s. This tree had been a replacement for the original elm donated by Rockefeller and was installed after the first tree had succumbed to Dutch Elm Disease. (figs. 4.9, 4.10) A Japanese zelkova was planted north of the home as a replacement for the elm. (fig. 4.11)

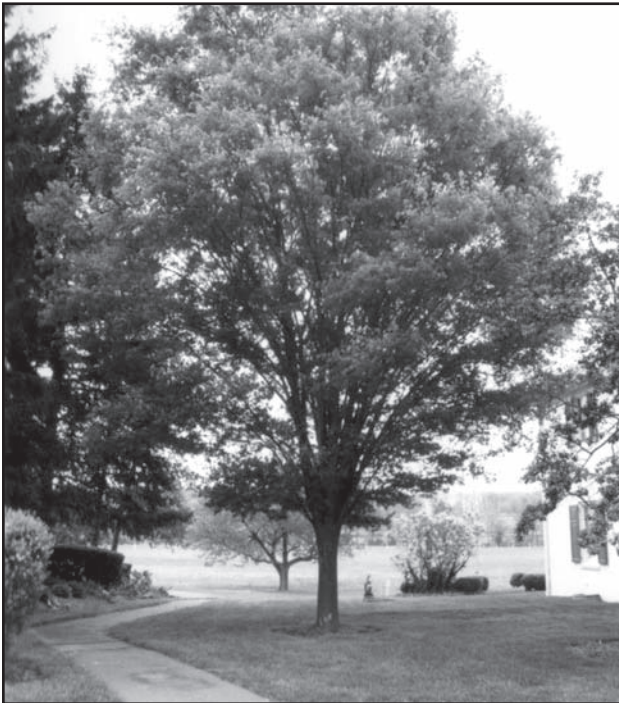
Figure 4.11. Japanese zelkova planted in the north lawn as a replacement for the American elm. (Photo by OCLP, 2002)

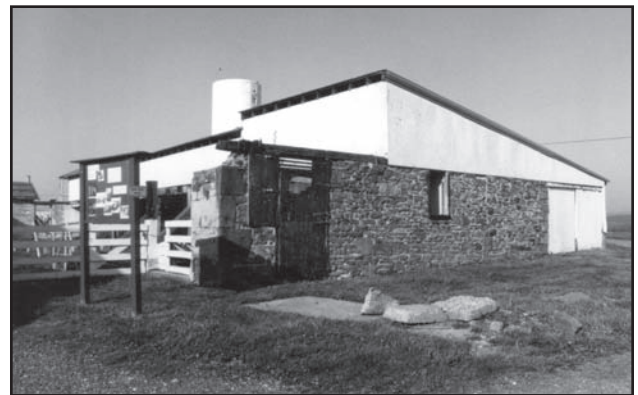
Figure 4.12. Remains of bank barn on Farm #2. (Photo by OCLP, 2002)

The most significant change to the farm occurred in 1993. An accidental fire led to the loss of 100-year-old Bank Barn. After the fire, the foundation of the building was left intact and a supporting structure was installed to prevent further deterioration of the remaining walls.<sup>9</sup> (fig. 4.12)

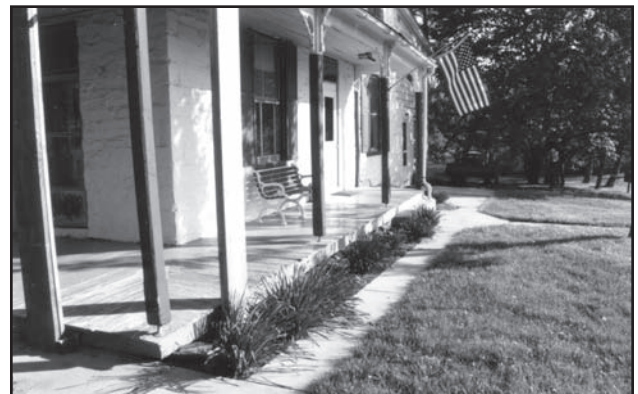
Figure 4.13. Detail of the vegetation around on the porch of the Farm #2 farmhouse. (Photo by OCLP, 2002)

Although several mature shade trees, both deciduous and evergreen, remain around the farmhouse, some of the individual trees present in the late 1960s have died and have been removed. As a result, the eastern side of the farmhouse is not as heavily screened from view as it once had been. Around the front porch, only a few stumps

remain to mark the previous locations of ornamental shrubs. (fig. 4.13)

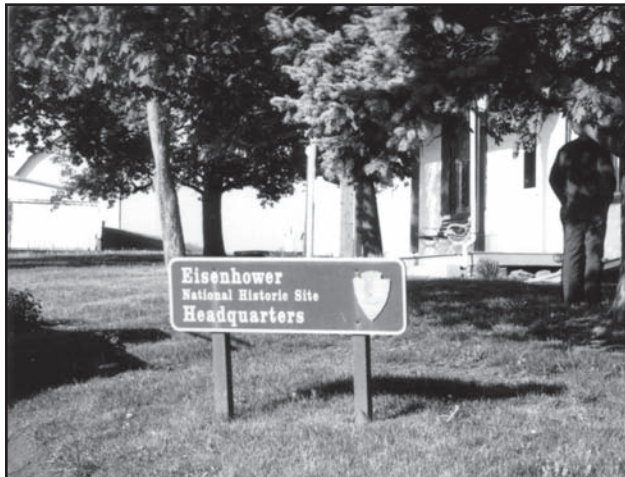
Figure 4.14. Detail of National Park Service signage on Farm #2. (Photo by OCLP, 2002)

As with Farm #1, a few additions were made to Farm #2 to accommodate visitor usage. Interpretive signage was installed at the Show Barn to correspond with the self-guided walking tour. Another sign was placed at the northeast corner of the Bank Barn foundation to interpret the building as it had been before the fire. Other standard NPS signage was placed along the entry drive and in front of the farmhouse identifying the offices of the Eisenhower NHS. (fig. 4.14)

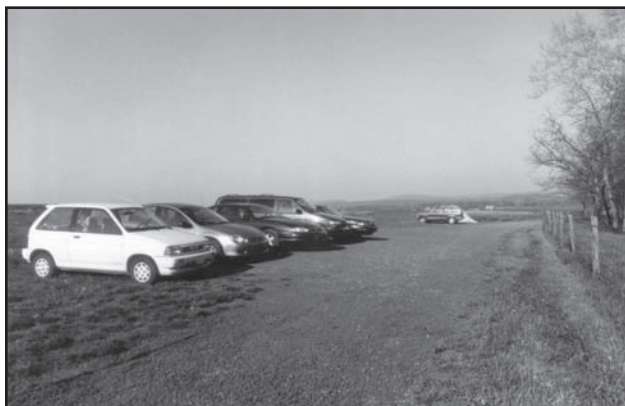
Figure 4.15. Employee parking lot on Farm #2. (Photo by OCLP, 2002)

In the early 1980s, a gravel parking lot was installed on the historic road trace northwest of the farmhouse. Located along the border with Farm #1, this lot was intended primarily for park employees. Access to the lot was from Emmitsburg Road until the site reorganized and the gate to the Red Rock Road was unlocked and opened. (fig. 4.15)

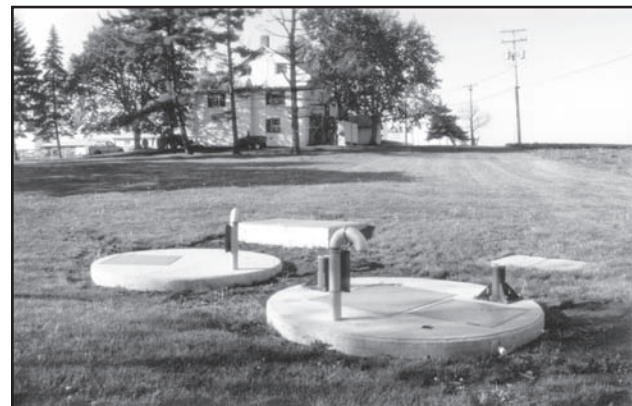
Figure 4.16. Detail of new septic system installed on Farm #2. (Photo by OCLP, 2002)

In 1999, a new septic system was installed to accommodate the needs of both Farm #1 and Farm #2. The concrete tanks for this system were placed on Farm #2, just east of the employee parking lot, directly across from the stream crossing between the farms. The tanks are below ground with three concrete pads exposed above grade. Ventilation pipes and mechanical access panels are located on these pads. (fig. 4.16) A new post and wire fence was installed along the stream and was a

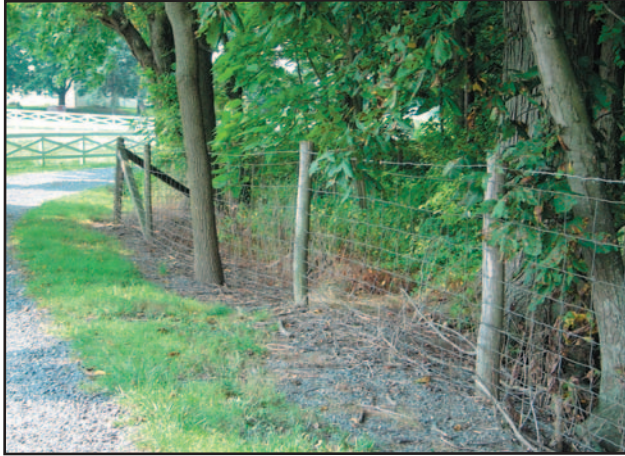
Figure 4.17. Detail of new (replacement-in-kind) post and wire fencing installed between Farm #1 and Farm #2. (Photo by Carol Hegeman)

replacement-in-kind for a fence that had just been removed. The new section of fence starts at the stream crossing and proceeds east along the stream until it reaches Nevins Lane. (fig. 4.17)

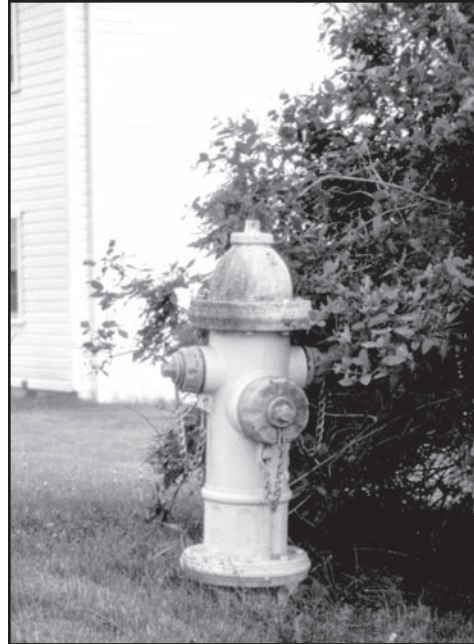
Figure 4.18. Fire hydrant near the Farm #3 farmhouse. (Photo by OCLP, 2002)

After Herb Dixon moved from Farm #3 in the 1970s, the farmhouse was leased to a tenant farmer. Later, it was converted into government housing and is currently used for park staff.<sup>10</sup> The other farm buildings have consistently been used by the permittees in the agricultural operations. No significant modifications have been made to these structures or the adjoining corrals and fences, however a few changes were made to the farm's utilities. A fire hydrant was placed along the entry drive. It is not known when this was installed. In 1999 a new septic system was added to the site to service the farmhouse. The concrete tank was located on the north side of the house and was completely buried under the sod. (figs. 4.18, 4.19)

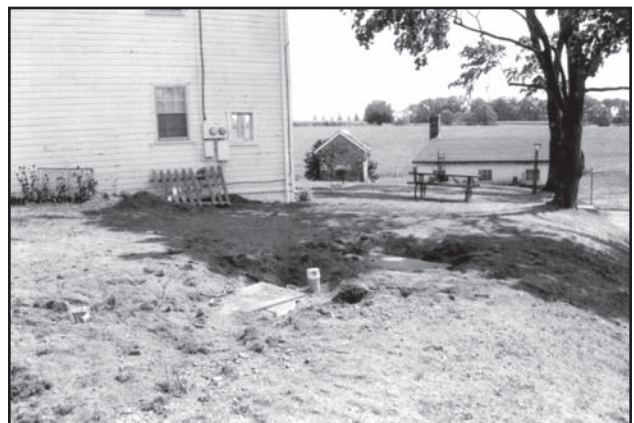
Figure 4.19. Septic tanks north of the Farm #3 farmhouse. (Photo by OCLP, 2002)

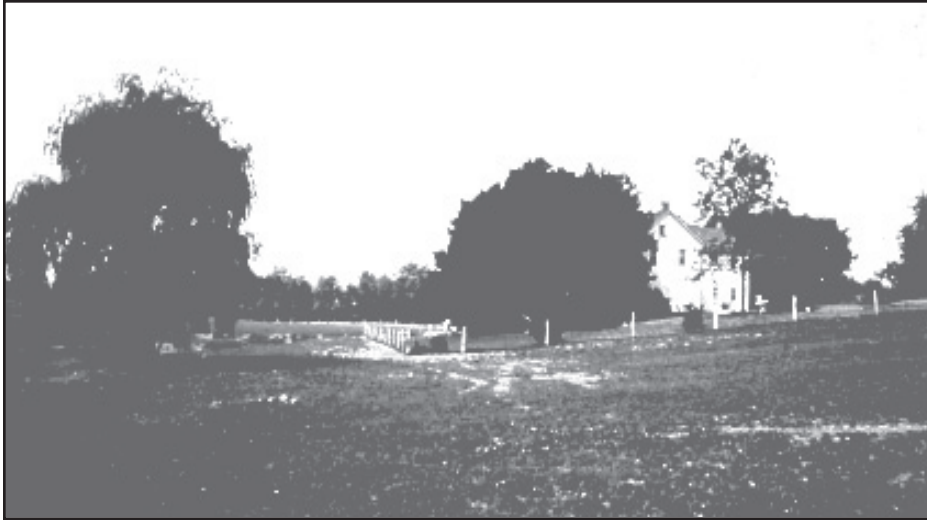
Figure 4.20. Farm #3 trees shown in this late 1960s photo are no longer extant, including trees adjacent to the farmhouse and trees in the field, view toward the west, May 1969. (W. E. Dutton, EISE NHS files)

on the site for a longer period. By 1999, a few old stumps around the smokehouse and garage were the only remains of some of the original trees, while the remaining trees provided a shady canopy for the farmhouse. In the late 1960s, there were also two large trees located in the pastures south of the farmhouse along a drainage swale. One of these had died by 1969, but was left standing in the field. The other tree survived until at least the mid-1970s.<sup>11</sup> Both trees had been removed by early 1999. (figs. 4.20, 4.21)

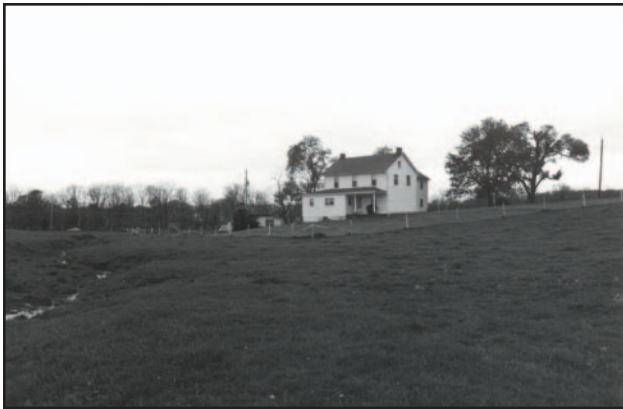
Figure 4.21. Farm #3 western view without the trees that were extant in the late 1960s. (Photo by OCLP, 2002)

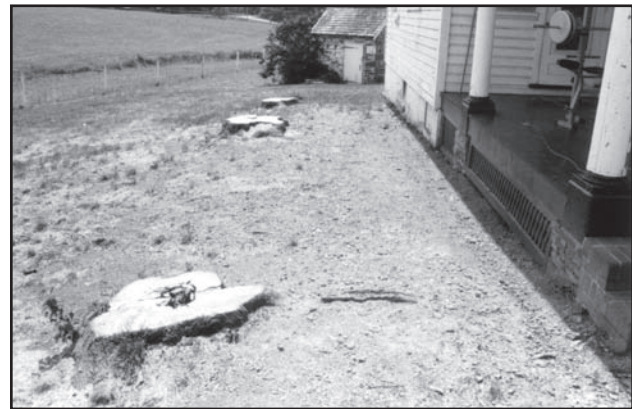
Figure 4.22. Stumps remain to mark the location of removed trees south of the Farm #3 farmhouse. (Photo by OCLP, 2002)

In August 1999, the farmhouse's tree canopy was reduced by half when five mature deciduous shade trees were removed. Three of these trees were located on the home's southern side, and two were adjacent to the farm

lane north of the house. Given their size, it is likely that these trees dated from the 1950s or earlier. Five mature trees remain on the site around the farmhouse, possibly dating to the early 1960s. (fig. 4.22)

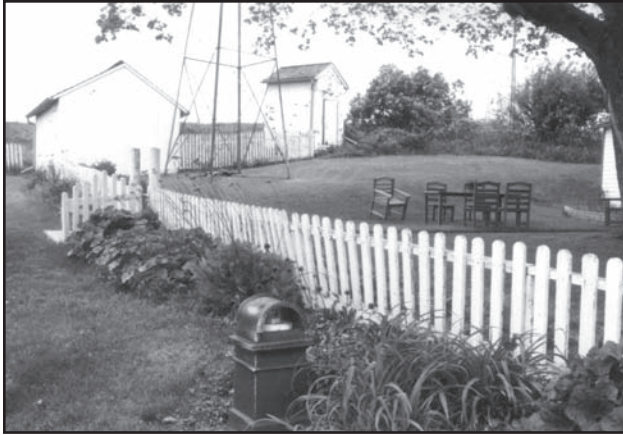
Figure 4.29. Miscellaneous annuals and perennials along the picket fence at the Clement Redding Farm. (Photo by OCLP, 2002)

removed from the front of the farmhouse in 1996. Other existing vegetation around the farmhouse includes small flowerbeds along the home's south and east foundations, another bed on the south edge of the lawn, and various shrubs along the fences on the northern and western edges of the lawn. (figs. 4.29, 4.30)

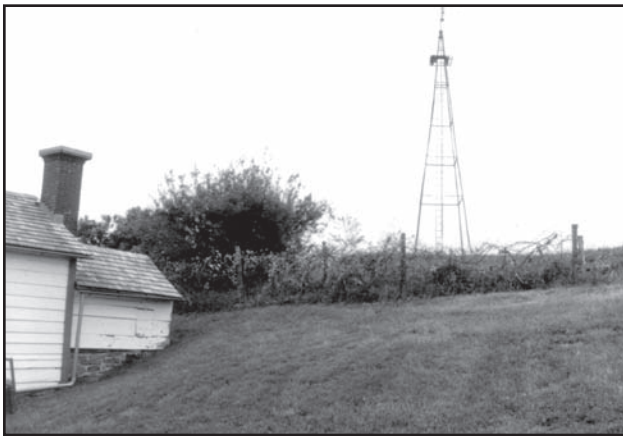
Figure 4.30. A steep hill and a row of shrubs separate the yard and the windmill. (Photo by OCLP, 2002)

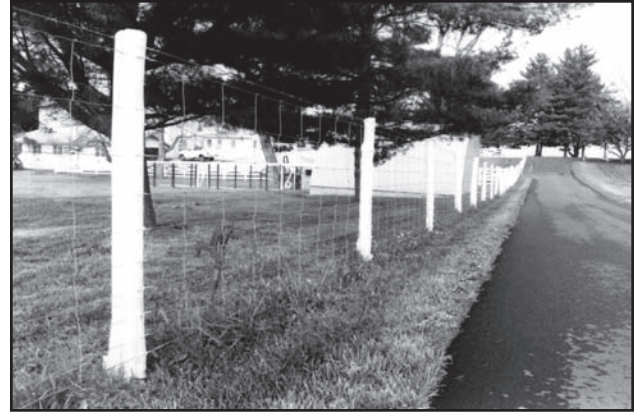
Figure 4.31. New style of electric fencing on Farm #1. (Photo by OCLP, 2002)

A new style of electric fencing was added to Farm #1 in the eastern pasture along the boundary with Biesecker Woods. This fencing consists of round wooden posts with five strands of electrified wire. It was installed in the early to mid-1990s to replace the concrete and pipe government boundary fence. (figs. 4.31, 4.32)

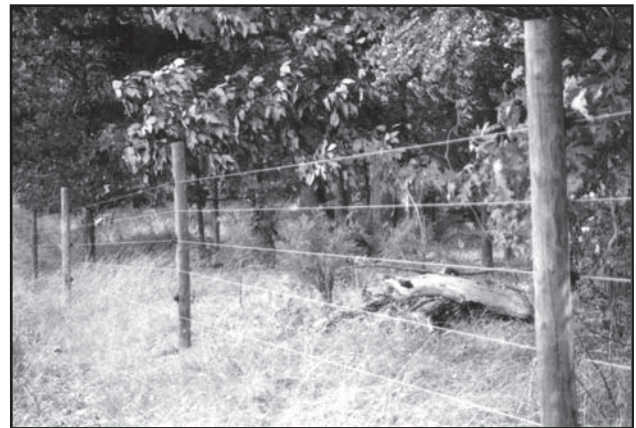
Figure 4.32. Electric fencing on Farm #1. (Photo by OCLP, 2002)
