# Cultural Landscape Report for Fort Baker Golden Gate National Recreation Area

## Golden Gate National Recreation Area

Fort Baker, Barry and Cronkhite Historic District  
Marin County, California

July 2005

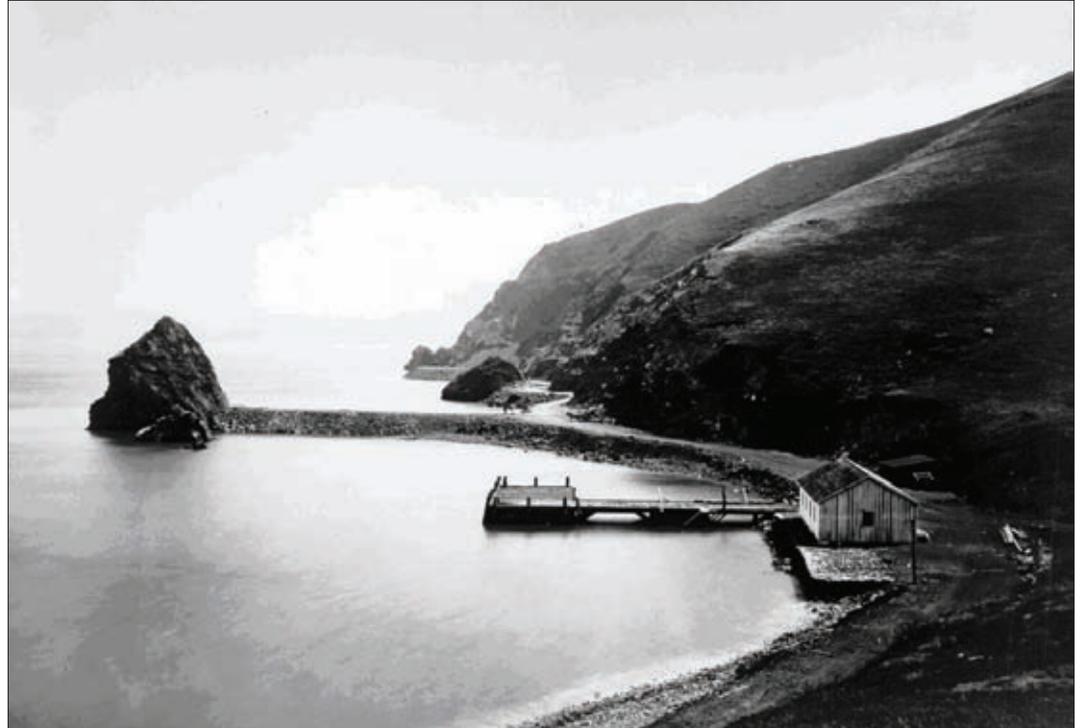
SH1 Engineer Wharf on lee side of Needles breakwater, near west end of Horseshoe Cove, looking west. 1868 (National Archives and Record Center, RG #77-F-100-140).

some protection to the cove from the currents of the open bay. Within this protected area, a small wharf was constructed which had a sixty-foot front of crib work covered with plank. (Photo SH1) Supplies and materials were barged in from San Francisco and unloaded at the wharf, and a steamer was used to transport personnel.<sup>15</sup>

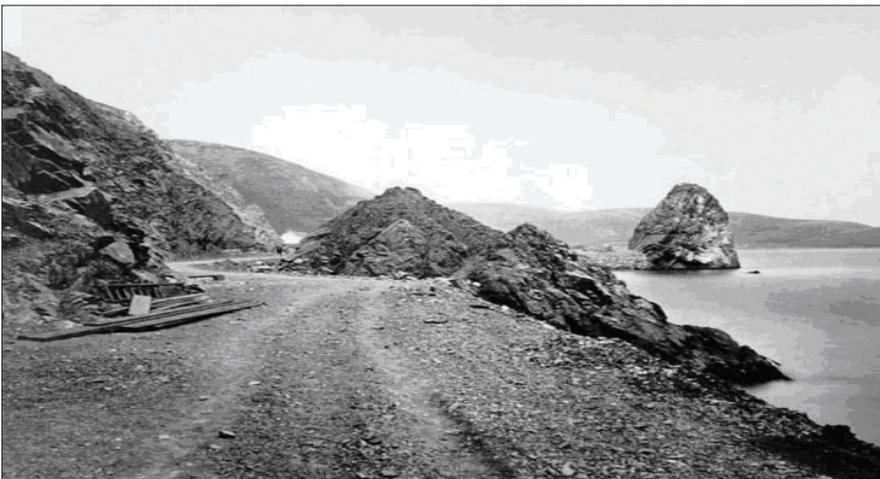
SH2 Road from Engineer Wharf to Engineer Camp, looking east. 1860 (National Archives and Record Center, RG #77-F-100-146).

Upon completion of the wharf, a road was built from its base to Engineer's Camp. The road was benched into the foot of the cliff, and when it was completed it was "passable throughout its entire length by carts." (Photo SH 2) This road was the origin of the current road that leads to the end of Lime Point, now known as Moore Road.<sup>16</sup>

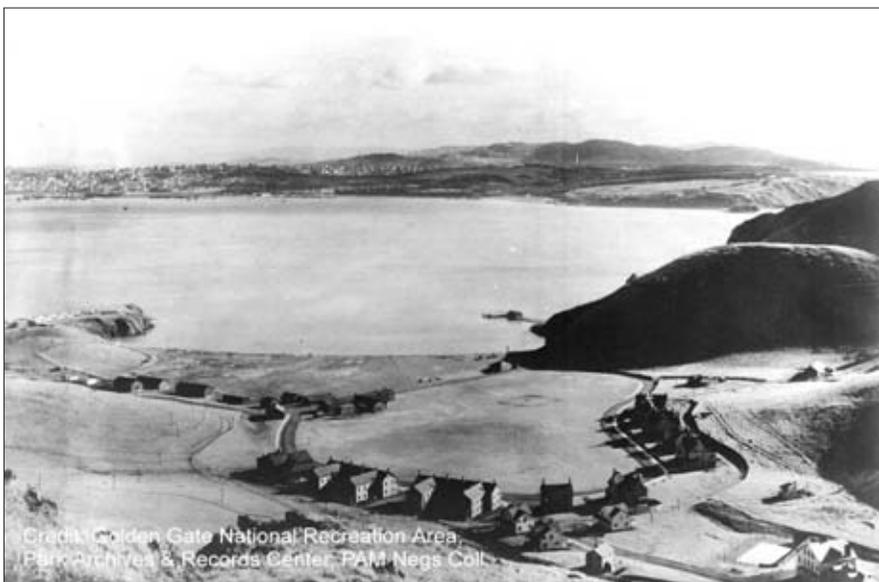
**SH4 Parade ground and Murray Circle. Note extent of cut required for construction of the parade ground and preparation of building site. Looking south. Circa 1905 (GGNRA Park Archives and Record Center, 40039.014).**

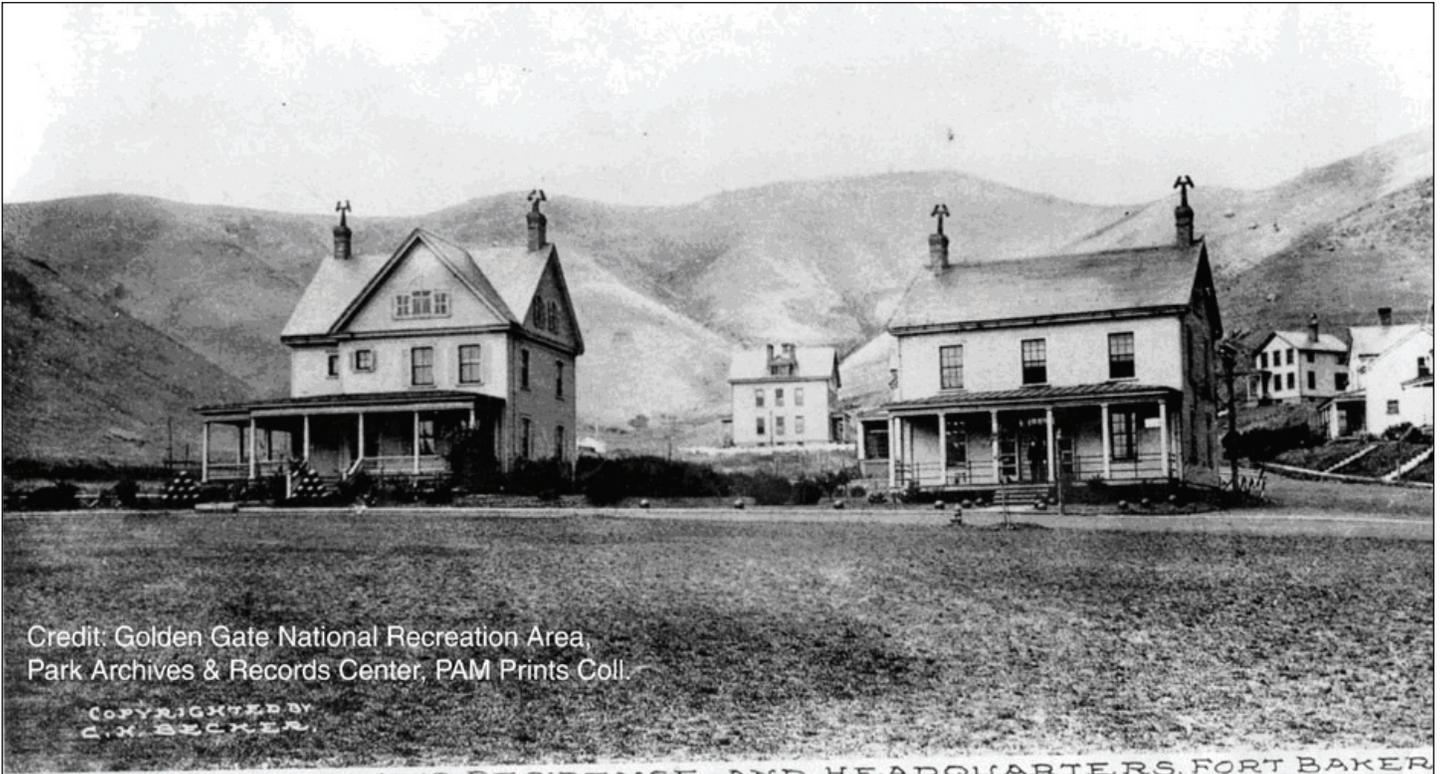
SH5 Cannonballs were used as decorative site furnishings at the commanding officer's residence and the administration building, looking north. Circa 1905 (GGNRA Park Archives and Record Center, 1766).

officer's residence was set apart from the adjoining buildings by side yards that were roughly twice the width of the space between the officers' quarters and barracks. In addition, the forty-foot drop in elevation created by the northwest-southeast slope of the valley created a building hierarchy. The commanding officer's residence was sited in a prominent location at the highest point of Murray Circle, from which a distant view toward Horseshoe Cove, San Francisco Bay, and the city of San Francisco could be obtained. The commanding officer's residence was embellished with special site furnishings. Stacked cannonballs flanked the walkway to the building's front porch, and single cannonballs were aligned along the sidewalk between the residence and the administration building, providing a symbolic connection between the two most important buildings fronting the parade ground. (Photo SH5)

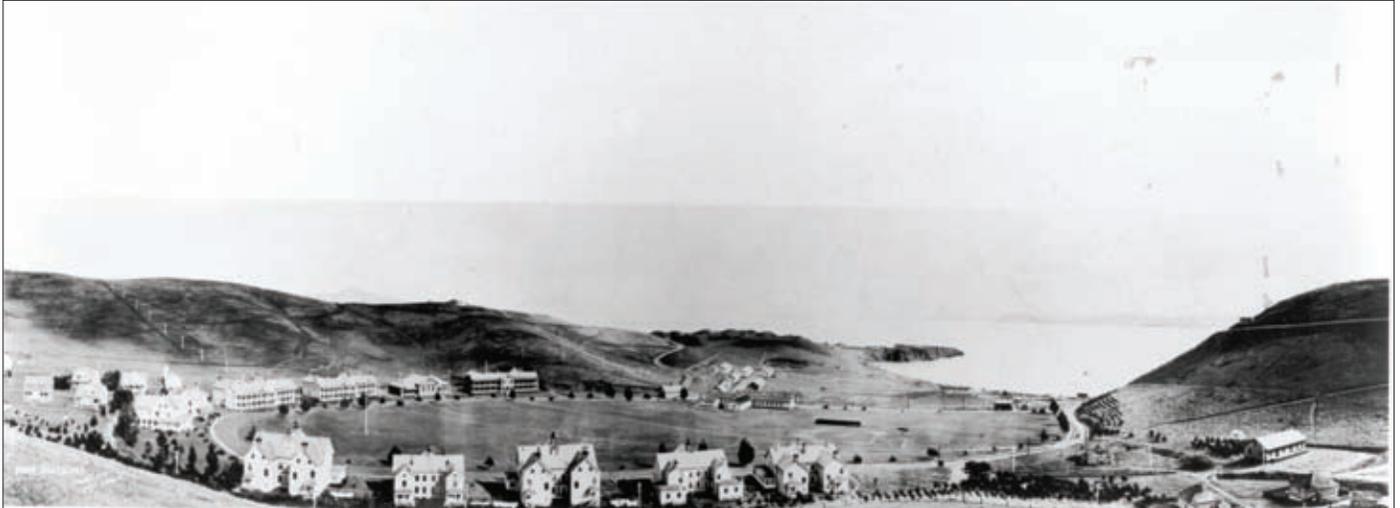
SH8 An early view of the windbreak and parade ground tree plantings, looking southeast. Circa 1909 (San Francisco History Center, San Francisco Public Library, Negative 6453.).

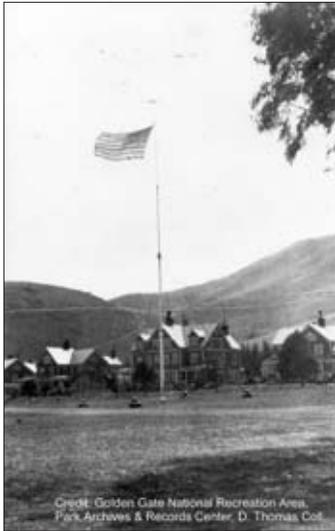
**SH10** The post flagstaff was sited near the head of the parade ground with cannonballs as decorative furnishings. Looking north. 1915 (GGNRA Park Archives and Record Center, 3311.008).

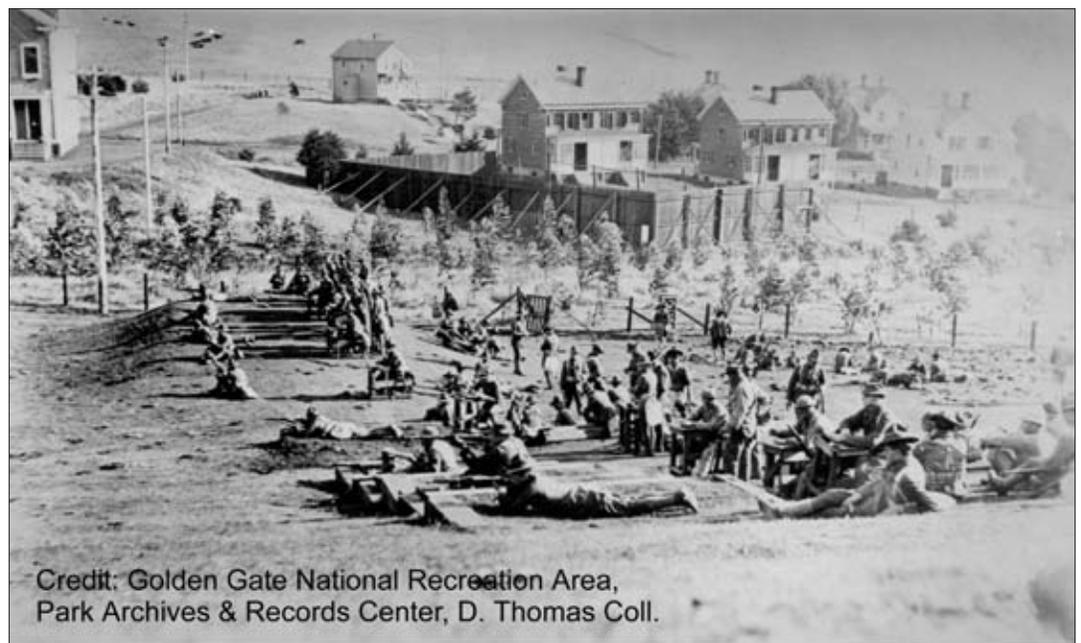
**SH11** The tennis court was built south of the hospital on Kober Street, shown here enclosed by a plank fence with the fort firing range in the foreground. Note spacing of eucalyptus windbreak, looking southeast. Circa 1915 (GGNRA Park Archives and Record Center, 3311.006).

In 1909, two non-commissioned officers' duplex residences, FB530 and FB531, were constructed on the southwest side of Kober Street, opposite two other non-commissioned officers' duplexes, FB523 and FB527, which had been built in 1902. In 1909, a tennis court was built in a small bowl between FB531 and the hospital. A photo from circa 1915 shows a wood fence surrounding the court. This photograph also shows the original spacing of the eucalyptus trees along the western boundary of the central developed area. (Photo SH11)

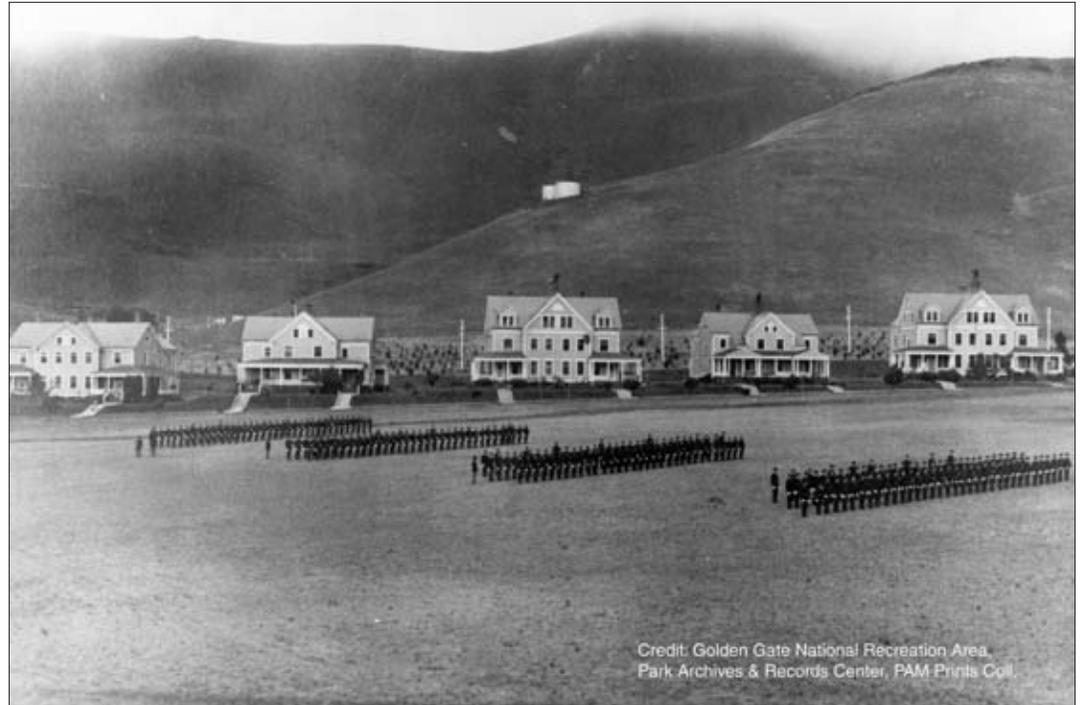
SH12 Concrete walkways and stairs led at regular intervals from the Murray Circle sidewalk to each building, looking west. Circa 1915 (GGNRA Park Archives and Record Center, 1766.0021).

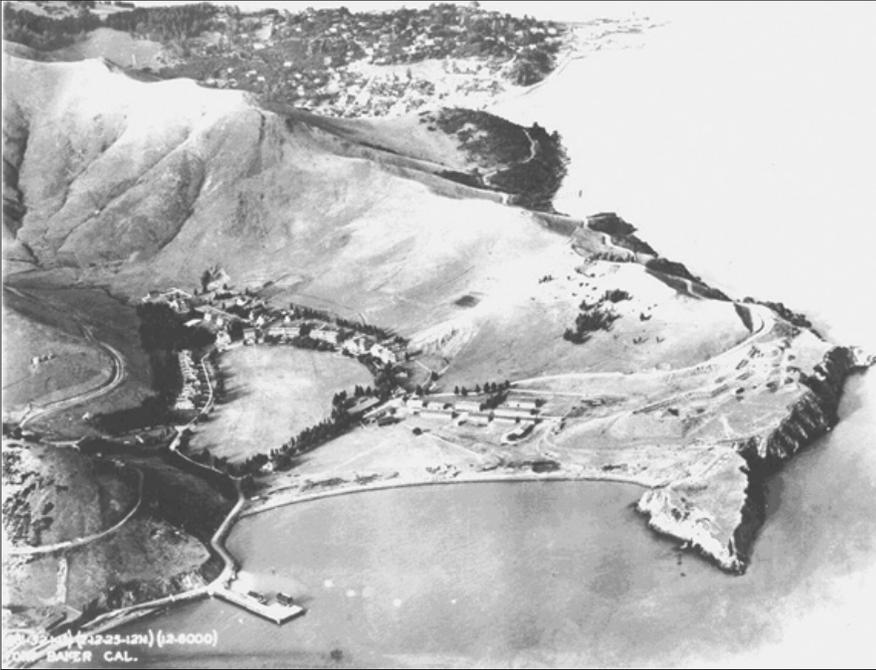
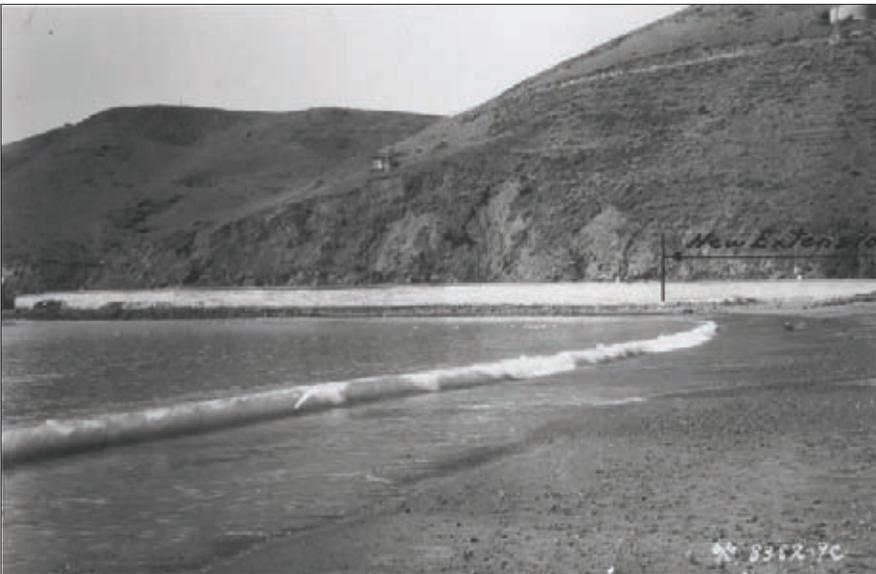
SH13 (upper) Aerial view of the site at the close of the Endicott period, with the batteries, core cantonment and quartermaster area extensively developed, prior to the intensive development of the Horseshoe Cove waterfront and road system that occurred in later years. Looking east. December 1925 (GGNRA Park Archives and Record Center, 32487).

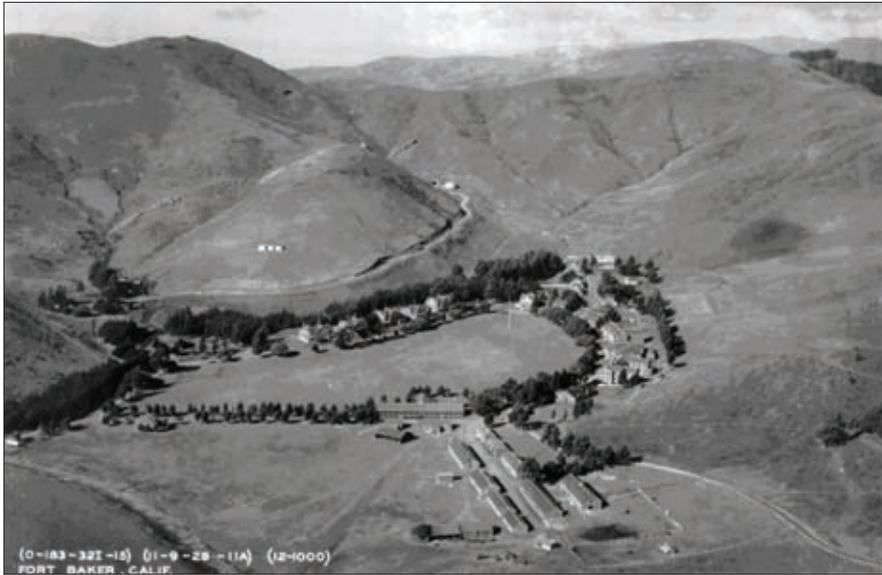
**SH15** Oblique air photo showing the fully developed Endicott-era military landscape. The historic core included the parade ground and Murray Circle; East Road with the quartermaster stables, blacksmith shop, bakery, YMCA auditorium, and other service buildings; and Bunker Road leading to the Baker-Barry tunnel in the background. Looking northwest. November 1928 (GGNRA Park Archives and Record Center, 2051).

An aerial photograph from 1928 provides a panoramic perspective on the historic core of Fort Baker, and records a fully developed Endicott-era military landscape. (Photo SH15, next page) The photograph shows Murray Circle, the parade ground, the Quartermaster stables, corral, the carpenter and blacksmith shops, the bakery, as well as East Road in the foreground and Bunker Road and the Baker-Barry tunnel in the background. By this time,

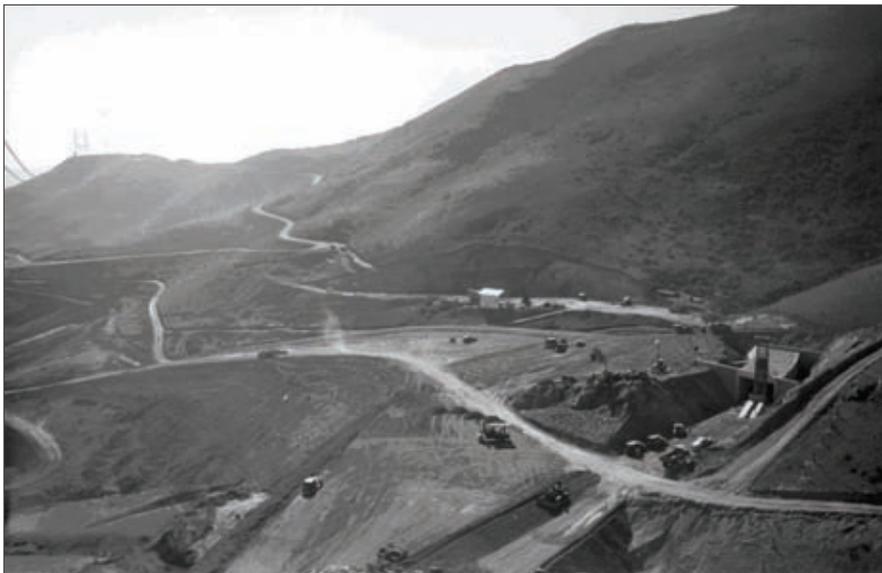
**SH16** Construction of the Golden Gate bridge and its approach roads created a significant alteration to the site's topography as U.S. Highway 101 cut through the northern section of Fort Baker on a massive earth fill. Looking south. November 1936 (Golden Gate Bridge Archives).

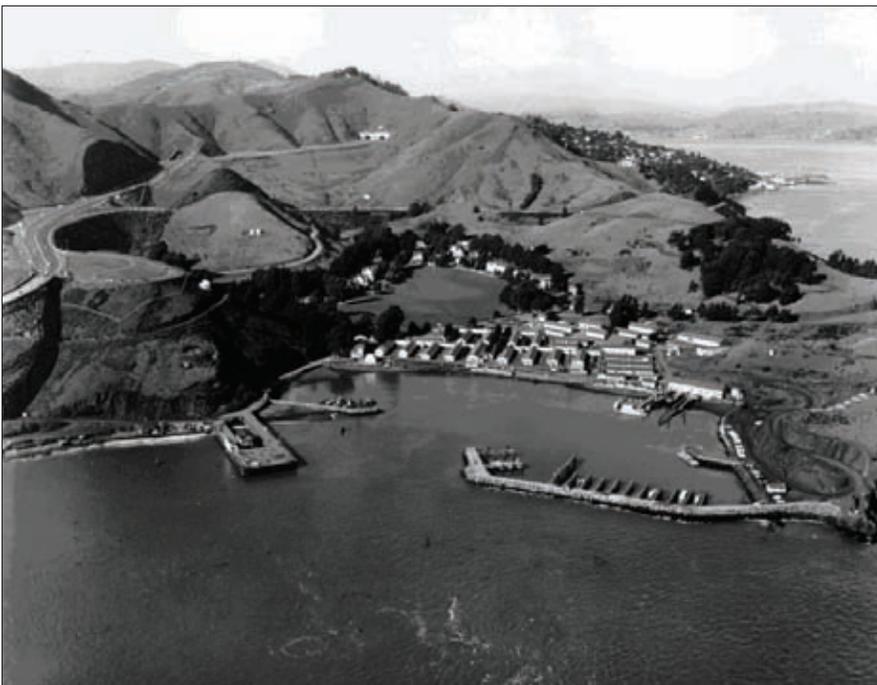
SH17 Mine depot structures clustered near the waterfront included storehouses, cable tank building and powerhouse, looking northeast. Circa 1941 (GGNRA Park Archives and Record Center, 2266-N1,02).

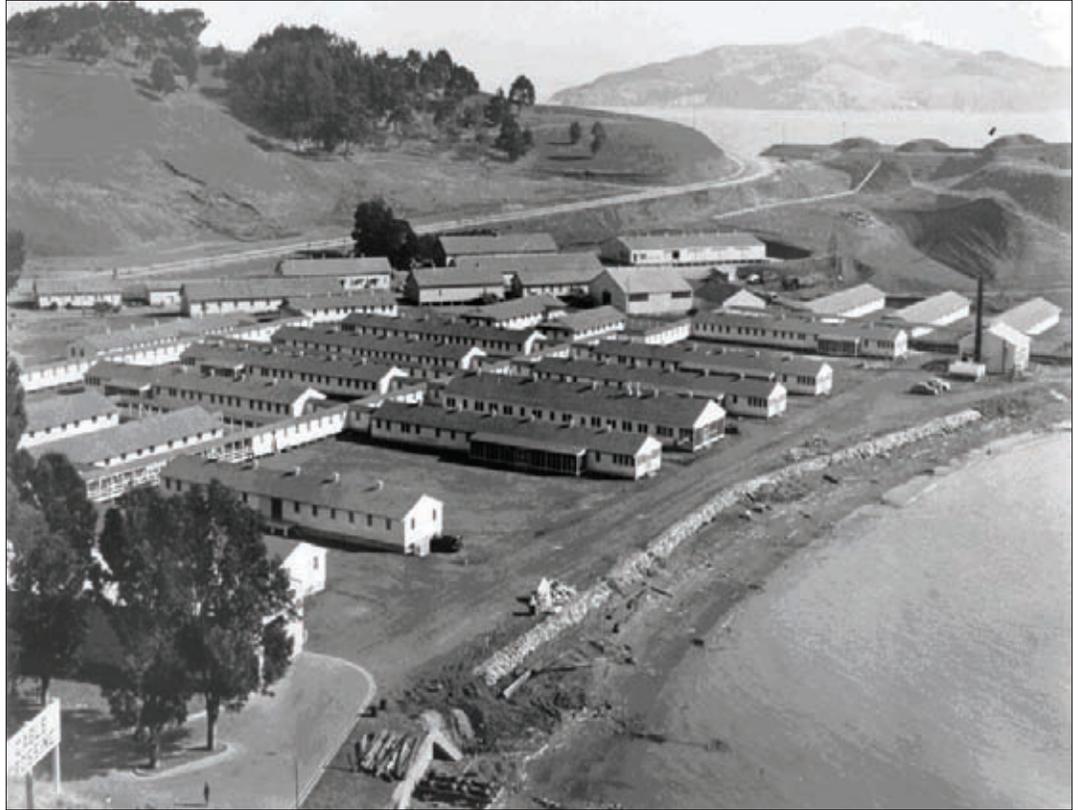
SH18 By 1940, Battery K of the 6<sup>th</sup> Coast Artillery and detachments of the Medical and Quartermaster Corps were stationed at Fort Baker. The station hospital, constructed between 1941 and 1942, was built on the filled-in marsh above Horseshoe Cove (San Francisco History Center, San Francisco Public Library, Negative 6449).

war, forty-five buildings of similar construction comprised the hospital complex.<sup>61</sup> (Photo SH18)

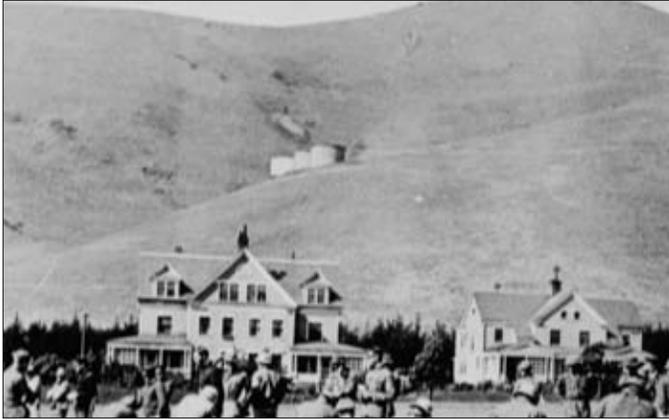
NS2 Water was pumped to storage tanks located on the hills above the cantonment. The hills provided a head to build water pressure to supply Fort Baker. Circa 1915 (GGNRA Park Archives and Record Center, 3311.007).

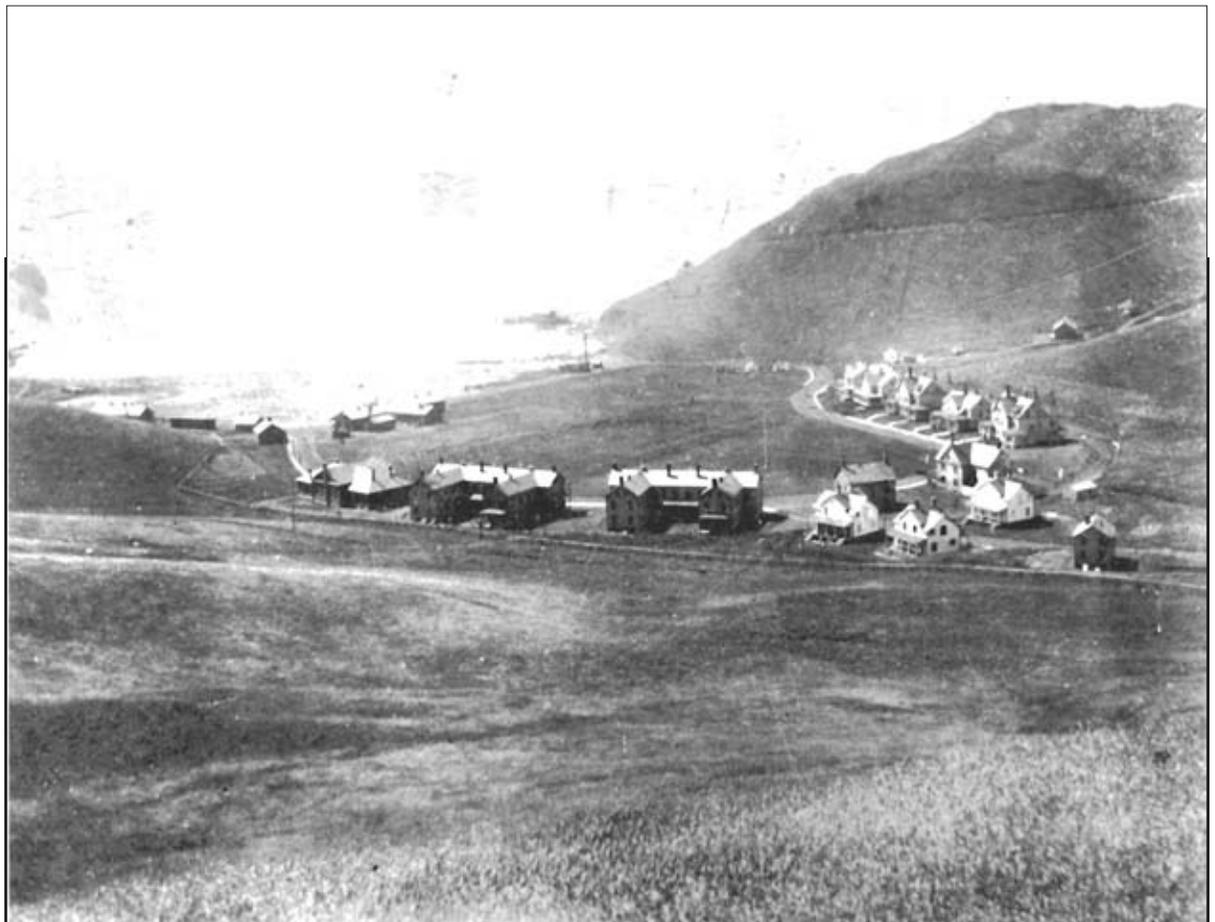
NS3 The valley north of Horseshoe Cove was a relatively flat and natural setting for buildings, a microclimate buffering the cantonment from inclement weather. Circa 1904-6 (Sausalito Historical Society, Chambers Family Photo Collection, Negative 9846.3).

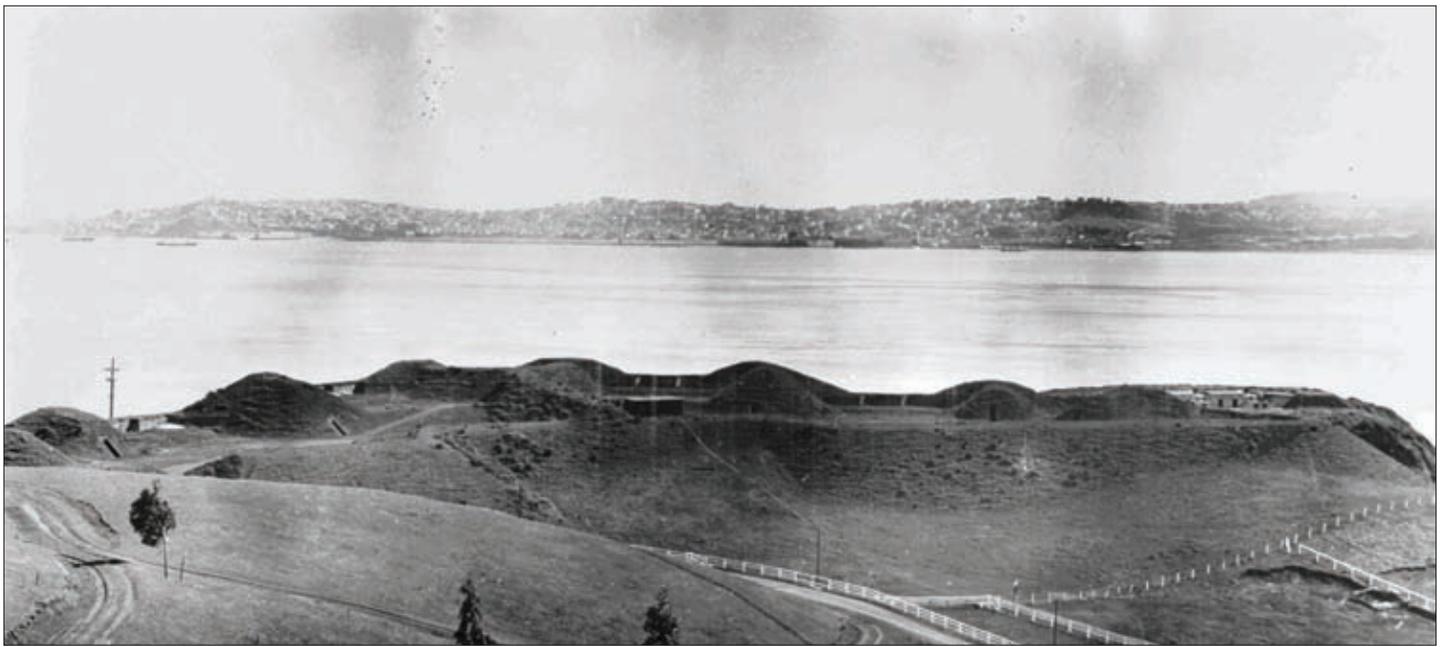
**T1** The silhouette of Cavallo Battery against the San Francisco Bay illustrates the extensive use of earth works in early battery construction. Circa 1914 (GGNRA Park Archives and Record Center, 1766).

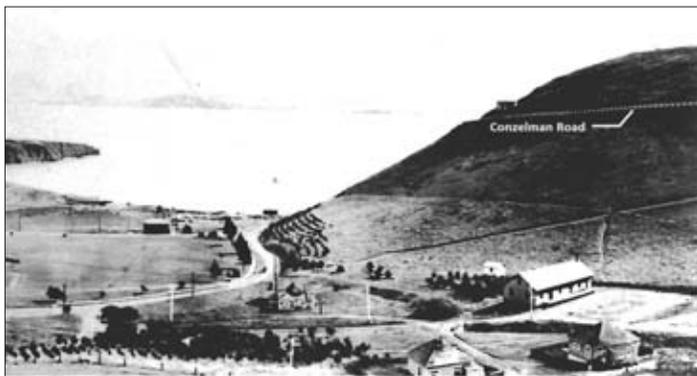
**T2** Conzelman Road was aligned to negotiate steep grades between Horseshoe Cove and Gravelly Beach. Circa 1904-06 (San Francisco History Collection, San Francisco Public Library, Negative 6453.)

Early roads between Engineer's Camp and the batteries also required extensive cuts as road grades were significant between the waterfront and the batteries built on the bluffs along the shoreline. In such instances, the military typically avoided the use of fill slopes in road construction. Construction of Conzelman Road from Lime Point to Gravelly Beach was initiated in September of 1870. Originally laid-out to follow the rocky shoreline around the point, this route was abandoned in favor of an inland one that traversed the ridge west of Horseshoe Cove (Conzelman Road). The resulting alignment was a circuitous road cut into steep hillsides, which negotiated severe grade changes with switchbacks. (Photo T2)

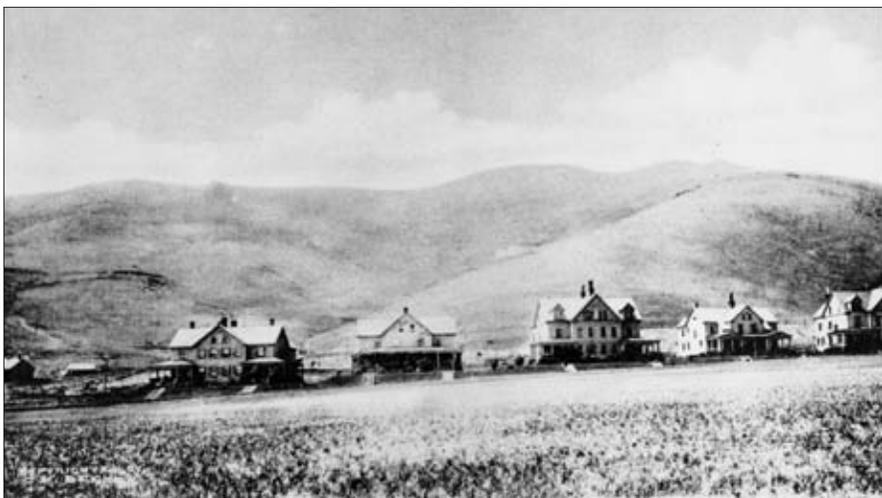
**T3** The buildings located on Murray Circle were constructed on a bench surrounding the Parade Ground. Circa 1905 (GGNRA Park Archives and Record Center, 18478.002)

add 25,000 cubic yards of fill to level the area. Work on the parade ground included rerouting several creeks into culverts and filling a ravine that ran through the parade ground. When the grading project was completed, the flattened parade ground sloped northwest to southeast towards Horseshoe Cove with a 40-foot drop in elevation. Photographs document the cuts and fills required adjacent to the parade ground for the construction of flat building pads for both roads and structures surrounding the parade ground and the rest of the developed area. (Photo T3)

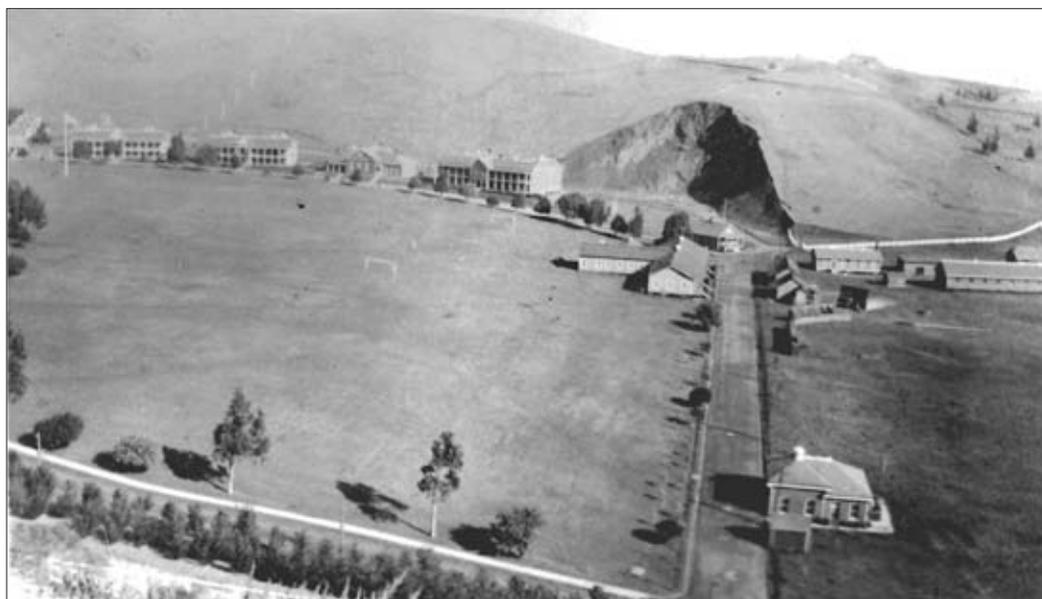
**T4** The sandstone quarry located southeast of the Parade Ground had significant visual impact on the landscape. Circa 1915-20 (GGNRA Park Archives and Record Center, 3311.003).

In 1913, a significant alteration of the landscape occurred when the hill that formed the eastern edge of Fort Baker was excavated. More than 75,000 cubic yards of sandstone were removed and barged to San Francisco for use in the 1915 Panama Pacific International Exposition. The hillside east of the hospital on Kober Street was also quarried for the red chert that was used for occasional road repairs. (Photo T4)

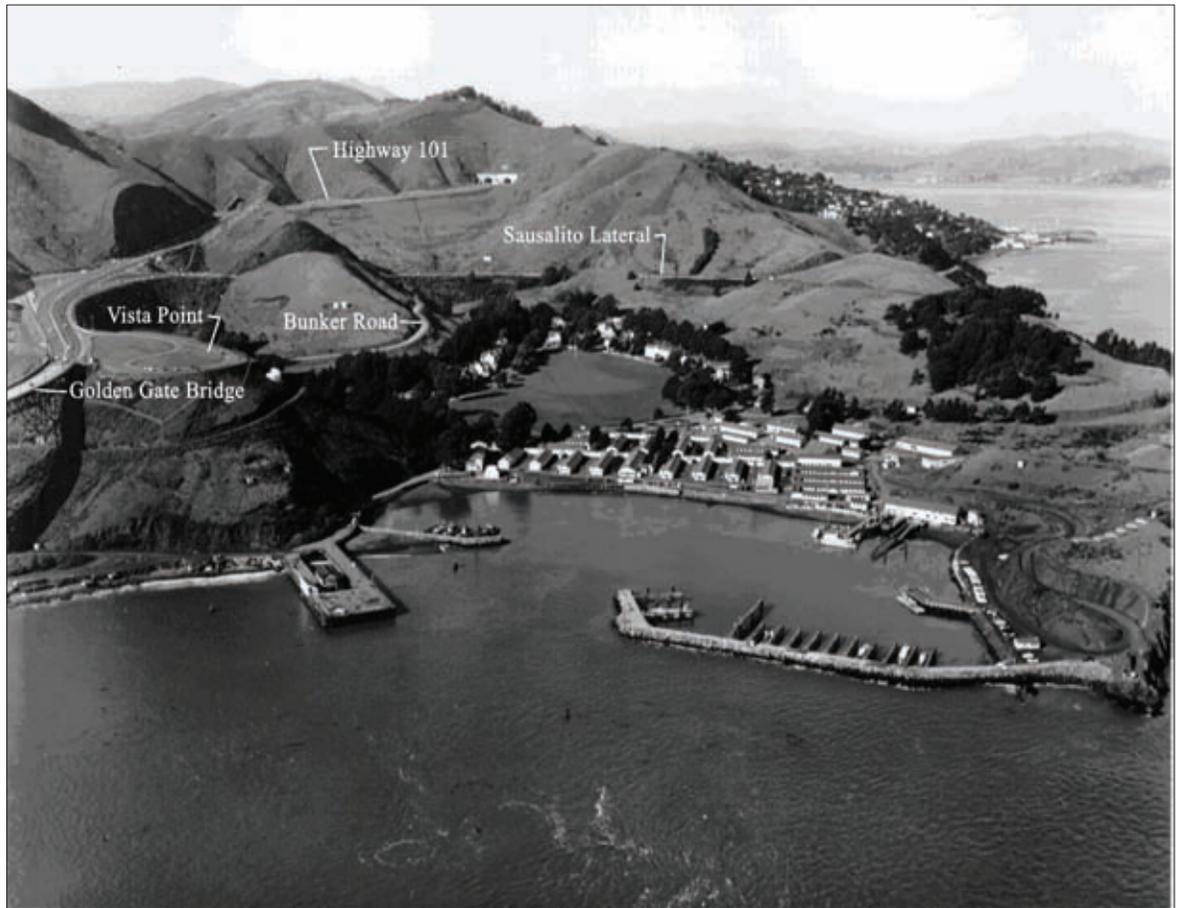
**T5** The construction of the Golden Gate Bridge involved the largest topographic manipulation at Fort Baker and created a distinction between East and West Fort Baker. Circa 1955-60 (GGNRA Park Archives and Record Center, 2266-N1,02).

Certainly the largest manipulation of the natural topography at Fort Baker occurred with the construction of the Golden Gate Bridge in 1937. A massive earthen dam was built at the head of the valley to accommodate Highway 101 on a steady grade as it approached the Waldo Tunnel. Alexander Avenue was also constructed using large quantities of fill. Also known as the Sausalito Lateral, Alexander Avenue transected the northern portion of Fort Baker before connecting with East Road just south of Sausalito. The creation of Alexander Avenue necessitated the construction of the tunnel and walls for Bunker Road, which now passed under the road leading into the cantonment. (Photo T5, next page)

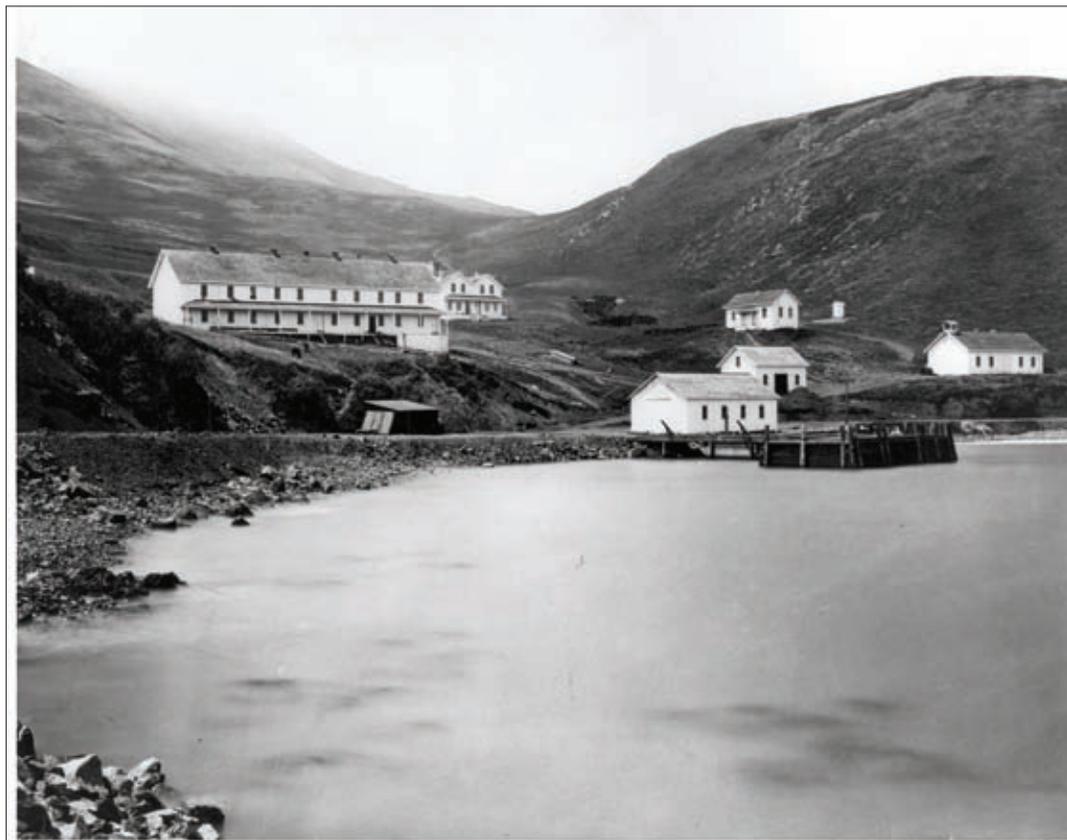
C2 The Engineers' Camp with the primary components of the early circulation - the wharf and roads constructed of gravel or dirt. 1868 (GGNRA Park Archives and Record Center, 4053).

Four other early roads provided limited access to batteries within the fort: Drown Road, Kirby Beach Road, Battery Yates Road (Satterlee Road) and Cavallo Road. (Photo C2) These roads were informal in character surfaced with earth or gravel. Between 1890 and 1910, this simple network of roads was the core circulation system at Fort Baker and remains in place today.

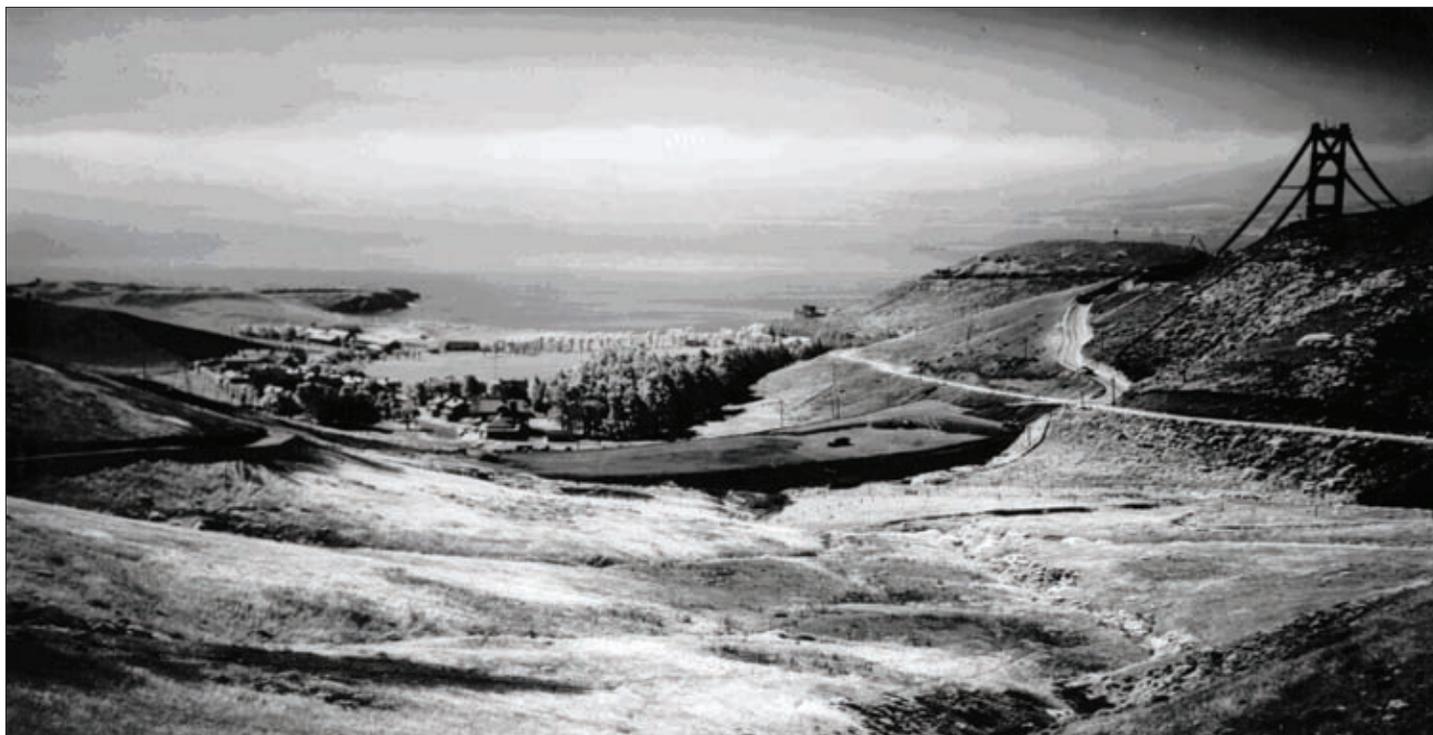
**C5 Construction of the Golden Gate Bridge and its approaches dramatically altered the Fort Baker landscape as well as the circulation system. Construction of the Sausalito Lateral is shown in the foreground. July 1936 (California Historical Society FN-32516)**

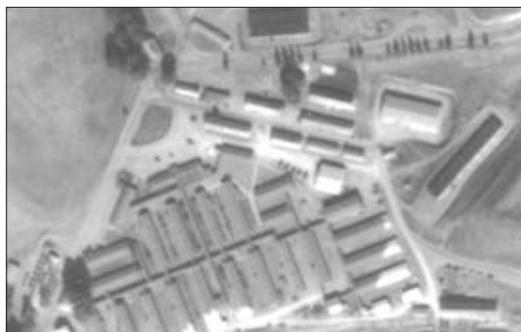
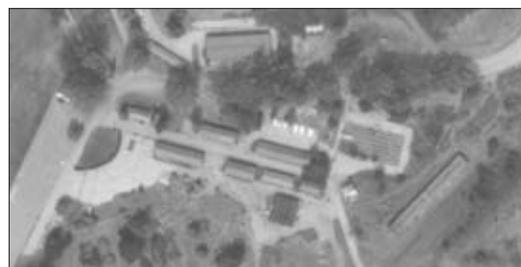
CA2 Historic photograph (October 1946, top) and contemporary photograph (March 1990, below) showing quartermaster warehouse south of East Road at Fort Baker (GGNRA Park Archives and Record Center, 4056 & Pacific Aerial Surveys AV-3766-0213-10).

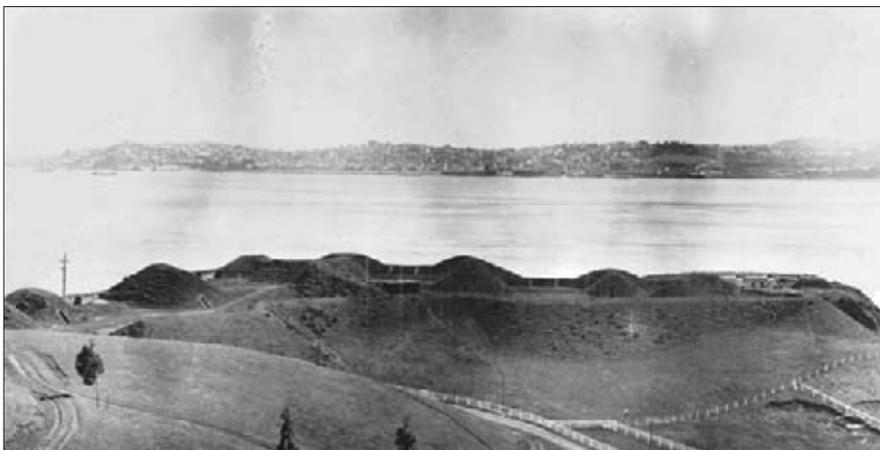
VG1 Low-lying shrubs and grasses characterized vegetation around the earthworks comprising Battery Cavallo Circa 1914 (GGNRA Park Archives and Record Center, 1766).

Vegetation at Battery Cavallo has changed from low grasses and shrubs, to primarily large shrubs and small trees obscuring portions of the battery earthworks. Although the vegetation historically associated with the battery was primarily native, the character of the mature vegetation is significantly different, and has altered the appearance of the batteries from the appearance during the period of significance. Batteries Yates, Spencer, and Orlando Wagner are located within grassland/coastal scrub communities that have also matured over time, although the difference is not as striking as that of Battery Cavallo. Overall, because of these changes, the existing vegetation does not contribute to the historic character of the cultural landscape at these batteries.

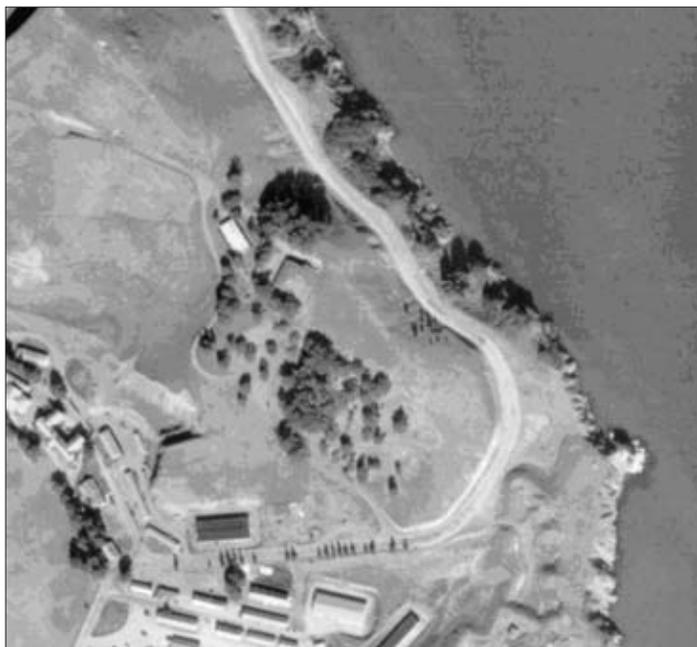
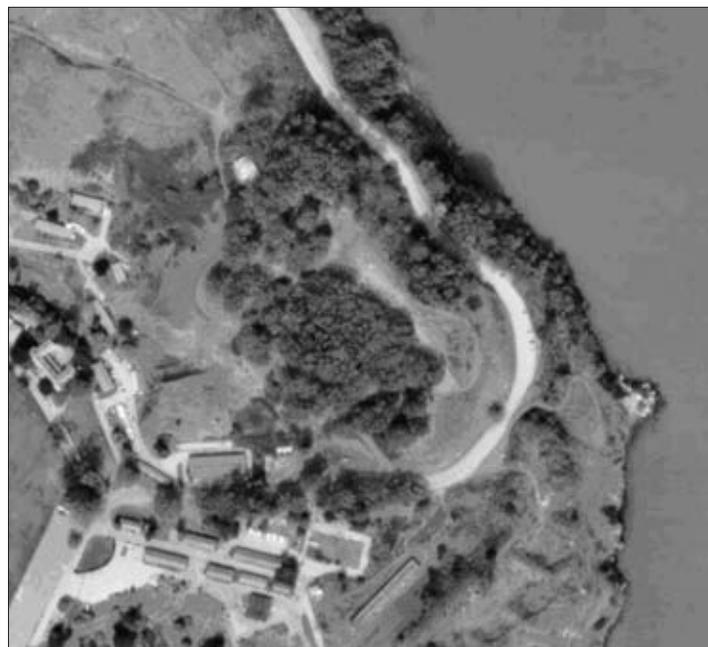
**VG2** Photos show the expansion of vegetation around Battery Duncan. Photo on left October 28, 1946 (historic period); photo on right March 15, 1990 (GGNRA Park Archives and Record Center, 4056 & Pacific Aerial Surveys AV-3766-0213-10).

The grove of eucalyptus trees planted at Battery Duncan between 1911 and 1945 remain, however, the trees have spread into open space areas beyond the original boundary for the planting, obscuring historic viewsheds. In this regard, the grove of eucalyptus is considered contributing to the character of the cultural landscape, but is in poor condition.

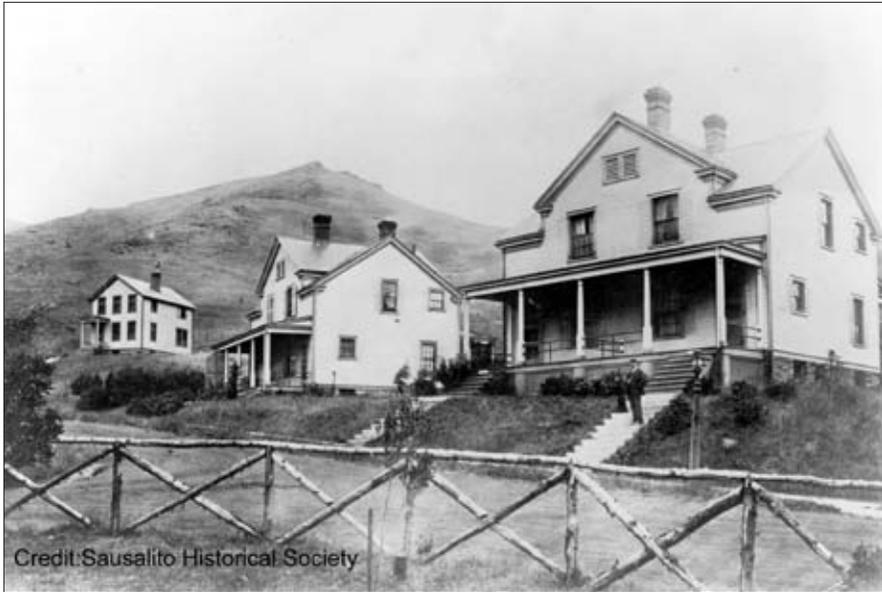
VG3 (upper) Formal landscaping efforts along Kober Street. Wooden fence in foreground was typical of early site furnishings. Circa 1905 (Sausalito Historical Society).

In many ways, the use of foundation plantings by the military at Fort Baker was consistent with larger, contemporary national trends in residential design. In general, foundation plantings were used to "connect" homes with their surrounding grounds, to soften building foundations, to provide color and diversity in the landscape, to screen unwanted views, provide privacy, and generally improve the aesthetic qualities of the structure.<sup>74</sup> (Photo VG3)

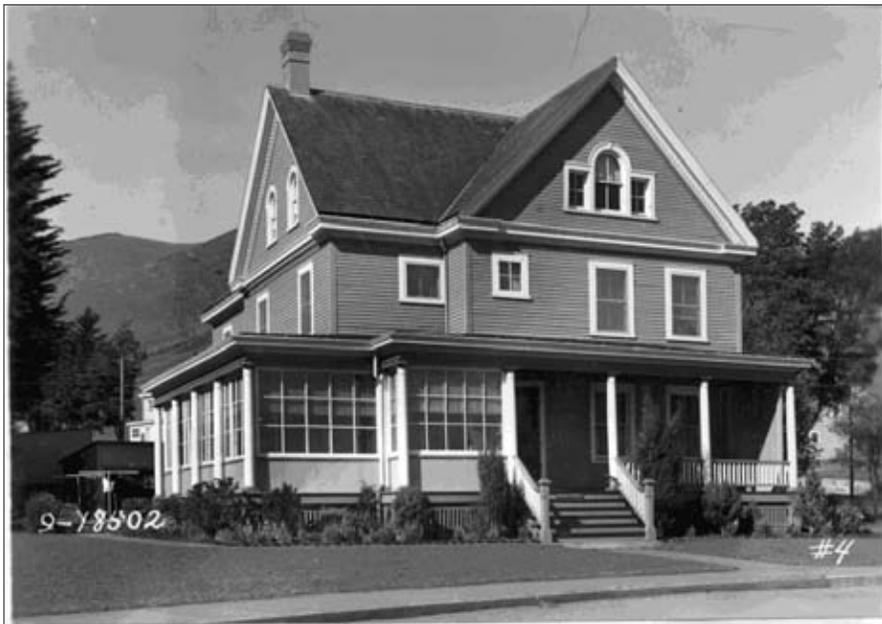
VG4 (lower) Buildings on the west side of Murray Circle such as the Commanding Officer's Residence (Building FB604) were extensively planted. Circa 1938 (GGNRA Park Archives and Record Center, 32426).

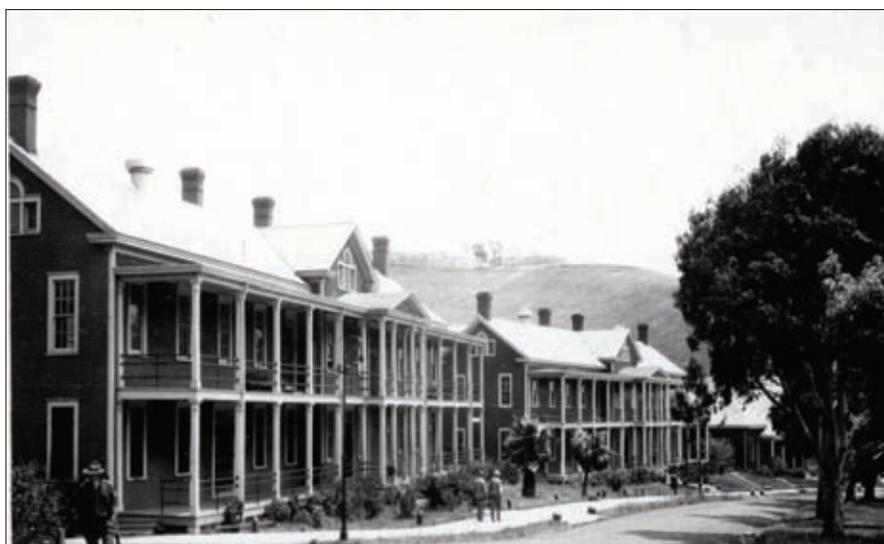
VG5 A view of plantings in front of buildings along the east side of Murray Circle which included a mix of specimen trees and foundation plantings. Circa 1923 (GGNRA Park Archives and Record Center, 40096).

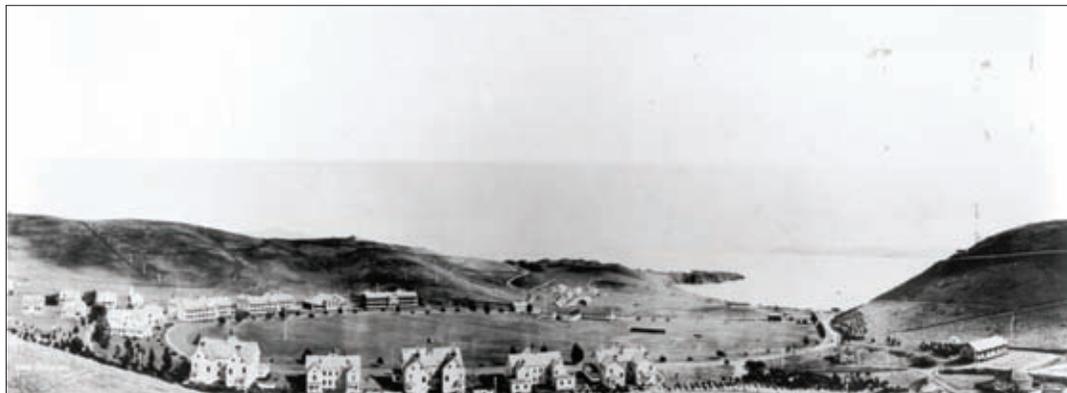
VG6 Early photograph showing the trees around parade ground and planting of Monterey cypress windbreak in foreground and right. Circa 1909 (San Francisco History Center, San Francisco Public Library, Negative 6453).

A 1909 photo shows a similar planting pattern using smaller trees on the south end of the parade ground. A short row of trees extended along Moore Road from its intersection with the parade ground towards the bay. (Photo VG6)
