# Cultural Landscape Report for Fort Baker Golden Gate National Recreation Area

## Golden Gate National Recreation Area

Fort Baker, Barry and Cronkhite Historic District  
Marin County, California

July 2005

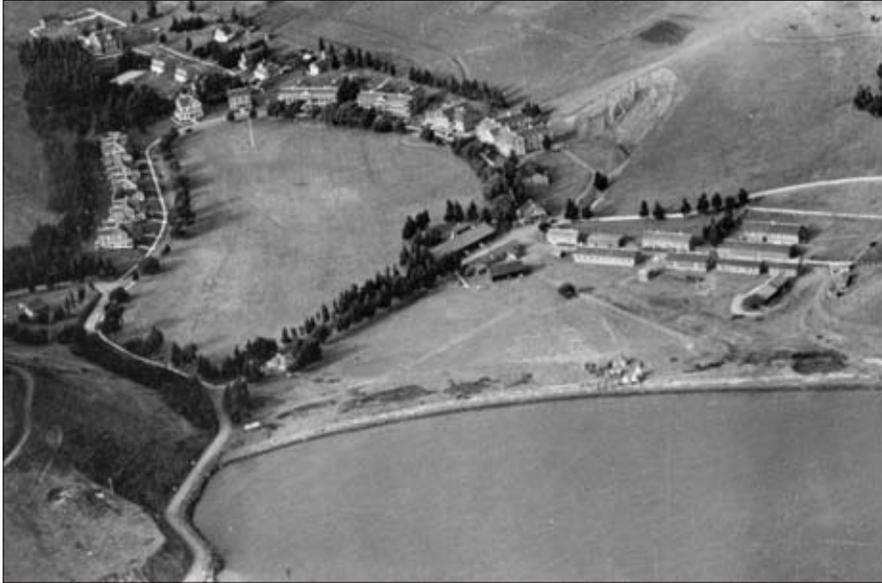
**VG7** Mix of trees planted on either side of Center Road including the southern portion of the parade ground. Note eucalyptus trees planted in quartermaster warehouse area on right side of photograph. Date: December 12, 1925 (GGNRA Park Archives and Record Center, 32487).

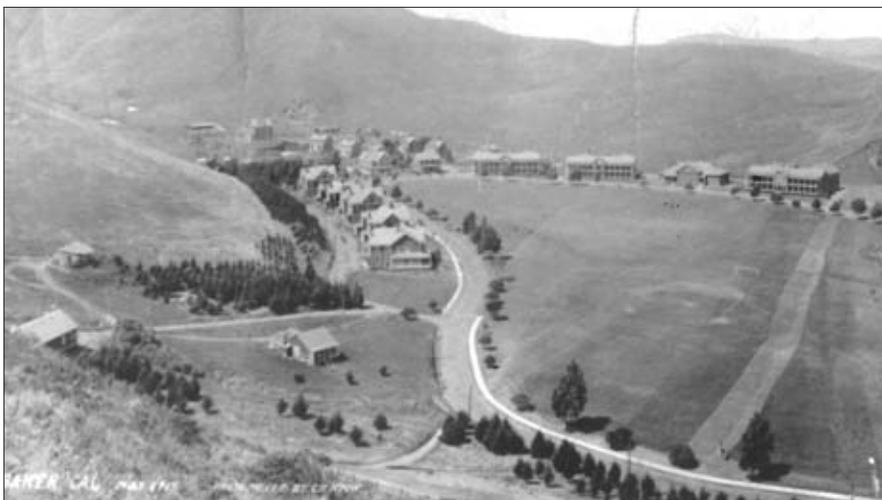
VG8 (upper) Windbreak planted on the west side of the parade ground behind officer quarters. Date: May 1915 (GGNRA Park Archives and Record Center).

As a result of the Quartermaster's efforts, a single major stand of Monterey cypress (*Cupressus macrocarpa*) was planted along the western side of the cantonment before the end of the Endicott period. Photographic evidence shows that a stand of Monterey cypress trees was planted, creating a major windbreak on the western side of the cantonment. The stand was located behind the residences and west of McReynolds Road, beginning about where Bunker Road enters the post and extending northward toward FB549 and south along Moore Road towards Horseshoe Cove. This stand was planted in a grid pattern that varied in width depending upon

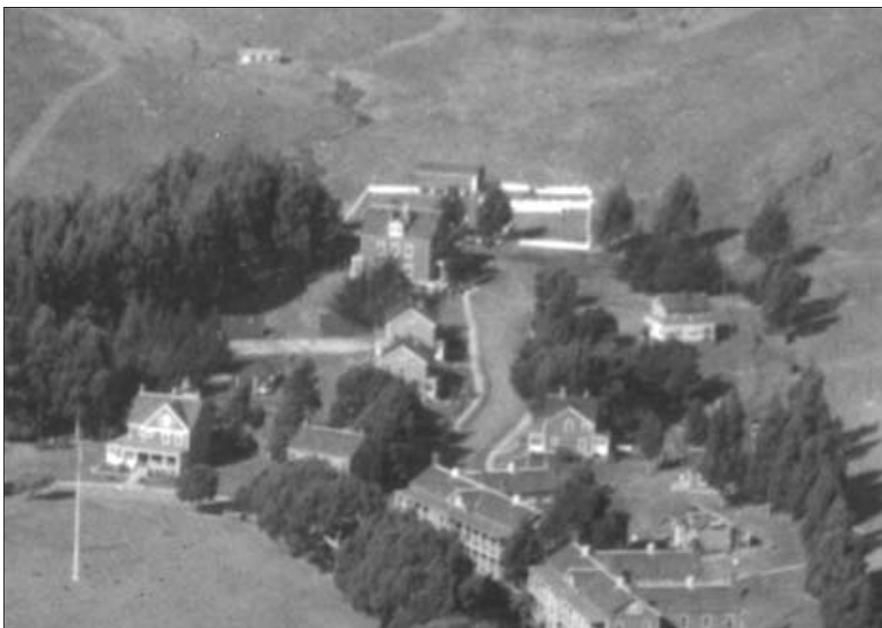
VG9 (lower) Clusters of Monterey cypress and blue gum eucalyptus planted around the buildings on the upper end of the cantonment, north of McReynolds Road. Circa 1928 (GGNRA Park Archives and Record Center, 2051).

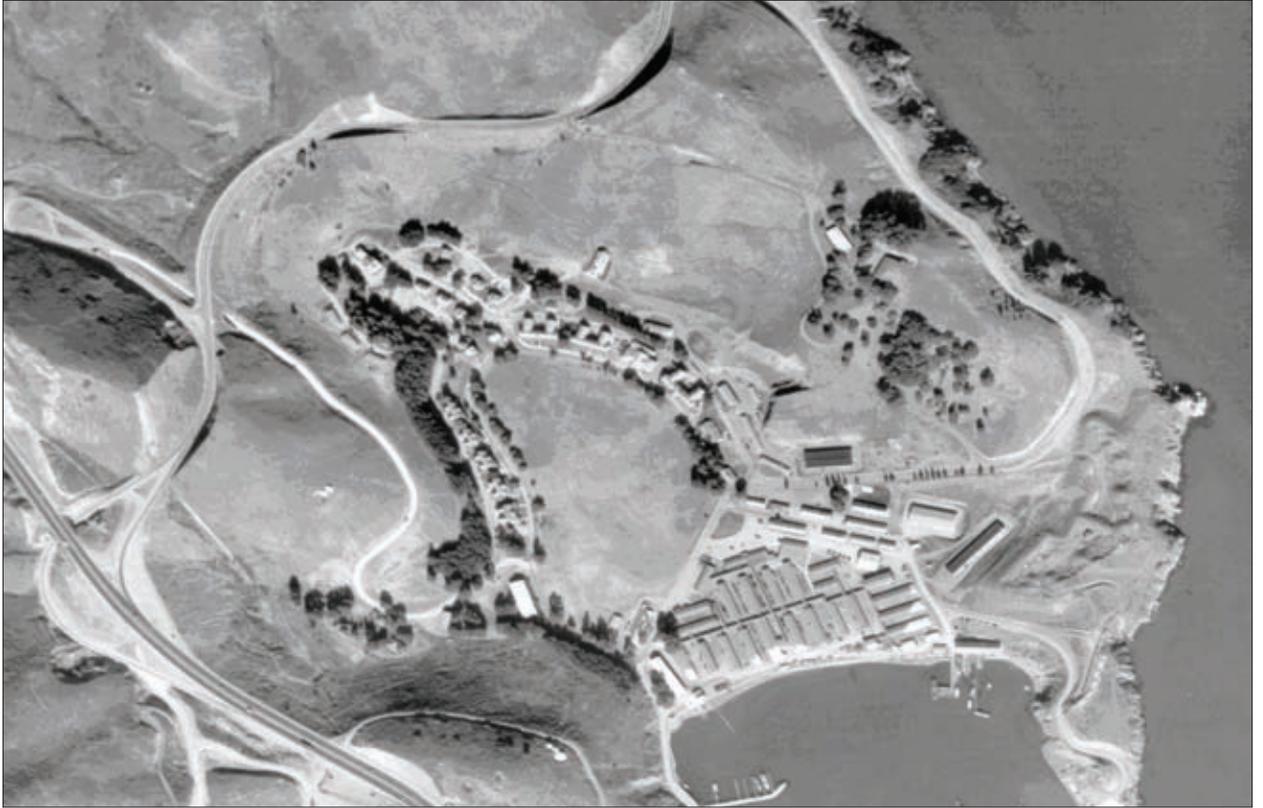
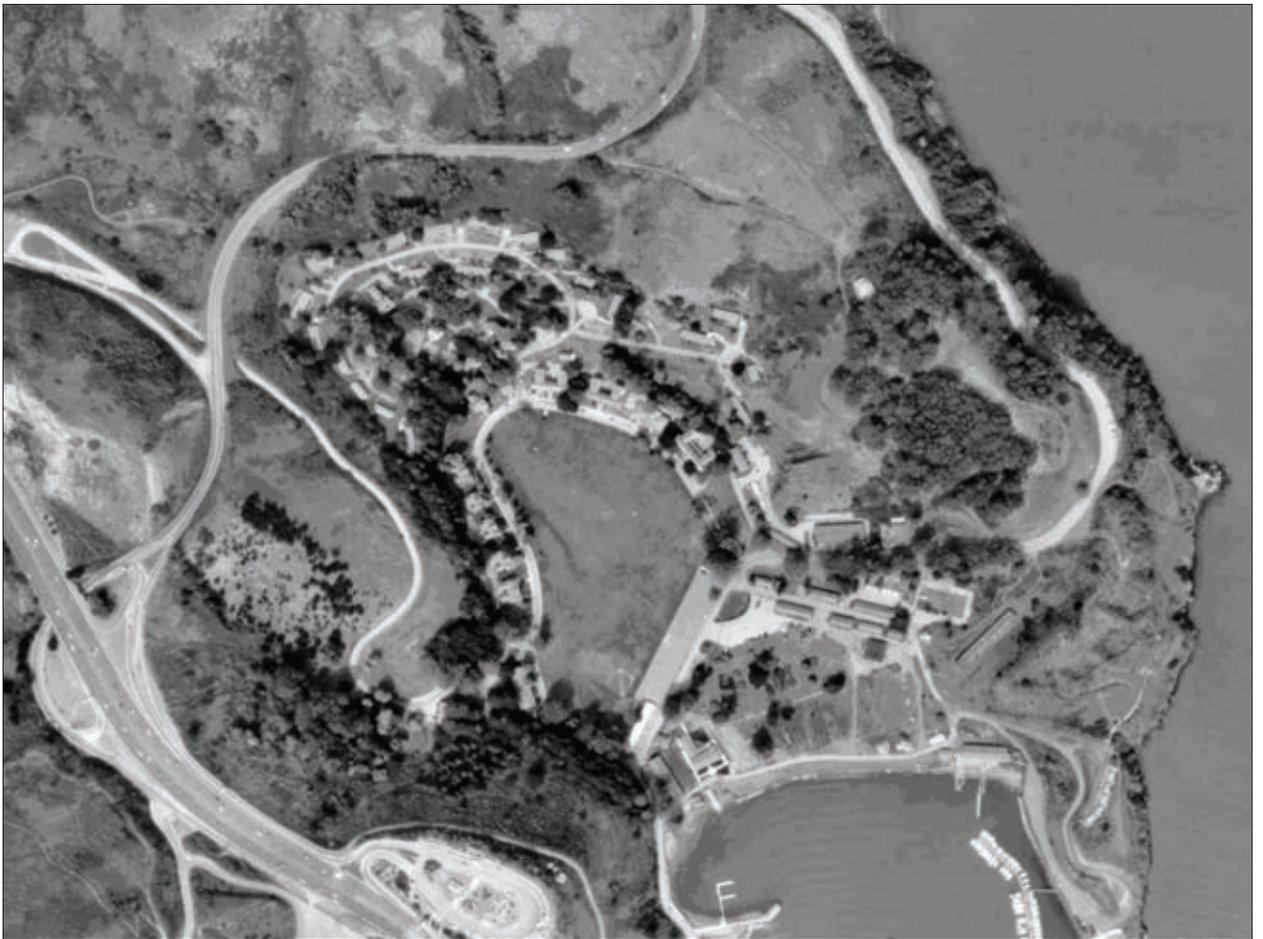
VG10 Aerial photograph from 1946 illustrates mature vegetation surrounding the cantonment. A comparison of 1946 photo (upper) and 1990 photo (lower) illustrates the expansion of vegetation in east Fort Baker (Pacific Aerial Surveys AV 9-6-2 GS-CP & AV-3766-0213-10).

After World War II, the trees planted around the cantonment and the batteries continued to mature. Numerous aerial photographs provide good documentation of the extent that these trees have spread outside of their original configurations, naturalizing in what had historically been open areas. (Photo VG10, next page)

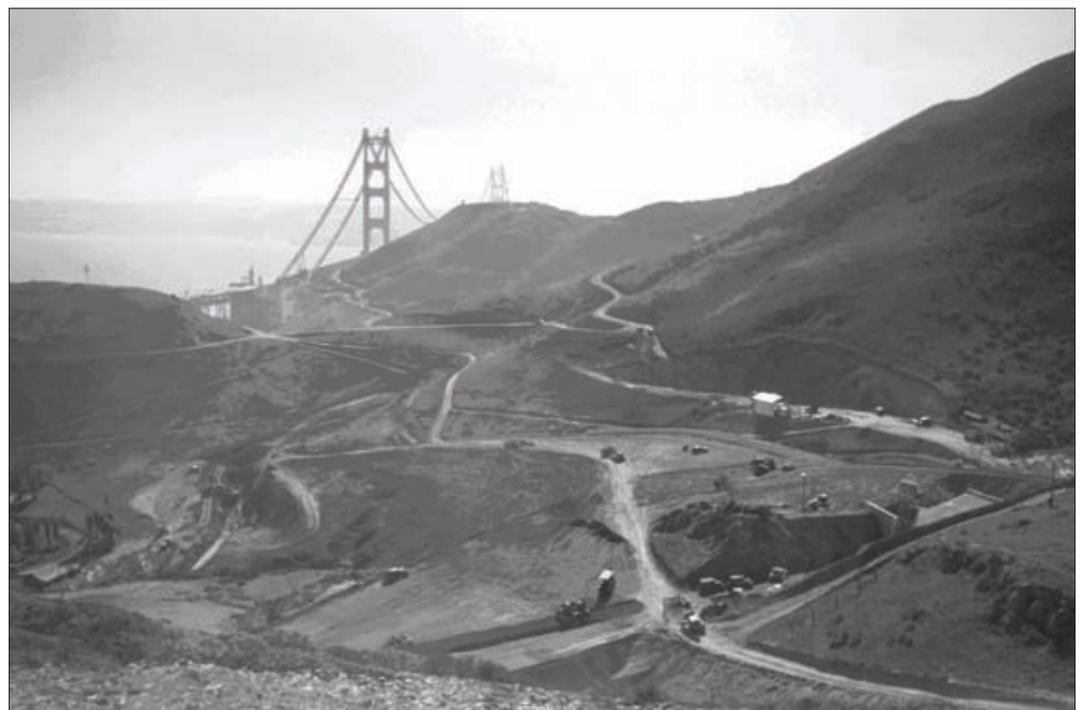
VG11 Construction of Highway 101 and Alexander Avenue resulted in the creation of extensive cut and fill slopes. The resulting revegetation efforts may have introduced invasive plant species to the open areas of Fort Baker. Date: November 9, 1936 (Golden Gate Bridge Archives).

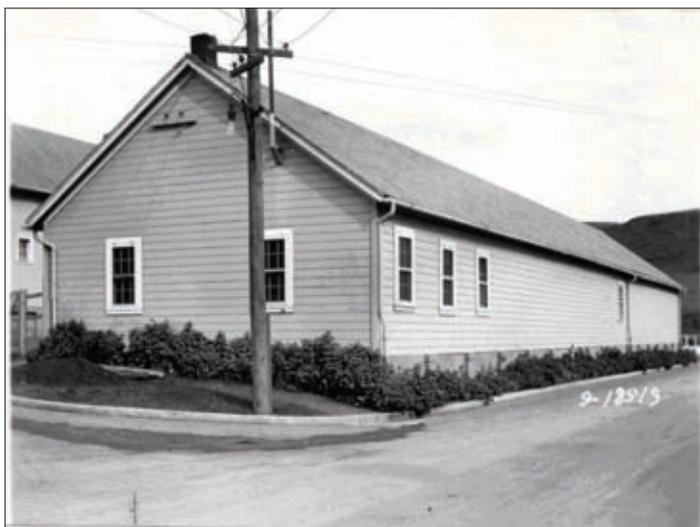
VG12  
Foundation plantings around many buildings in the quartermaster warehouse area consisted of low plantings and lawns. Building FB561 is a typical example. Circa 1938 (GGNRA Park Archives and Record Center, 32426).

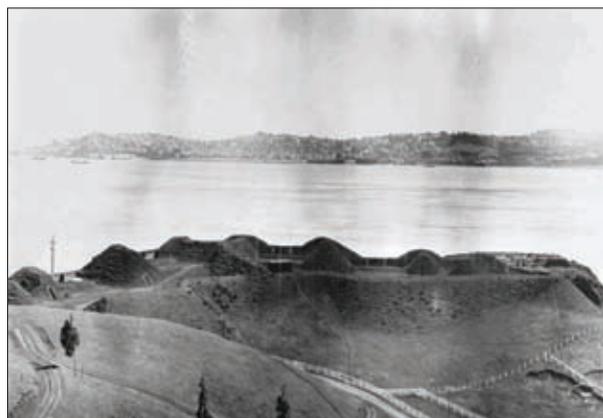
BS1 (above) Historic photograph showing Cavallo Battery earthworks. Circa 1914 (GGNRA Park Archives and Record Center, 1766).

Battery Cavallo, built in 1872, is considered a superior example of a post-Civil War brick battery and earthwork (“star fort”). It is located on the coastal bluffs north of Point Cavallo and oriented east/southeast to defend entrances to San Francisco Bay, and anchorages leeward of the Point. Battery Cavallo consists of two parts: the battery itself, which is a triangular-shaped enclosed earthwork fortification containing positions for fifteen guns; and an outwork containing emplacements for an additional pair of cannons. Guns emplaced in 1900, with removal in 1905. (Photo BS1 and Diagram BS2)

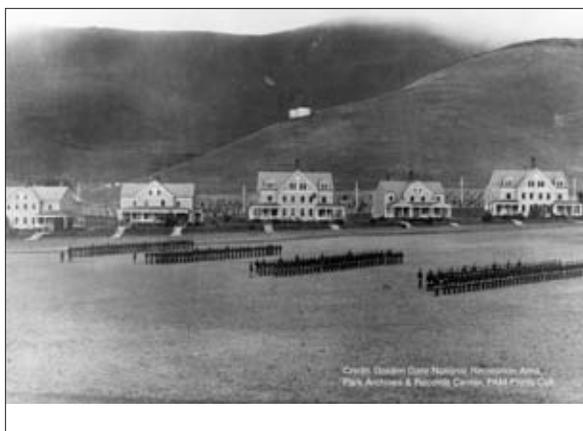
**VW1 (right) View of Parade Ground ensemble opening to San Francisco Bay. Circa 1906 (GGNRA Park Archives and Record Center, 17206).**

During the Endicott era, a site plan was developed for Fort Baker that responded to the topography of the site and proximity to San Francisco Bay by placing its most significant structures in a horseshoe alignment opening to the bay. (**Photo VW1**)The resulting design created a panorama that is the most enduring image of Fort Baker. The panorama is anchored by a raised bench on which the buildings are placed, backset by windbreaks, with finished front lawns, varied foundation plantings and specimen tree plantings.

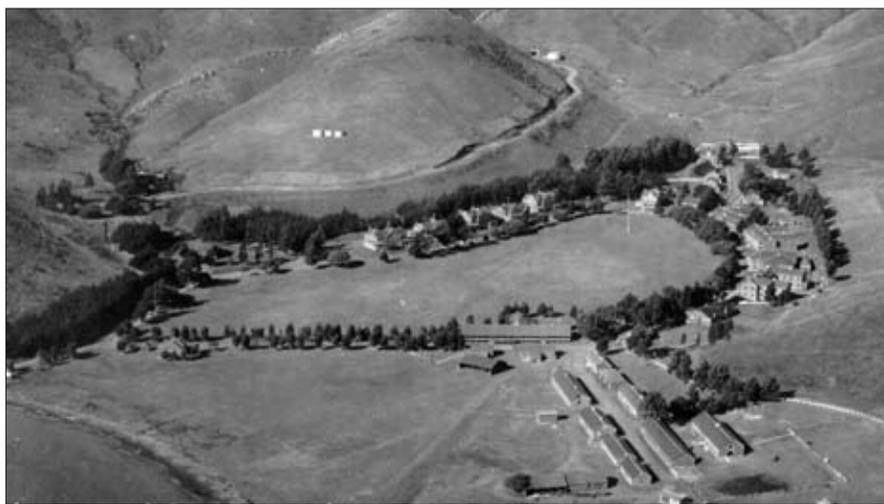
**VW2 (below) The area in front of the commanding officer's residence was purposefully excluded from the ring of trees planted around the Parade Ground. November 1928 (GGNRA Park Archives and Record Center, 2051).**

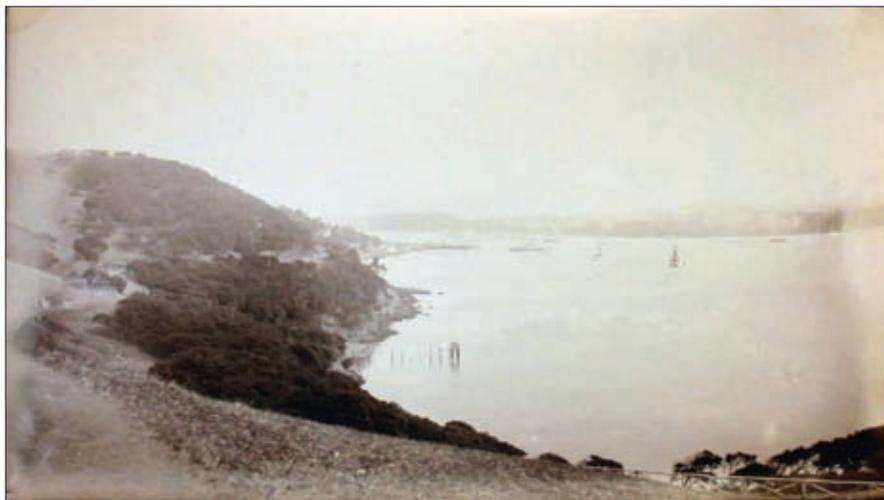
VW4 (below) Historic View Along East Road. Circa 1910, (Sausalito Public

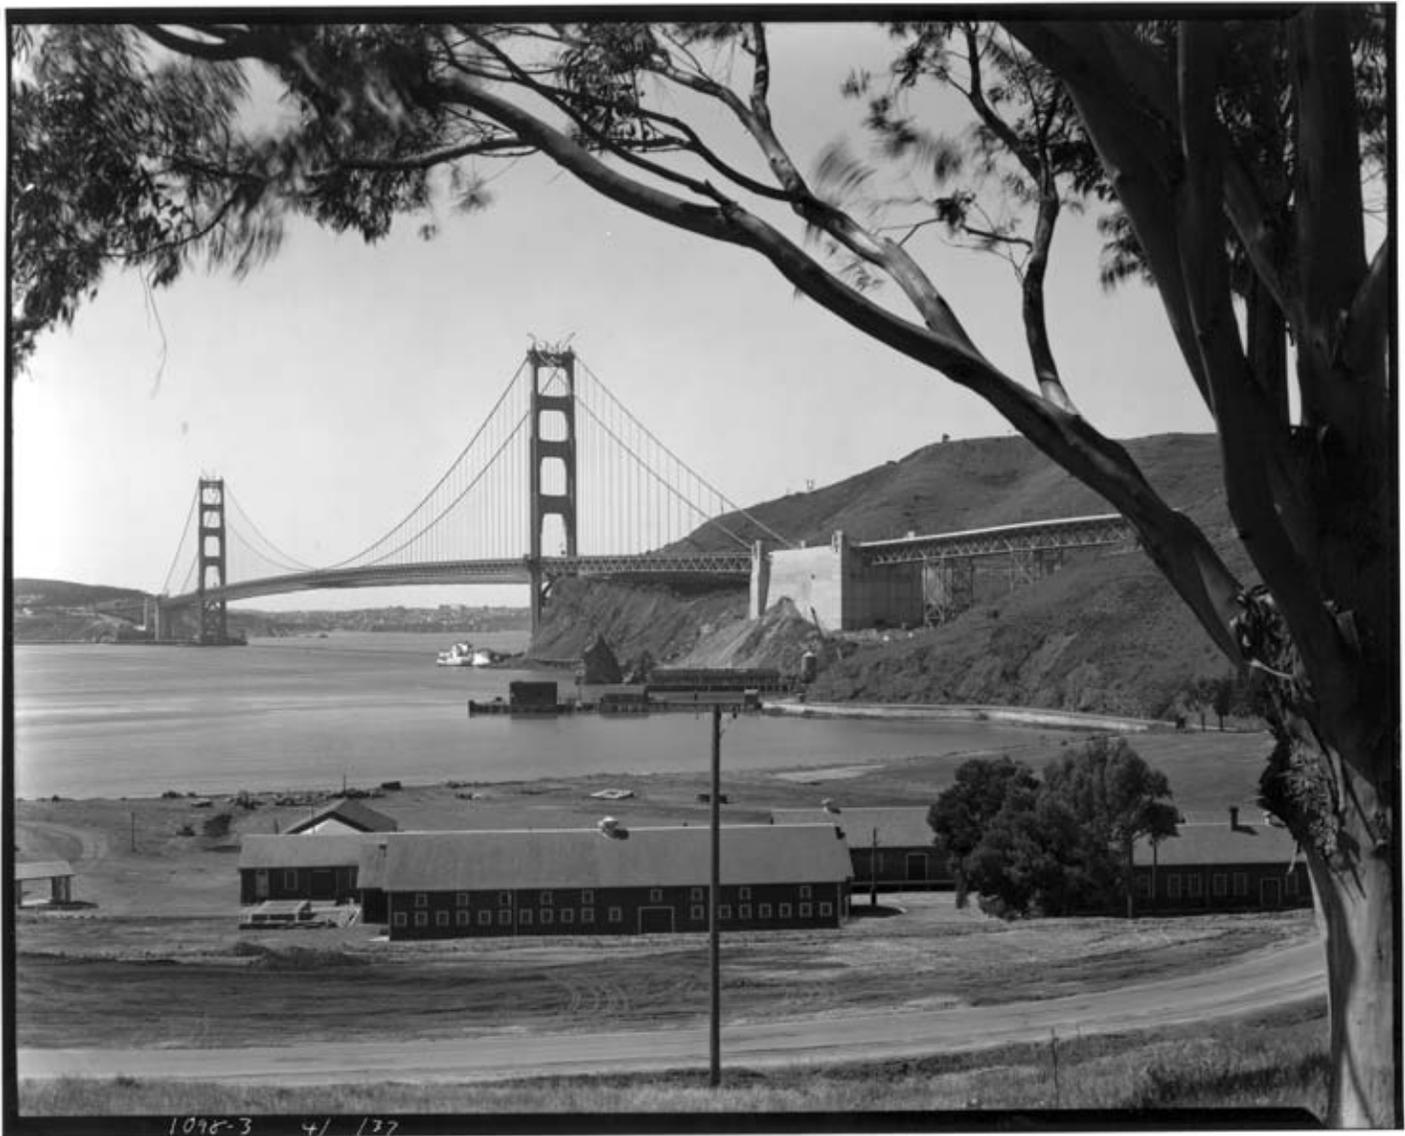
VW7 Historic View of Golden Gate and Bridge. April 1937, (Golden Gate Bridge Archive)

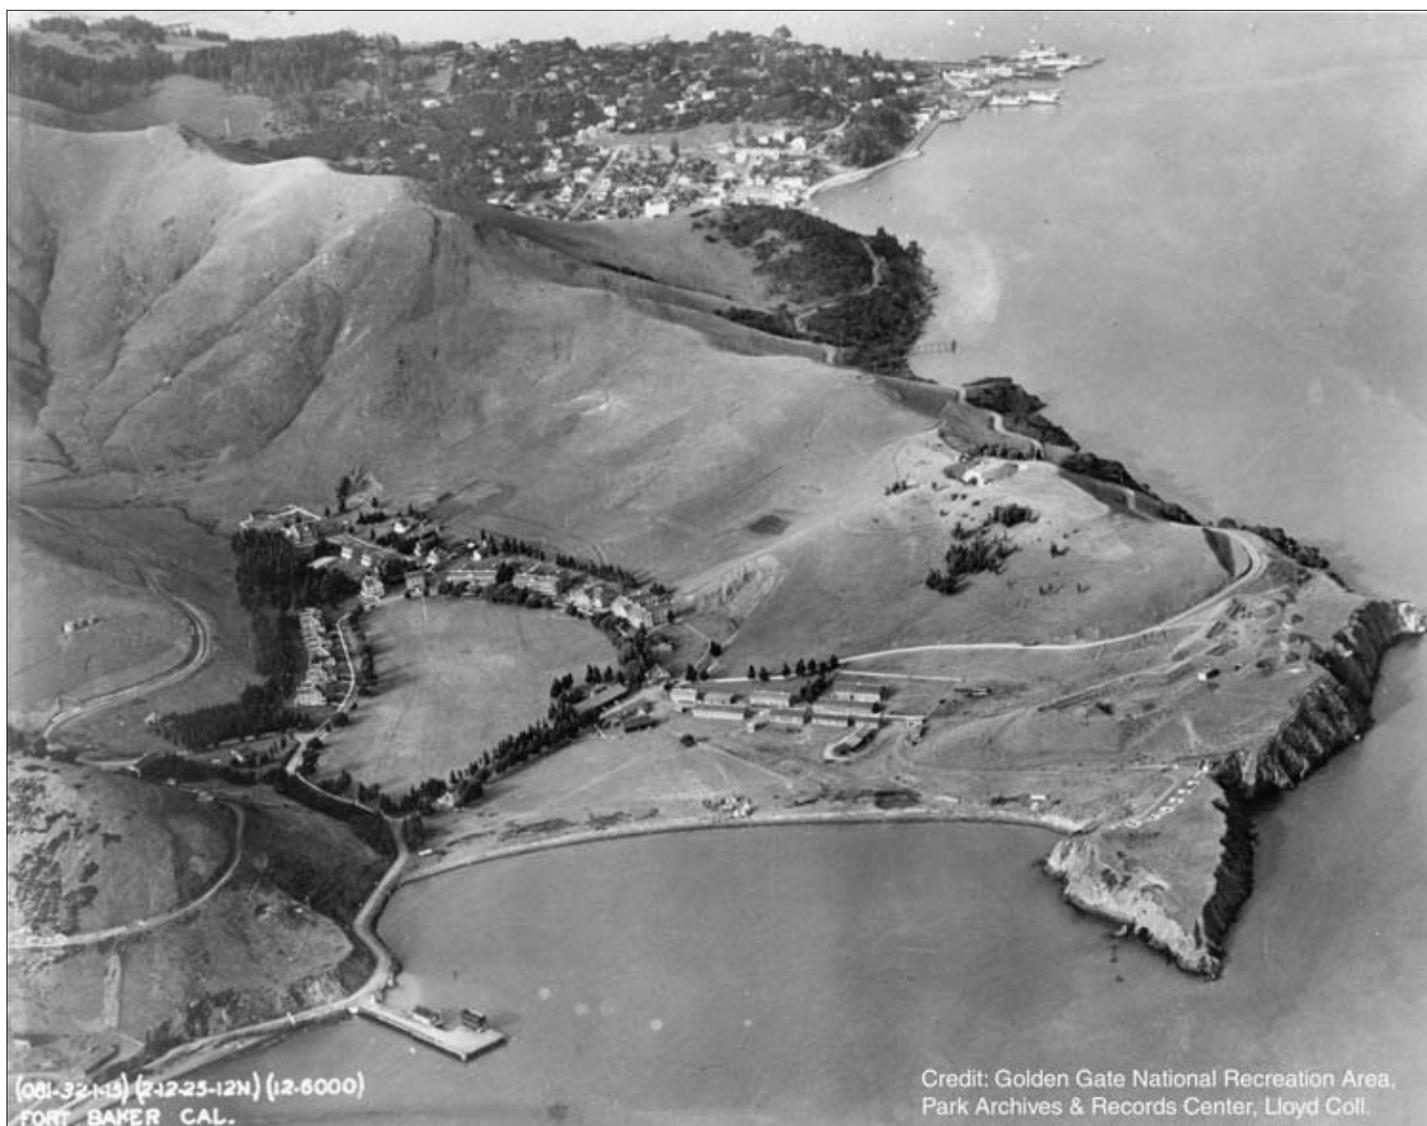
VW 8 Historic View of Waterfront Approach. February 1925, (GGNRA Park Archives and Record Center, 32847).

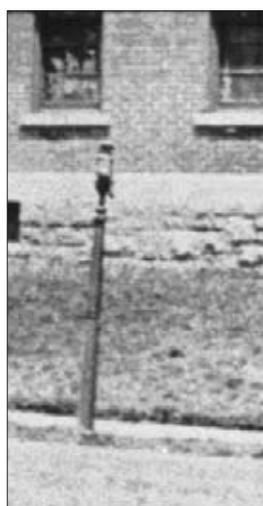
Streetlight (gas), Circa 1902  
Location: FB623  
Removed

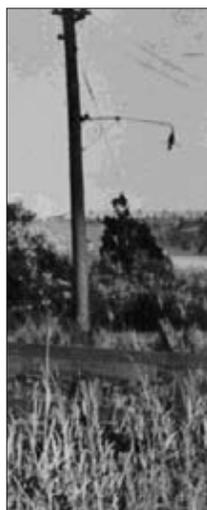
Streetlight (electric),  
Circa 1915  
Location: Fort Baker  
Removed

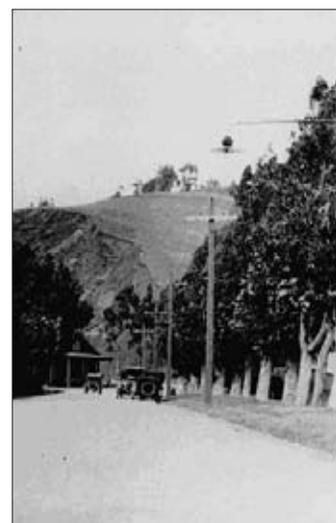
Streetlight (electric)  
September 1929  
Location: Center Road  
Removed

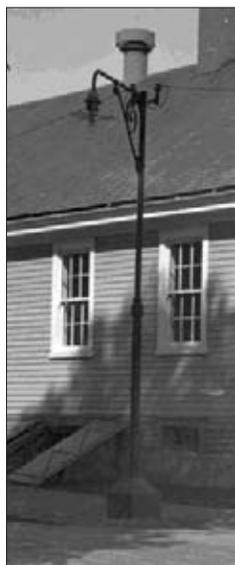
Lamppost, Circa 1938  
Location: FB615  
Removed

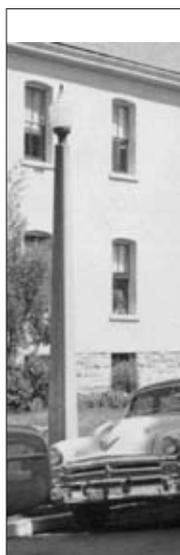
Lamppost, Circa 1955  
Location: FB636  
Extant, Non-contributing

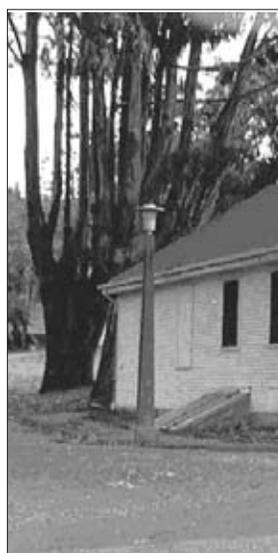
Lamppost, 2001  
Location: FB615  
Extant, Non-contributing

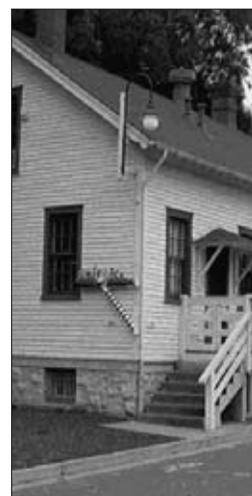
Lamppost, 1990  
Location: Quartermaster Area  
Extant, Non-contributing

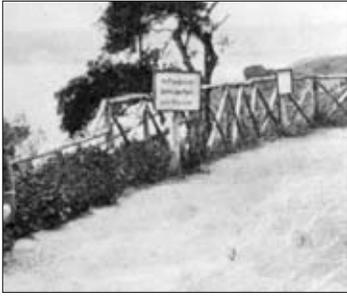
Fence, Circa 1900  
Location: East Road Entrance  
Removed

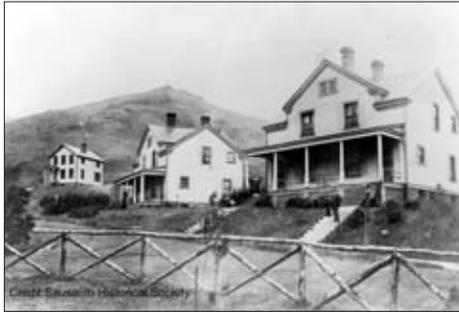
Fence, Circa 1900  
Location: Kober Street (FB527, FB523,  
and FB522)  
Removed

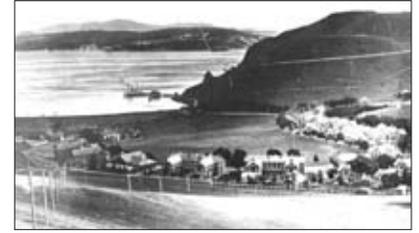
Fence, Circa 1907  
Location: Murray Circle, looking south  
Removed

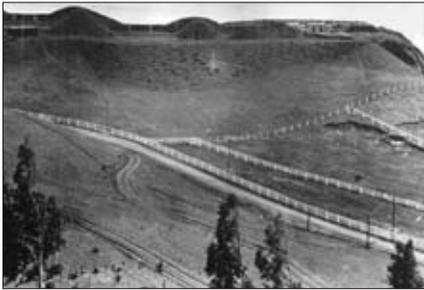
Fence, Circa 1914  
Location: Near Battery Cavallo and  
Battery Yates  
Removed

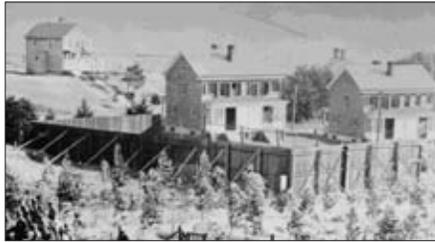
Fence, Circa 1915  
Location: Tennis Court (FB537)  
Removed

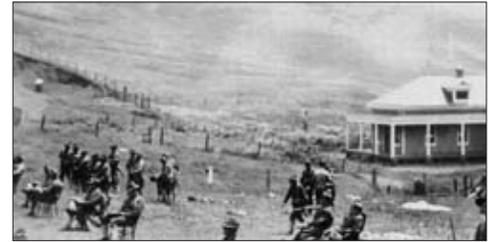
Fence, Circa 1915  
Location: FB533, looking east  
Removed

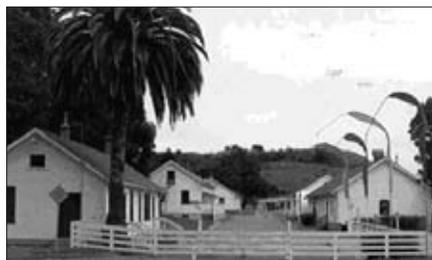
Fence, 2001  
Location: Satterlee Road (FB557 and  
FB637) looking east  
Extant

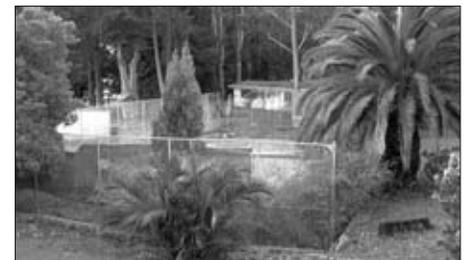
Fence, 2001  
Location: Tennis Court (FB537)  
Extant

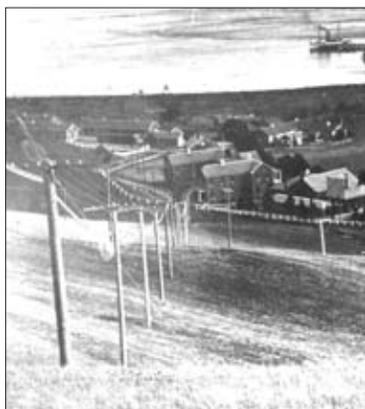
Utility Pole, Circa 1907  
Location: East side of Murray Circle,  
looking south  
Removed

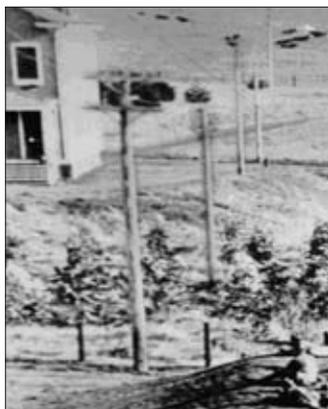
Utility Pole, Circa 1915  
Location: East side of Murray Circle,  
(FB601) looking east  
Extant

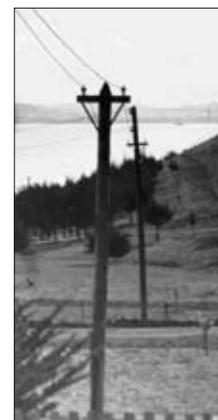
Utility Pole, Circa 1915  
Location: West side of Murray  
Circle, looking south  
Extant

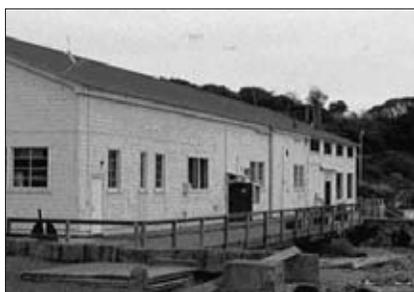
Railing, 2001  
Location: FB679, looking east  
Extant

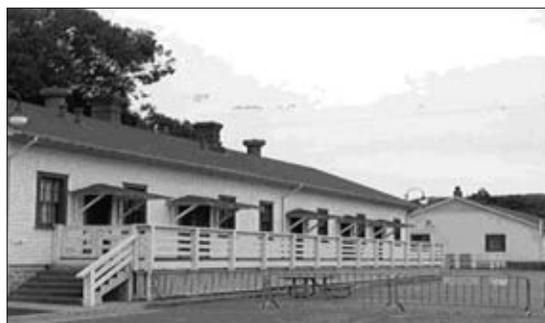
Railing, 2001  
Location: Service area  
Extant

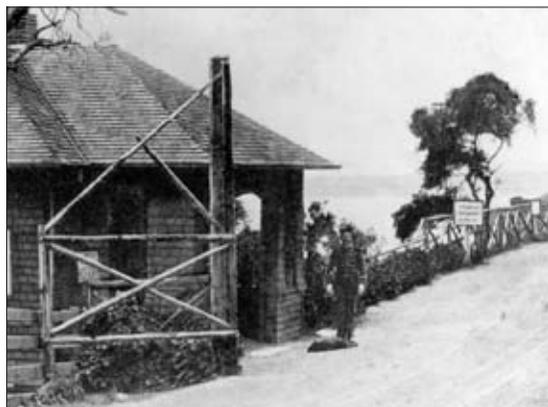
Entrance Gate, Circa 1900  
Location: East Road Entrance  
Removed

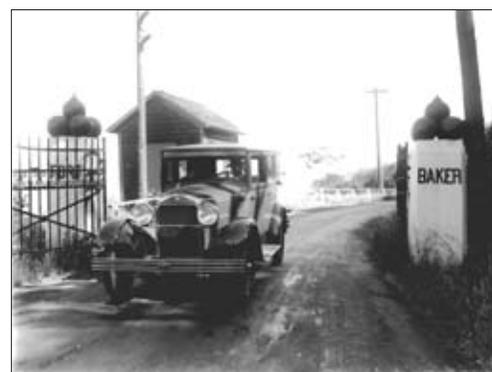
Entrance Gate, Circa 1925  
Location: East Road Entrance (Marin  
History Museum)  
Removed

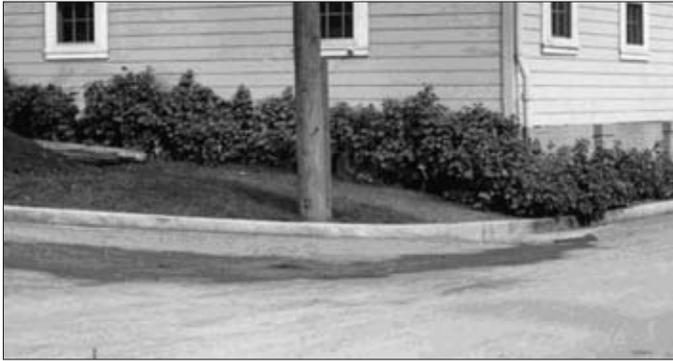
Street Curb, 1938  
Location: FB561  
Extant

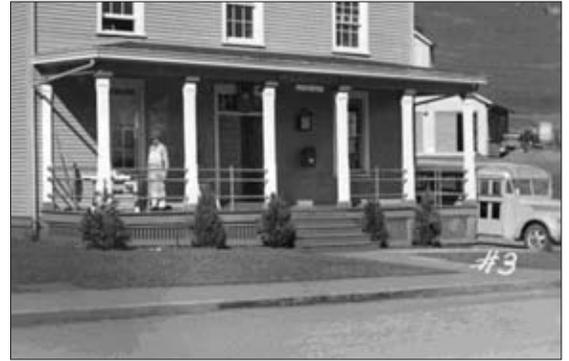
Sidewalk Curb, Circa 1938  
Location: FB603  
Extant

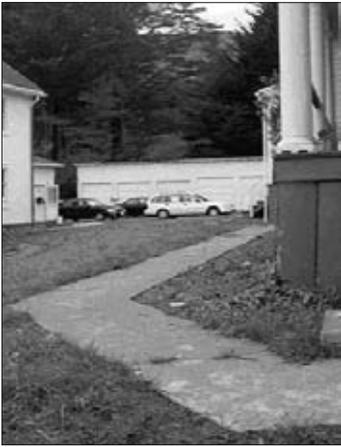
Walkway, 2001  
Location: FB631  
Extant

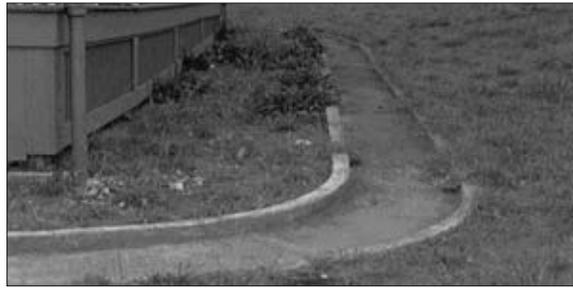
Walkway, 2001  
Location: FB607  
Extant

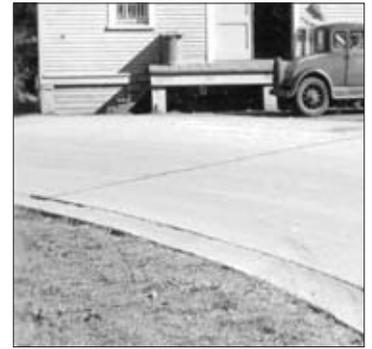
Road Gutter, Circa 1925  
Location: FB631  
Extant

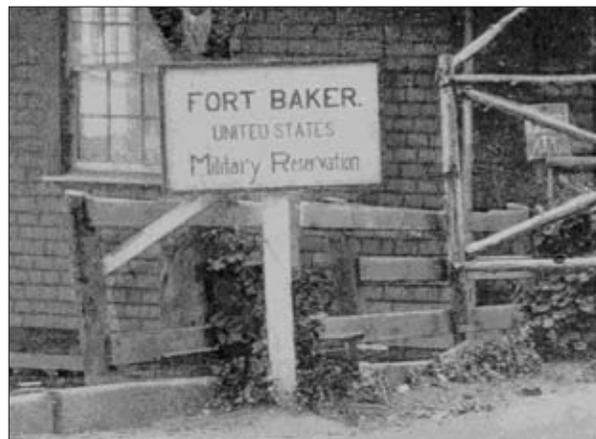
Sign, Circa 1900  
Location: East Road Entrance  
Removed

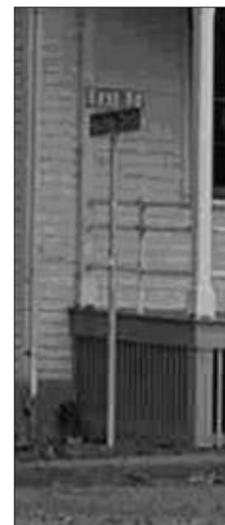
Sign, 2001  
Location: FB615  
Extant

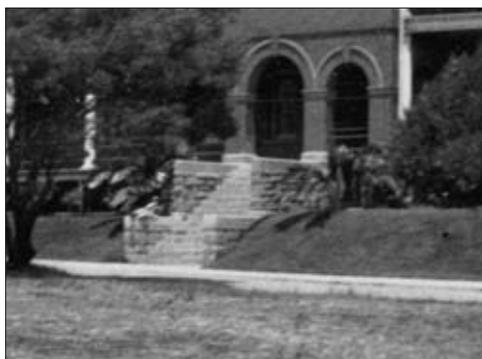
Stairs, Circa 1915  
Location: FB636  
Removed

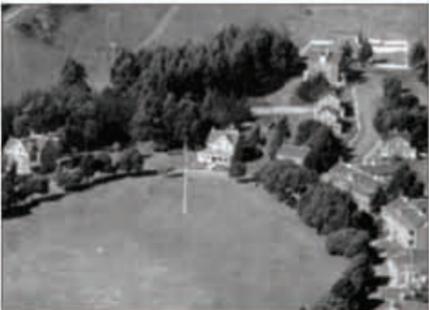
**A** Retain gap in tree planting. Throughout the period of significance, the Commanding Officer's residence, FB604, retained a direct view to Horseshoe Cove and San Francisco Bay. alternately, the Commanding Officer's residence was the most visible building on the parade ground from the waterfront (Photo National Archives and Record Center, September 1929).

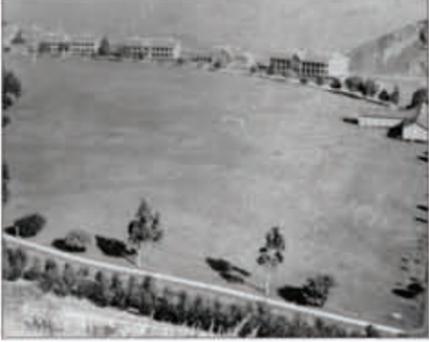
**B** Character of Parade Ground planting. Blue gum eucalyptus (*Eucalyptus globulus*) and black acacia (*Acacia melanoxylon*) trees lined Murray Circle. These two species were planted in an alternating rhythm that varied the height and spread of tree canopies, in contrast to the uniform Monterey cypress windbreak planting visible in the foreground (Photo Golden Gate National Recreation Area collection, circa 1915).

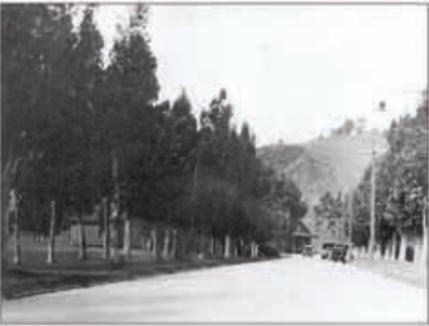
**C** A uniform planting of eucalyptus created a formal allee on Center Road (Photo Golden Gate National Recreation Area Collection, 1928).

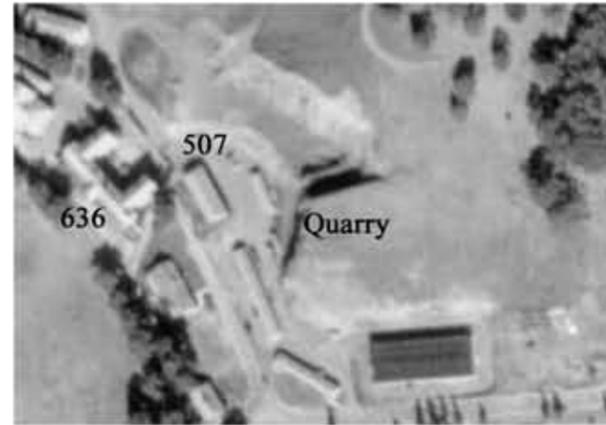
Building FB507 is almost entirely surrounded by the quarry. (NPS photo, 1946 Aerial Photo)

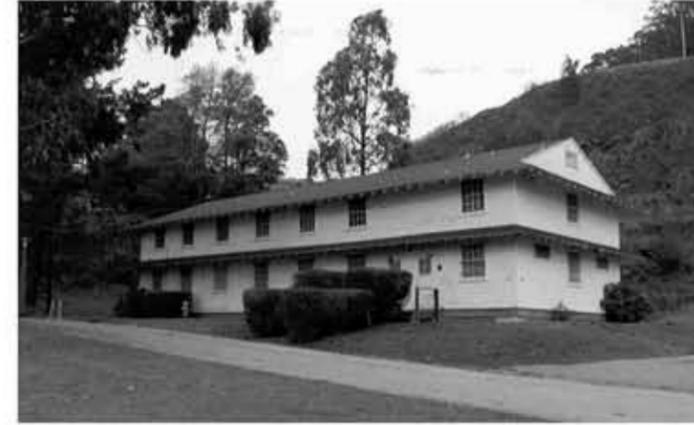
Building FB507, looking north. The foundation plantings are assumed to be historic. (NPS, 2001)

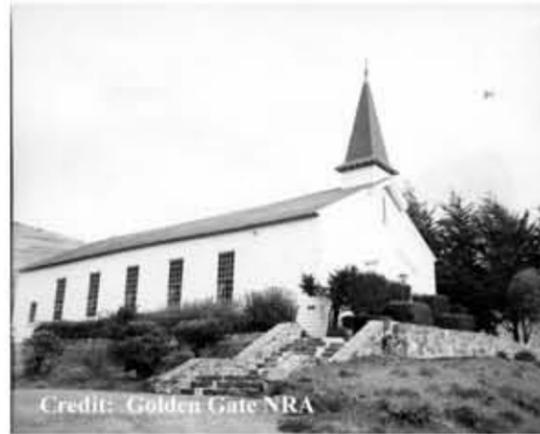
Credit: Golden Gate NRA  
 A mix of flowering and evergreen foundation plantings are visible in front of and around the building. (NPS photo, 1956)

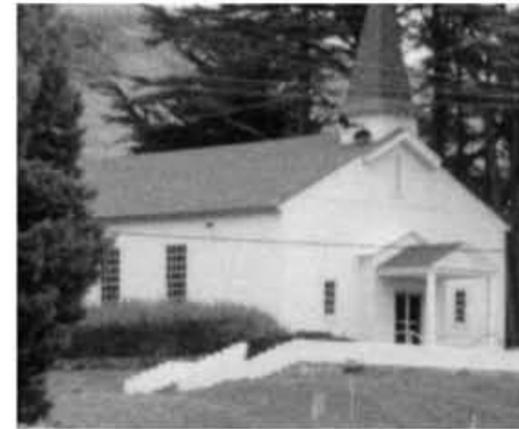
Building FB519, view looking west. Removal of historic vegetation has altered the landscape character. (NPS, 2001)

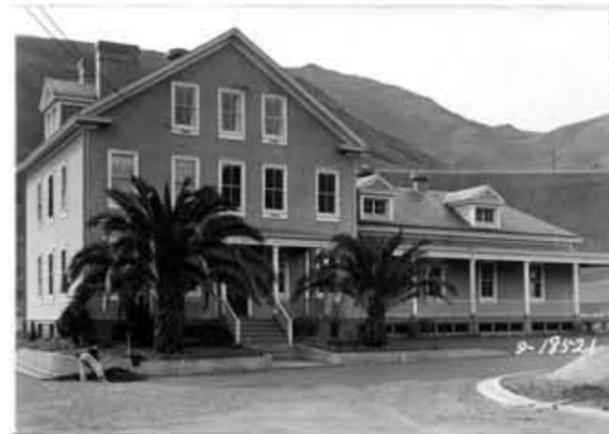
Ground cover, shrubs and flowering herbaceous material was used in the foundation planting surrounding the hospital. (NPS photo, 1938 Quartermaster Report)

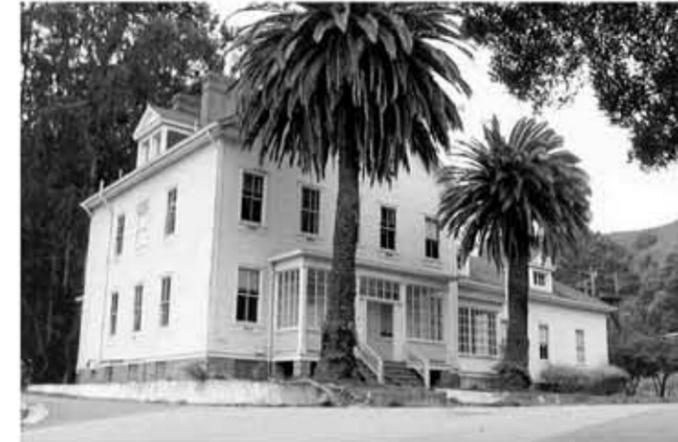
Building FB533, view looking west. Some of the historic vegetation has been removed which has altered the landscape character. (NPS, 2001)

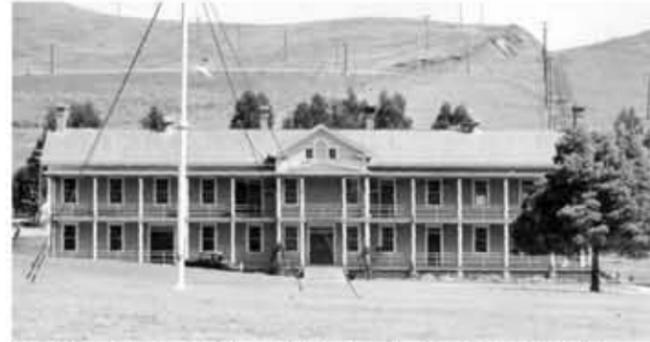
Foundation plantings are visible along the front porch and on the south side of the building. Columnar shrubs marked the building entrance. (NPS photo, 1941)

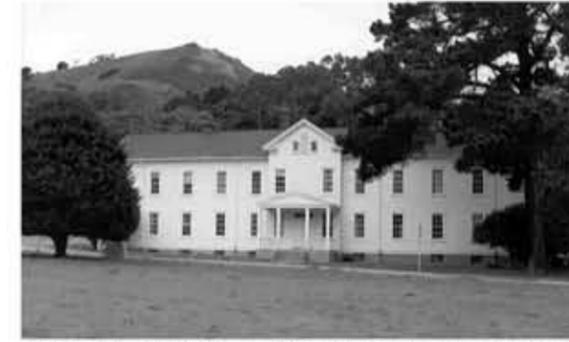
Building FB601, looking west. The foundation plants have all been removed.

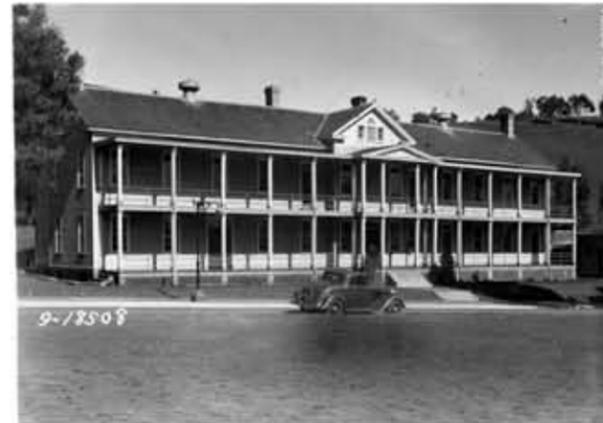
Building FB602, circa 1938. Columnar shrubs which flank the entry steps are the only visible foundation plantings. (NPS photo, 1938 Quartermaster Report)

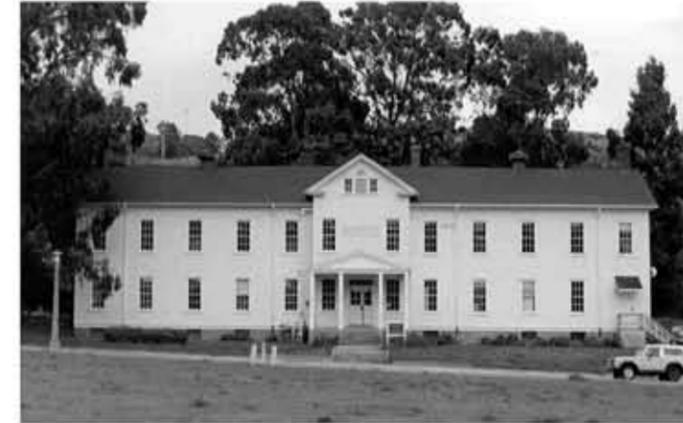
Building FB602, looking east. The front porch was removed in 1959. A sporadic foundation planting exists today. (NPS, 2001)

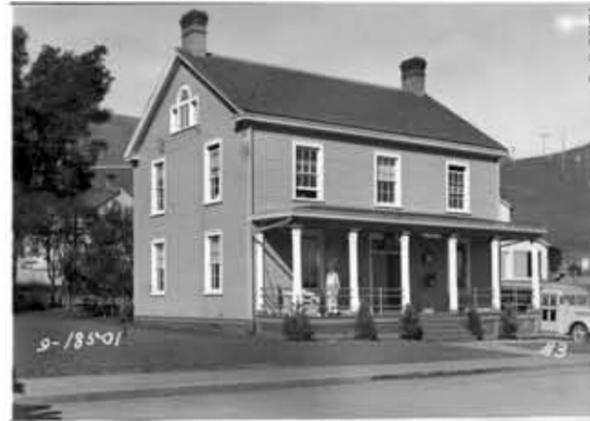
Five evergreen shrubs were located at regular intervals along the front facade of Building FB603. (NPS photo, 1938 Quartermaster Report)

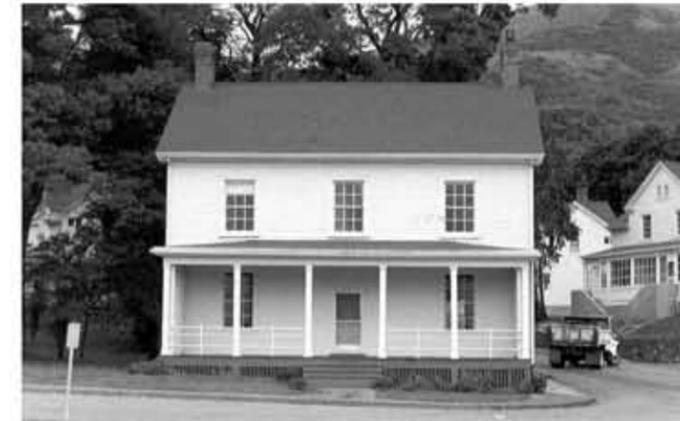
Building FB603, looking north. The existing foundation plants are of a different character, yet in the approximate location of the historic plantings. (NPS, 2001)

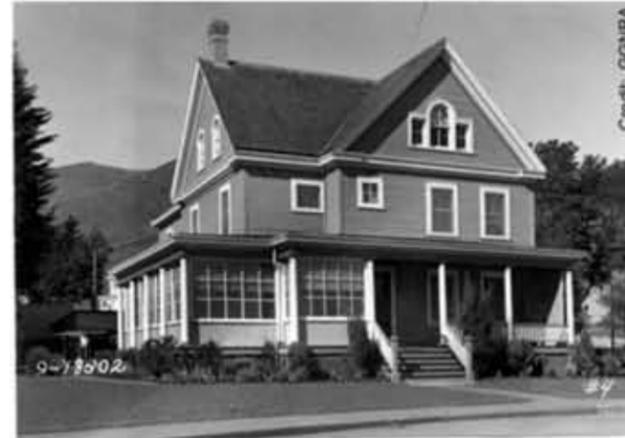
The foundation plantings around the commanding officer's residence contained a mix of flowering herbaceous and evergreen shrubs. (NPS photo, 1938 Quartermaster Report)

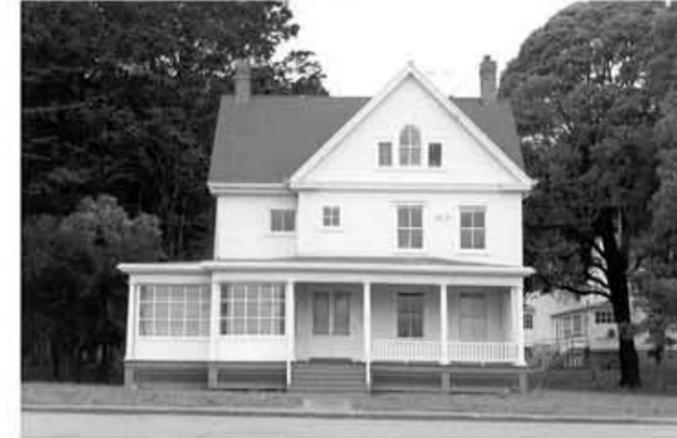
Building FB604, looking north. The foundation plants have all been removed.

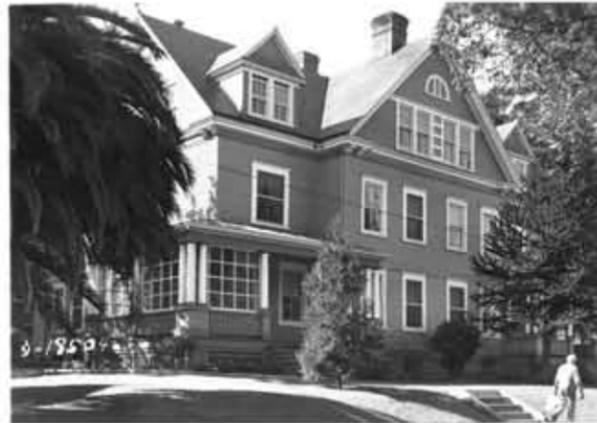
Building FB605, circa 1938. Flowering foundation plantings are visible in front of and around the building. (NPS photo, 1938 Quartermaster Report)

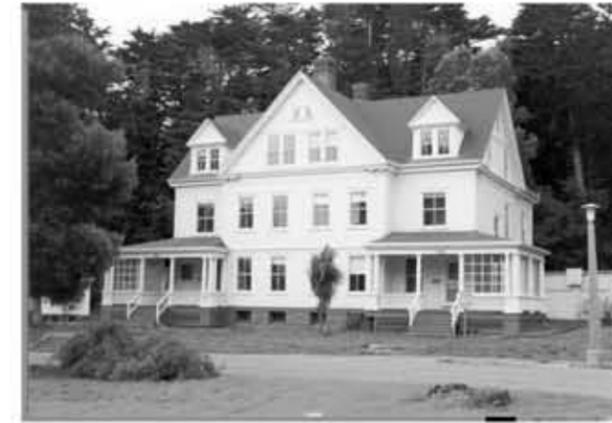
Building FB605, view looking west. Removal of historic vegetation has altered the landscape character. (NPS, 2001)

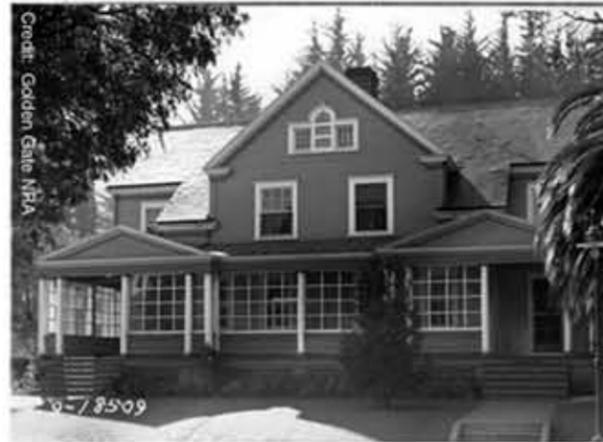
A mix of flowering and evergreen foundation plantings are visible in front of and around the building. (NPS photo, 1938 Quartermaster Report)

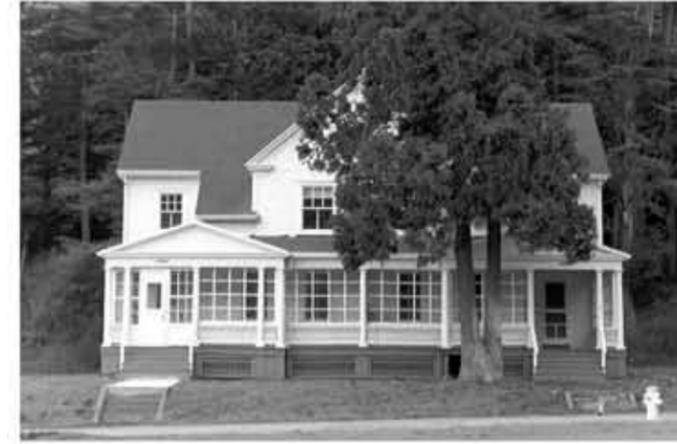
Building FB606, view looking west. Removal of historic vegetation has altered the landscape character. (NPS, 2001)

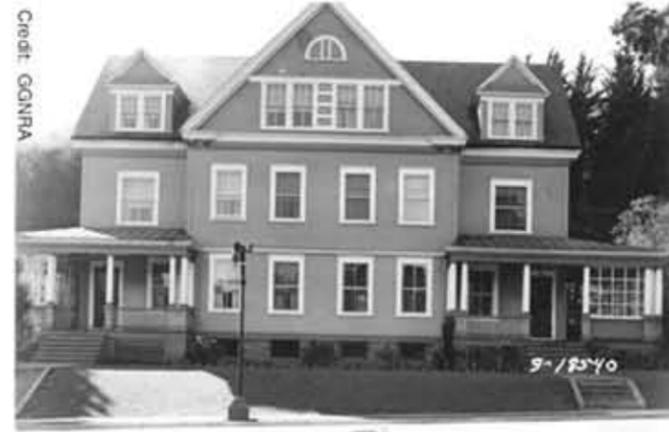
A mix of flowering and evergreen foundation plantings were planted between basement windows along the front facade. (NPS photo, 1938 Quartermaster Report)

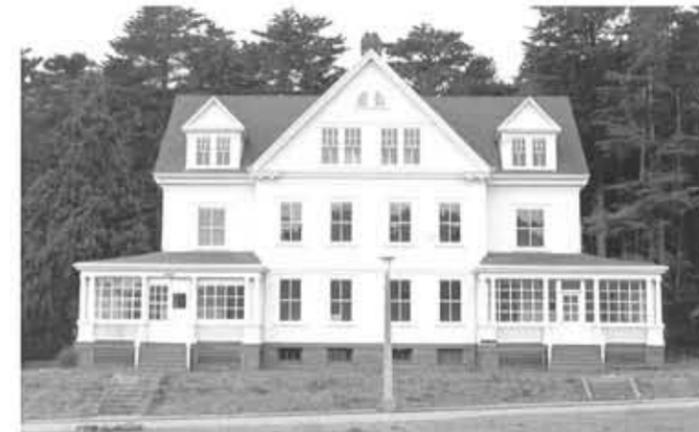
Building FB607, view looking west. Removal of historic vegetation has altered the landscape character. (NPS, 2001)

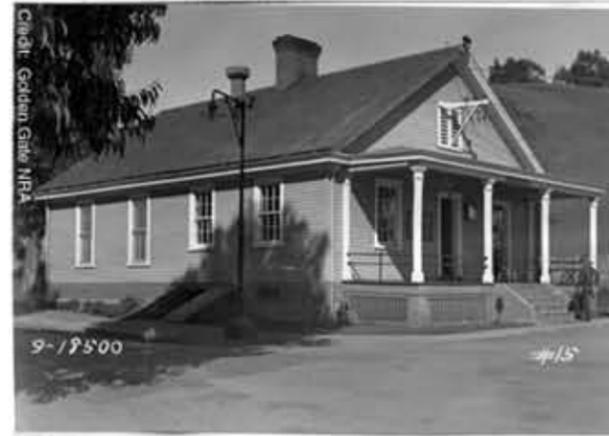
Foundation plantings were primarily located on the west side of FB615, facing the parade ground. (NPS photo, 1938 Quartermaster Report)

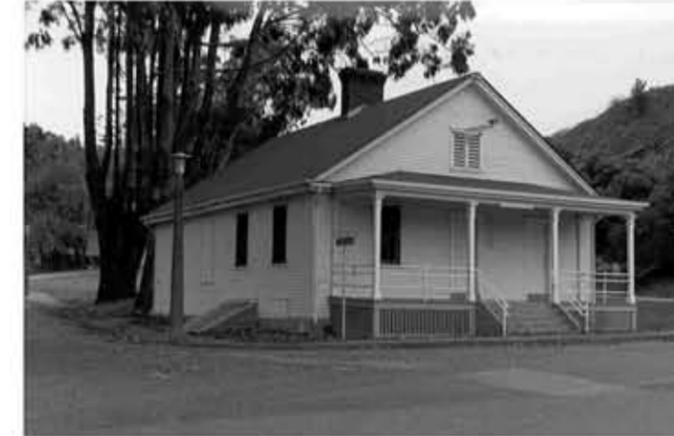
Building FB615, view looking north. The historic vegetation has been removed. (NPS, 2001)
