# Cultural Landscape Report for Fort Baker Golden Gate National Recreation Area

## Golden Gate National Recreation Area

Fort Baker, Barry and Cronkhite Historic District  
Marin County, California

July 2005

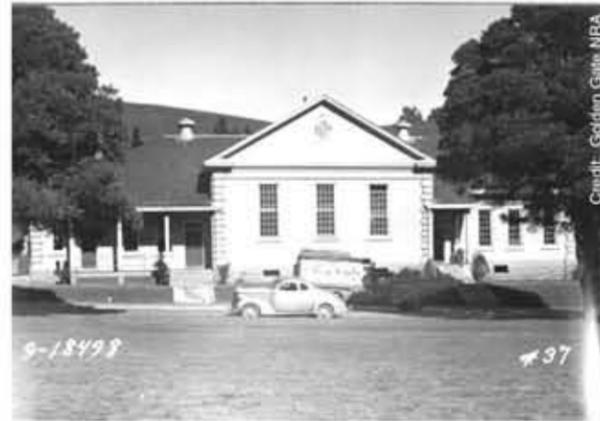
Columnar shrubs marked the building entrances. (NPS photo, 1938 Quartermaster Report)

Replace flowering broad leaf shrubs (character and form of hydrangea) at the entrance to the building, flanking walk.

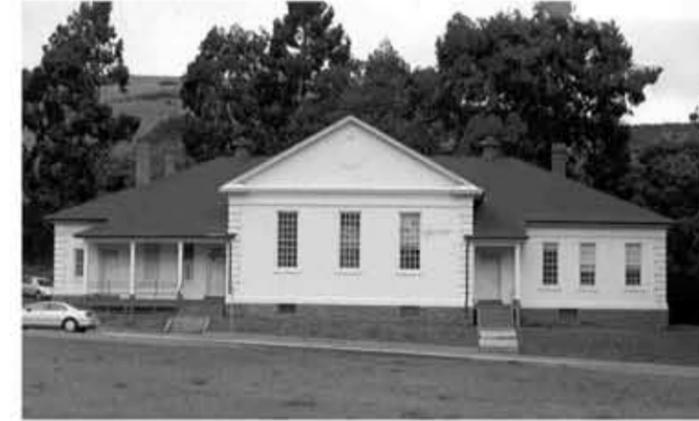
Building FB623, looking east. All plant material has been removed. (NPS, 2001)

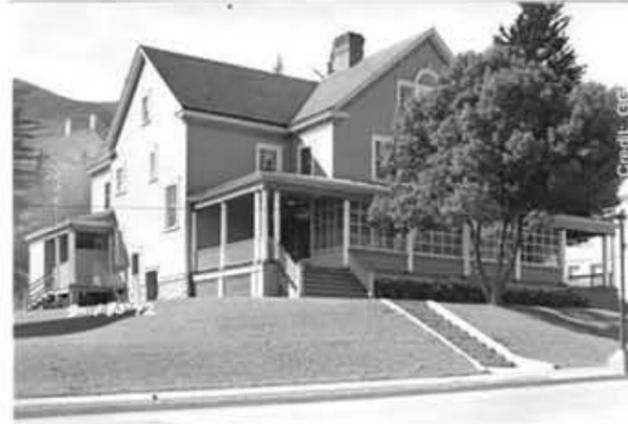
A mix of flowering and evergreen foundation plantings are visible in the foundation planting along the front facade. (NPS photo, 1938 Quartermaster Report)

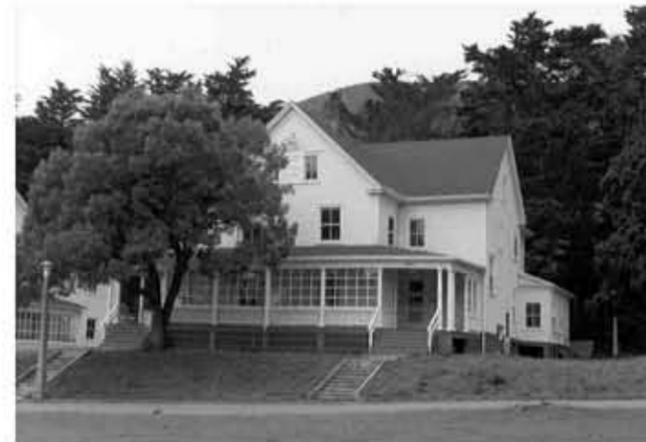
Building FB629, view looking west. Removal of historic vegetation has altered the landscape character. (NPS, 2001)

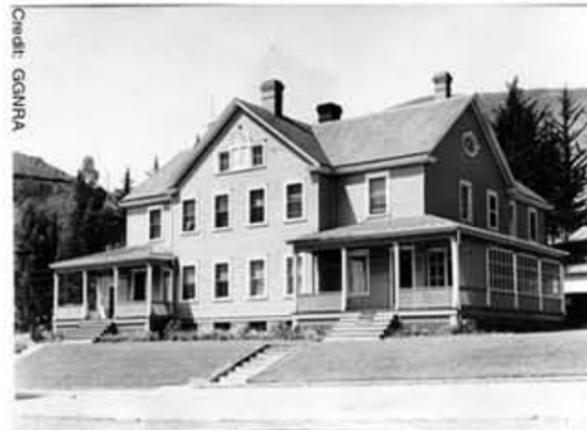
A mix of flowering and evergreen foundation plantings are visible in front of and around the building. (NPS photo, 1938 Quartermaster Report)

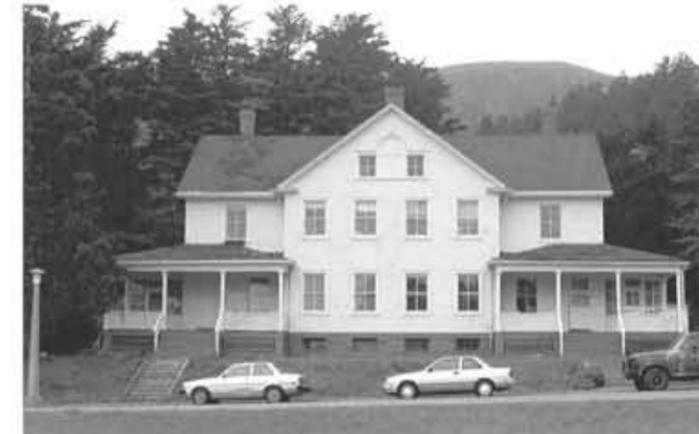
Building FB631, view looking west. Removal of historic vegetation has altered the landscape character. (NPS, 2001)

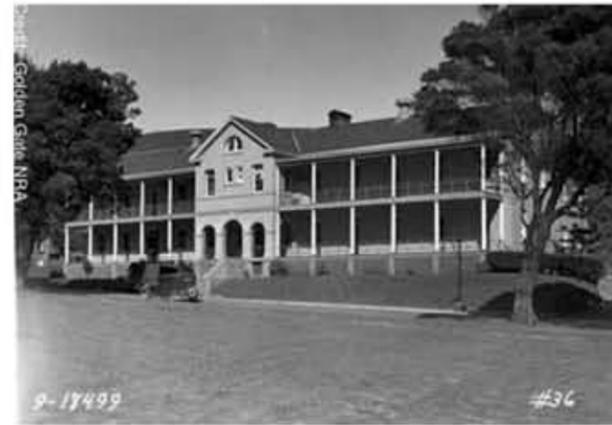
A distinctive hedge extended south from the end of the front porch of Building FB636 to the road. (NPS photo, 1938 Quartermaster Report)

Reestablish single species evergreen hedge as indicated in diagram. Hedge is not to exceed three feet in height.

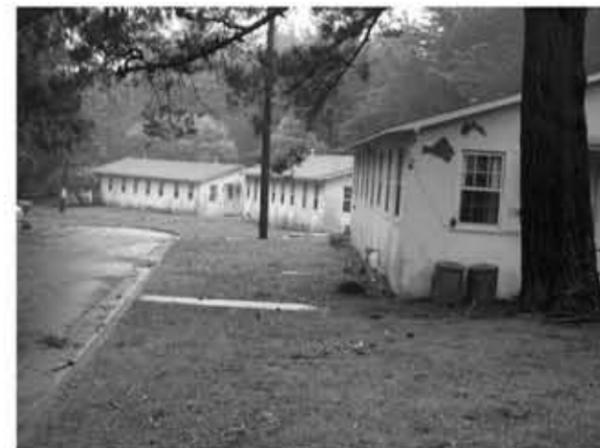
Contemporary photograph of the Enlisted Family Quarters. (NPS 2002)

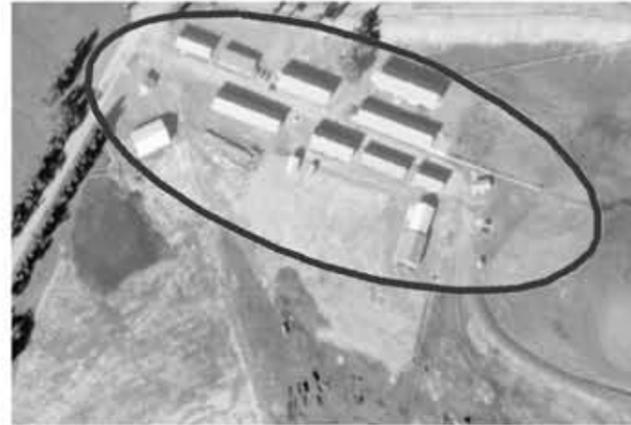
1937 aerial photograph depicts the service area free from tree cover. (1937, GGNRA Collection)

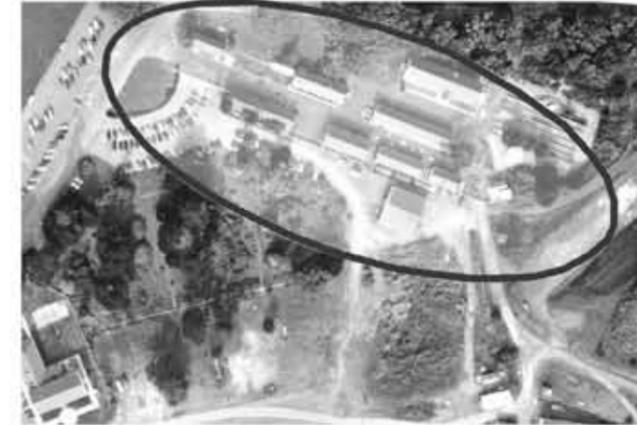
Contemporary view of the service area depicts an increase in tree cover. (1997, Towil Survey)
