HISTORIC RESOURCE STUDY  
FORT DAVIS NATIONAL HISTORIC SITE

By  
Jerome A. Greene

November 1986

U.S. Department of the Interior / National Park Service

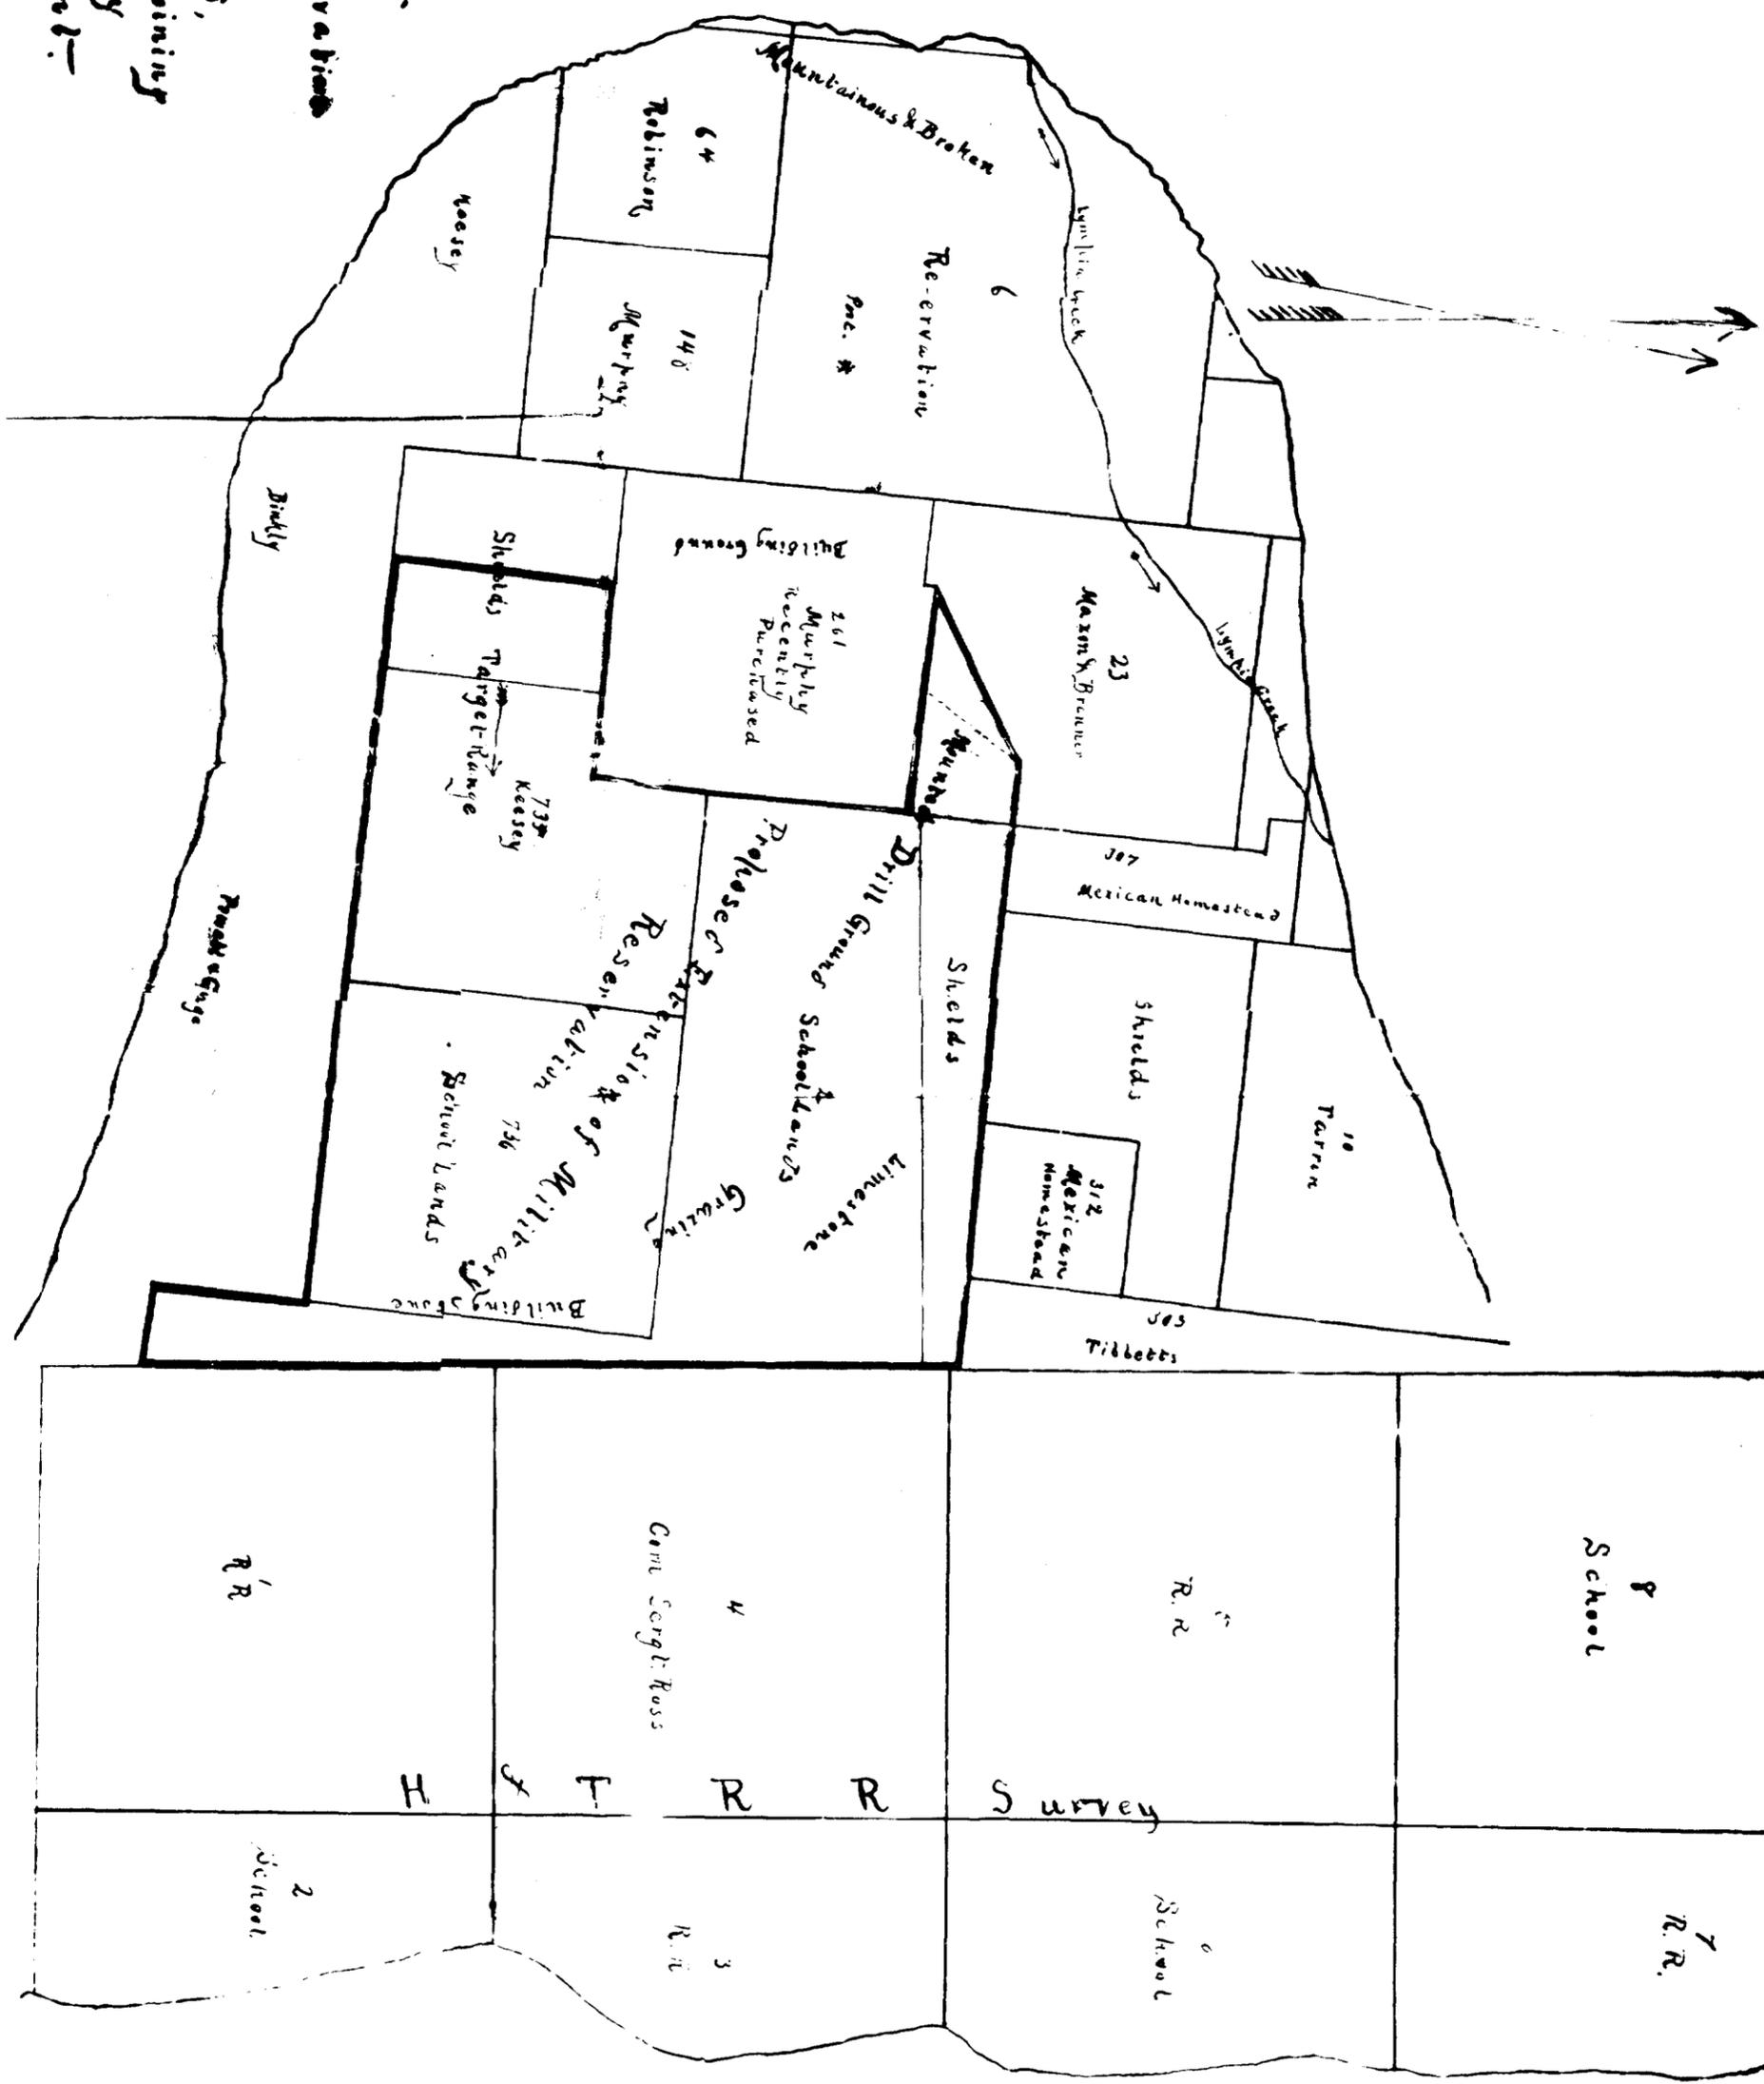
Illustration No. 30

Private Harrie F. Jordan's "Plan of the Reservation and Post of Fort Davis, Texas," 1889.

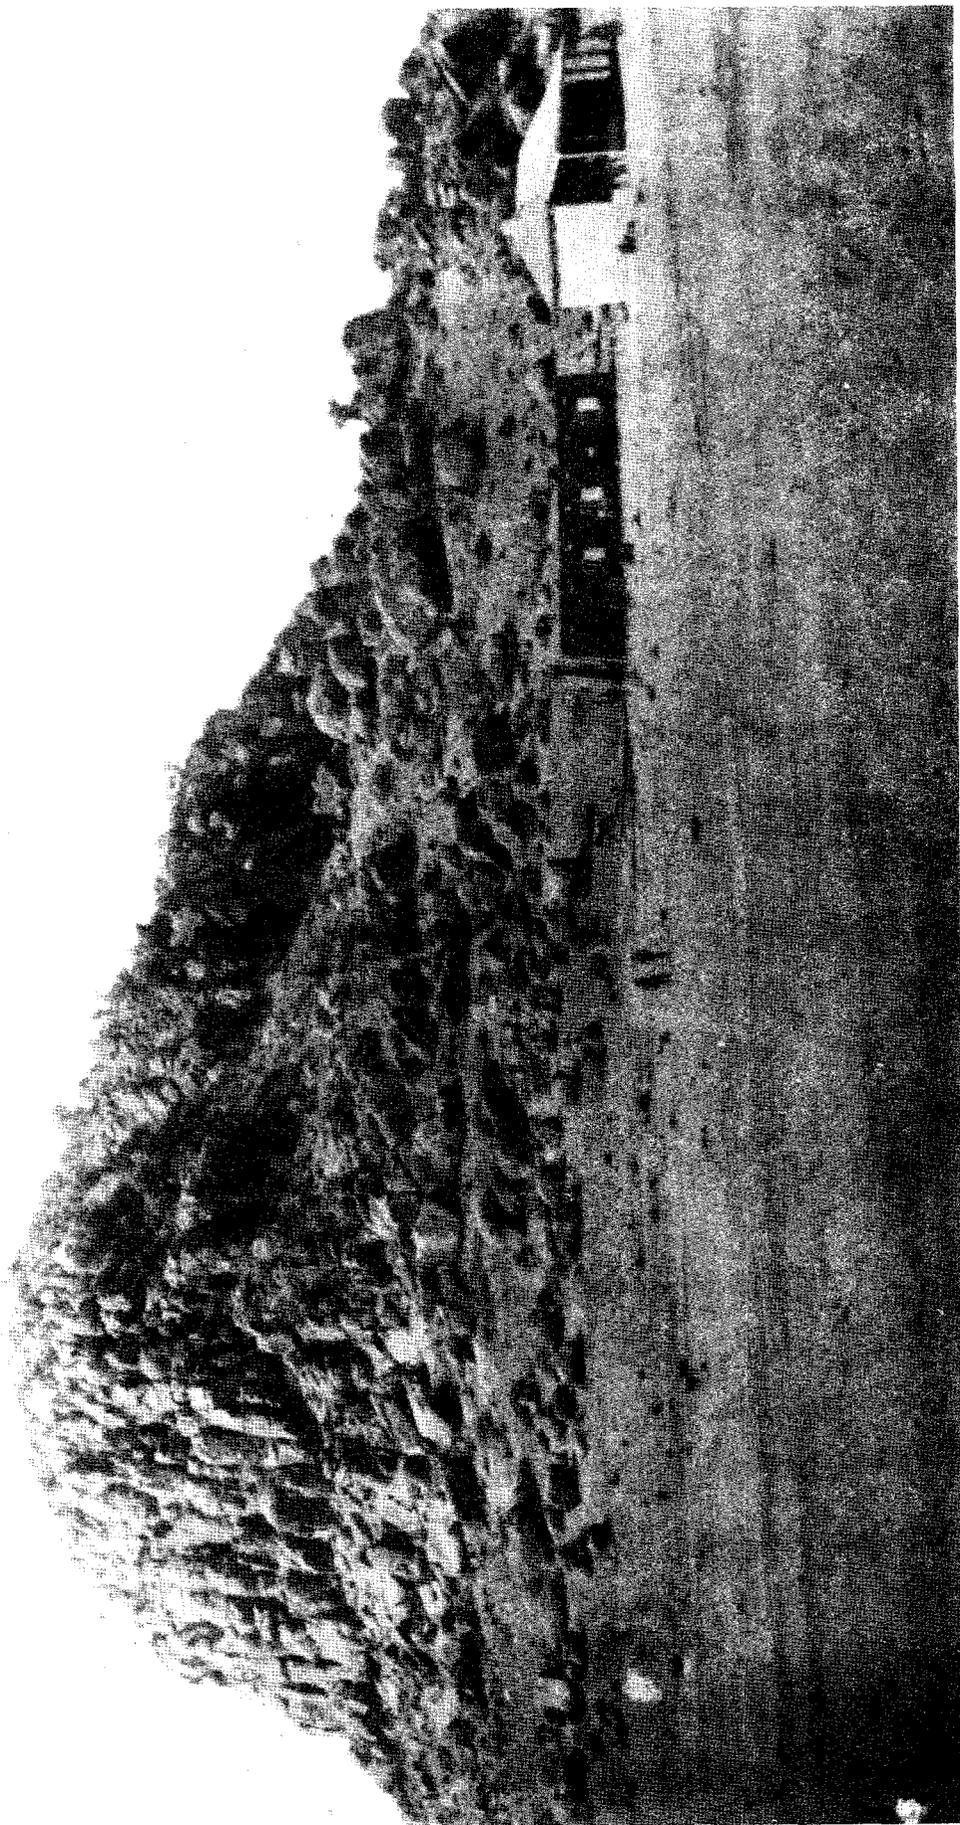
Illustration No. 38

Fort Davis, 1871, showing from left, post trader's store, first guard house, ruins of first fort barracks, and officers' quarters.

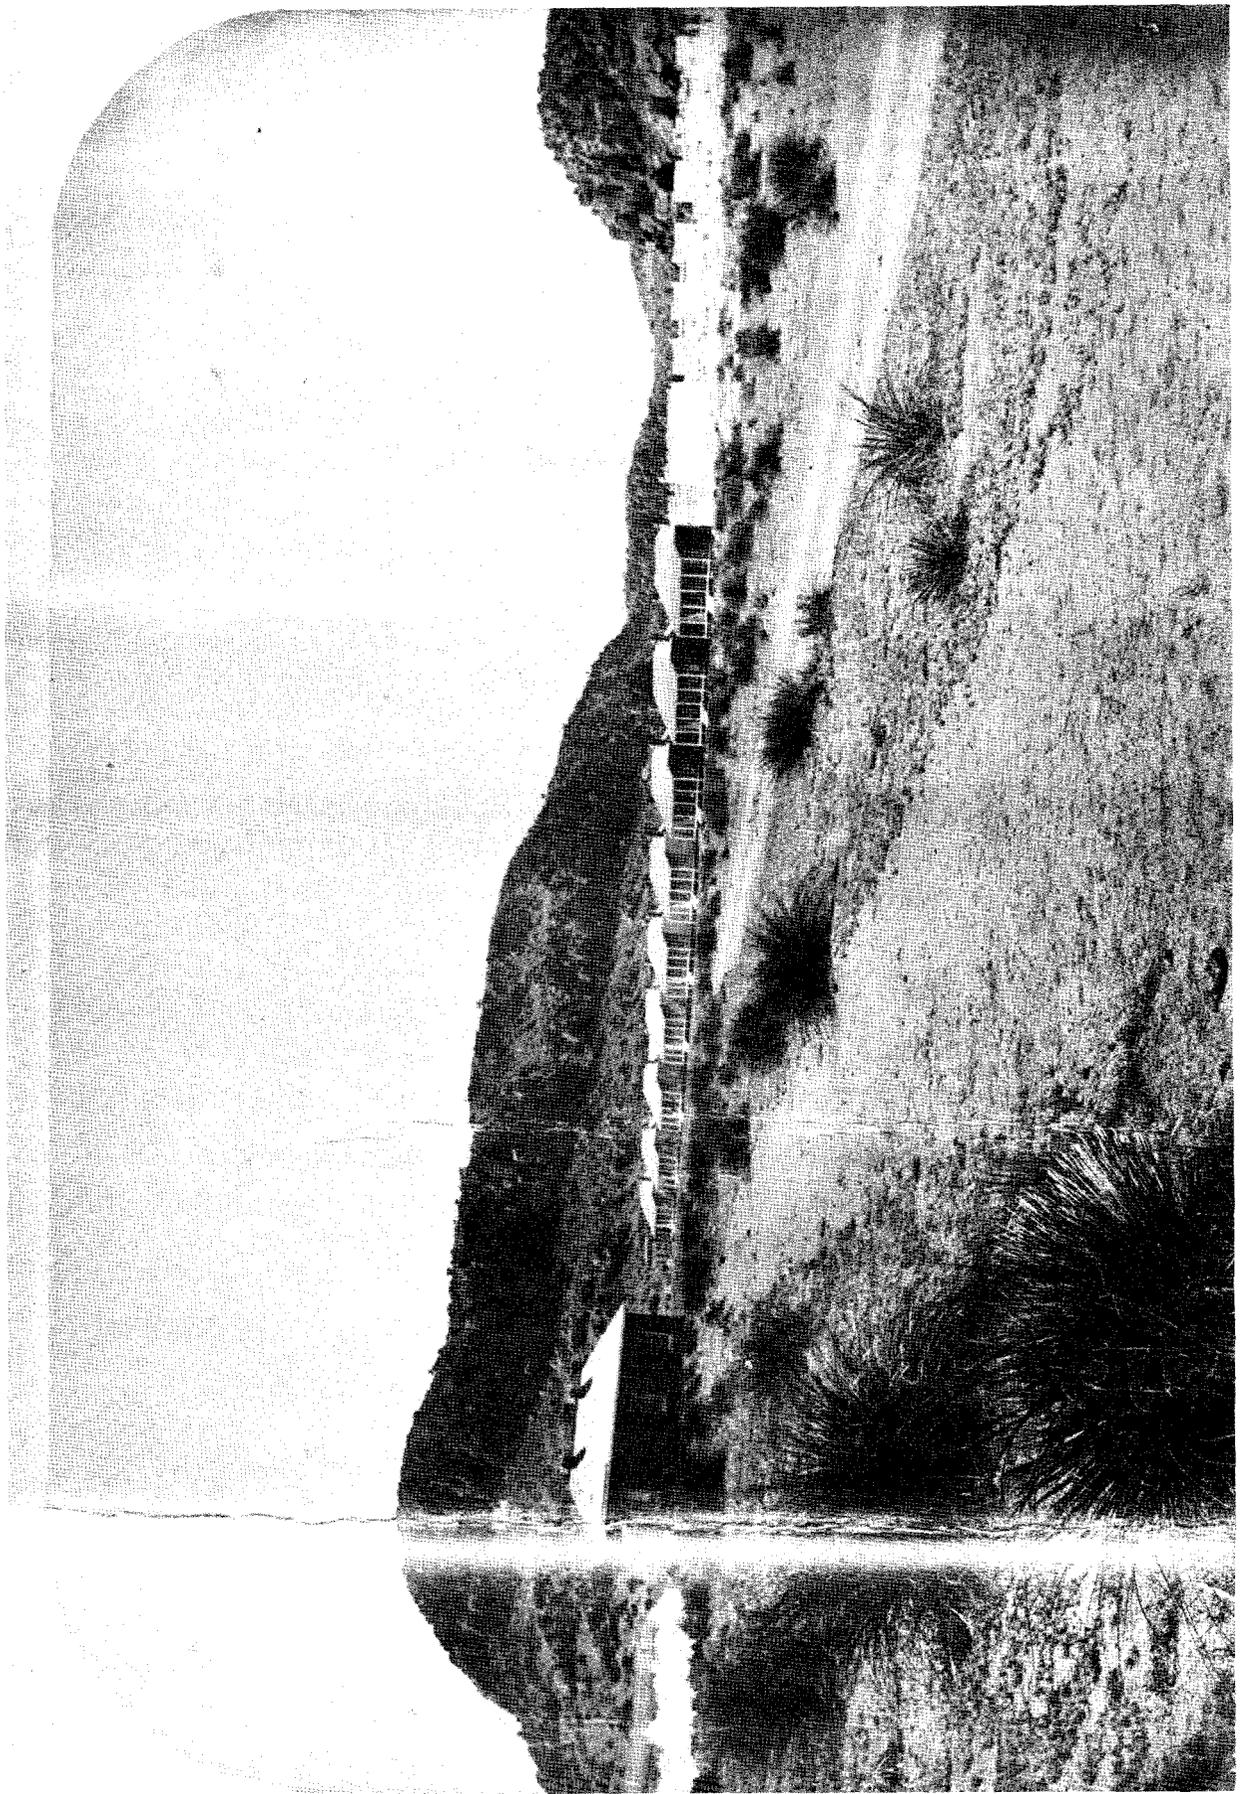
Illustration No. 41

Officers Row, 1871, showing HB-4 through HB-13. Ruin of first fort barrack is at left.

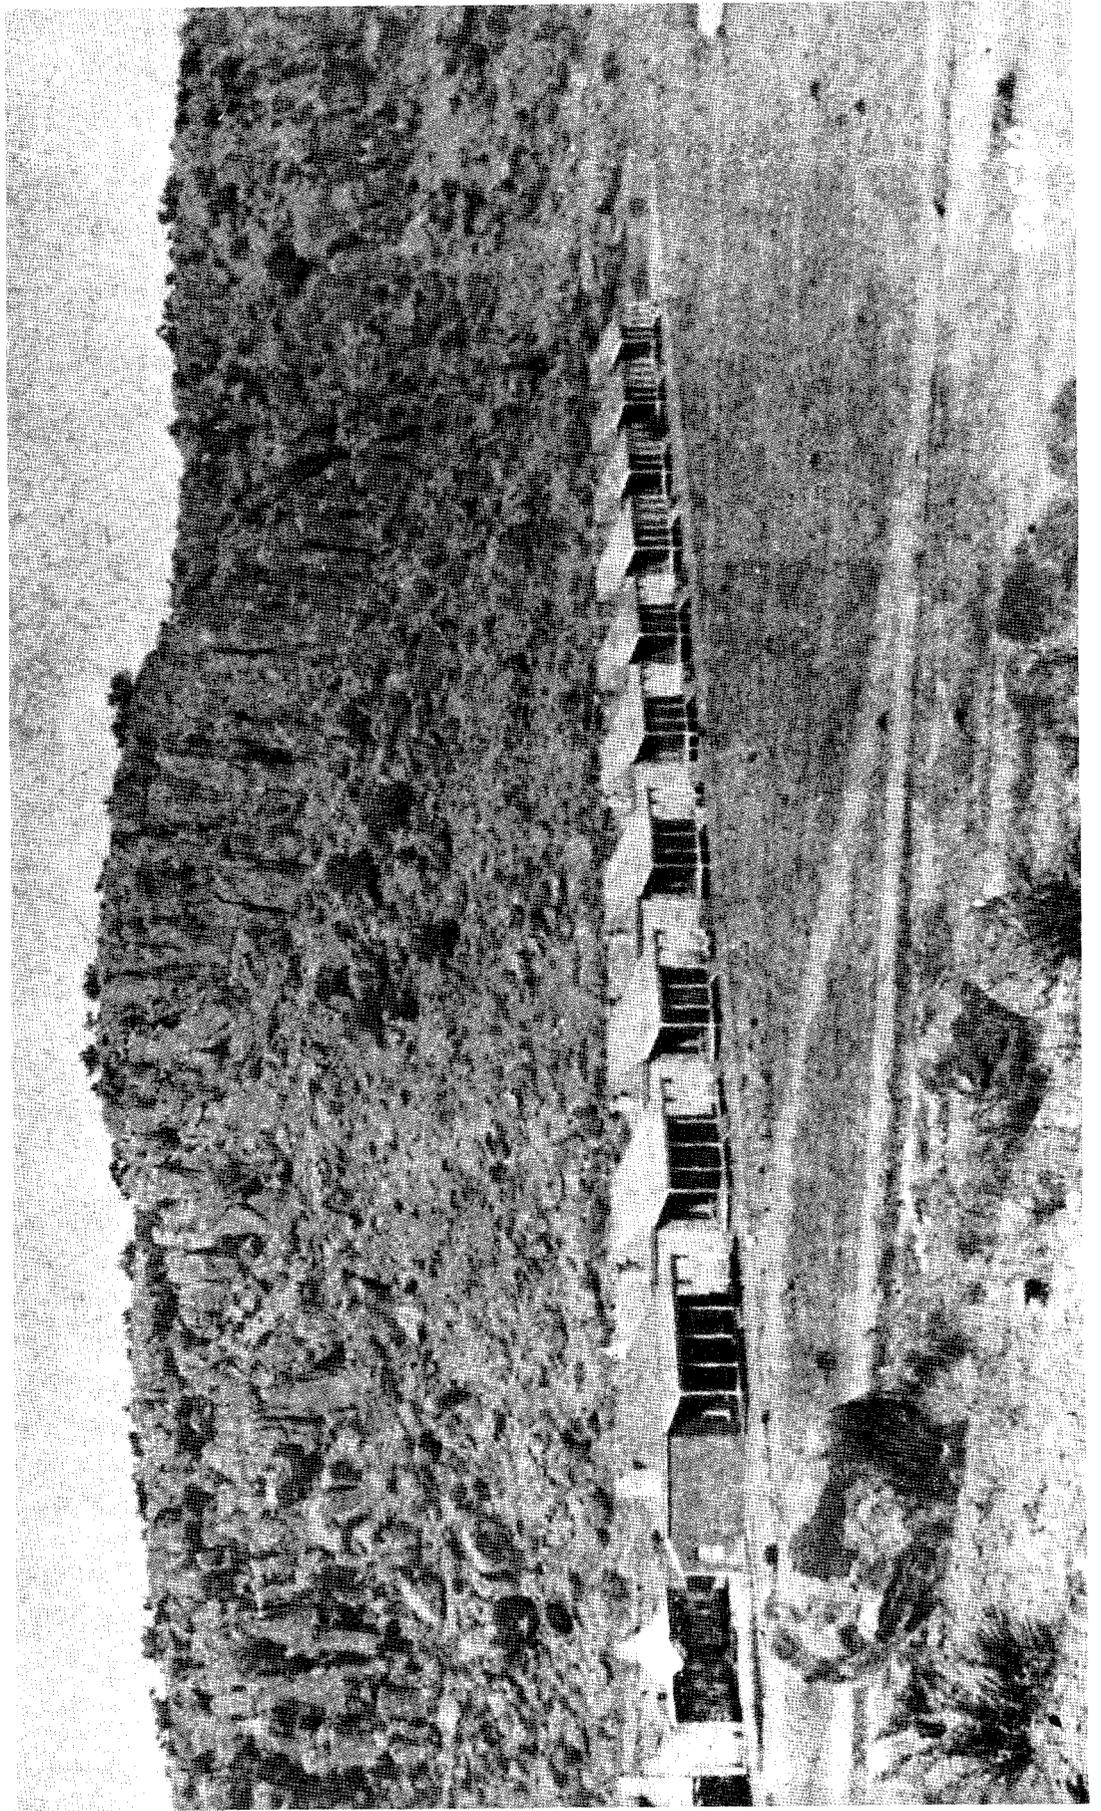
Illustration No. 43

View of first Guard House and Enlisted Men's Barracks  
HB-20 and HB-21, in 1871. Part of Post Trader's Store  
(HB-42) is at right.

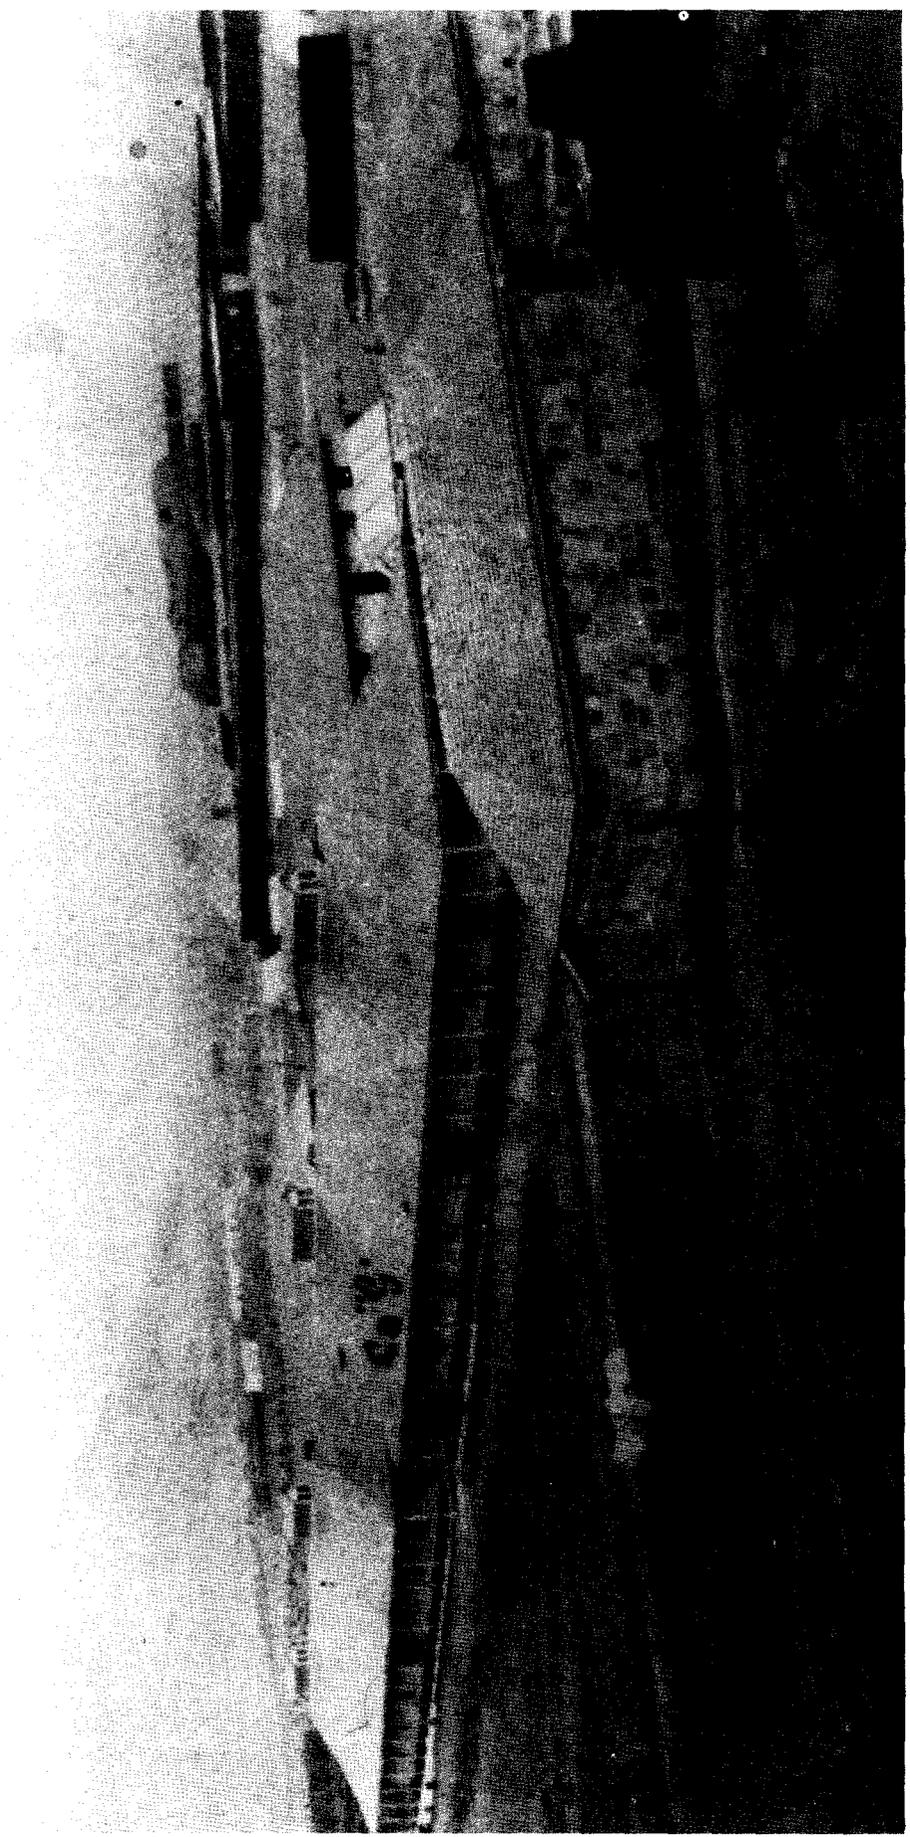
Illustration No. 44

Barracks HB-20 and HB-21, 1875. Unfinished Barracks HB-23 is at left, while the Quartermaster Corral (HB-40) and Cavalry Corral (HB-41) are in rear.

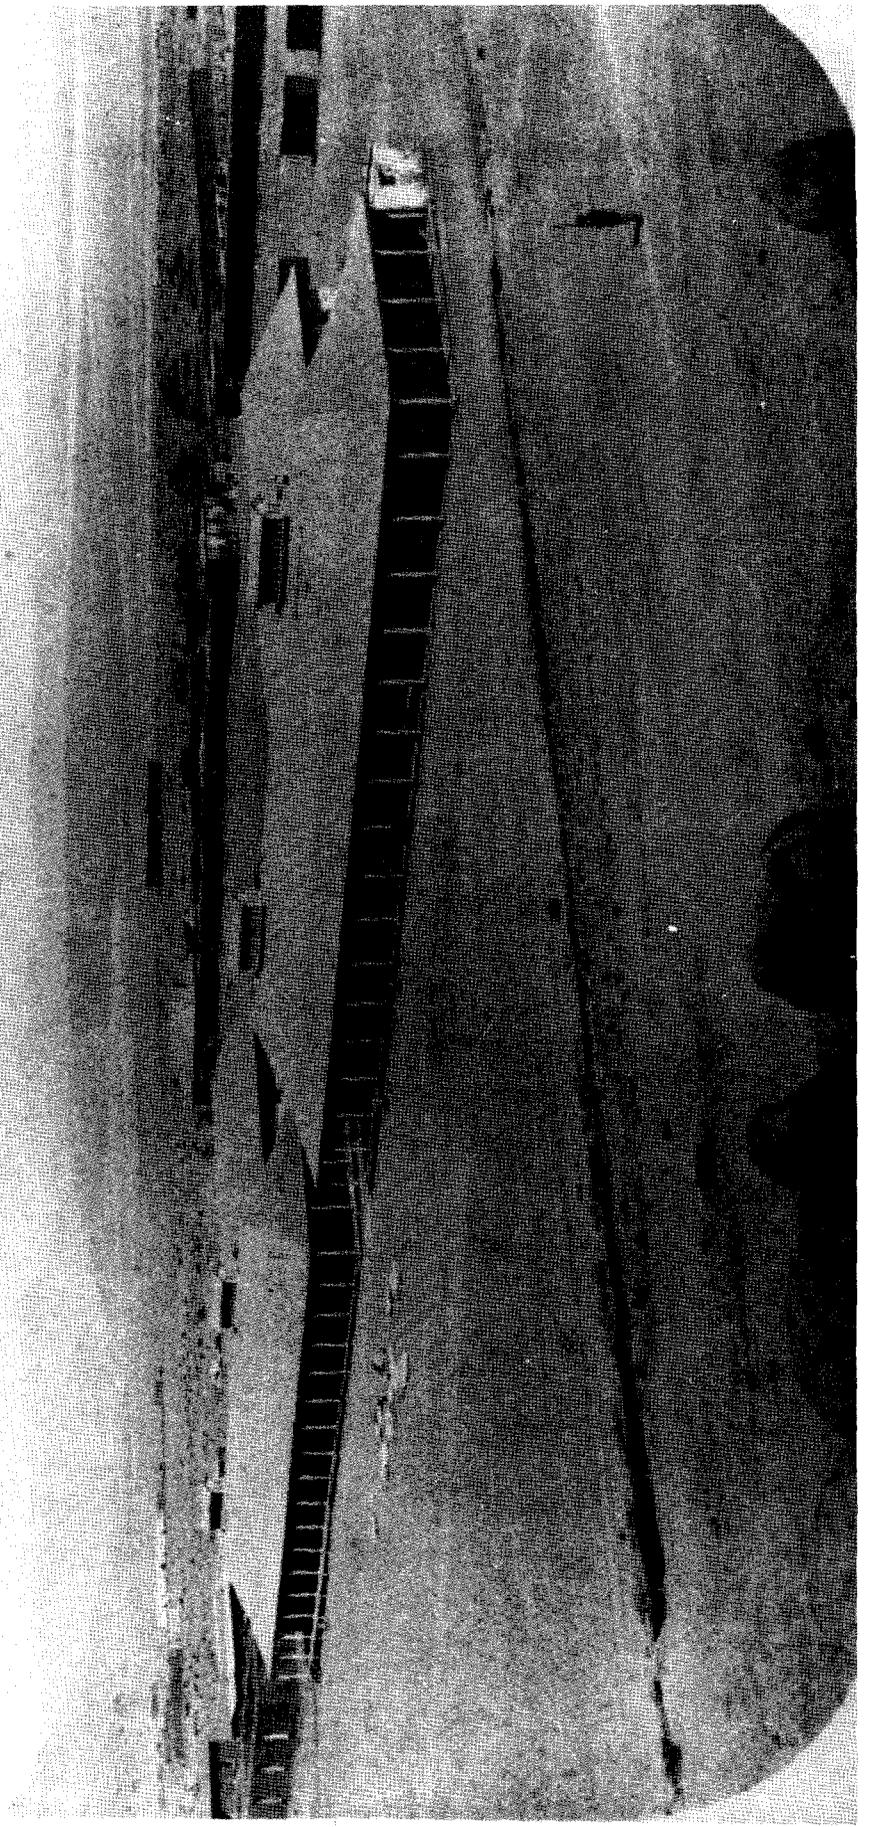
Illustration No. 45

View of post ca. 1875. Trader's Store (HB-49) is at right, behind first Guard House. Barracks HB-20 and HB-21 are at center. Unfinished barracks HB-22 and HB-23 appear at left.

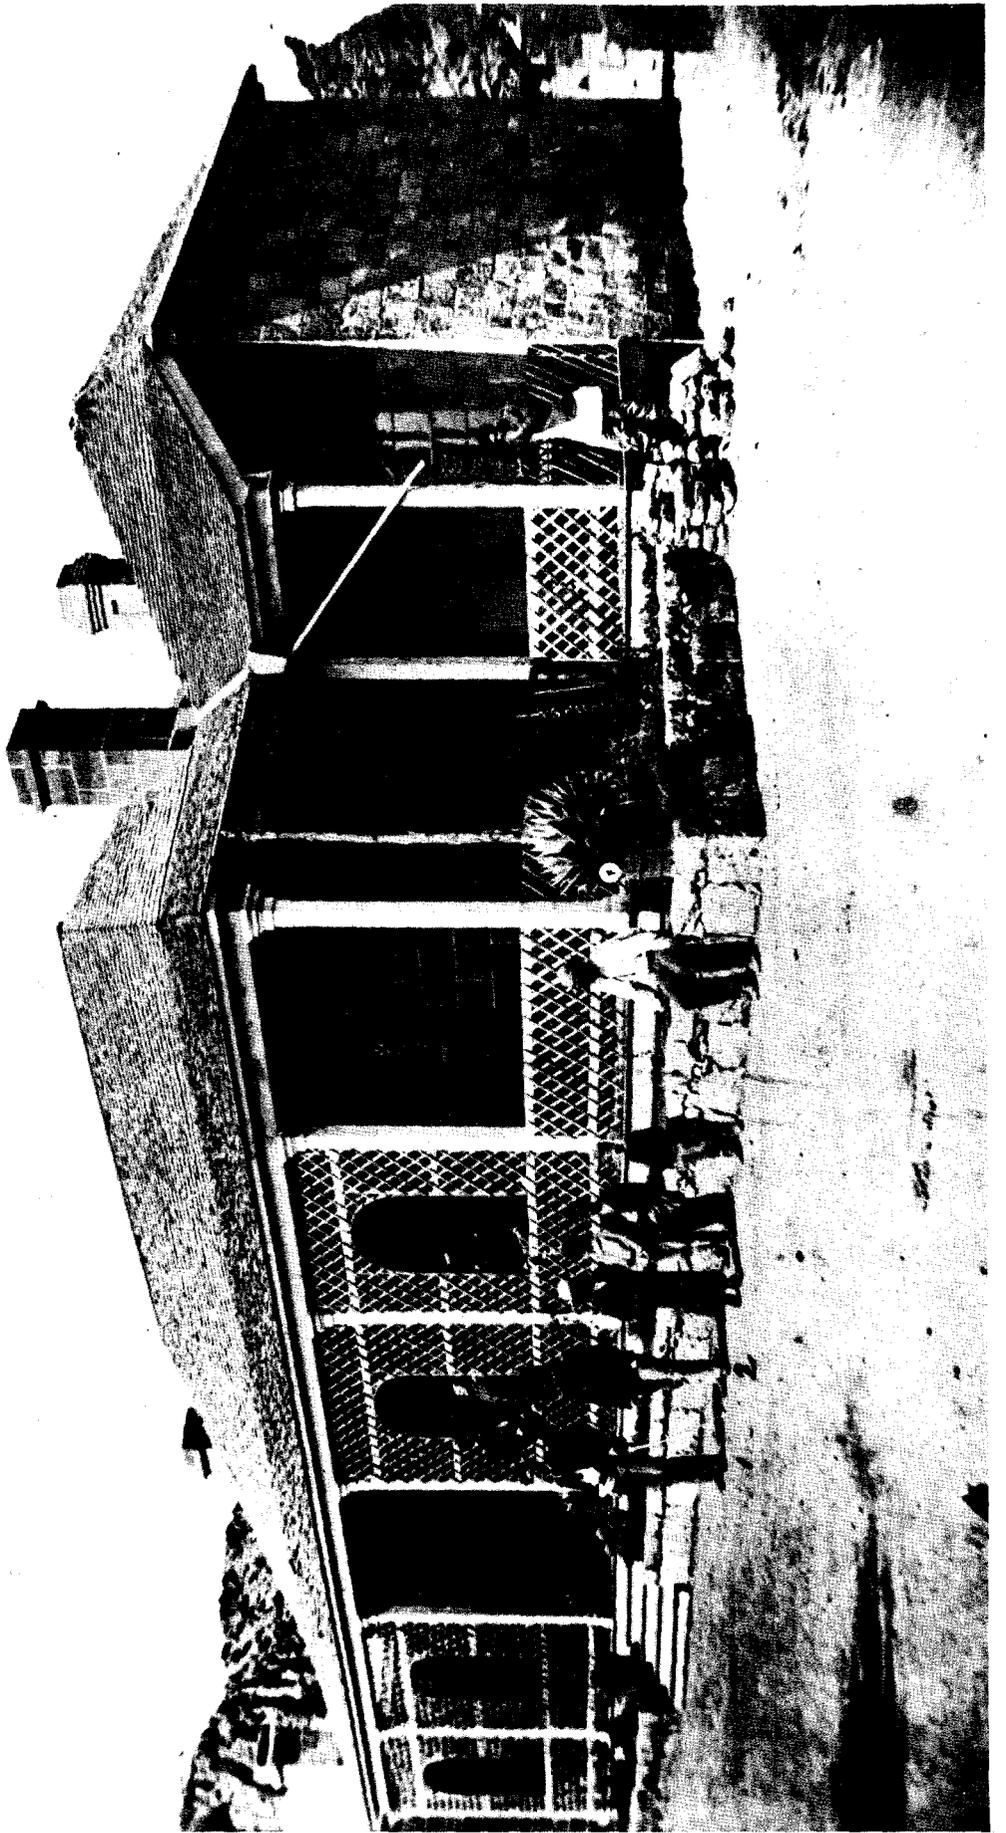
Illustration No. 48

Post Hospital (HB-46), ca. 1876-80, before south ward was added.

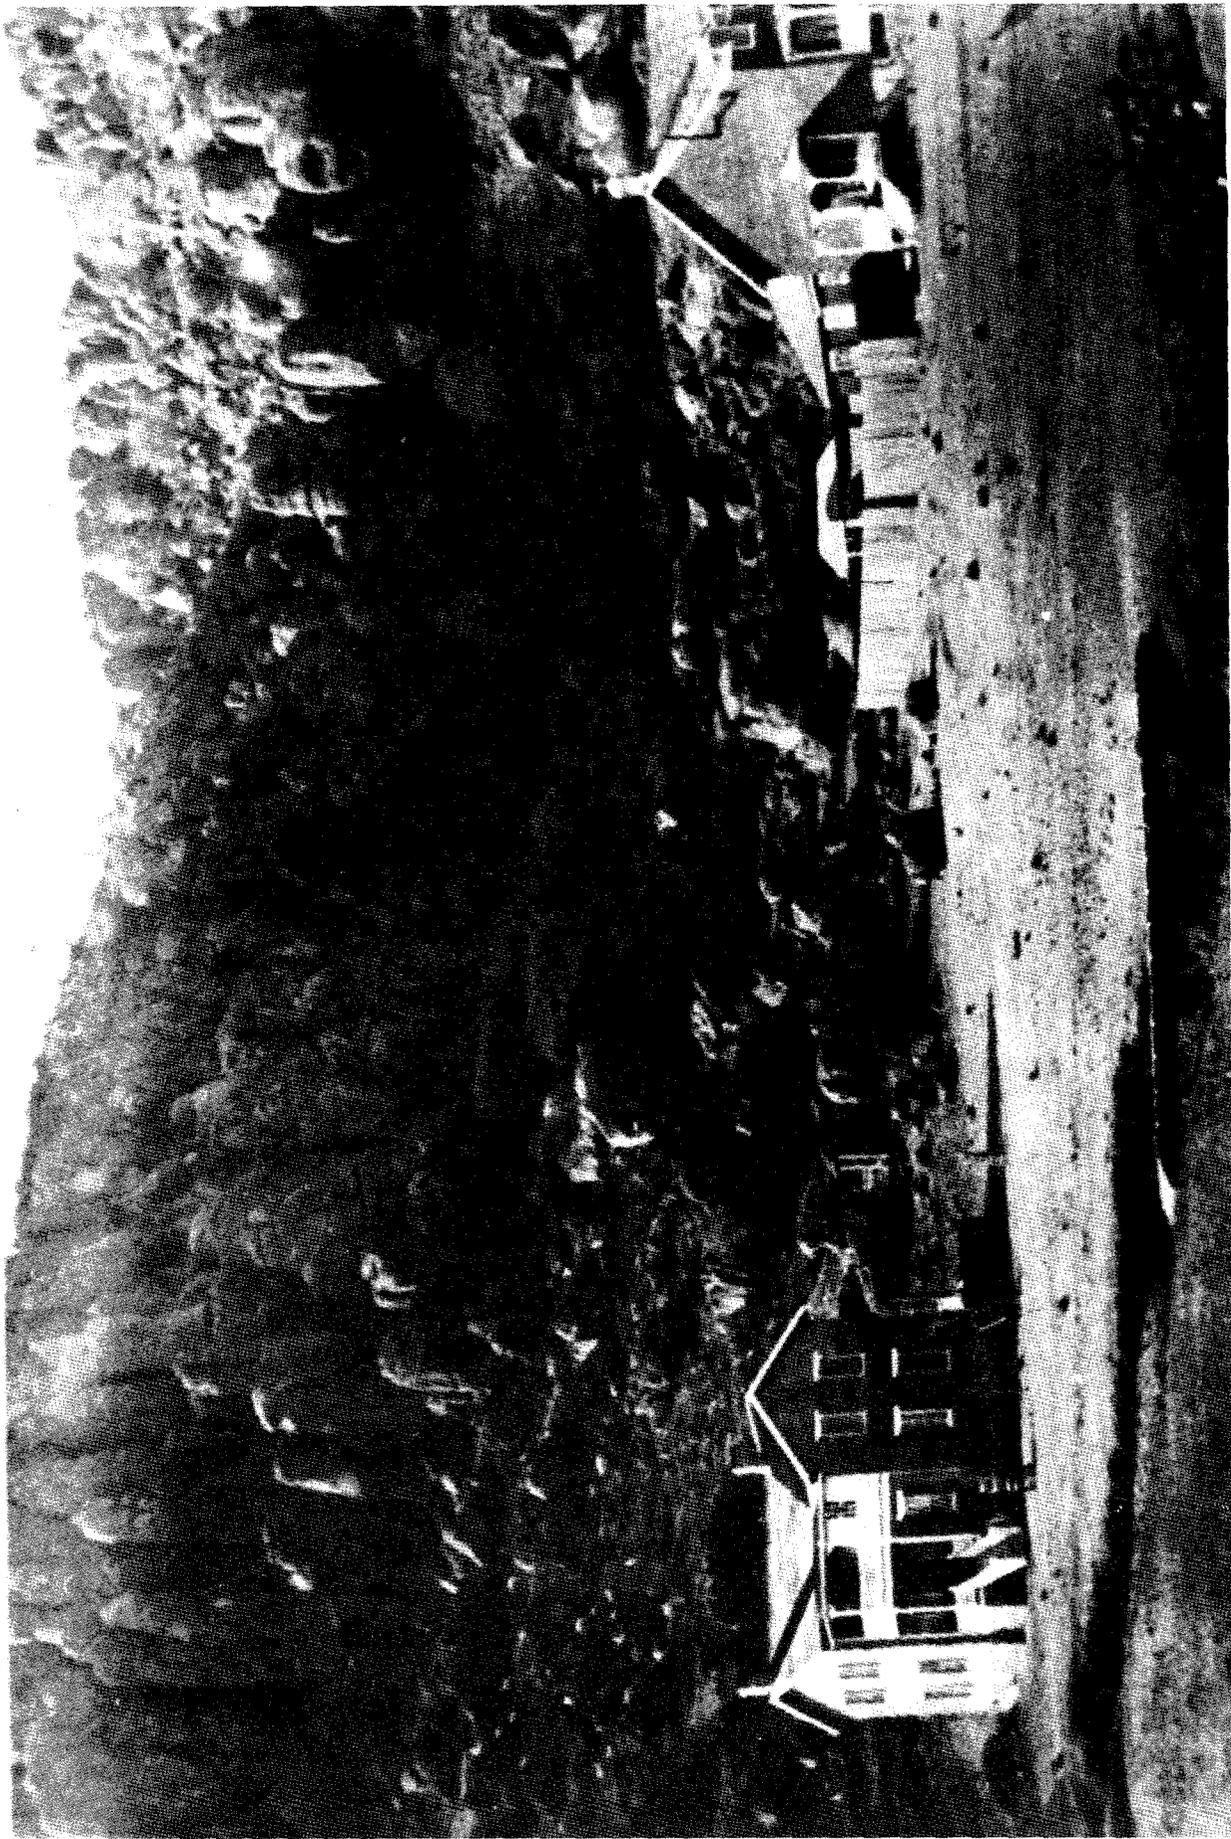
Illustration No. 51

Post Hospital complex (HB-46-50), ca. 1885-88. Magazine  
(HB-49) is at base of cliff.

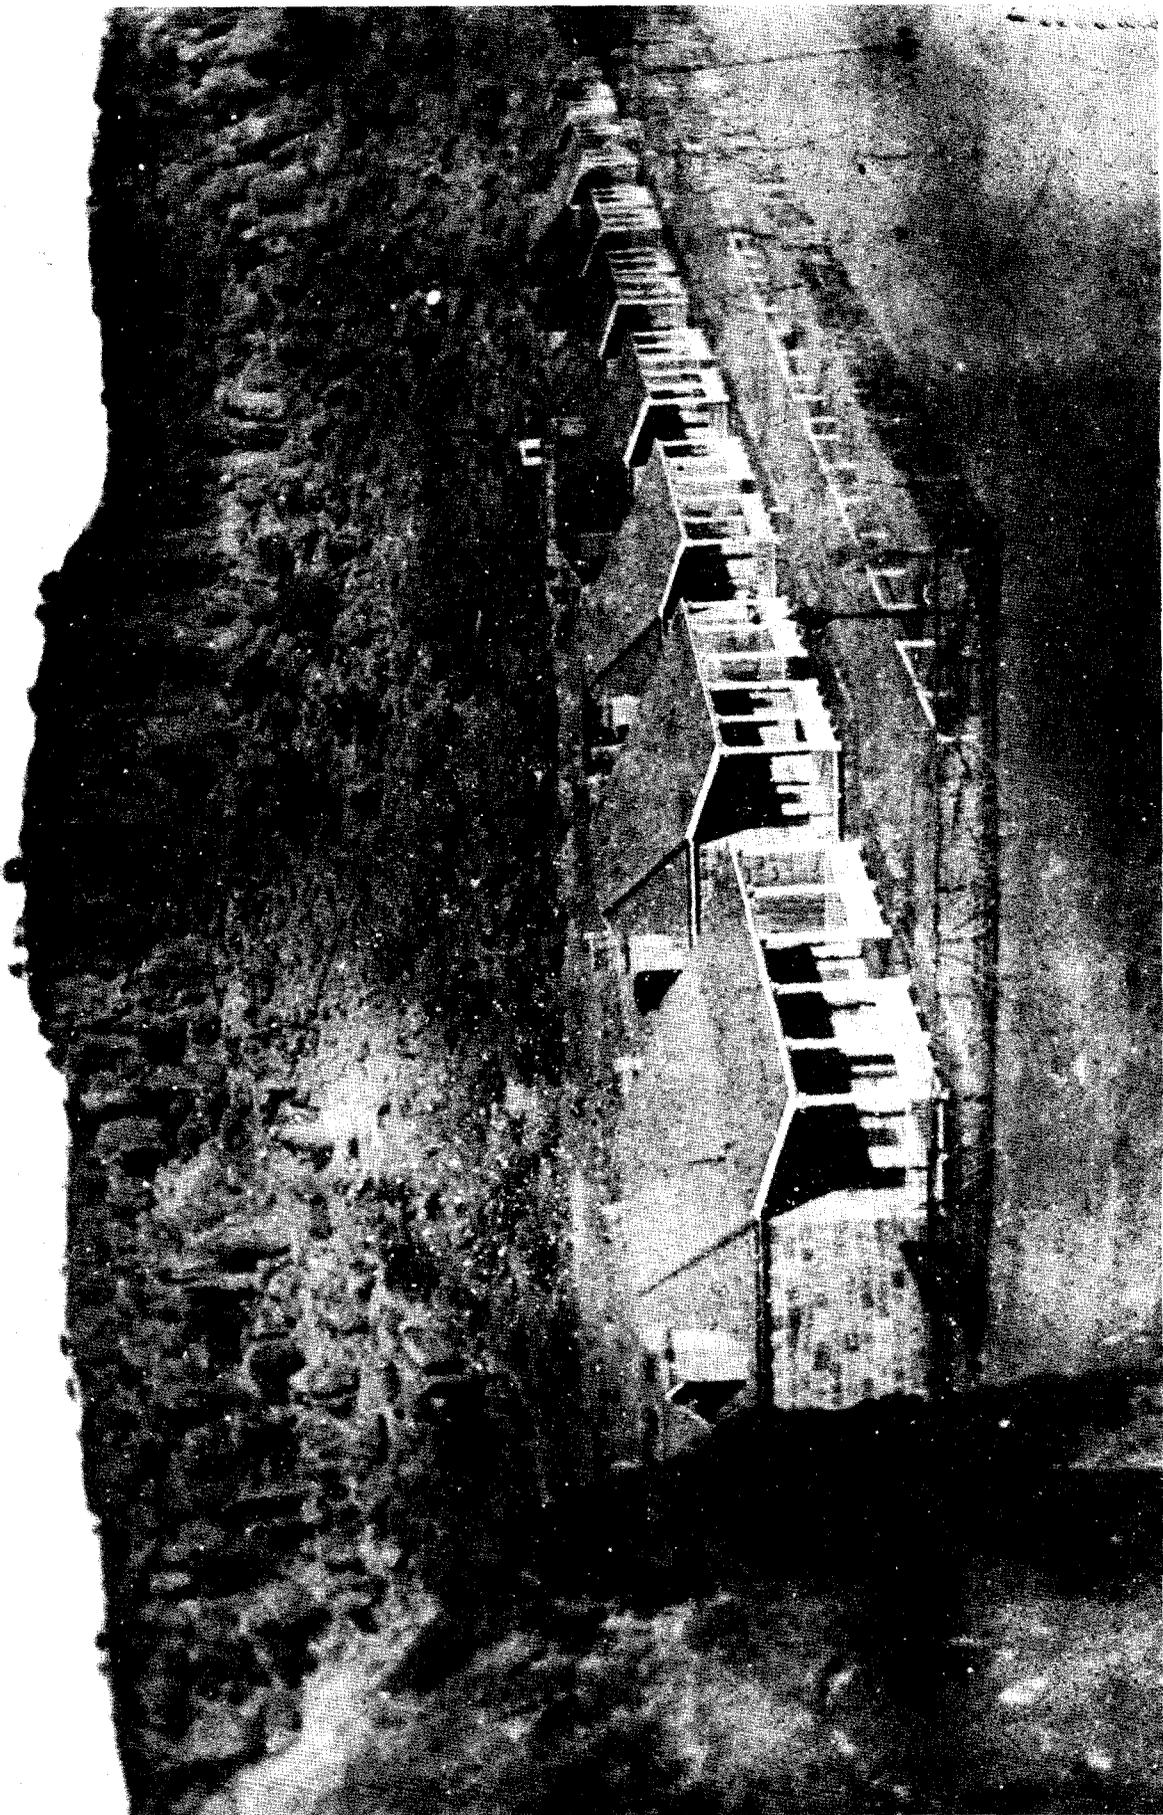
Illustration No. 60

Fort Davis from the west, ca. 1889. Note drainage ditch  
in foreground and behind Officers' Row.

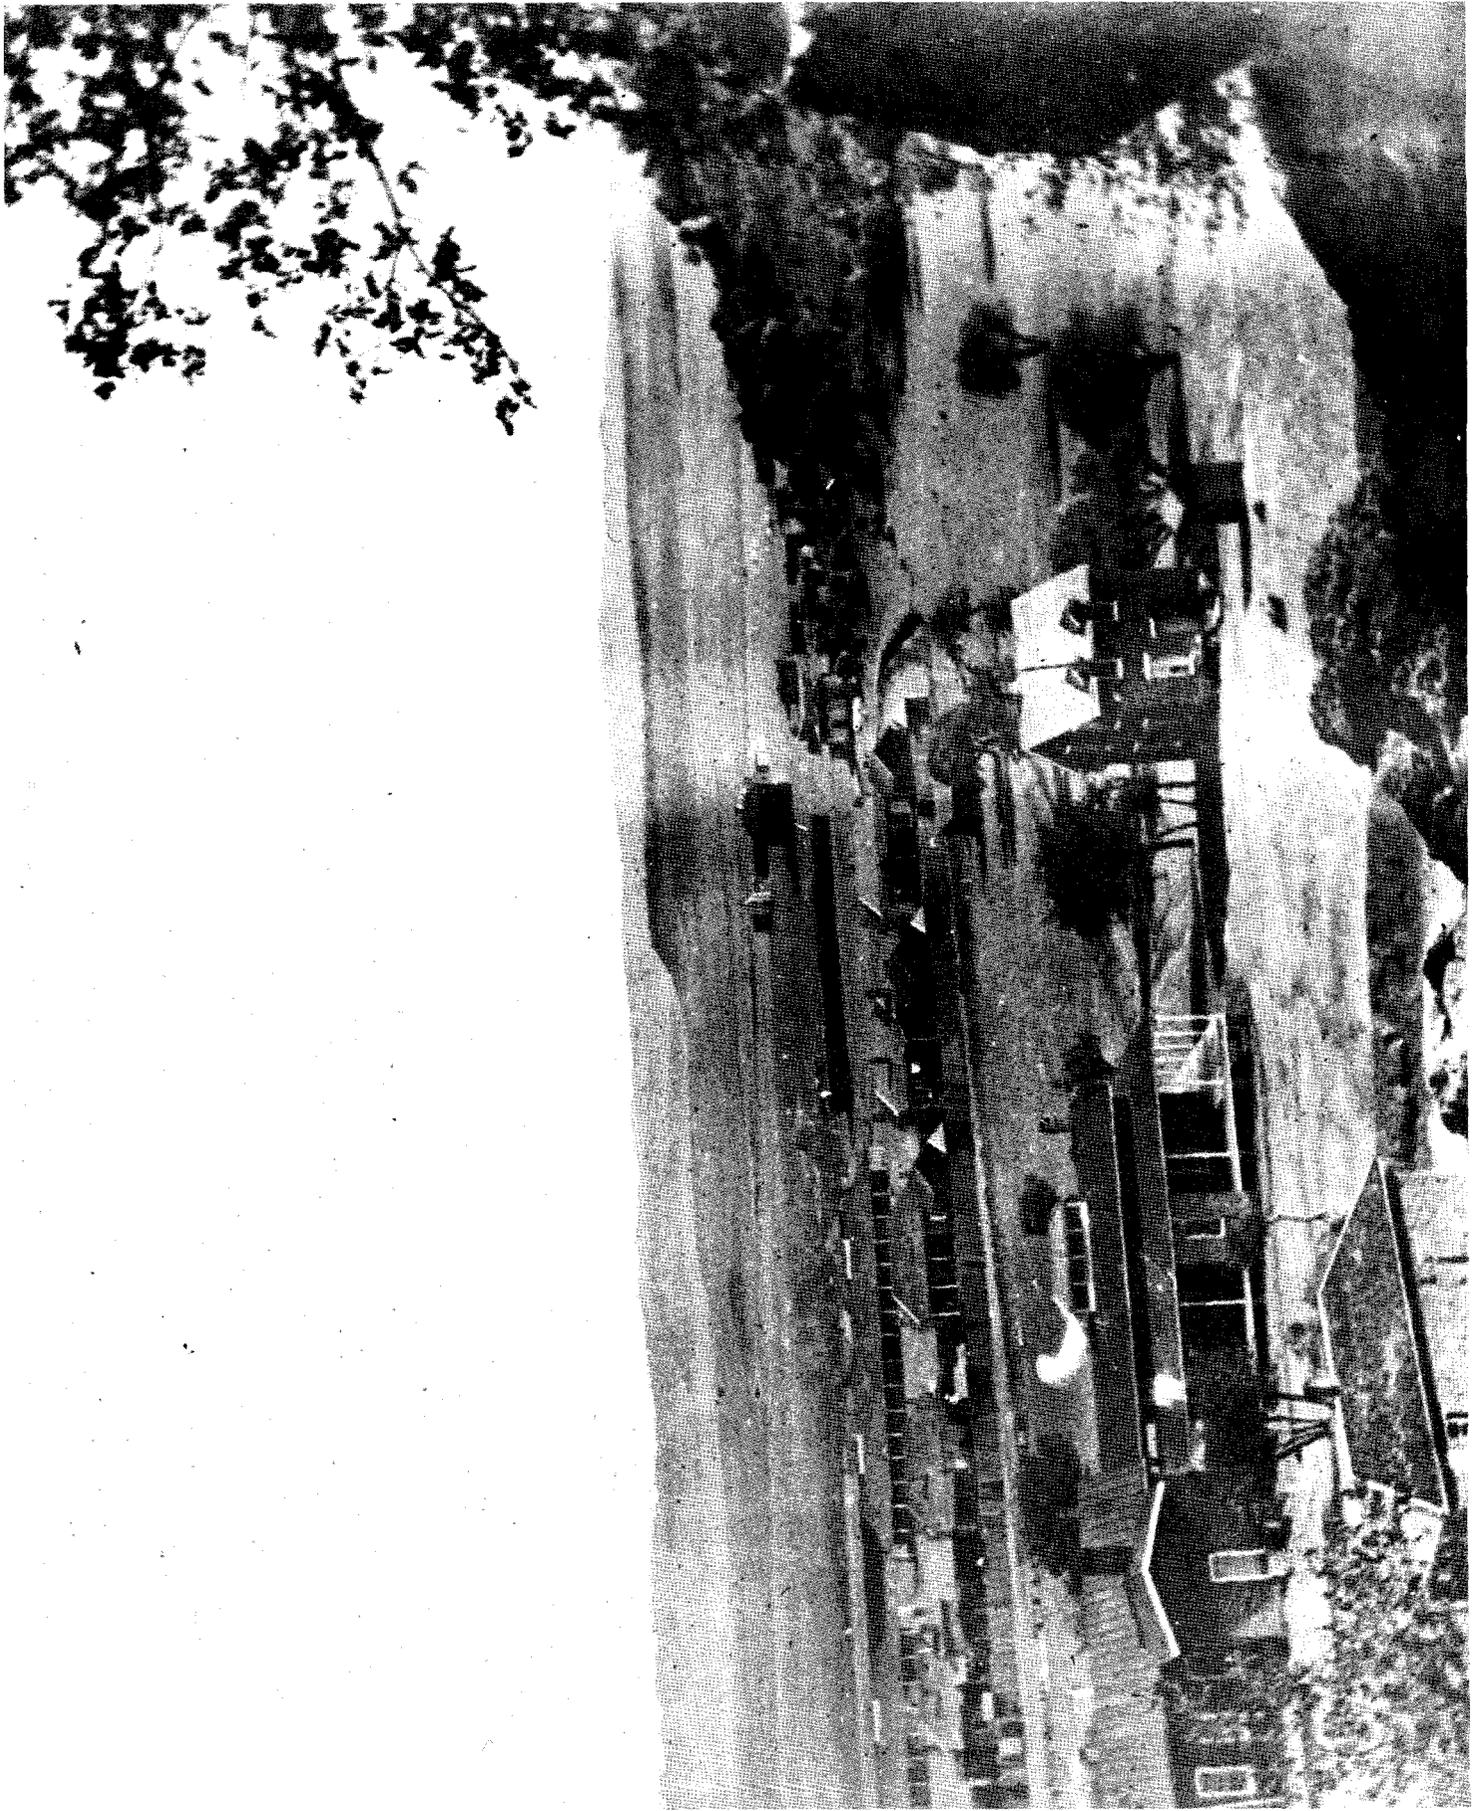
Illustration No. 61

Post Hospital (HB-46) and Steward's Quarters (HB-48),  
ca. 1889.
