HISTORIC RESOURCE STUDY  
FORT DAVIS NATIONAL HISTORIC SITE

By  
Jerome A. Greene

November 1986

U.S. Department of the Interior / National Park Service

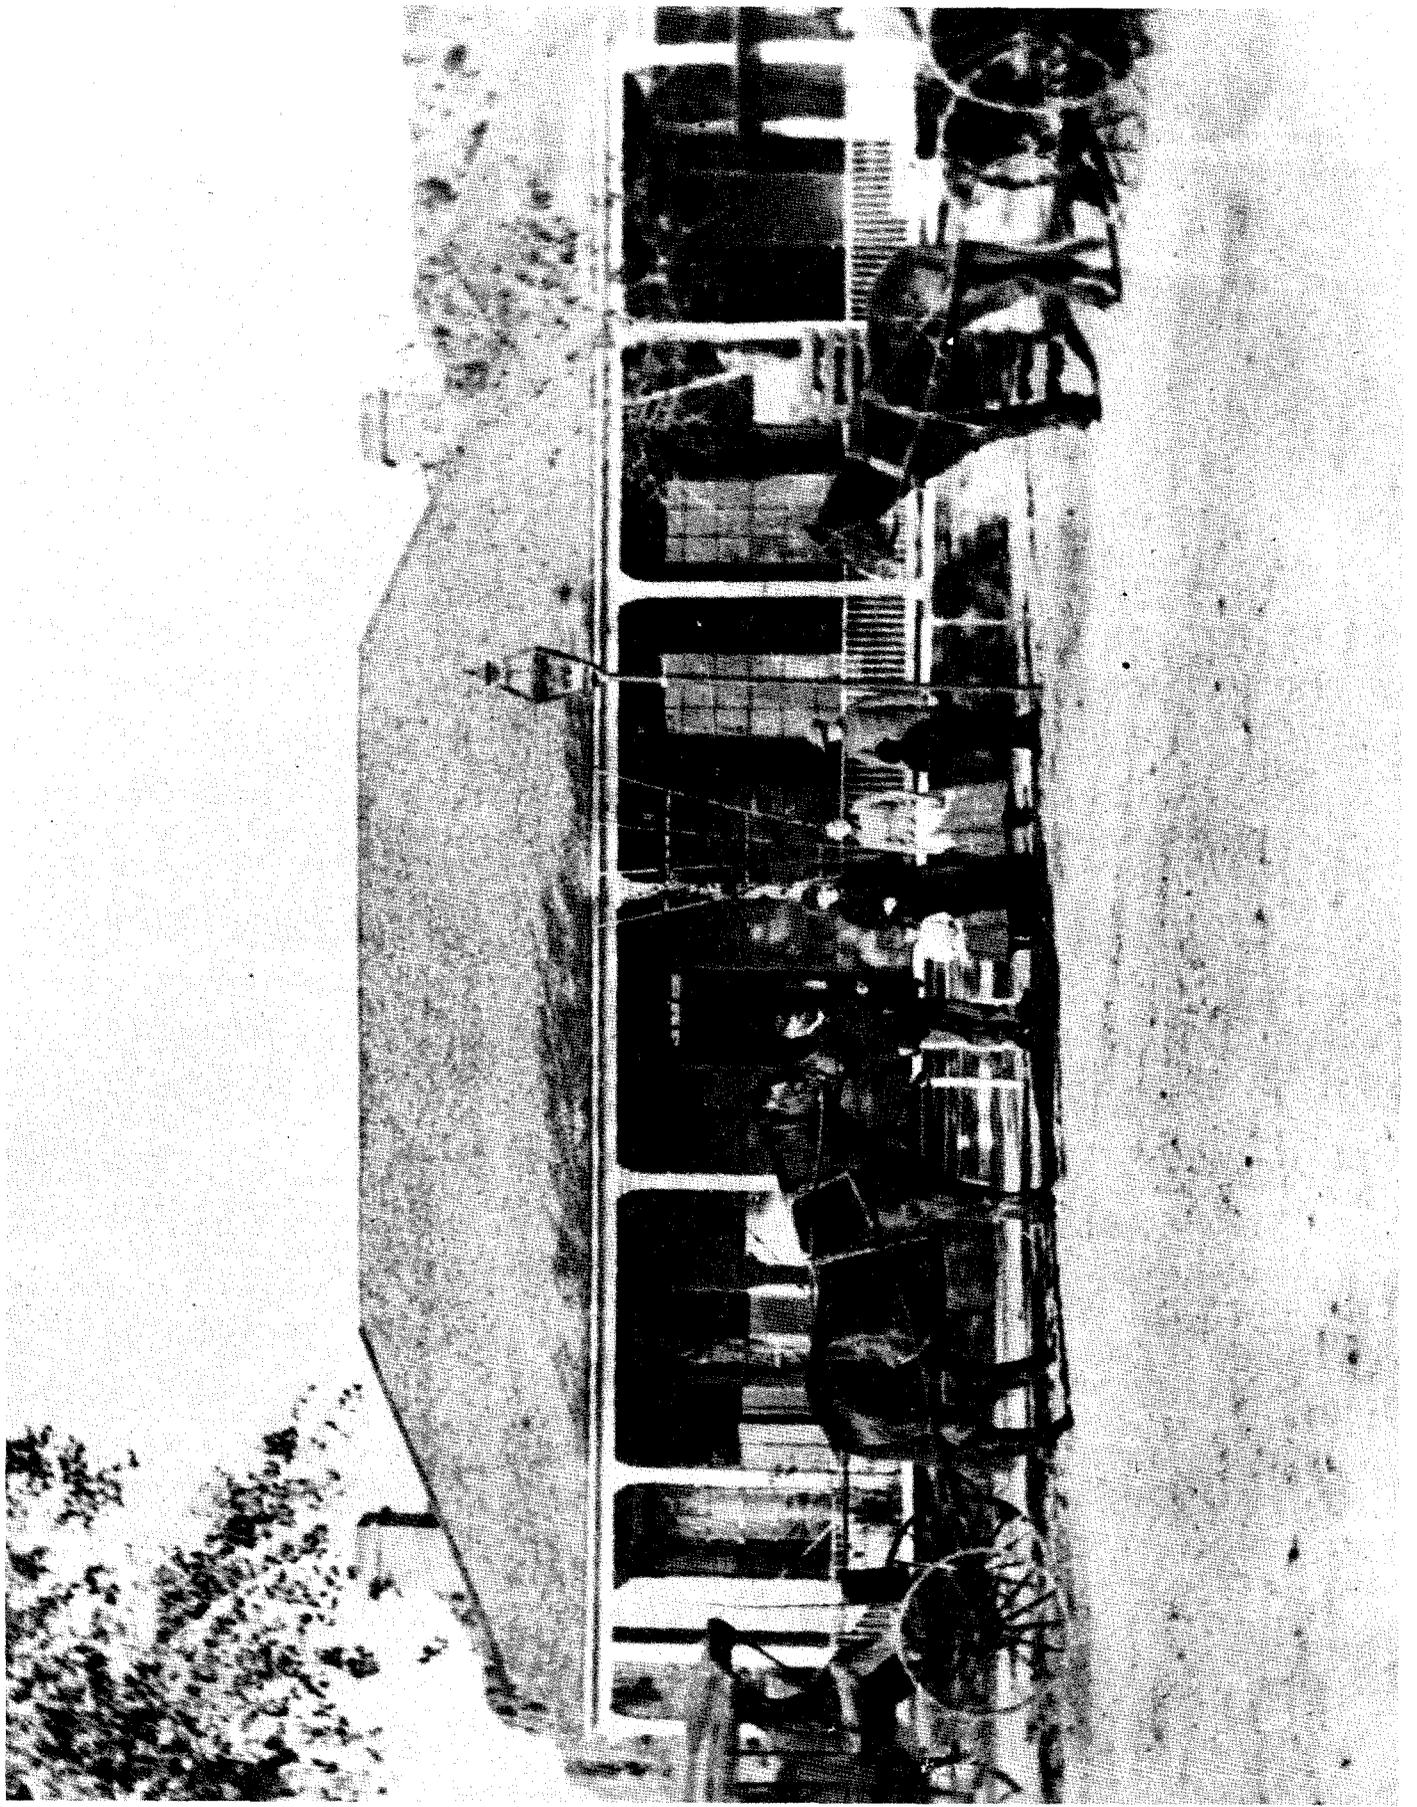
Illustration No. 63

Hospital Steward's Quarters (HB-48) and Post Hospital (HB-46), ca. 1889. Magazine (HB-49) is on hill in rear.

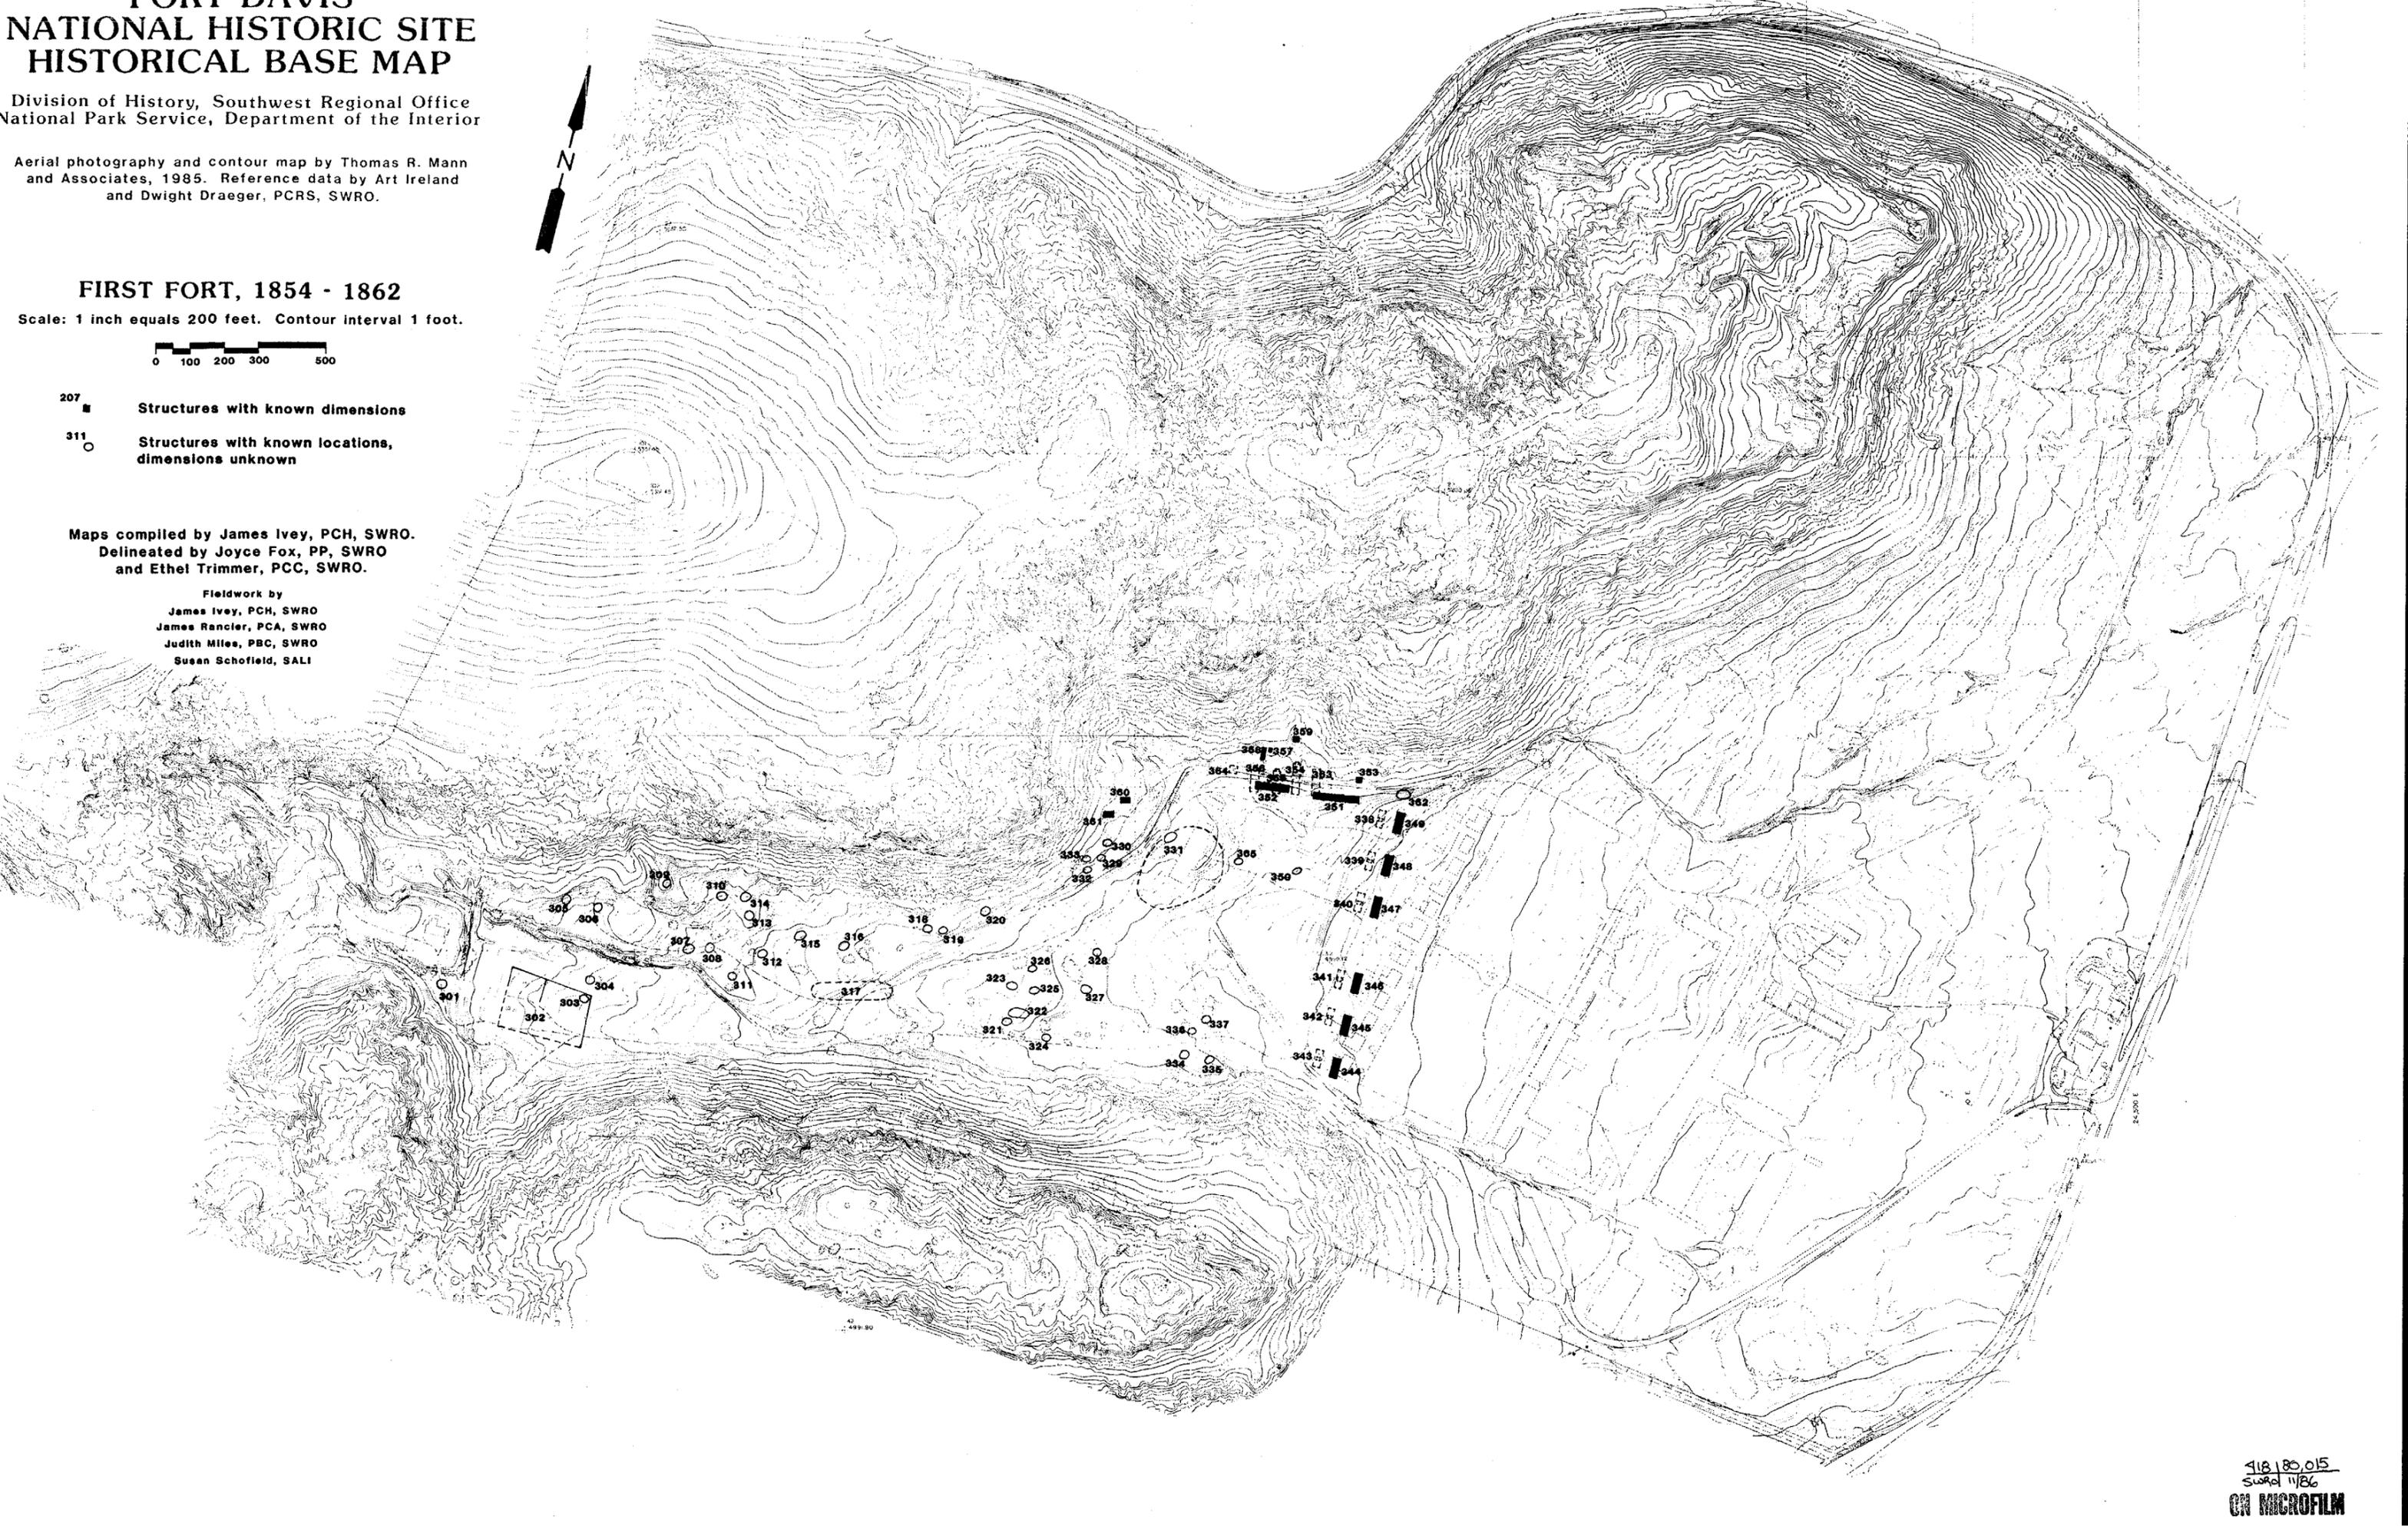
# NATIONAL HISTORIC SITE HISTORICAL BASE MAP
