CASTLE WILLIAMS

HISTORIC STRUCTURE REPORT

Governors Island National Monument
National Parks of New York Harbor
New York, New York

Barbara A. Yocum, Architectural Conservator
Historic Architecture Program
Northeast Region, National Park Service
Lowell, Massachusetts

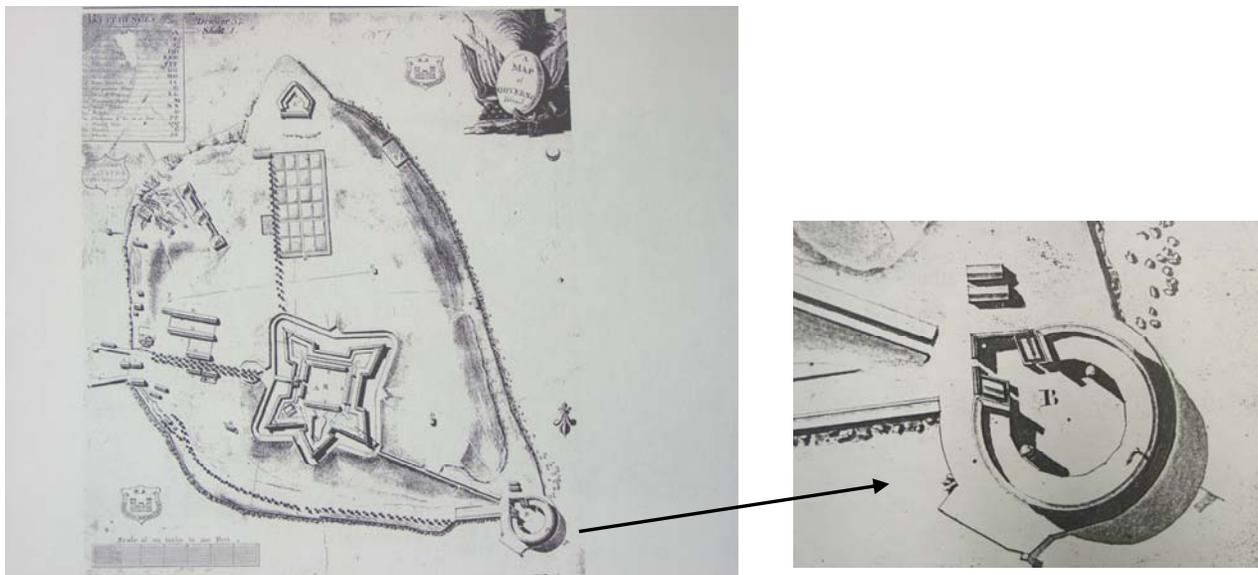
Figure 2. Map of Governors Island, 1813, with detail view of Castle Williams (right).

1813. Drawing: “A Map of Governors Island,” showing plan of Castle Williams and Fort Columbus, by Joseph Mangin, 1813. (Drawer 37, Sheet 1; RG 77; CAB/NACP.) See fig. 2.

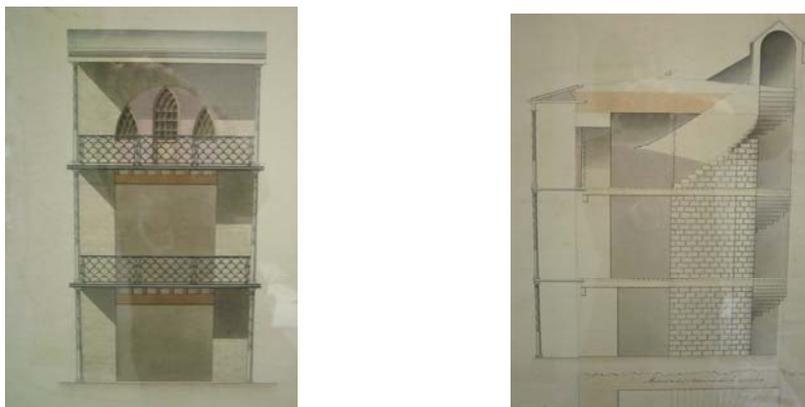
Figure 5. Details showing proposed iron piazzas and stair, 1832.

1832, October 17. “Plan exhibiting the Iron Piazzas proposed for the upper Tiers of Castle Williams of Governor’s Island, New York—Also a Front View of the Manner it is Intended to Close the Arches of the Third Tier,” and “A plan exhibiting a perpendicular section through Castle Williams wherein the Stairway is proposed to be Constructed,” Oct. 17th 1832. Signed by Maj. De Russy. Note that neither the iron piazza and nor the stair was constructed. (Drawer 154, Sheet 43- 7; RG 77; CAB/NACP.) See fig. 5.

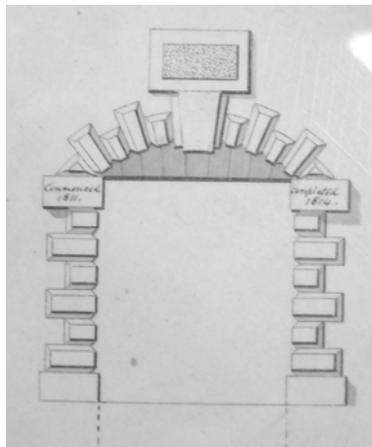
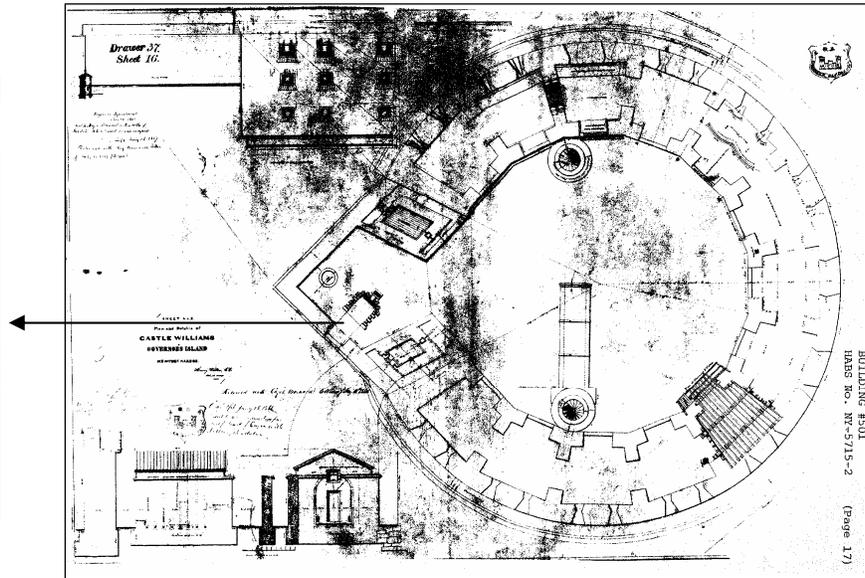
Detail of sally port, exterior elevation.

Figure 6. Plan and details of the first tier of Castle Williams, 1839.

1839. Drawing: "Sheet No. 2, Plan and Details of Castle Williams, Governor's Island, New York Harbor" by Henry Waller, 1839. Noted on the drawing: "Received with Capt. Barnard's letter of Jan. 10th 1840." Floor planks are noted to be 3 inches thick in the first-tier casemates, and 1 ½ inches thick in the second-tier casemates. Engraving on the exterior side of the sally port reads "Commenced 1811" on the left side, "Completed 1814" on the right side. (Drawer 37, Sheet 16; RG 77; CAB/NACP. Reproduced in HABS, "Castle Williams," p. 17.) See fig. 6.

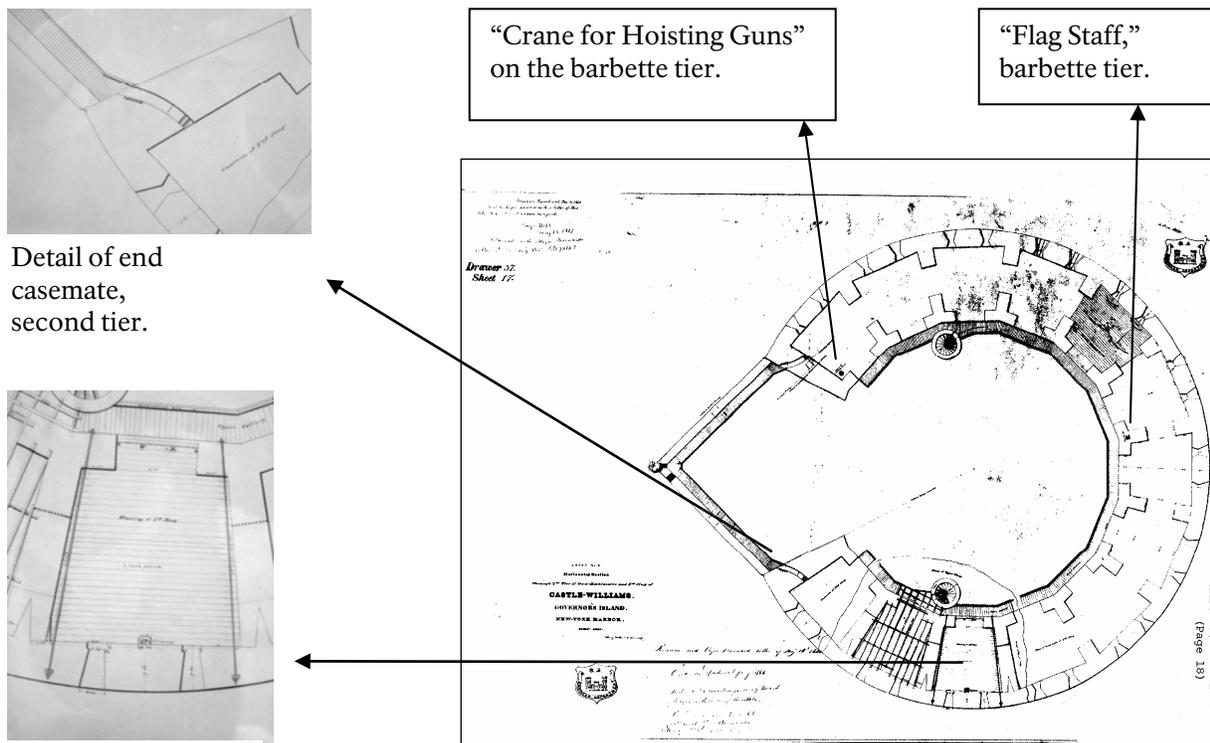
Figure 7. Plan of the second tier, and two casemates in third tier, with features noted on the barbette tier of Castle Williams, 1839.

1839, December. Drawing: “Sheet No. 3. Horizontal Section Through 2nd Tier of Gun Embrasures and 3rd Story of Castle Williams, Governor’s Island, New- York Harbor,” by Henry Waller, C.E., December 1839. Noted on the drawing “Received with Capt. Barnard’s letter of Jany 10th, 1840.” Floor planks are noted to be 2 inches thick in the third-tier casemates. A projecting chimney is illustrated at the exterior wall, between the embrasures, of a third-tier casemate. A “crane for hoisting guns” is shown on the barbette tier [roof] above the first casemate, and a “flag staff” between casemates 6 and 7. (Drawer 37, Sheet 17; RG 77; CAB/NACP. Reproduced in HABS, “Castle Williams,” p. 18.) See fig. 7.

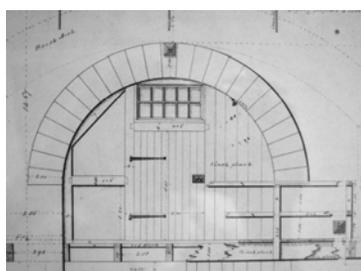
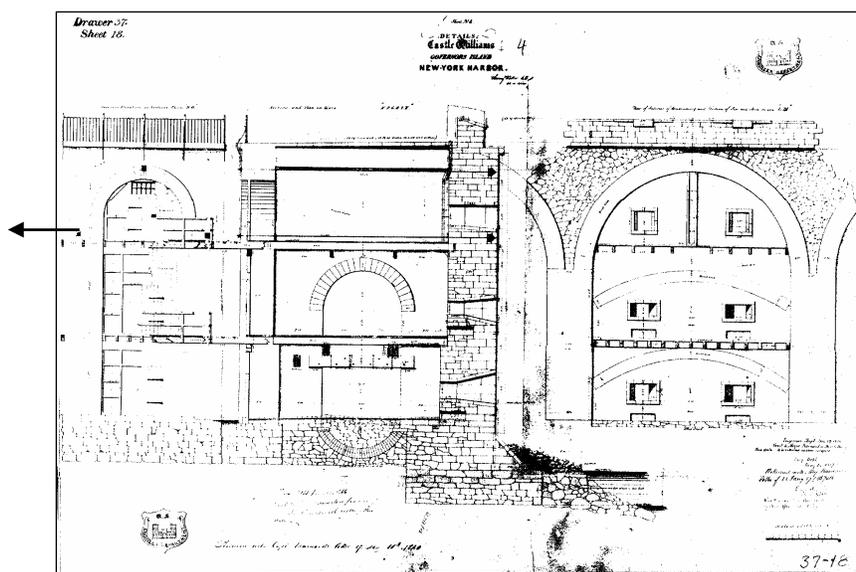
Detail of infill at casemate opening and gallery railing, third tier.

Figure 8. Section elevations and details of Castle Williams, 1839.

1839. Drawing: “Sheet No. 4, Details, Castle Williams, Governors Island, New- York Harbor,” and “View of Interior of Embrasures and Section of Pier and Arch,” by Henry Waller, C.E. Noted on the drawing: “Received with Capt. Barnard’s letter of Jan’y 10th 1840.” A chimney is clearly illustrated between the embrasures of a third- tier casemate, ventilated in the (roof) tier above. The casemate openings in the third tier were enclosed on the courtyard side with vertical 1- inch boards and a board- and- batten door hung on strap hinges. The iron railing on the courtyard side of the barbette tier [roof] was made of iron bars, the balusters “1 inch square” and the curved supports “1 ½ in. square.” (Drawer 37, Sheet 18; RG 77; CAB/NACP. Reproduced in HABS, “Castle Williams,” p. 19.) See fig. 8.

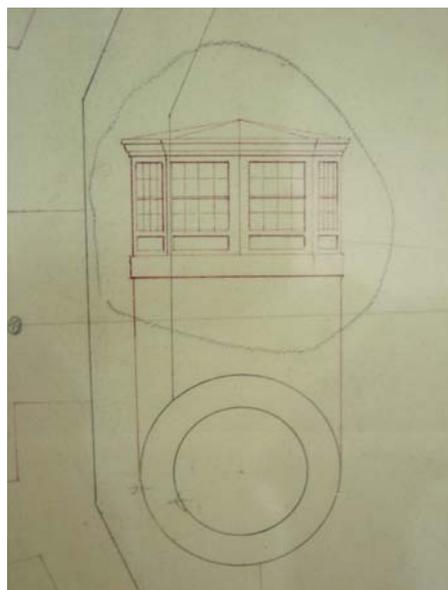
Figure 9. Design of proposed octagonal cupola for the stair towers at Castle Williams, 1841.

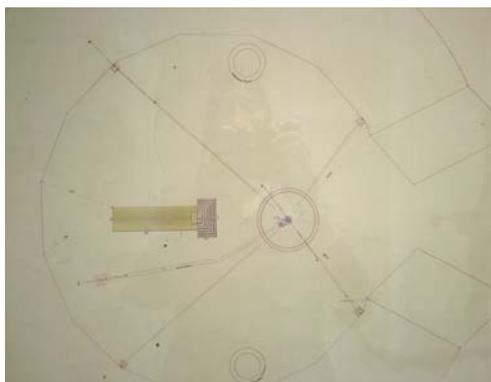
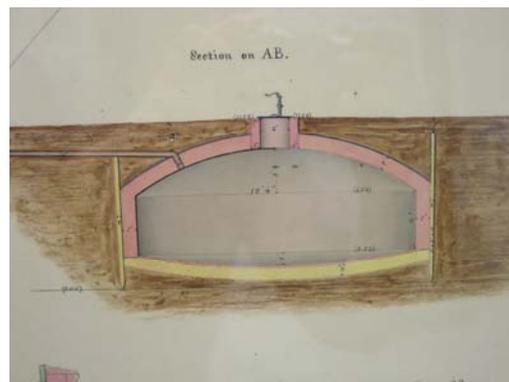
Figure 11. Plan and section of proposed cistern at Castle Williams, 1859.

1859, November. Drawing: “Plan & Section of Cistern at Castle Williams, Drawn under the Direction of Maj. J.G. Barnard, U.S.E., 1859.” Noted on the drawing: “Sent to Engineer Dept. with letter of Nov. 3, 1859.” Shows an underground cistern in the courtyard with hand pump. (Drawer 37, Sheet 47; RG 77; CAB/NACP.) See fig. 11.

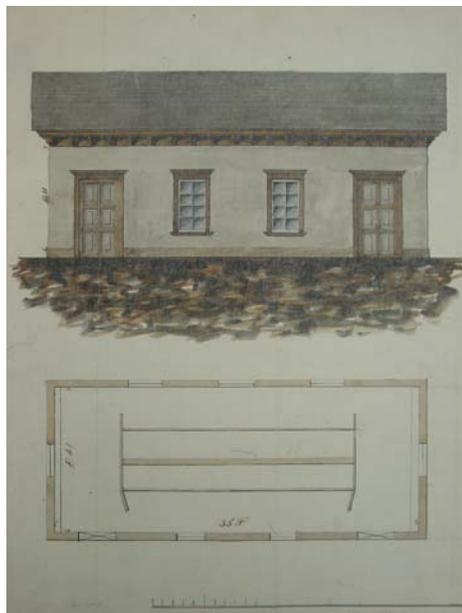
Figure 16. “Water closet” for Castle Williams, approved by the Secretary of War, June 1870.

1870, June 1. Drawing: “Water Closet Castle Williams.” Noted on the drawing: “Approved by Secretary of War, June 1, 1870.” (Misc. Forts File, Sheet 36; RG 77; CAB/NACP.) See fig. 16.

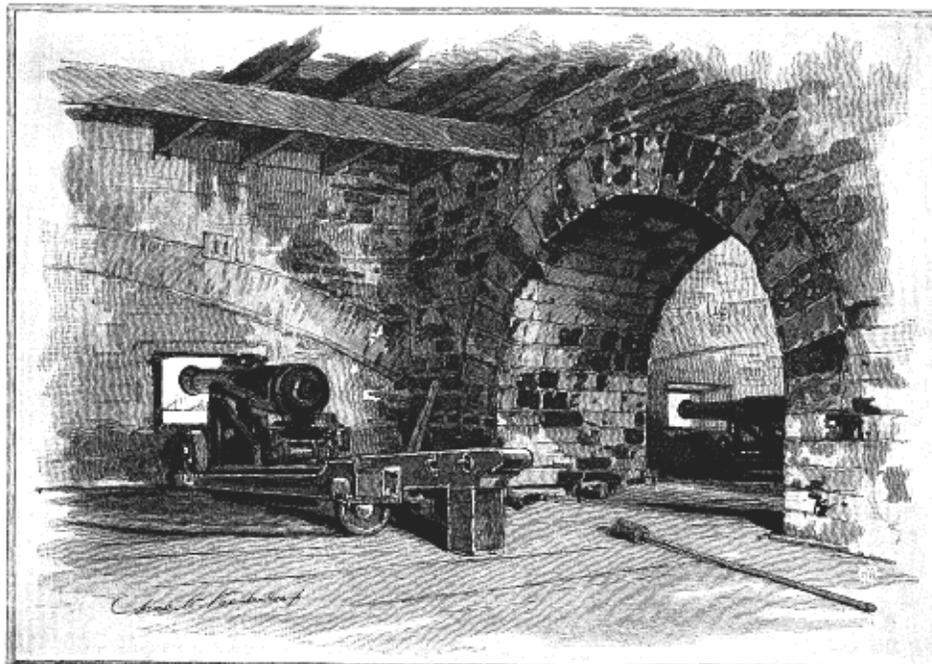
Figure 23. "A Gun Casemate," in Castle Williams, 1881.

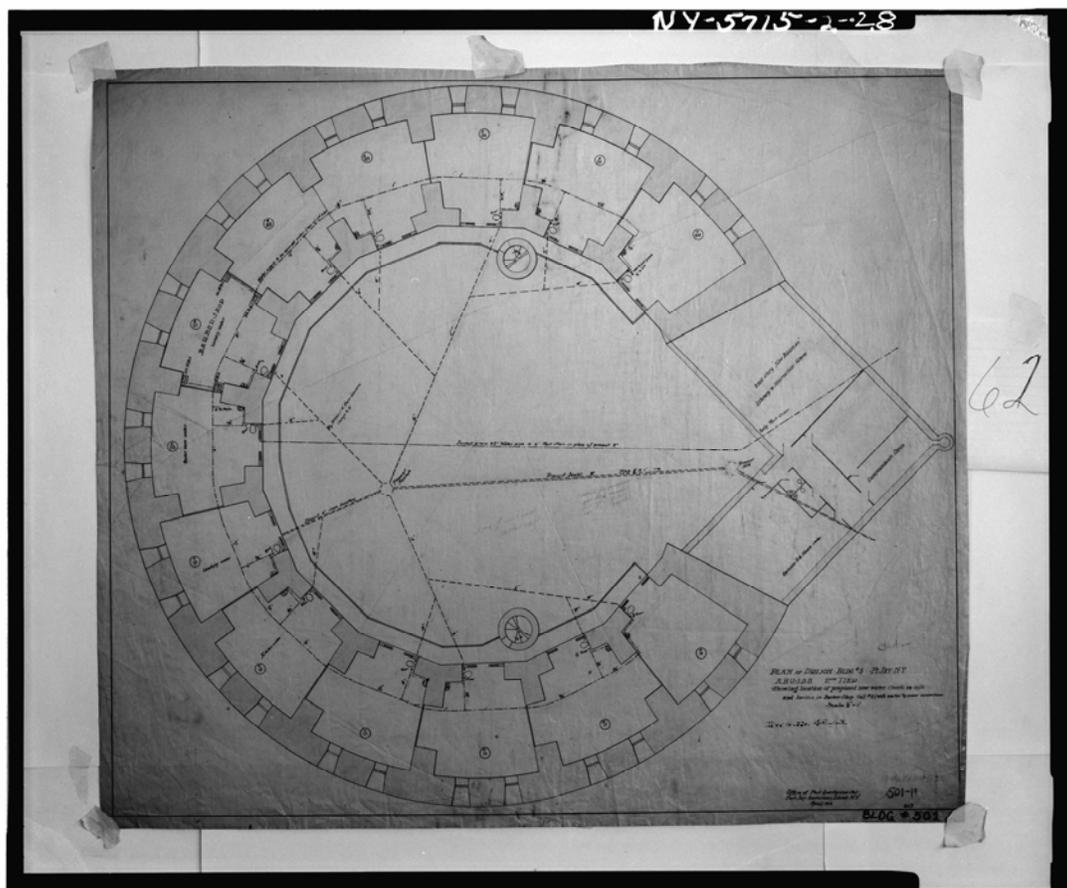
Figure 35. Plan of the second tier of Castle Williams, 1916.

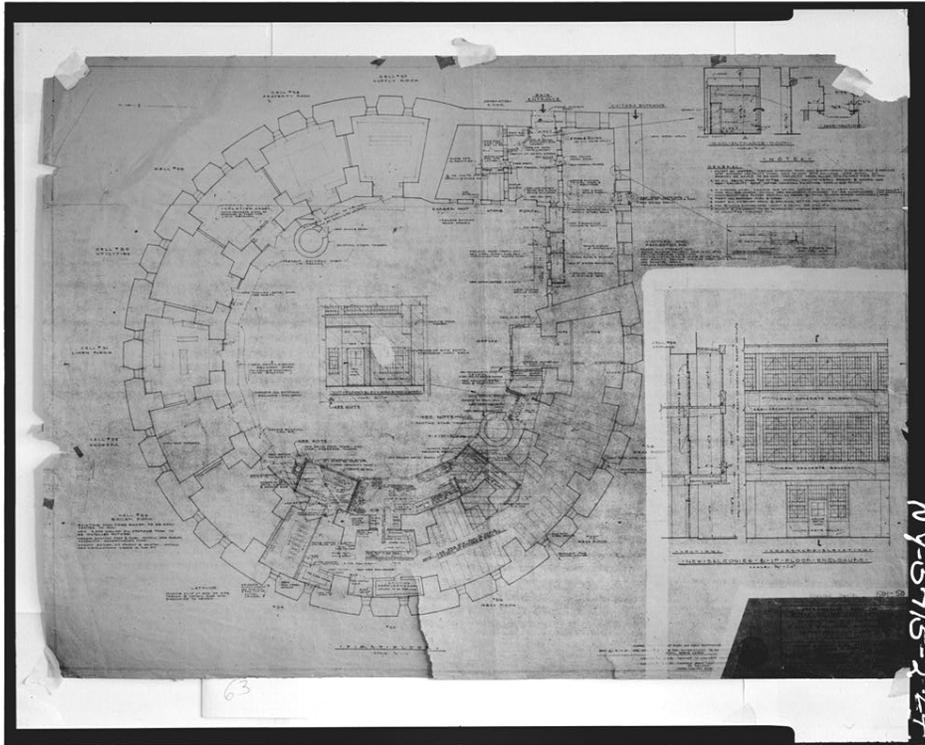
Figure 39. First- floor plan of Castle Williams, March 1947.

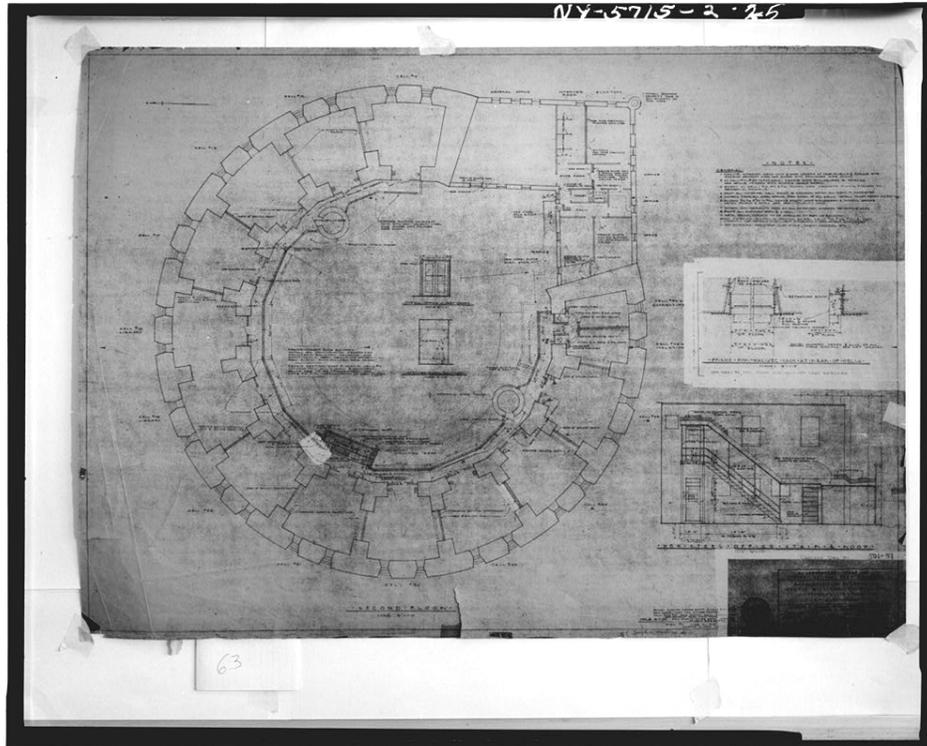
Figure 40. Second- floor plan of Castle Williams, March 1947.

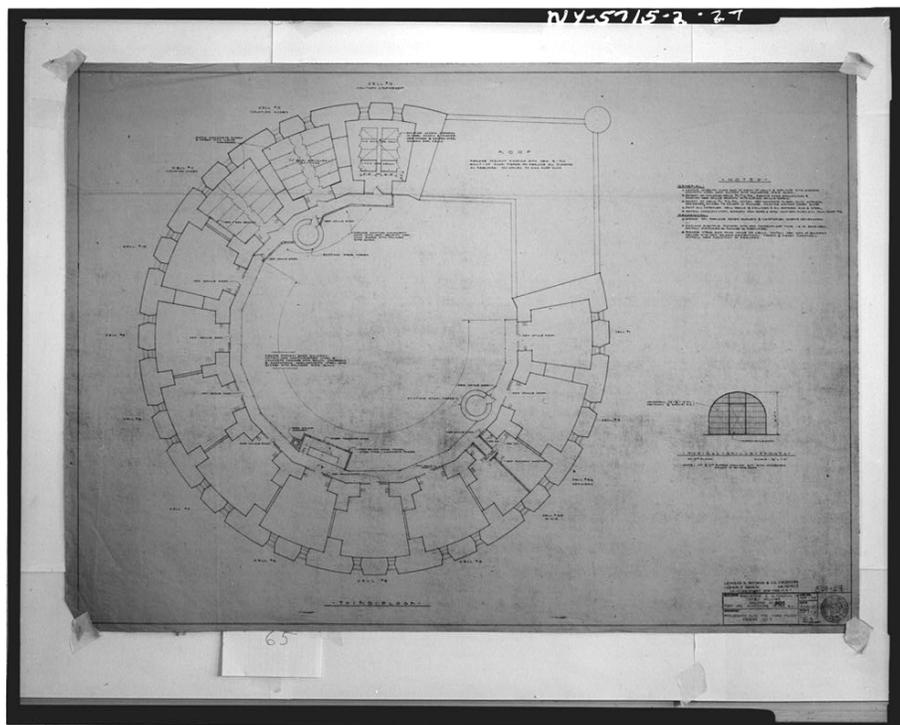
Figure 41. Third- floor plan of Castle Williams, March 1947.

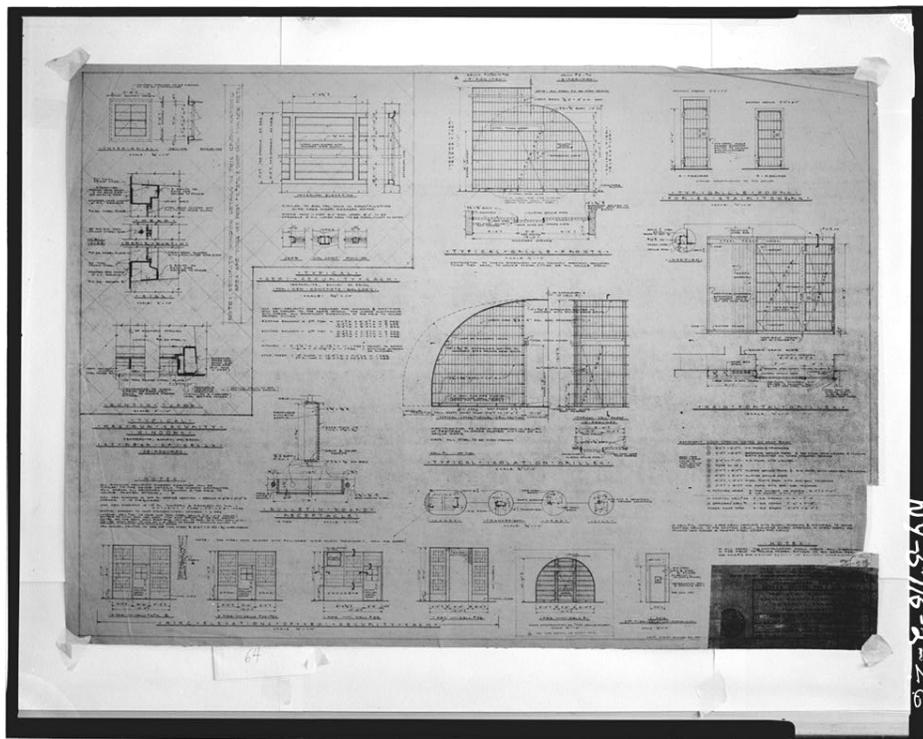
Figure 42. Security details for Castle Williams, 1947.

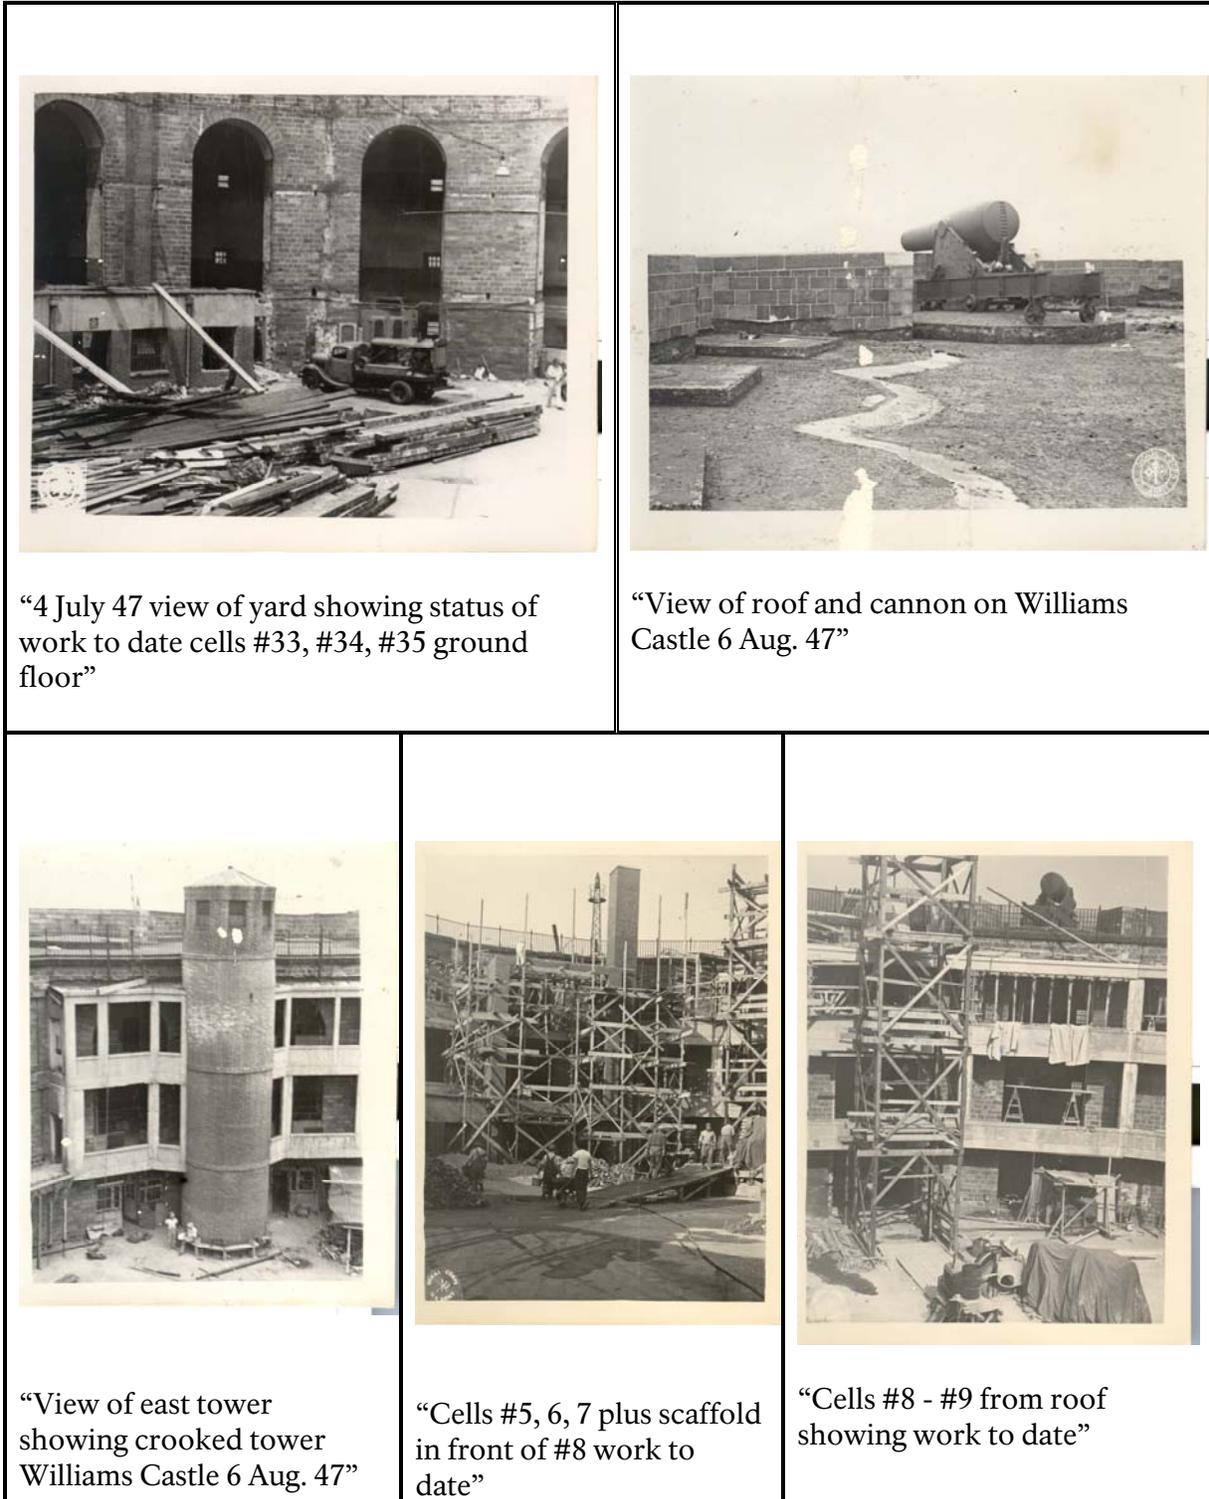
Figure 43. Construction photographs of Castle Williams with original captions, 1947.

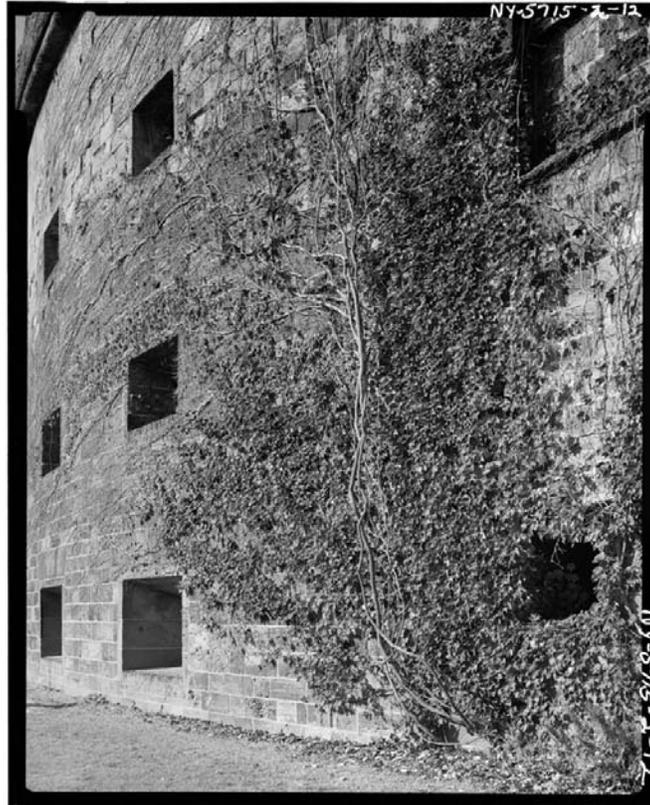
Figure 50. Detail of vegetation on the exterior south wall of Castle Williams, 1982- 83.

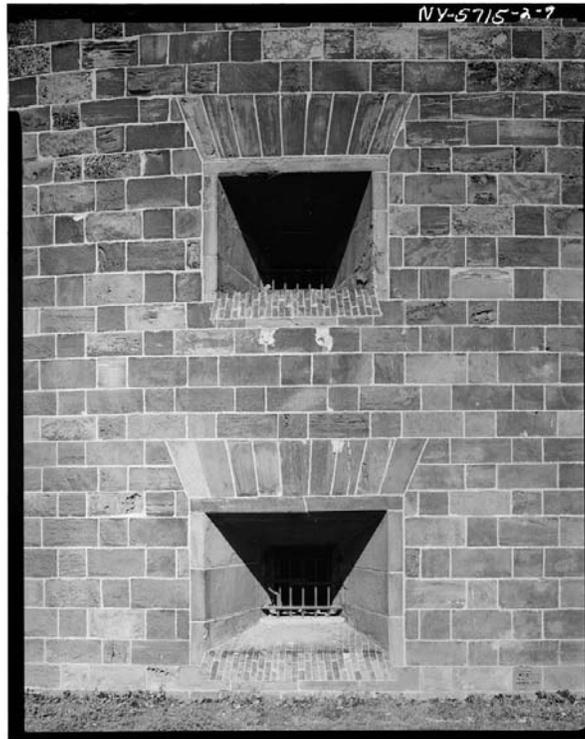
Figure 52. Detail of exterior embrasures in the first and second tiers of Castle Williams, 1982- 83.

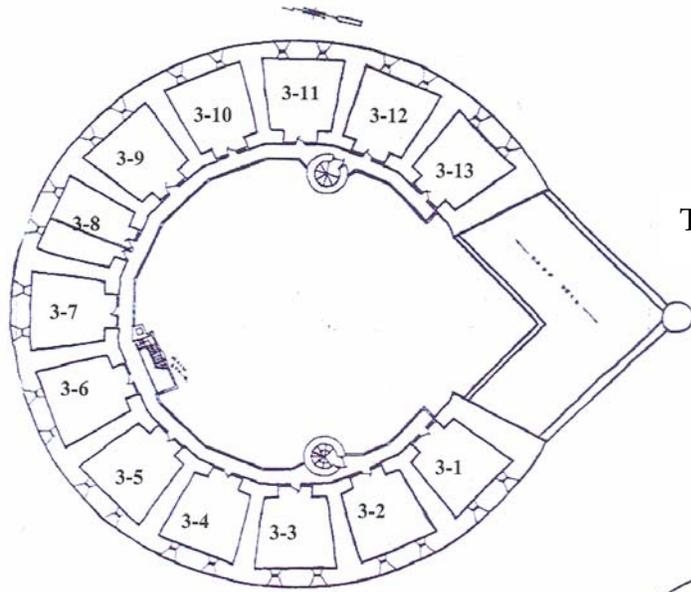
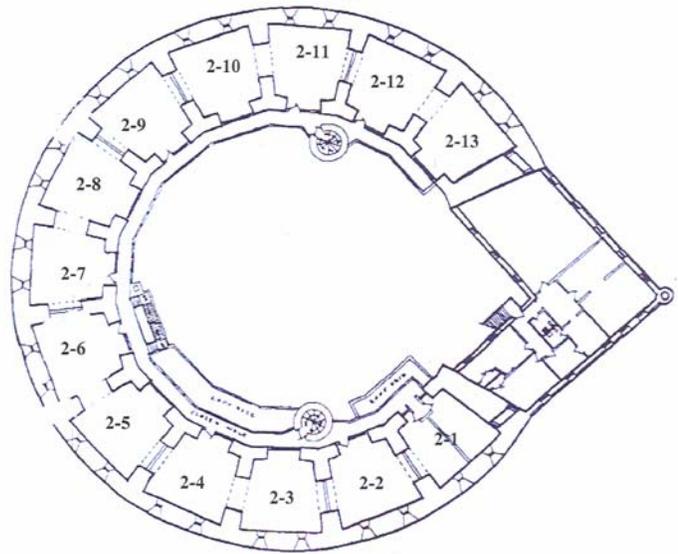
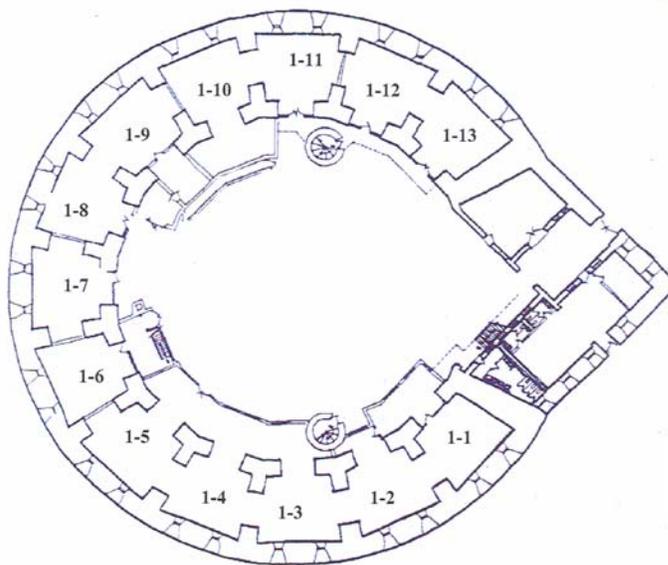
Diagrams showing casemate numbering system

Third (barbette) Tier

Second Tier

First Tier
