Cultural Landscape Report

for
The Frijole Ranch
Guadalupe Mountains National Park

CULTURAL LANDSCAPE REPORT

THE FRIJOLE RANCH

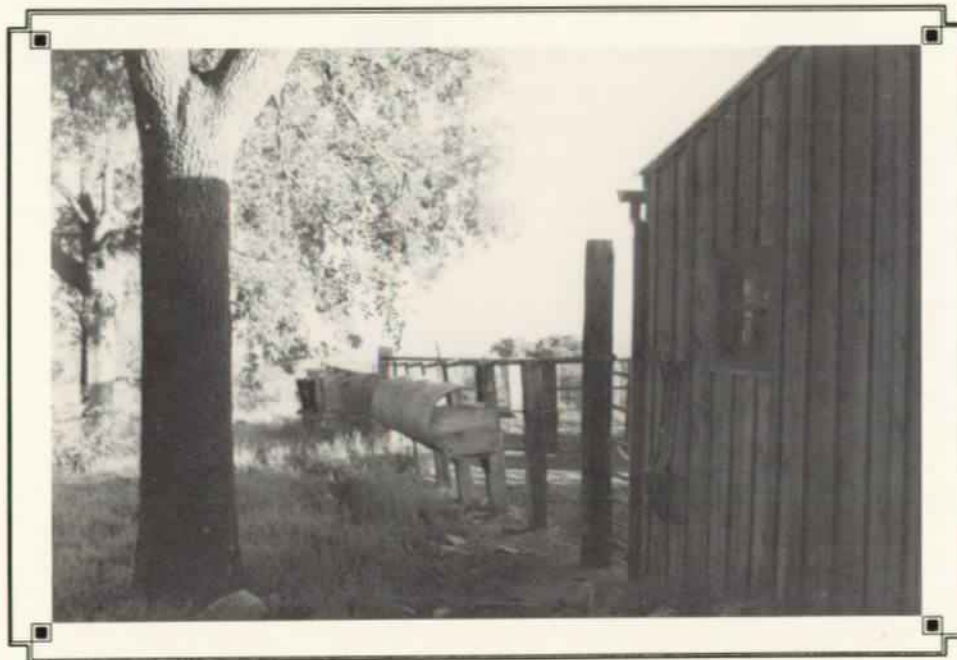
33: Horse and mule corral adjacent to Frijole barn. Note feed troughs. 1993.

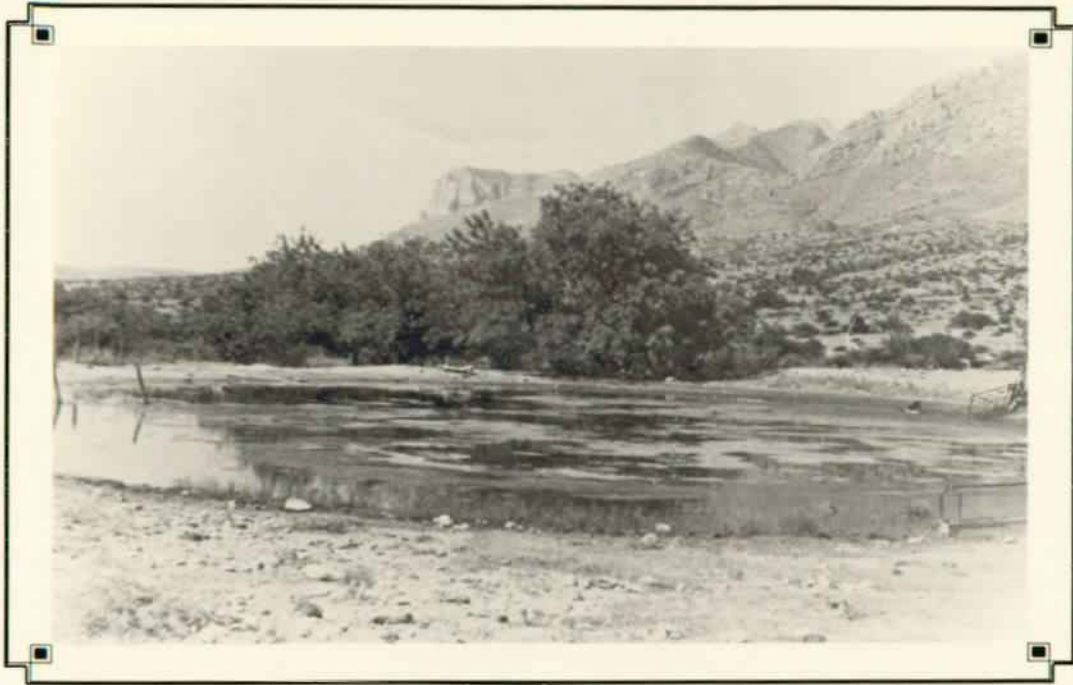
55: Manzanita Spring area. Note post-and-wire fencing along back edge of pond. 1970.

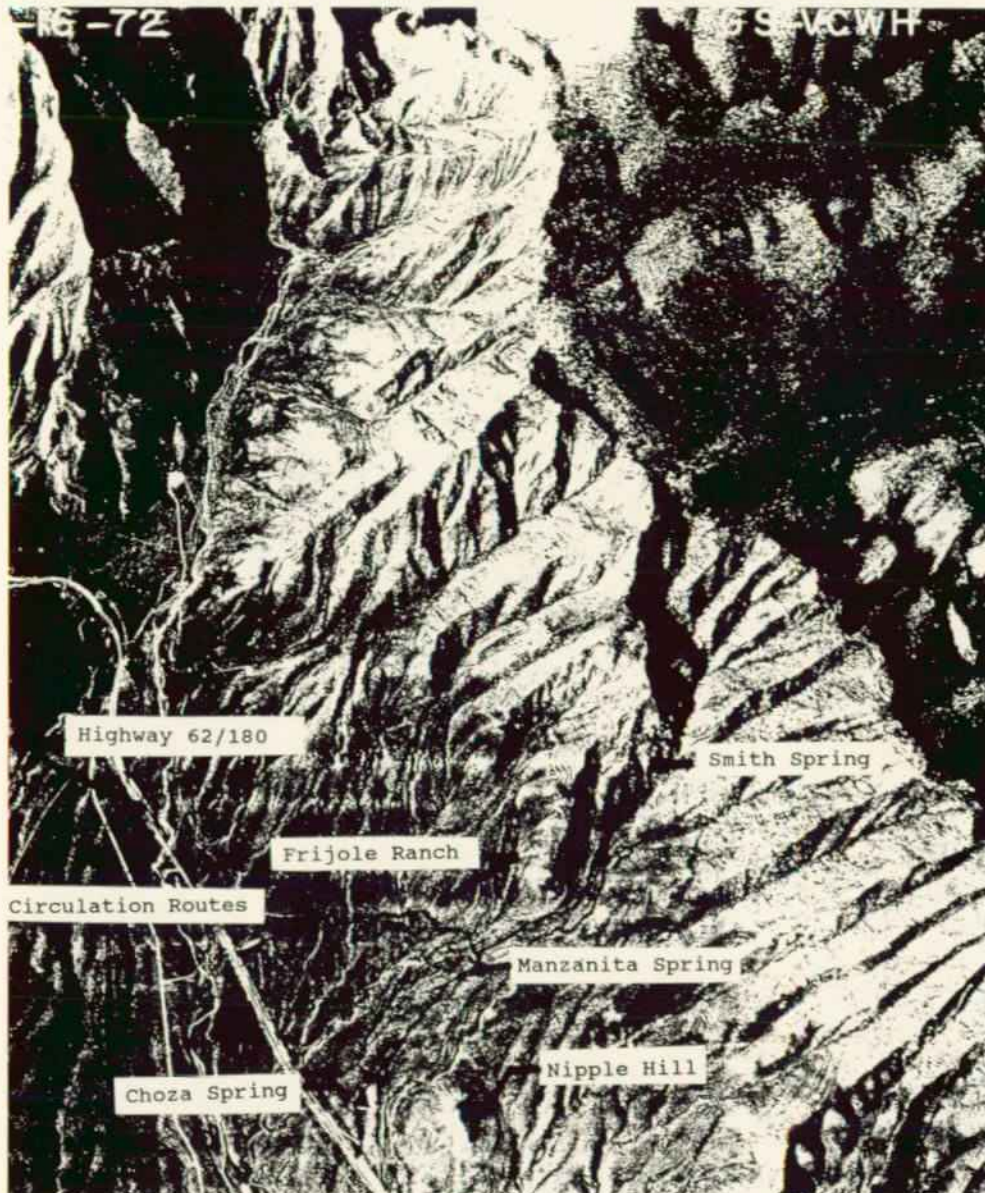
4: Aerial photograph with circulation patterns highlighted, 1972.

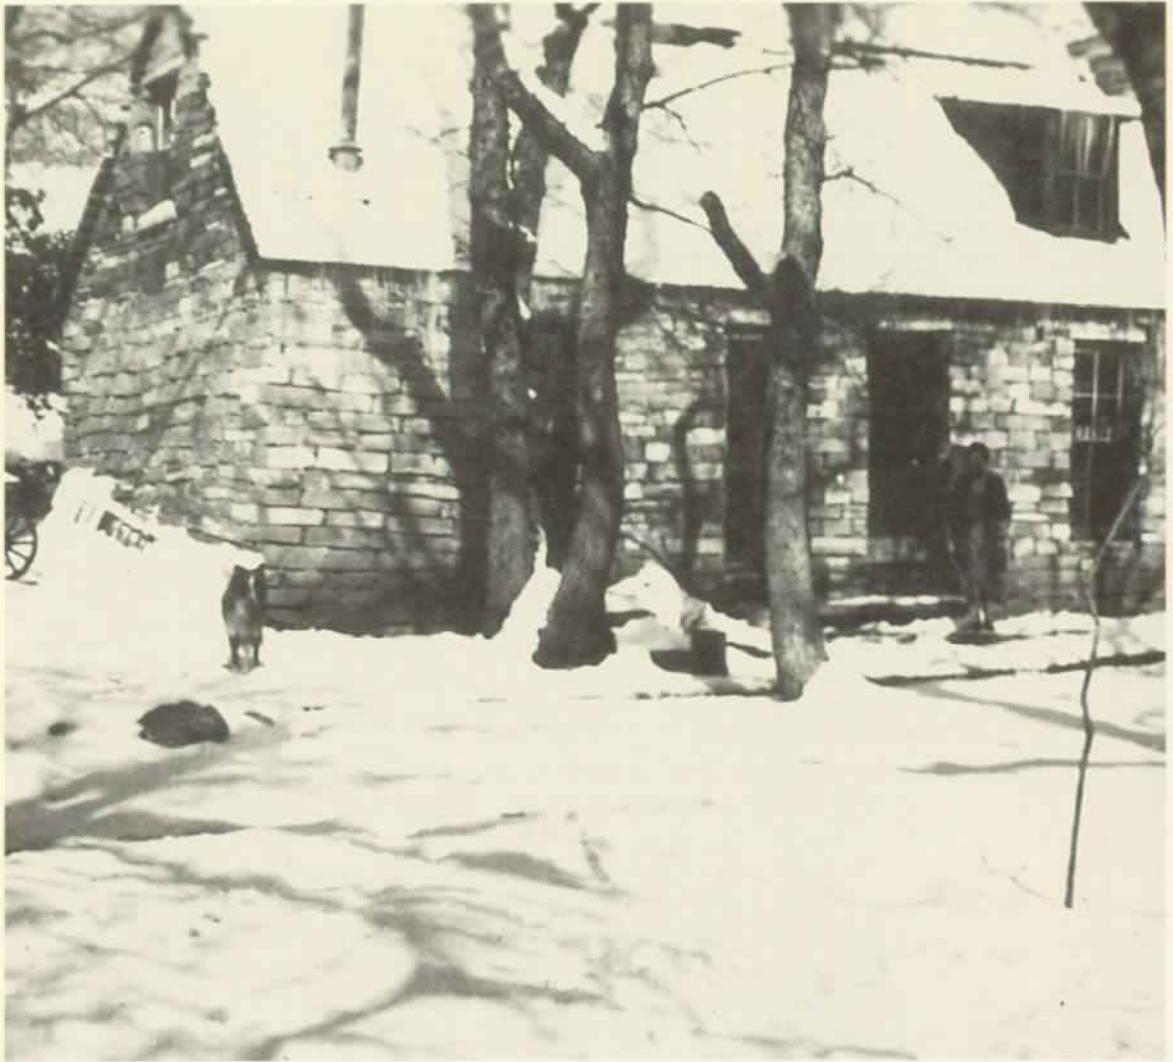
A-1: Frijole Ranch, sometime after 1910. Note irrigation trough and open stone-lined Frijole Spring in left foreground.

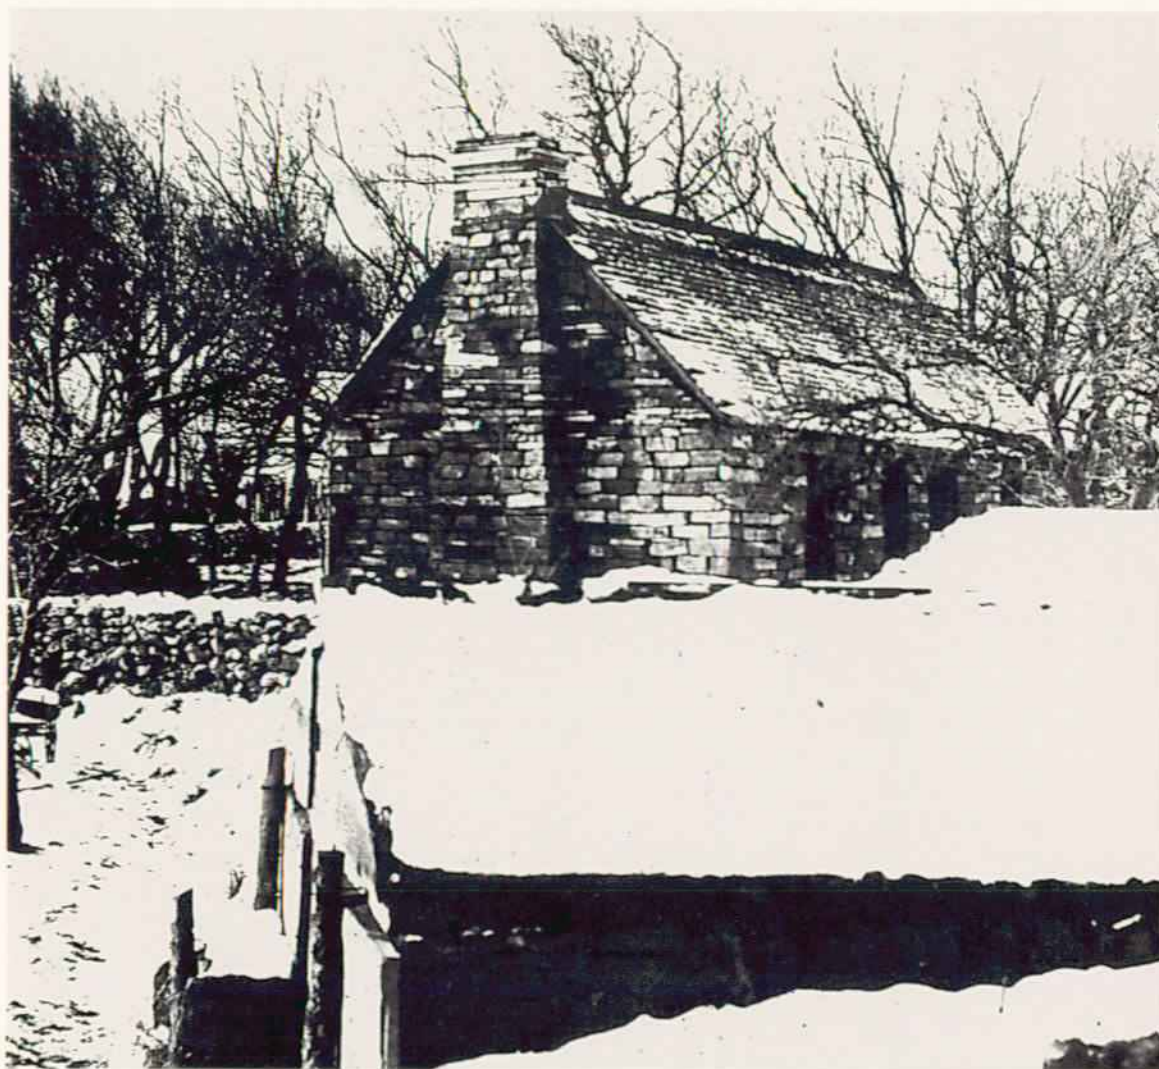
A-2: Frijole Ranch, circa 1910. Note roof line to root cellar and hot-house/greenhouse in immediate foreground. Also note shallow irrigation trench and fruit trees.
