CULTURAL LANDSCAPE REPORT FOR SPRINGWOOD

HOME OF FRANKLIN D. ROOSEVELT NATIONAL HISTORIC SITE

VOLUME II: TREATMENT

HYDE PARK, NEW YORK

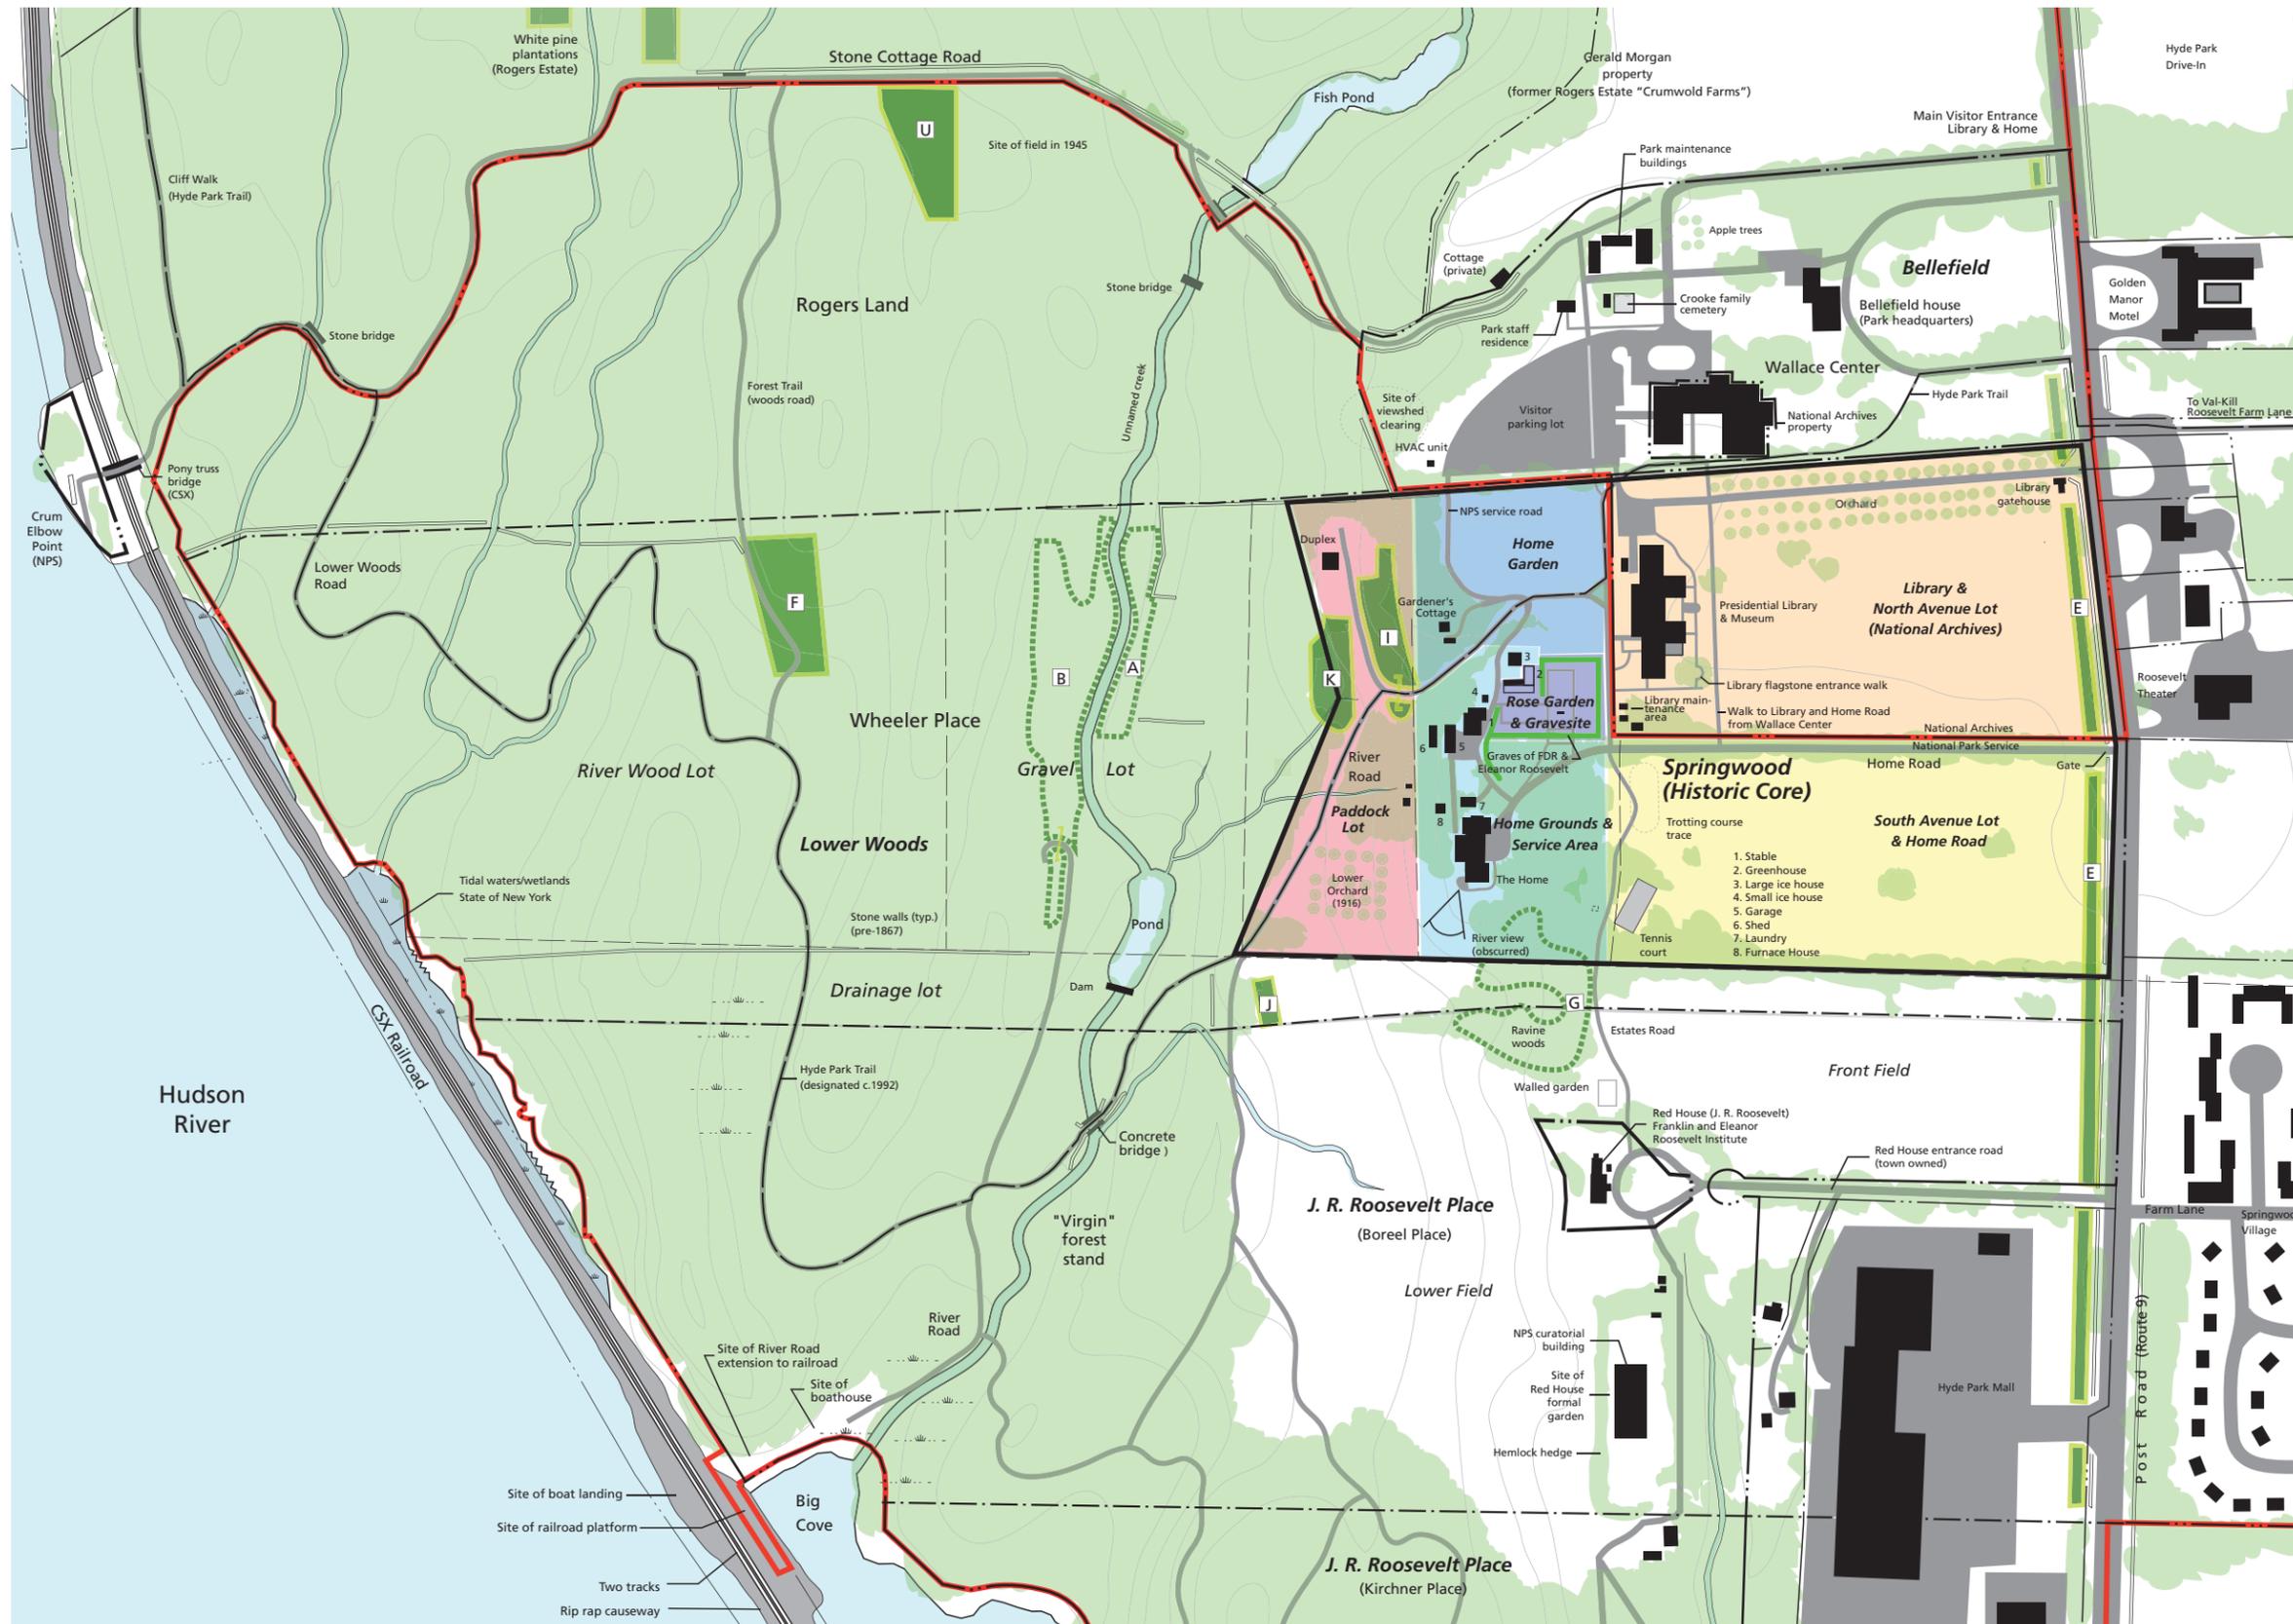
Drawing 1

1. All features shown in approximate scale and location.
2. Plan provides overview of existing (2009) conditions within the historic core (original 33-acre area surrounding the Home), with less detail in adjoining areas.

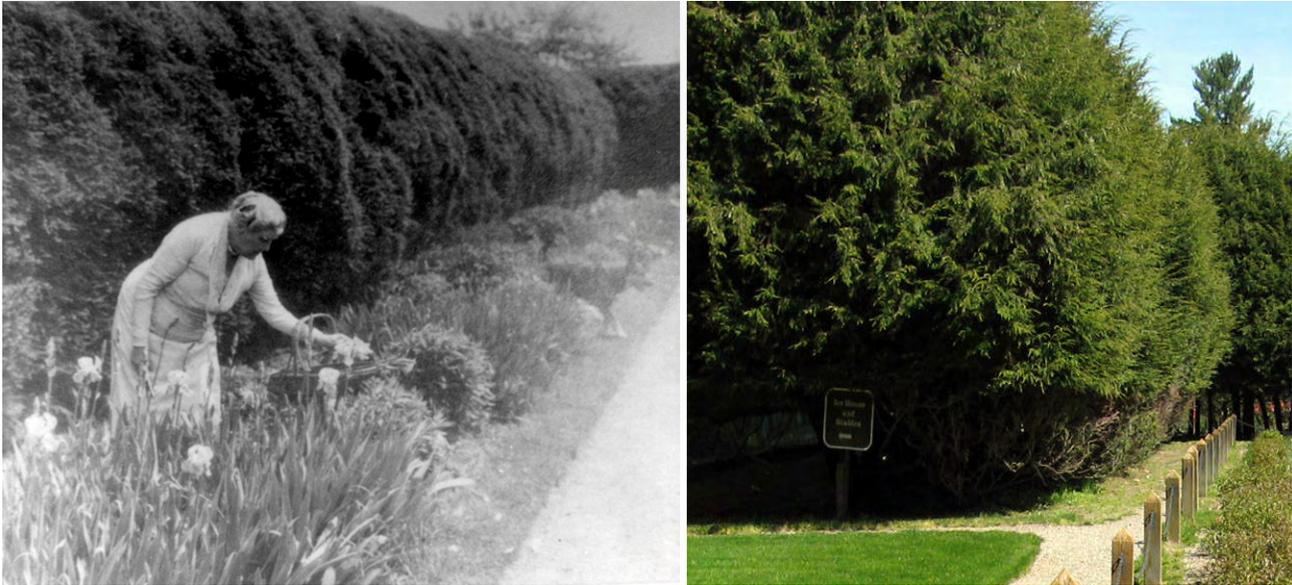
Figure 1: View in the Rose Garden in c.1935 looking north showing Sarah Roosevelt tending to the well-maintained border along the west side of the garden, compared with recent view of the same area. Note change in character of walks, turf, and hedges. Recent replacement of the hedge has allowed the bed to be restored. (Photograph NPx 50-104:13, Franklin D. Roosevelt Library and Museum.)

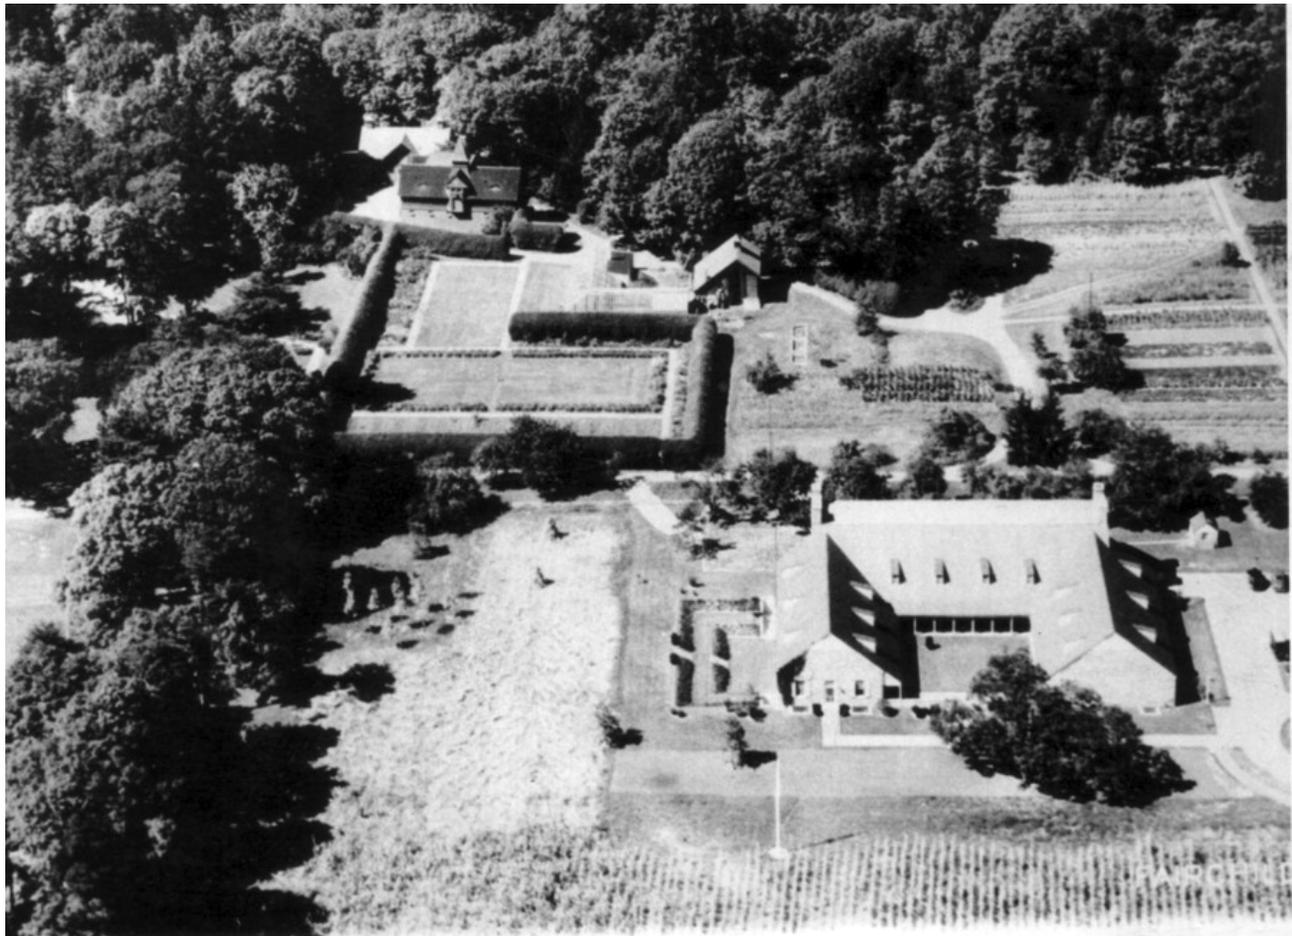
Figure 2: Historic aerial photograph taken in c.1941 illustrating integration of working agricultural lands and formal landscapes. Note the proximity of the Library to hay and corn crops, with the vegetable plots of the Home Garden and hedge-enclosed Rose Garden to the rear. (Photograph 48-223790/388, Franklin D. Roosevelt Library and Museum.)

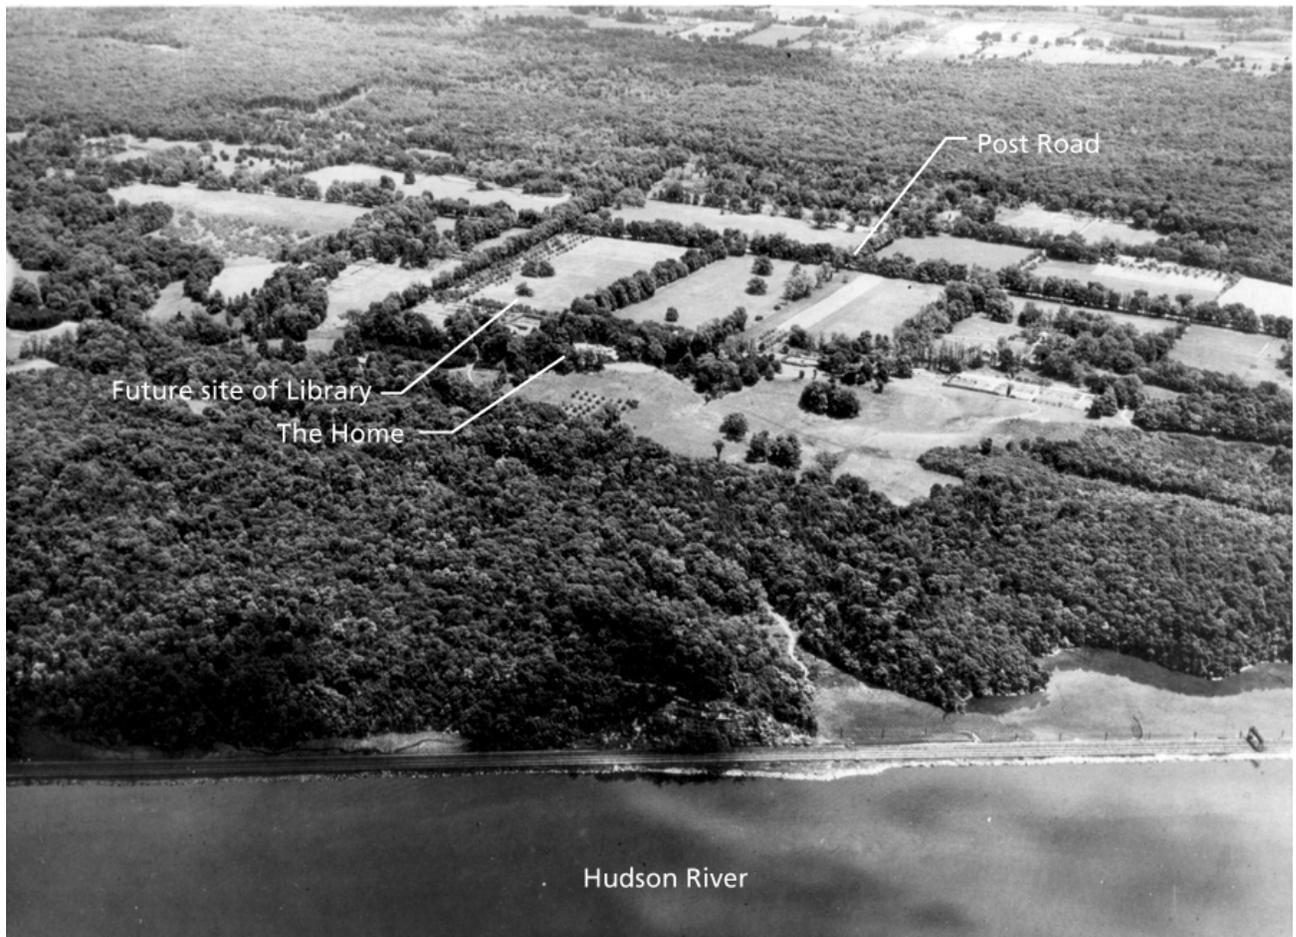
Figure 3: Aerial view looking east from the Hudson River over the historic core in 1932 illustrating the rural setting. The long line of trees running horizontally across the upper part of the photograph is the Post Road. (Photograph Px48-2213837, Franklin D. Roosevelt Library and Museum, annotated by SUNY ESF.)

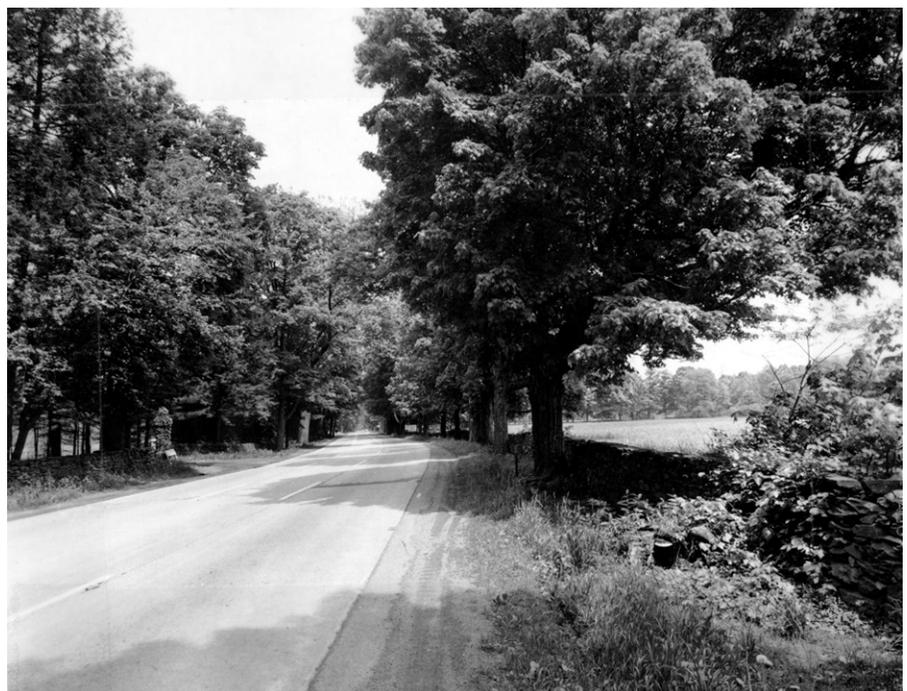
Figure 4: View looking north along the tree-lined Post Road through the Roosevelt estate in c.1946 with the Home Farm at right and Home Road entrance gate at left. Today, commercial development occupies the field at right, the road has been widened, and most of the roadside trees have been lost. (Photograph R-378, Roosevelt-Vanderbilt National Historic Sites.)

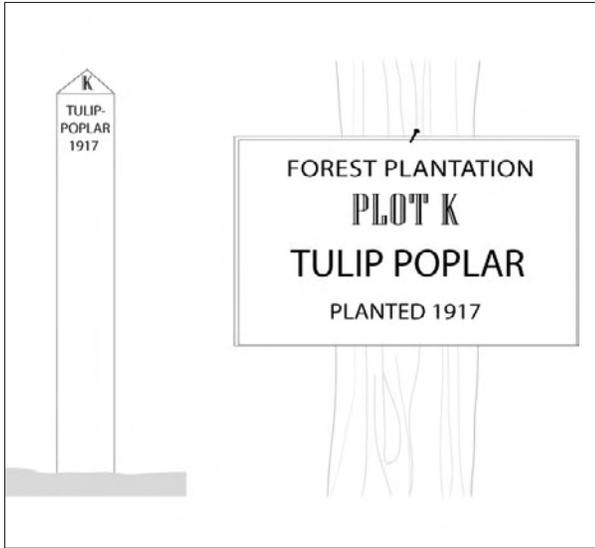
Figure 5: Suggested design for post (boundary) and signboards to identify the forest plantations. Signs should be attached with fasteners that do not damage trees. Not to scale. (SUNY ESF.)

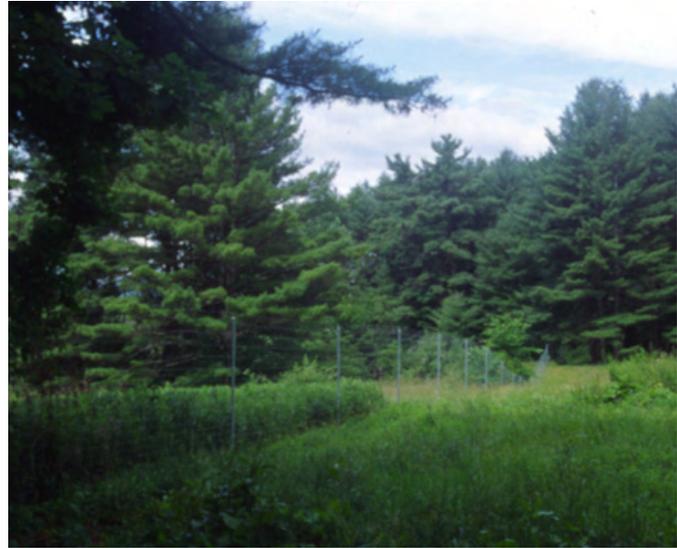
Figure 6: Recent photograph of site-wide deer fencing at The Mount, Lenox, Massachusetts showing inconspicuous design that visually recedes through open field conditions. (SUNY ESF.)

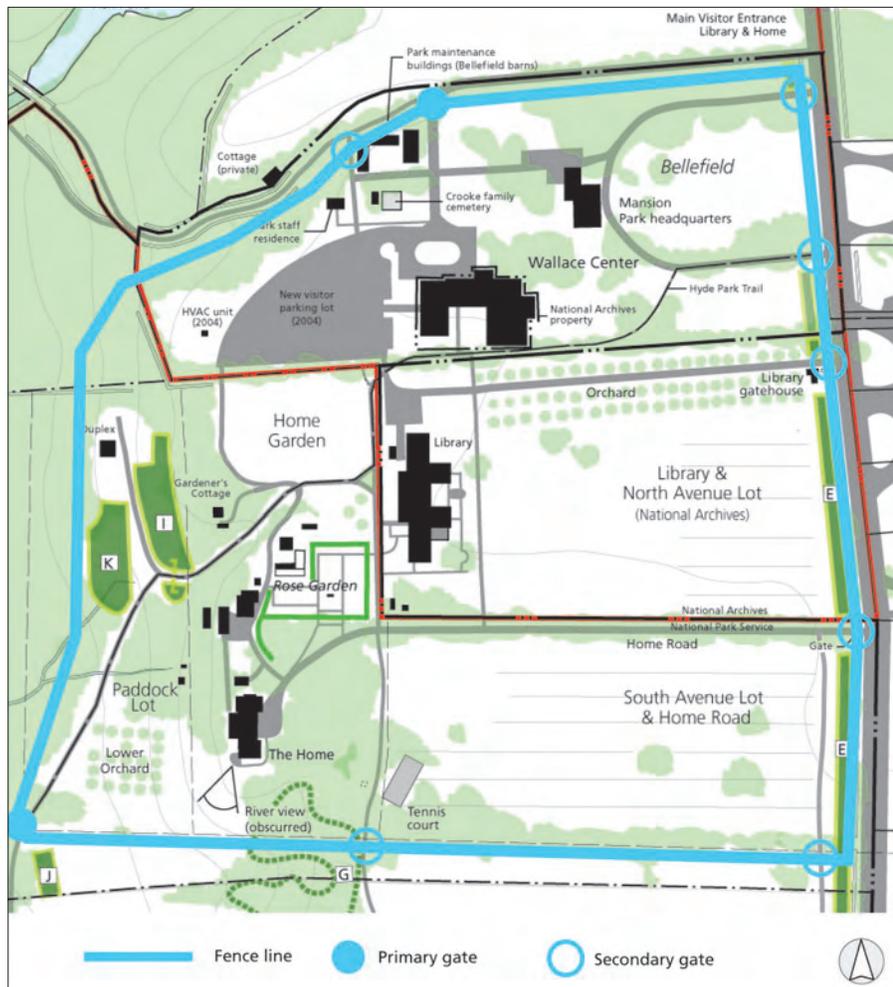
Figure 7: Plan showing possible location of site-wide deer fencing to protect the historic core and Bellefield. The plan includes two primary fence gates and seven secondary gates. (SUNY ESF.)

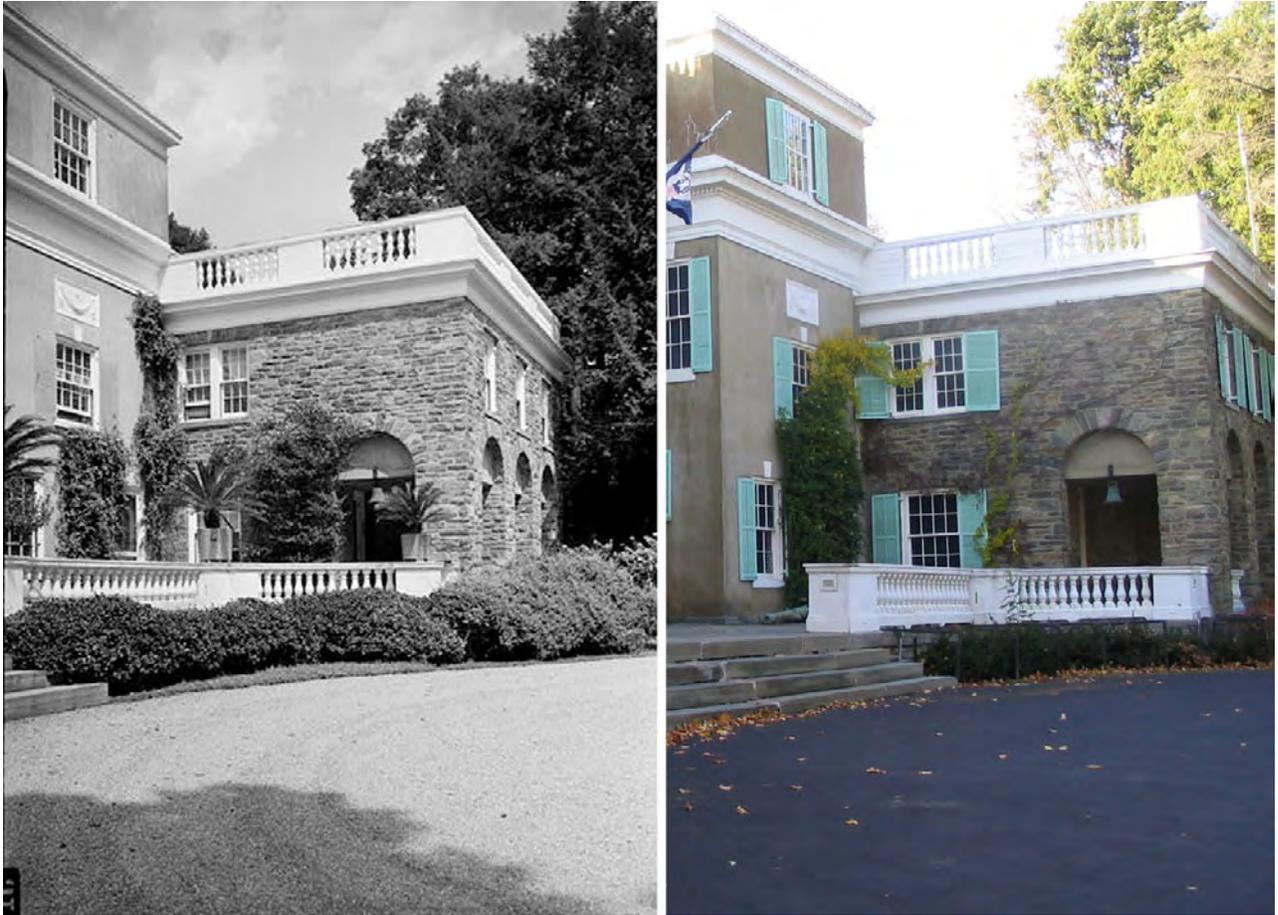
Figure 8: Comparison of paving character showing gravel-surfaced turn-around in July 1941 and the existing black asphalt that replaced it. These images also changes to the foundation shrubs. (Left: Digital image 115847pr, Historic American Building Survey, Library of Congress American Memory Collection; right: SUNY ESF, 2005.)

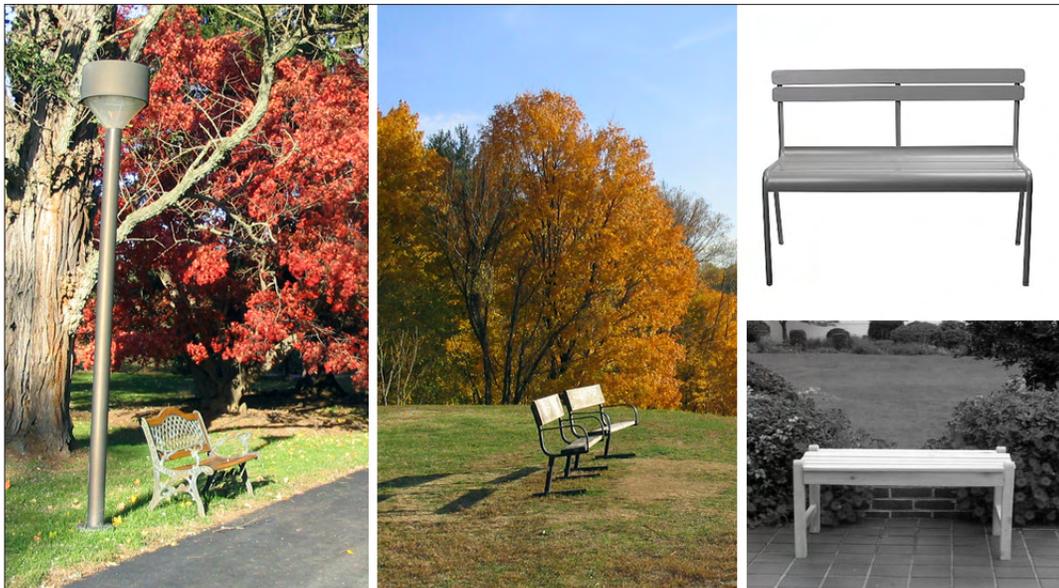
Figure 9: Existing park furnishings showing light standard and two styles of benches (left and center), and suggested bench styles that would be compatible with the historic character of the landscape. (SUNY ESF, 2005; right, bottom: WoodenBench.us, <http://www.woodenbench.us>; right top: Luxembourg Verbena Bench, <http://www.conranusa.com>.)

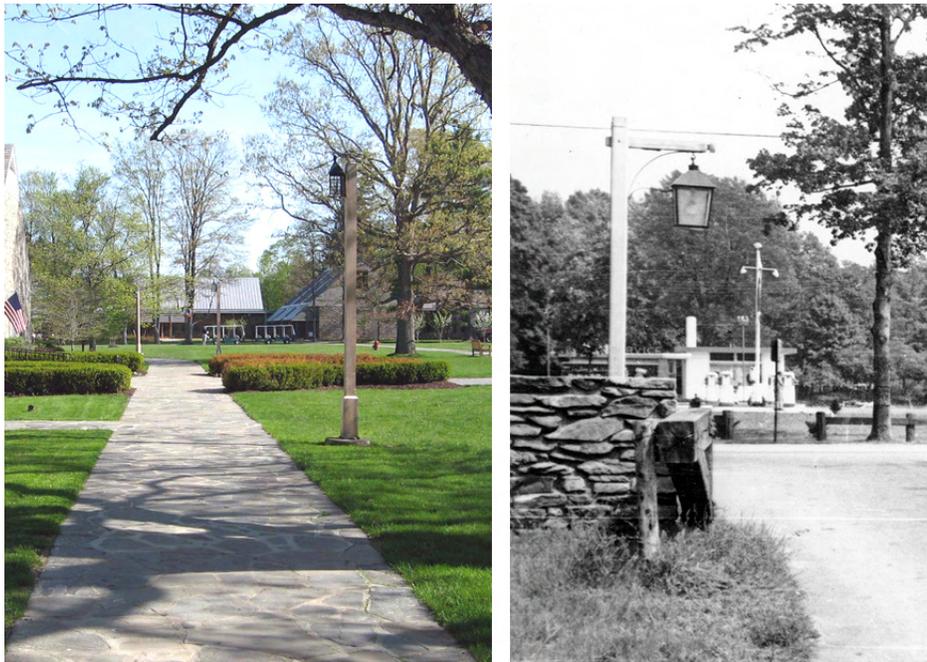
Figure 10: Recently installed light standards along the Library entrance walk (left) and historic light standards at the Library entrance. (Right: Photograph R78B, c.1946, Roosevelt-Vanderbilt National Historic Sites; left: SUNY ESF, 2007.)

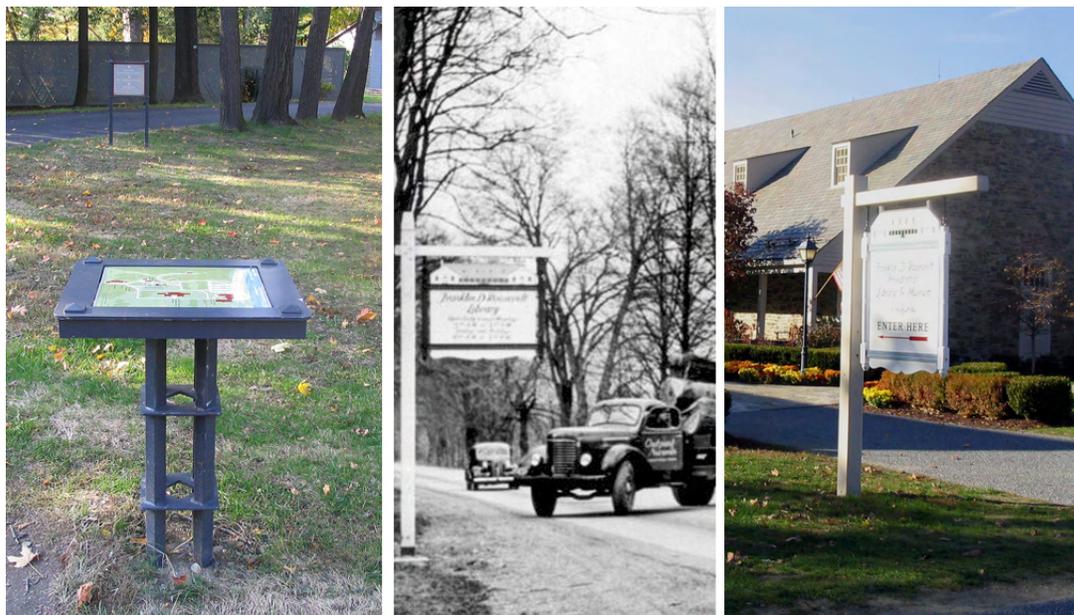
Figure 11: Example of current National Park Service directional sign, historic Library entrance sign on the Post Road, and existing entrance sign in front of the Library. (Left and right: SUNY ESF, 2005; center: detail of photograph Px61-294129, c.1944, Franklin D. Roosevelt Library and Museum.)

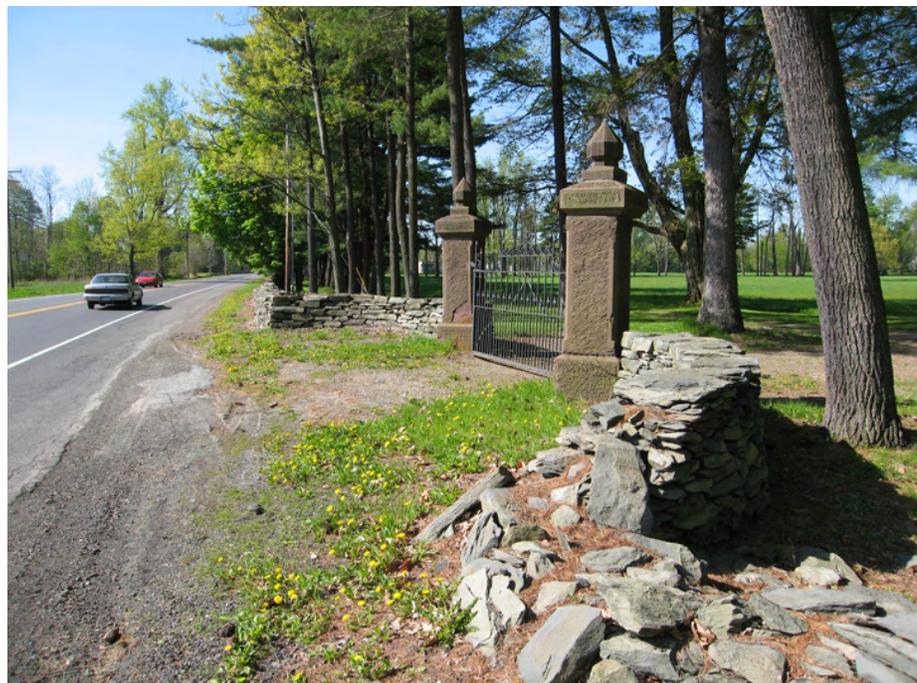
Figure 12: Recent view of the Home Road entrance looking south along the Post Road showing deteriorated condition of road shoulder, earthen roadbed, and stone wall. (SUNY ESF, 2007.)

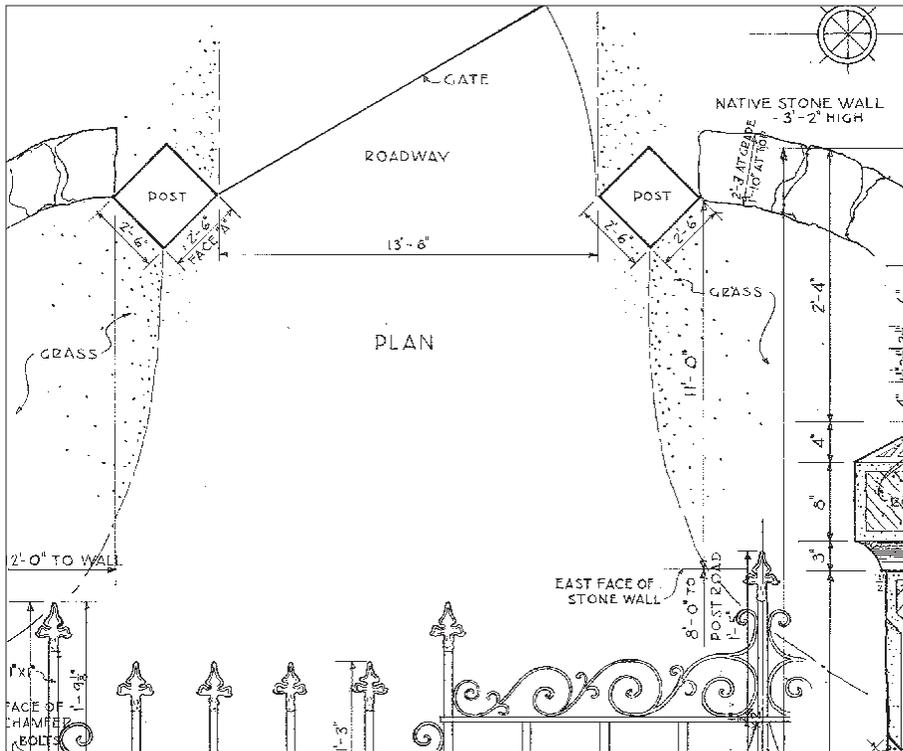
Figure 13: Plan of the Home Road entrance gate and head of the Home Road as drawn by the Public Works Administration in July 1941. Note well-defined, curved edge of the Home Road. (Detail, file NY1240, Library of Congress, American Memory Collection.)

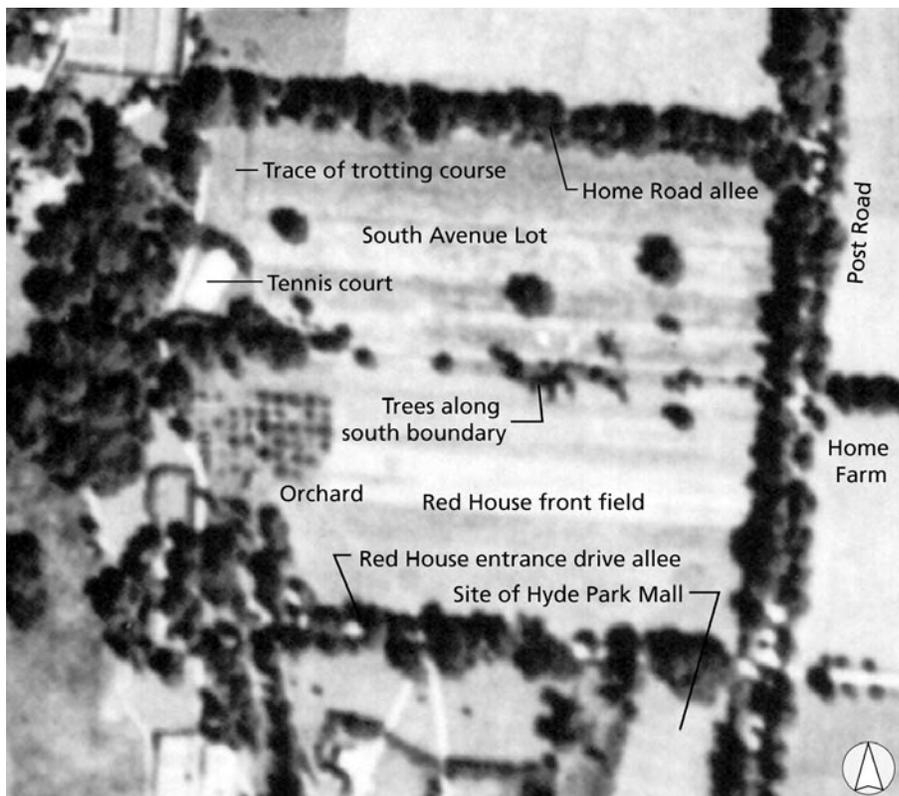
Figure 14: Historic aerial photograph taken in 1936 showing the historic character of the trees along the boundary of the South Avenue Lot and the open relationship to the Red House front field (J. R. Roosevelt Place). This photograph also shows the tennis court, trace of the trotting course, and the tree-lined Red House entrance road. The existing Hyde Park Mall was built in c.1969 in the field south of this road. (Roosevelt-Vanderbilt National Historic Sites, annotated by SUNY ESF.)

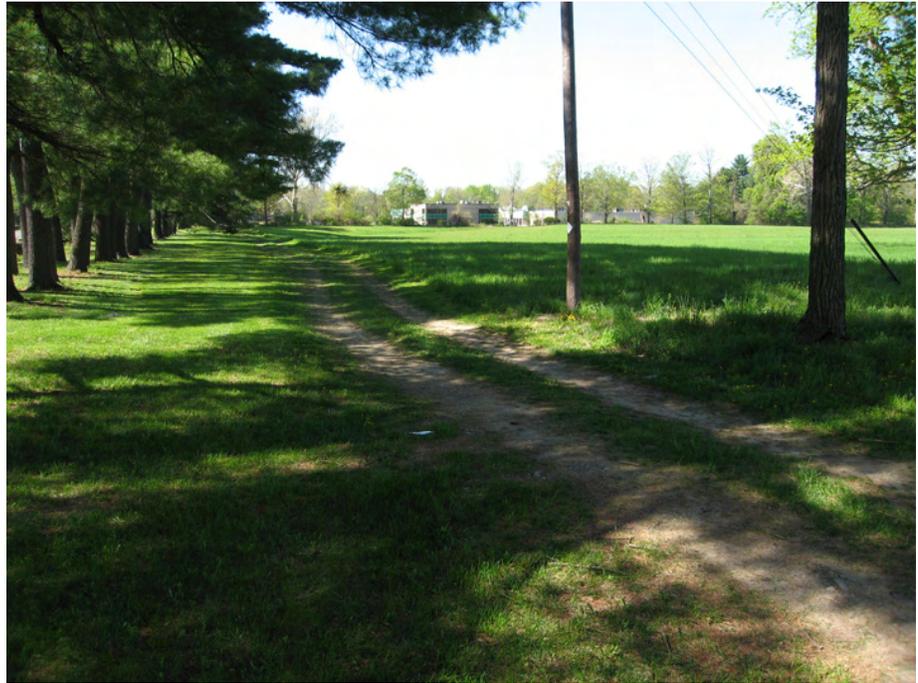
Figure 16: Recent view along the South Avenue Lot farm road looking south from the Home Road with the white pine screen (Plot E) at left. The Red House front field shown in figure 15 is visible in the background. (SUNY ESF, 2007.)

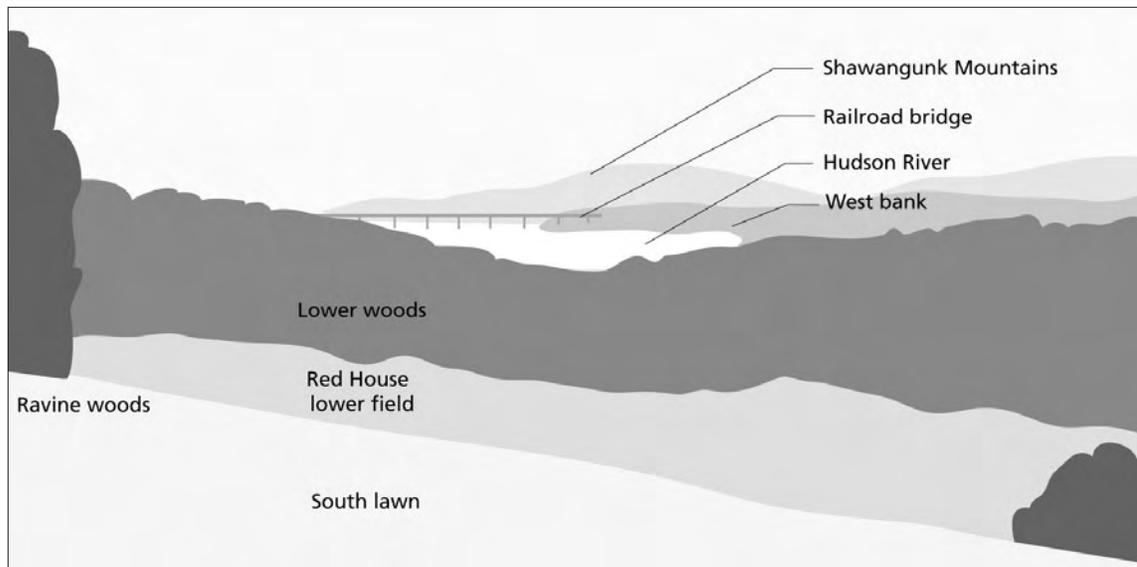
Figure 18: Diagram of the historic organization of the river view, showing elements of foreground, middle ground, and distance. (SUNY ESF.)

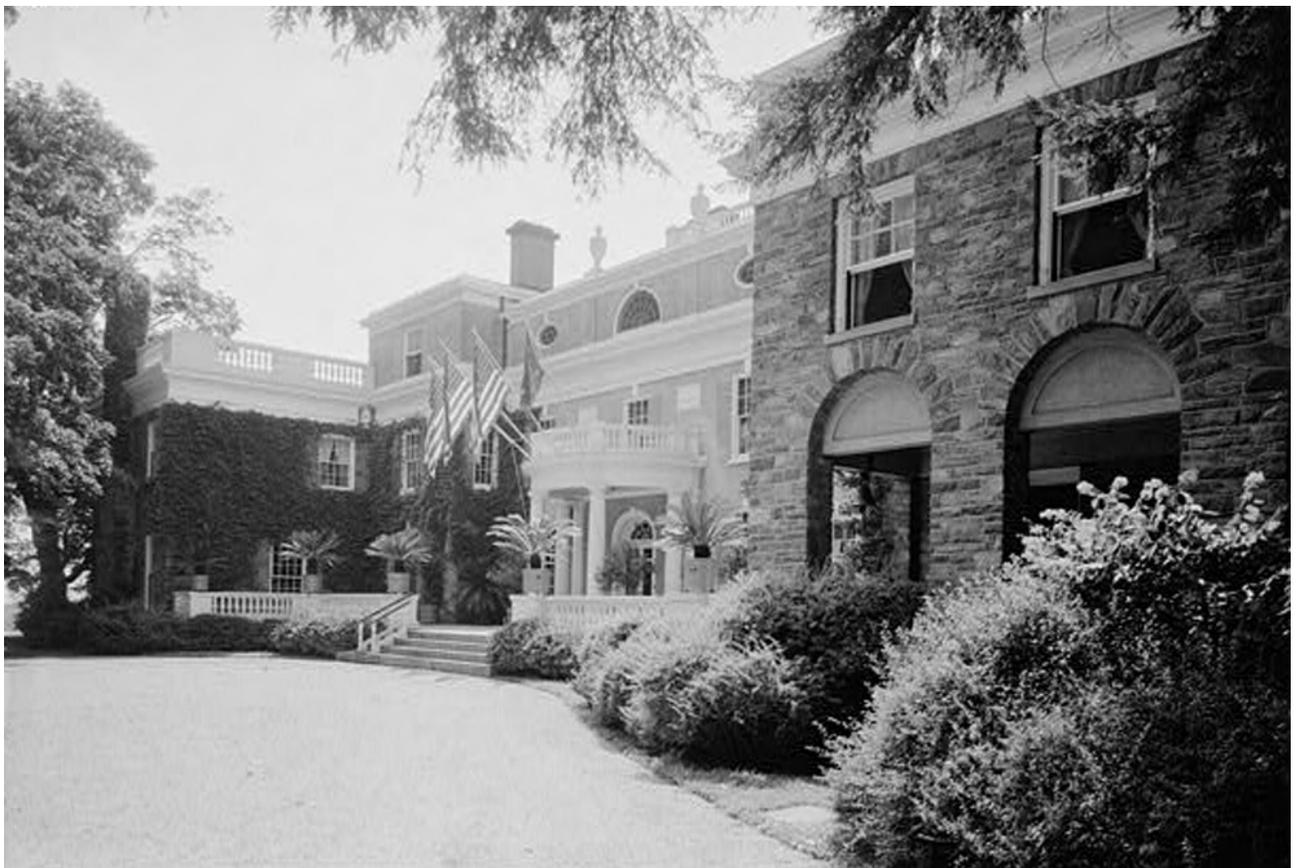
Figure 19: Historic view of the foundation plantings along the front of the Home as photographed in July 1941 showing euonymus (along terrace balustrade) and mixed spirea-barberry-mock orange (larger shrubs in front of the north and south wings). See figure 8 for a close-up view of the euonymus. (Digital image 115842, Historic American Building Survey, Reproduced on Library of Congress American Memory Collection.)

19.	Historic view of foundation plantings along the front of the Home, 1941.	69
20.	Historic view of foundation plantings along the south and west sides of the Home, 1941.	70

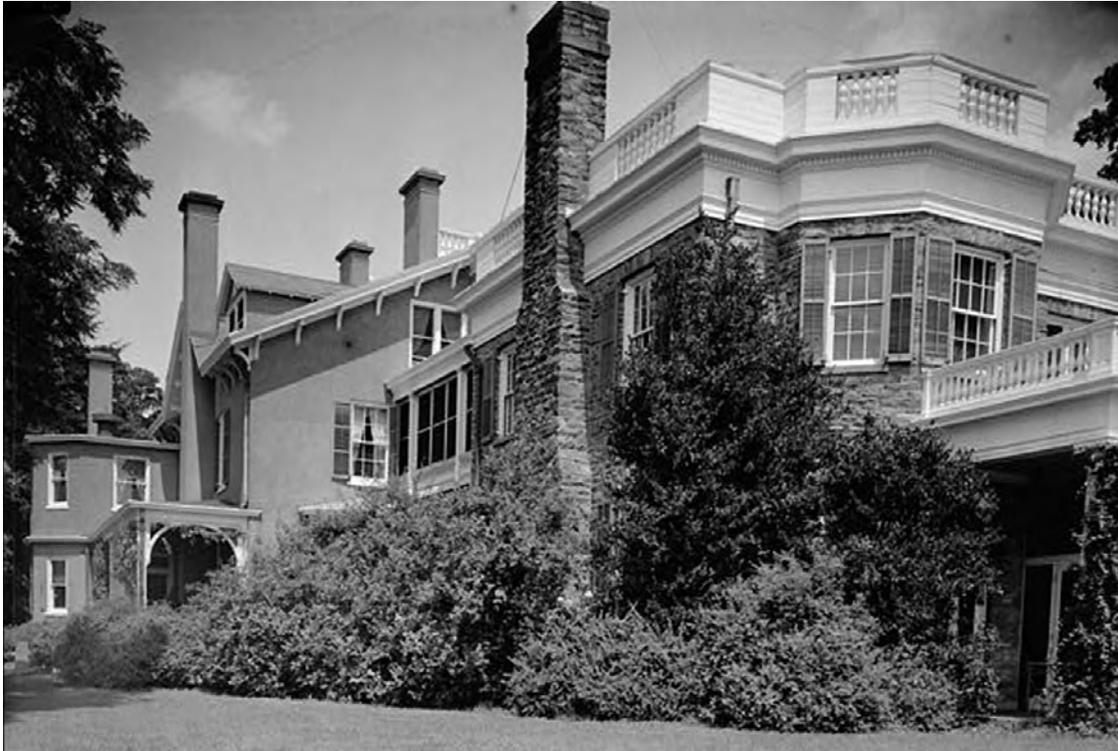
Figure 20: Historic view looking north at the foundation plantings at southwest corner of the home, July 1941 showing informal massing of spirea and barberry accented by taller holly. Also note the vines on the south and west porch columns. (Digital image 115849pr.Historic American Building Survey, Library of Congress American Memory Collection.)

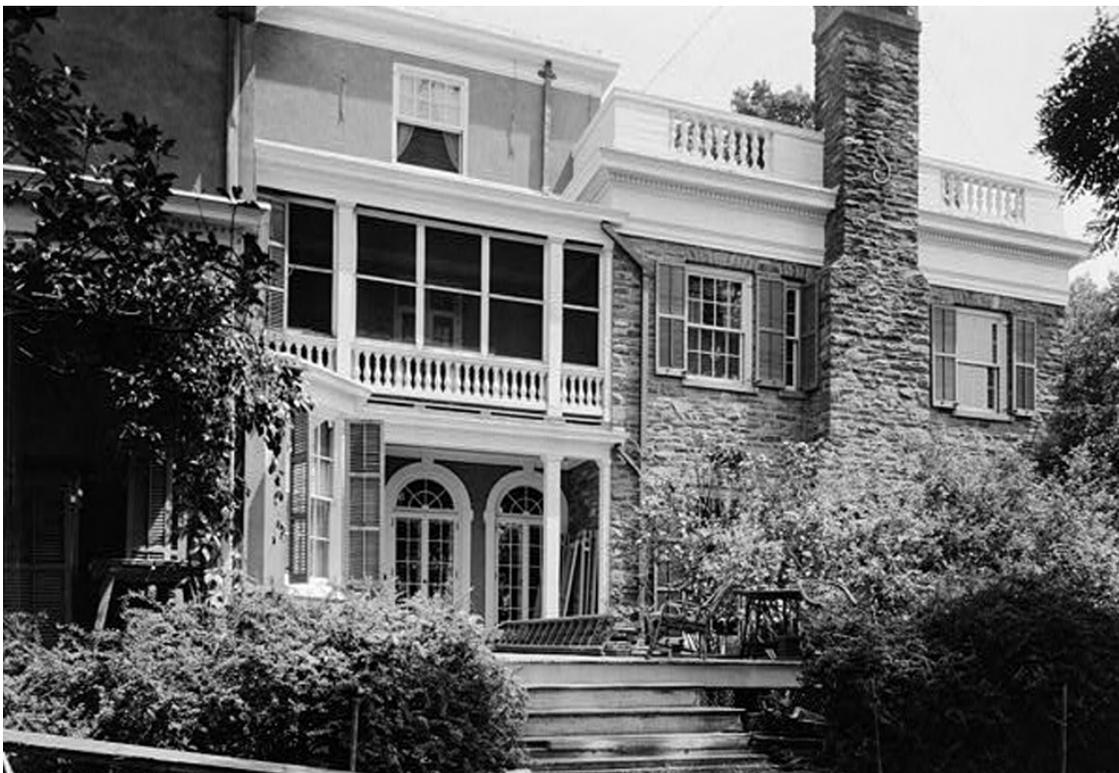
Figure 21: Historic view looking east at the plantings along the west deck, July 1941. To the left of the steps is a clipped spirea hedge; to the right is a mass of barberry and spirea. Honeysuckle is growing on the west porch column at left. (Digital image 115850pr, Historic American Building Survey, Library of Congress American Memory Collection.)

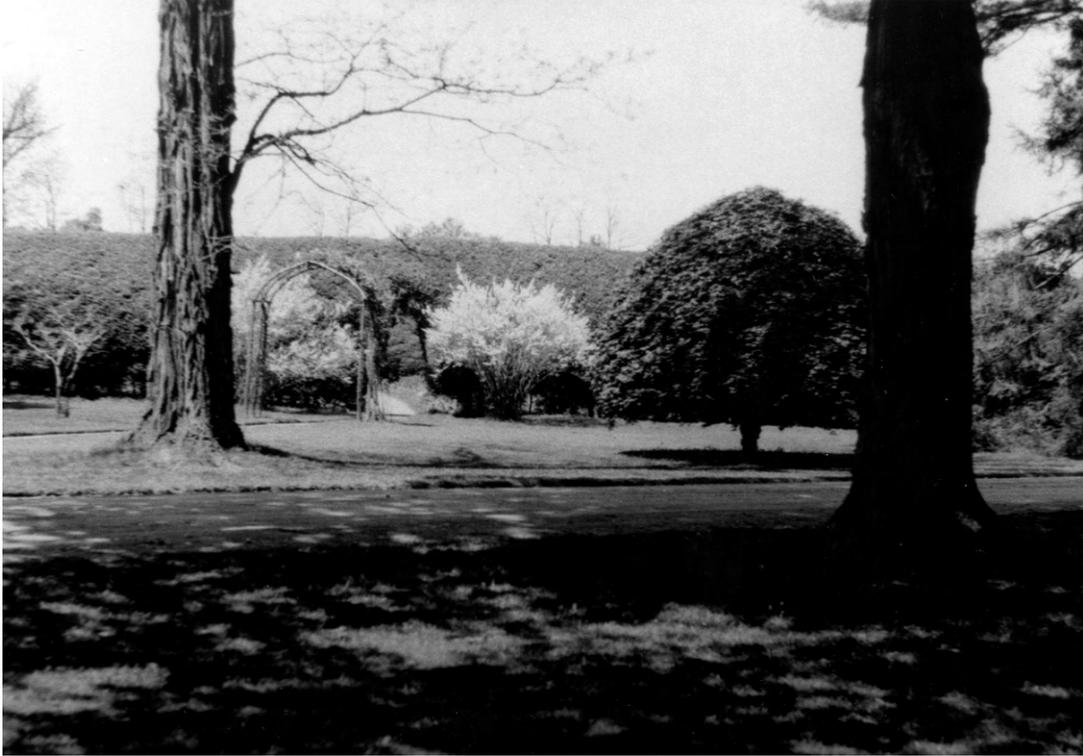
Figure 22: Historic view looking north toward the Rose Garden from the main lawn, c. 1935. Note the edged unpaved roads and walks, and the arched rustic rose arbor. Hemlock shrubs may have been planted to either side of the arbor by 1941. The clipped tree at right is the existing Japanese red maple. (Photograph NPx 80-165 10, Franklin D. Roosevelt Library and Museum.)

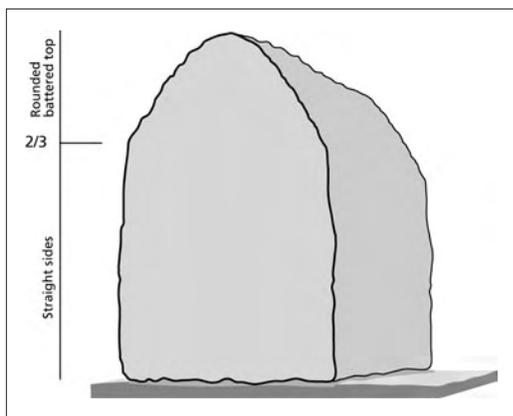
Figure 23: Section-elevation diagram showing clipping profile used in the service area and Rose Garden hemlock hedges. The batter was also carried around the hedge ends. (SUNY ESF.)

21.	Historic view of foundation plantings along the west side of the Home, 1941.	70
22.	Historic view of the north lawn and rose arbor, c.1935.	71
23.	Diagram of hemlock hedge clipping profile.	71

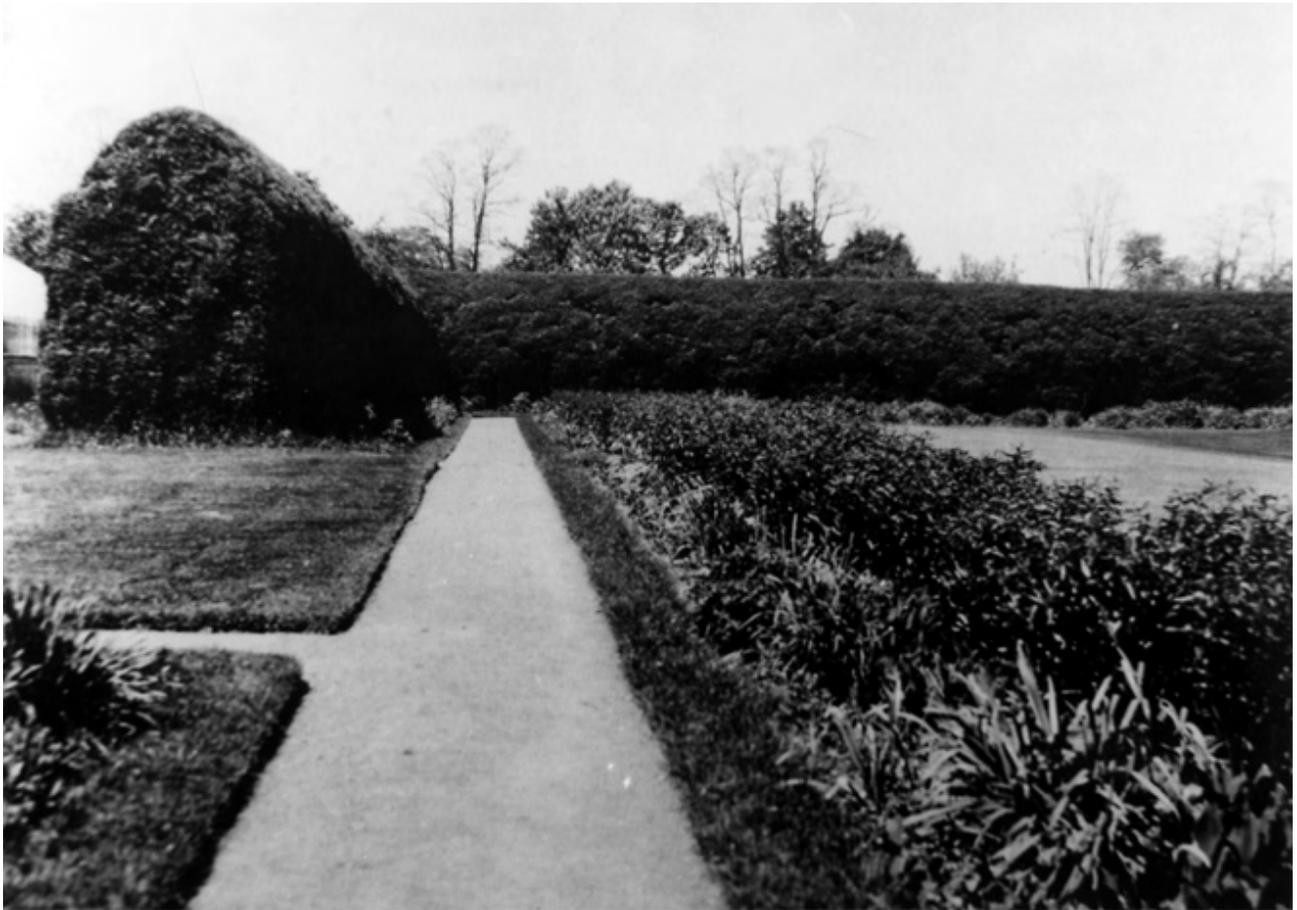
Figure 29: Historic view of the Rose Garden hedge in c.1942 looking north showing straight sides and battered top. Also note stone dust surface of walks, neatly edged into the lawn; and narrow turf strip between the herbaceous borders and the walks. (Photograph NPx 80-165 9, Franklin D. Roosevelt Library and Museum.)
