CULTURAL LANDSCAPE REPORT FOR SPRINGWOOD

HOME OF FRANKLIN D. ROOSEVELT NATIONAL HISTORIC SITE

VOLUME II: TREATMENT

HYDE PARK, NEW YORK

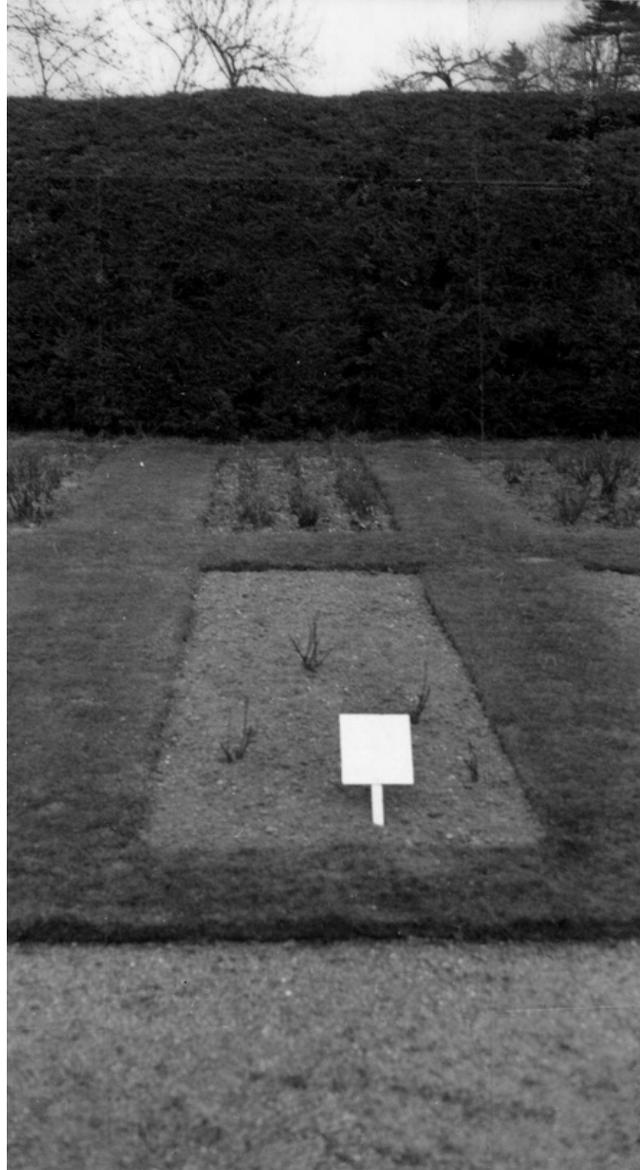
Figure 30: View of two of the rose beds looking east taken soon after the end of the historic period in April 1946. The bed at the rear is planted with roses dating from the historic period, while the front bed had apparently been replanted by the park. Note that the bed level is below the turf and there is a lack of heavy mulch. (Photograph R-268-269, Roosevelt-Vanderbilt National Historic Sites.)

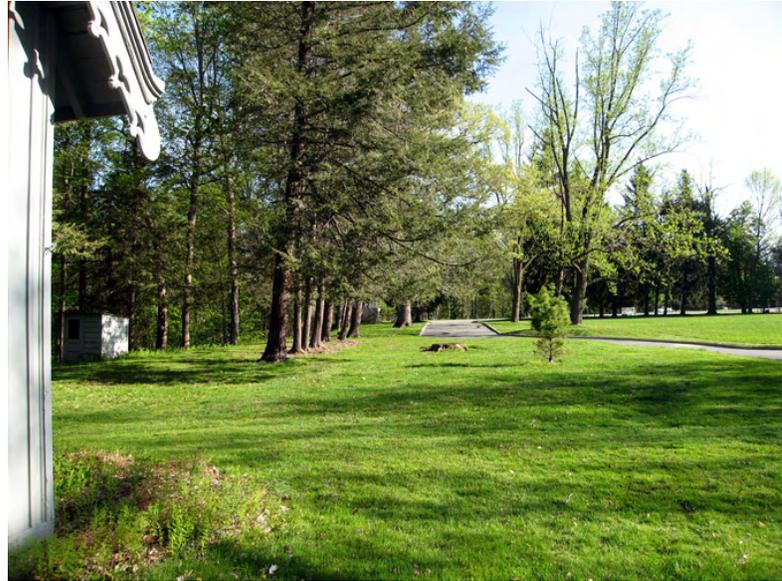
Figure 31: Recent view looking north along the west side of the large vegetable garden field showing non-historic tulip trees to the right of the NPS service road. The line of hemlocks is on the 1946 survey. (SUNY ESF, 2007.)

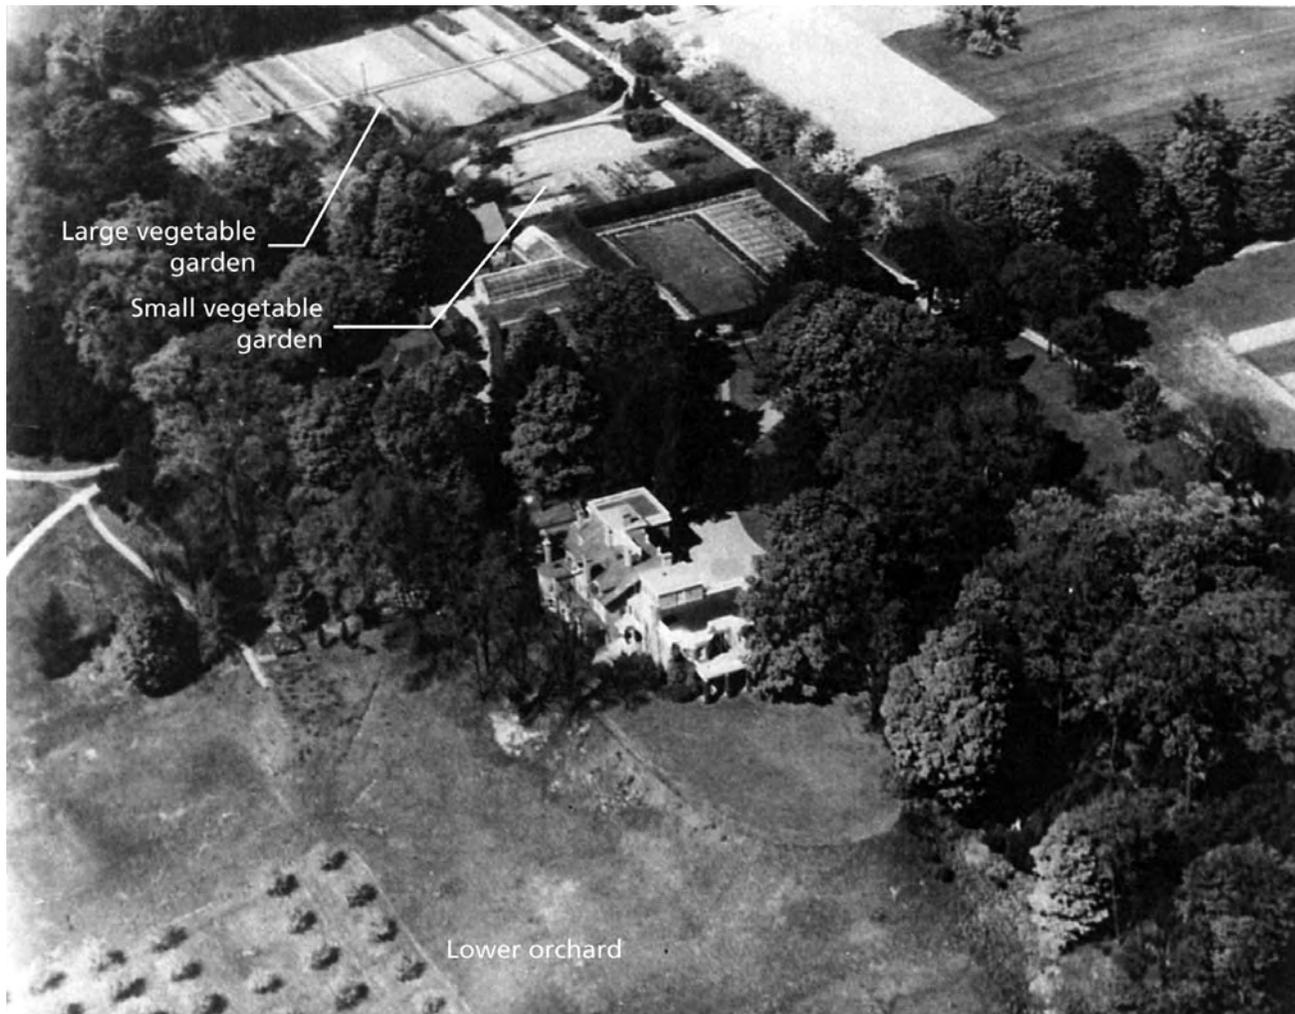
Figure 32: Historic aerial view looking northeast over the Home in 1933 illustrating character of the Home Garden eight years prior to the treatment period of 1941. Note the axial garden roads that organized the large vegetable garden into four quadrants, and well-defined surfaces of the roads throughout the landscape. (Detail of photograph NPx 62-61, Franklin D. Roosevelt Library and Museum, annotated by SUNY ESF.)

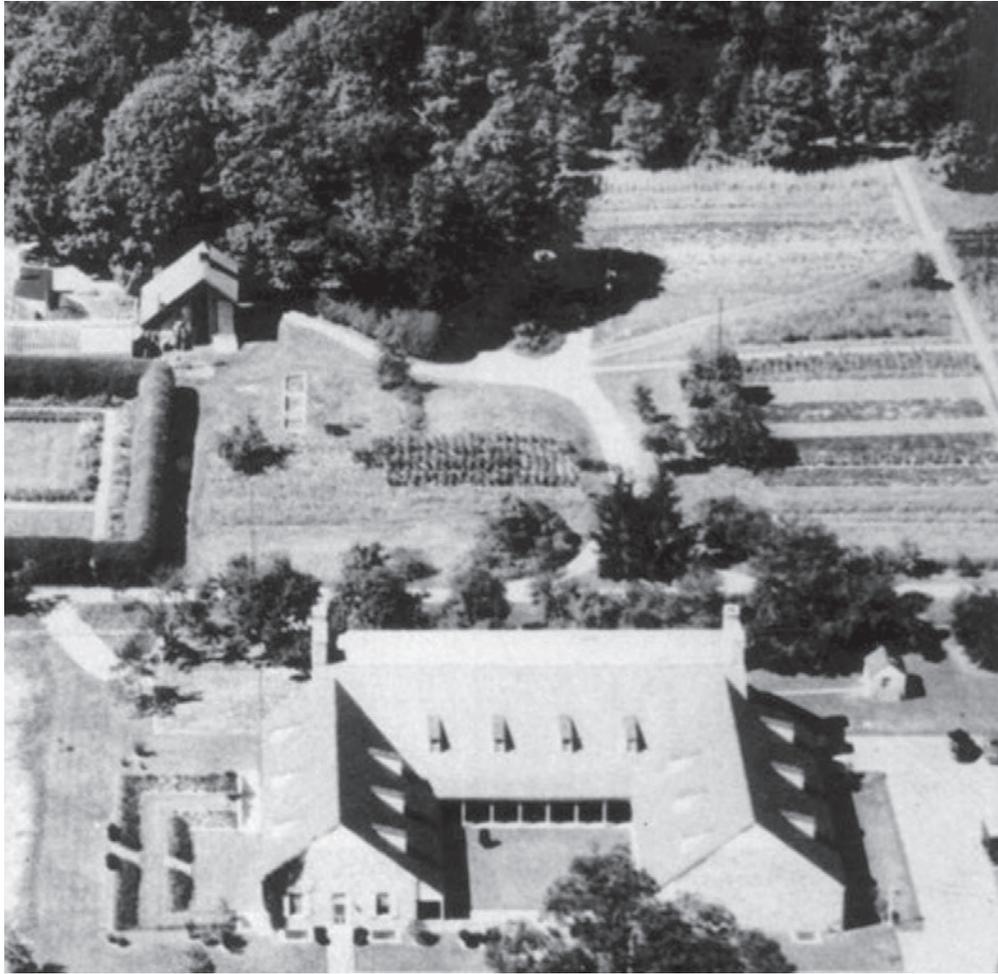
Figure 33: Historic aerial view looking west over the southern half of the Home Garden at the treatment period in c.1941, with the large vegetable garden at right and small vegetable garden with tree nursery at left. Note north-south direction of rows within garden plots. (Detail of photograph 48-223790(388), Franklin D. Roosevelt Library and Museum.)

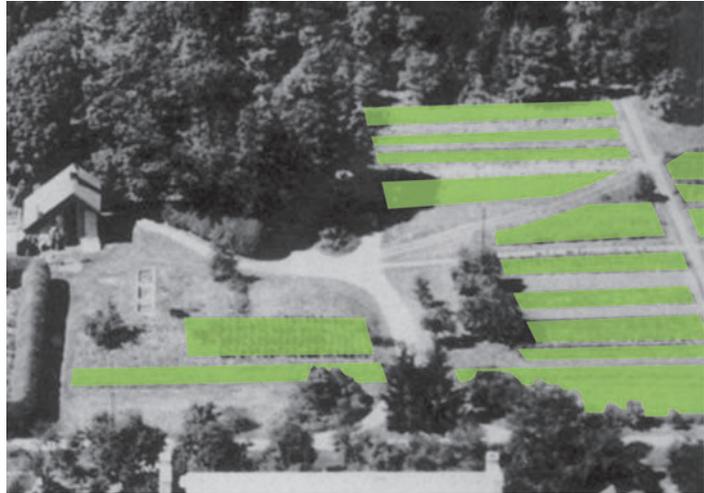
Figure 36 (below): Photograph of the apiary in 1948 prior to removal for construction of visitor parking lot. The pole was placed to indicate scale. (Photograph R-211, Roosevelt-Vanderbilt National Historic Sites.)

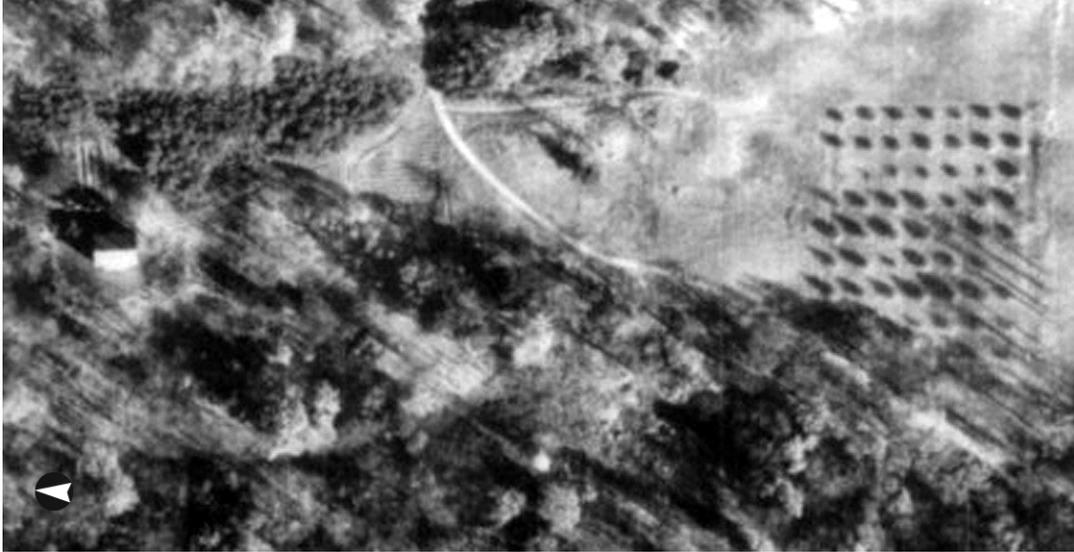
Figure 40: Historic aerial view of the Paddock Lot in 1931 showing limits of field, character of lower orchard, and extent of white pine plantation (Plot I, dark area at upper left). Although ten years earlier than the treatment date, the landscape did not change significantly over this time aside from the growth of trees between the Pump House Road and River Road at the north end of the field. (Detail, photograph Npx48-223922(1), Franklin D. Roosevelt Library and Museum.)

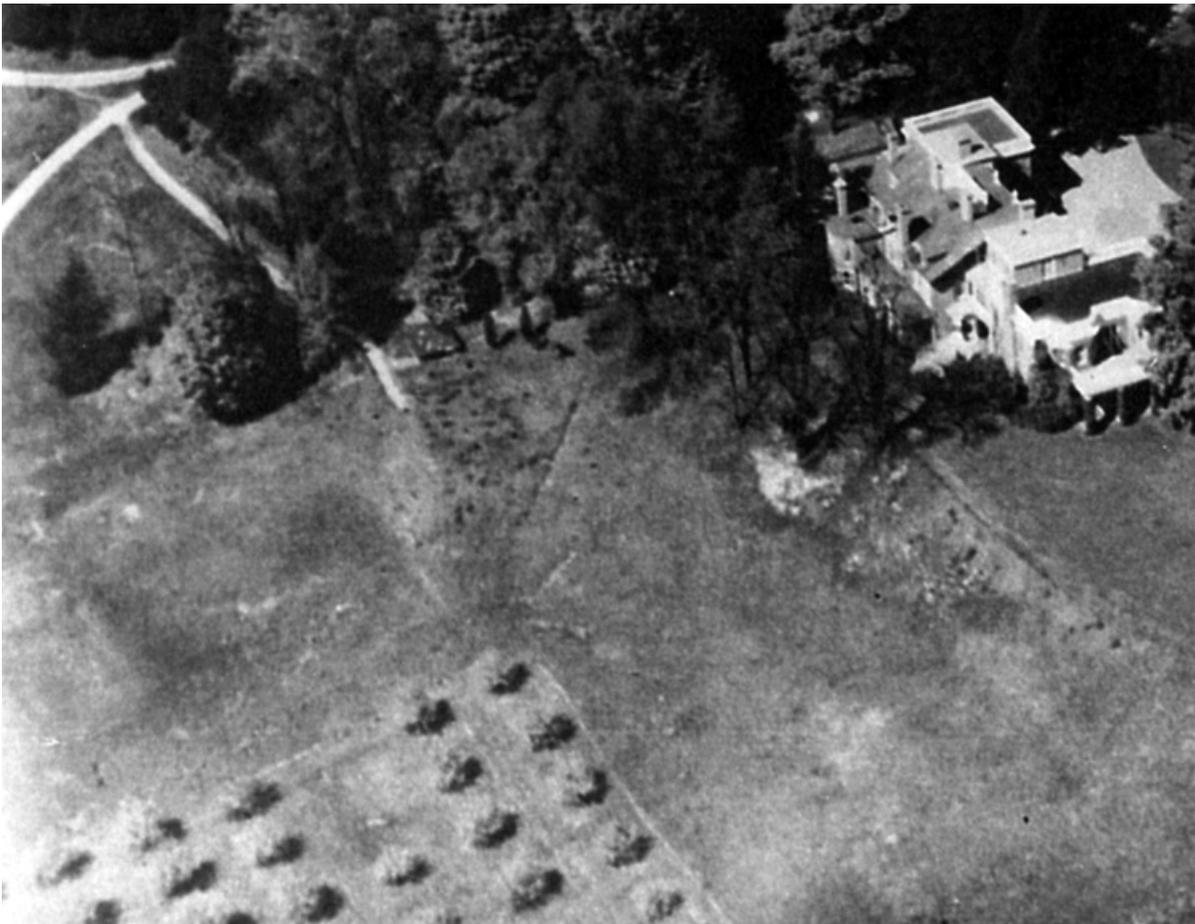
Figure 41: Historic aerial view of the southern half of the Paddock Lot in 1933 showing the character of River Road, Duplex Road, and Pump House Road (left); and the lower orchard. Note the well-defined surface of the roads and mowing pattern around the orchard. (Detail, photograph NPx 62-61, Franklin D. Roosevelt Library and Museum.)

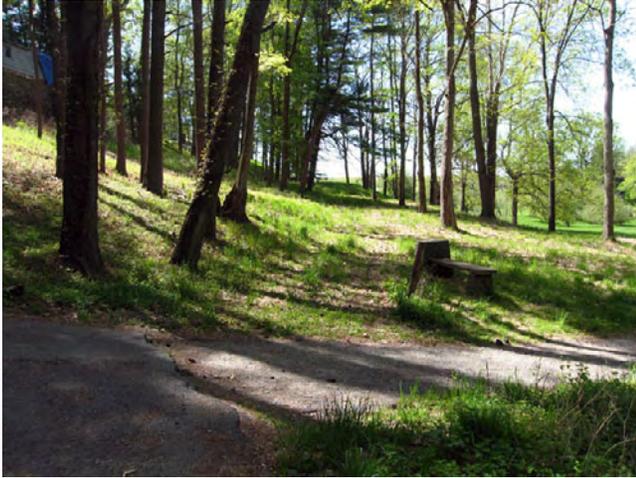
Figure 42: Recent view of the Pump House Road trace looking south from River Road. Note variety of road pavement and surface types compared with historic conditions shown in figure 39. At right is the non-historic audio-interpretive station. (SUNY ESF, 2007.)

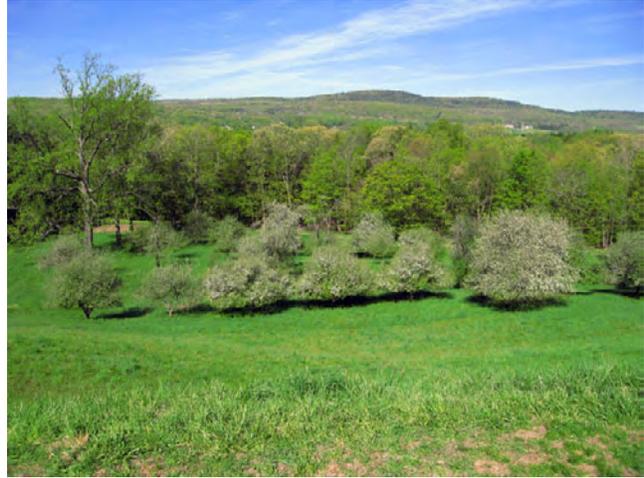
Figure 43: Recent view of the lower orchard looking west from the south lawn at the Home. Note missing trees and lack of uniform pruning. (SUNY ESF, 2007.)

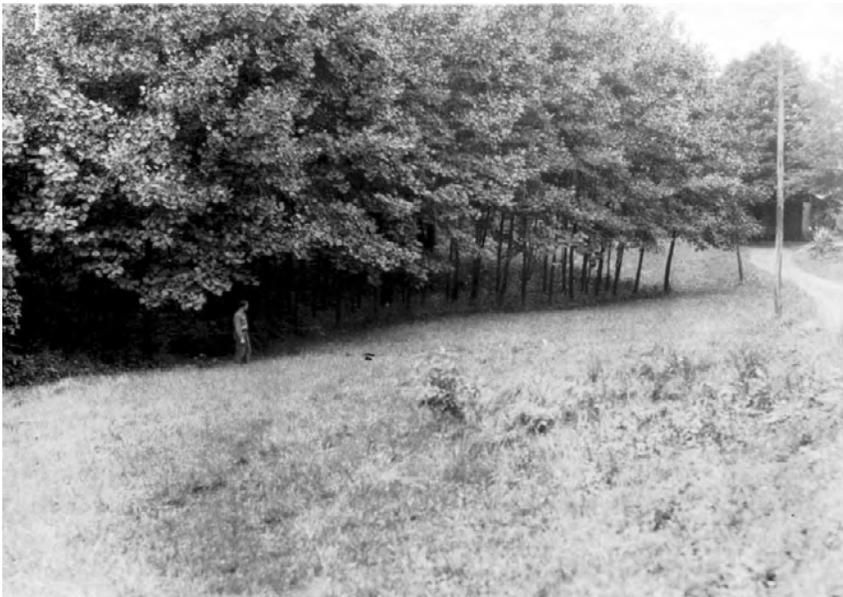
Figure 44 (above): Historic view of Plot K (tulip poplar planted in 1917) in 1931 looking north with the Duplex Road at right. Note managed character with pruned lower trunks and understory free of debris and brush. (Photograph 48-223837[23], Franklin D. Roosevelt Library and Museum.)

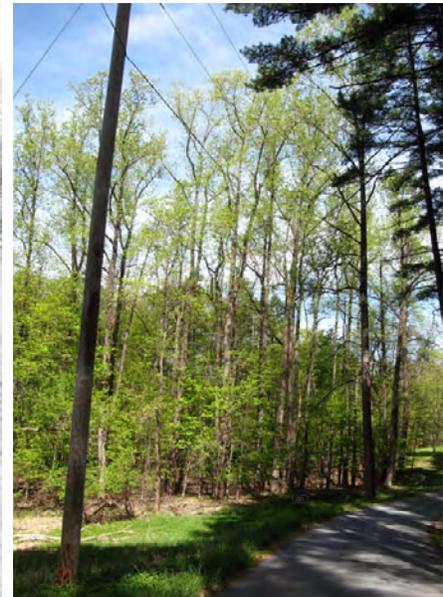
Figure 45 (upper right): Recent spring view of Plot K showing mature tulip trees with leafed-out successional understory hardwoods. At right is the Duplex Road. (SUNY ESF, 2007.)

45.	Recent view of Plot K showing mature tulip trees and undergrowth.	108
46.	Recent view of the old reservoir showing debris-strewn condition.	108
47.	Historic view of the Library looking northwest, 1941.	120

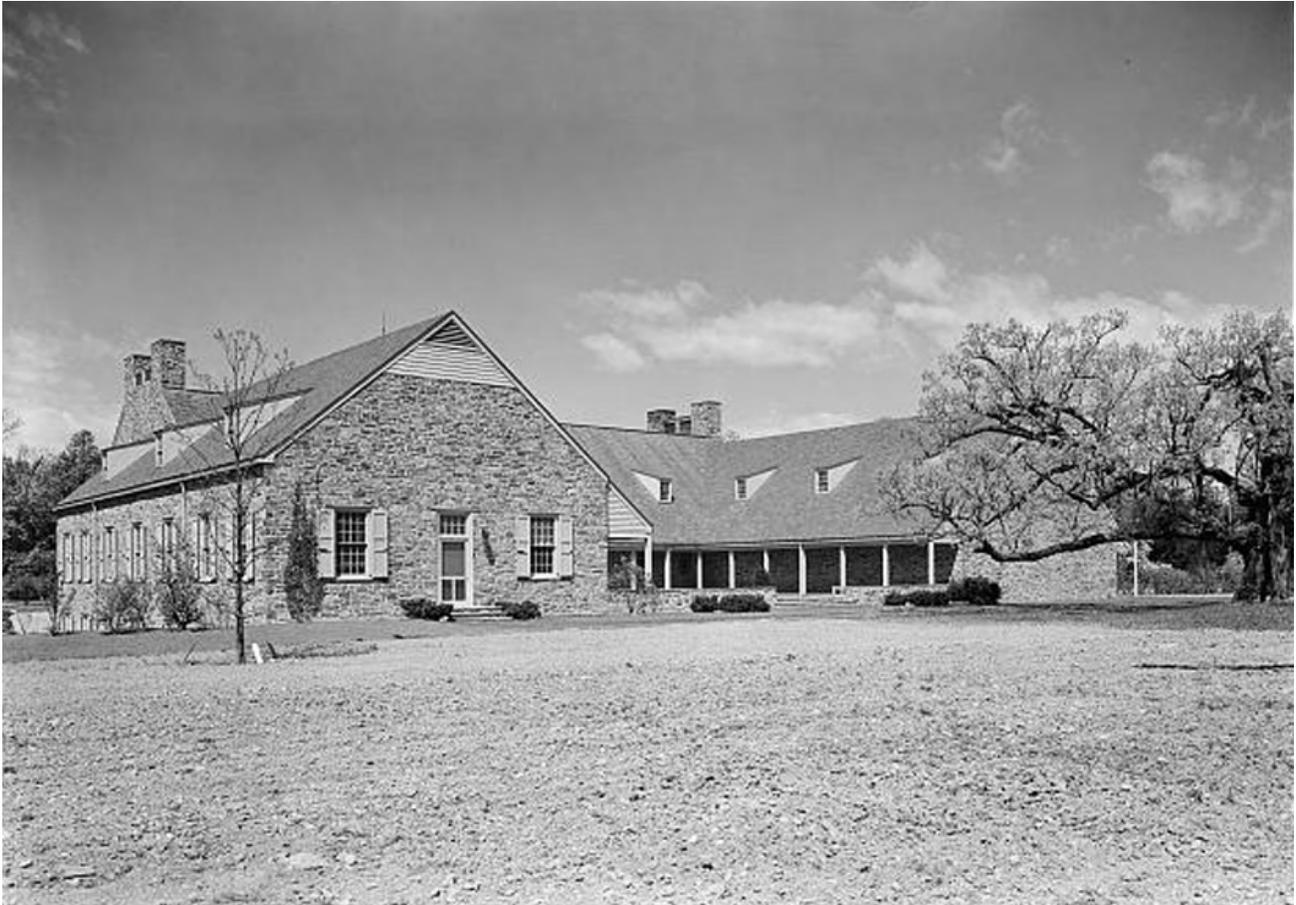
Figure 47: Historic view of the Library looking northwest, 1941. Note relationship to the cultivated field, simple foundation plantings, open character of the courtyard, aged white oak to the right of the entrance, and the recently planted red oak at left. (Digital image 5a07074r, Historic American Building Survey, Library of Congress American Memory Collection.)

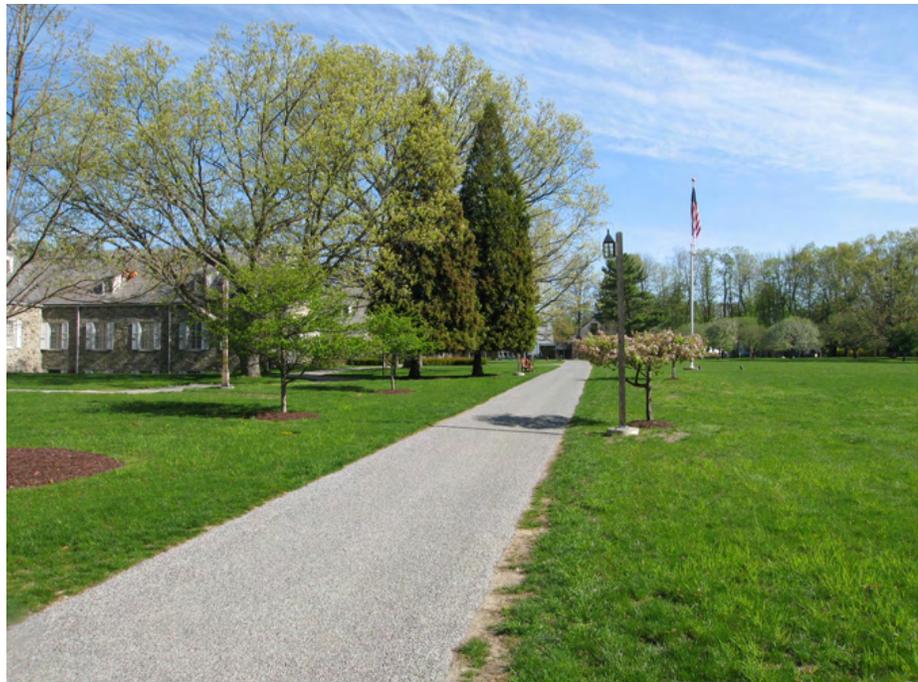
Figure 48: Recent view looking north along the recently built new Library entrance walk showing ornamental fruit trees and cedars. Compare with figure 47. Much of the mown lawn was historically maintained as agricultural field. (SUNY ESF.)

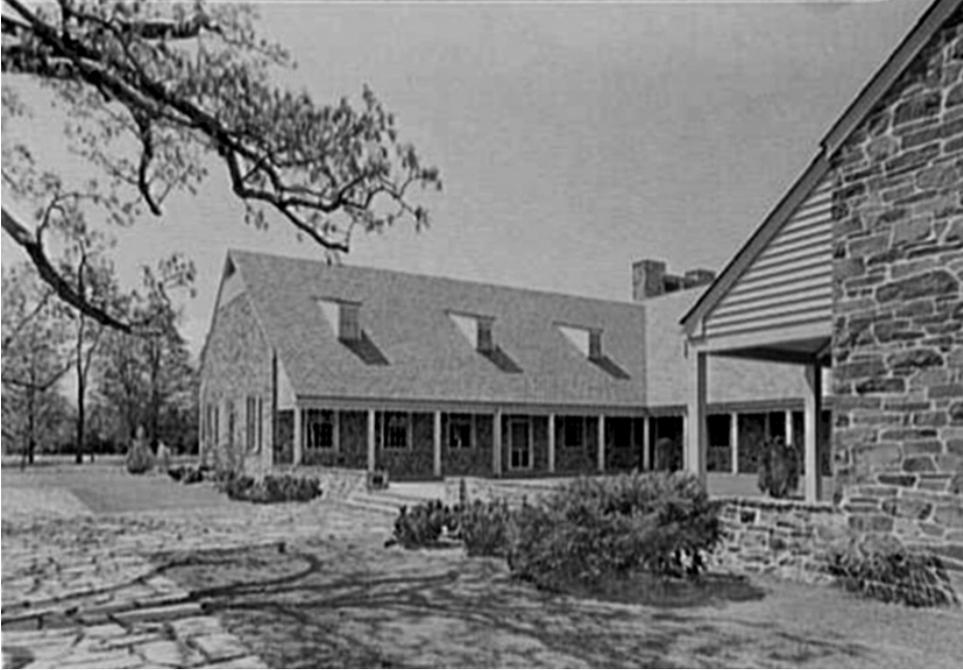
Figure 49: Historic view of the Library entrance plantings and courtyard lawn looking southwest, 1941. Also note flagstone walk and simple treatment of courtyard. (Digital image 5a07078r, Historic American Building Survey, Library of Congress American Memory Collection.)

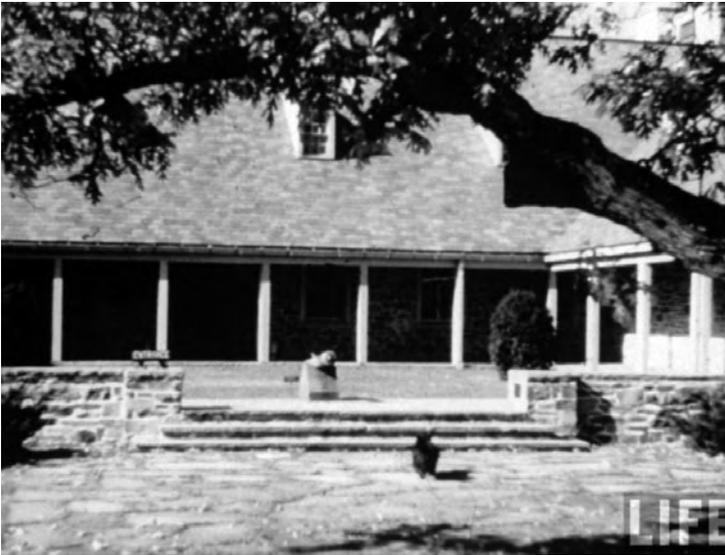
Figure 50: Historic view into the Library courtyard in 1945 showing simplicity of original landscape design. Fala is in the foreground. (LIFE photograph archives, copyright Getty Images.)

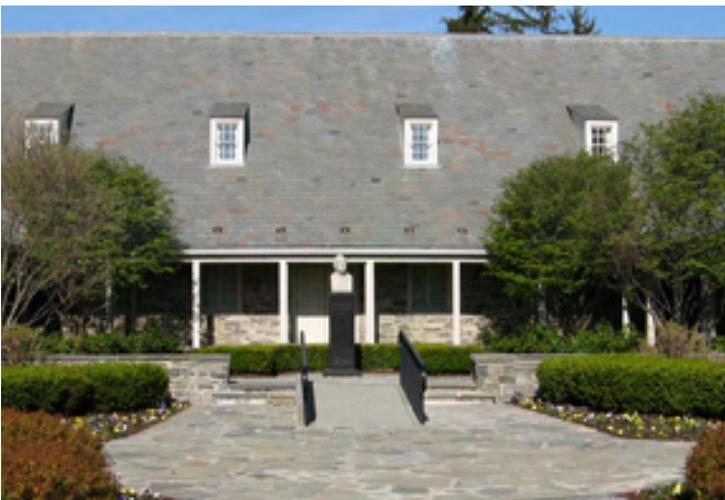
Figure 51: Recent view into the Library courtyard showing plantings made after 1971. (SUNY ESF, 2007.)

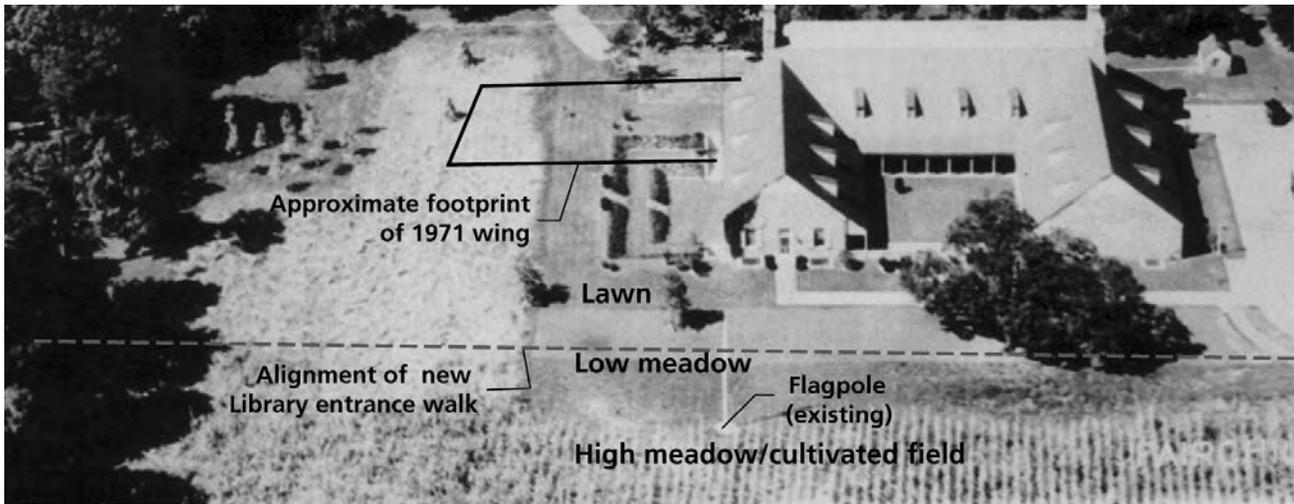
Figure 53: Historic aerial view of the Library taken in 1941 showing the extent of lawn, low meadow, and high meadow/cultivated field in relation to the existing flagpole and the new Library entrance walk. (Detail Photograph 48-22379C [388], Franklin D. Roosevelt Library and Museum, annotated by SUNY ESF.)

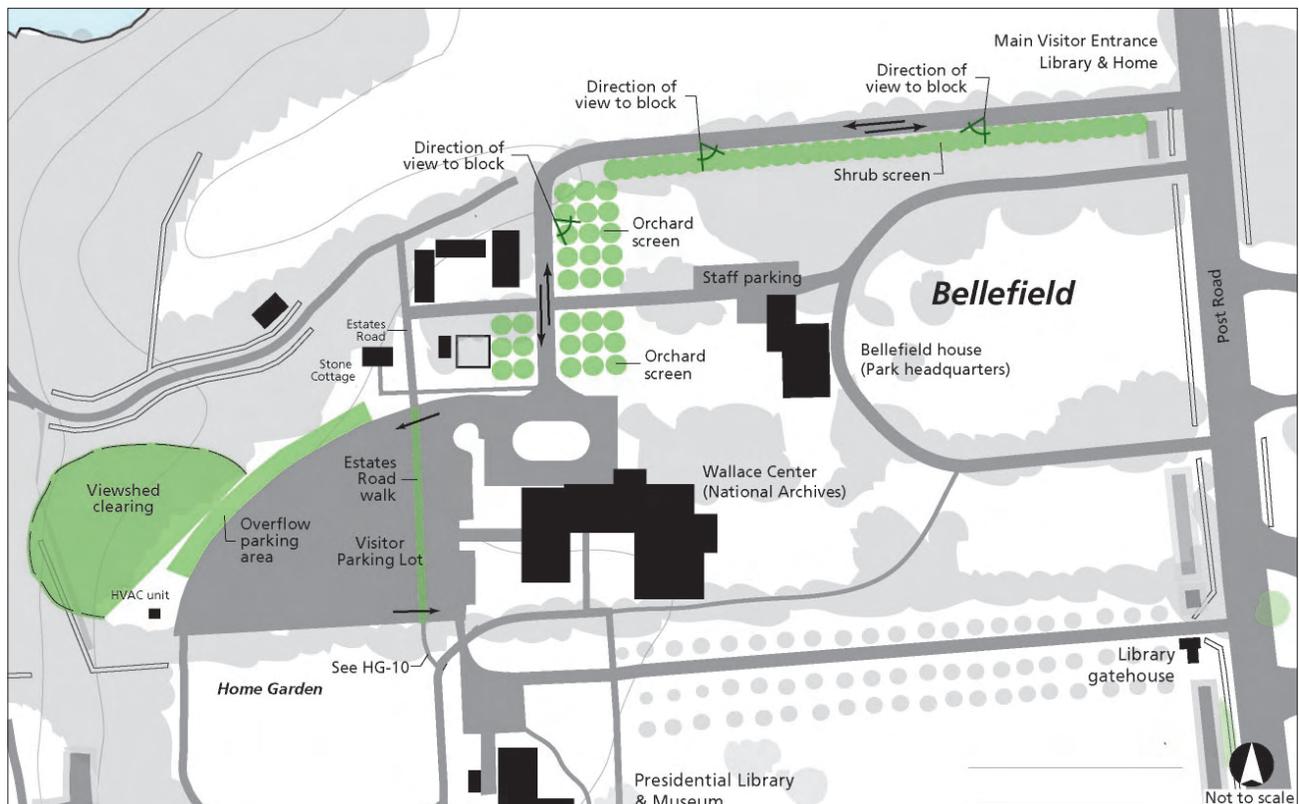
Figure 55: Plan showing preliminary treatment recommendations at Bellefield. Features warranting treatment are shown in green. (SUNY ESF.)

54.	Section of proposed lawn-meadow conditions at the Library.	122
55.	Plan of preliminary recommendations for visitor wayfinding at Bellefield.	129
