## CULTURAL LANDSCAPE REPORT

# HOPEWELL FURNACE NATIONAL HISTORIC SITE

Prepared for  
**National Park Service,**  
Northeast Region,  
Philadelphia Support Office,  
Philadelphia, Pennsylvania

Prepared by  
**KFS Cultural Resources Group**  
Kise Franks & Straw, Philadelphia, Pennsylvania

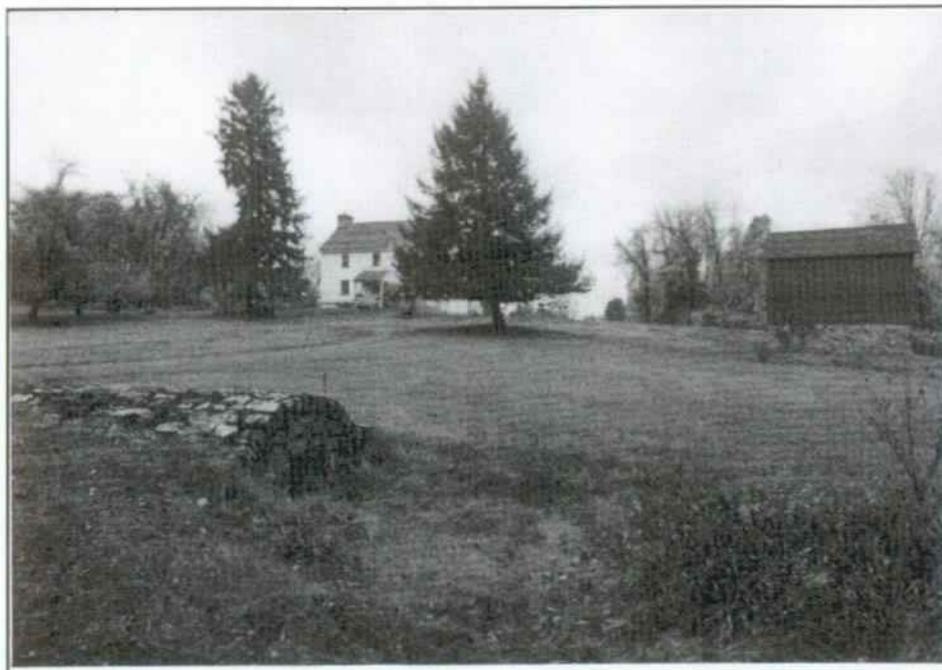
Figure 2.1. Thomas Lloyd Complex, 1995. Menke & Menke photo.

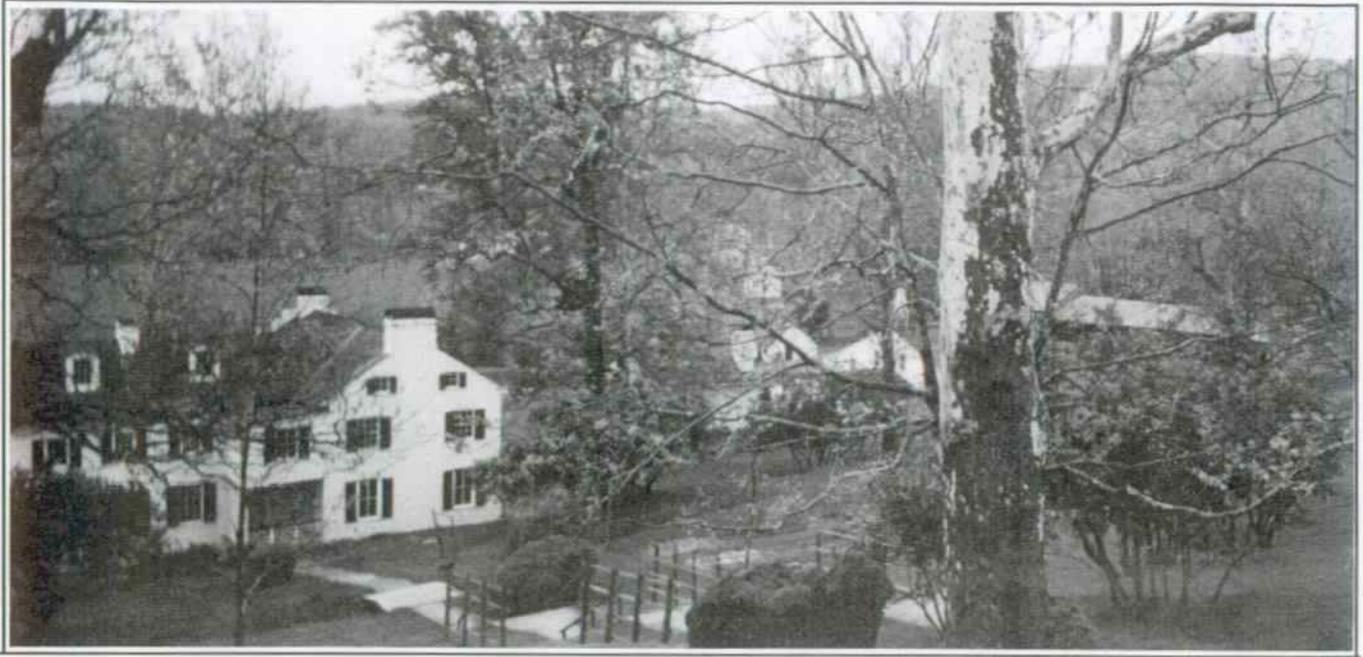
Figure 2.7. View from Visitor Center into the village, 1995. Menke & Menke photo.

The Visitor Center, located on a slope above the core village, is easily accessible from the parking areas. A picture window and balcony at the upper level of the Visitor Center provides views downhill into the core village (Figure 2.7). Although most of the slopes within the core village are moderate, the transition between the Visitor Center and the village, where the Furnace, Cast House, Blacksmith Shop, and Tenant Houses are located, is relatively steep, rendering the village inaccessible to some visitors. Because of the steep slopes, there are a series of walls and stairs that connect the various levels of the core village.

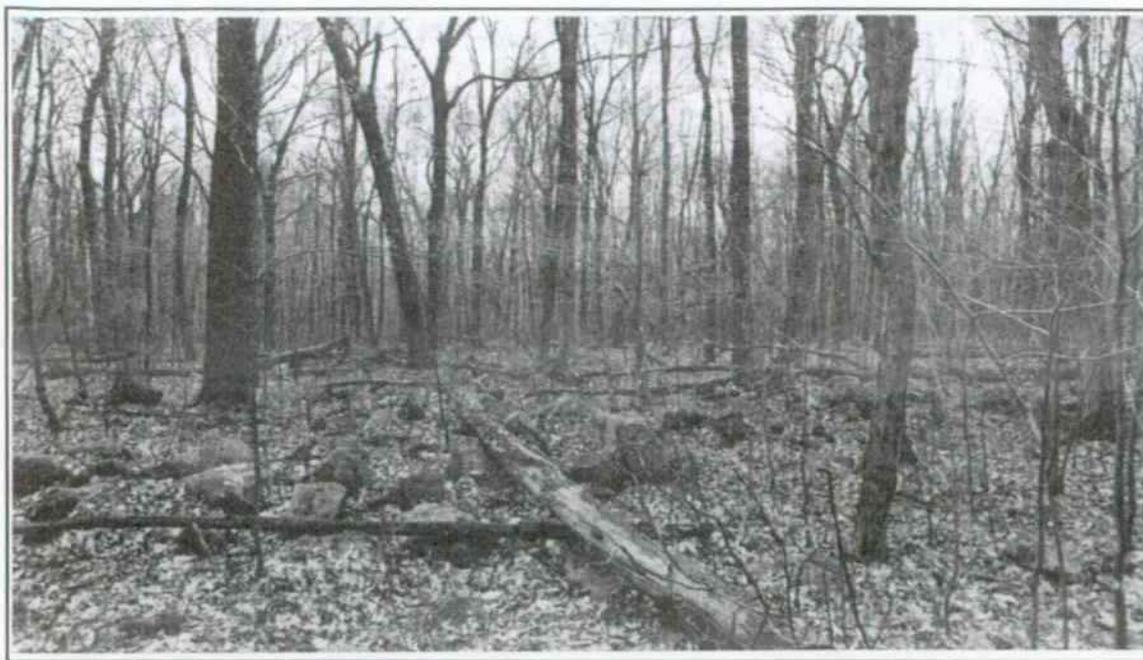
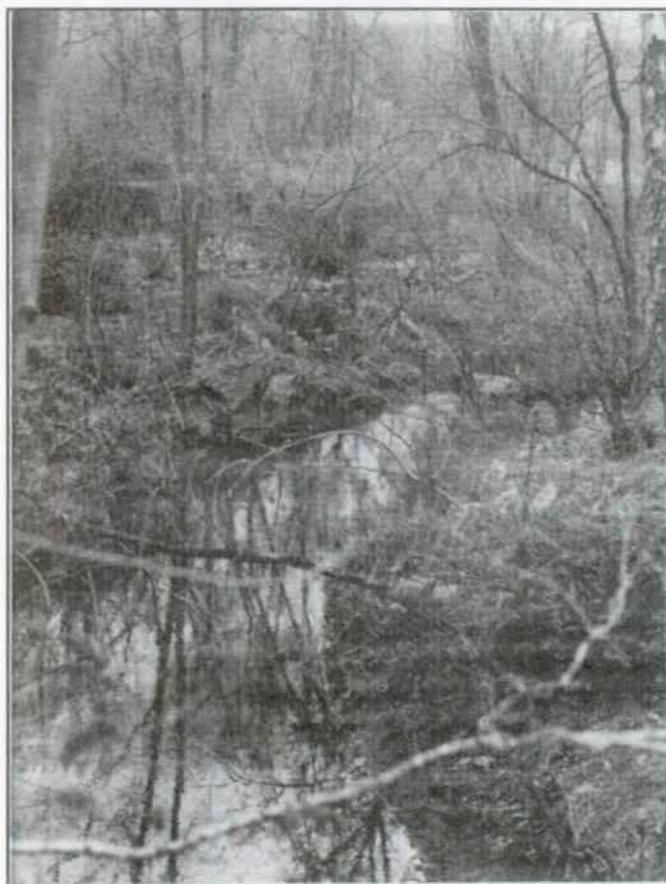
Figures 2.8 (above) and 2.9 (left). Top photo of Upland forested areas near Shed Road revealing well-drained, stony soil conditions. Bottom photo of French Creek at PA Route 345. Menke & Menke photos.

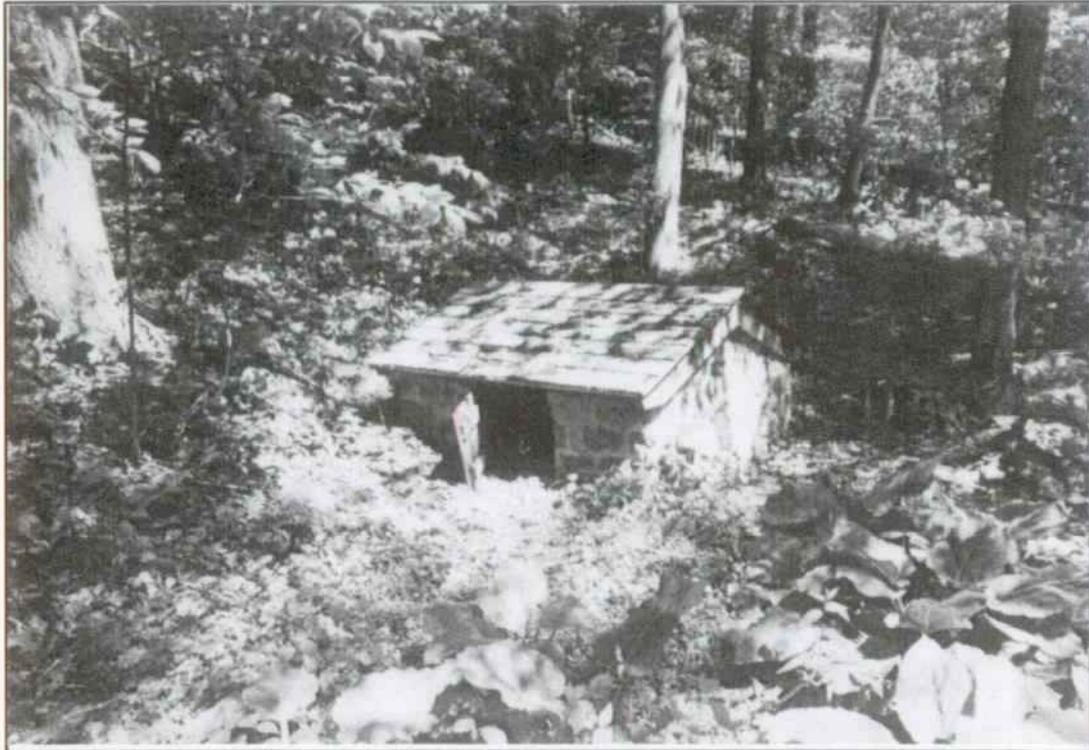
Figure 2.10. Springhouse along Lenape Trail, 1995. Menke & Menke photo.

originated in numerous springs, and some of their associated springhouses are still extant (Figure 2.10).

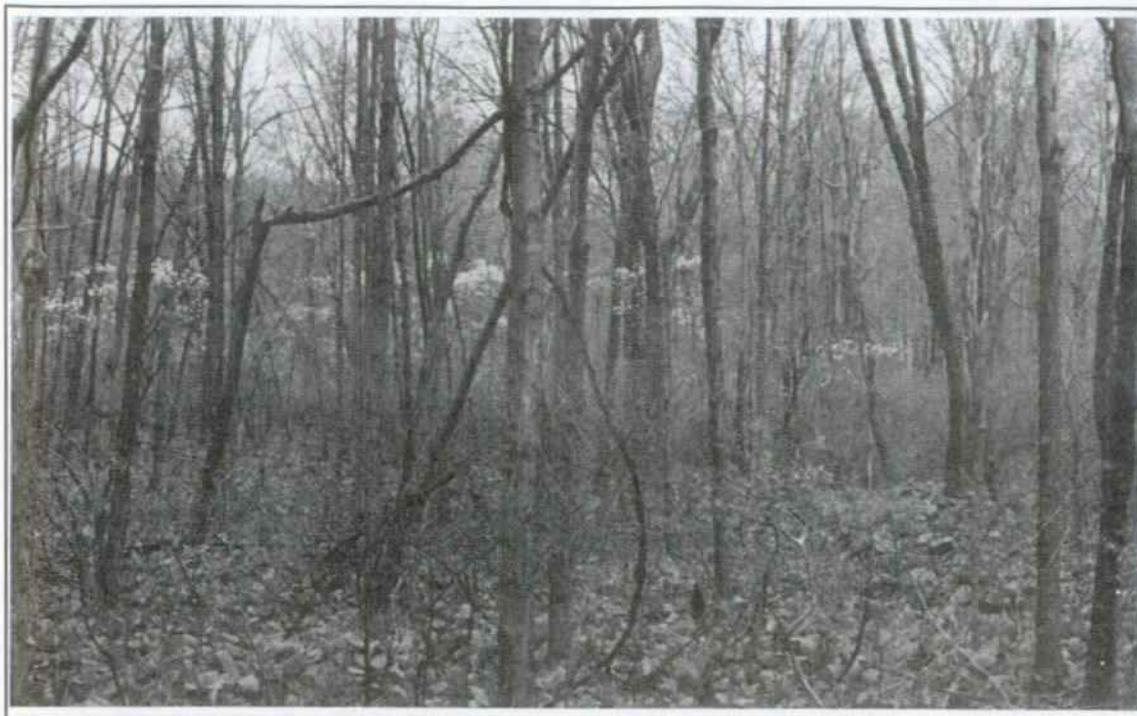
Figure 2.12. Lowland forest in poorly drained soils near the confluence of Baptism and French Creeks, 1995. Note the lack of understory plants on account of intensive deer browsing. Menke & Menke photo.

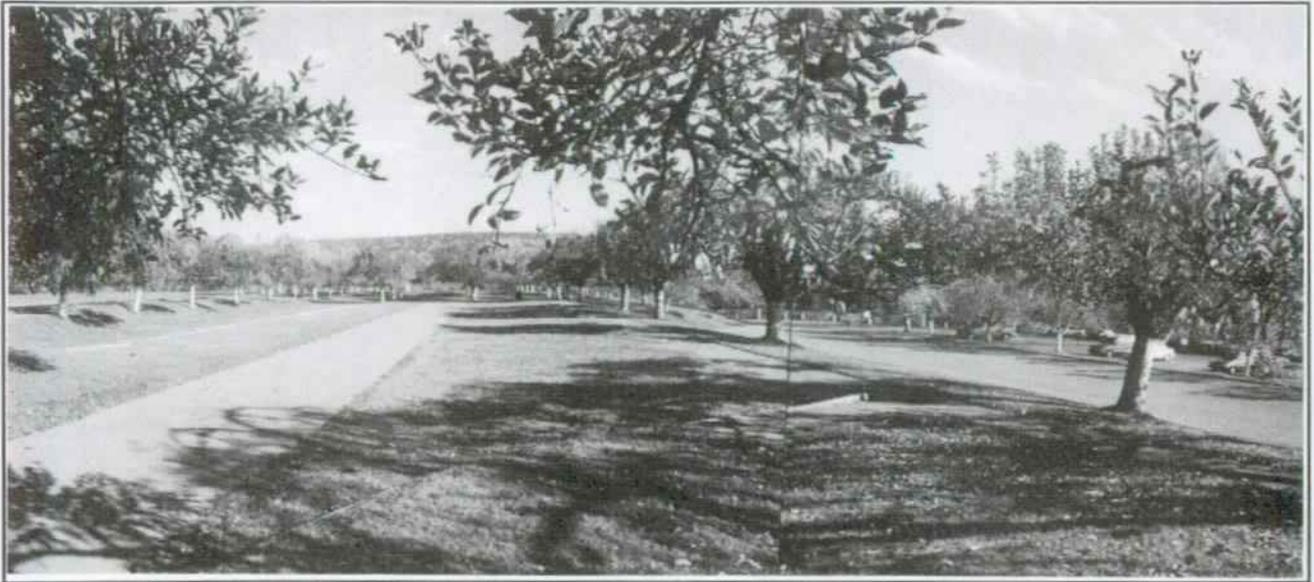
Figure 2.14. Apple Orchard and Visitor Parking Area, 1995. Menke & Menke photo.

The predominant trees in the core village are Sycamore (*Platanus occidentalis*) Black Walnut (*Juglans nigra*) and Tulip Poplars (*Liriodendron tulipifera*). The Apple Orchard, which is located near the Visitor Center and visitor parking areas, has been replanted several times. Apple location and type are mapped on the 1991 "Apple Orchard Plan." twenty-five distinct types are noted, including Baldwin, Delicious, Jonathan, Greening, Macintosh, Northern Spy, Rome, Summer Rambo, and York (Figure 2.14).

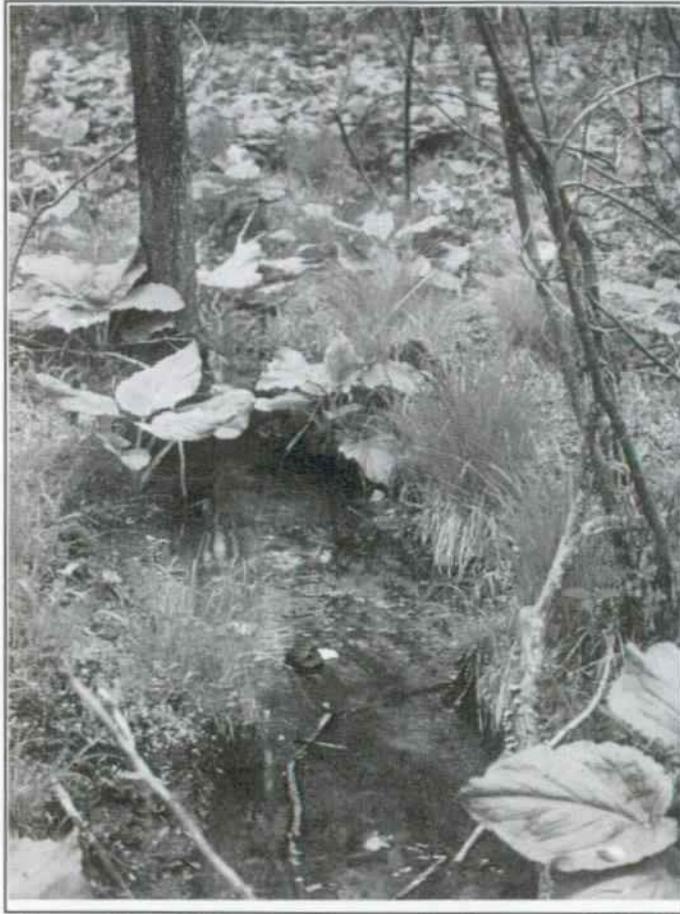
Figure 2.15. Wetlands with a small tributary and skunk cabbage near French and Baptism Creeks, east of PA Route 345, 1995. Menke & Menke photo.

Wetlands currently exist throughout the site, particularly in stream edge situations with slopes of less than 3 percent and in areas of silt soils underlain with rocky conditions. The largest areas are in close proximity to the juncture of French and Baptism Creeks, on either side of PA Route 345 (Figure 2.15). The presence of historic drainage channels in this area suggests that the area was historically cultivated. Field investigation indicates that the historic drainage channels that helped keep this area drained have fallen into disrepair. Consequently, the area has become wetter, supporting more non-tidal, palustrine wetland species of plant material (this phenomenon was particularly investigated in the 1994 Vanderwerff report).<sup>9</sup>

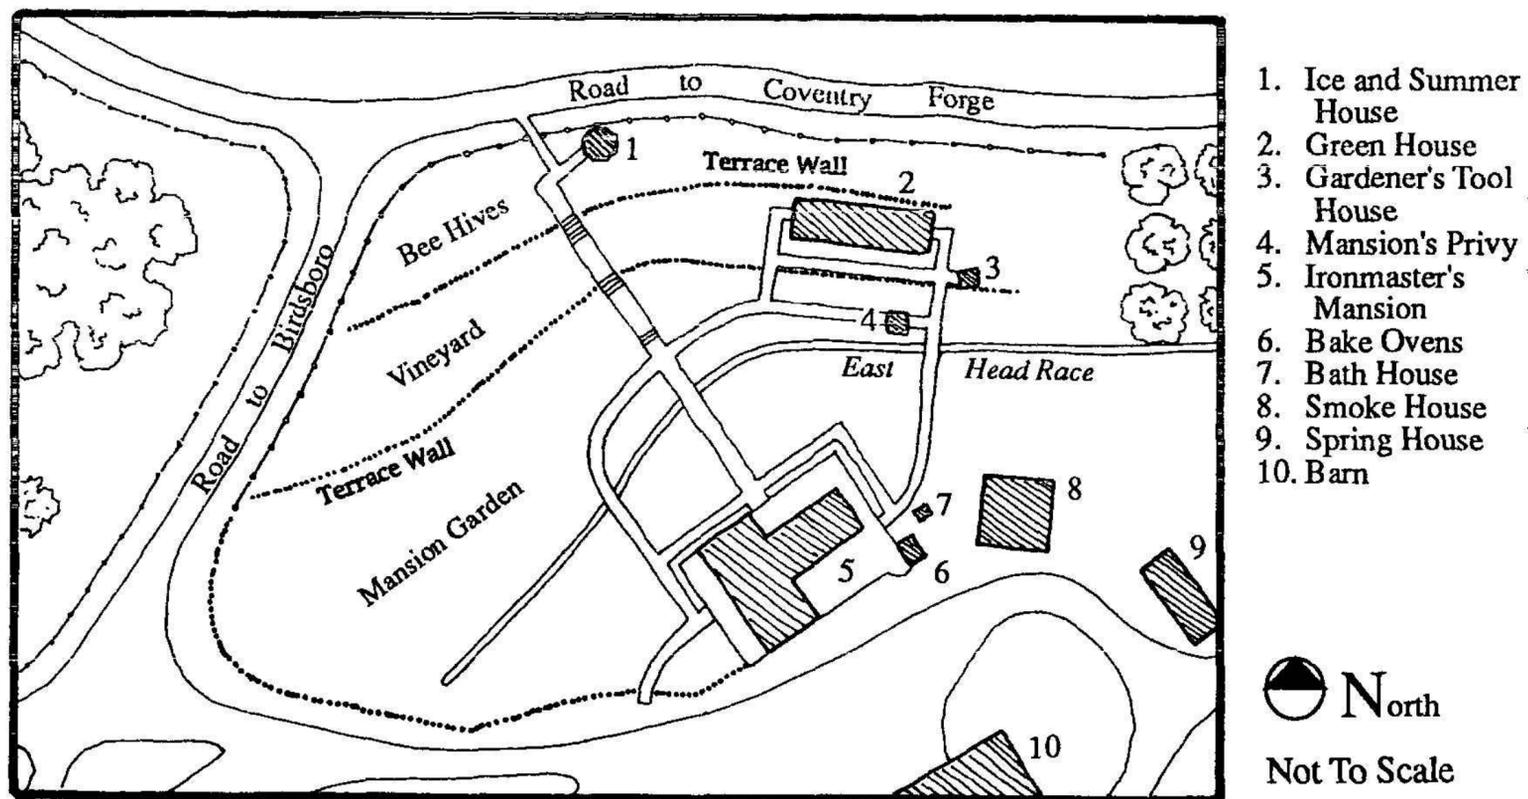
Figure 3.8. Tracing of garden section taken from Apple's "Historical Base Map, 1830-1840."

Additional work in the garden area during 1832 included construction of the stone steps in the garden and, probably, the garden terraces, although the furnace records do not mention these latter features. The terraces appear to have been used to separate different areas of the garden. Oral tradition holds that, west of the main path, the terrace immediately north of the East Head Race had a vegetable garden at its west end and flowers at the east end. The intermediate terrace, located between the two retaining walls, is described as containing both a vineyard and a large raspberry patch. The upper terrace apparently supported beehives. East of the main path were flowers and boxwoods.<sup>58</sup>

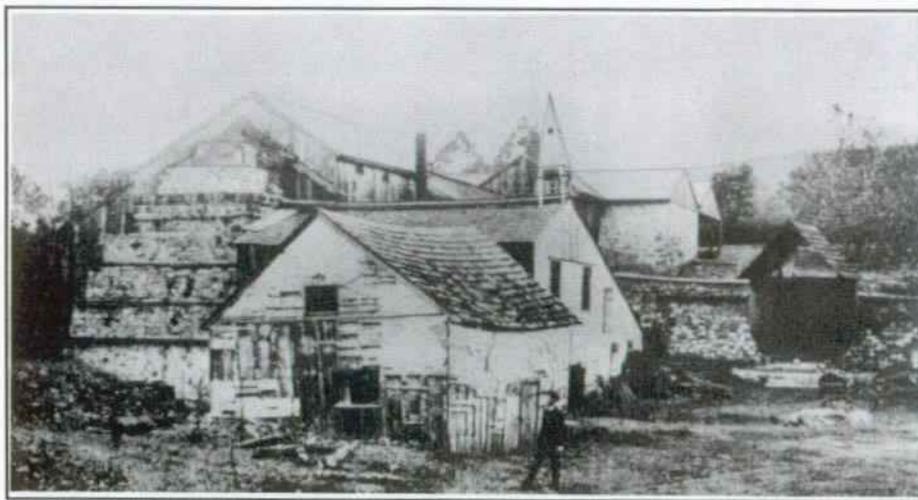
Figure 3.13. View of furnace grouping including Carpentry/Wheelwright Shop in foreground (Bldg. 35, demolished), Ore Roaster on right (Bldg. 34, stabilized ruin), and Furnace (Bldg. 7) with Cast House (Bldg. 33) and Charcoal House (Bldg. 9) looking north, ca. 1887. HOFU archive photo.

None of these last gasp efforts restored the furnace to profitability. In 1883 the furnace, according to Union Township tax records, owned only five tenant houses in the township, a fifty percent decline in a decade. The five houses no longer on the books in 1883 may have been sold to tenants, although records of such transactions do not survive, or they may have simply been demolished, especially if they had been constructed of log. Finally, on 15 June 1883, Hopewell Furnace went out of blast for the last time. After a period of approximately 112 years, iron ceased to be produced at Hopewell (Figures 3.13 and 3.14).<sup>79</sup>

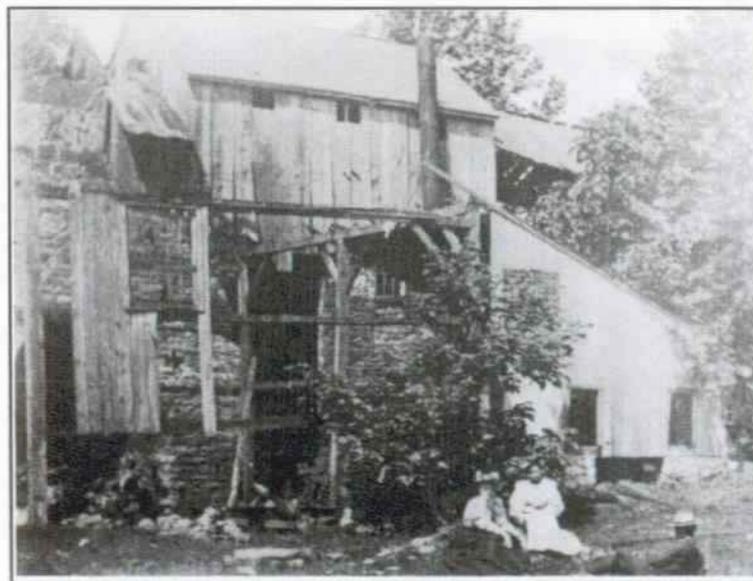
Figure 3.18. View of Furnace (Bldg. 7), Bridge House (Bldg. 10), and remains of Cast House (Bldg. 33) looking west, ca. 1896. HOFU archive photo.

in front of the furnace stack and the area in front of the Cast House and North Molding Room had become overgrown with grass (Figure 3.18). Other areas removed from the furnace complex also showed signs of deterioration. Circa 1893 the Boone House (Tenant House No. 4) had reportedly burned. Other tenant houses apparently did not fair much better. One tenant noted that the house he then lived in was "in a state of disrepair with its roof leaking, porch falling off, and fences rotting." The brick kiln house (Building 39 -

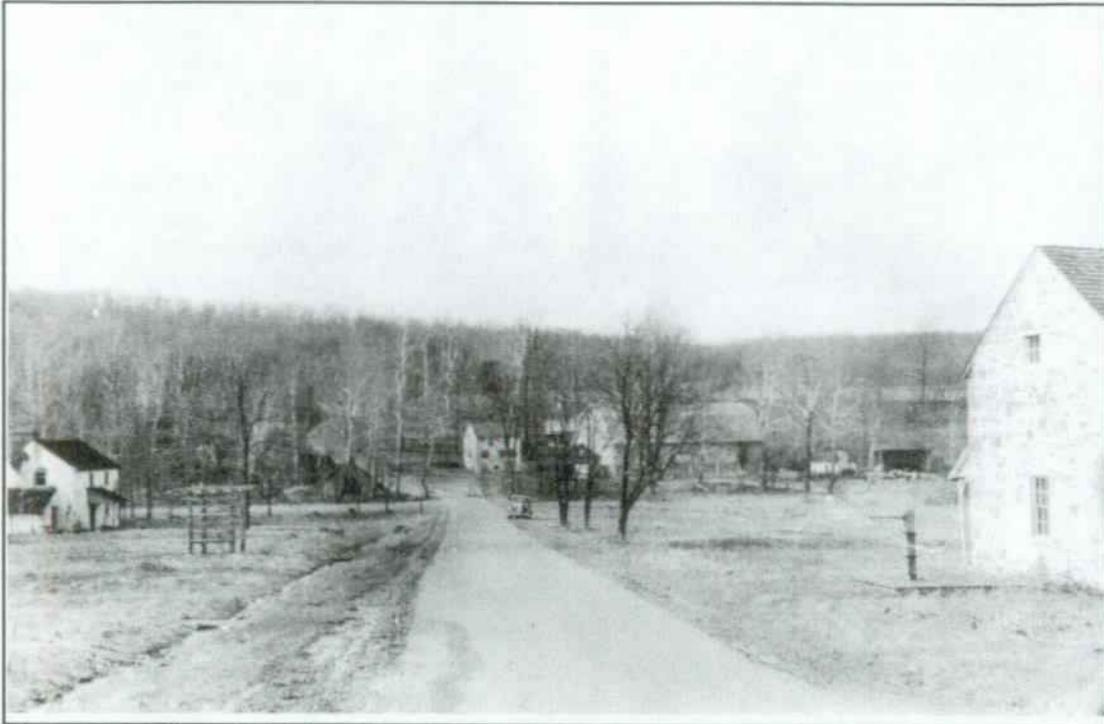
Figure 3.24. View of Birdsboro-Warwick Road looking north, ca. 1940. HOFU archive photo.

In 1932 Berks County road crews realigned portions of the 1804 and 1825 roads through the Hopewell Furnace property, especially in the vicinity of the Office & Store. Reconstruction of this stretch of road substantially changed the physical appearance of this portion of the site. The work entailed demolishing a large portion of the stone wall between the Office & Store (Building 3) and the Bridge House (Building 10). Construction of the road covered the Ore Roaster (Building 34), as well as the foundations of the Cast House (Building 33) and Carpenter's Shop (Building 35 - Wheelwright Shop). The new road passed in close proximity to both the Blacksmith Shop (Building 6) and the Furnace remains. The realigned road continued on a relatively straight course north, past the Charcoal House (Building 9) and cut off part of the Ironmaster's House yard and eliminated a portion of the west garden wall. This realignment reduced the road's previously steep grade and eliminated the dangerous tight turn between the Barn and Office & Store (Figure 3.24).<sup>91</sup>

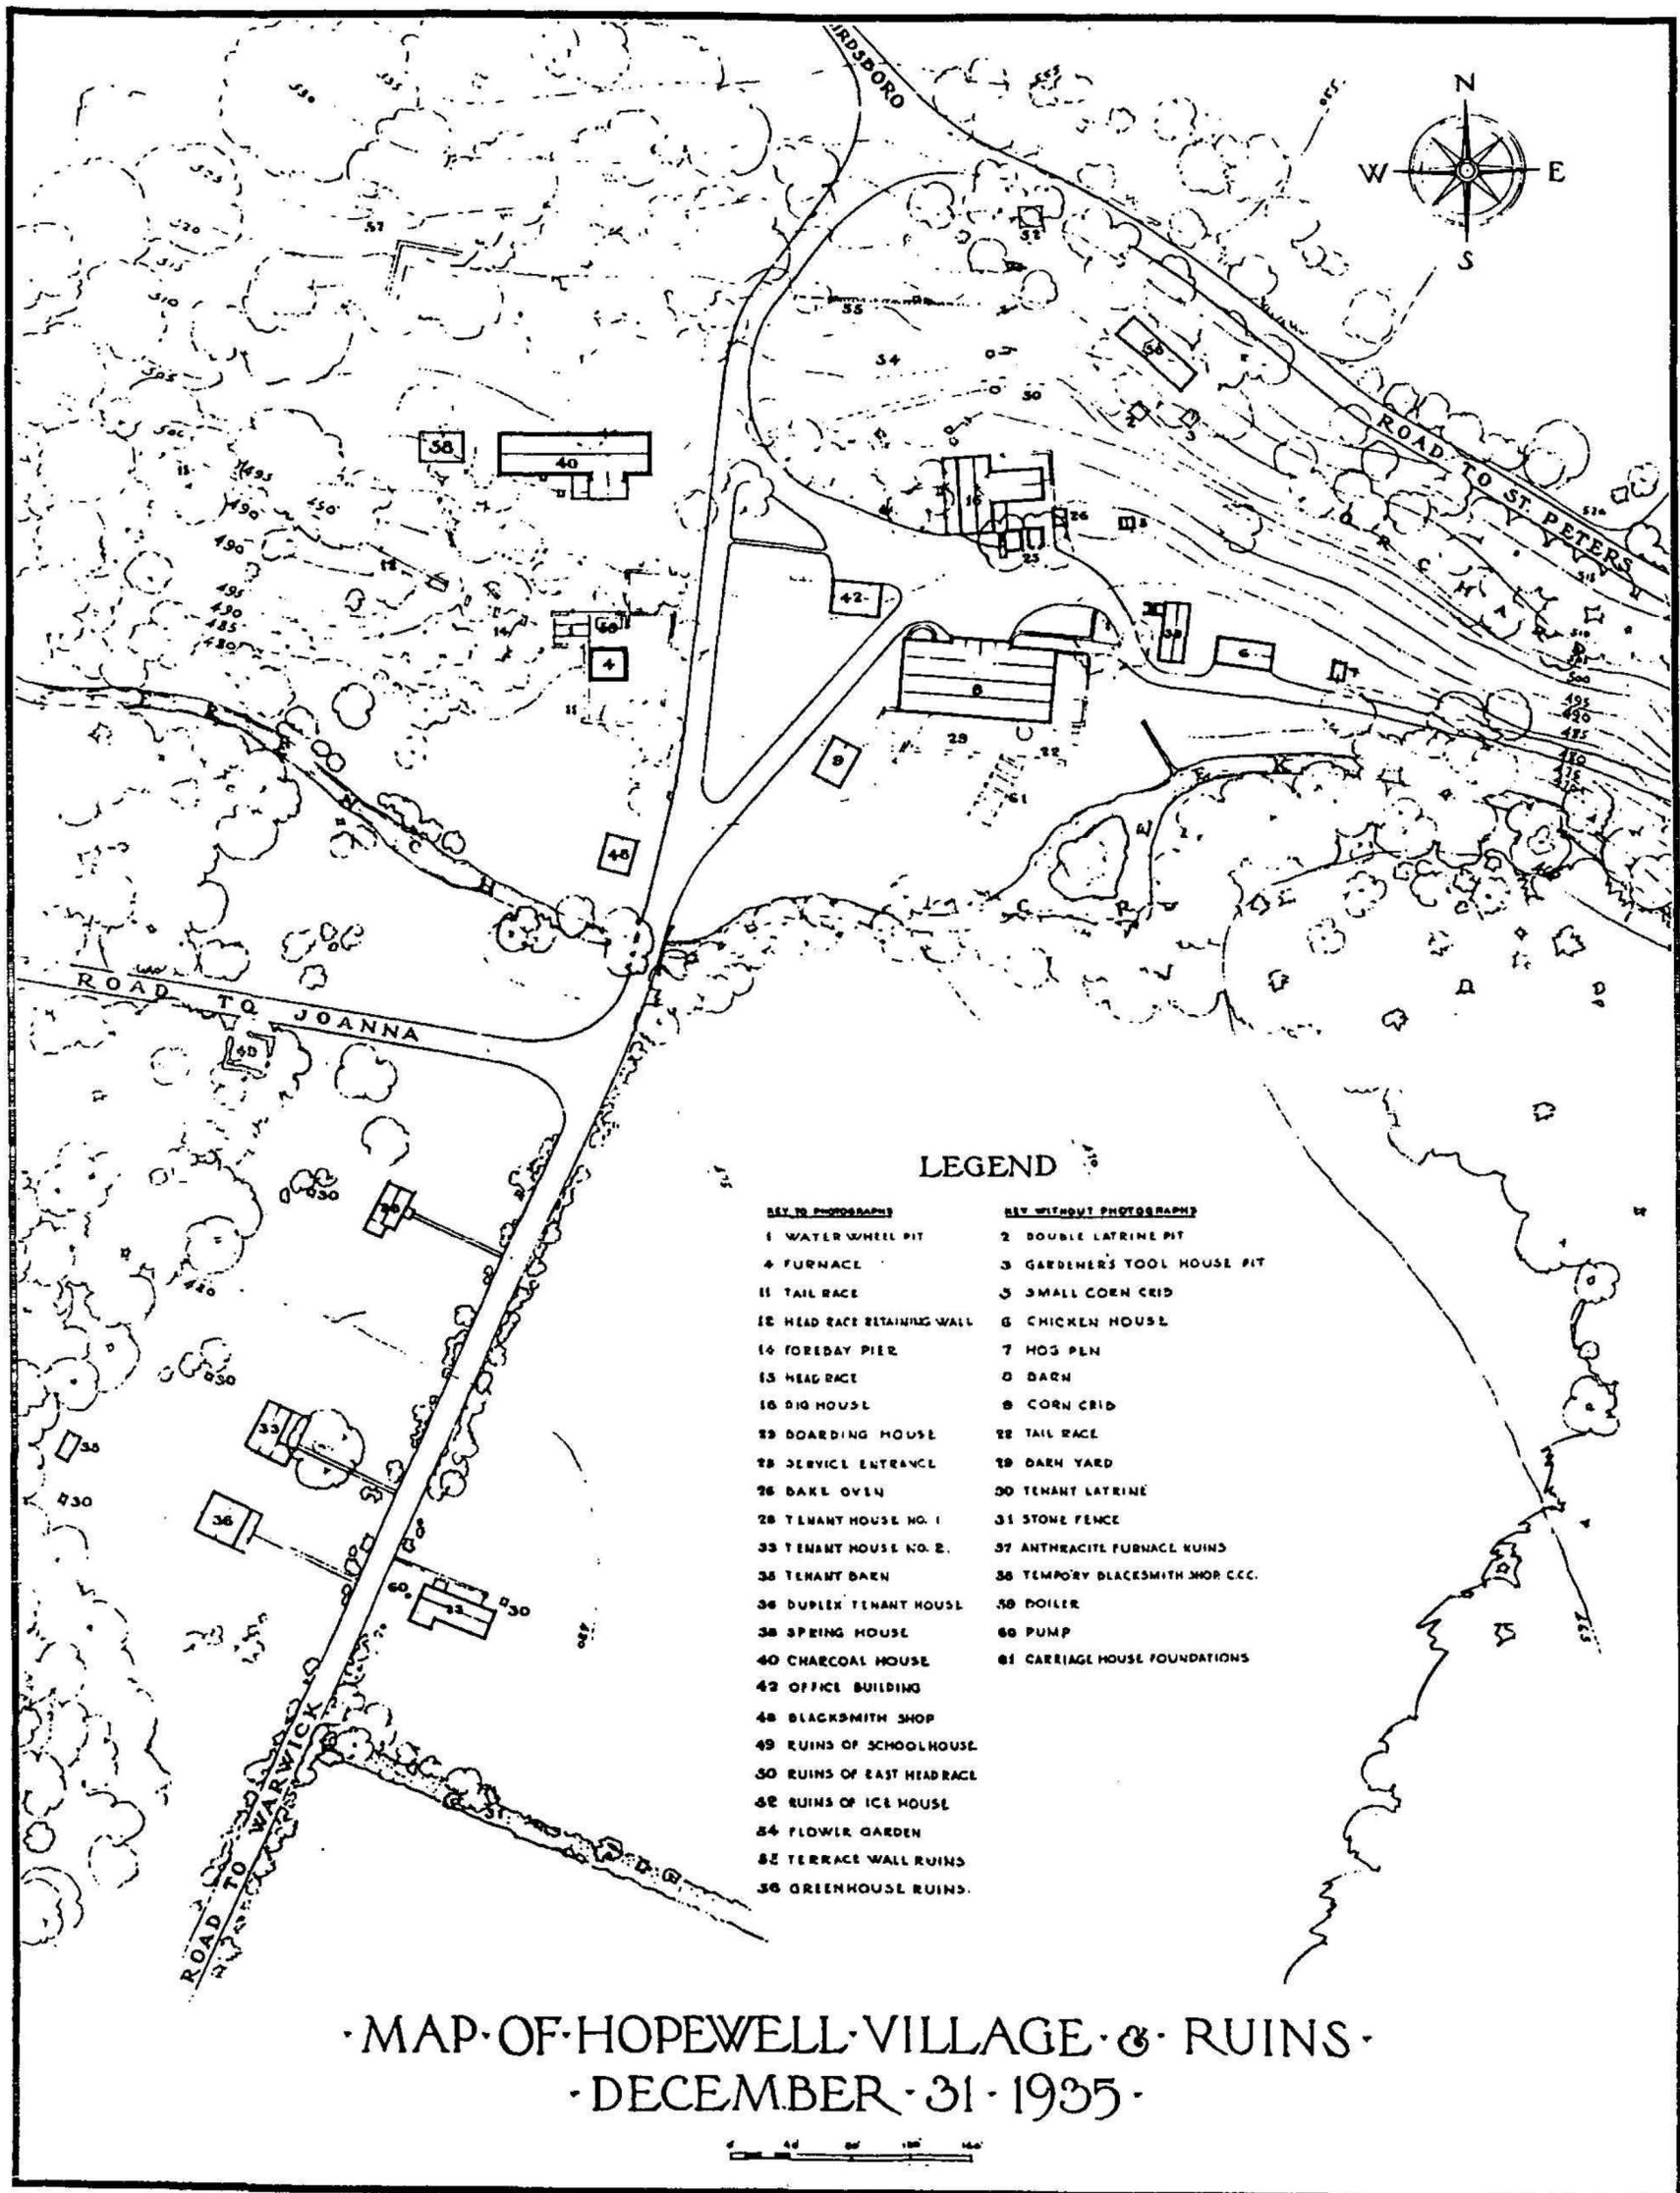
Figure 3.25. Appleman, Roy Edgar. "Map of Hopewell Village & Ruins." December 31, 1935. On file at Hopewell Furnace National Historic Site. Approximate Scale: 1 inch = 175 feet

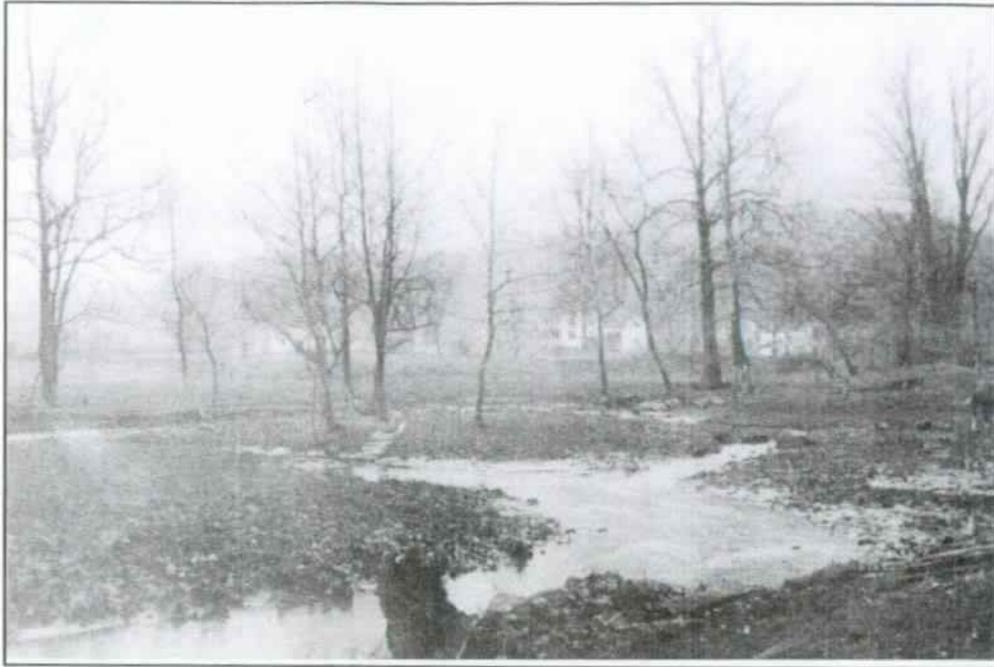
Figure 4.2a and 4.2b. French Creek in Hopewell Village in 1936 (top) and 1995 (bottom). View to southwest towards Boarding House and Tenant Houses. Though presently viewed primarily as an aesthetic amenity, the Creek played a vital role in the economy of the Village, the Furnace, and the later dairy operation. Top photo HOFU archive, bottom photo Menke & Menke.

Evidence of earlier historical responses to the natural environment remain visible. These include the location of the furnace and reconstructed bridge house against the slope of Brush Hill, which clearly depicts one of the historic responses to the site's topography. The continued presence of French, Spout, and Baptism Creeks is reminiscent of historic responses to the natural watercourses (Figures 4.2a and 4.2b), while the continued presence of

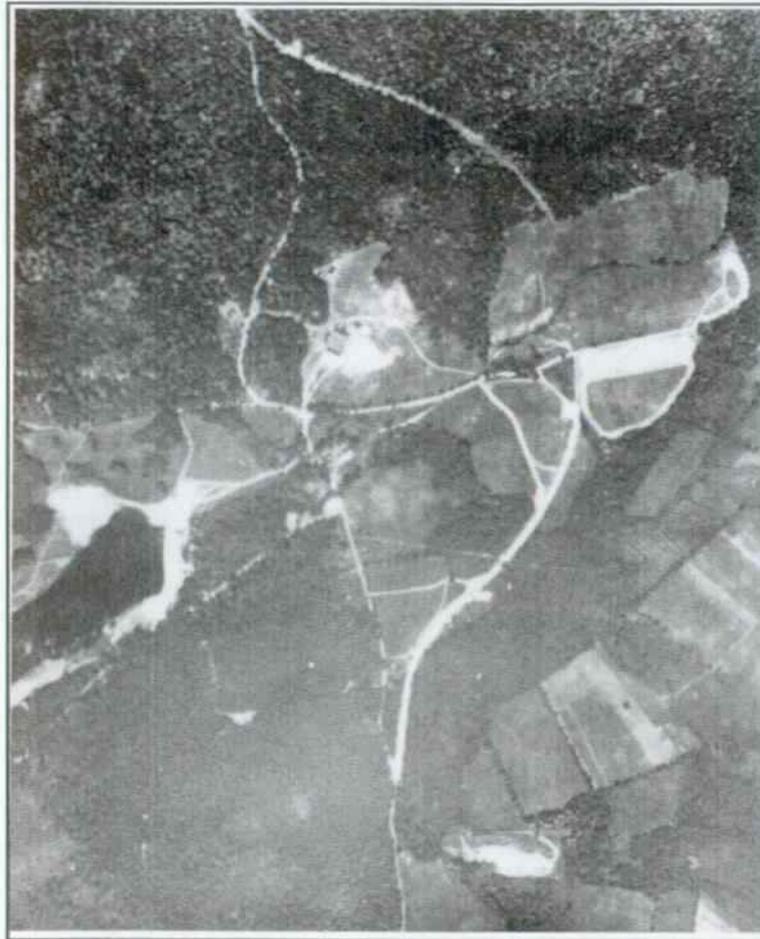
Figure 4.8. 1937 aerial view of the Hopewell Furnace site with PA Route 345 as a new organizational structure. This view shows the broad curve of the by-pass road (PA Route 345) under construction. Also evident are the dam earthworks for the expanded Hopewell Lake (to the left), the CCC Camp SP-7 (center), and the curvilinear parking area for the Baptism Creek Picnic Area (now the Environmental Study Area) (at right). Other light areas are presumed to be borrow areas that provided rock, clay, and soil for construction of the dam, roads and parking areas. HOFU archive photo.

Construction of the bypass road east of the village, presently PA Route 345, resulted in significant changes to the spatial organization of the property (Figure 4.8). The removal of vehicular traffic from the Birdsboro-Warwick Road, effectively separated the core village from the historic road network that had carried the furnace's products to market. The core became a protected historic resource, essentially an outdoor museum separate and distinct from its surroundings. In addition to disconnecting the core village from its historically significant position as a crossroads community, the re-routed PA Route 345 also disrupted the historic continuity of the agricultural fields through which it passed. These large open tracts were, as a consequence, subdivided by the bypass into smaller units. This altered the historic patterns of spatial organization and introduced an entirely new series of views. While these views are not associated with any historical period prior to the 1930s, the bypass does provide the sense of moving through wooded areas into an open space. The bypass cut the open area associated with the Church Farmhouse into several smaller units, eliminating the sense of unified open space that had previously characterized this area north of Reading-Valley Forge Road.

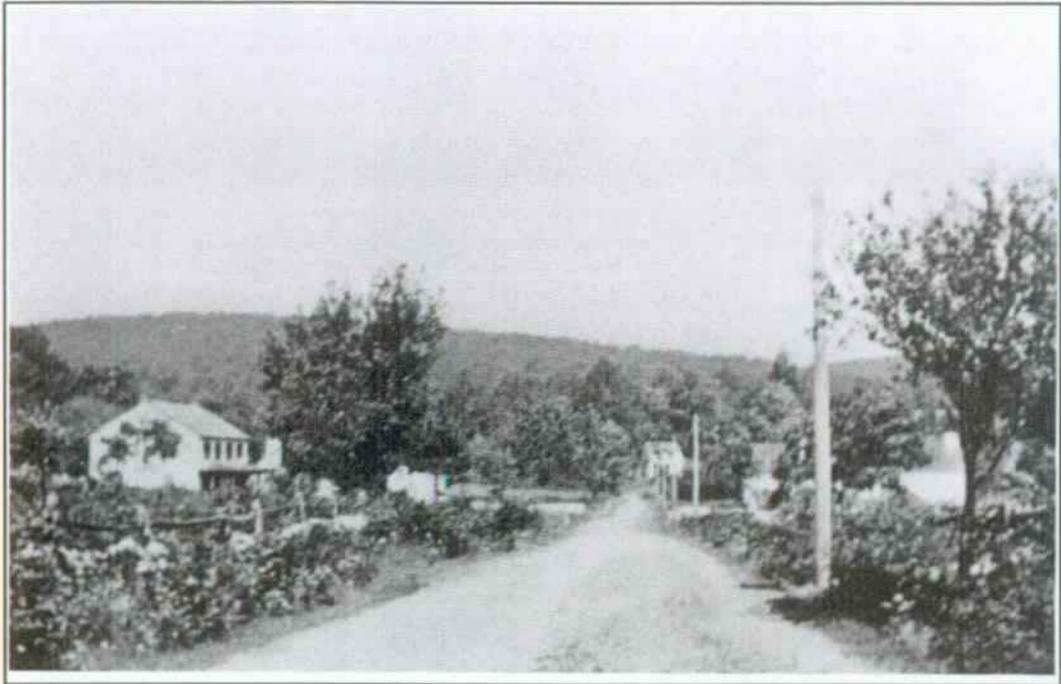
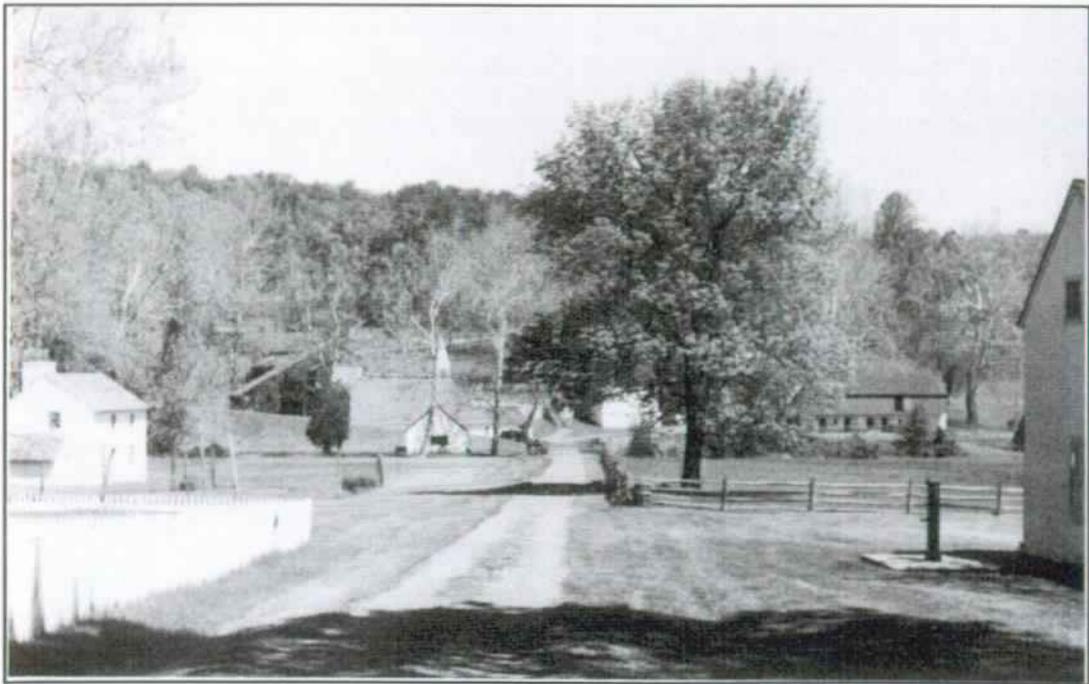
Figures 4.10a (top ) and 4.10b (bottom). Birdsboro-Warwick Road in 1914 and 1995. Two views of the village street looking north from between Tenant House No. 3 and the Boarding House. The early view shows what appears to be a post and rail fence on top of a stone wall on the west side of the road. Top photo HOFU archive, bottom photo Menke & Menke.

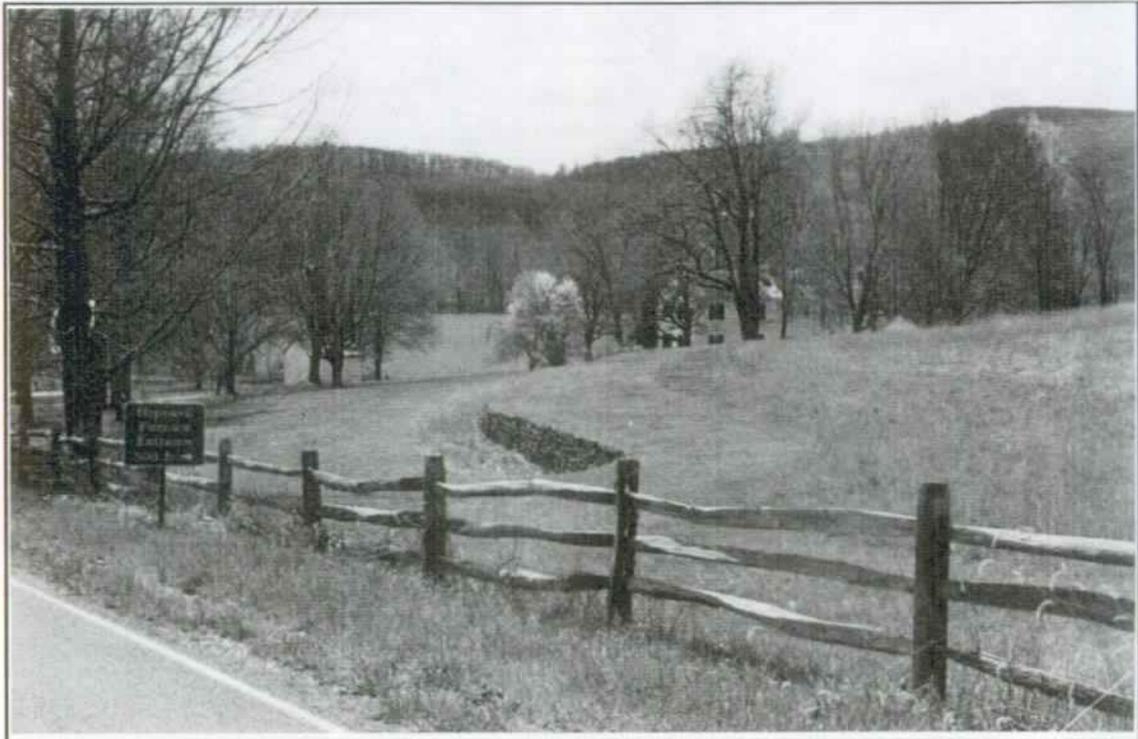
Figure 4.14. The East Head Race forms a boundary in Field 1 next to the Church House, as well as separating Fields 2 and 3 to the east, 1995. The fence and road are post-1930 additions that have divided a single large field into the present Fields 1 and 2. Menke & Menke photo.

Stone walls or fences are also present at the site. The earliest may date from this period. These features largely represent the efforts of farmers to clear stones and rocks from agricultural fields. In some instances farmers laid the stones into walls and in others they simply created rough piles of stone and rock along the field boundaries. The remnants of these walls or piles are found throughout the southern portion of the property, which was largely owned by independent farmers until the twentieth century. Extant examples, often in deteriorated condition and seldom completely enclosing a former or present field, exist in fields associated with the Thomas Lloyd, Harrison Lloyd, Church, and Nathan Care farms. These stone walls form important boundaries, depicting and delineating the agricultural areas of the site and its adjacent farms. Stone walls are also found demarcating the Bethesda Church yard and cemetery. Although not designed as a boundary, the stone retaining wall that forms the north side of the East Head Race clearly divides the large open area now designated as Fields 1 through 6 near the Church House (Figure 4.14).

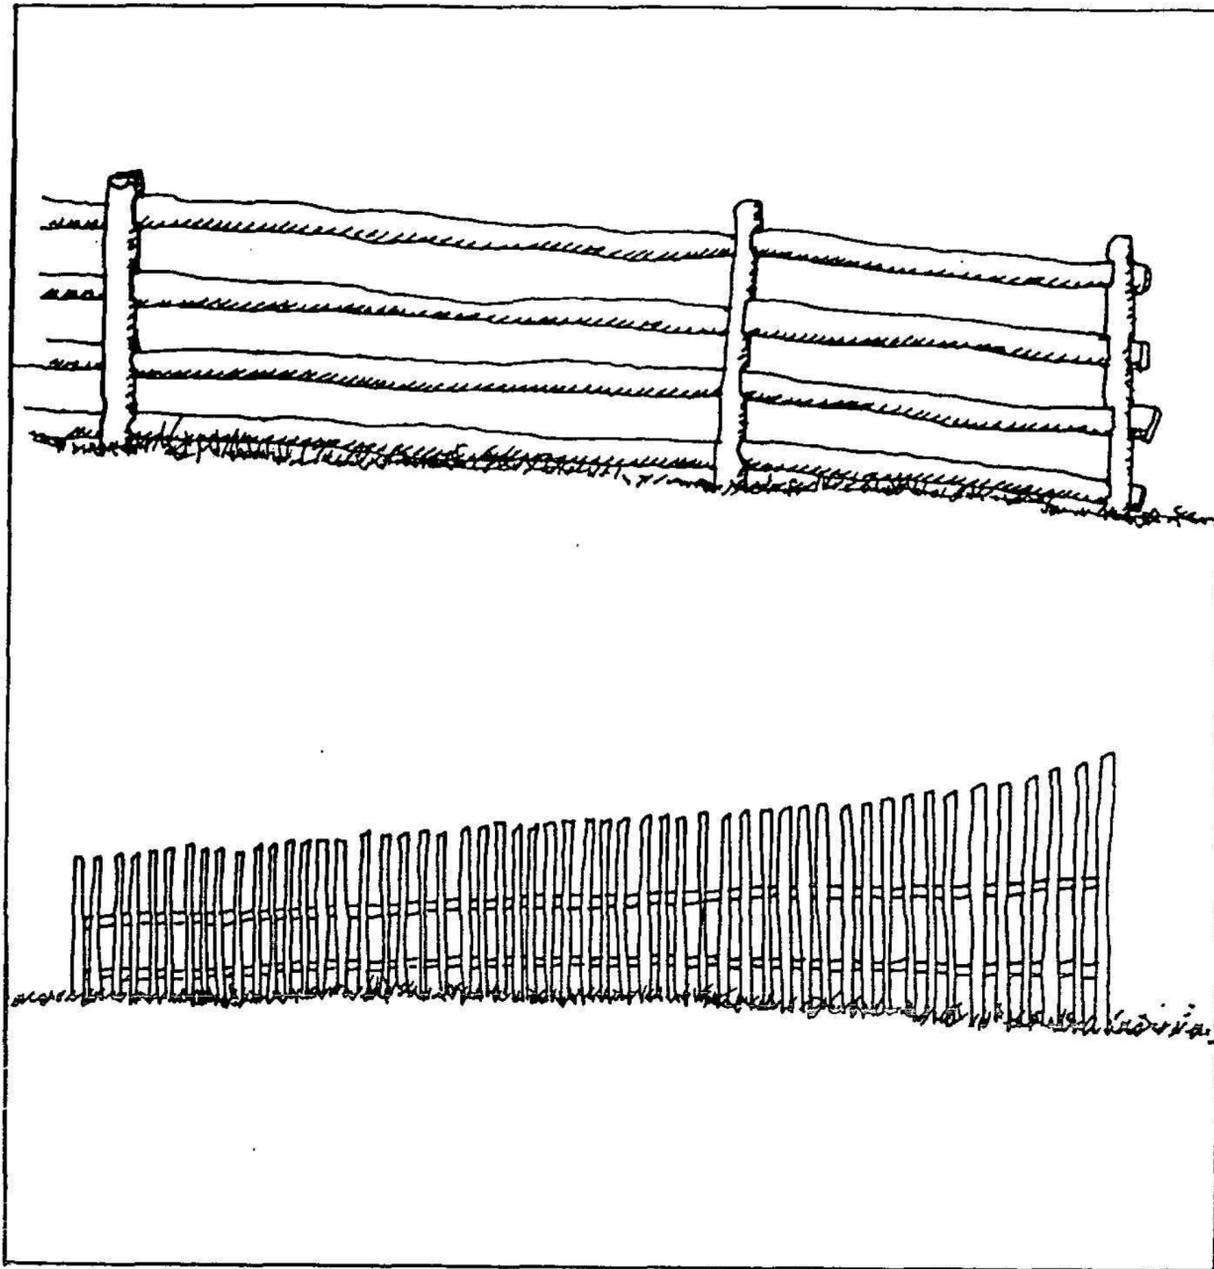
Figure 4.15. Fences at Hopewell Furnace from historic photographs. Top, four-rail fencing ca. 1920 near the Cedar Pasture and Charcoal House; bottom, picket fencing near East Head Race at the Ironmaster's House, ca. 1890. HOFU archive photos.

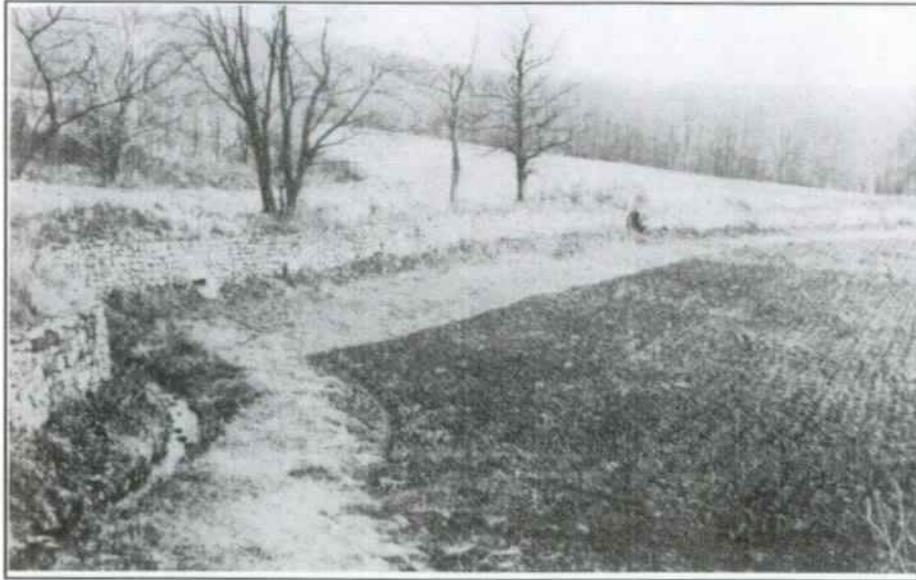
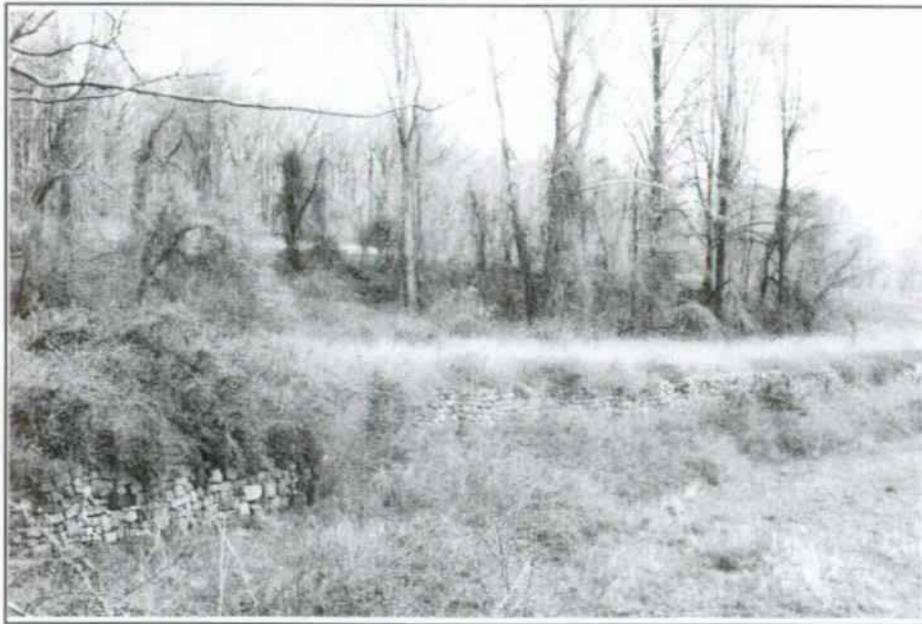
Figure 4.16a (top) and 4.16b (bottom). Invasive vegetation obscures the field and East Head Race boundary edges, 1954 and 1995. Top photo reproduced from Kurjack *Hopewell Village* (Washington, D.C.: National Park Service, 1954), bottom photo Menke & Menke.

Remnants of stone walls are extant in the woods near most outlying buildings and ruins. These features indicate the locations of former farmsteads and agricultural fields. In many instances they are overgrown and difficult to discern. The vegetation associated with the reforestation of former fields has created and altered boundaries. This has created thick new, predominantly deciduous, hedgerow-type boundaries along stone walls, former field edges, stream banks, and roadway edges. This vegetation has at times created new boundaries and altered existing boundaries (Figure 4.16a and 4.16b).
