## CULTURAL LANDSCAPE REPORT

# HOPEWELL FURNACE NATIONAL HISTORIC SITE

Prepared for  
**National Park Service,**  
Northeast Region,  
Philadelphia Support Office,  
Philadelphia, Pennsylvania

Prepared by  
**KFS Cultural Resources Group**  
Kise Franks & Straw, Philadelphia, Pennsylvania

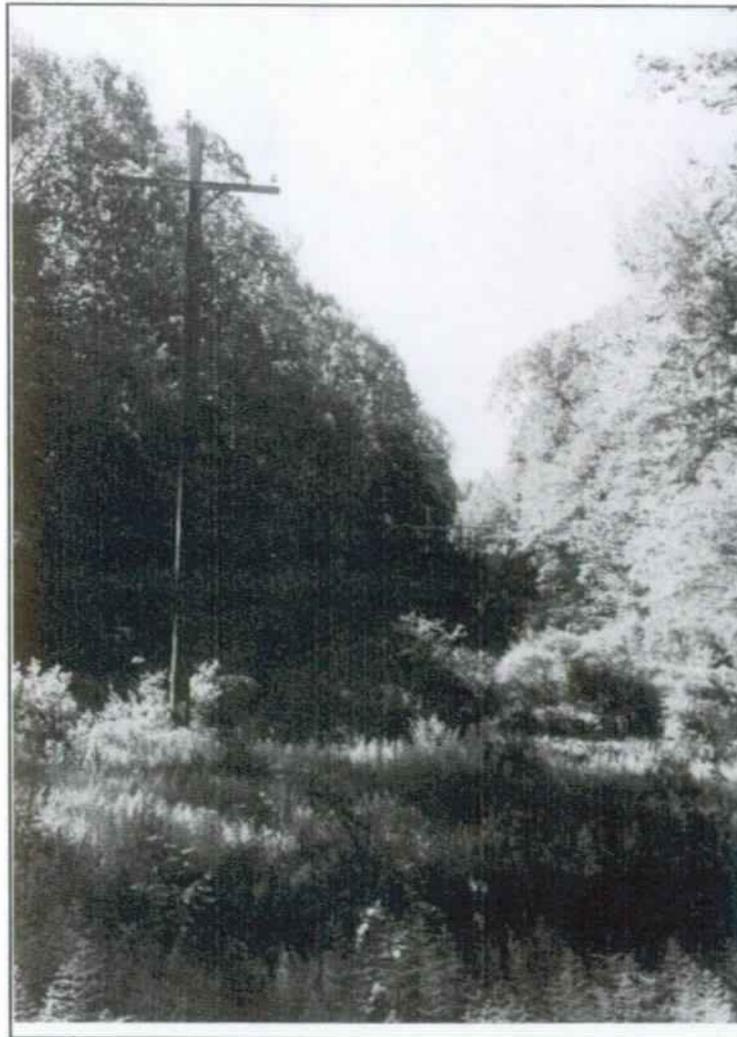
Figure 4.17. Low vegetation under power lines at Hopewell's northeast boundary, 1995. Menke & Menke photo.

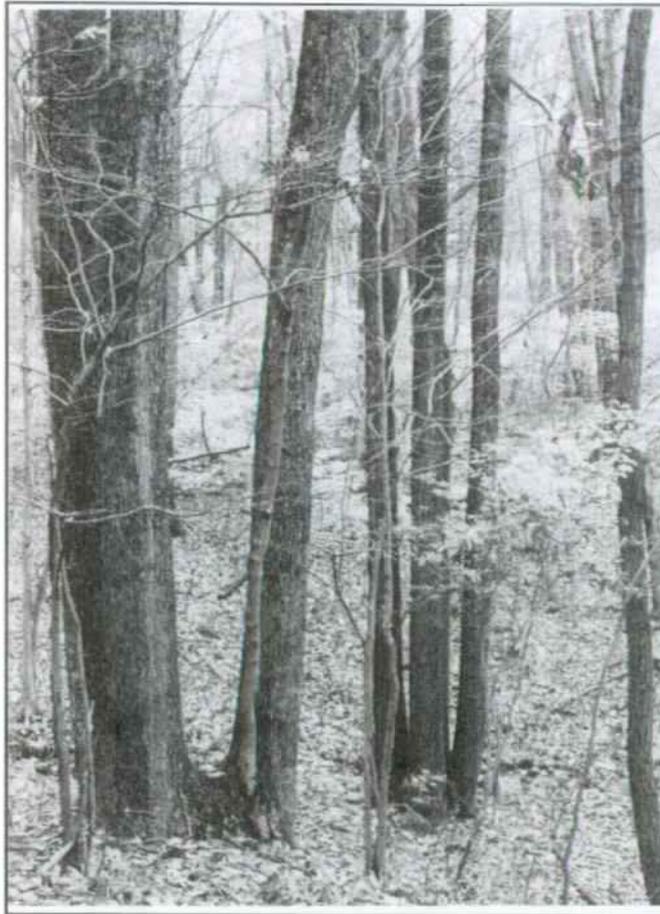
Figure 4.18. An example of tree stumps sprouting new timber near the Nathan Care House, 1995. Menke & Menke photo.

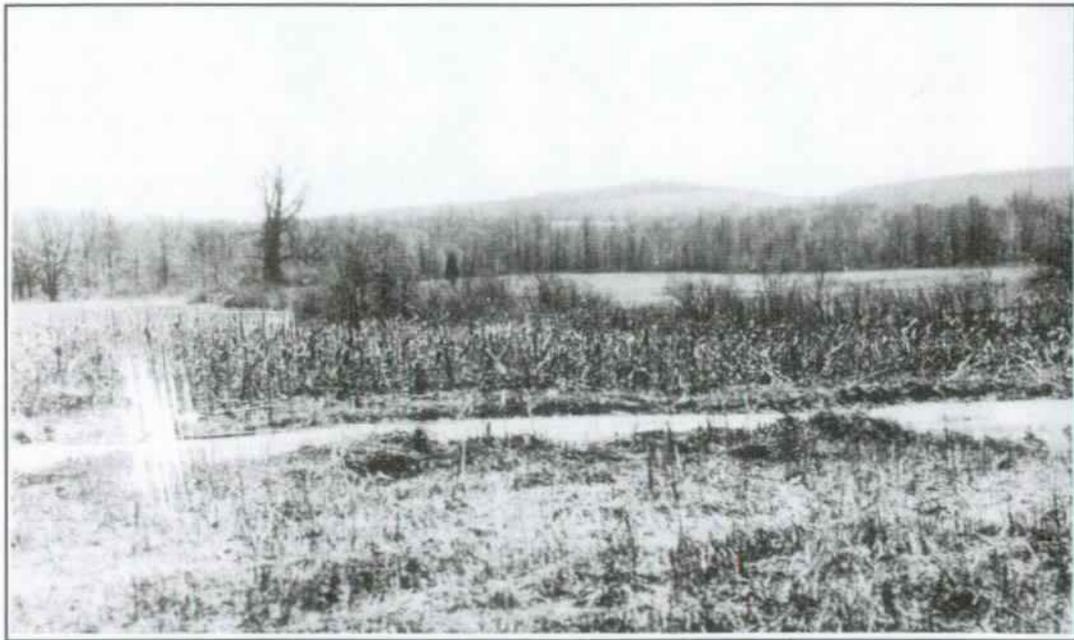
Figure 4.19. An agricultural field, typical of the Hopewell vicinity that was farmed for many periods of tenancy, with a view toward Mt. Pleasure. Note the cut-over base of the mountainside and the corn fields in the foreground of what appears to be present-day Field 2.

An analysis of early twentieth century photographs, in conjunction with documentary records reviewed by Walker and Wells, indicates that in the southern two-thirds of the site numerous cultivated fields, mostly on independent farms, existed during this period. These were likely planted with wheat, rye, oats, buckwheat, and corn. Farm houses and their associated outbuildings were surrounded by from six to ten of these open fields, some of which may have been planted with the same crop.<sup>36</sup> As Hopewell's owners began to acquire adjacent tracts and begin a dairy operation in the early twentieth century, it is likely that the site began to assume the appearance of the local dairy farms seen in turn of the century photographs (Figure 4.19).

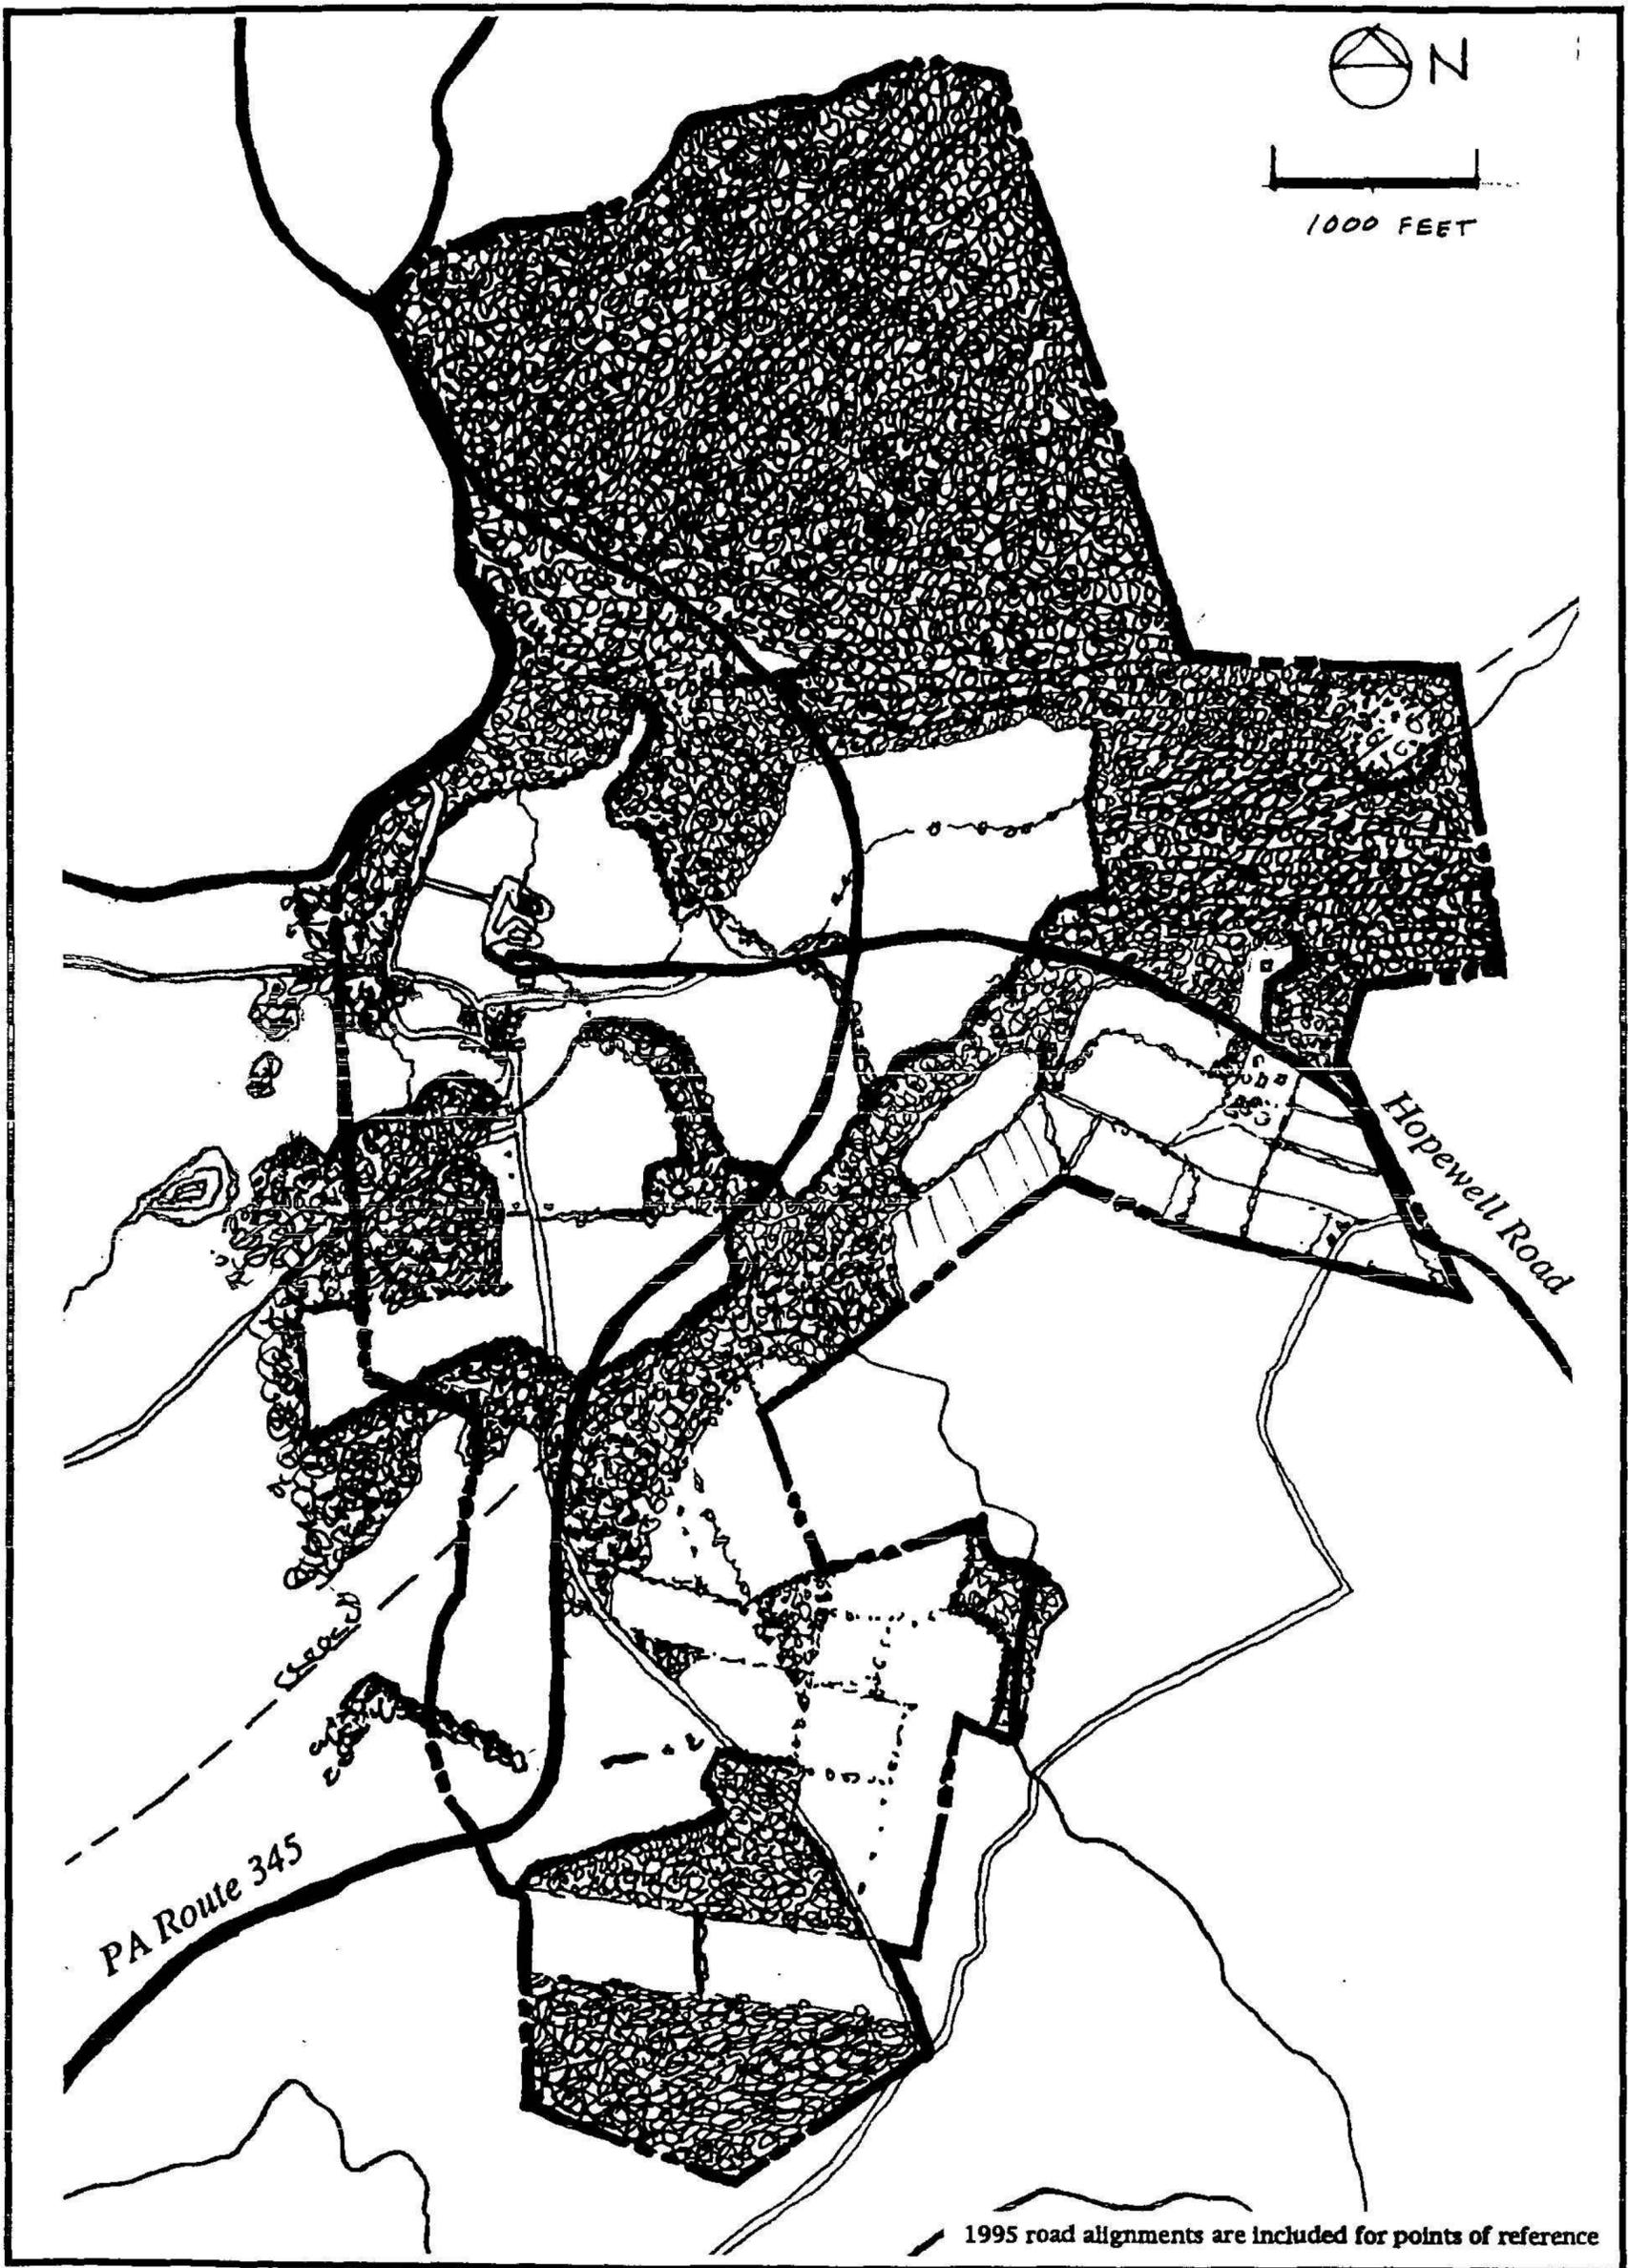
Figure 4.20. Historic field division ca. 1880-1920.

Changes in the relationship between forests and fields shown on the accompanying 1883 and 1938 plans indicate that a number of formerly open areas reverted to successional wooded stands during this period. The encroaching forest overtook large portions of open space on the Thomas Lloyd, Harrison Lloyd, and Nathan Care farms. South of the Nathan Care House and Barn is a stand of birch and maple, indicative of open fields that have reverted to successional wooded stands (see 1883 and 1938 historic plans). Other fields remained agricultural well into the twentieth century (see Figure 4.20).<sup>37</sup>

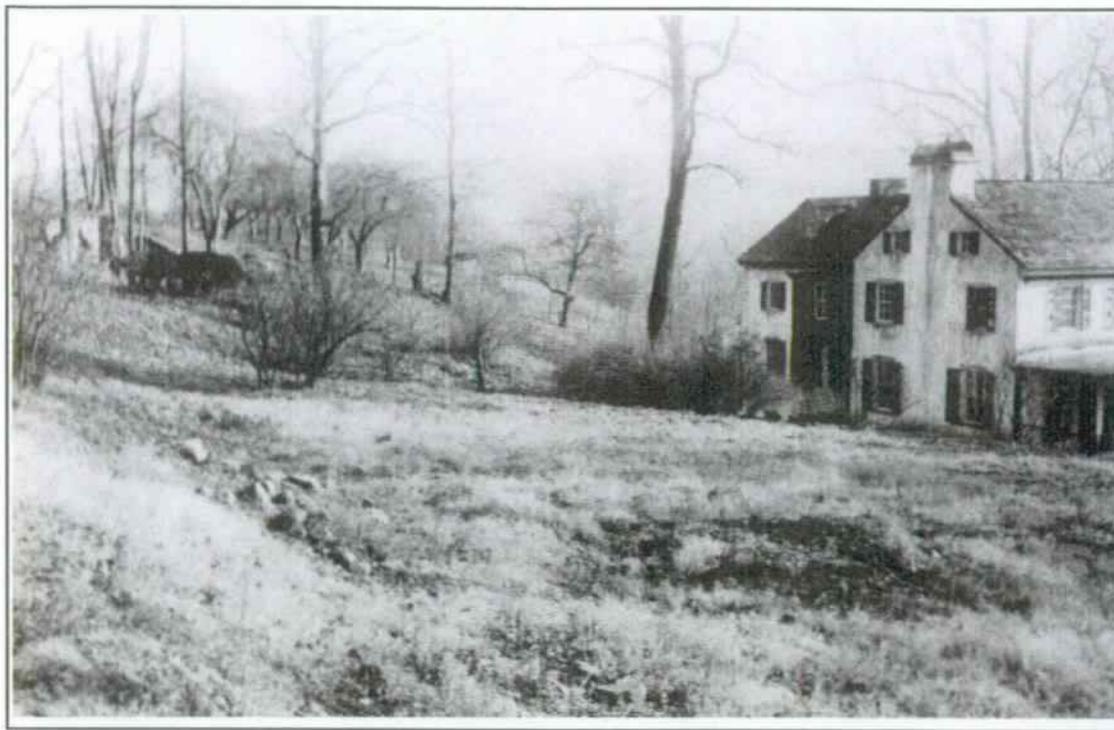
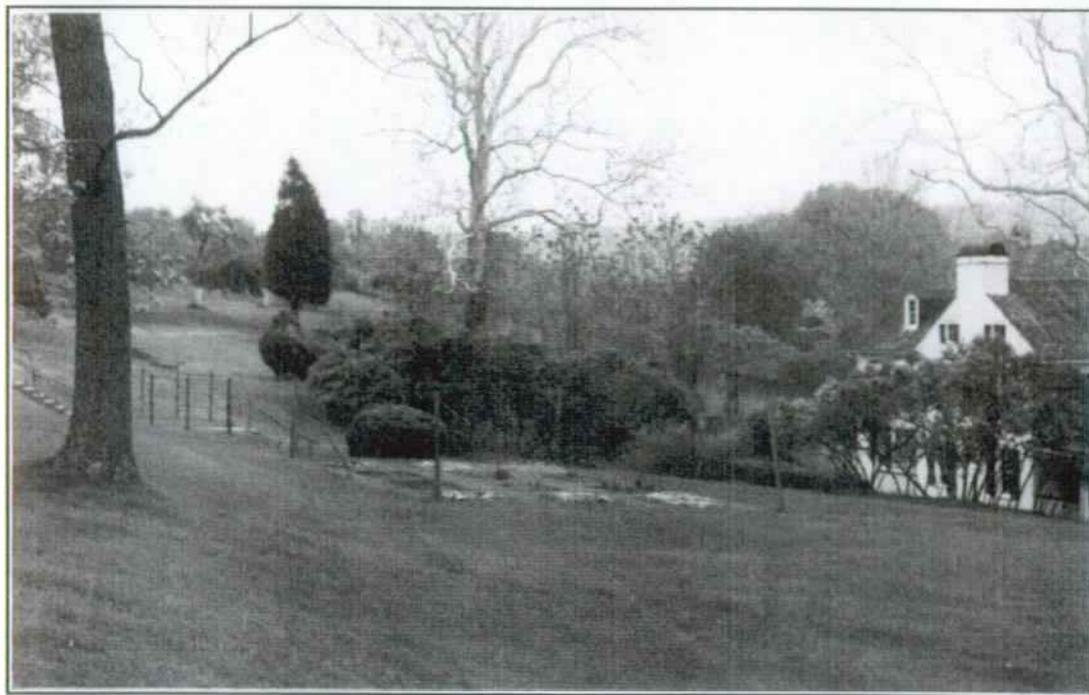
Figure 4.22a (top) and 4.22b (bottom). View east to the garden terraces, steps, Greenhouse, and Ironmaster's House in 1936 and 1995. Top photo HOFU archive, bottom photo Menke & Menke.

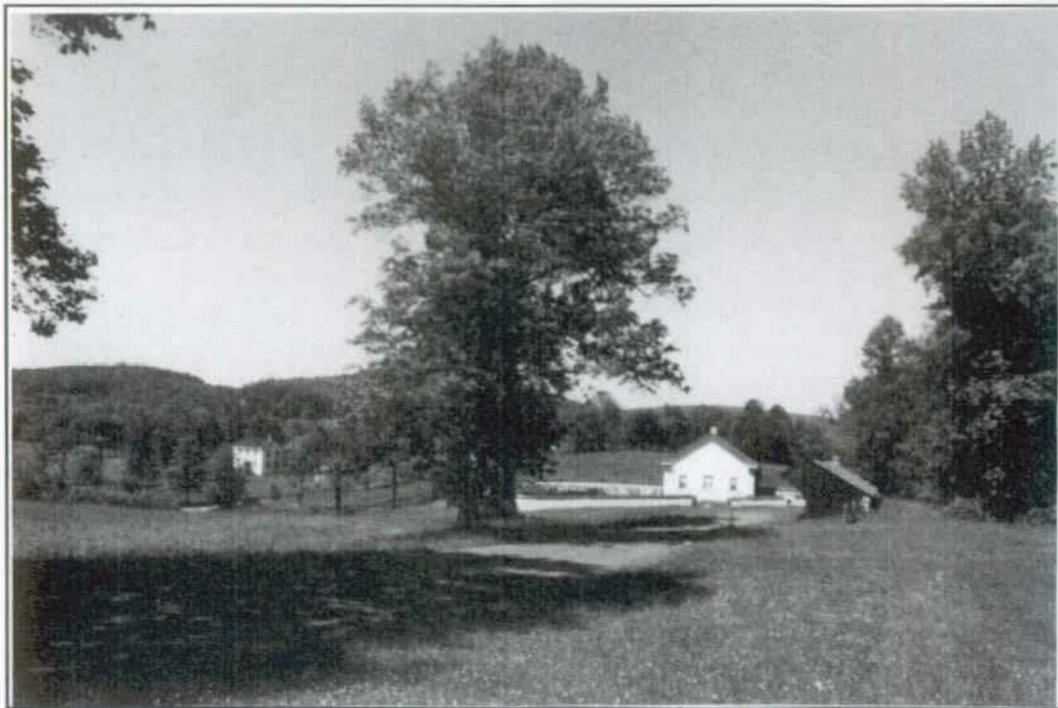
Figure 4.25. Bethesda Church Cluster 1995. The cluster includes Bethesda Baptist Church (79), Bethesda Carriage Shed (80), Privy (81), stone walls with wooden caps (79A) and cemetery gravestones (79B). Menke & Menke photo.

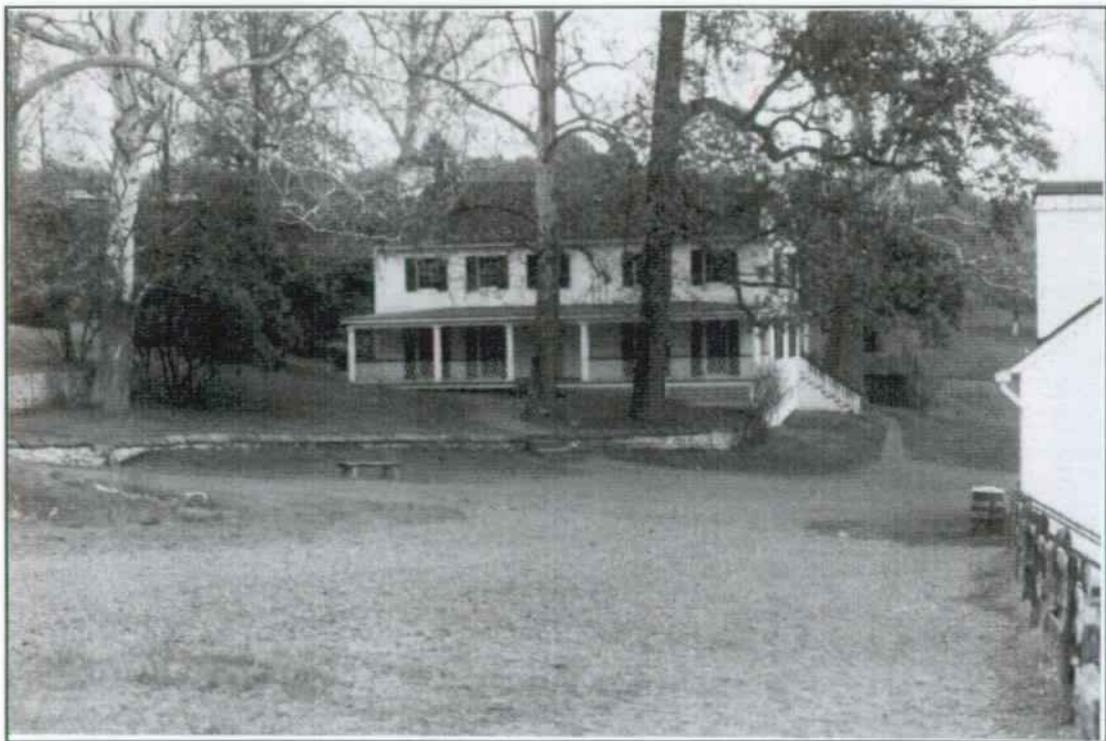
Figures 4.27a (top) and 4.27b (bottom). Ironmaster's House as a summer residence, in the early twentieth century. The same view in 1995 reveals a more manicured landscape with less vegetation. Small-scale elements in the 1995 view include fencing, a bench, and a barrel. The Ironmaster's House, Office & Store, and wall are seen in both views. Top photo HOFU archive, bottom photo Menke & Menke.

Little new construction occurred during this period. Much of this construction was associated with the use of the property as a summer home (Figures 4.27a and 4.27b) and the effort to develop a working dairy farm on the tract. Large additions transformed the Village Barn into a dairy barn, while a series of chicken coops were erected near the former site of Tenant House No. 4. Tenant House No. 4 reportedly burned in 1893.

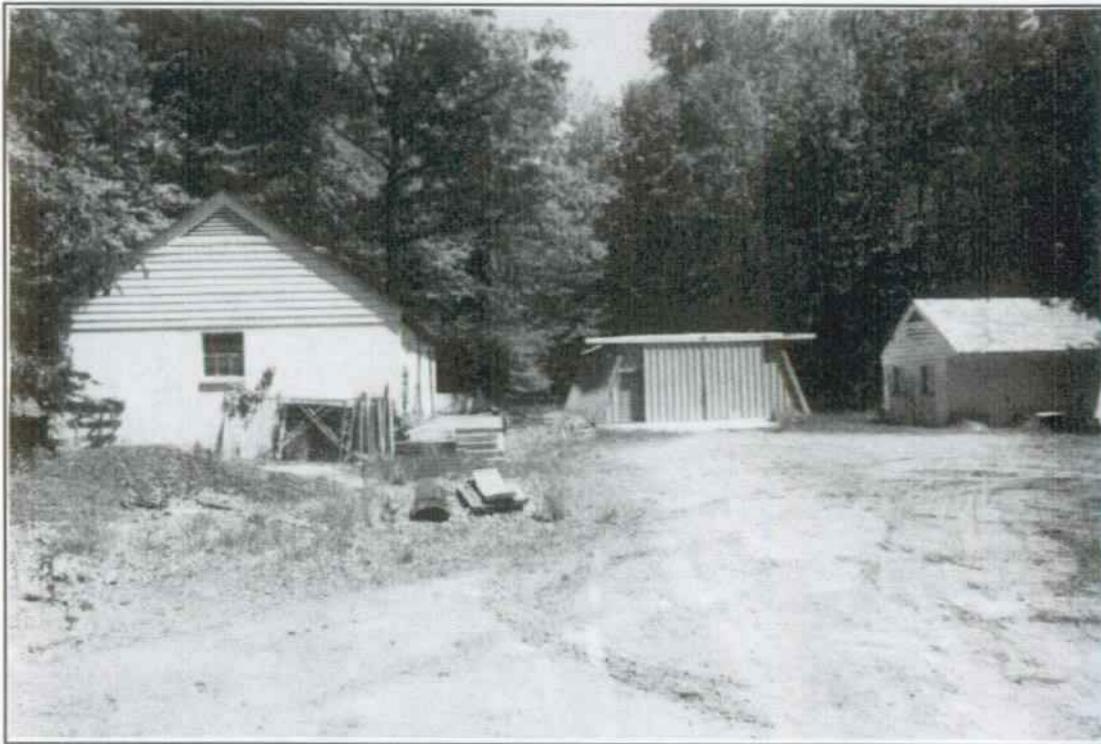
Figure 4.28. Two of three buildings extant from the vicinity of CCC SP-17 Camp (on the left and right), 1995. The center building is of much more recent construction. Menke & Menke photo.

The arrival of the CCC inaugurated a massive building program at the site. CCC Camp SP-7 consisted of a cluster of buildings north of the core village. Barracks, mess halls, recreation halls, and various support structures, were all arranged around an open parade ground in accordance with military site planning precepts. CCC construction activities included stabilization and rehabilitation of the furnace stack, rehabilitation of the tail race, construction of the bypass road, and completion of trails, picnic areas, and other recreational facilities. Only three buildings constructed by the CCC in this area are extant: the Pump House (Building 51), and two maintenance structures Buildings 66 and 67 (Figure 4.28). The later two buildings date from the end of the CCC's tenure at Hopewell (1941).

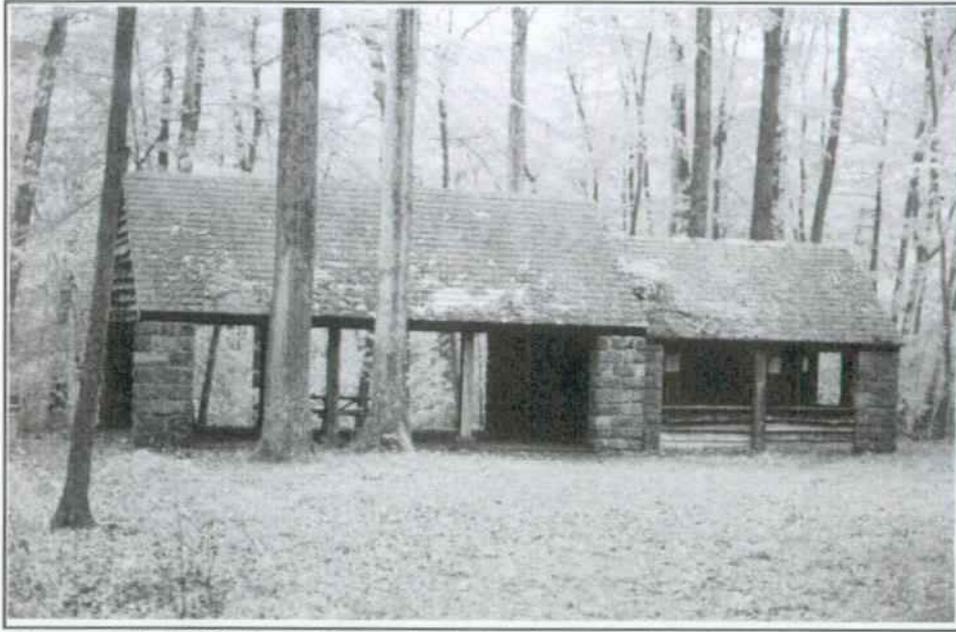
Figure 4.30. CCC Picnic Shelter in the Environmental Study Area near Baptism Creek, 1994. Menke & Menke photo.

The main structure, the 1936 picnic shelter, has been determined eligible for inclusion on the National Register of Historic Places (Figure 4.30). Other extant elements associated with the picnic area include fireplaces, rustic bridges, drinking fountains, springhouses, and latrine ruins.

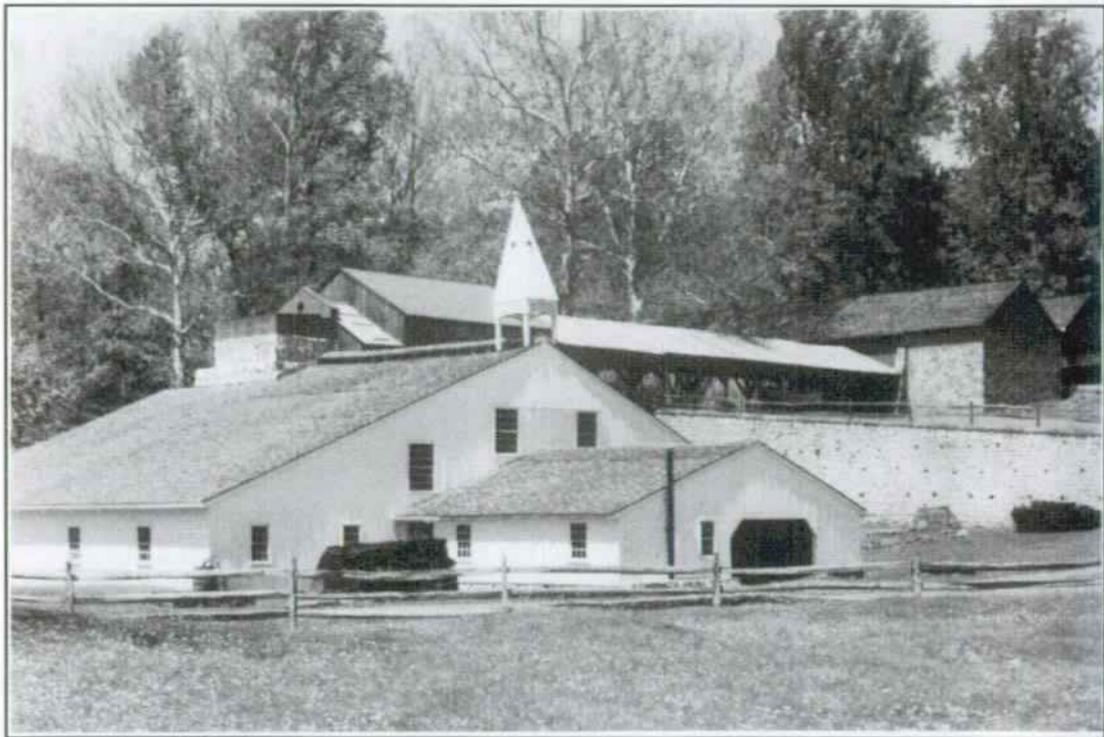
Figure 4.31. 1995 view of the reconstructed furnace complex. Menke & Menke photo.

The National Park Service has engaged in significant construction efforts at Hopewell Furnace National Historic Site. Many of the key buildings in the core village are reconstructions, based upon extensive documentary and physical evidence, constructed during the 1950s and 1960s. These include the Cast House (Figure 4.31), Cooling Shed, Bridge House, Charcoal House

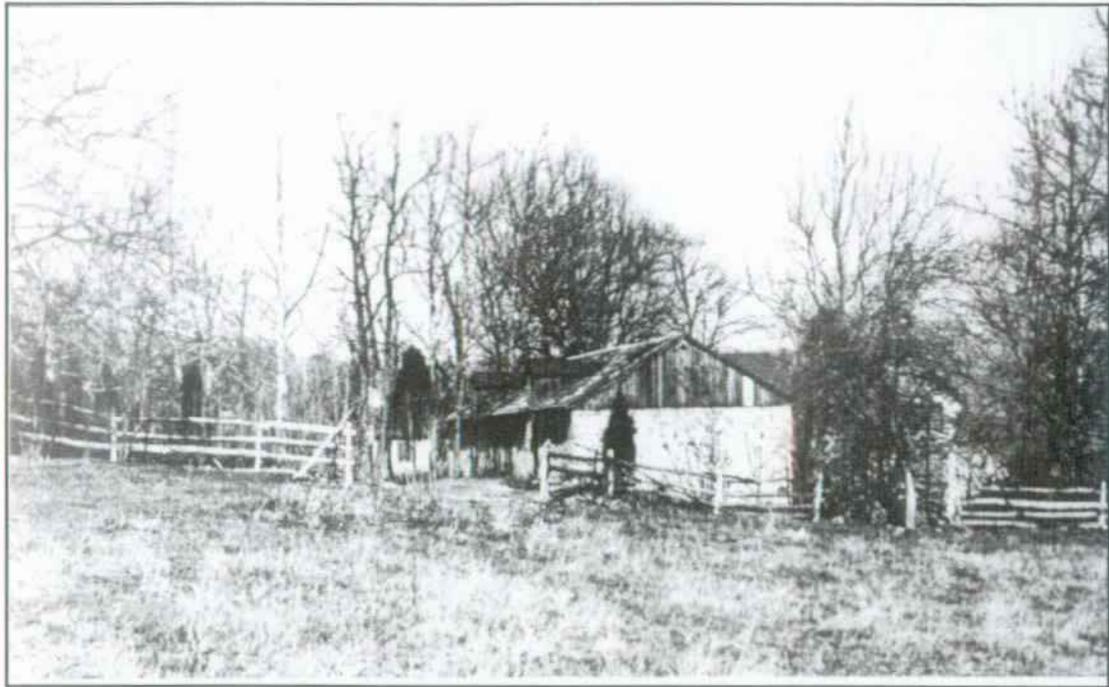
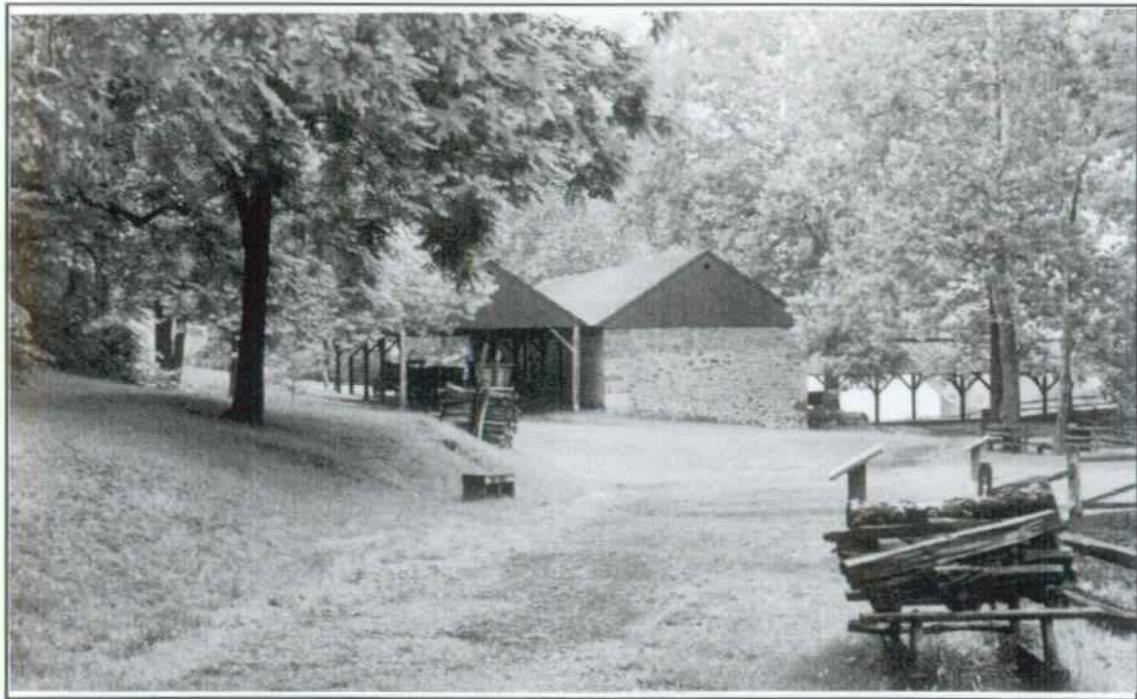
Figures 4.32a (top) and 4.32b (bottom). Charcoal House from the west in 1920 and in 1995. Note that the dormers in the 1920s view were deleted in the restoration and the shed portion and Bridge House were reconstructed. Top photo HOFU archive, bottom photo Menke & Menke.

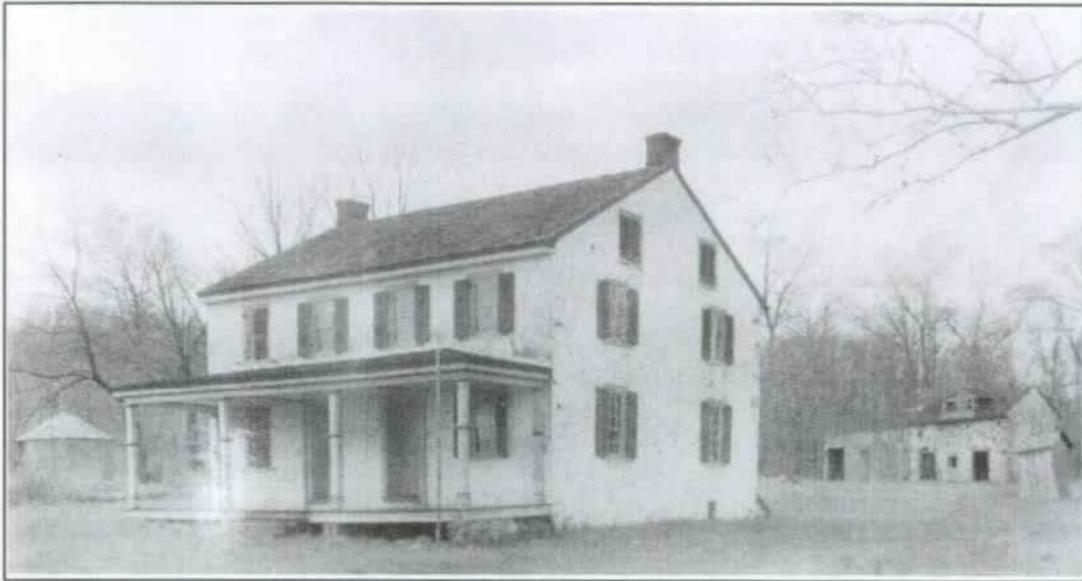
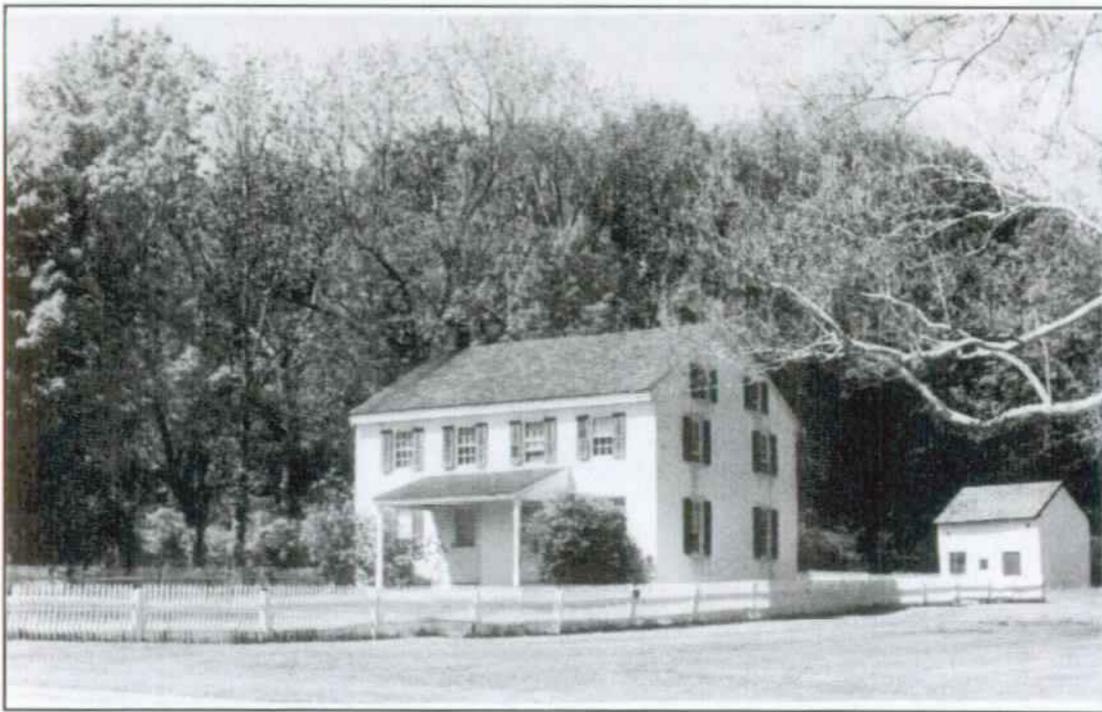
Figures 4.33a and 4.33b. Two views of Tenant House No. 3. Top, "View of Tenant House and Privy Looking West, 1936." Bottom, similar view in May 1995. A small grain silo, privy and a shed addition to the outbuildings are no longer extant, but the porch has been restored, a picket fence added, and the trees have grown. Top photo HOFU archive, bottom photo Menke & Menke.

In the 1960s, the Tenant Houses were rehabilitated (Figures 4.33a and 4.33b). No effort was made to reconstruct missing outbuildings and other structures. The absence of these elements prevents a fuller interpretation of the lives of the furnace workers. These buildings appear today as residential structures surrounded by lawns and managed by a single caretaker.

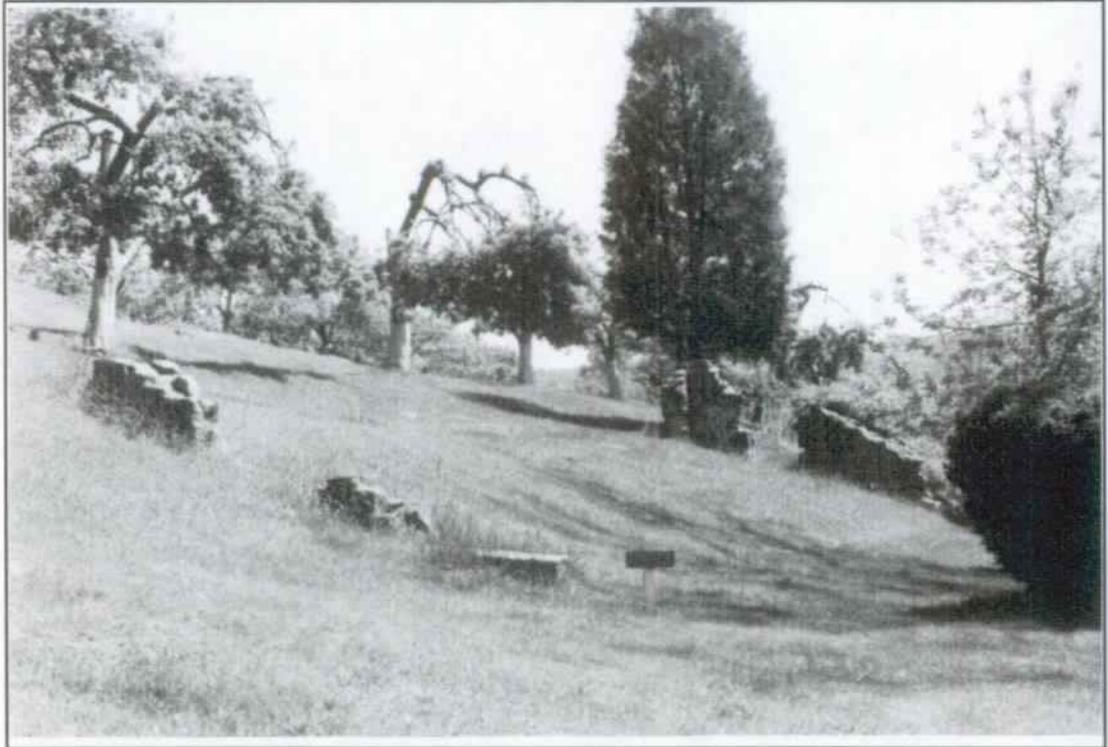
Figure 4.37. Greenhouse Ruins, 1995. Menke & Menke photo.

There are primary archeological resources in the core village dating from this period whose locations are well established. These include the Carpenter's Shop; ruins within the Ironmaster's grounds, including the gardener's tool house, privy, ice house, smoke house, and greenhouse, as well as the terraced gardens themselves (Figure 4.37); and the School House. The Carpenter's Shop, which dates from the 1820-1844 period, was in ruins by the late-nineteenth century and was razed ca. 1900. The 1830s Ironmaster's House gardens and associated outbuildings and structures were in ruins when the federal government acquired the site in the 1930s. However, it is likely that they fell into disrepair well before that time, as Mary Krewson specifically mentions the Greenhouse ruins in her recollections. The School House dates from 1836 and was abandoned after construction of a new school house in the 1870s. The remains of the School House are barely visible today (Figure 4.38). Both the Greenhouse and School House presently are identified by National Park Service signage.

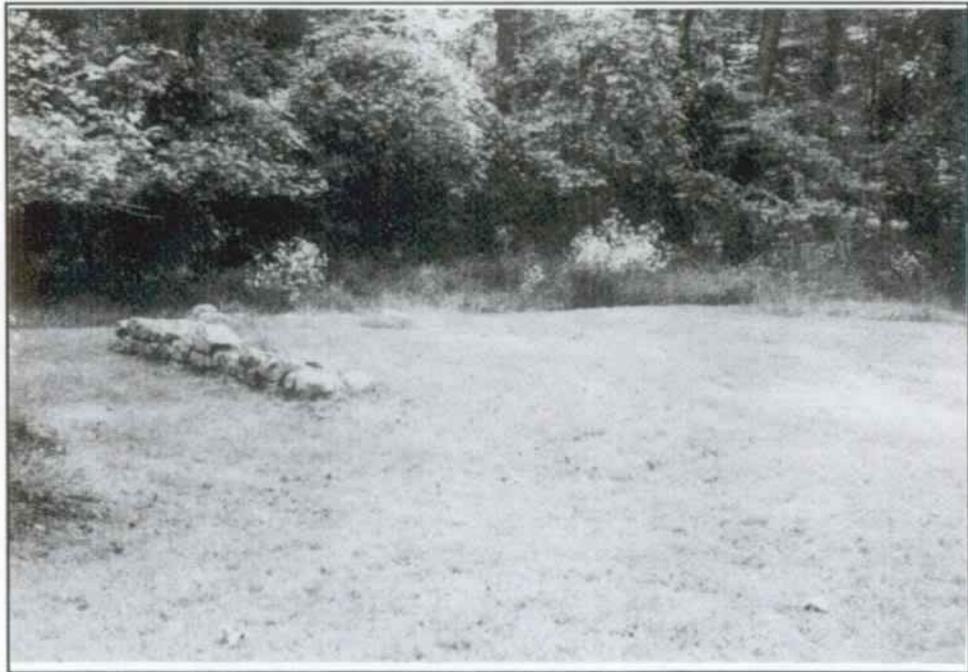
Figure 4.38. School House Ruins, 1995. Menke & Menke photo.

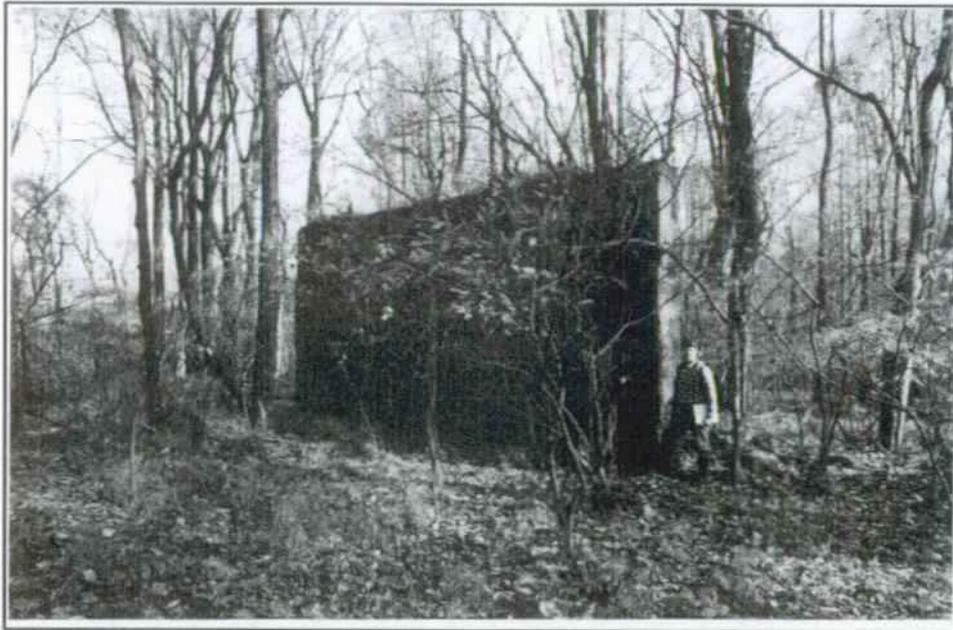
Figure 4.39. Harrison Lloyd Farm; ruins of former barn, 1995. The end wall of one of several buildings visible in historic aerial photographs. Other archeological resources in the area include the house and blacksmith shop (72C) ruins, stone walls (73), a well, and several bank barn ruins. Menke & Menke photo.

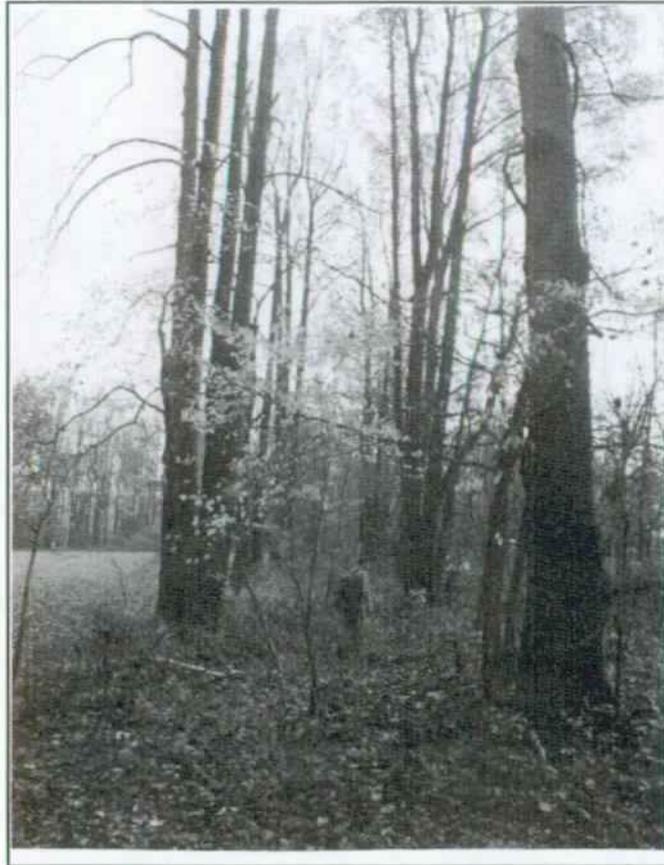
Figure 4.40. Possible Harrison Lloyd farm lane with an alley of trees, 1995. Menke & Menke photo.

A number of outlying farms and building sites date from this period. As noted previously, the Harrison Lloyd farm site includes ruins and features that may date to as early as the late-eighteenth century. Since the site remained occupied and active throughout this period, archeological investigations have the potential to reveal significant information pertaining to nineteenth century activities and practices at this location. Among the remains are the house foundations, an apparent blacksmith shop with a fireplace, several barn walls and foundations (Figure 4.39), and an open well. The trace of a possible former lane leading to the farmstead can be identified by parallel rows of trees forming an alley (Figure 4.40).

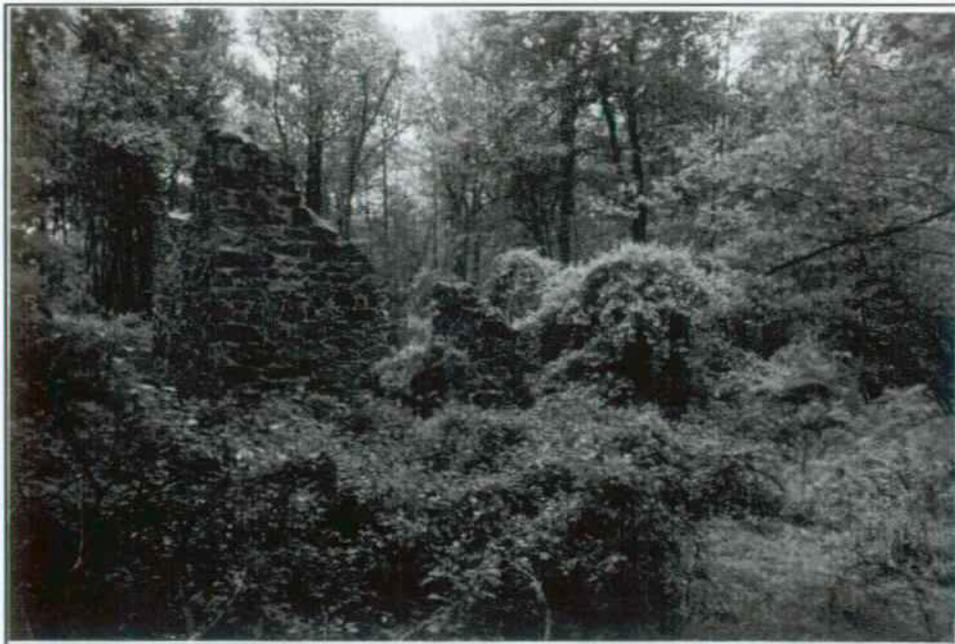
Figure 4.41. Woodlot House ruins in enveloping vegetation, 1995. Menke & Menke photo.

Other outlying ruins include those associated with the Woodlot House (Figure 4.41) and Brison House. The Woodlot House site includes a possible privy or well pit. The ruins at both sites, located in wooded areas, were stabilized in the 1970s-1980s. Nevertheless, they are continuing to deteriorate. The stabilization of the above-ground ruins did not protect potential archeological resources at either location. Like the Woodlot and Brison ruins, the

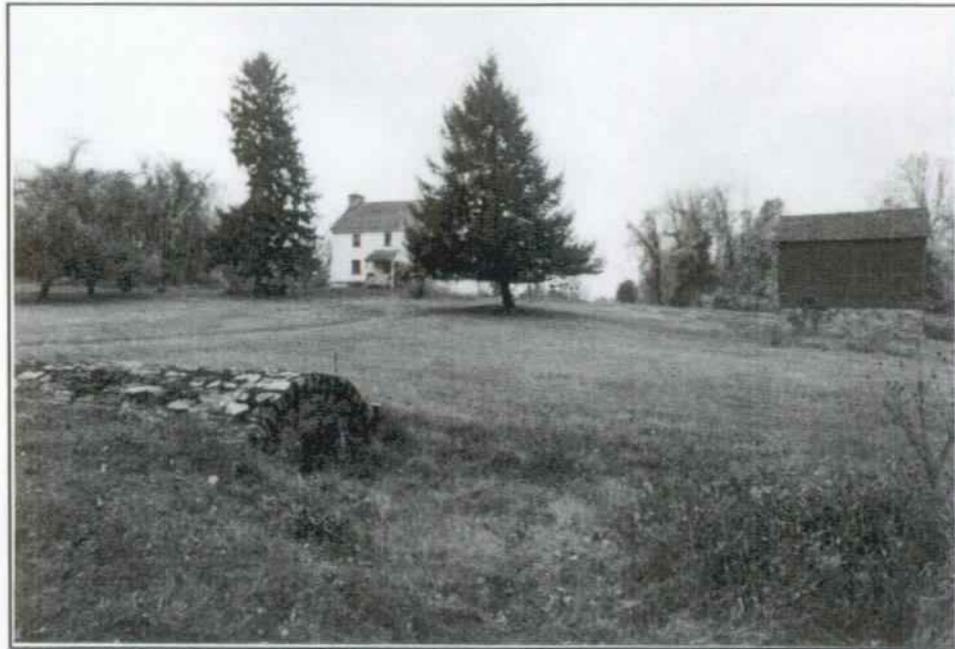
Figure 4.43. Thomas Lloyd House, Barn, and Springhouse, 1995. Menke & Menke photo.

Just as the village residences had outbuildings, the farmsteads adjacent to the furnace property also had privies, barns, and other small structures. For example, by 1798, Thomas Lloyd had erected a barn and constructed a stone springhouse near his residence (Figure 4.43). Nearby, at Bethesda Church, small-scale elements included gravestones in the cemetery (Figure 4.44) and a carriage house erected soon after the church's construction in 1782.

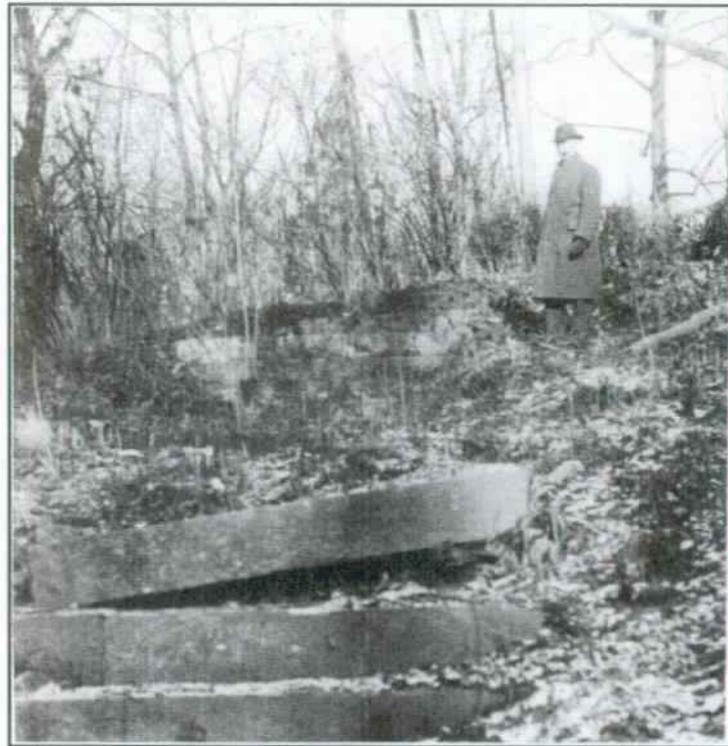
Figure 4.48. Ironmaster's terrace garden steps in ruins, 1936. HOFU archive photo.

When the federal government acquired the property in the 1930s, numerous outbuildings and site elements were in deteriorated or ruinous condition. Plans and existing condition photographs from this period provide some of the best documentation of small-scale site elements (Figure 4.48).

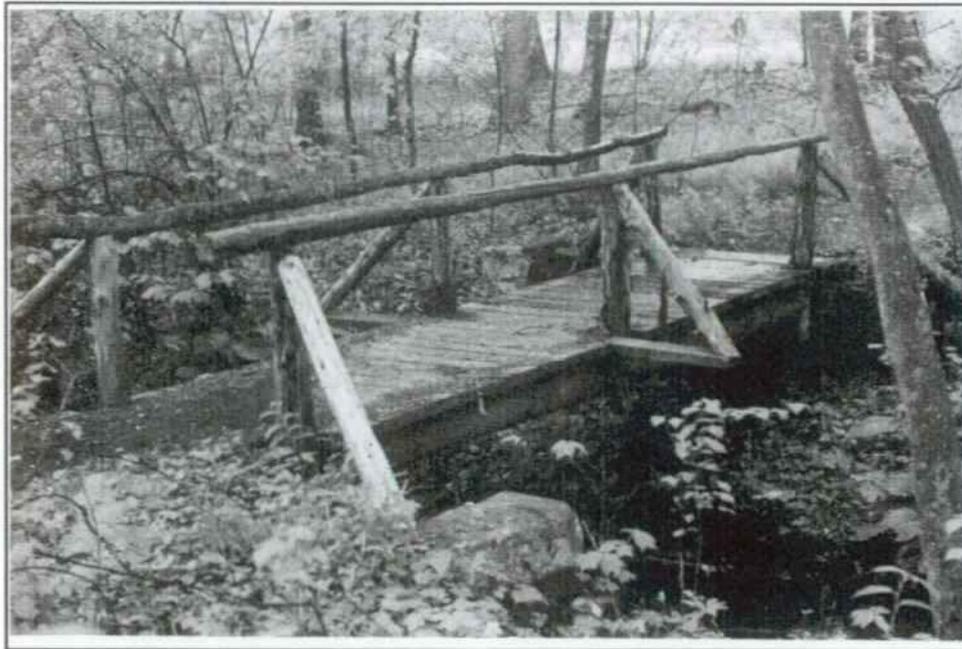
Figure 4.49. Rustic Bridge at the Baptism Creek Picnic Area, north of Hopewell Road. The stone footing dates from ca. 1940, however, the wood bridge is more recent. Menke & Menke photo, 1995.

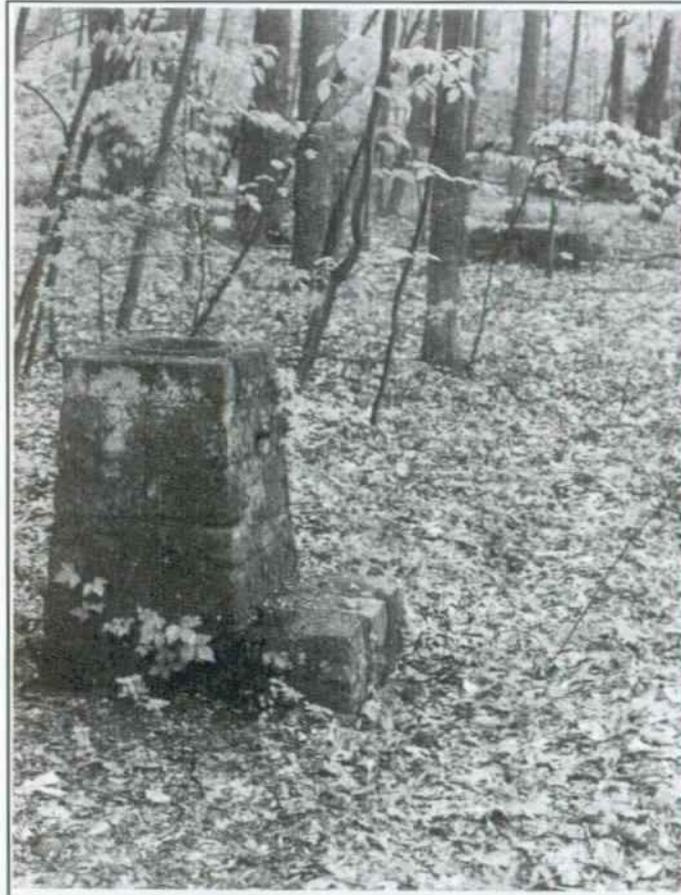
Figure 4.50. Drinking fountain and fireplace site elements dating from ca. 1940 at the Baptism Creek Picnic Area north of Hopewell Road. Menke & Menke photo, 1995.
