## CULTURAL LANDSCAPE REPORT

# HOPEWELL FURNACE NATIONAL HISTORIC SITE

Prepared for  
**National Park Service,**  
Northeast Region,  
Philadelphia Support Office,  
Philadelphia, Pennsylvania

Prepared by  
**KFS Cultural Resources Group**  
Kise Franks & Straw, Philadelphia, Pennsylvania

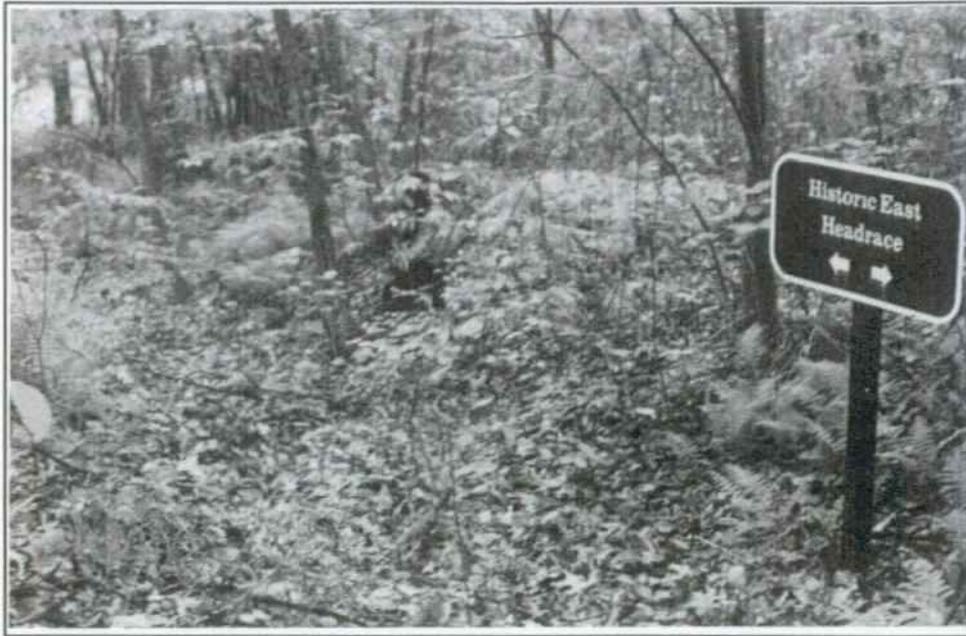
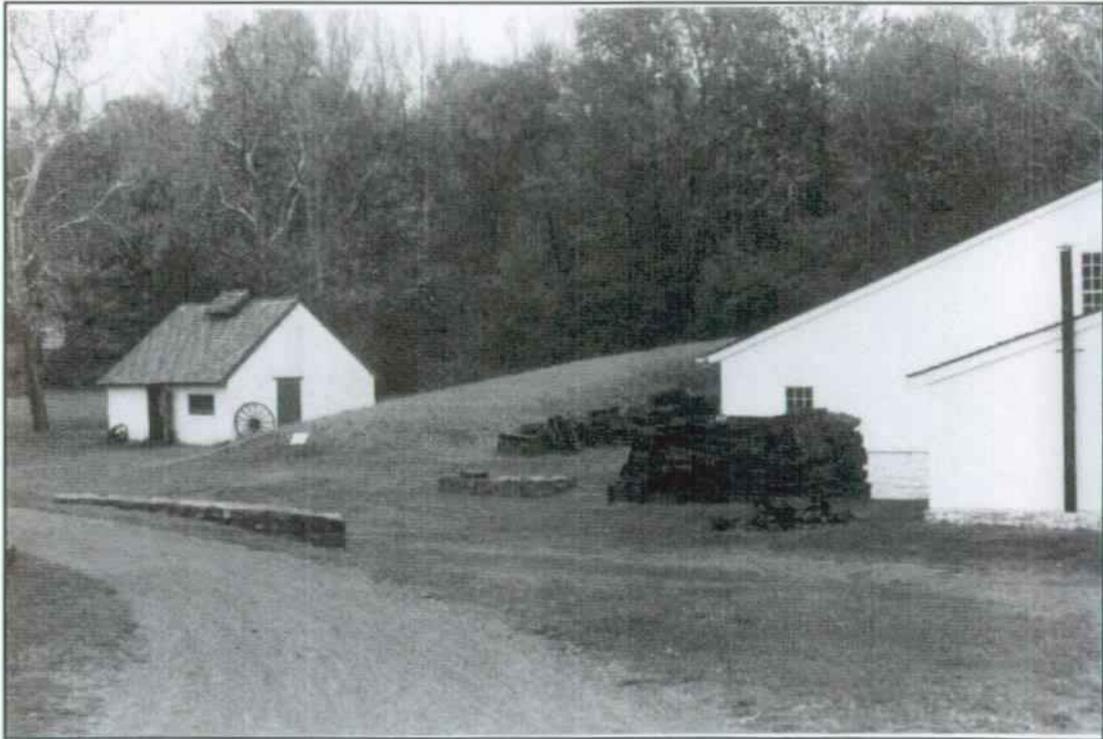
Figures 4.52 & 4.53. Top, East Head Race sign near Baptism Creek, 1995. Bottom, stacks of iron, grass-covered slag piles, molding frames, and a wagon wheel near the furnace, 1995. Menke & Menke photos.

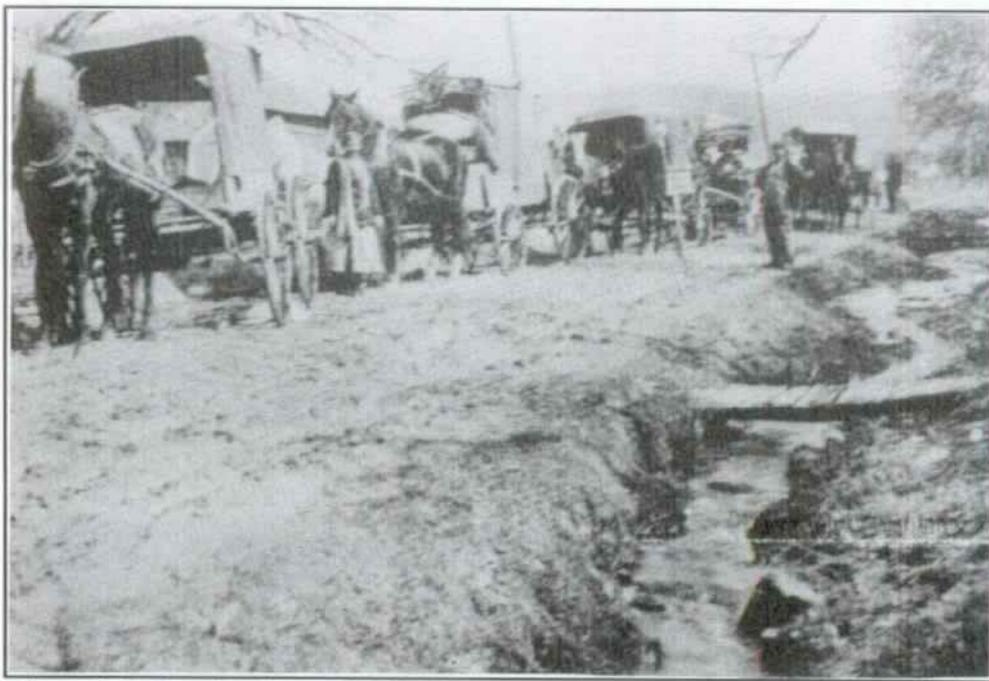
Figure 6.6. A regional example of a nineteenth century road with an adjacent ditch and boardwalk crossing. N.d. Photo reproduced from Fegley *Farming, Always Farming* (Birdsboro, Penn.: The Pennsylvania German Society, 1987). Use of photo courtesy of Schwenkfelder Library.

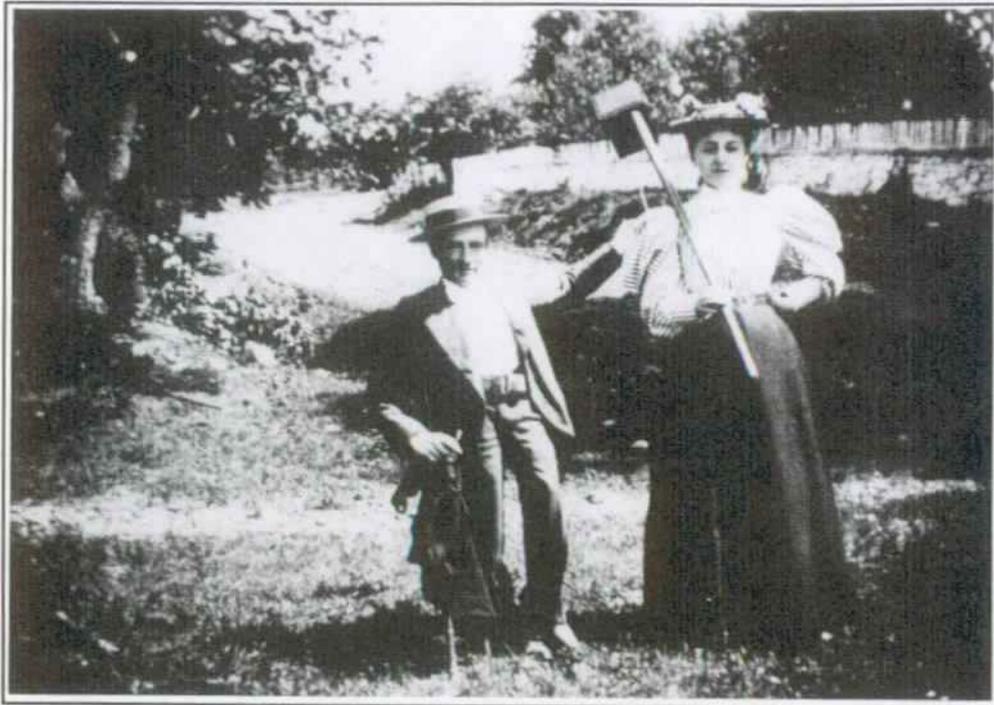
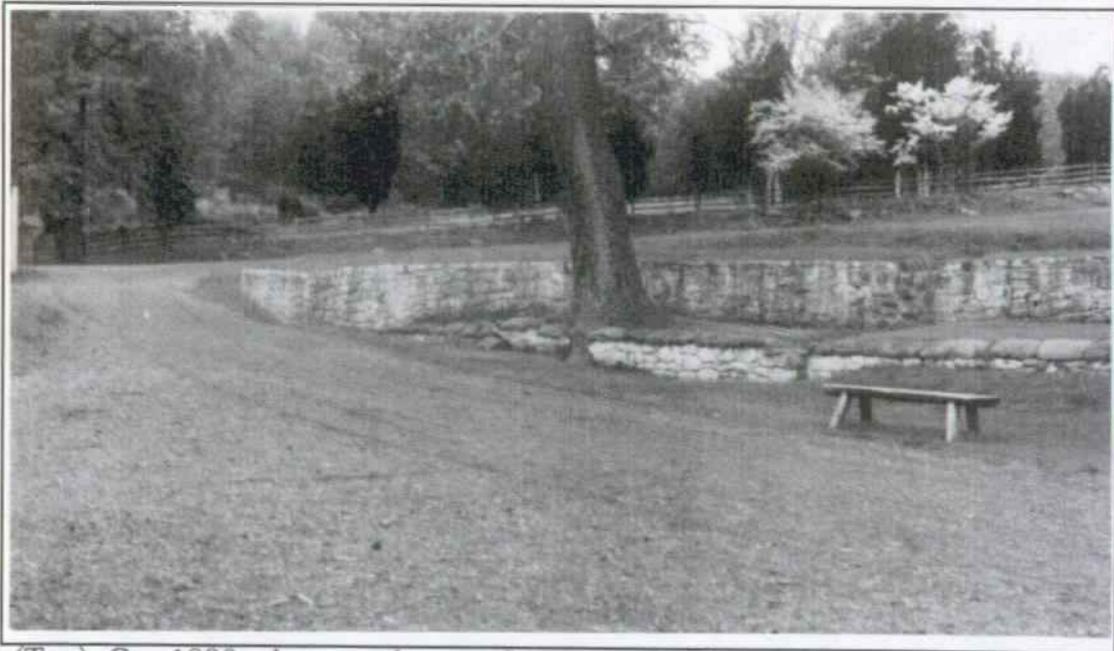
(Top) Ca. 1890 photograph near Ironmaster's House showing photographer (possibly Octavius Bull) and assistant as well as stone wall with picket fencing located near edge of East Head Race. On file at HOFU archives. (Bottom) 1995 view of Ironmaster's Stone Wall. Menke & Menke photo.

- Continue to preserve the wall at the edge of the Ironmaster's House garden, which is presently in good condition.
- Implement a less rigorous schedule of whitewashing the wall between the Office & Store and the Furnace. This would convey a more historic impression of this feature without jeopardizing its preservation.

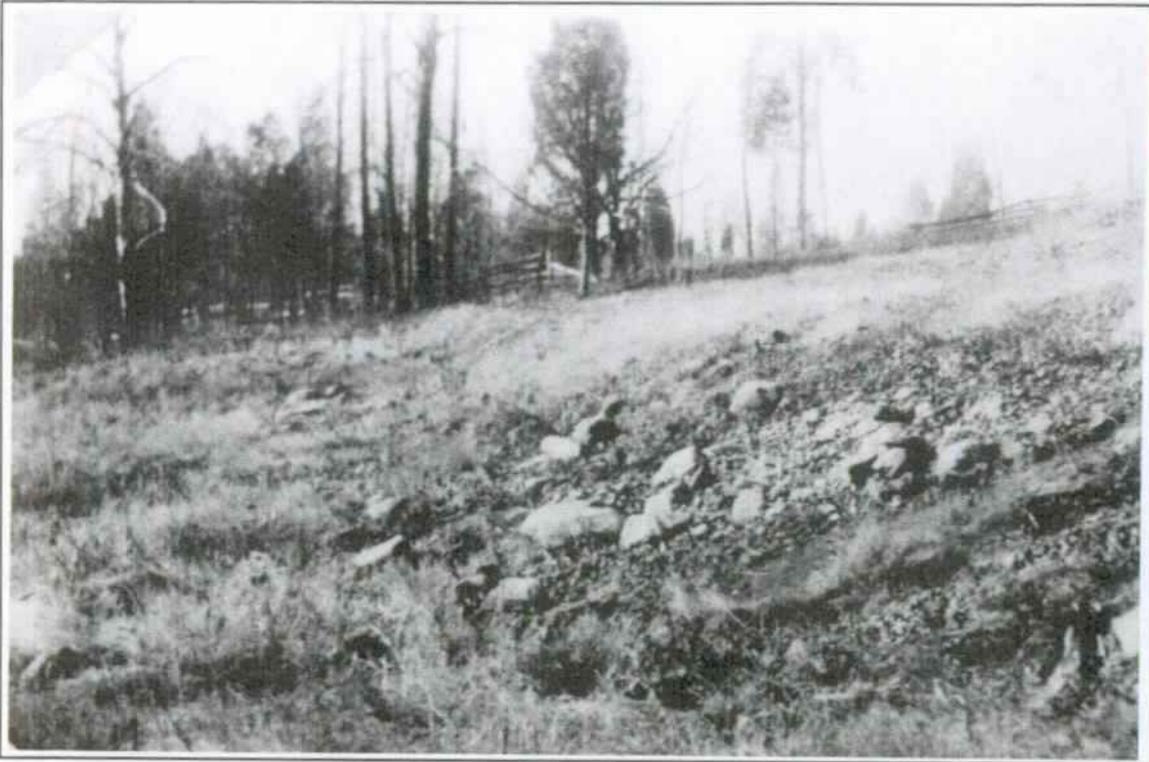
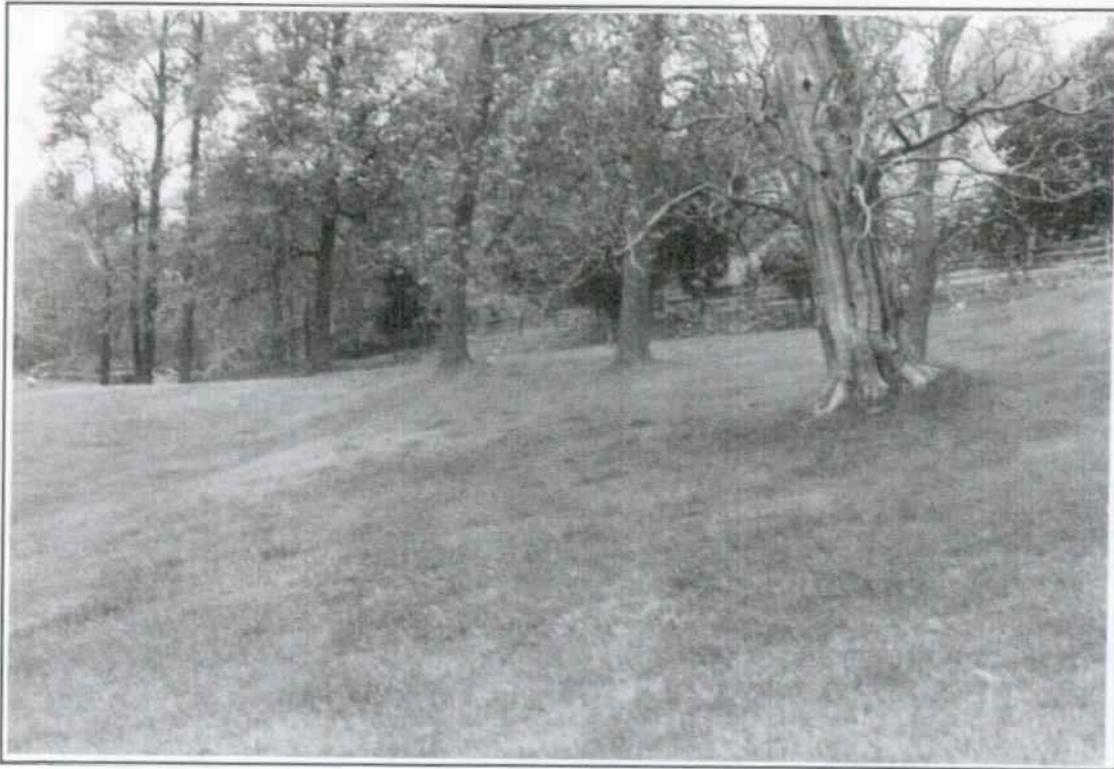
Terraces in Ironmaster's Garden in 1936 (top) and 1995 (bottom). Top photo on file in HOFU archives, bottom photo Menke & Menke

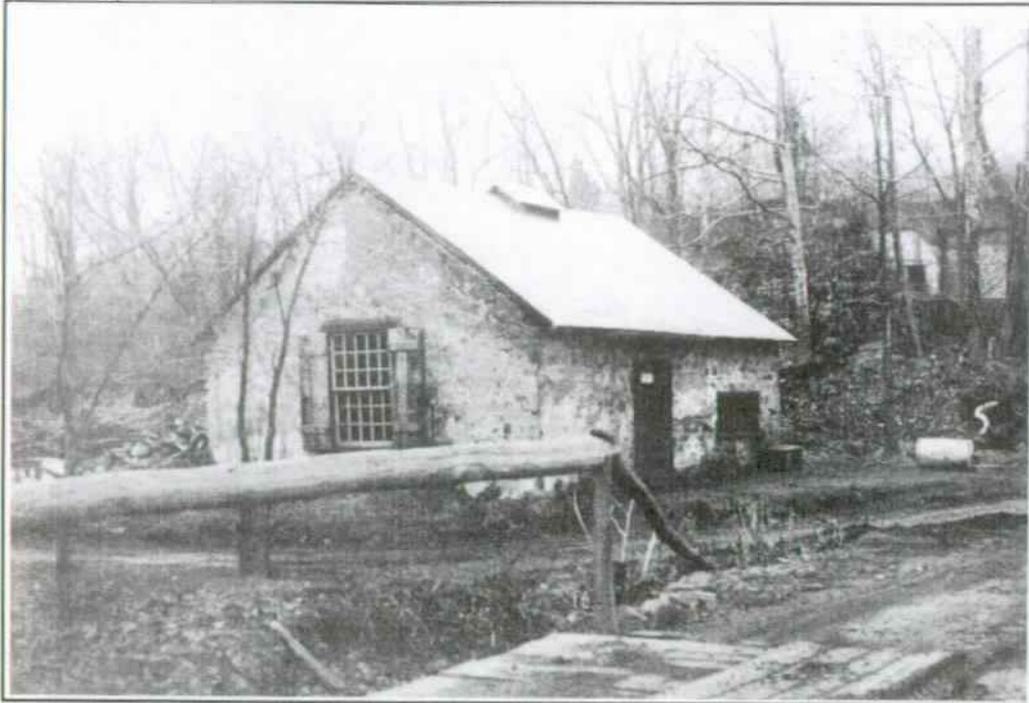
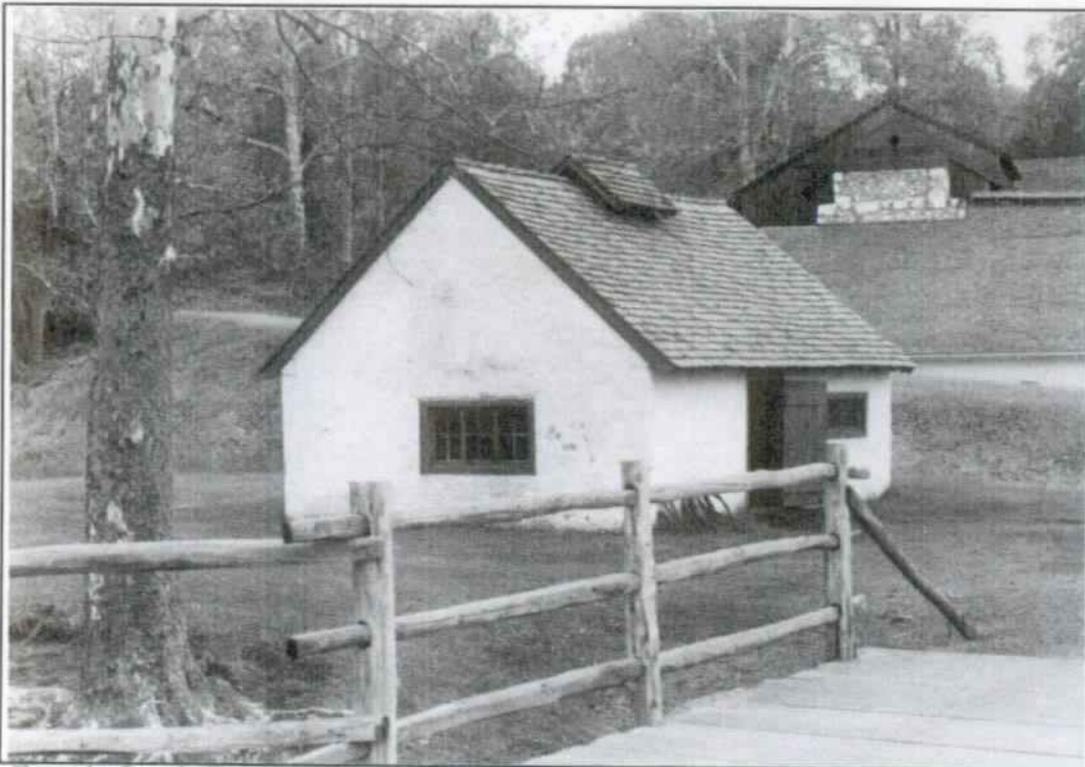
French Creek Bridge and Blacksmith Shop in 1936 (top) and 1995 (bottom). Notice Furnace ruin in background of the 1936 photo and bridge modifications in the 1995 photo. Top photo on file in HOFU archives, bottom photo Menke & Menke.

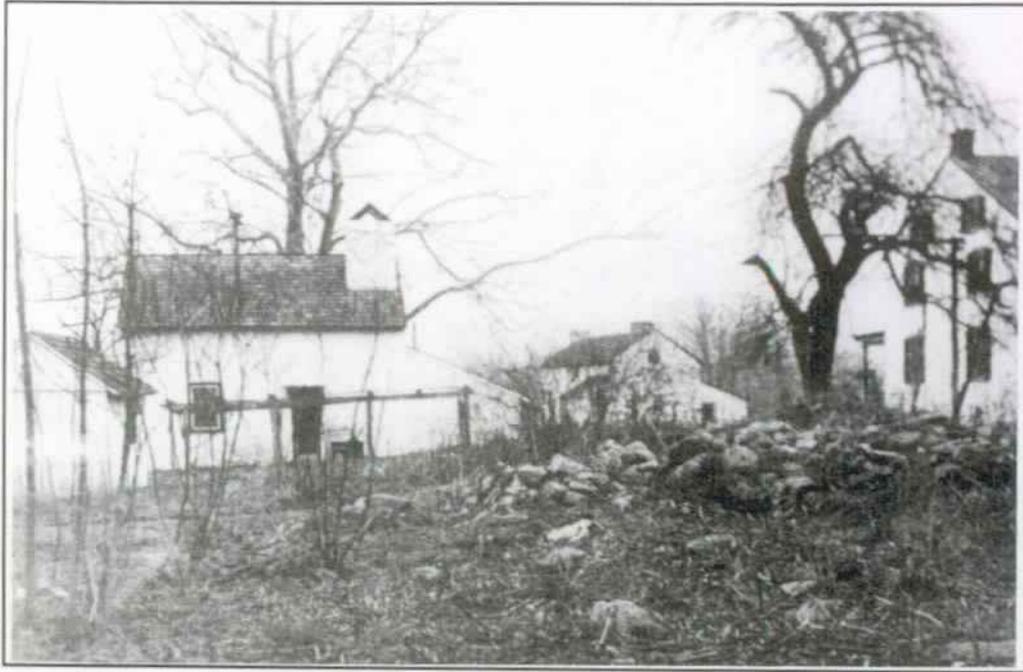
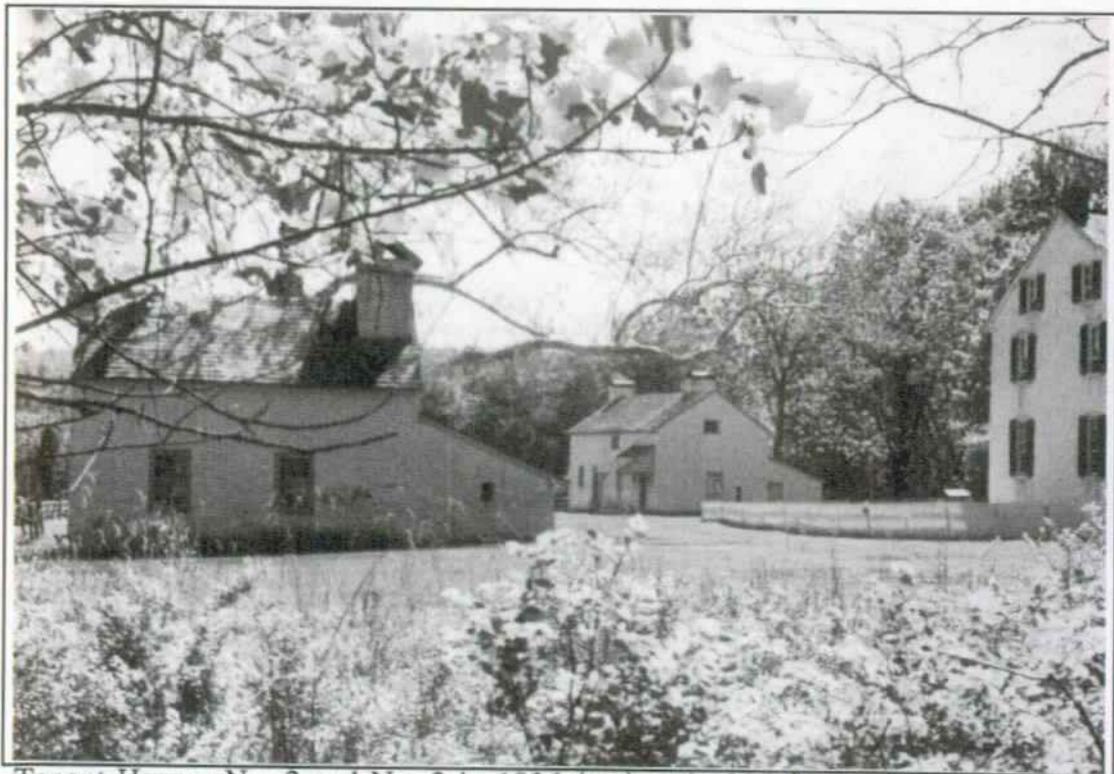
Tenant Houses No. 2 and No. 3 in 1936 (top) and 1995 (bottom) with Boarding House in center background. Note the removal of outbuildings, pergola, and possible apple tree as well as the addition of picket fencing in the 1995 photo. Top photo on file in HOFU archives, bottom photo Menke & Menke.

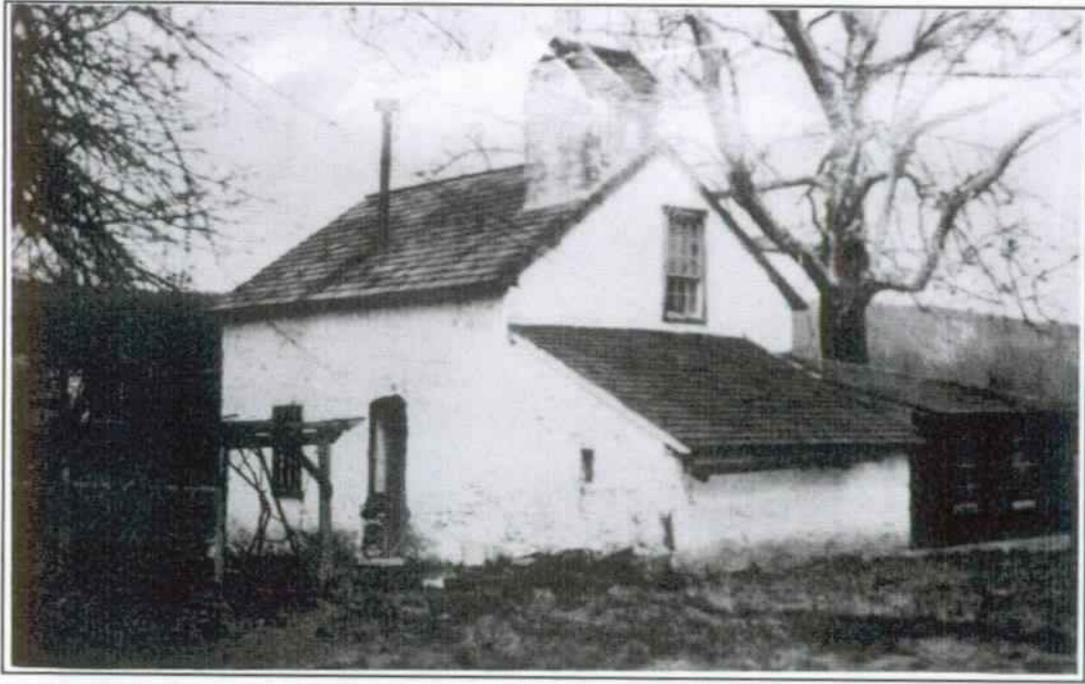
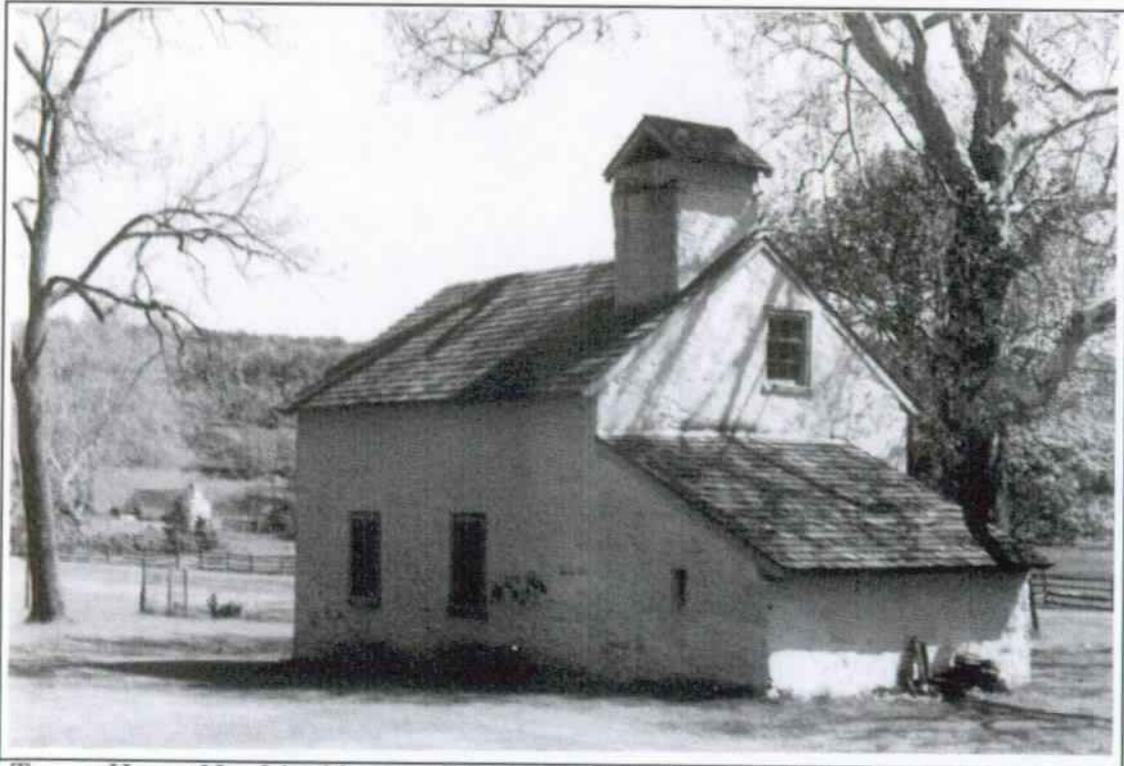
Tenant House No. 2 looking north in ca. 1935 (top) and 1995 (bottom). Pergola and addition no longer remain in 1995 photo. Top photo on file at HOFU archives, bottom photo Menke & Menke.
