OLMSTED  
CENTER  
*for* LANDSCAPE PRESERVATION

# CULTURAL LANDSCAPE REPORT FOR JOHN MUIR NATIONAL HISTORIC SITE

VOLUME 1: SITE HISTORY, EXISTING CONDITIONS, AND ANALYSIS

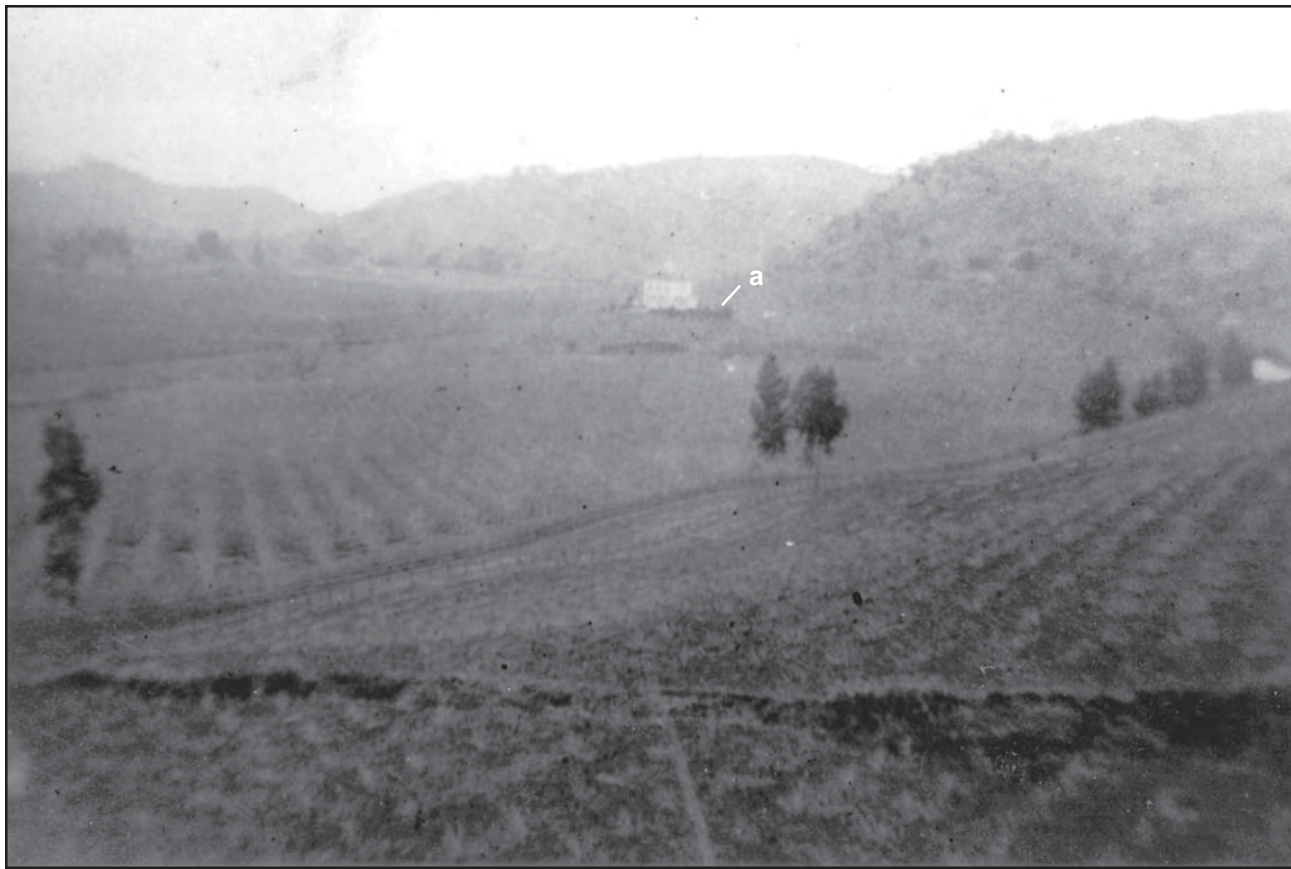
**Figure 2.3:** This view, looking southeast c.1883, is the earliest known photograph of the Strentzel-Muir Ranch and the Redfern Place. Taken soon after completion of the Strentzel House, it shows the Road to Oakland, called Franklin Canyon Road by this time, defined by two and three-board fencing and occasional conifers. The road is flanked by young orchards to the east and a field of wheat, hay, or silage on the west. In the background is the Strentzel House and the outline of Mt. Wanda. The mass of vegetation (a) west of the house is situated along Franklin Creek, just north of the main farm road that connects to Franklin Canyon Road. The dark mass of vegetation on the west side of the house is a mass planting of Monterey pine and incense cedar. (A1-33, Ref:1883cP20).

Historic photographs from the 1880s show some of the crops noted above at the Redfern Place as well as the vast extent of the orchards, vineyards, and crops that surrounded this area. The earliest known photograph dates from c.1883, soon after the new Strentzel House was completed (Figure 2.3). The photograph shows the Road to Oakland, which by this time is called Franklin Canyon Road, bordered by rows of orchard trees and a field of wheat, hay, or silage. In the background is the Strentzel House, which even from this distance appears to be quite imposing, and the outline of Mt. Wanda. A distant view of the Redfern Place looking west in c.1885 shows crops planted across the lower hills west of the Martinez Adobe and on the east slope of Mt. Wanda (Figure 2.4). A closer

Much of the infrastructure required to operate the huge Strentzel- Muir fruit ranch was in place by the mid- 1880s. Figure 2.3 shows an early view of the Franklin Canyon Road, which by this time was undoubtedly the primary means of access into the fields comprising the Redfern Farm and other properties at the ranch.

Several early historic photographs of the Redfern Place – along with Mrs. Strentzel’s diary entries and archival and field analysis of historic trees at the park by James K. Agee in 1978 – provide insight into some of the early non- agricultural plantings. Figure 2.3 shows several evergreen trees along Franklin Canyon Road, and Figure 2.6 shows similar trees along the edge of the field northeast of the Strentzel House. The trees appear to be cypress, and while it is not known if they were purposely planted, they surely provided a shady rest area for the workers toiling in the fields.

Shade was also found along portions of Franklin Creek. Figure 2.3 shows two concentrations of vegetation north and west of the Strentzel House. One of these appears to correspond to the tall and dense mass of plants north of the main farm road and especially around the Franklin Creek well and windmill, as shown in Figures 2.5 and 2.6. These plants may possibly be a mix of oak, willow, and other riparian vegetation. Interestingly, the portion of the creek just south of the main farm road appears to virtually absent vegetation; Muir occasionally cleared vegetation along the Arroyo del Hambre behind the Alhambra ranch house and the gravesite and may have done the same here along Franklin Creek. This work was presumably undertaken to maintain an unobstructed channel upstream from the Franklin Creek Bridge and to prevent creekside vegetation from growing tall enough to shade the adjacent orchards. The tallest vegetation in this area at this time, though, encircles the Franklin Creek Windmill and almost touches the blades.

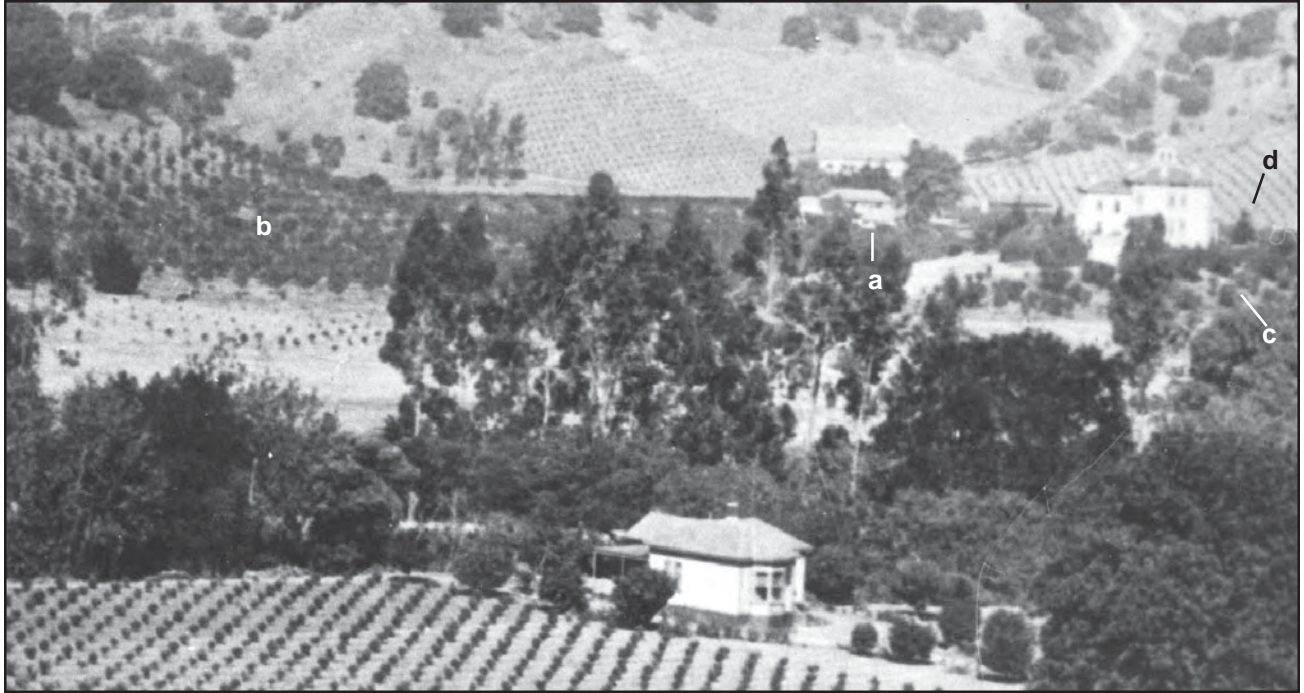
**Figure 2.4:** This view from c.1885 looks west at the distant Strentzel House, Martinez Adobe (a), fruit packing shed, and a barn. Proximate to the Redfern Place is a pear orchard (b) on the lower east slope of Mt. Wanda and an orchard, possibly apples (c), on the east slope of the knoll. A young Monterey pine (d) is visible northeast of the house. (A1-67, JOMU).

Relief from the dusty valley winds may also have influenced mass plantings on the south and southwest sides of the house. Figure 2.4 shows a mass of conifers and/or deciduous trees and shrubs planted in the vicinity of the Woodshed on the southeast side of the house. Figure 2.6 shows a line of evergreens, possibly a cypress hedge, wrapping around the south side of the knoll in an arc shape similar to that of the incense cedars.<sup>79</sup> This feature included an opening for the knoll path.

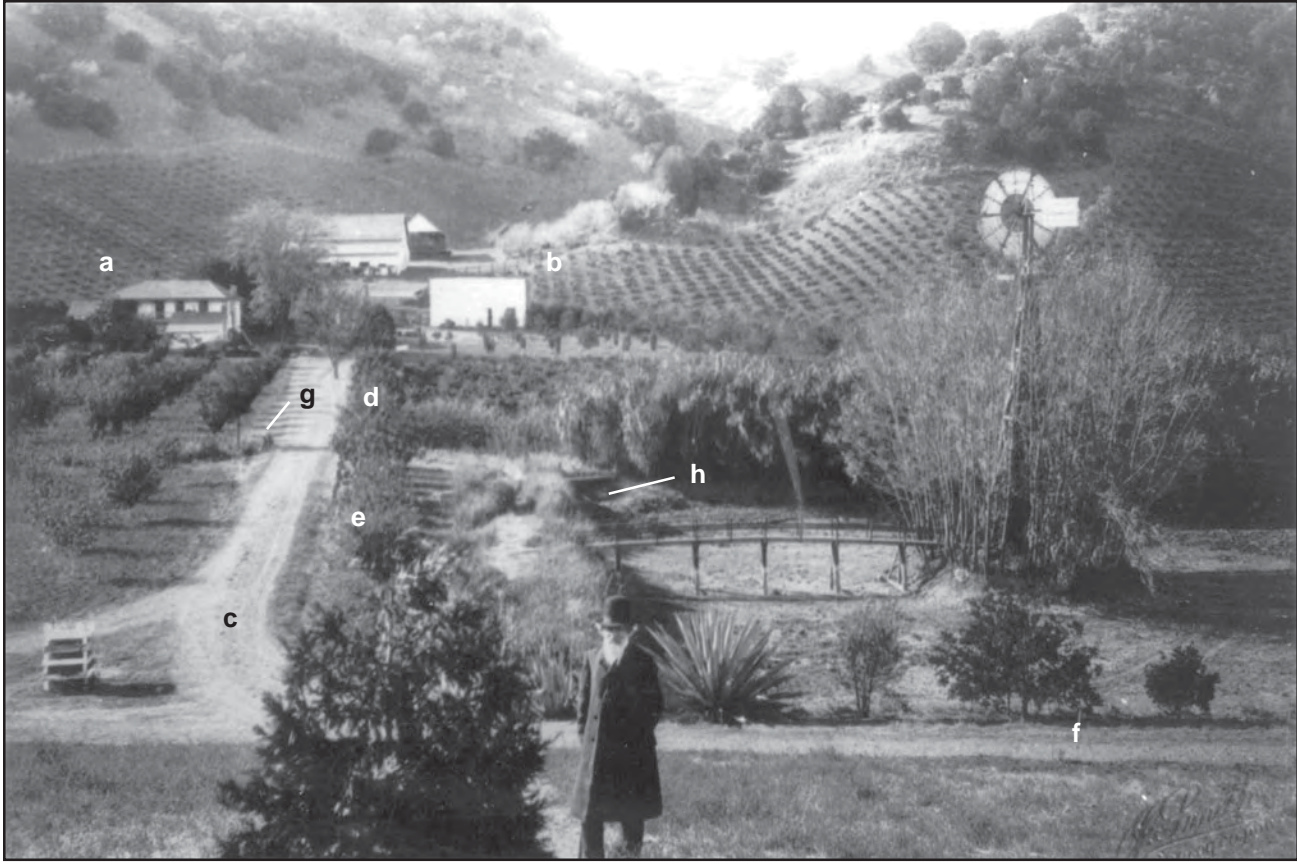
**Figure 2.5:** Pictured is Dr. Strentzel in c.1885 next to one of the incense cedars planted on the slope west of the Strentzel House. In the background is the Martinez Adobe (a) (fronted by a lean-to), a ranch managers shed to the southwest, and a packing shed (b) to the northwest. Barns, corrals, and vineyards were situated on the other side of Franklin Canyon Road. The main farm road (c) connected the adobe area to the Strentzel House via a bridge and was bordered by cherries, apricots, grapes, and figs (d) on the west side of Franklin Creek and by plums, quince (e), the fish pond, and the Franklin Creek windmill and well on the east side. The road split at the base of the knoll, with one branch - the southeast farm road - continuing to the southeast and the other - the carriage drive loop (f) - heading up to the front of the house. Several other features are worthy of mention: plantings at the adobe include cypress or pines in back, an unidentified tree or shrub grows in the front, and two black locust -one just to the north of the adobe and one in the main farm road; a young conifer grows at the southwest corner of the bridge (g); vegetation along Franklin Creek is more tall and dense on the north side of the bridge compared to the south side; plants growing up through the windmill almost touch the blades; a possible sluice structure (h) is located west of the irrigation pipe; agaves and other plants separate the carriage drive loop from the fish pond; and the crate at the road intersection may possibly protect a seedling giant sequoia. (D6-1, Ref: 1885cP17).

Figures 2.5 and 2.6 provide good views of the main farm road and the point at which it splits, at the west side of the knoll. One branch is shown heading southeast along the base of the knoll to the fields beyond. This lane may have continued southeasterly into the upper Alhambra Valley, and possibly connected to the Alhambra Valley Road (formerly the Road to Martinez) and the Alhambra ranch house where Muir lived at this time. This road, along with the main farm road, was probably the two main routes into the Redfern Place. Another branch heads northeast and traverses the north side of the knoll to end as a loop at the front entrance of the Strentzel House. For this report, these lanes are named, respectively, the "southeast farm road" (because of its utilitarian use) and the "carriage drive-loop" (because of its primarily domestic use). The center of this important intersection was defined by a triangle-shaped wedge of land. Figure 2.6 also shows a very faint trace of what may be another farm lane at the lower south slope of the knoll, on the south side of the vineyard. The lane appears to track westerly through the orchards. For this report, this lane is called the "east-west farm lane."

There are several other identifiable plantings in the creek area and at the Martinez Adobe. Analysis of Figure 2.5 reveals a conifer at the southwest corner of the Franklin Creek Bridge and a black locust in the middle of the main farm road at its junction with another farm lane. At the adobe, a plant of some type was growing in the front toward the south end and a large black locust grew on the north side (also visible in Figure 2.7).<sup>76</sup> The mass of conifers behind the adobe are either pine or possibly the cypress Mrs. Strentzel referred to in her diary entry in April 1882. Additionally, an entry in Mrs. Strentzel’s diary from February 24, 1877 refers to “planting eucalyptus trees on the Redfern place.”<sup>77</sup> The specific location of this reference is not known, but a later historic photograph suggests it may be south of the adobe along Franklin Creek, and possibly provided shade for the corrals in that area.

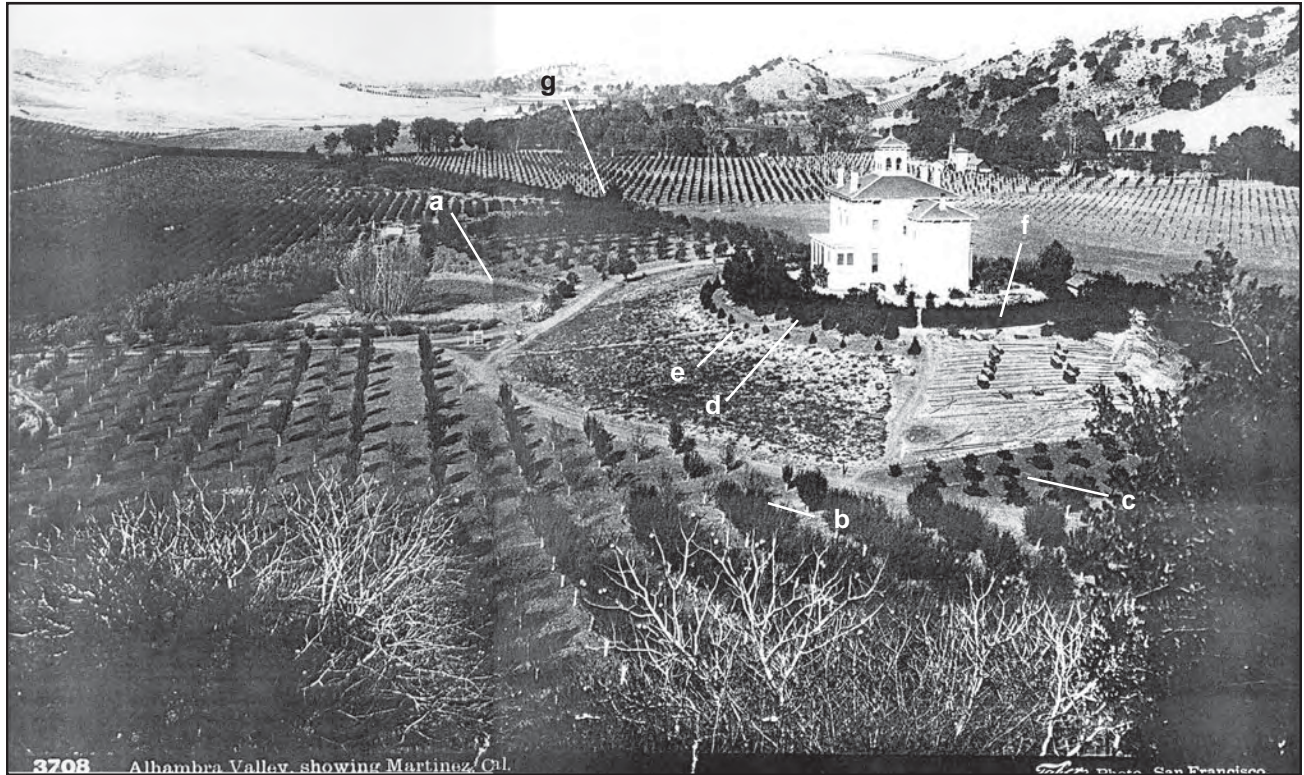
**Figure 2.6:** This photograph is from c.1887 and looks north over buckeye trees growing on the north slope of Mt. Wanda. In this view, the imposing Strentzel House overlooks acres of orchards and vineyards that fill the rich Alhambra Valley and is surrounded by a dry yard and grape vineyard to the south, pears and plums to the west and southwest, peaches to the north and northwest, and hay fields or cover crops to the east as well as the west side of the knoll. The main farm road, southeast farm road, and carriage drive loop converge next to the fish pond, some of which is defined by agave and other plantings that appear to be part of an earthen berm (a). An east-west farm lane (b,c) tracks along the south side of the knoll, crosses the southeast farm road, and passes between the pears and plums. The knoll itself is relatively barren save for Monterey pines (d), incense cedars (e), and a hedge (f) around the south side of the house. Conifers similar in shape to those along Franklin Creek, possibly cypress (g), grow along the hayfield northeast of the house. (Isaiah West Taber photo No. 3707).

Another interesting photograph of the Strentzel House and its environs was taken c.1887 from the north slope of Mt. Wanda and shows orchards and vines extending northward across the floor of the Alhambra Valley (Figure 2.6). The clarity of the photograph yields specific information about the crops around the Strentzel House: to the north and northwest are peaches; to the west and southwest are plums and pears; and to the south are Muscat, Tokay, and Zinfandel vines. At this time, the south slope of the knoll was devoted to a dry yard with trays of grapes stacked and ready to dry out, probably to produce raisins.<sup>65</sup> The lower west slope was planted with a cover crop, probably wheat or wild oats, while the field east of the knoll was planted in hay.<sup>66</sup>

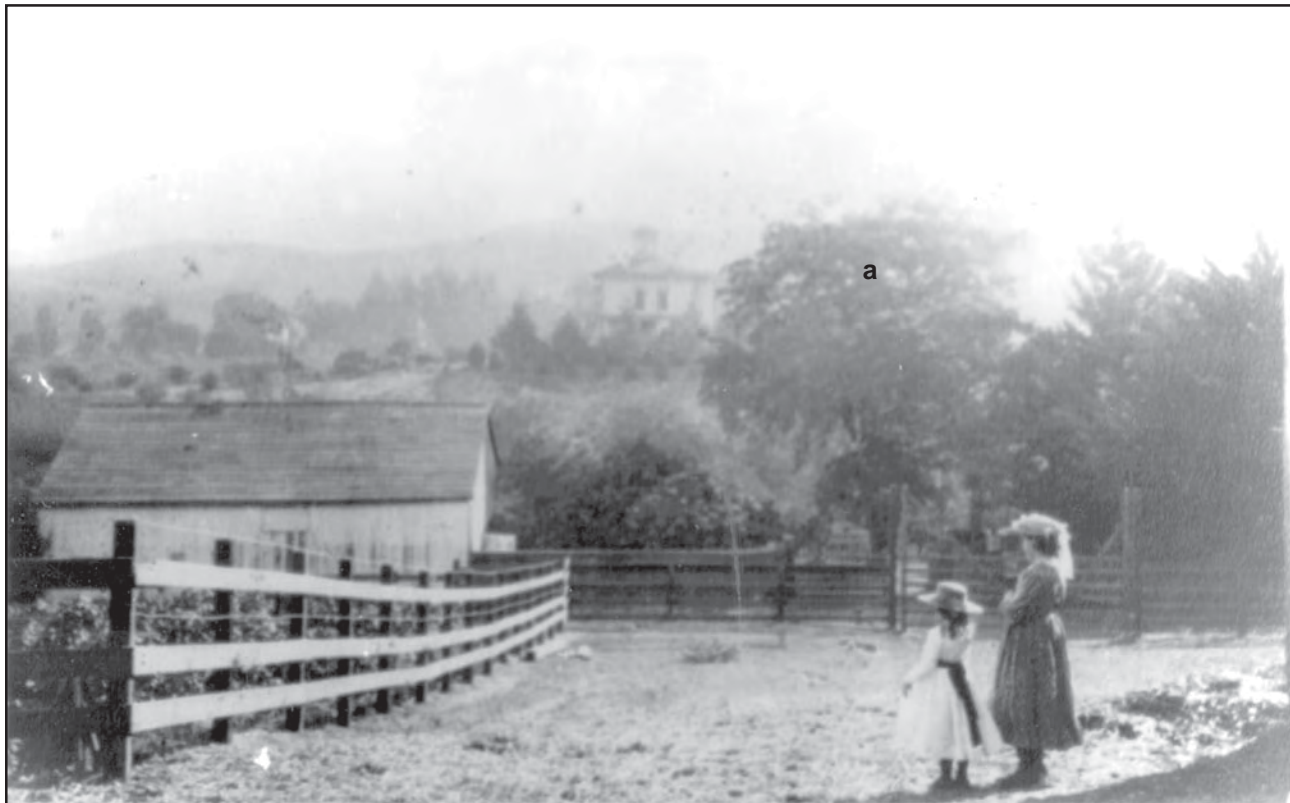
**Figure 2.7:** This photograph of Helen (on the left) and Wanda Muir was taken next to the barn in the late 1880s and looks east toward the Strentzel House. A board and barbed wire fence separates a corral from the adjacent vineyard and Franklin Canyon Road, which tracks between this fence and a building probably related to fruit packing. The corral gate lines up with a picket gate on the other side of the road, which is the main farm road leading to the Strentzel House situated atop the knoll in the distance. The large deciduous tree behind the picket gate is a black locust (a). Note the mass of Monterey pines and the row of incense cedars fronting the west side of the house. Franklin Creek windmill is visible behind the packing shed. (A1-16, Ref: 1890cP19).

Another historic photograph, taken from the corral adjacent to the barn in the late 1880s, shows the other side of the packing shed and provides several more clues about this area (Figure 2.7). The corral was enclosed by a run of three- board and two- wire fencing and accessed through a paired wood swing gate off Franklin Canyon Road. A variation of this type of fencing continued north along the road. On the other side of the road, a section of vertical board fence stretched from the shed to a section of picket fencing and gate, opposite the corral gate. The picket fence and gate appear to line up with the main farm road and would suggest that this area was a key circulation point between the barns and corrals, the Martinez Adobe, and the Strentzel House (barely visible up on

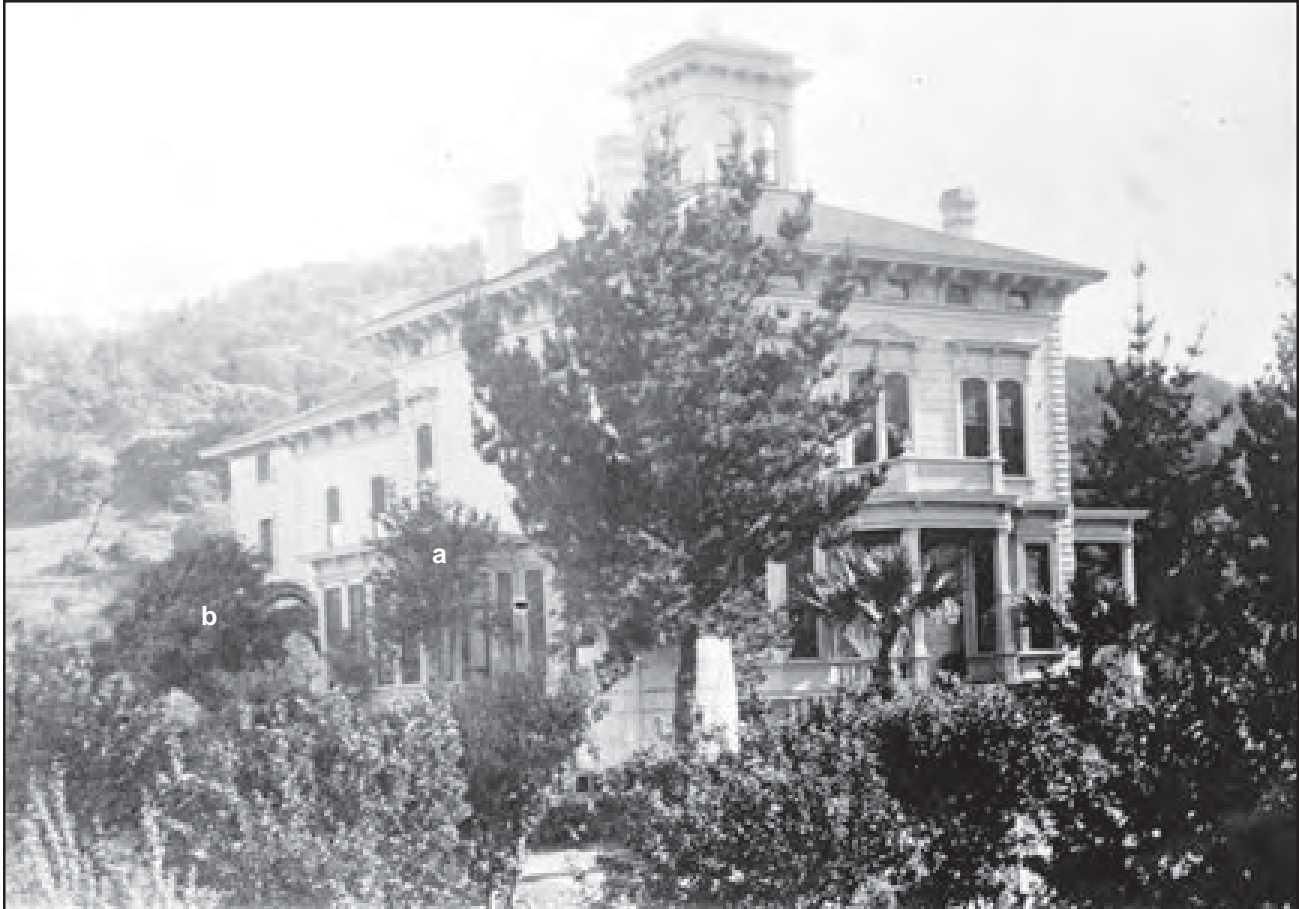
**Figure 2.9:** This photograph of the Strentzel House, looking southwest toward the wooded north slope of Mt. Wanda, dates from c.1890. Directly northeast of the house is the Monterey pine and wood cistern. A lemon tree (a) grows near the east porch door, and to the south is the loquat (b), behind which the arched leaves of a Canary Island date palm can be seen. The arched leaves of a small windmill palm are barely visible in front of the loquat. Two California fan palms flank the front steps and to the west are some of the tall Monterey pines. A dense planting of shrubs in the foreground defines the east side of the carriage drive loop. They appear to include roses and hollyhocks. (A1-34, Ref 1890cP18a).

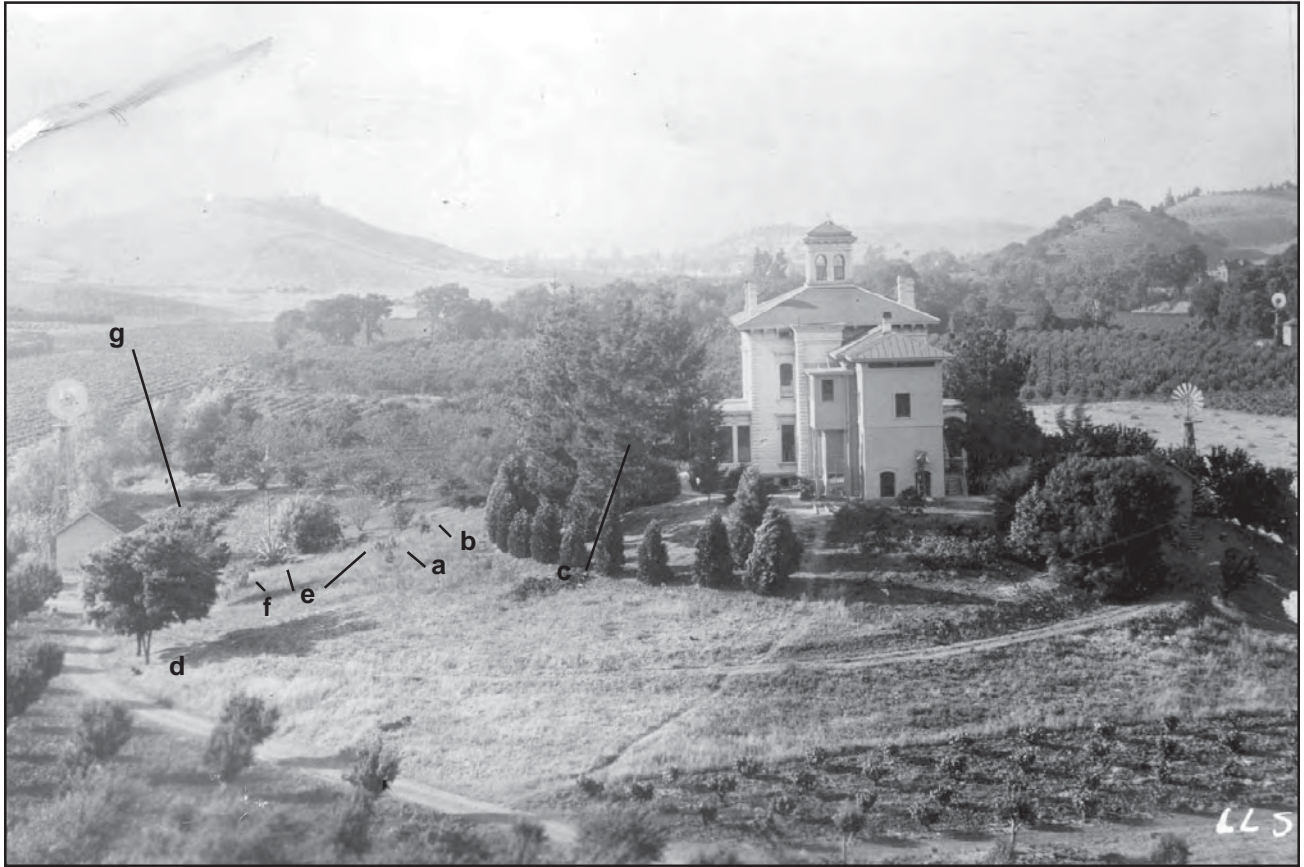
**Figure 3.4:** This photograph was taken in c.1898 and looks north toward the Muir House and the orchards, vineyards, and hayfields surrounding the knoll; in this view grapes occupy the lower south slope, plums and pears the field to the southwest, and peaches cover the northwest side. This photograph also shows both the Franklin Creek and Alhambra windmills and provides the first view of the Carriage House and the Woodshed Road on the south slope of the knoll. Additionally, numerous young plantings can be identified around the house: a small Lebanon cedar (a) and an Atlas cedar (b) are visible downslope from the row of incense cedars; a Monterey cypress (c) grows at the south end of what is left of the large planting of pines on the west side of the house; two black locust (d) grow along the Woodshed Road; and agaves (e) and an arborvitae (f) have been planted along the lower portion of the carriage drive loop. There is also a small planting of grapes or vegetables (g) on the north side of the fish pond. (A1-20, JOMU, Ref: 1898c P24).

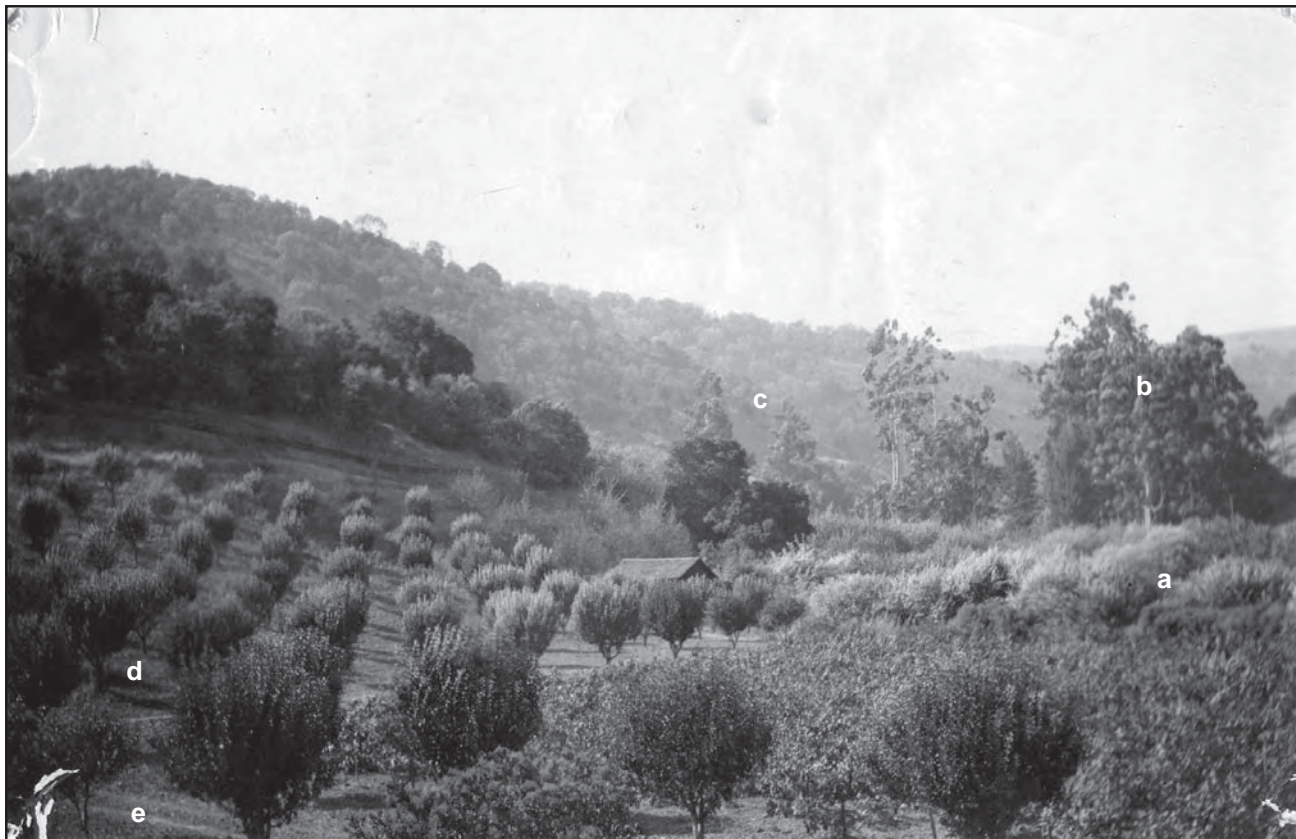
**Figure 3.5:** This photograph dates from the late 1890s and was taken from the west side of the knoll looking southwest at the pear orchard, China House, and the wooded north slope of Mt. Wanda. The plum trees in the foreground are all that remains of a larger orchard displaced by the grape vineyard shown behind them. Although the waters of Franklin Creek cannot be seen in this photograph, certain plantings hint to its course through this part of the Redfern Place: the light-colored foliage of buckeye trees (a) line the creek as it passes west of the grapes, while further upstream are tall eucalyptus trees along the creek (b) and at the base of Mt. Wanda (c). At lower left are the tracks of the east-west farm lane (d) running roughly between the grapes and pears. This lane probably accessed the China House and crossed the creek to the stables and corrals south of the Martinez Adobe. Another lane (e) runs north-south and is probably a cutoff spur to the southeast farm road and the fish pond area. (JOMU, no file #).

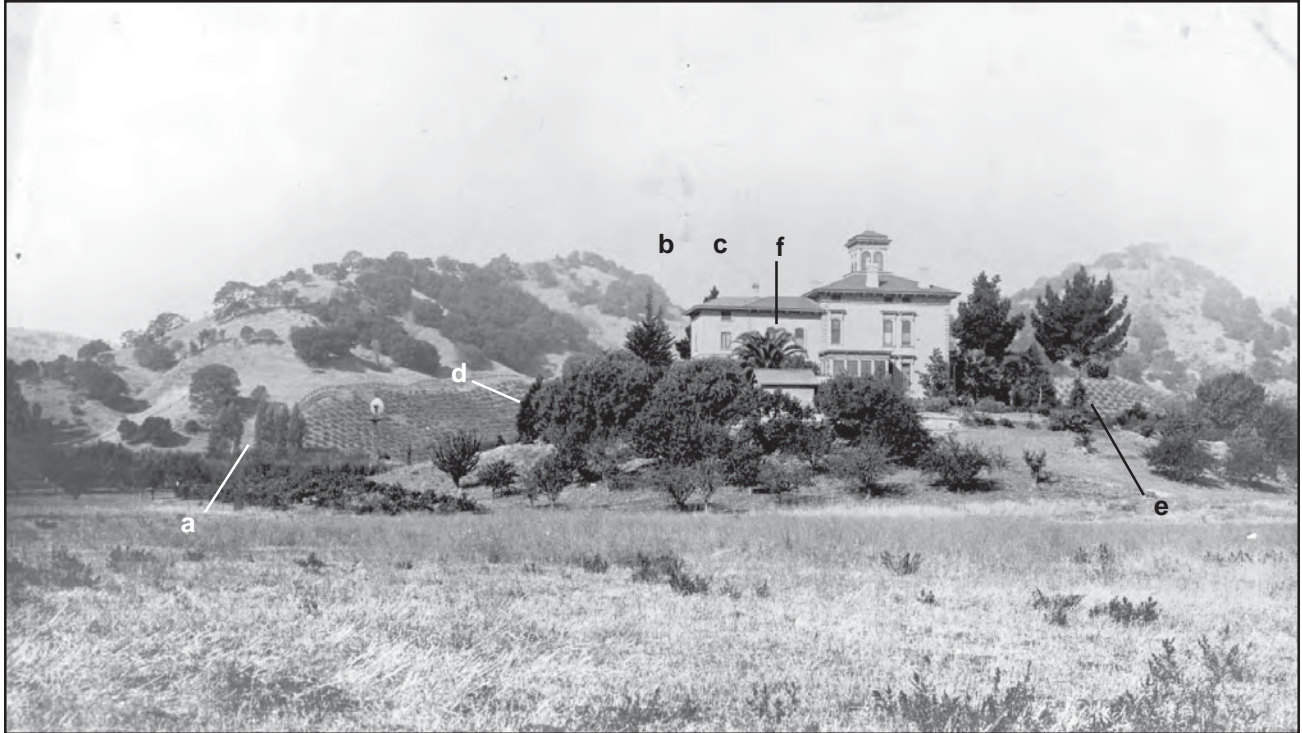
**Figure 3.6: View looking west c.1900-1905 at the hay field east of the Redfern Place and some of the apples and grapes holding the east and south slopes of the knoll. In the distance, the upstream windmill along Franklin Creek can be seen, as can the mass of cypress and pine (a) behind the Martinez Adobe. Notable plantings around the Muir House include: Monterey cypress (b) and Monterey pine (c) on the west side, which now rise above the roofline; the southernmost specimen in the row of incense cedars (d); and banksia rose (e) growing up the trunk of the Monterey pine northeast of the house. The Canary Island palm (f) on the east side of the house now reaches up to the second floor windows. (F13, Fr. #651, Holt-Atherton).**

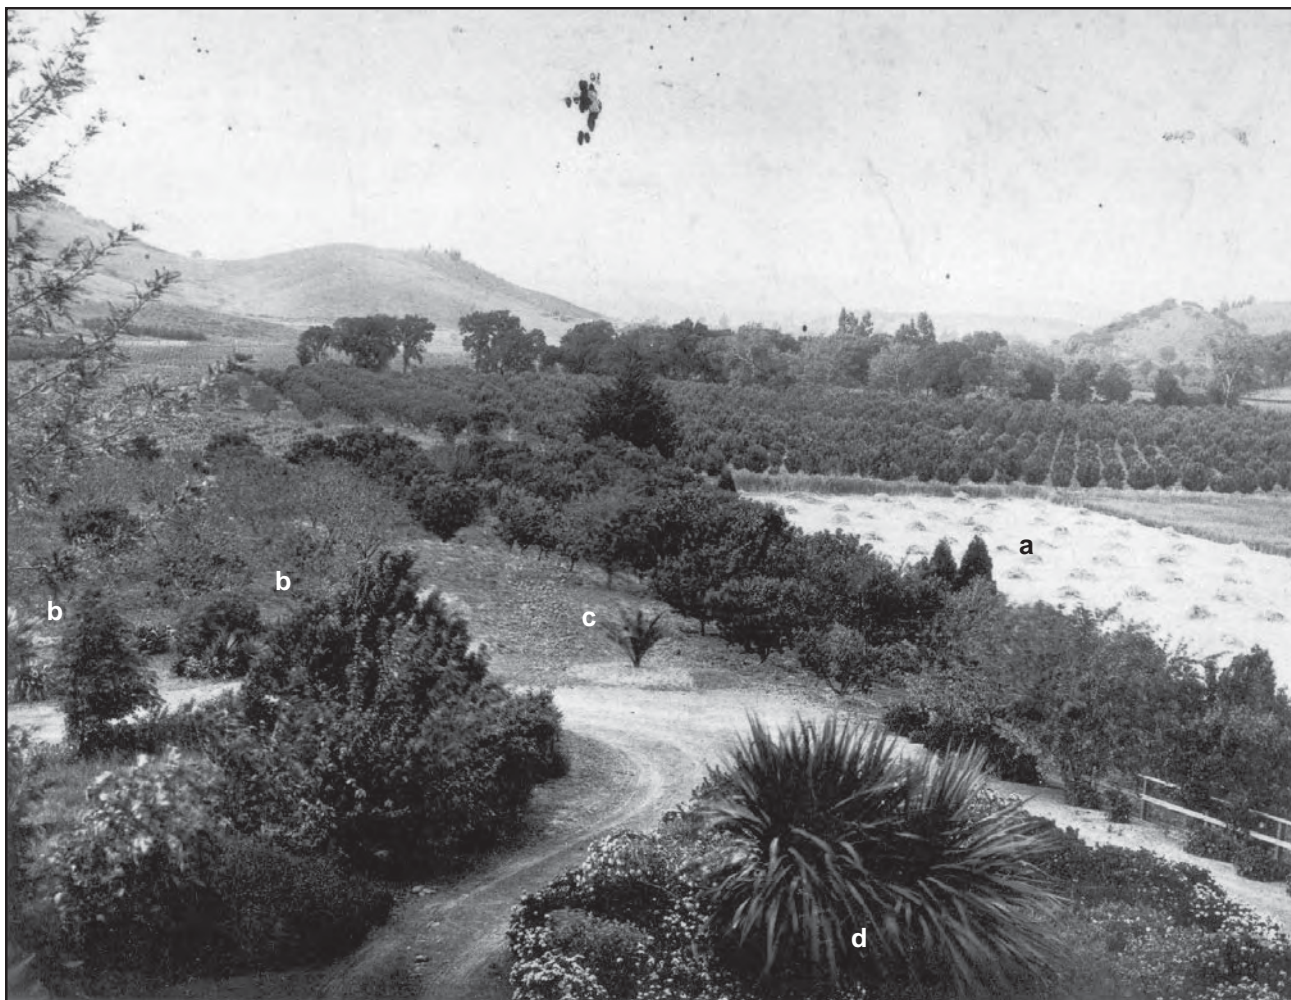
**Figure 3.7: Circa 1900-1905 view looking north-northeast from around the front porch roof of the Muir House toward adjacent fields, orchards, and vineyards. A small clearing just north of the carriage drive loop separates the peach trees from other fruit trees (possibly apples) that extend down the east slope of the knoll to the hay field. Along the hayfield, the cypress and the pyramidal tops of the third and fourth incense cedars (a) north of the Alhambra well are visible. At the carriage drive loop, two California fan palms (b) and a Canary Island date palm (c) are planted along the north side. A dense mass of roses and possibly ice plant appear to fill the island formed by the carriage drive, but the view is partially blocked by the top of a cordyline tree (d) situated in front of the house. (D3-2, JOMU, Ref: 1900-05cP30).**

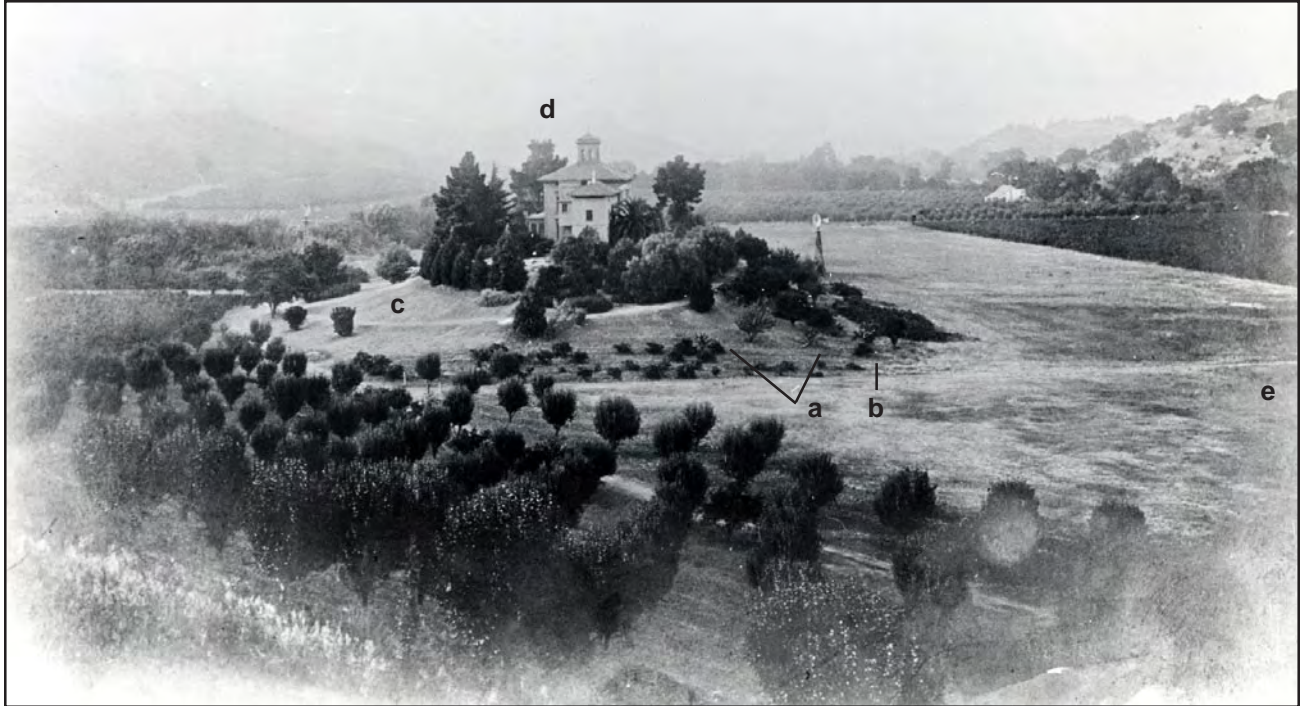
**Figure 3.8:** This c.1905 photograph, looking north from the pear orchard on Mt. Wanda, shows apples and grapes east and south of the Muir House, plums and grapes to the southwest, and more orchards and hay fields extending off to the north and east. Three new plants appear in this photograph: two Canary Island date palms (a) and a Mexican fan palm (b) have been planted between the grapes and the apples. Closer to the house, the two true cedars and two black locust (c) on the west slope are taller, as is the large Monterey pine (d) northwest of the house. Sometime after this photograph was taken, this pine was removed. Also visible is the trace of the eastern portion of the east-west farm lane (e) passing along the south side of the knoll. (A1-14, JOMU, or F13 Fr. # 641, Holt-Atherton).

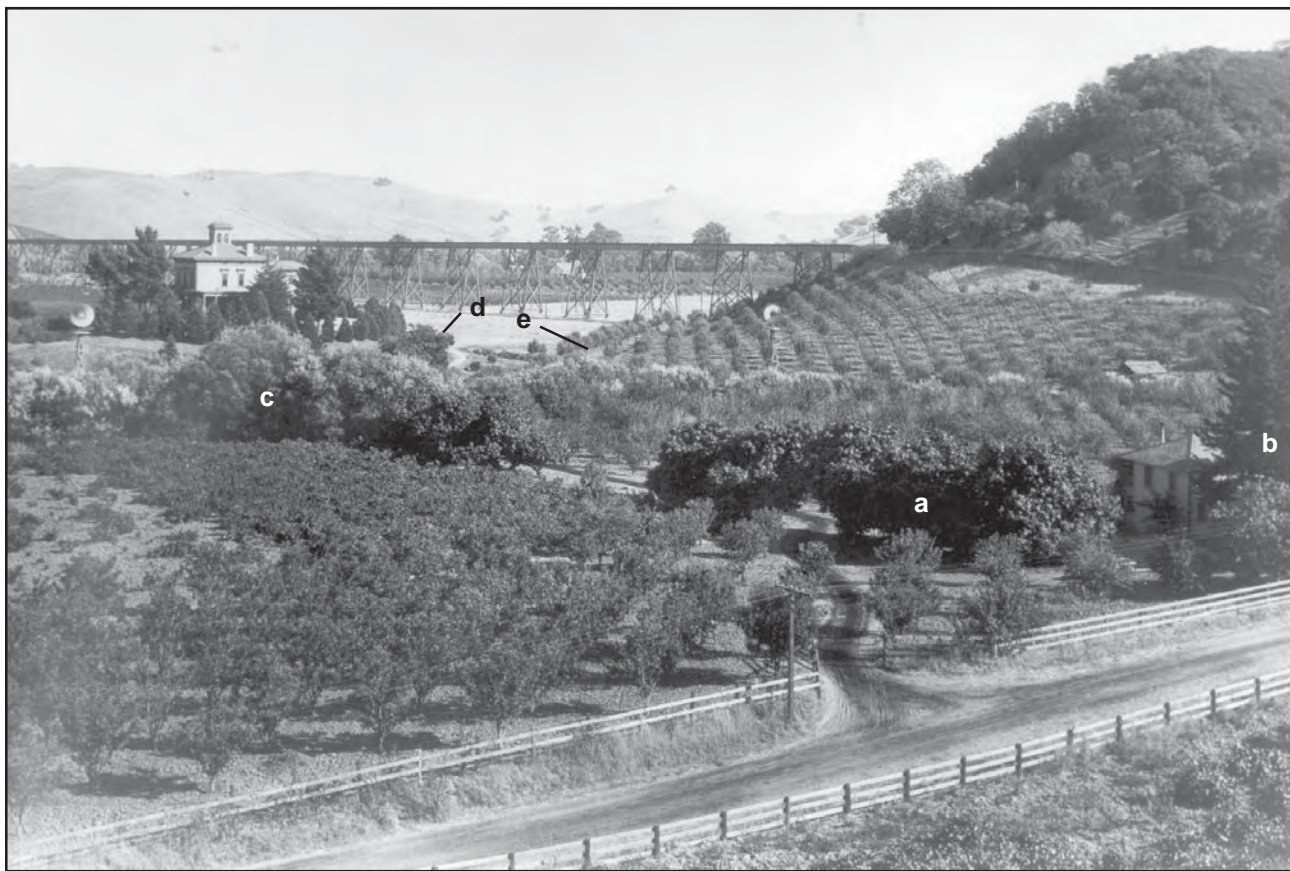
**Figure 3.9: View looking southeast in c.1905 at the Muir House, railroad trestle, and the Martinez Adobe. The grapes and apricots in the foreground are bounded by the main farm road, which is partially lined by figs and a grouping of large fruit trees that appear to be oranges (a). South of the road is an orchard of apricot or cherry, while lands on the other side Franklin Creek are comprised of pears set out around the China House and up Mt. Wanda. Non-agricultural plantings can also be identified, such as the mass of cypress or pine (b) behind the adobe, tall vegetation (c) bordering Franklin Creek, and the two black locust (d) next to the Woodshed Road, to the south of which is the grape orchard. In the foreground is Franklin Canyon Road and a gated entrance posted as a "Private Road." This may have served as the main entrance to the Redfern Place at this time. Note that the tall black locust tree and the packing shed north of the adobe have been removed. In the distance is the southeast farm road (e) heading toward the trestle. (F13, Fr. #645. Holt-Atherton).**

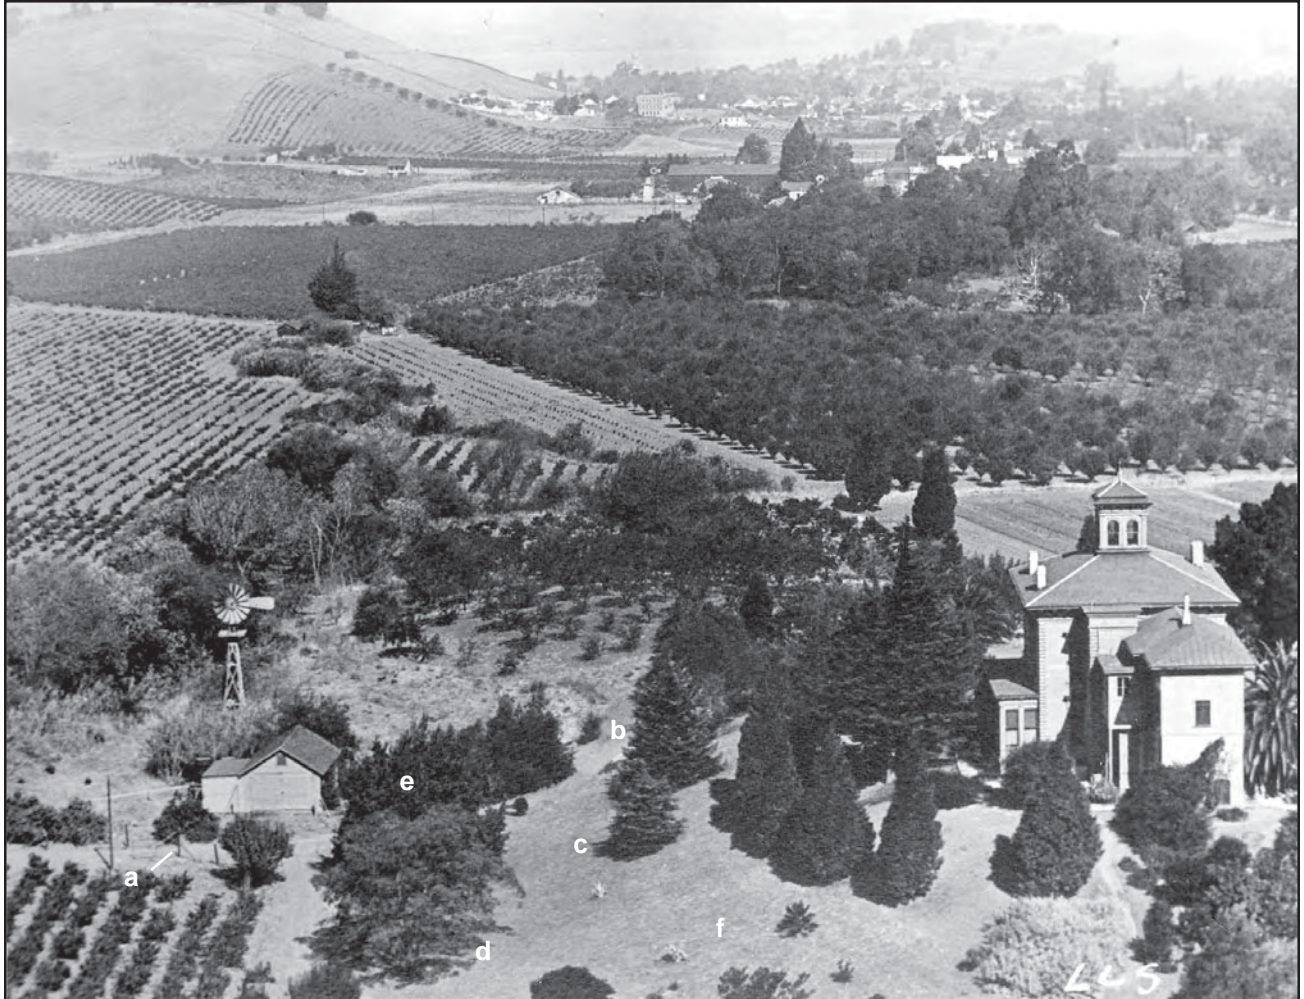
**Figure 3.15:** This view taken c.1910 from Mt. Wanda looks north at the Muir House and towards the town of Martinez and the Straits of Carquinez. Several items are worthy of note around the fish pond: the grapes or vegetables planted in the north part of the pond are gone; three quinces separate the fish pond from the main farm road; vegetation around the windmill is shorter than vegetation along Franklin Creek and a conifer behind the Carriage House; a new addition and possibly a cistern has been built on the west side of the Carriage House, from which a pipe runs to the southwest; and a fence and gate (a) crosses the main farm road. The northeast corner of the Muir Homestead was located at the incense cedar visible behind the cupola. Regarding plantings, some of the incense cedars west of the house have been removed, probably to ease overcrowding. The Atlas cedar (b) and Lebanon cedar (c) continue to thrive, as do the two black locust trees (d) along the Woodshed Road and a mass of plantings (e) at the lower end of the carriage drive loop. The small plants amongst the cover crop or grass on the west slope may be poppies (f). (A1-19, JOMU, Ref: 1910-14cP27).

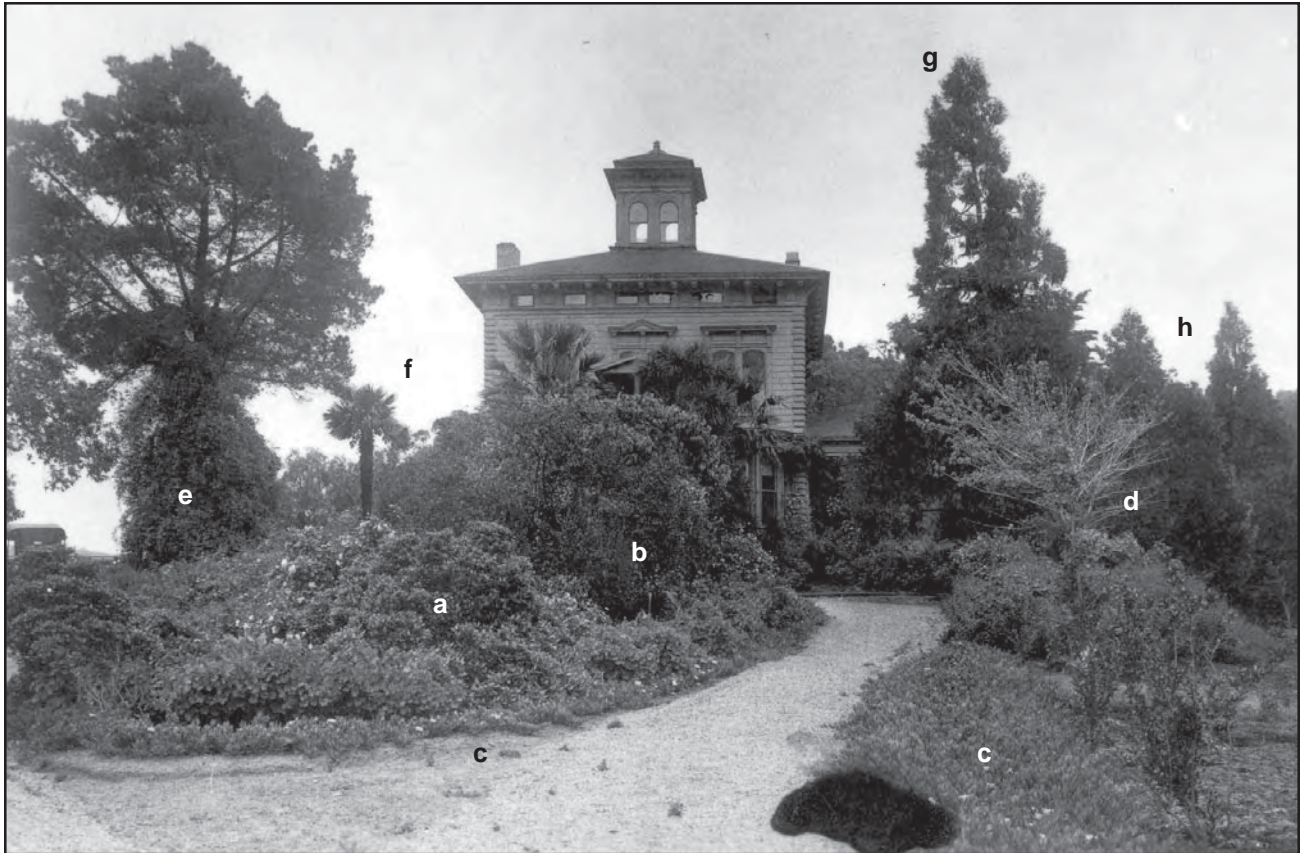
**Figure 3.17:** This view from c.1914 looking south shows the front of the Muir House surrounded by a thick and lush palette of shrubs. From this vantage, the center island features many roses (a) and a California bay shrub (b) at the upper end. Ice plant (c) creeps along both sides of the carriage drive loop, which appears to be macadamized. West of the driveway is a fruit tree, possibly an elderberry (d). The Monterey pine northeast of the house is now completely enveloped in banksia rose (e), and behind this specimen is the windmill palm (f). The tall tree west of the house is a Monterey pine (g), next to which the tops of some of the incense cedars (h) can be seen. The California fan palm and cordyline tree on the west side of the front door almost obscure the view from Muir's "scribble den." Note the roof of a buggy at far left. (A1-32, JOMU).

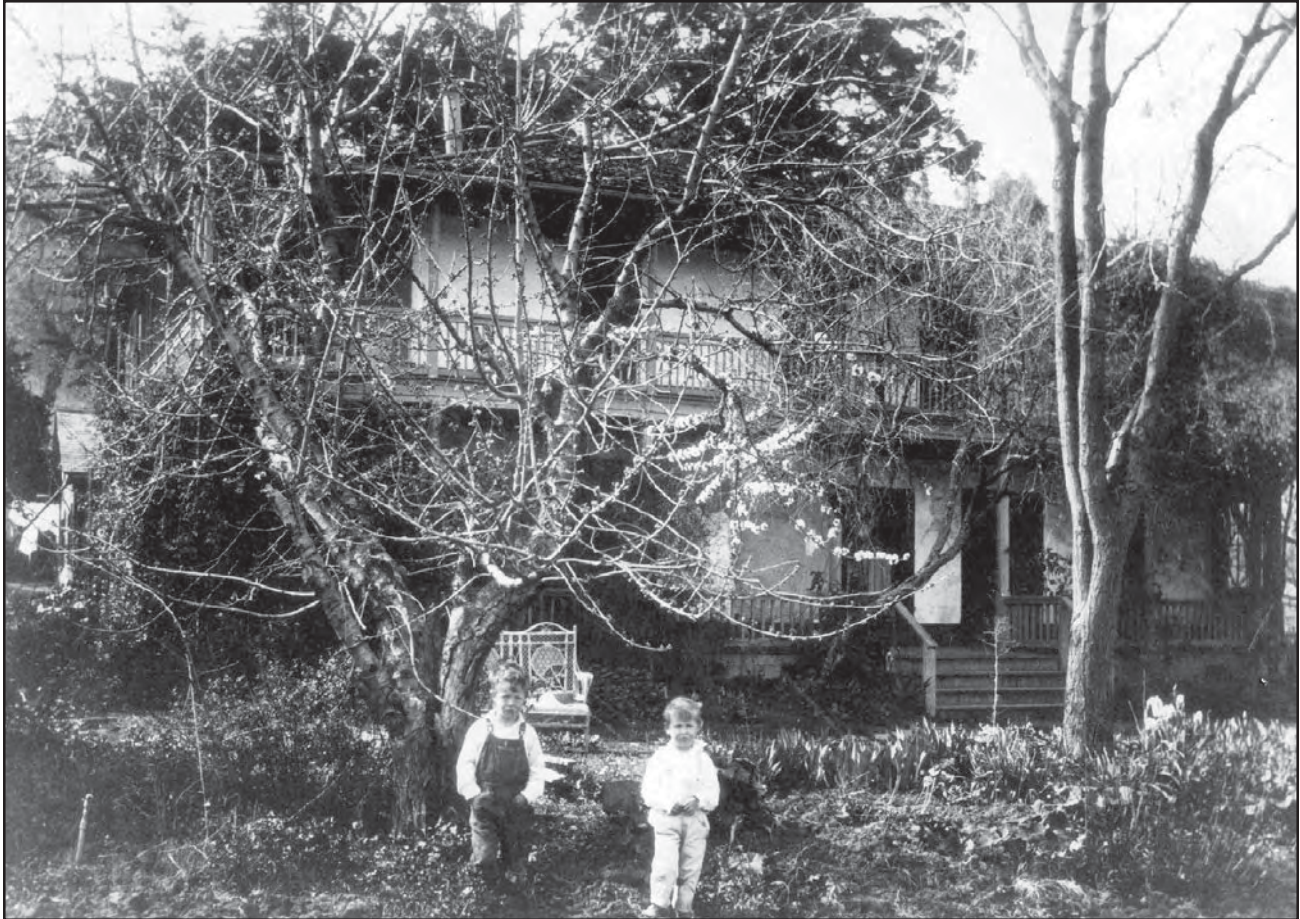
**Figure 3.18: View from c.1912-13 looking west at the front of the Martinez Adobe. Directly behind Strentzel and John Hanna, two of Wanda and Tom's children, is a fruit tree, and to the right is the trunk of a black locust surrounded by shrubs and flowers. Shrubs are planted on either side of the steps but it is difficult to determine species, and wisteria vines climb up to the second floor veranda, especially at the north end. The tops of the pine and cypress trees behind the adobe are barely visible. (B1-39, JOMU).**
