OLMSTED  
CENTER  
*for* LANDSCAPE PRESERVATION

# CULTURAL LANDSCAPE REPORT FOR JOHN MUIR NATIONAL HISTORIC SITE

VOLUME 1: SITE HISTORY, EXISTING CONDITIONS, AND ANALYSIS

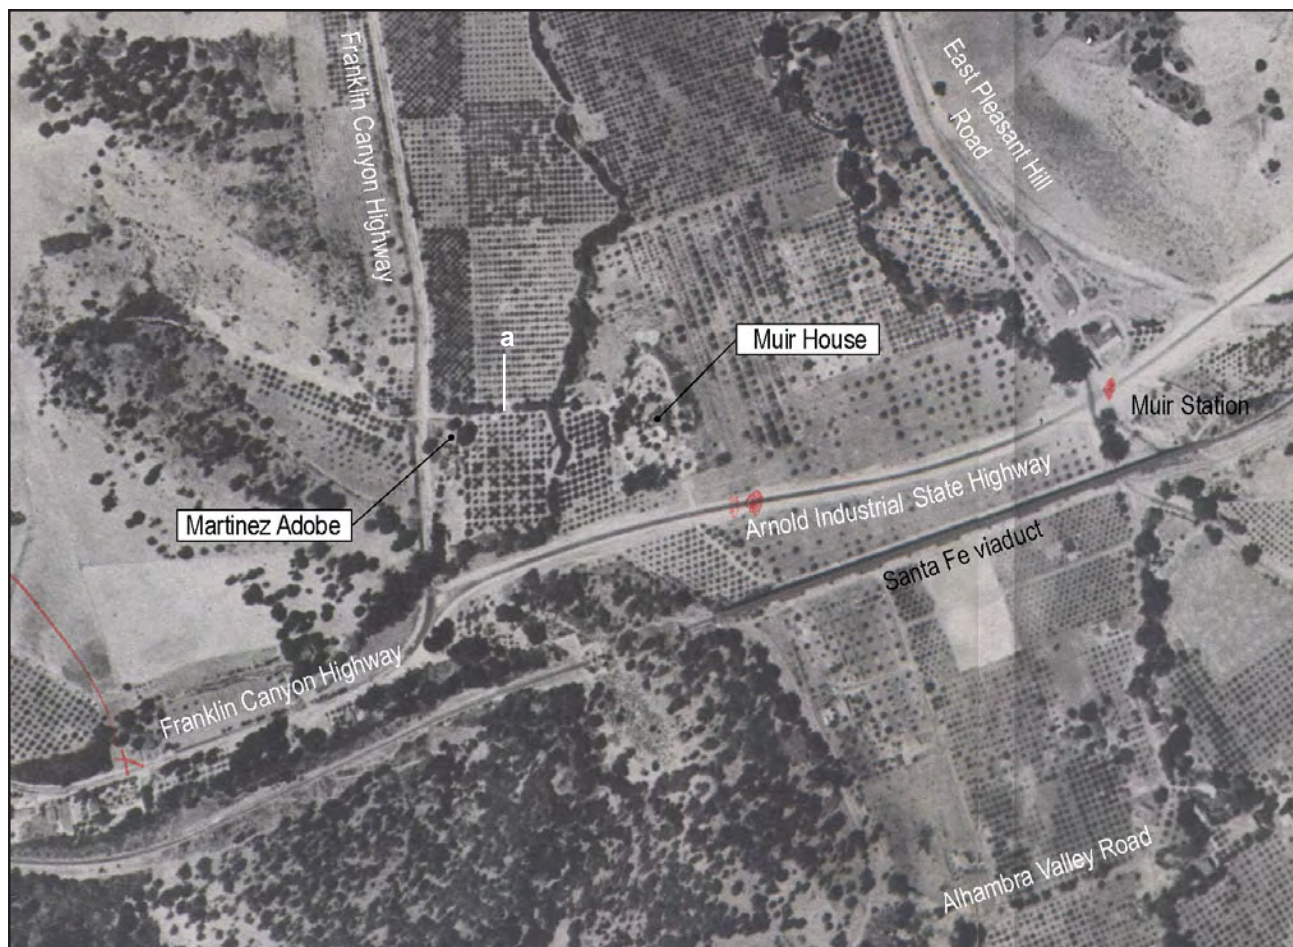
**Figure 4.2:** This aerial photograph from 1939 shows the Arnold Industrial State Highway passing between the Muir House and the AT&SF trestle and bisecting a landscape still dominated by orchards, vineyards, and pastures. The highway passed directly over the China House along Franklin Creek. Access into the Muir Homestead at this time was from the main farm road (a) crossing Franklin Creek. It appears as though most of the outbuildings associated with the Strentzel-Muir Ranch have been removed. (JOMU, no #).

Figure 4.2 reveals several observations worth noting in the area between the Martinez Adobe and Muir House. On the south side of the main farm road, the

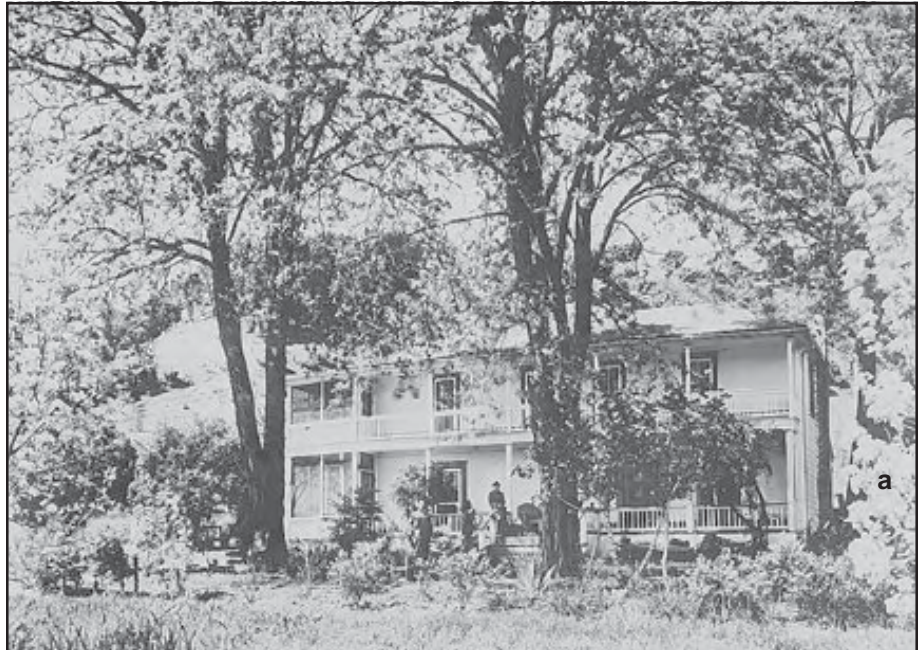
**Figure 4.3:** Two black locust trees tower over shrubs and understory trees in front of the Martinez Adobe in this view from c.1945. A large shade tree is visible on the north side of the adobe, behind a conifer (a). (HABS, CAL-1913, Jack Boucher).

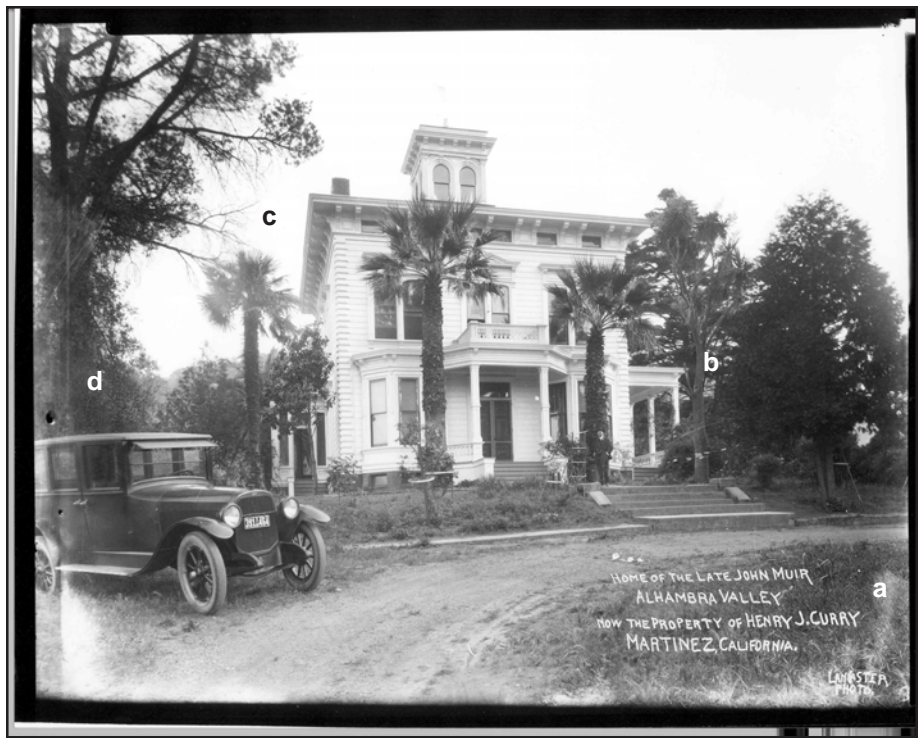
**Figure 4.4:** This photograph dates from c.1923 (the license plate on the Buick reads 1923). The northern portion of the center island (a) of the carriage drive-loop appears to be free of plants at this time. The front lawn is also relatively open, and is dominated by the cordyline tree (b) and the two California fan palms - the western specimen is shorter than its counterpart and now blocks the view from Muir's old scribble den. The east side of the Muir House features the tall windmill palm (c), while the Monterey pine (d) to the northeast is still cloaked in Banksia rose but appears to be in decline. (Property of Henry J. Curry, Martinez, California. Courtesy US Department of Interior, National Park Service, Pacific West Regional Office, Oakland).

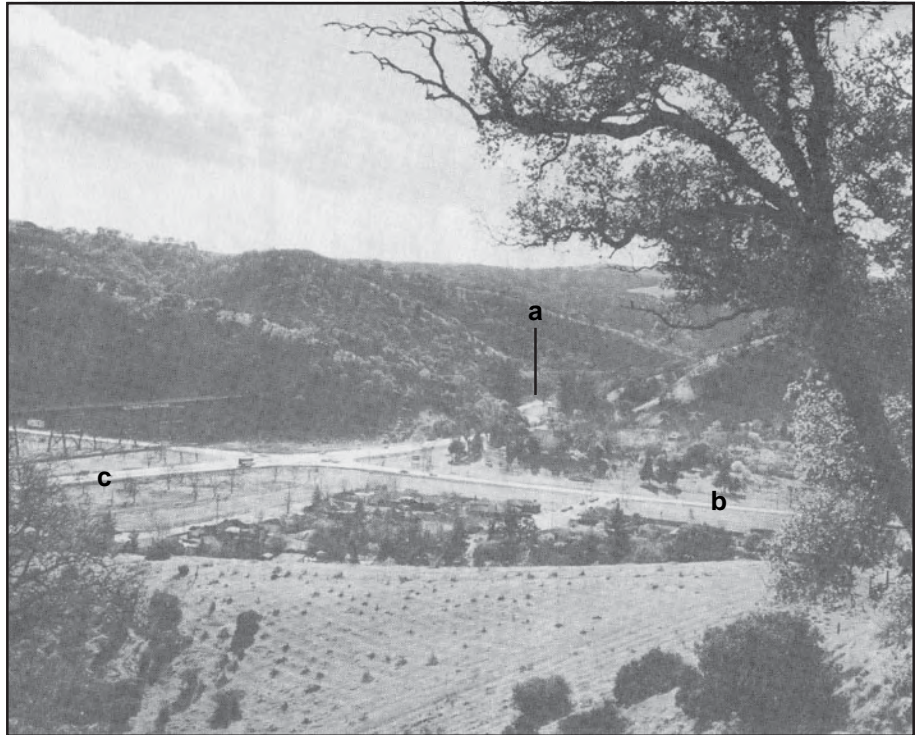
**Figure 4.10: View south from around the south side of the Muir House towards old State Route 4 and the railroad trestle, in 1963. The new divided freeway would be built on twenty feet of fill on alignment with the old highway. According to the "Feasibility Study," the trees in the foreground were to remain. (From Hussey, John and Ronald N. Mortimore, Charles S. Pope, Lewis Koue, and John Wosky. "Feasibility Report, John Muir Home and Vicente Martinez Adobe, Martinez, California." San Francisco, CA: National Park Service, Western Regional Office, March 1963).**

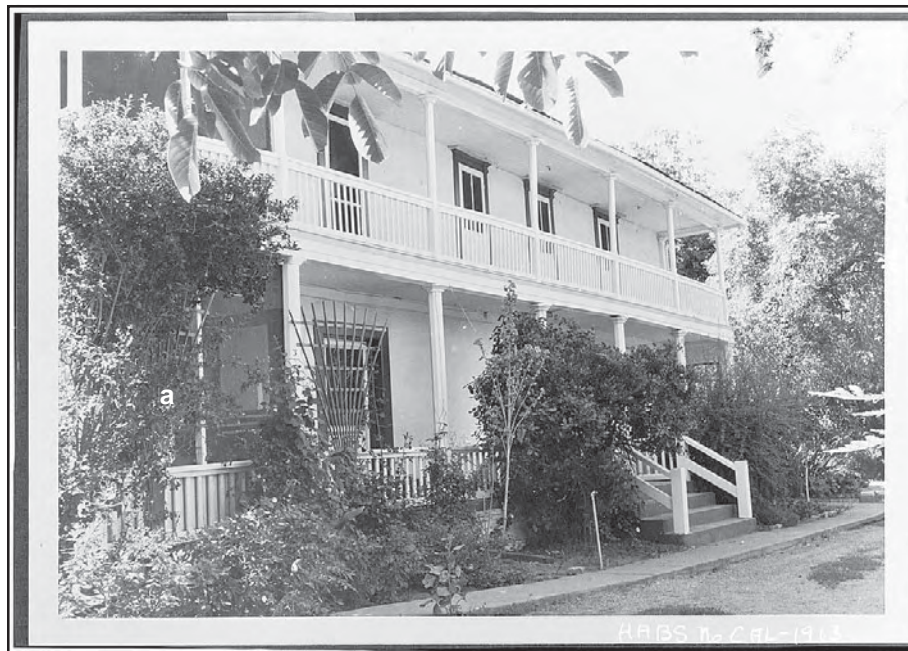
**Figure 4.12:** This view from 1963 shows the narrow concrete sidewalk fronting the Martinez Adobe originally installed by Parsowith, part of which is lined with a single row of bricks. The driveway parallel to the sidewalk connects the main farm road to a wood-frame garage/shed to the southeast. On the right is a walnut tree (a). (R. N. Mortimore, JOMU files).

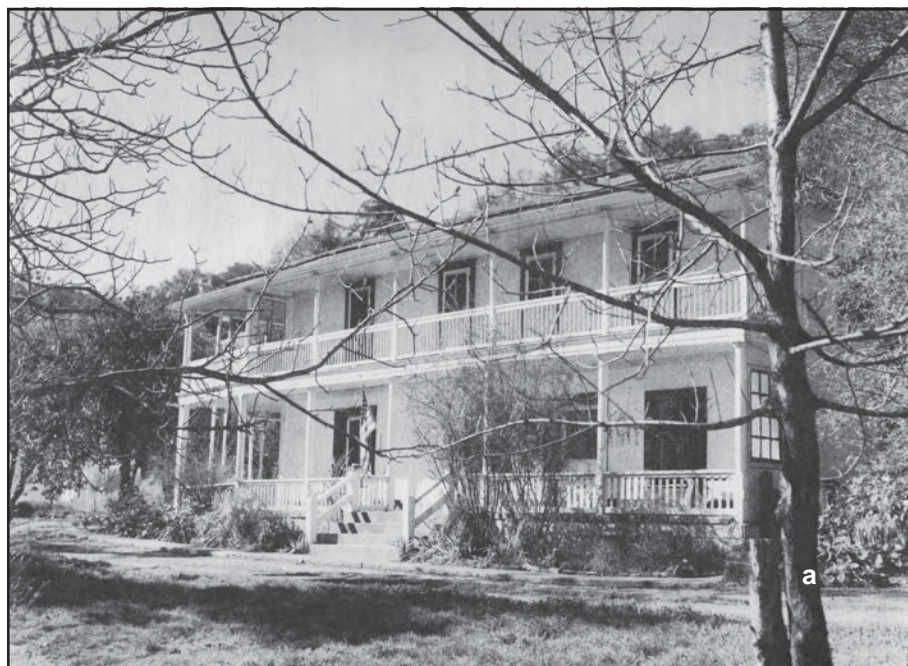
**Figure 4.13: View looking west from near Franklin Creek at the Martinez Adobe and the orchard space in 1963. Except for a tall tree on the south end, there appears to be much less tall vegetation behind the adobe. In front, part of the redwood septic tank (a) can be seen northeast of the building and next to a fruit tree (b). By this time, most of the former orchard has given way to a meadow of grass. At far right is the main farm road (c), which appears to be a two track road at this time. (R. N. Mortimore, JOMU files).**

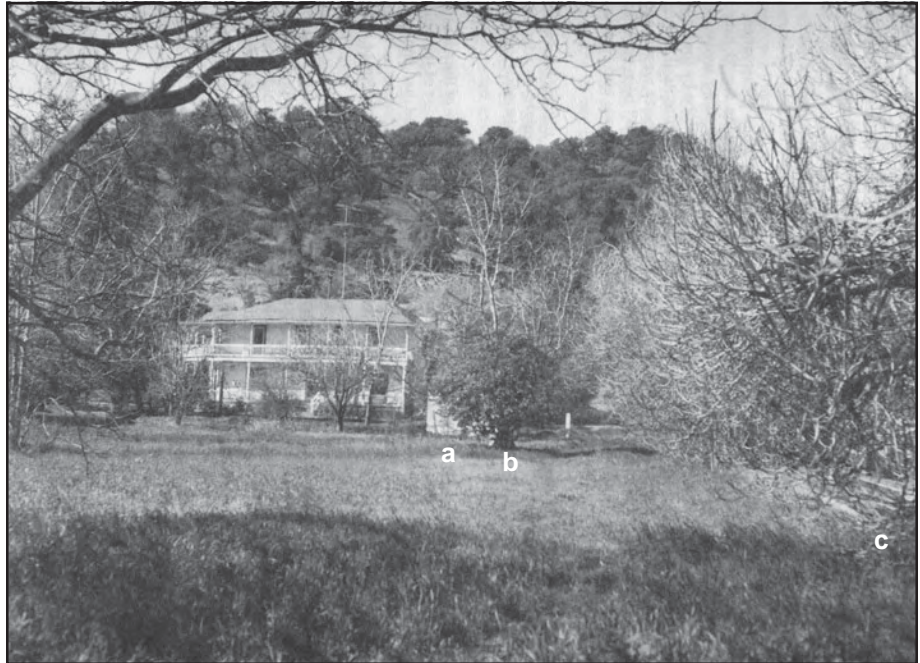
**Figure 4.14: This photograph was taken c.1955-c.1960, some forty years after Muir's death and soon after the Saxes' purchased the 4.83-acre Muir Homestead. Much like the Muir House, the landscape shows the passage of time and has taken on a somewhat ragged and overgrown appearance. Plants dating from Muir's time, such as the California fan palms at the front door, the Canary Island date palm (a) in the back, and the California bay (b) continue to thrive. Post-Muir plants also appear to be growing well, such as the two arborvitaes (c) next to the front porch, two firethorns flanking the front steps, and roses (d) next to the carriage drive loop. (Holt-Atherton, F13, Fr. 652).**

**Figure 5.8:** This view of the Muir House was photographed in 1966. Note the appearance of the landscape compared to ten years earlier, c.1955, in Figure 4.14. Historic plants visible in this photo include the top of the Canary Island date palm (a), California fan palms at the front, and the California bay tree (b) in the center island. Also note the bench at far right, next to the house. (Photograph by Fred E. Mang, Jr. July 29, 1966. Courtesy US Department of Interior, National Park Service, Pacific West Regional Office, Oakland).

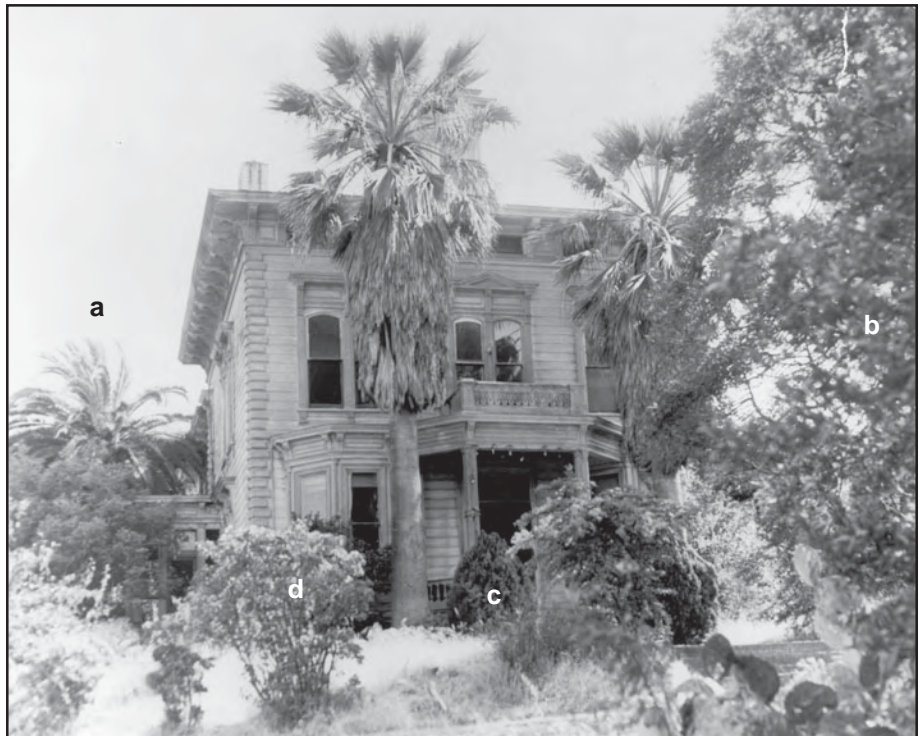
**Figure 4.15: View looking south at the northwest porch of the Muir House, in 1960. A Banksia rose (a) grows along the side of the porch, next to the sidewalk. On the left side of the steps are a small scotch broom (b) and a camellia (c), while in the background are some of the incense cedars (d). The space west of the walkways appears to be grass. (HABS, CAL-1890, 7-MART, 1-6, by Jack Boucher).**

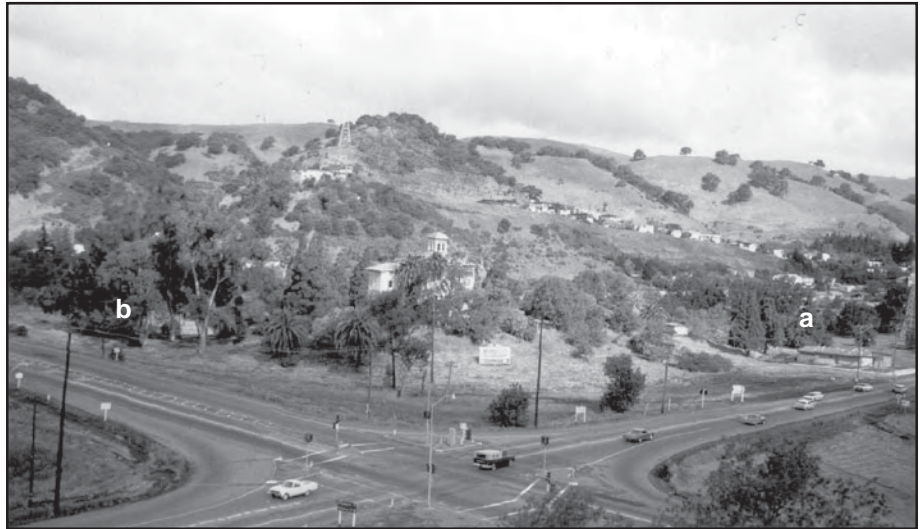
**Figure 5.1:** This view, taken c.1965 prior to reconstruction of State Highway 4, looks northwest from the railroad trestle showing new houses on the hillsides to the west. At lower right is the Martinez Animal Hospital (a) on land proposed in the park boundaries. On the left is the grove of historic eucalyptus (b). (Louis Stein Collection, D6-19, JOMU).

As described in the previous chapter, adjacent suburban and commercial developments and proposed highway plans influenced the location of the park’s boundaries (Figure 5.1). By 1966, the upgrade of State Route 4 on the south side of the new park was well underway, and Florence Street and a new residential lots were platted north and west of the park a year later (Figures 5.2 and 5.3).<sup>1</sup> Fortunately, the park had an ally in preserving the historic scene at the park; in 1966, the City of Martinez established the John Muir National Historic Site District – a multiple block area surrounding the site – which required a review of development plans by the town planning commission.<sup>2</sup>

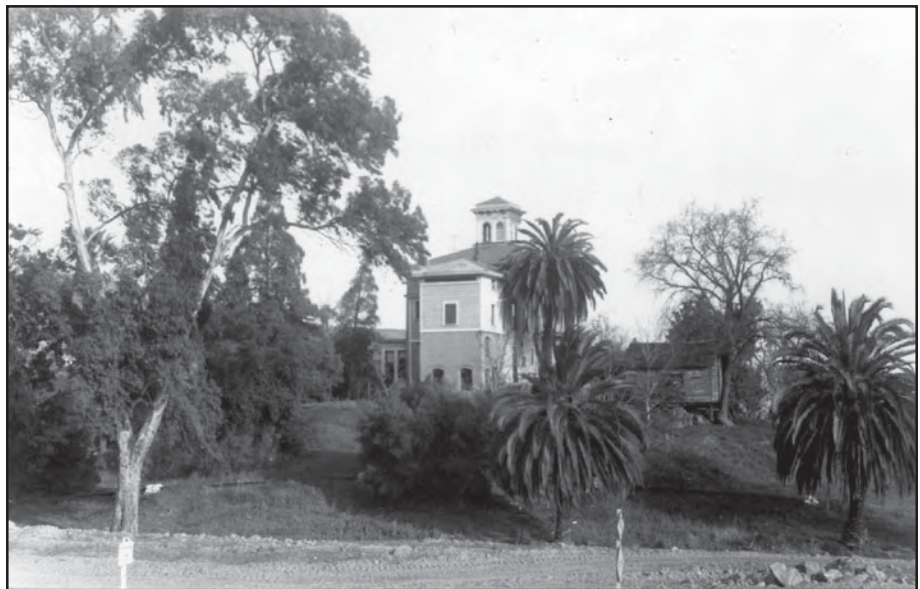
**Figure 5.2:** View looking north of the Muir House and Carriage House in 1966. Grading for the new on-ramp from Alhambra Avenue to the new highway, in the foreground, almost touches the eucalyptus and two Canary Island date palms. Note the old retaining wall at the Carriage House. (Photograph by Paul E Schulz. A1-4, JOMU).

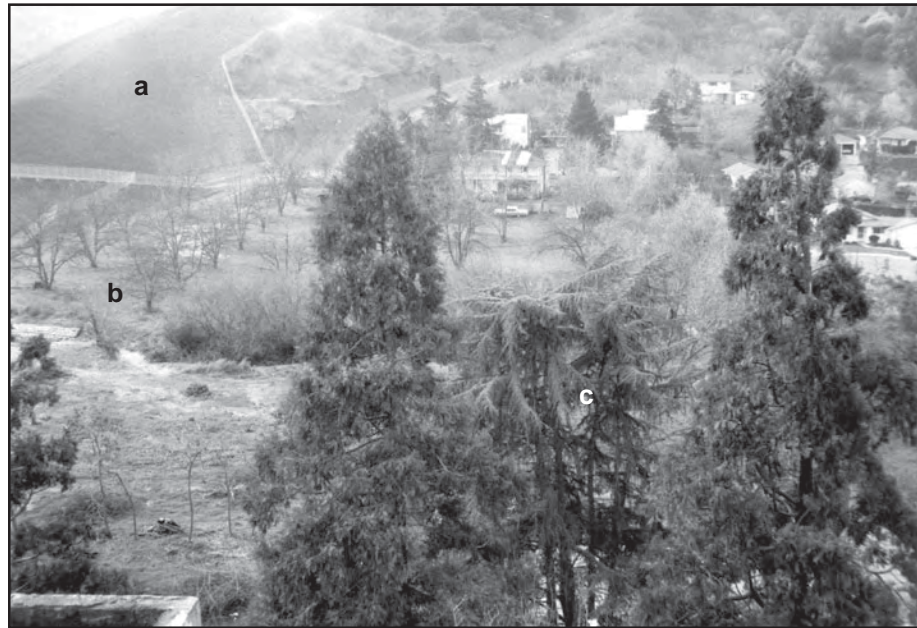
**Figure 5.3:** This photograph was taken from the cupola of the Muir House in 1967 and shows massive amounts of fill (a) for the new highway. The vineyard between the house and Franklin Creek has been cleared by this time, but on the other side, remnant walnut trees (b) remain. In the foreground is the Atlas cedar (c), which has apparently been topped to provide a view from the cupola to the Martinez Adobe. (Photograph by John E. Jensen. D6-6, JOMU).

Several photographs document some of pruning undertaken around the Muir House. Figure 5.3 illustrates some rather radical activity on the Atlas cedar on the west slope of the house. Fortunately, better results were achieved with the arborvitae and California fan palms in the front of the house (Figure 5.8). Compared to conditions in the mid- 1950s, by this time the landscape around the house had taken on a much tidier look with pruned shrubs, trimmed grass, and even a bench on which to admire the surroundings. Some of the plantings shown around the foundation of the house in the Historic Planting Plan were consistent with the recollections of Helen Muir in her 1958 interview with Faire Sax (Figures 5.9 and 5.10) (see Table 3.1: Plantings around the Muir House from c.1890 to c.1914, in Chapter 3). However, it is not exactly clear what was existing, proposed, or installed. The only datable record of plantings at the house concerns the mass of ice plant that was installed in the island of the carriage drive- loop, which was subsequently lost to the 1972 freeze.<sup>7</sup>

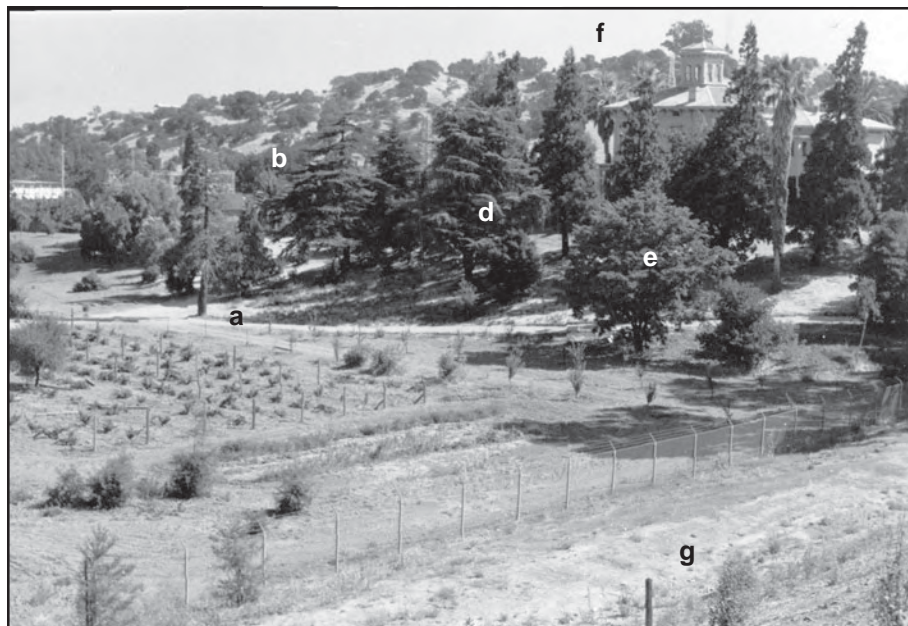
**Figure 5.7: View looking northeast from the freeway in August 1969 at newly planted grapes and plums. Some historic trees visible include: incense cedars around the Muir House; arborvitae, olive, and giant sequoia (a); Canary Island date palm (b); Lebanon cedar (c); Atlas Cedar (d) which has been topped; black locust (e); and a California fan palm (f) in front of the house. Eucalyptus, redwood, oak, buckeye, and redbud was proposed in a 1967 CALTRANS plan for the highway side of the fence (g). (Photograph by Peter Allen, D6-16, JOMU).**

The Historic Planting Plan departed from the Master Plan in that it showed the west slope of the knoll full of existing and/or proposed plants, whereas the earlier plan recommended opening up the slope and planting meadow grasses. This would suggest that although renewing the visual relationship between the Muir House and the Martinez Adobe was important, the park was hesitant in taking out the many trees needed to achieve it. It may explain why only certain trees were pruned, such as the topped Atlas cedar shown in Figure 5.3, which created a narrow viewshed for visitors to see the Martinez Adobe from the cupola. Figure 5.7 shows some of the large historic and non- historic trees present on the west slope in 1969.

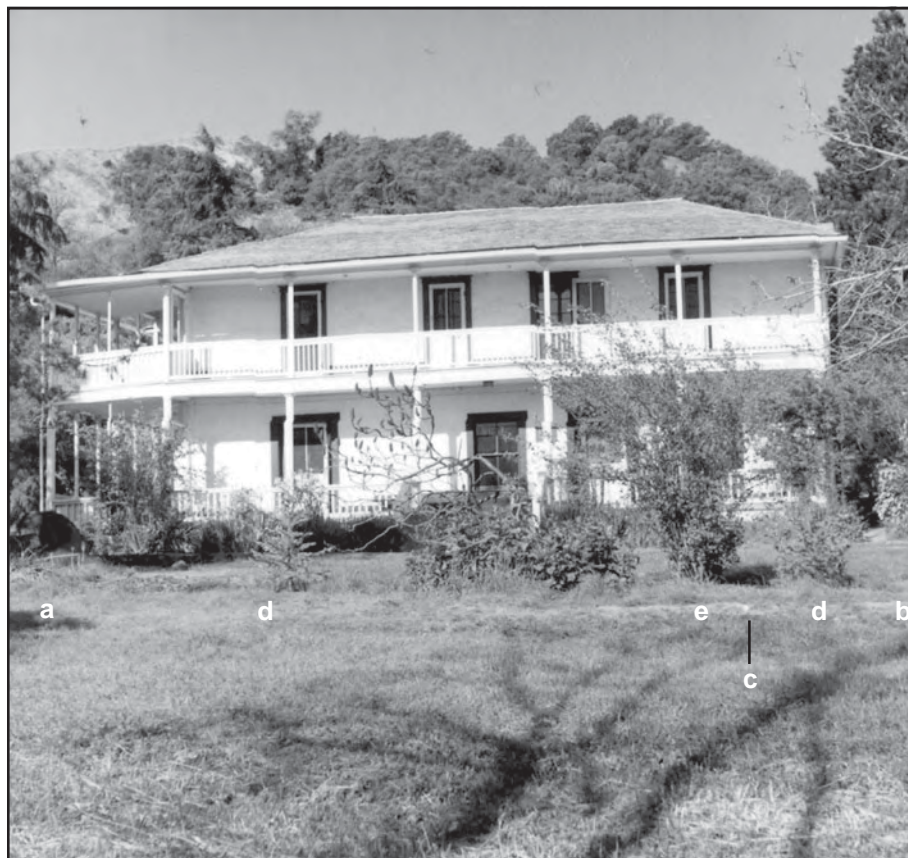
**Figure 5.12:** View of the Martinez Adobe and the ramada in 1967, looking northeast from Franklin Canyon Road prior to installation of the boundary fence around the park. The large tree in the foreground was removed soon after this photograph was taken. To the left is a walnut tree (supported by a brace) and wisteria vines around the ramada and at far right is one of Deodar cedars. (Photograph by John E. Jensen, 1967, JOMU).

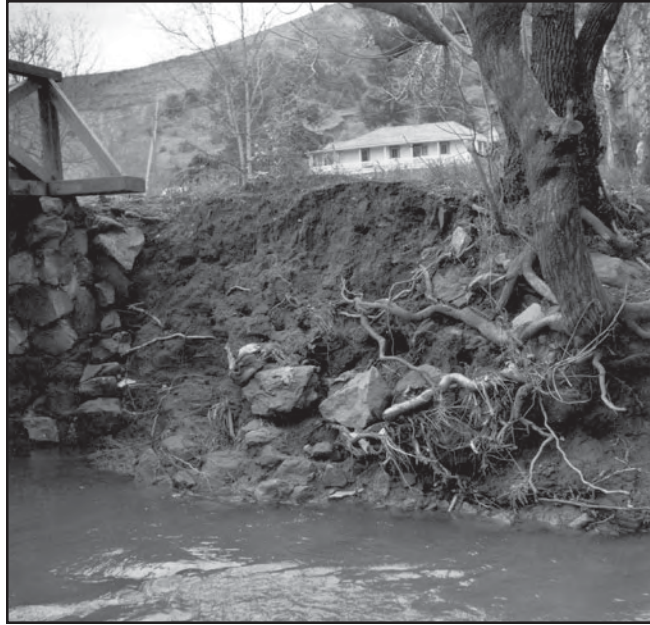
**Figure 5.17:** This photograph shows flood damage along Franklin Creek in 1970. (Photographer and catalog number unknown. From Jensen, John E. "Historic Structures Report, Franklin Creek Bridge, Part 1, John Muir National Historic Site, Martinez, California." Martinez: US Department of Interior, National Park Service, August 1966).

- 5.17 Photograph showing flood damage along Franklin Creek in 1970. (Photographer and catalog number unknown. From Jensen, John E. “Historic Structures Report, Franklin Creek Bridge, Part 1, John Muir National Historic Site, Martinez, California.” Martinez: US Department of Interior, National Park Service, August 1966).

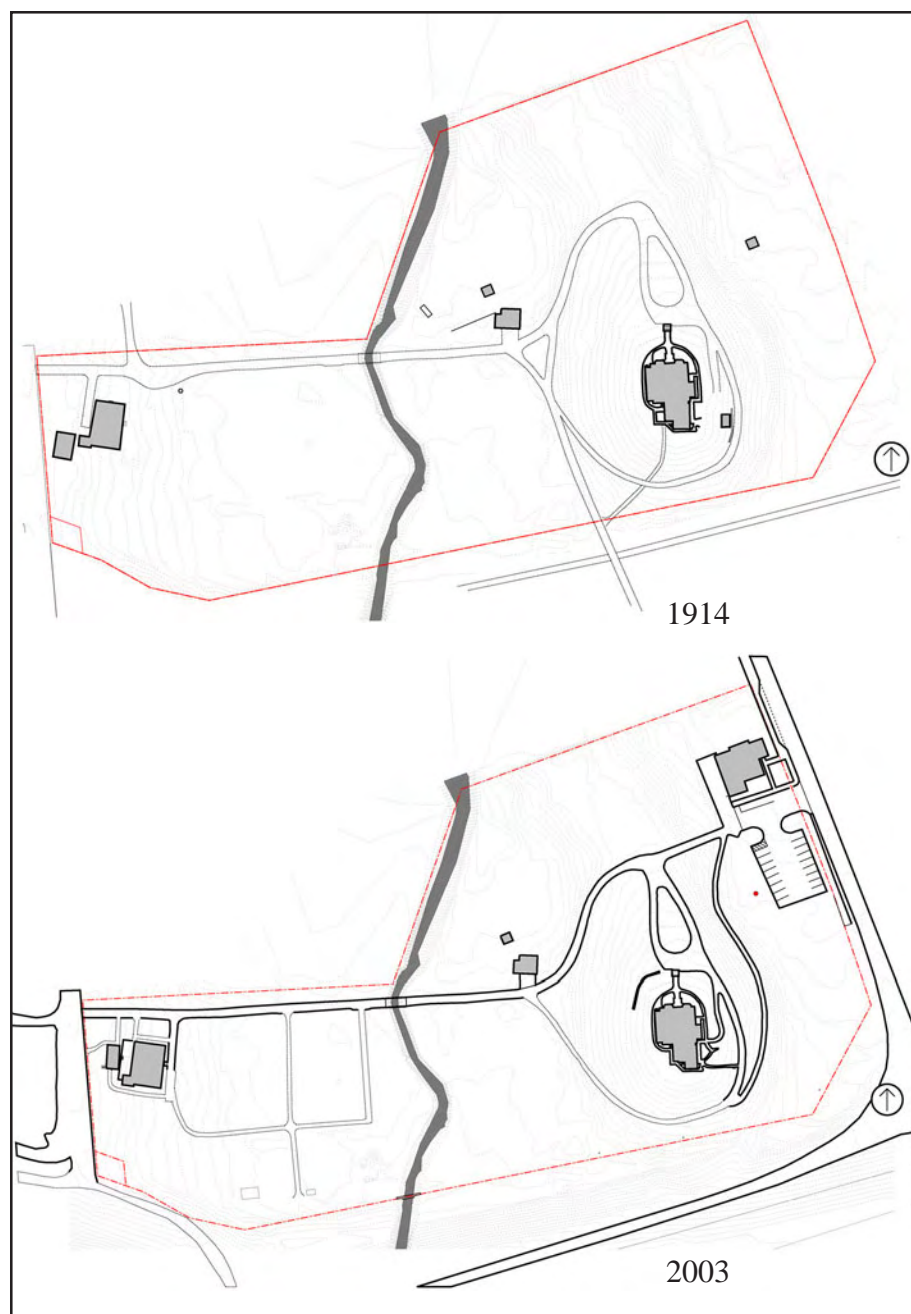
**Figure 8.3: Predominant land use at the House Unit at the end of the historic period and in 2003. Light gray areas indicate agricultural uses; medium gray represents non-agricultural uses, and dark gray indicates contemporary, or park uses. (OCLP, 2003).**

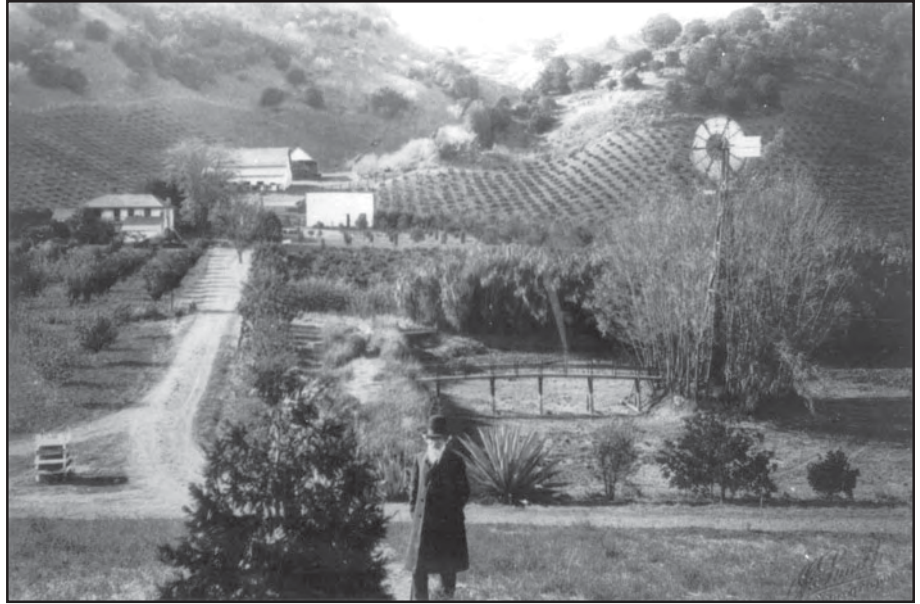
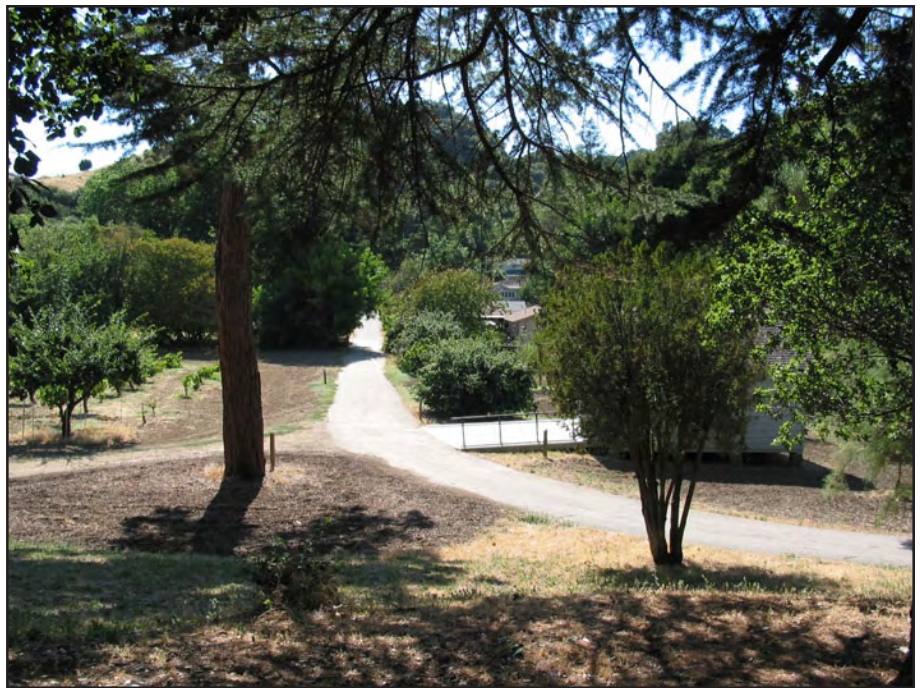
**Figure 8.8: Views looking west from the west slope of the knoll in c.1885 and 2003. (D6-1, Ref: 1885cP17 and OCLP, 2003).**

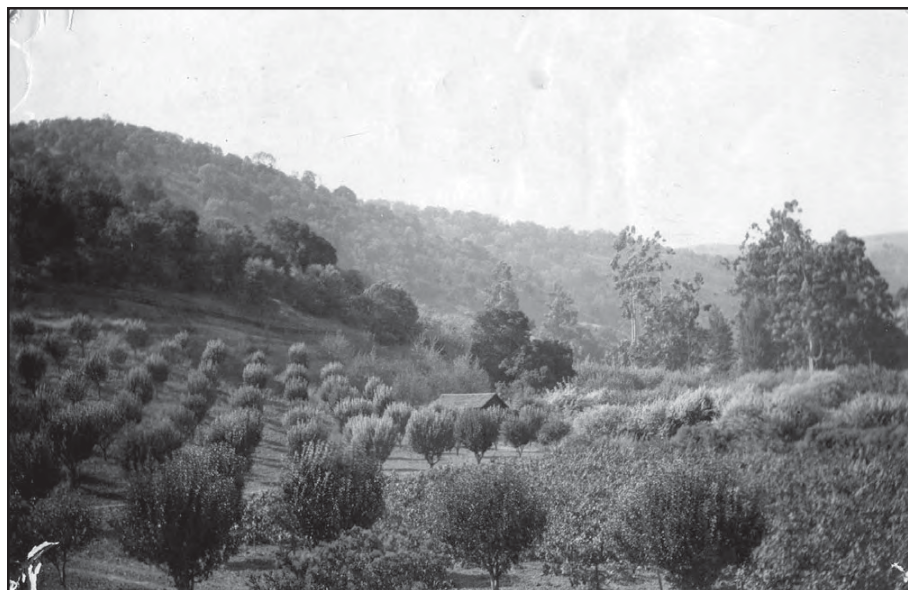
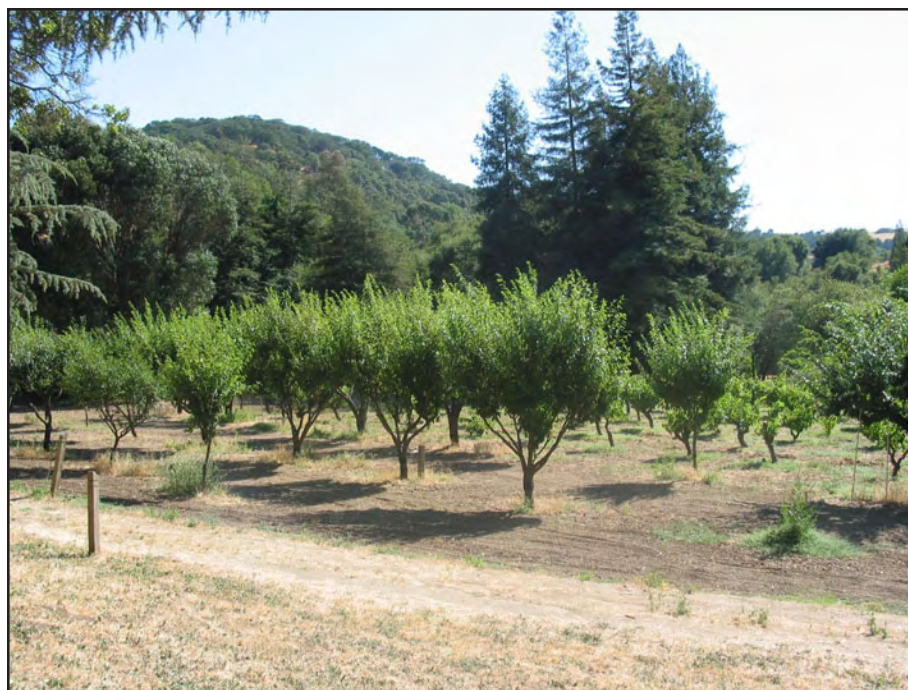
**Figure 8.9: Views looking southwest from the west slope of the knoll in the late 1890s and 2003. (JOMU, no file # and OCLP, 2003).**

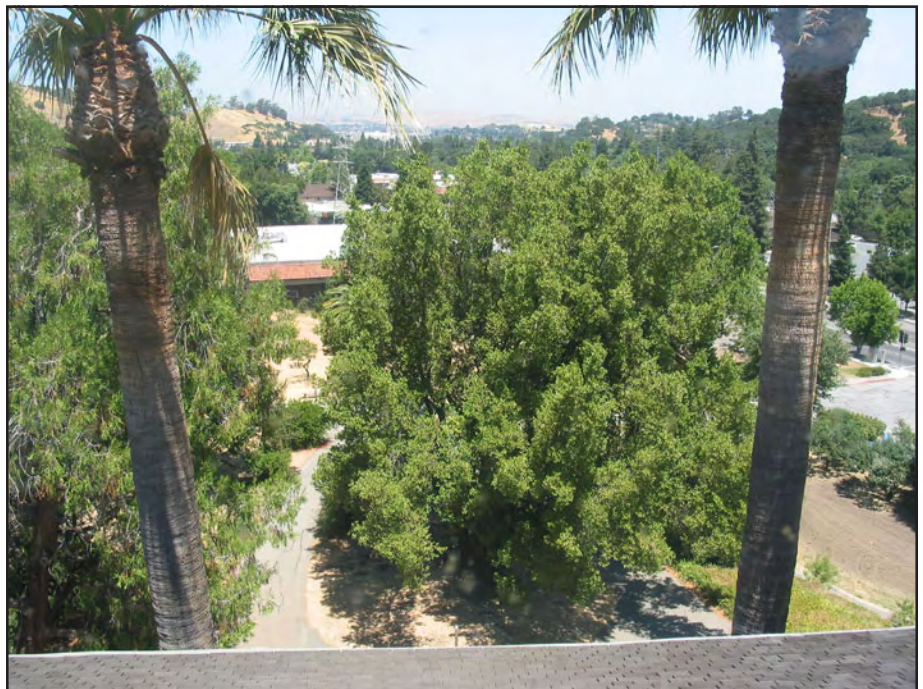
**Figure 8.10: Views looking northeast from the second floor of the Muir House in c.1900-1905 and 2003. (D3-2, JOMU, Ref: 1900-05cP30 and OCLP, 2003).**

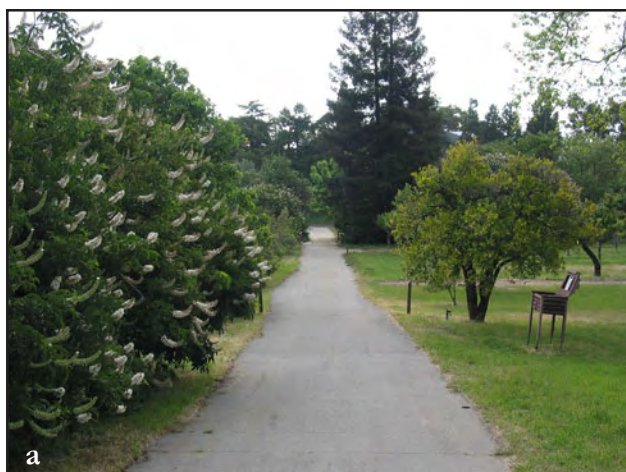
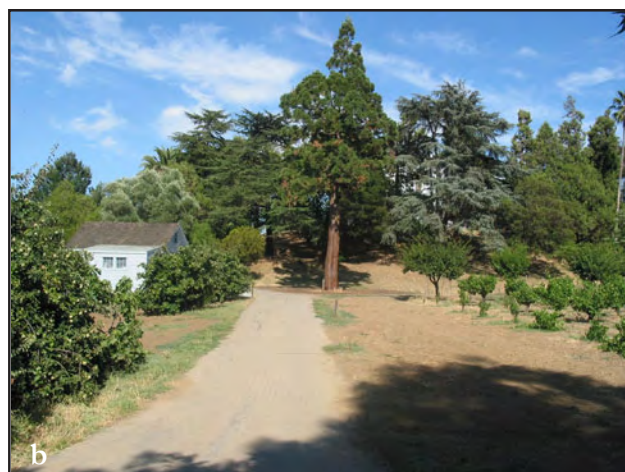
**Figure 8.11: Views approaching the Muir House from the west on the main farm road heading towards Franklin Creek (a) and just after passing over it (b). (OCLP, 2003).**

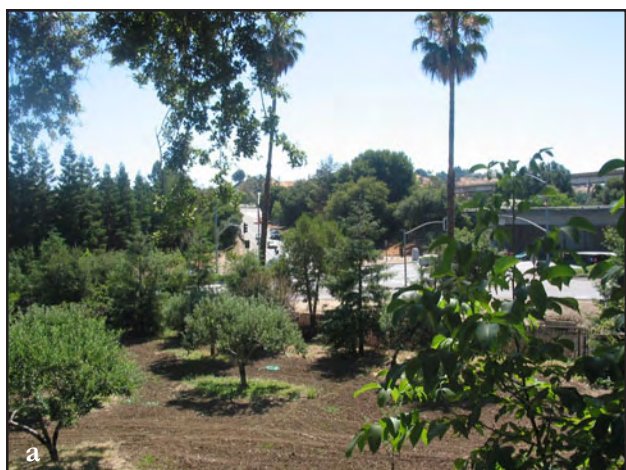
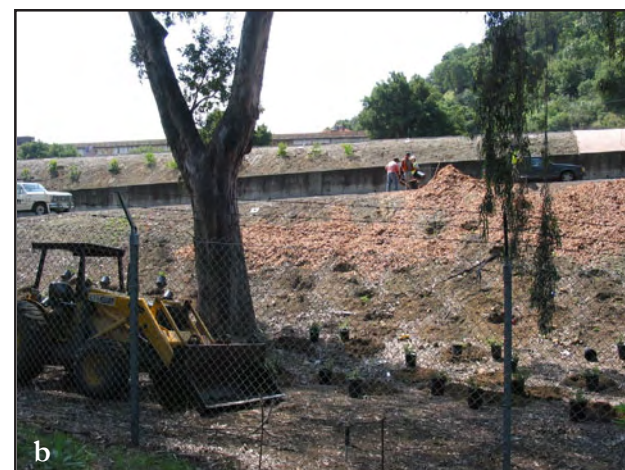
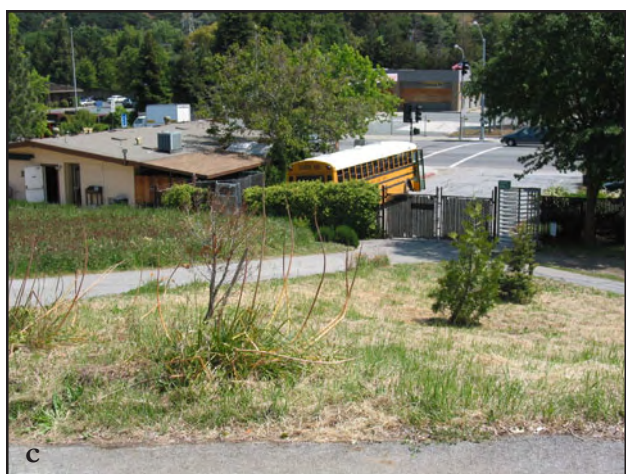
**Figure 8.12: Views from the Muir House and knoll looking east toward the State Route 4 westbound off-ramp (a); southeast toward the westbound on-ramp (b); and east toward the Visitor Center, parking lot, and Alhambra Avenue (c). (OCLP, 2003).**

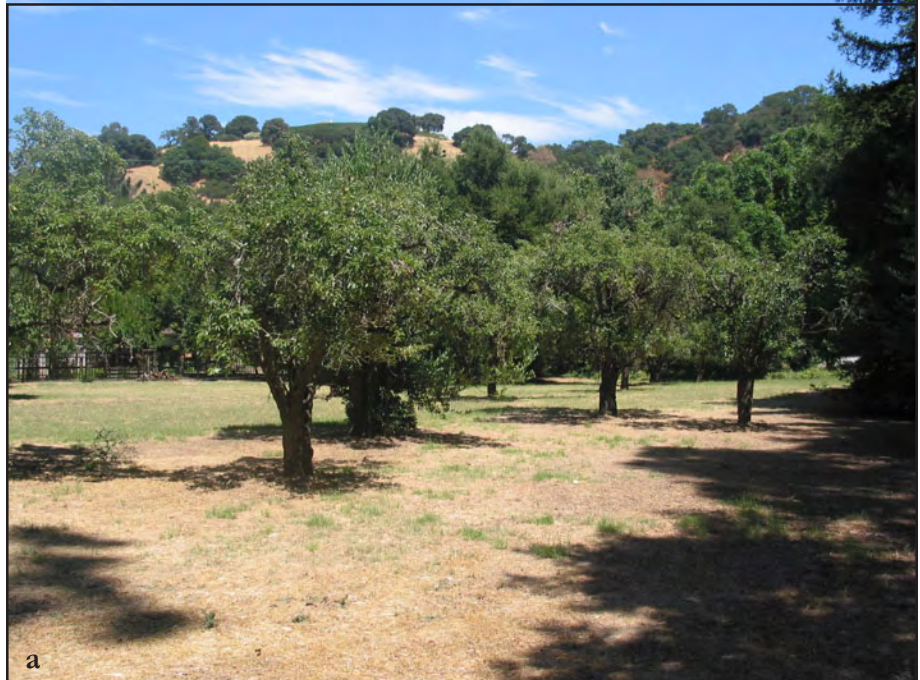
**Figure 8.13: Vegetation screens much of the residential development that surrounds the Gravesite Unit but still allows views of the distant hillsides (a). The exception is the small orchard space in the southern half of the parcel which features a private landowner's vegetable garden (b). (OCLP, 2003).**

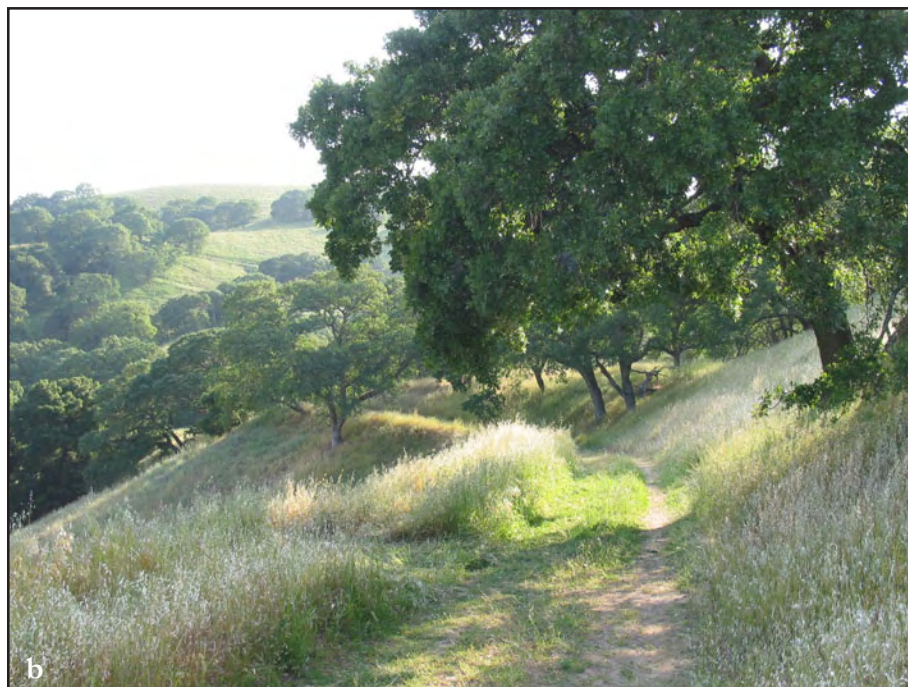
**Figure 8.14: Views on Mt. Wanda reveal both changes in the Alhambra Valley and features that Muir would recognize today. The view looking north today offers a glimpse of the Franklin Creek Windmill and orchards in the House Unit, which is bordered by subdivisions that extend down the Alhambra Valley (a). Pastoral scenes of undeveloped hill land gesture to conditions that were likely present during Muir's time (b). (OCLP, 2003).**

- 8.14 Views on Mt. Wanda reveal both changes in the Alhambra Valley and features that Muir would recognize today. The view looking north today offers a glimpse of the Franklin Creek Windmill and orchards in the House Unit, which is bordered by subdivisions that extend down the Alhambra Valley. Pastoral scenes of undeveloped hill land gesture to conditions that were likely present during Muir's time. (OCLP, 2003).

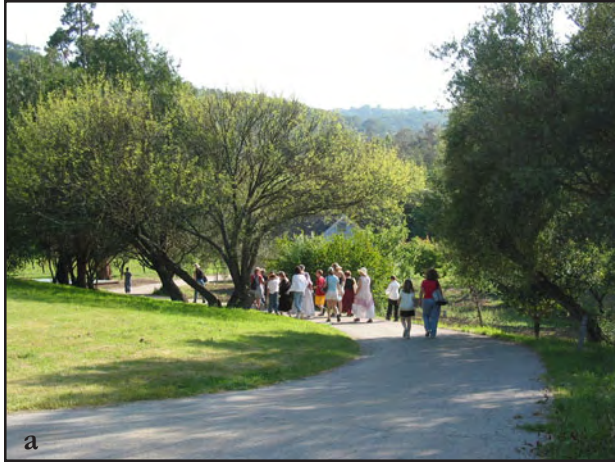
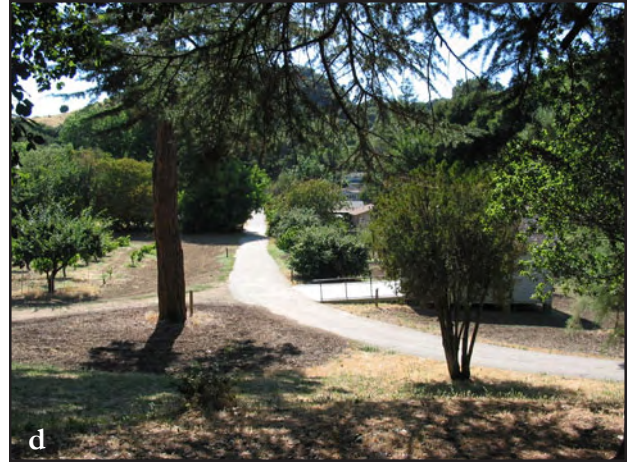
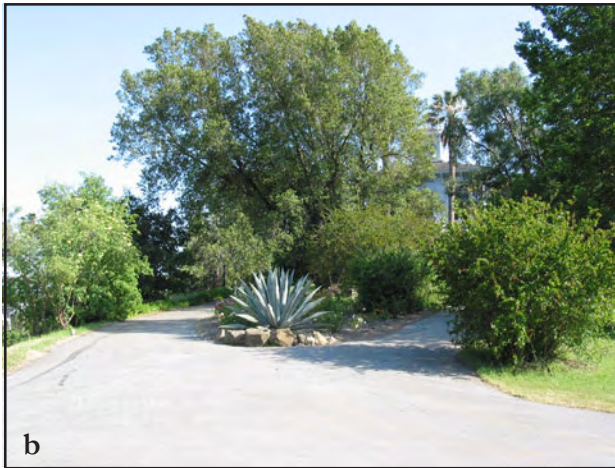
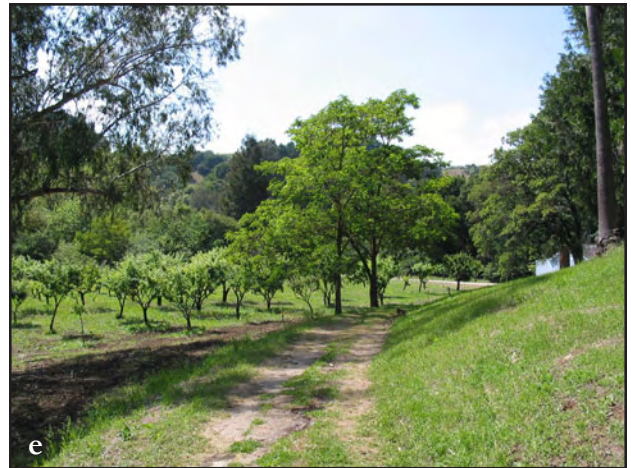
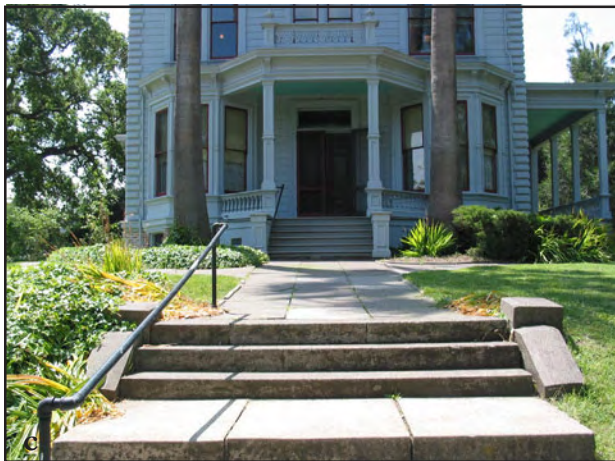
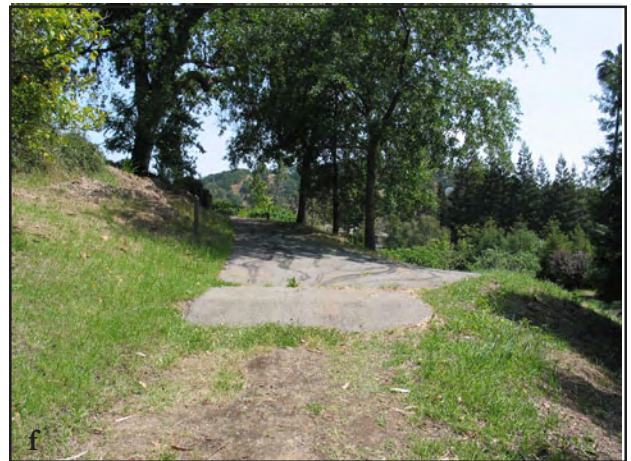
**Figure 8.15: Muir House and knoll - Circulation**

(a) Carriage drive-loop, view southwest from bottom of loop; (b) Carriage drive-loop, view south from bottom of loop; (c) Front walk and steps, view south from top of loop; (d) Triangle intersection, view west from west slope of knoll; (e) Woodshed Road, view northwest from the road; (f) Woodshed Road and junction with easy access route, view northeast from the road. (OCLP, 2003).

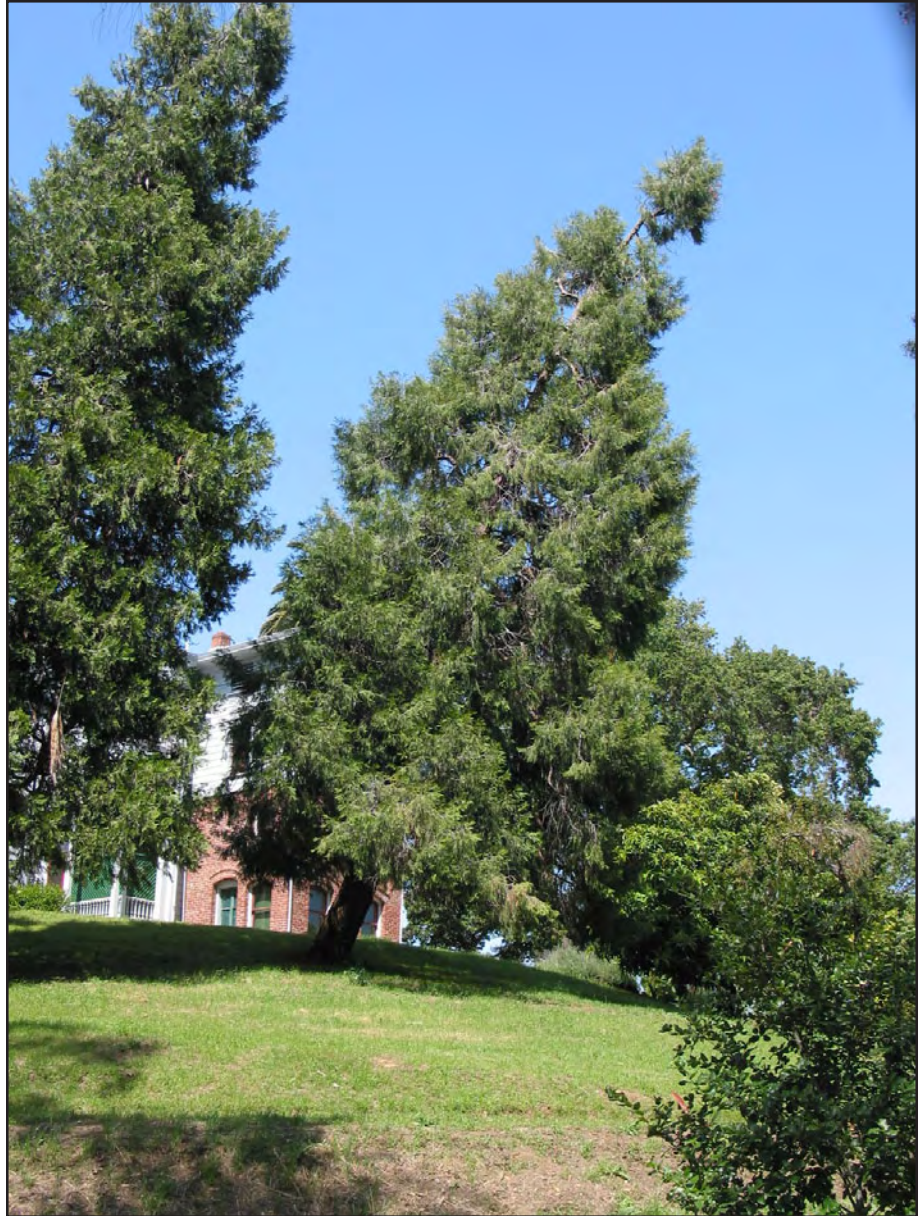
**Figure 8.16: Muir House and knoll - Circulation**  
 (a) Junction from Woodshed Road and east driveway, view south from carriage drive-loop; (b) Walkway in Victorian garden, view west from stone steps; (c) Walkway at incense cedars, view southwest from northwest area of lawn; (d) Fire lane, view west from bottom of knoll; (e) Easy access trail, view south from fire lane. (OCLP, 2003).
