OLMSTED  
CENTER  
*for* LANDSCAPE PRESERVATION

# CULTURAL LANDSCAPE REPORT FOR JOHN MUIR NATIONAL HISTORIC SITE

VOLUME 1: SITE HISTORY, EXISTING CONDITIONS, AND ANALYSIS

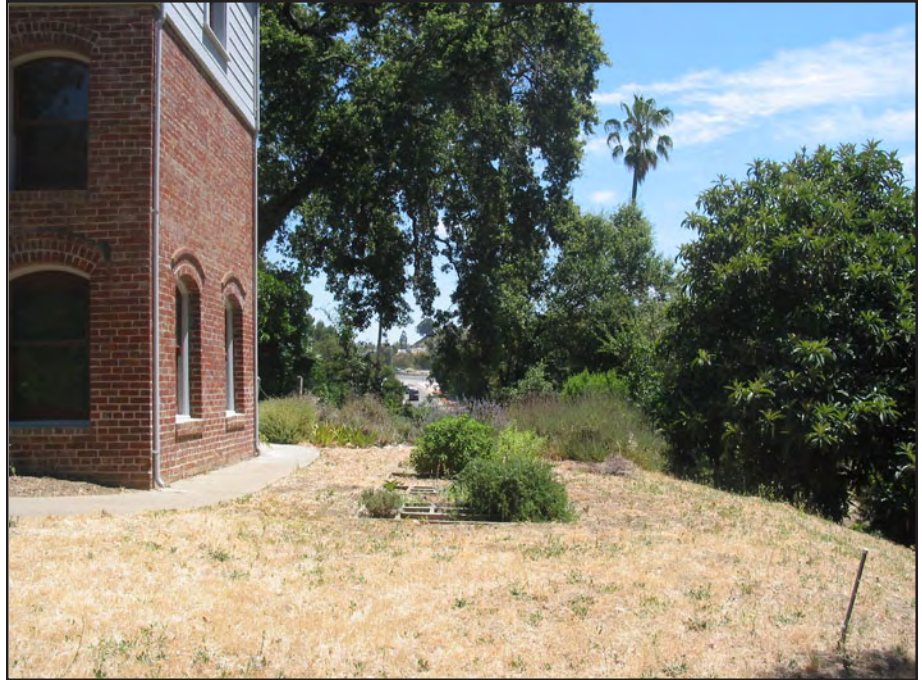
**Figure 8.22: Muir House and knoll - Vegetation (South side and foundation)**  
**Herb garden, view east from southwest side of house.**  
 (OCLP, 2003).

### **MH: VEGETATION – SOUTH SIDE (FIGURE 8.22)**

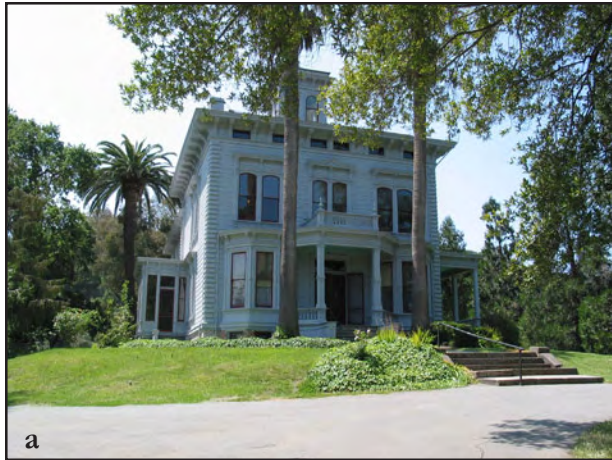
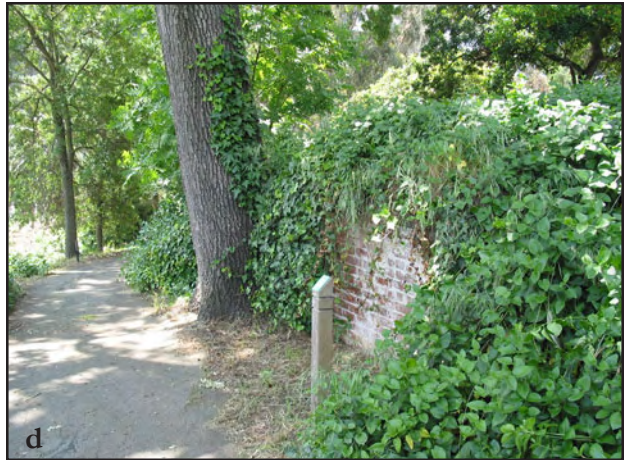
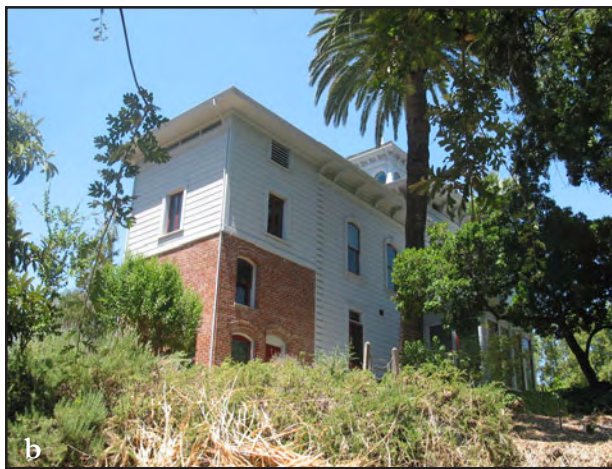
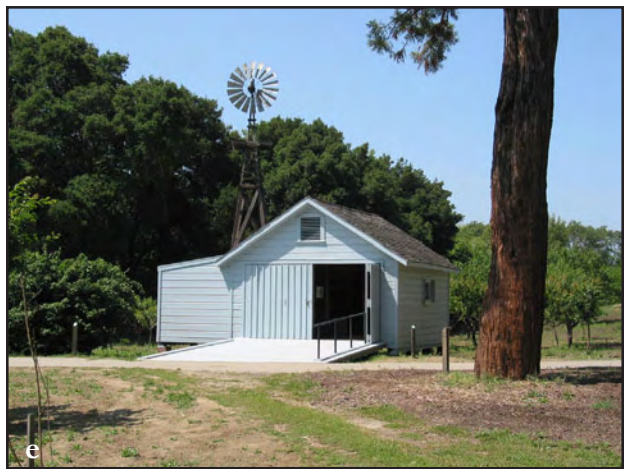
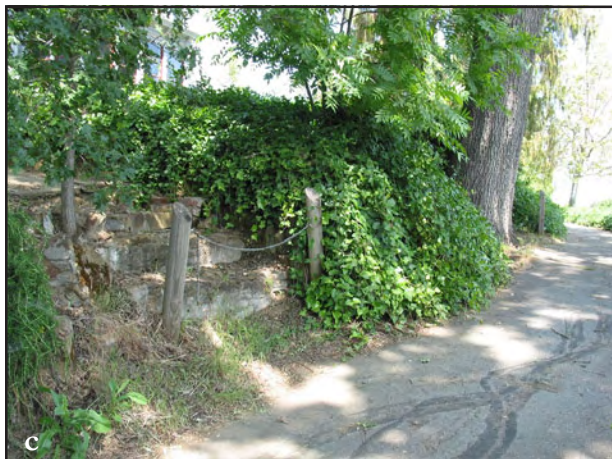
**Figure 8.24: Muir House and knoll - Buildings and structures**

(a) North (front) and east facades of Muir House, view southwest; (b) South and east facades of Muir House; (c) Stone wall and steps along Woodshed Road, view northwest from road; (d) Brick wall along Woodshed Road, view south from road; (e) South (front) and east facades of Carriage House, view northwest from lower part of Woodshed Road. (OCLP, 2003).

**MH: BUILDINGS AND STRUCTURES (FIGURE 8.24)**

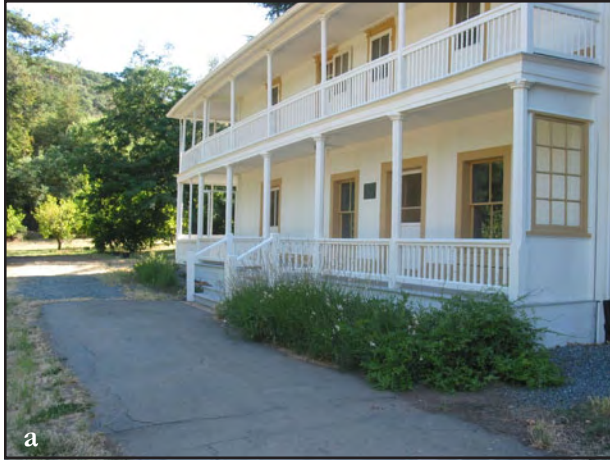
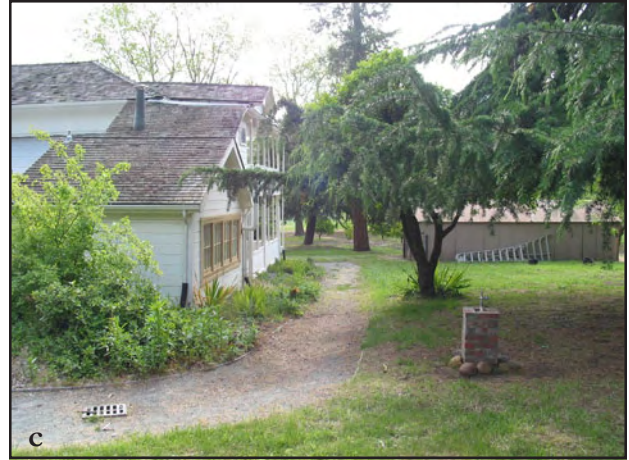
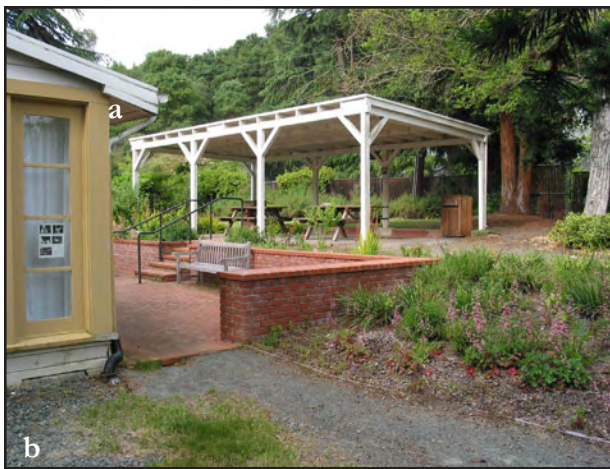
**Figure 8.25: Martinez Adobe - Circulation**  
 (a) Driveway on east side of Martinez Adobe, view south from north end of driveway; (b) Gravel path and patio on west side, view southwest from main farm road; (c) Stone path on south side, view east from west boundary fence. (OCLP, 2003).

### **MA: CIRCULATION (FIGURE 8.25)**

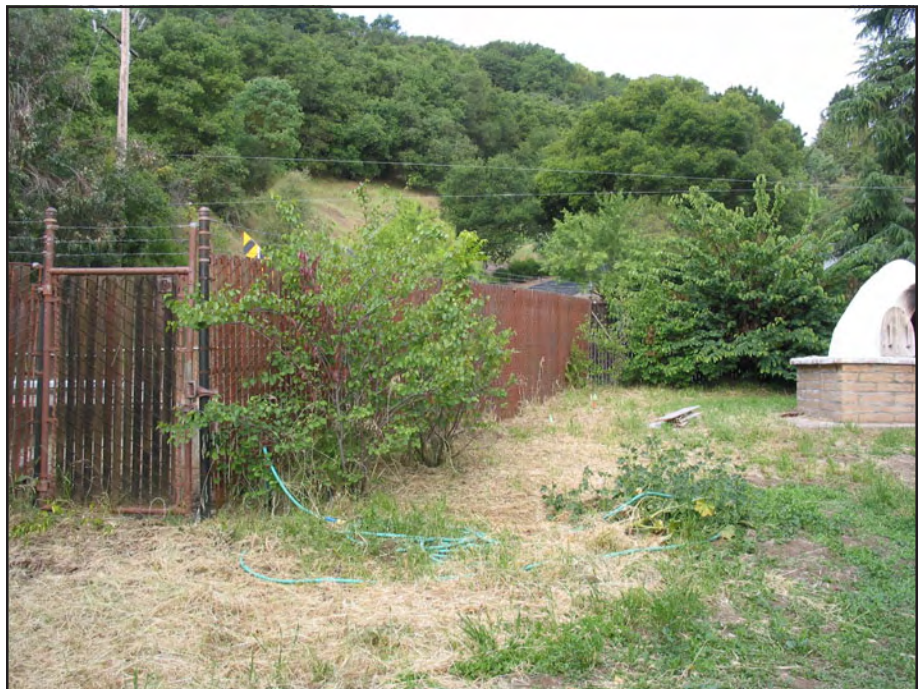
**Figure 8.27: Martinez Adobe - Vegetation (North side and foundation)**  
Trunk of elderberry and canopy of Douglas fir, view west from adobe driveway. (OCLP, 2003).

**MA: VEGETATION – NORTH SIDE (FIGURE 8.27)****North side area**

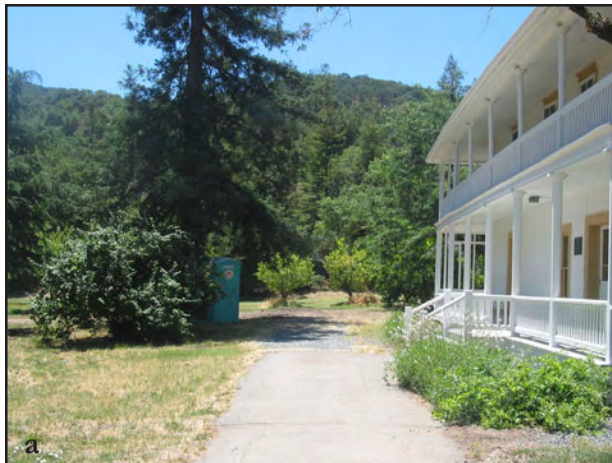
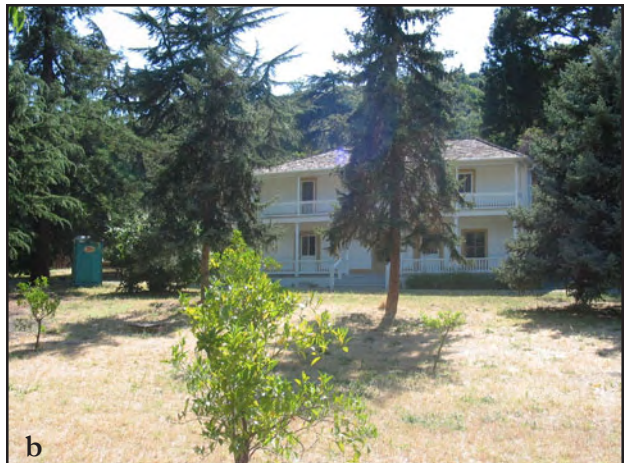
**Figure 8.28: Martinez Adobe - Vegetation (East side and foundation)**  
(a) Quince and coast redwood southwest of adobe and foundation plants in front, view south from driveway; (b) Two Colorado blue spruce frame a white spruce on the east side of the adobe, view west from the oranges in the west orchard space. (OCLP, 2003).

**MA: VEGETATION – EAST SIDE (FIGURE 8.28)****East side area**

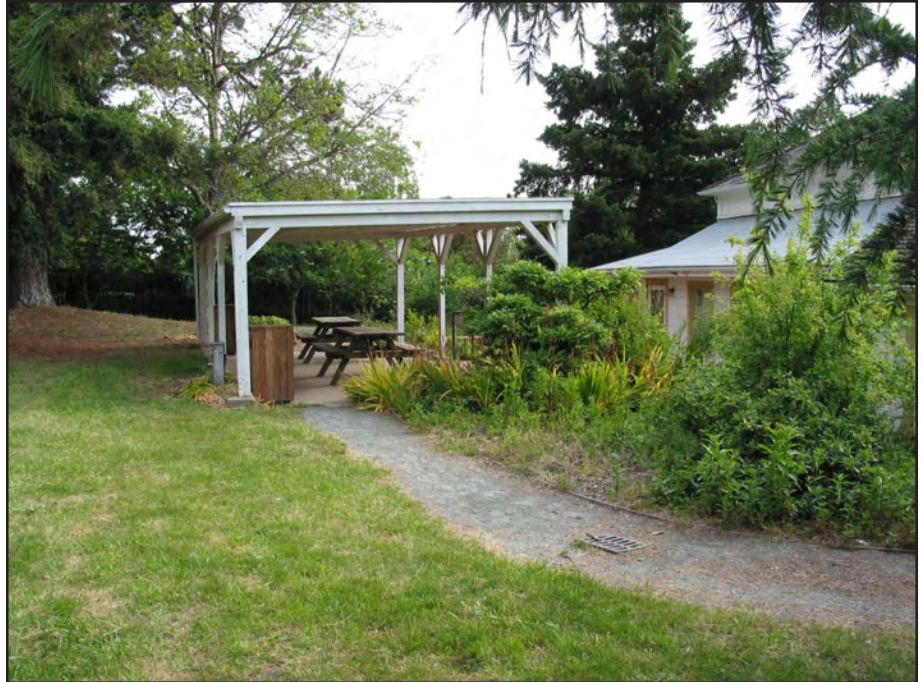
**Figure 8.29: Martinez Adobe - Vegetation (West side and foundation)**  
Perennials and lawn area on west side of Martinez Adobe. (OCLP, 2003).

**MA: VEGETATION – WEST SIDE (FIGURE 8.29)**

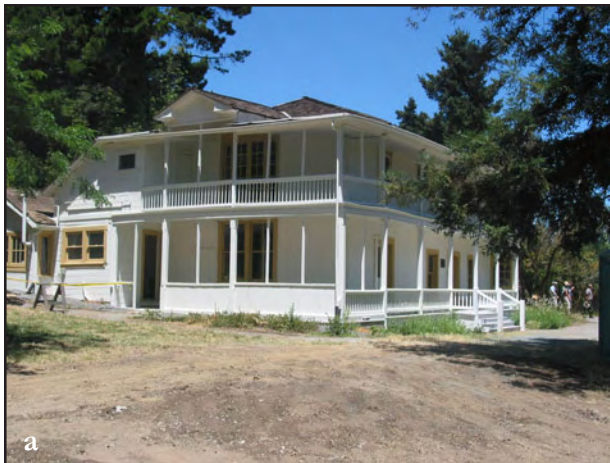
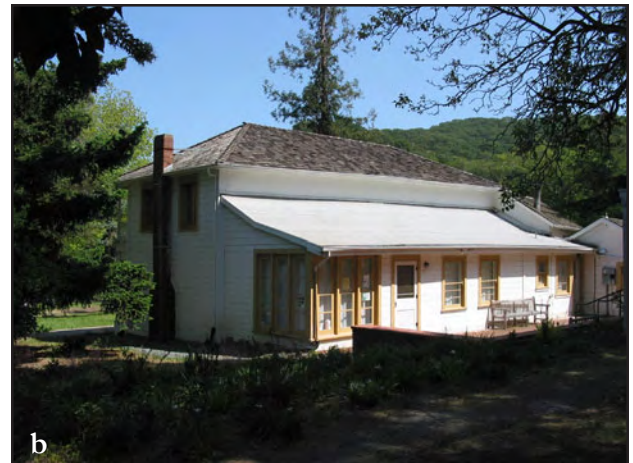
**Figure 8.30: Martinez Adobe - Buildings and structures**  
(a) East (front) and south facades of Martinez Adobe, view northwest from orchard; (b) North and west facades of adobe, view southeast from near main farm road. (OCLP, 2003).

- 8.29 Martinez Adobe – Vegetation (West side and foundation). (OCLP, 2003).
- 8.30 Martinez Adobe – Buildings and structures. (OCLP, 2003).
- 8.31 Agriculture – Circulation. (OCLP, 2003).

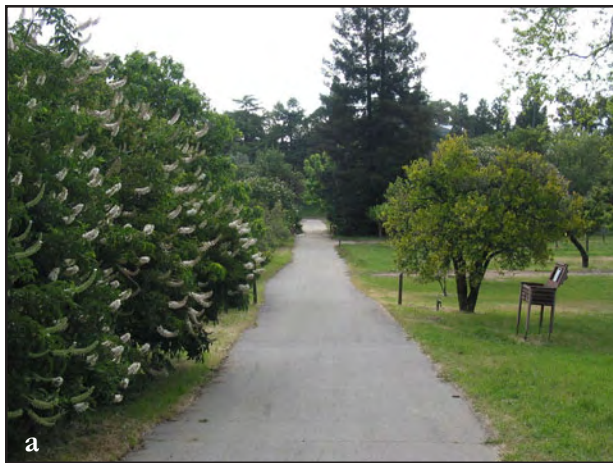
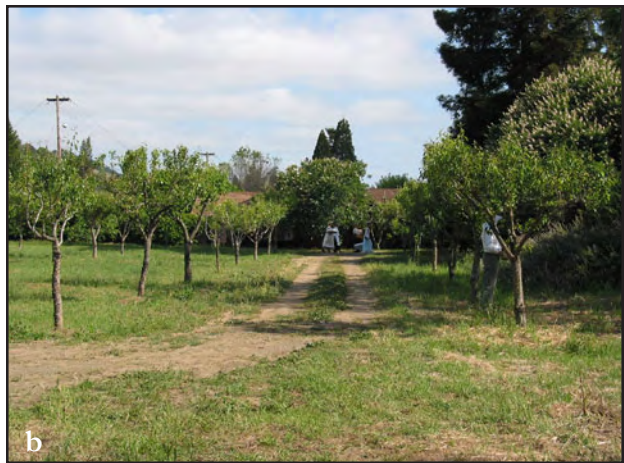
**Figure 8.31: Agriculture - Circulation**

(a) Main farm road, view east from near Martinez Adobe; (b) Farm lane in west orchard near Franklin Creek, view north from orchard. (OCLP, 2003).

**AGRICULTURE AREAS – (AG)****AG: CIRCULATION (FIGURE 8.31)****Main farm road**

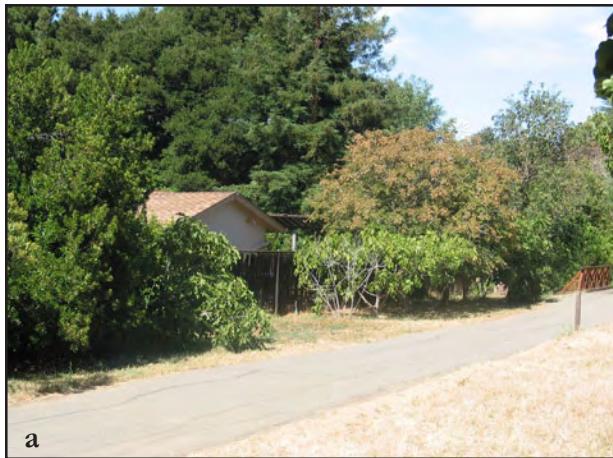
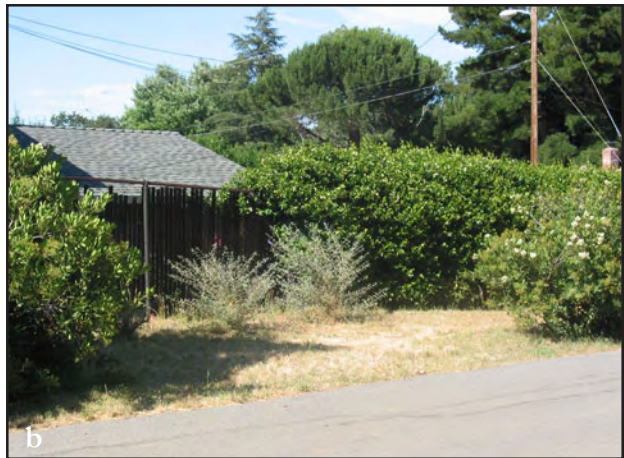
**Figure 8.32: Agriculture - Vegetation (North-west boundary)**

(a) Toyons and young figs, view northeast from main farm road; (b) Butterfly-bush, toyon, and star jasmine (on fence), view northeast from main farm road. (OCLP, 2003).

**AG: VEGETATION – NORTH-WEST BOUNDARY (FIGURE 8.32)****Row of fig trees**

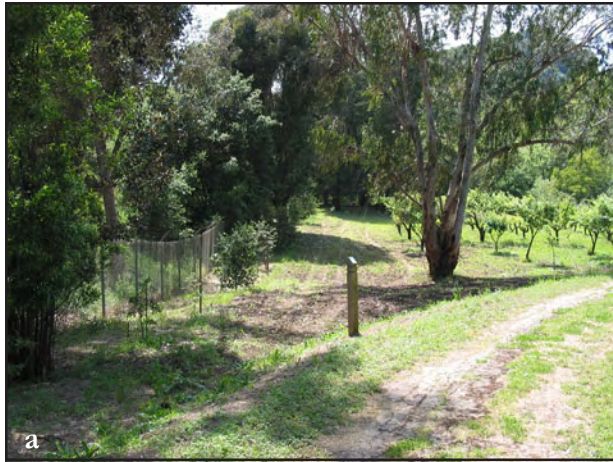
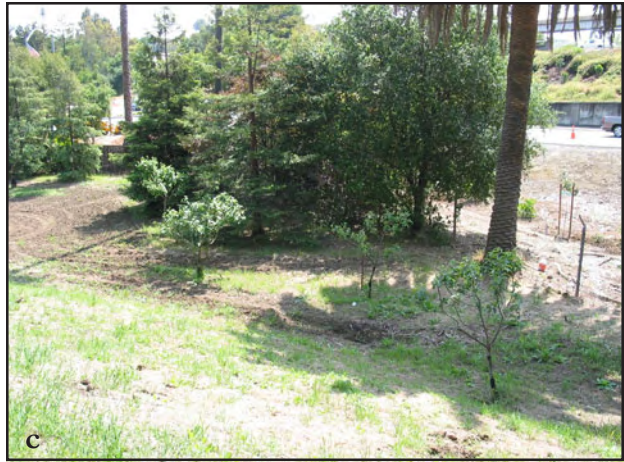
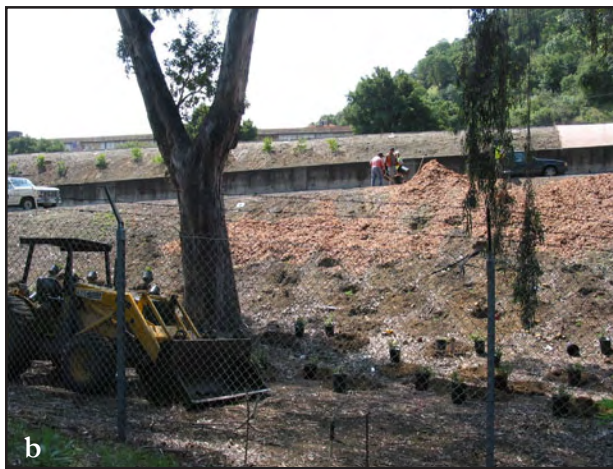
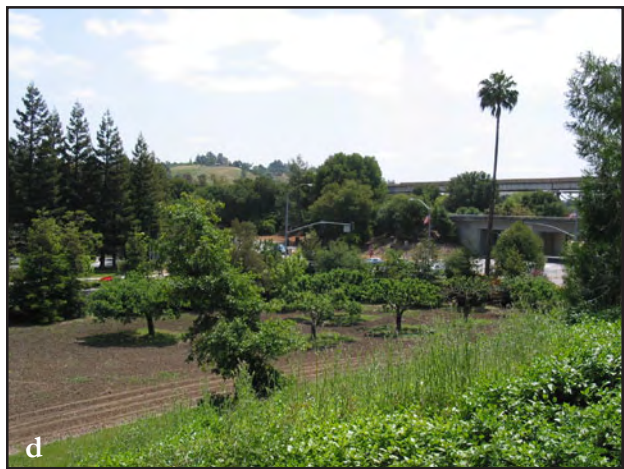
**Figure 8.34: Agriculture - Vegetation (South-east boundary)**

(a) Large eucalyptus and row of small seedling oaks and redwoods along fence, view west from Woodshed Road; (b) Historic eucalyptus and new highway plantings on CALTRANS property, view south from Woodshed Road; (c) Trunk of historic Canary Island date-palm and mass of coast redwoods and oaks along fence, view east from easy access trail; (d) Distant view of a non-historic Mexican fan palms and coast redwoods and oaks along fence line. (OCLP, 2003).

**AG: VEGETATION – SOUTH-EAST BOUNDARY (FIGURE 8.34)****Eucalyptus grove (4)**

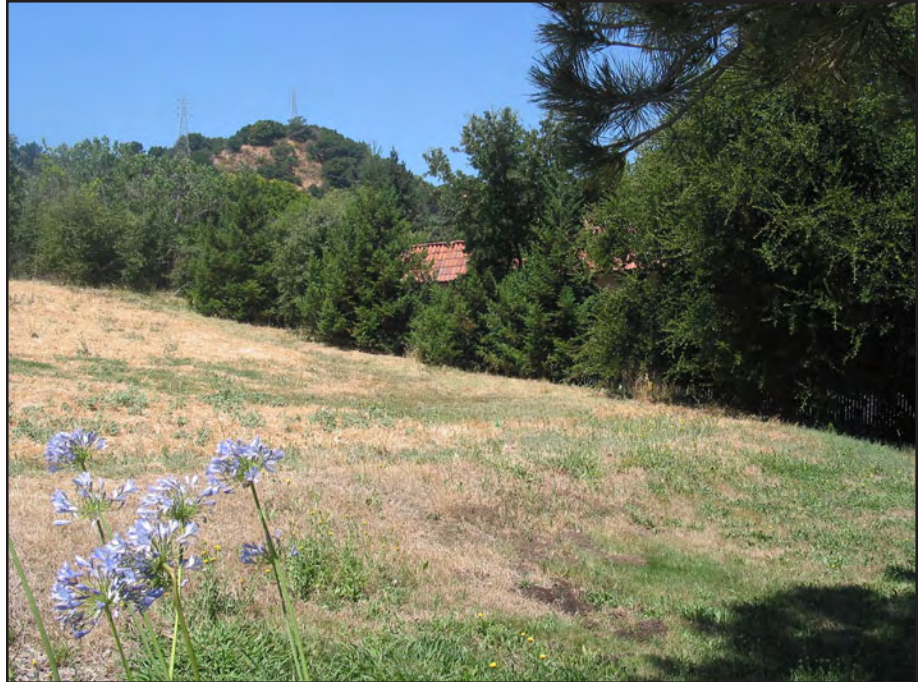
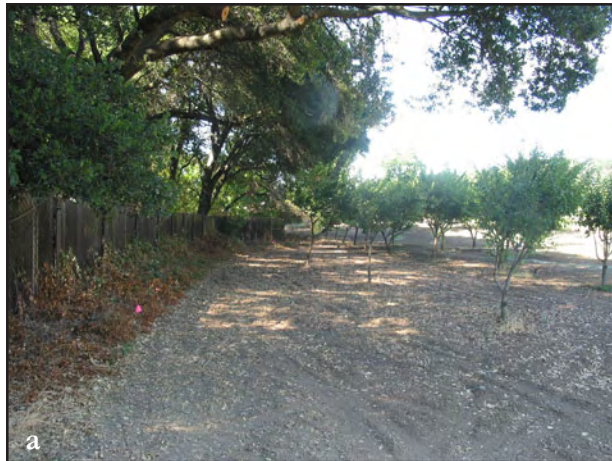
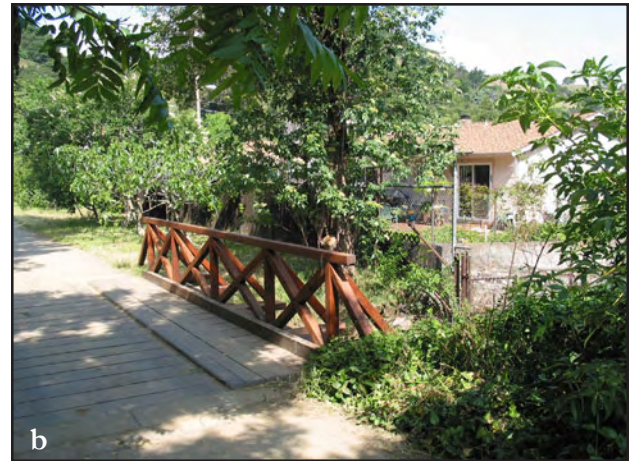
**Figure 8.36: Agriculture - Vegetation (Franklin Creek)**  
(a) Massive coast live oaks on the creek side of the boundary fence north of the bridge, view north from near main farm road; (b) Gap in riparian vegetation along Franklin Creek at the bridge, view northwest from east end of bridge. (OCLP, 2003).

**AG: VEGETATION – FRANKLIN CREEK (FIGURES 8.36 AND 8.37)****Riparian vegetation, north of main farm road**

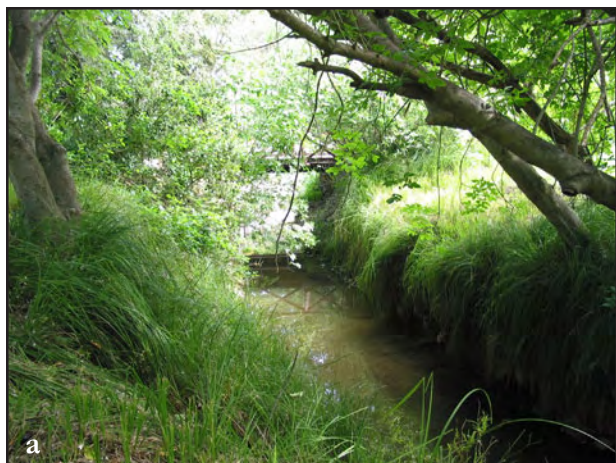
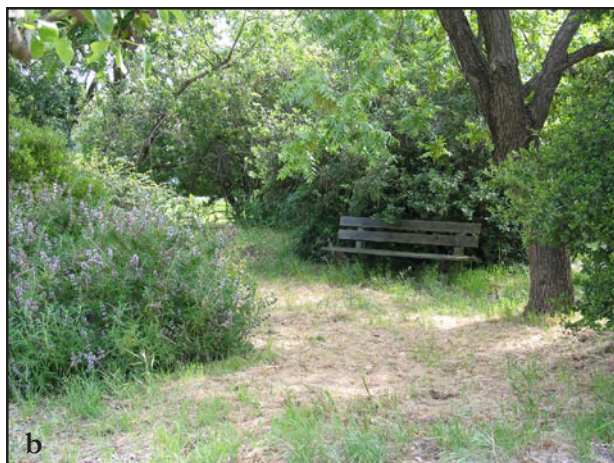
**Figure 8.37: Agriculture - Vegetation (Franklin Creek)**

**(a) Dense canopy of riparian plants along Franklin creek south of bridge, view north from west creek bank; (b) Native plant garden on west side of Franklin Creek, view northeast from near beehive. (OCLP, 2003).**

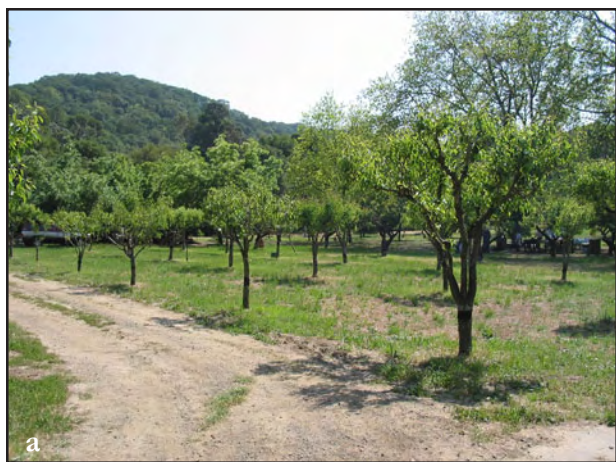
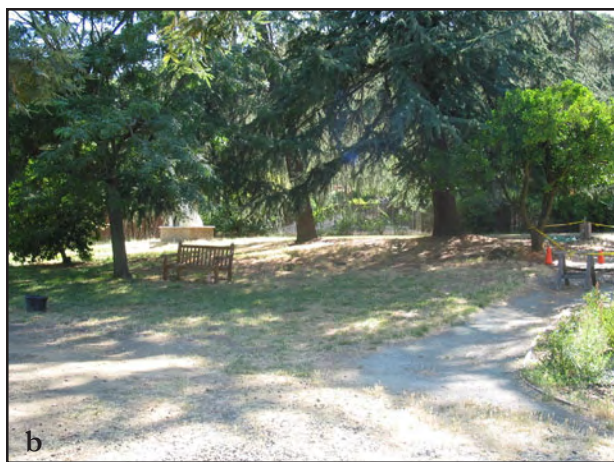
**Figure 8.38: Agriculture - Vegetation (West orchard space)**

**(a) Pear trees in the west orchard, view southwest from main farm road just west of the Franklin Creek Bridge; (b) A California black walnut and an orange tree set within lawn area on south side of the Martinez Adobe, view southwest from gravel portion of driveway. In the background are two tall Deodar cedars.. (OCLP, 2003).**

**AG: VEGETATION – WEST ORCHARD SPACE (FIGURE 8.38)****West orchard**

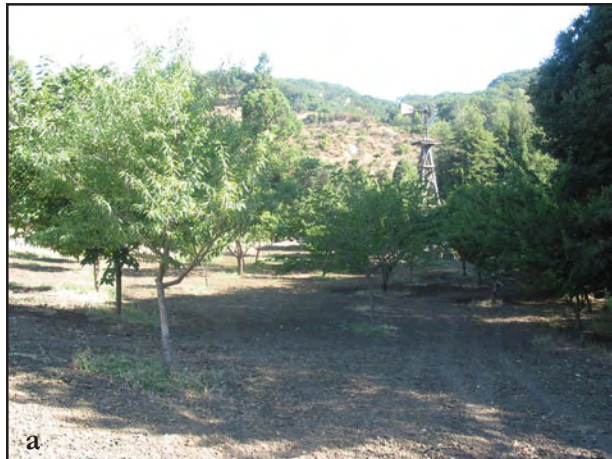
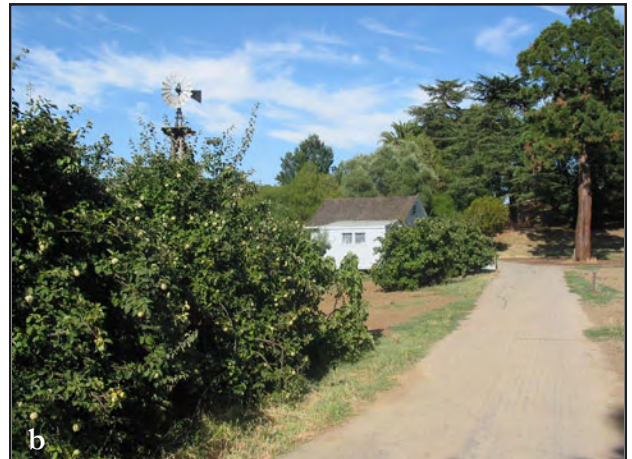
**Figure 8.40: Agriculture - Vegetation (Fish pond space)**  
**(a) Apricots and almonds in upper area of fish pond, view southwest from north orchard; (b) Quince and figs on north side of main farm road, view east from road. (OCLP, 2003).**

**AG: VEGETATION – FISH POND SPACE (FIGURE 8.40)****Fish pond space**

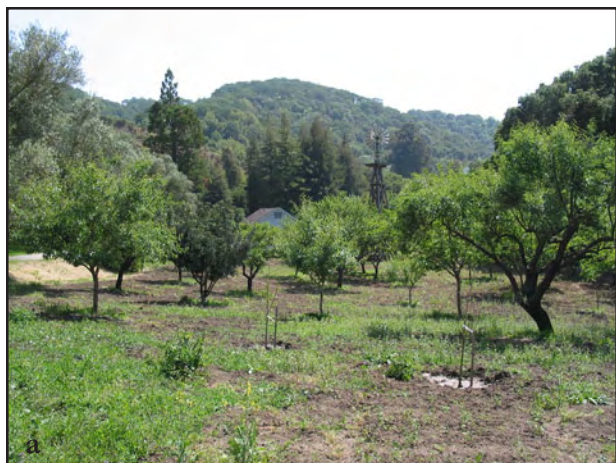
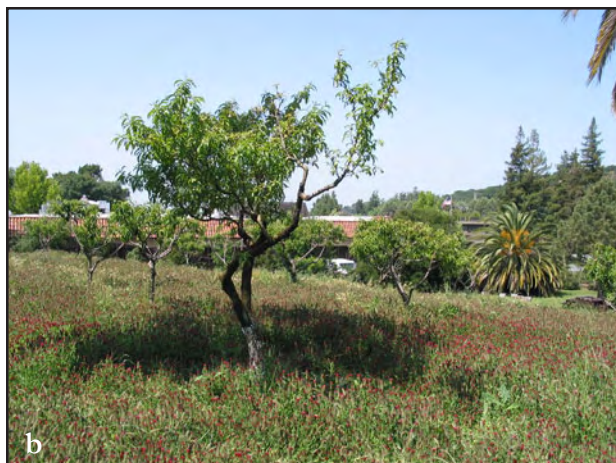
**Figure 8.41: Agriculture - Vegetation (North orchard space)**

(a) Almond trees in north orchard, view southwest from near north-east boundary fence; (b) Peach tree near high point of north orchard, view northeast from south side of the orchard. (OCLP, 2003).

**AG: VEGETATION – NORTH ORCHARD SPACE (FIGURE 8.41)****North orchard**

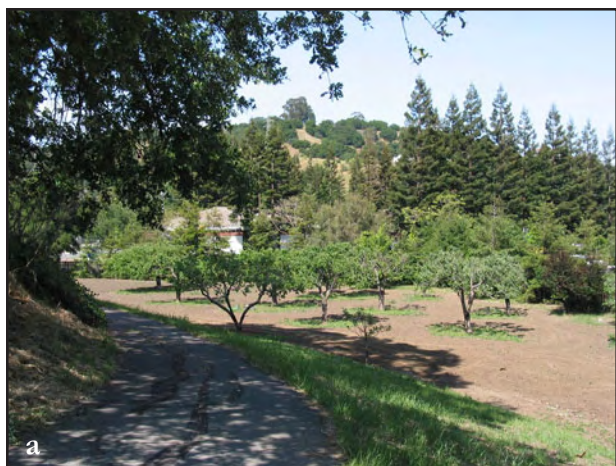
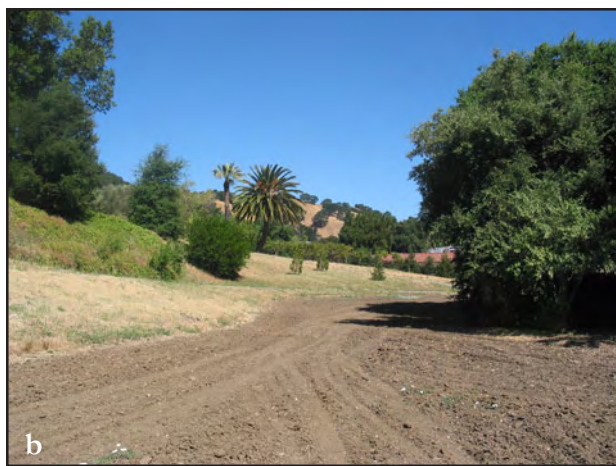
**Figure 8.42: Agriculture - Vegetation (East orchard space)**

(a) Apple trees in south end of east orchard, view northeast from easy access path; (b) Open north section of east orchard space, view north from near apple trees. (OCLP, 2003).

**AG: VEGETATION – EAST ORCHARD SPACE (FIGURE 8.42)****East orchard**

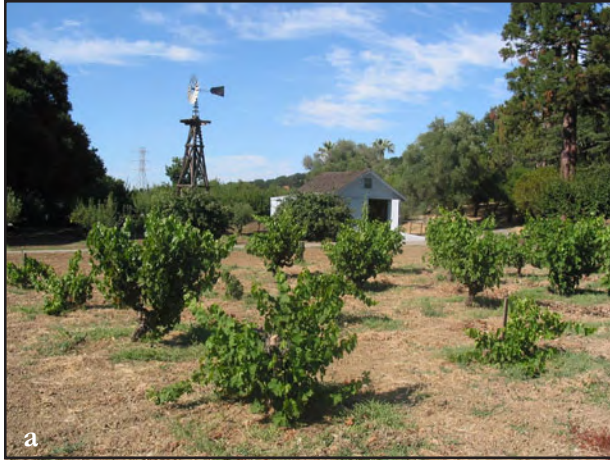
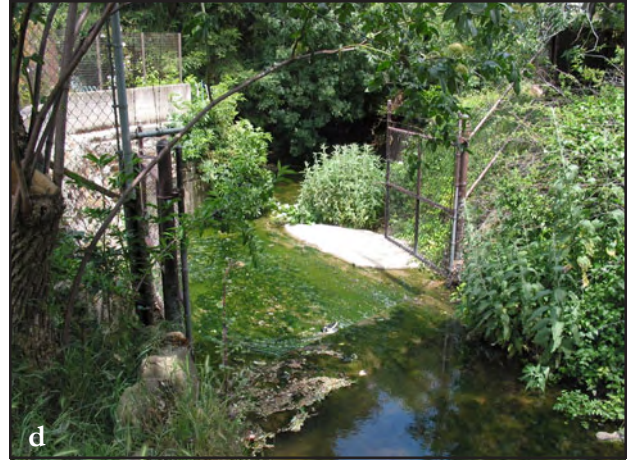
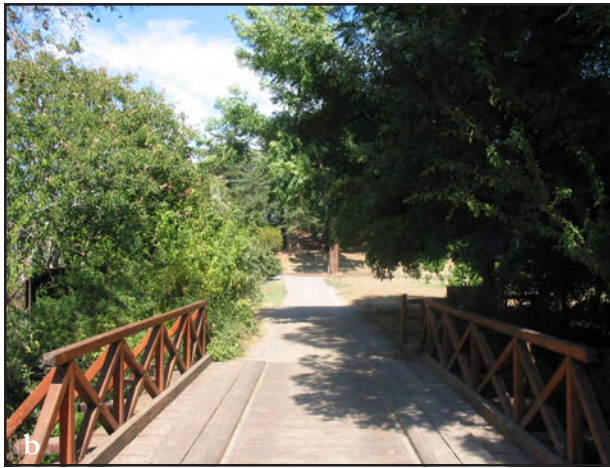
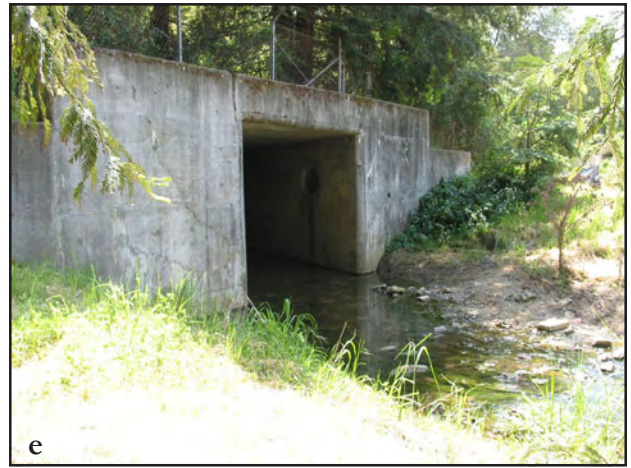
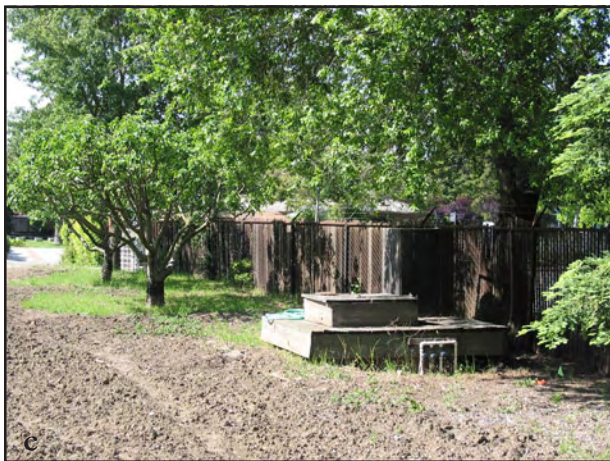
**Figure 8.43: Agriculture - Buildings and structures**  
 (a) Franklin Creek Windmill and Well, view north from grape orchard; (b) Franklin Creek Bridge, view west from main farm road; (c) Alhambra well, view north from near parking lot fence; (d) Top of dam below Franklin Creek Bridge at the park's boundary fence, view north from bridge; (e) Outfall of Franklin Creek culvert that passes under State Route 4. (OCLP, 2003).

**AG: BUILDINGS AND STRUCTURES (FIGURE 8.43)**

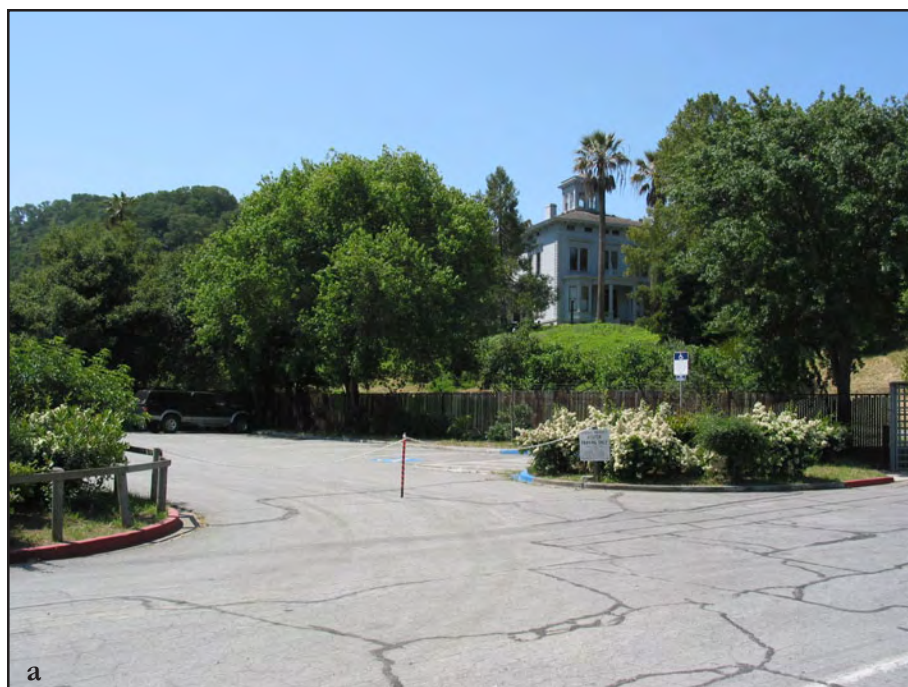
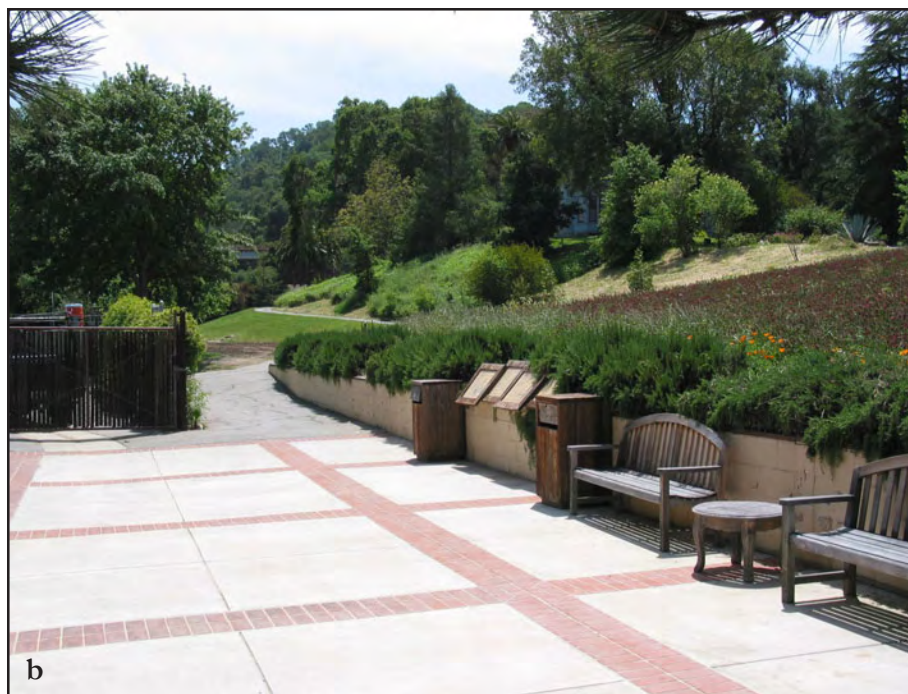
**Figure 8.44: Visitor Center - Circulation**  
(a) Parking lot and entrance, view southwest from sidewalk along north side of lot; (b) Concrete and brick patio on west side of Visitor Center, view south from patio. (OCLP, 2003).

### **VC: CIRCULATION (FIGURE 8.44)**

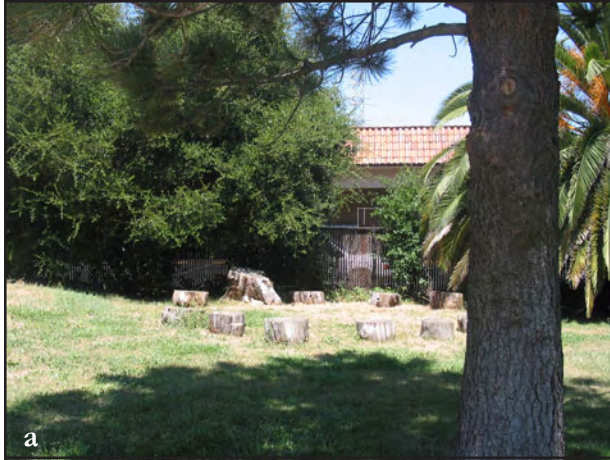
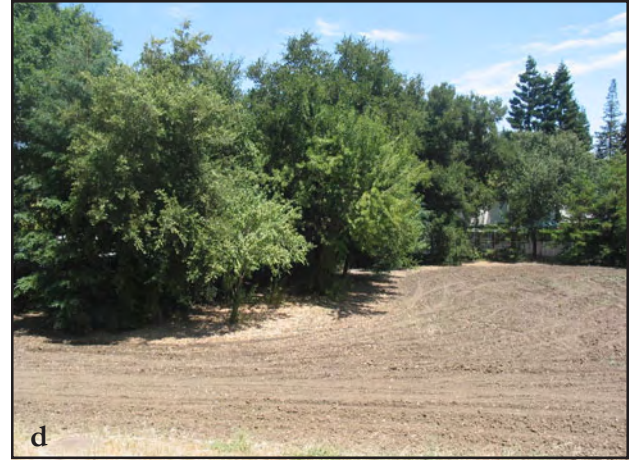
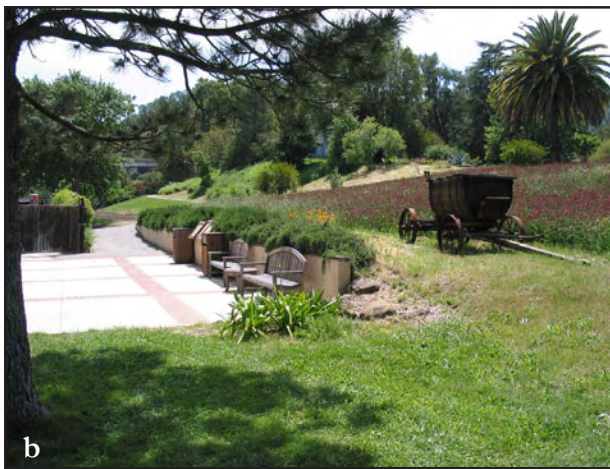
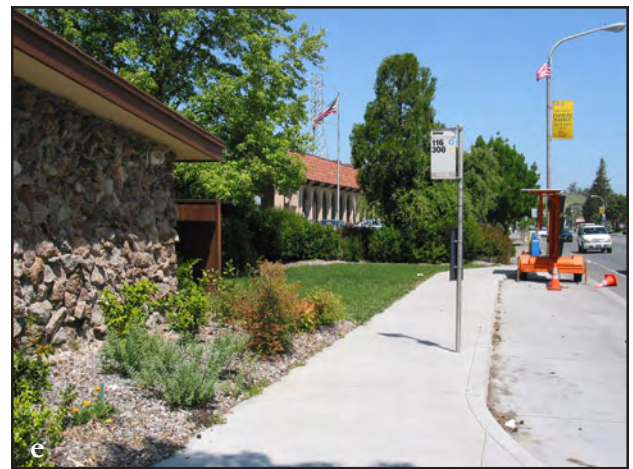
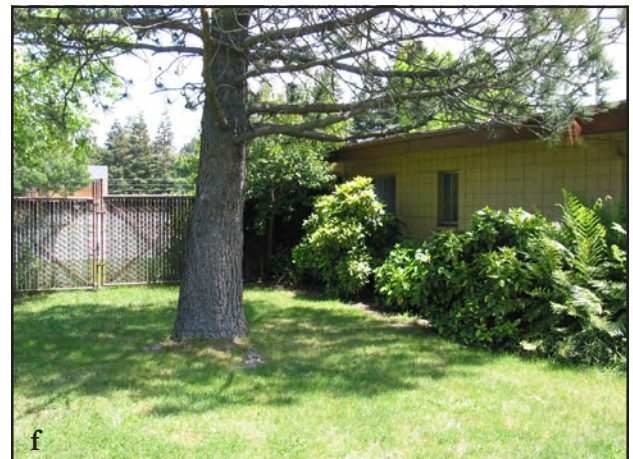
**Figure 8.45: Visitor Center - Vegetation**

(a) Coast live oak and Canary Island date-palm along north-east boundary fence, view north from patio; (b) Perennials and mass of rosemary along patio wall, view southwest from northwest of Visitor Center; (c) California white oak and apples along west parking lot fence, view south from patio retaining wall; (d) Mass of apricot, cork oak, and coast redwood along south parking lot fence, view east from easy access path; (e) Planting beds along east foundation wall, view north; (f) Coulter pine and foundation plants along north wall; view east from lawn. (OCLP, 2003).

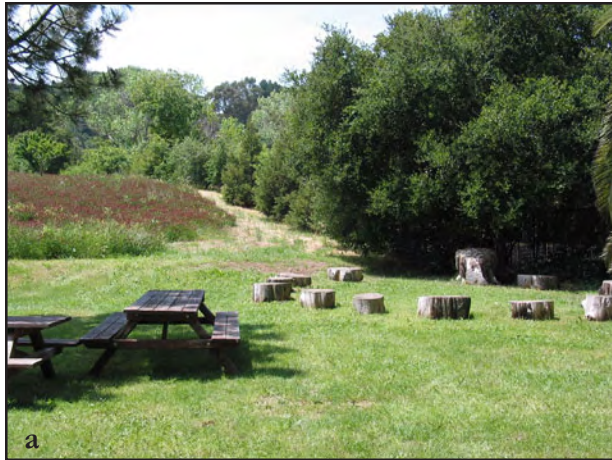
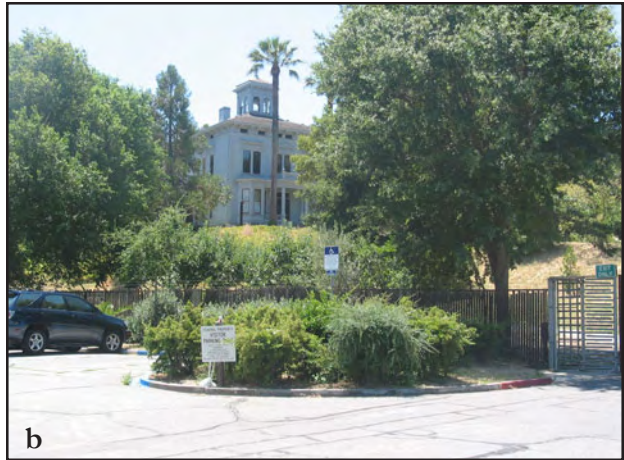
**Figure 8.46: Visitor Center - Vegetation**

(a) Lawn area on northeast side of Visitor Center, view west from near boundary fence; (b) Mass of toyons in parking lot island, view southwest from parking lot. (OCLP, 2003).

**VC: VEGETATION (FIGURES 8.45 AND 8.46)**

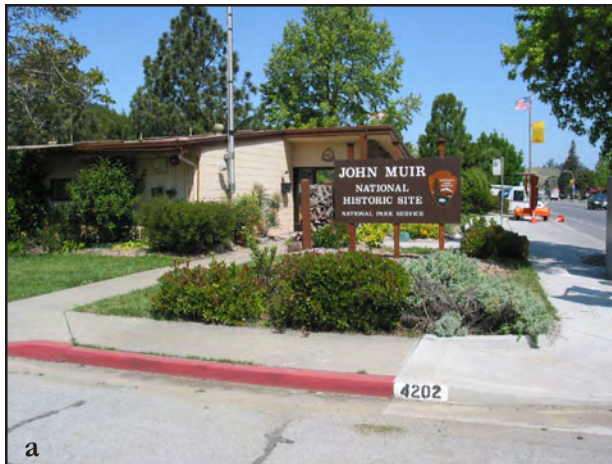
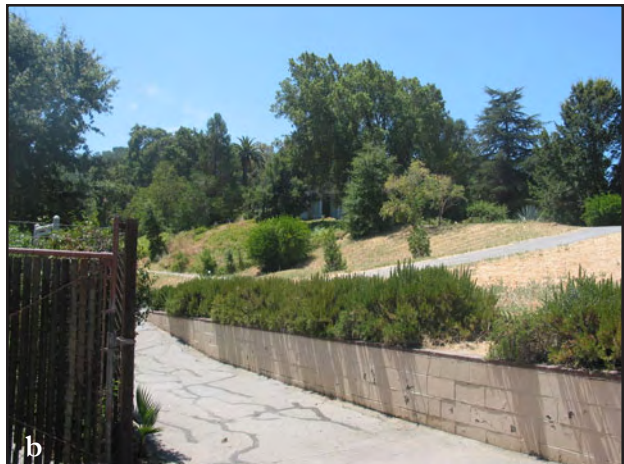
**Figure 8.47: Visitor Center - Buildings and structures**

(a) Visitor Center, view north from parking lot entrance; (b) South end of patio retaining wall, view southwest from patio. (OCLP, 2003).

**VC: BUILDINGS AND STRUCTURES (FIGURE 8.47)****Visitor Center**

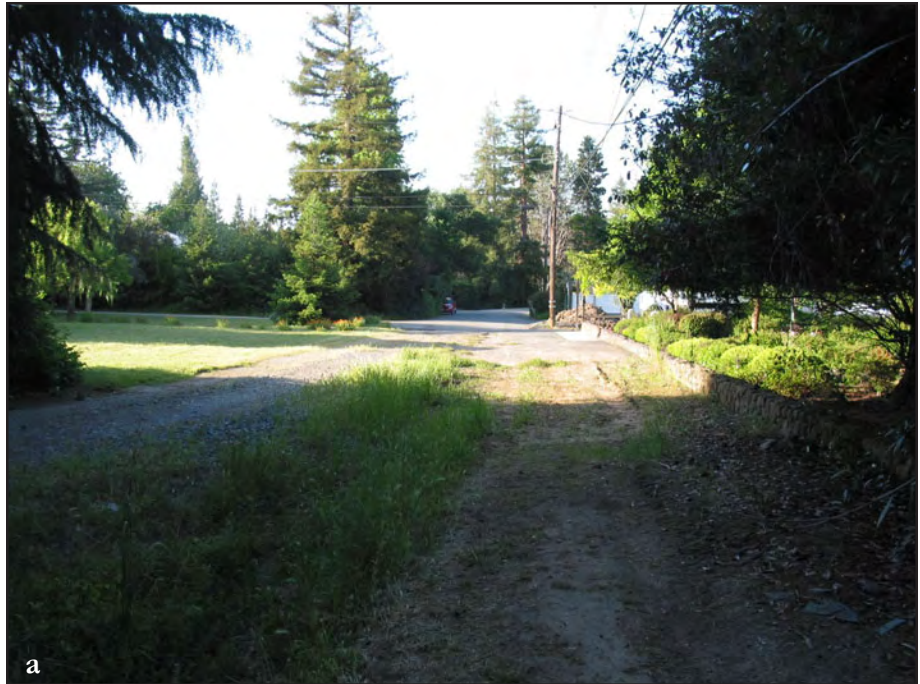
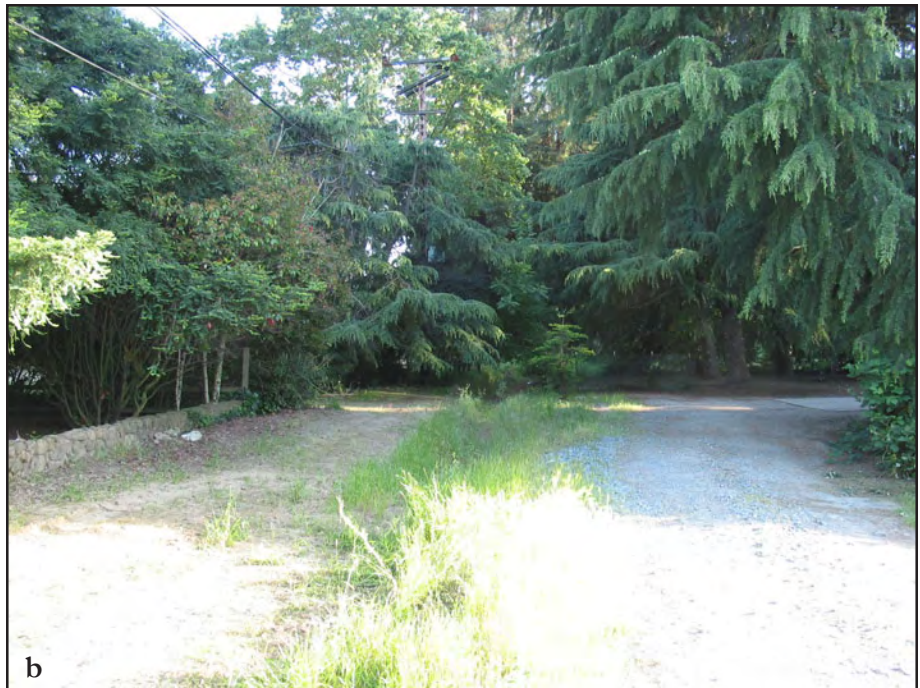
**Figure 8.48: Gravesite - Circulation**  
(a) View looking north at Strentzel Lane, a paper street, from the entrance clearing at the Gravesite Unit; b) View looking south at the same street and the entrance opening at mid-left. Both were photographed prior to recent plantings of olives. (OCLP, 2003).

**GRAVESITE UNIT – (GR)****GR: CIRCULATION (FIGURE 8.48)****Parking area and entrance**

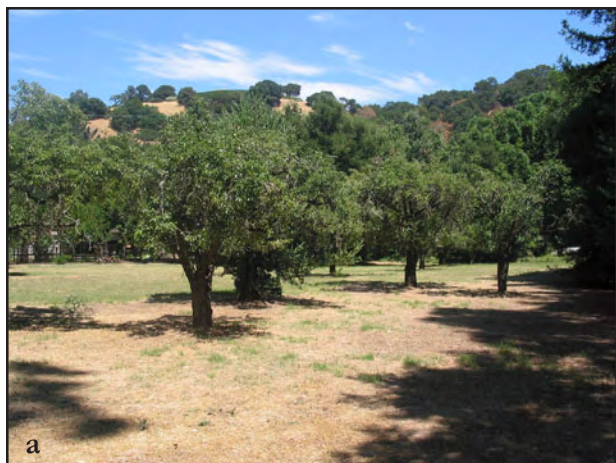
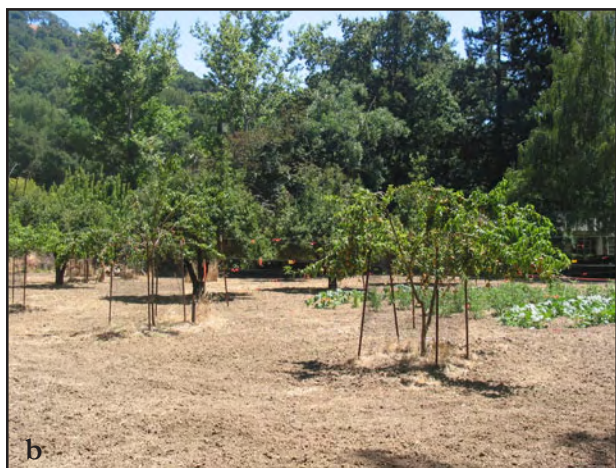
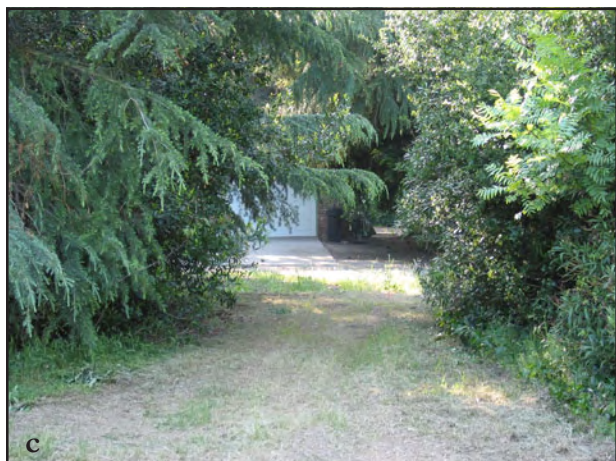
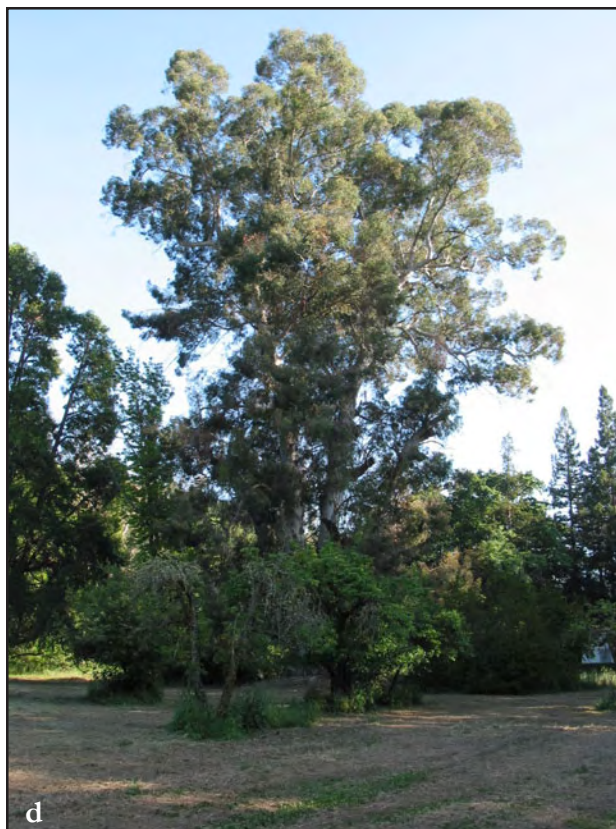
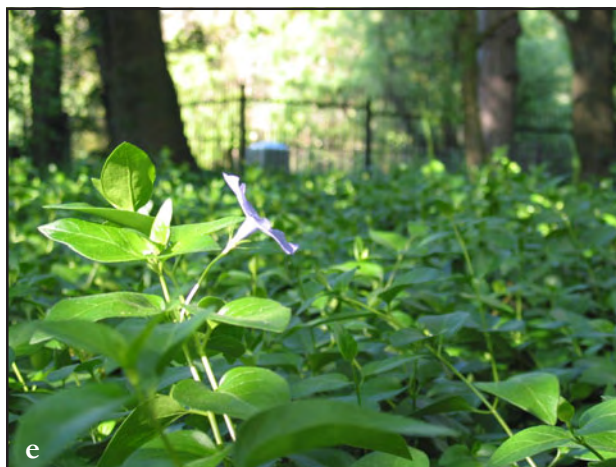
**Figure 8.49: Gravesite - Vegetation**

(a) Remnant pear trees from the historic orchard occupying the northern half of the parcel, view northeast; (b) Non-historic pear and peach trees and a vegetable garden in the southern wedge of the property, view southwest; (c) Oleander and Sitka spruce frame the pedestrian entrance and designated staff parking area, view west; (d) Historic pear trees dwarfed by the historic eucalyptus, view south from orchard; (e) Mass of vinca under a canopy of riparian vegetation south of the gravesite, view north. (OCLP, 2003).

**GR: VEGETATION (FIGURE 8.49)**
