OLMSTED  
CENTER  
*for* LANDSCAPE PRESERVATION

# CULTURAL LANDSCAPE REPORT FOR JOHN MUIR NATIONAL HISTORIC SITE

VOLUME 1: SITE HISTORY, EXISTING CONDITIONS, AND ANALYSIS

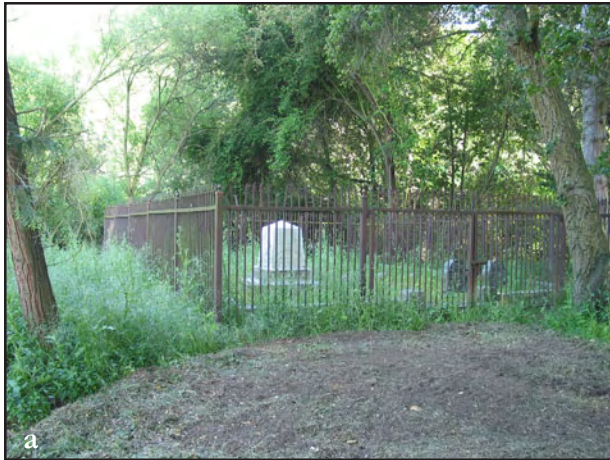
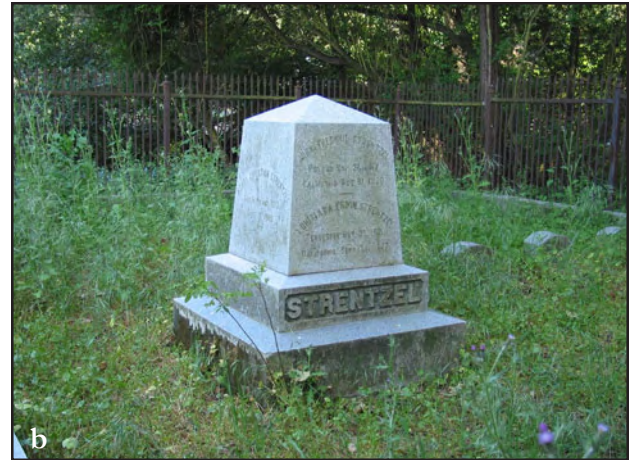
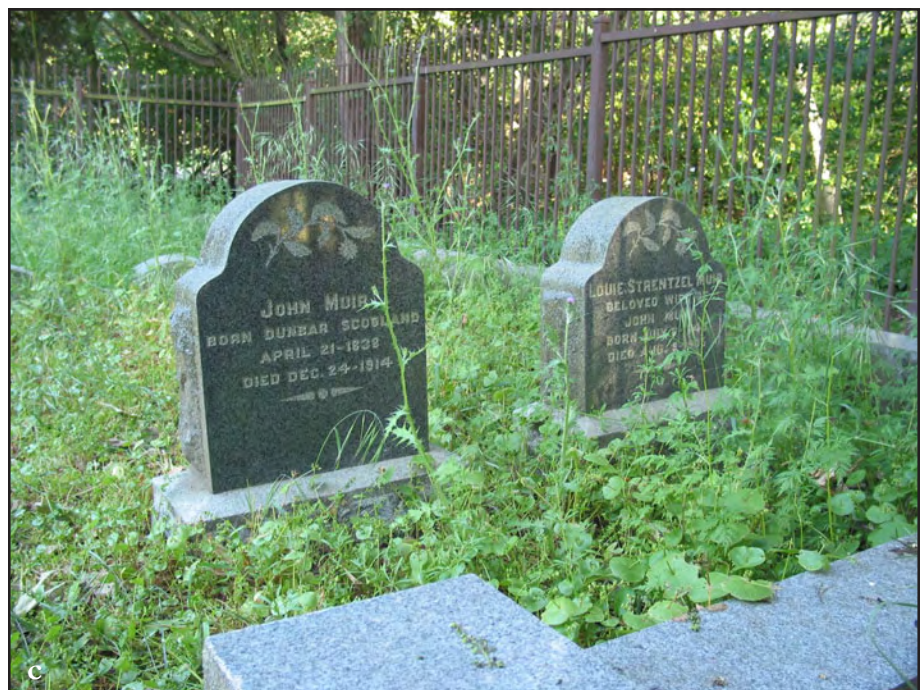
**Figure 8.50: Gravesite - Buildings and structures**  
 (a) Wrought iron fence on top of the cemetery enclosure that surrounding the graves, view southeast; (b) Strentzel family monument, view southeast; (c) Gravemarkers of John Muir and Louie Strentzel Muir, view southeast. (OCLP, 2003).

#### **GR: BUILDINGS AND STRUCTURES (FIGURE 8.50)**

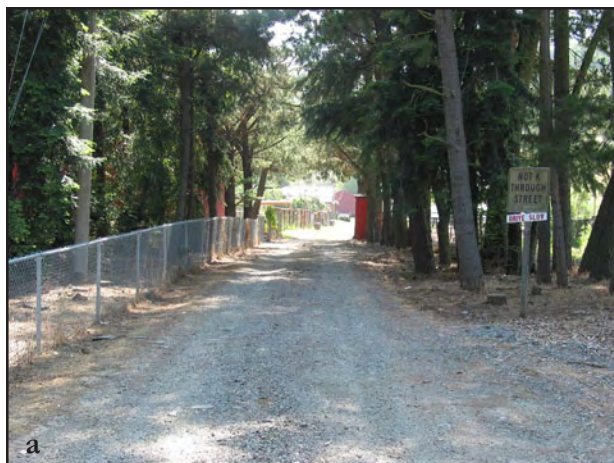
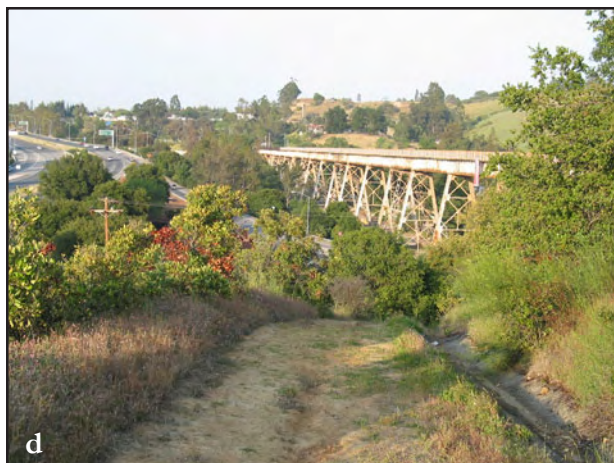
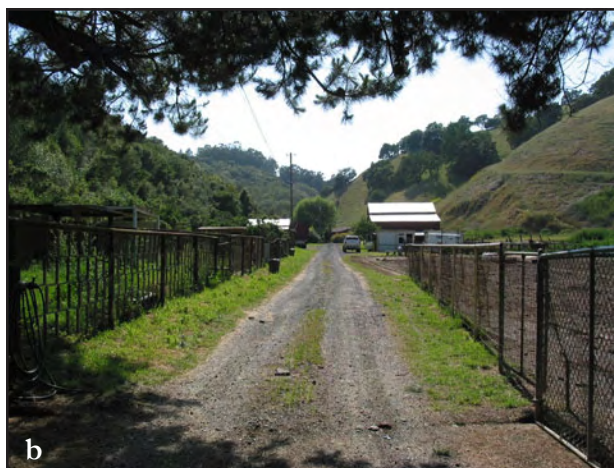
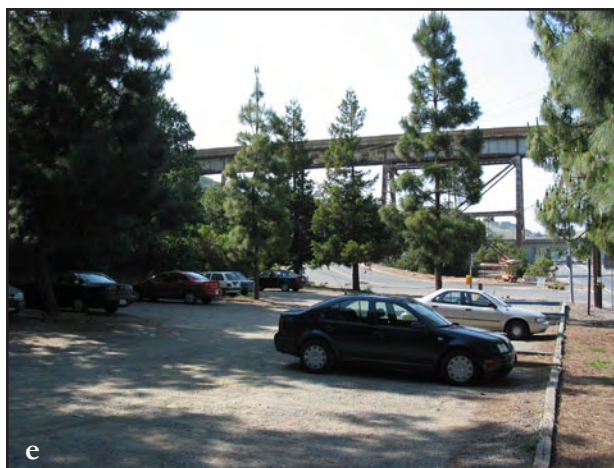
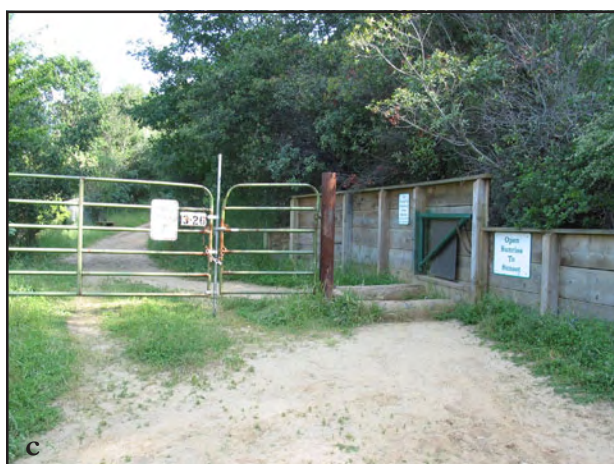
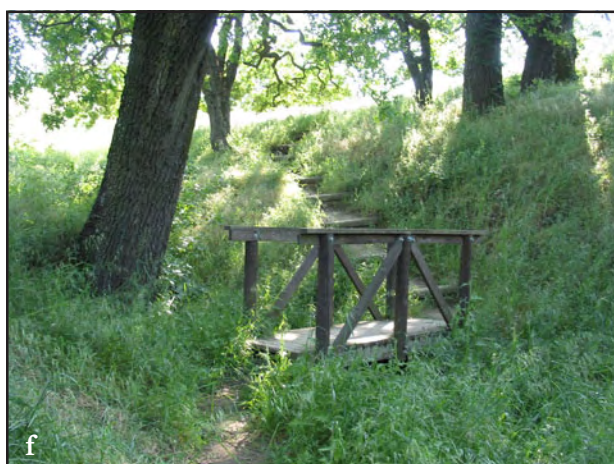
**Figure 8.51: Mt. Wanda - Circulation**

(a) Entrance of farm road at Strain Ranch, view west from Alhambra Valley Road; (b) Farm road at Strain Ranch, view west from corrals; (c) Lower trailhead of main fire road, view south; (d) Section of California Riding and Hiking Trail on north slope of Mt. Wanda, view east from trail; (e) Park and ride lot at trailhead, view north; (f) Footbridge along nature trail loop, view southwest. (OCLP, 2003).

### **WA: CIRCULATION (FIGURE 8.51)**

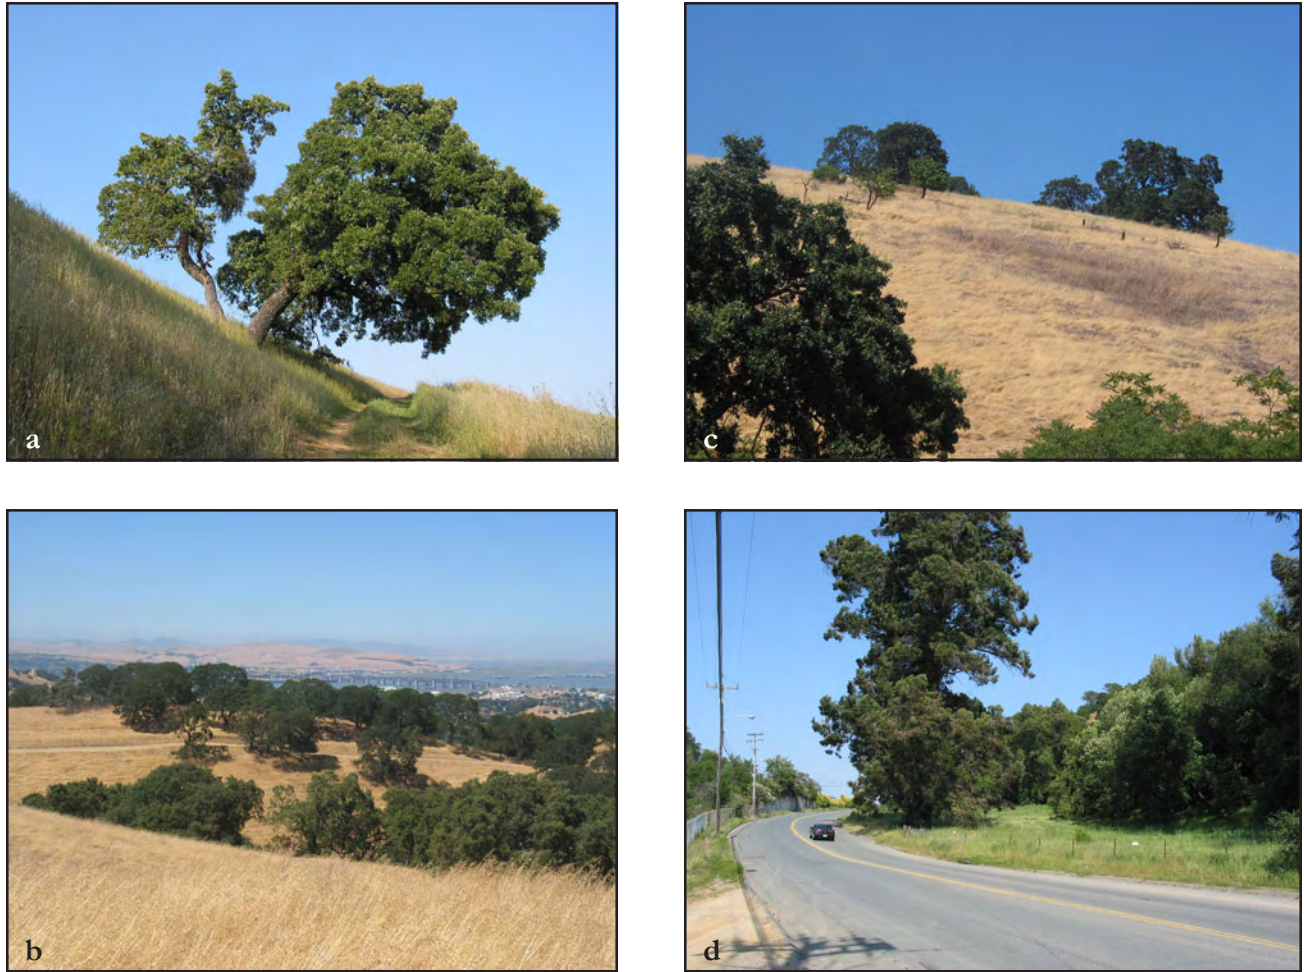
**Figure 8.52: Mt. Wanda - Vegetation**

(a) Grasslands and part of a woodland on a south-facing slope at Mt. Wanda, view east from main fire road; (b) Woodlands and grasslands on top of Mt. Wanda, view northeast from radio repeater tower; (c) Remnant apricot trees on south-facing slope above Mt. Wanda, view north from Strain Ranch farm road; (d) Historic eucalyptus tree at lower north slope of Mt. Wanda. (OCLP, 2003).

**WA: VEGETATION (FIGURE 8.52)****Woodlands and grasslands**

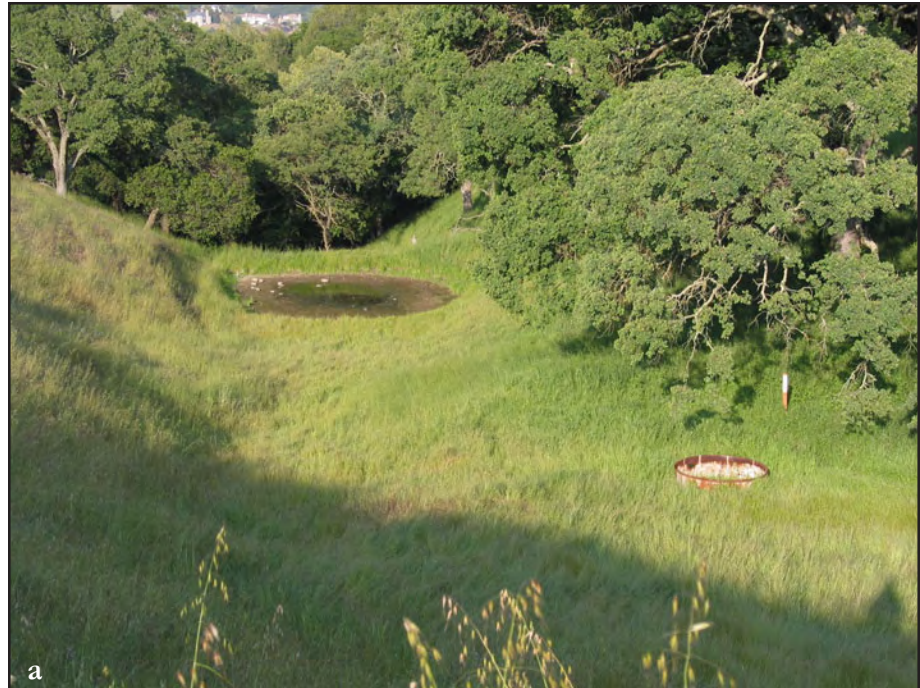
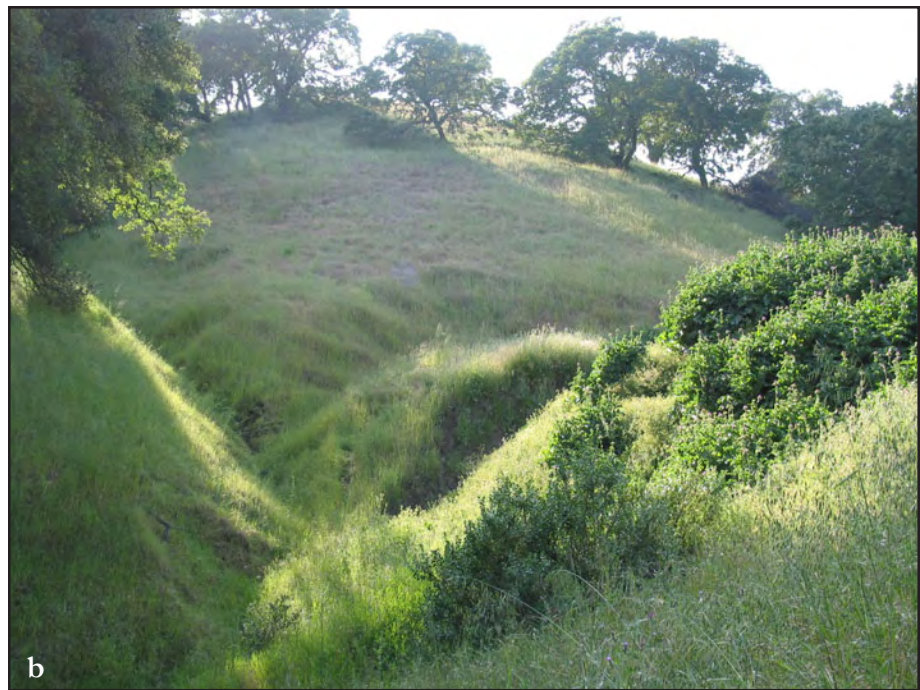
**Figure 8.53: Mt. Wanda -  
Buildings and structures  
(a) Earthen dam and pond  
south of main fire road, view  
east; (b) Breached earthen  
dam east of western end of  
main fire road, view  
northwest. (OCLP, 2003).**

**WA: BUILDINGS AND STRUCTURES (FIGURE 8.53)****Bungalow**

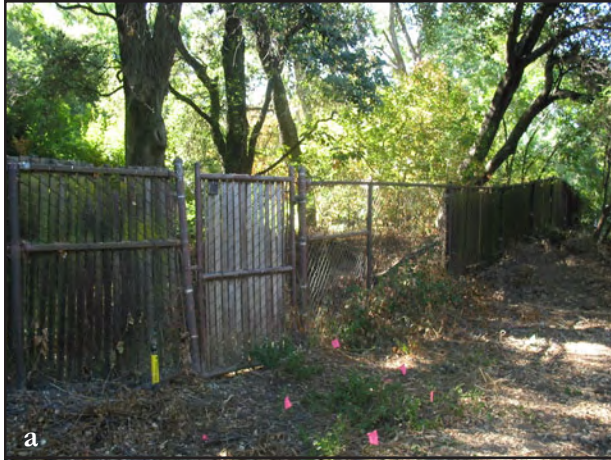
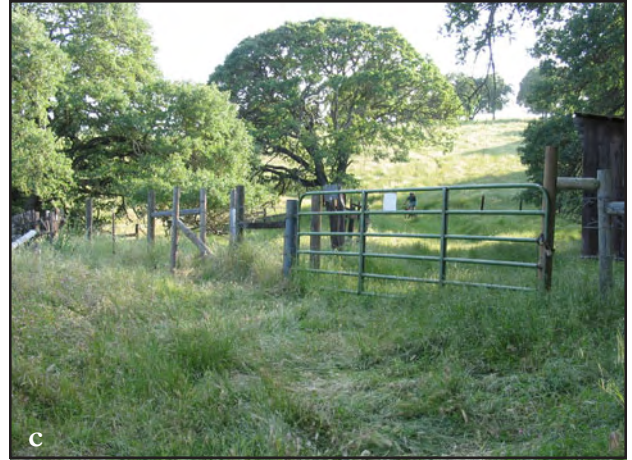
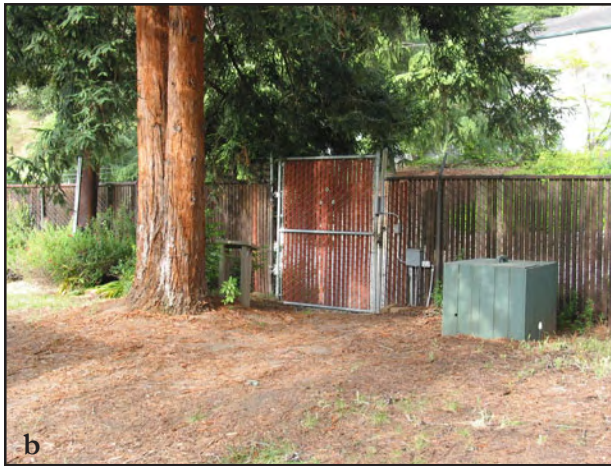
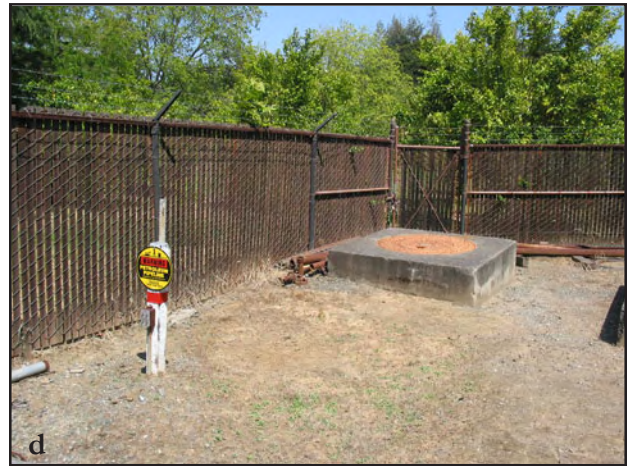
**Figure 8.54: Small-scale features - Fences and gates**

(a) Portion of House Unit boundary fence with missing slats, view northwest from fish pond; (b) Portion of west boundary fence at the House Unit, view southwest from main farm road; (c) Portion of wire and board fencing along west boundary of Mt. Wanda, view southwest from main fire road; (d) Interior of Union Oil Company easement at southwest corner of House Unit, view northeast from Canyon Way. (OCLP, 2003).

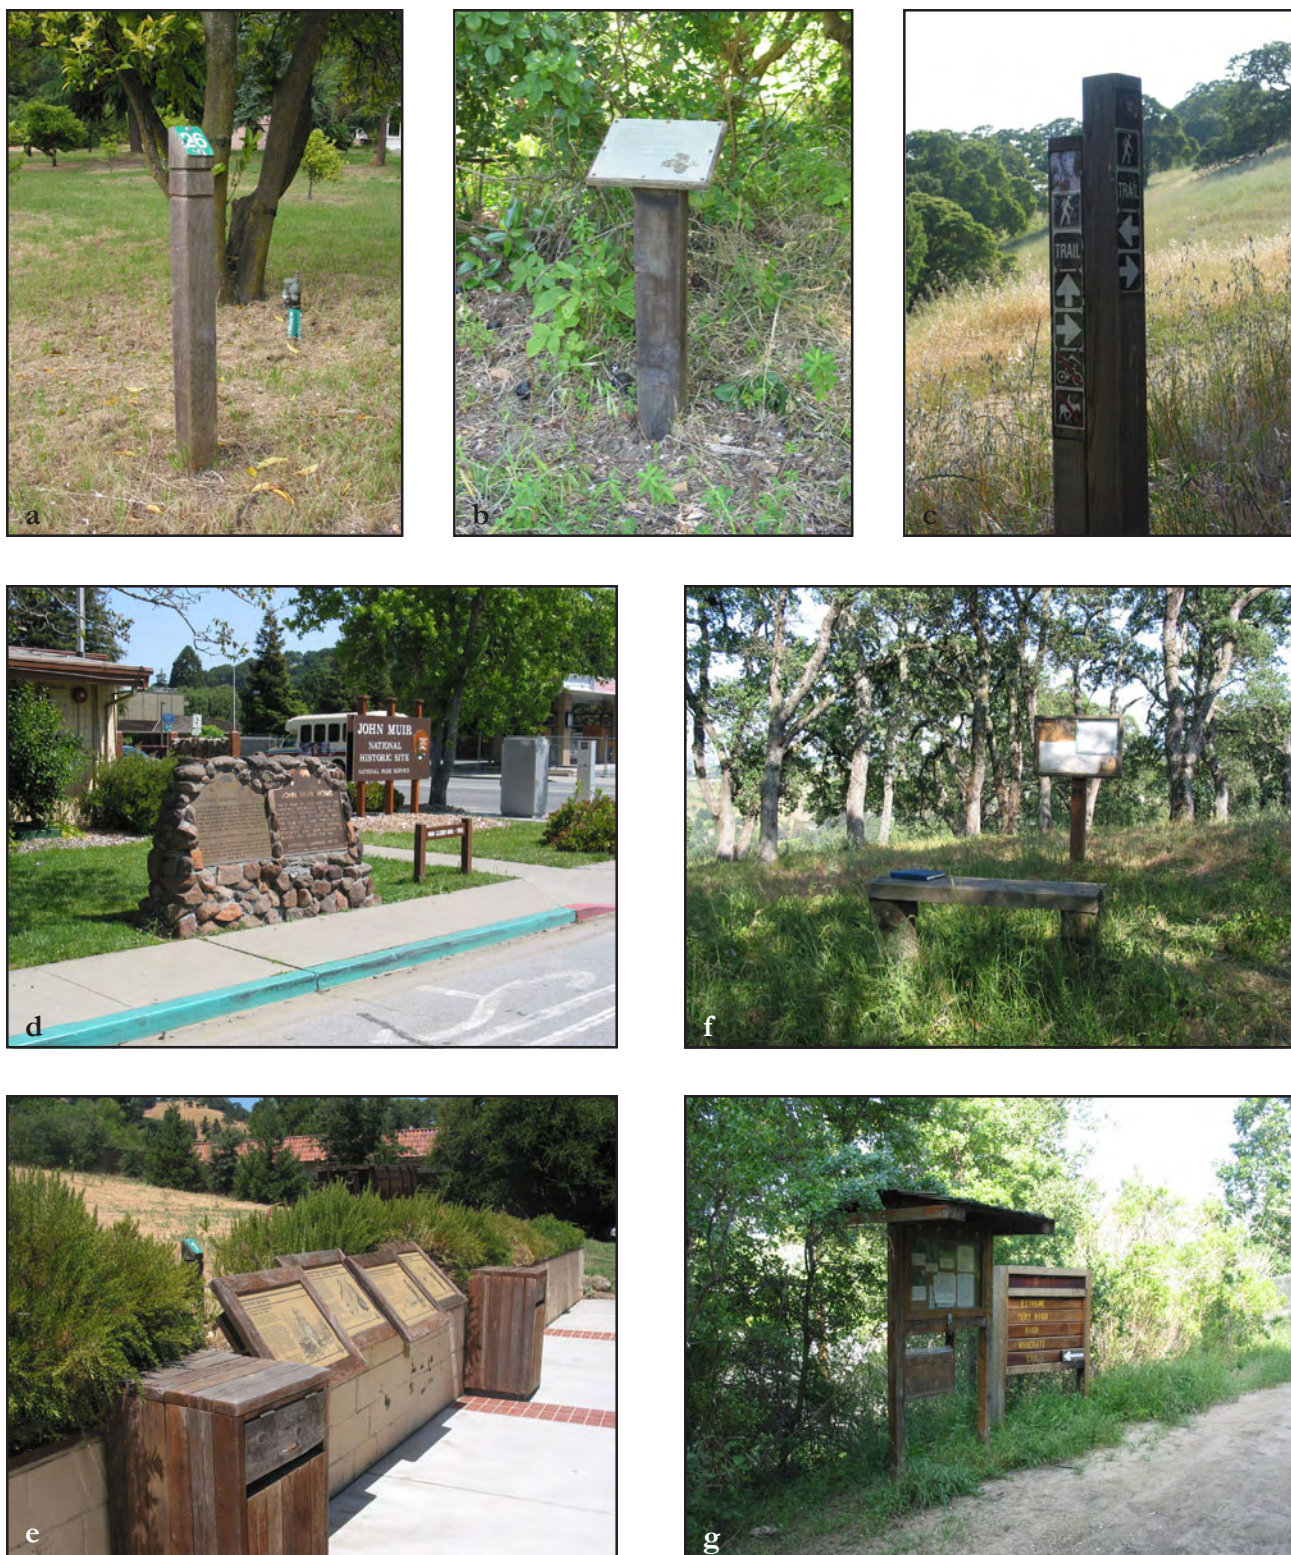
**Figure 8.55: Small-scale features - Signs**

(a, b, c) Trail signs at the House and Mt. Wanda units; (d) California historical marker monument, hours of operation sign, and main park sign at the Visitor Center, view northeast from parking lot; (e) Wayside signs attached to the patio wall at the Visitor Center, view northwest from patio; (f) Bench and interpretive sign off of Mt. Wanda nature trail,, view south; (g) Kiosk and fire danger sign at foot of main fire road on Mt. Wanda, view southwest. (OCLP, 2003).

**PW: SMALL-SCALE FEATURES – SIGNS (FIGURE 8.55)**

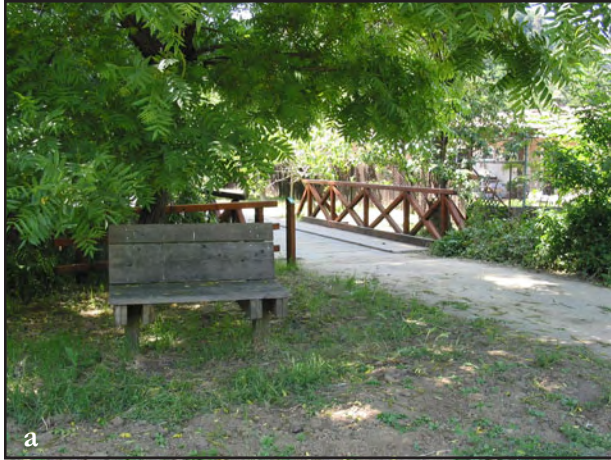
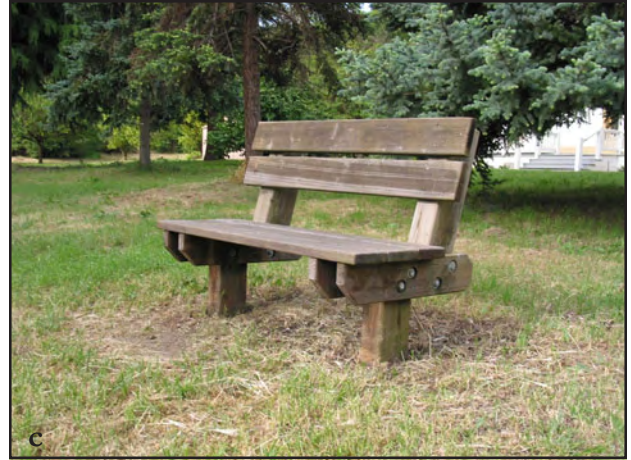
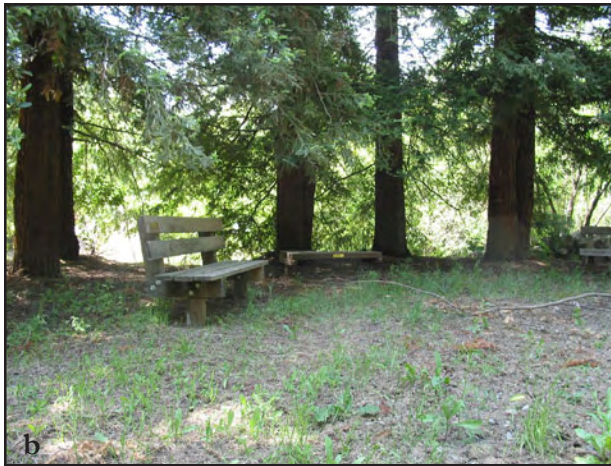
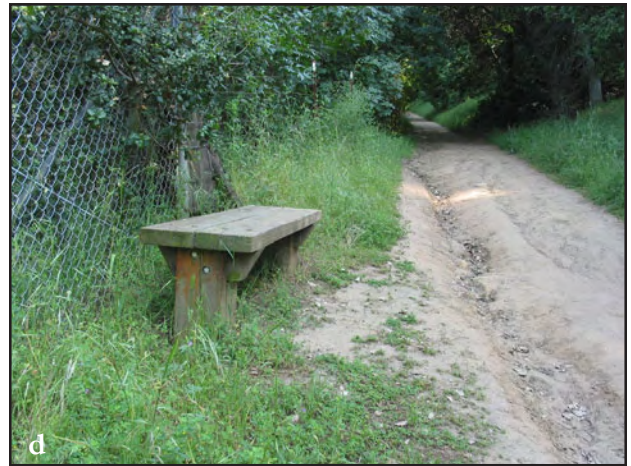
**Figure 8.56: Small-scale features - Benches**

**(a) Bench at House Unit at Franklin Creek; (b) Two types of benches amongst the redwood grove along Franklin Creek; (c) Bench with back northeast of Martinez Adobe; (d) Bench along main fire road near the park and ride lot. (OCLP, 2003).**

#### **PW: SMALL-SCALE FEATURES – BENCHES (FIGURE 8.56)**

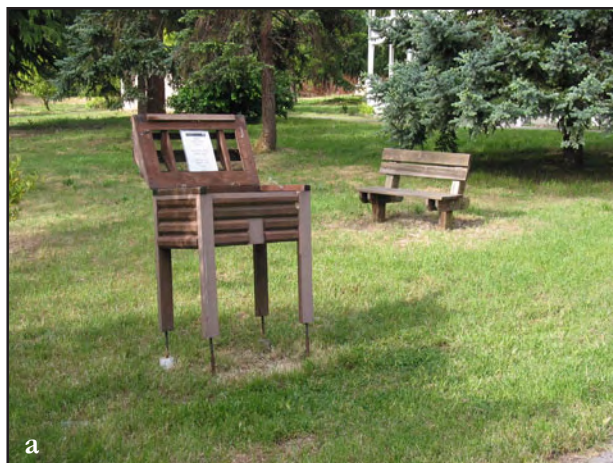
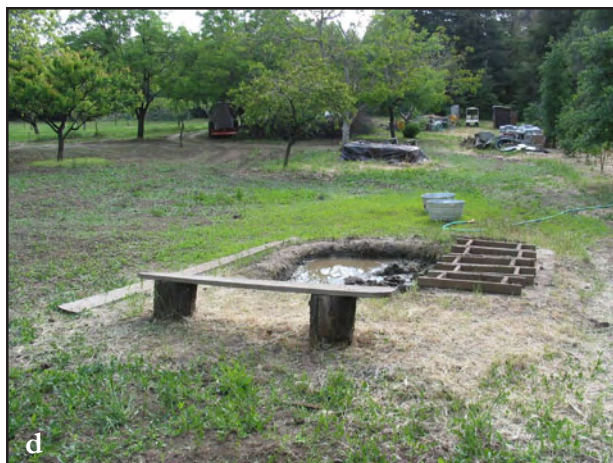
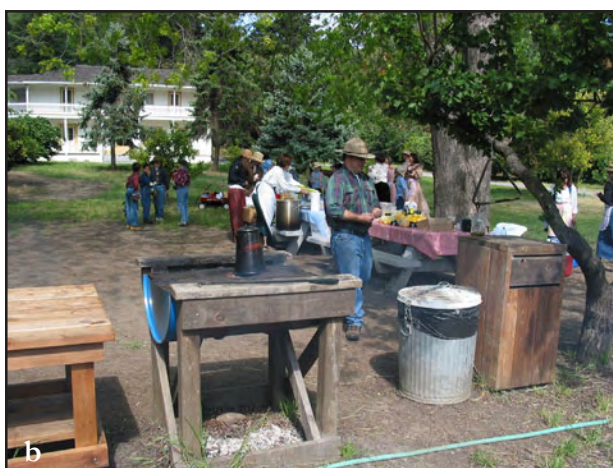
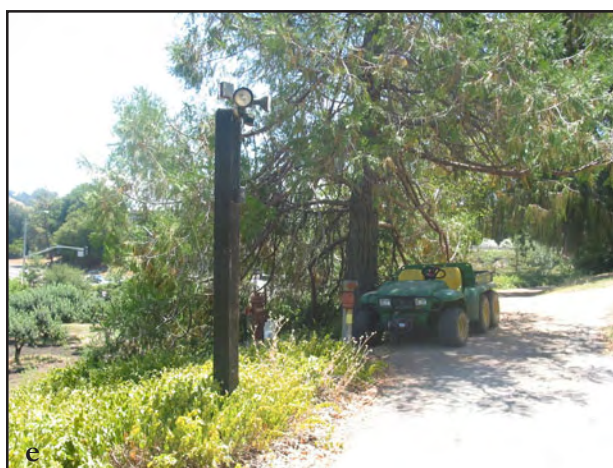
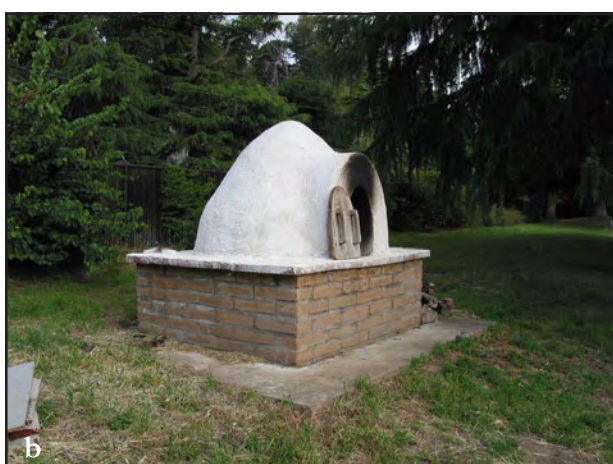
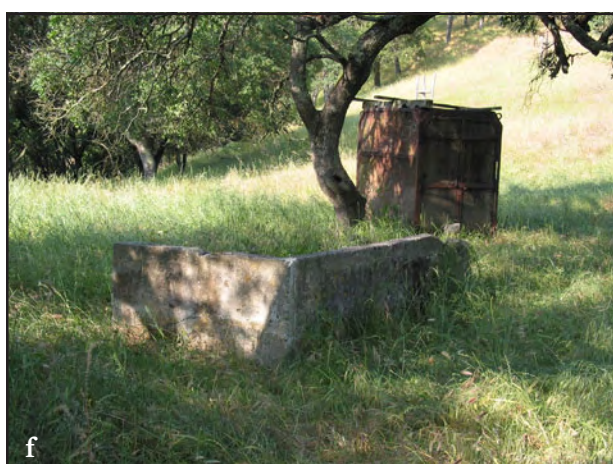
**Figure 8.57: Small-scale features - Miscellaneous**

**(a) Fruit box northeast of Martinez Adobe; (b) Grill and picnic area in west orchard; (c) Beehive oven south of adobe; (d) Adobe brick-making pit in west orchard; (e) Security light northeast of Muir House; (f) Remnant livestock grazing structures on top of Mt. Wanda. (OCLP, 2003).**

#### **PW: SMALL-SCALE FEATURES – MISCELLANEOUS (FIGURE 8.57)**

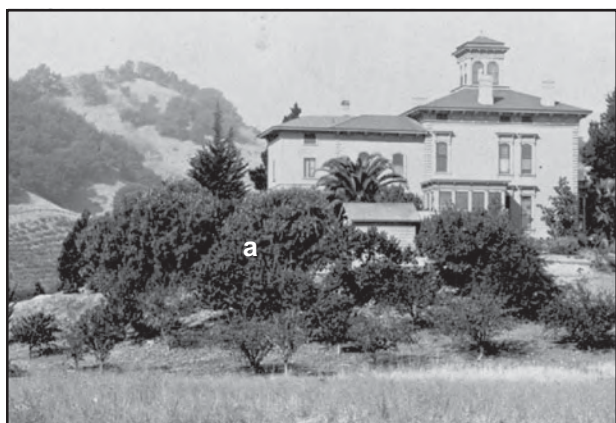
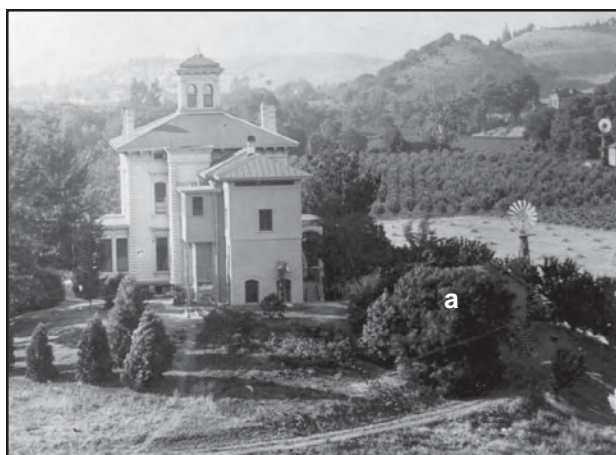
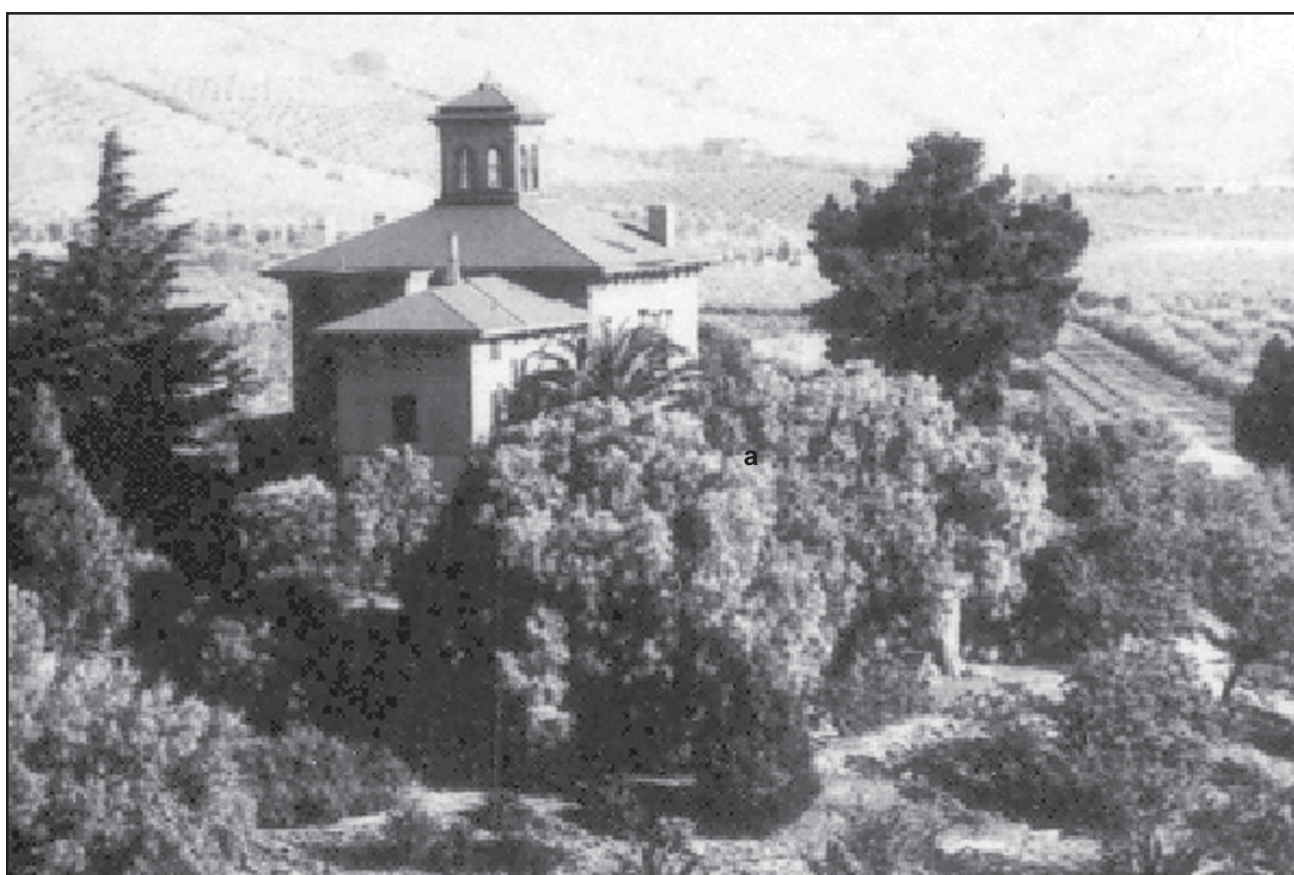
**Figure A4.3: Three historical views of the mass of trees (a) southeast of the Muir House from the early 1890s (top left), c.1898 (top right), and c.1910-1914 (bottom). (F13, Fr. #651, Holt-Atherton; A1-20, JOMU, Ref: 1898c P24; and A1-30, JOMU, Ref: 1910-14c P29).**

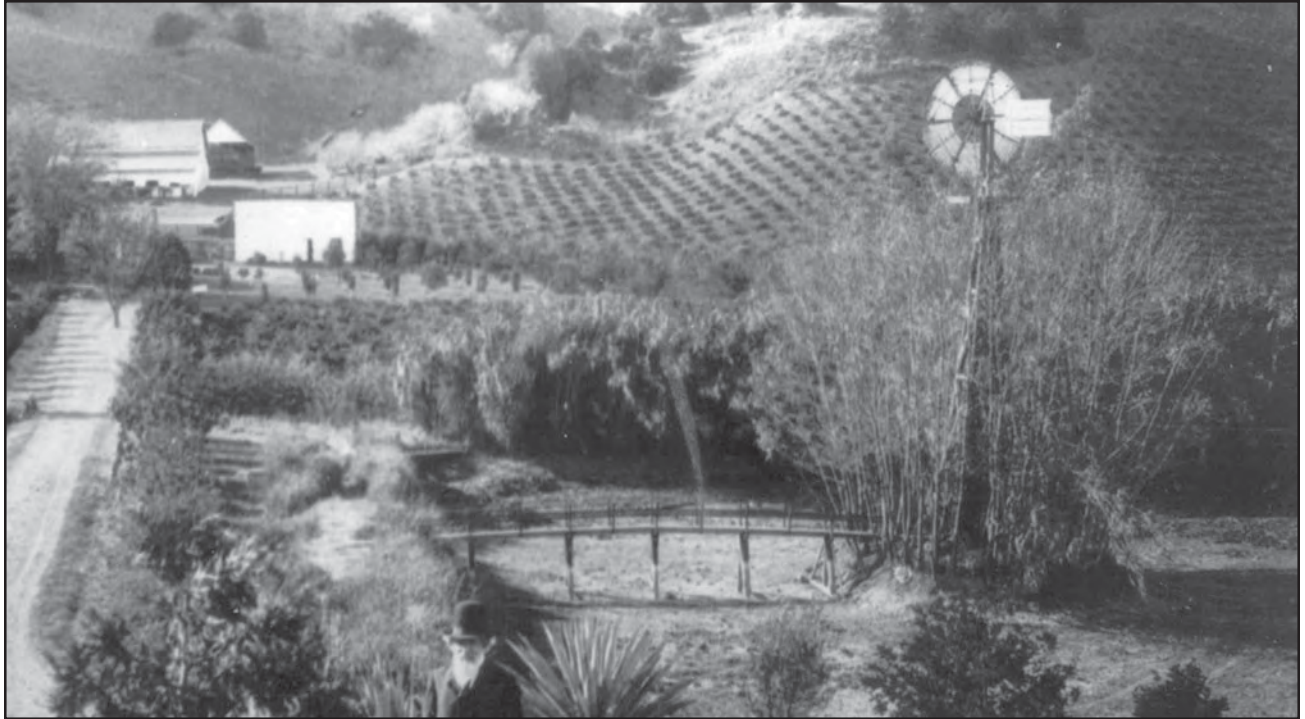
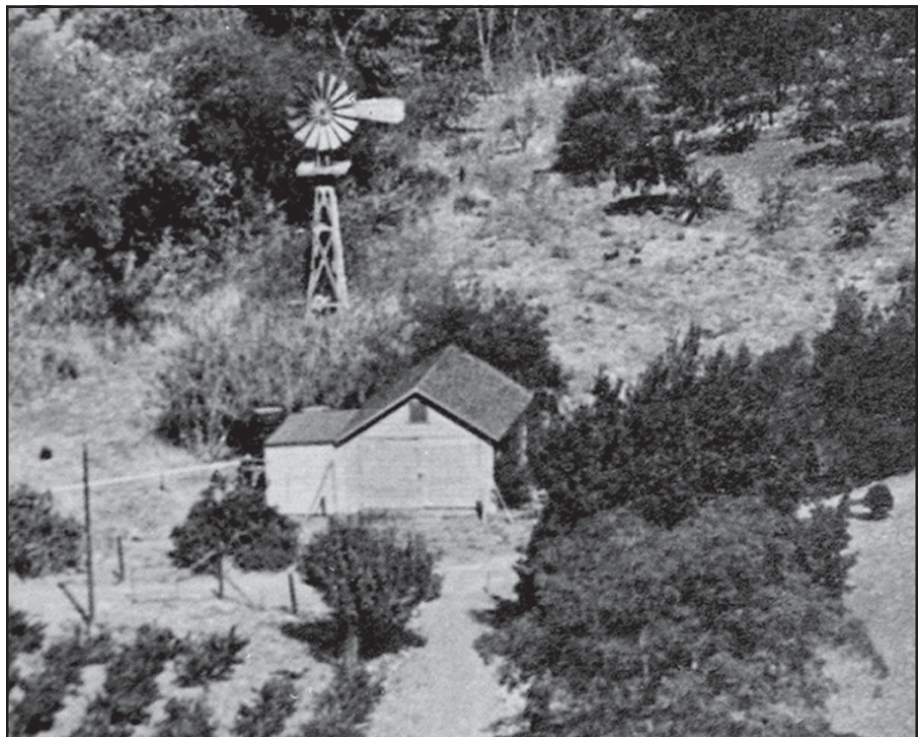
**Figure A4.4: Two vantages of vegetation around the Franklin Creek Well and Windmill from c.1885 (top) and c.1910 (bottom). (D6-1, Ref: 1885cP17 and A1-19, Ref: 1910-14cP27).**

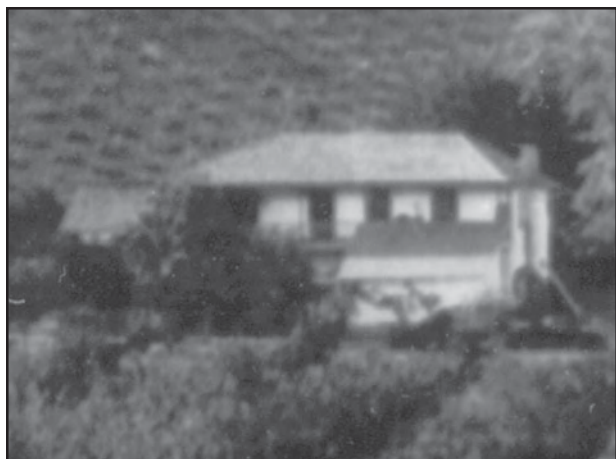
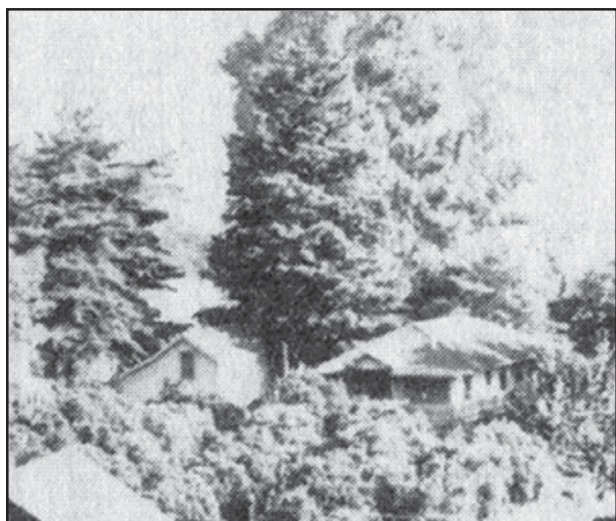
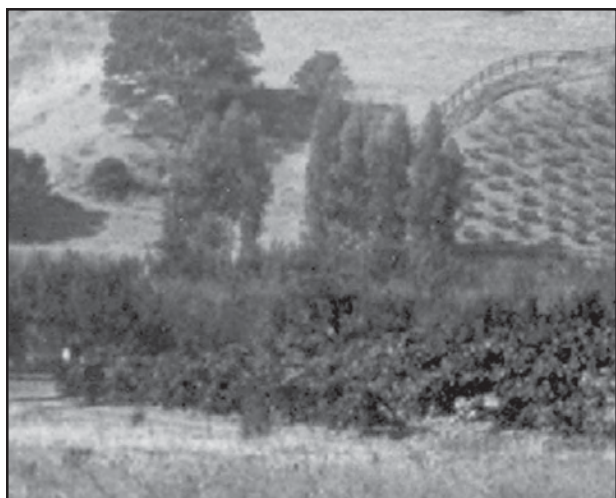
**Figure A4.5: Three detailed views of the mass of cypress or pines behind the Martinez Adobe in c.1885 (top); c.1901 (middle); and c.1900-1905 (bottom). (D6-1, Ref: 1885cP17; Historic Structures Report, Martinez Adobe; and F13, Fr. #651, Holt Atherton).**

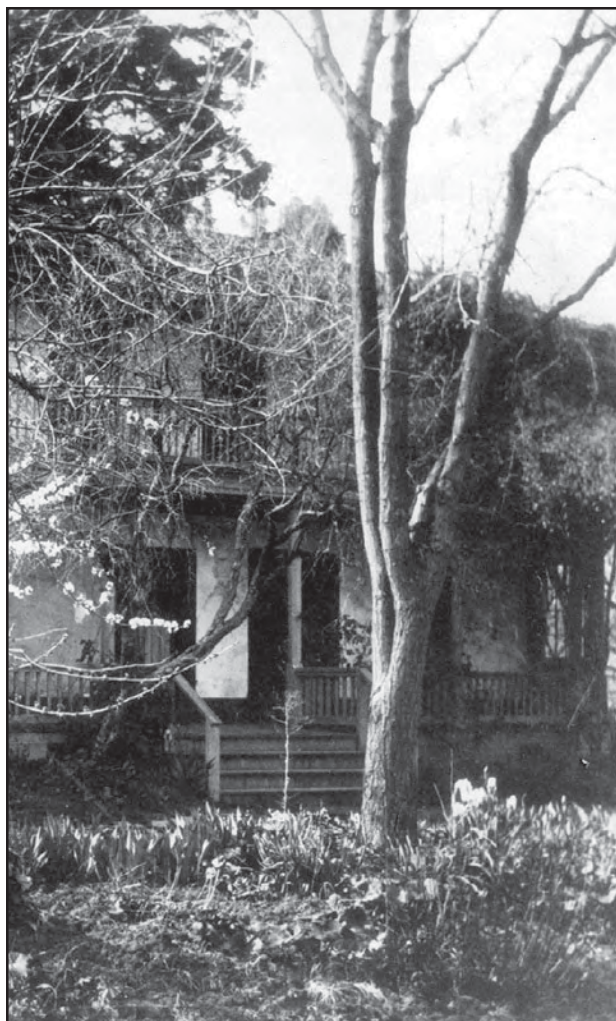
**Figure A4.6: Closeup view of one of the three black locust trees that grew in front of the Martinez Adobe from c.1912-1913. (B1-39, JOMU).**

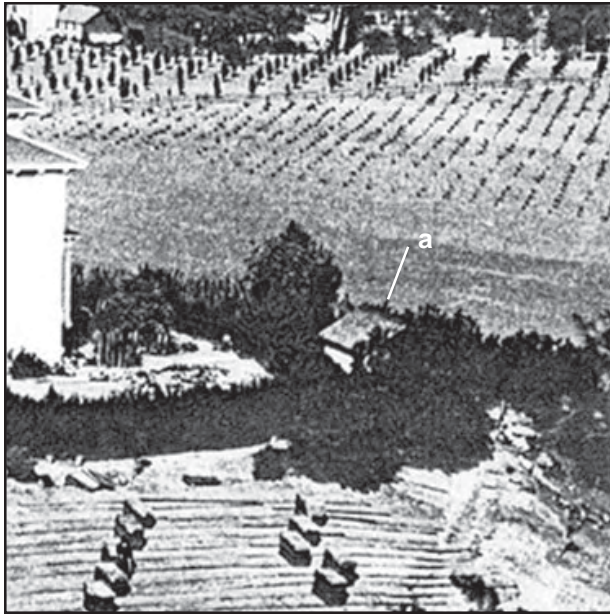
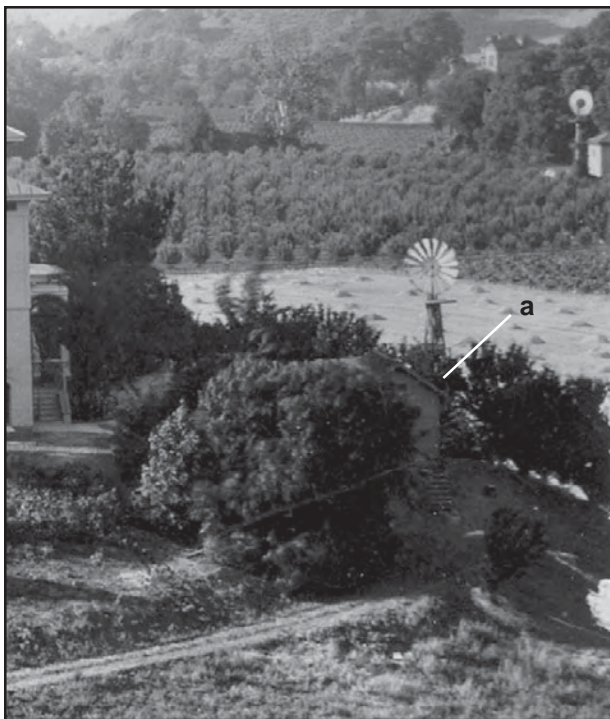
**Figure A4.7: Three views of the Woodshed (a) on the east side of the Muir House from c.1887 (top left); c.1898 (top right); and c.1900-1905 (bottom left). (Isaiah West Taber photo No. 3707; A1-20, Ref: 1898cP24; and F13, Fr. #651, Holt-Atherton).**

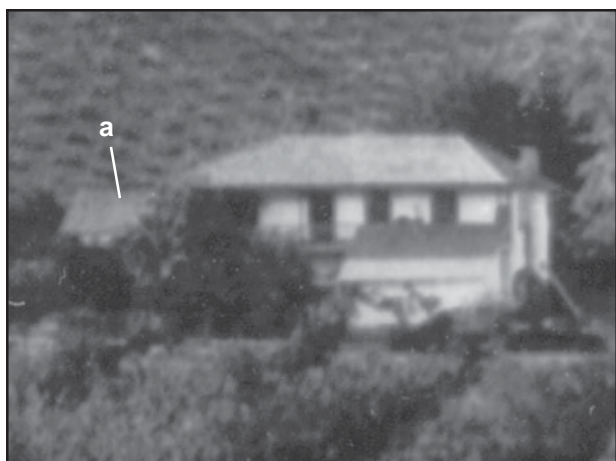
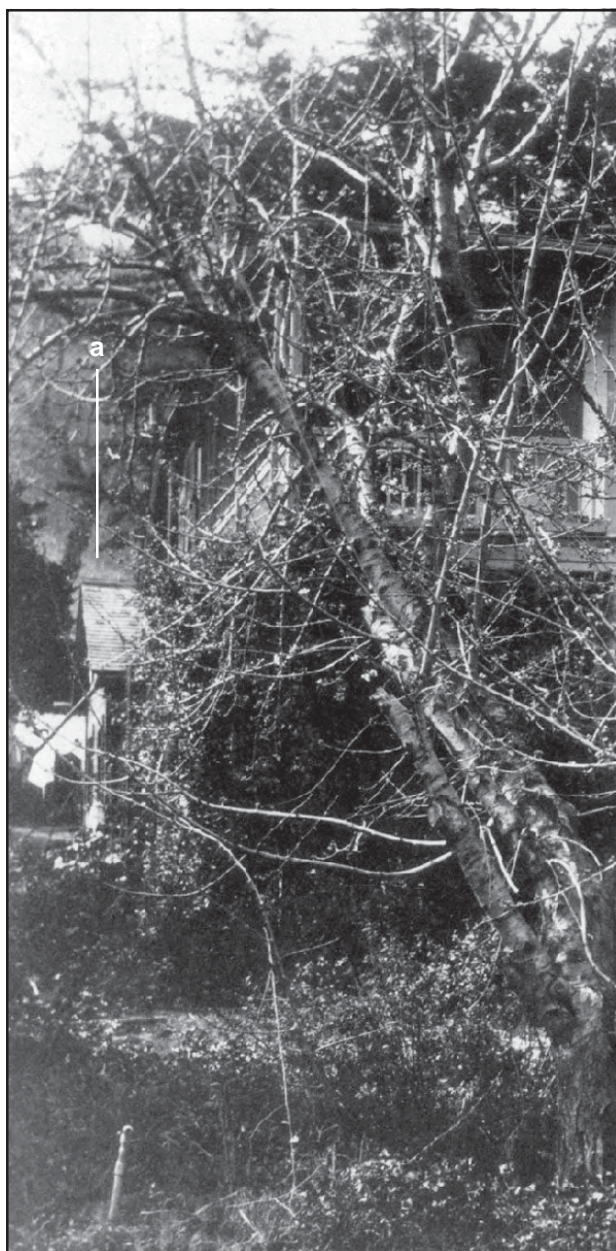
**Figure A4.8: Three views of the Bunkhouse/Ranch foreman's house (a) from c.1885 (top left); c.1901 (bottom left); and c.1912-1913 (right). (D6-1, Ref:1885cP17; HSR, Martinez Adobe; and B1-39, JOMU).**

apparently rented the building to the Hirano family until c.1922. In the late 1920s, the building was rented to Charlie Curry. The structure was removed in c.1962-1963 except for the foundation. Between 1964 and 1976, the foundations of the Bunkhouse as well as the Cookhouse were removed or covered.

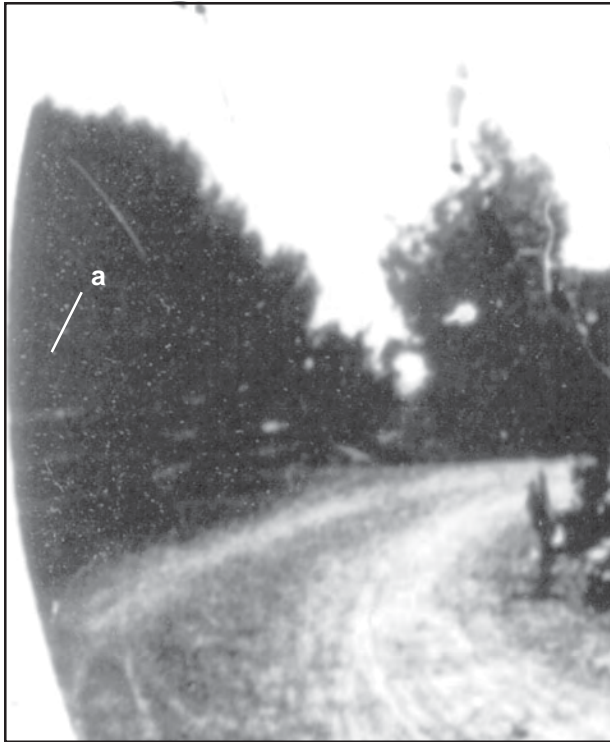
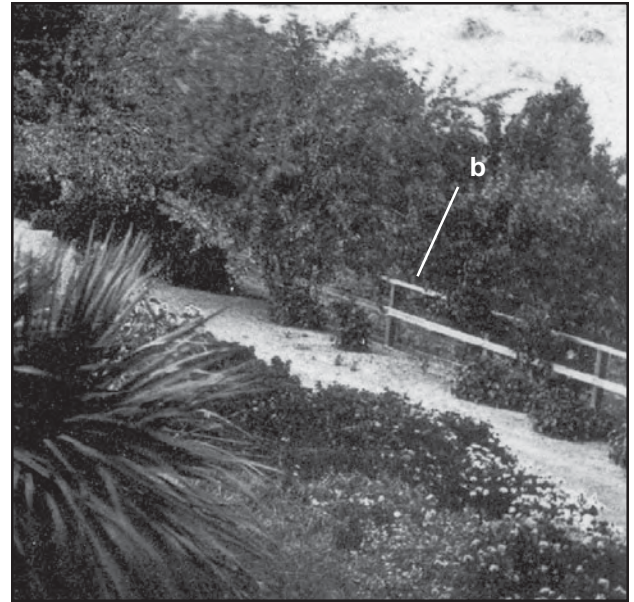
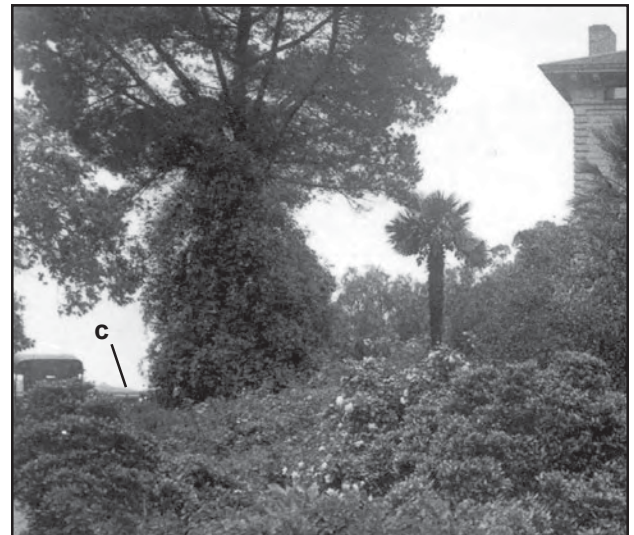
**Figure A4.12: Closeup views of the three-board fence (a) along the east side of the carriage drive-loop in c.1886, a two-board fence (b) in approximately the same location in c.1900-1905; and the top of a fence (c) in c.1914 which appears to continue southward, east of the Muir House (A1-93, Ref: 1886cP1; D3-2, JOMU, Ref: 1900-05cP30; and A1-32, JOMU).**

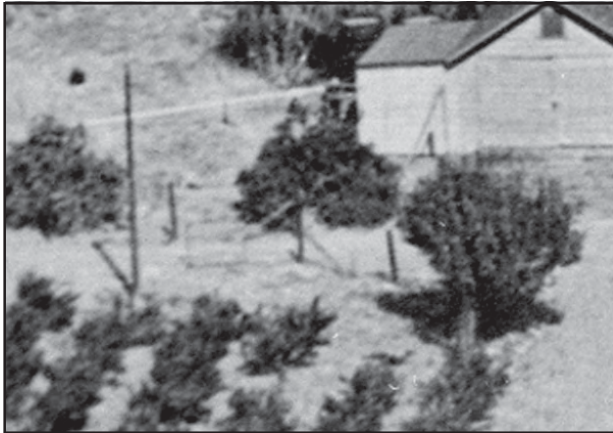
**Figure A4.13: Post and wire fencing marked the boundaries of the Muir Homestead beginning in 1908. Two photographs from c.1910 show a section of fencing and a gate across the main farm road (left) and along the south side of the knoll (below). (A1-19, JOMU, Ref: 1910-14cP27 and A1-30, JOMU, Ref: 1910-14cP27).**
