# BURCH HOUSE

LINCOLN HOME NATIONAL HISTORIC SITE

## HISTORIC STRUCTURE REPORT

May 19, 2006

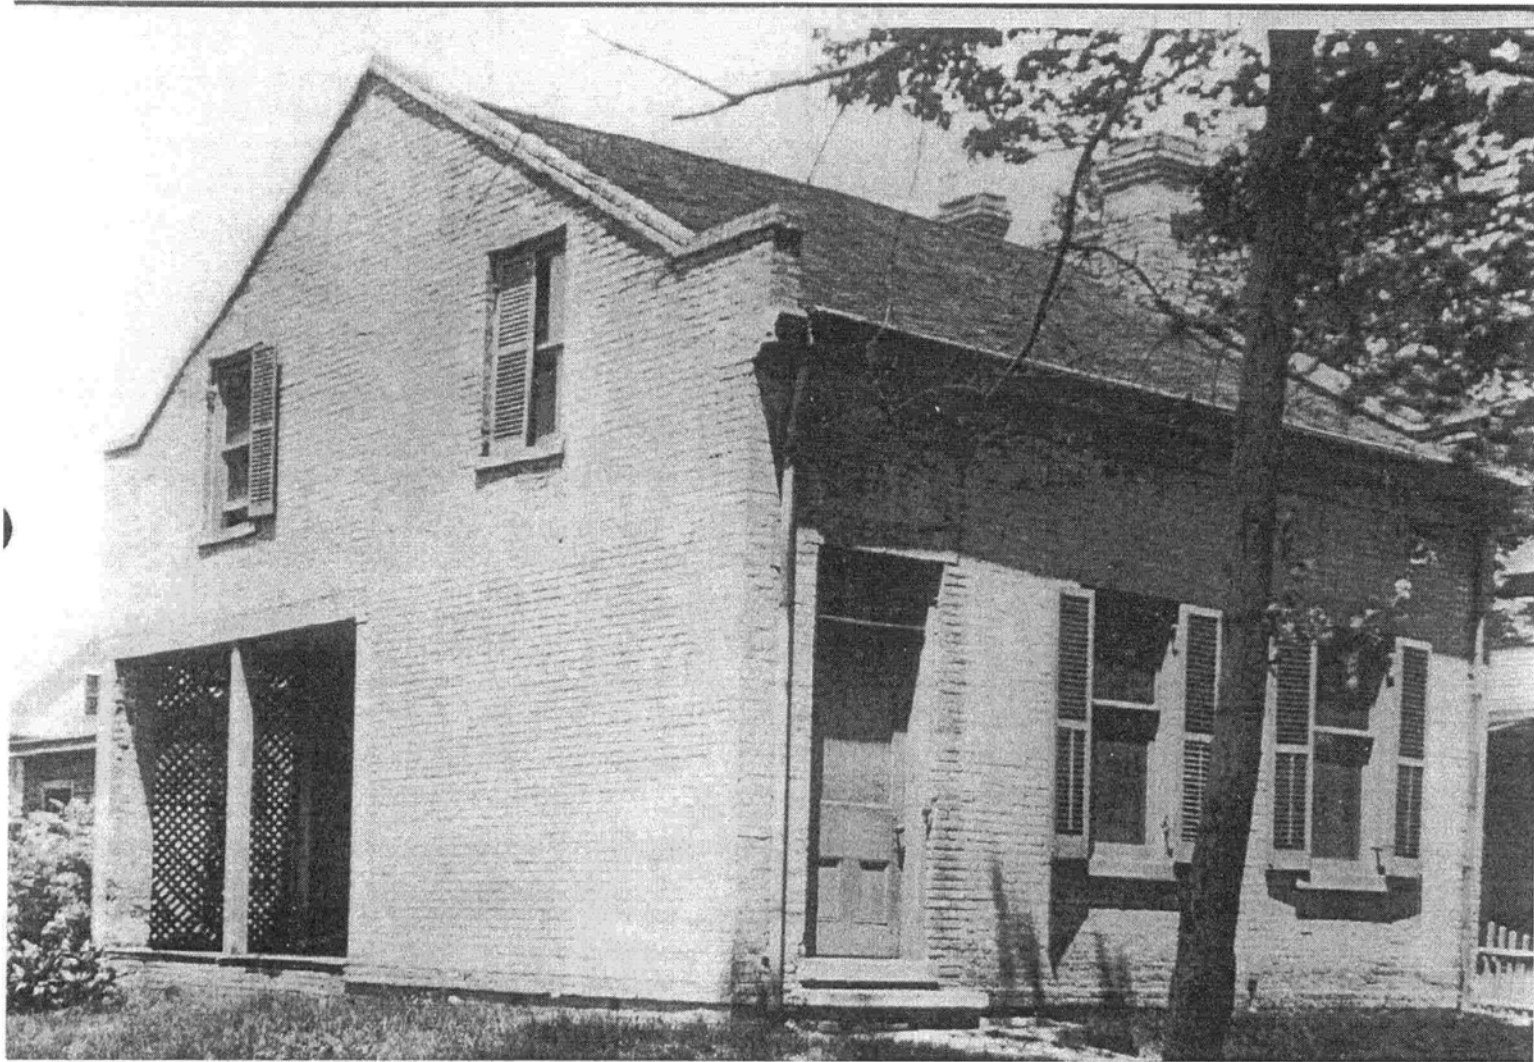
Figure 2-8. The Burch House, c. 1880. View looking northwest. (Courtesy Lincoln Home National Historic Site) It is interesting to note that the Ira Brown, Jr. House, seen to the far right beyond the picket fence, was demolished prior to 1884 the first publication year of the Sanborn maps.

Viewed from the NW corner of Eighth and Jackson, the photographs show a three bay front façade with an open porch on the south elevation. A wood frame extension from the rear can be partially seen. Additionally, a few landscape features are visible. The house appears to be in fair condition. The photograph reveals that several shutters are missing and/or in disrepair and the brick on the corner pier of the open porch is damaged. In addition, the stone lintel above the door appears to be sagging. The area immediately in front of the house is grass covered with no additional landscaping material. A tree is located in the front yard just south of the front walk and branches from a second tree in the front yard are visible in both photographs. Shrubs can be seen planted at the southwest corner of the open porch. A short picket fence runs along the north property line.

The brick is laid in a modified common bond pattern with a header row located on every 7th course. A decorative, two brick corbled band along the foundation can be seen along the east and south elevations. Also along the foundation are vents for a crawl space or basement. There is one located on the front façade between the two windows and two located on the south elevation east of the open porch. The open porch was a feature of the house from its construction, however the post found in the center of the opening on the south elevation may have been placed at a later date for structural support of the wood beam above the porch. Latticework has been installed on the west side of the open porch as a shading mechanism from the harsh late day western sun. A single chimney with a decorative corbelled cap can be seen on the north elevation of the main portion of the house. Another chimney is visible in the photograph, however it likely belongs to the Ira Brown, Jr. House on Lot 10. If the Burch house had another chimney located further west along the north elevation as archeology evidence indicates, it would not be visible because of the angle of the photograph. A parapet rising approximately 21 inches above the roofline along the gabled ends is also visible. Two header rows of brick comprise the coping and a decorative stone corbel is

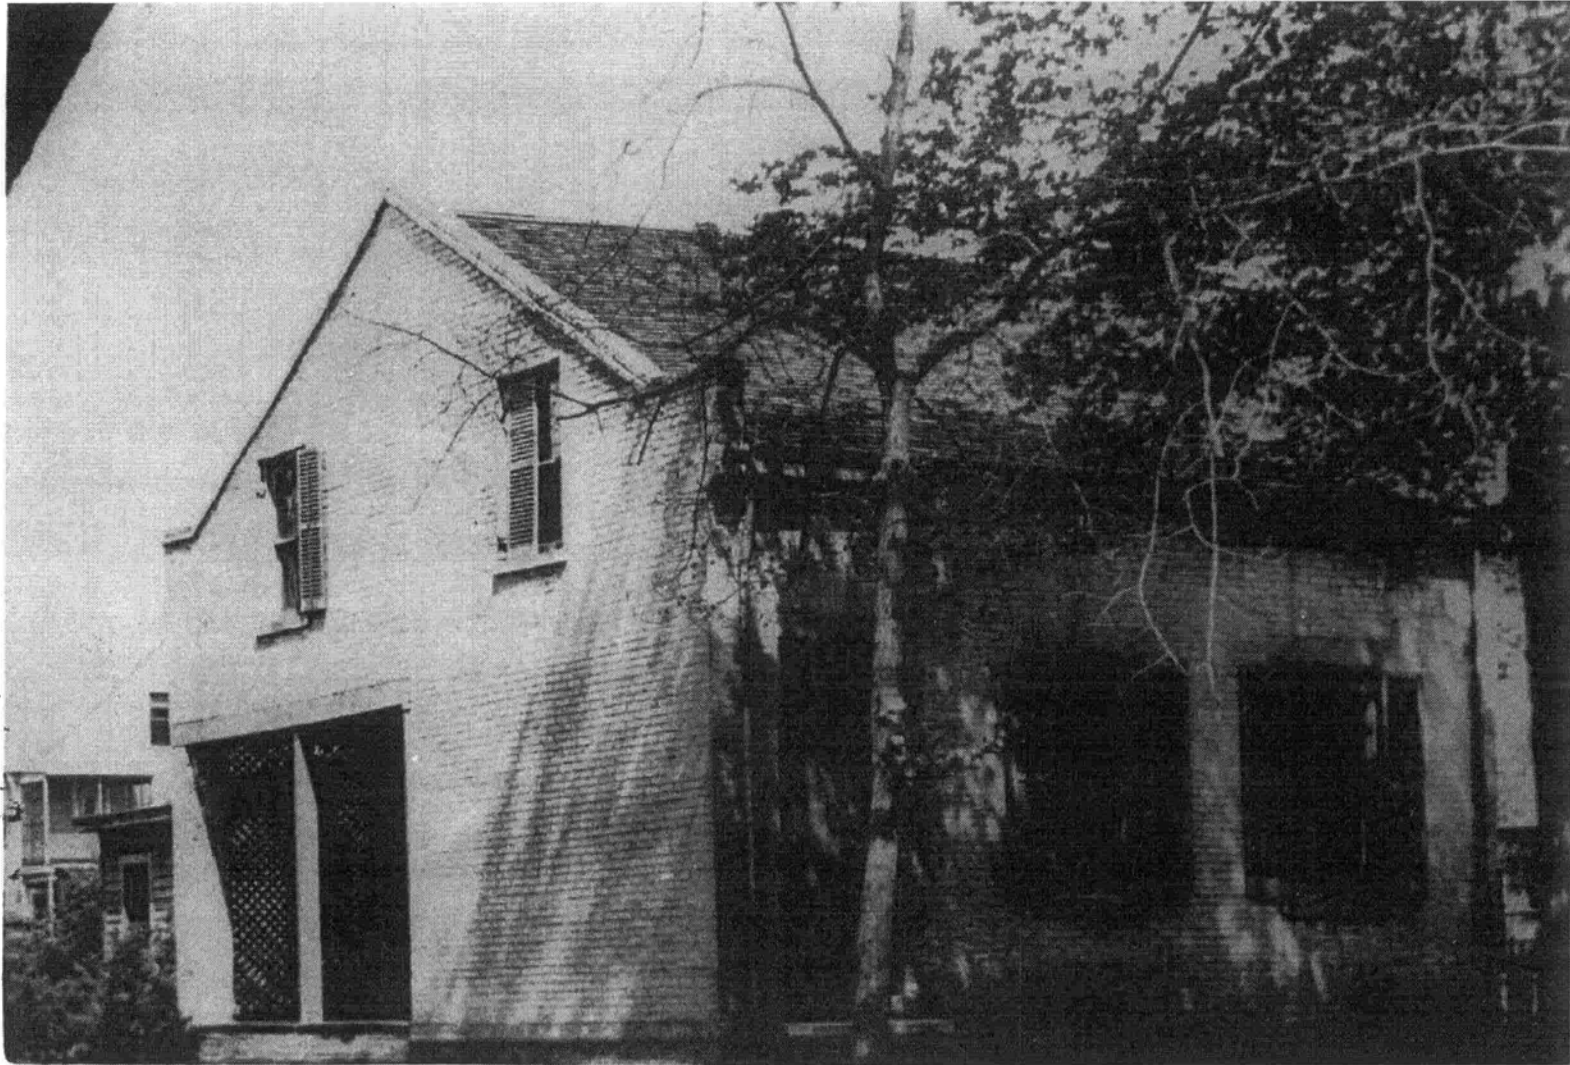
Figure 2-9. The Burch House, c. 1880. View looking northwest. (Courtesy Sangamon Valley Collection, The Lincoln Public Library, Springfield)

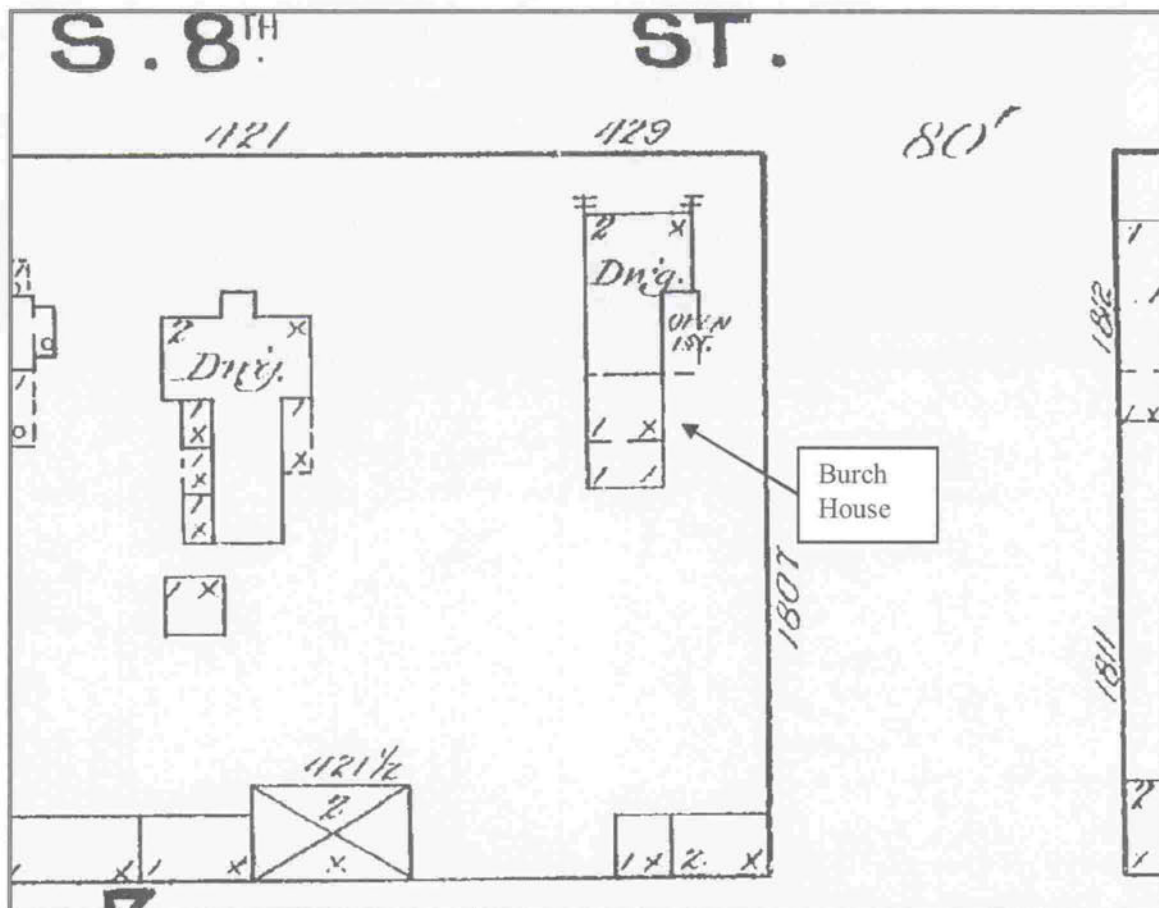
Figure 2-15: Sanborn Map, 1884.

The 1884 map, the earliest Sanborn map of Springfield, shows the Burch house, 429 S. 8<sup>th</sup> Street, unchanged in form compared to the 1858 map. New to the site are two outbuildings of frame construction along the alley to the west. One out-building is larger and indicated as being two-stories, the other is smaller and enumerated as one-story. The 1884 Sanborn map indicates a 12-inch "firewall" or parapet above the roofline, a feature not delineated on the previous Springfield maps.

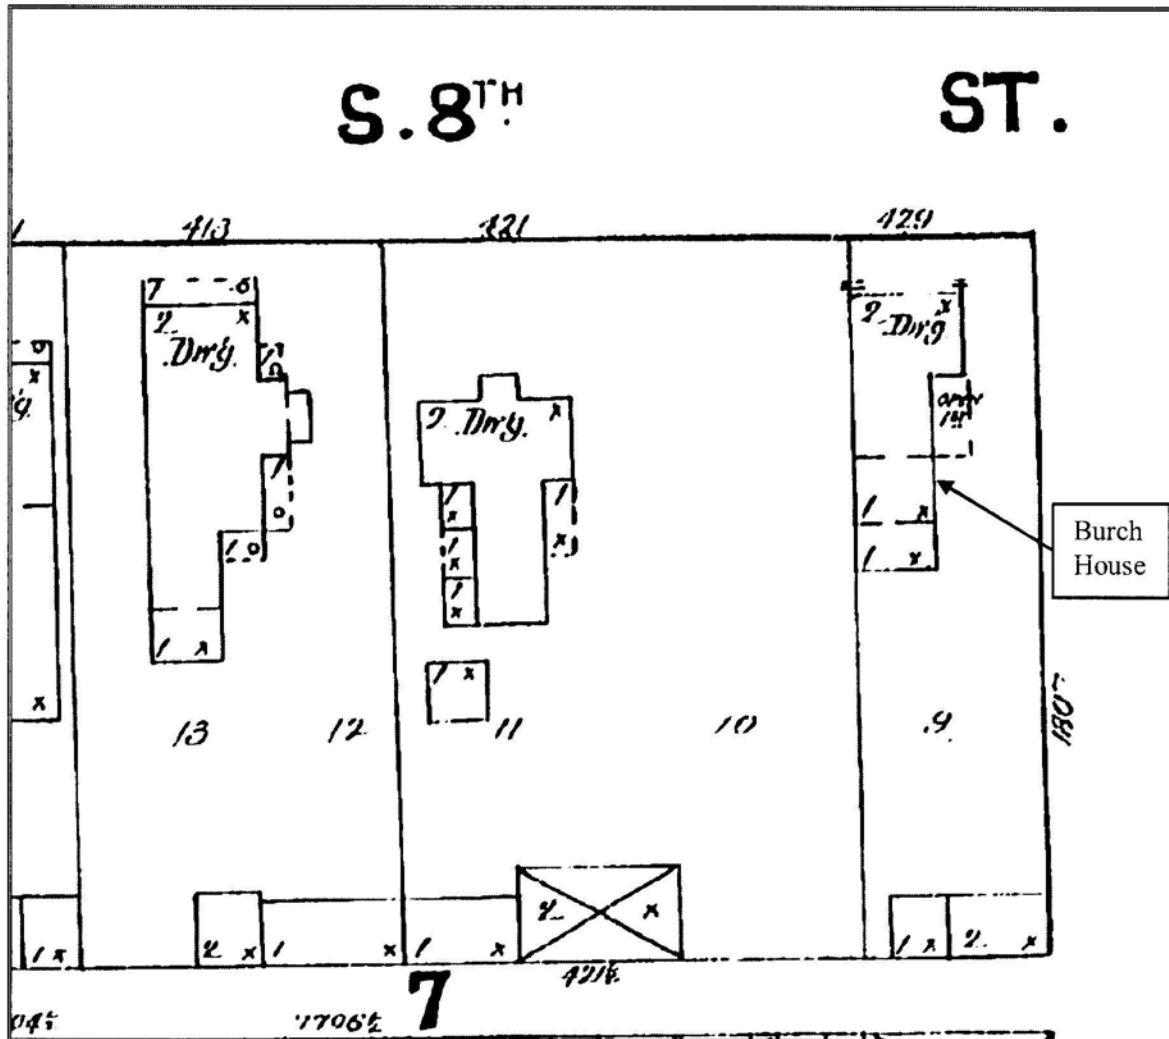
Figure 2-16: Sanborn Map, 1890.

The 1890 Sanborn map shows no changes to the Burch lot during the previous six years. This map does indicate the lot lines and numbers. It is interesting to note that the Ira Brown, Jr. House, formerly on lot 10 had been demolished by 1884.

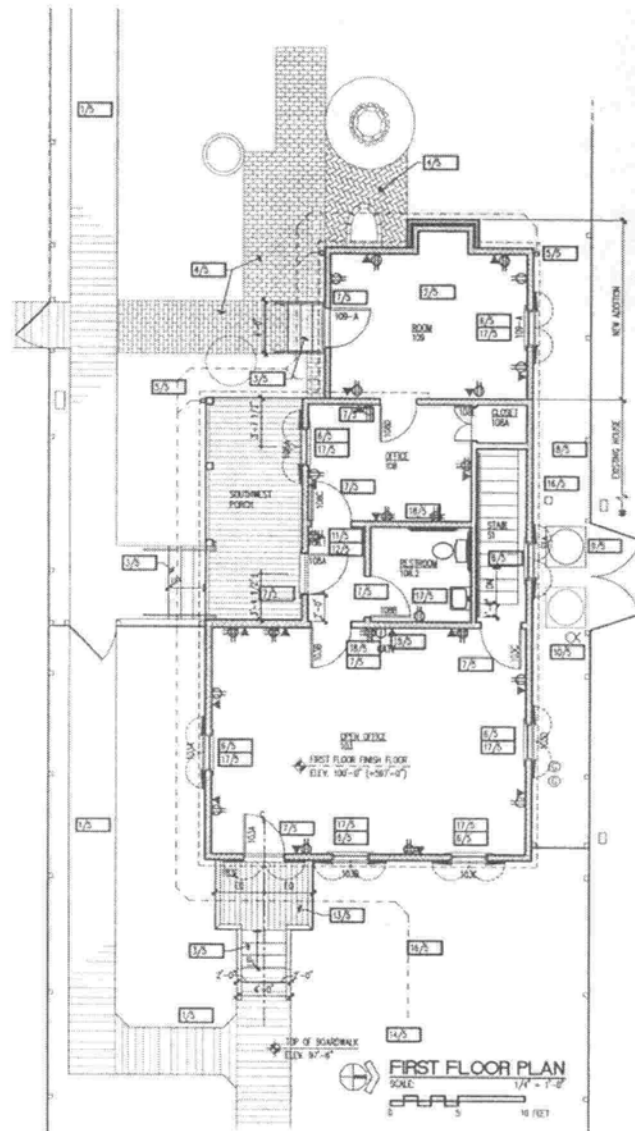
Figure 2-25: The Julia Sprigg House conjectural plan c.1851. (Supplemental Historic Structure Report: Julia Sprigg House (HS-11), Lincoln Home National Historic Site Springfield, Illinois, March 16, 2005)

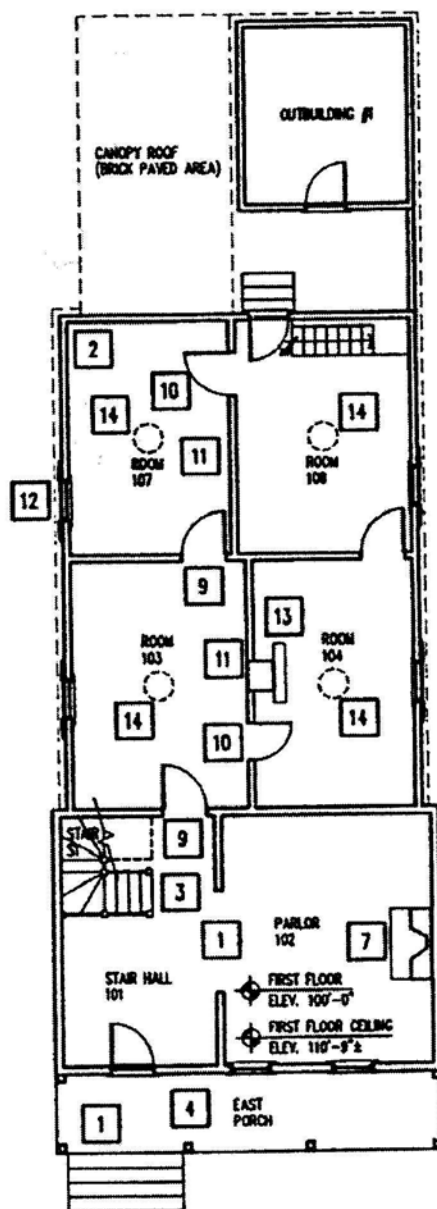
Figure 2-26: The Julia Sprigg House conjectural plan c.1874. (Historic Structure Report: Julia Sprigg House (HS-11), Lincoln Home National Historic Site Springfield, Illinois, May 1995)

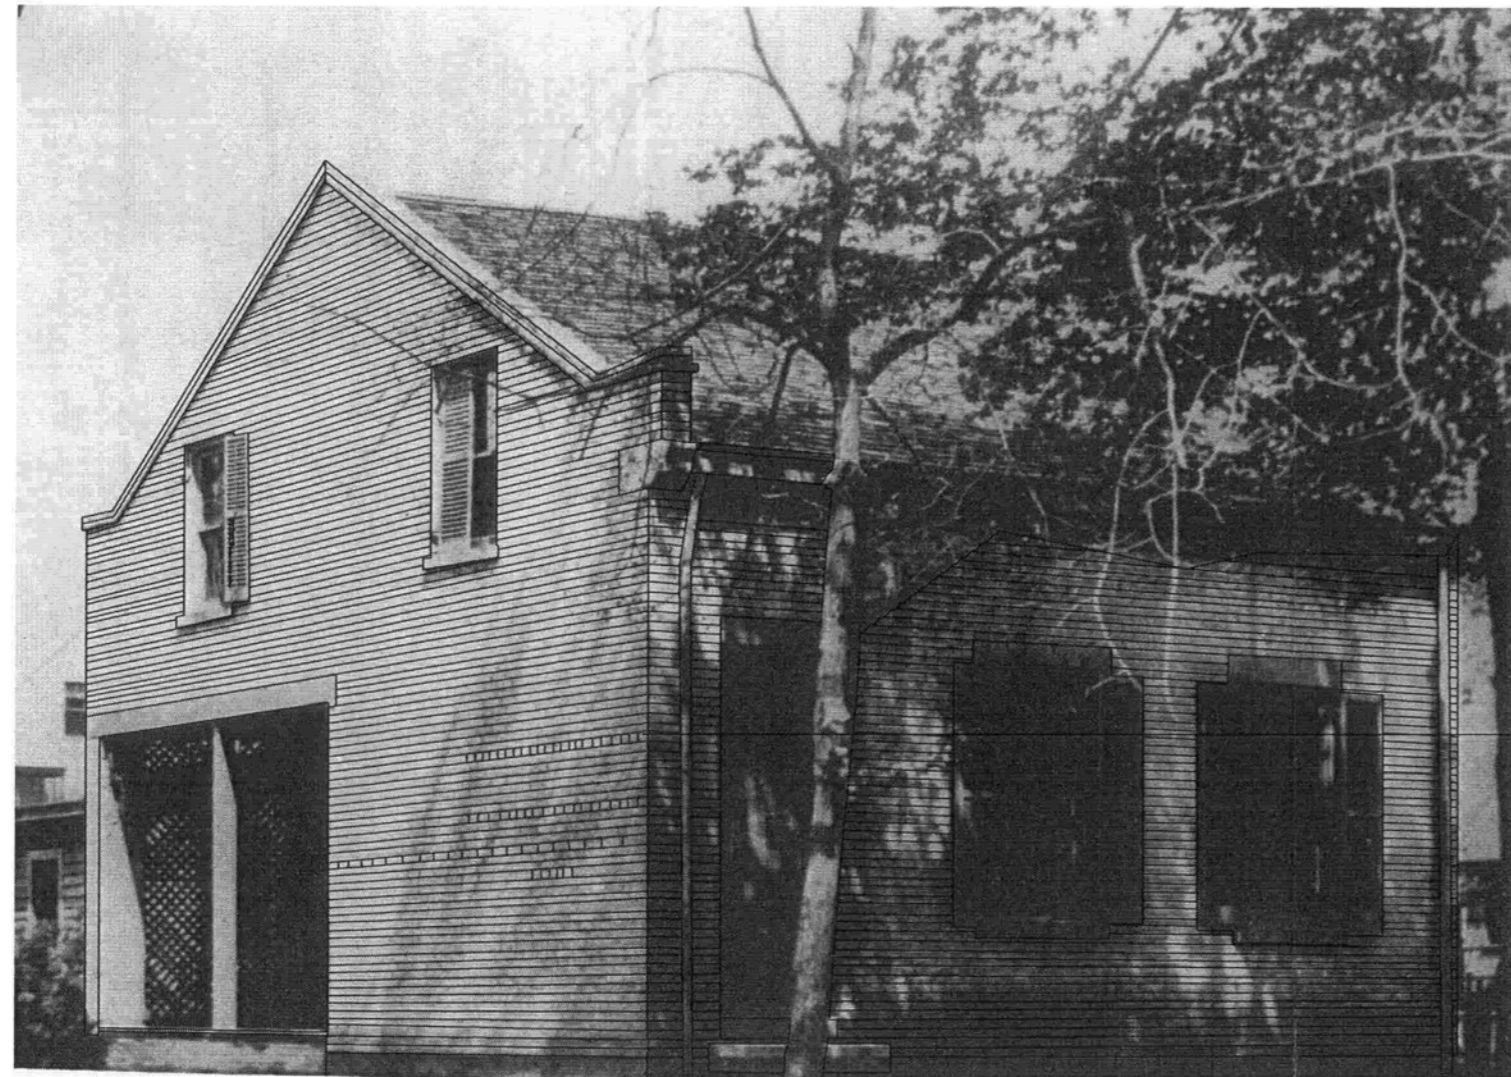
BRICK COURSE COUNTING MA-2a

BRICK LAID UP WITH A FIELD OF RUNNING BOND WITH EVERY SEVENTH COURSE BEING A HEADER COURSE

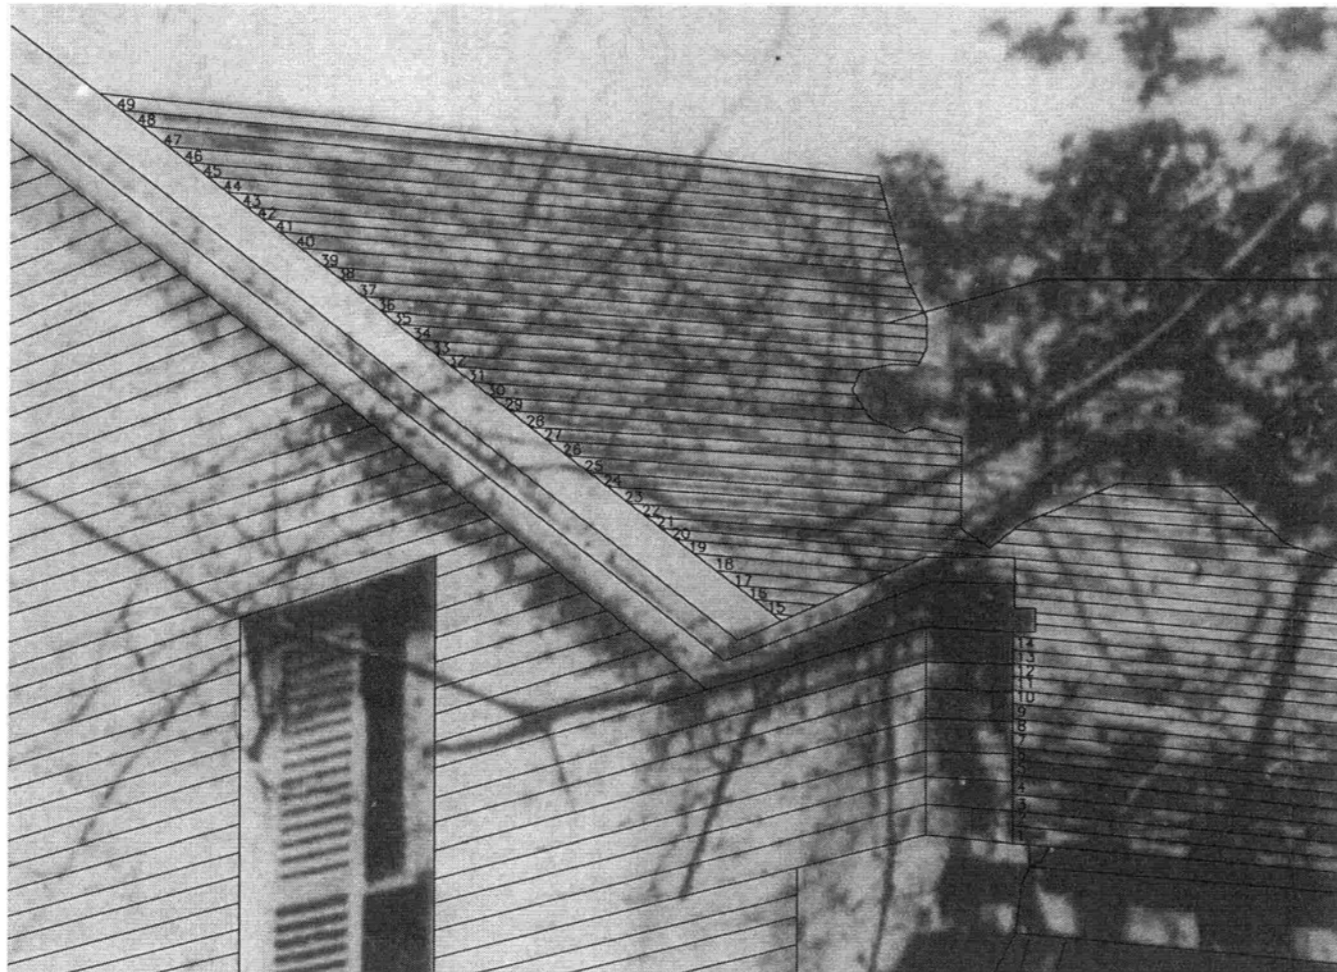
ROOF SHINGLE COURSE COUNTING MA-3a

WOOD SHINGLE ROOF WITH 49  
ROOF COURSES

2 VISIBLE DOWNSPOUTS ON  
EAST FACADE

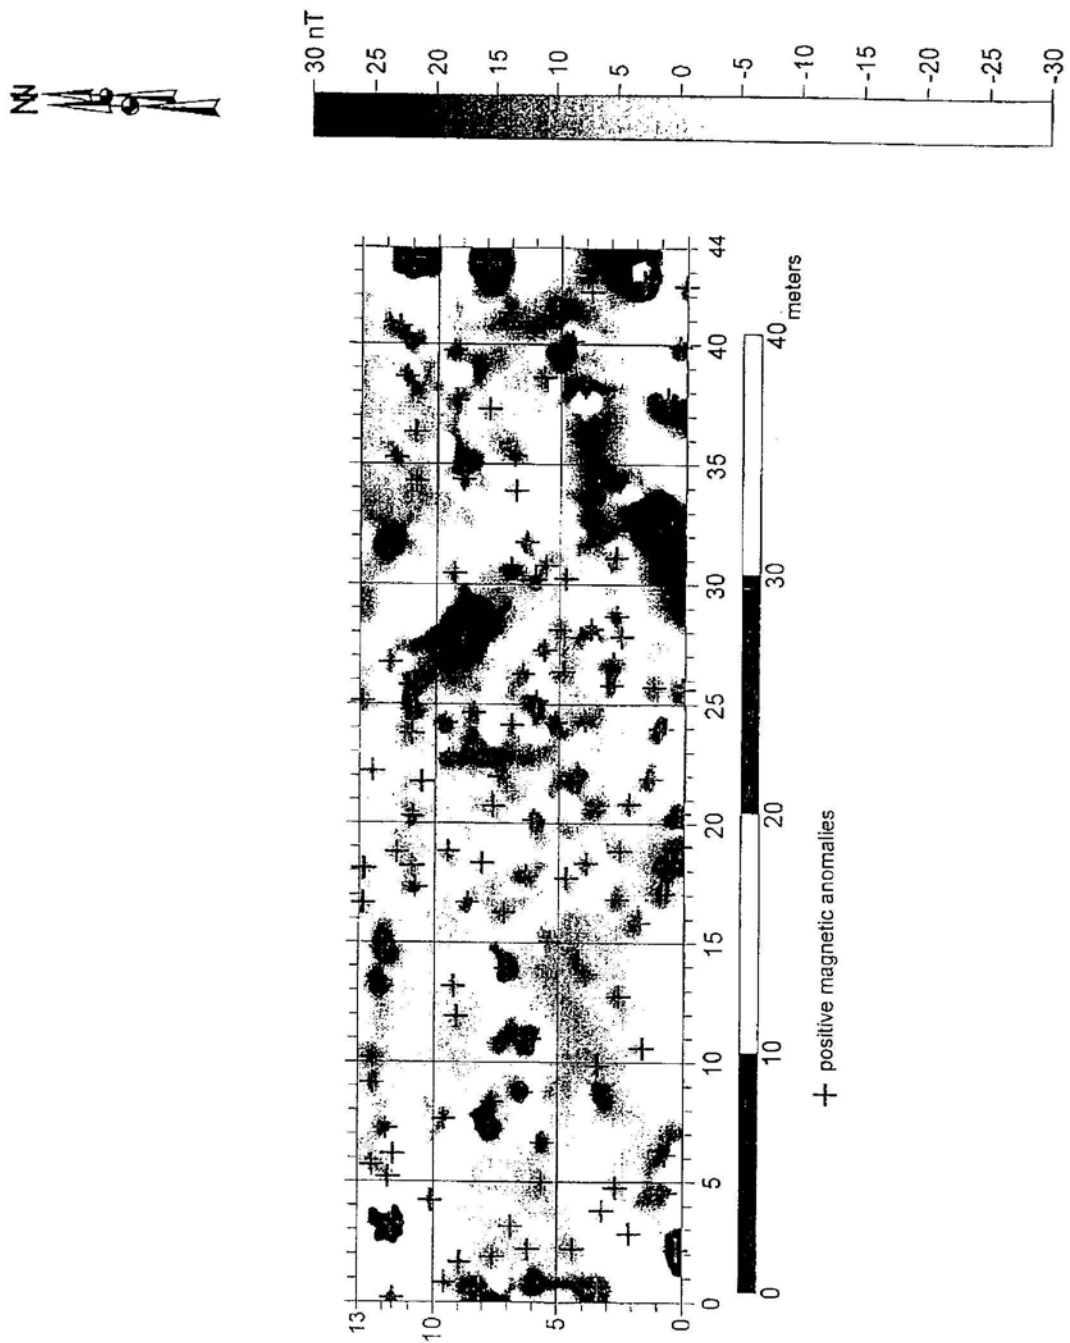
Figure 21. Interpretative map of magnetic gradient data from the Burch lot.

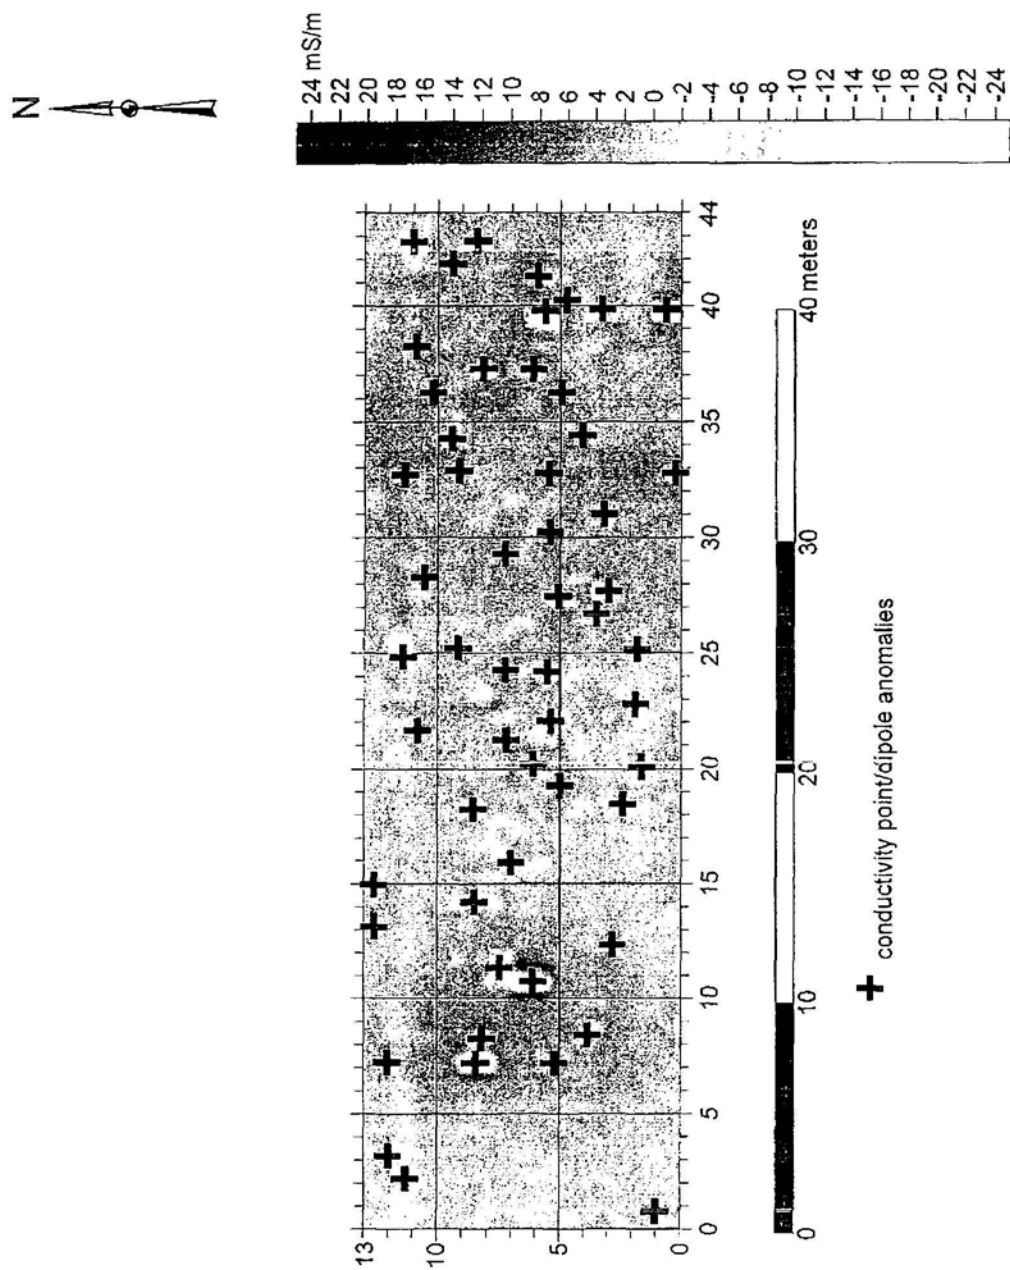
Figure 22. Interpretative map of conductivity data from the Burch lot.

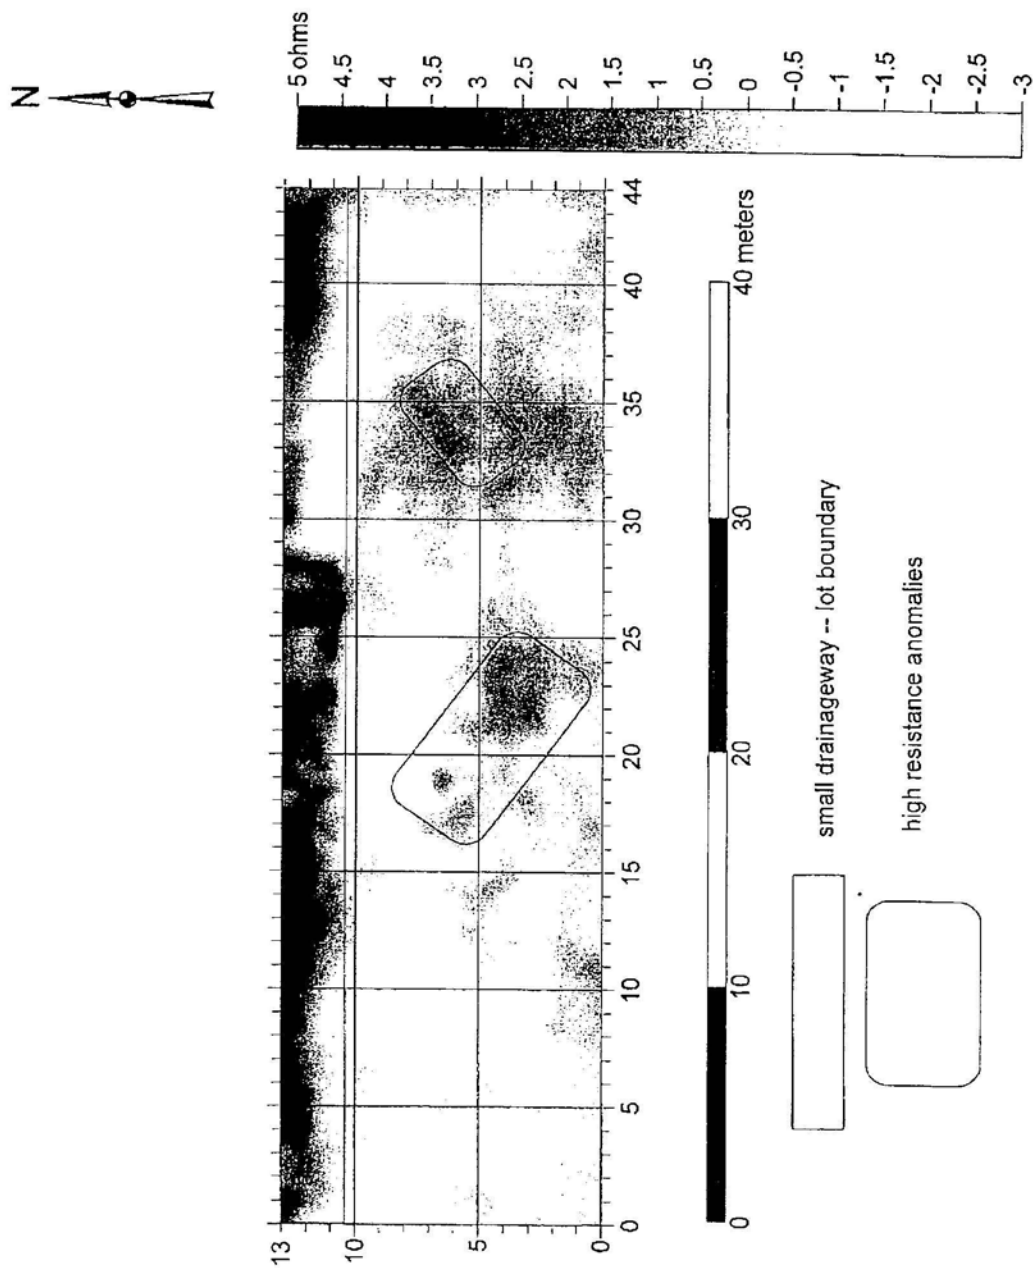
Figure 23. Interpretative map of resistance data from the Burch lot.

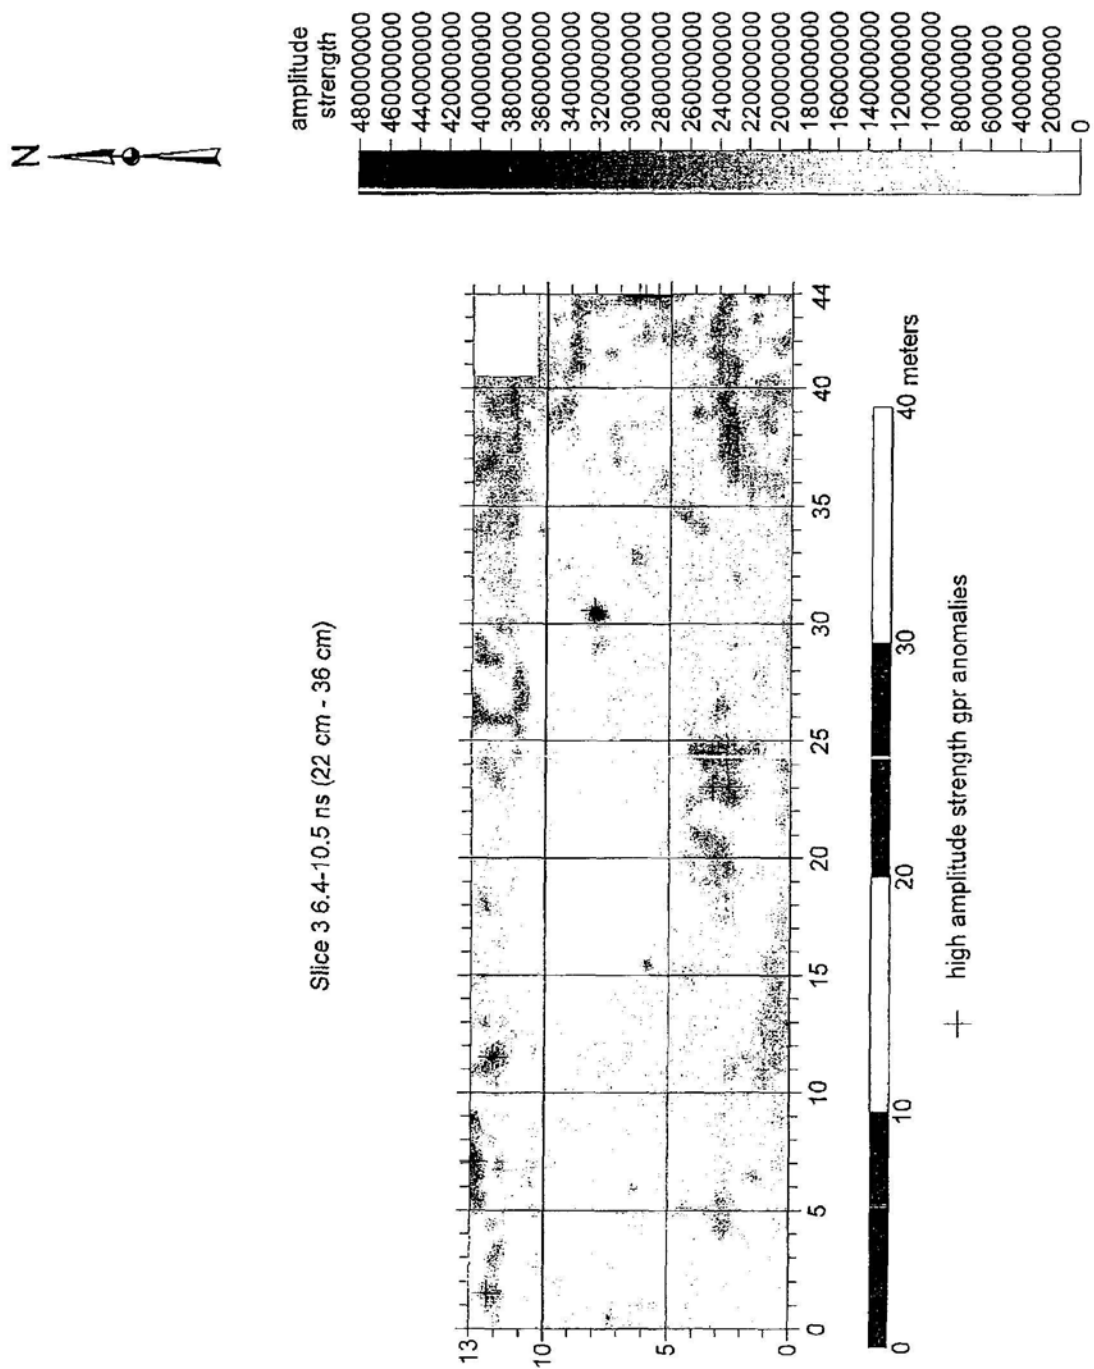
Figure 24. Interpretative map of time slice 3 gpr data from the Burch lot.

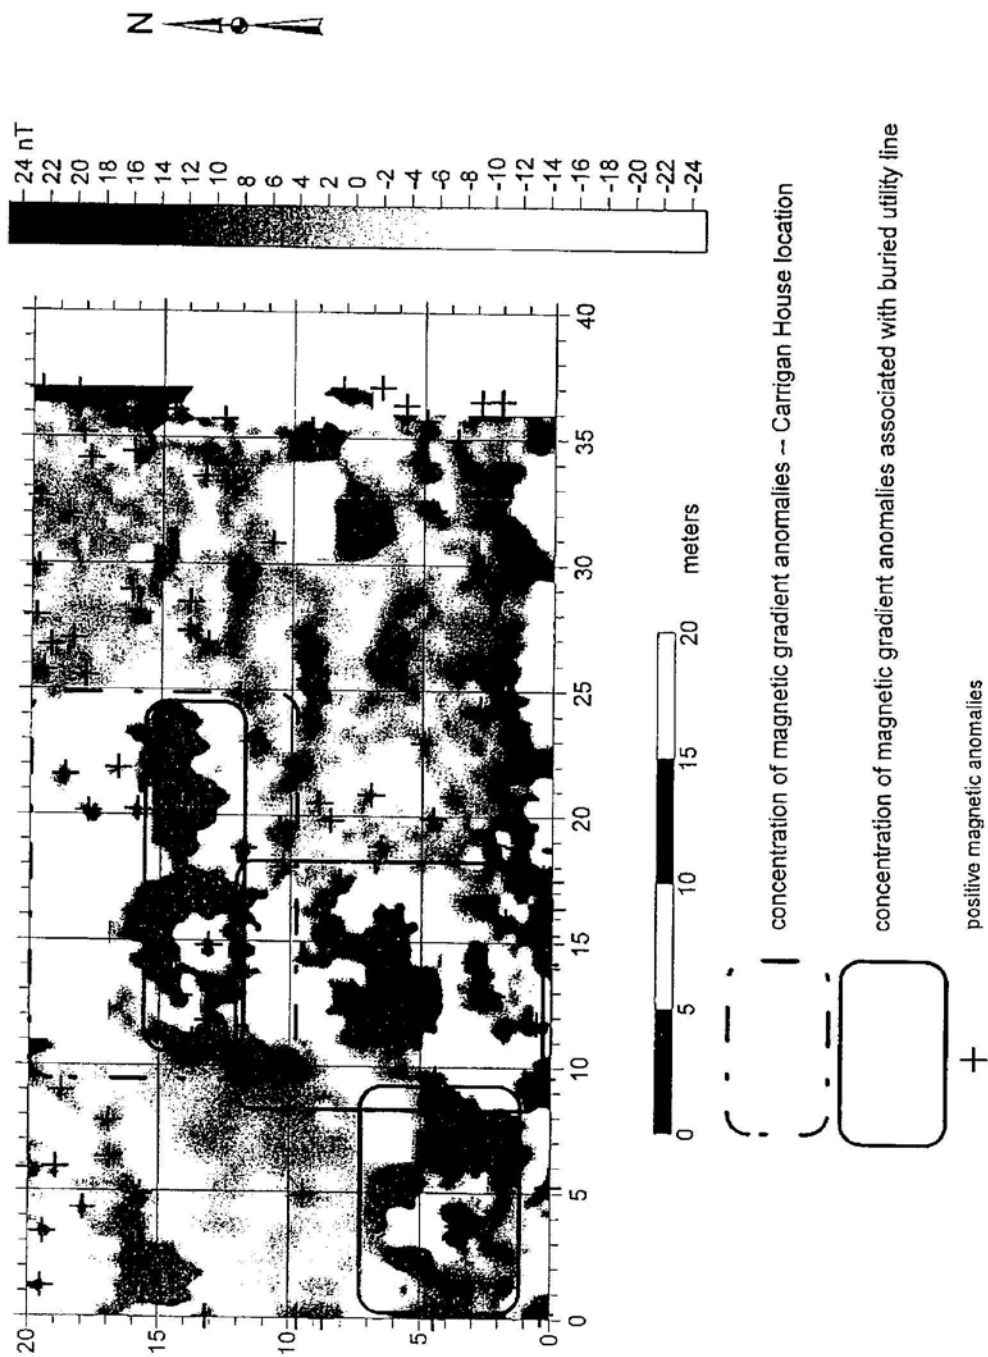
Figure 25. Interpretative map of magnetic gradient data from the Carrigan lot.

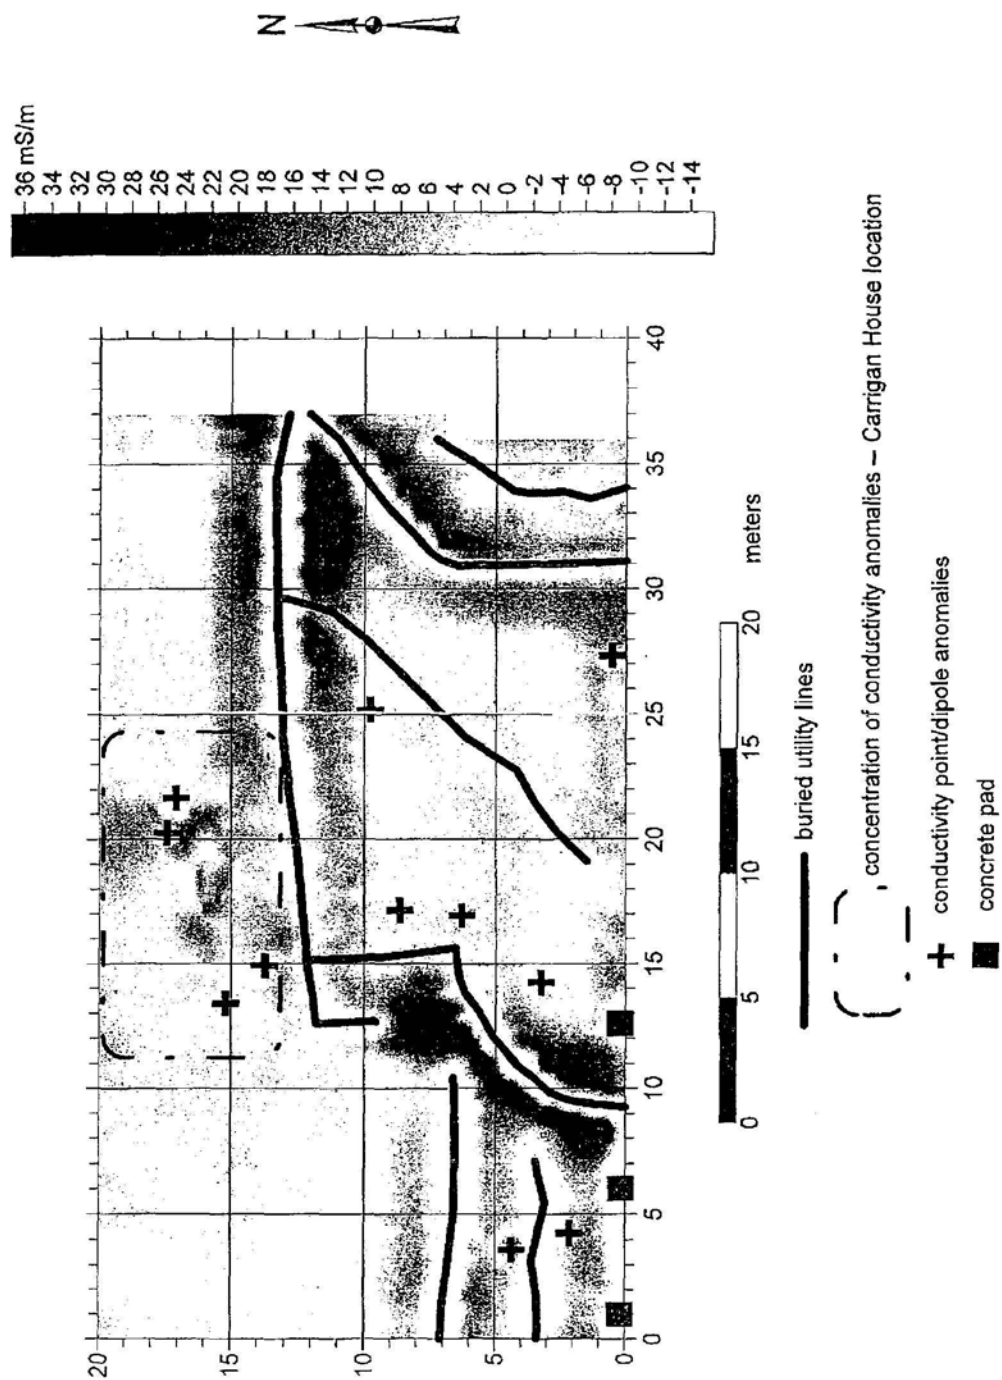
Figure 26. Interpretative map of conductivity data from the Carrigan lot.

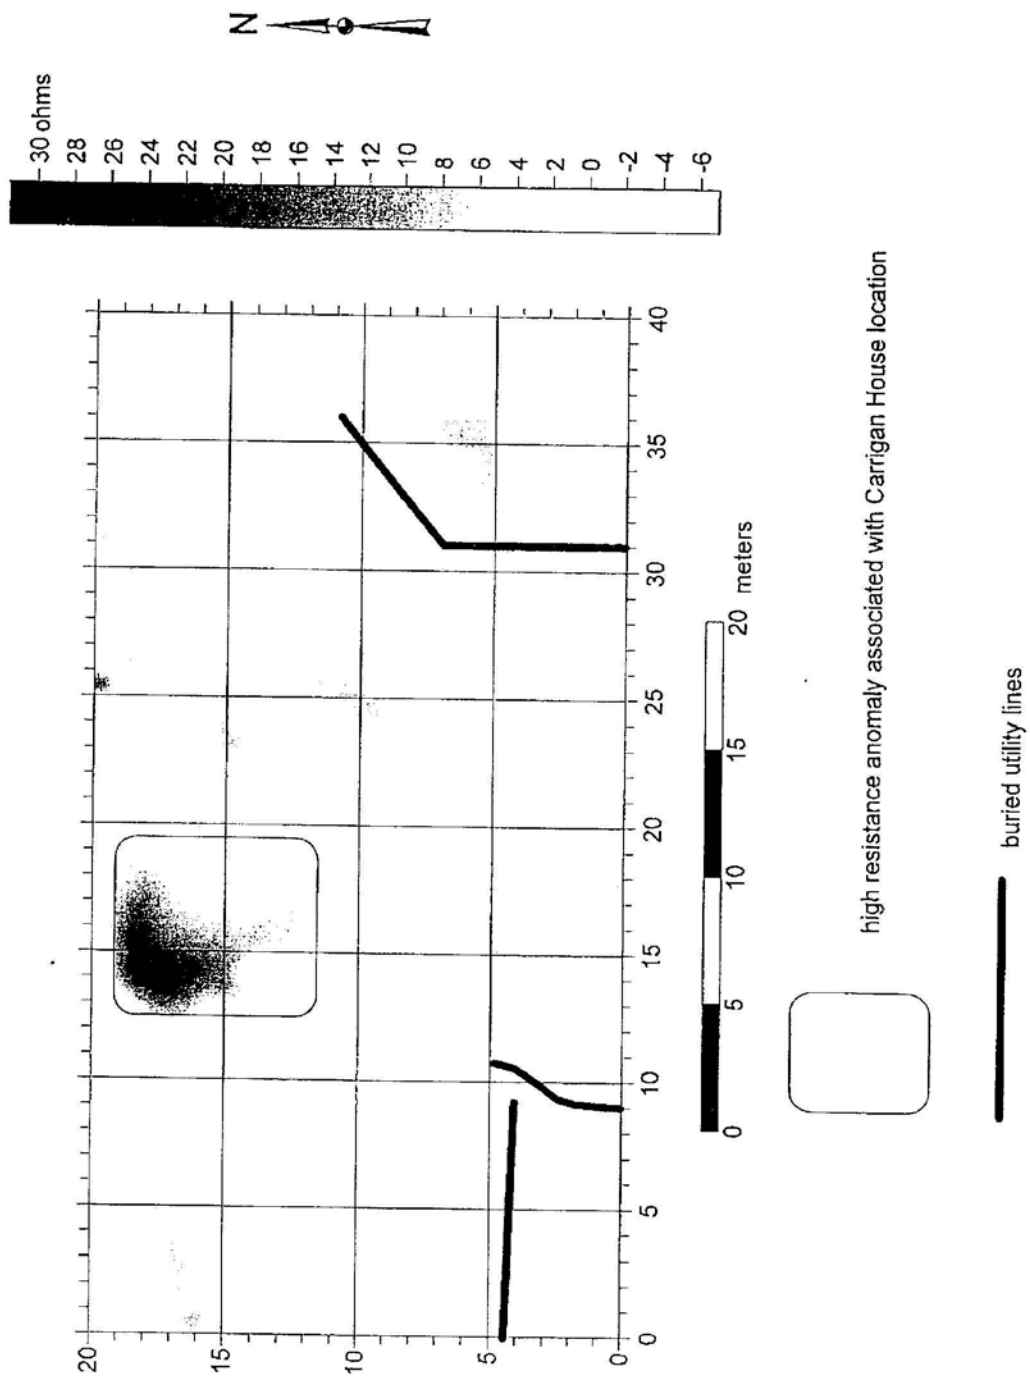
Figure 27. Interpretative map of resistance data from the Carrigan lot.

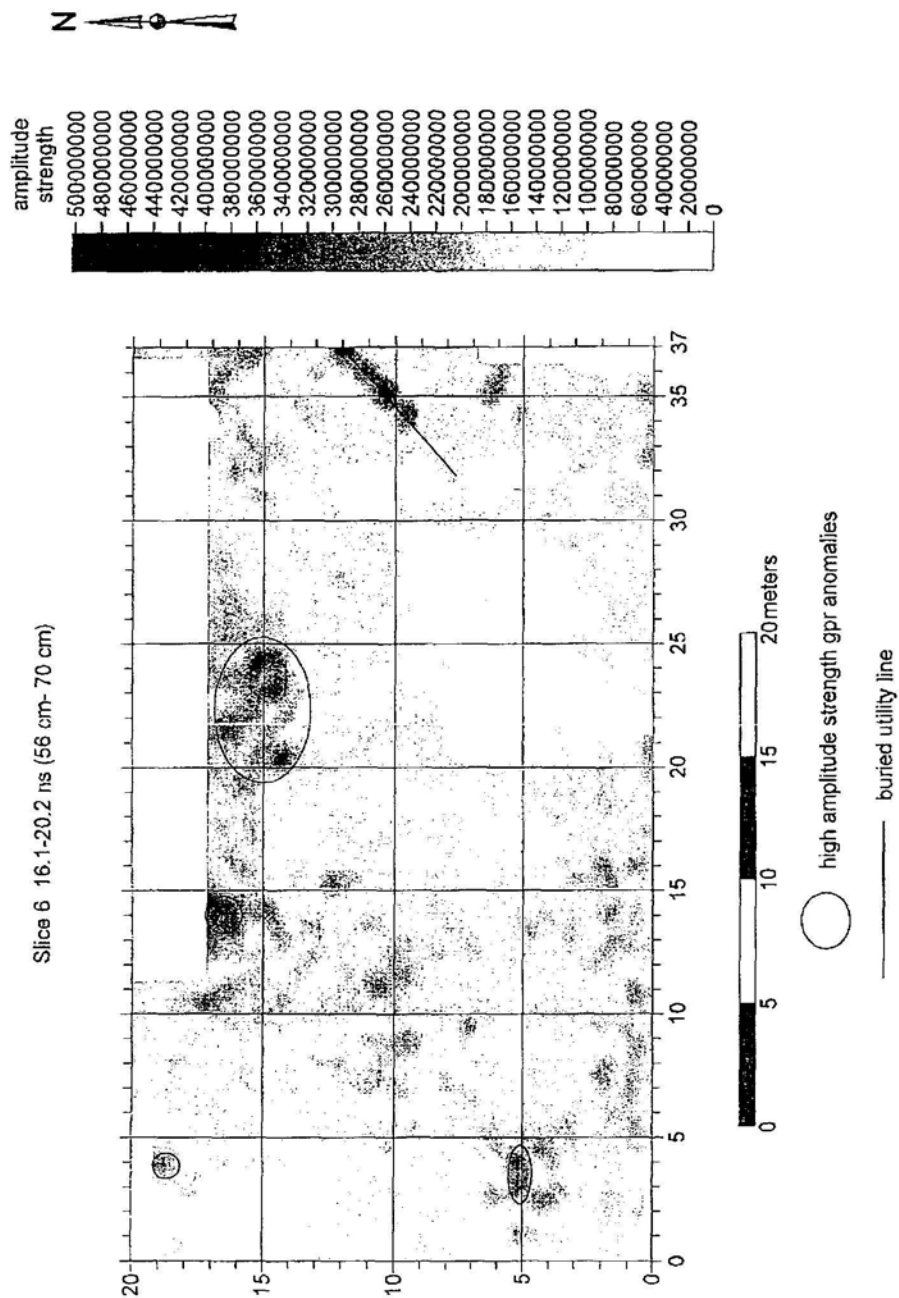
Figure 28. Interpretative map of time slice 6 gpr data from the Carrigan lot.
