CARRIGAN HOUSE (HS-25)

Lincoln Home National Historic Site
Springfield, Illinois

Historic Structure Report

May 19, 2006

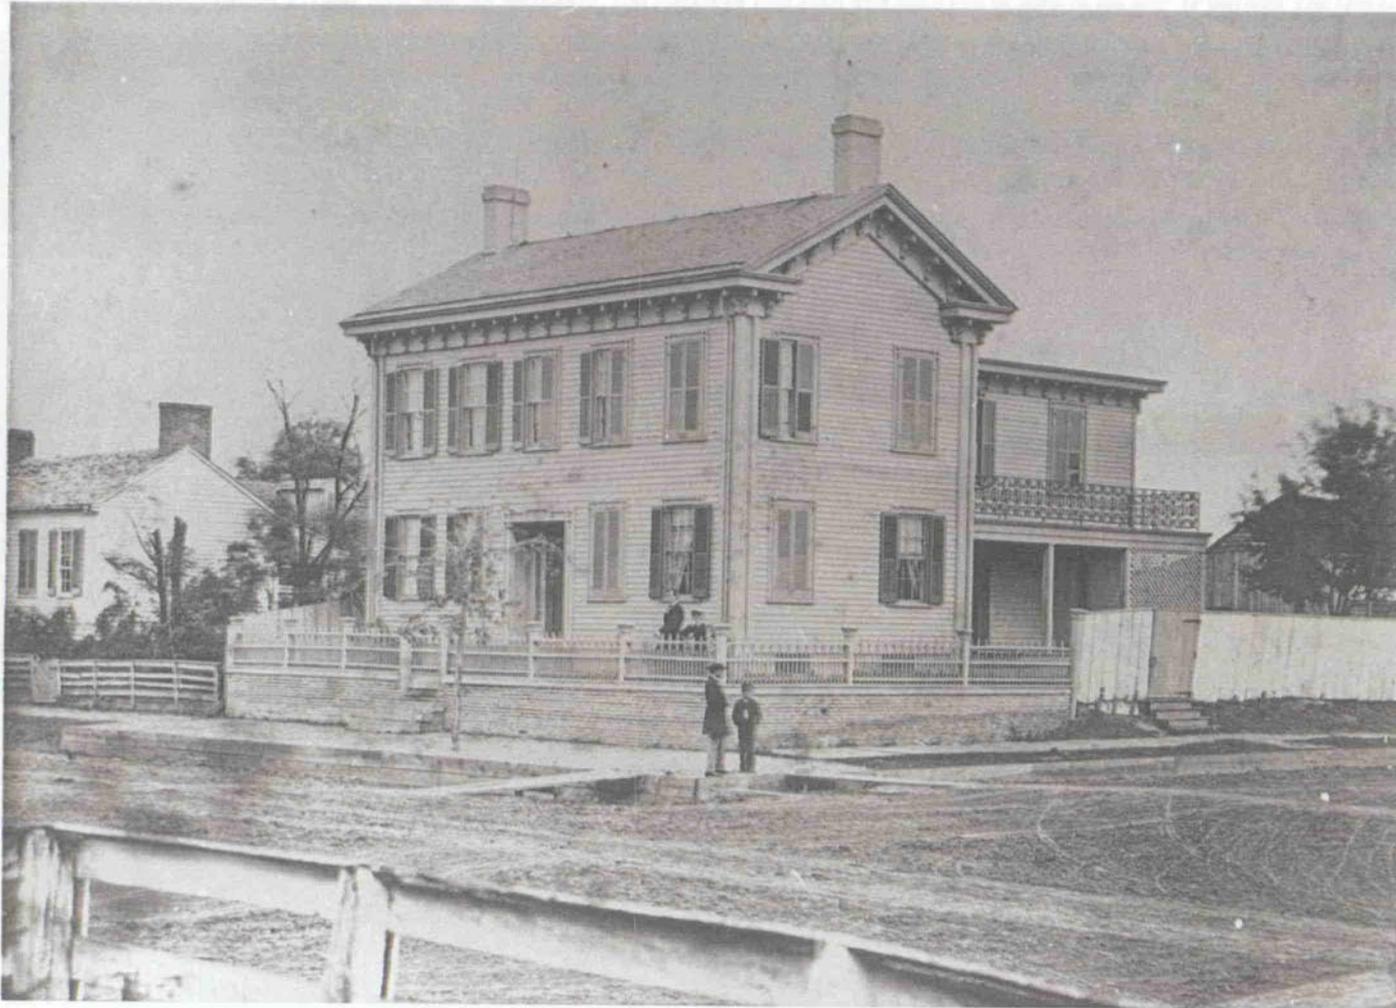
Figure 2-5: “Home of Abraham Lincoln”, summer 1860. View looking northeast. A partial view of the Carrigan front facade and the roof of the ell with a gabled dormer can be seen to the left. (Courtesy The Abraham Lincoln Presidential Library)

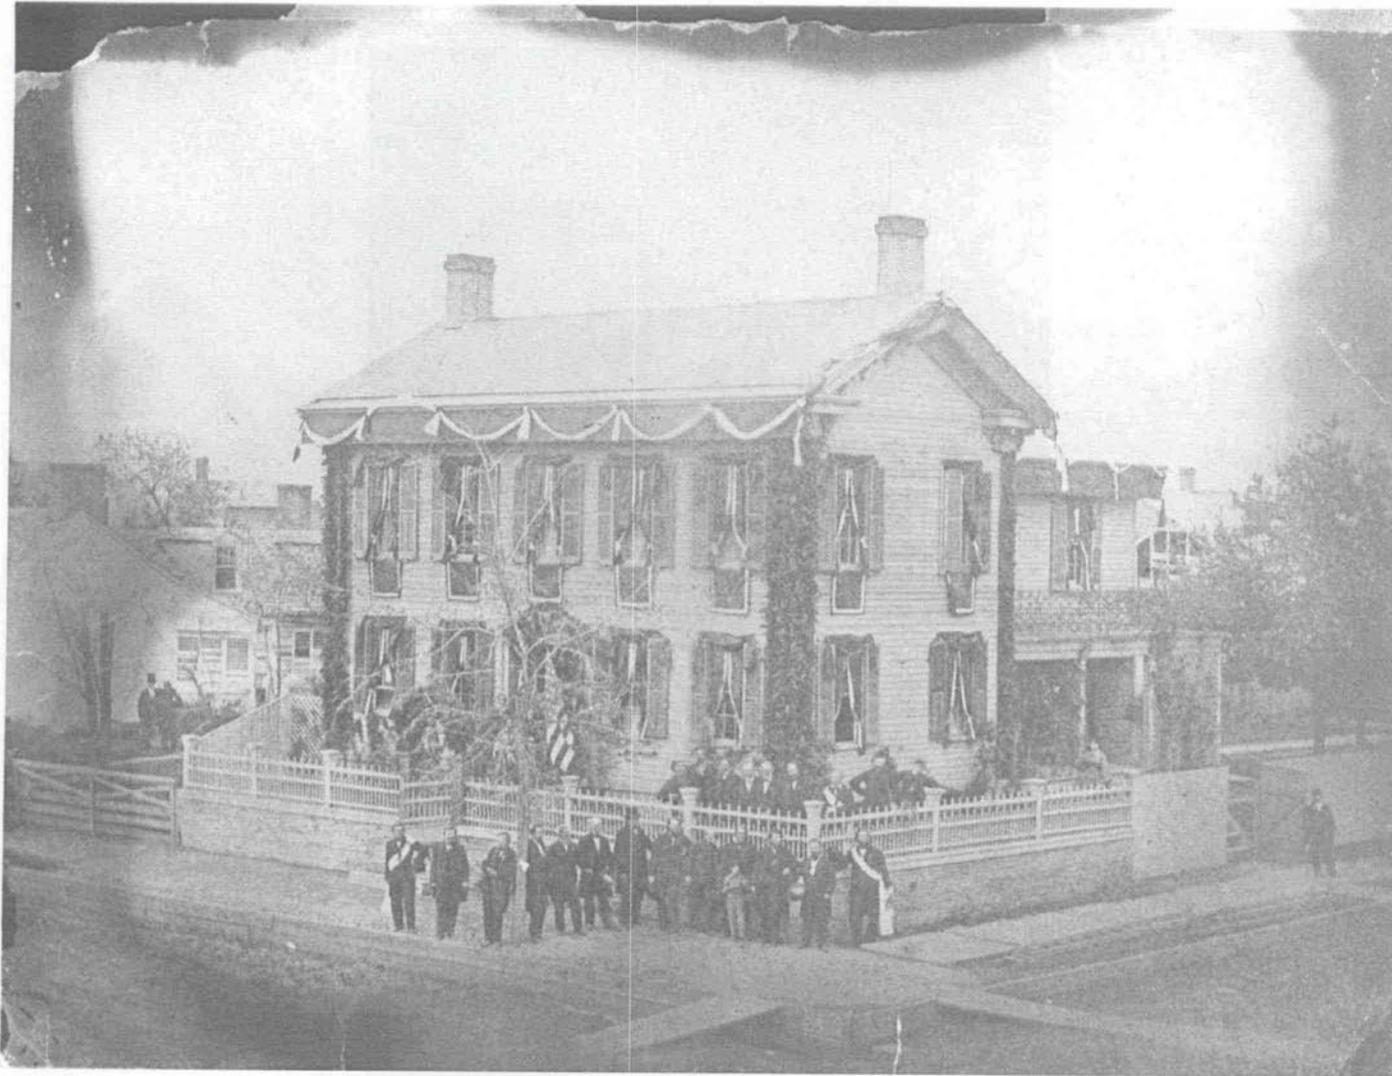
Figure 2-8: The Lincoln House dressed for mourning, 1865. View looking northeast. The rear extension to the Carrigan House can be seen to the left, including the ell with louvered porch. (Courtesy of the Abraham Lincoln Presidential Library)

Figure 2-8 and 8a: In this photograph taken in 1865, the ell can be viewed to a greater extent. Two gabled dormers can now be seen. The two dormers on the ell indicate one and one-half story construction for this portion. The windows in the dormers are six-over-six. An enclosed porch on the southeast corner of the house can also be seen. This porch and the porch on the ell are similarly enclosed with tall wooden, fixed-in-place louvers with adjustable slats. The louvers on the ell are in disrepair and missing slats. The brick chimney along the north wall of the ell can be seen for the first time.

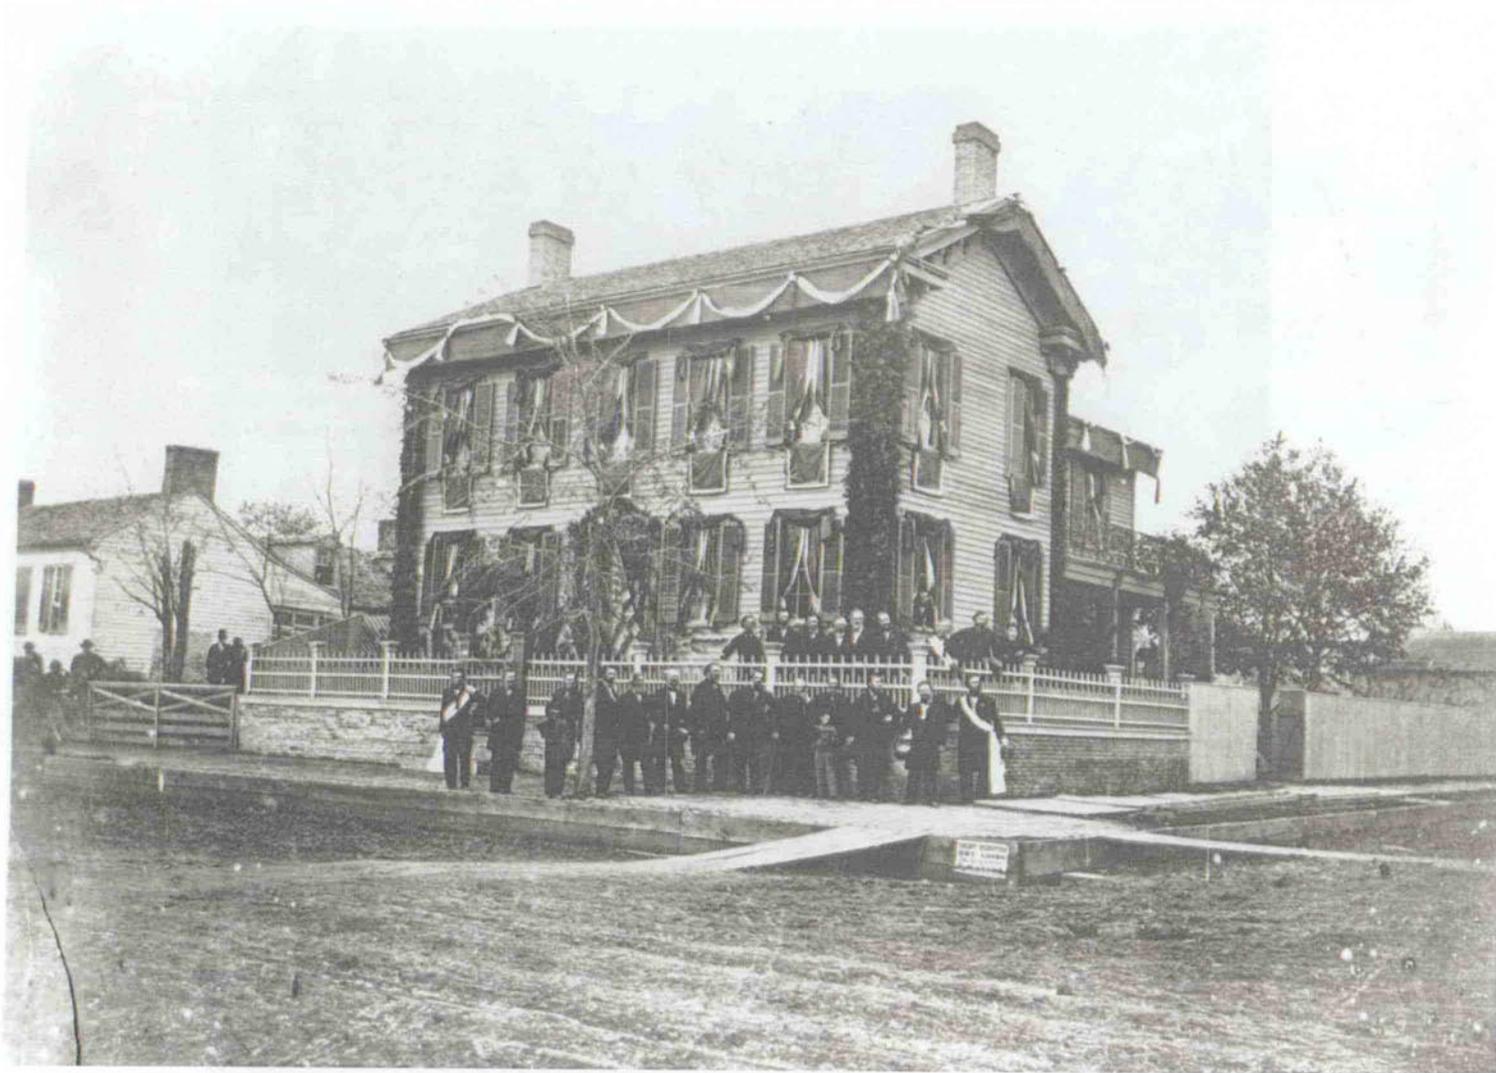
Figure 2-9: A partial view of the west and south elevations of the Carrigan House, 1865. Two dormers and a third chimney on the ell are visible. (Courtesy The Abraham Lincoln Presidential Library)

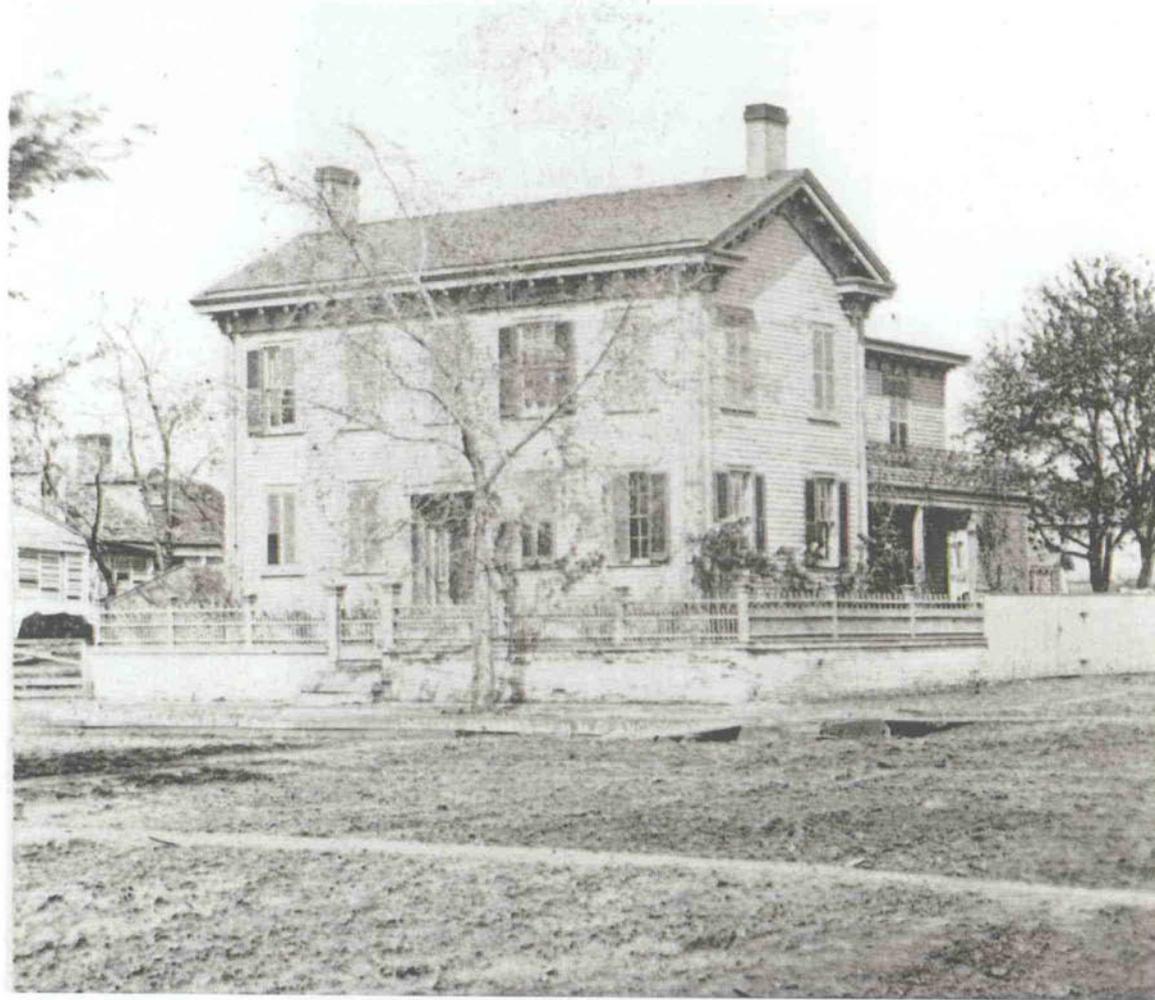
Figure 2-10: A view of the rear louvered porch and ell addition, c.1870. (Courtesy The Abraham Lincoln Presidential Library)

Figure 2-10 and 10a: This photograph provides a long view of the ell and porch structure. Two gabled dormer windows with diagonal wood siding can be seen on the roof of the ell. A fuller view of the porch is also presented. Although this photo is not dated, it was most likely taken in the 1870's due to the dilapidated condition of the porch structure. The ell's roofline is sagging in the center, above the louvered porch.

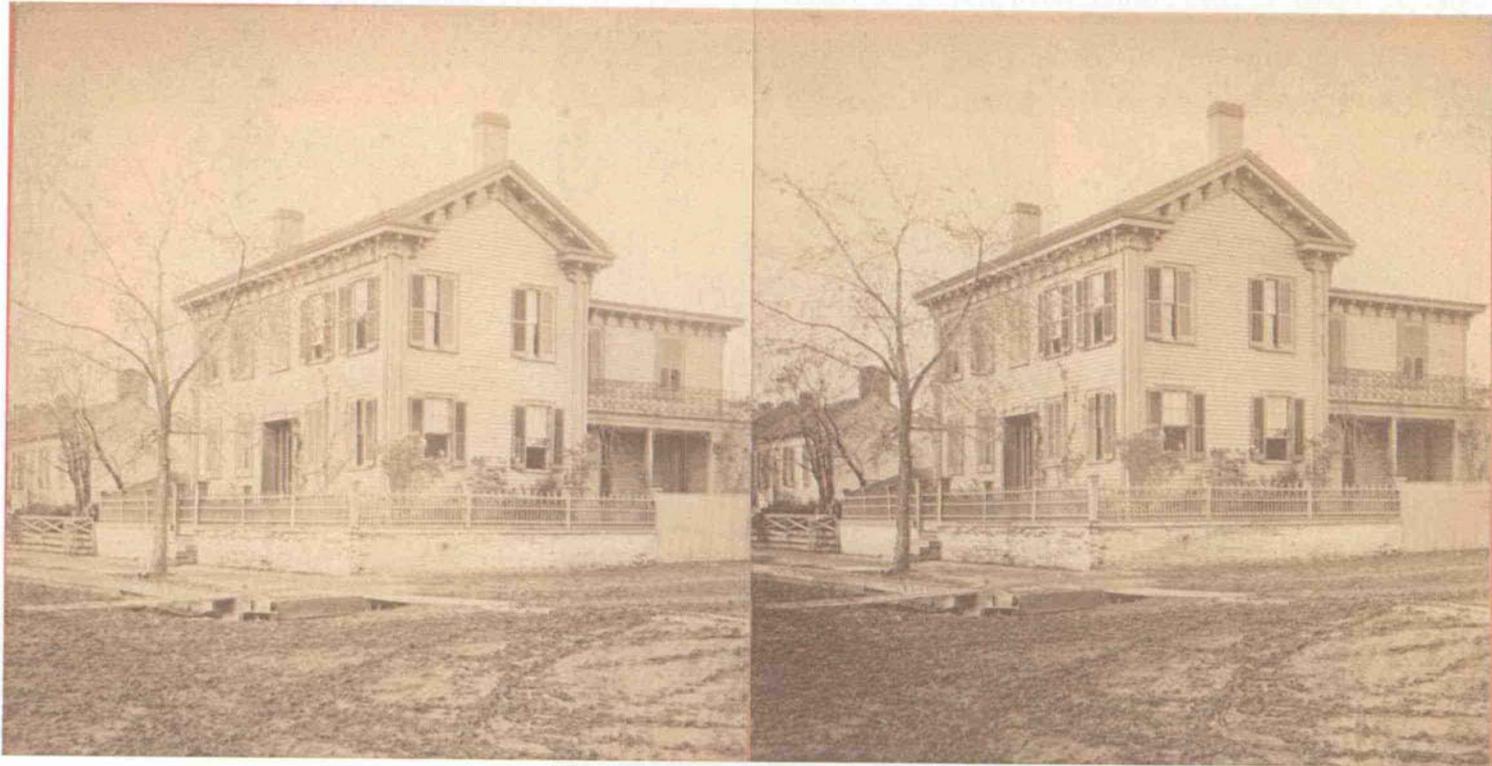
Figure 2-12: A stereoview of the west (front) elevation including the fence c.1870. (Courtesy Lincoln Home National Historic Site)

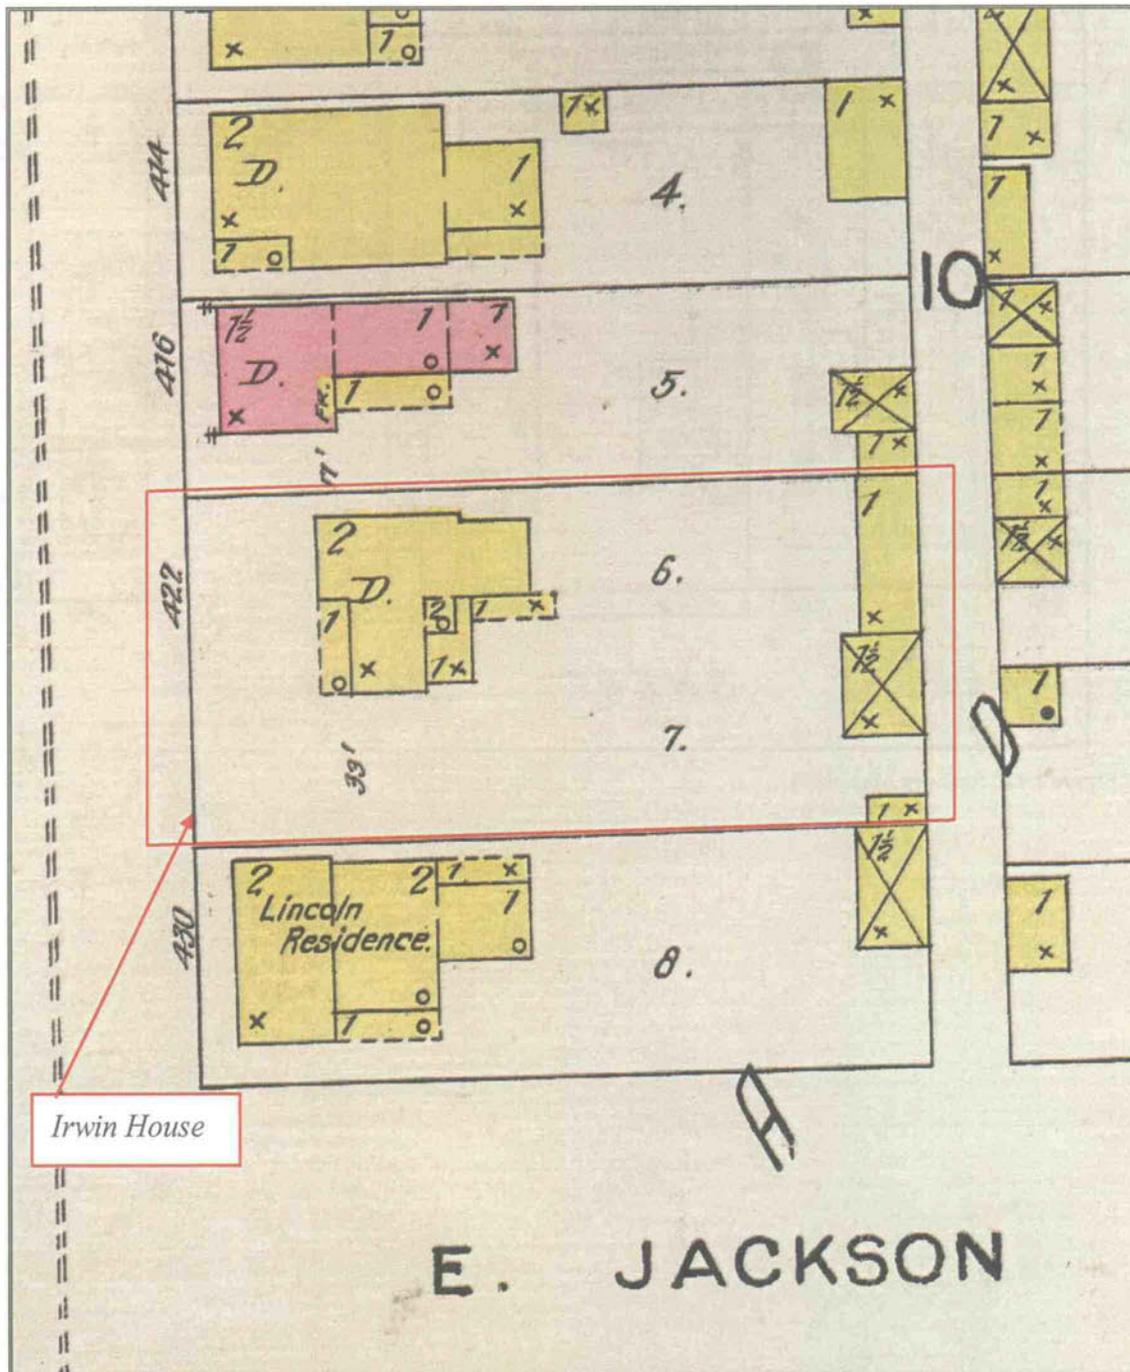
Figure 2-23: Sanborn Map, 1896. Courtesy The Lincoln Public Library, Springfield, IL.

Several changes can be seen in the 1896 map. The house address has now changed from 416 1/3 to 422. The house is now located just south of the north property line. The large two-story square shaped outbuilding that first appeared on the 1890 map is now indicated as a 1-1/2 story stable. The shape is not quite square and the smaller wood frame outbuilding is drawn smaller than in 1890.

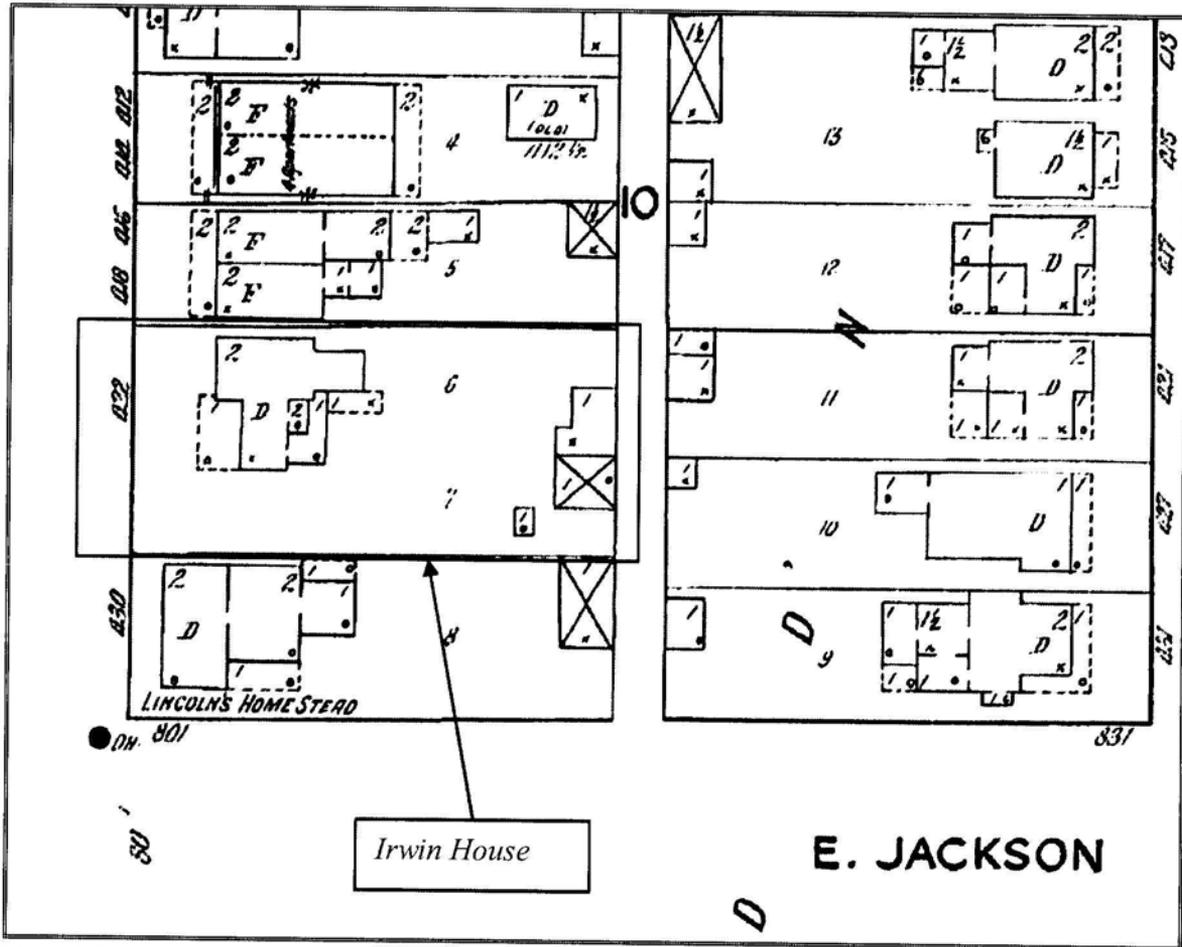
Figure 2-24: Sanborn Map, 1917.

Between 1896 and 1917, the house has seen some major changes. The front porch was enlarged to extend past the front of the house and some of the one-story portions of the house have new composition roofs. The house has been drawn in the same configuration but larger in comparison to the lot. All of the outbuildings from the 1896 map have been removed and three new outbuildings are indicated. Two large outbuildings are located in the center of the lots along the alley. The southern-most is a one-story, square shaped stable with a composition roof and the northern outbuilding is a one-story structure with a shingle roof.

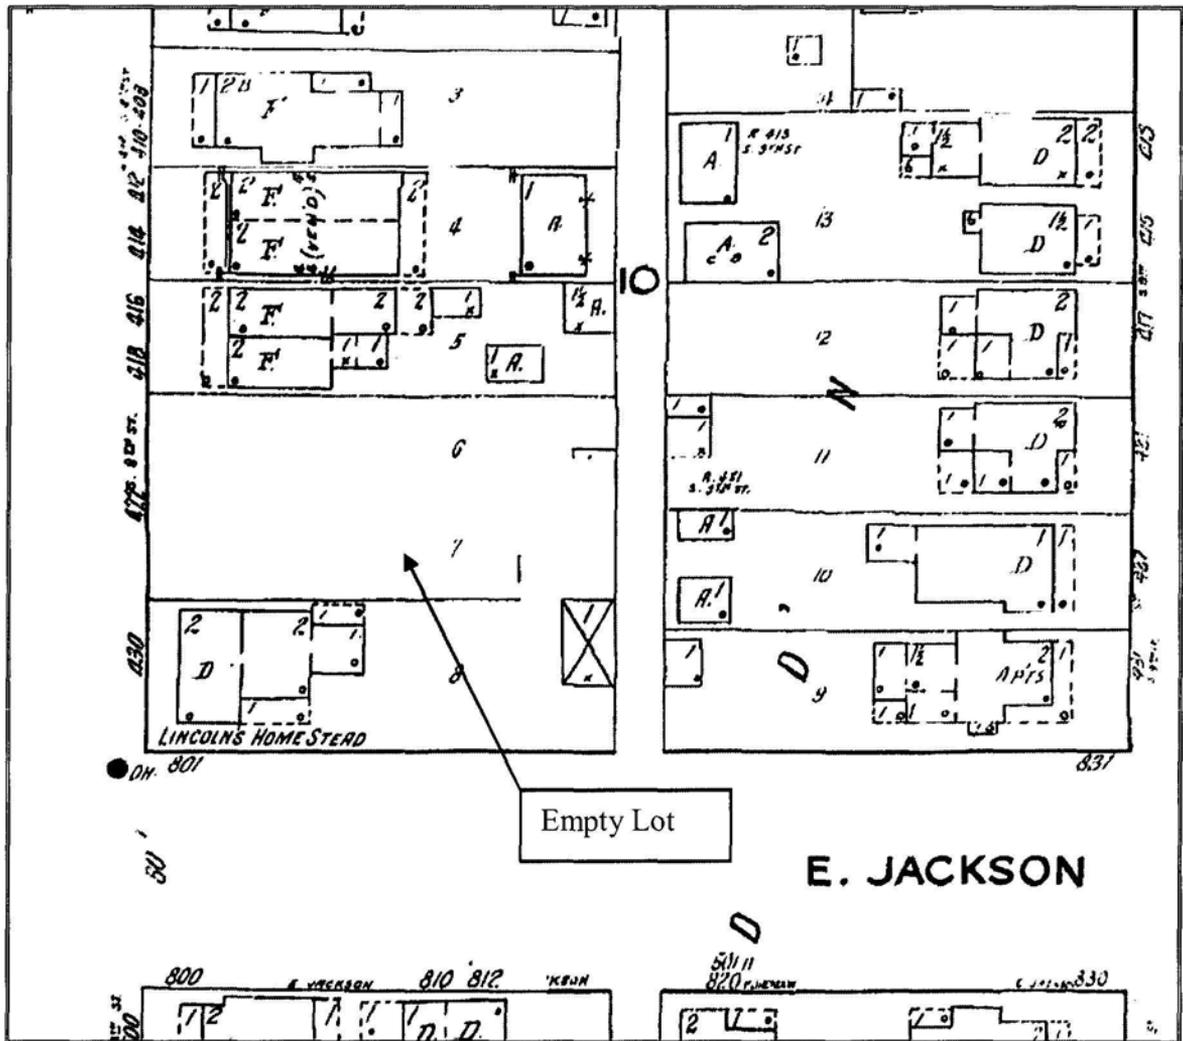
Figure 2-25: Sanborn Map, 1941

By 1941 all of the buildings and outbuildings on lots 6 and 7 have been demolished. In this Sanborn revision, the lot lines have been removed between lots 7 and 8. The State of Illinois had approved the demolition of the Irwin property in 1923.

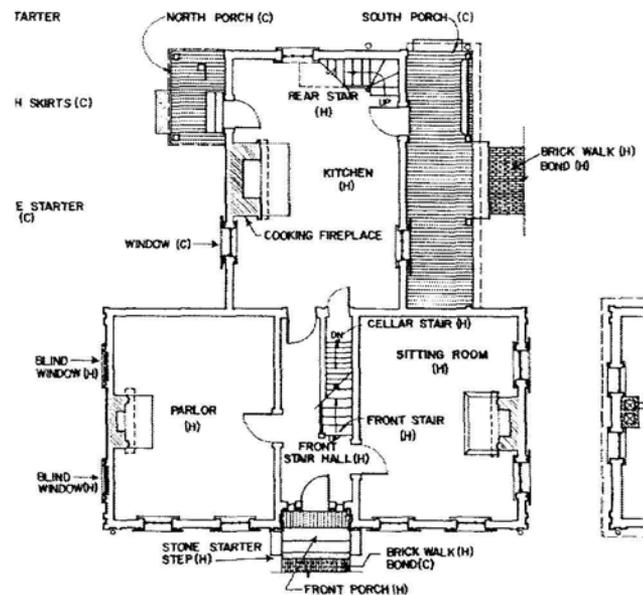
Figure 2-29: The conjectural first floor plan for the Rev. Charles Dresser/Abraham Lincoln cottage. (Historic American Buildings Survey, National Park Service, Brad McCormick, 1986.)

The Lincoln Home, as originally constructed by Charles Dresser, (**Figure 2-29**) was also similarly designed. The Lincoln cottage was a Central Passage plan built in 1839. The cottage had minor Greek Revival characteristics delineated by such details as the returned eaves and the recessed entry and small porch. The T plan shows an ell projecting from the center of the main portion of the house containing a kitchen. Chimneys were located on each end of the end-gabled dwelling.

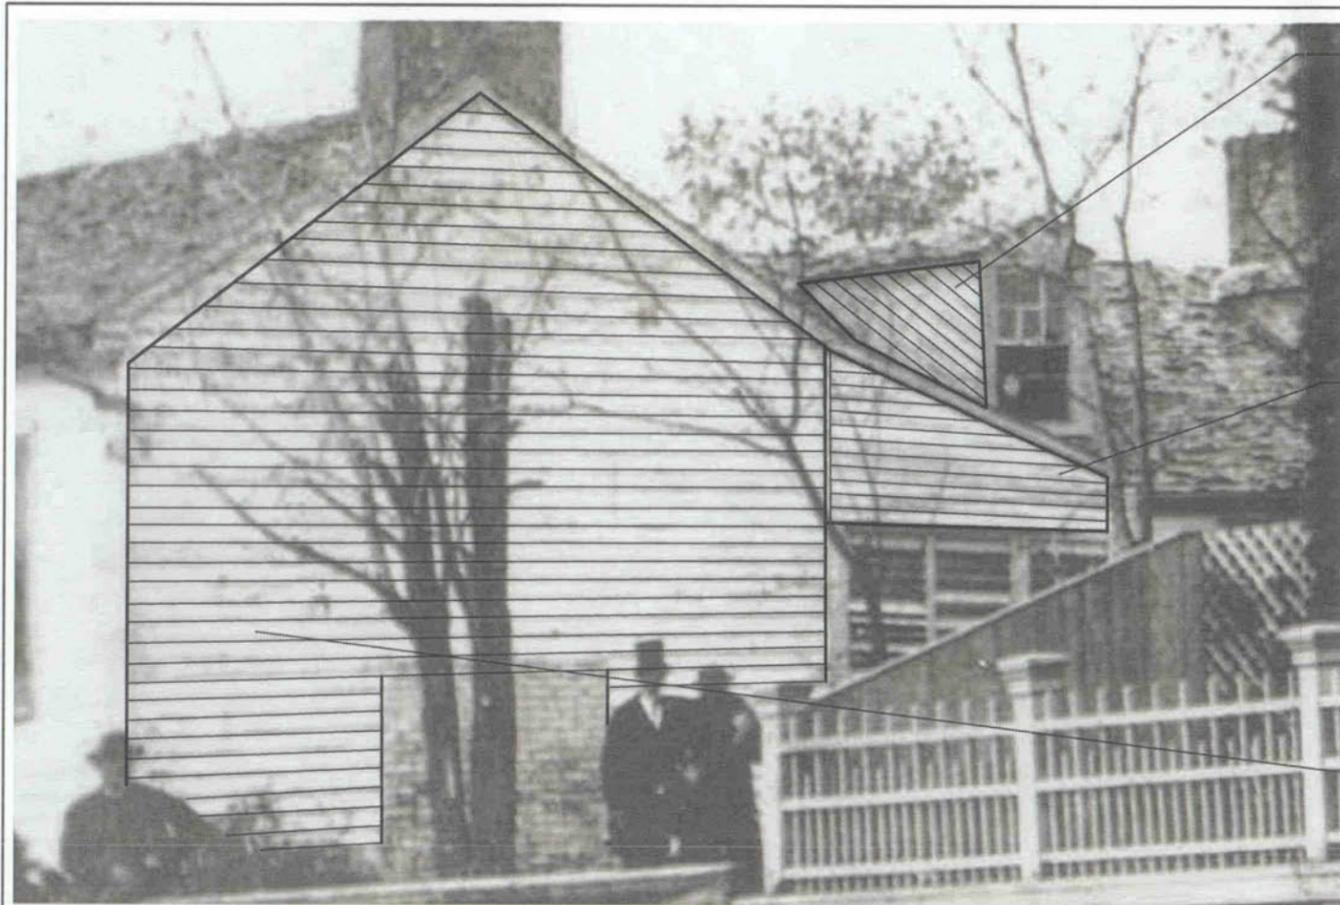
DIAGONAL SIDING ON DORMERS WITH SIDING COUNT OF 10

All of the roofing appears to be of the wood shingle variety where visible. There are 25 shingle courses on the western portion of the house and 35 courses at the east ell. With the slope of the roof determined in the wood clapboard analysis, this would bring the shingle exposure to around four inches.

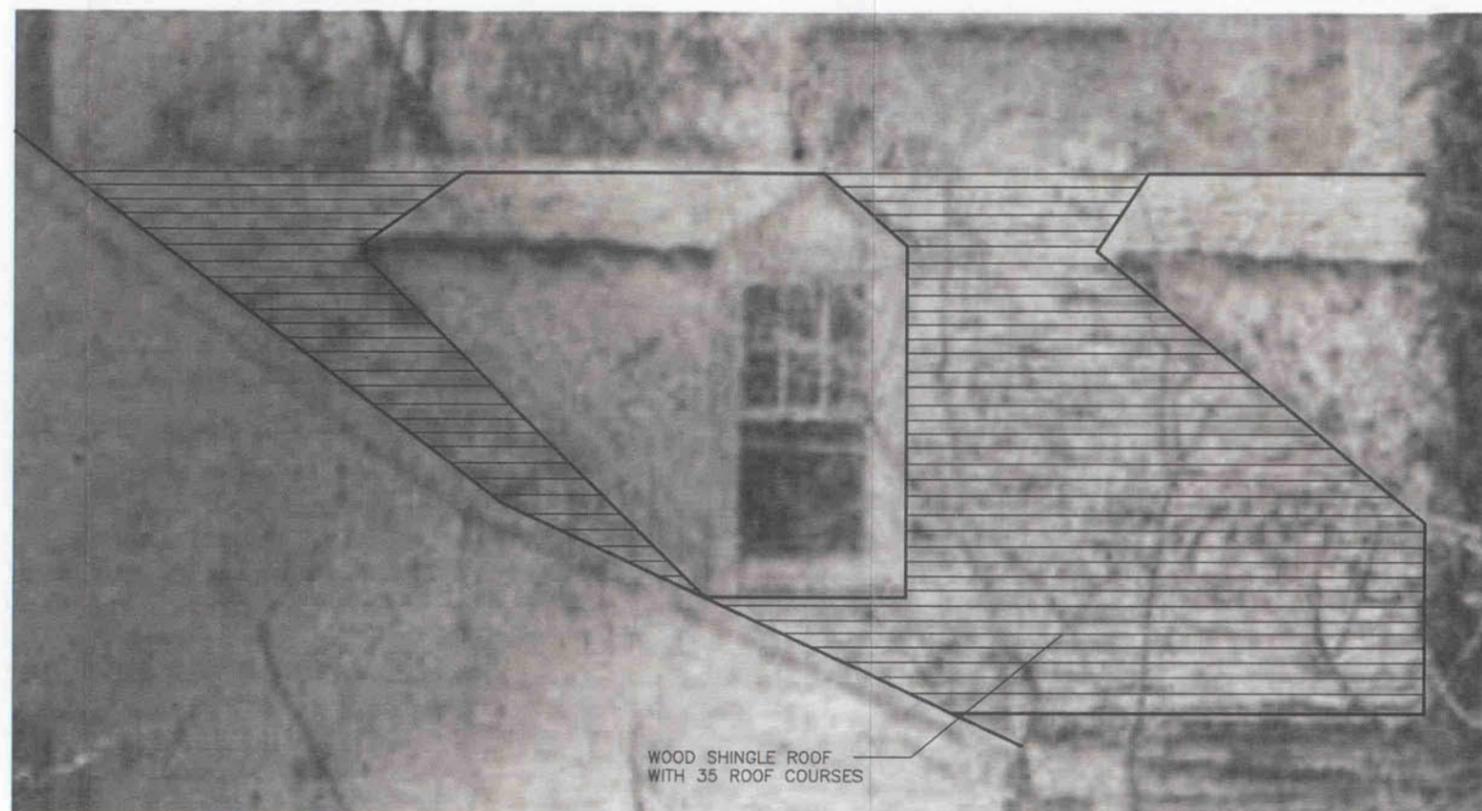
ROOFING COUNT ON ADDITION MA-2b

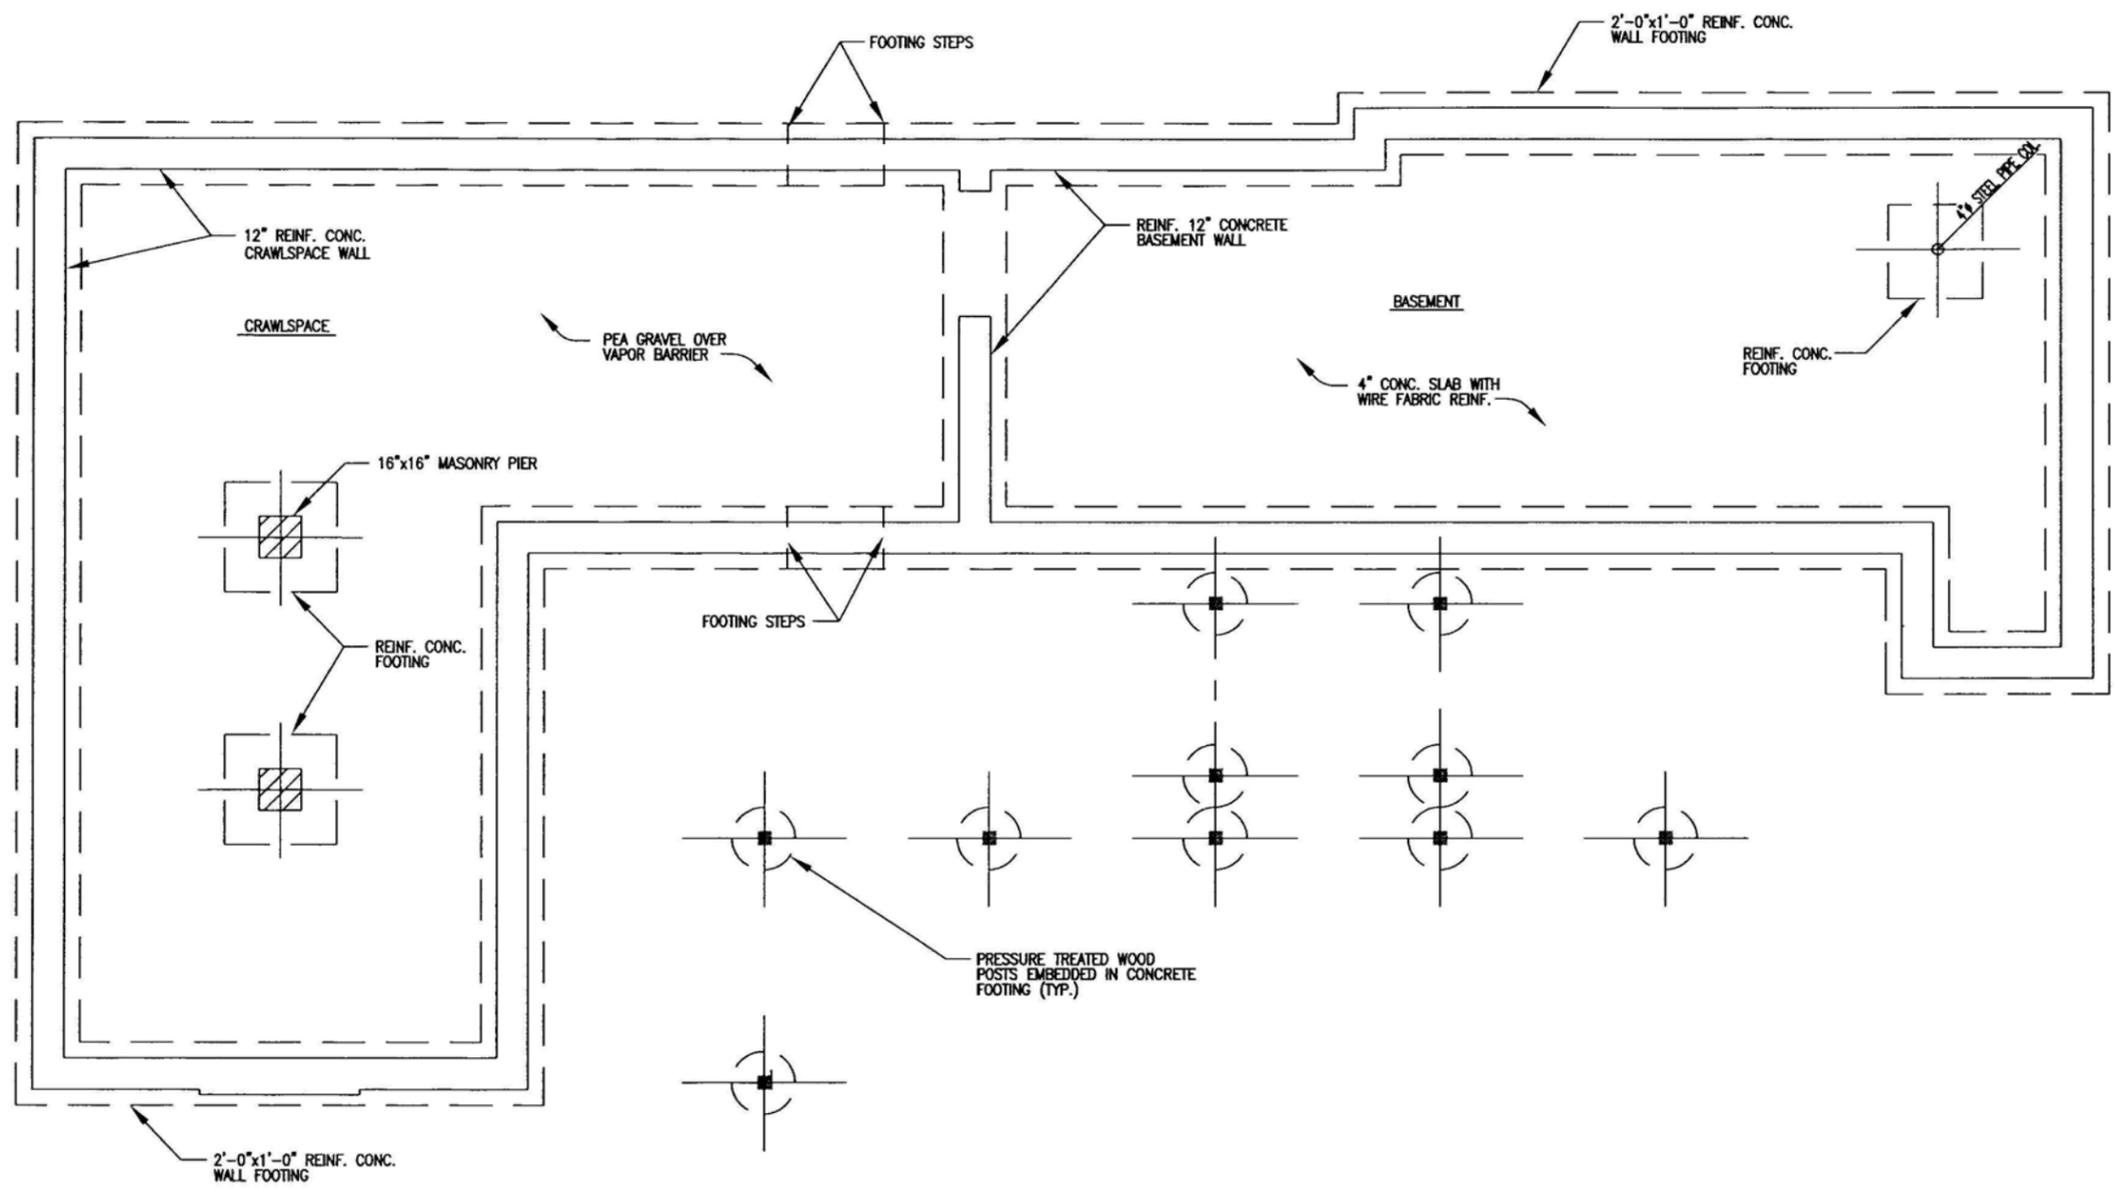
1 FOUNDATION PLAN
S1.1 3/8" = 1'-0"

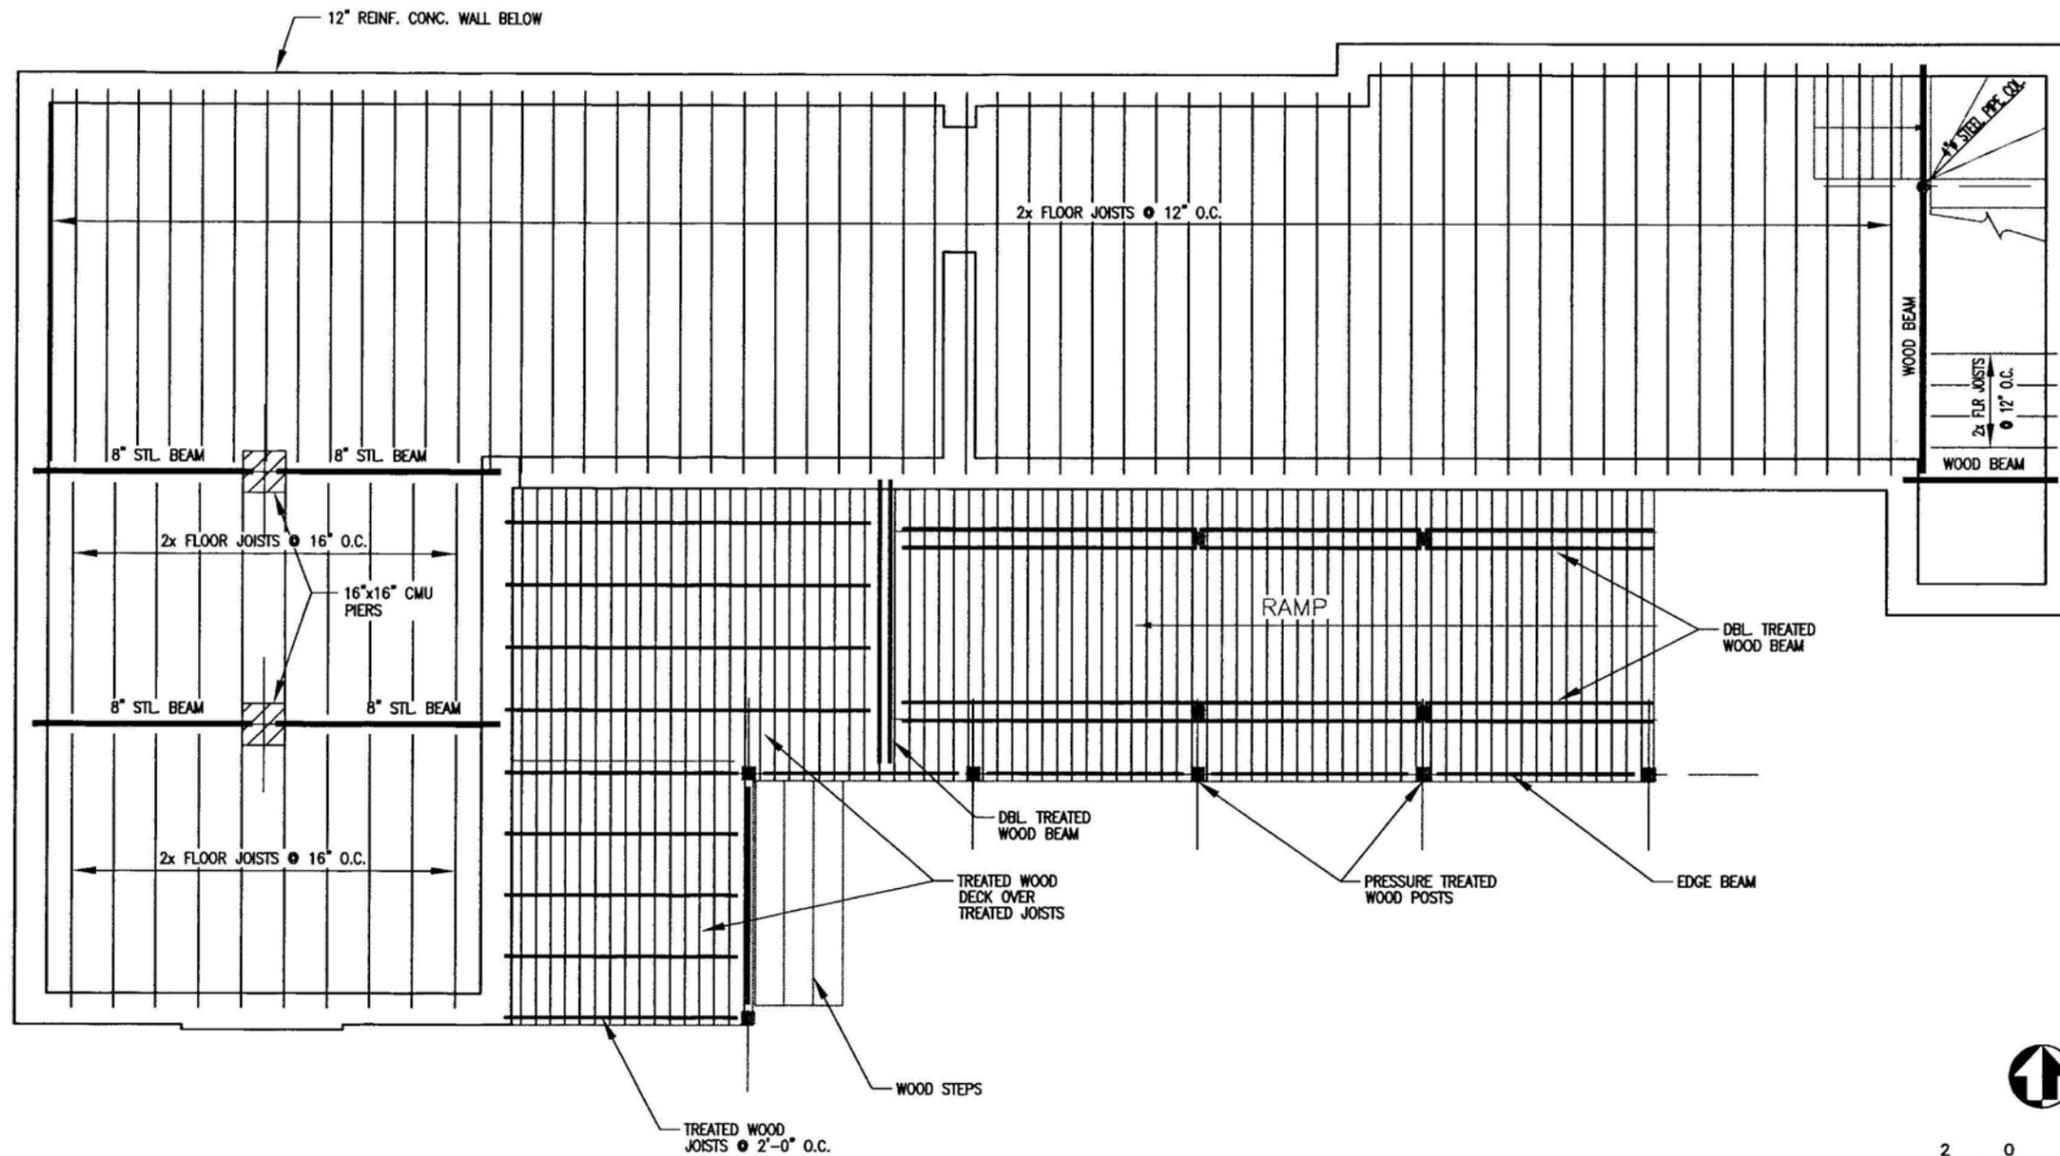
1 1ST FLOOR FRAMING PLAN
 S1.2 3/8" = 1'-0"

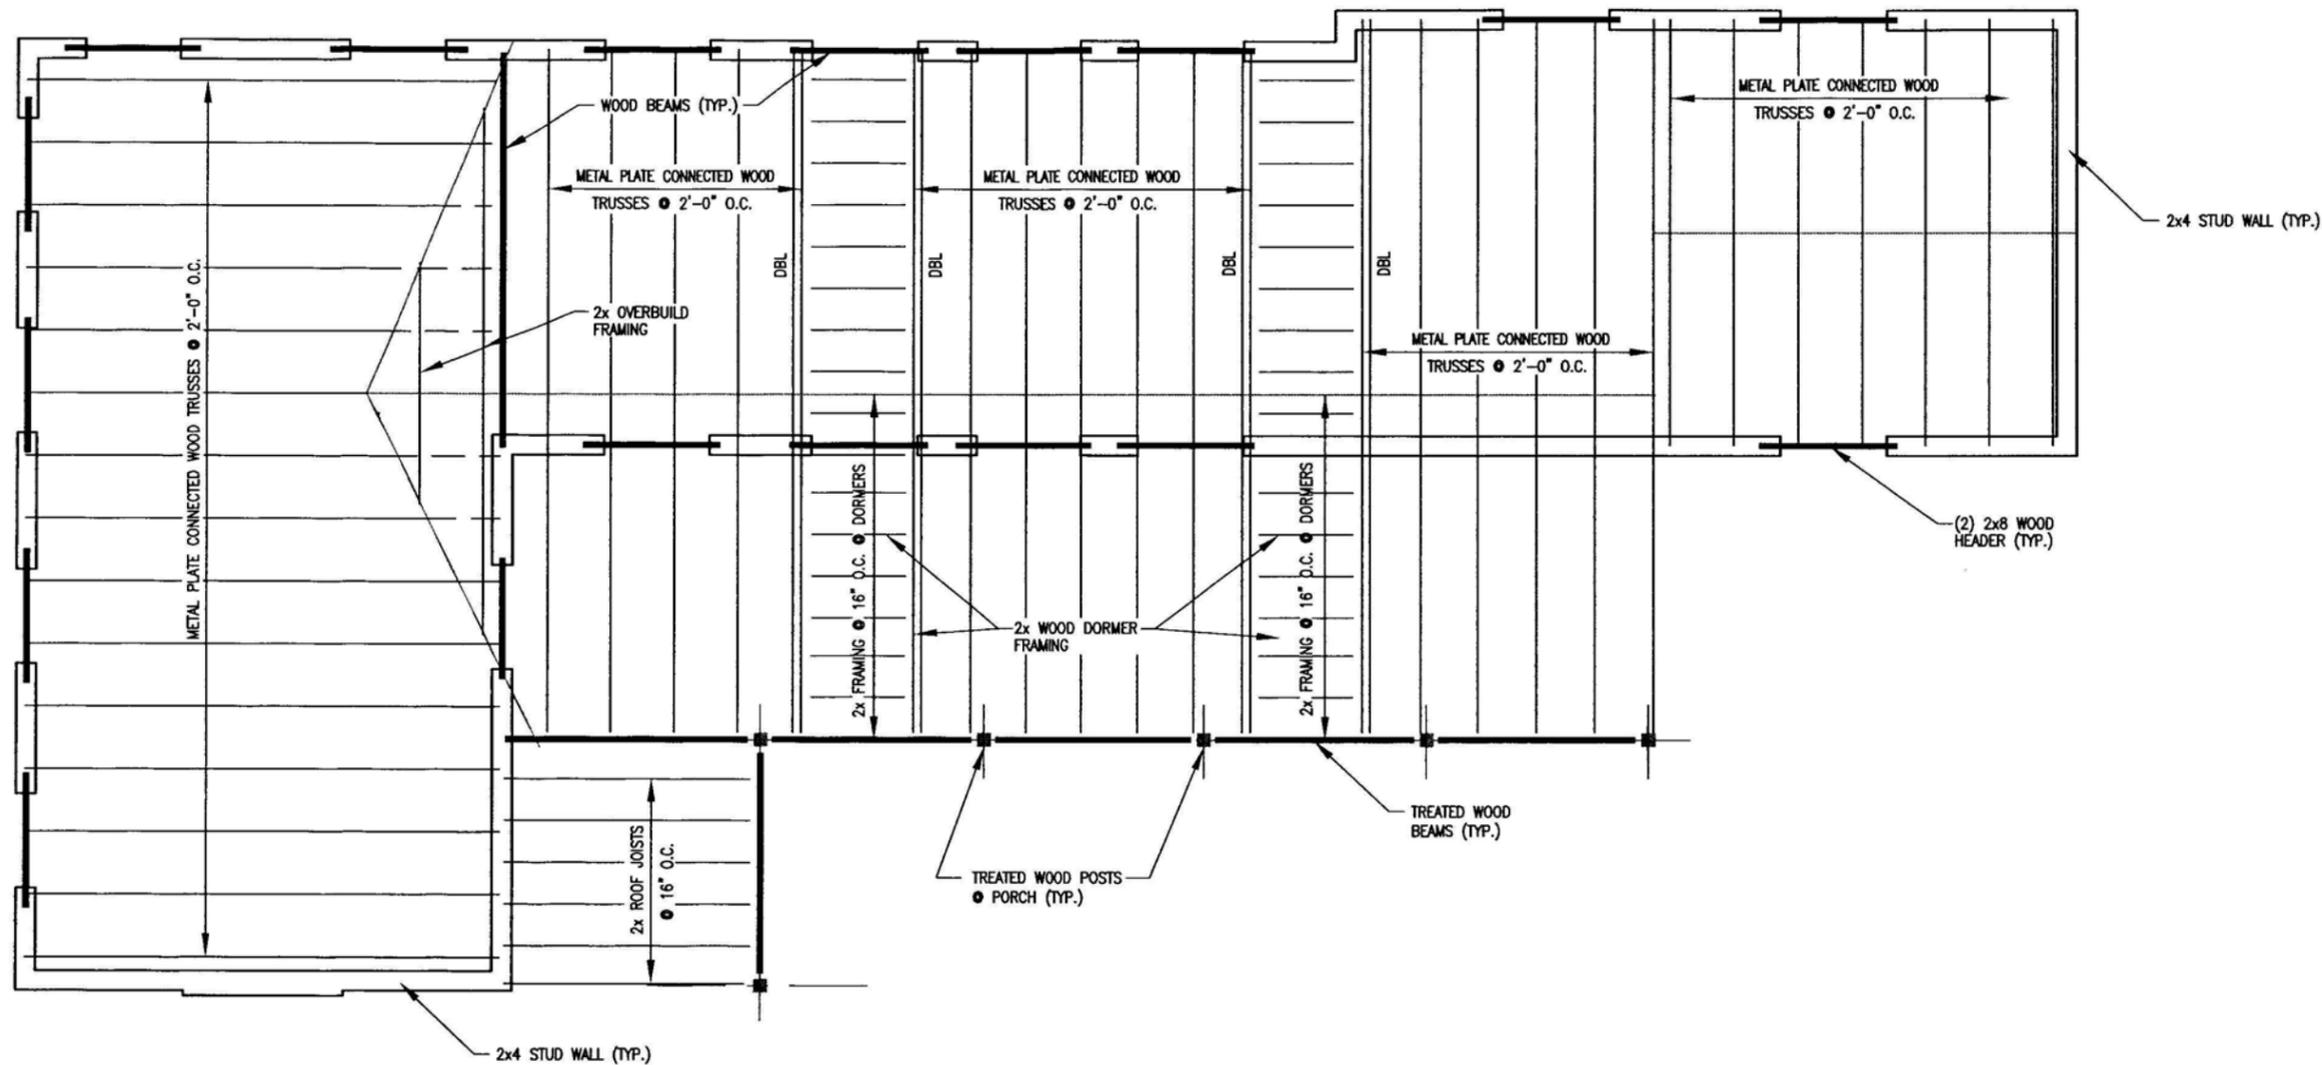
1 ROOF FRAMING PLAN
S1.3 3/8" = 1'-0"
