CARRIGAN HOUSE (HS-25)

Lincoln Home National Historic Site
Springfield, Illinois

Historic Structure Report

May 19, 2006

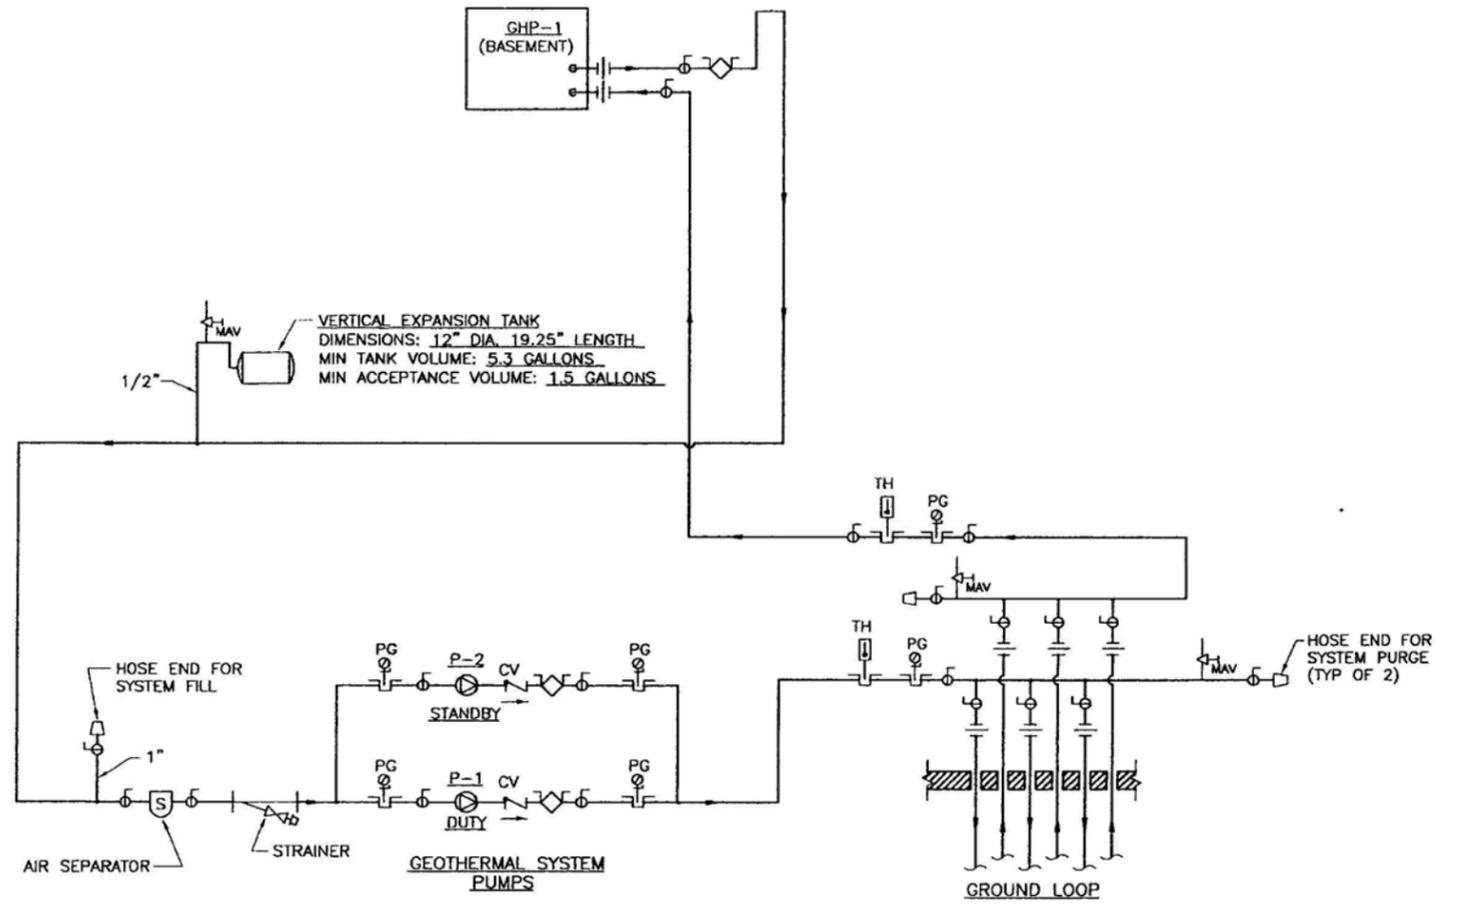
GEOHERMAL PIPING SYSTEM SCHEMATIC
NO SCALE

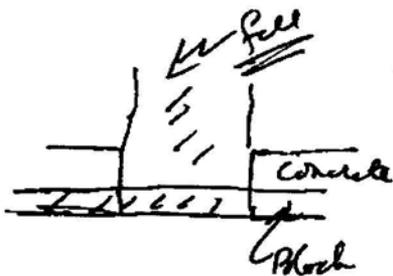
Bob holes had wide foundation (concrete) with old ground surface about 10" b.s. trench lead to opening in wall

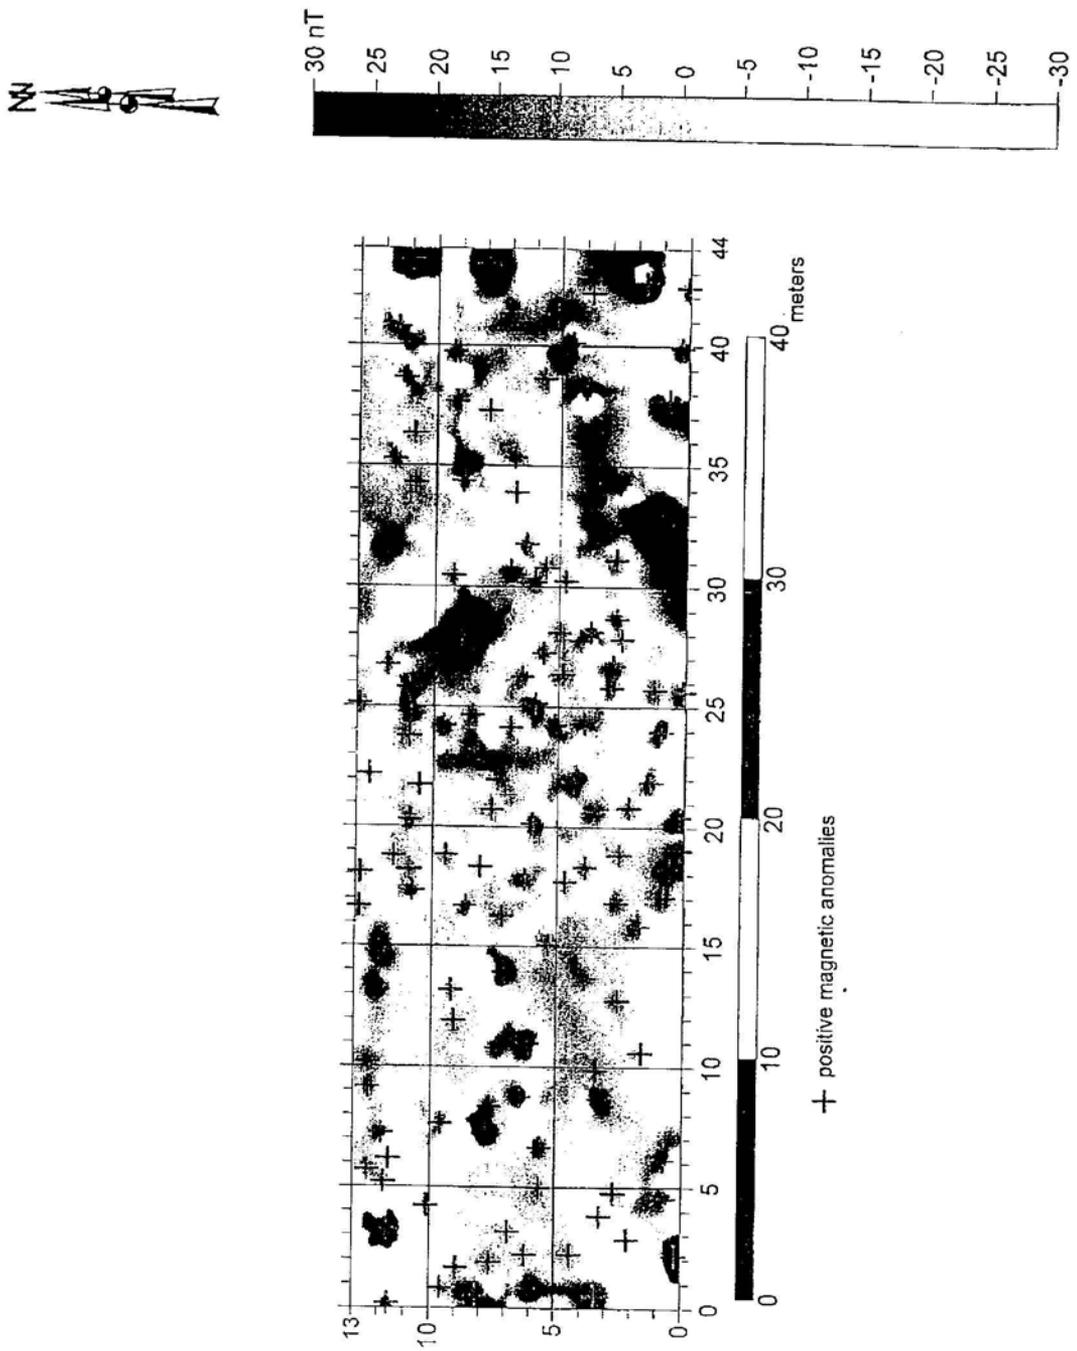
Figure 21. Interpretative map of magnetic gradient data from the Burch lot.

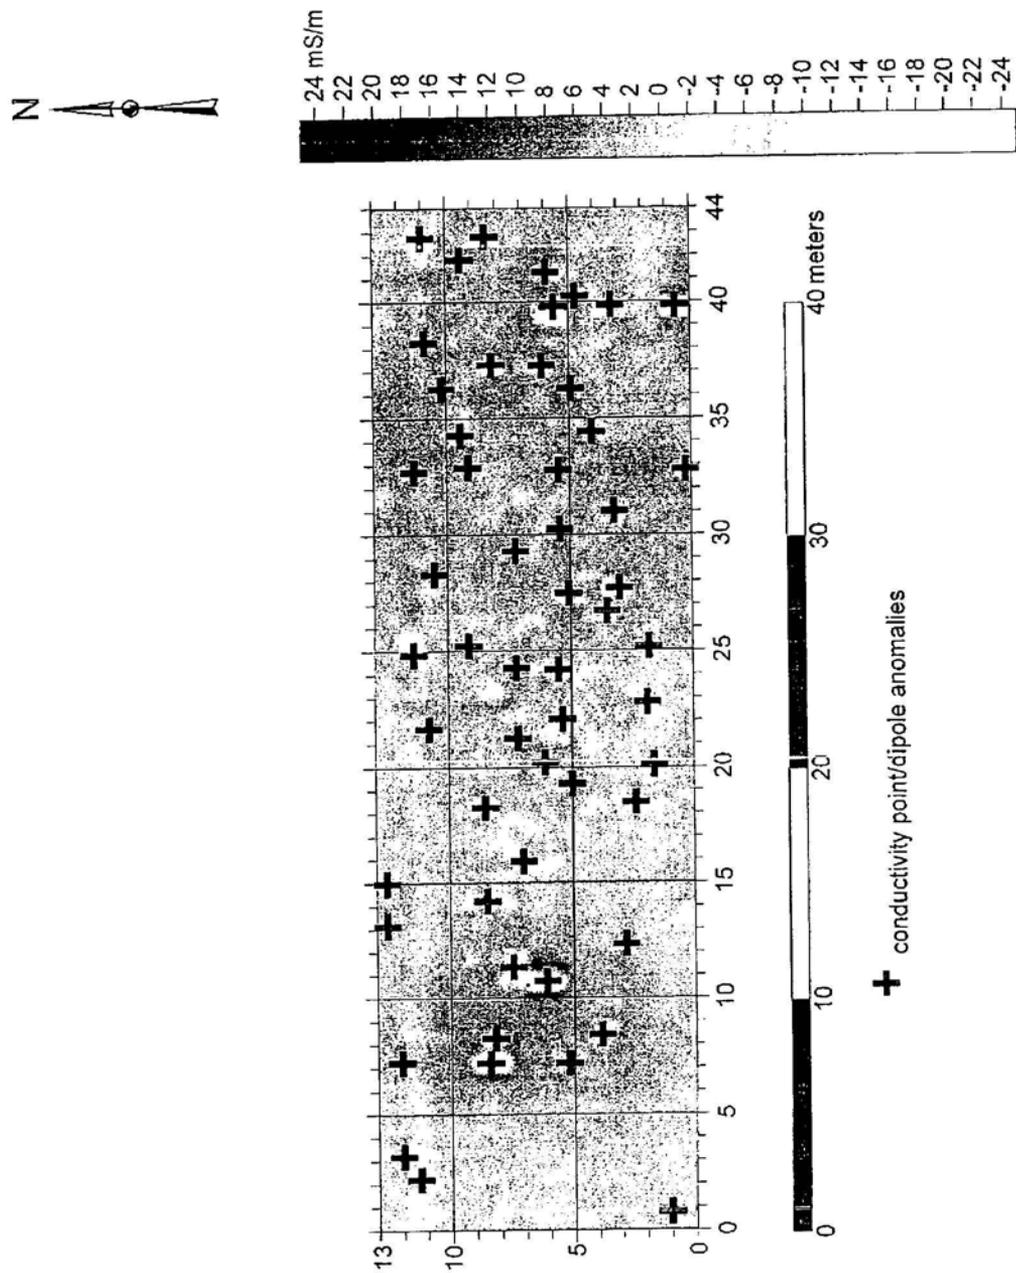
Figure 22. Interpretative map of conductivity data from the Burch lot.

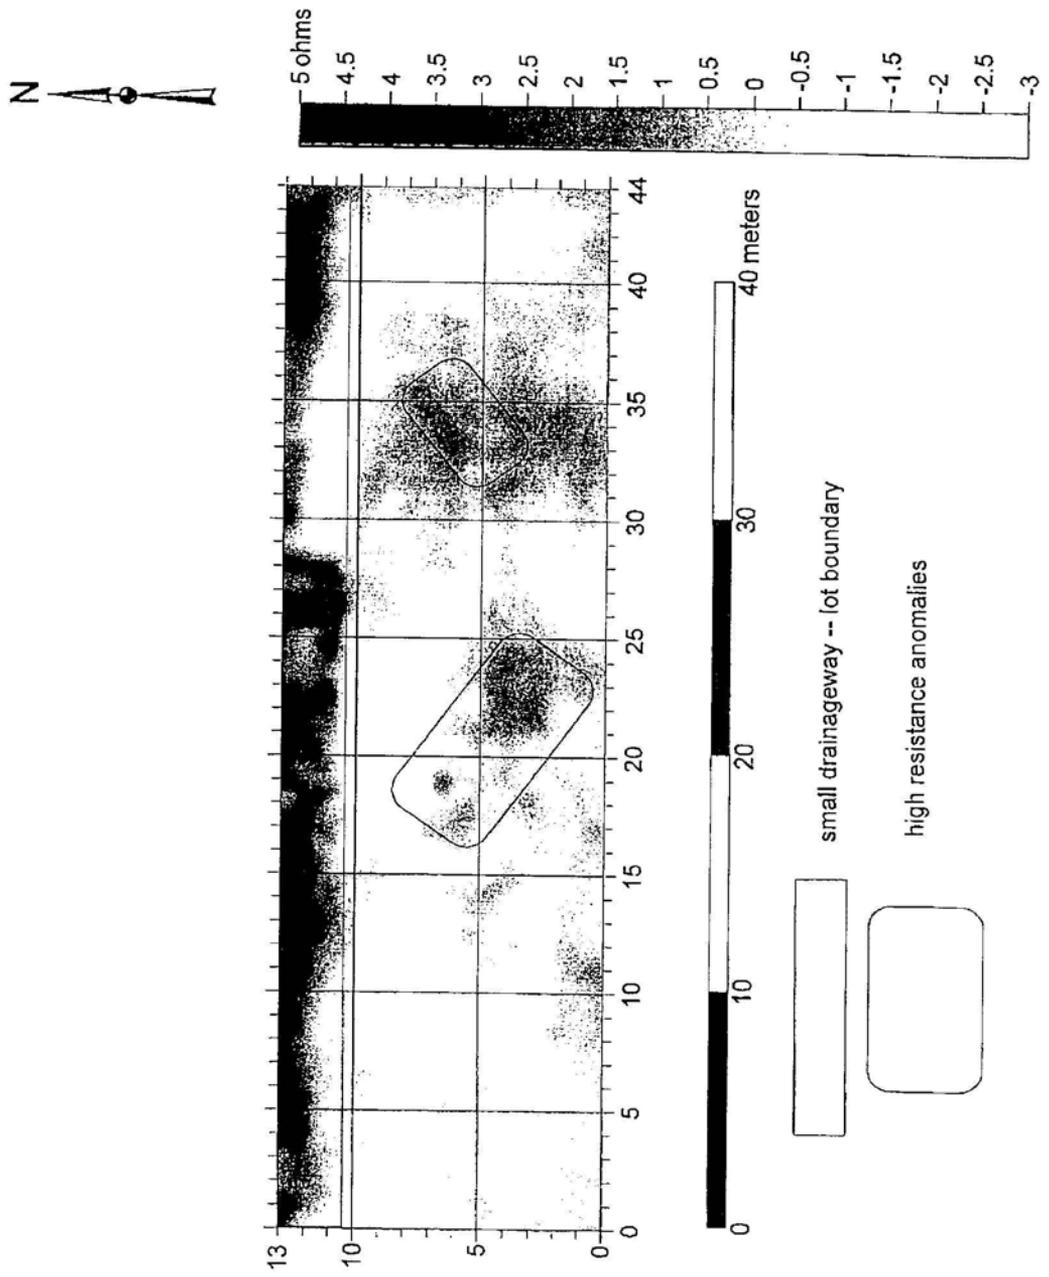
Figure 23. Interpretative map of resistance data from the Burch lot.

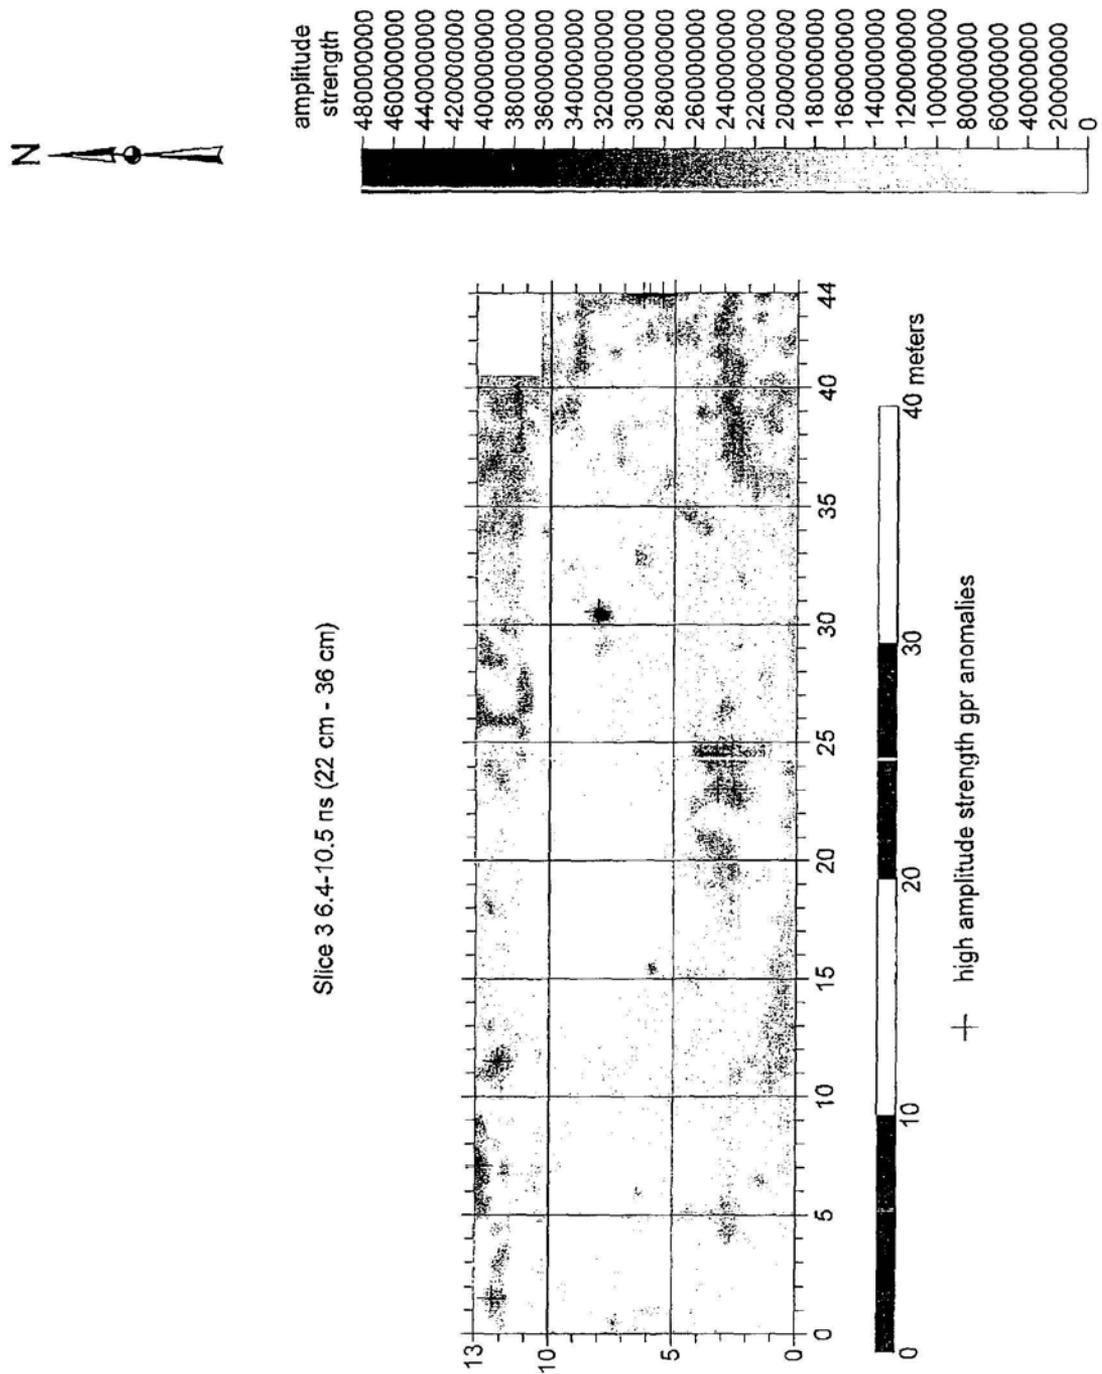
Figure 24. Interpretative map of time slice 3 gpr data from the Burch lot.

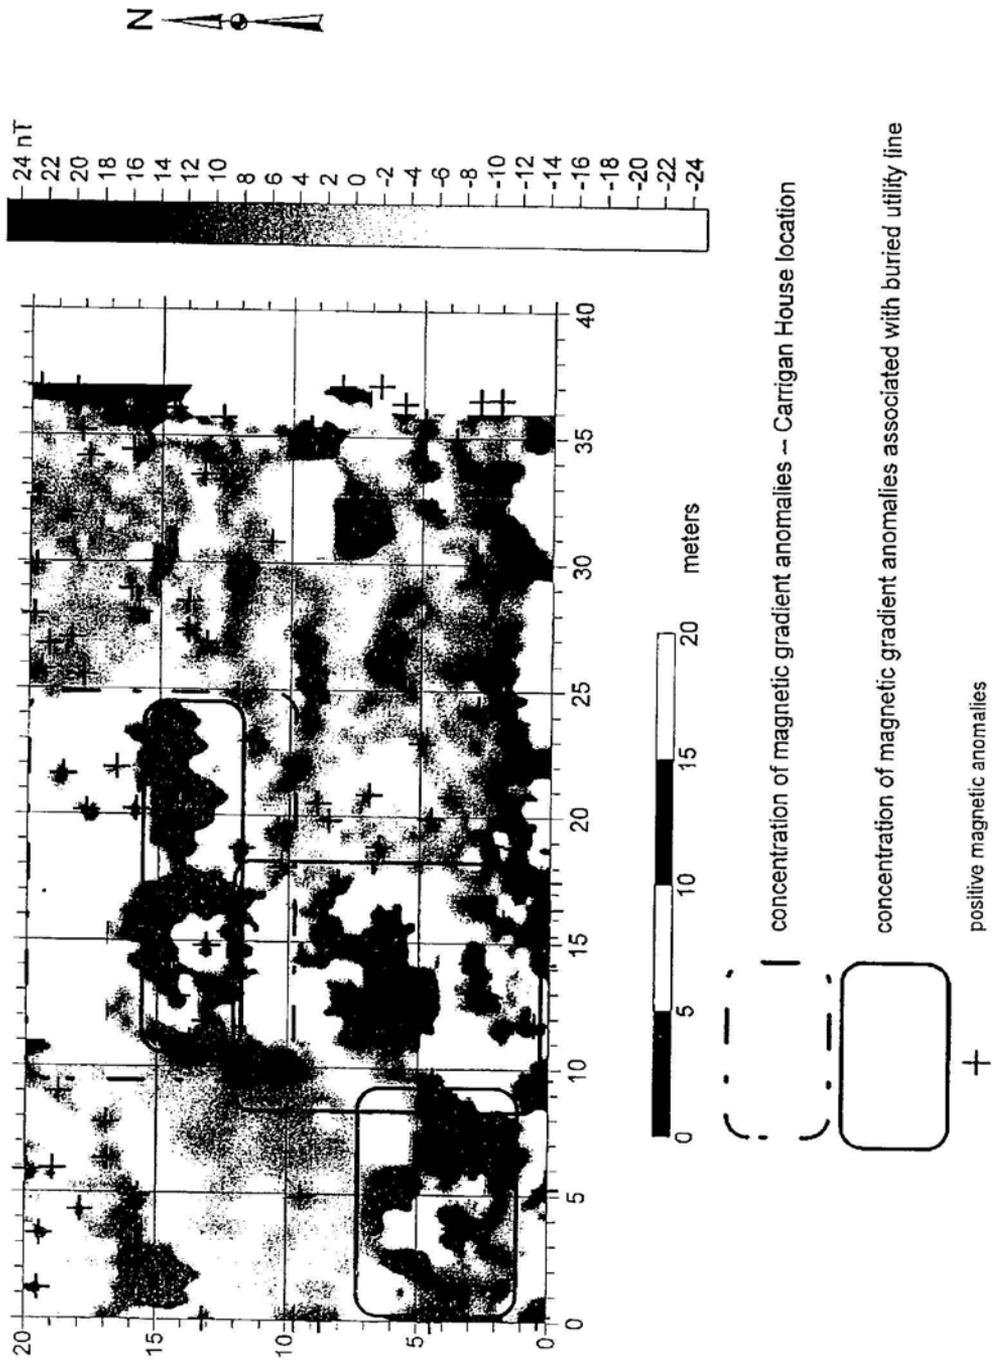
Figure 25. Interpretative map of magnetic gradient data from the Carrigan lot.

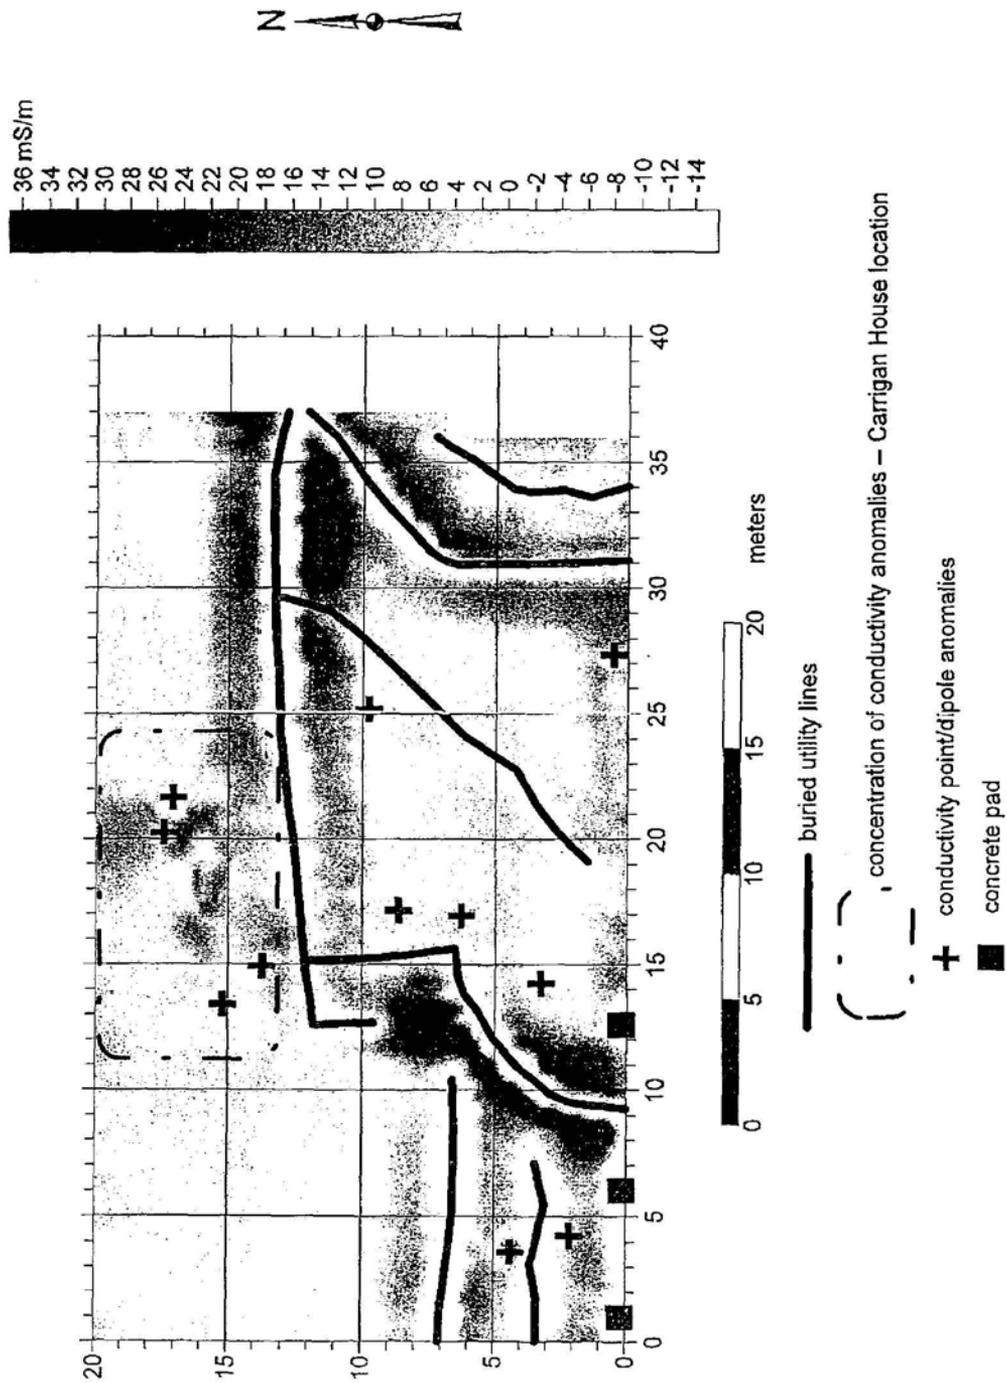
Figure 26. Interpretative map of conductivity data from the Carrigan lot.

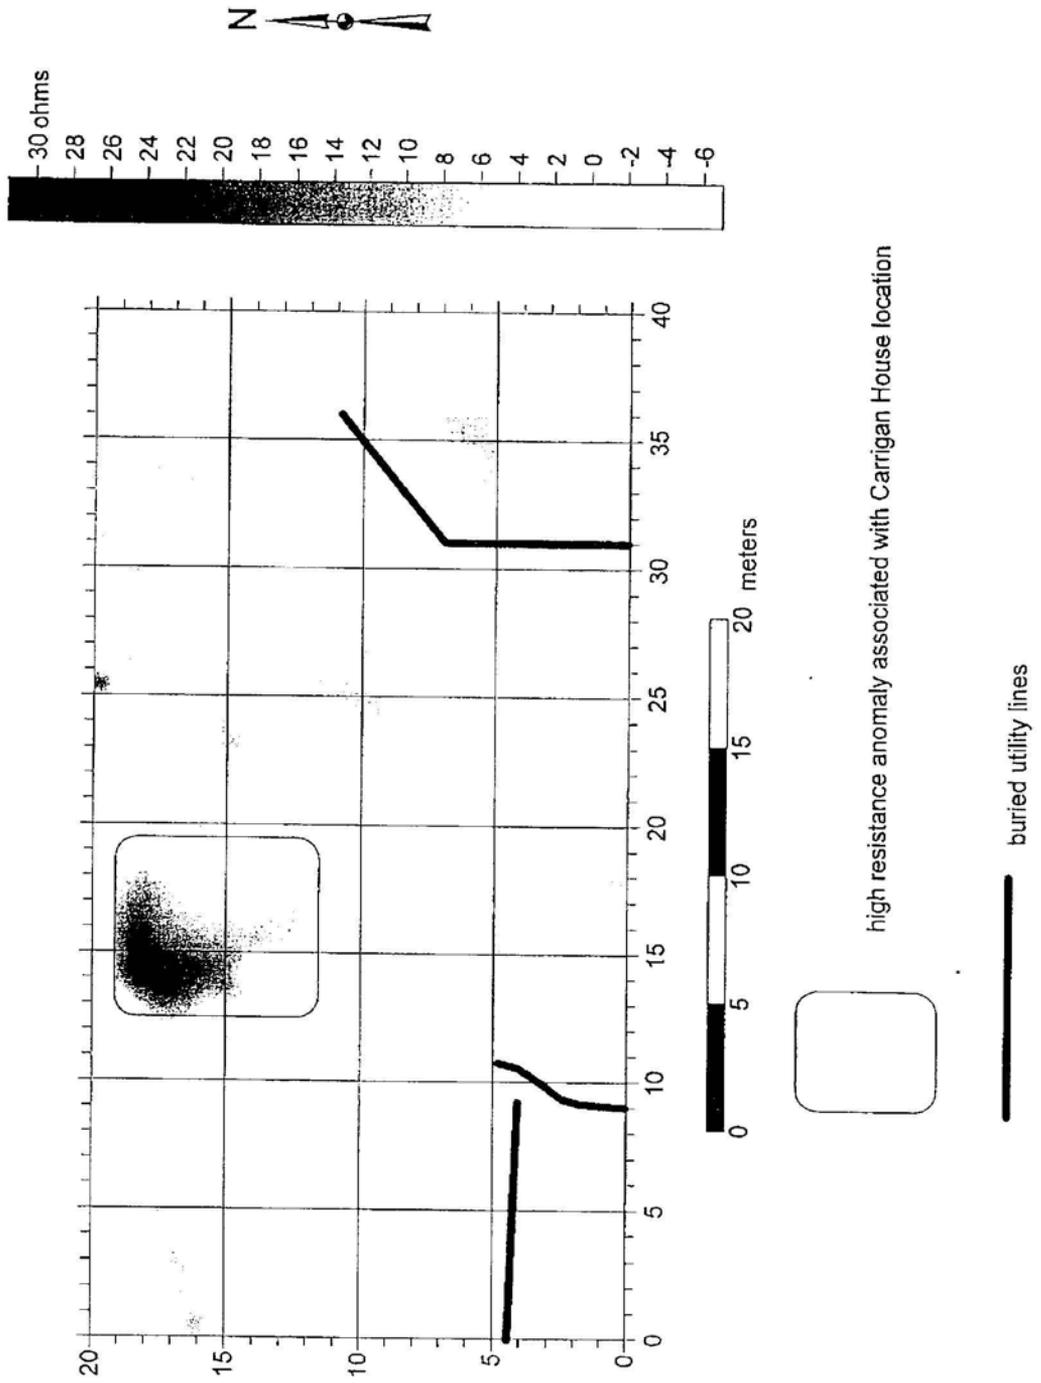
Figure 27. Interpretative map of resistance data from the Carrigan lot.

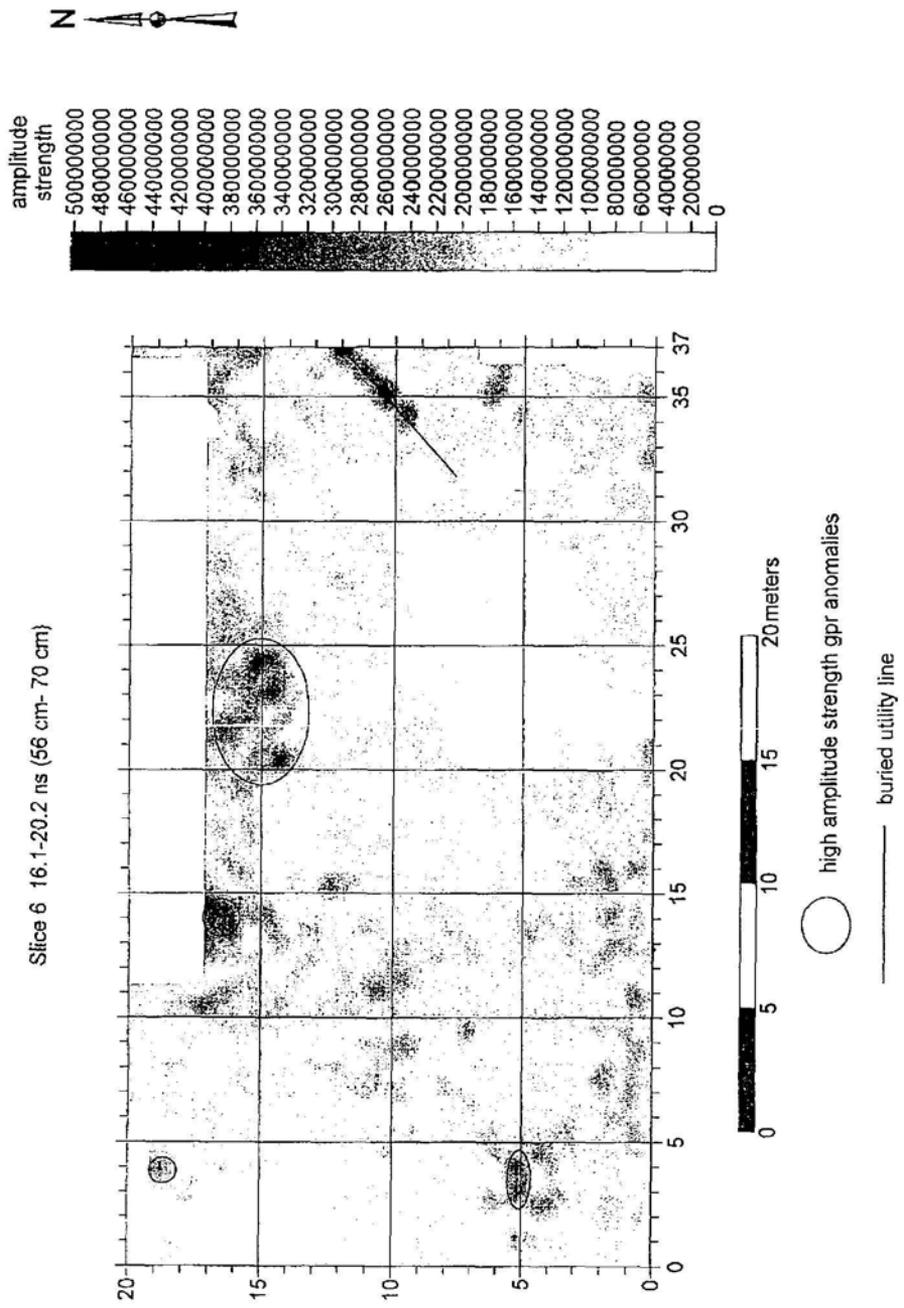
Figure 28. Interpretative map of time slice 6 gpr data from the Carrigan lot.
