Yellowstone National Park

Submerged Resources Survey

Submerged Resources Center
Professional Reports
Number 16

Cultural Resources Management
Professional Paper
Number 65

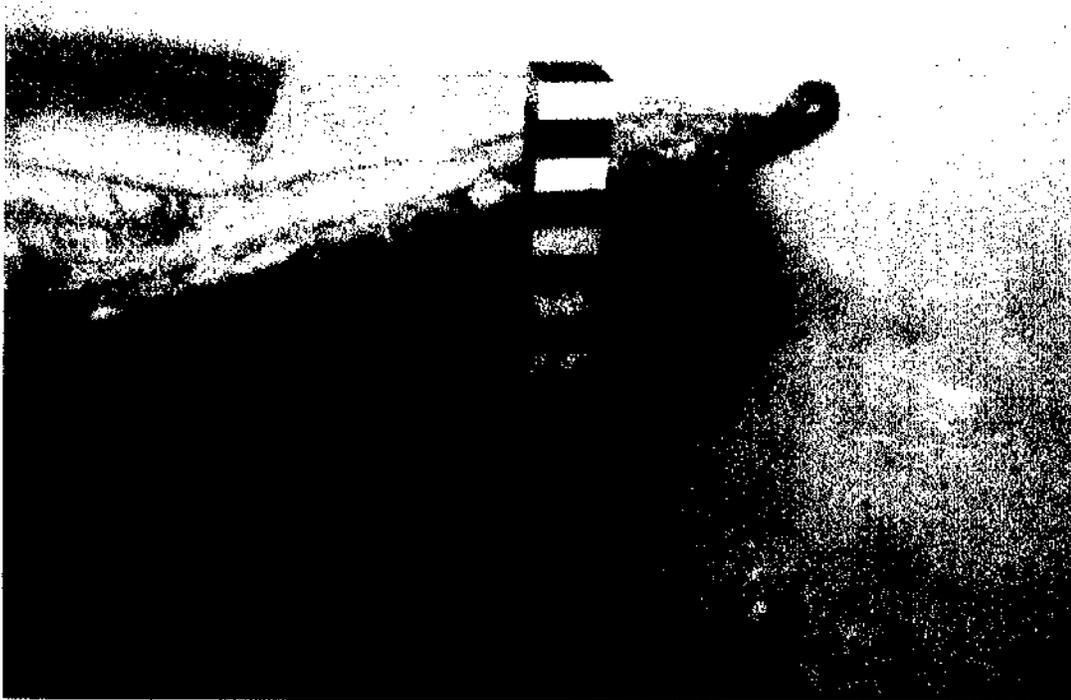
Figure 5.18. Small boat bow. Scale in inches. NPS photo by John Brooks.

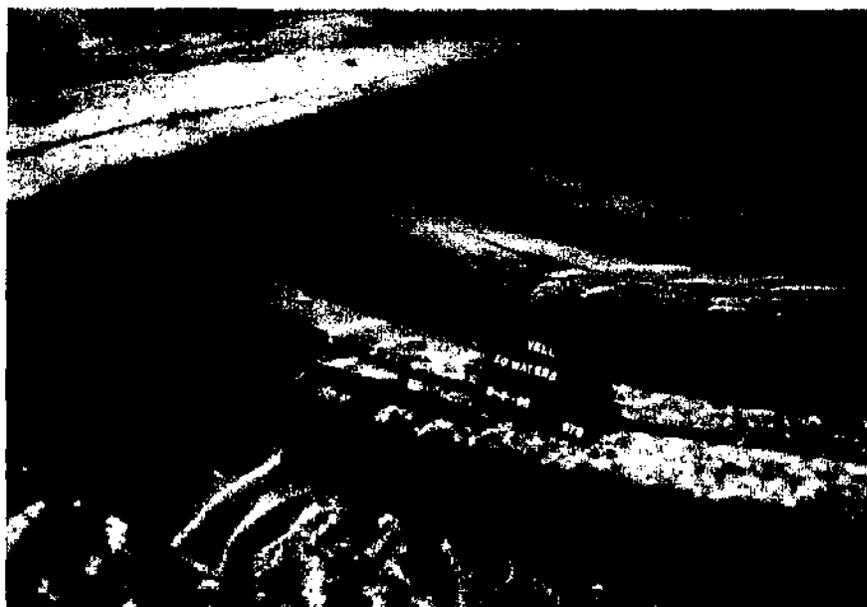
Figure 5.29. *E. C. Waters'* frames. View aft of paired frames with butt joints in the wreck's forward port section. The main and sister keelsons overlay the frames in the upper left. Scale = 1 foot. NPS photo by Brett Seymour.

E. C. Waters' framing was constructed using a peculiar combination of the long-and-short-

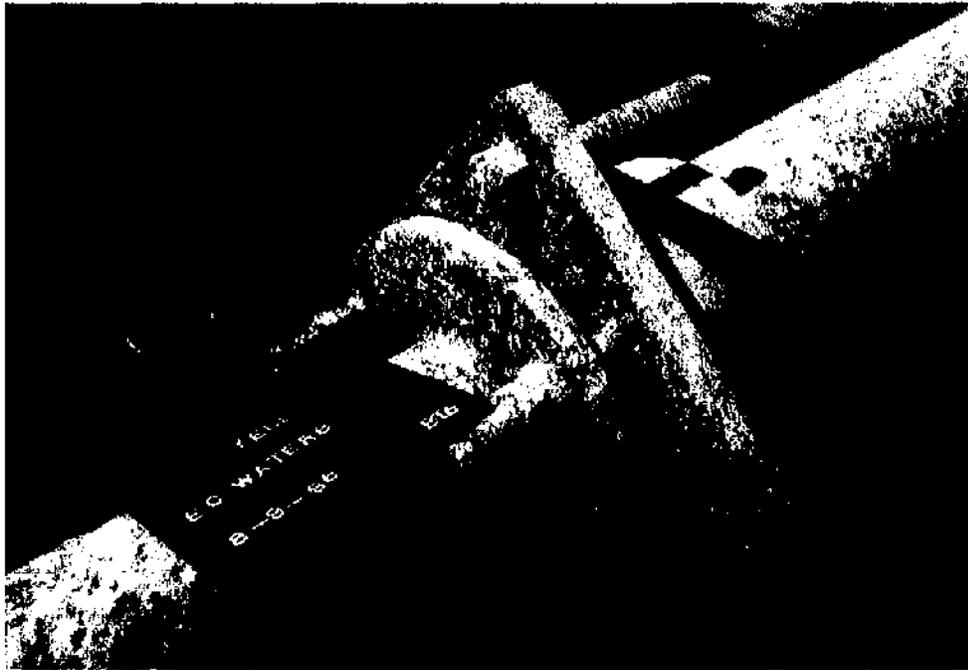
Figure 5.39. View southwest of forward end of stern tube stuffing box and gland. Note large bolt on top that secured the shaft to the stern deadwood (now missing) through which it passed. Marked section of scale = 6 inches. NPS photo by Brett Seymour.

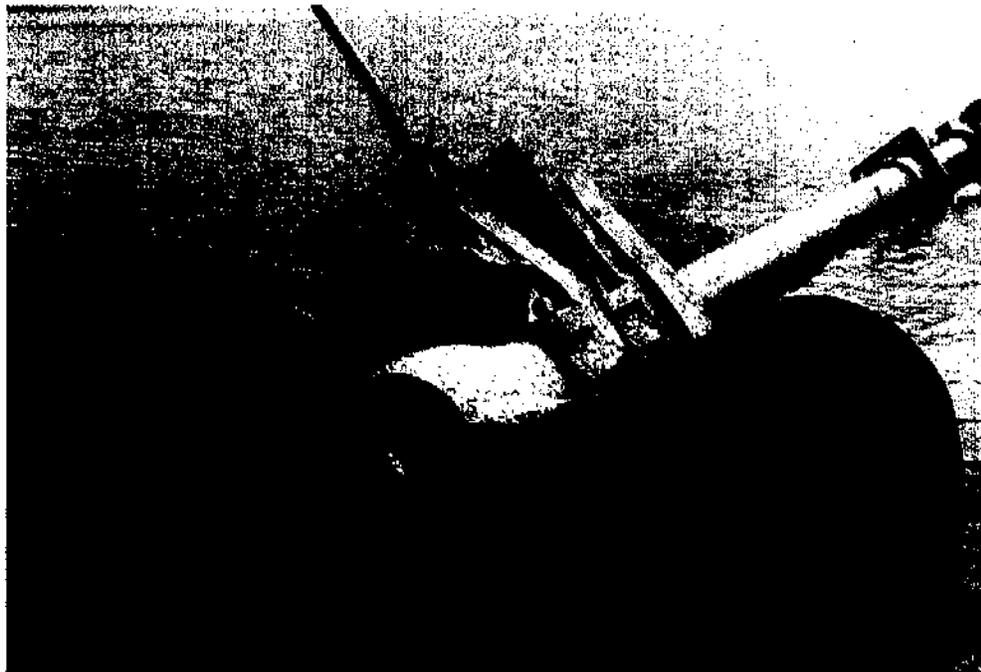
Figure 5.42. View northeast of propeller. NPS photo by John Brooks.
