83001 OLD BRIDGE, CONCORD

CULTURAL LANDSCAPE REPORT
NORTH BRIDGE UNIT
MINUTE MAN NATIONAL HISTORICAL PARK

SITE HISTORY, EXISTING CONDITIONS,
ANALYSIS & EVALUATION, TREATMENT RECOMMENDATIONS

CONCORD
MASSACHUSETTS

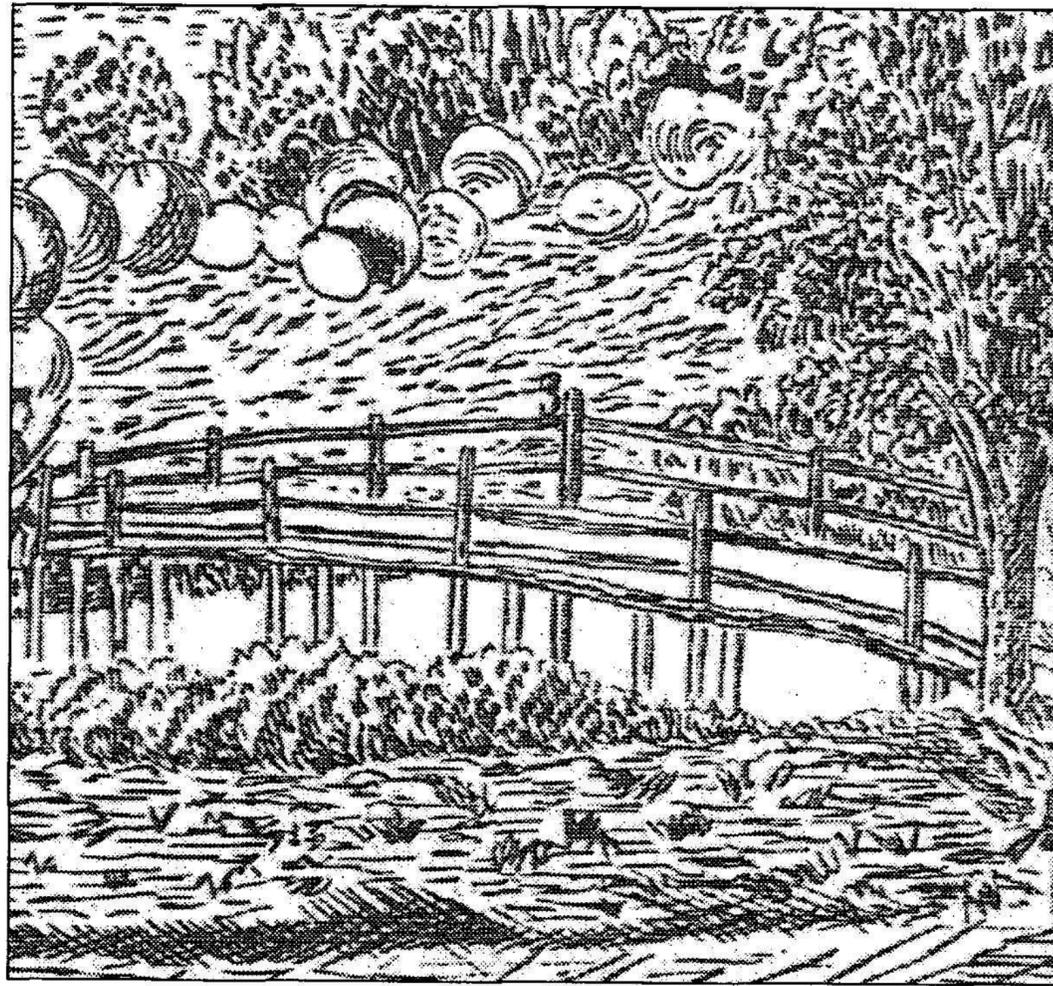
Figure 7. Detail of the North Bridge, as depicted in the Doolittle Print, Plate III, The Engagement at the North Bridge in Concord, c. 1775.

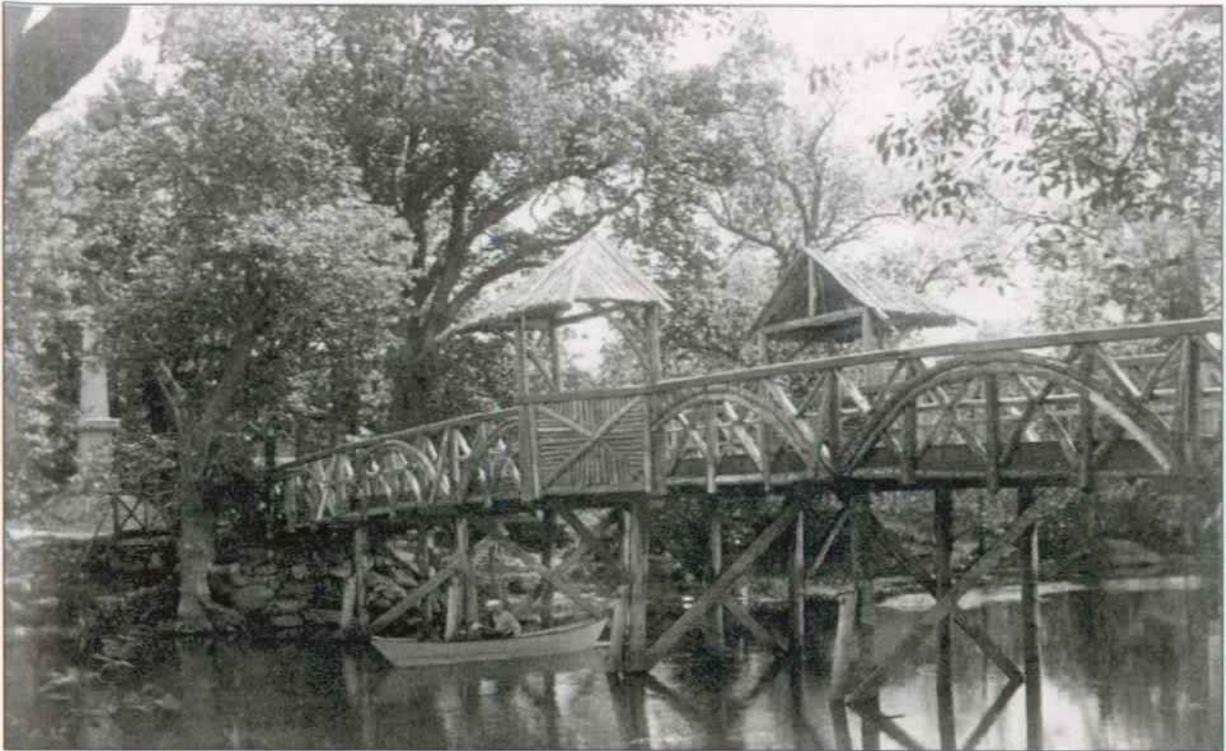
Figure 20. 1874 commemorative North Bridge, view southeast. Photograph by Alfred Hosmer, c. 1880-1888. Also visible is the 1836 Battle Monument. (MIMA Photographic Collection, Box 12, #34167, MIMA Archives)

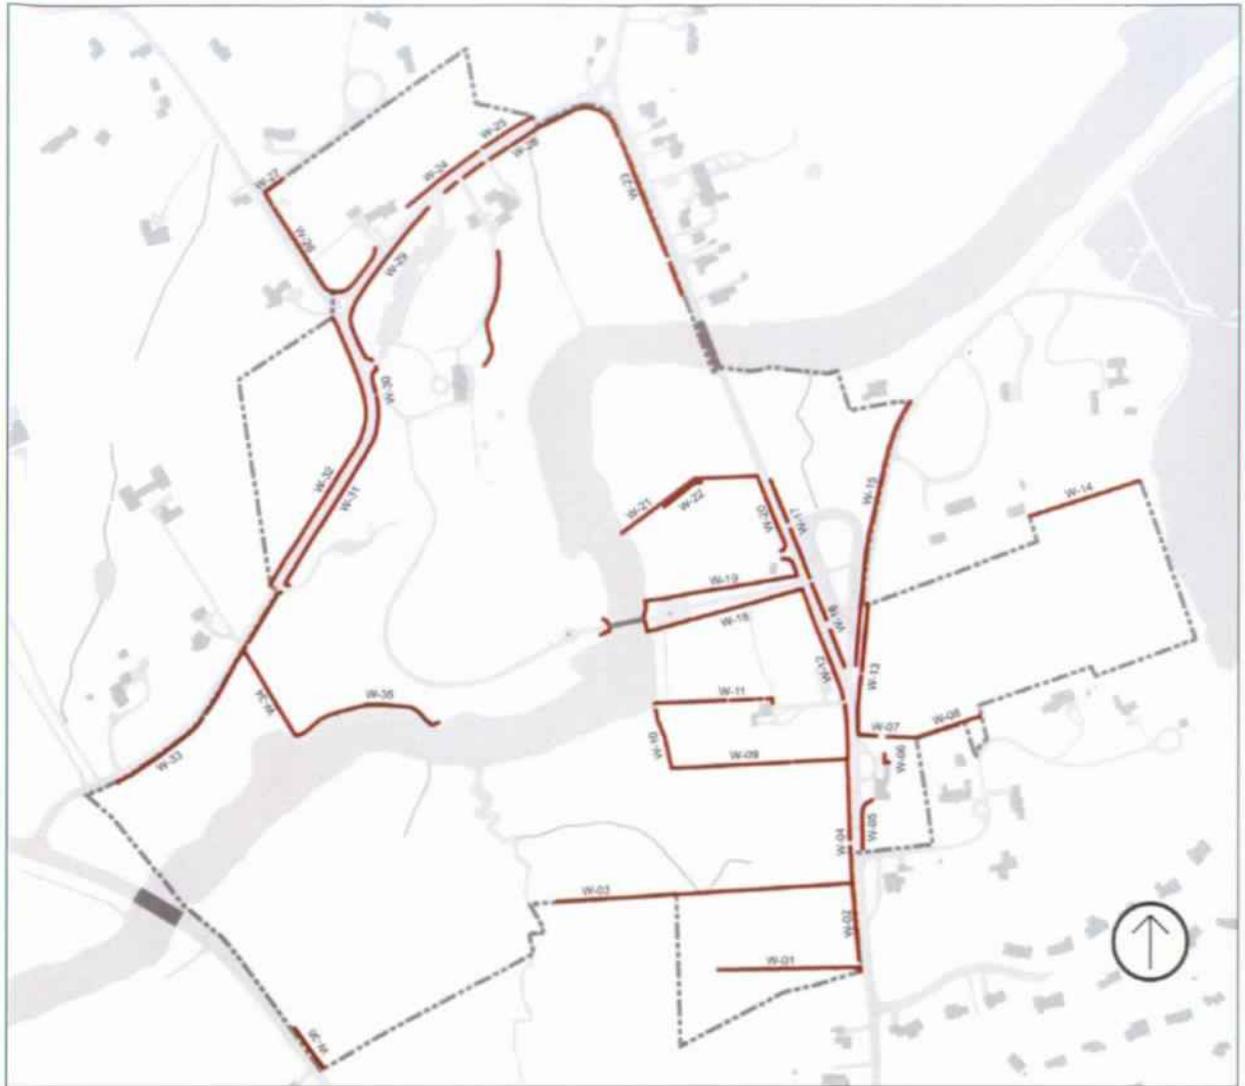
Figure 83. Stone walls location map, 2003. (OCLP).

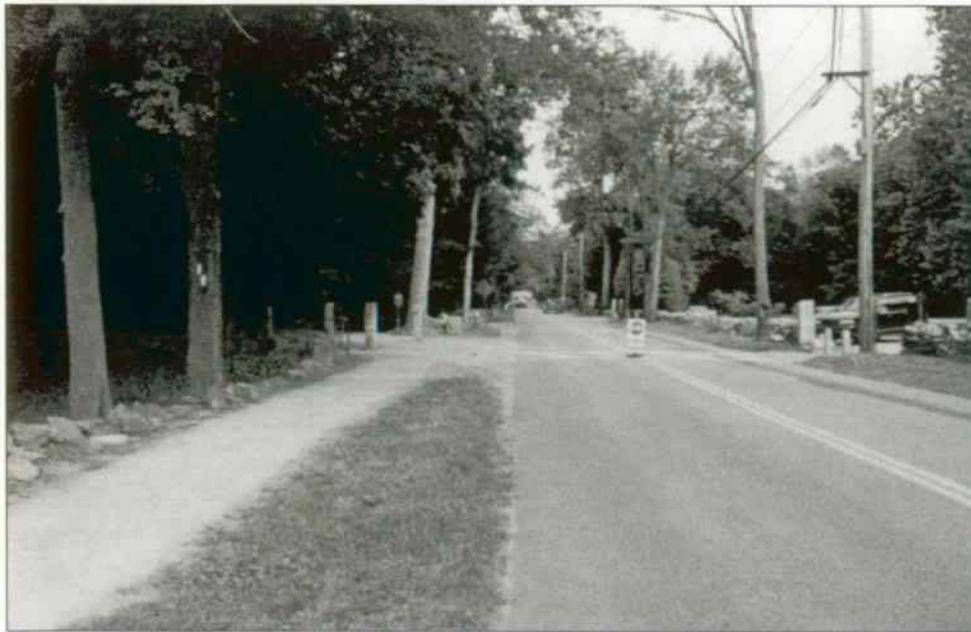
Figure 85. View north of Monument Street, 2002. Note stone wall (W-16) bordering the Monument Street parking (right), Stone wall (W-12) bordering the Old Manse field (left), and the pedestrian crosswalk. (OCLP)

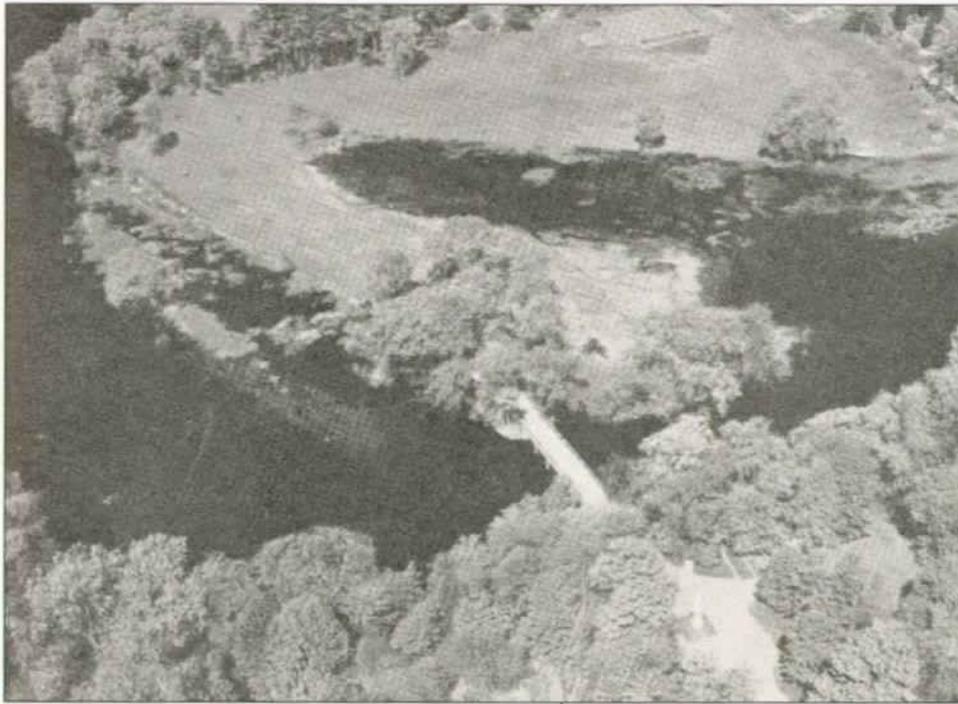
Figure 117. Aerial view northwest of the Groton Road causeway (west of the 1956 commemorative North Bridge), 1950. Also shown is the 1836 Battle Monument (lower right). (Photograph depicted in Ruth Wheeler's "North Bridge Neighbors")

- Figure 116 View southwest of the Ephraim and/or Willard Buttrick house(s) site, 2002. (OCLP)
- Figure 117 Aerial view northwest of the Groton Road causeway. (Photograph depicted in “North Bridge Neighbors”)

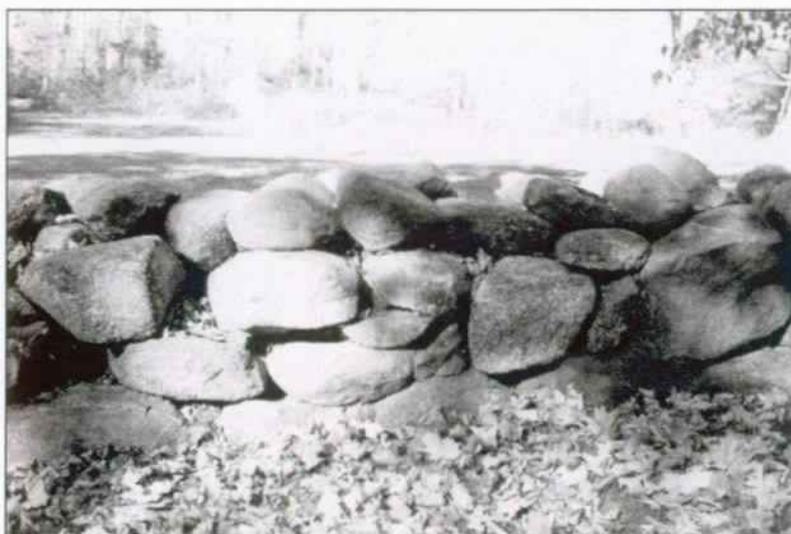
Figure 120. Stone wall (W-19), an example of a thrown stone wall found within the North Bridge Unit, 2003. (OCLP)

- Figure 120 Stone wall (W-19), an example of a thrown stone wall found within the North Bridge Unit, 2003. (OCLP)
- Figure 121 Stone wall (W-20), an example of a laid stone wall found within the North Bridge Unit, 2003. (OCLP)

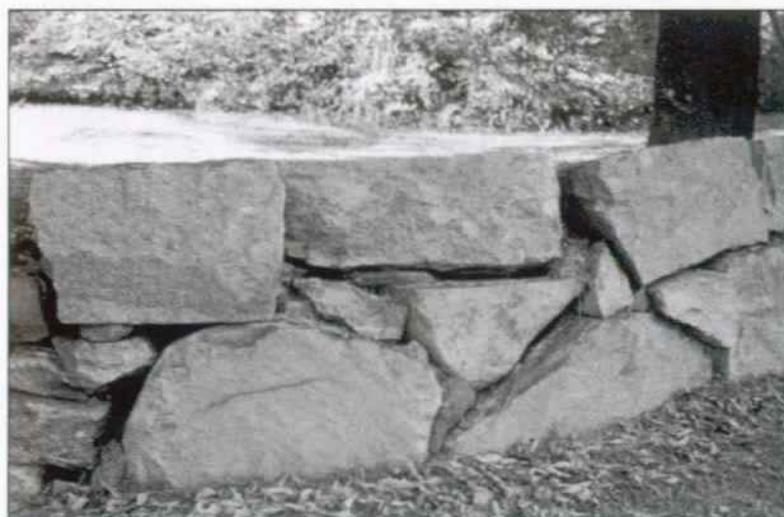
Figure 121. Stone wall (W-20), an example of a laid stone wall found within the North Bridge Unit, 2002. (OCLP)

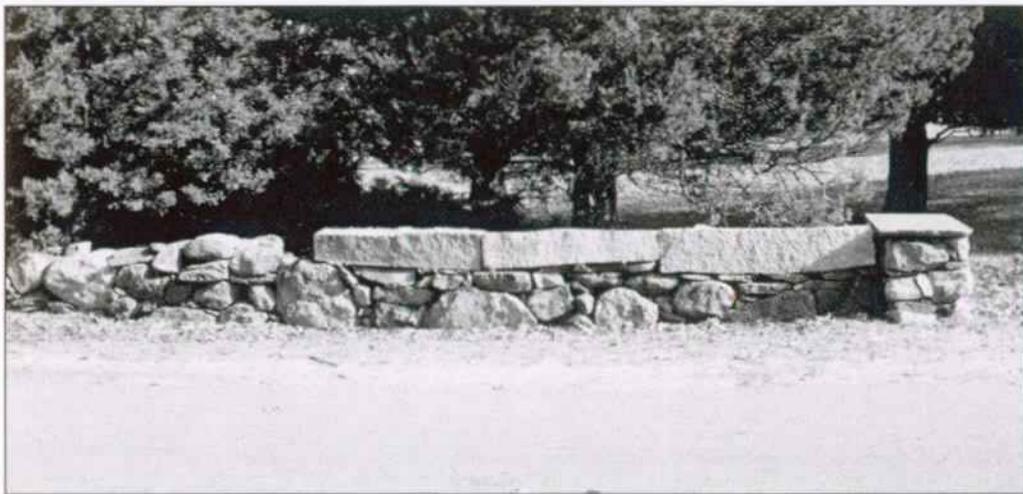
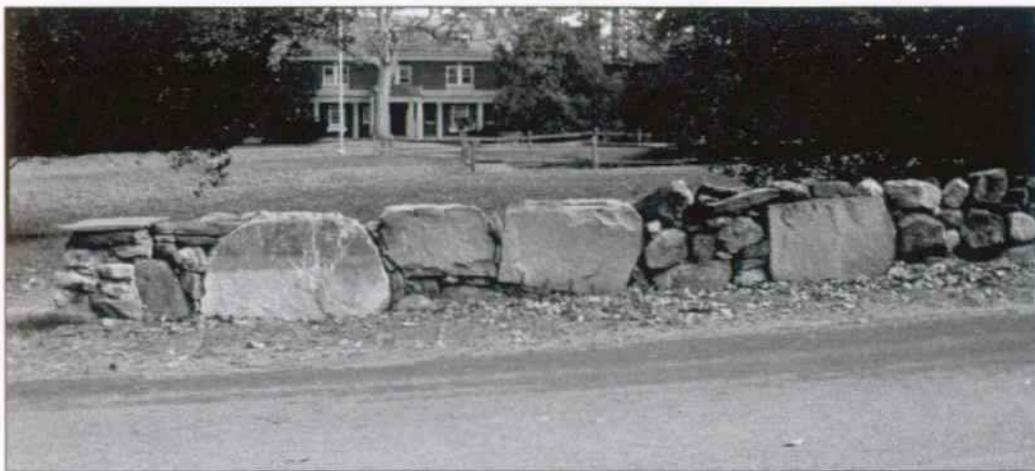
Figure 130. View east of stone wall (W-30), section B, 2002. Top photo depicts portion north of the Groton Road trail entrance and the bottom photograph depicts the portion south of the trail entrance. (OCLP)

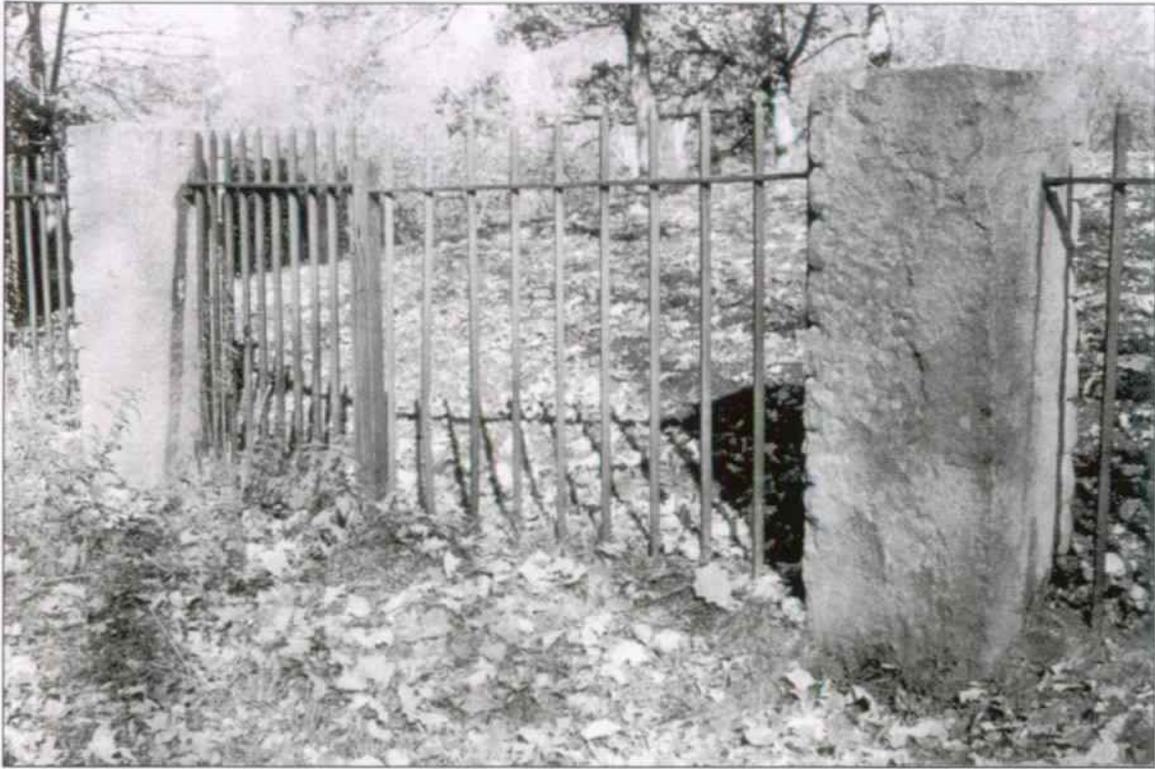
Figure 143. The Minute Man statue fencing, 2002. Depicted in the photograph is the gate that originally stood at the entrance to the battleground, before 1875. (OCLP)

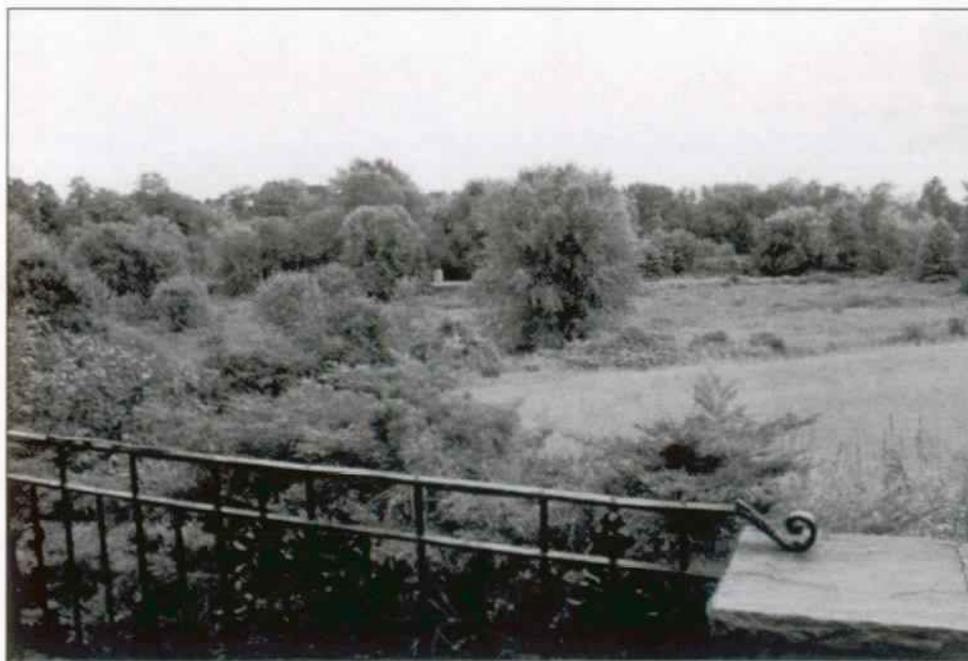
Figure 149. View southeast from the Buttrick lower garden overlook towards the commemorative landscape, 2002. Vegetation growing in the wetland along the river blocks views of the 1956 commemorative North Bridge. (OCLP)
