# MUSEUM BUILDING

## Morristown National Historical Park Morristown, New Jersey

### HISTORIC STRUCTURE REPORT

Historic Architecture Program  
Northeast Region, National Park Service  
U.S. Department of the Interior  
Lowell, Massachusetts

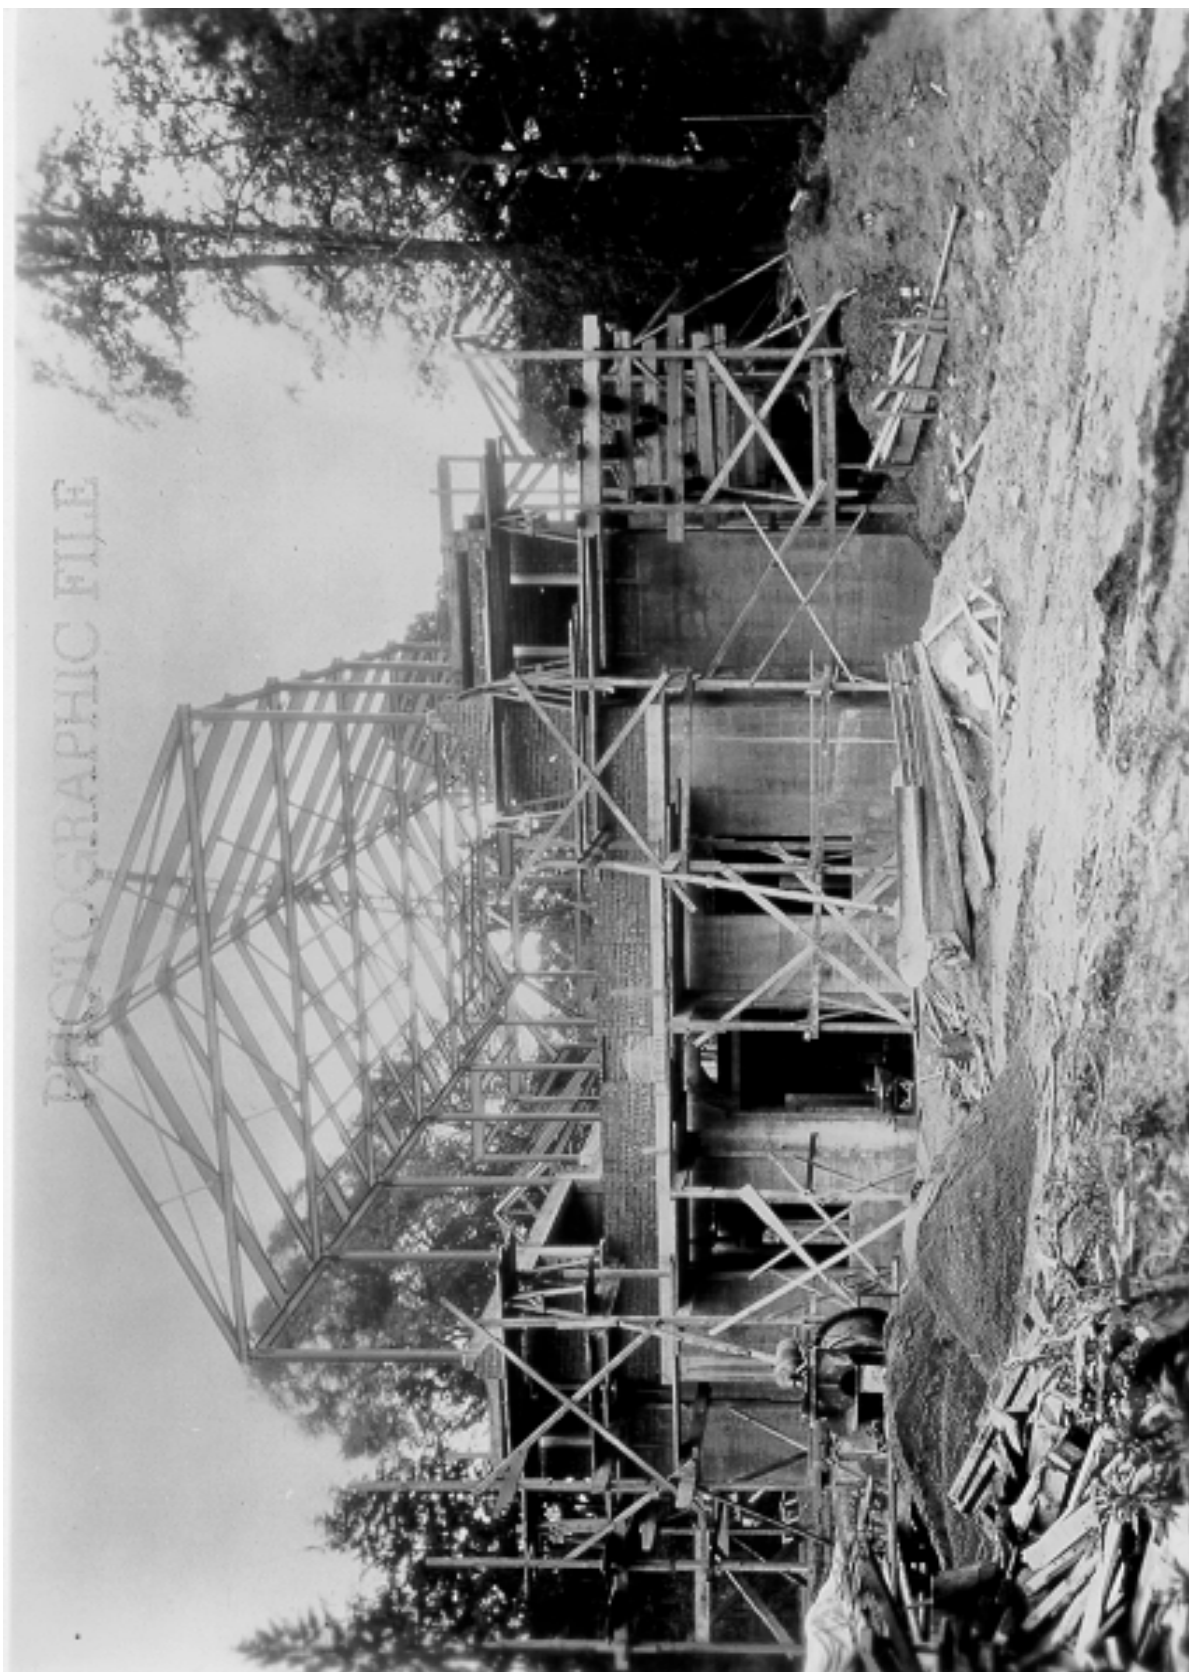
Figure 11. Morristown Museum Building: north elevation, poured- concrete foundation and steel framing (June 1936).

10.	Morristown Museum Building: east elevation, poured- concrete foundation, June 1936. Morristown NHP archives HP 580 .....	62
11.	Morristown Museum Building: north elevation, poured- concrete foundation and steel framing, June 1936. Morristown NHP archives HP 586 .....	63

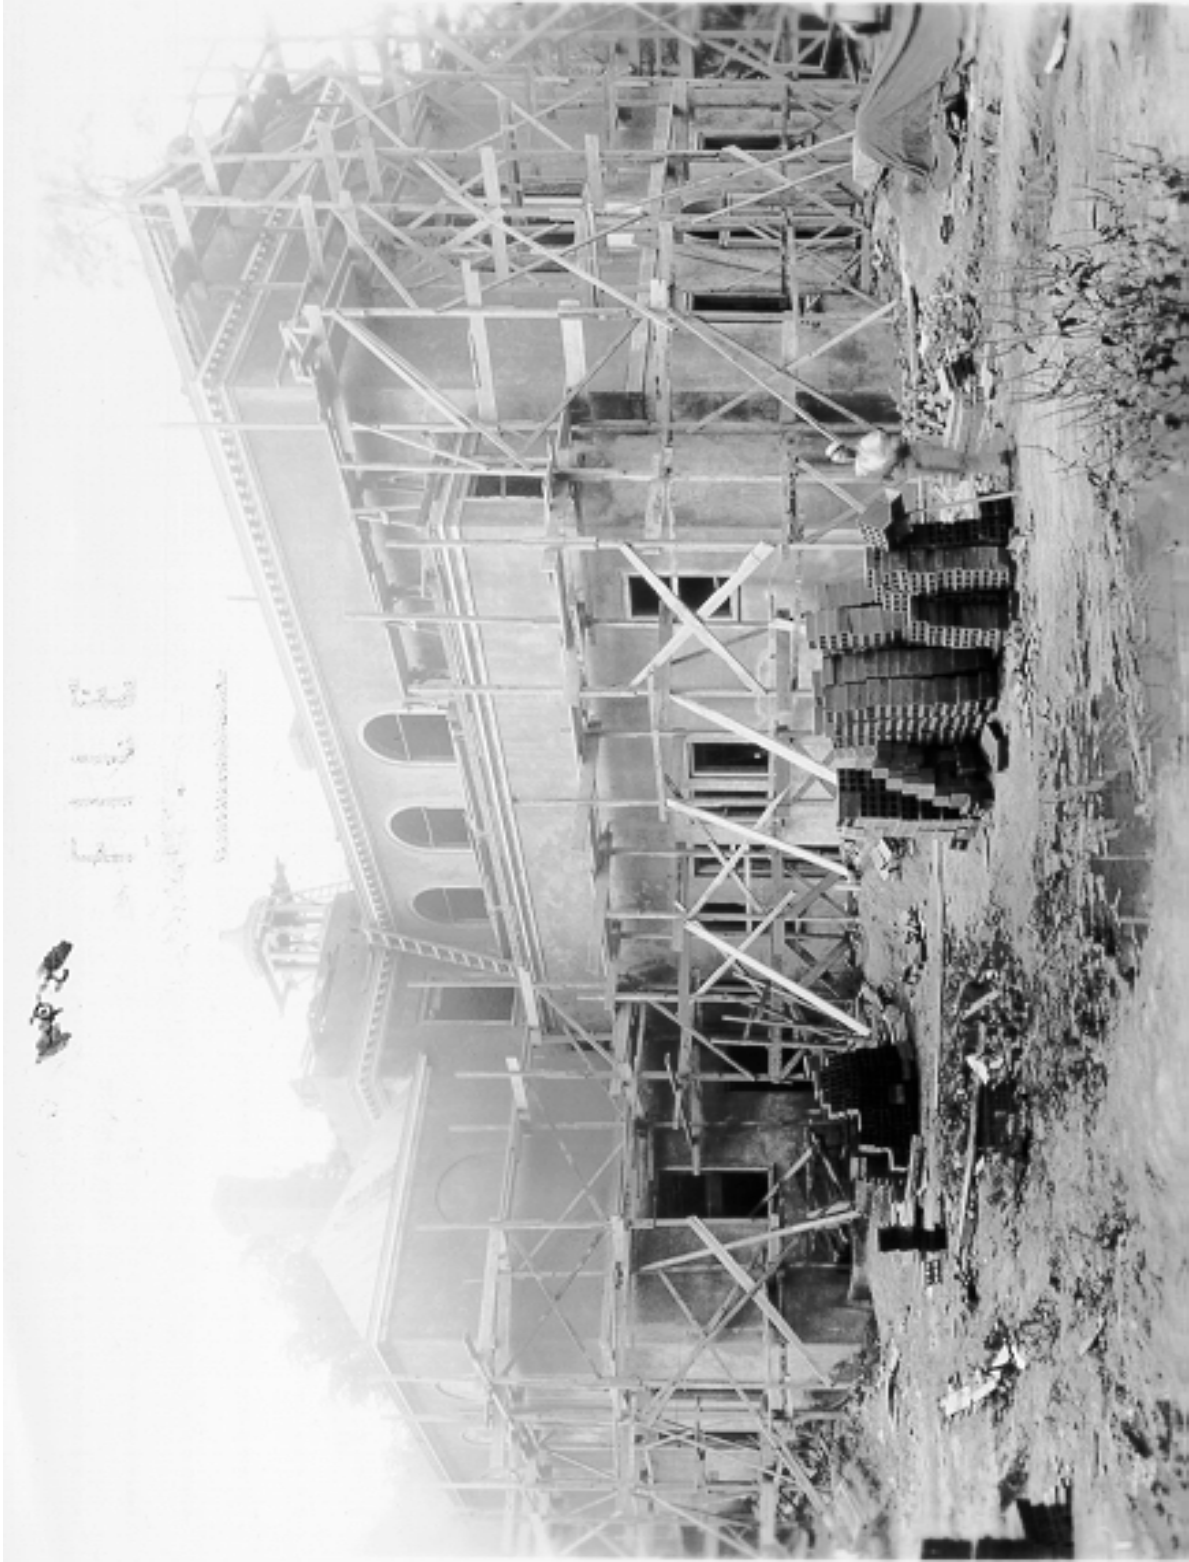
Figure 13. Morristown Museum Building: east and north elevations, stucco application. Note stacks of terra- cotta blocks (1936).

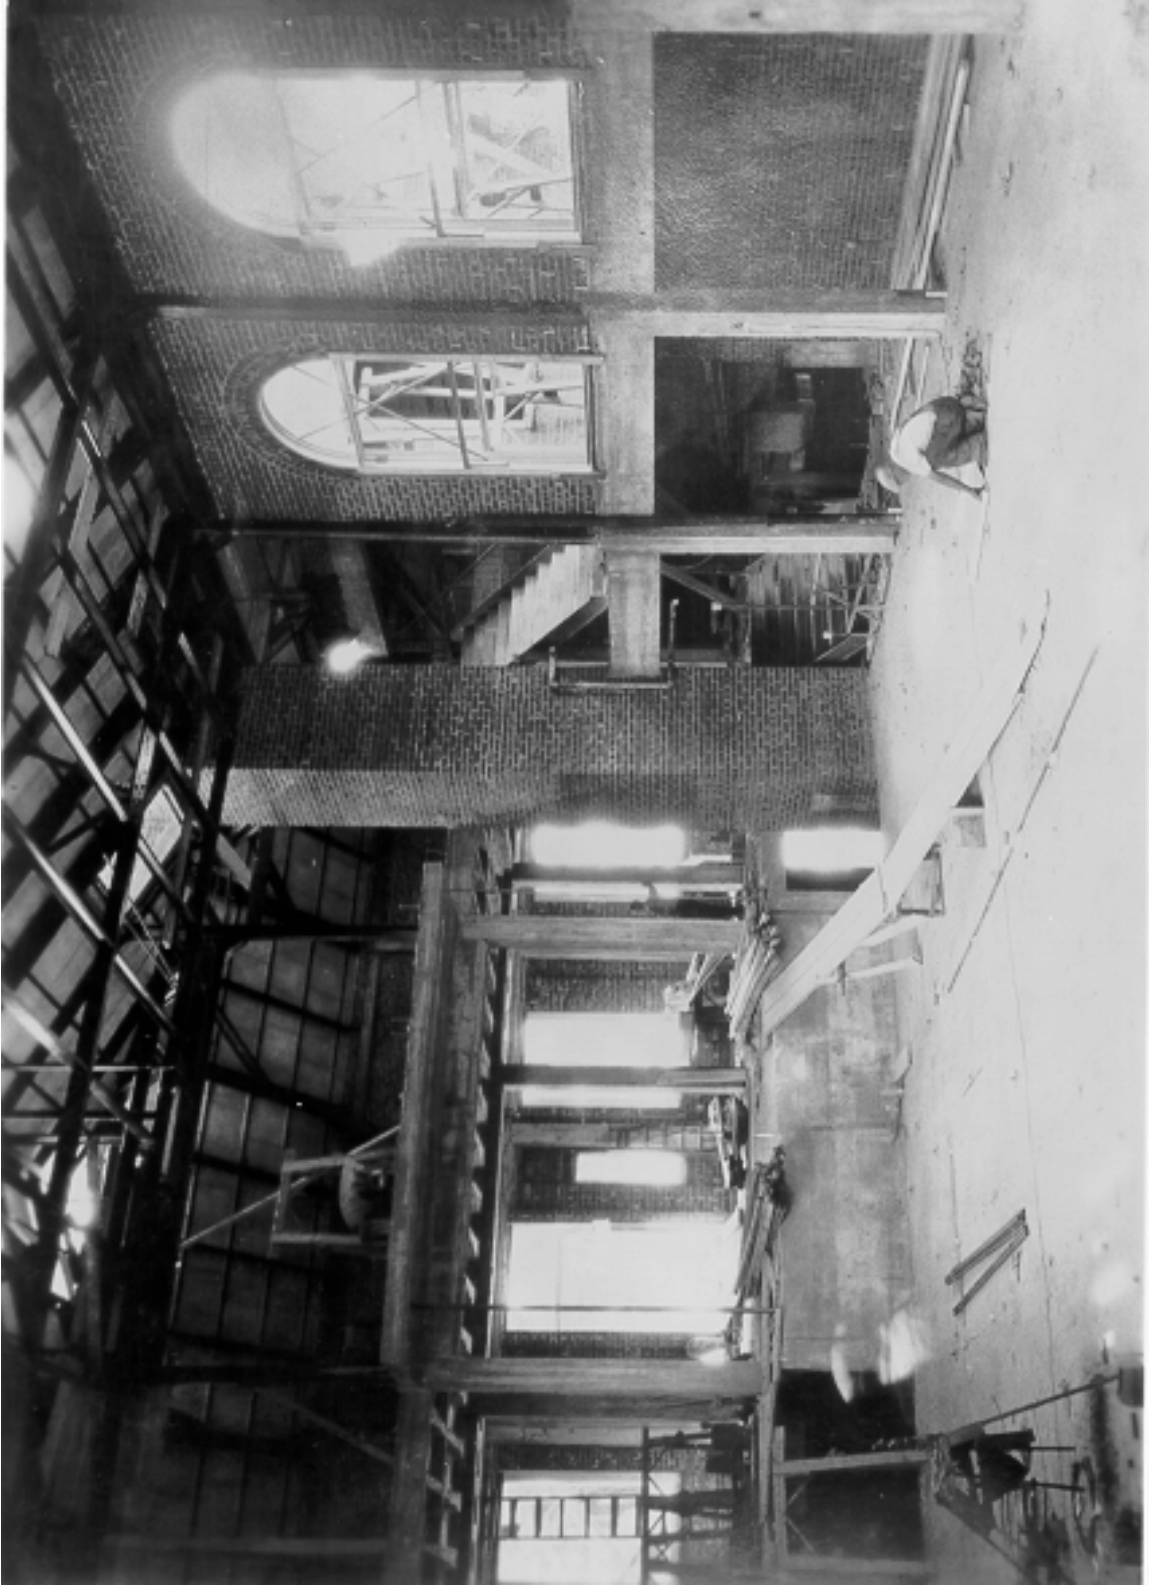
Figure 14. Morristown Museum Building: auditorium during construction, view south/southwest toward foyer (June 1936).

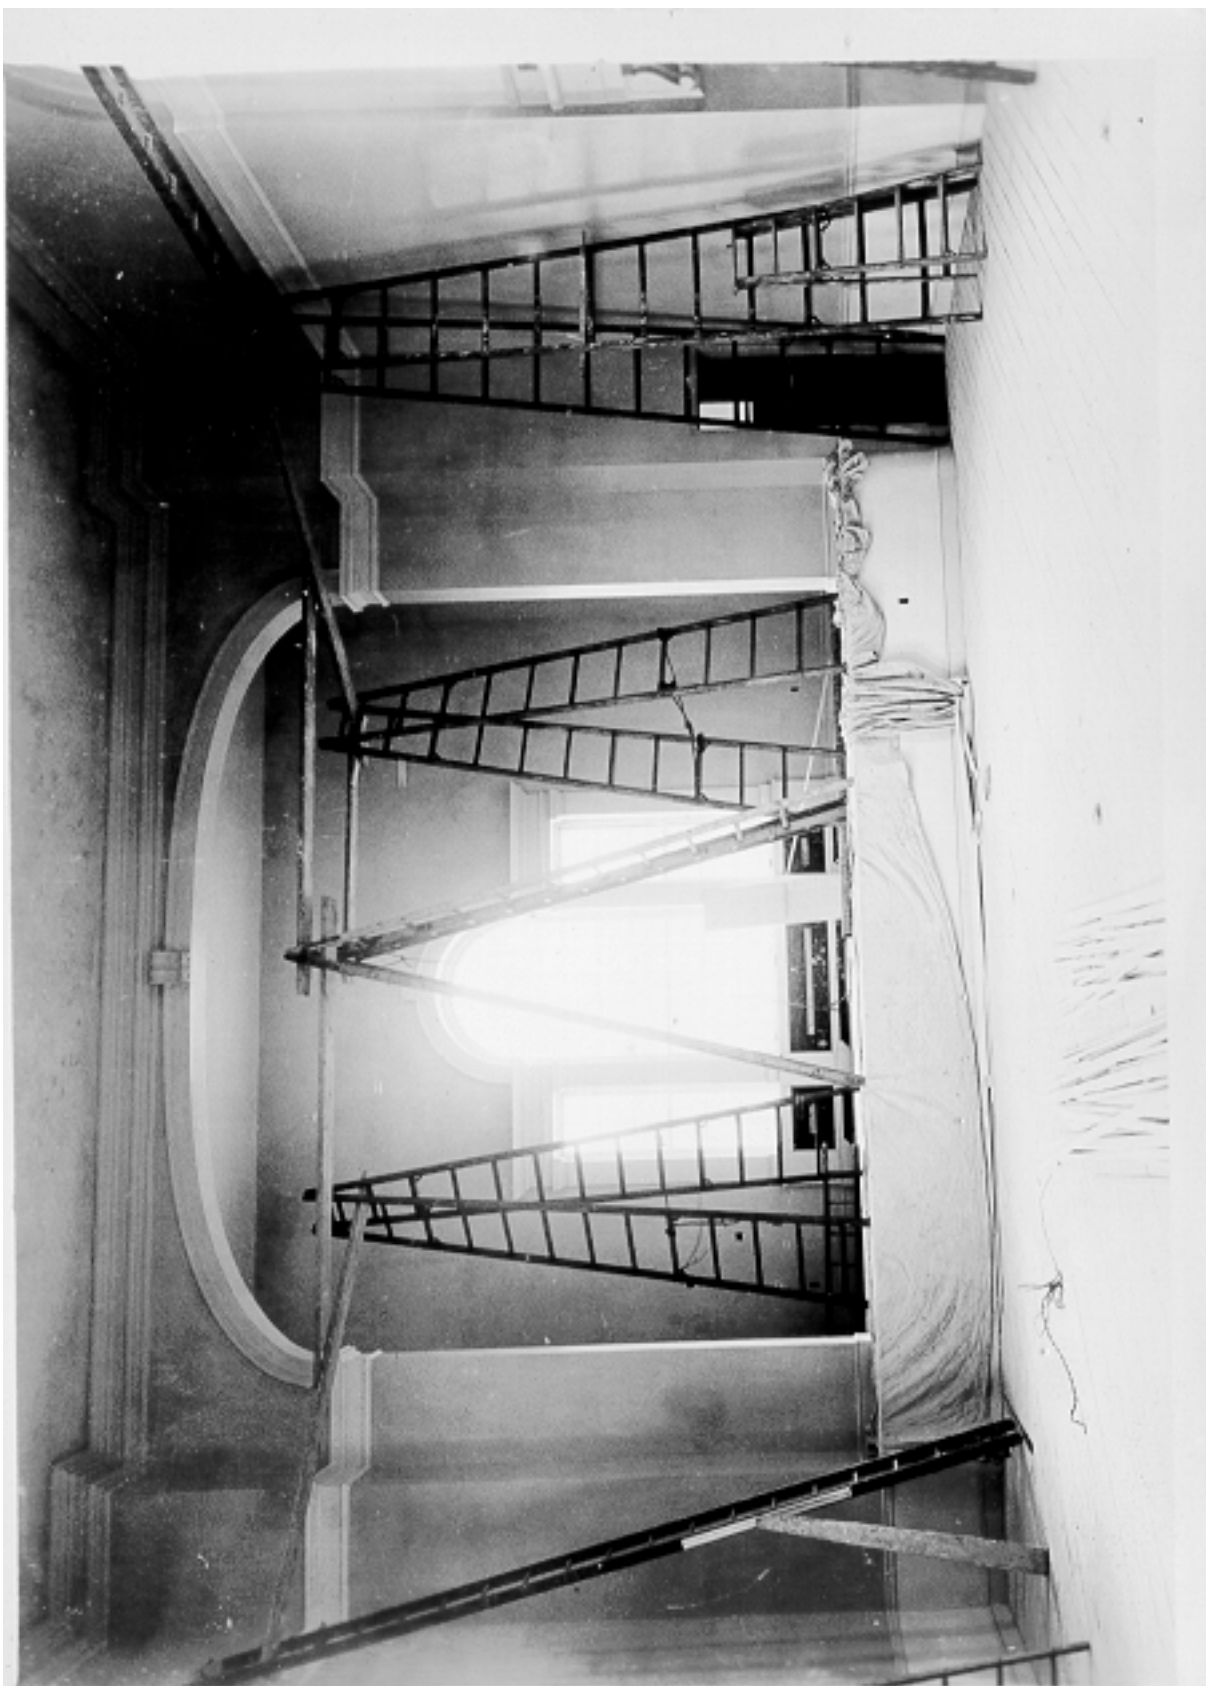
Figure 15. Morristown Museum Building: auditorium during construction, view north to stage (ca. January 1937).

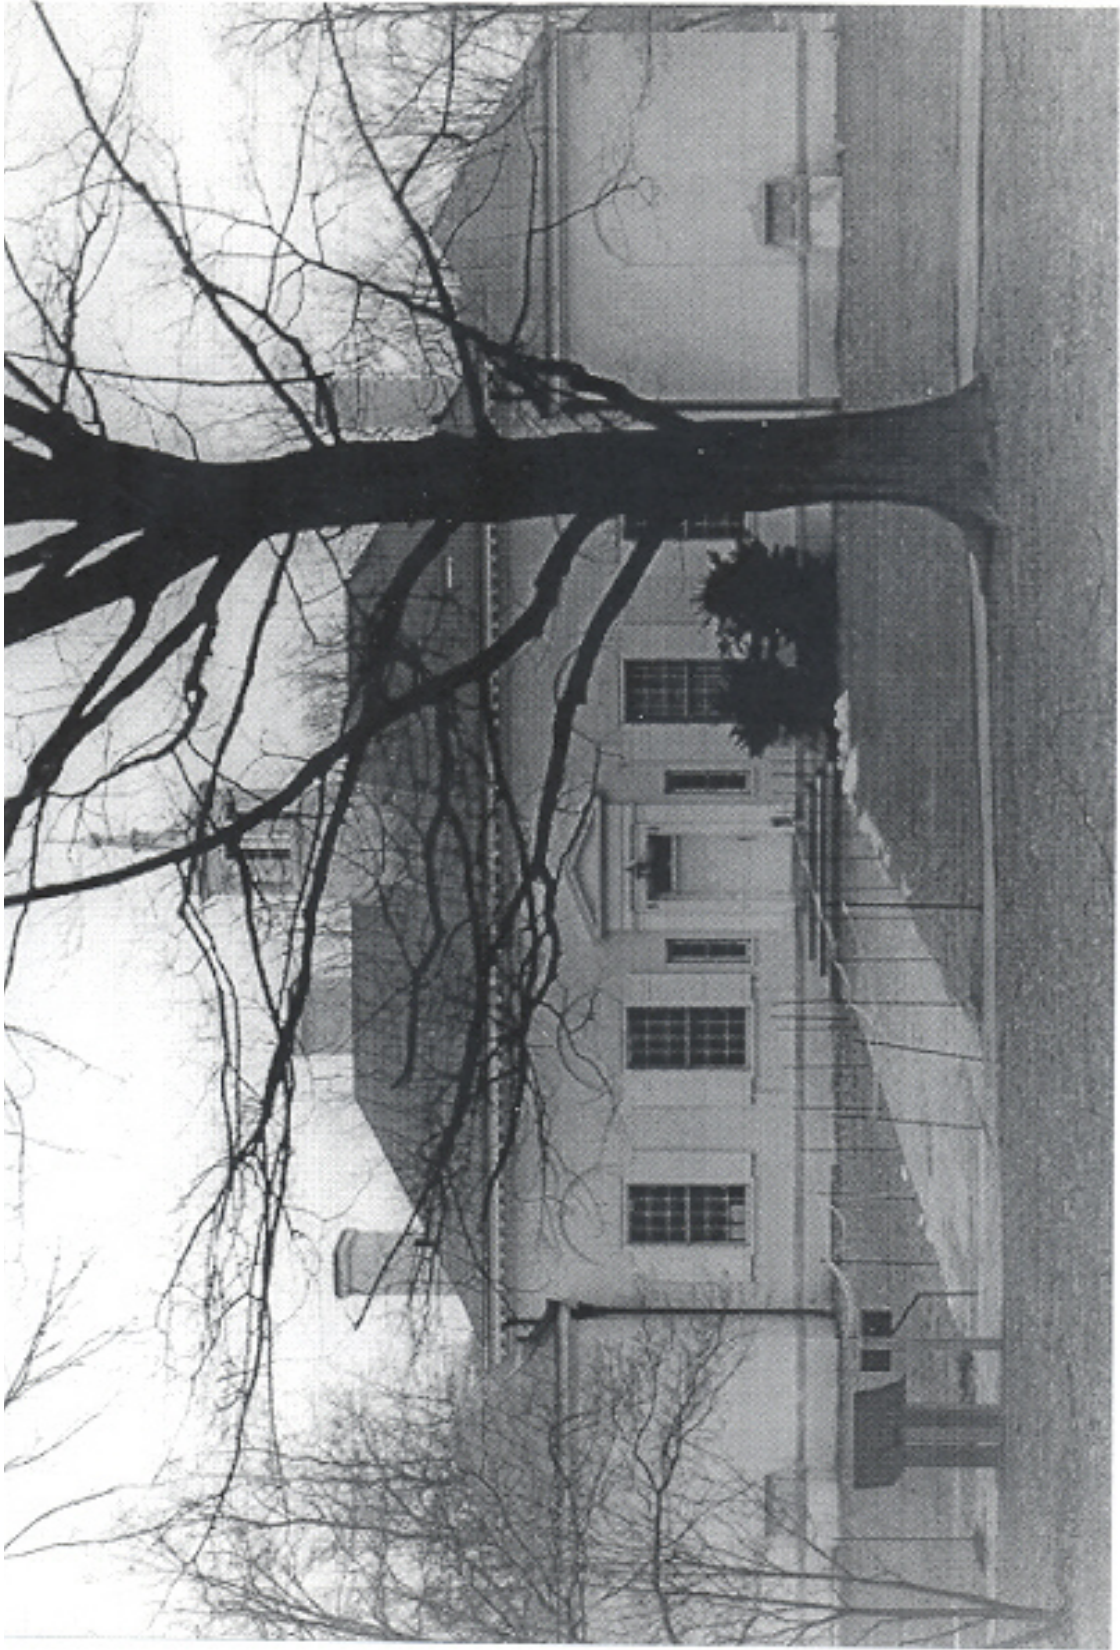
Figure 42. Morristown Museum Building: south façade (February 7, 1979).

On the exterior the alterations had no visual impact on the south façade of the Museum Building (**fig. 42**), and little impact on the other elevations, other than some blocked windows on the ground- story level. But the integrity of many of the original interior spaces was severely compromised. Logical circulation patterns were closed, the ambiance of spaces was destroyed, and elegant finishes removed. The 1975 remodeling may have answered the needs of the 1970s, but did so at a significant cost to the building.

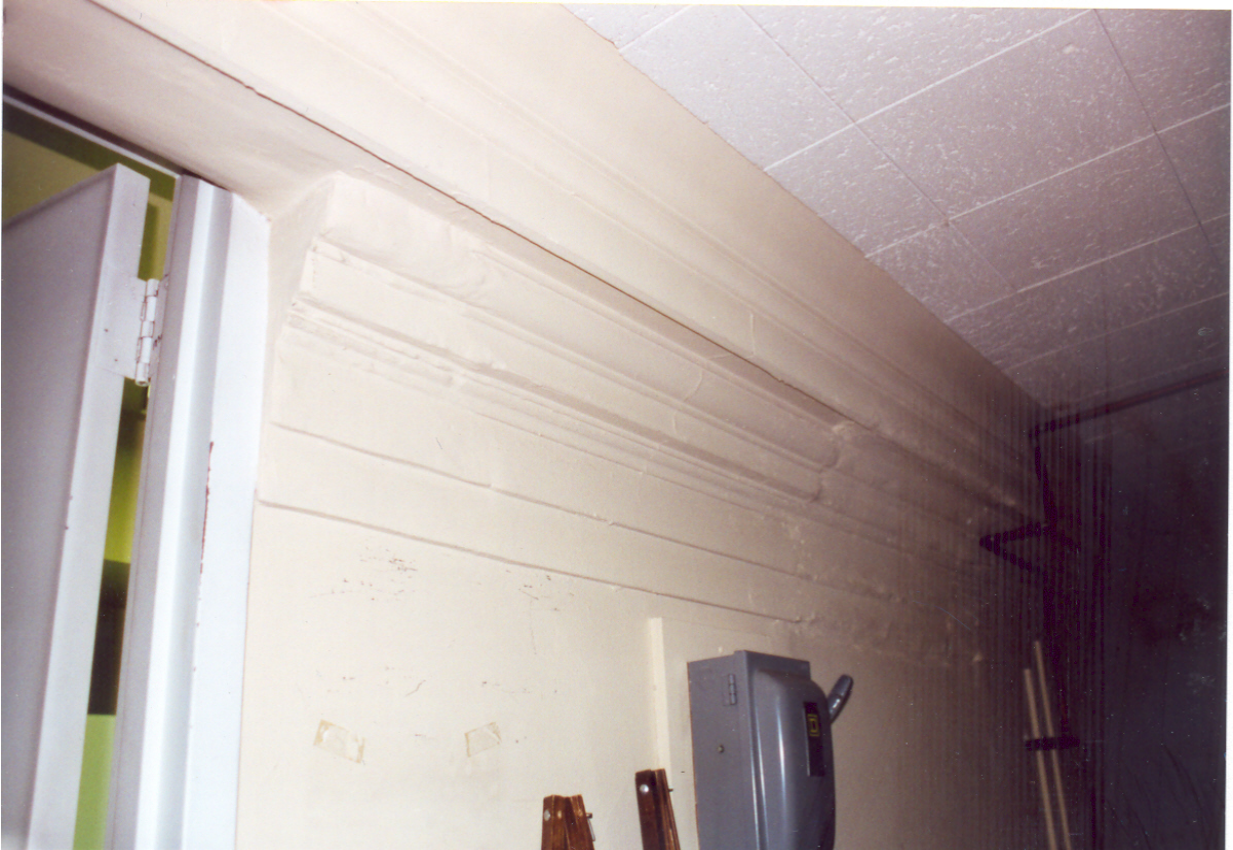
**Figure 157.** Room 203 – second- story mechanical room: south wall, 1937 auditorium plaster cornice with 1975 patching (2001).
