Appendix B. Historic Photographs/Figures

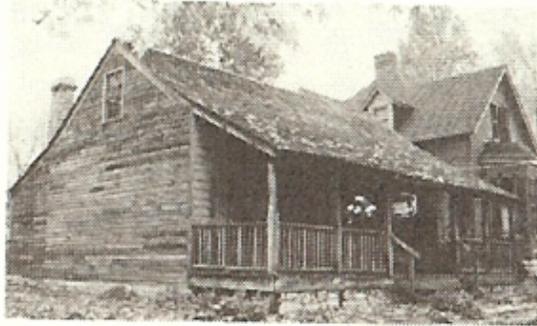
Figure 3. “Pigeon’s Ranch, a famous stopping place on route to Santa Fe from Fort Bascom, May, 1869,” sketch by Vincent Colyer, Albuquerque Museum. In 1869, Vincent Colyer sketched Pigeon’s ranch and shows the large complex, with a gabled roof main house with wing. The outbuildings were probably granaries. Wooden fences enclose fields in the foreground. The road alignment suggests it was originally further from the front of the building. Colyer also painted a water color that has not been located.

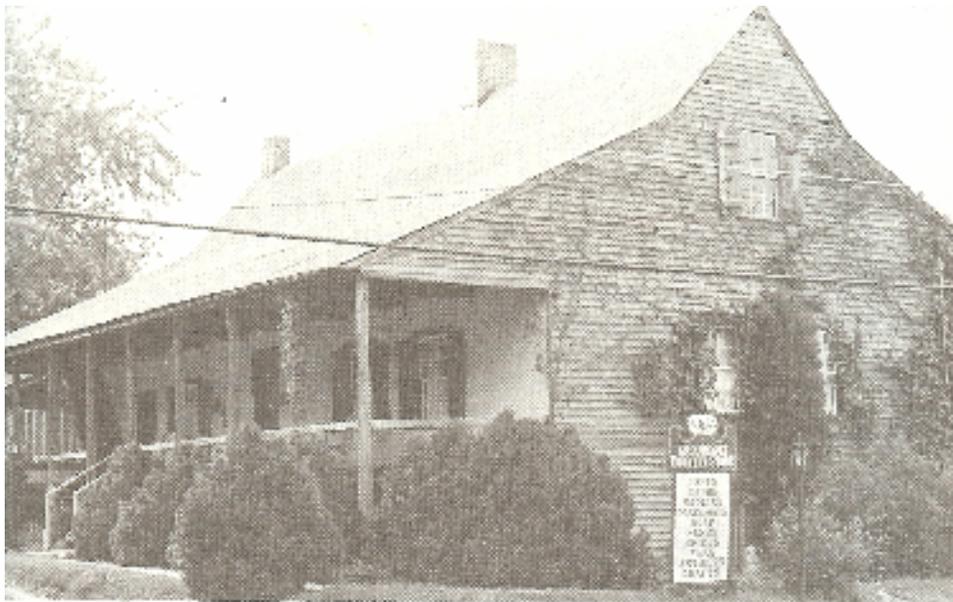
Figure 4. French traditional double-house in St. Charles, Missouri. The extended roof forms the *galerie* or front porch like at Pigeon's Ranch. The house was divided between a residence in one house while a business occupied the other house. One roof covered both. Historic American Building Survey collections, Library of Congress.

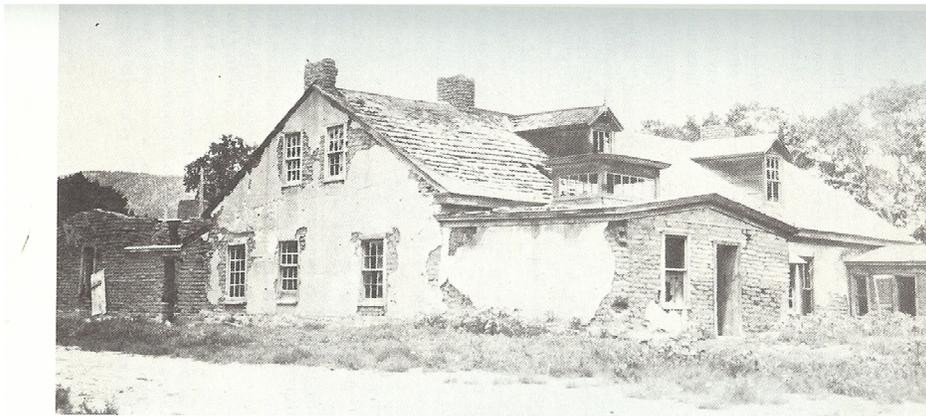
Figure 6. The Historic American Building Survey drawing of the Felix Valle (no relation) house in St. Genevieve, Missouri with many of the design elements of French vernacular, which was used by Maxwell and Valle in New Mexico.

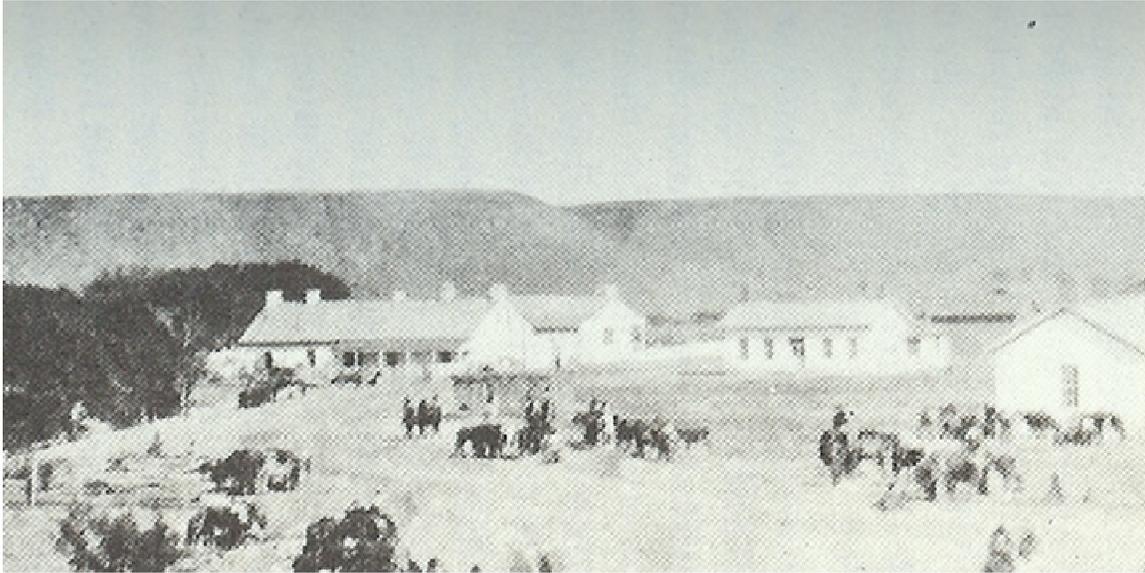
Figure 7. Like Alexander Valle, Lucien Maxwell came from Missouri and brought with him French traditional architecture to New Mexico. A close-up of the Maxwell home at Cimaron early in the twentieth century shows it built of adobe, like Pigeon's Ranch, and its roof line using French traditions of Missouri. The Maxwell house reflects the design of the Felix Valle house of St. Genevieve, Missouri and the aspirations of Alexander Valle's "Pigeon's Ranch" house. Museum of New Mexico.

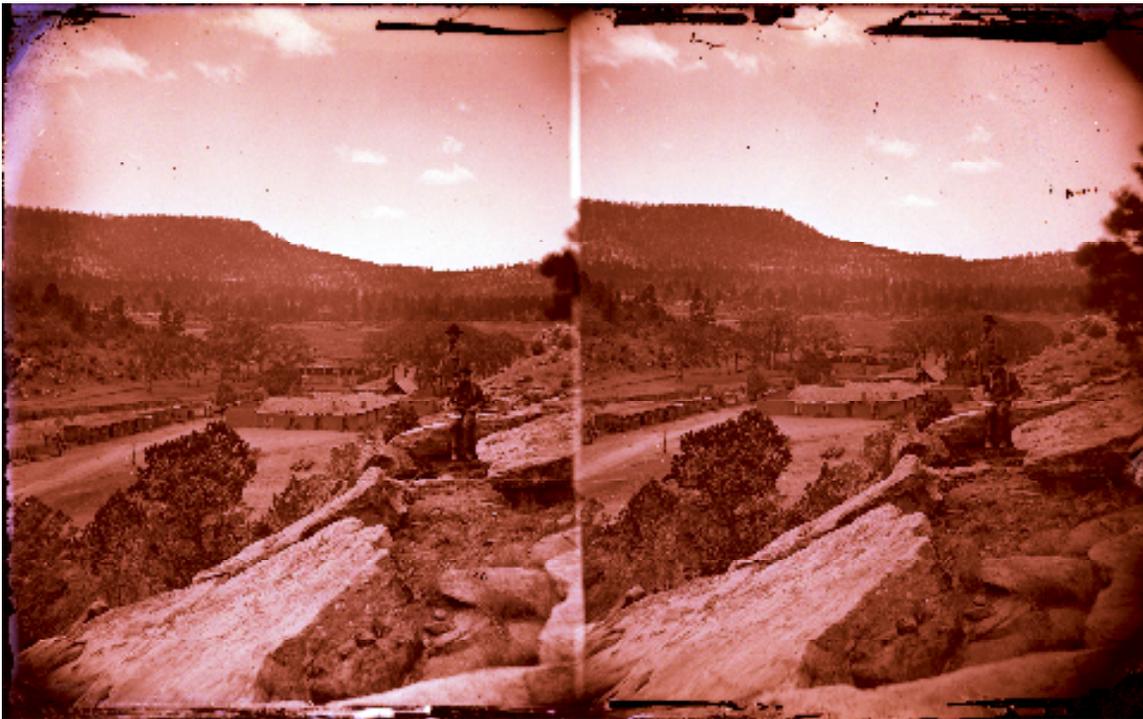
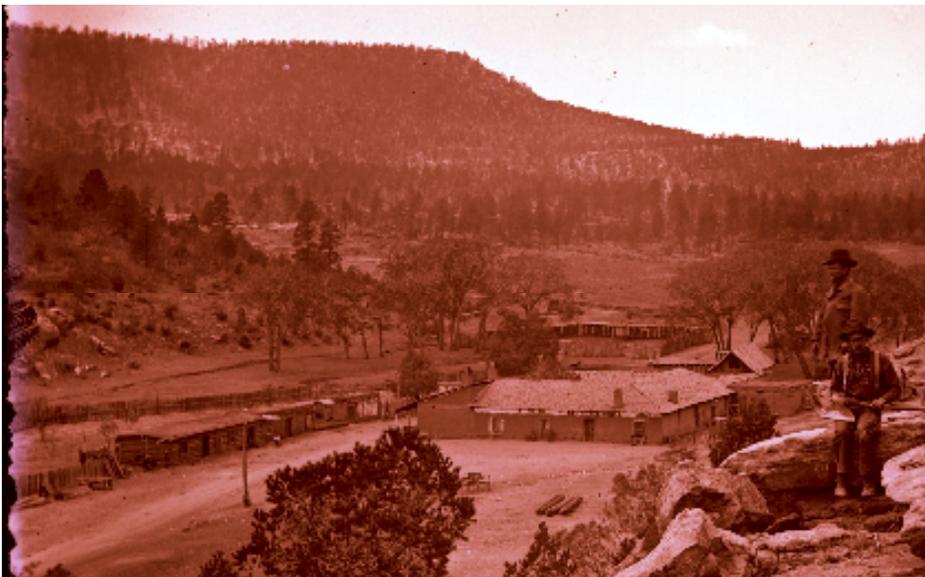
Figure 11. “Glorieta Battlefield, Glorieta, New Mexico June, 1880,” Photograph by Ben Wittick, Courtesy Palace of the Governors, Museum of New Mexico, Negative no. 15782. The photographs of Ben Wittick show the Pigeon's Ranch stage stop, inn, freight stop complex in June, 1880, shortly after its peak years of use. The main ranch building, or trailside structure, at center, has been enlarged from the 1869 Colyer sketch. Outbuildings for wagon repair, corrals, and farm produce storage can be seen in this view looking southwest.

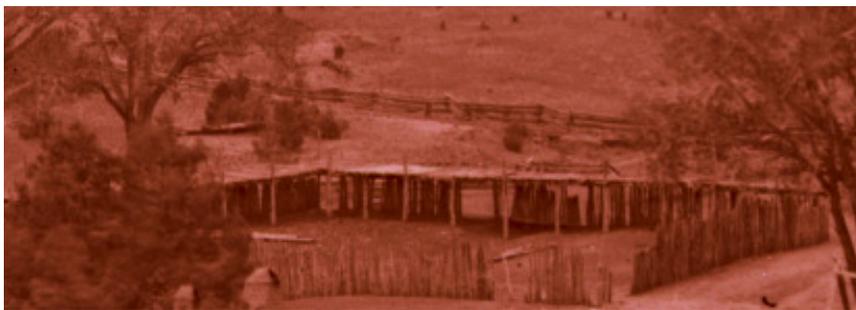
Falling down corral with stables

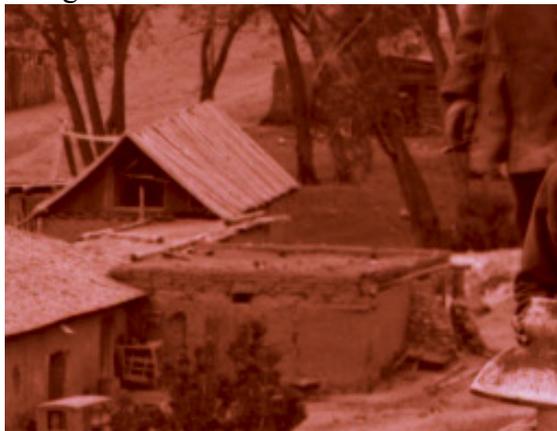
Small adobe storage building behind stables

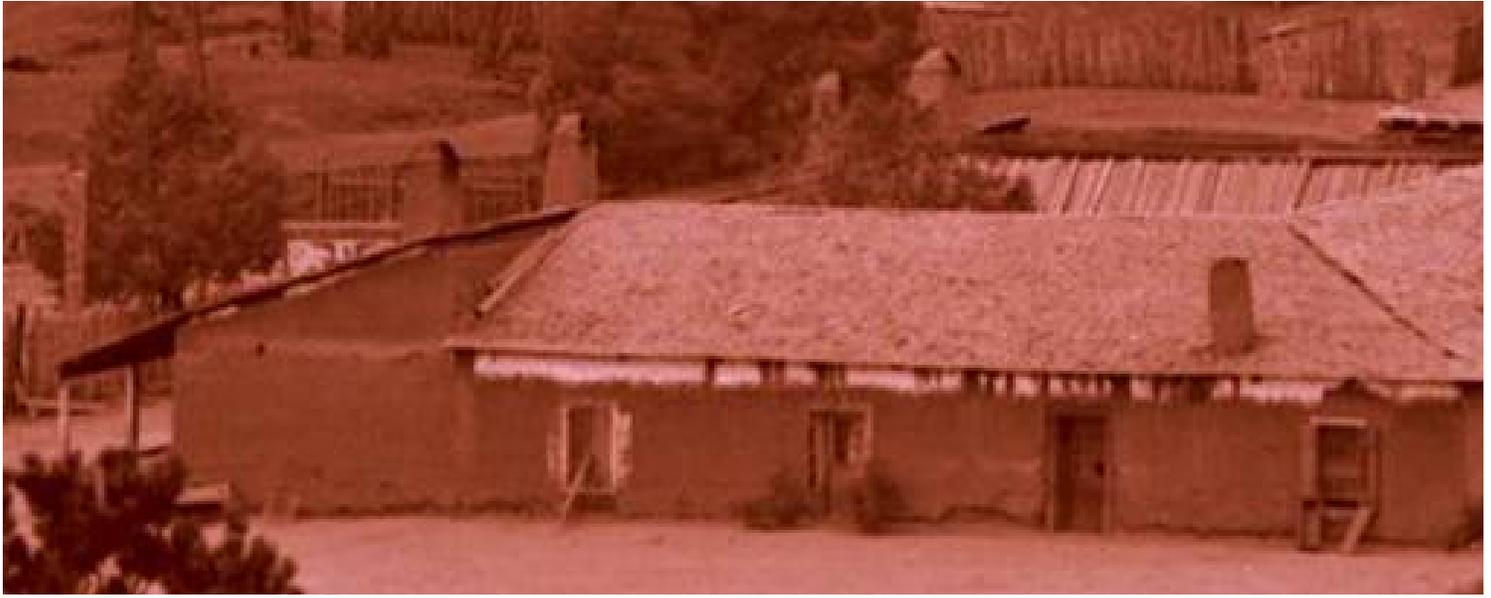
Figure 11 Detail. An enlargement of main house at Pigeon's Ranch, a four sided complex with courtyard. Note rough lumber roof of the interior courtyard porch.

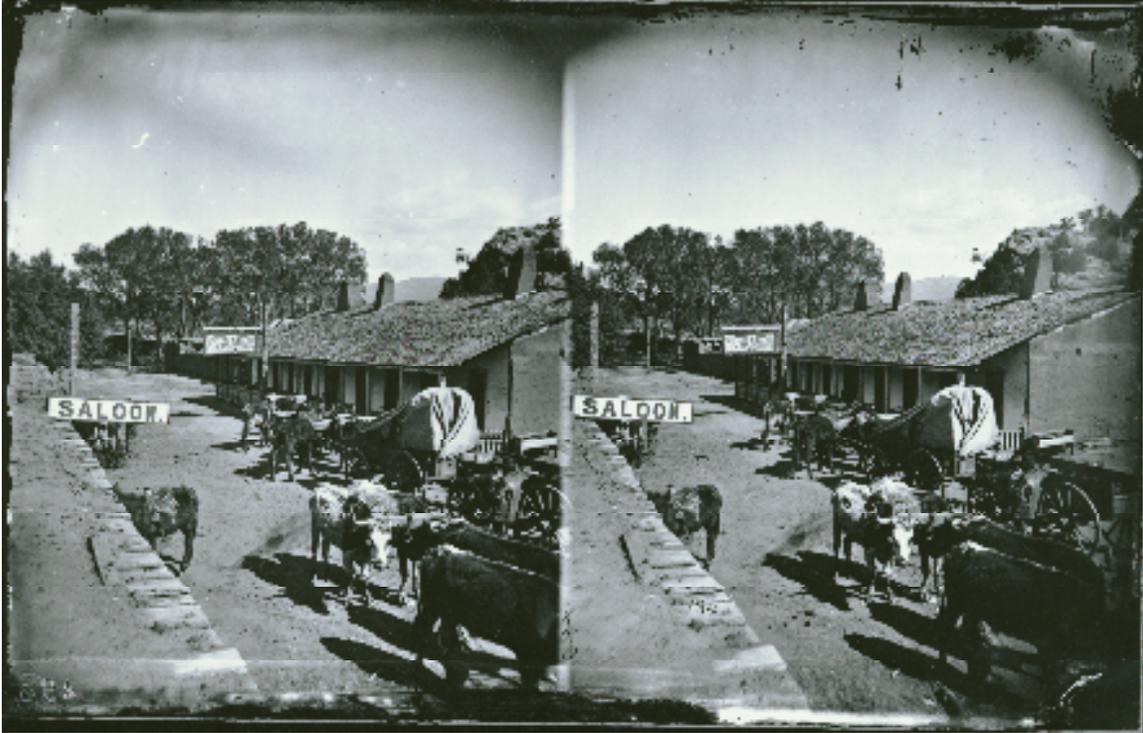
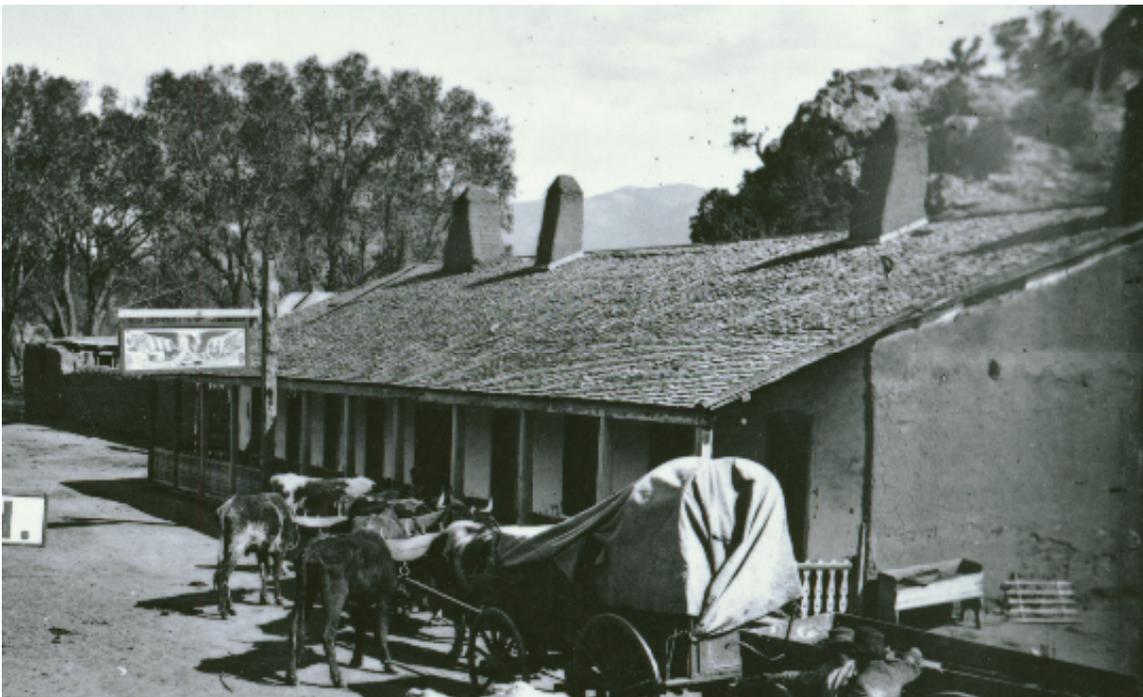
Figure 13. “Pigeon’s Ranch, Glorieta, New Mexico June 1880” photograph by Ben Wittick, Courtesy Palace of the Governors, Museum of New Mexico, Negative no. 15783. The main building has the porch or *galerie* with railings.

Figure 13 Details. Details of roof line, chimneys, signs, railings, posts and beams.

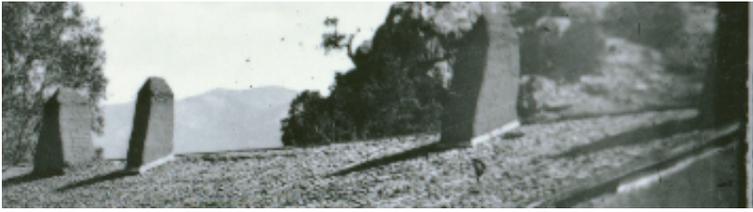
Four adobe chimneys along front rooms of Pigeon's Ranch.

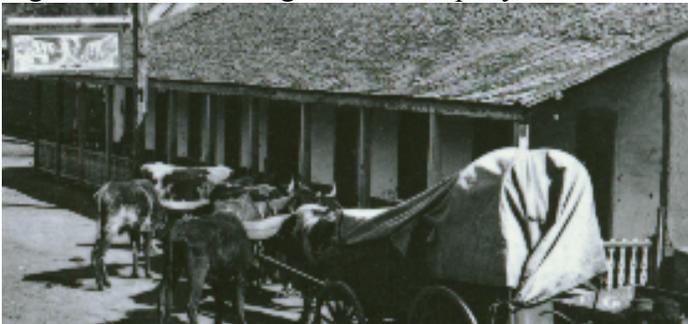
Porch or *galerie* detail.

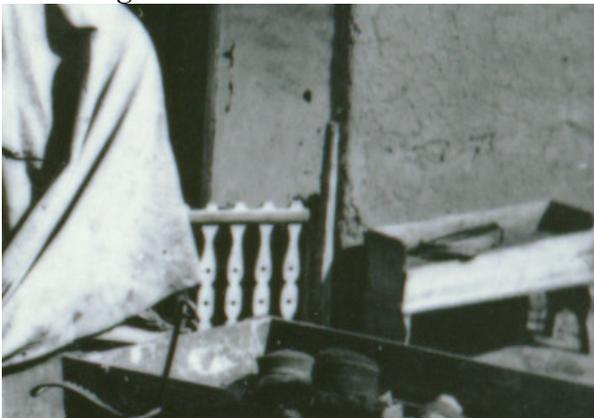
Porch railing details.

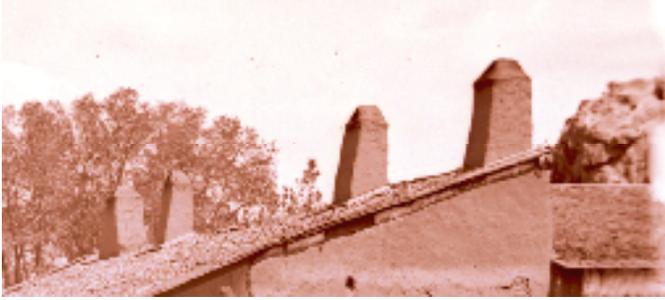
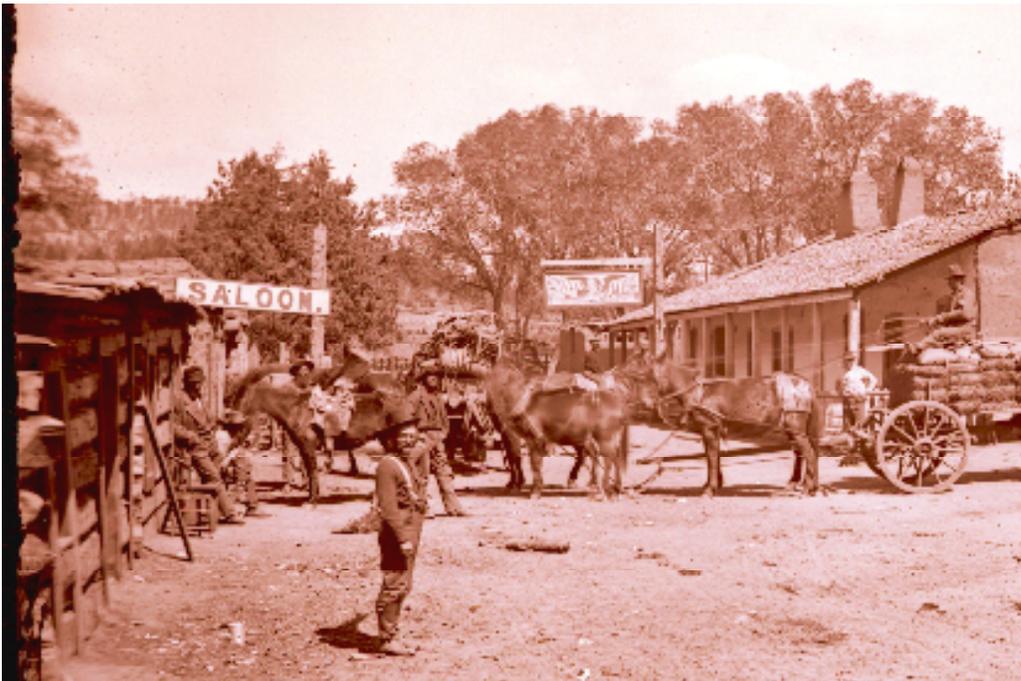
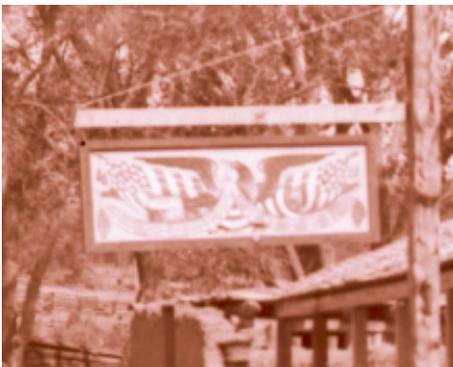
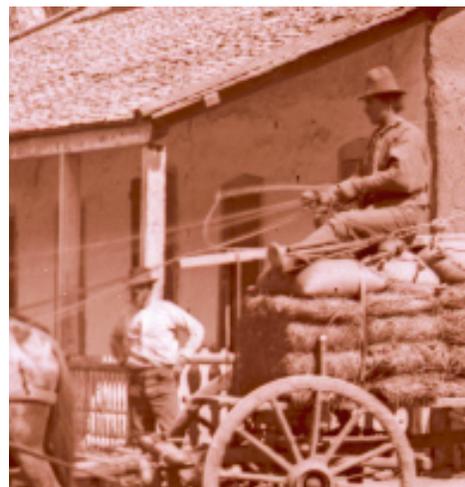
Figure 14 Details. Details of roof, chimney, railings, sign, road

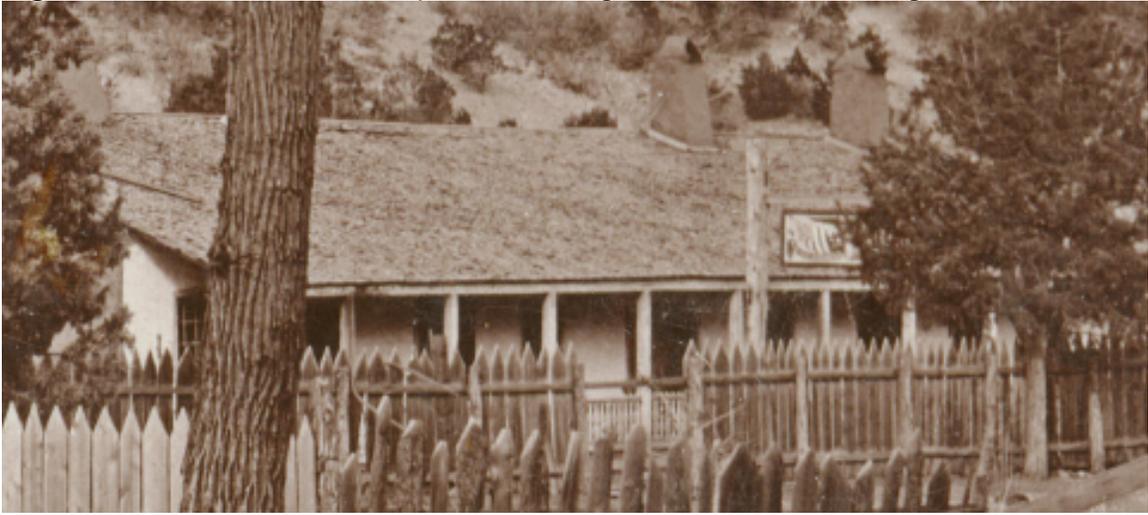
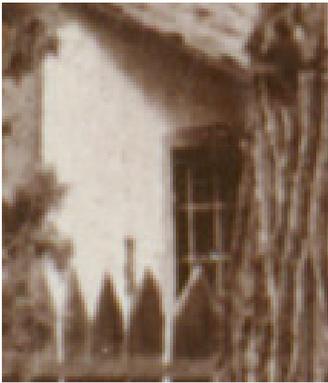
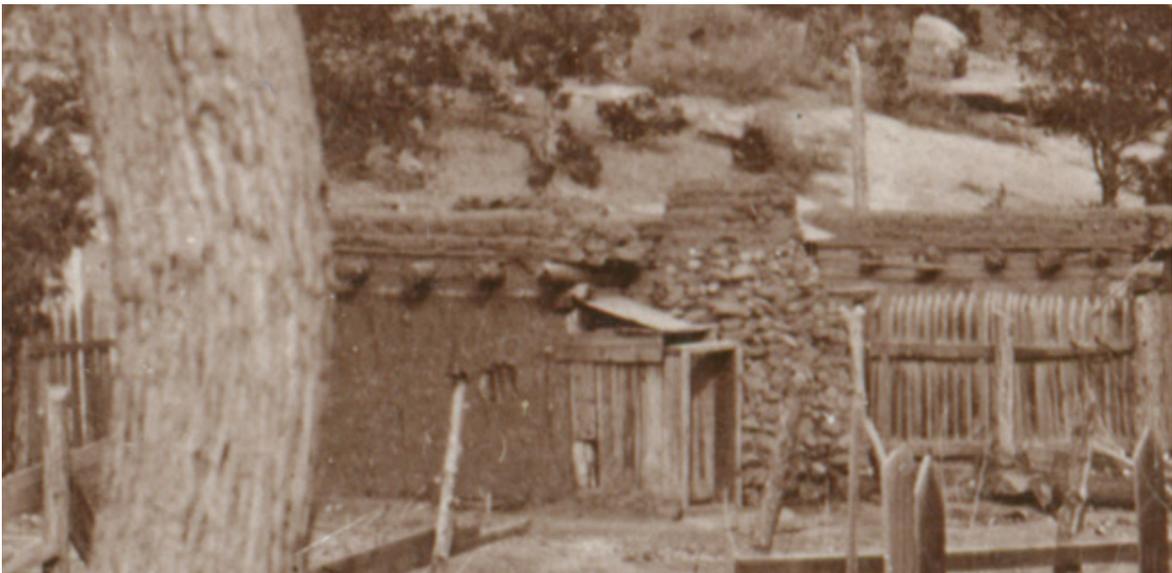
Figure 15 Details. Details of façade, window glass, and adobe building across street.

Note doorway and rubble stone chimney.

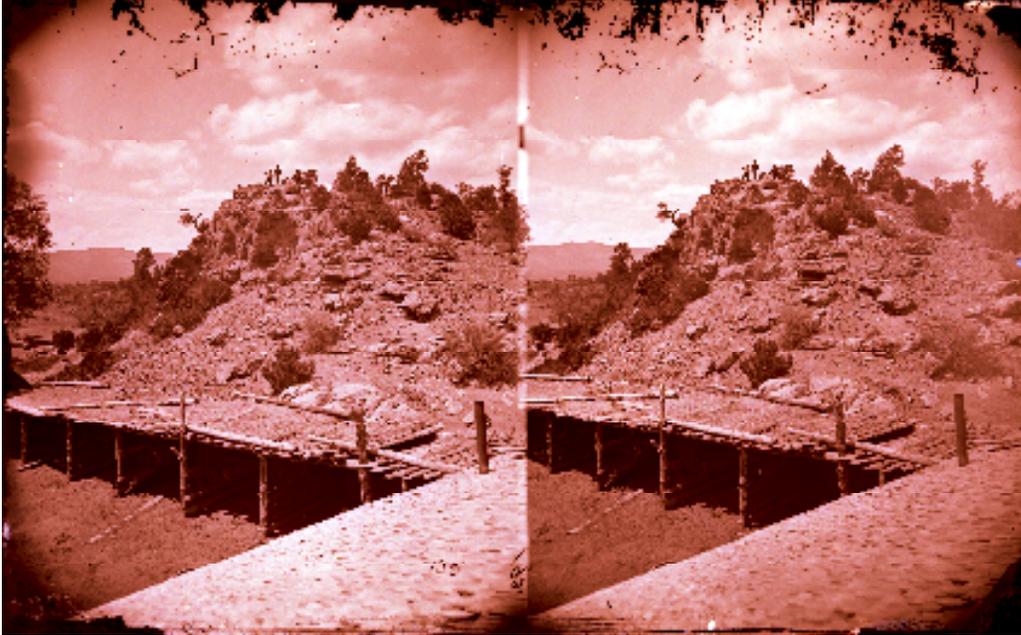
Figure 16. “Sharpshooter’s Ridge 1880” photograph by Ben Wittick, Courtesy Palace of the Governors, Museum of New Mexico, Negative no. 149386. Photographer stood on roof of west wing of Pigeon’s Ranch main house looking northwest to ridge. The stables stood at the back of the complex and extended from the main house to the gabled roof structure (barely visible) adjacent the adobe western wall.

Rough built stables. Note roofline of gabled roof building at end of stables (at left – also shown in detail from Fig.11 at right. Detail from Fig 11 also shows roof of stables).

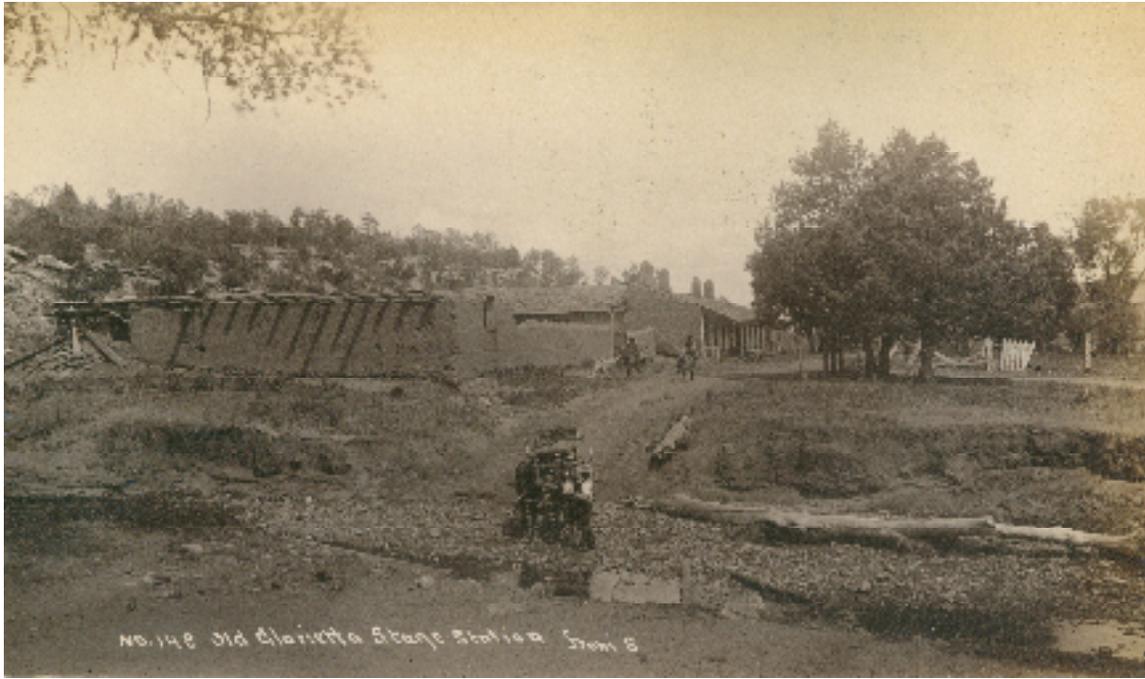
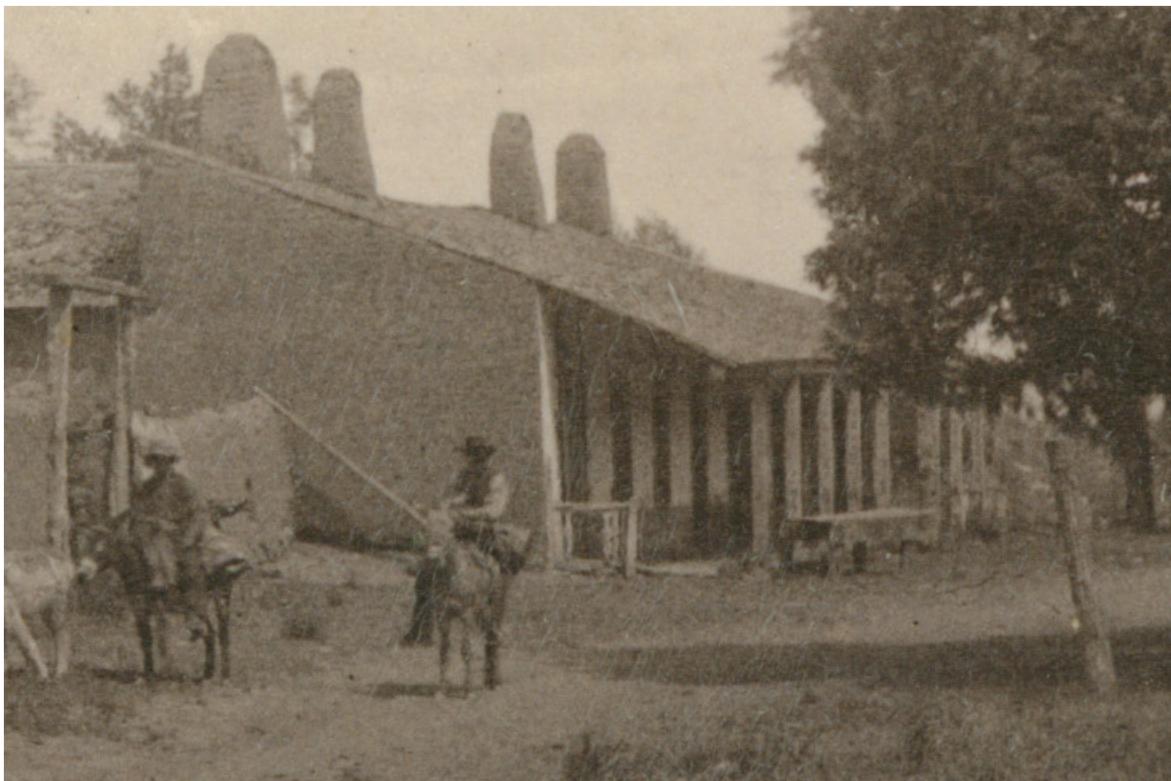
Figure 20. "Old Glorieta Stage Station," ca. 1888, J. R. Riddle photograph. Courtesy Palace of the Governors, Museum of New Mexico, Negative no. 76032. Two ca. 1890 photographs, one looking east and the other west, shows the complex beginning to deteriorate. The outbuildings south of the wagon road are gone and the rear additions of the main structure have fallen.

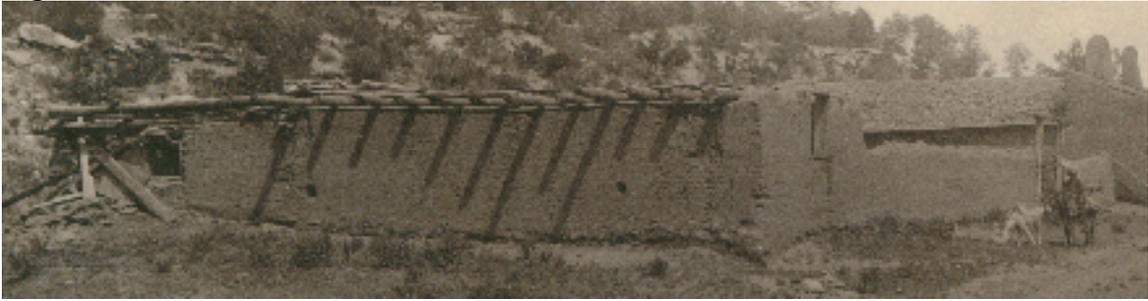
West adobe wall of complex, which was the back of the corrals and granaries. The gabled roofed buildings on each end have collapsed.

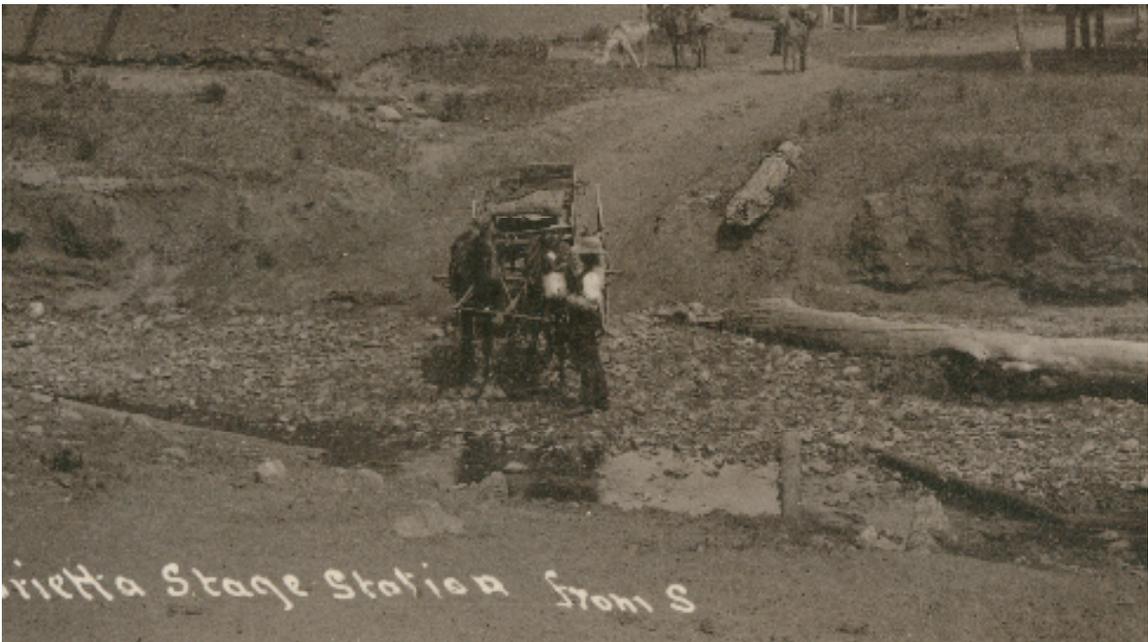
Continued erosion of the creek bed has deepened the crossing of Glorieta Creek.

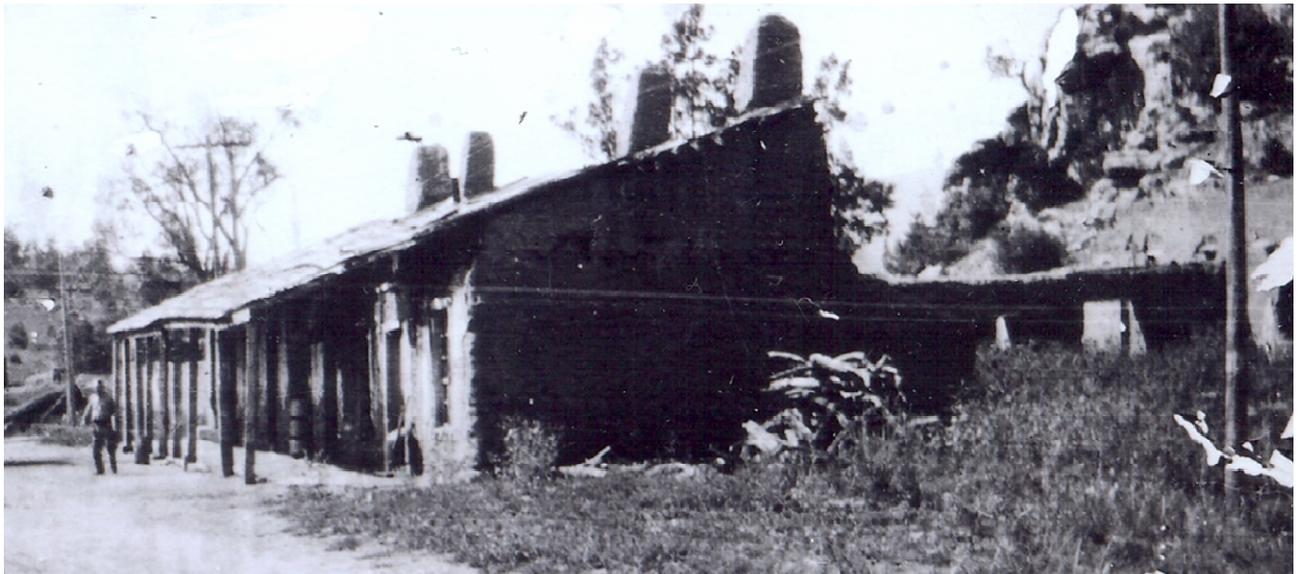
Figure 21. Pigeon's Ranch from the east, ca. 1890. New Mexico State Records Center and Archives image No. 21850.

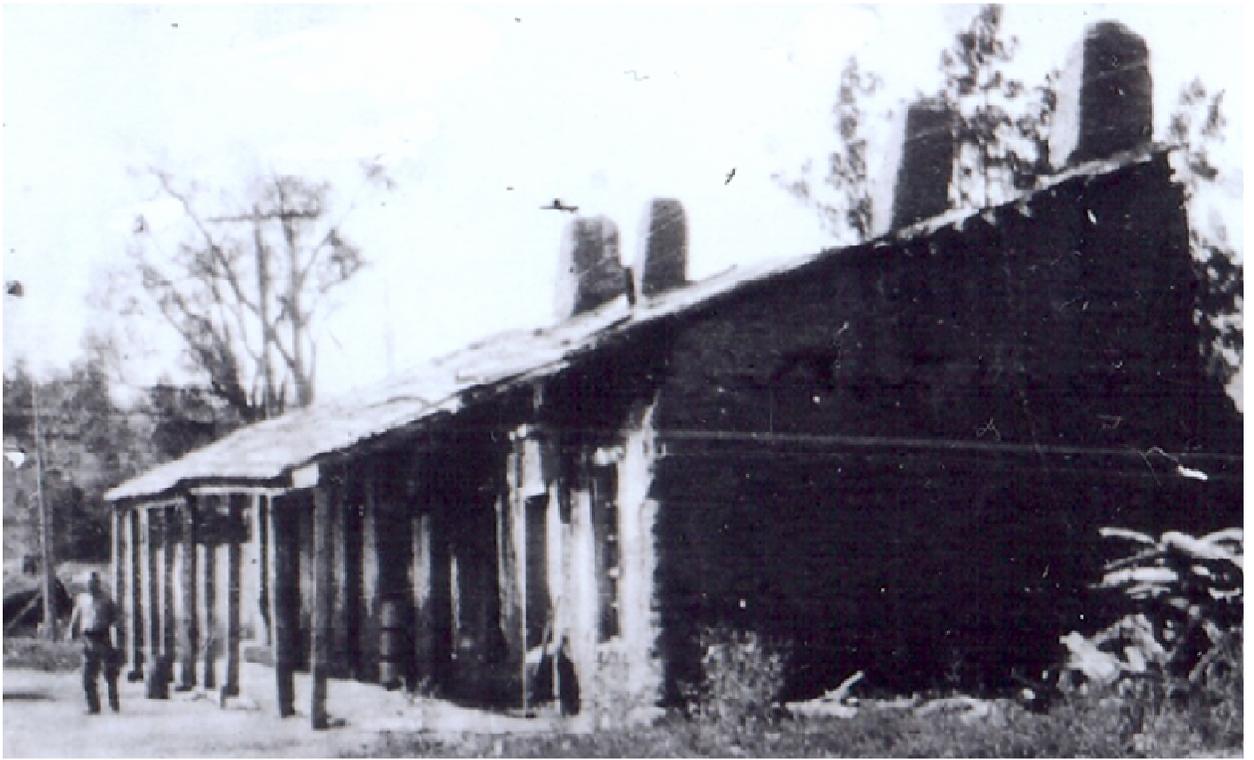
Figure 21 Detail. The back rooms of the structure are gone (a scratch on the print makes it appear as if part of the rear room has a shed roof).

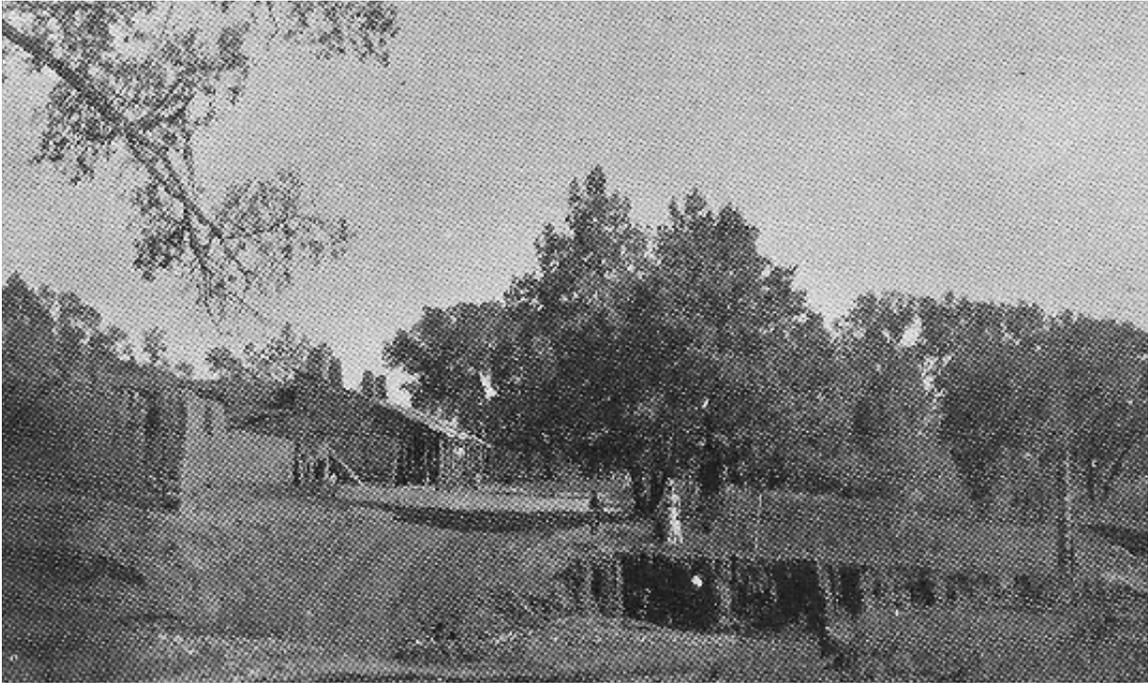
Figure 22. The front of Pigeon's ranch showing patch-repairs to roof. Burttram collection, Pecos NHP.

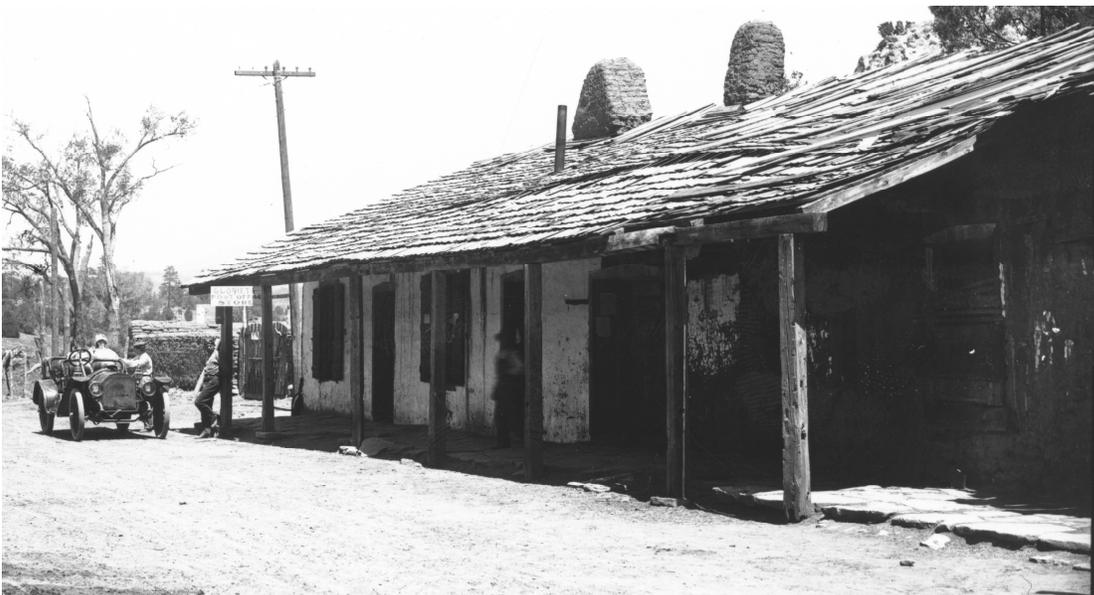
Figure 27. “Pigeon’s Ranch” Jesse Nusbaum, 1912. Courtesy Palace of the Governors, Museum of New Mexico, Negative no. 9351. Note the rough log beams have been replaced with squared posts on the porch. Hanging from the porch is the sign advertising Walter Taber’s “Glorieta Post Office and Store.” Because of the increase in automobiles, the old wagon road between Las Vegas and Santa Fe, passing by Pigeon’s Ranch, was improved

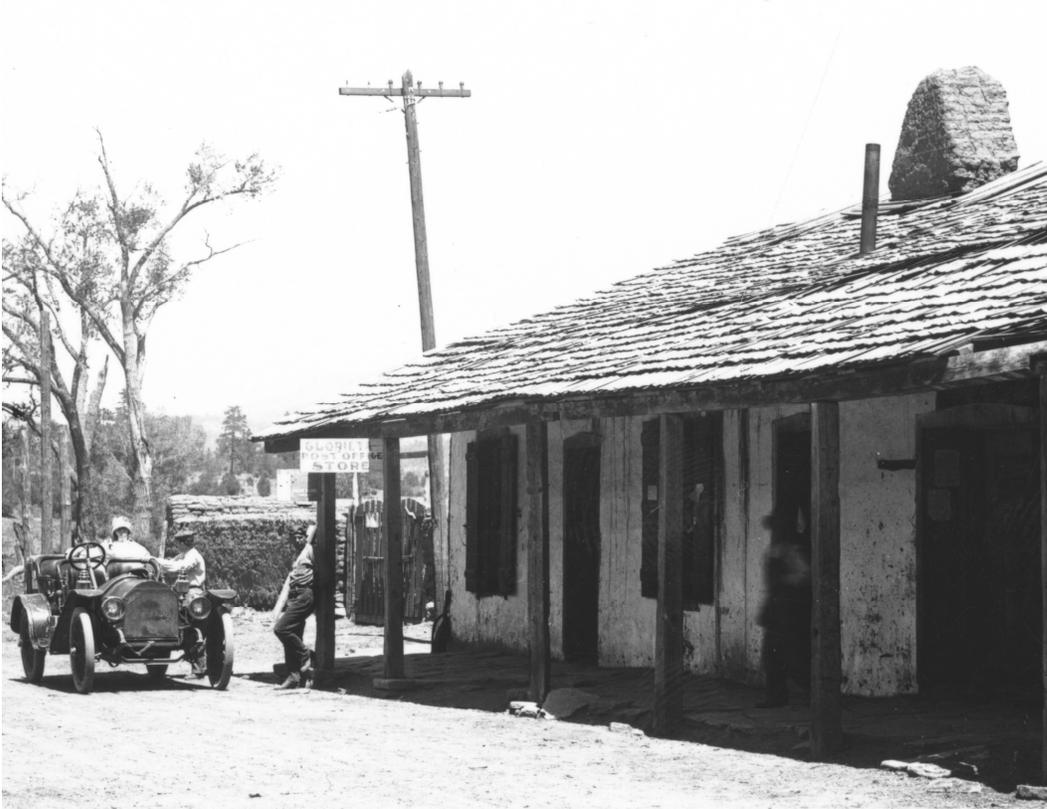
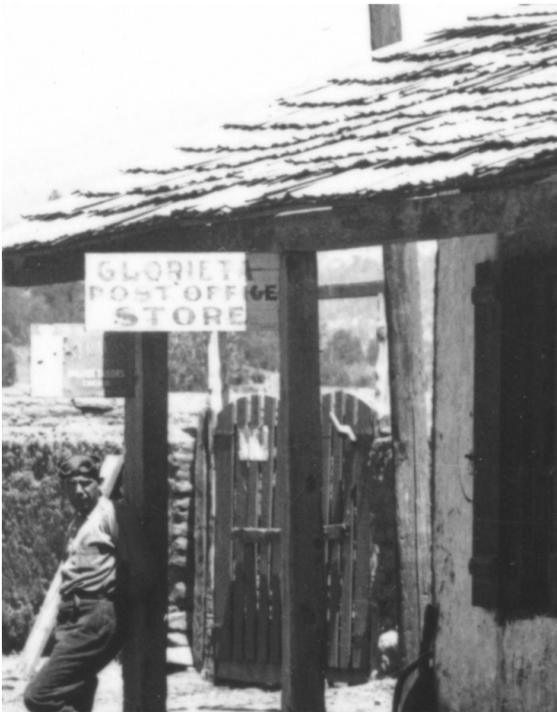
Figure 27 Details.

Sign for Taber's store and post office.

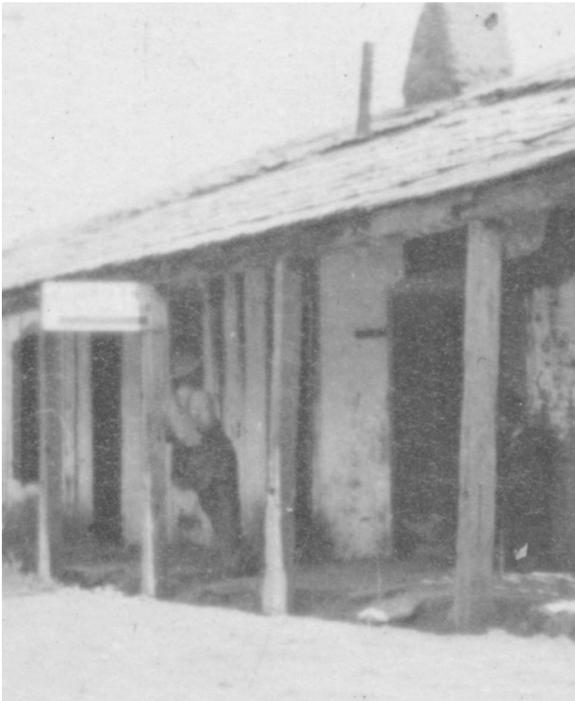
The “store” lettering has been removed from under the “Glorieta Post Office” sign.

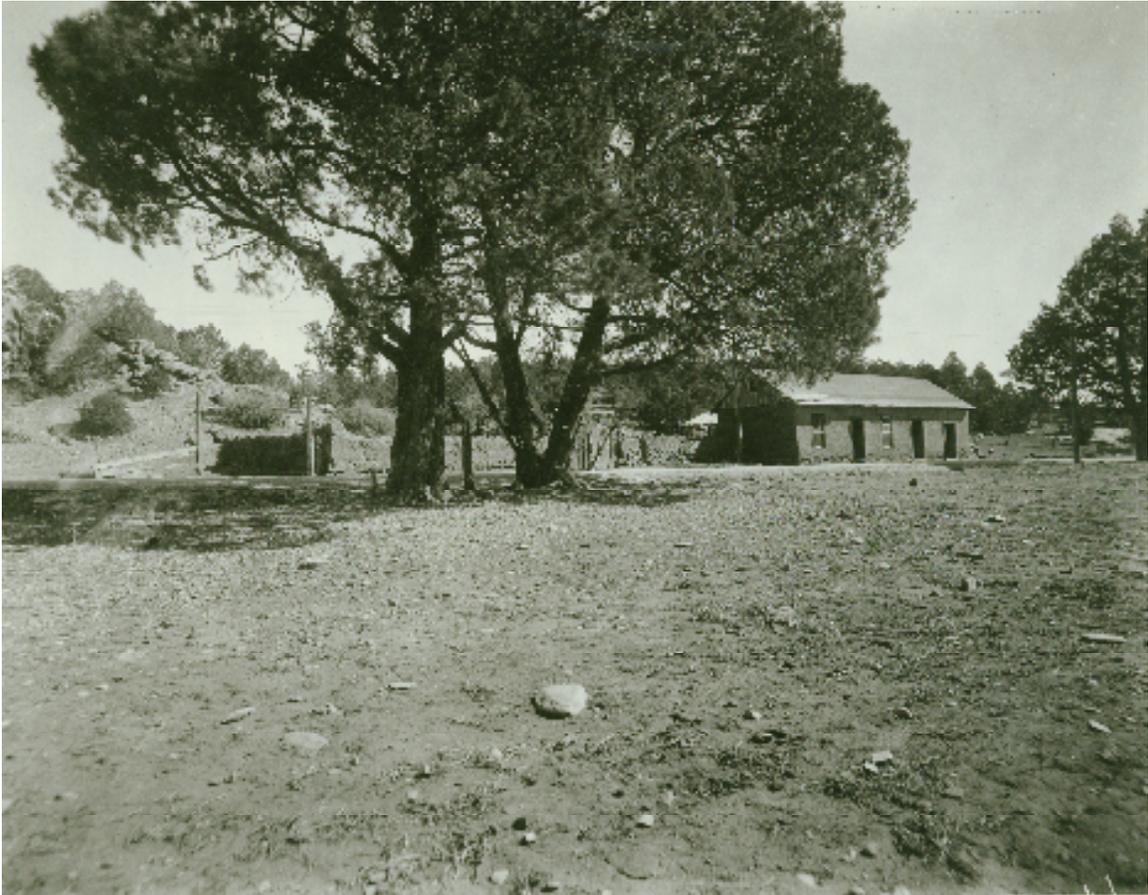
Figure 31. “Historic Pidgeon [sic.] Ranch on Old Santa Fe Trail,” n. d, ca. 1926. Courtesy Palace of the Governors, Museum of New Mexico, Negative no. 947938. Photographs from the 1920s show that Tom Greer had removed buildings while repairing the remaining portion of the main ranch and adding a gable roof. He reportedly started with a store, residence in the building, but soon created a roadside tourist attraction for increasing number of automobile tourists along Route 66, opened in 1926.

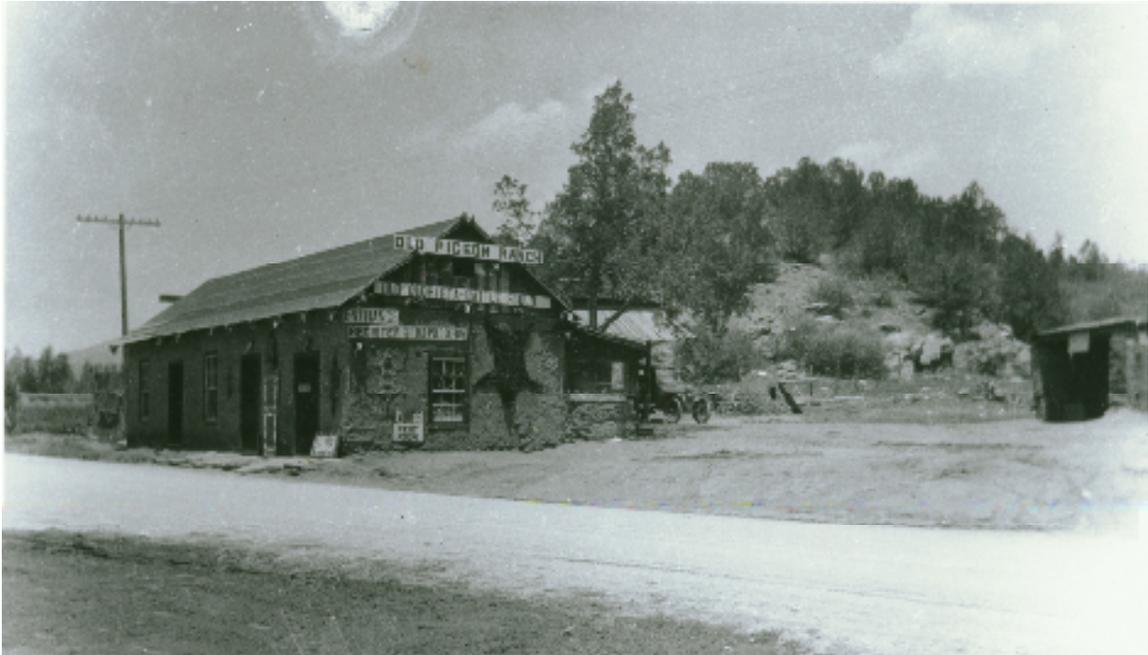
Figure 32. John C. Howard photo, Museum of New Mexico, Neg. 51738, ca. 1926. Greer refurbished the house and added a simple shed addition on the back north-eastern corner.

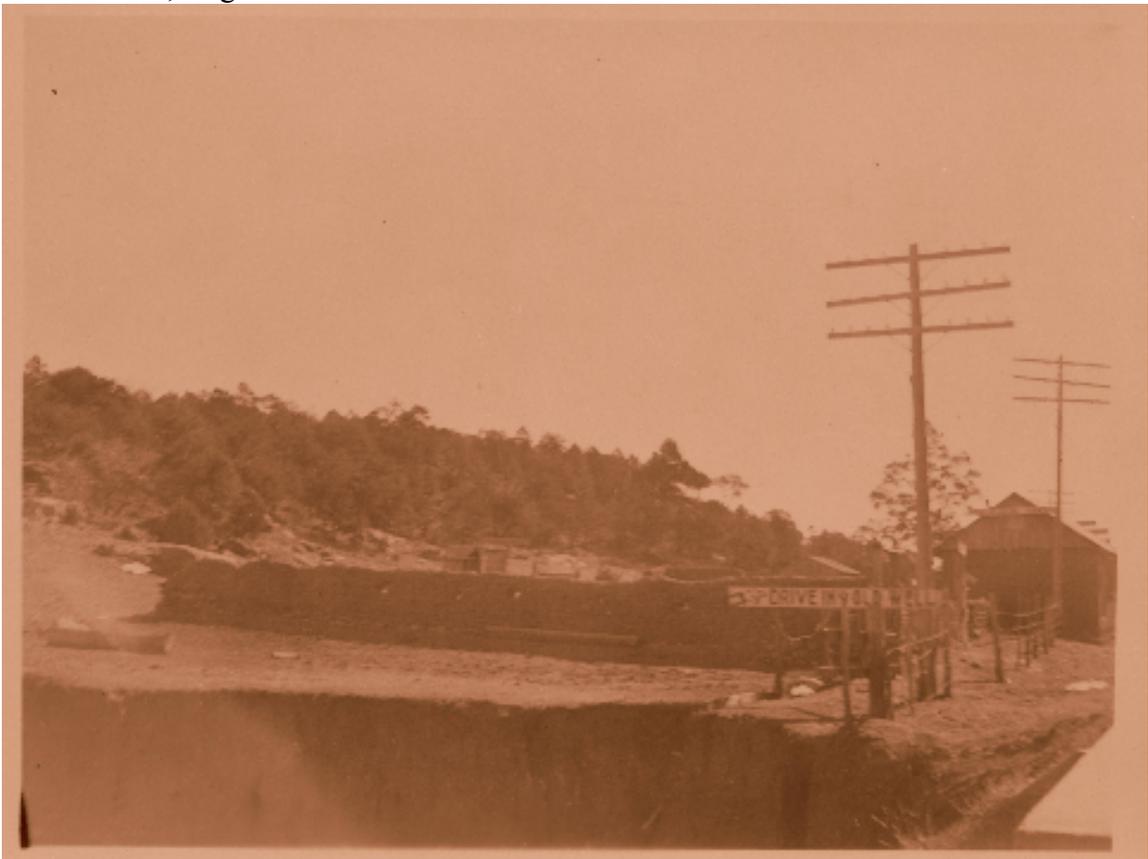
Figure 39. “Pigeon’s Ranch Glorieta, New Mexico,” n. d. Courtesy of the Museum of New Mexico, Negative MNM 91625. Pigeon’s ranch from the west showing the repaired adobe wall with newly opened “gun ports.”

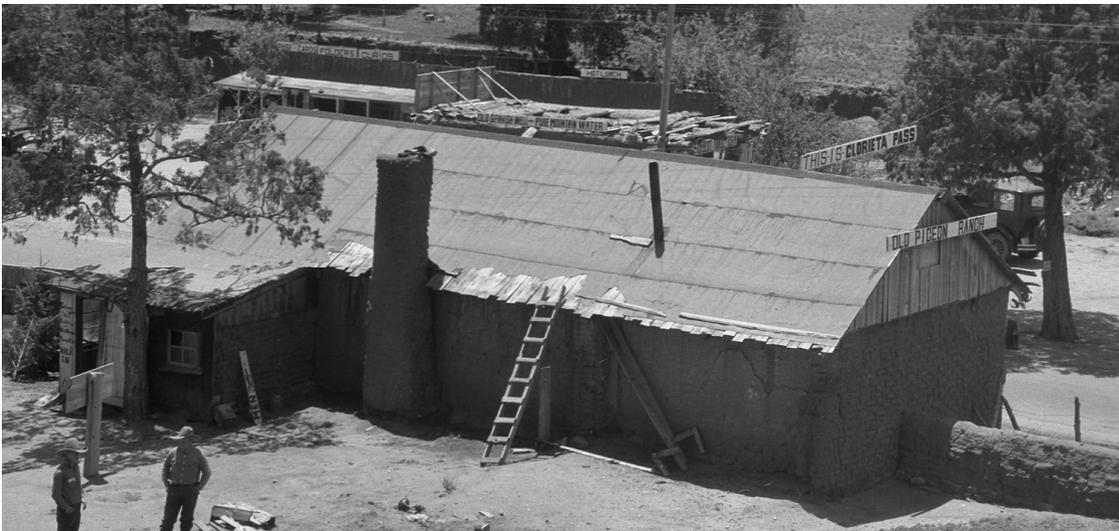
Figure 42. 1935, T. Harmon Parkhurst photograph. Museum of New Mexico, Neg. No. 9616. Tom Greer's roadside attraction at its peak, two years before the re-routing of Route 66 away from Santa Fe (and Pigeon's Ranch). Greer had expanded the number of outbuildings and attractions. The main structure was a curio shop, museum, rest stop, and entrance to the fenced in area's attractions.
