Appendix B. Historic Photographs/Figures

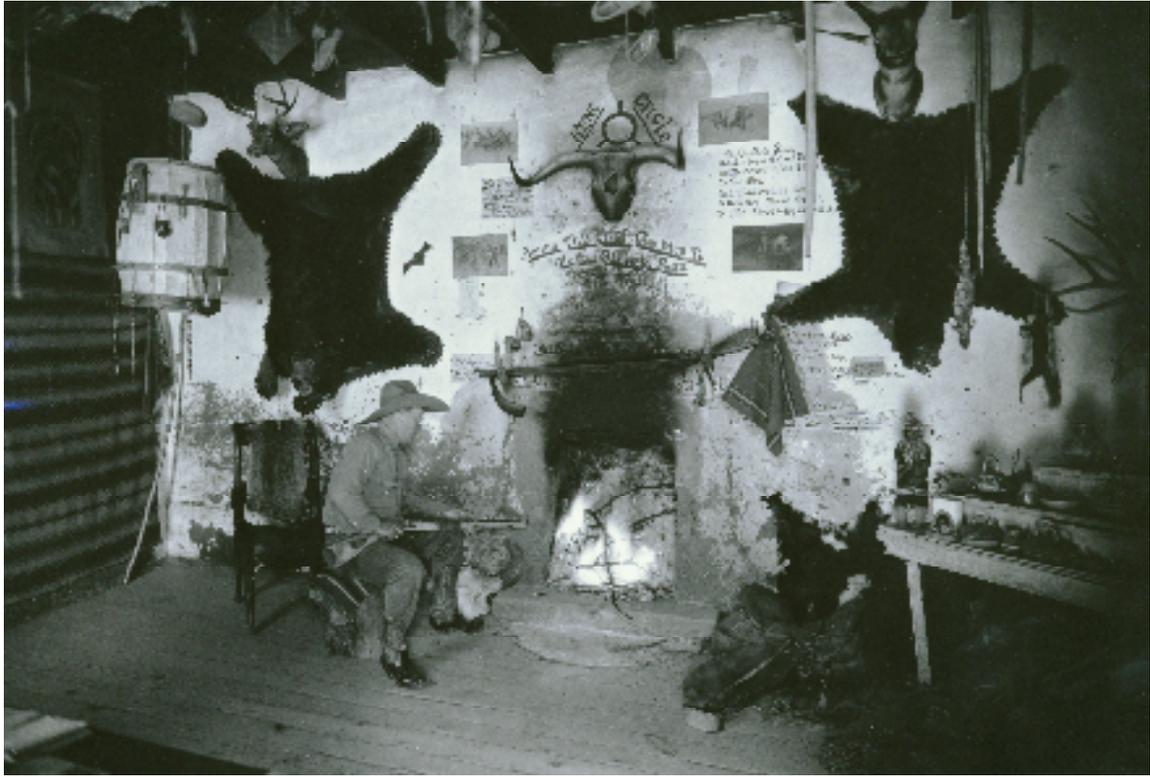
Figure 43. “Pigeon’s Ranch Glorieta, New Mexico” ca 1929 photo by T. Harmon Parkhurst, courtesy of the Museum of New Mexico, Negative MNM 68908. Interior image shows plastered walls with writings, the fire place in the middle room, and the collectibles on walls and furnishings. Tom Greer sits at left.

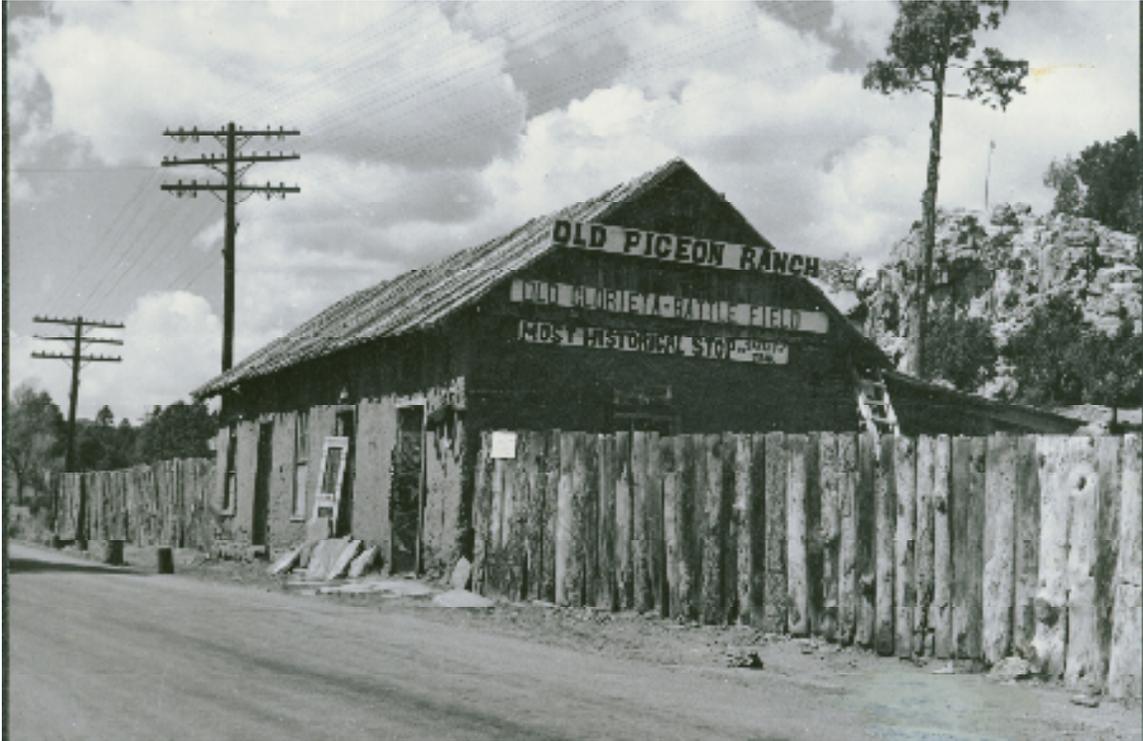
Figure 47. Raymond McCoy, 1951, Museum of New Mexico Negative no. 90717. Also used in McCoy, “The Battle of Glorieta Pass.” Note relocation of fence to southeast corner, parallel to front wall.

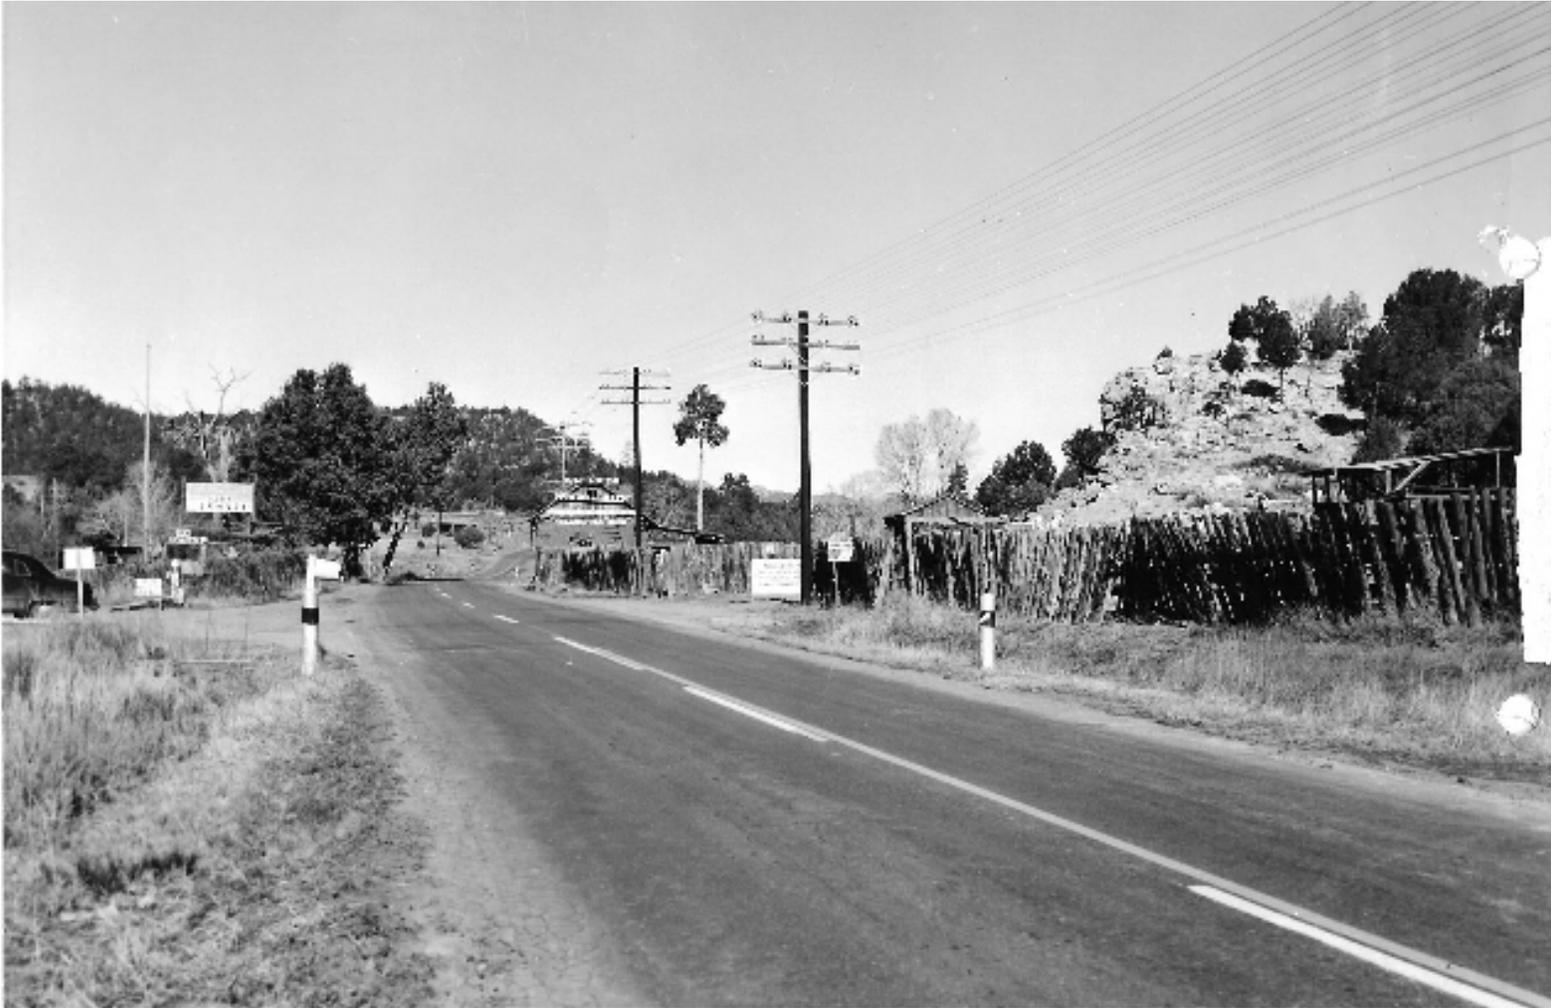
Figure 50. Al. L. Schroeder photograph, 1960. Glorieta Battlefield National Historic Landmark file, NPS, Santa Fe. With the rerouting of the U. S. 85 highway in the late 1950s, the roadside attraction closed. The Glorieta Battlefield was designated a National Historic Landmark on November 5, 1961, which included the Pigeon Ranch structure. Owner Tom Greer died in 1968.

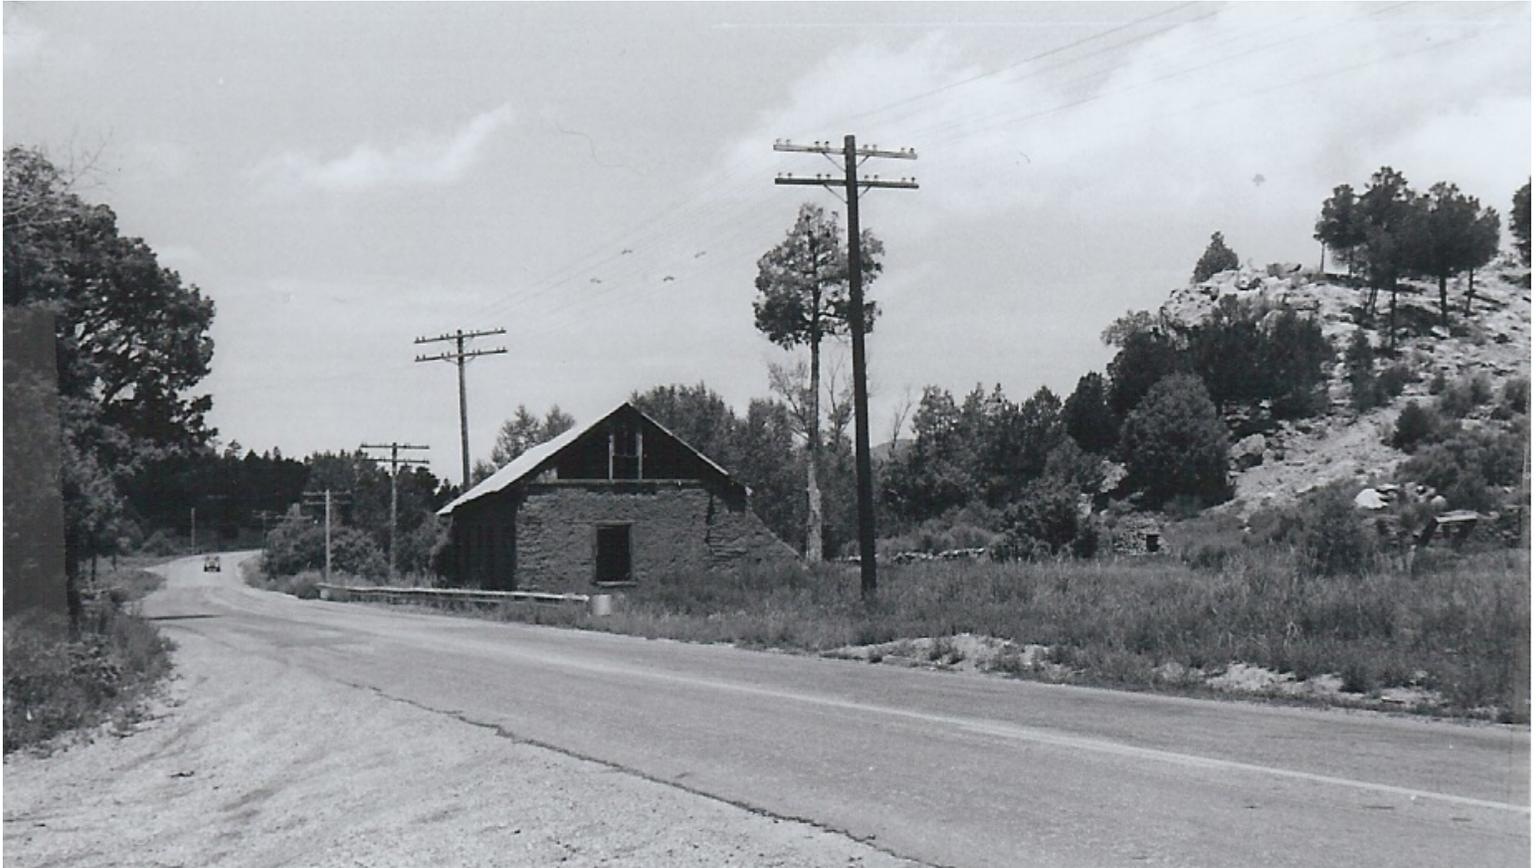
Figure 53. Melody Webb photograph, 1980, Glorieta Battlefield National Historic Landmark file, NPS, Santa Fe. A new owner in the 1970s removed much of the Greer era developments.

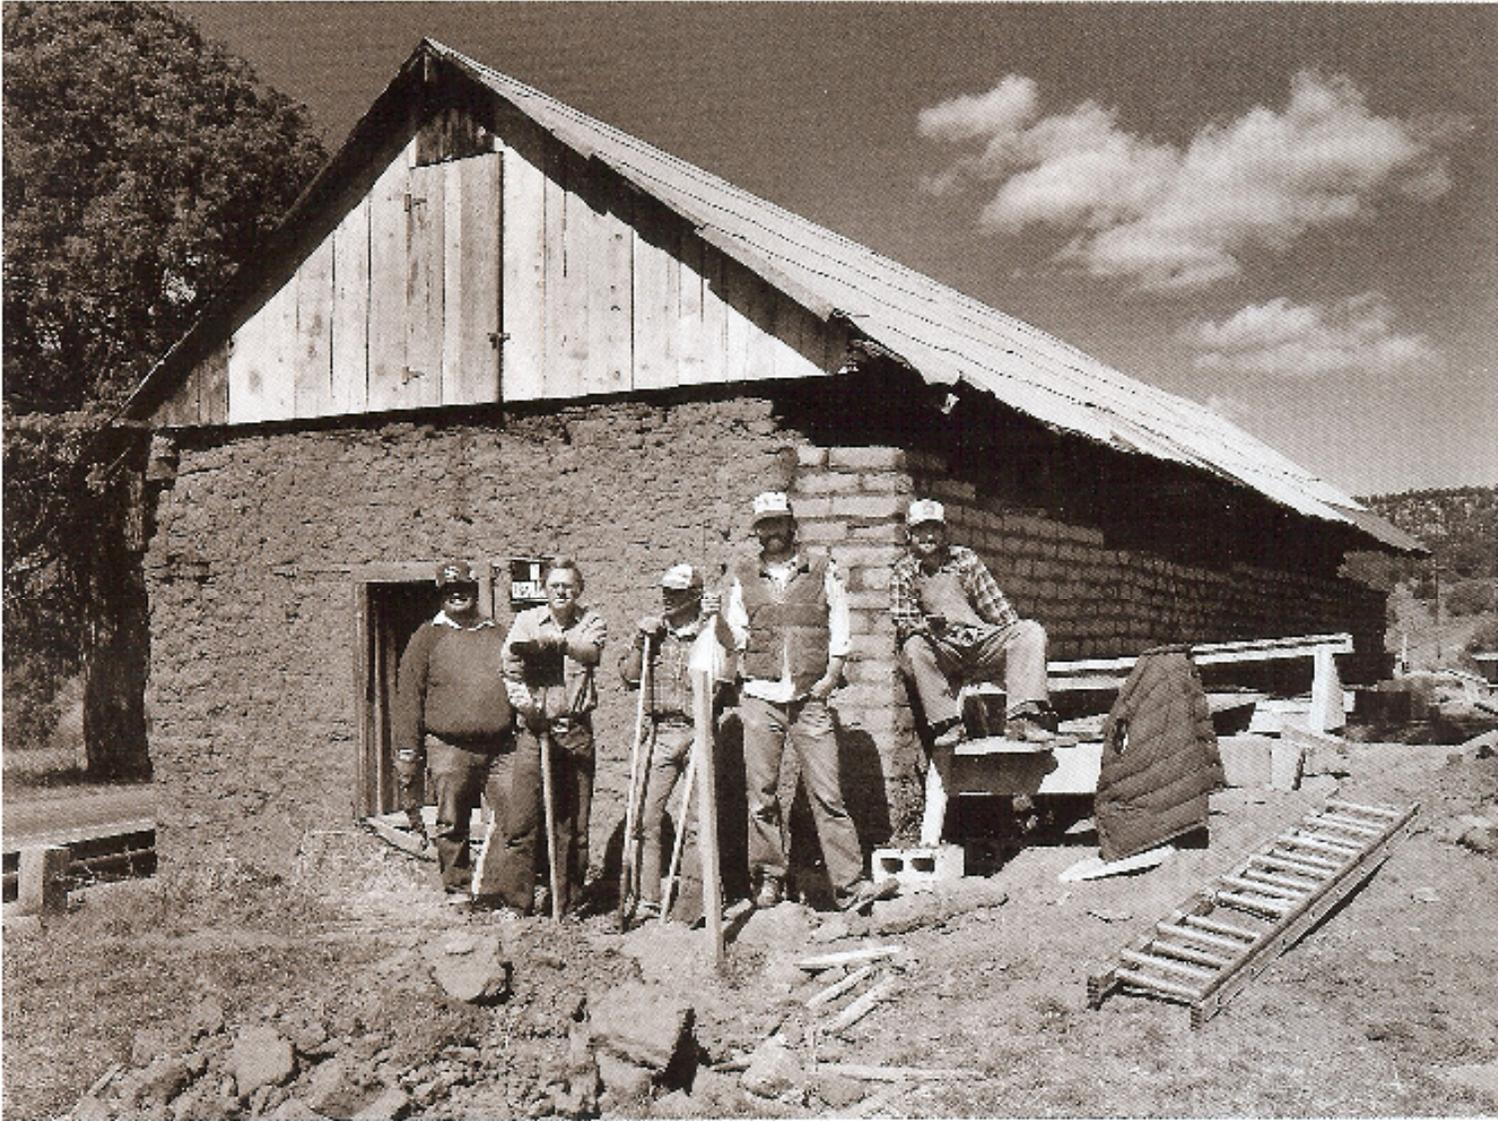
Figure 55. From Marc Simmons and Joan Myers, *Along the Santa Fe Trail* (Albuquerque: University of New Mexico Press, 1986), p. 177
Stabilization crews rebuilt the back wall and replaced the roof after a winter storm caused its collapse in April 1983. Additional images in Appendix.
