# Historic Furnishings Report Painted Desert Inn

Petrified Forest National Park  
Petrified Forest, Arizona

## **PAINTED DESERT INN PETRIFIED FOREST NATIONAL PARK**

**Part 1: Historical Data  
Part 2: Implementation Plan**

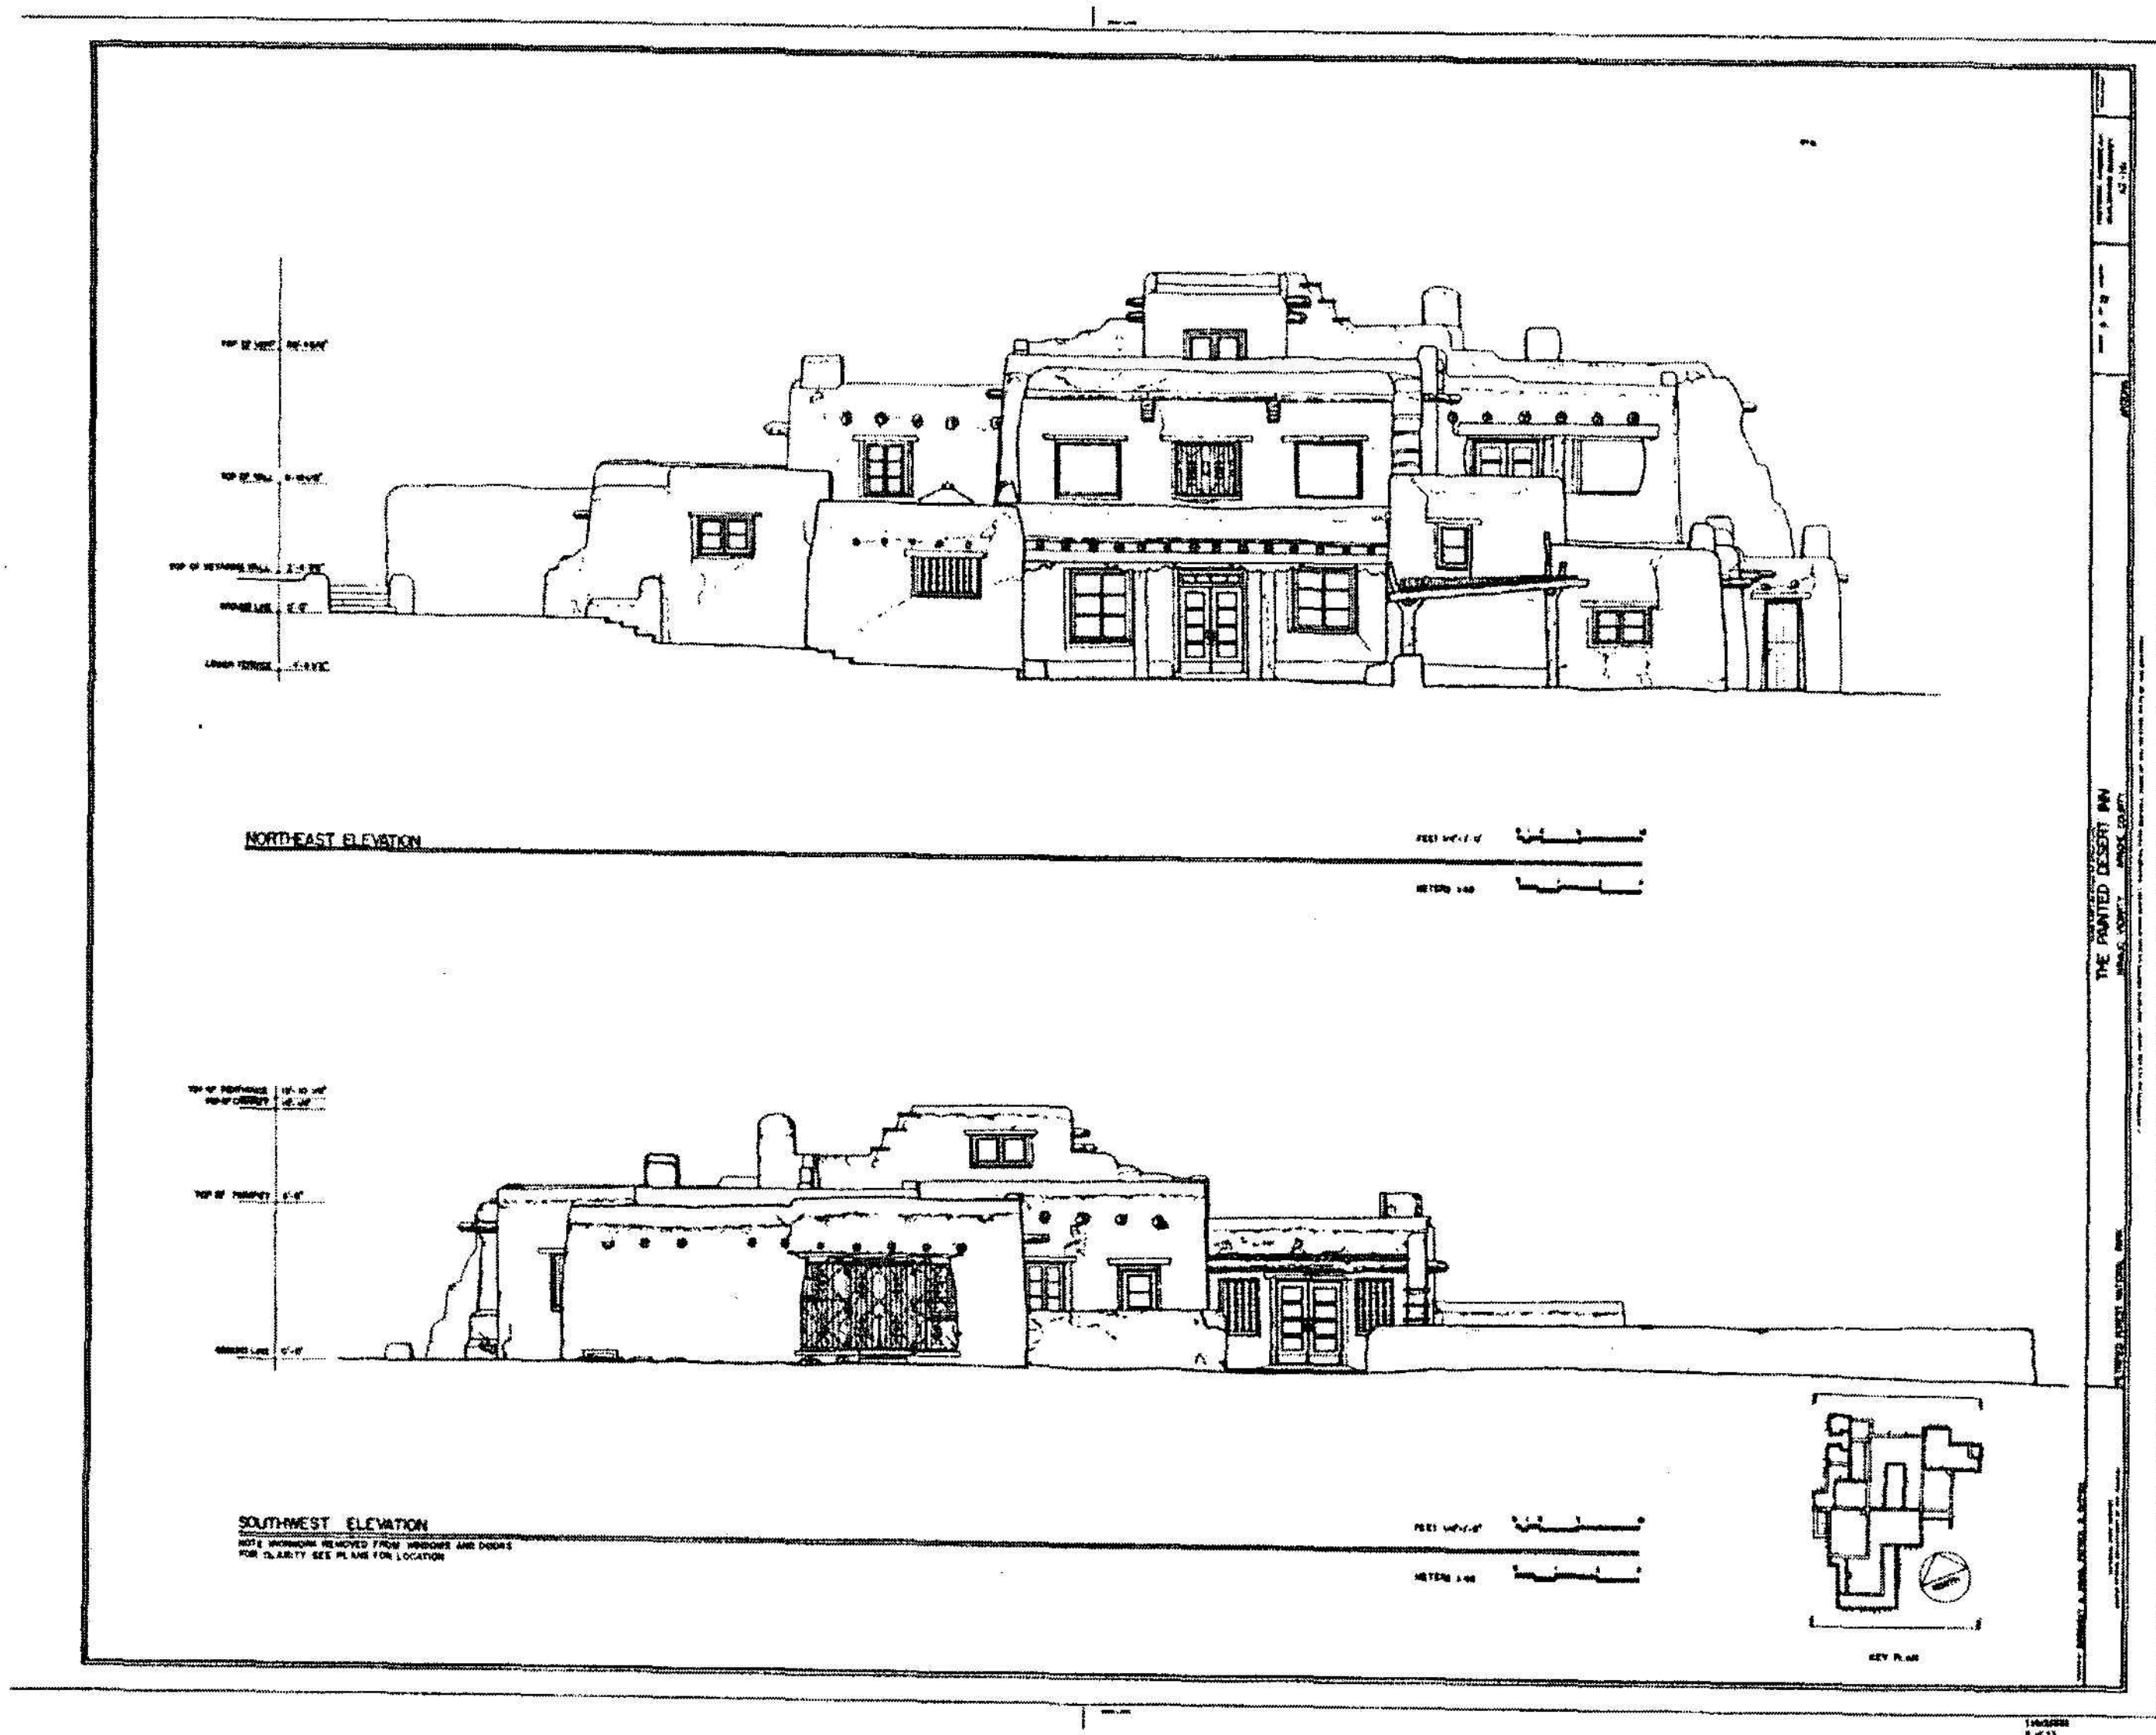
1. "Southwest Elevation of Painted Desert Inn." 1992, Drawing by Historic American Buildings Survey, Museum Collection, Archives, Petrified Forest National Park, Petrified Forest, Arizona, HABS: AZ-161, sheet 5 of 12.

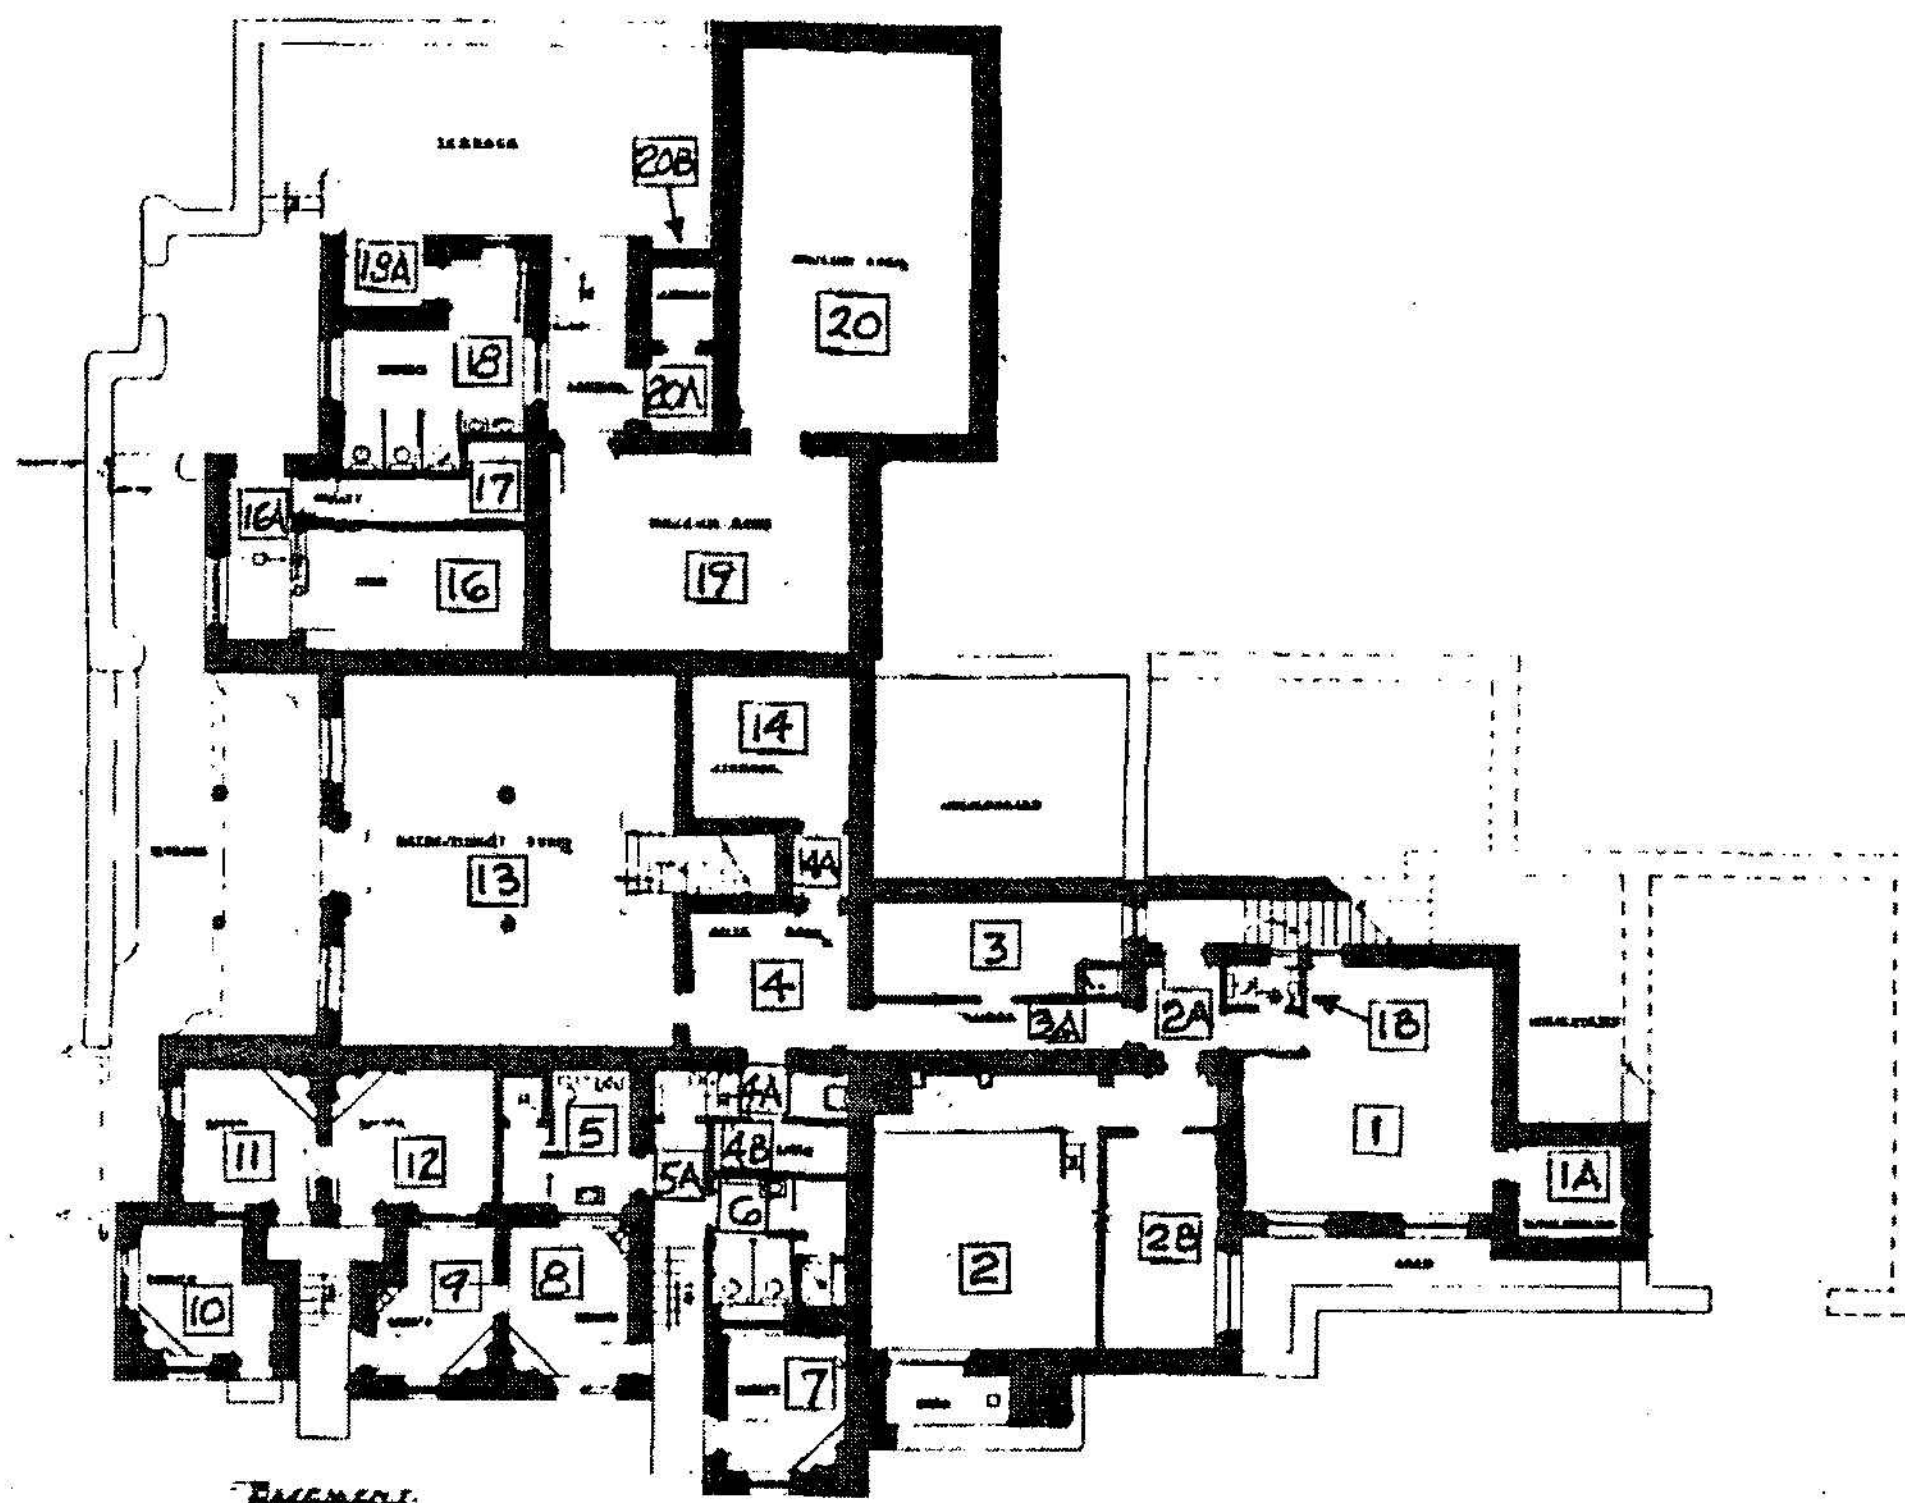
4. "Painted Desert Inn Basement Plan with Room Numbers." 1992, in *Historic Structure Report: Painted Desert Inn, Petrified Forest National Park* (Denver: Denver Service Center, United States Department of the Interior, October 1994), 56.

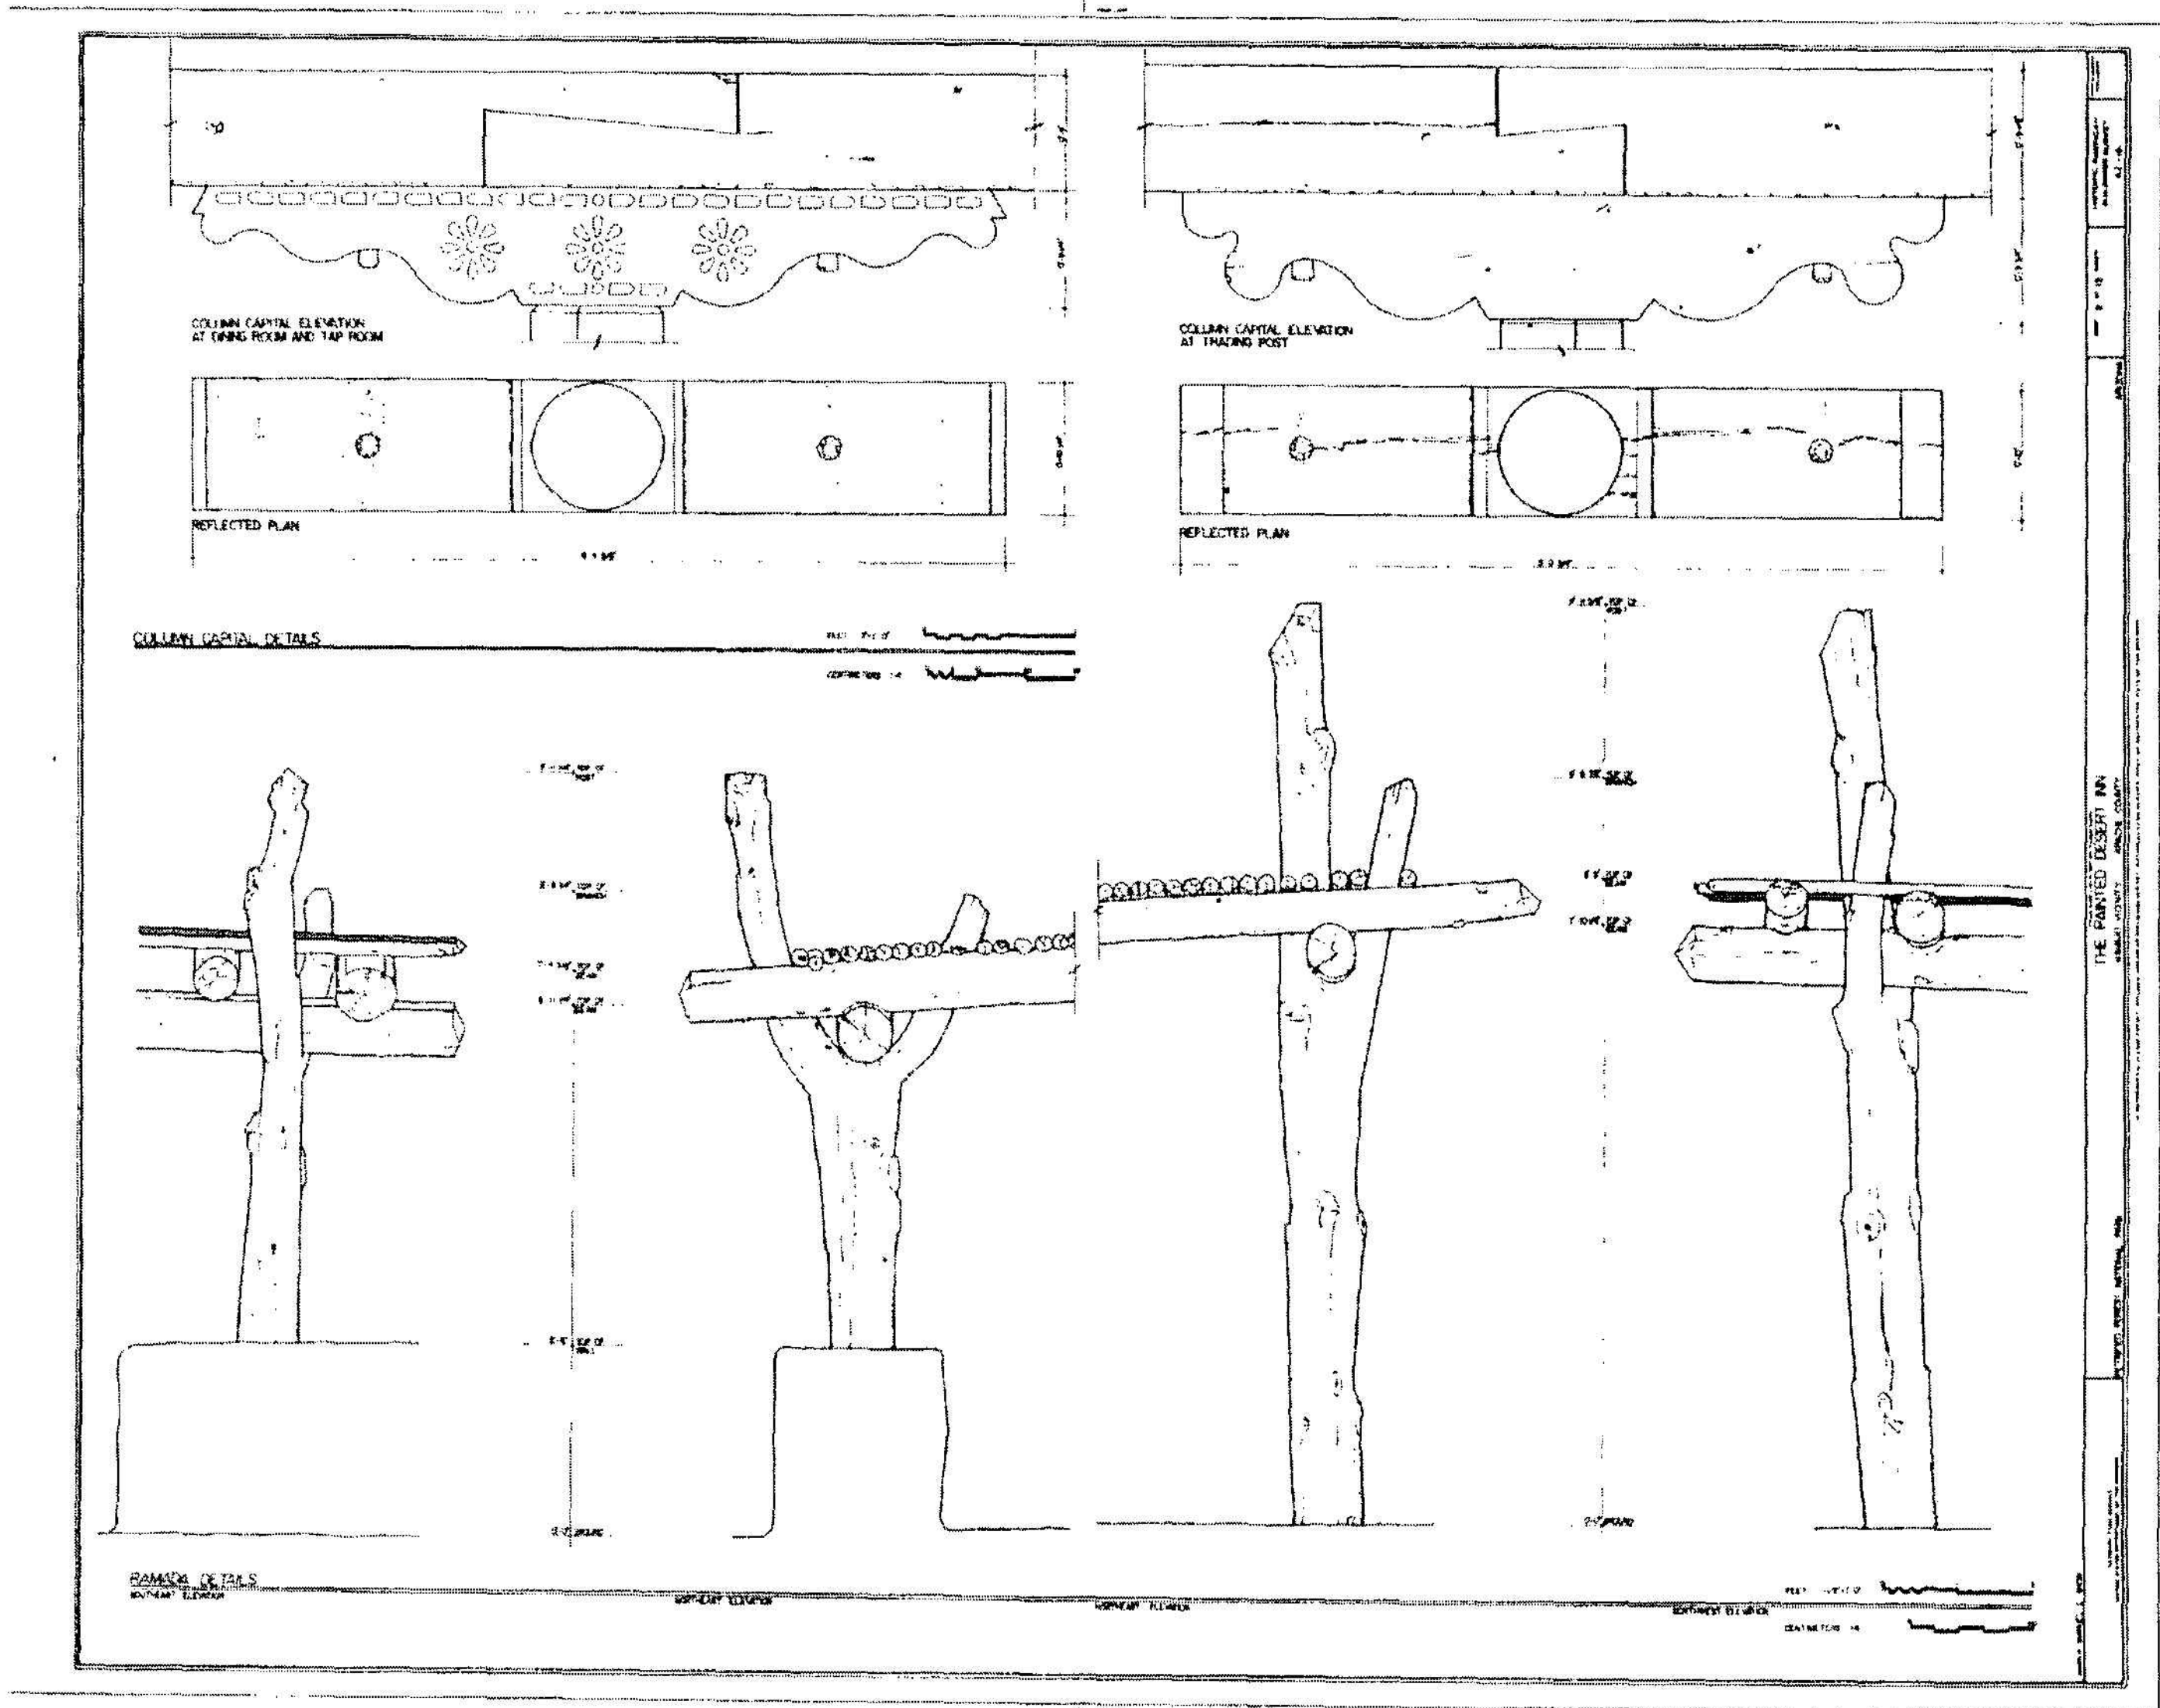
7. "Corbel (Zapata) and Ramada Details." 1992, Historic American Buildings Survey, Museum Collection, Archives, Petrified Forest National Park, Petrified Forest, Arizona, AZ-161, sheet 8 of 12.

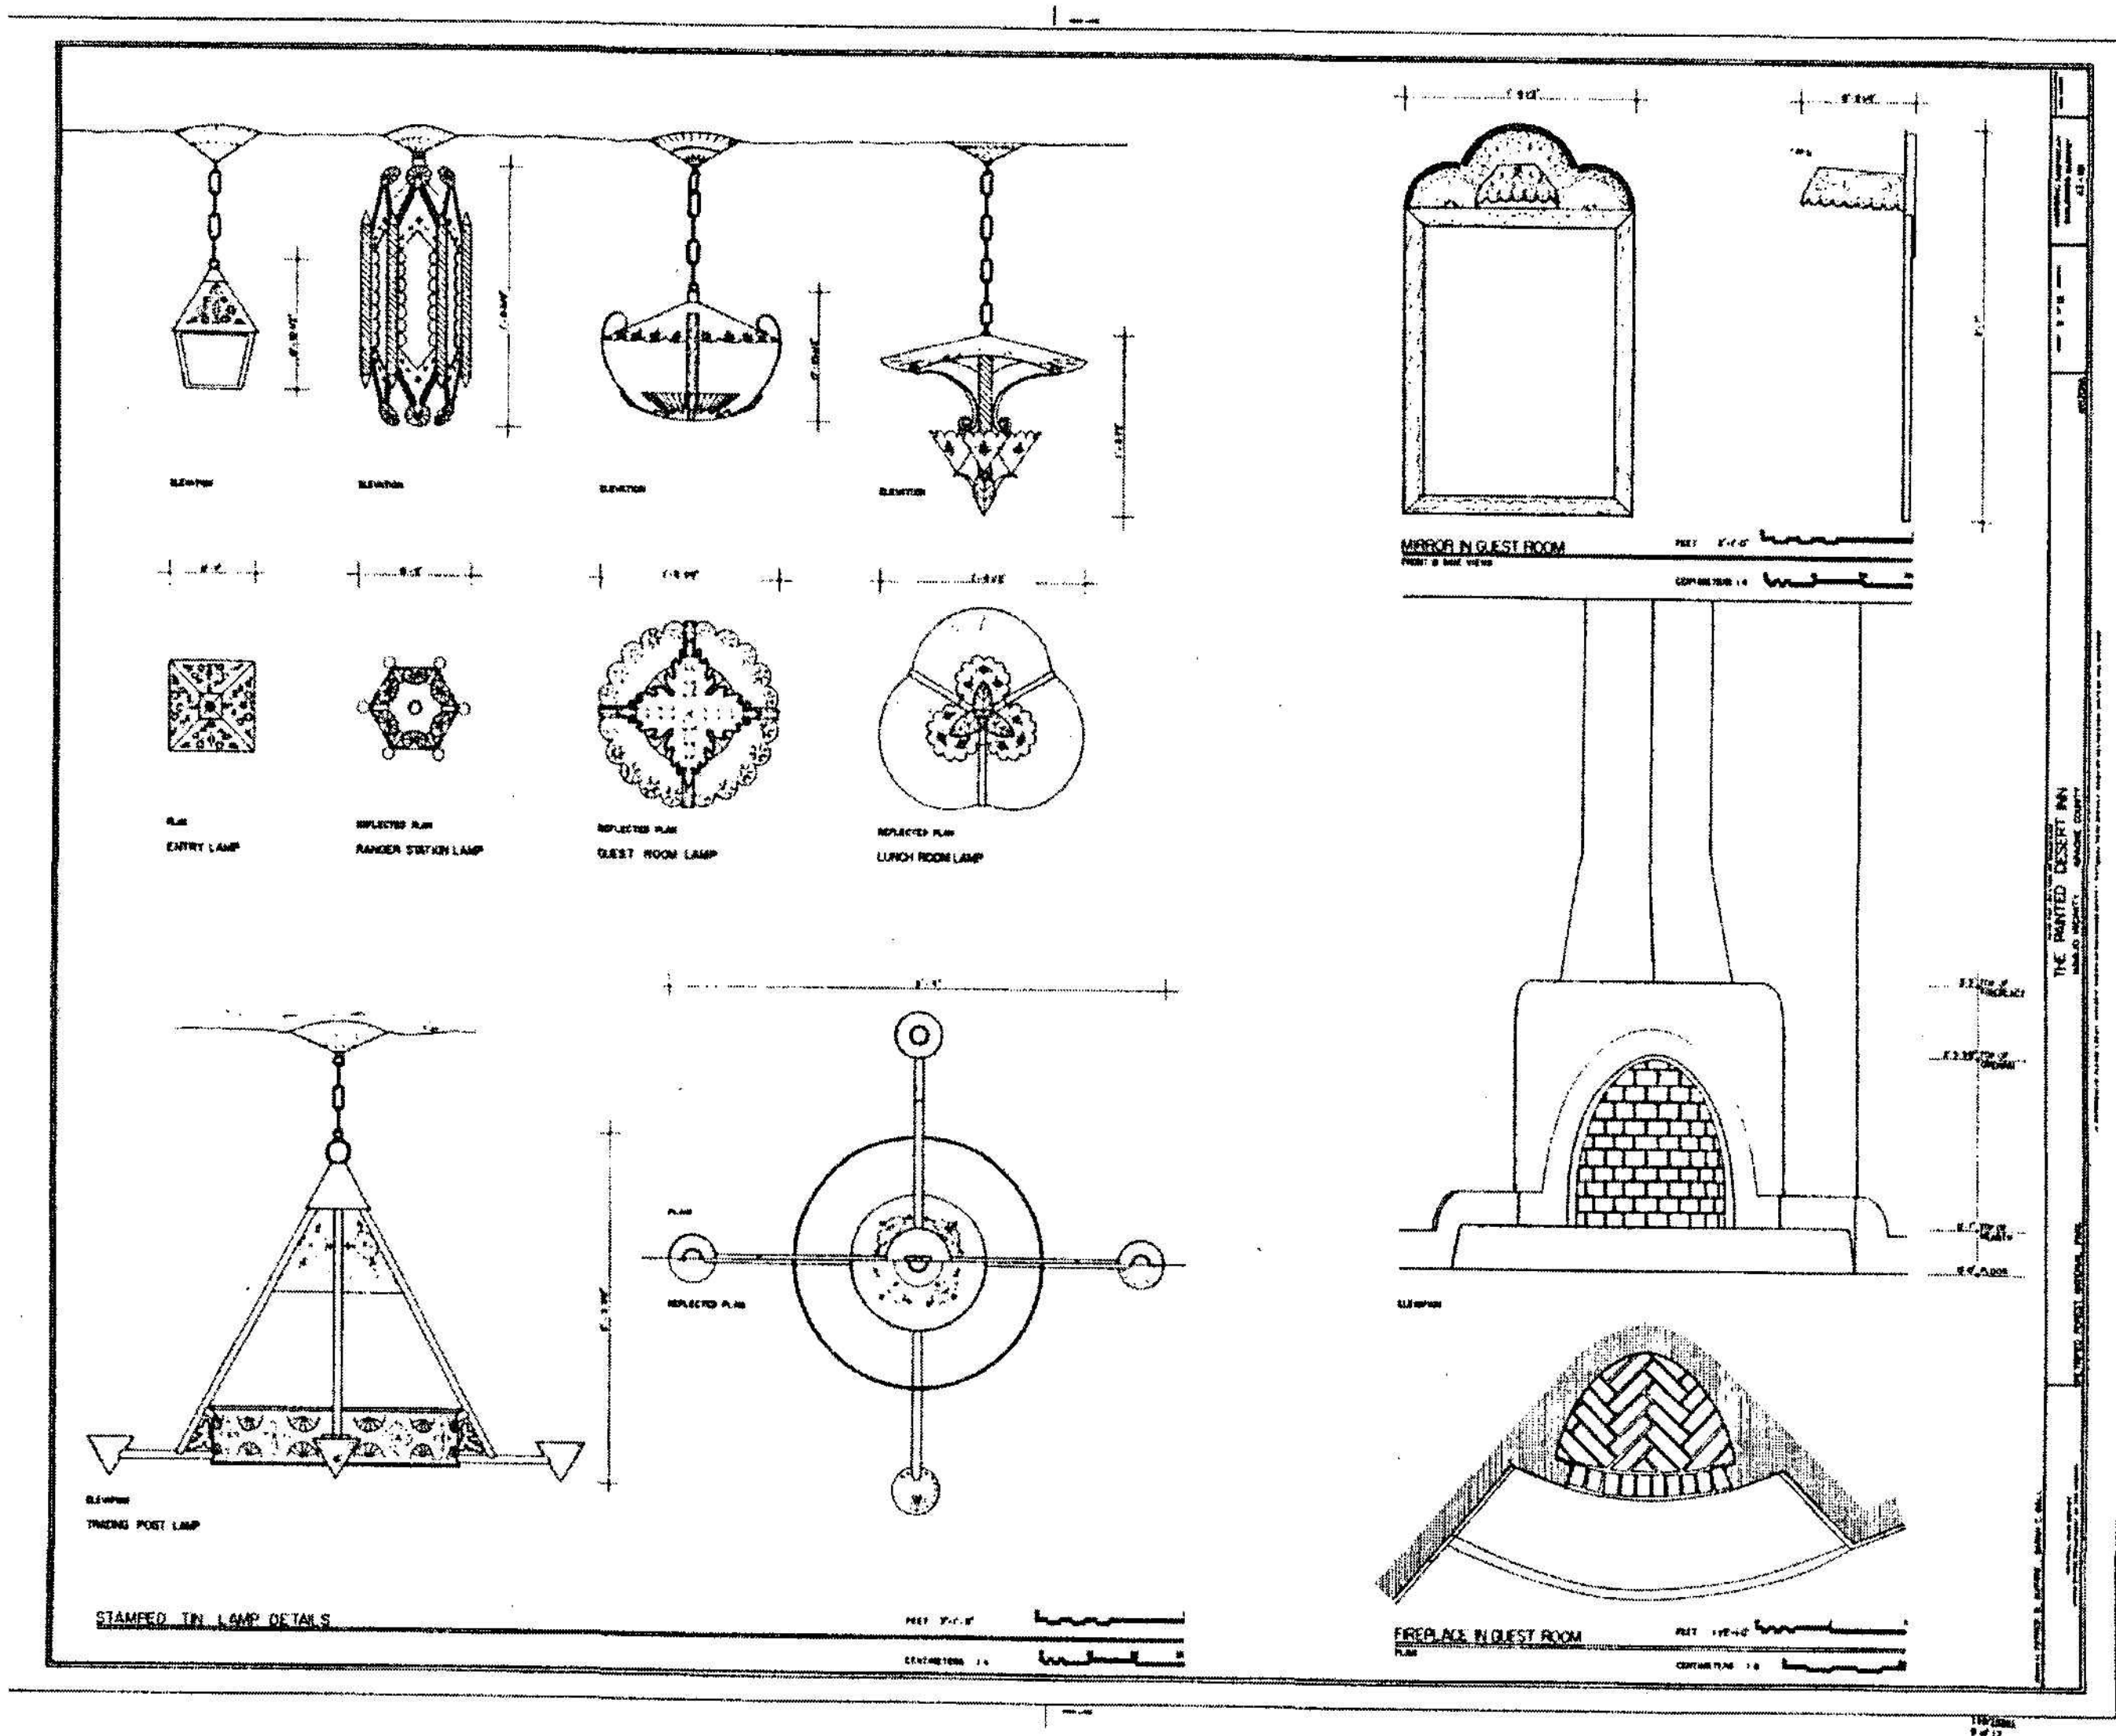
8. "Stamped Tin Lamp Details." 1992, Drawing by Historic American Buildings Survey, Museum Collection, Archives, Petrified Forest National Park, Petrified Forest, Arizona, HABS: AZ-161, sheet 9 of 12.

One tin lighting fixture in the lunchroom has been conserved. Others that currently hang in the Painted Desert Inn dining room, lunchroom, trading post room, ranger room, and guest room are intact but need to be assessed in terms of condition. Other tin fixtures in storage all need to be conserved and vary in terms of condition. Once conserved, *in situ* extant shelving and furnishings (such as the tap room bar, and fogon fireplaces in the guest rooms) can be used as installation objects.

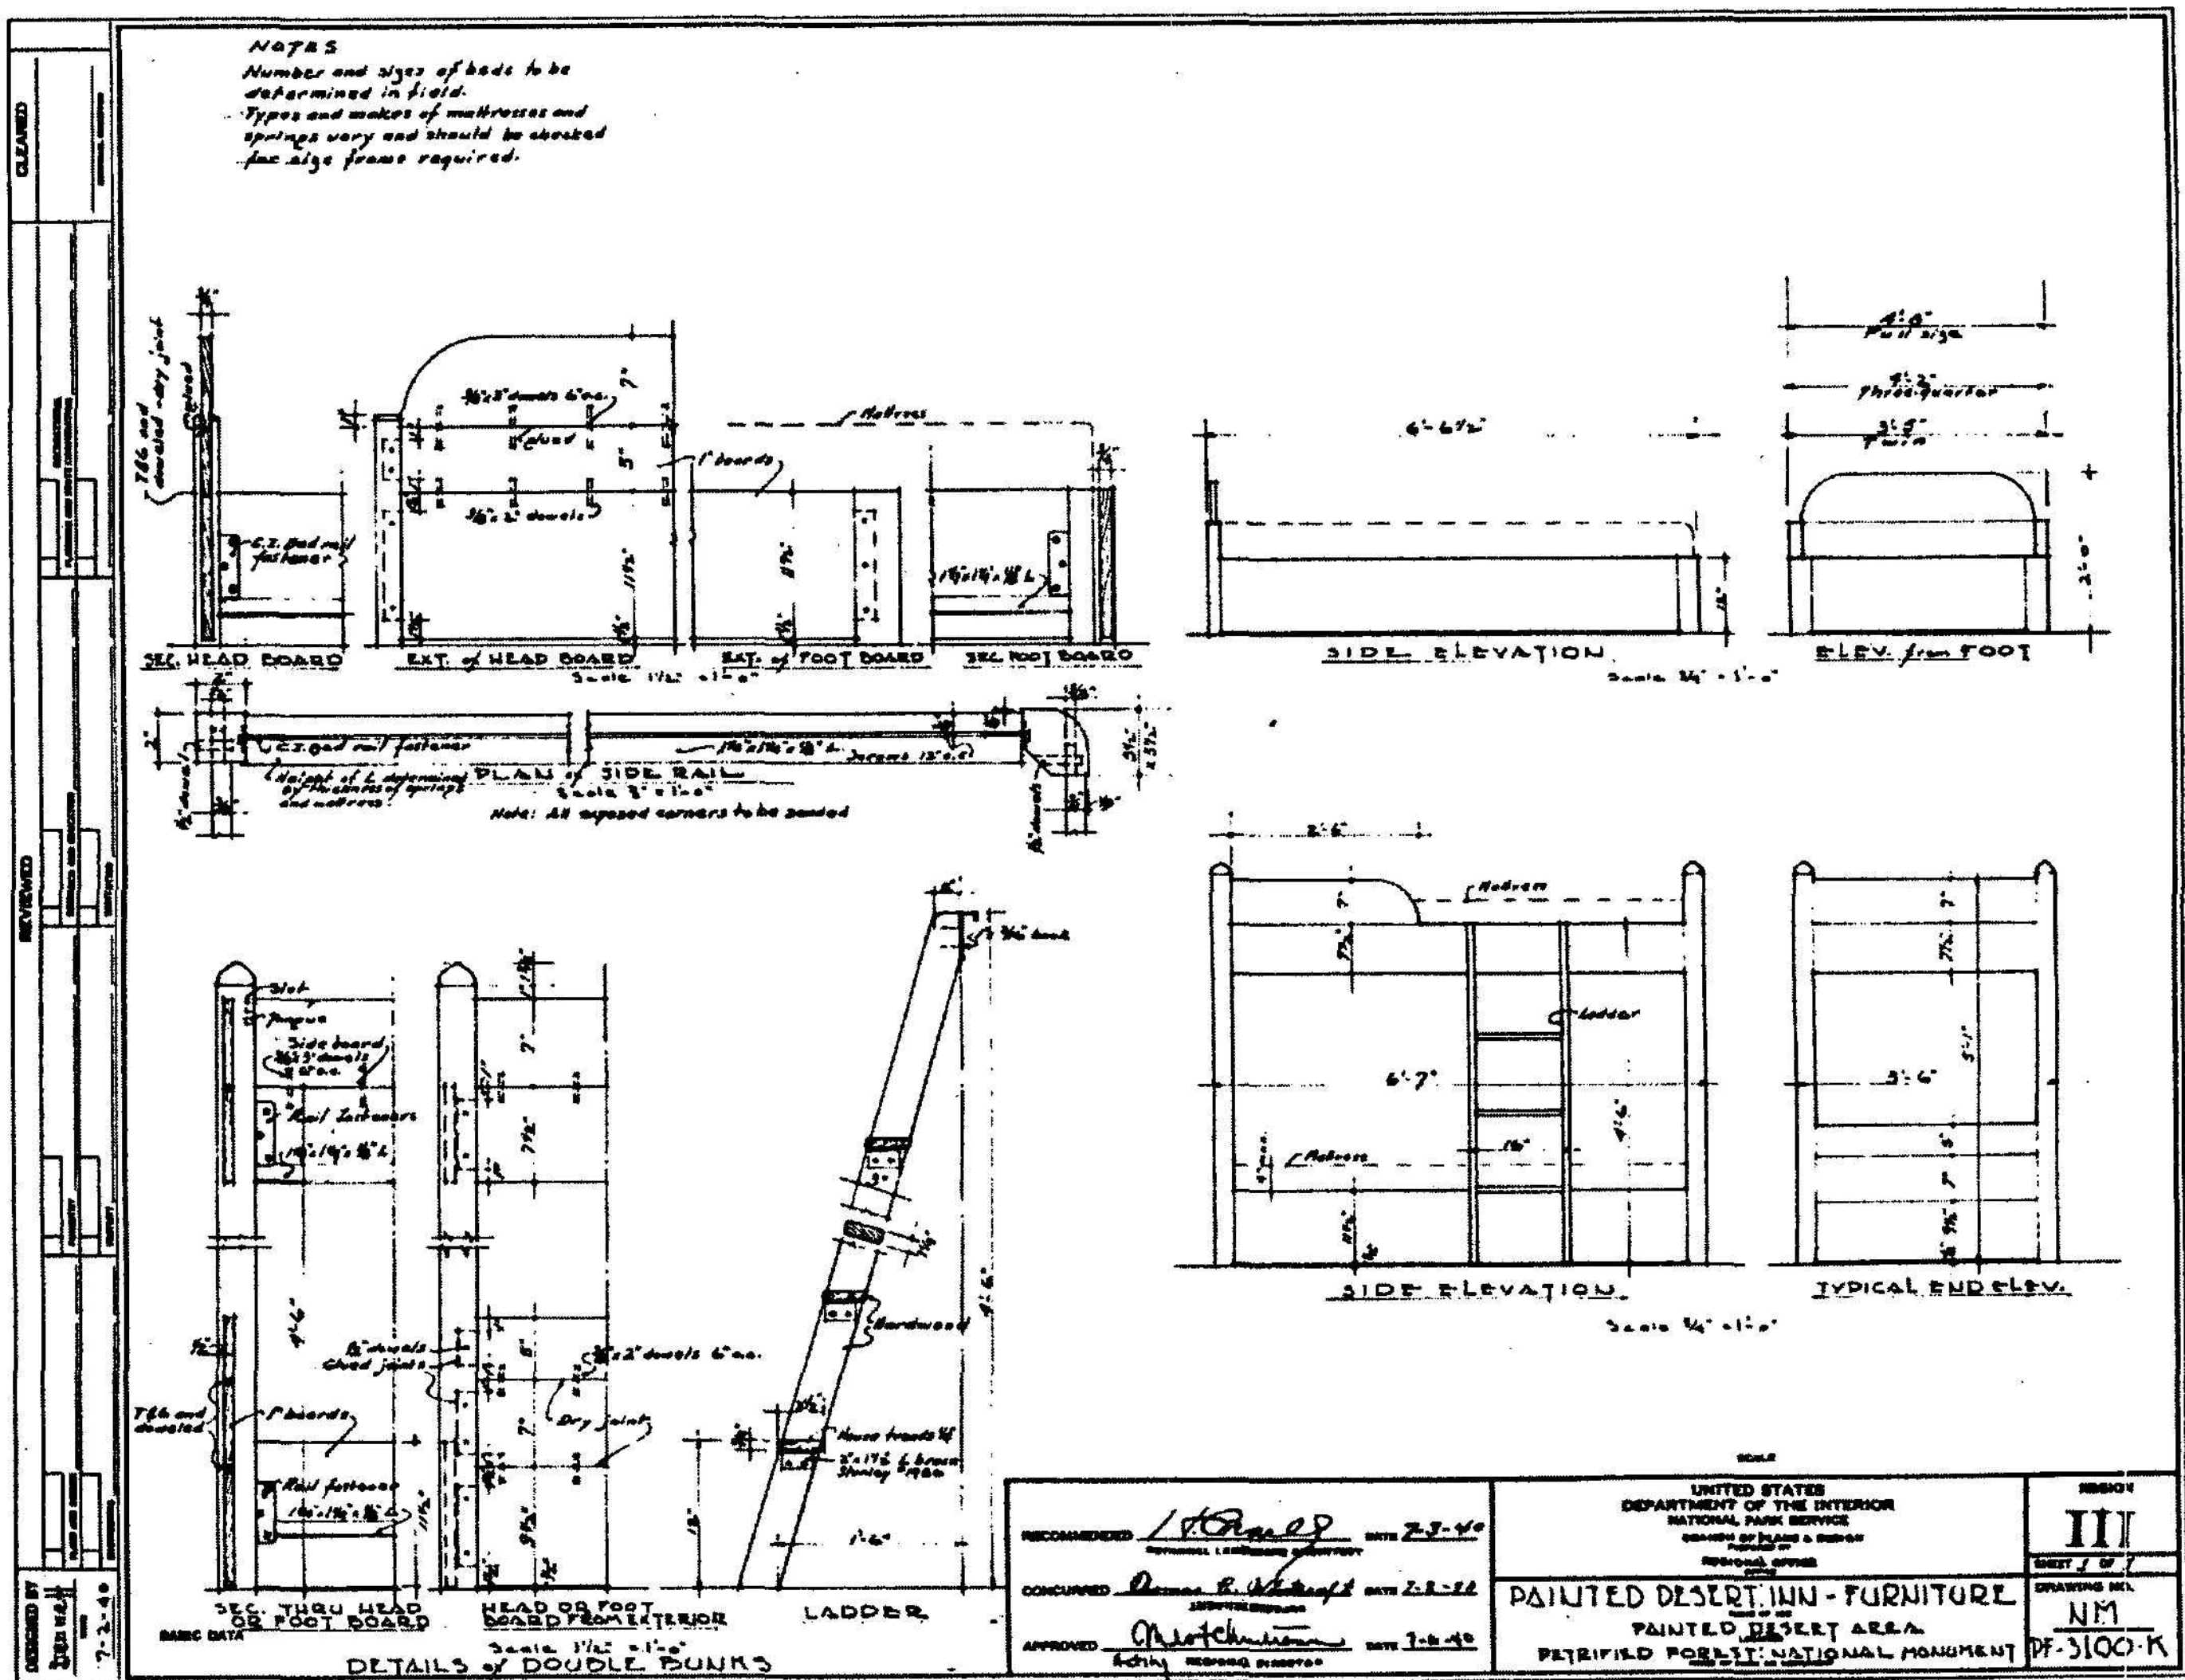
24. "Guest Room Furnishings--Bunk Beds." July 2, 1940, Plan by Lyle Bennett, Museum Collection, Archives, Petrified Forest National Park, Petrified Forest, Arizona, PF 3100-K.

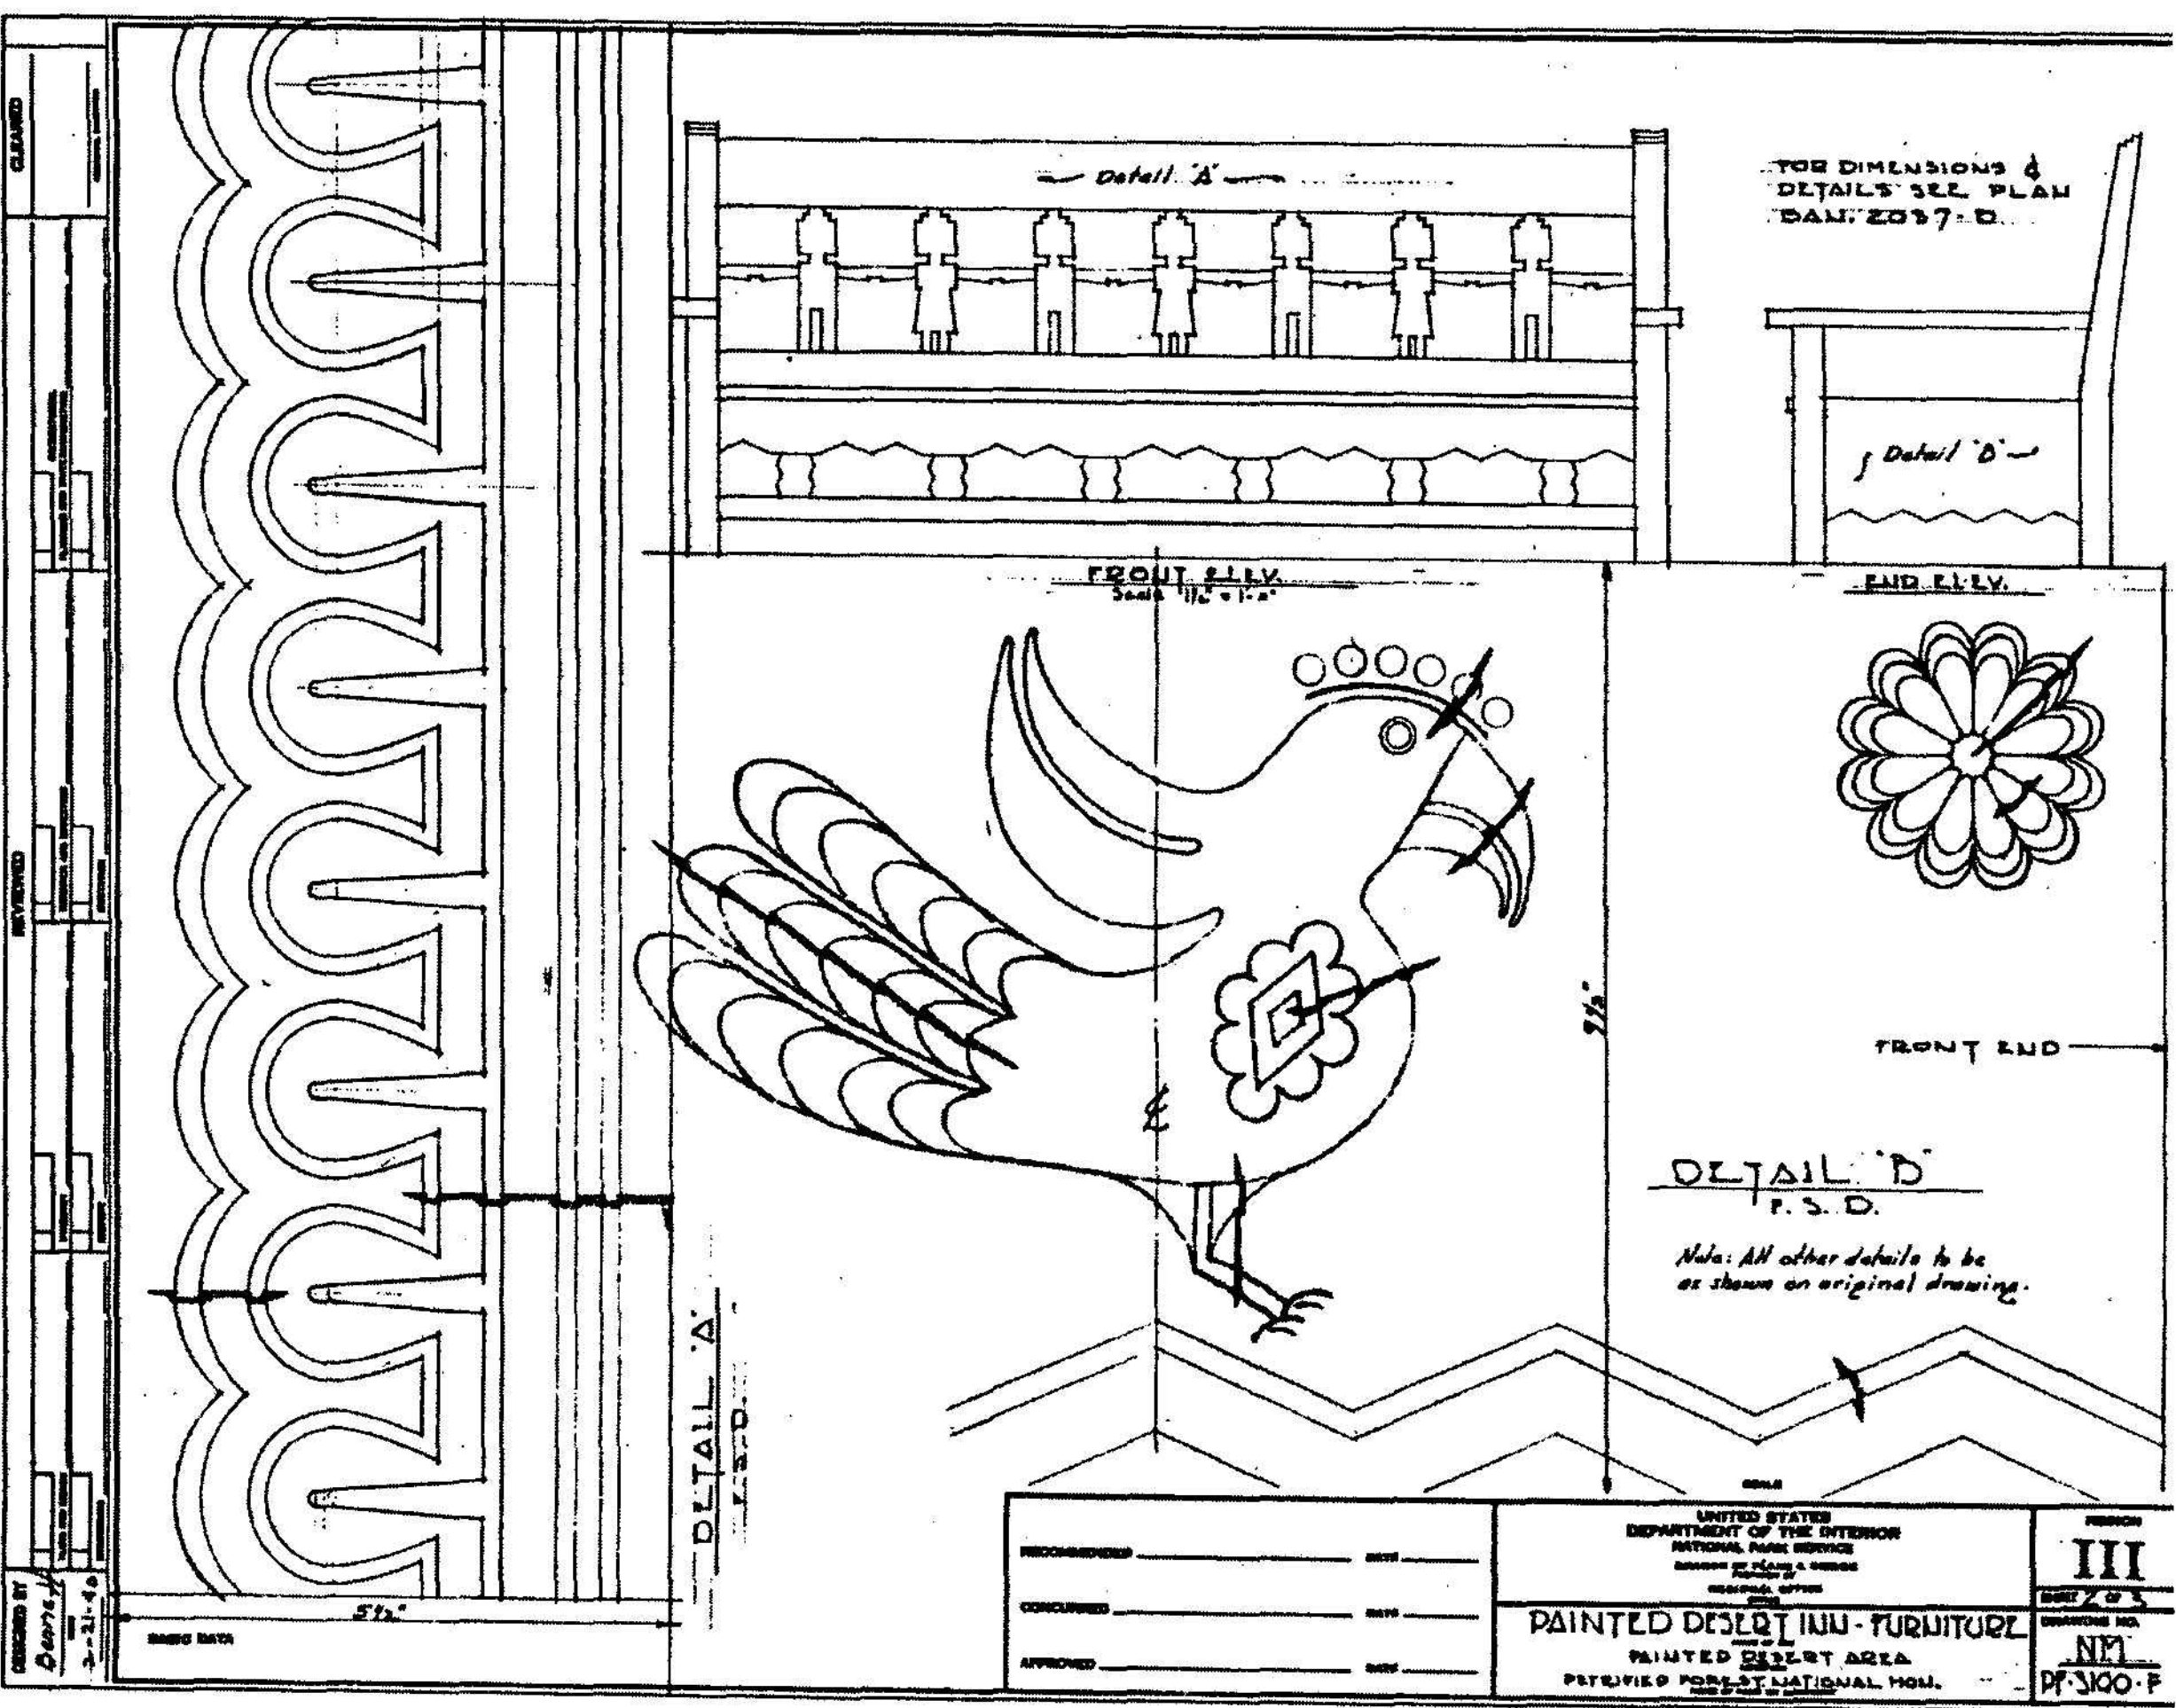
29. "Furniture--Details of Wood Bench in Lunchroom with Carved Decorative Patterns." February 1940, Plan by Lyle Bennett, Museum Collection, Archives, Petrified Forest National Park, Petrified Forest, Arizona, PF 3100-F, Sheet 2.
