# Historic Furnishings Report Painted Desert Inn

Petrified Forest National Park  
Petrified Forest, Arizona

## **PAINTED DESERT INN PETRIFIED FOREST NATIONAL PARK**

**Part 1: Historical Data  
Part 2: Implementation Plan**

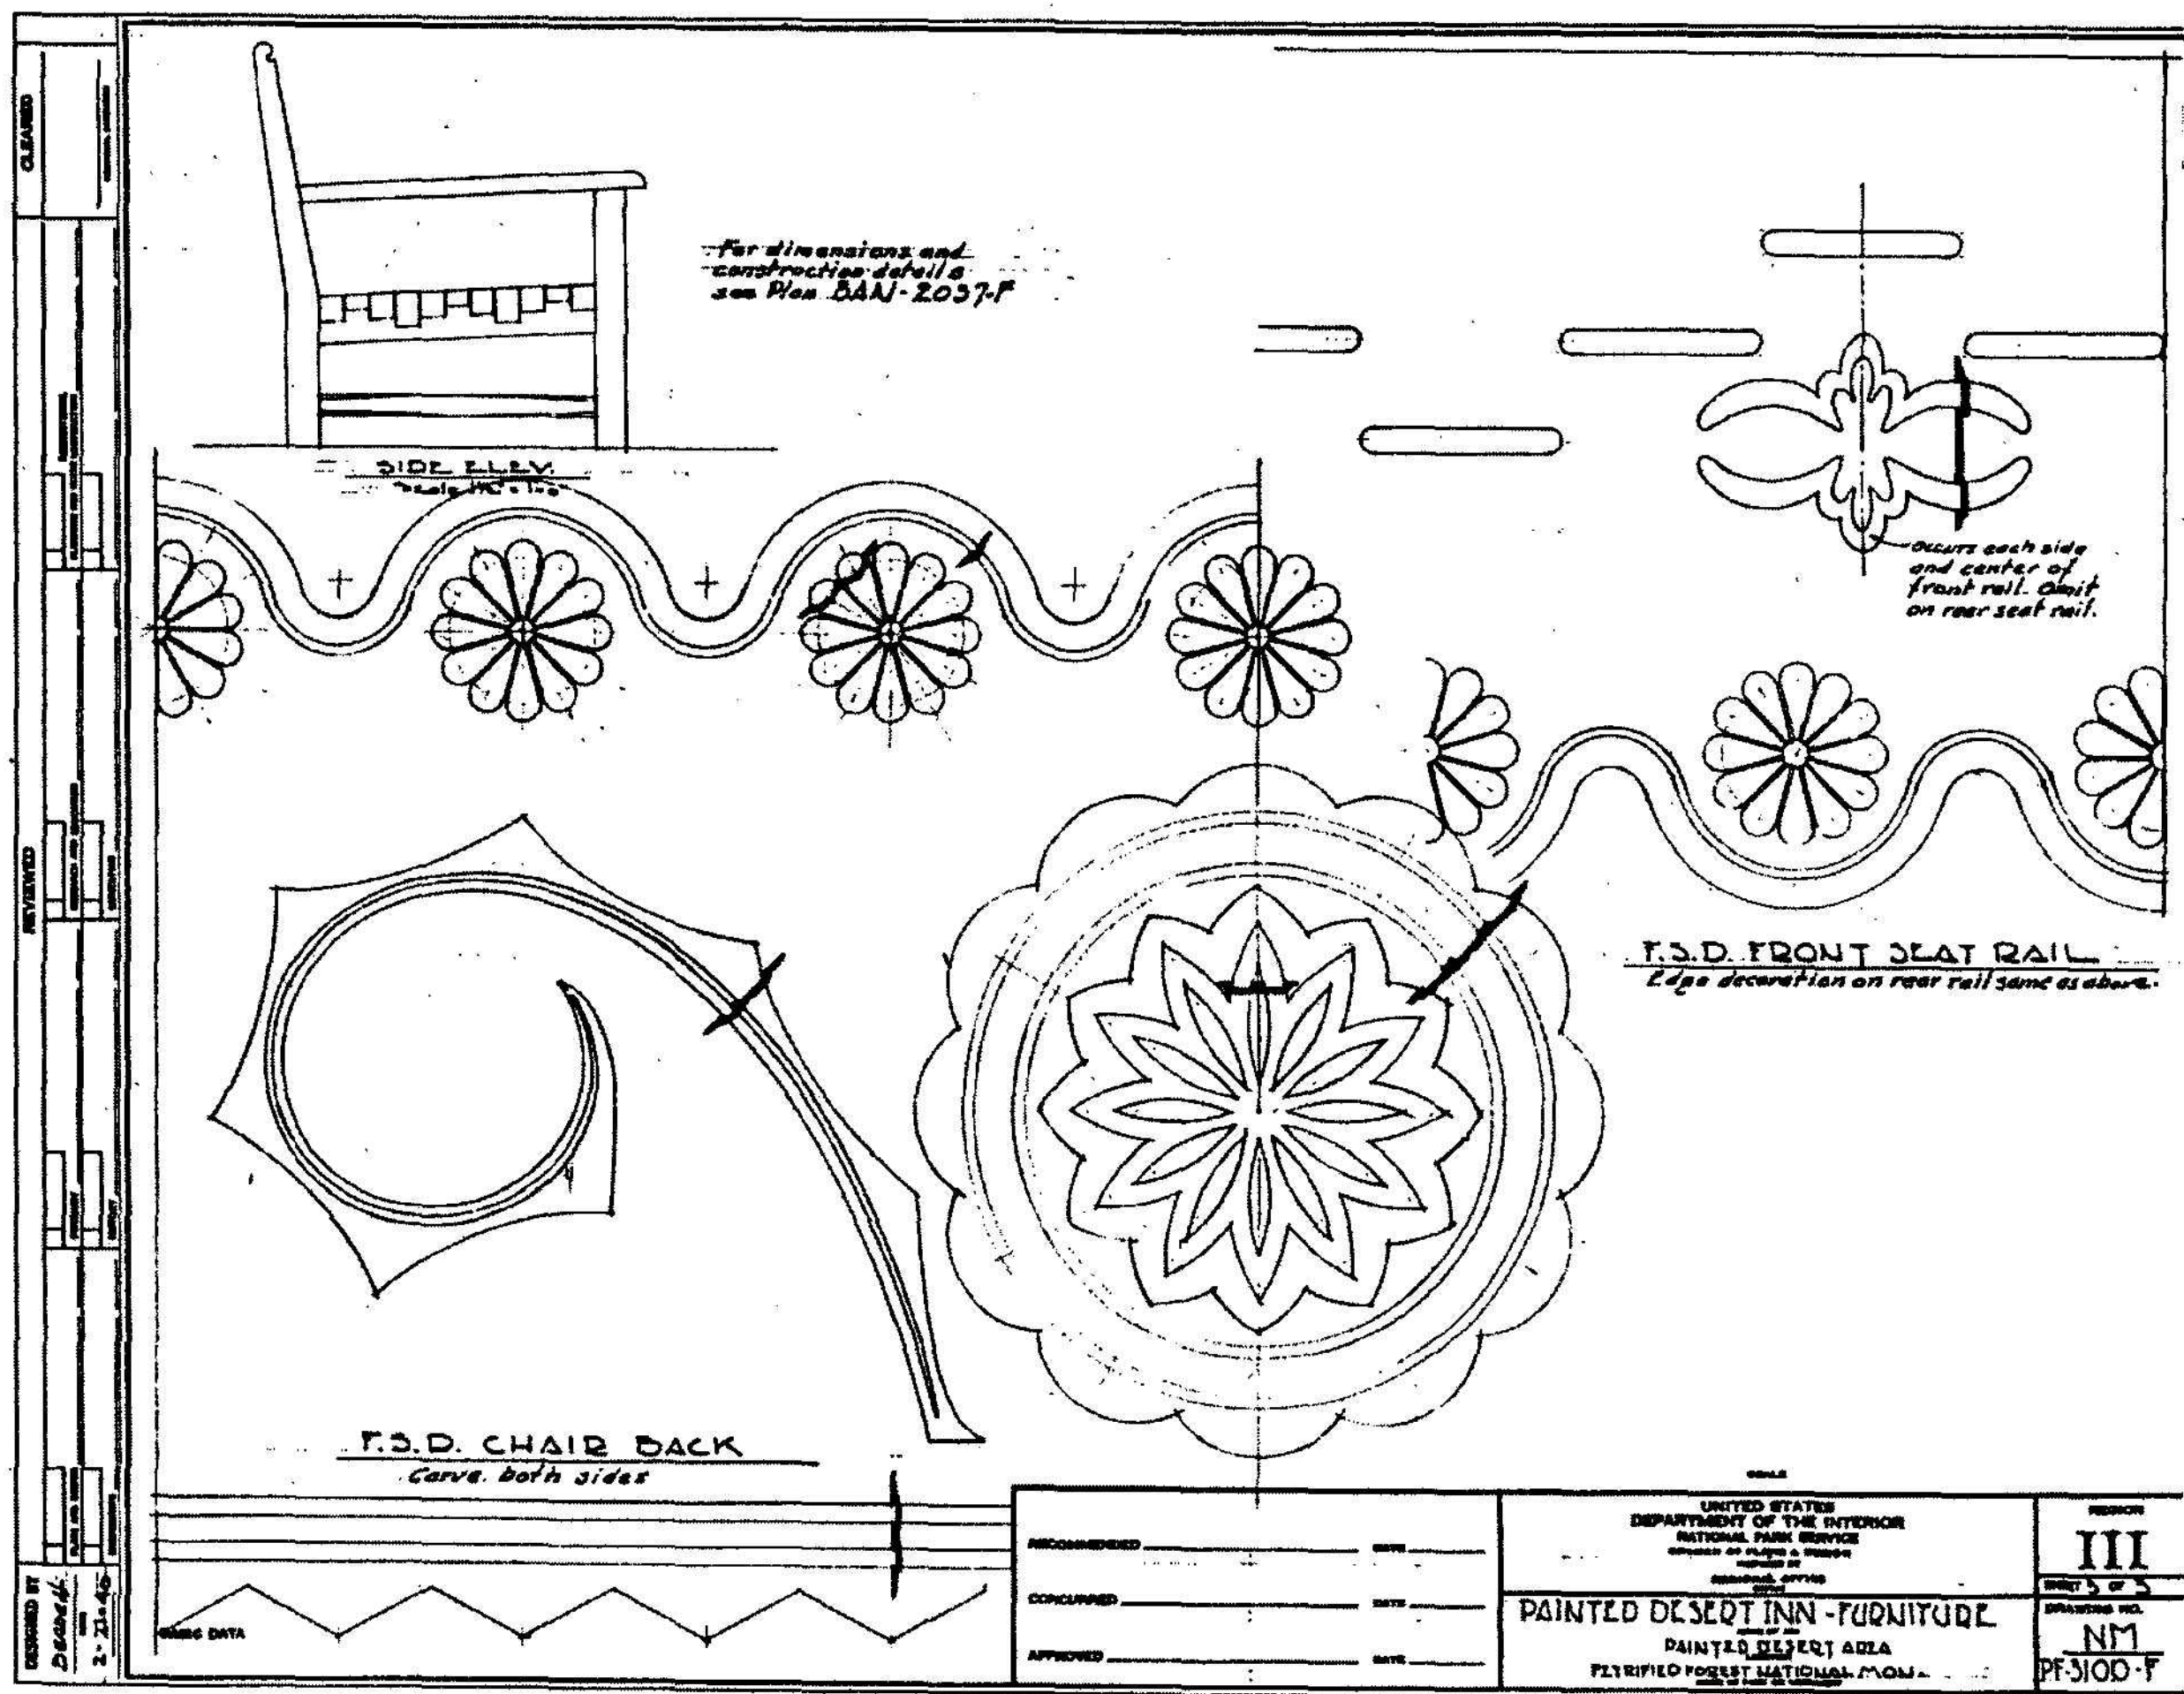
30. "Furniture--Details of Wood Bench with Carved Decorative Patterns."  
February 1940, Plan by Lyle Bennett, Museum Collection, Archives,  
Petrified Forest National Park, Petrified Forest, Arizona, PF 3100-F,  
Sheet 3.

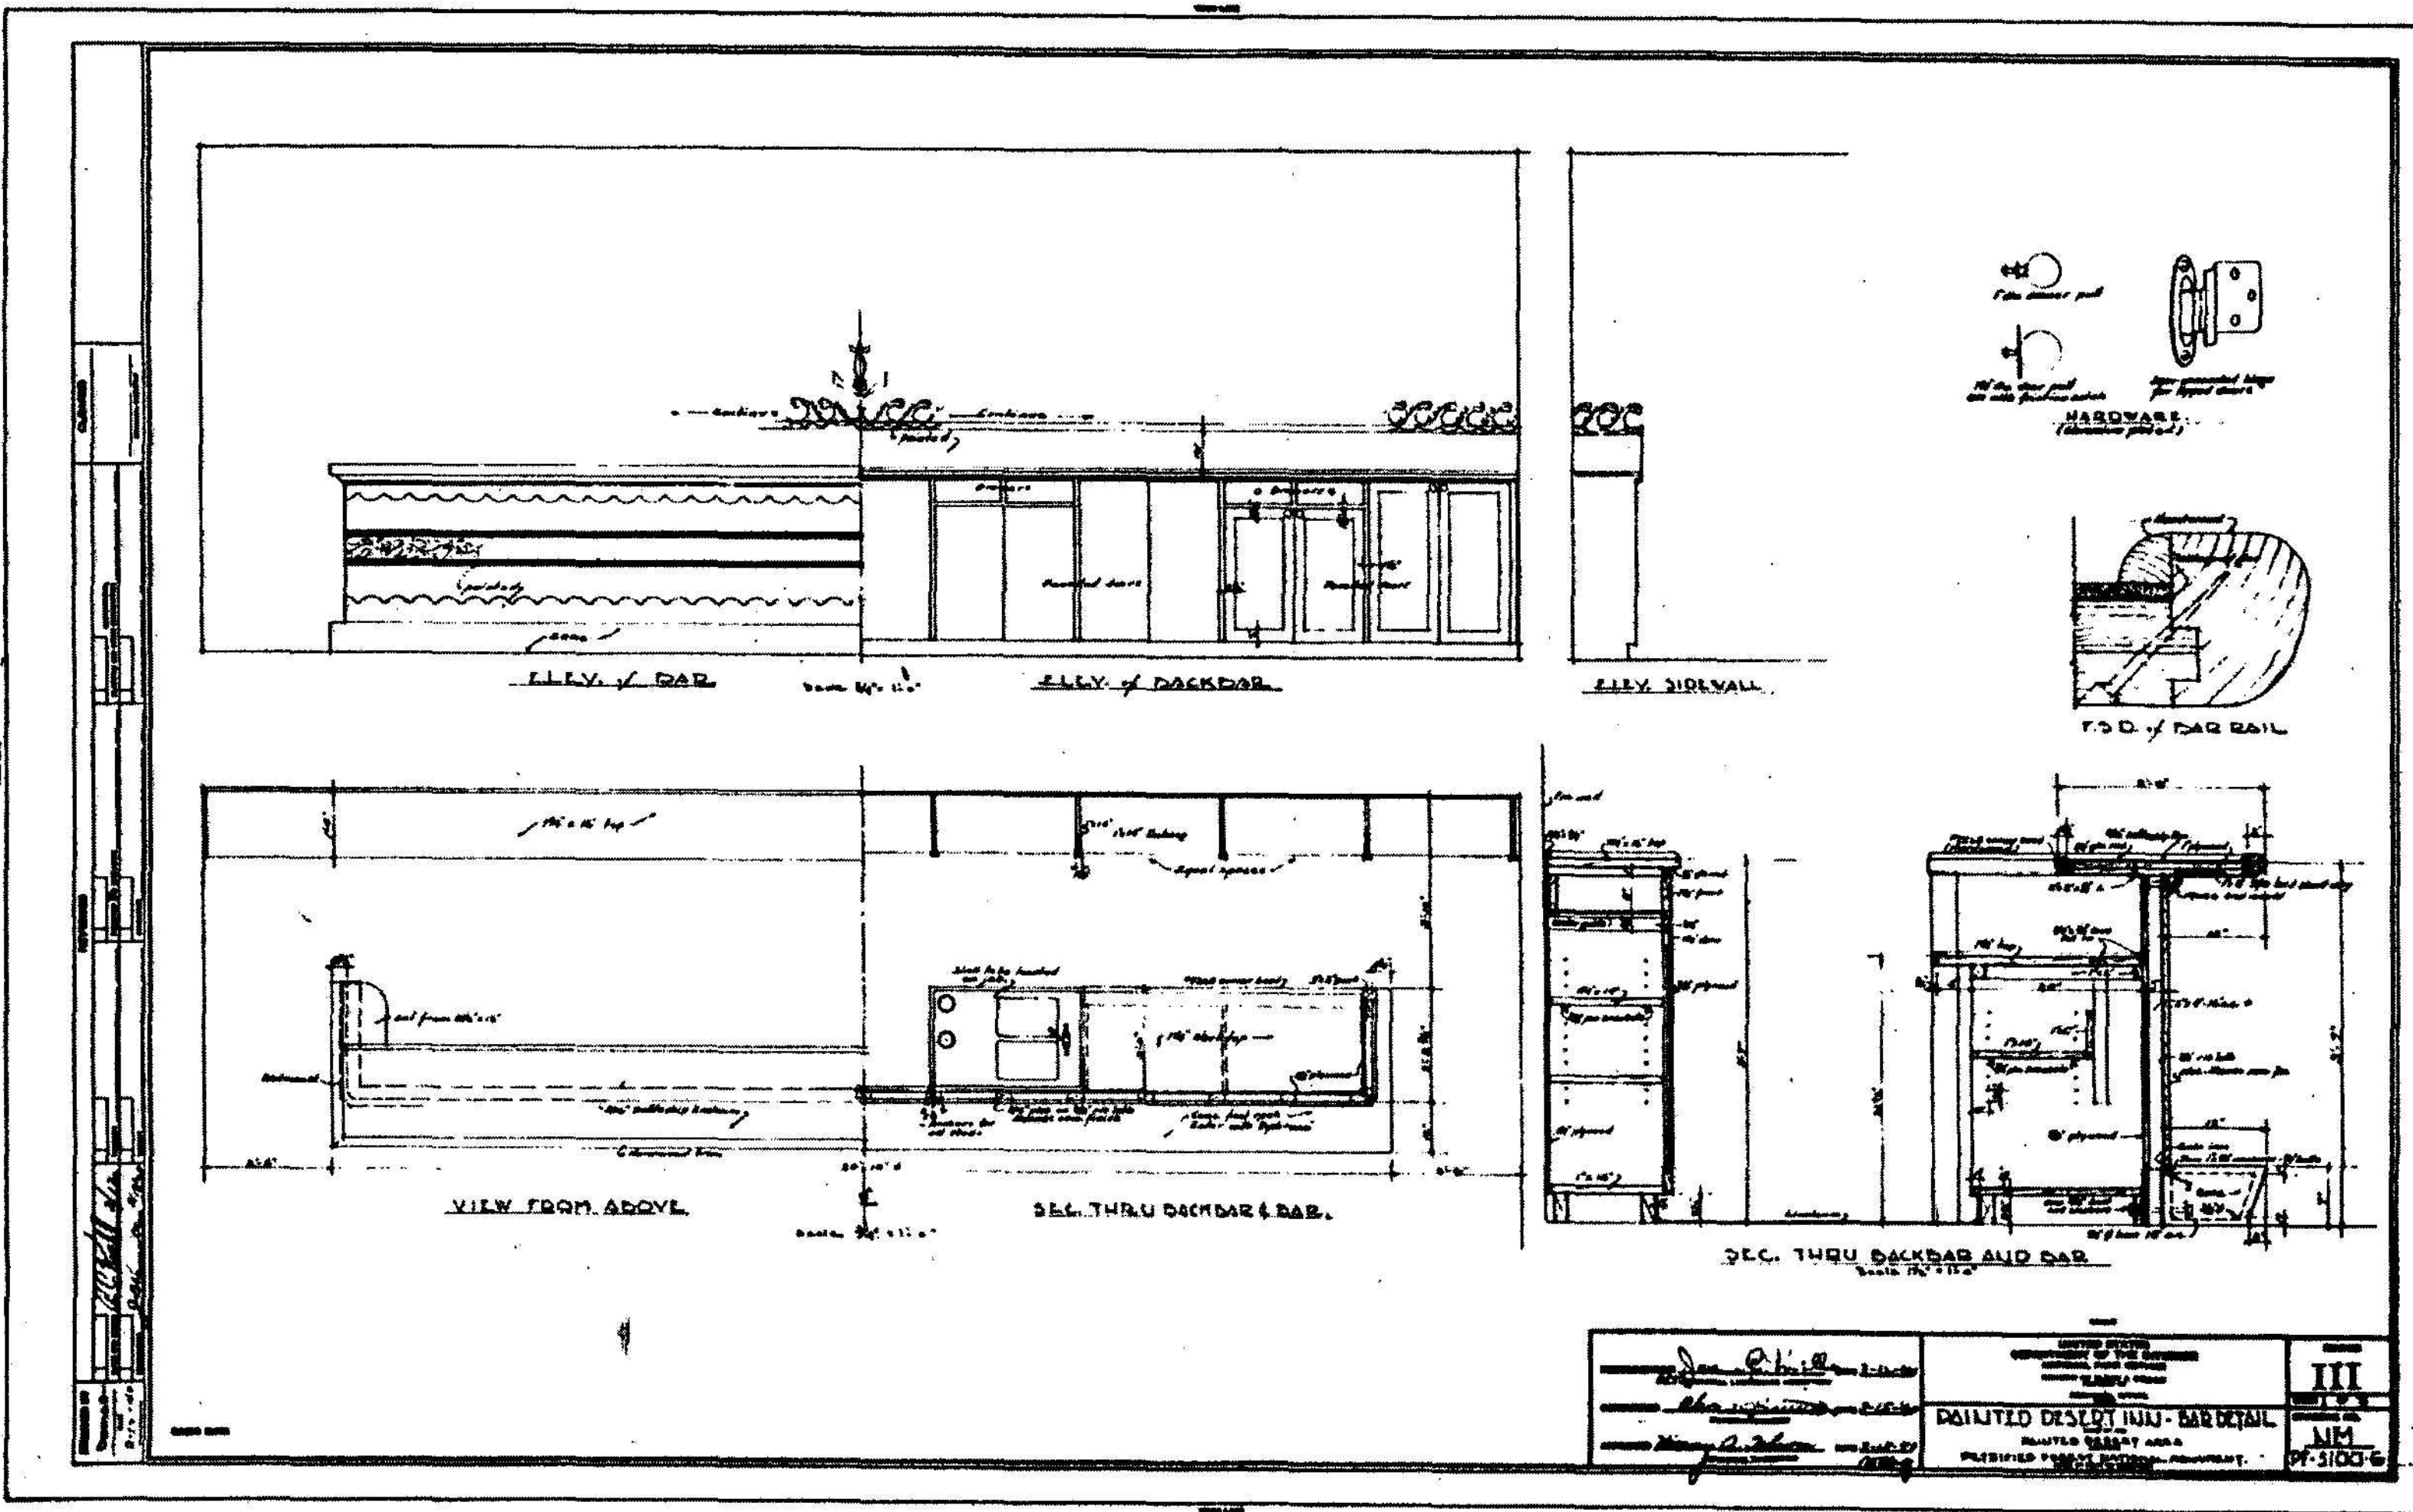
31. "Bar Detail." March 12, 1940, Plan by Lyle Bennett, Museum Collection, Archives, Petrified Forest National Park, Petrified Forest, Arizona, PF 3100-G, Sheet 1.

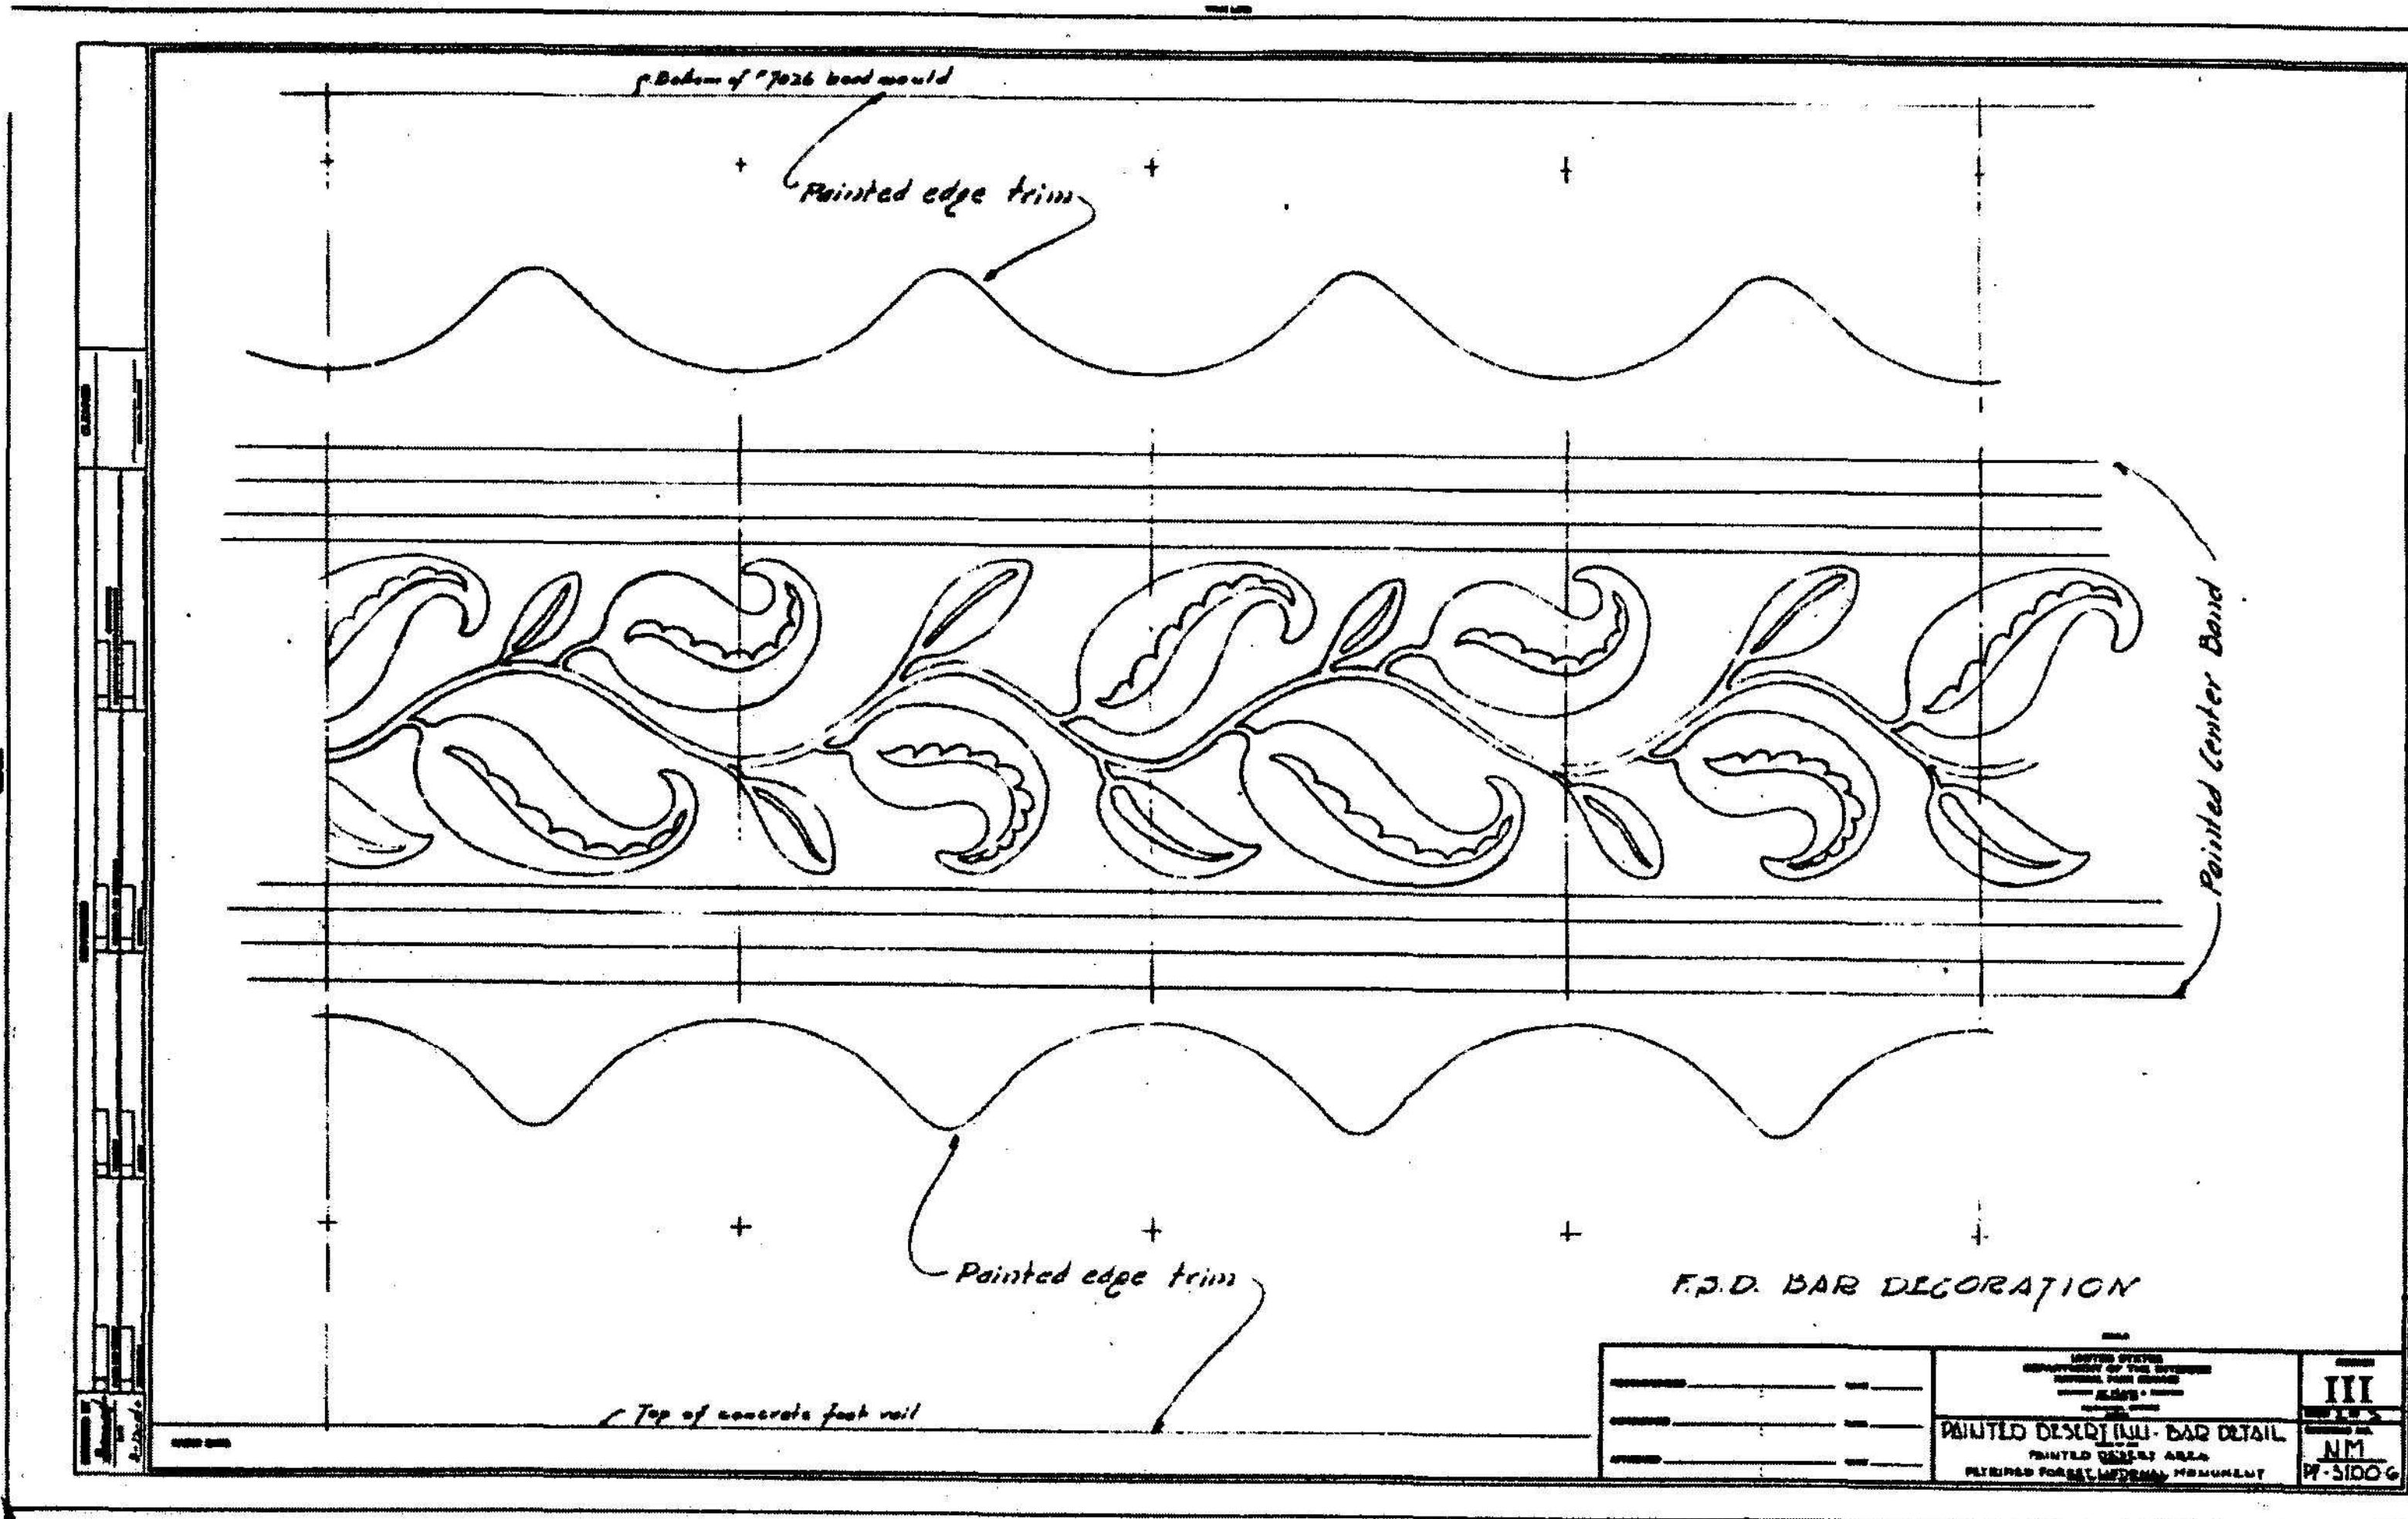
32. "Bar Detail." March 12, 1940, Plan by Lyle Bennett, Museum Collection, Archives, Petrified Forest National Park, Petrified Forest, Arizona, PF 3100-G, Sheet 2.

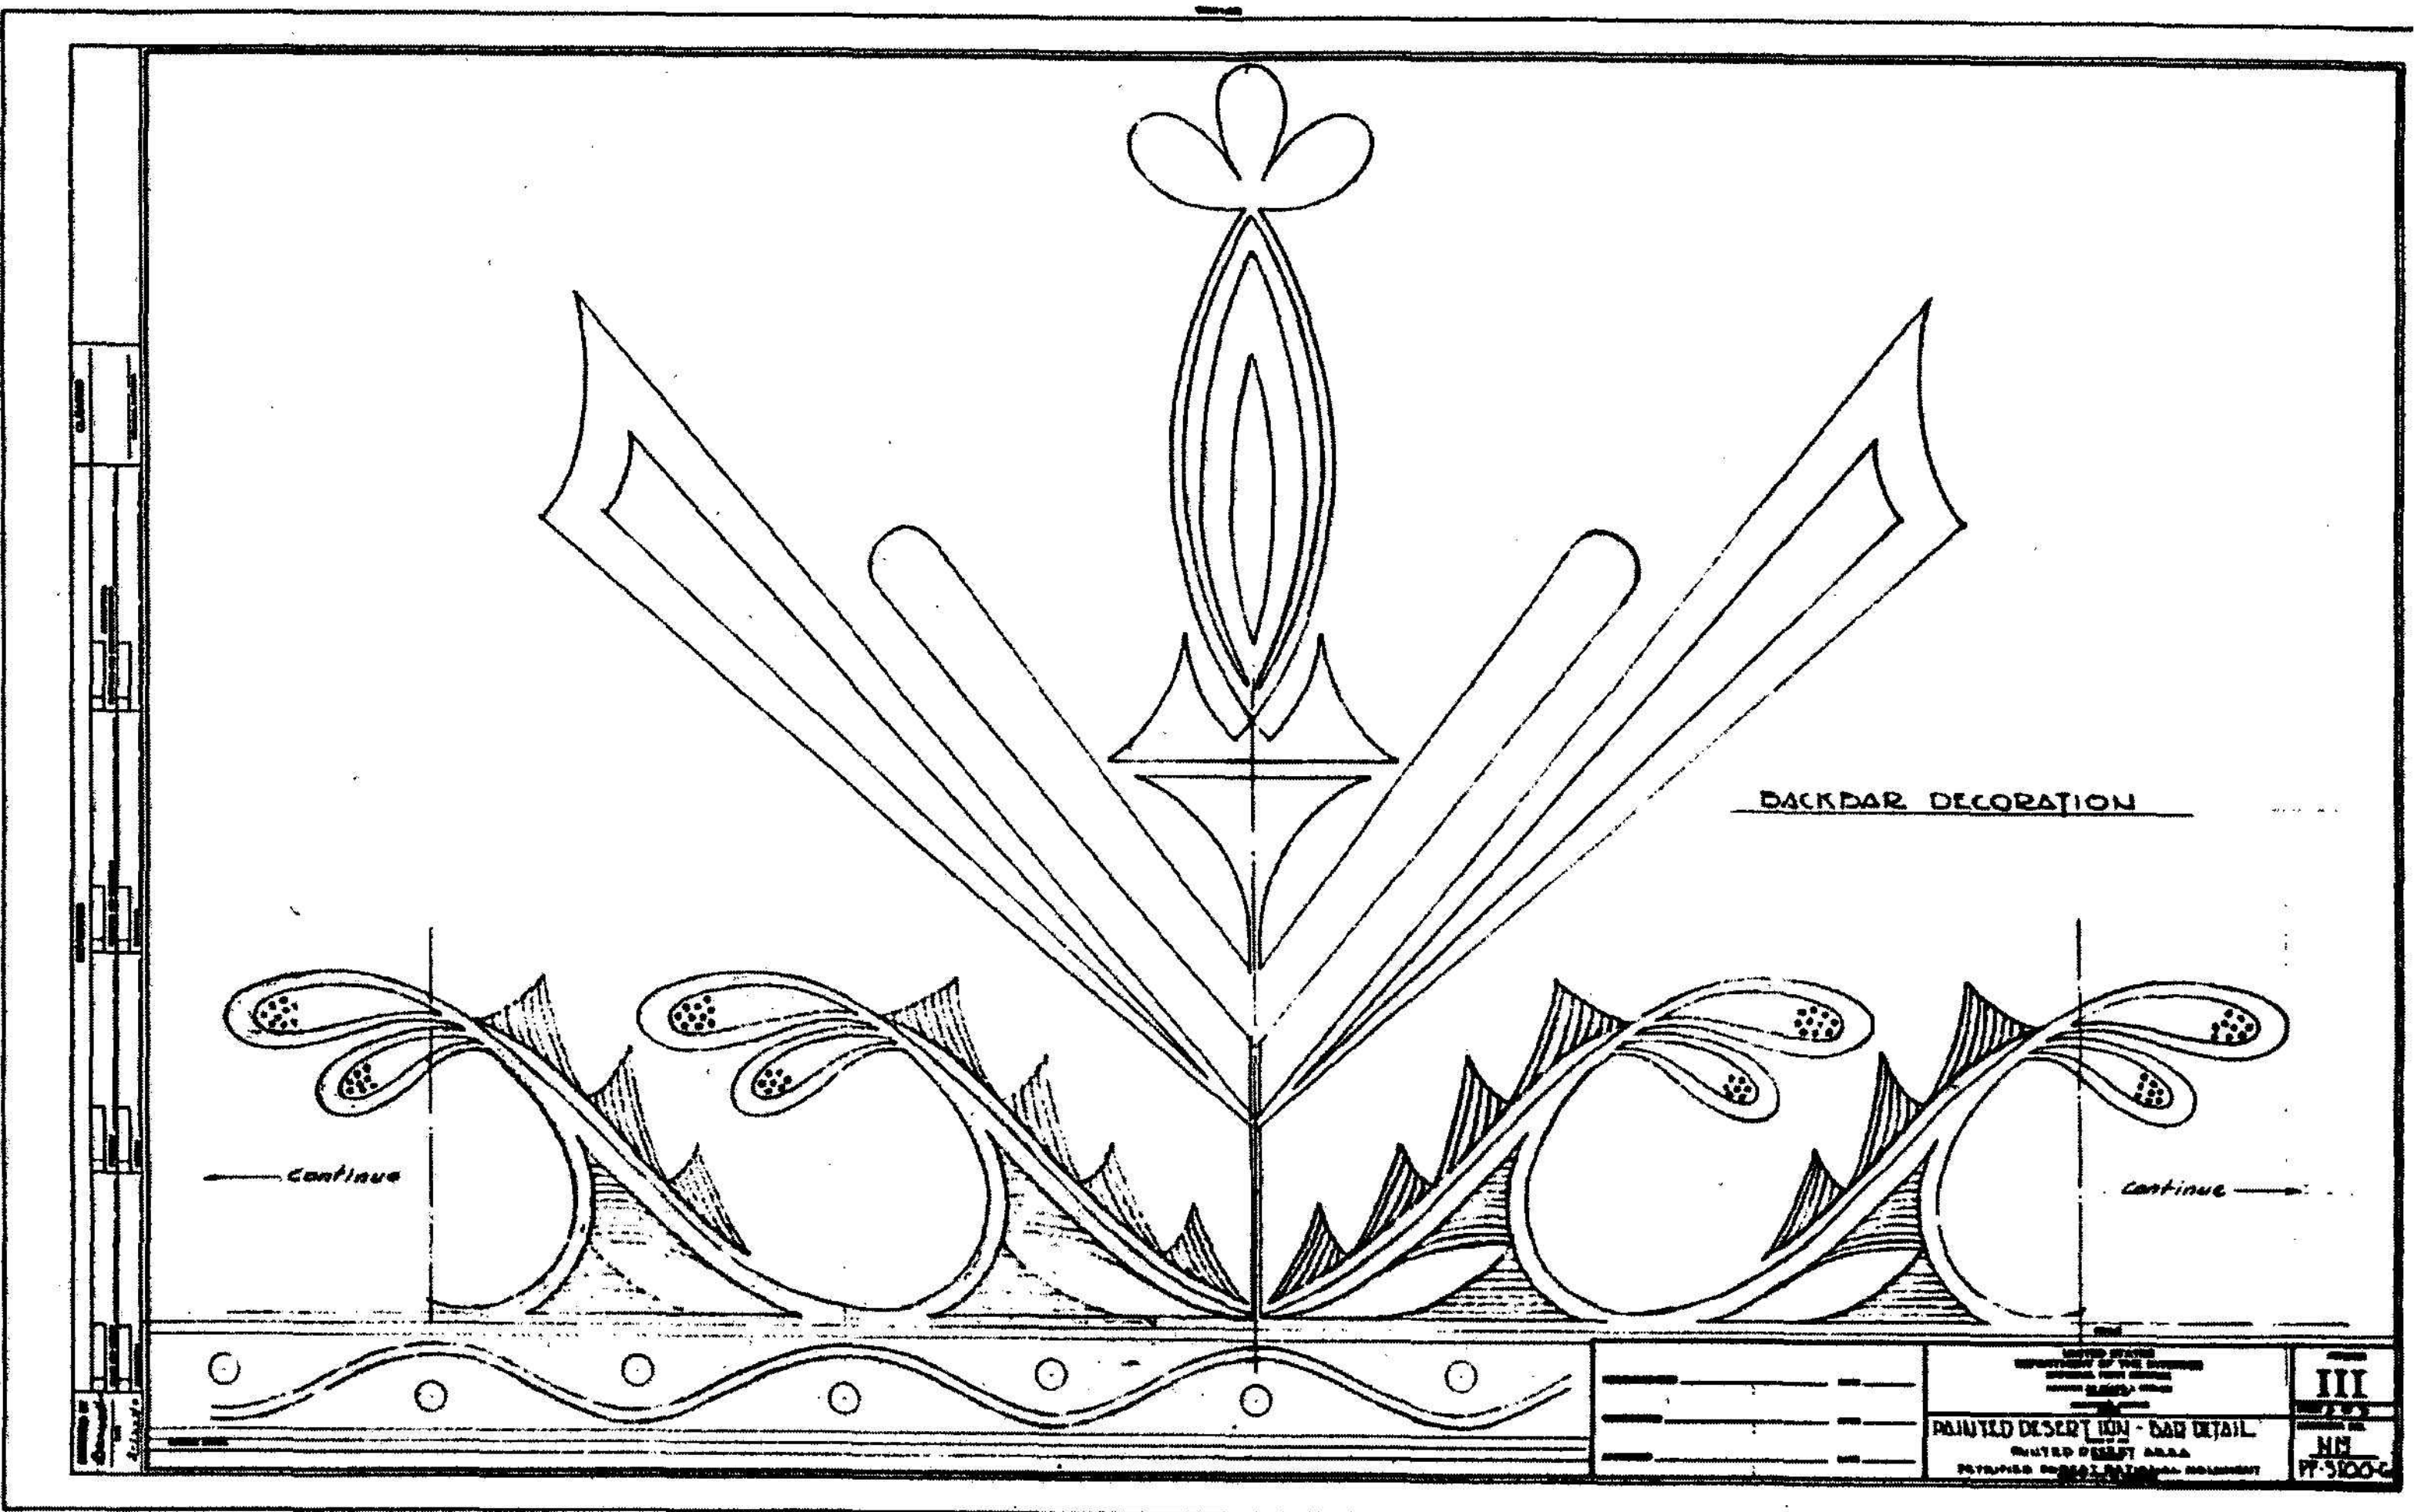
33. "Bar Detail." March 12, 1940, Plan by Lyle Bennett, Museum Collection, Archives, Petrified Forest National Park, Petrified Forest, Arizona, PF 3100-G, Sheet 3.

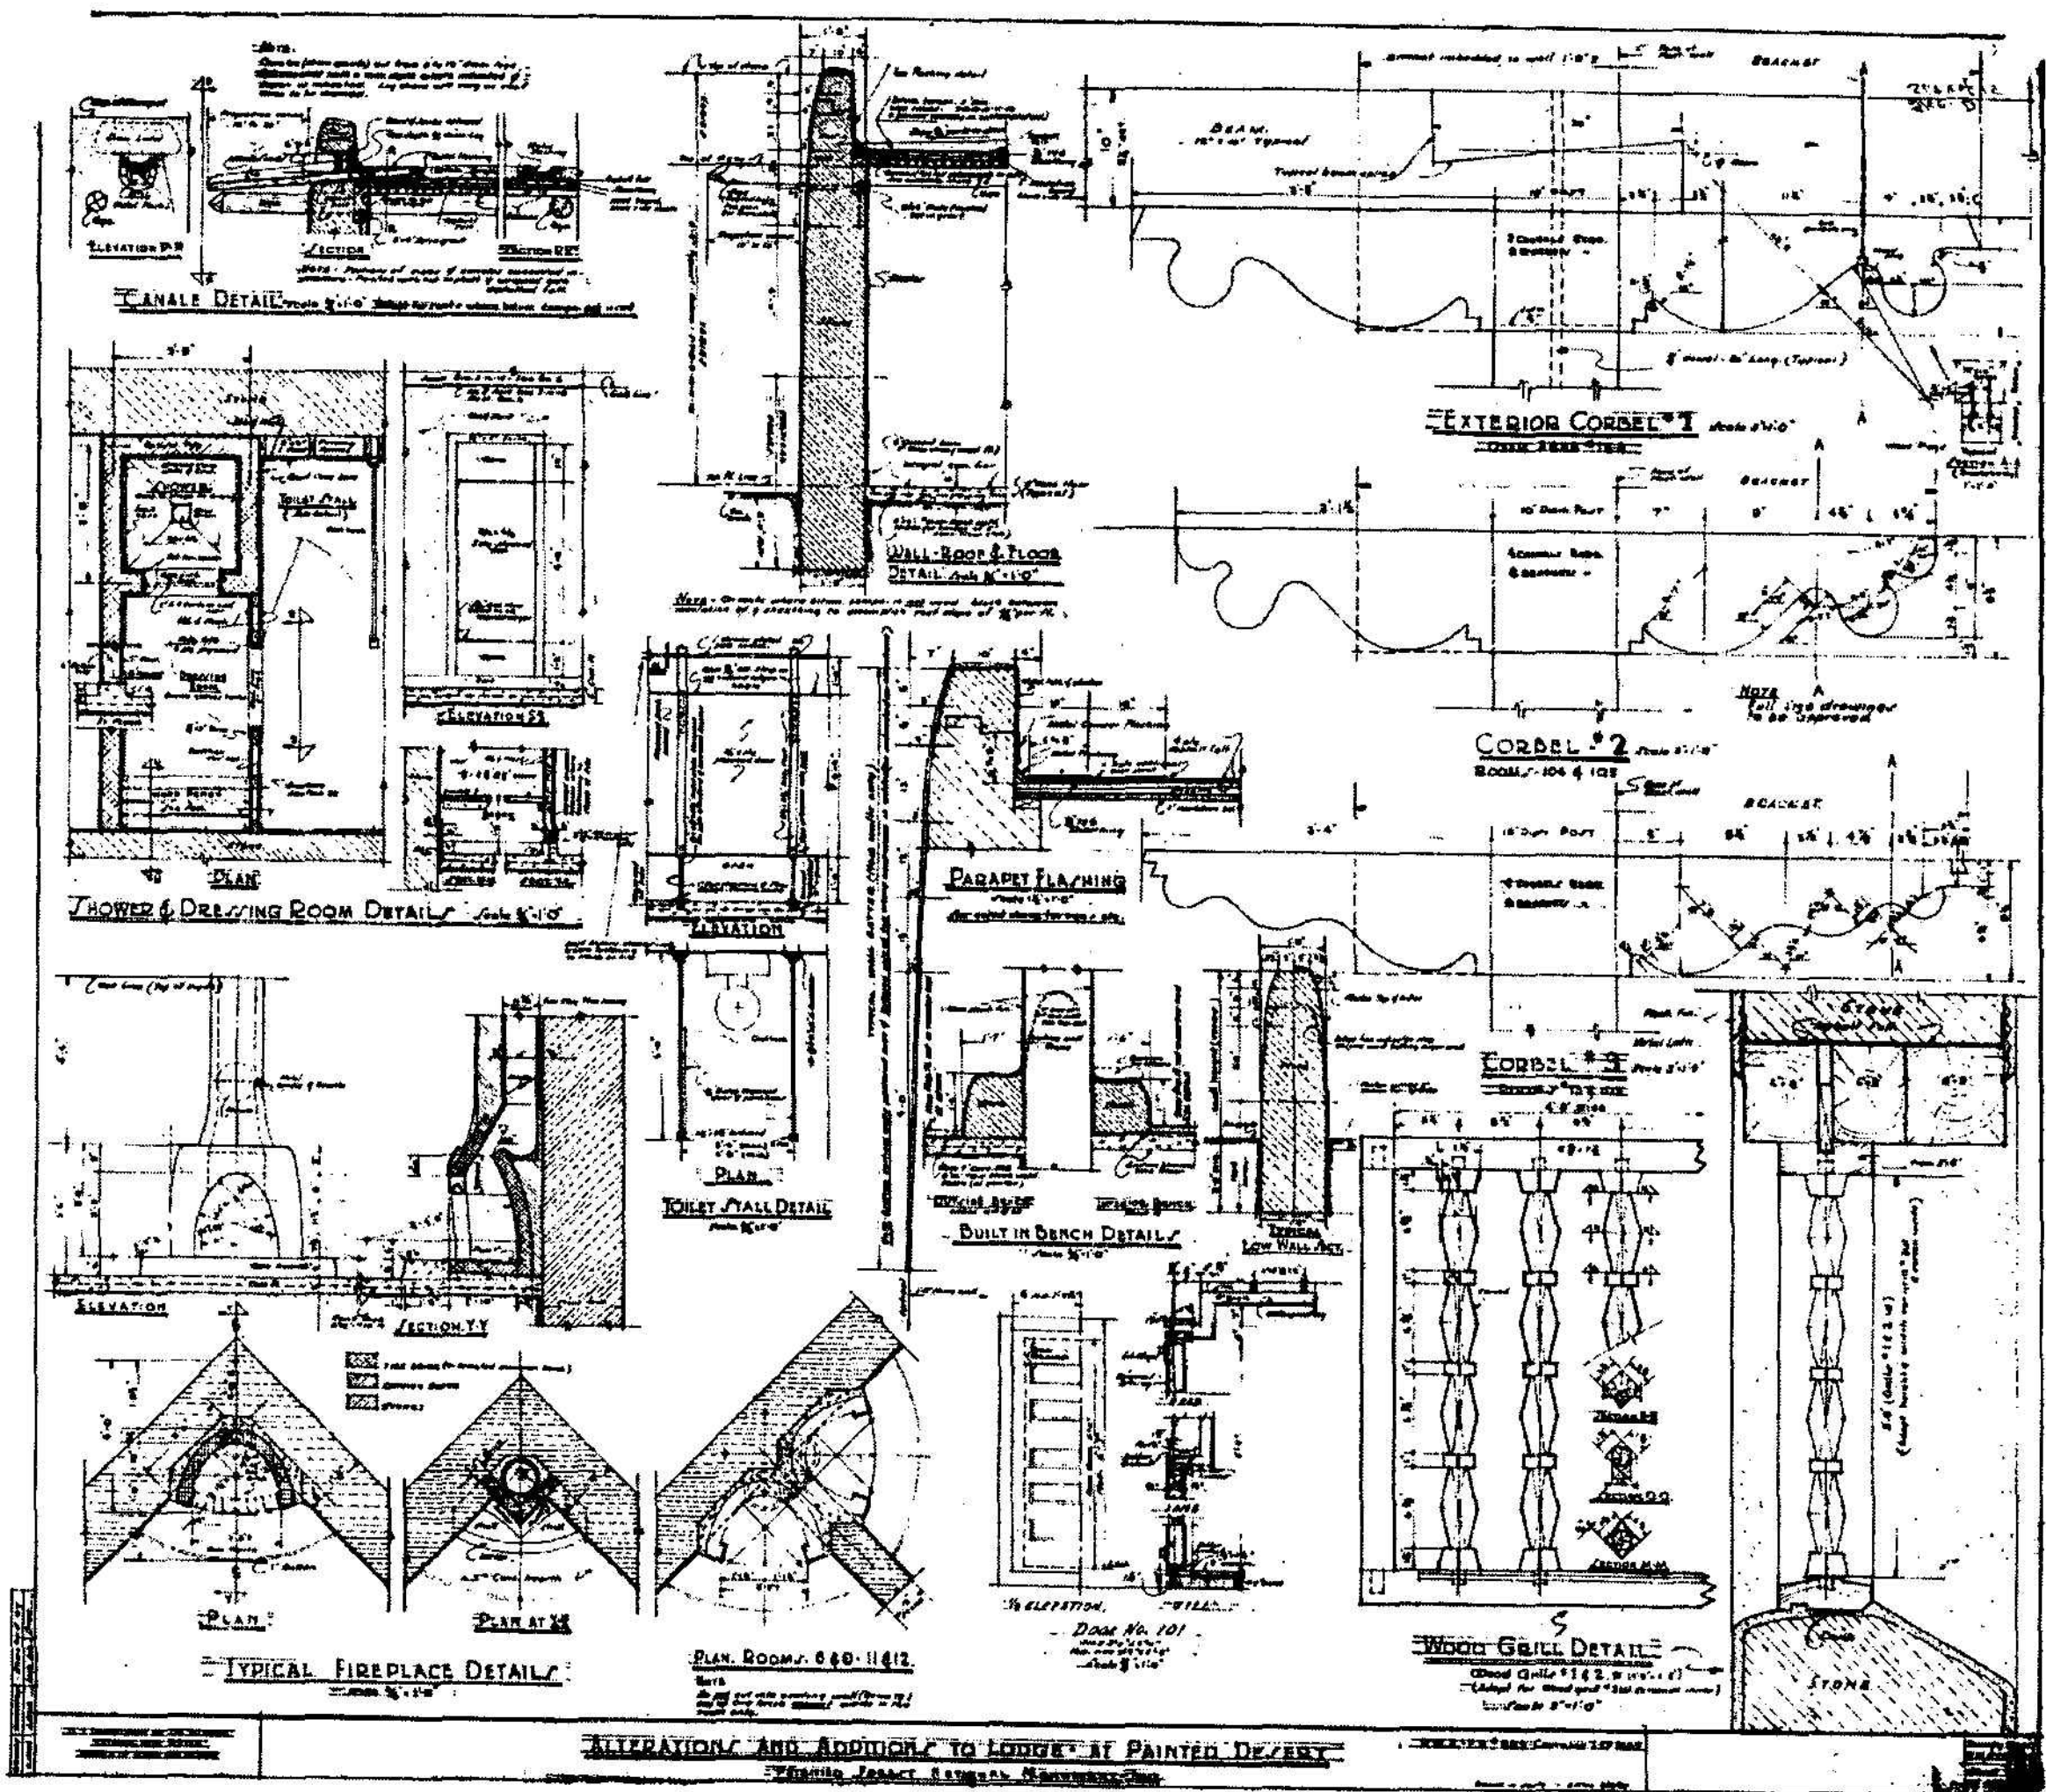
35. "Wall Section, Fireplace Details, Corbel (Zapata) Details; Wood Grill Details." January 1937, Plan by Lyle Bennett, Museum Collection, Archives, Petrified Forest National Park, Petrified Forest, Arizona, PF 3100-D, Sheet 8.

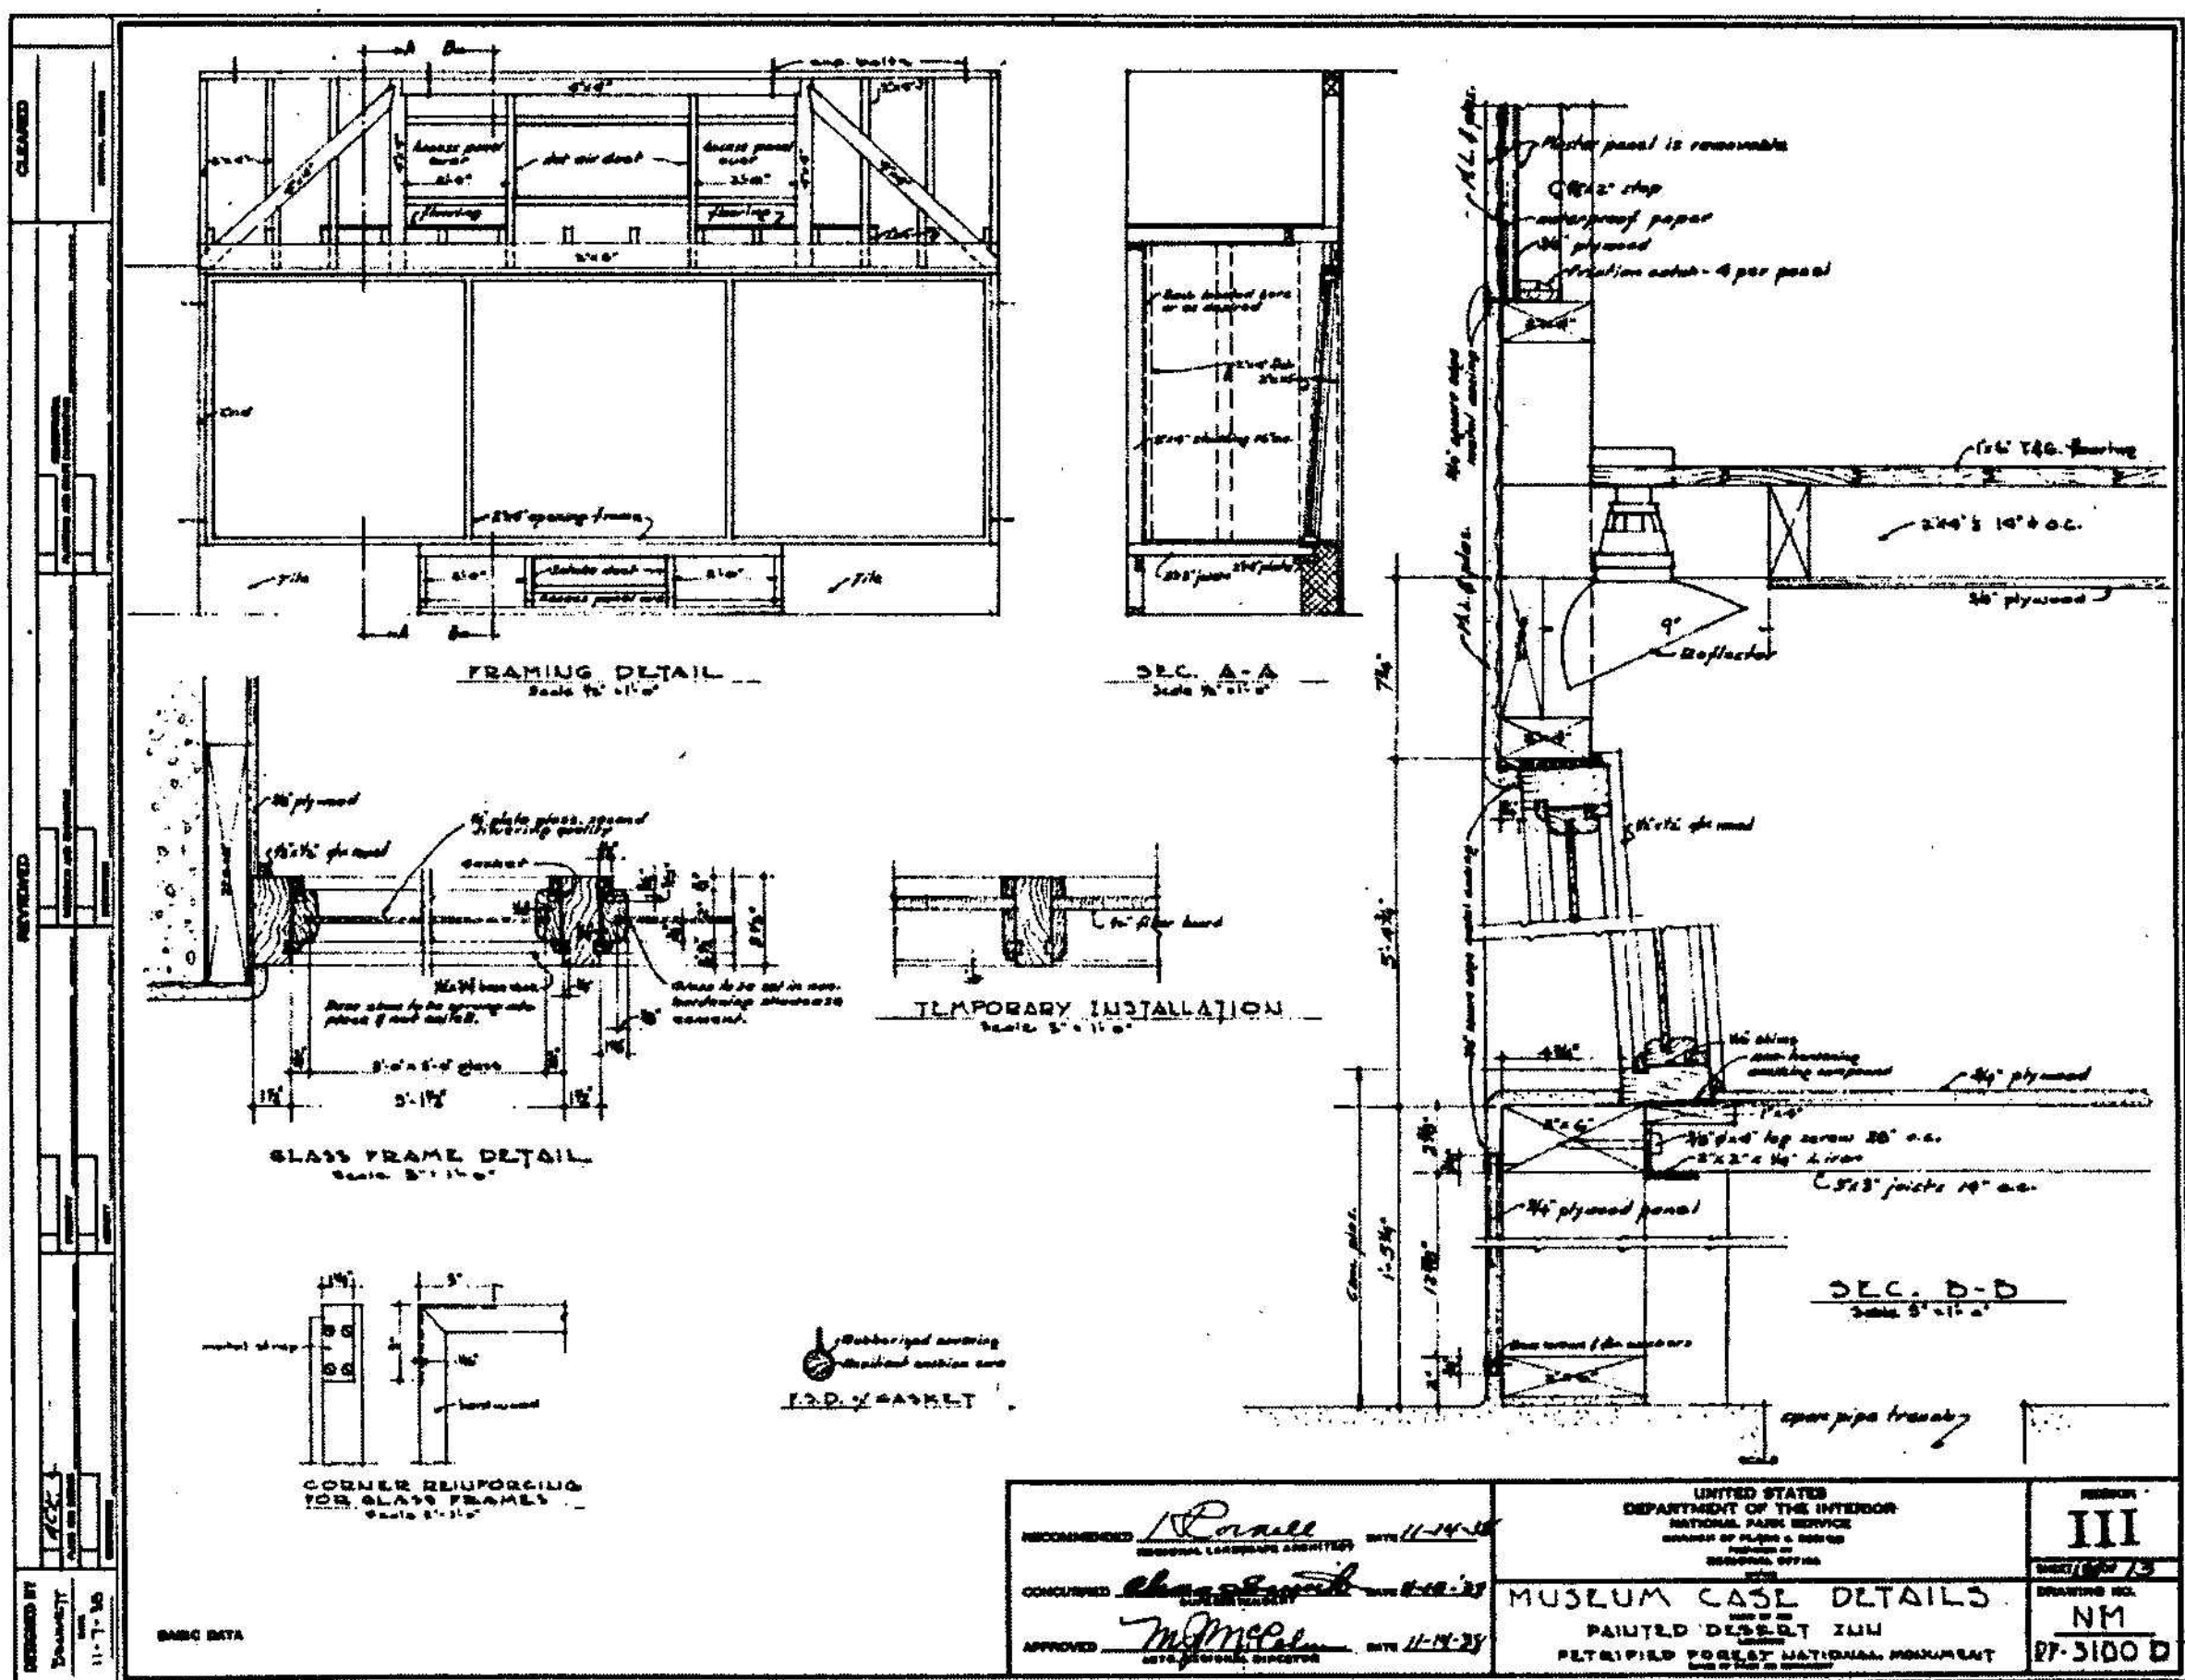
37. "Museum Case Details for Room 19." November, 1938, Plan by Lyle Bennett, Museum Collection, Archives, Petrified Forest National Park, Petrified Forest, Arizona, PF 3100-D, Sheet 13A.
