# Historic Furnishings Report Painted Desert Inn

Petrified Forest National Park  
Petrified Forest, Arizona

## **PAINTED DESERT INN PETRIFIED FOREST NATIONAL PARK**

**Part 1: Historical Data  
Part 2: Implementation Plan**

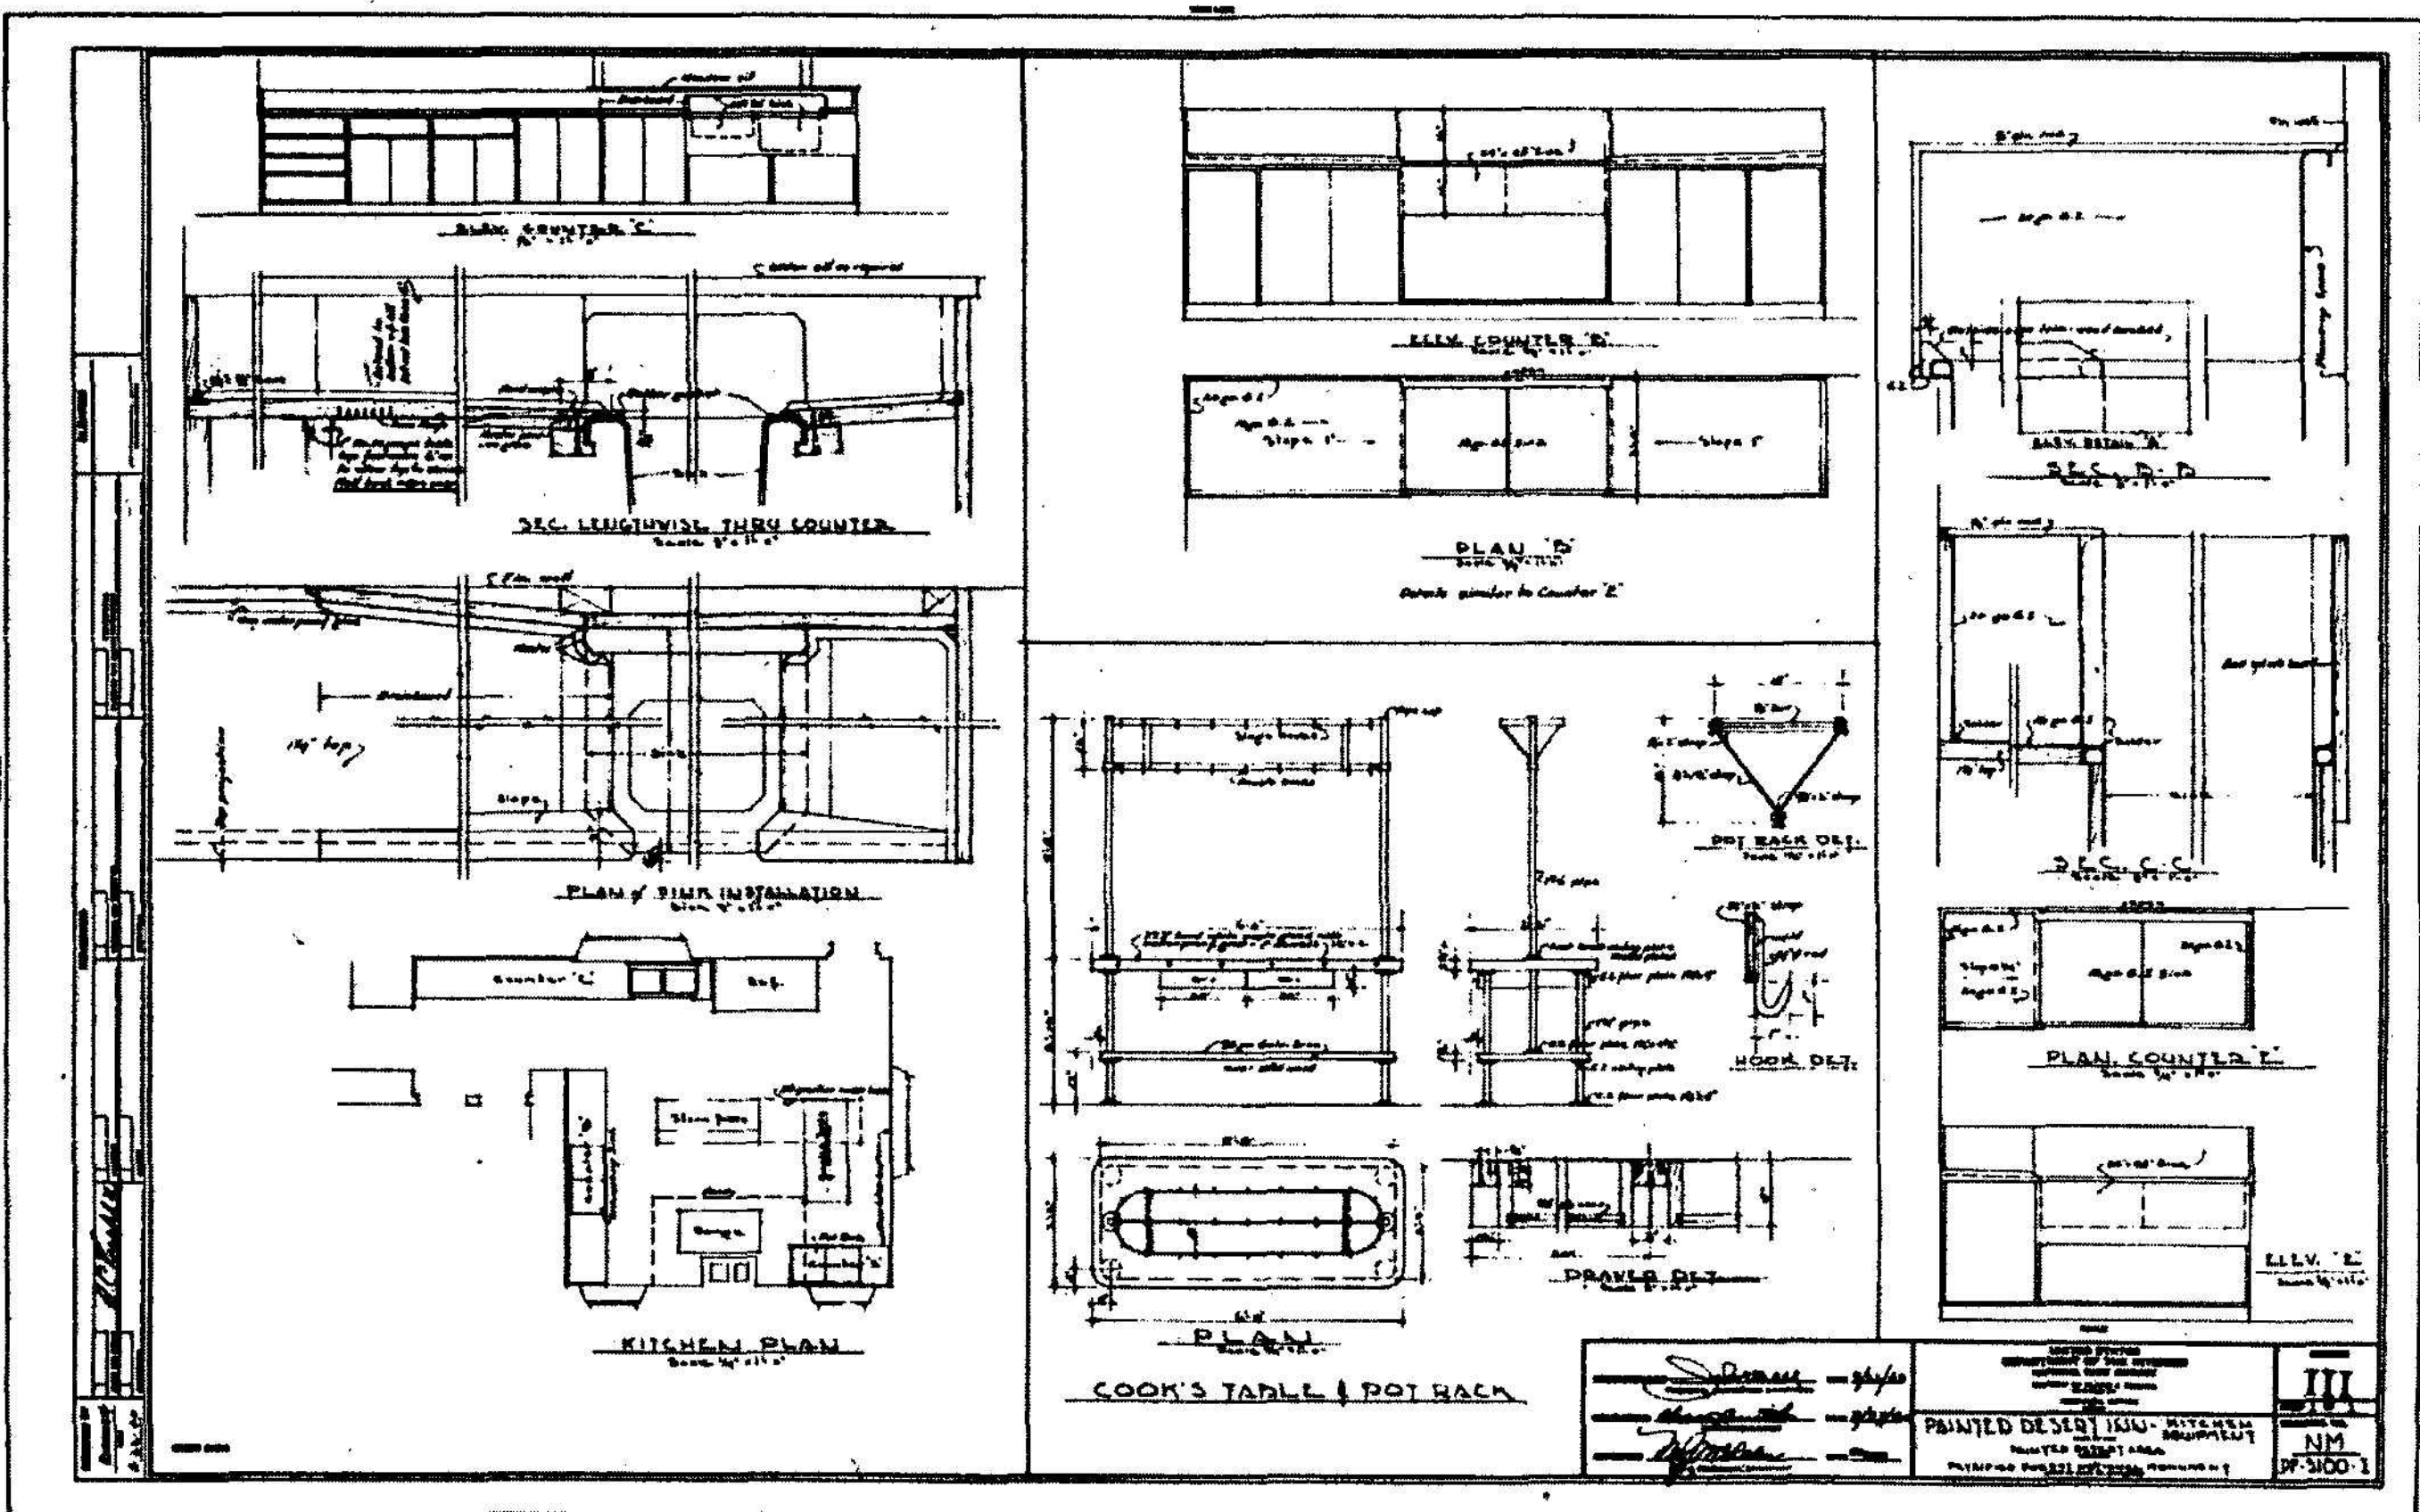
39. "Kitchen Equipment." March 22, 1940, Plan by Lyle Bennett,  
Museum Collection, Archives, Petrified Forest National Park, Petrified  
Forest, Arizona, PF 3100-I.

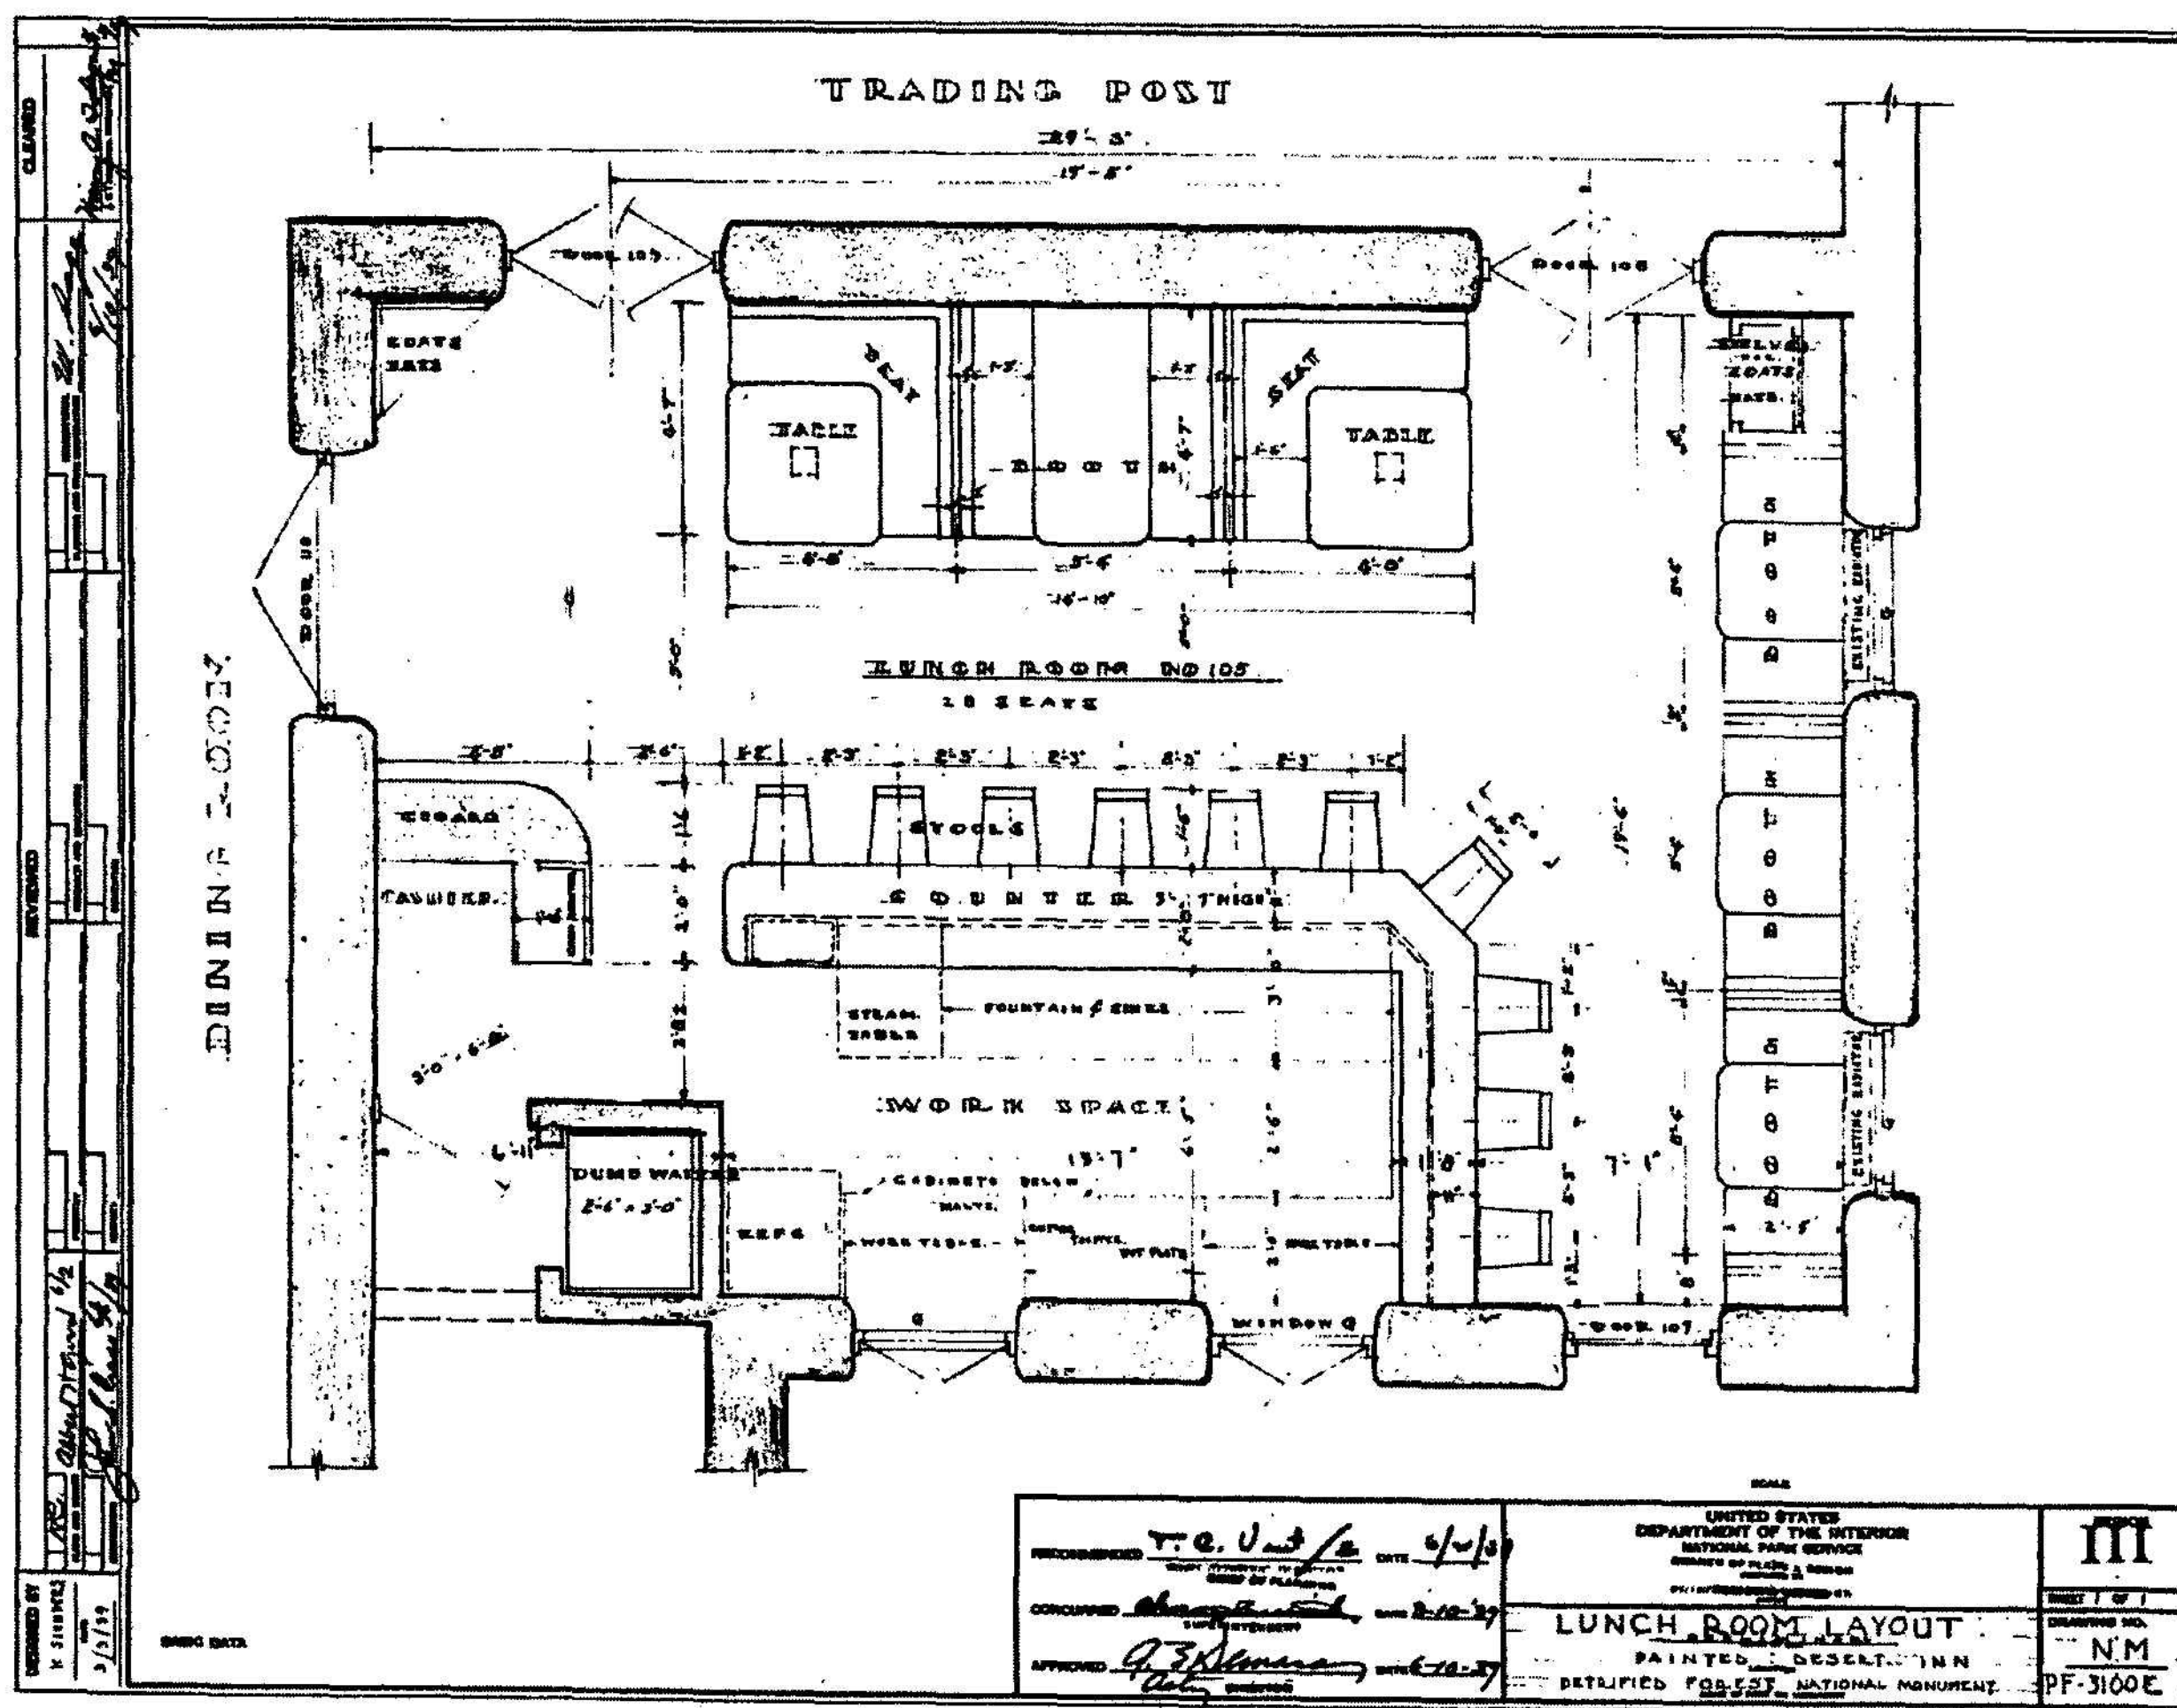
54. "Lunchroom Layout." March 3, 1939, Plan by Lyle Bennett, Museum Collection, Archives, Petrified Forest National Park, Petrified Forest, Arizona, PF 3100-E, Sheet 1.

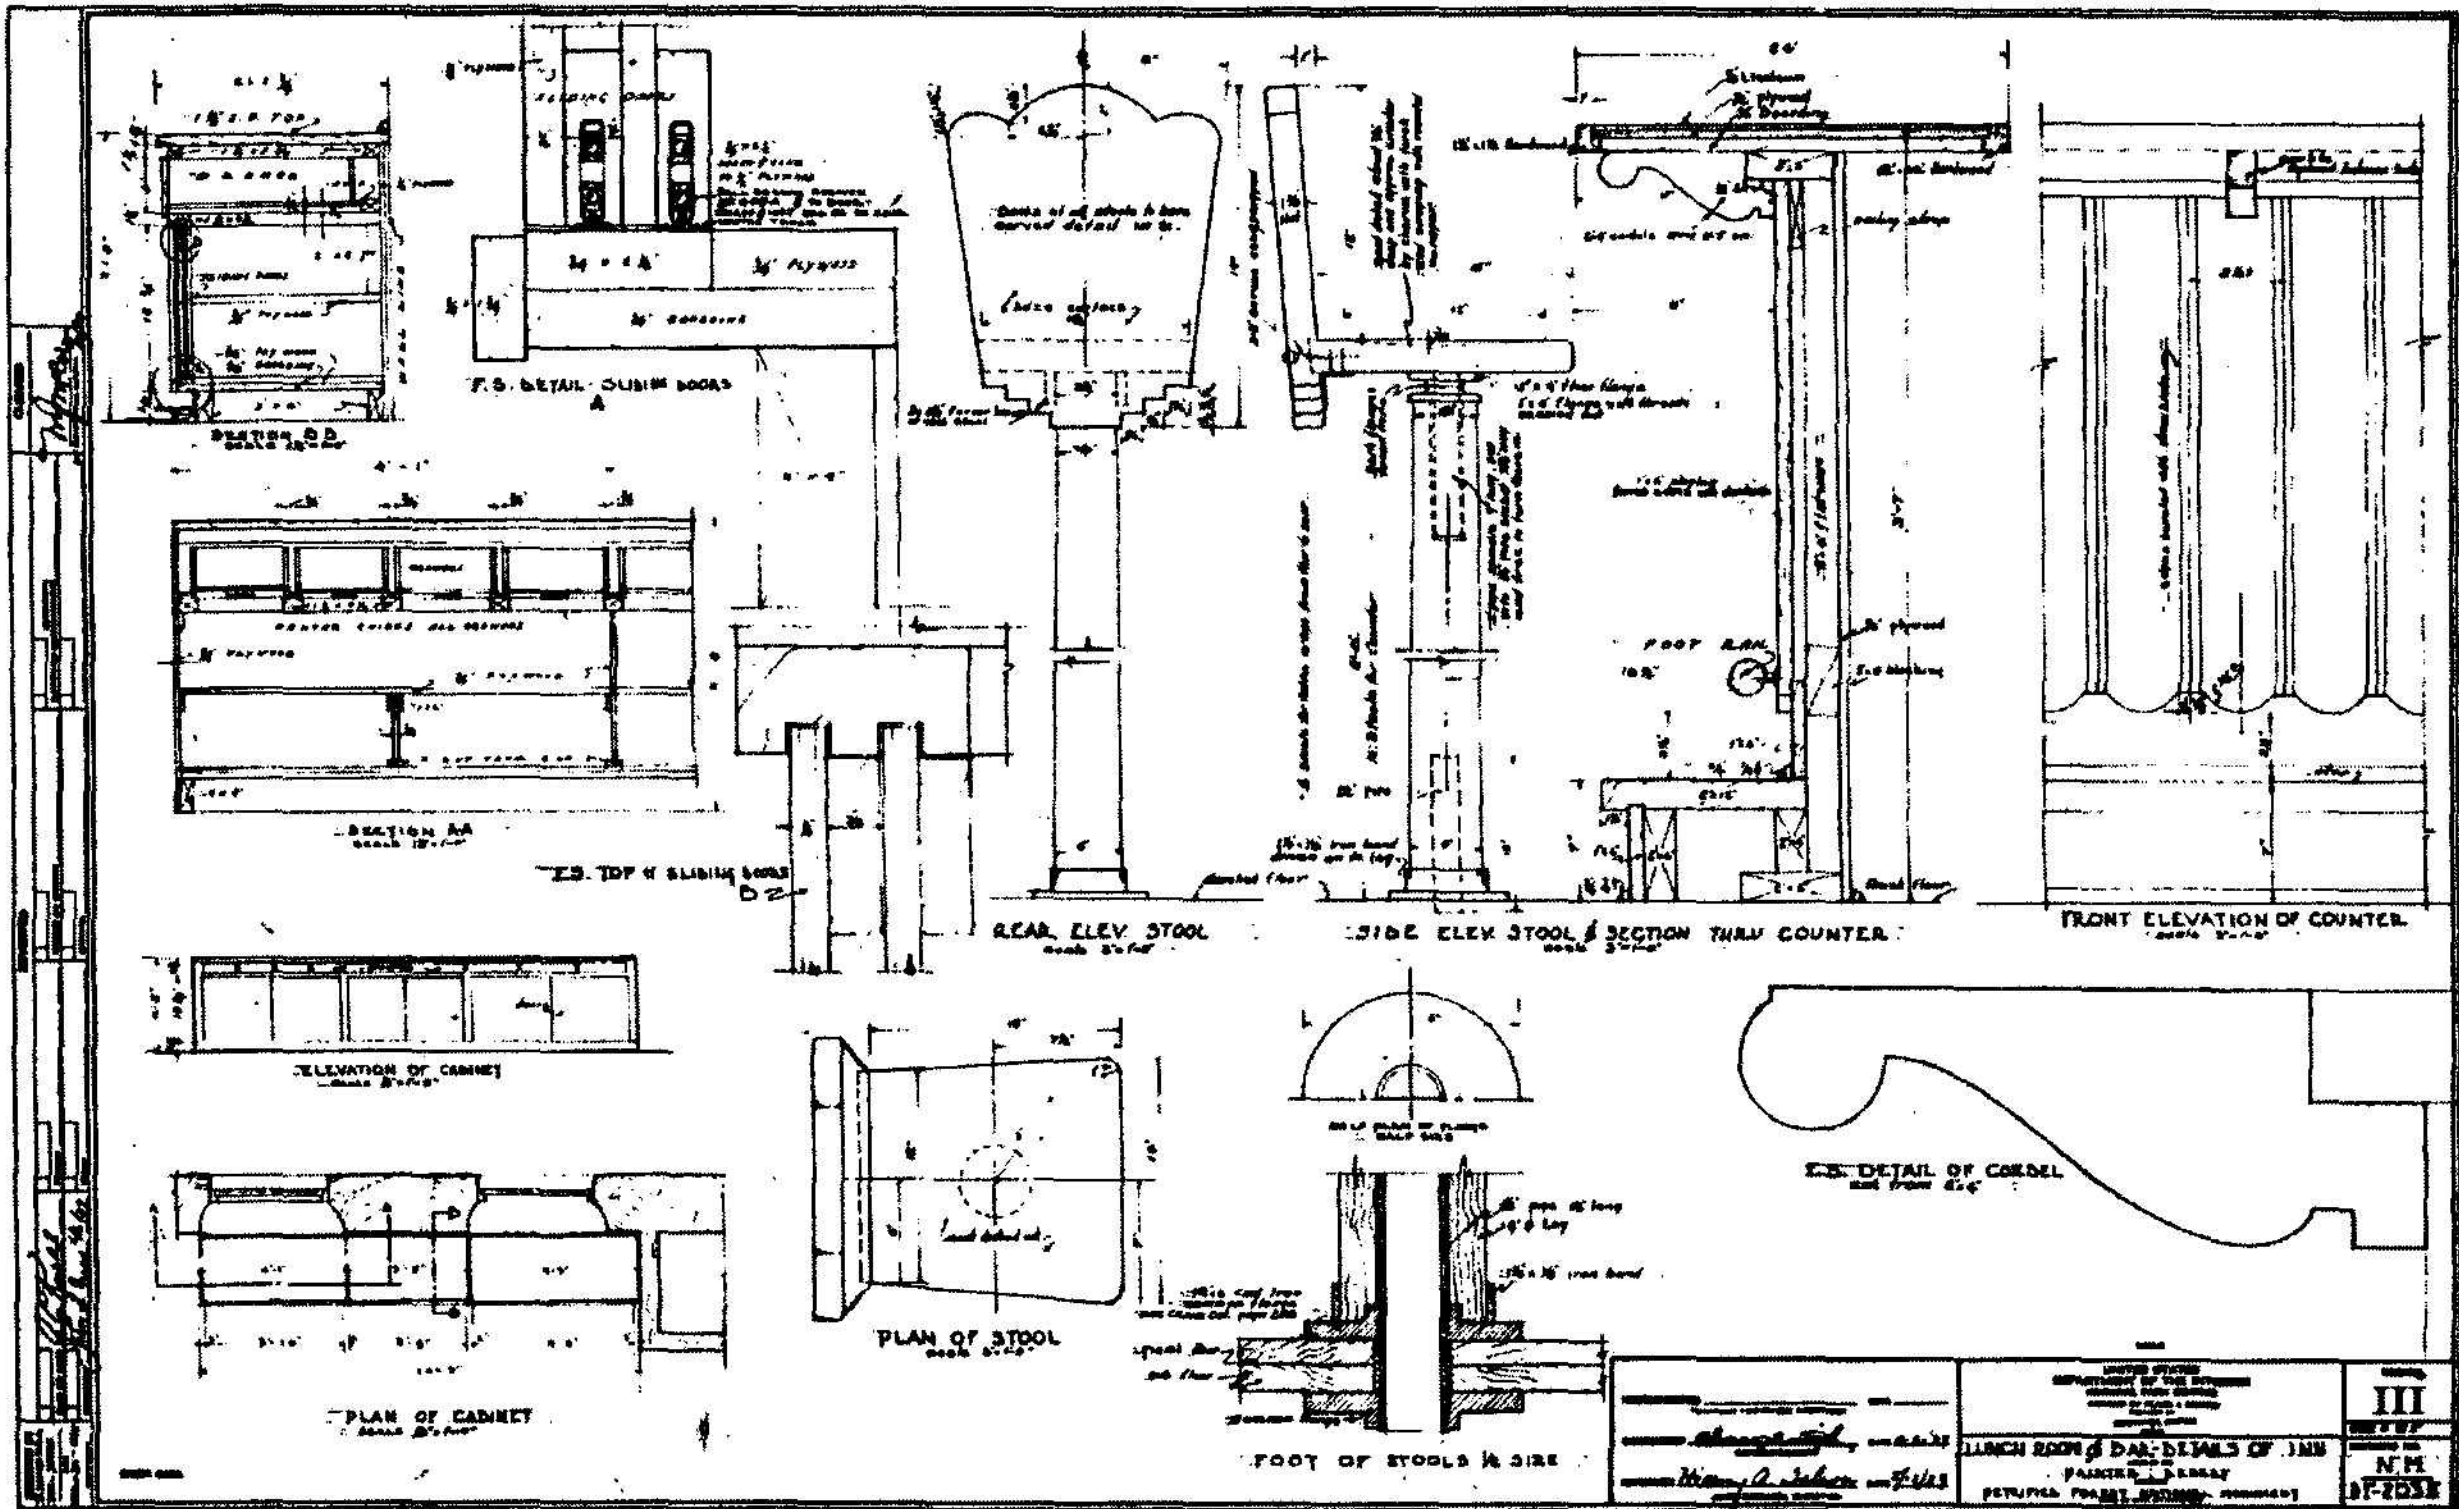
55. "Lunchroom and Bar Details." March 30, 1939, Plan by Lyle Bennett, Museum Collection, Archives, Petrified Forest National Park, Petrified Forest, Arizona, PF 2035, Sheet 3.

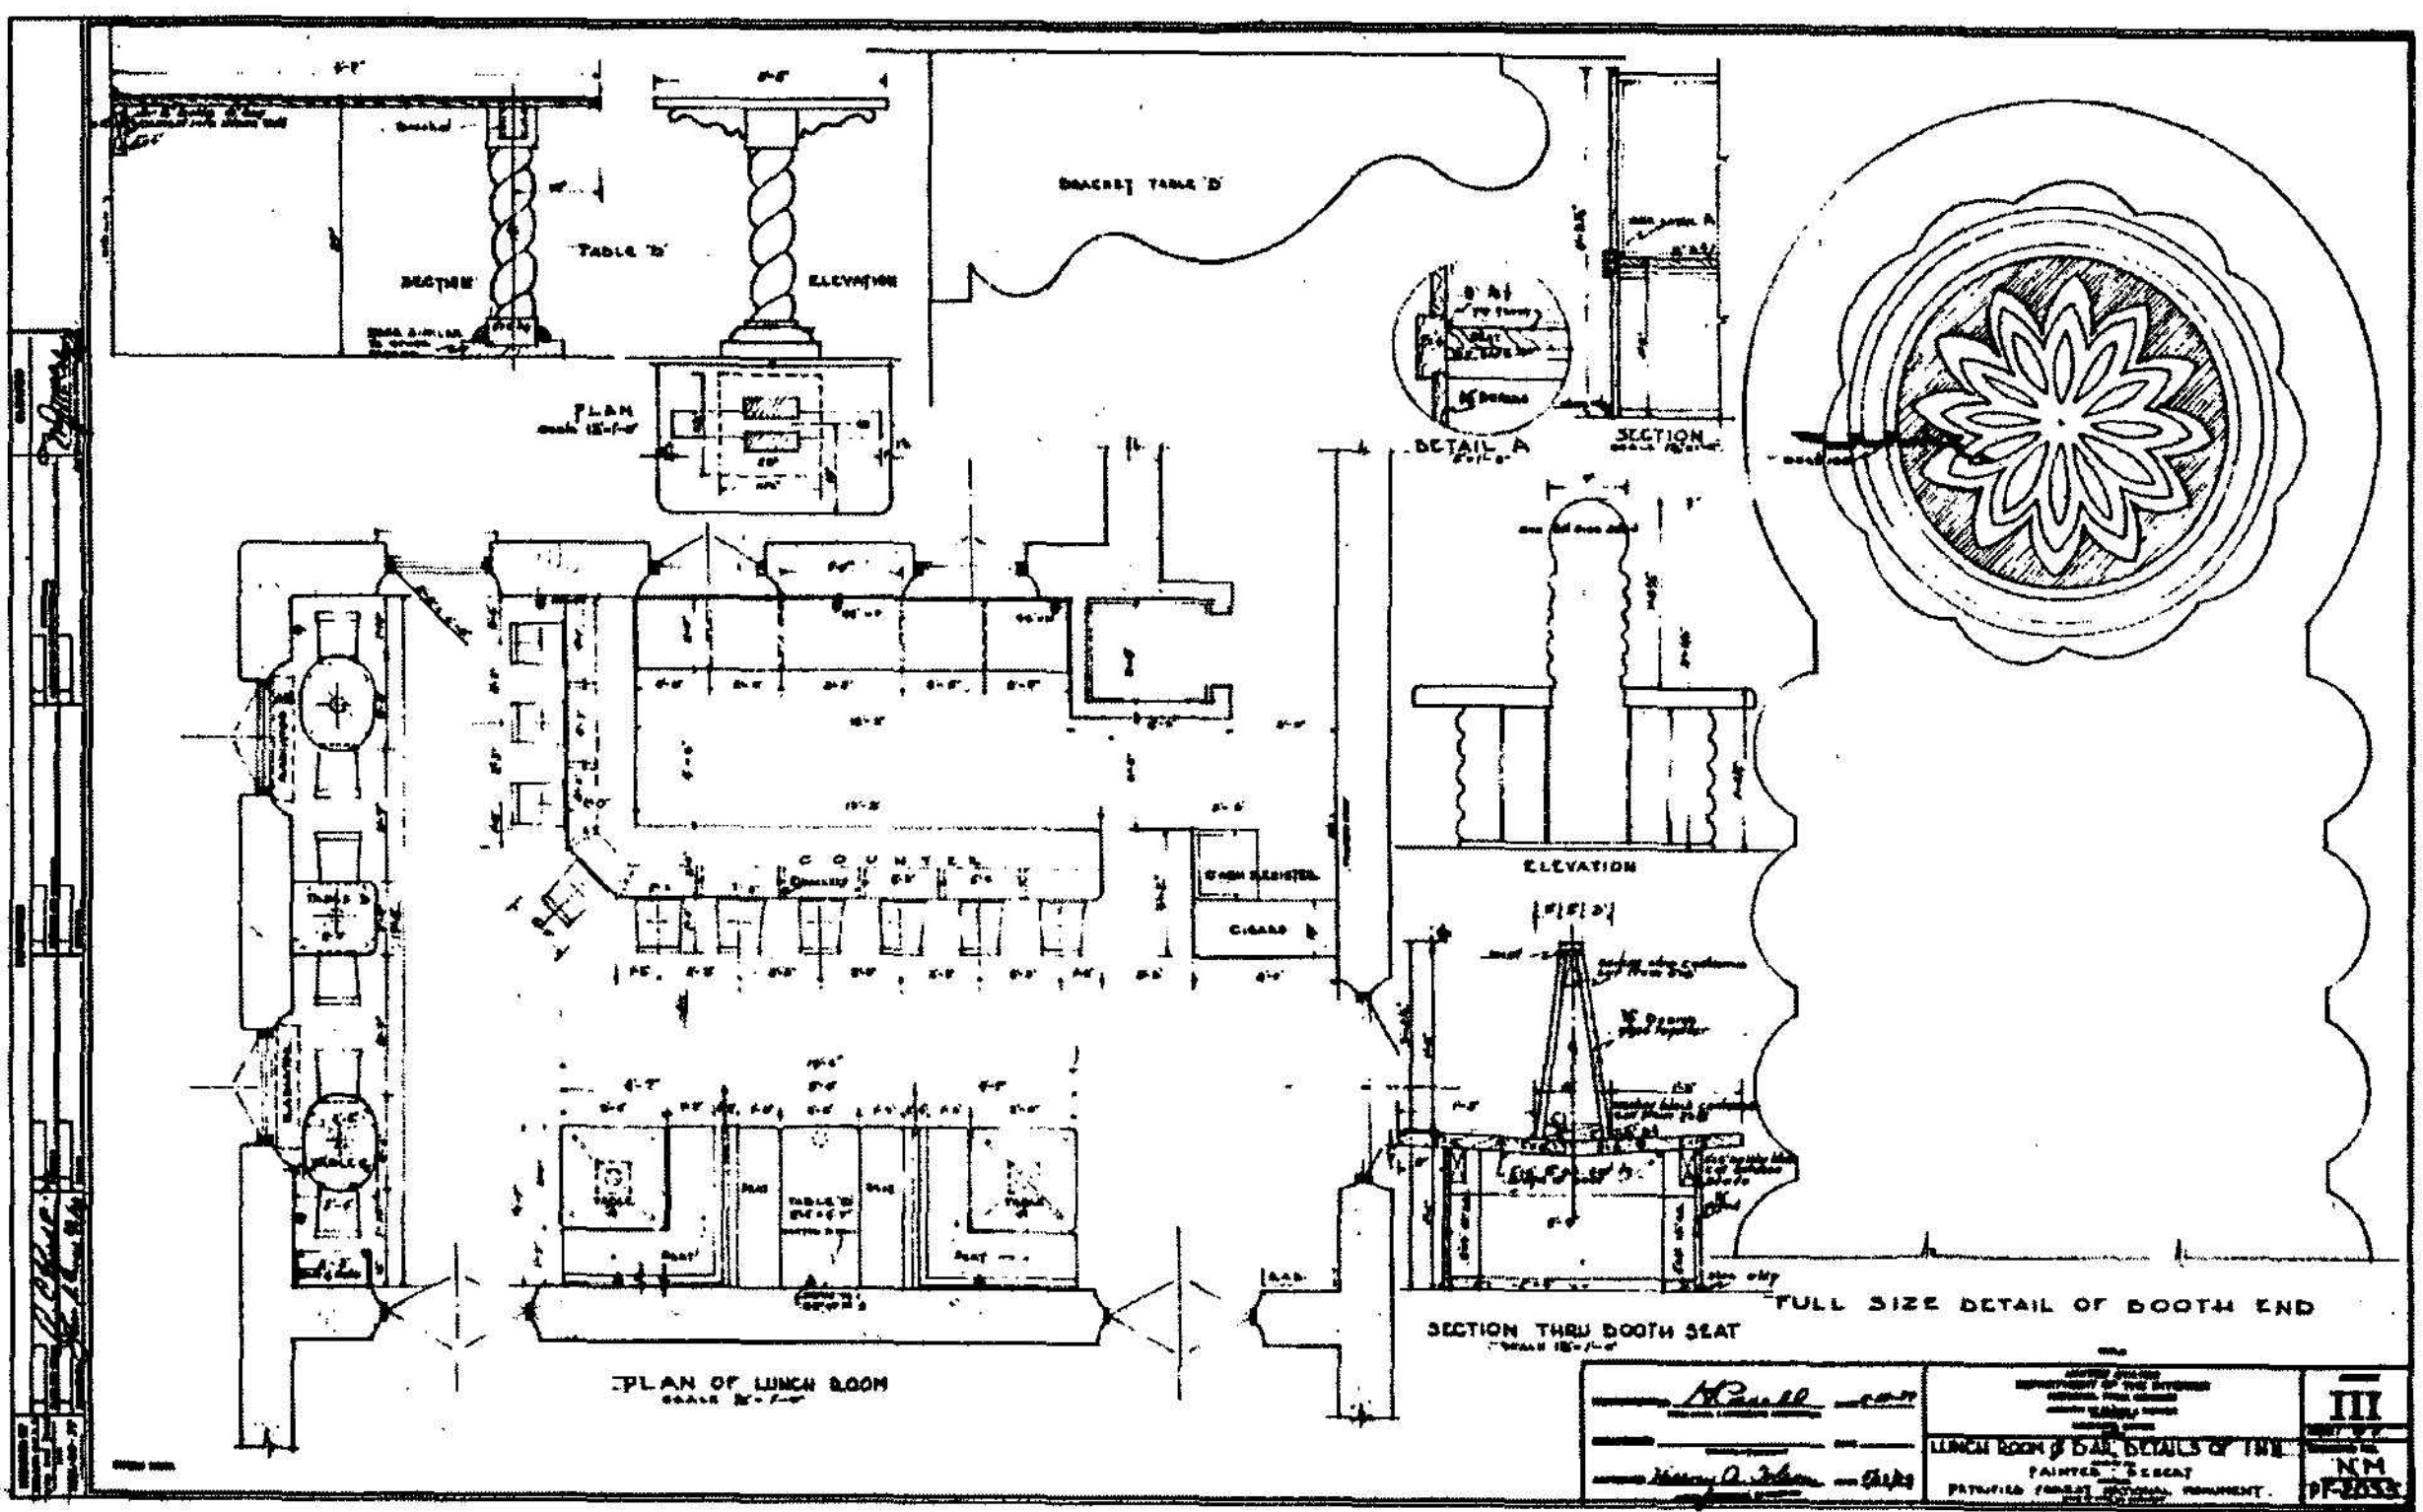
56. "Lunchroom and Bar Details." March 30, 1939, Plan by Lyle Bennett, Museum Collection, Archives, Petrified Forest National Park, Petrified Forest, Arizona, PF 2035, Sheet 1.

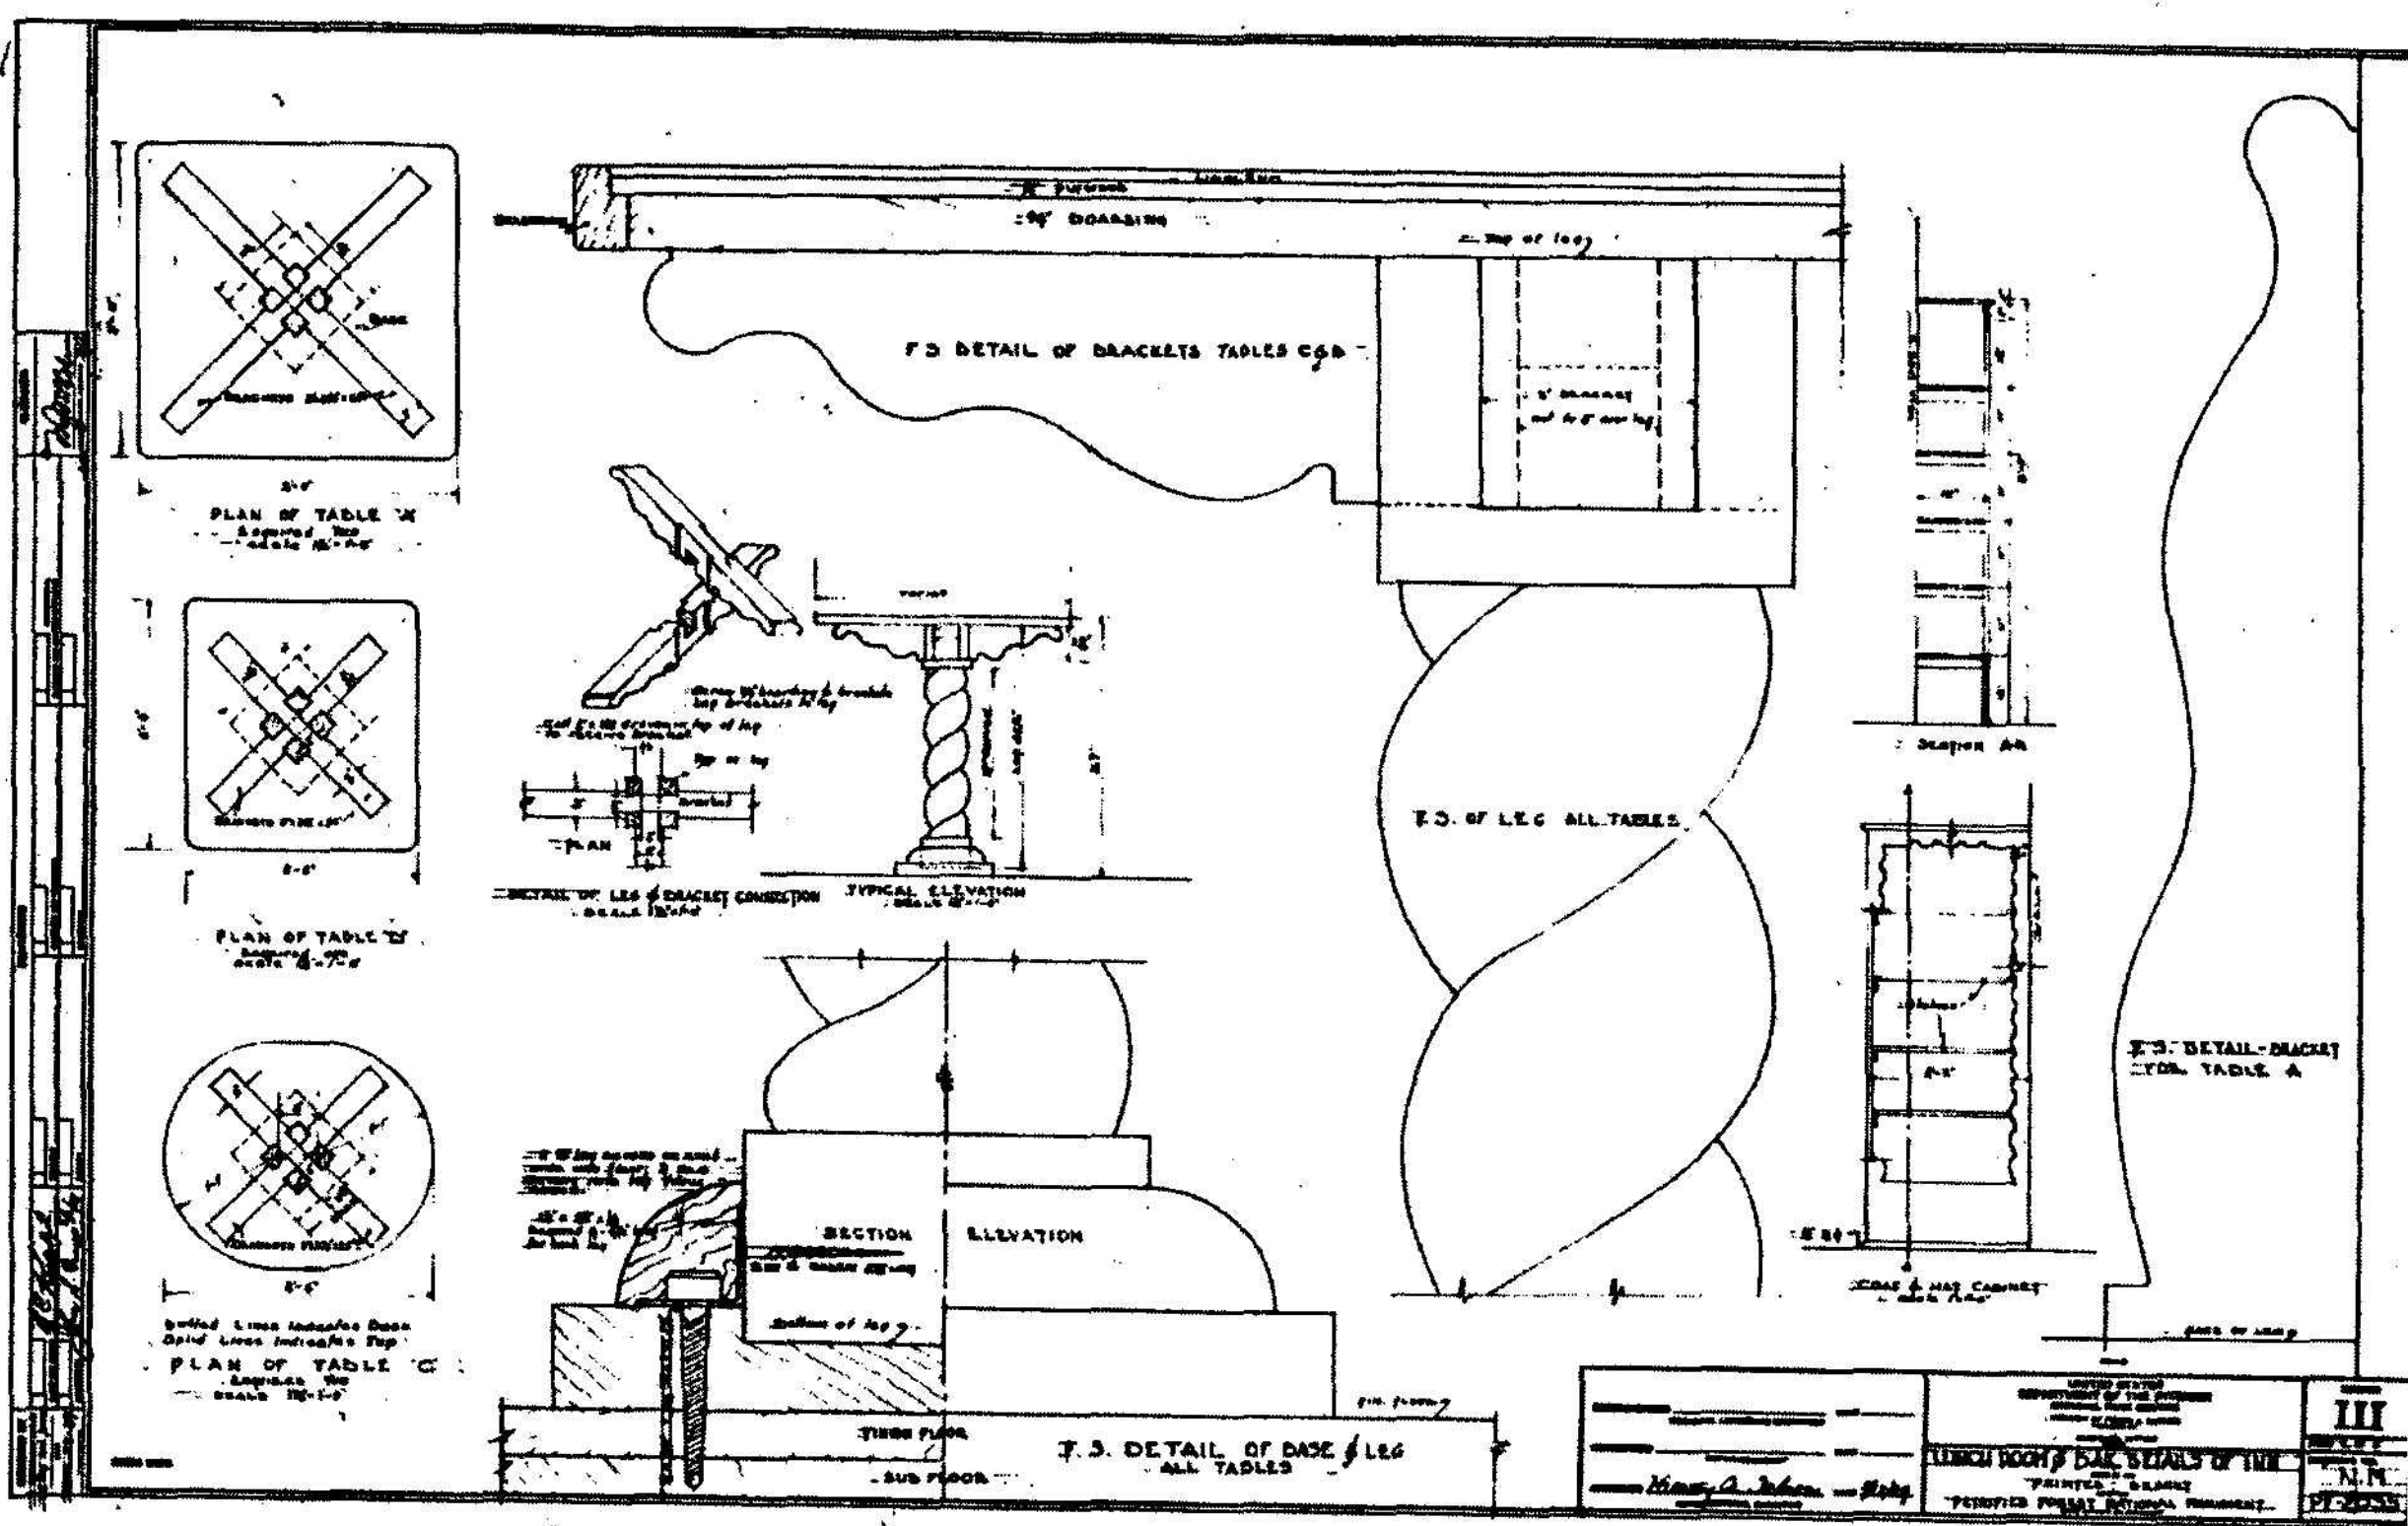
57. "Lunchroom and Bar Details." March 30, 1939, Plan by Lyle Bennett, Museum Collection, Archives, Petrified Forest National Park, Petrified Forest, Arizona, PF 2035, Sheet 2.

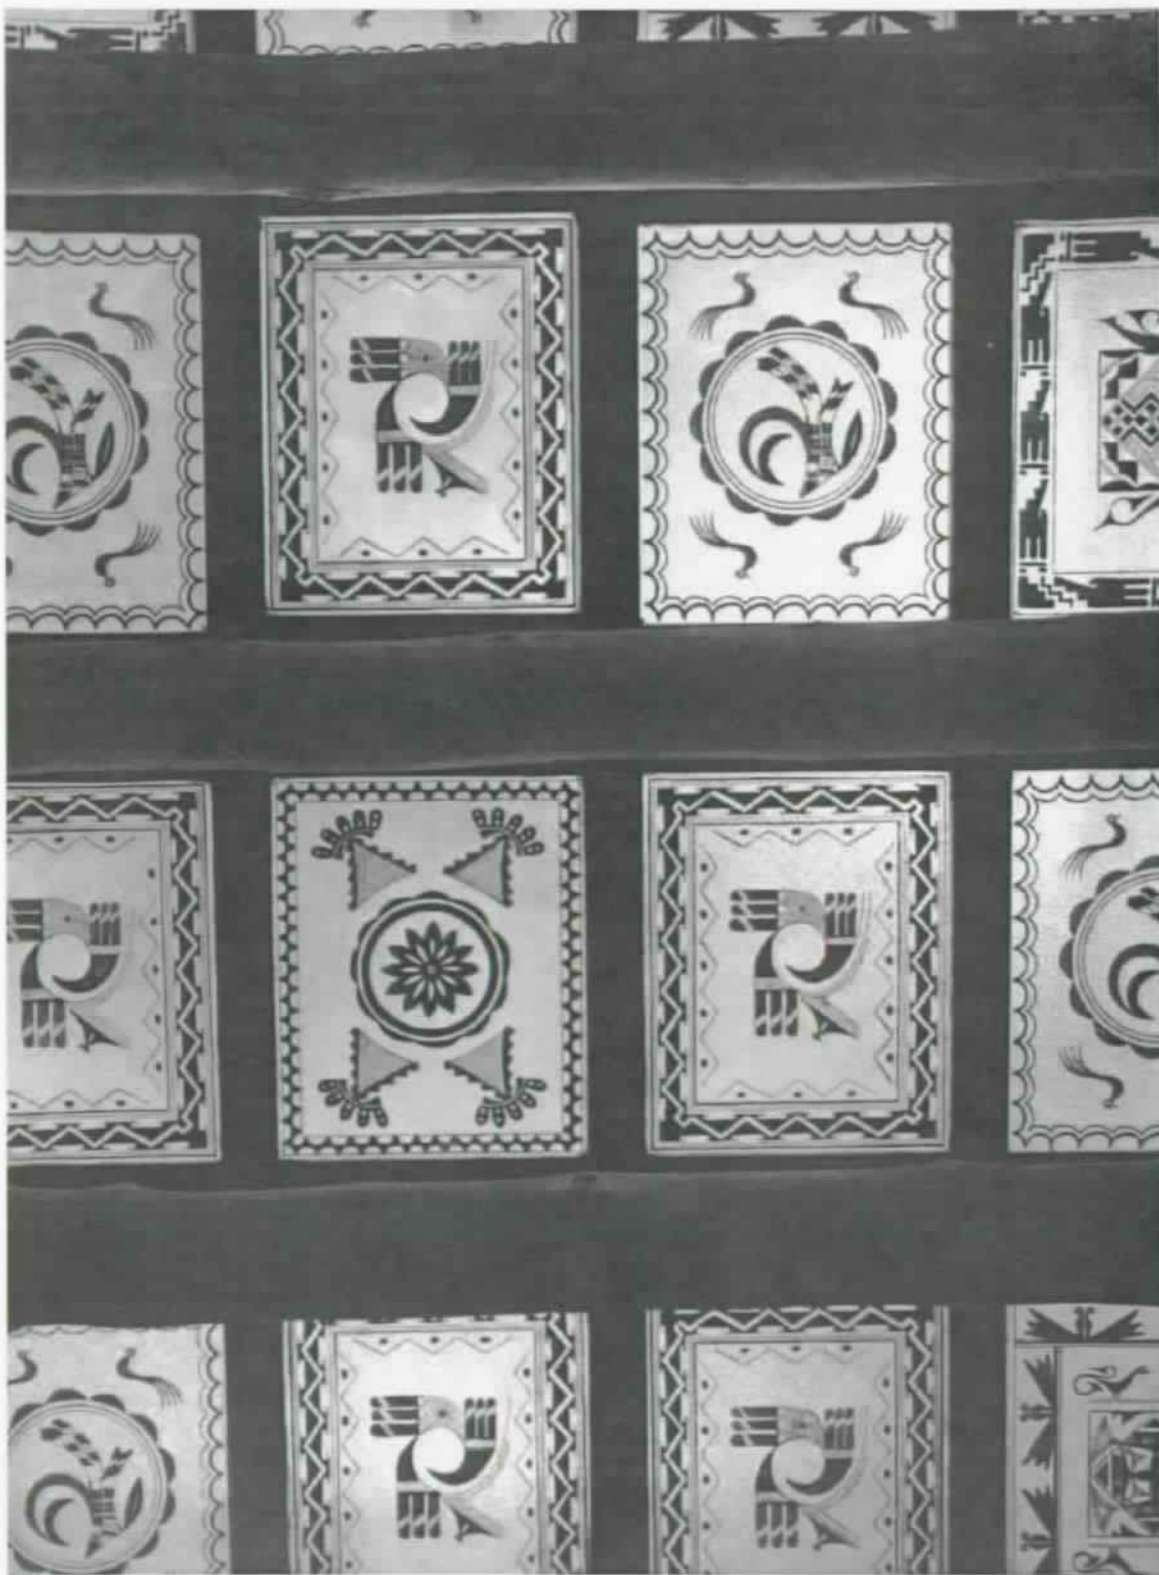
65. "Skylight Details, Multiple Glass Panels, Trading Post Room, (Room 104)." 1975, Unknown Photographer, Museum Collection, Archives, Petrified Forest National Park, Petrified Forest, Arizona, PEFO CAT. # 20756.
