CULTURAL LANDSCAPE REPORT

SAGAMORE HILL

Volume 2: Treatment Recommendations
and Implementation Plan

Sagamore Hill National Historic Site
Landscape Rehabilitation Plan: Historic Core

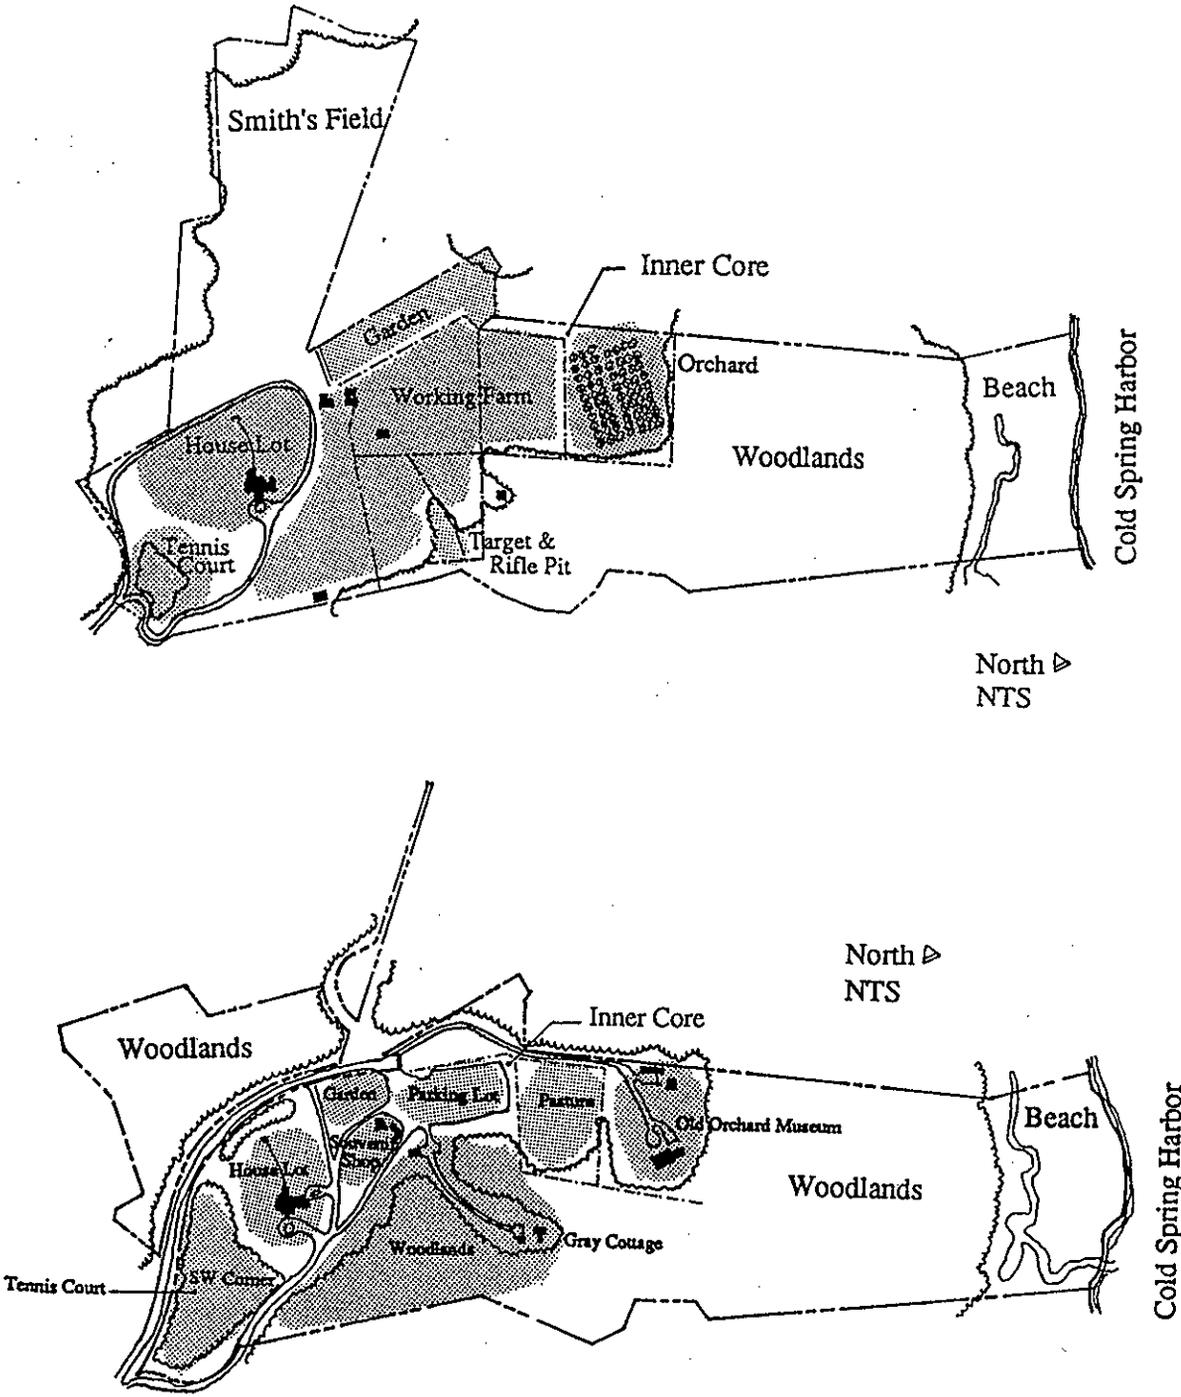
Figure 3: Spatial organization of Sagamore Hill. Top: Theodore Roosevelt stewardship (1919), bottom: NPS stewardship (1993) (Bellavia, 1993).

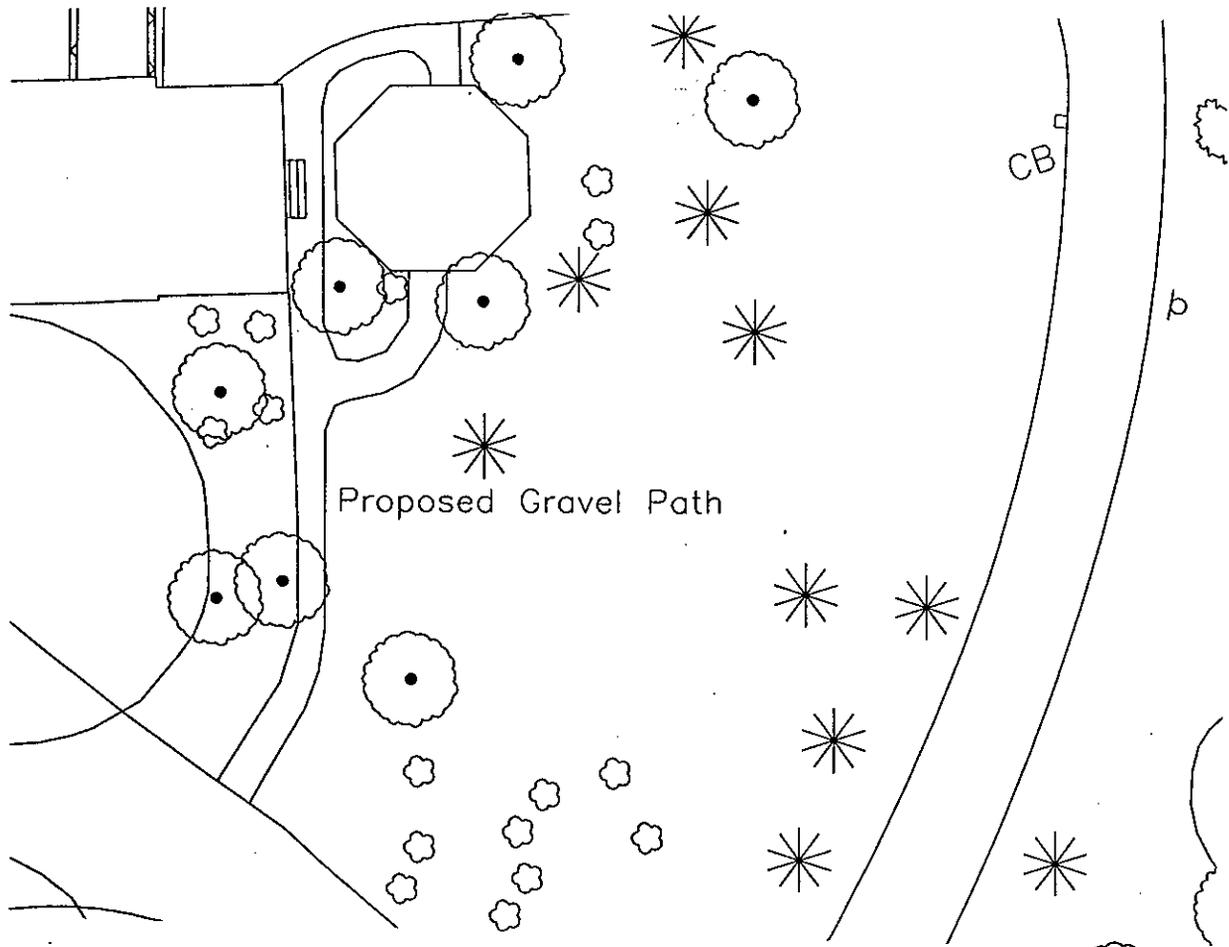
Figure 7: Proposed path to ice house (Uschold, OCLP).

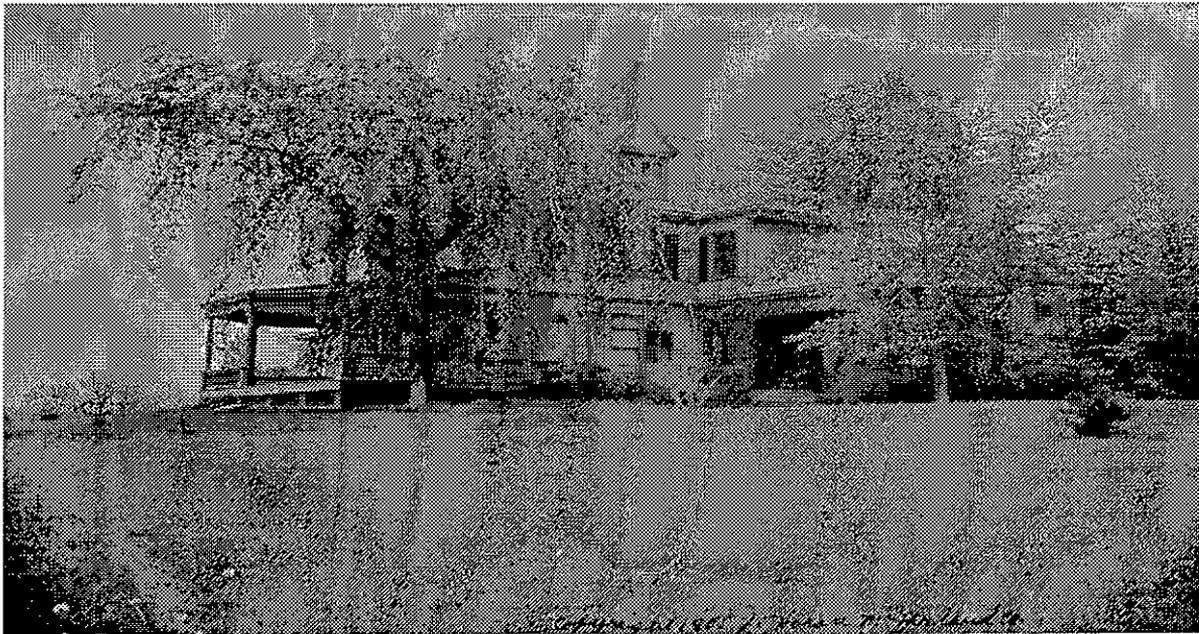
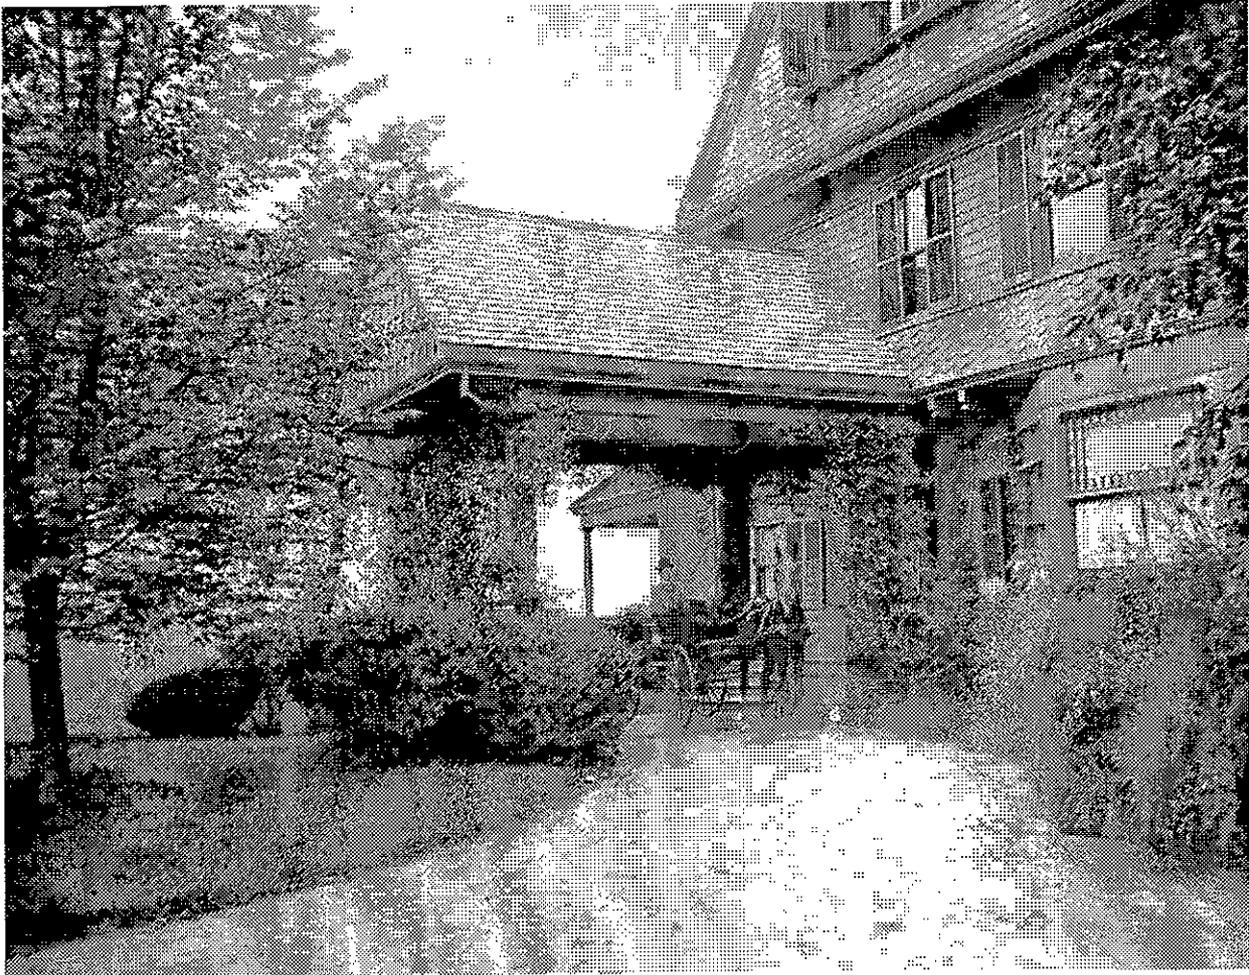
Figure 11: Lawn and vegetation around main house, 1905 (SAHINHS, no. 1117, Box 6).

Figure 12: Plantings around porte-cochere, 1905 (SAHINHS, no. 1123A, Box 6).

- Common Honeylocust (*Gleditsia triacanthos*, 1-1-36) on the southwest corner of the main house veranda should be replaced with a Weeping Elm (*Ulmus* sp.). The elm (fig. 11) was planted in 1916, during Roosevelt's tenure, and was replaced with a honeylocust by the TRA.
- Two cherries (*Prunus* sp., 1-1-31 and 1-1-32) in the circular lawn adjacent to the porte-cochere should be replaced with a Scotch Elm (*Ulmus glabra*), American Elm (*Ulmus americana*), and Tulip-tree (*Liriodendron tulipifera*) (fig. 11 and 12).

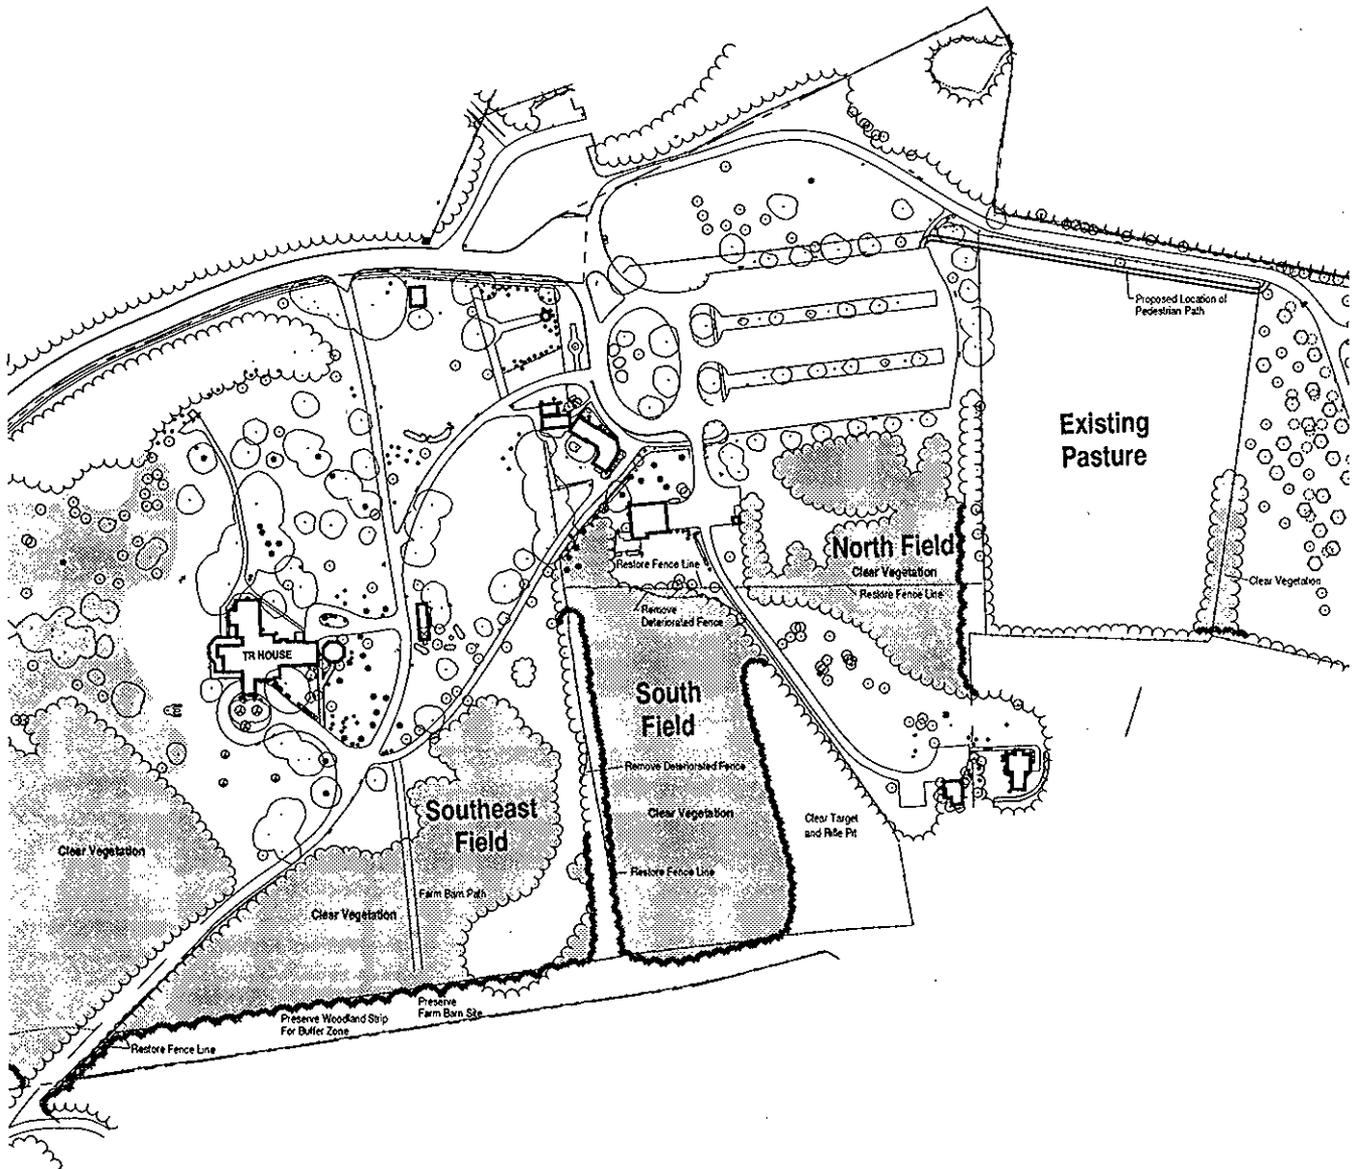
Figure 16: Re-establishment of historic agricultural fields (Uschold, 1998).

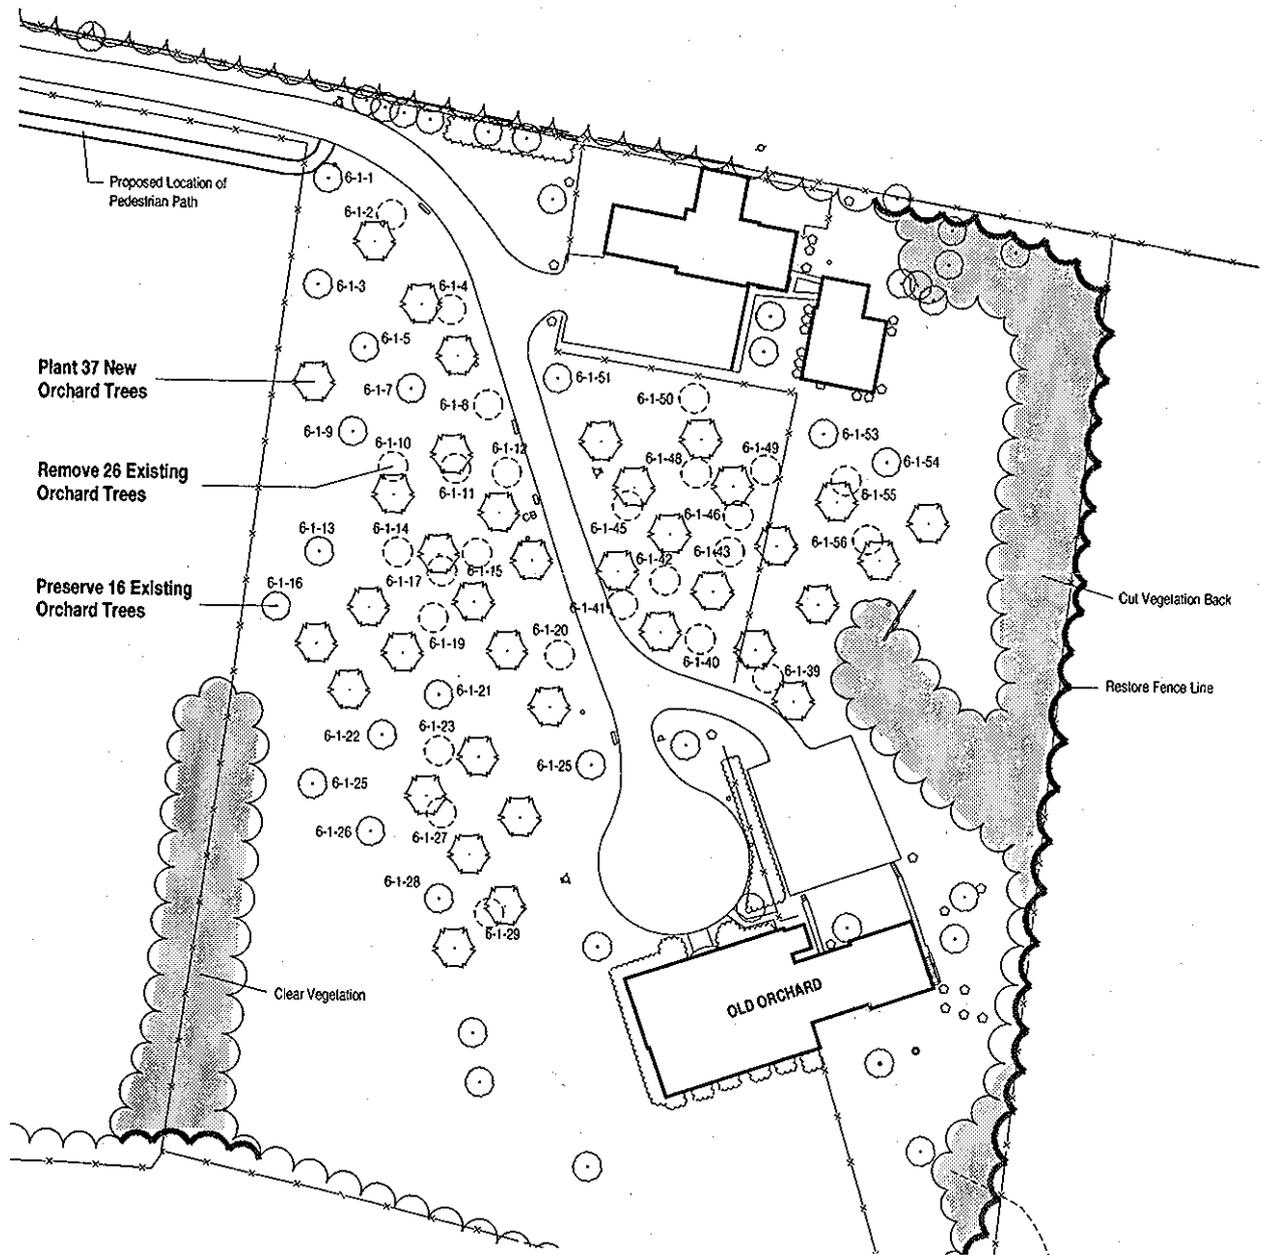
Figure 17: Orchard, planting plan (Uschold, 1997).

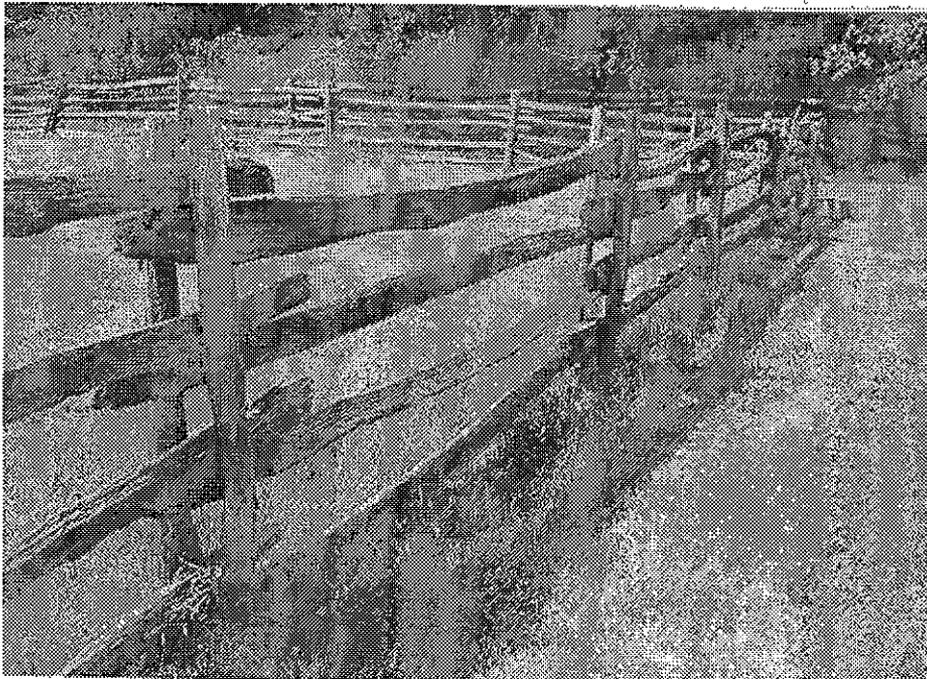
Figure 22: Existing post and rail fence (Uschold, 1997).

Four sections of post and rail fence have been lost completely and should be replaced. They include the fence between the southeast field and the south field, the fence between the south field and the north pasture, and two sections between the orchard and the woodland. The design of the new fence should mimic the existing post and rail fences (fig. 22) and be located as indicated on Figure 4.

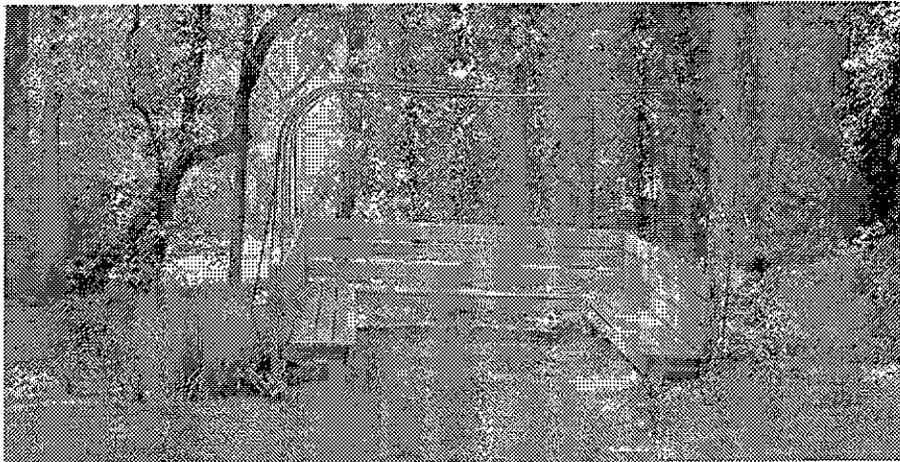
Figure 23: Existing pet cemetery arbor, 1997 (Uschold, OCLP).

During the historic period, an arched arbor with a bench under either side stood in the pet cemetery (fig. 13). The non-historic existing arbor is a rectangular u-shape with three benches underneath it. While the location of the extant arbor is historically accurate, its construction and character are quite different (fig. 23). When the arbor and benches need to be replaced, they should be replaced in the same location with a more historically accurate arbor and benches. The replacement arbor should be constructed similar to the existing arbor but have a circular form rather than rectangular. Benches should stand along both sides of the arbor but not the back edge (fig. 24).

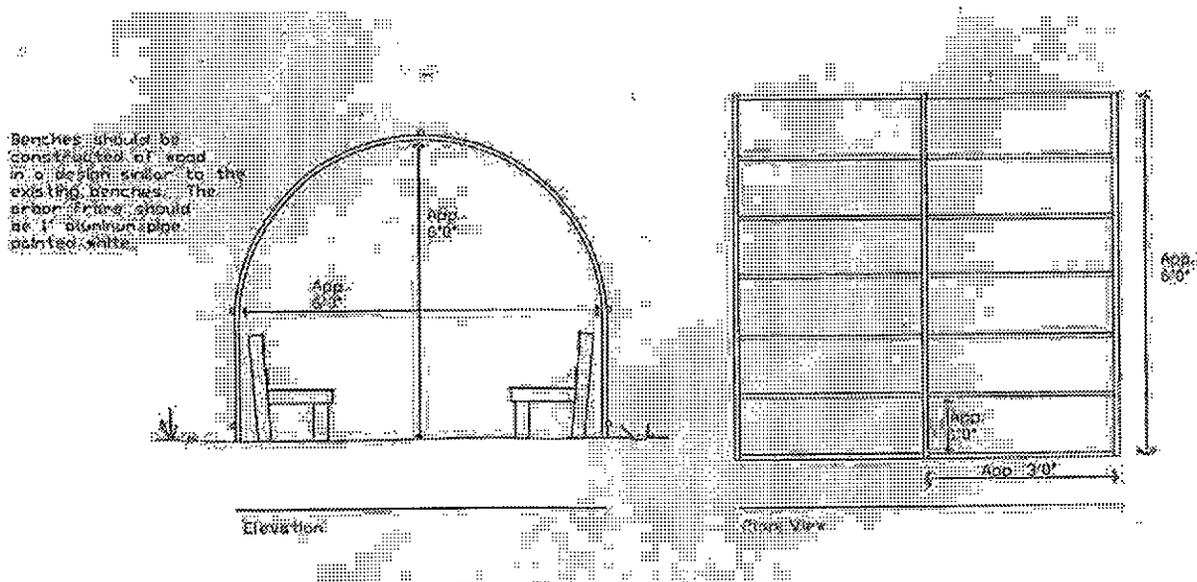
Figure 24: Detail of replacement pet cemetery arbor (Uschold, 1997).

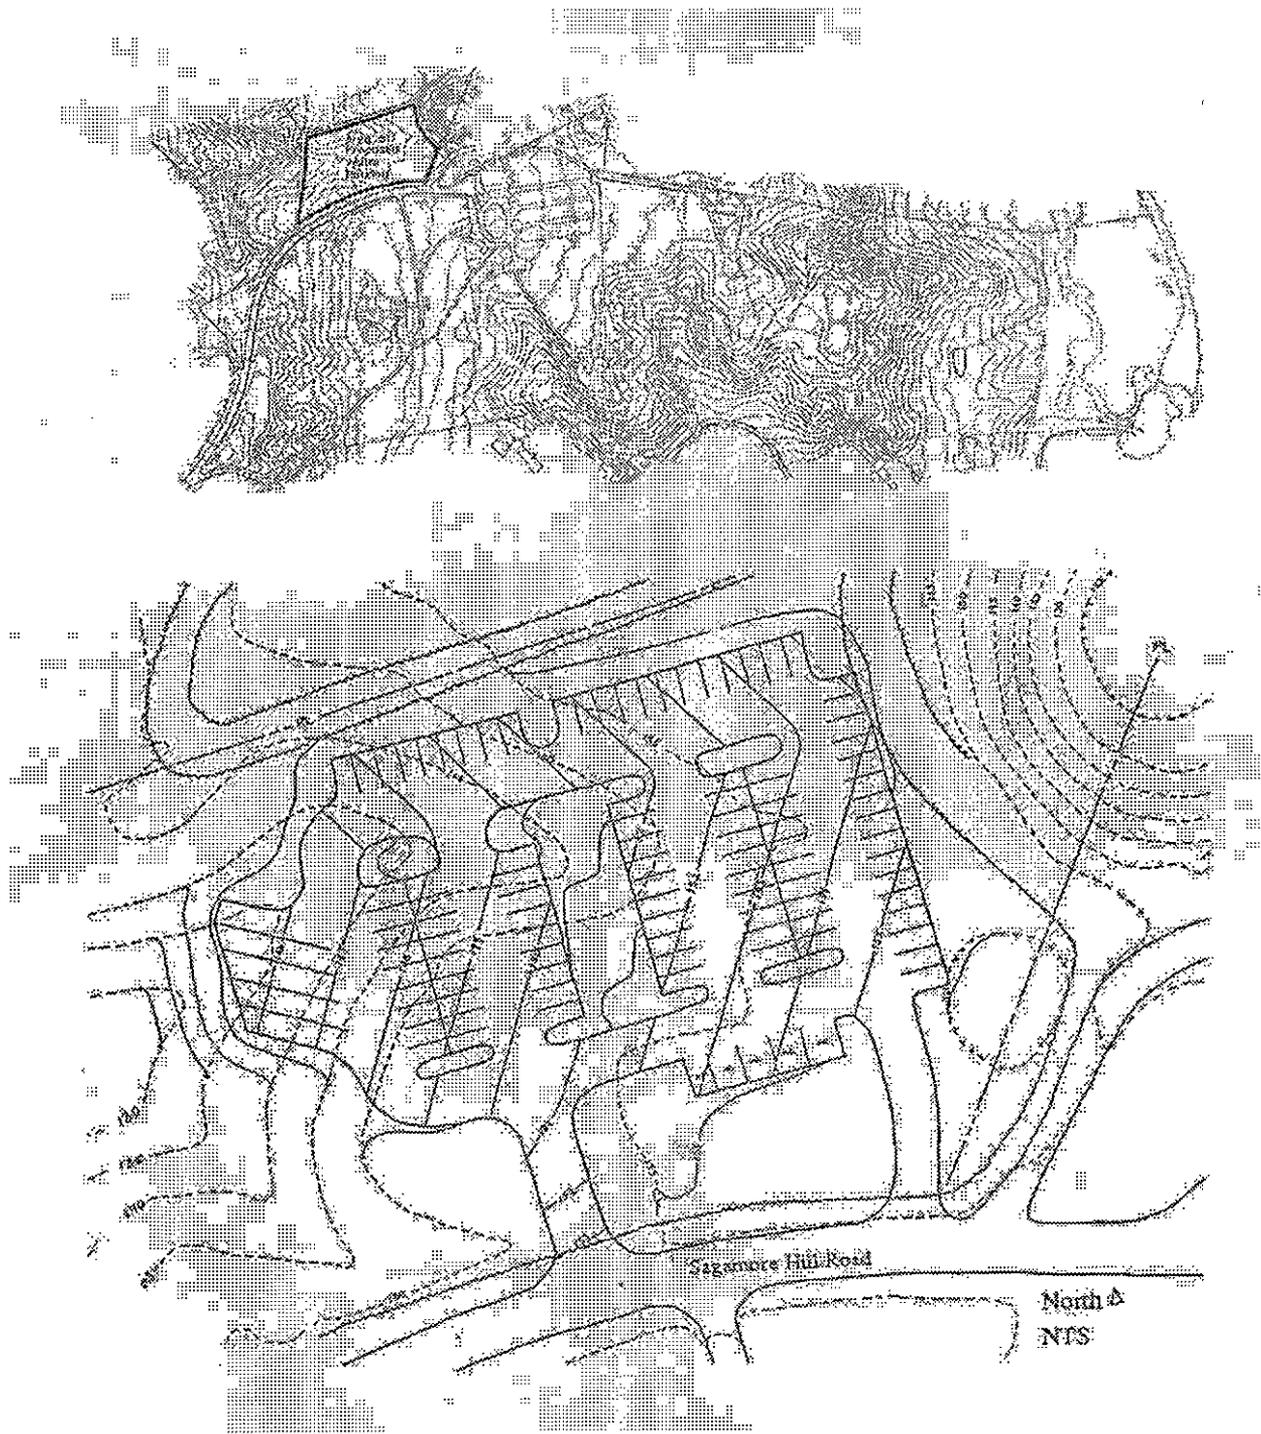
Figure 27: Conceptual alternative for proposed parking area (Bellavia, 1993).

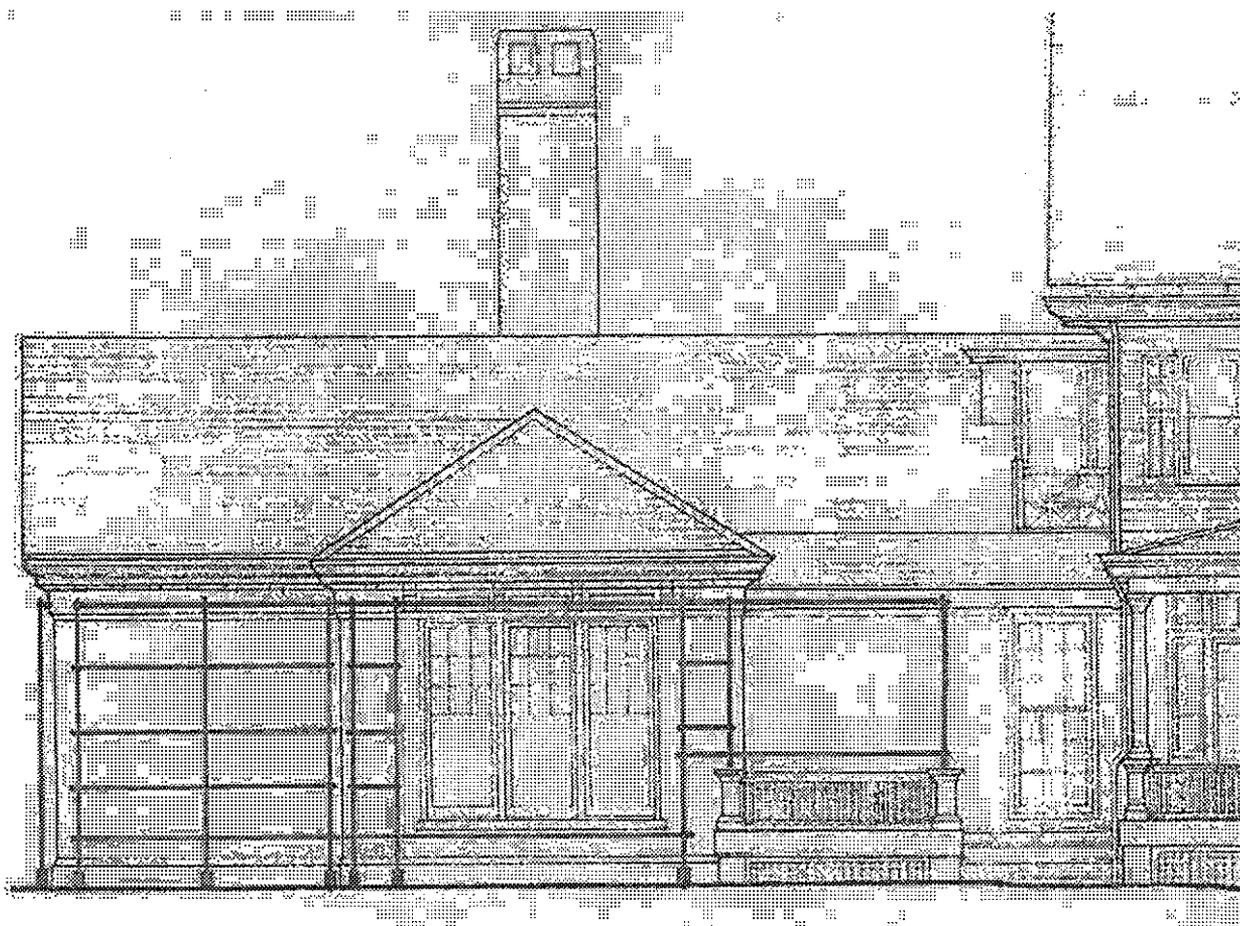
The conceptual trellis design below is an example of a potential layout for a trellis that could be constructed on the north room at Sagamore Hill. The trellis would be constructed in a manner similar to the design noted on the Preservation Tech Note: *Restoring Vine Coverage to Historic Buildings*. As noted in the Tech Note, the materials used to construct the trellis will be virtually non-intrusive to the visual character of the house. A finalized design of the trellis would be developed by the wood crafter/carpenter on the scoping trip.

Conceptual Design for North Room Trellis (Uschold, 1998).

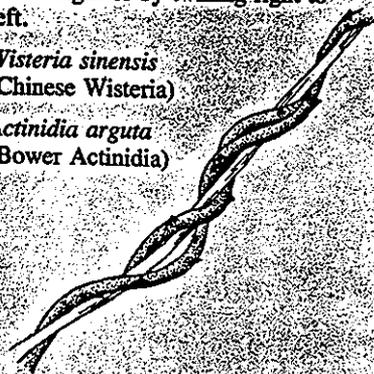
Tendrils

The tendrils wrap themselves around anything that they come in contact with.

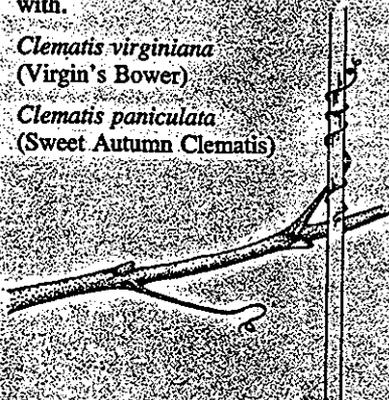
Aerial

Small roots firmly attach the vine to either wood or masonry.

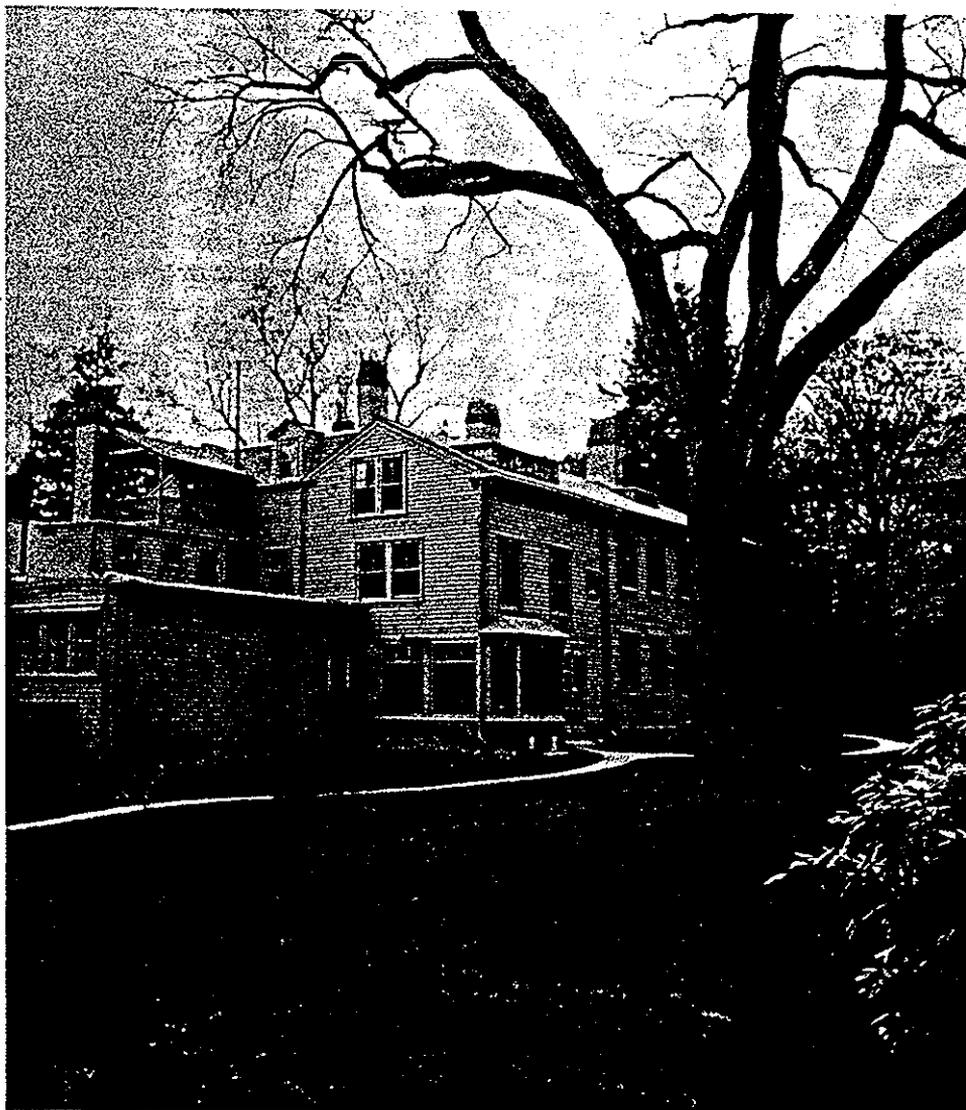
Figure 1. Historic plant materials can be retained while restoration of the historic structure is underway. The *Wisteria* and *Actinidia* vines that were historically used by Olmsted, were cut back during the restoration of Fairsted in 1988. Photo by Charles Pepper, courtesy of the Olmsted National Historic Site.

Olmsted's intention (*see figure 1*). Furthermore, long-term frequent pruning risked a higher incidence of pest-related problems to the plants and restricted their natural climbing habit. It was therefore important to the public site that a new trellis system be devised that would protect both the historic vegetation and the historic structure, while re-establishing the appearance of a "vine clad mansion."

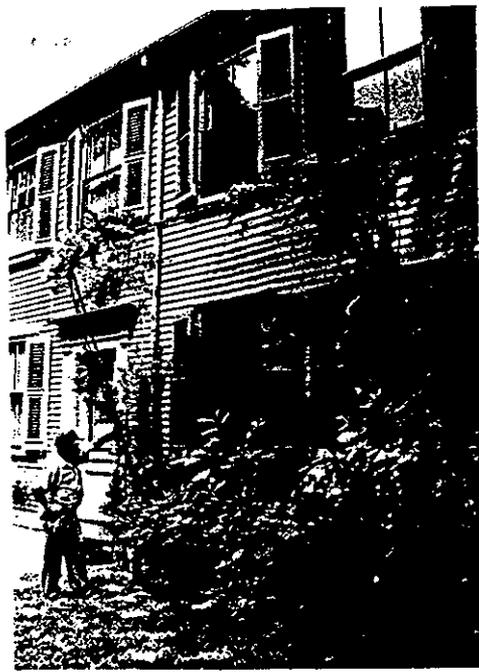
Figure 4. The pipe and strapping system, constructed with swivel sockets, allows the rigid support system to fold down away from the house. The strapping can also be removed from the pipe support for limited maintenance. Photo by Karen Day.

The weight of a mature vine must also be considered in this solution. This pipe and strapping combination is not historically accurate in appearance. The twining vines cover the strapping, but the pipe structure behind is exposed.

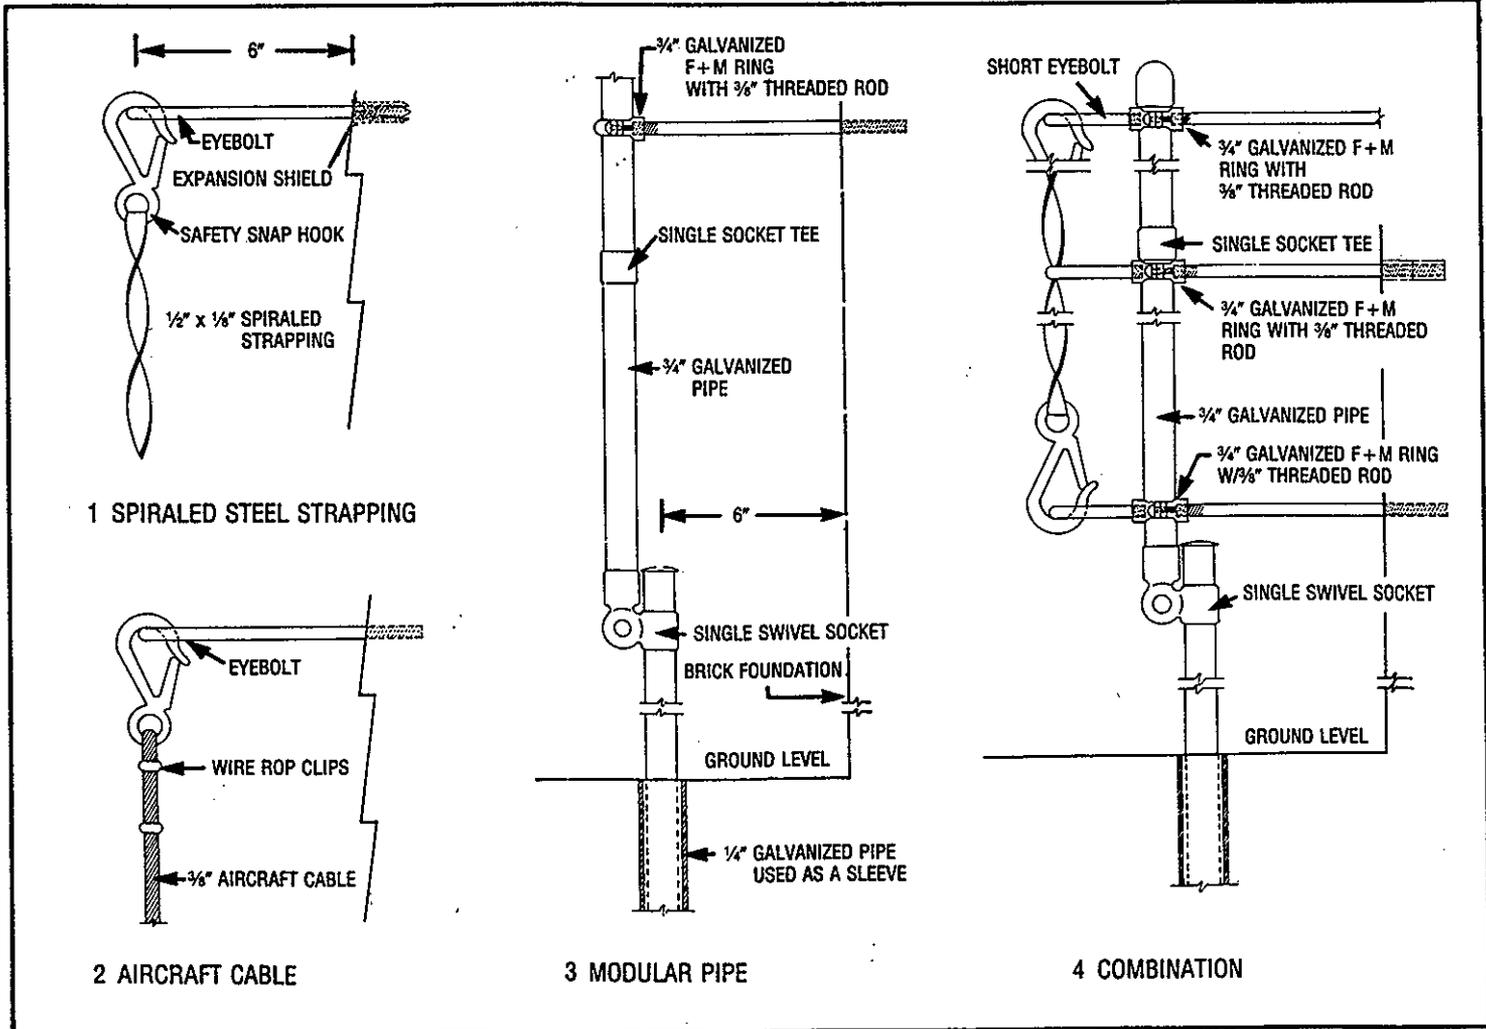
Figure 5. Details of the four experimental trellis systems. Drawings by Sharon Runner, National Park Service.

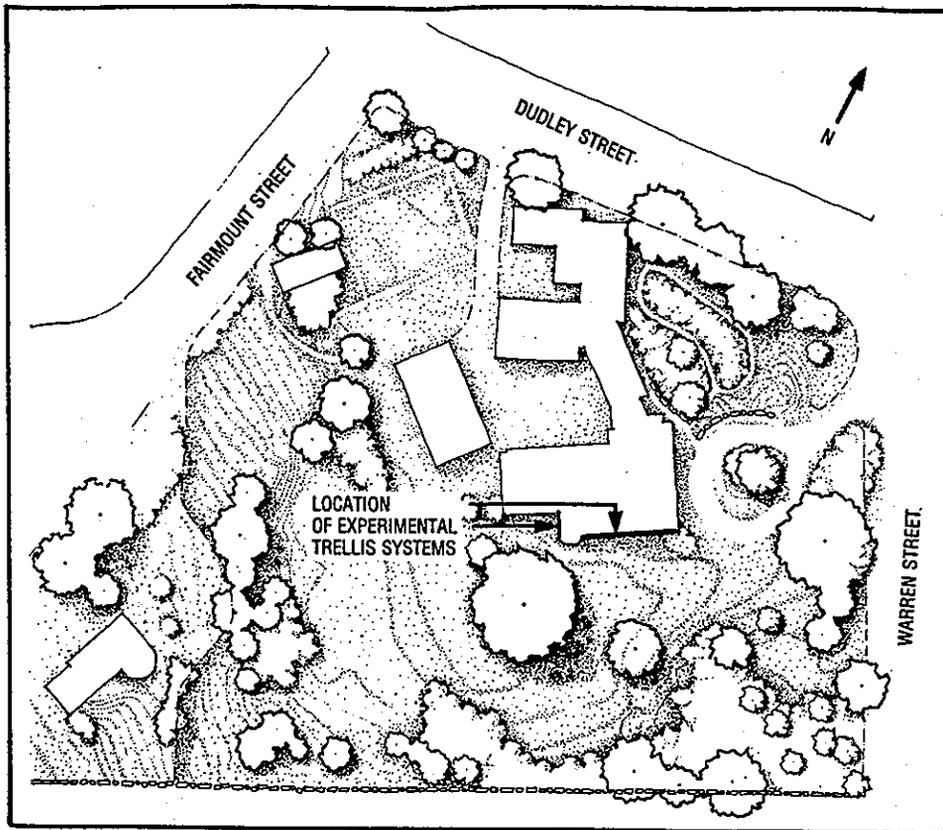
Figure 6. Site plan of Fairsted; the experimental trellis systems were installed on the south and west elevations. Drawing by Karen Day.
