CENTRAL RAILROAD OF NEW JERSEY SUBURBAN COACH No. 1157 HISTORIC STRUCTURE REPORT

Part I

NATIONAL PARK SERVICE
Steamtown National Historic Site

Prepared by Mark L. Morgan

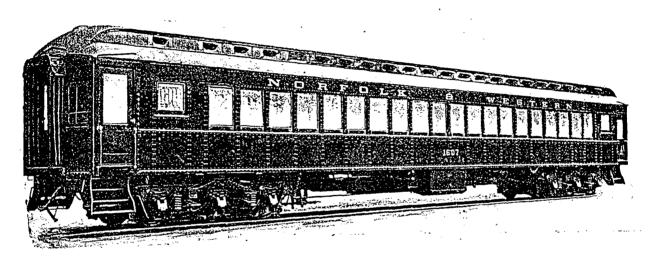
Fig. 1. Heavyweight steel passenger coach built by Bethlehem Shipbuilding Corporation's Harlan Plant for the Norfolk and Western Railroad. Roy V. Wright, ed., <u>Car Builder's Cyclopedia of American Practice</u> 10th ed. (New York: Simmons-Boardman Publishing Company, 1922), 314.

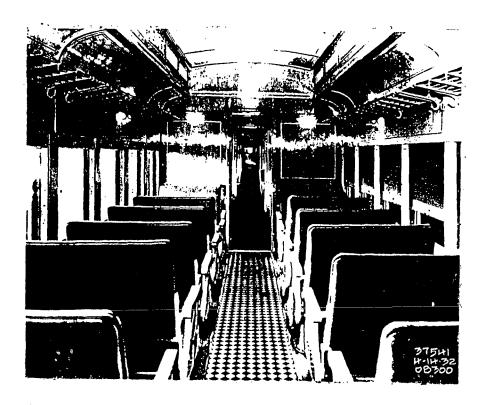
Fig. 2. Interior view of a CNJ passenger coach compartment, showing parcel racks, floor material and walkover seats, 14 April 1932. Photograph No. 30 from the Reading Company Collection, Pictorial Collections and Audiovisual Services Department, Hagley Museum and Library.

Seats - Thirty-six H&K Neverbreak pressed steel car seats were installed, eighteen per side. No. 1157 had standard walkover seats, with seat backs that could be slid across the cushion to change the direction of seating. "H&K" was the brand name for Hale & Kilburn Corporation of Philadelphia, PA.⁵⁹

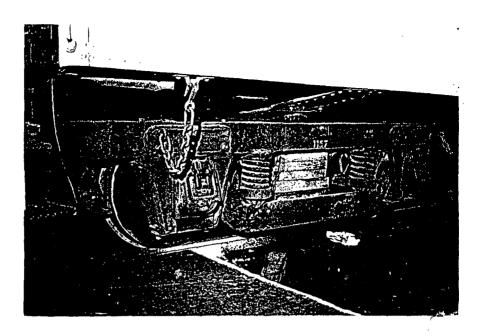
The Harlan & Hollingsworth trucks marked for coach No. 1157 are currently under CNJ suburban coach No. 1022.

Fig. 8. Correct Harlan & Hollingsworth passenger car truck for coach No. 1157, currently installed on CNJ coach No. 1022. Photograph by Kenneth Ganz.

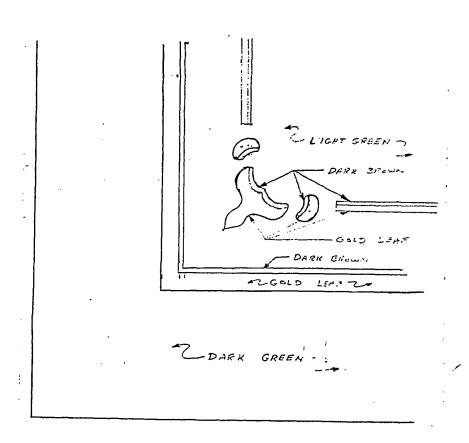
Investigation of No. 1157 and other Central of New Jersey passenger cars in the Steamtown collection has revealed the presence of detailed gold leaf scroll work, applied to a base coat of light green and Pullman green (Figure 10).

Fig. 10. Sketch of gold leaf detailing found on the interior roof panels of Central Railroad of New Jersey coaches in the Steamtown collection. Drawing by Willard Sturdevant.

This decorative detailing is underneath the Old English Ivory and other layers of paint on the ceiling panels of No. 1157. It should be restored.

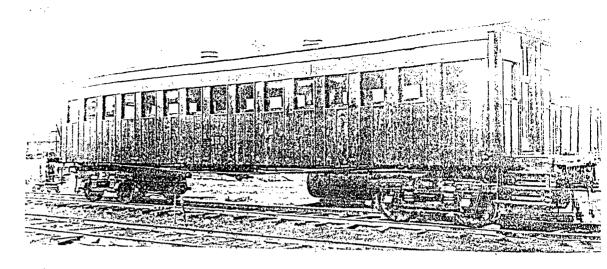
The car number was approximately eight inches tall, centered on the body below the windows (Figure 12).

Fig. 12. Example of the first Central Railroad of New Jersey passenger car paint scheme, as depicted by coach No. 159. From John White, Jr., The American Railroad Passenger Car, pt. 1 (Baltimore: Johns Hopkins University Press, 1978), 26.

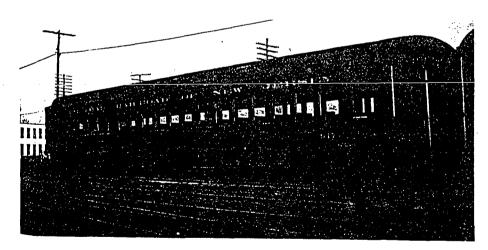
Finally, photographic references indicate that the handrails were painted the body color (Figure 13).

Fig. 13. Central Railroad of New Jersey suburban coach No. 947, in the railroad's second passenger paint scheme. Central Railroad of New Jersey photograph, collection of Willard Sturdevant.

This second scheme is the period chosen for the restoration of coach No. 1157.

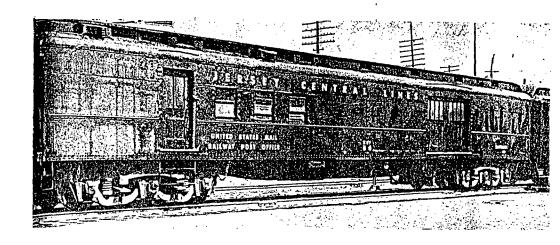
A photograph of CRP Railway Post Office No. 66 depicts a variat of the third scheme (Figure 14.) The lettering for the Jer Central Lines remain, but the "Statue of Liberty" logo is abse The car number is centered on the body, below the lower win line, and the CRP initials are centered above the numbers.

Fig. 14. The third Central Railroad of New Jersey pascheme, minus the "Statue of Liberty" markings, on Cent Railroad of Pennsylvania Railway Post Office car No. Railroad Magazine, January 1968, 19.

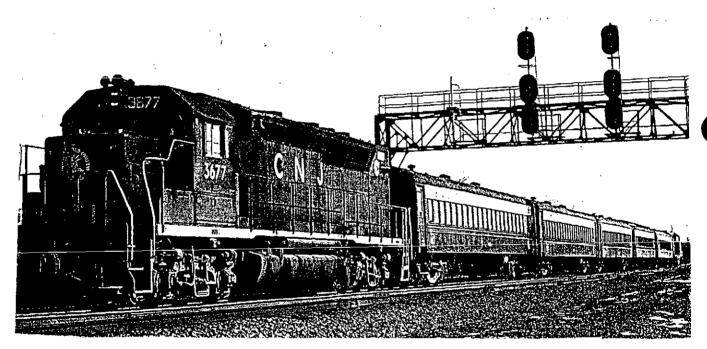
The cars were dark blue, with a broad yellow letter board. A thin yellow stripe (approximately two inches wide) was painted below the window line, encircling the body. The car number was centered at mid-body. The CNJ liberty head emblem was applied at the left corner of the car; "Central Railroad of New Jersey" replaced "Jersey Central Lines" on the circular emblem (Figure 15).

Fig. 15. Joint-use Central of New Jersey/New Jersey Department of Transportation coaches display the fourth scheme while operating near Bound Brook, NJ. From William J. Brennan, Jersey Central Lines In Color (Edison, NJ: Morning Sun Books, 1991), 62.
