This letter and Notice of Intent (NOI) is submitted for the Drakes Estero Restoration Project to restore natural conditions to Drakes Estero through removal of 95 oyster racks extending approximately 5 miles over subtidal lands within Drakes Estero. This project will remove the remaining non-historic and non-essential facilities associated with the Johnson Oyster Company and Drakes Bay Oyster Company (DBOC) and restore wilderness conditions to the marine waters within Drakes Estero.

The Drakes Estero Restoration Project is intended to remove all oyster racks and aquacultural debris and to restore conditions supporting natural ecological and hydrologic process within Drakes Estero within Point Reyes National Seashore (Figure 1). The restoration actions include removal of wooden racks, aquacultural debris (including tubes, bags and strings), oyster mats, anchors and lines, as well as development and implementation of long-term monitoring programs to document the ecological response and transition of Drakes Estero to the cessation of aquaculture activities and restoration. The project involves the following activities:

Drakes Estero Restoration Project Goals, Environmental Considera

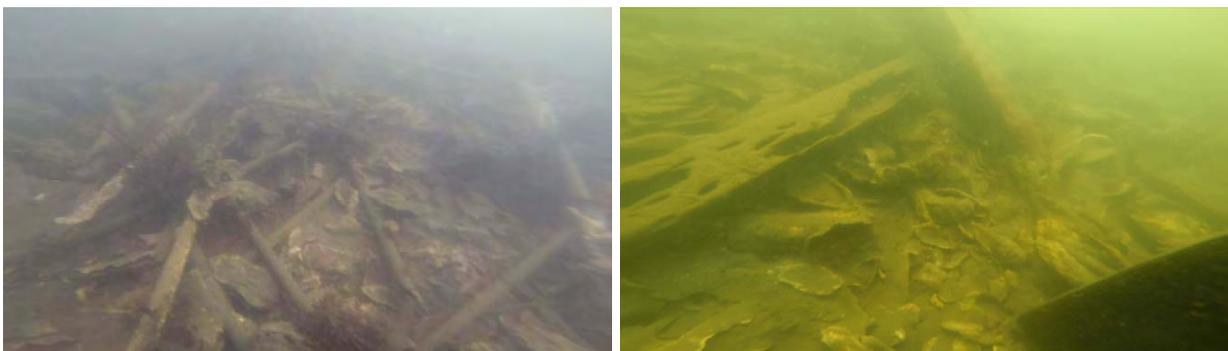
Heavy Debris is generally defined as having >75% cover, precluding eelgrass growth and covering most of the estero floor under a rack. This periodically includes large piles of oyster bags or French tubes that have fallen from the rack and almost always includes complete bottom coverage of oyster shell. It is unknown how deep into the sediment this debris may be.

Examples of heavy debris: (Left) oyster shell and French tubes under rack 6B on 1/29/2015, (Right) oyster shell under rack 22B on 1/30/2015.
