DELINEATION OF WETLANDS AND DEEPWATER HABITATS

GIACOMINI WETLAND RESTORATION PROJECT

MARIN COUNTY, CALIFORNIA

March 1, 2005

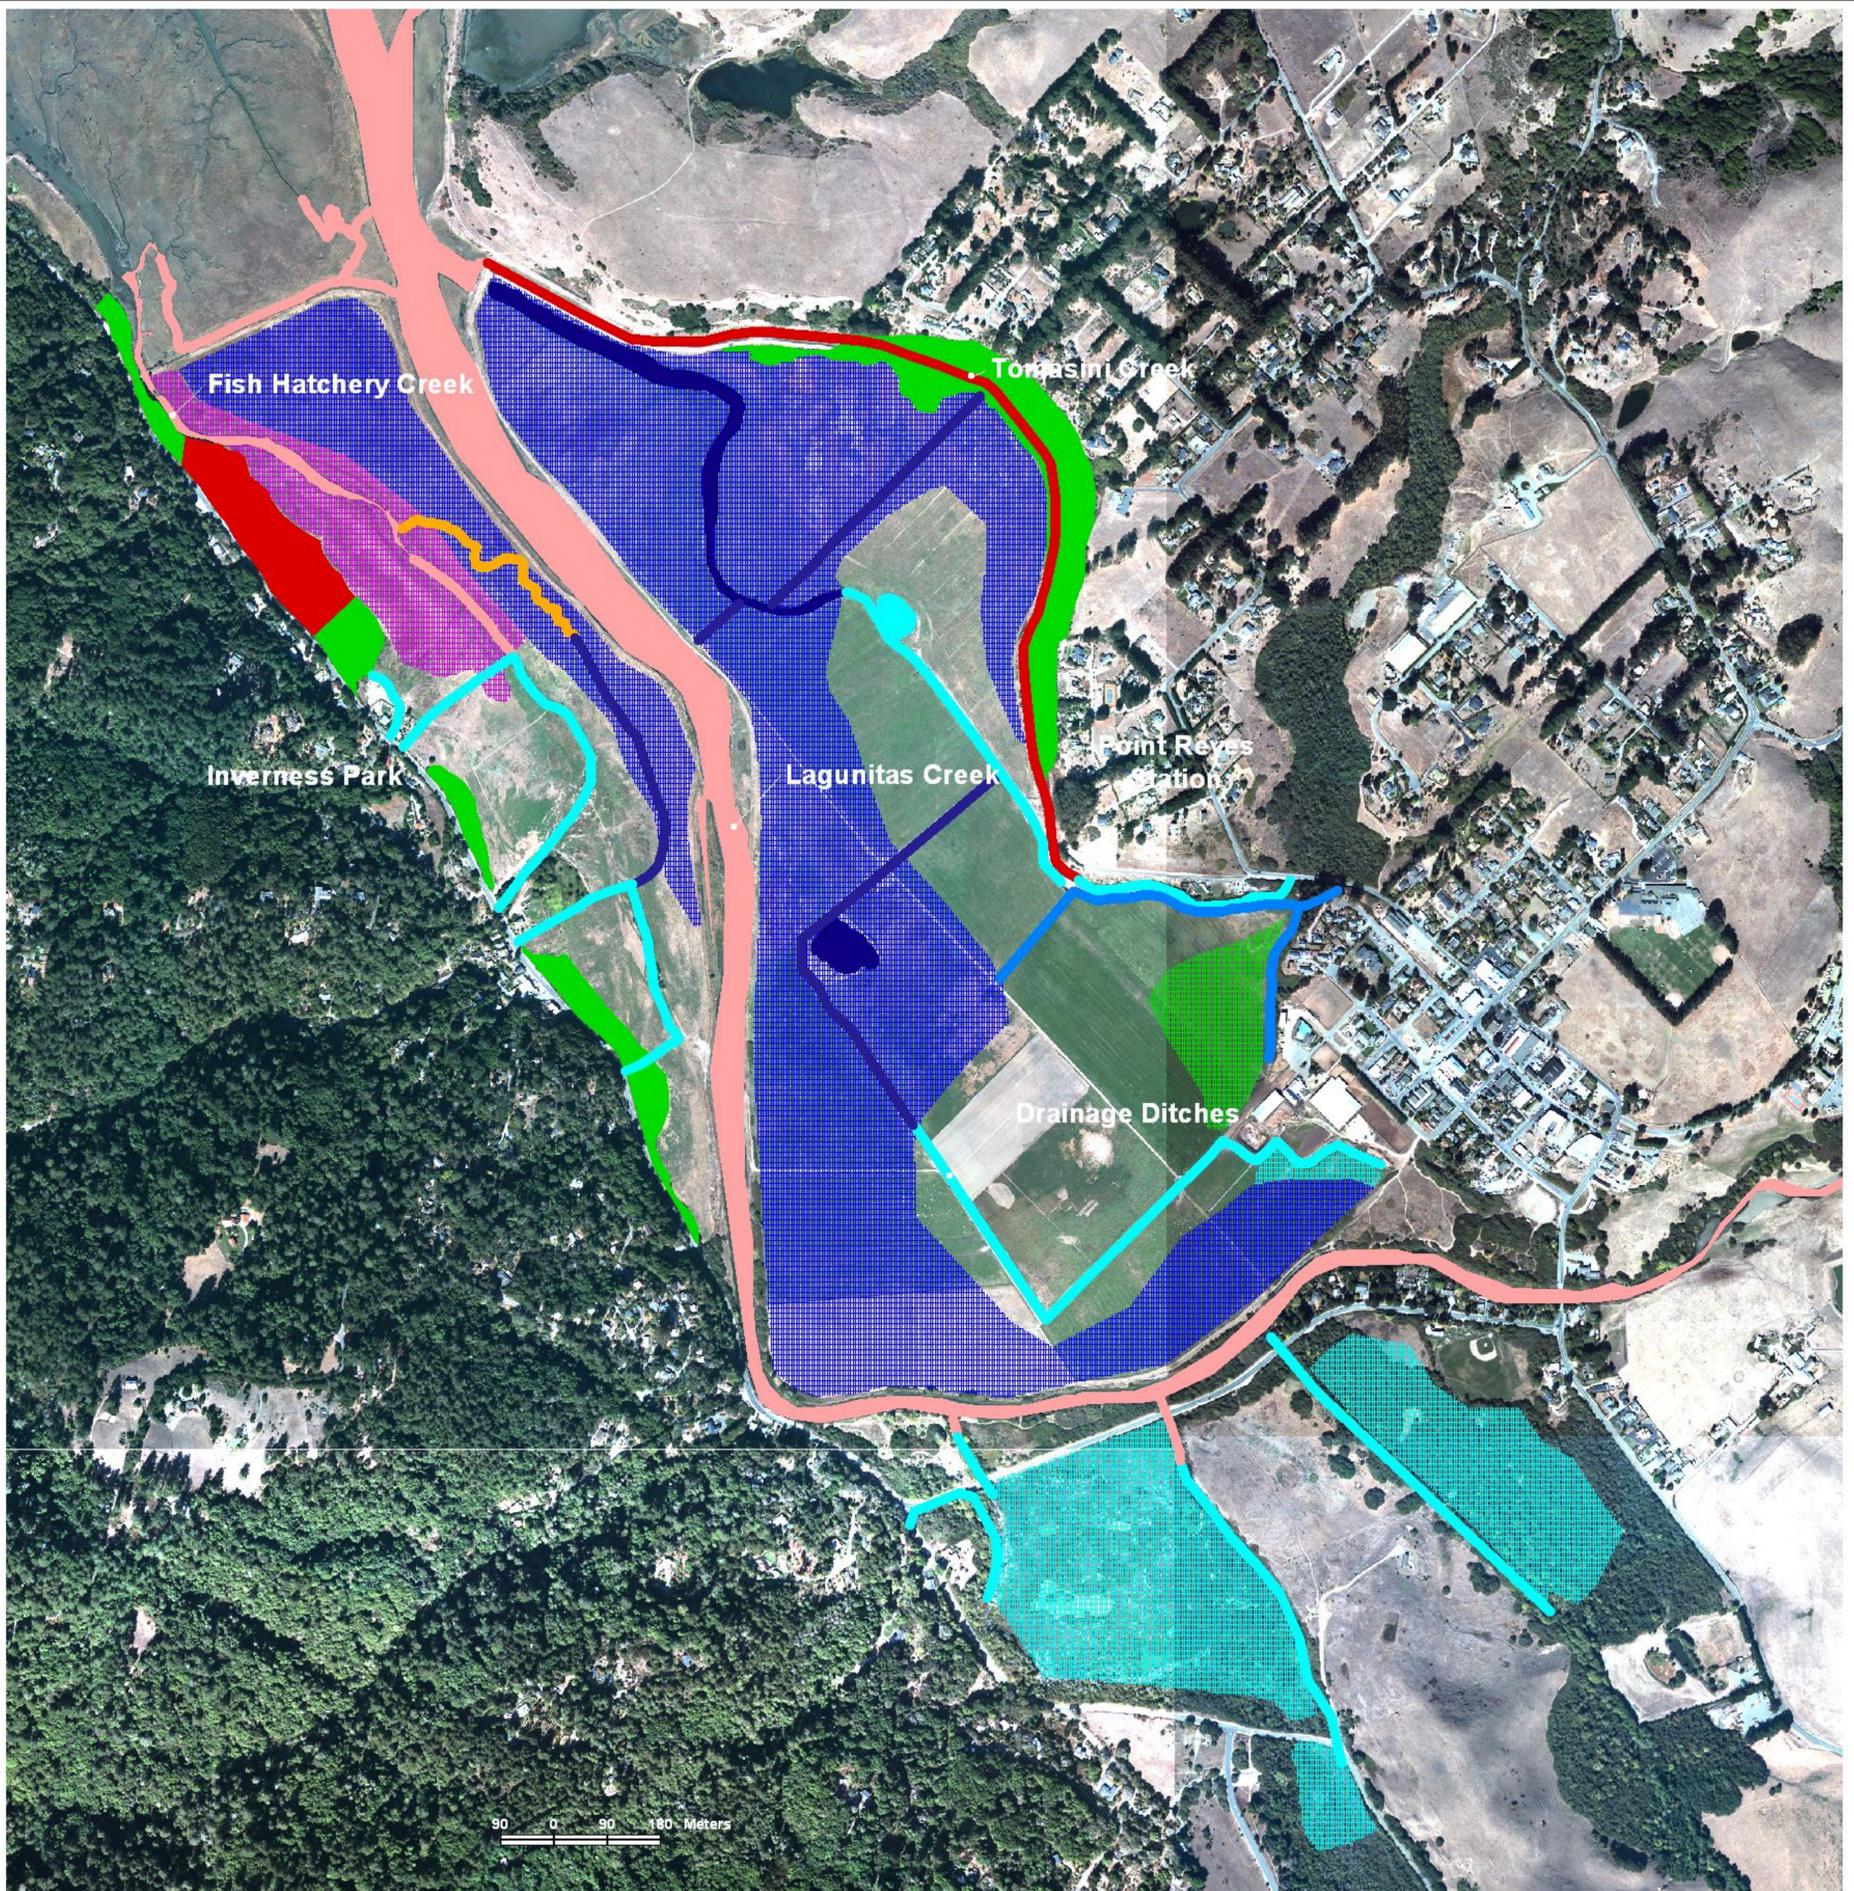
Sources of Hydrology

- Hydrologic Sources**
- Groundwater - Freshwater
 - Surface - Freshwater
 - Surface - Freshwater/Groundwater - Freshwater
 - Surface - Freshwater/Groundwater - Tidally Influenced
 - Surface - Tidally Influenced
 - Surface - Tidally Influenced/Groundwater - Freshwater
 - Surface - Tidally Influenced/Groundwater - Tidally Influenced
- Hydrologic Influences**
- Groundwater-Freshwater
 - Groundwater-Tidally Influenced
 - Surface-Freshwater
 - Surface-Tidally Influenced

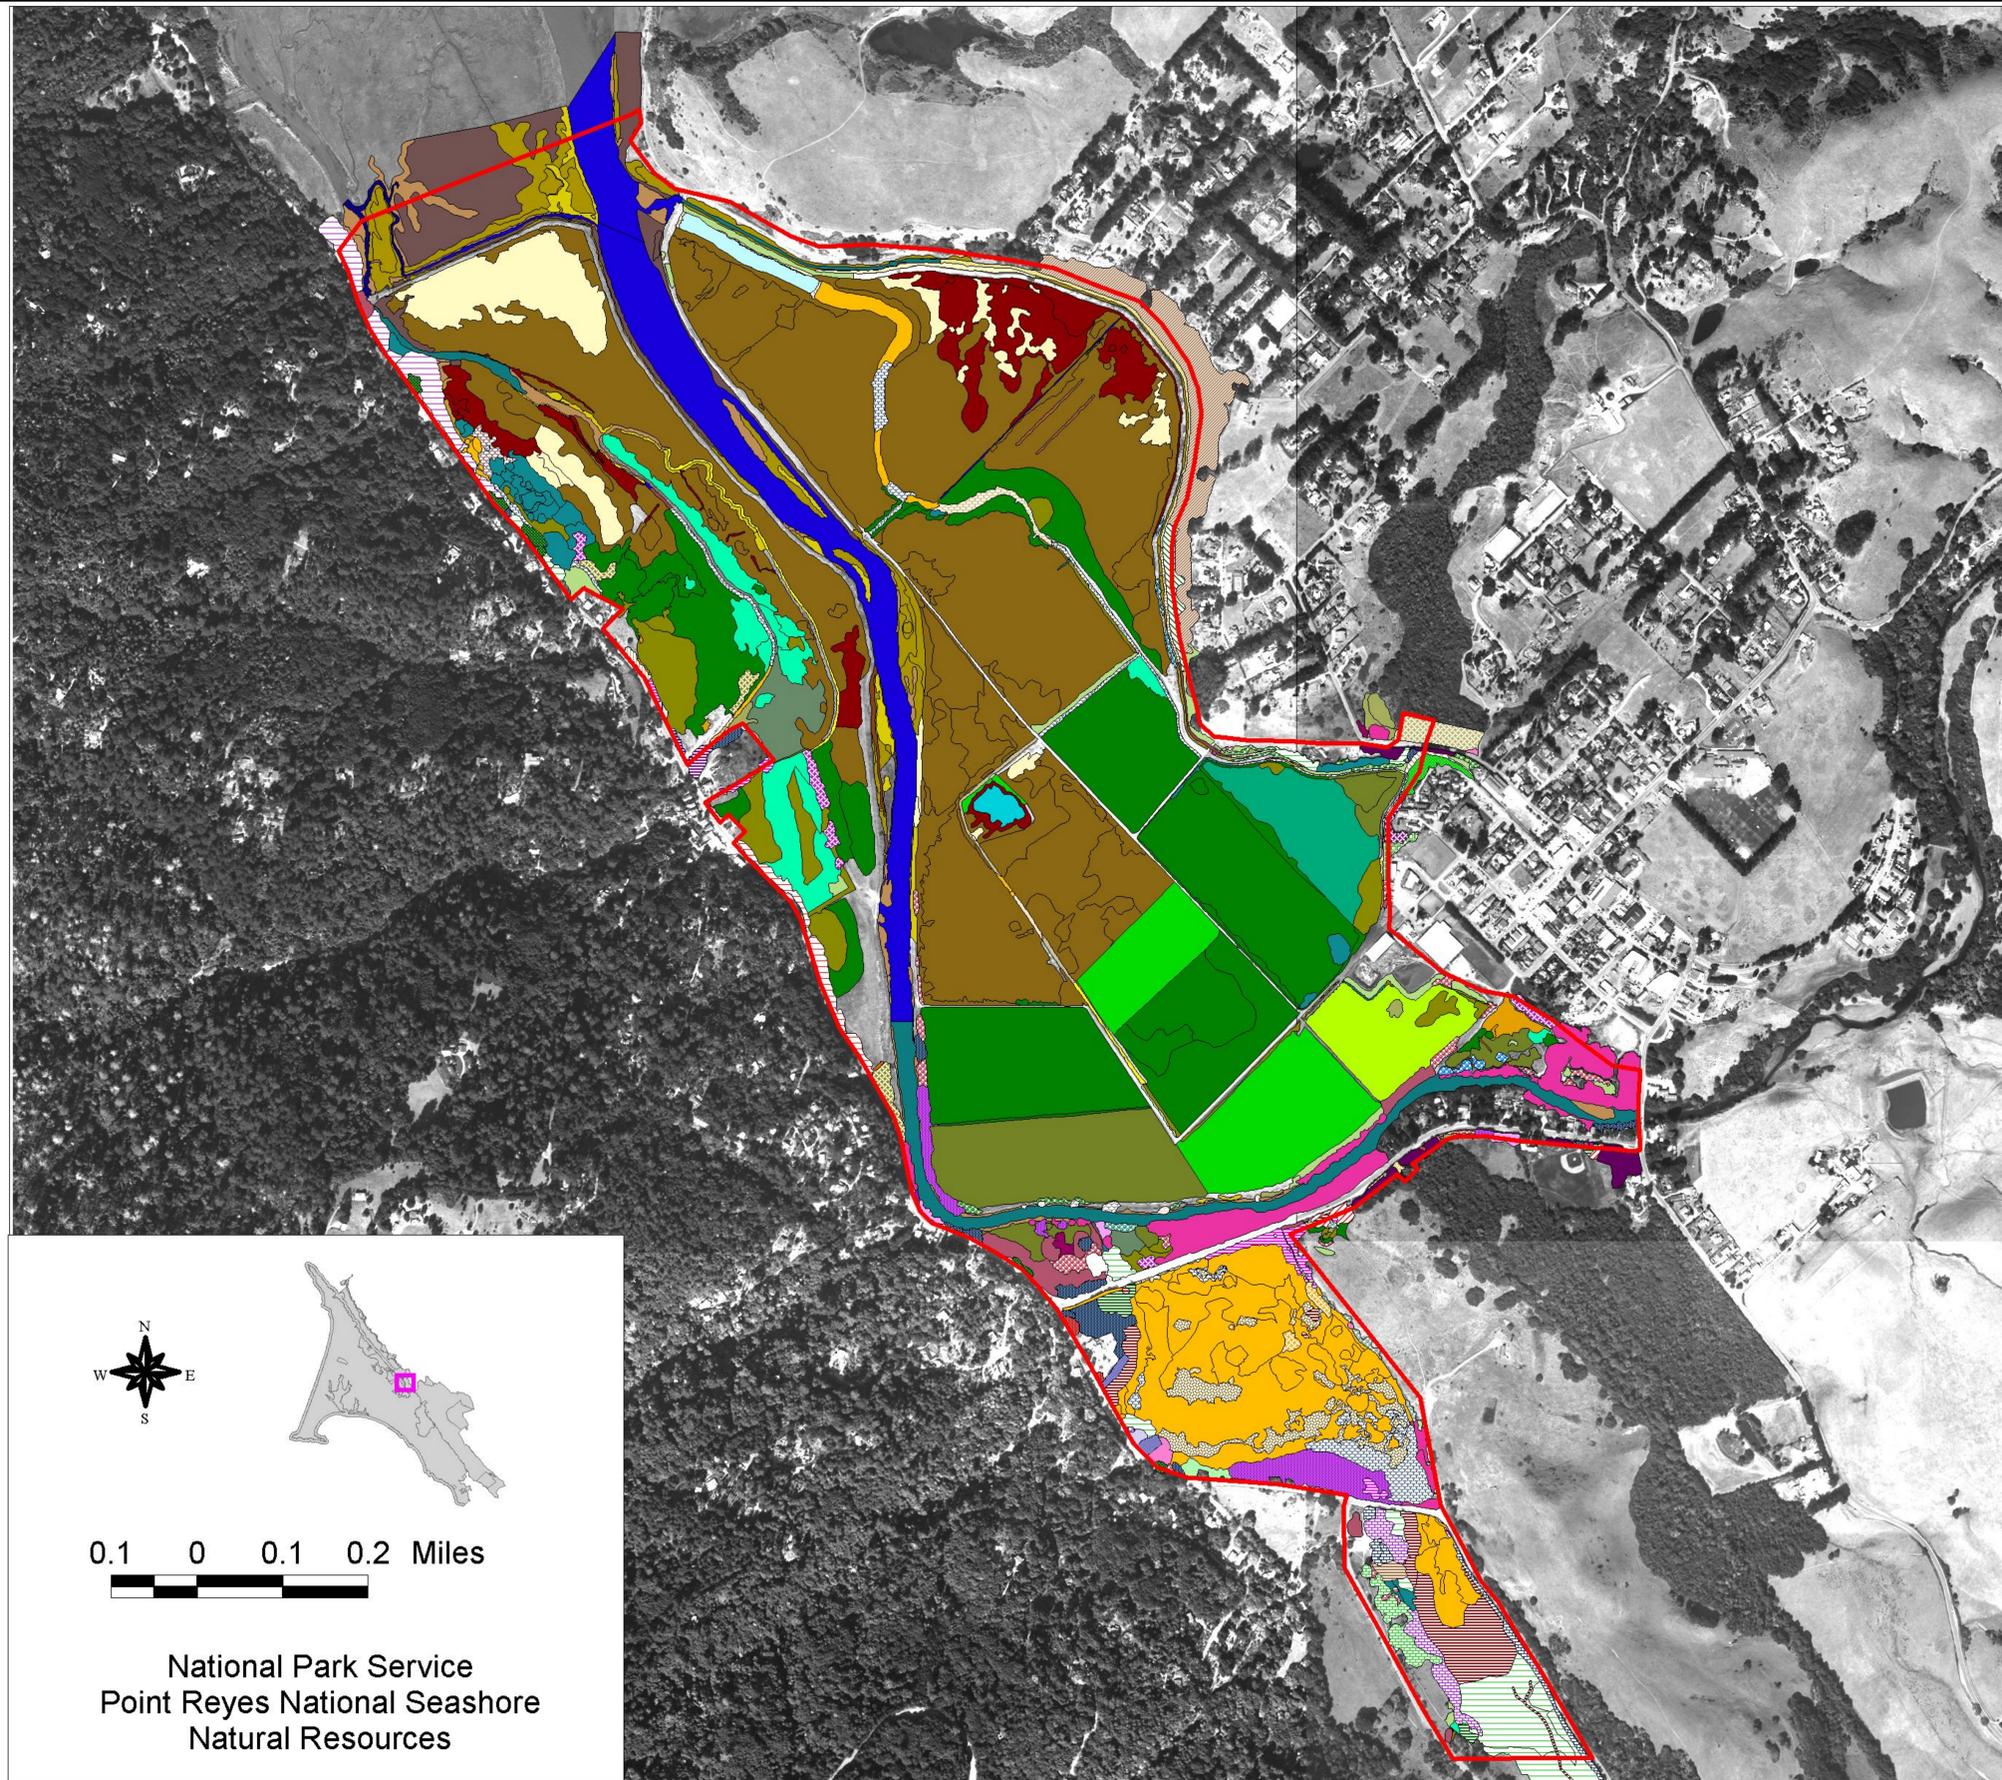
Figure 7. Wetlands delineated according to a modified Cowardin methodology. View of entire Project Area.

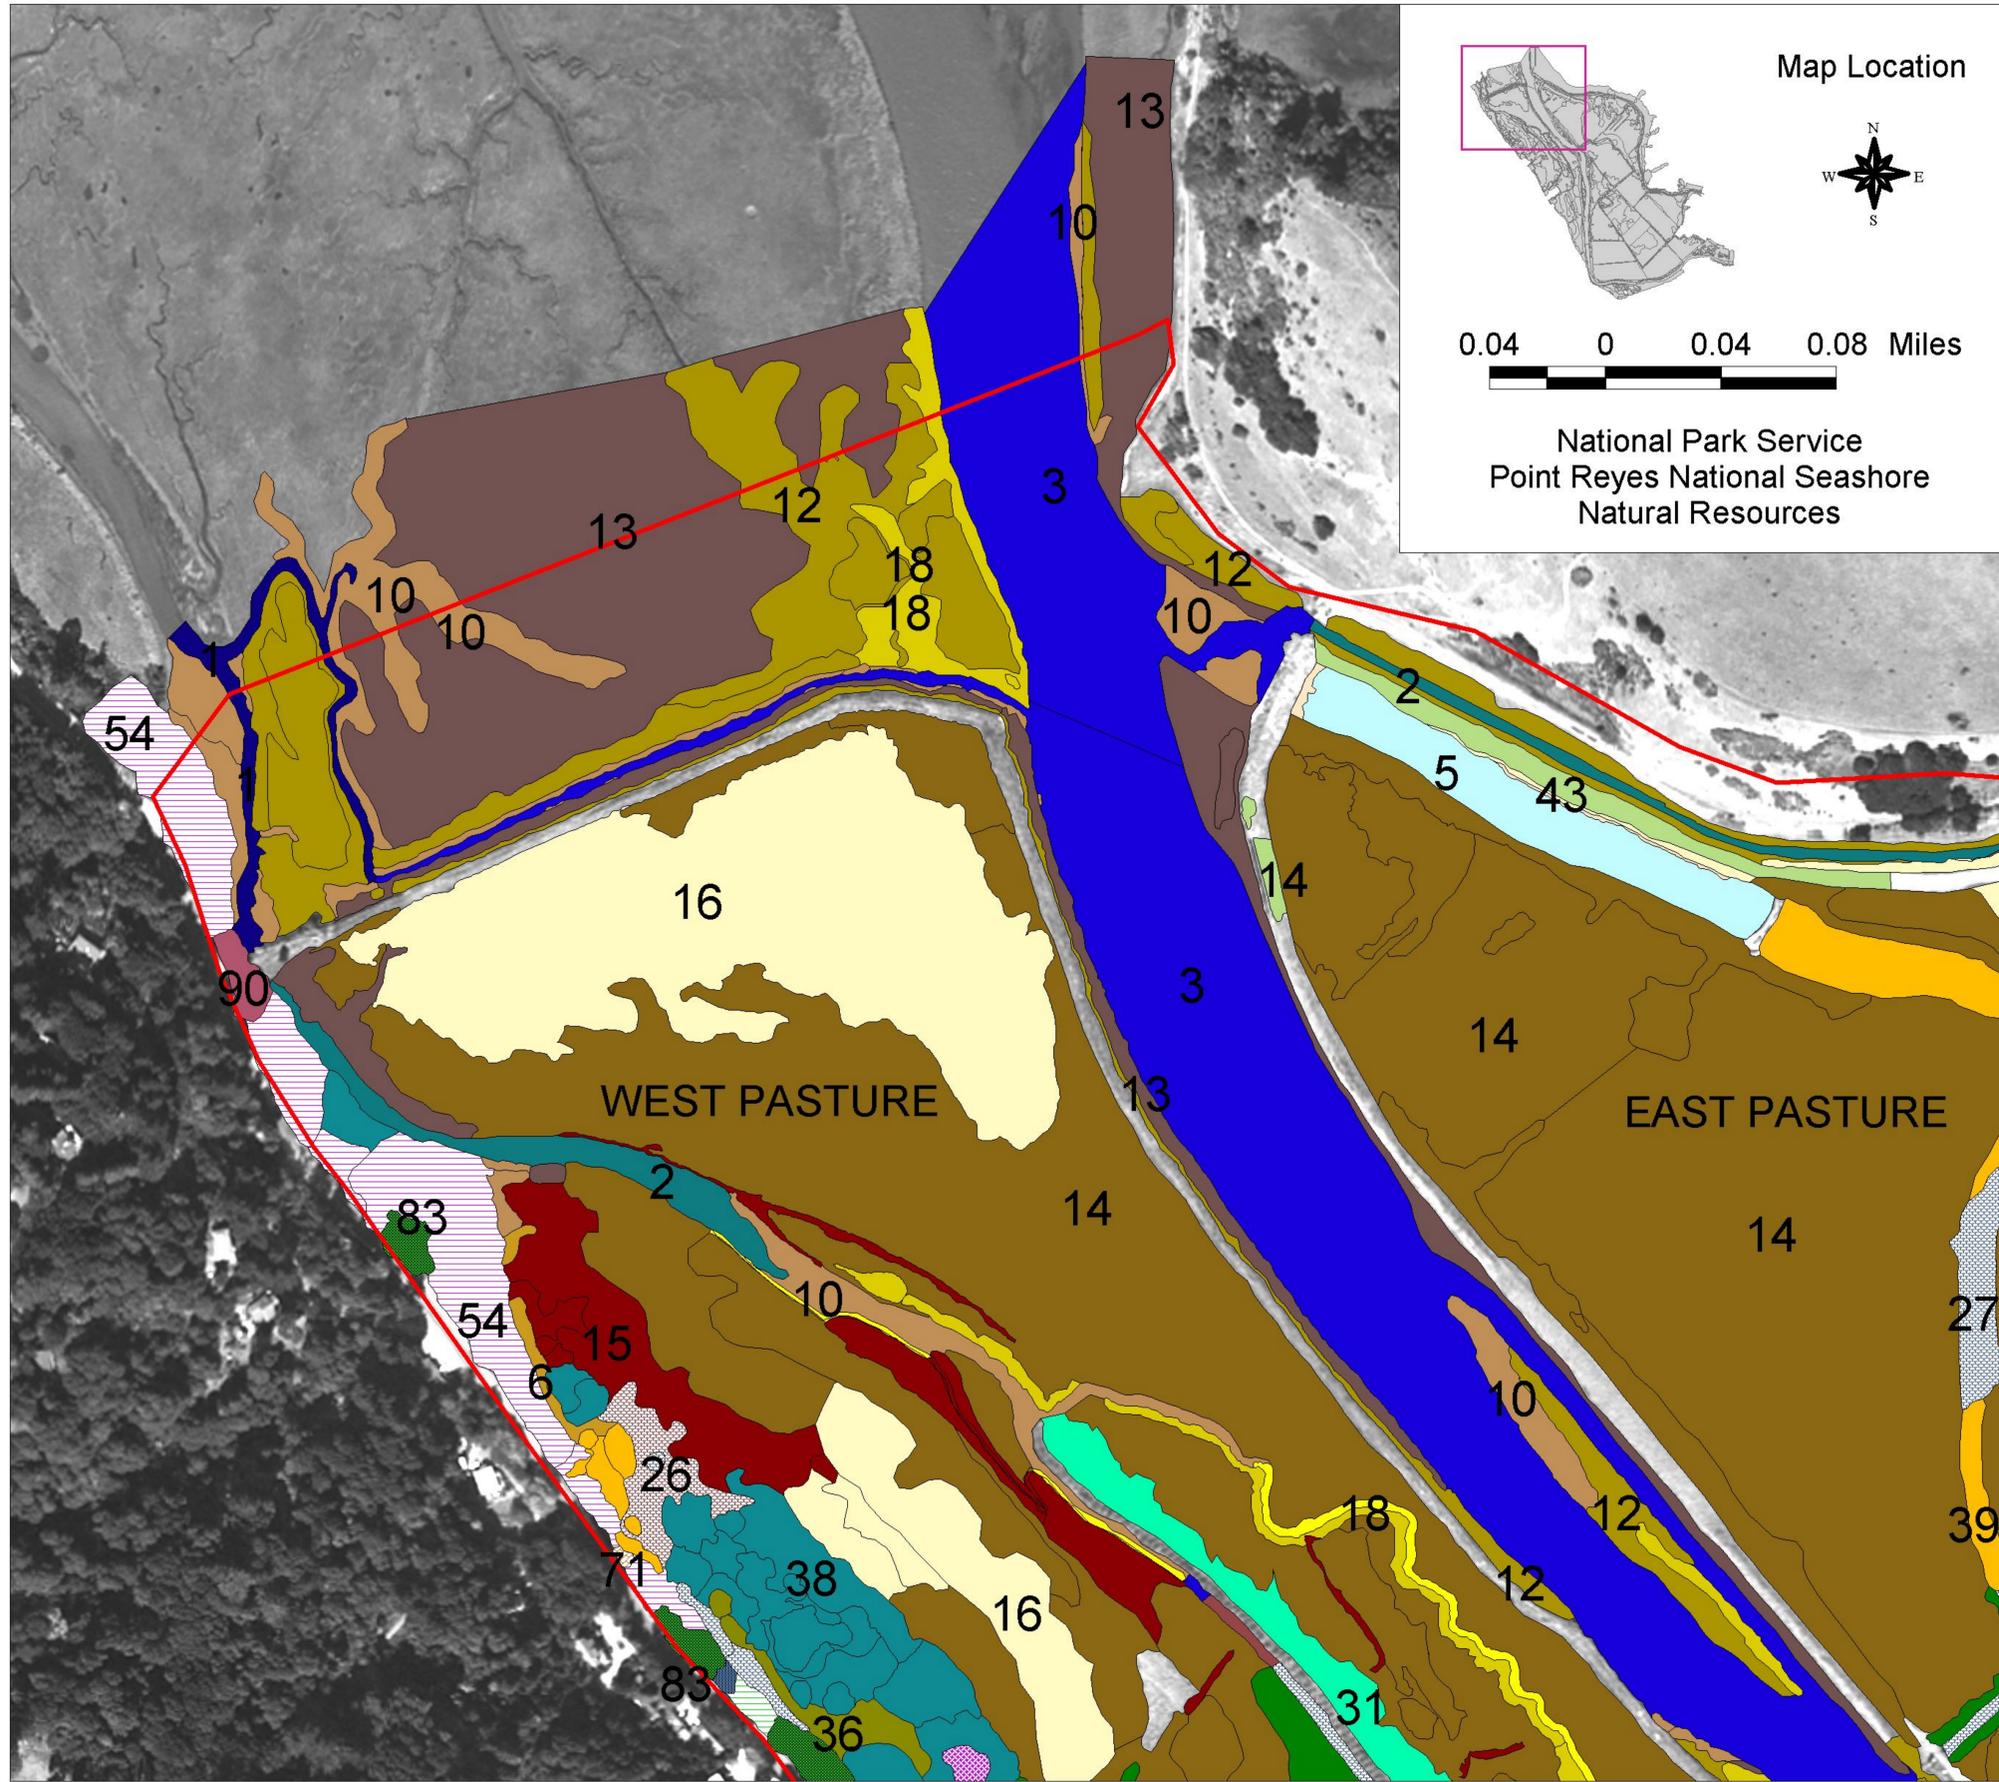
Figure 8. Detail of Cowardin wetlands in northern Project Area and vicinity.

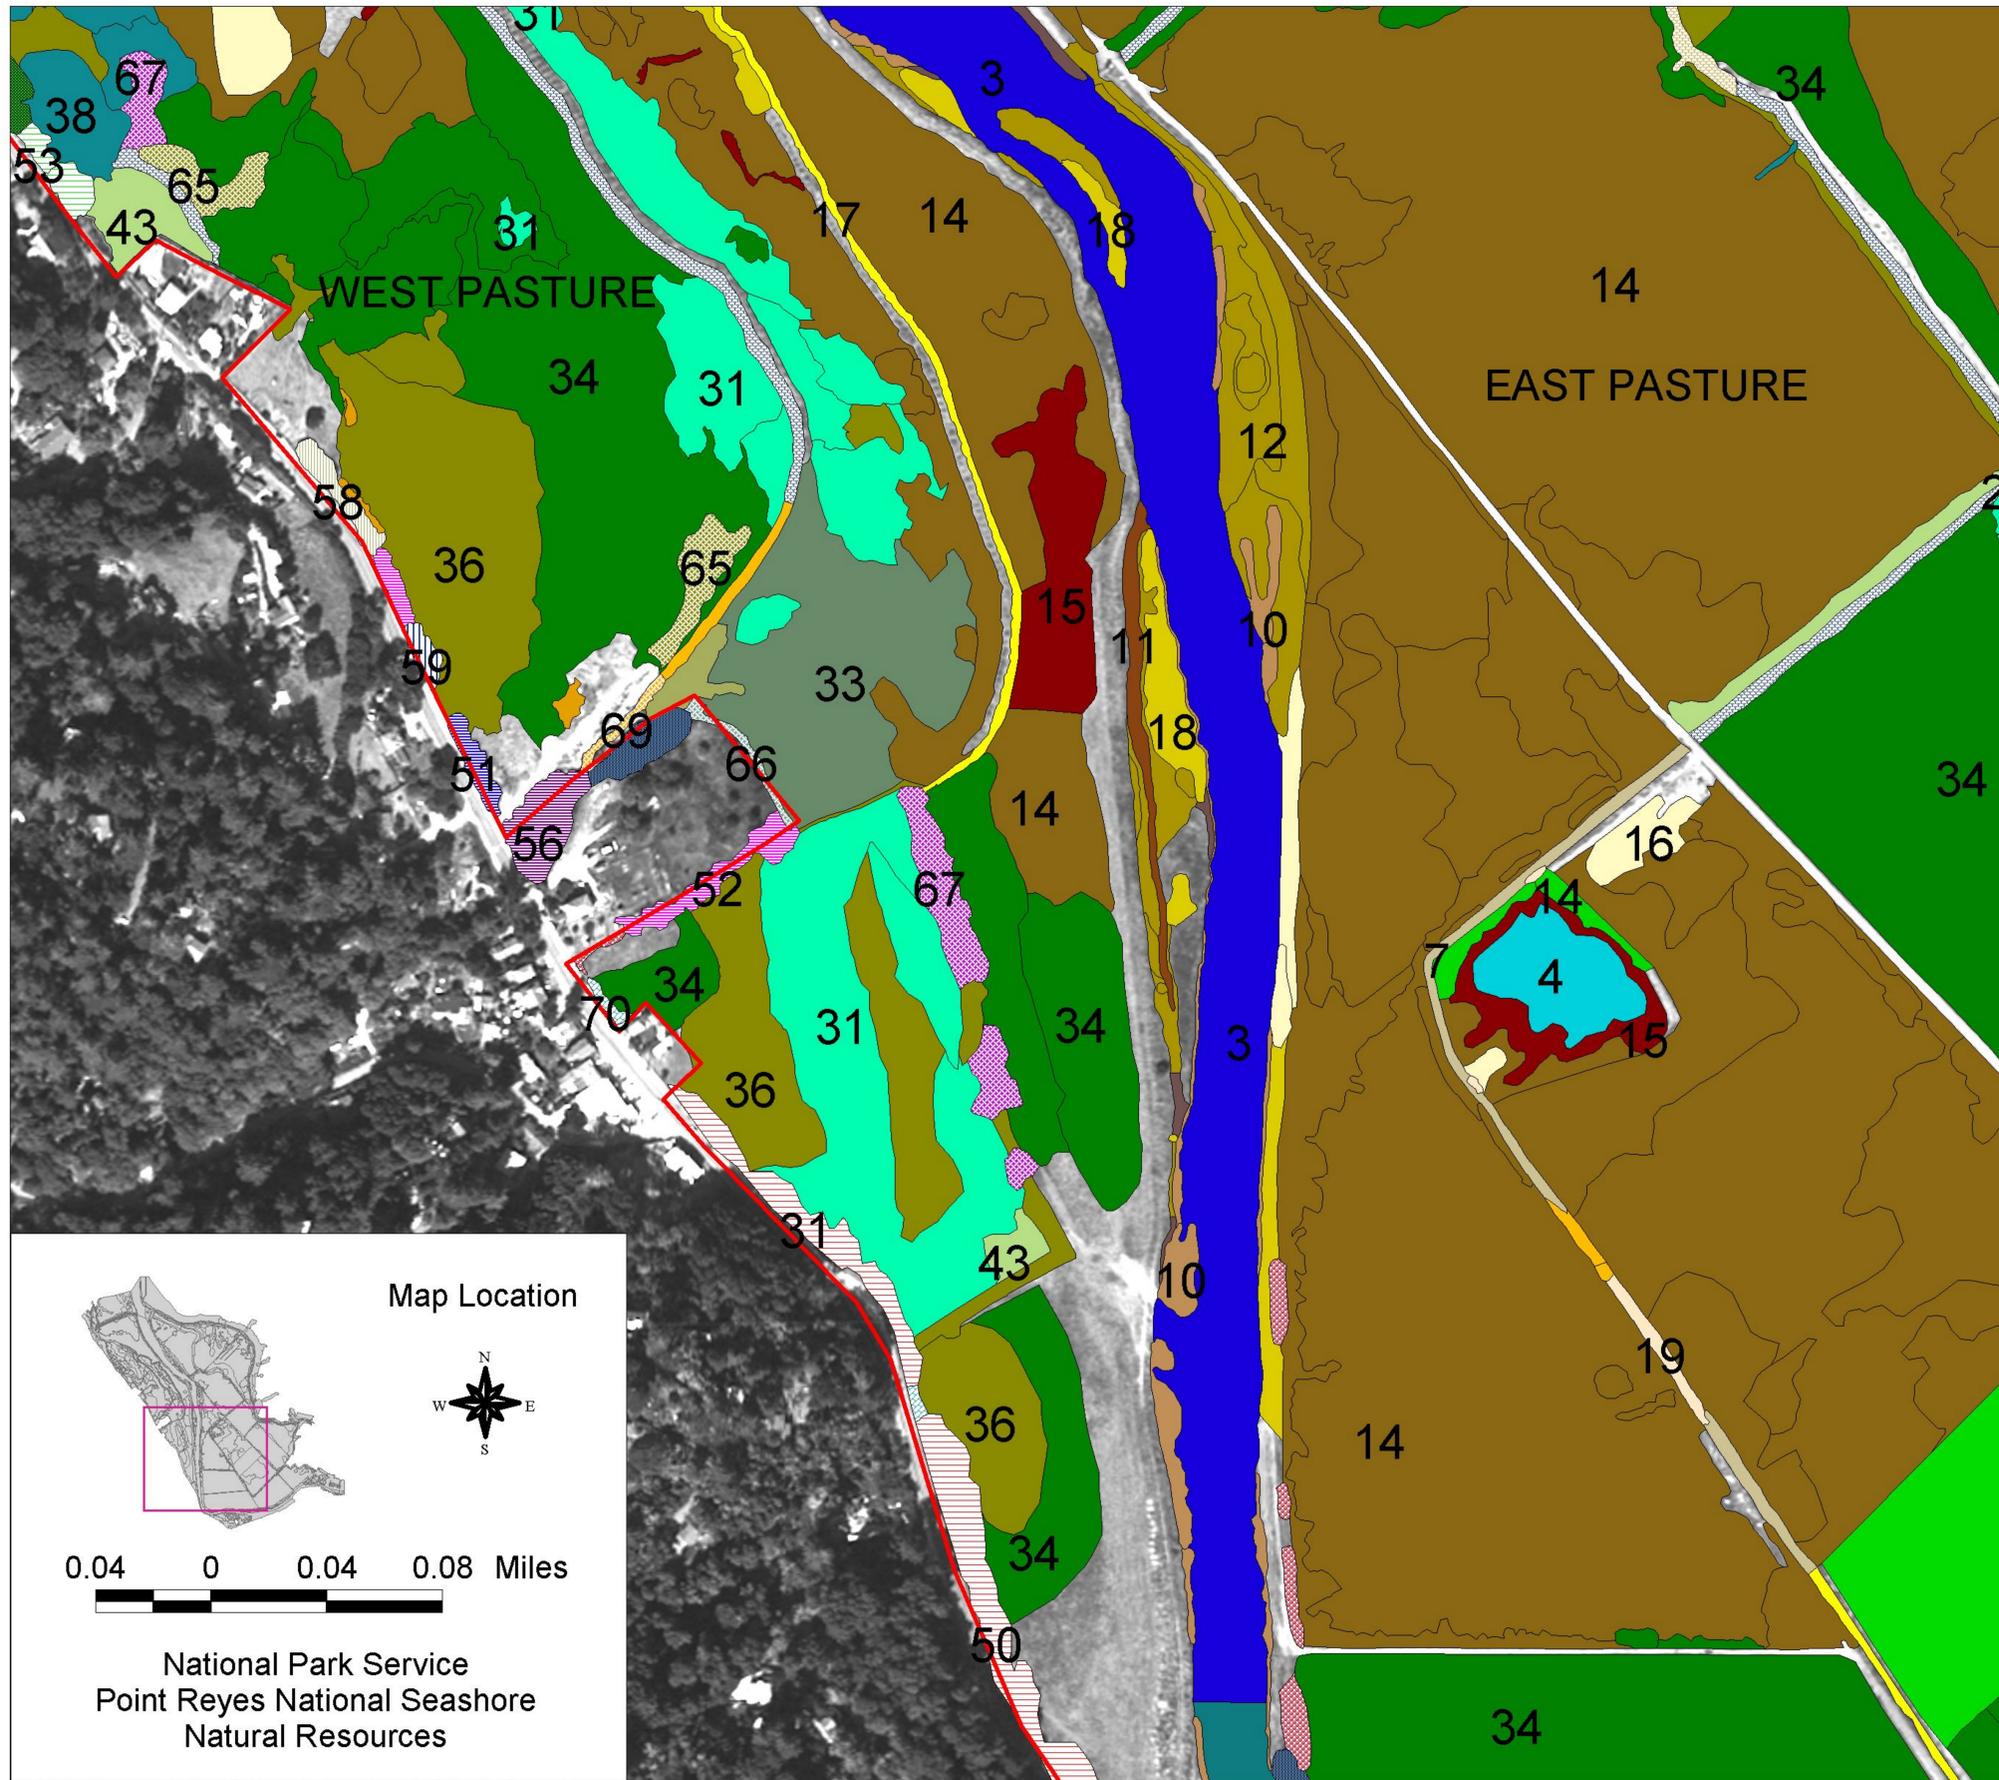
Figure 9. Detail of Cowardin wetlands in southwestern Project Area and vicinity.

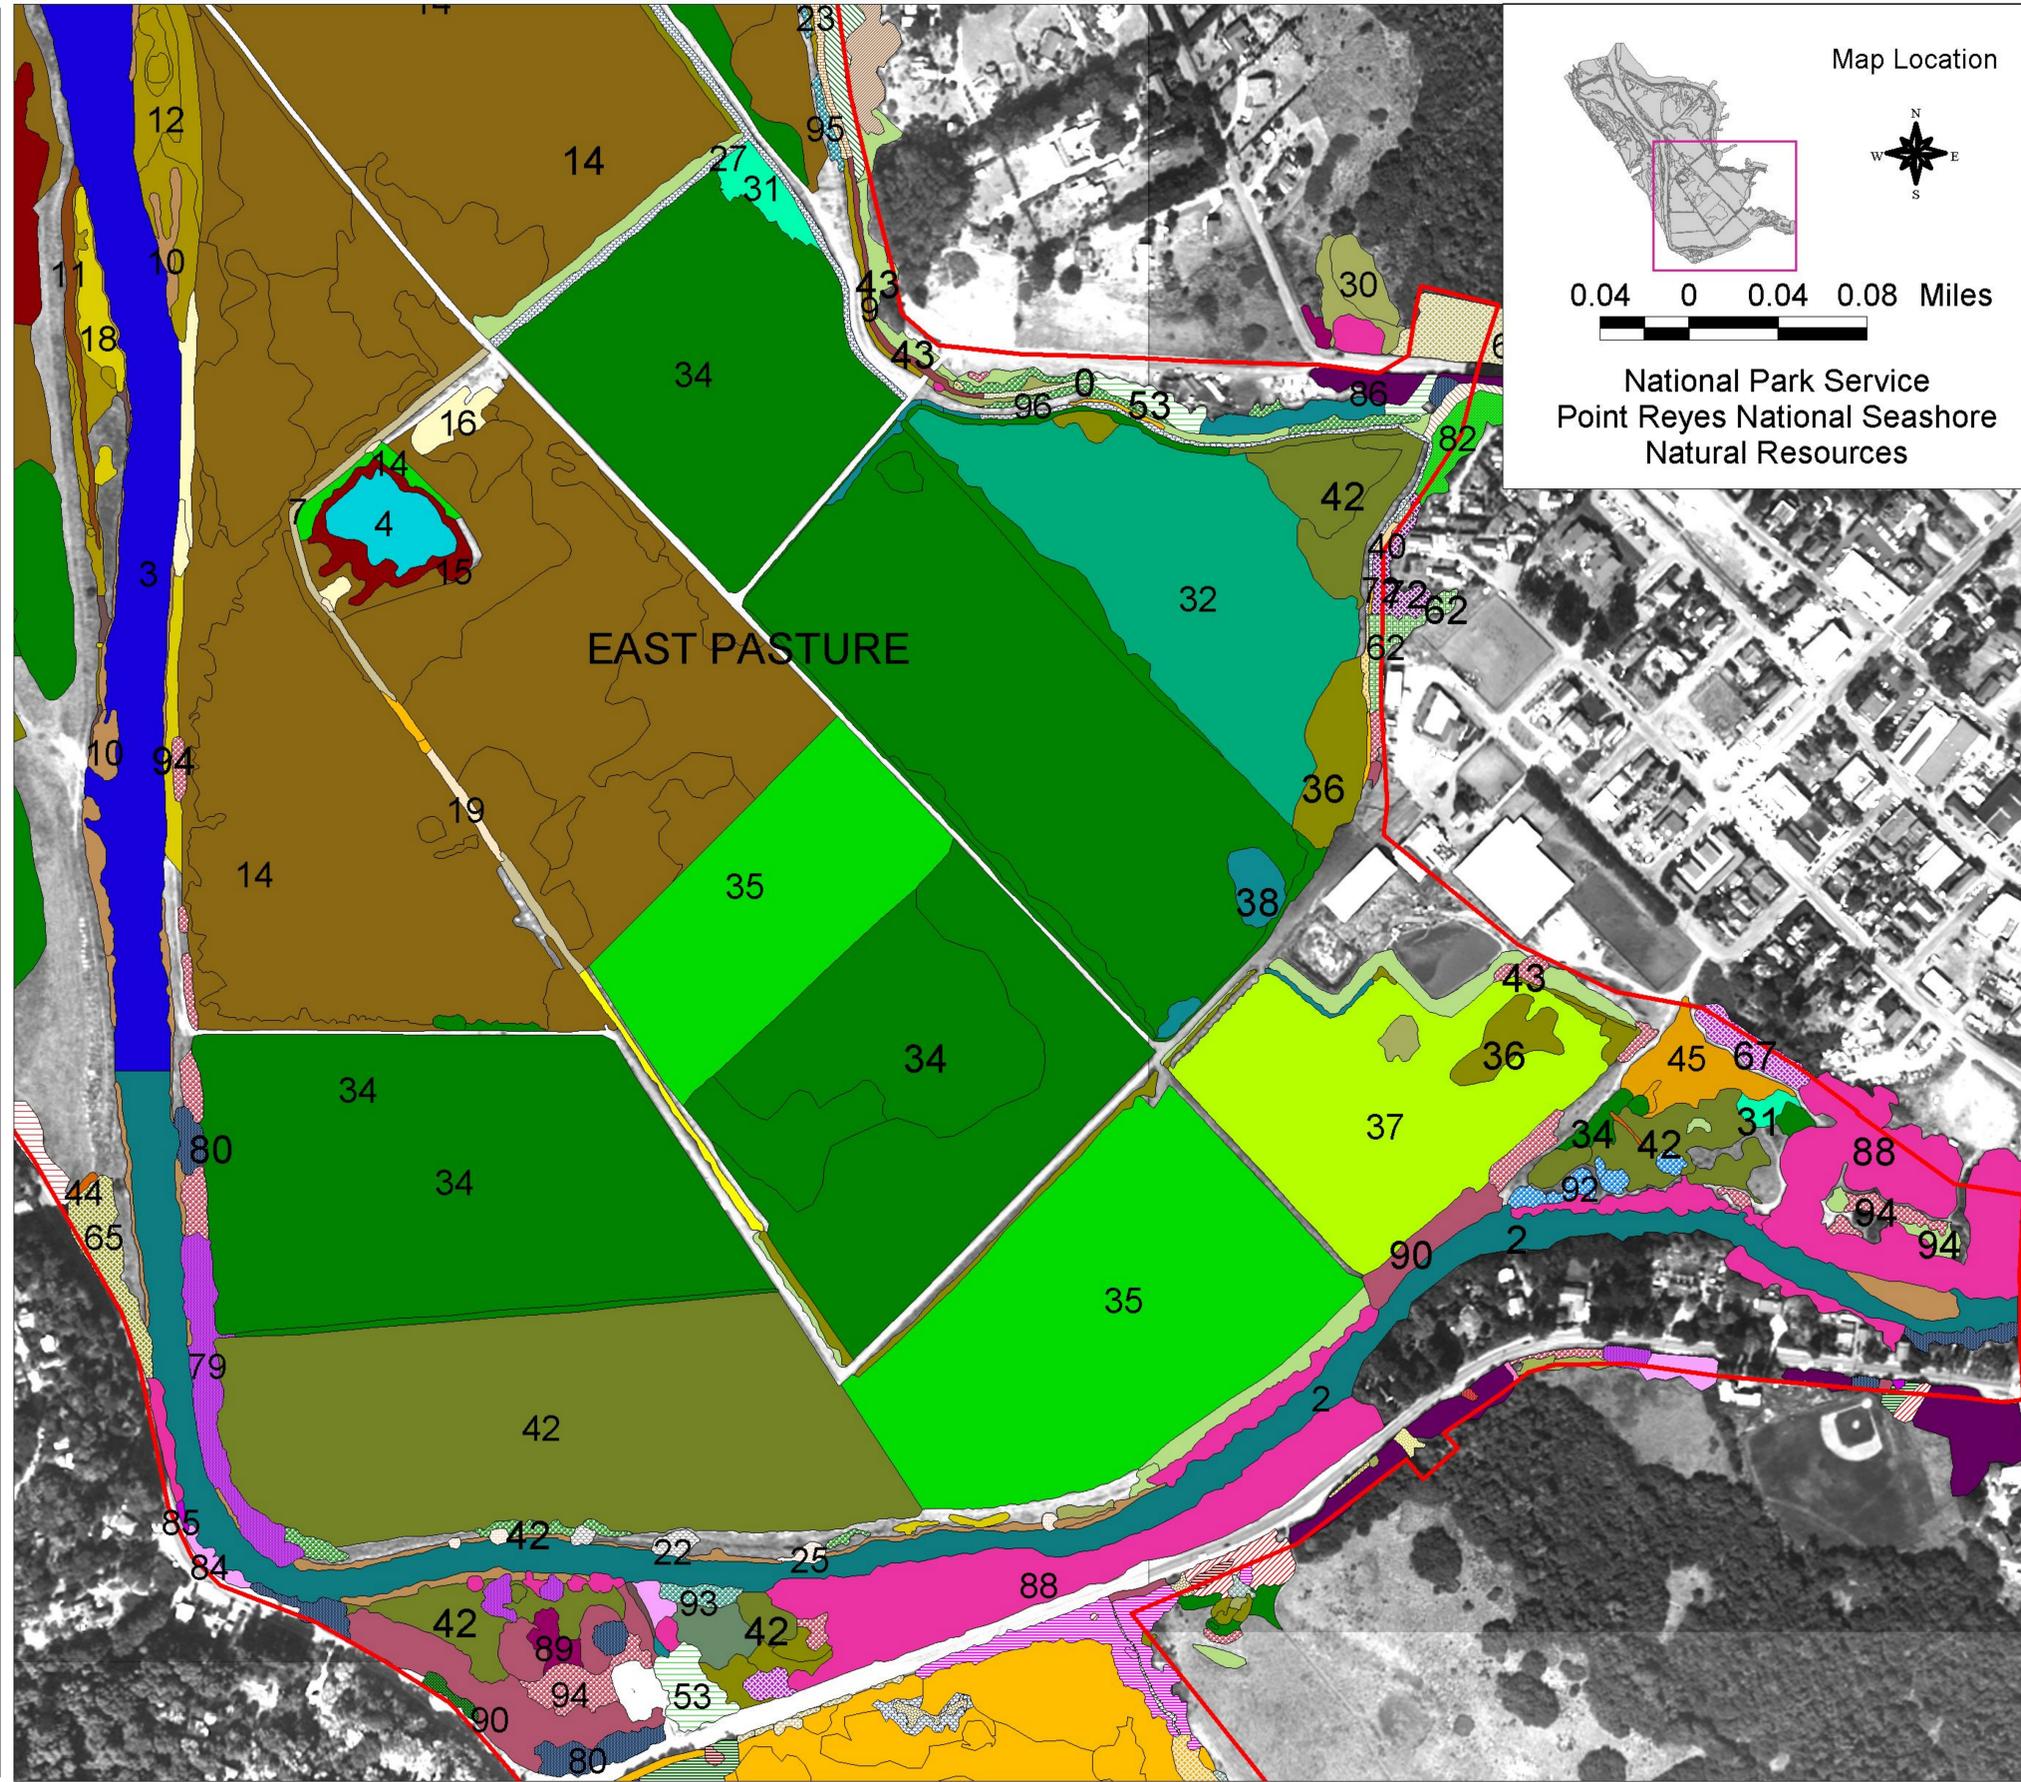
Figure 10. Detail of Cowardin wetlands in southern Project Area and vicinity.

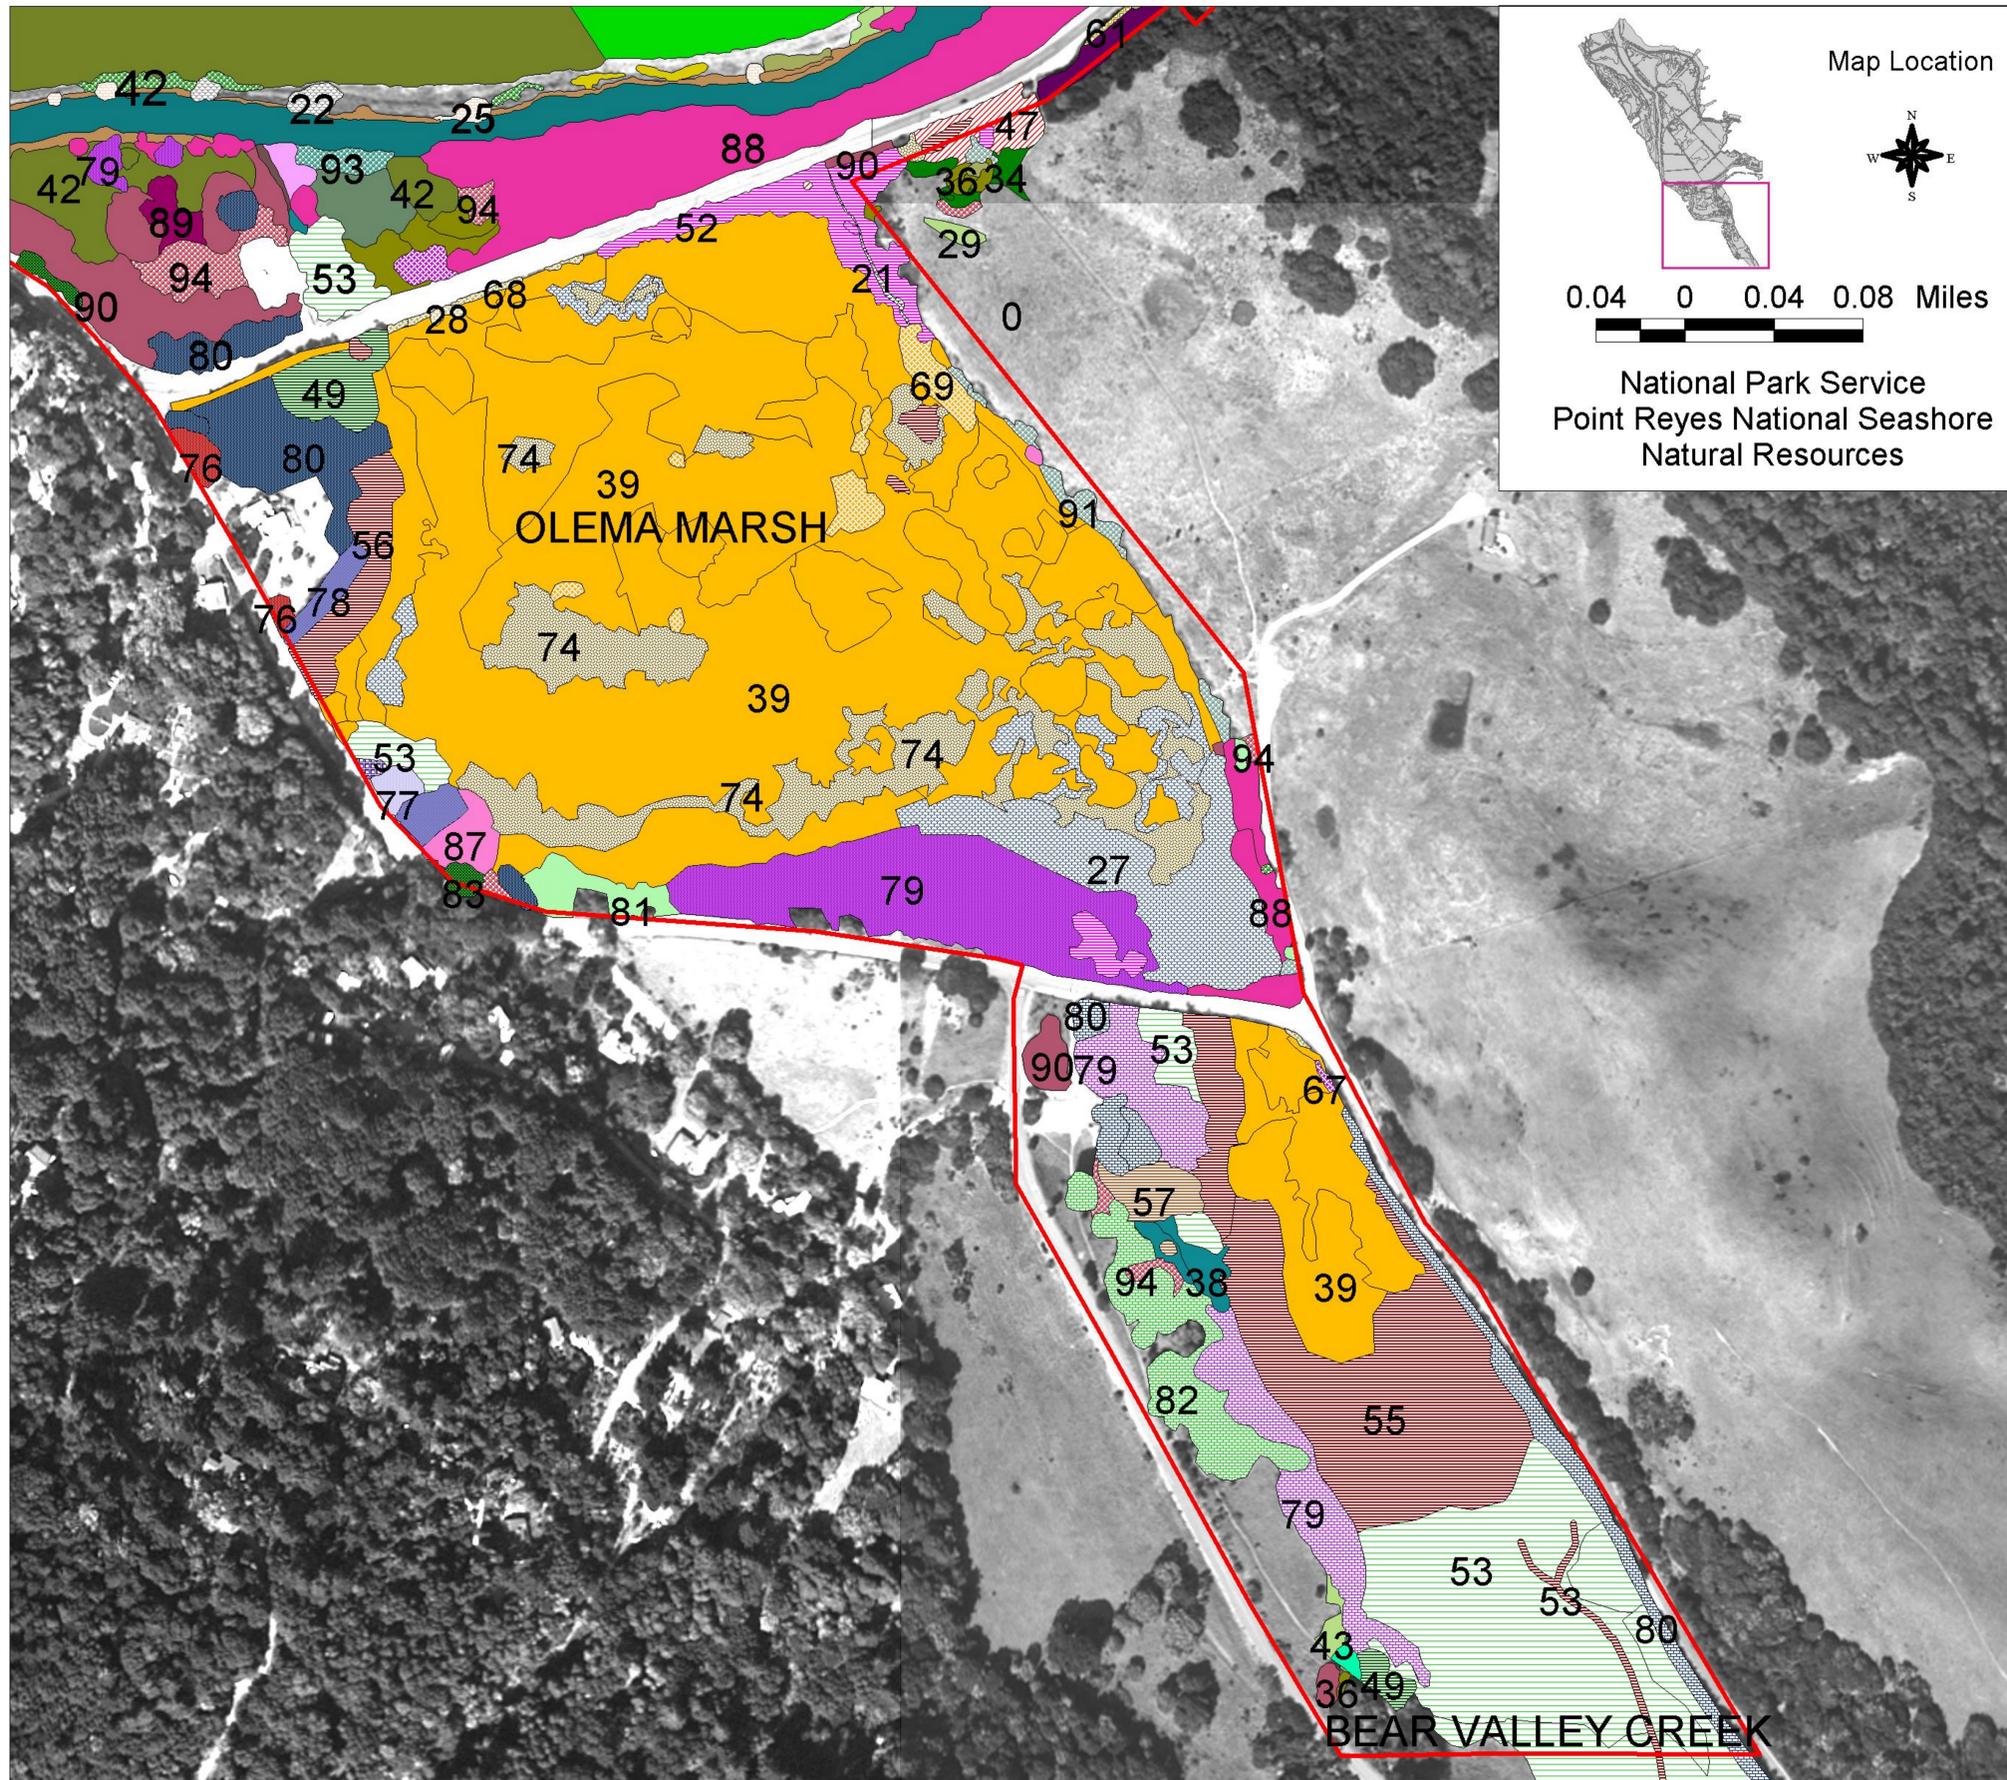
Figure 12. Detail of Cowardin wetlands in Olema Marsh, White House Pool, and northern portion of Bear Valley Creek.
