DELINEATION OF WETLANDS AND DEEPWATER HABITATS

GIACOMINI WETLAND RESTORATION PROJECT

MARIN COUNTY, CALIFORNIA

March 1, 2005

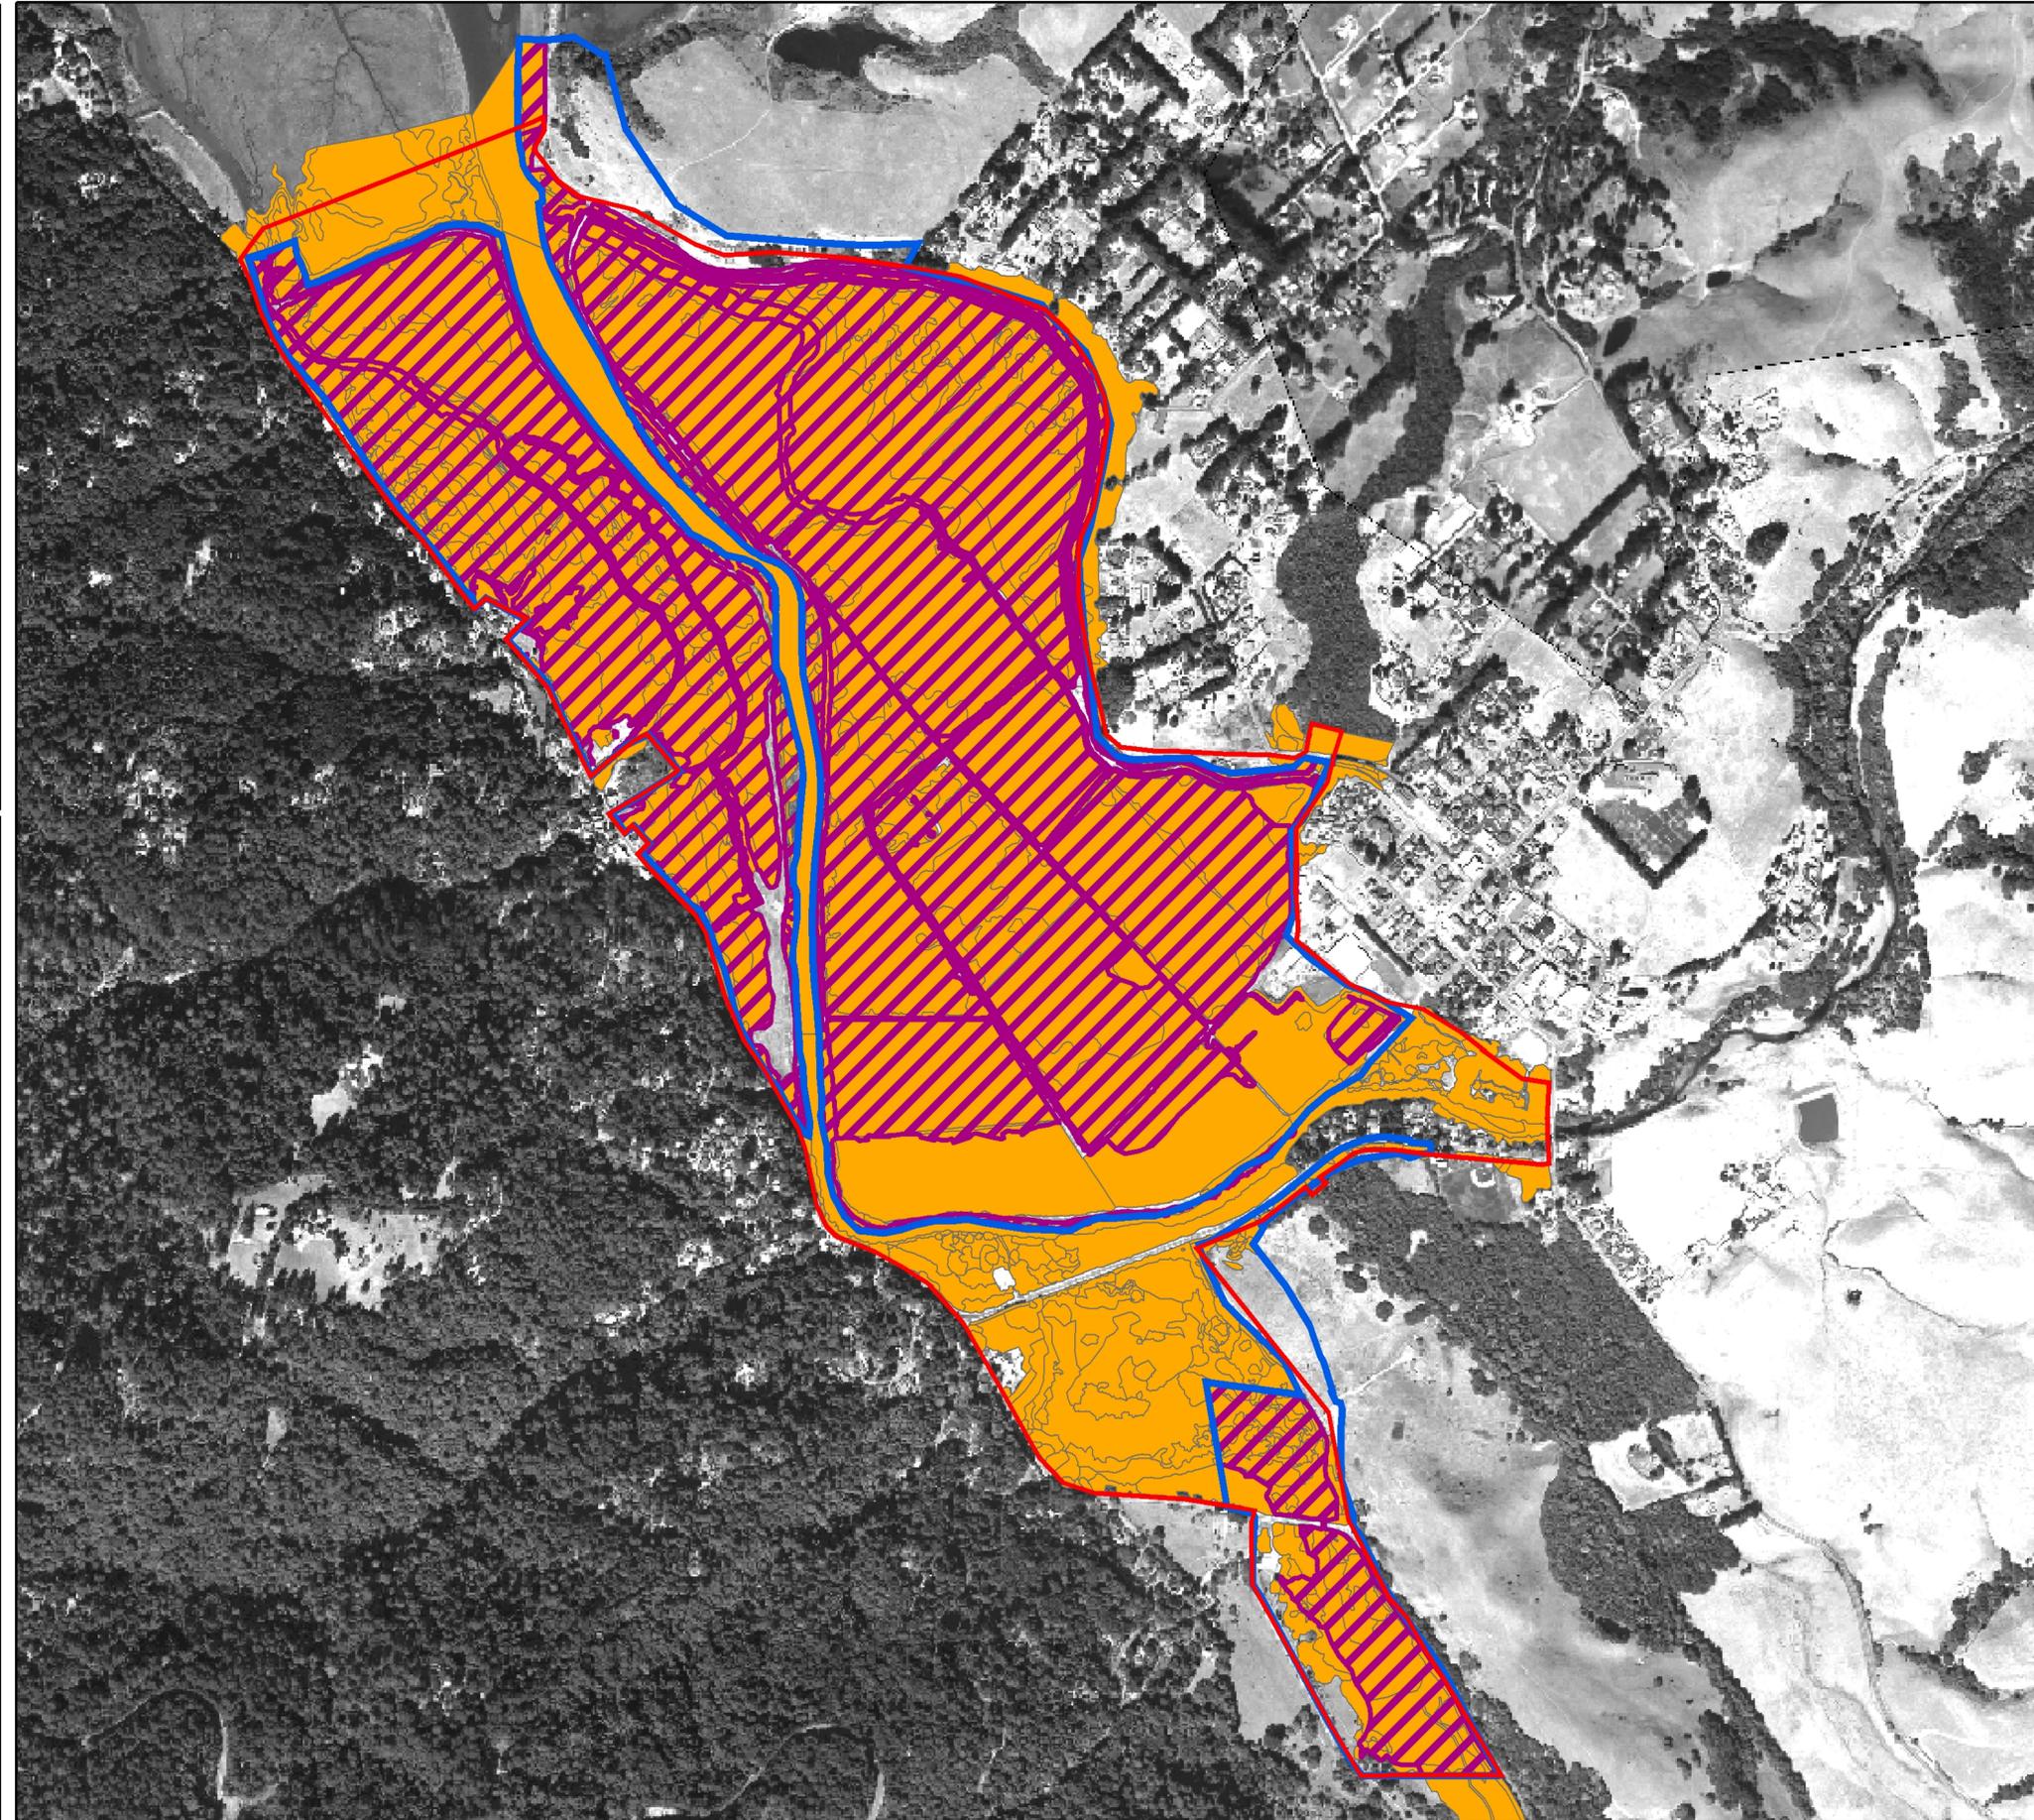
Figure 13. Wetlands delineated within the Giacomini Wetland Restoration Project Boundary according to Park Service and California Coastal Commission wetland delineation methodologies.
