**HORSESHOE POND RESTORATION PROJECT  
WETLAND DELINEATION REPORT**

**POINT REYES NATIONAL SEASHORE**

**Amy Parravano  
Wetland Biologist**

**Point Reyes National Seashore  
February 2002**

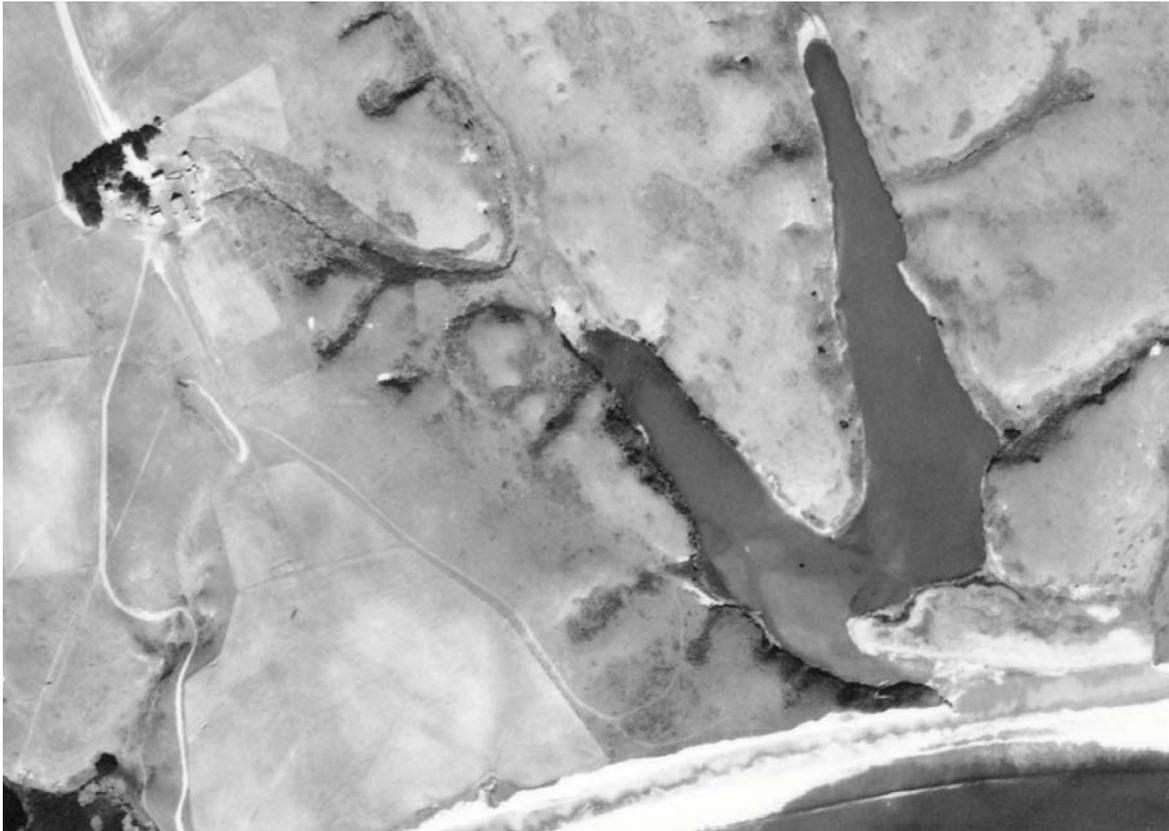
Figure 2. Aerial Photograph Illustrating Historic Outflow of Horseshoe Pond (PRNS Archives 1943)

Aerial photos from 1941 and 1943 reveal that the historic outflow of Horseshoe Pond existed in the southwest corner of the pond, opposite the current channel out onto Drakes' Beach (Figure 2). Visible in these photographs is a broad, sandy channel set against the west slope of the drainage. A large plume of sand is seen washed far into the pond from the channel. From these historic photos, the current channel on the west side of the pond appears to be dominated by exterior dune vegetation and interior wetland vegetation. The 1941 photograph, taken in December, shows a small pond set just behind the foredune.
