Watershed Restoration

The Redwood Creek Legacy

From Protecting Redwoods to Restoring a Watershed

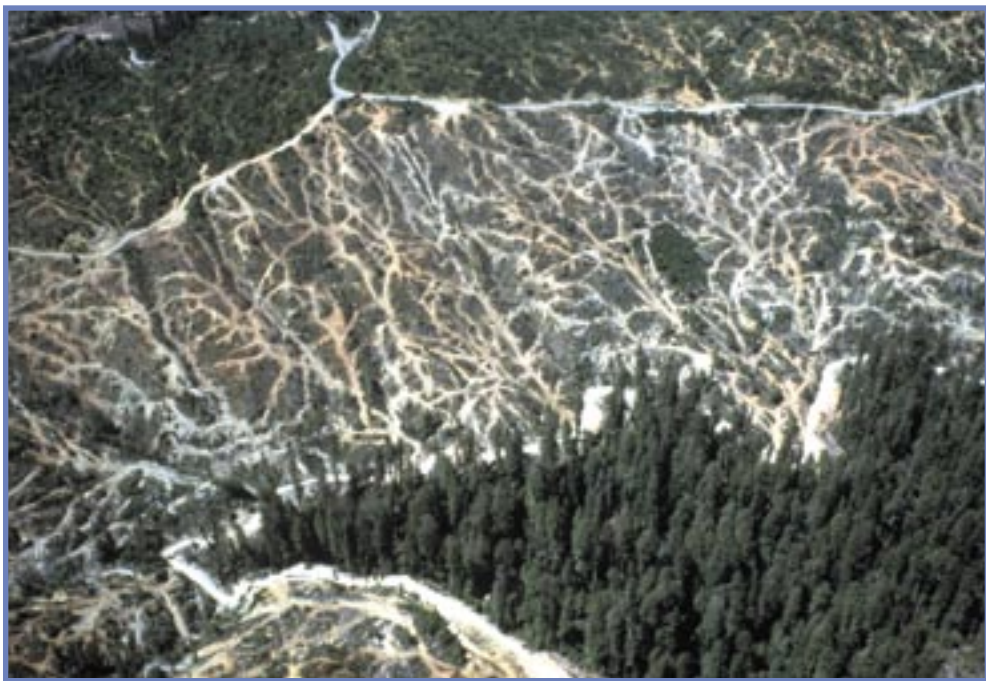
Bond Creek, a tributary of Redwood Creek, in 1978. The web of “skid” roads provided access to individual trees. Once a tree was cut down, a bulldozer dragged (skidded) the log to the nearest landing on a haul road (visible at the top and bottom of this photo).

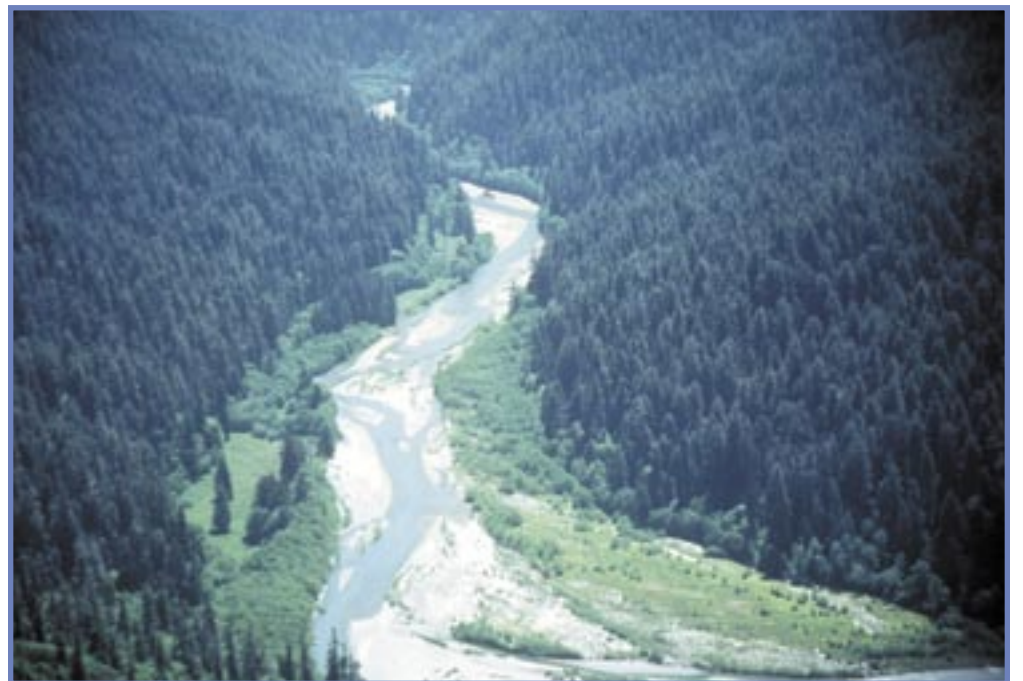
Lower Redwood Creek in 1983. This section of the watershed has been preserved since 1968 when Redwood National Park was created. Timber harvesting continues upstream of the park and sediment from eroding slopes travels into protected parklands.

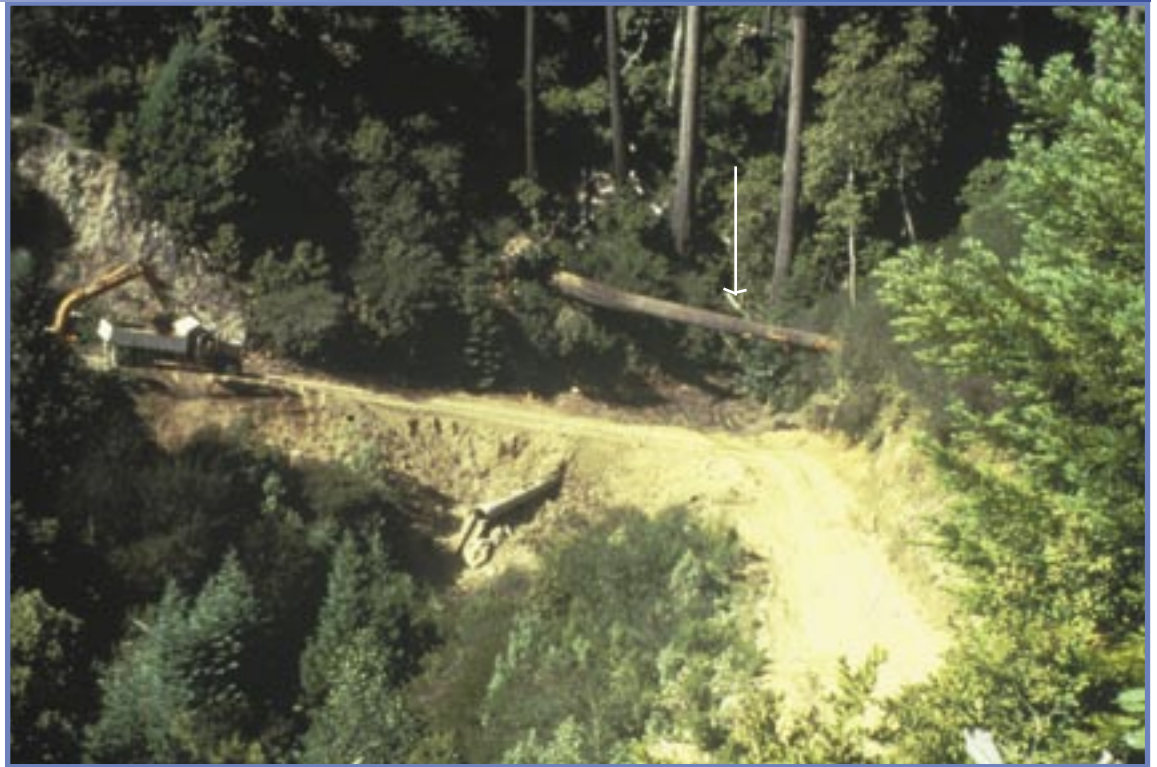
Above: Logging road crossing on Emerald Creek just prior to excavation.

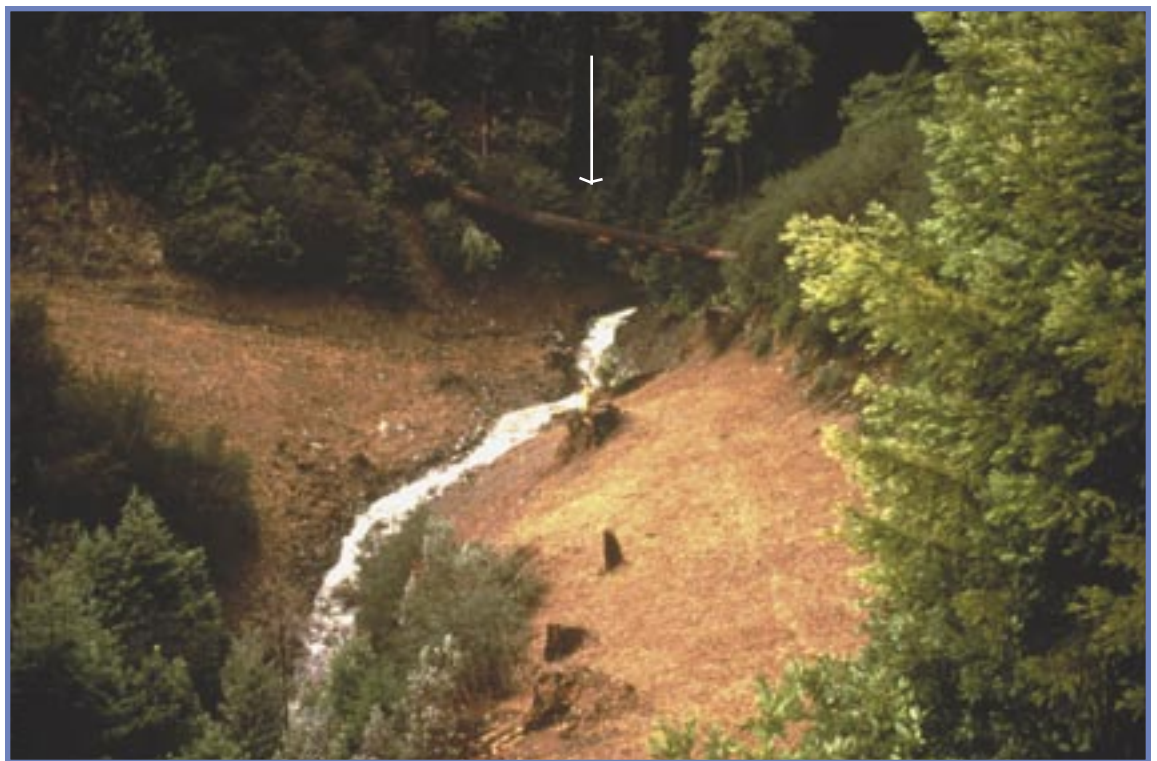
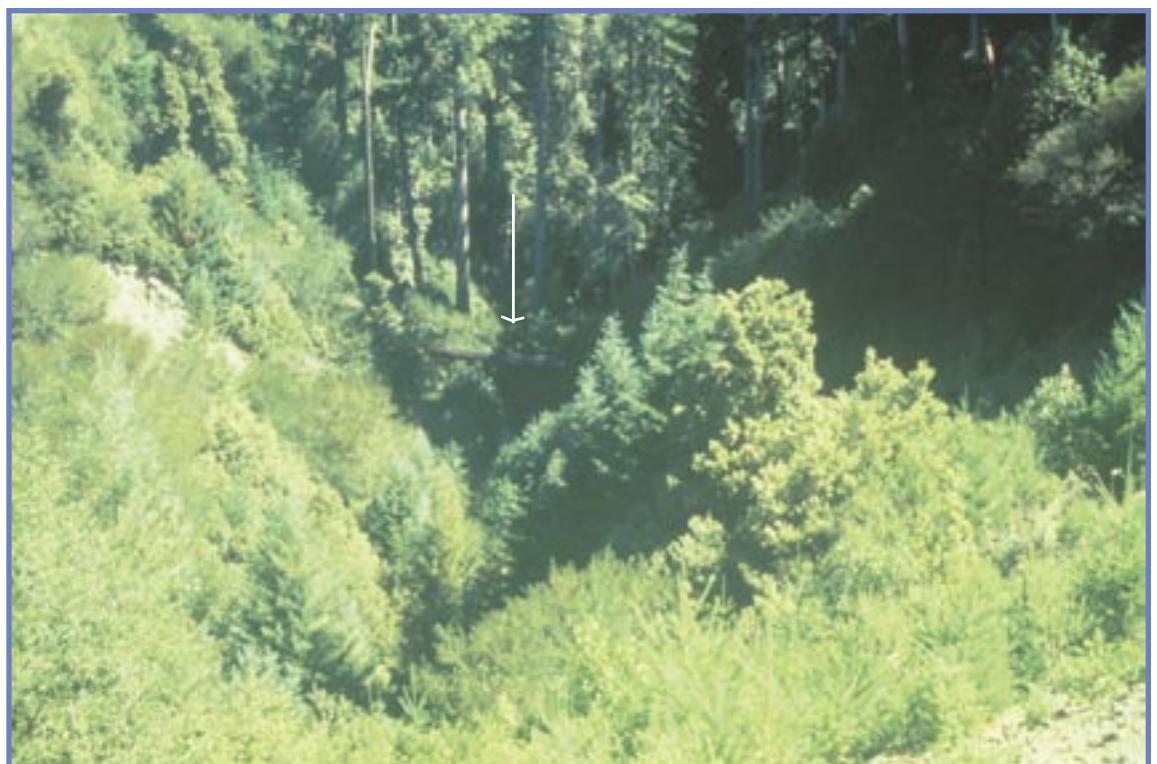
Above: Emerald Creek during storm one year after restoration. Below: Emerald Creek six years later.

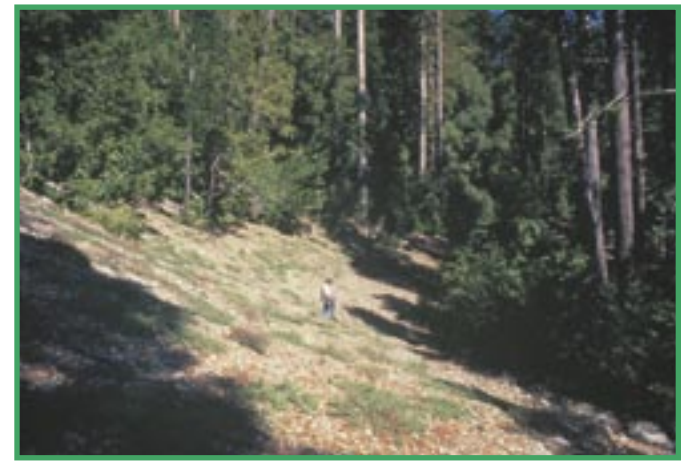
A logging road one year after removal. Topsoil uncovered from beneath the road allows the area to revegetate naturally.

As equipment techniques improved, another significant discovery occurred. The topsoil and stream channel beds that had been buried during road construction could be successfully uncovered. Rather than designing excavations according to engineered specifications, the equipment operators and park geologists worked together as a team to find and uncover the natural shape and features of the land.

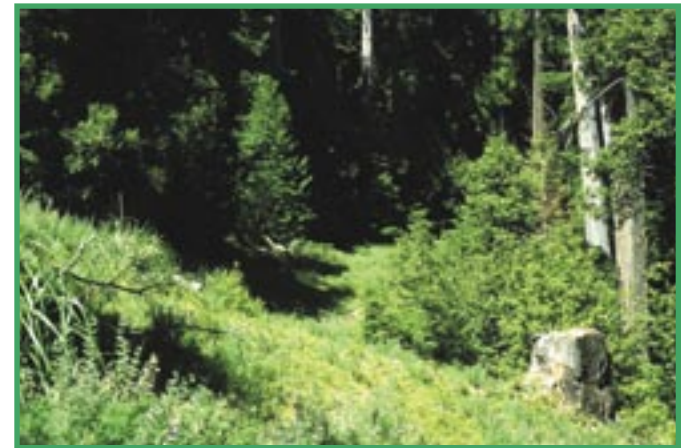
The same area four years later. Native forest species are reestablished in the rich topsoil.

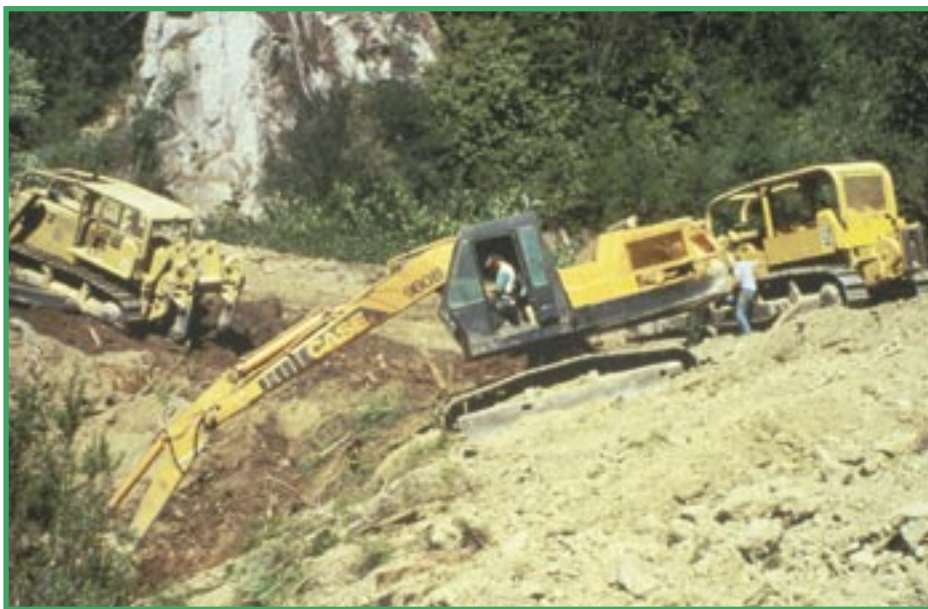
Geologists and heavy equipment operators work together as a team to ensure that they leave a naturally functioning ecosystem after road removal.

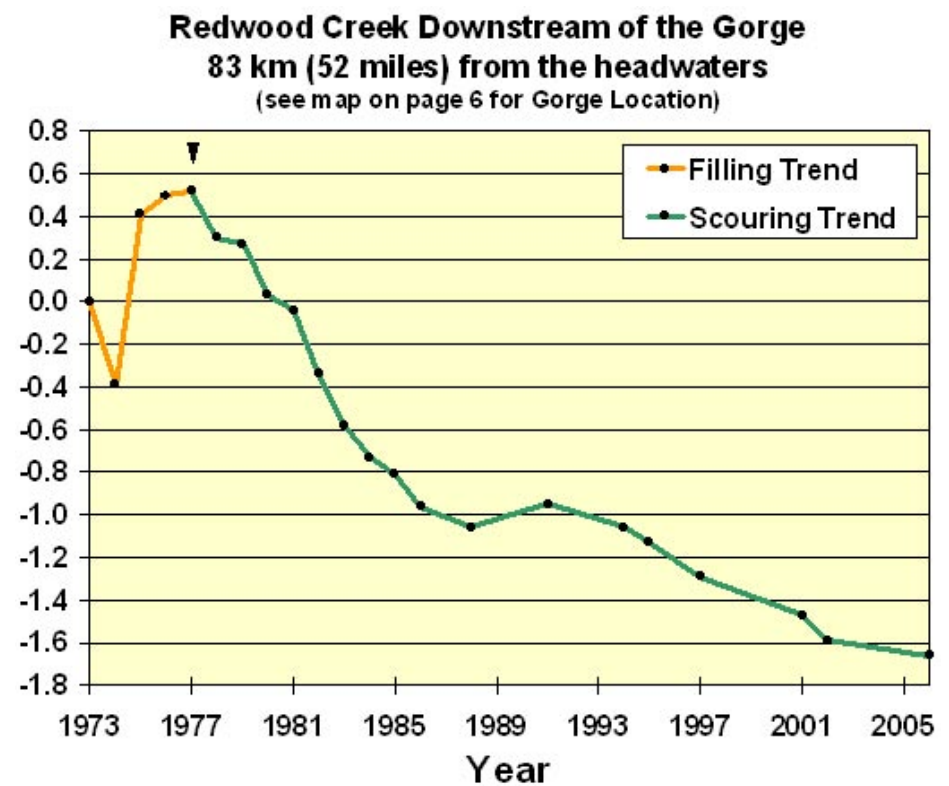
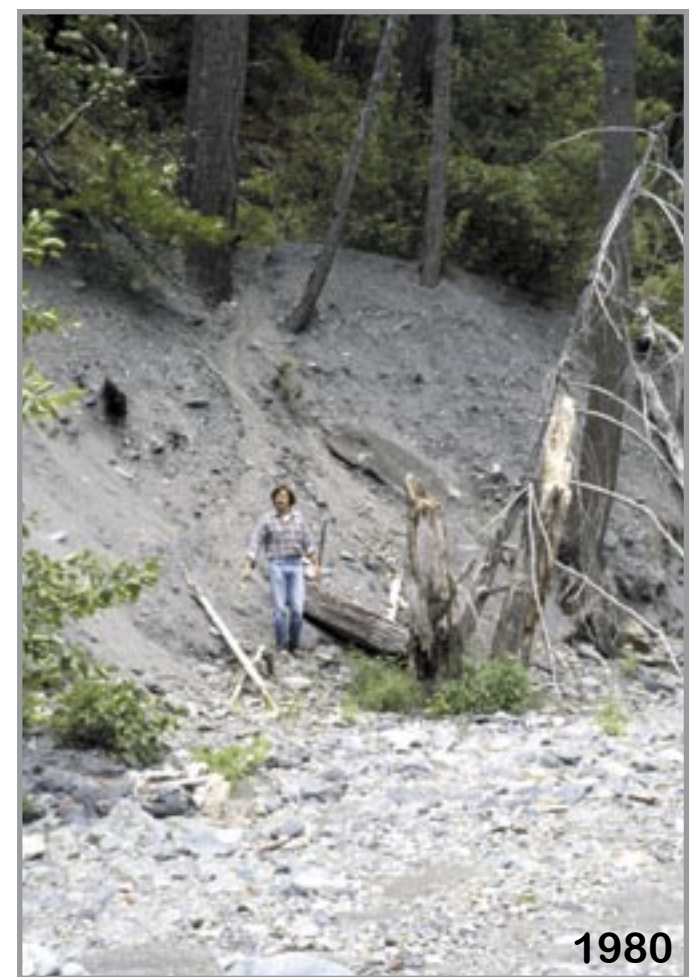
Above, during the flood of 1964 more than 20 feet of sediment dumped into upper Redwood Creek, killing old-growth streamside trees. Since 1964, Redwood Creek has flushed much of that sediment downstream. The reexposed trees on the right died from being buried by sediment.

Top left, during the winter, a plume of sediment emanates from the mouth of Redwood Creek, altering life cycles of salmon, steelhead trout, marine mammals, and seabirds that depend on the river estuary for food, growth, and migration.

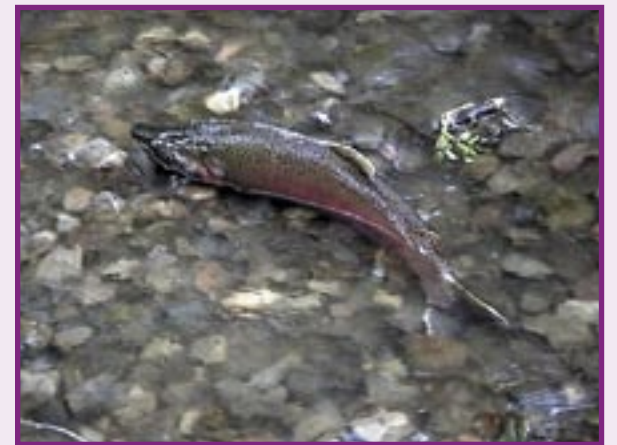
Sediment delivered to Redwood Creek during floods in the last five decades has significantly altered fish habitat and water quality. While the stream habitat is recovering from these past events, water quality is still impaired from high stream temperatures and heavy sediment loads. Salmon such as this adult coho require clean, pea to fist-sized gravels for spawning.

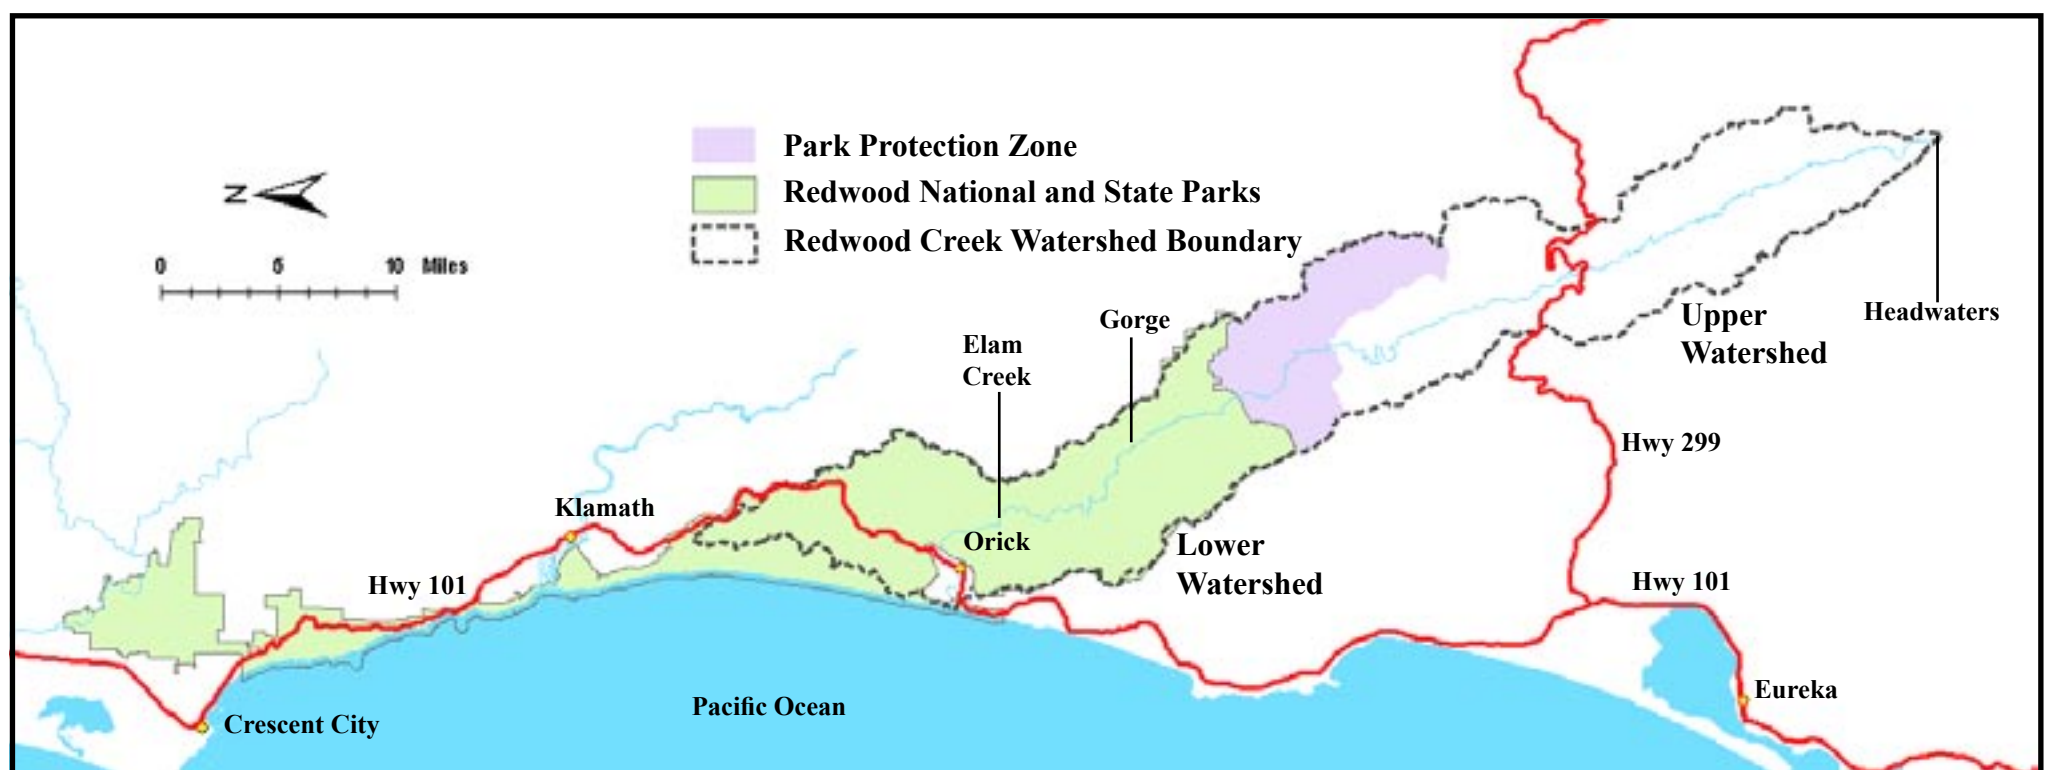
REDWOOD NATIONAL AND STATE PARKS AND REDWOOD CREEK WATERSHED

Logging of the Redwood Creek watershed began in the mid-1940s and continues on private land in the upper watershed. The flood of 1964 washed tons of sediment from the bare slopes into the channel. During the floods of 1972 and 1975, the sediment was flushed down the

channel, and by 1980, had reached the gorge above the Tall Trees Grove. It has taken more than 20 years for the wave of sediment to move from the gorge to Elam Creek, where it resides today.

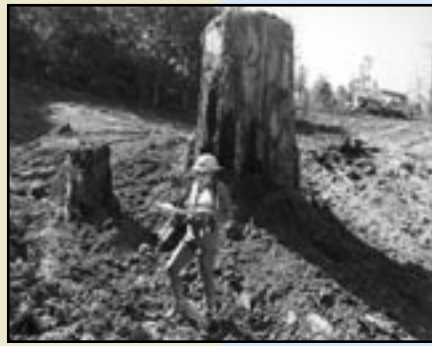
Geologist Terry Spreiter in front of an "unearthed" redwood stump in 1983.

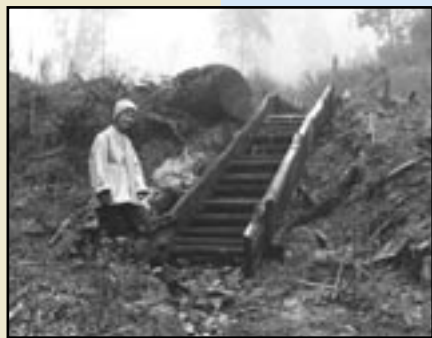
Geologist Mary Ann Madej beside an experimental water ladder in 1979.
