National Park Service  
U.S. Department of Interior  
Rocky Mountain National Park

## Front Range Floods Teacher Guide

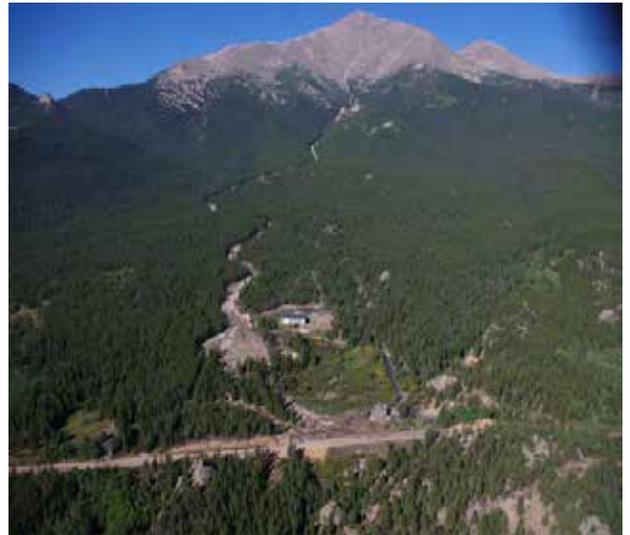
Debris Flow on Mount Meeker  
Photo By Dr. Jonathan Godt (USGS)

Another notable factor from this storm and flood event is the number of debris flows recorded. Scientists define a debris flow as “a moving mass of loose mud, sand, soil, rock, water and air that travels down a slope under the influence of gravity. To be considered a debris flow, the moving material must be loose and capable of “flow,” and at least 50% of the material must be sand-size particles or larger.” Once scientists were able to get into helicopters and start looking at the Front Range, they recorded over 1,000 debris flows, some small and others huge. One of the larger flows occurred on Mount Meeker, located in Rocky Mountain National Park, with a straight-line length of 2.39 miles. Another large debris flow on West Twin Sister, also located in Rocky Mountain National Park, had an estimated straight-line length of 1.02 miles. A two meter (six feet) thick debris flow also covered the streets of Jamestown, while the building at 100 Arapaho Ave in Boulder was cut in half by a debris flow. Estimates of the rate some debris flows moved show boulders six feet in diameter moving at speeds of 20-30 miles per hour. Plotting these debris flows on a map shows south facing slopes along the Front Range were more susceptible to debris flows. This is not unusual, considering that south facing slopes tend to be warmer with less vegetation covering them and fewer roots to help stabilize the soil.

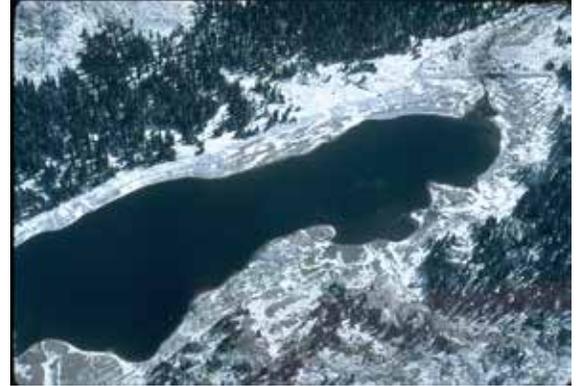
Lawn Lake Before Dam Break

When the last glaciers receded from Rocky Mountain National Park, water trapped behind the glacial debris created what would be called Lawn Lake. In 1903 an irrigation company enlarged the lake by building a 26 foot high earthen dam at the lake's outlet, accumulating 674 acre feet (219,623,863 million gallons) of water over time. The irrigation company intended to catch spring melt water and slowly release the water during the dryer parts of the summer for crop irrigation in Loveland, CO. Over the years the road leading to the dam crumbled, causing the area to be accessible only by a steep six mile hike. Because of the inaccessible nature of the dam, maintenance and inspections of the dam lapsed. The Lawn Lake dam collapse began with the failure of the lead caulking connecting the outlet pipe to the gate valve. (Lead caulking had never approved for sealing these two pieces together.) As the water leaked from the pipe it eroded the dam fill contacting the pipe. The night before the complete dam failure, campers reported hearing a noise which sounded like strong wind. This report later led the accident investigators to determine that the dam had been discharging water for 3-4 hours before the hole enlarged enough to cause it to collapse in only ten minutes. The breach in the dam measured 28 feet deep, 97 feet wide at the top, and 55 feet wide at the bottom. The water coursed down through Roaring River, gouging out a 50 foot or deeper steep walled canyon, hurling rocks and debris through the air as it moved toward Horseshoe Park, where its velocity would slow due to the meadow's flat topography. The flood waters caused the failure of the Cascade Lake dam over six and a half miles below Lawn Lake.

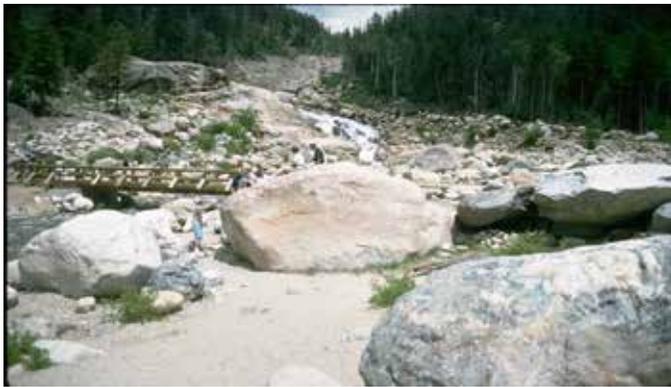
17 foot tall 425 ton boulder deposited during the Lawn Lake Flood.
