## Archeological Site Condition Assessment

# Resource Brief

National Park Service  
U.S. Department of the Interior  
Saguaro National Park  
Cultural Resources

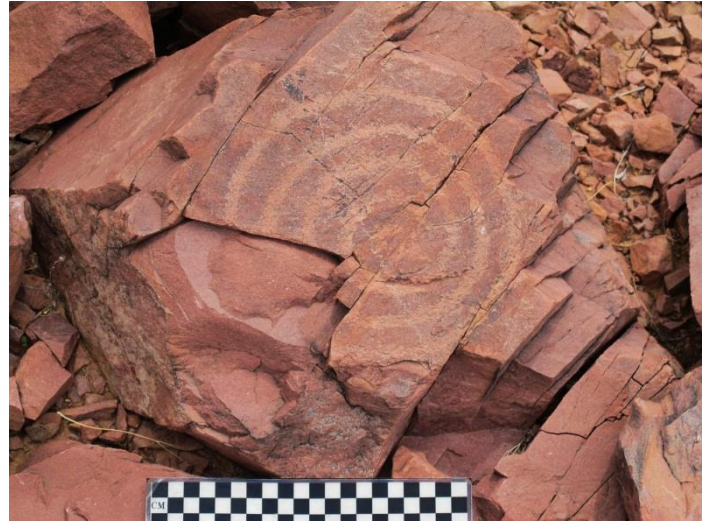
**Figure 1. Petroglyph panel at SNP. The condition of features such as this petroglyph panel are routinely assessed and recorded in the park's ASMIS database.**

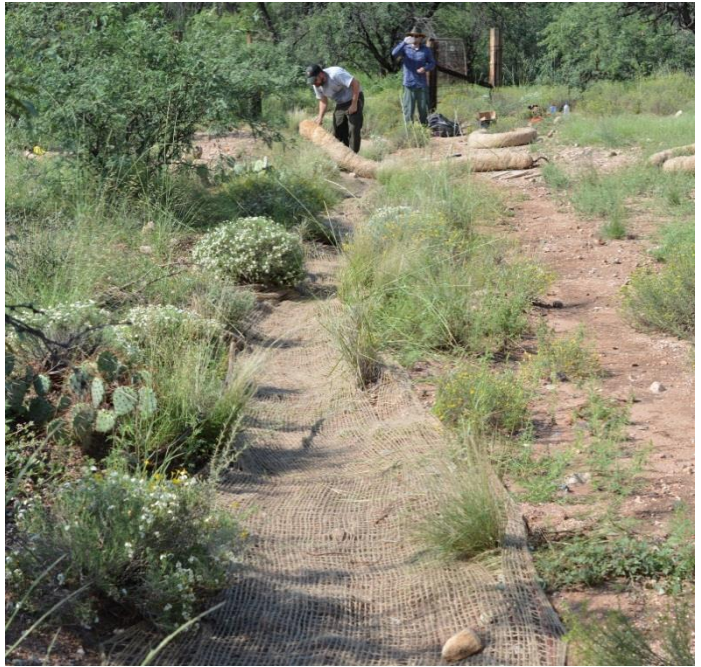
**Figure 4.** Jute matting (foreground) has just been placed over the erosion channel. Cultural resource staff is preparing to install excelsior waddles (background).

Funds were allocated, and the project was completed in the summer of 2015. To slow the water runoff and help retain soil Excelsior waddles and jute matting (Figure 4) was laid over the erosion cut. The site will be monitored to determine if further erosion control measures are needed.

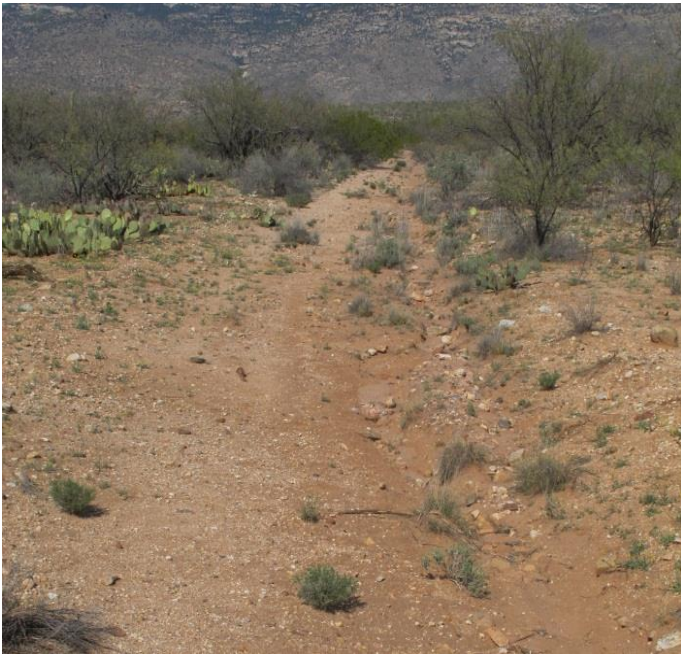
In 2014 while monitoring the condition of archeological sites at SNP, it was noted that water run-off along an old two-track dirt road was causing substantial soil erosion within a large prehistoric Hohokam site (Figure 2). The soil erosion was not only exposing prehistoric pottery (Figure 3) and chipped stone fragments, but also dislodging the material and washing it off site. Because

**Figure 2.** Soil erosion within an old road bed is impacting the condition of an archeological site at SNP. The degree of disturbance at this archeological site warranted mitigation.

this site had been monitored, and condition assessments made on a regular basis, the Cultural Resource staff could document the amount of ongoing soil erosion and propose an erosion control project to mitigate the problem. With this documentation and proposed mitigation plan in hand a request for project funds was made.

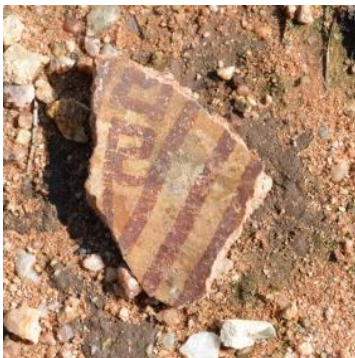
**Figure 3.** Prehistoric pottery eroding from the road cut.
