**HISTORIC LANDSCAPE
REPORT:
AMERICAN CAMP
& BRITISH CAMP
1987**

**SAN JUAN ISLAND
NATIONAL HISTORICAL PARK**

HISTORIC LANDSCAPE REPORT :
AMERICAN CAMP AND BRITISH CAMP
SAN JUAN ISLAND NATIONAL HISTORICAL PARK
WASHINGTON

Cathy A. Gilbert
Historical Landscape Architect

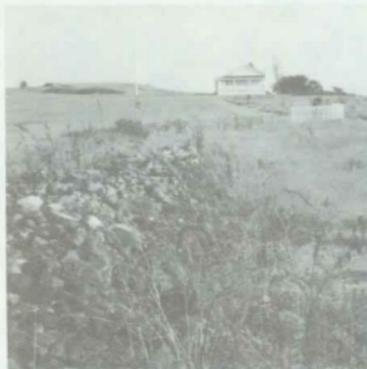
The officer's quarters, flag pole and the parade ground at American Camp. Stack of field stones in the foreground. View from the NW. (Photo by C. Gilbert, NPS, 1987)

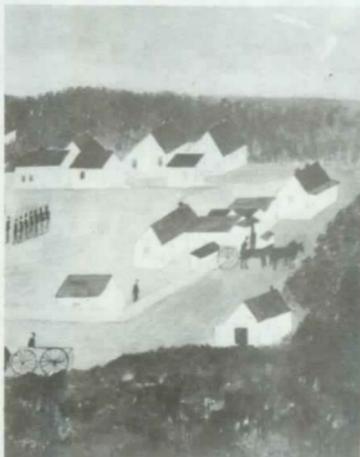
Detail from a watercolor of American Camp showing the newly constructed kitchen, messroom and bakehouse along the north edge of the encampment. Date and artist unknown. (Provincial Archives, Victoria, B.C.: SAJH photo file)

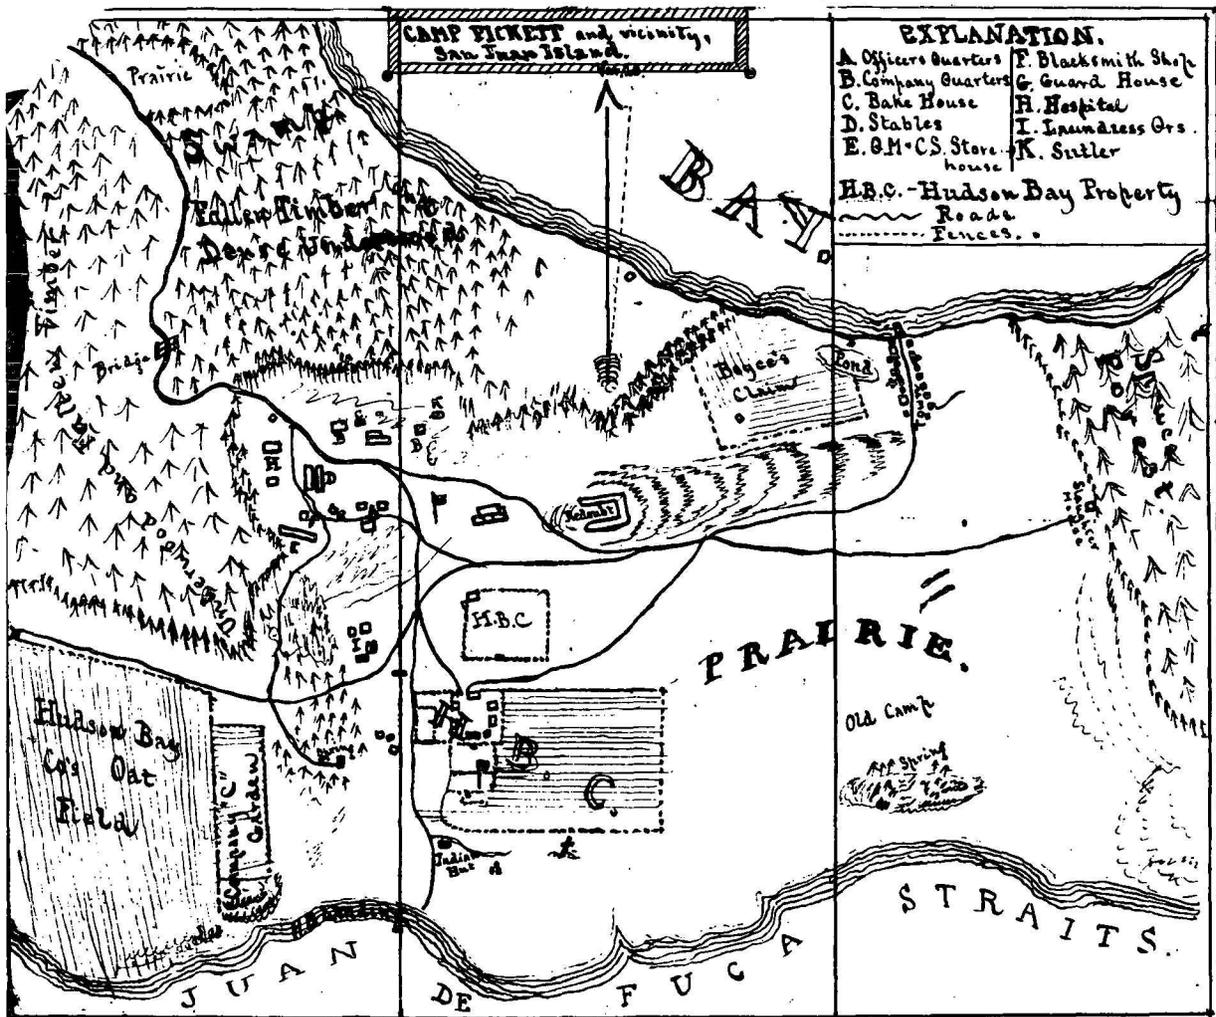
Early map illustrating the American encampment, Bellevue Farm, San Juan Town and significant landscape features in the early 1860s. (National Archives, Washington, D.C.: SAJH map file)

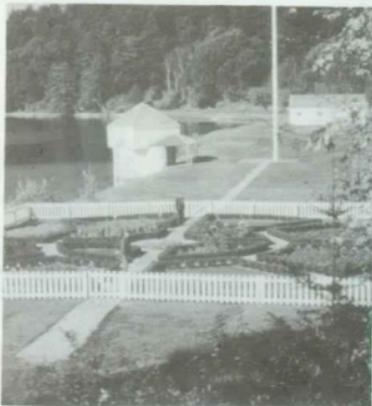
The reconstructed formal garden at British Camp, with the blockhouse and commissary storehouse in the background. (Photo by C. Gilbert, NPS, 1987)

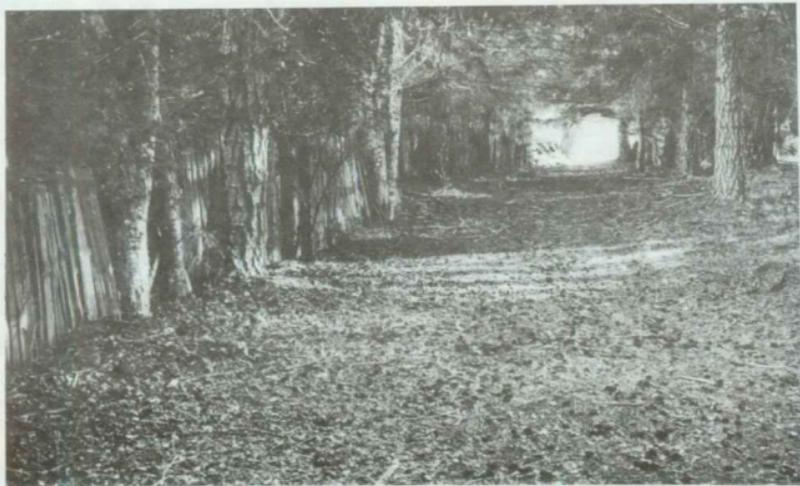
Tree-lined road that led to Captain Delacombe's residence on the top of Officers' Hill. View from the E, ca. 1875. (SAJH photo file)

Access to the Captain's house from the main camp road led two hundred feet across the slope of the hill. The road was approximately 15 feet wide, with fir trees planted on both sides of the road, creating a rather rustic, if not somewhat formal, entryway. The road ended at the carriage house.[14]

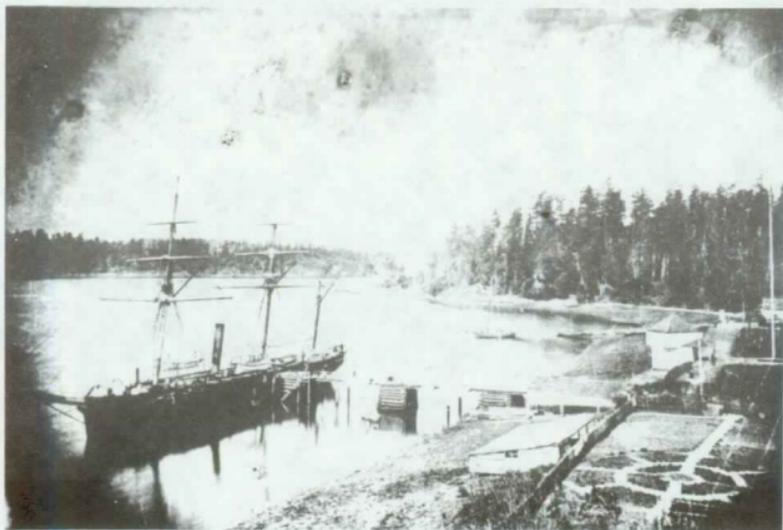
The waterfront at British Camp ca. 1870, showing the large wharf, blockhouse, service buildings and formal garden. (Provincial Archives, Victoria, B.C.: SAJH photo file)

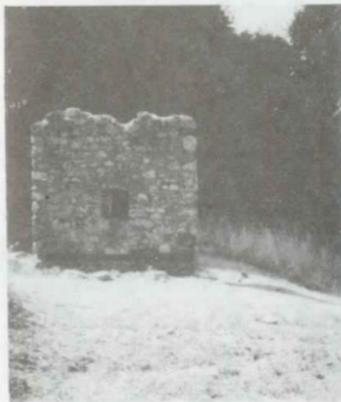
*Masonry ruin believed to have been the forge for the blacksmith.
(Photo by C. Gilbert, NPS, 1987)*

HS 4 BLACKSMITH SHOP (op 12) Several trenches were dug in front, in back, and to the side of the "forge" in 1971. Evidence for blacksmithing includes slag, charcoal, metal tongs, coal, remnants of a wooden coal bin, and a large post (anvil support). Structural evidence includes several other posts and, of course, the standing ruins of the forge. It appears that while much of the building was excavated, the outline of the structure's foundation is not yet clear.

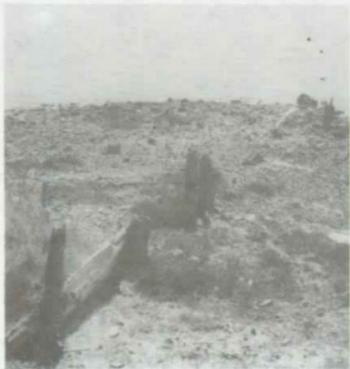
Remnants of the pier by the commissary storehouse can still be seen at low tide. (Photo by H. LaFleur, NPS, 1975)

HS 25 PIER (op 38) The beach survey mentioned above (HS 24) apparently also covered this area. In 1970 two small test pits were dug near the pier in order to recover bottles visible on the surface. In 1971 an underwater survey of the bay had, as its starting point, the last piling of the pier. Apparently little was found in that survey. In 1975 a single small trench was dug in this area but above the shoreline in order to find out how the ramp (to the pier?) was constructed. No structural evidence was found in the trench but the remnants of the pier in the bay were mapped in.

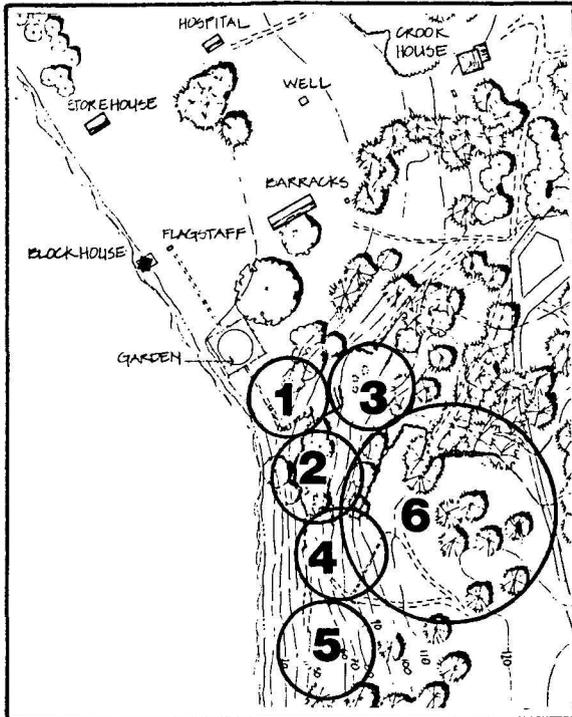
Diagram and location of the six conceptual zones on Officers' Hill.

1. Structural Walls - These walls are considered the primary structures on the hillside. Occasionally battered and often vertical along a fill or a cut, they were designed to reinforce the hillside for a building site on the expanded level area created by the

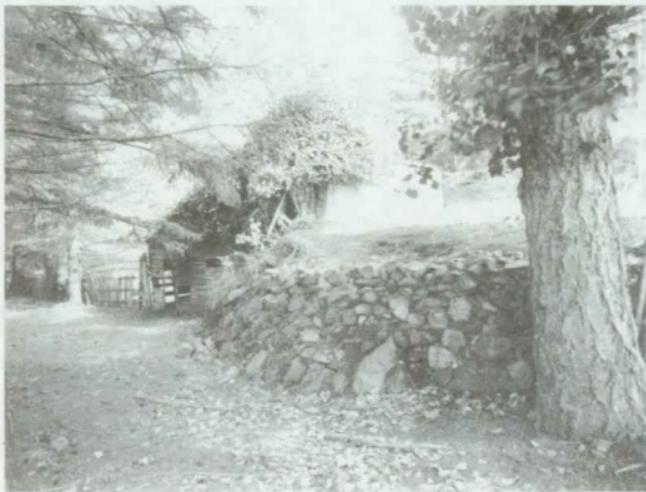
Structural wall 6.3, ca. 1900. Compare the condition of the wall with the existing feature pictured on the previous page. (SAJH photo file)

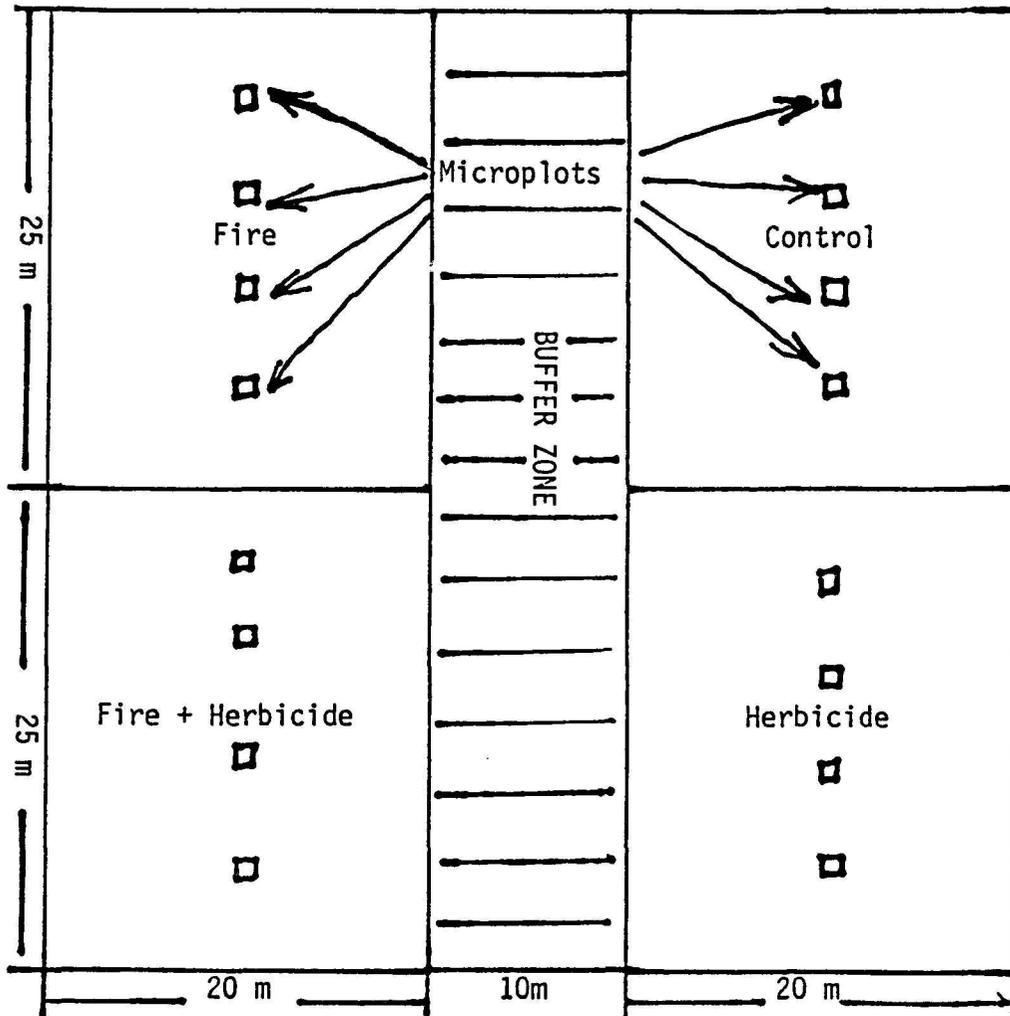
Schematic of block, plot, and microplot layout for studying the effects of fire, fire and herbicides, and herbicides in controlling tansy ragwort.
