# Stones River National Cemetery

# Cultural Landscape Report

November 2015

Prepared by:  
Wiss, Janney, Elstner Associates, Inc.  
330 Pfingsten Road  
Northbrook, Illinois 60062

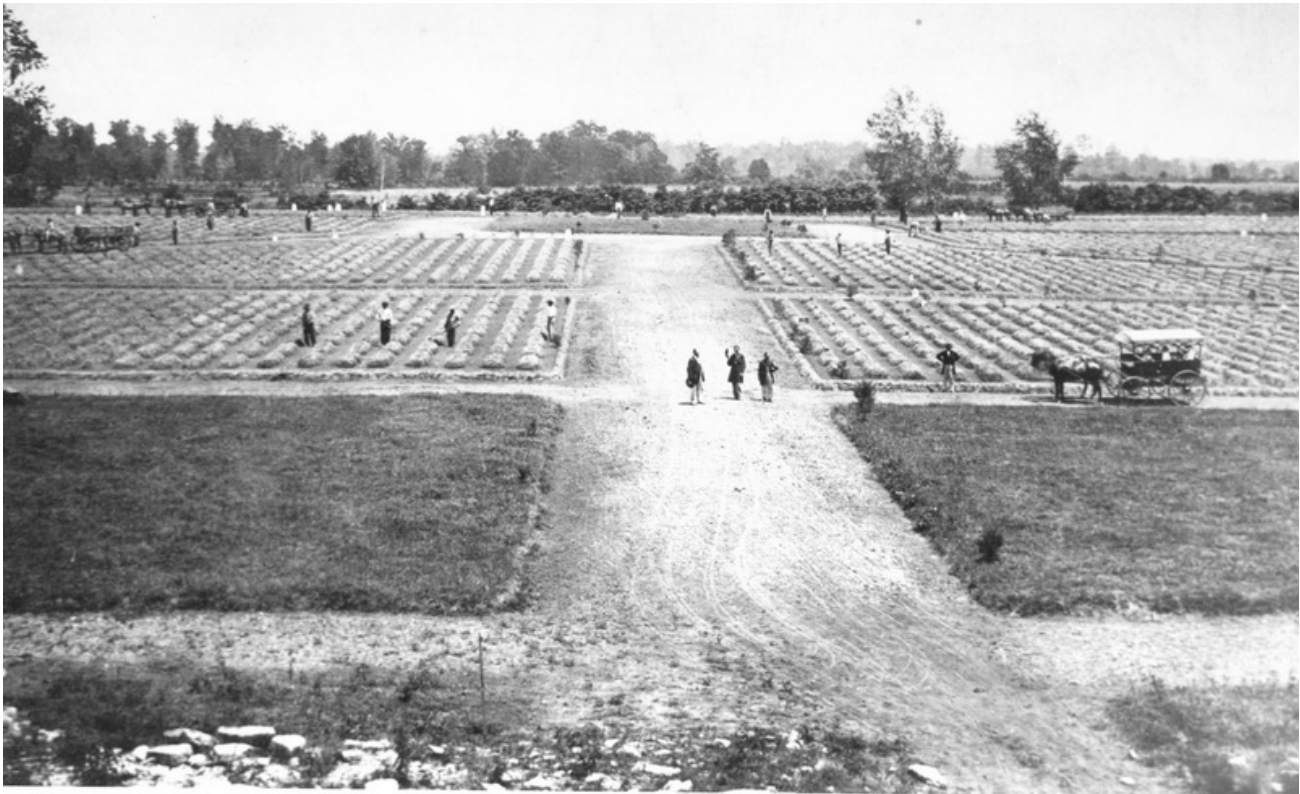
**FIGURE 9.** An 1865 view of Stones River National Cemetery. Source: Stones River National Battlefield Archives, image STRI-8x10p1920-0062.

The cemetery was laid out in an orderly manner with graves arranged in a trapezoidal pattern centered on a gravel carriage path leading to a central ceremonial open space, known as Lincoln Square (Figure 9 and Figure 10). A wooden flagstaff was placed at the center of Lincoln Square, with two standing cannon (siege gun) monuments nearby. A wood picket fence enclosed the cemetery (Figure 11).

36. As shown in the photograph included as Figure 9, as well as the 1865 period plan. Sources for tree locations include the E. B. Whitman sketch, a 1865 photograph of the cemetery, and the map of the national cemetery surveyed and drafted under the direction of Brig. Gen. H. P. Van Cleve.

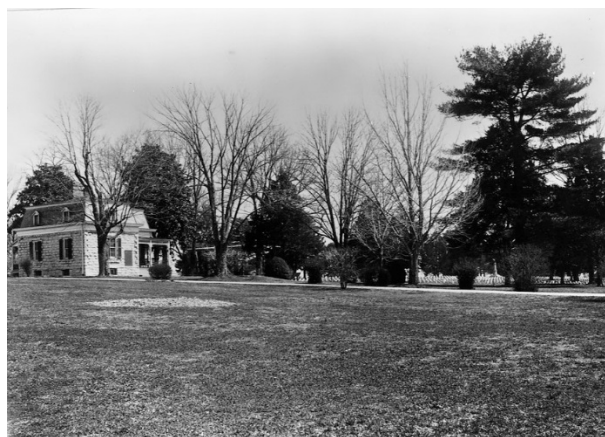
**FIGURE 14.** An undated view of the 1871 superintendent's lodge. Source: Stones River National Battlefield.

In 1871, a new superintendent's lodge was constructed, based on designs prepared by Quartermaster Gen. Montgomery C. Meigs (Figure 14). The new building contained administrative offices and housing for the superintendent and his family.<sup>49</sup> By 1874, a wooden structure occupied by laborers, a barn, a wooden buggy house, and two hen houses had been constructed adjacent to the superintendent's lodge on the new property.<sup>50</sup> However, by 1892, only one wooden shed remained behind the superintendent's house, the other outbuildings having been removed.

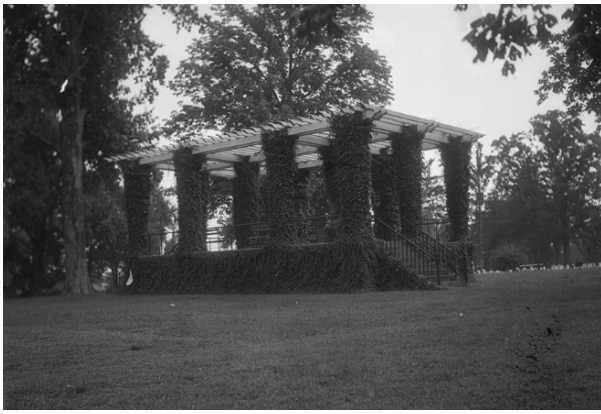
**FIGURE 16.** The rostrum at Stones River National Cemetery circa 1930. Source: Stones River National Battlefield Archives, image STRI-NN-0184.

In 1882, a brick rostrum with a wood trellis roof was constructed in the cemetery, west of the burial area. The cemetery staff placed a variety of plants within and adjacent to the rostrum (Figure 16 and Figure 17).

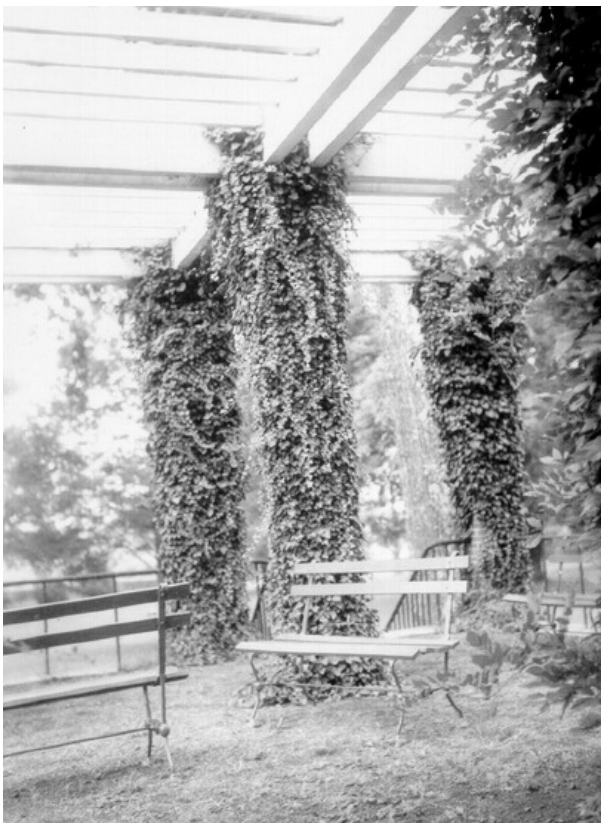
**FIGURE 17.** An undated view from within the rostrum at the cemetery that includes two wood and iron settees like those placed within the cemetery in 1878. Source: Stones River National Battlefield Archives, image 1058.

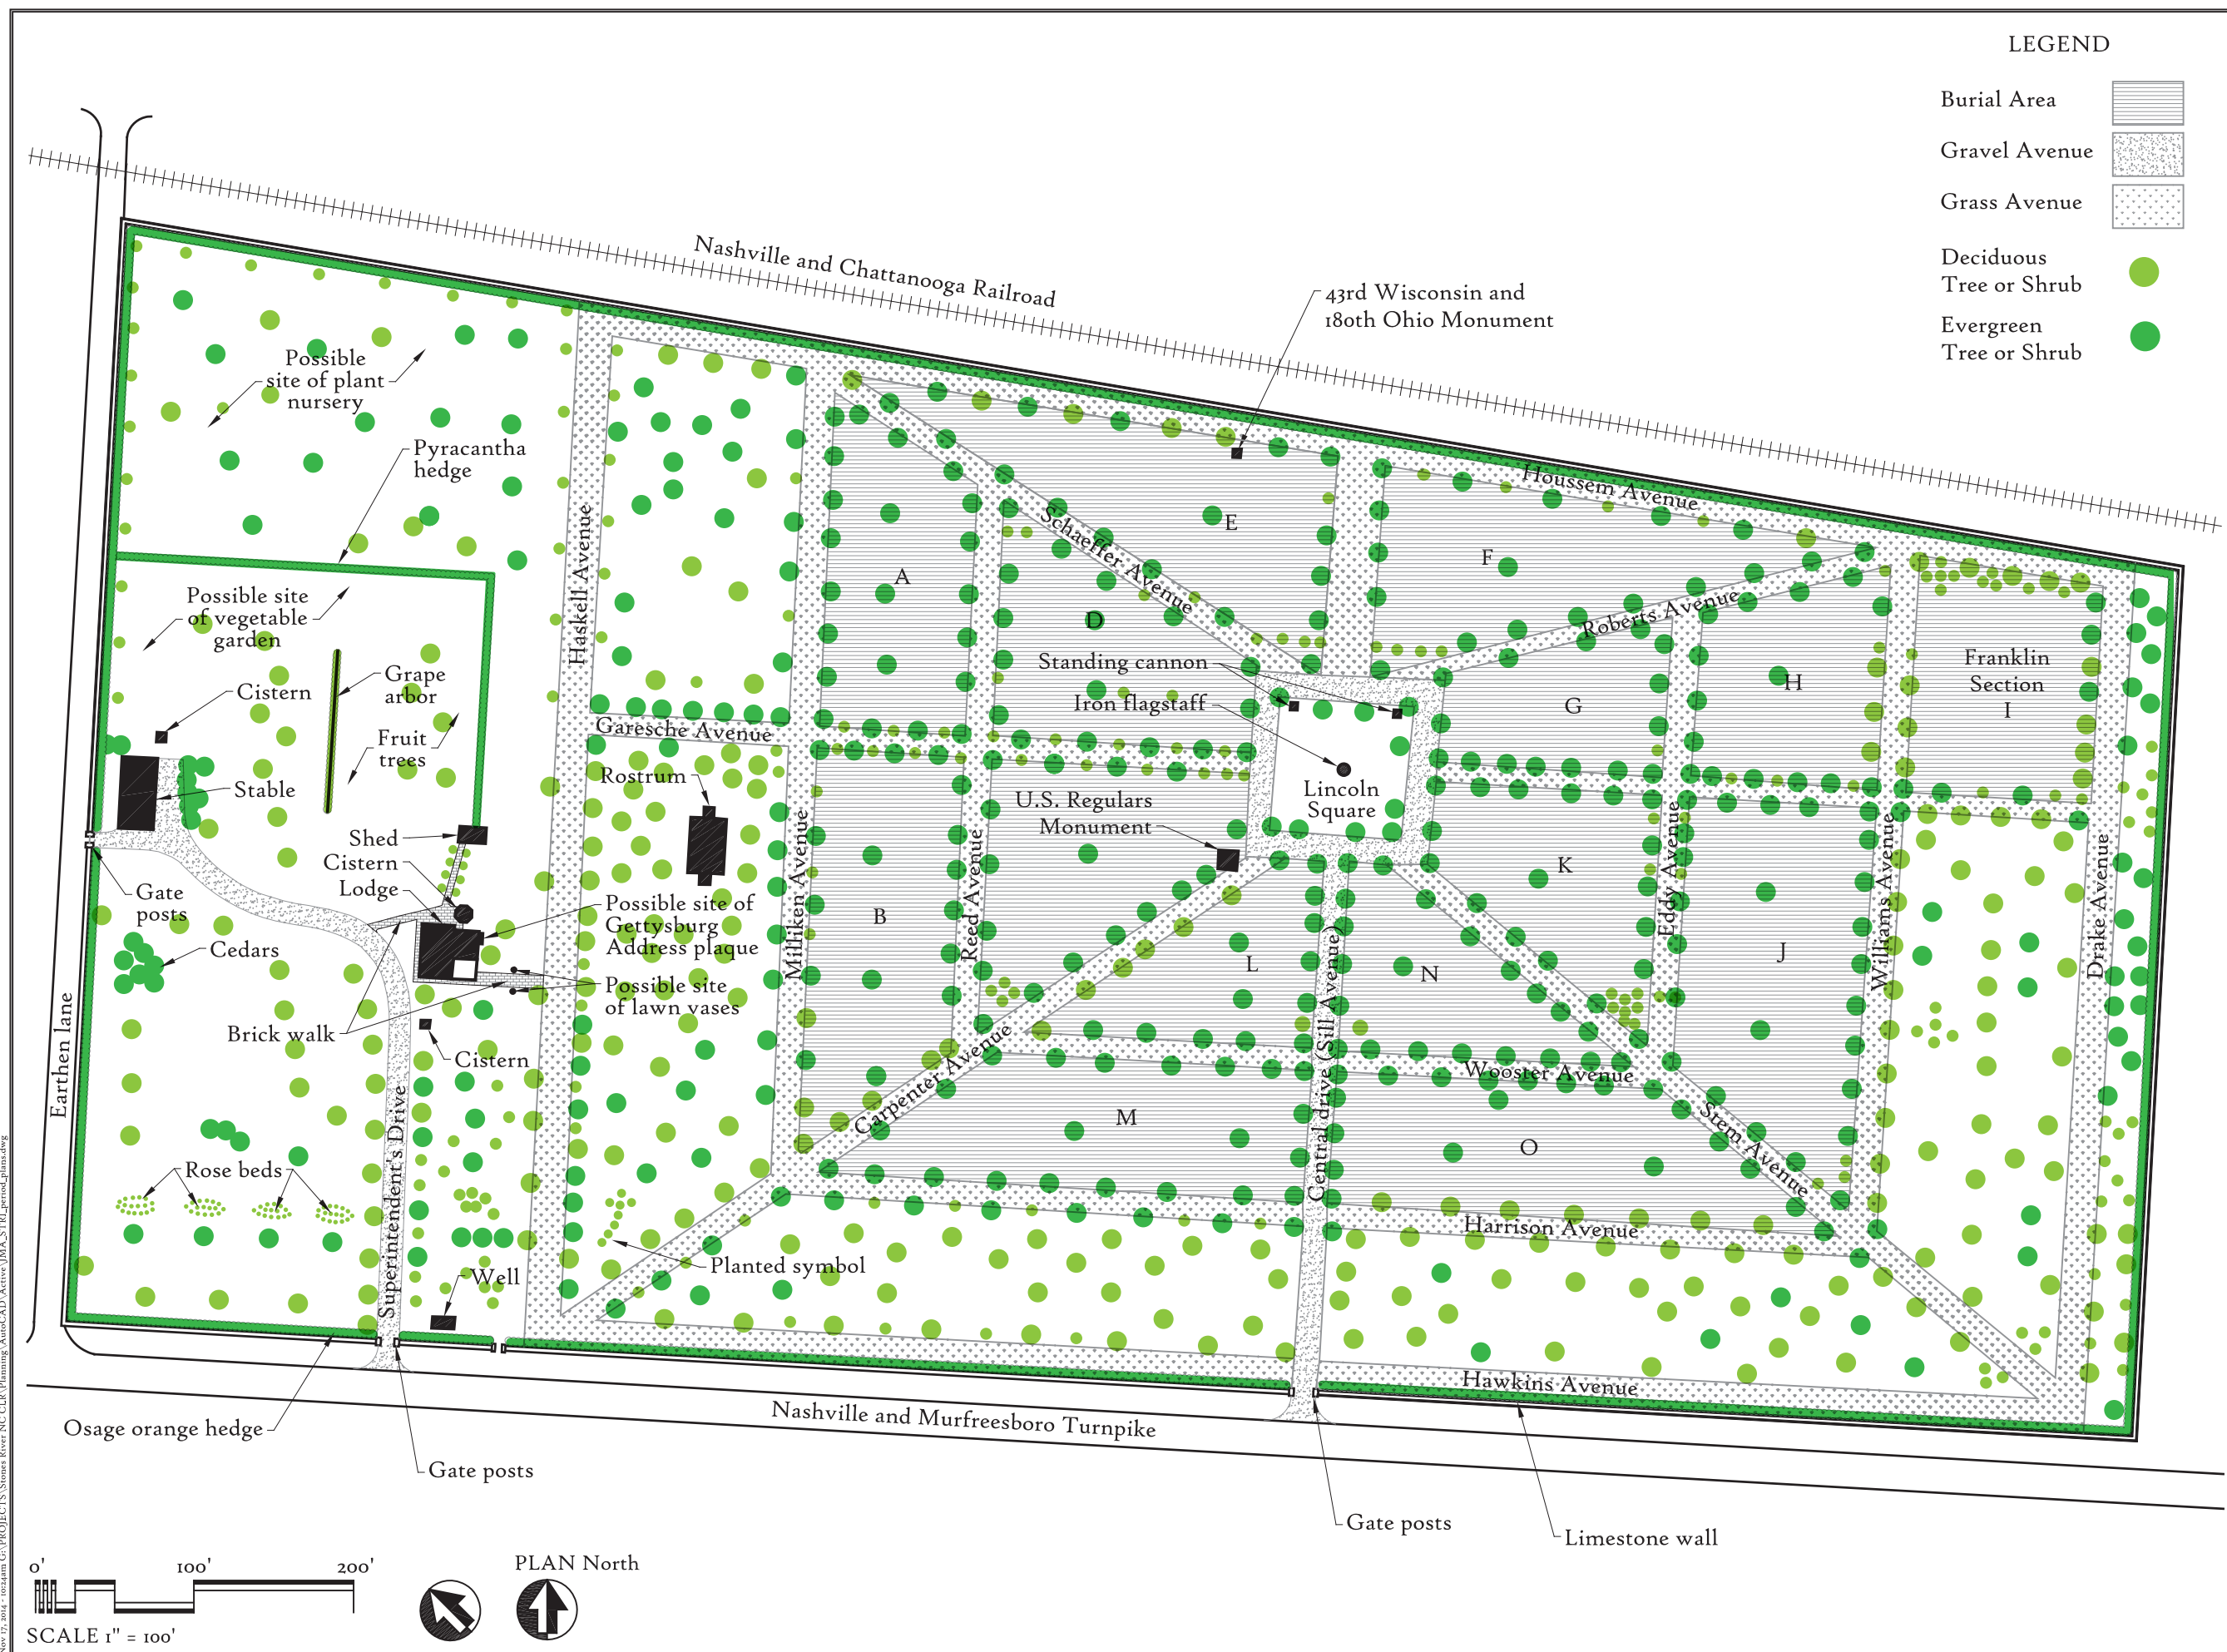
Figure 20.  
1888 Period Plan

Sources:  
Office of Q.M.G., U.S. Army,  
June 16, 1892 Planting Plan

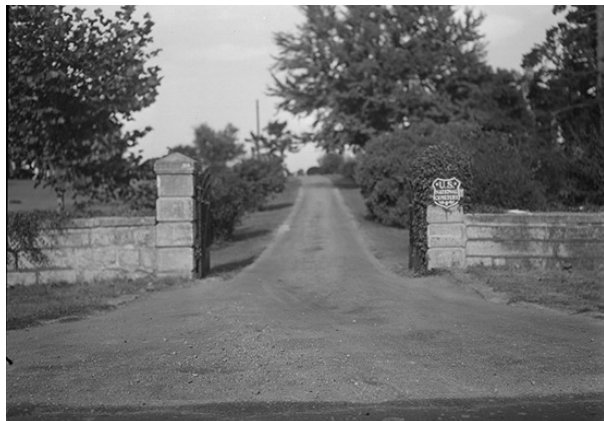
**FIGURE 25.** An undated view of main entrance gate; the 1913 iron shield is visible on the right pier. Source: Stones River National Battlefield Archives, image STRI-NN-0166. Note the rusticated concrete piers constructed in 1896.

Also in 1896, the maintenance gate and main vehicular gate into the cemetery were rebuilt, with new rusticated concrete piers with pyramidal concrete caps.<sup>72</sup>

In 1913, two iron shields were provided to the superintendent for installation at the cemetery's entrance gates. The plaques identified the site as a U.S. National Cemetery. One plaque was placed at the main entrance, while the other was placed at the gate leading to the maintenance and housing area (Figure 25). The superintendent was instructed to paint the shields black and to use bronze paint for the lettering, border, and decorative motifs.<sup>75</sup>

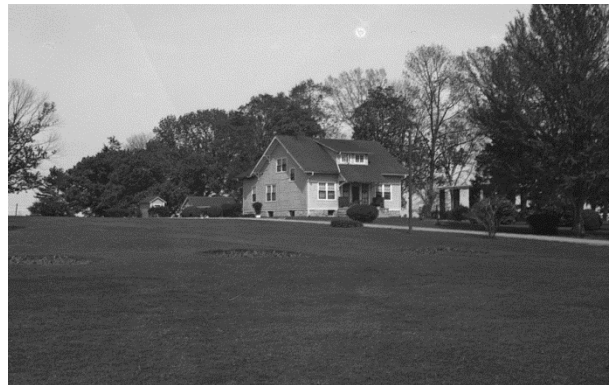
**FIGURE 27.** An undated view of the 1926 superintendent’s lodge, with nineteenth century shed and privy remaining behind the house. Source: Stones River National Battlefield Archives, image STRI-NN-0133.

In August 1926, the stone superintendent’s lodge constructed in 1871 and reconstructed in 1909 was removed, and a new wood structure was completed on the same site (Figure 27). Like the old structure, the new superintendent’s lodge served as an office as well as living quarters for the superintendent’s family. A nineteenth century shed and privy remained behind the house (refer to Figure 27).

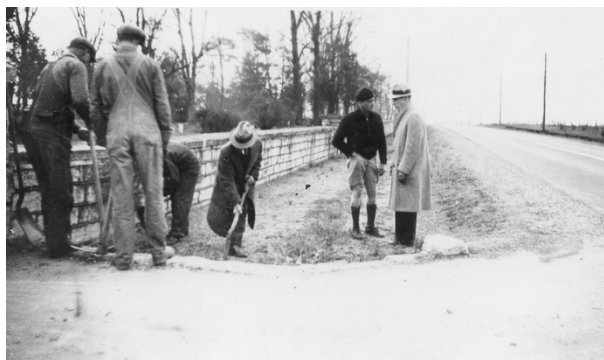
**FIGURE 28.** The start of drainage work at the north entrance gate to the cemetery in spring 1934. Source: Stones River National Battlefield Archives, image STRI-ICP-0436.

Beginning in 1933 and continuing through 1935, PWA and CCC workers made improvements to the national cemetery and the battlefield. In 1933 and 1934, the Nashville Turnpike adjacent to the cemetery was re-graded to improve drainage. However, these efforts did not prevent the significant flooding that occurred within the cemetery walls in February 1935 (Figure 28 and Figure 29). During this time workers also assisted in planting new vegetation in the national cemetery. Plantings by the CCC included five beds of canna lilies, present by 1934 (refer to Figure 37).<sup>89</sup>

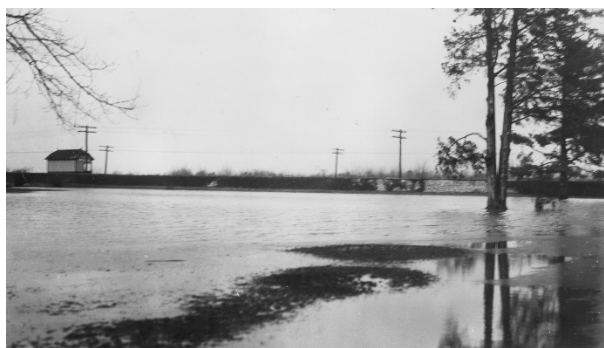
**FIGURE 29.** Flooding in the cemetery, February 1935. Source: Stones River National Battlefield Archives, image STRI-ICP-1285.

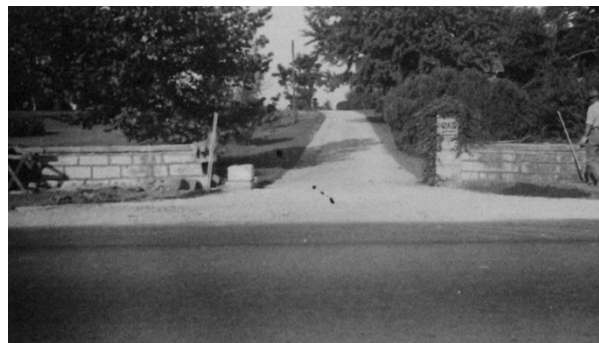
**FIGURE 31.** The maintenance gateway undergoing reconstruction, 1937. Source: National Archives, Record Group 79: Records of the National Park Service, Records of the Branch of Engineering, Final Construction Reports, 1934–1942.

In 1937, funding was provided to widen two avenues in the cemetery. The drive leading to the superintendent's lodge and maintenance area was widened from 8 to 12 feet, while the drive that connected the entrance gate with Lincoln Square was widened from 12 to 16 feet (Figure 30 and Figure 31). The road around Lincoln Square was widened to 18 feet (refer to Figure 40).<sup>90</sup>

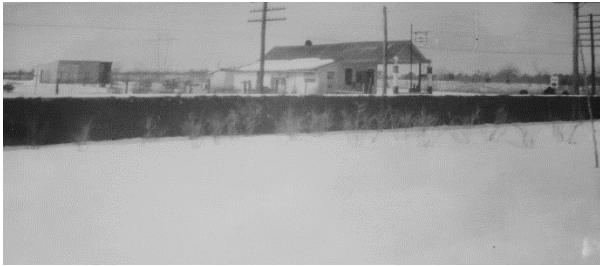
**FIGURE 33.** Cemetery wall looking west across Old Nashville Highway, after screen planting. Source: National Archives, R.G. 79, Records of the Branch of Engineering: Final Construction Reports, Box 1, Entry 75, Superintendent Richard B. Rudolph, "Report on Plating at Stones River National Military Park: Public Works Project No. 481" (February 6, 1935.)

Also during the mid-1930s, crews from the PWA and the CCC worked to improve drainage along the Nashville Highway and planted ornamental shrubs throughout the cemetery to serve as vegetative screens, primarily along the south boundary wall and also in the northwest corner (Figure 32 through Figure 35). They also planted trees to replace many lost to storm damage.

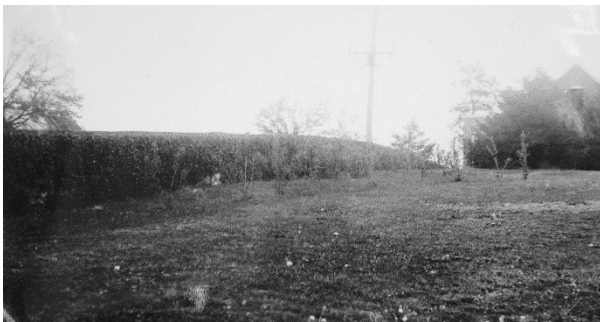
**FIGURE 34.** North wall viewed from within the cemetery wall, after screen planting. Source: Ibid.

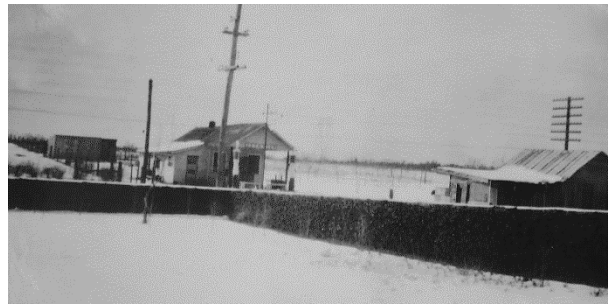
**FIGURE 35.** North wall viewed from within the cemetery wall, after screen planting. Source: Ibid.

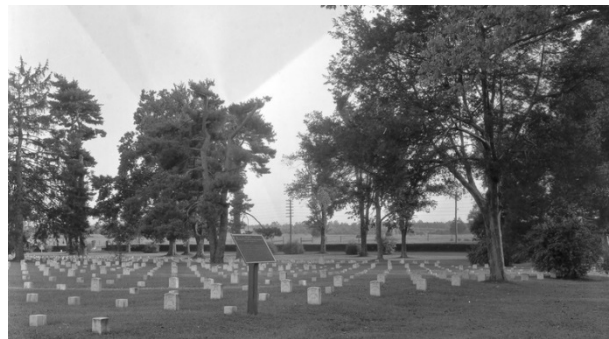
**FIGURE 36.** View of the cemetery in September 1935, showing the cast iron plaques possibly supplied by the U.S. War Department. Source: Stones River National Battlefield Archives, STRI-Central Files 5566-Rinehart-Sept1935.

Stones River was also supplied with cast-iron tablets during the 1930s, possibly by the U.S. War Department following the establishment of Stones River National Military Park in 1927. The tablets served different purposes, but may have interpreted battle events consistent with the tablets found at other national military parks. One is known to have displayed the text of the "Act to Establish & Protect National Cemeteries Approved February 22, 1867."<sup>91</sup> These tablets are visible in a 1935 photograph of the cemetery (Figure 36). Their locations are indicated on a 1934 planting plan for the cemetery (refer to Figure 38).<sup>92</sup> In 1937, park staff placed a map of the Battle of Stones River in the cemetery. (The map remained in the cemetery until 1958, when it was removed to make way for new exhibits.)

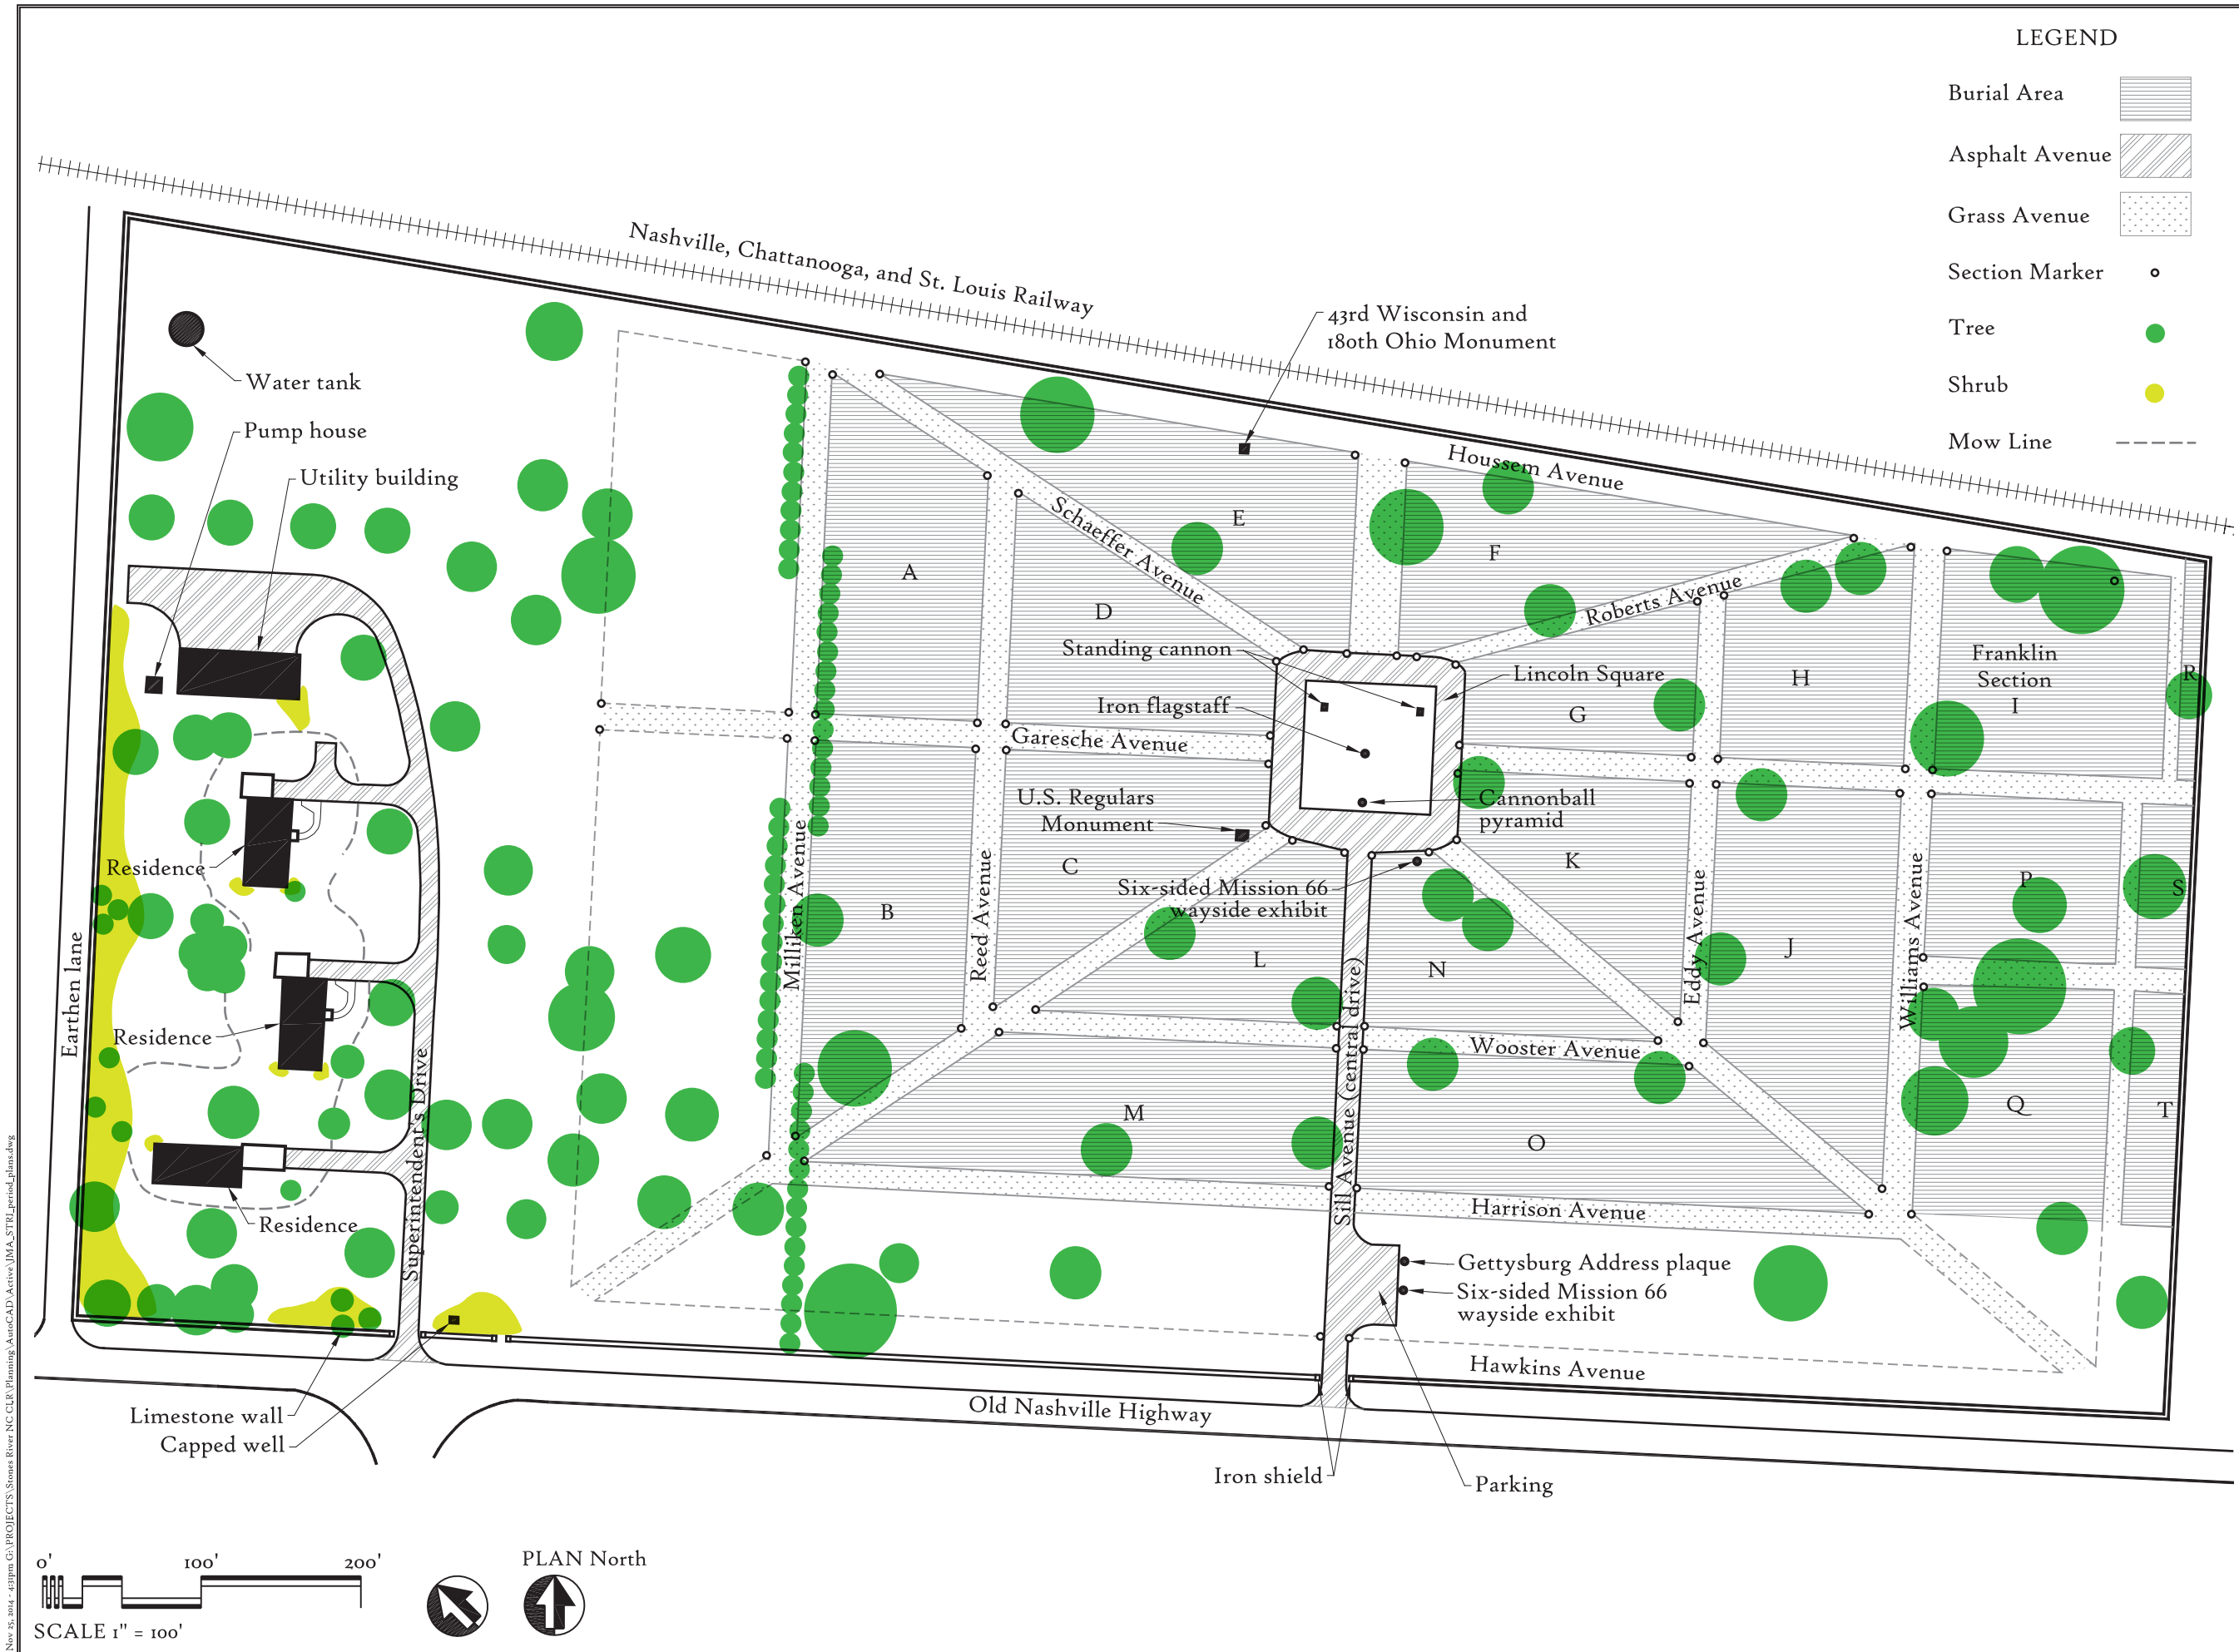
Figure 42.  
1968 Period Plan

Sources:  
Interment Plan, Cemetery & Headquarters Area, Dwg. No. SR-2037, 1963.  
Planting Plan & Incidental Construction, Headquarters Area, 1963.  
Tree Key, Stones River National Cemetery, revised 1973.  
Aerial photograph, c. 1960s.

Within the burial grounds area, three new burial sections—R, S, and T—were created between Sections I, P, and Q and the cemetery boundary wall (refer to Figure 42). The graves were sited within a space originally designated for a cemetery avenue between the burial sections and the wall.

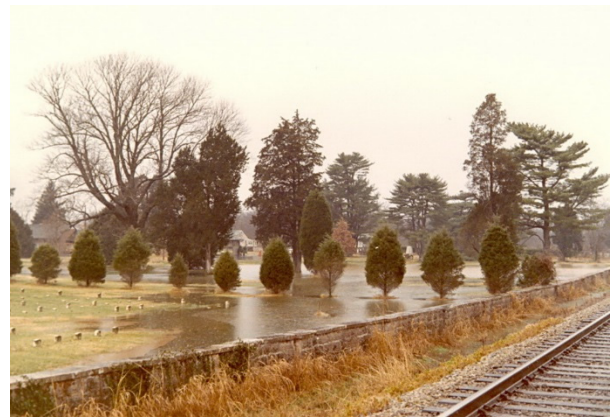
**FIGURE 44.** View of flooding in the cemetery soon after planting of the second row of Eastern red cedars in 1979. Source: Stones River National Battlefield Archives, STRI-5X7P-0007.

Flooding continued to be a problem in the cemetery (Figure 44 and Figure 45). Burials in Sections R, S, and T ceased entirely in the 1970s due to regular problems with flooding. In 1975,

drainage swales were constructed and fill was placed for flood control in the cemetery. In 1978, fill was added in the vicinity of the maintenance area. Fill was also added to the burial section where Vietnam veterans were buried in the 1970s and 1980s.

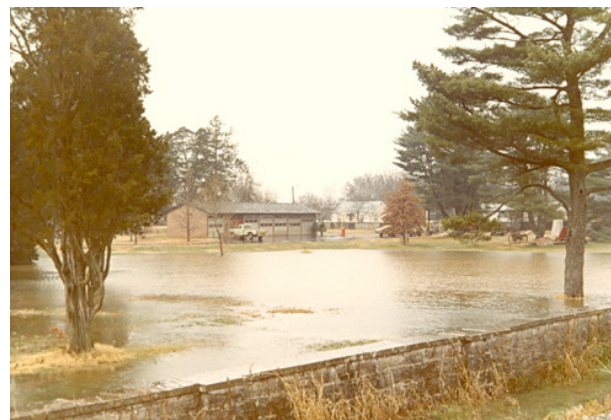
**FIGURE 45.** View of flooding in the maintenance area of the cemetery circa 1979–1980. Source: Stones River National Battlefield Archives, STRI-5X7P-0008.

In 1978, to address flooding problems in the northwest corner of the cemetery, the National Park Service added 3 feet of gravel fill, forming the basis for the present-day gravel parking area and the powder magazine enclosure.

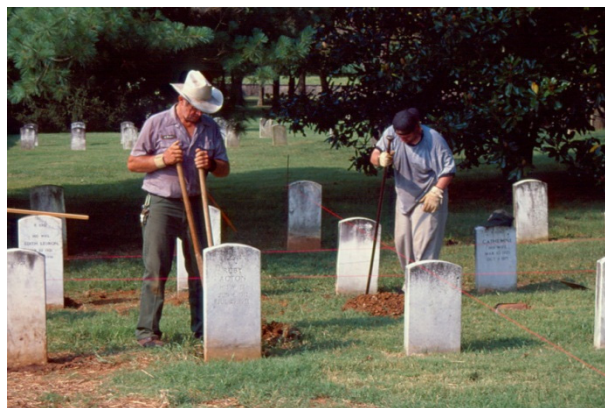
**FIGURE 46.** Resetting grave markers in the cemetery, 2001. Source: Stones River National Battlefield Archives, slides, collection 67, image 67-01-011-0011.

In the 1990s, work began by private contractors engaged by the park to remove and reset grave markers throughout the cemetery (Figure 46). This program continued in 2009–2011, at which time approximately 2,000 grave markers in sections C, D, E, L, and M of the cemetery were reset.<sup>120</sup> Contractors working on marker resetting included Veterans of the Land, September 11 to November 22, 2009; Dozier Memorials, August 27, 2009, to April 15, 2011; and Avatara, June 1, 2009, to November 5, 2009.<sup>121</sup>

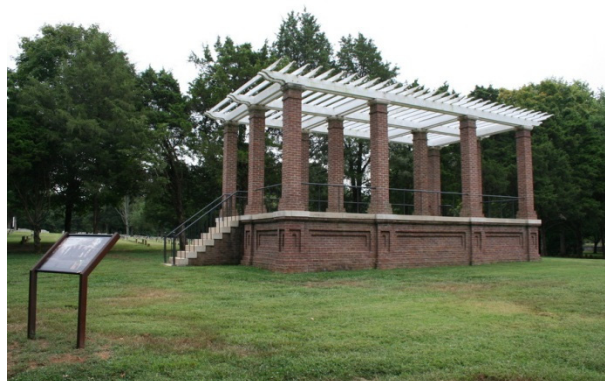
**FIGURE 47.** The reconstructed rostrum, shown in a 2010 photograph. Source: Photo by authors, 2010.

Plans were made in July 2005 to reconstruct the rostrum at Stones River National Cemetery. The plans were based on 1878 plans that were used to construct rostrums at several national cemeteries. The new rostrum was completed in 2007 (Figure 47), matching the original design, except that the stairs were placed along the east half of the

north and south ends of the structure rather than the west half as originally built.<sup>122</sup>

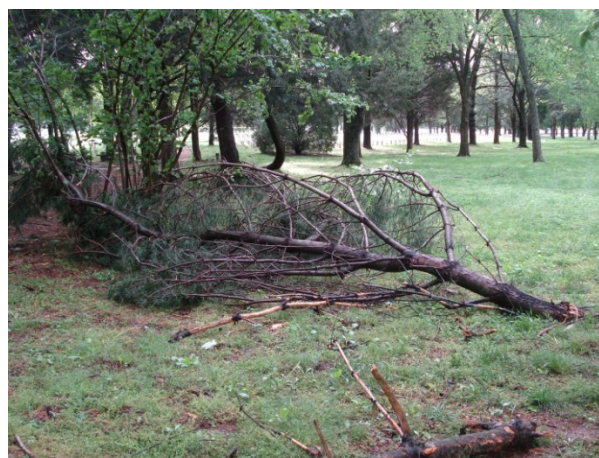
**FIGURE 48.** One of several trees and large branches that fell during storms on April 27, 2011. Source: Stones River National Battlefield, photo by park staff, 2011.

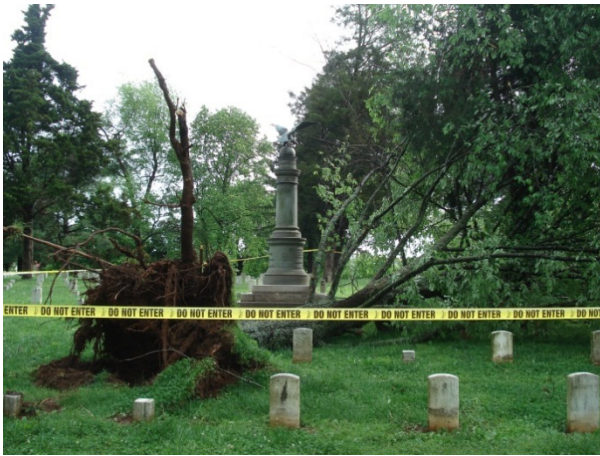
**FIGURE 49.** The U.S. Regulars Monument narrowly escaped damage when a nearby tree was uprooted by a tornado. Source: Stones River National Battlefield, photo by park staff.

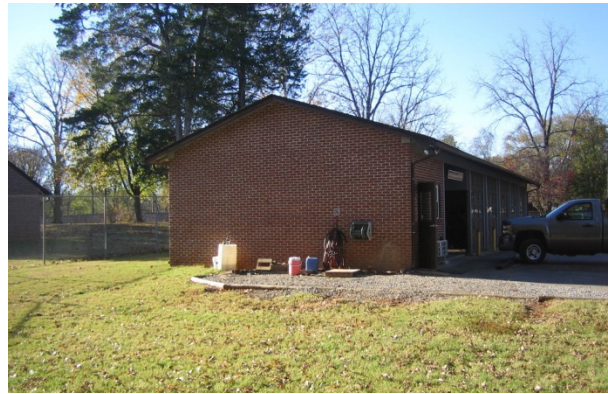
**FIGURE 50.** The maintenance building before renovation, view from the northeast, November 2010.

A major renovation of the maintenance shop was completed in September 2012 (Figure 50 through Figure 52, and compare to similar views in the Existing Conditions Documentation chapter). As part of this work, the north elevation was altered by infilling two bays. At the second bay from the east end, the original recessed entry with a pedestrian door was altered to include brick infill and a paired window opening. The next bay toward the west was originally an overhead garage door but was altered to include brick infill and two

personnel doors. Additionally, a new personnel door was created at the west end wall.

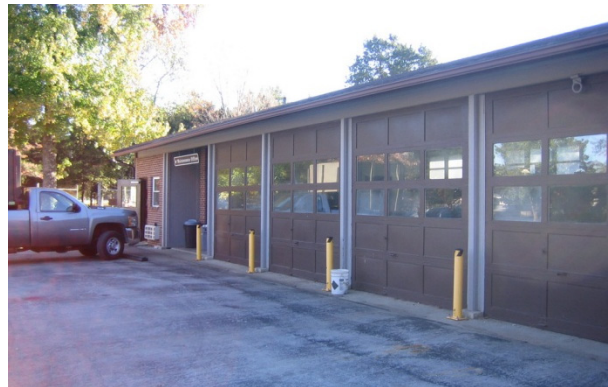
**FIGURE 51.** The maintenance shop before renovation, view toward the east end of the north elevation, November 2010.

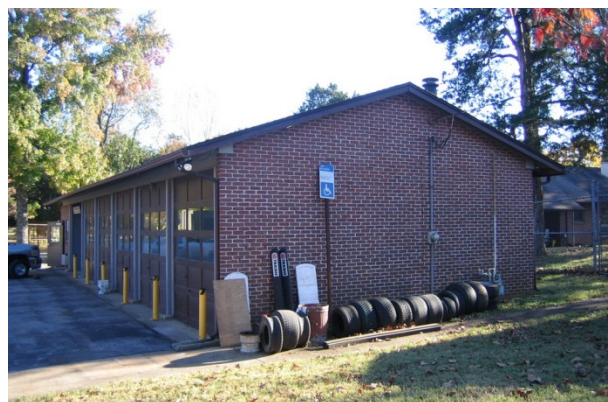
**FIGURE 52.** The maintenance shop before renovation, view from the northwest, November 2010.

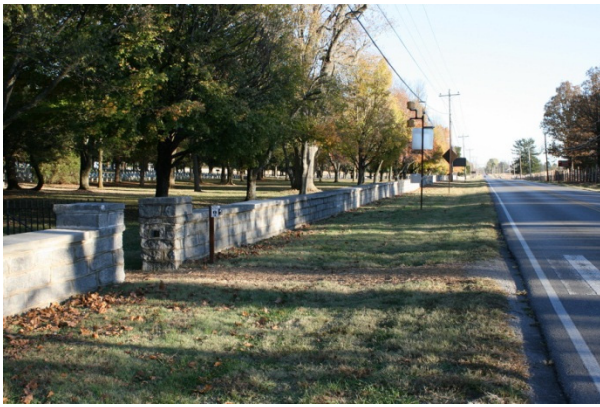
**FIGURE 56.** The limestone perimeter wall marks the boundary of the cemetery and provides a distinct visual break between the cemetery and the surrounding landscape characterized by the Old Nashville Highway, the battlefield park, and the railroad.

The cemetery, which was sited to take advantage of a prominent knoll, is oriented toward, and lies parallel to, Old Nashville Highway. The Old Nashville Highway and the CSX railroad corridor define the northern and southern edges of the national cemetery (Figure 55). These edges, as well as the western and eastern boundaries of the cemetery, are marked by a limestone perimeter wall (Figure 56). Internally, the two character areas

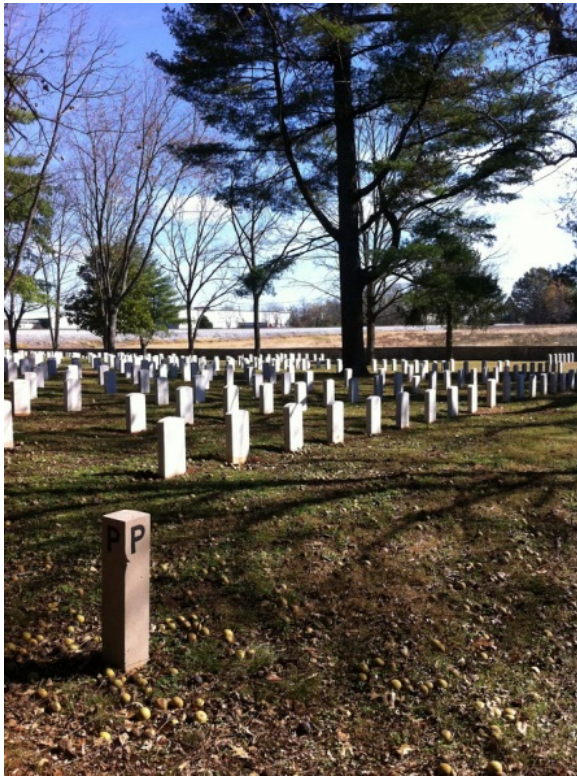
**FIGURE 60.** The burial sections are characterized by regularly spaced, uniform grave markers set in rows identified at the corners by lettered section markers.

The burial sections are characterized by regularly-spaced, uniformly-sized headstones set in rows designated by lettered section markers (Figure 60).

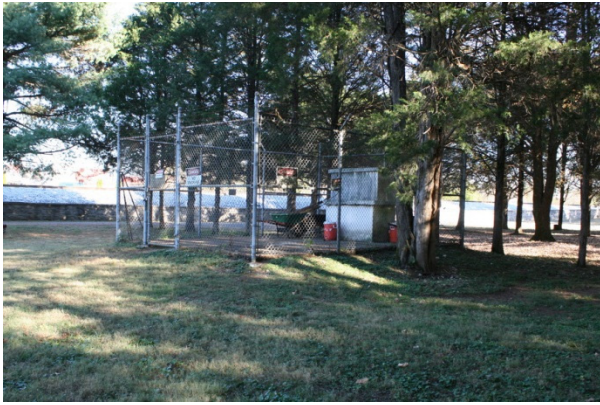
**FIGURE 65.** Another chain link fence surrounds a storage area where the black powder used in artillery demonstrations conducted by the park for visitors is kept. This area is shielded from view from most other areas of the cemetery by densely planted Eastern red cedars.

The maintenance yard is separated from the residential area by a chain link fence installed in the late 1970s (Figure 64). A second chain link fence surrounds a black powder storage area located to the east of the maintenance area (Figure 65). The original masonry powder magazine is no longer in use. A newer, active powder magazine has been built within the chain link enclosure.

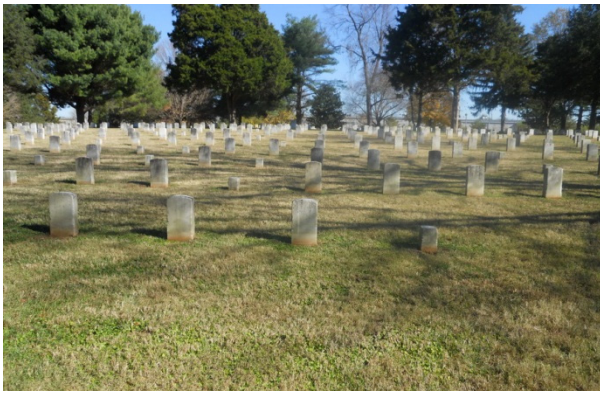
**FIGURE 66.** Today, the national cemetery has an evenly graded lawn that is the result of extensive fill and grading efforts.

Stones River National Cemetery is characterized by an evenly graded lawn that is the result of historic efforts to fill and grade the land in order to create a bucolic setting worthy of honoring fallen United States military personnel (Figure 66). Grading has been used to establish the grass avenues and asphalt-paved roads as smooth, evenly sloped travel corridors (Figure 67). Grading has also been used to fill sunken graves, and to emphasize the central focal point of the cemetery at Lincoln Square. Specifically, grading was used to create a mound atop which the flagstaff was set for emphasis (Figure 68).

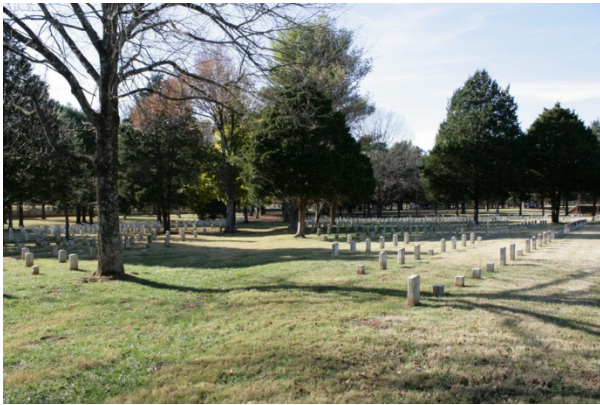
**FIGURE 67.** The grass avenues that divide cemetery burial sections were graded to create a smooth and even plane that emphasizes the geometric design of the cemetery and facilitates passage for visitors.

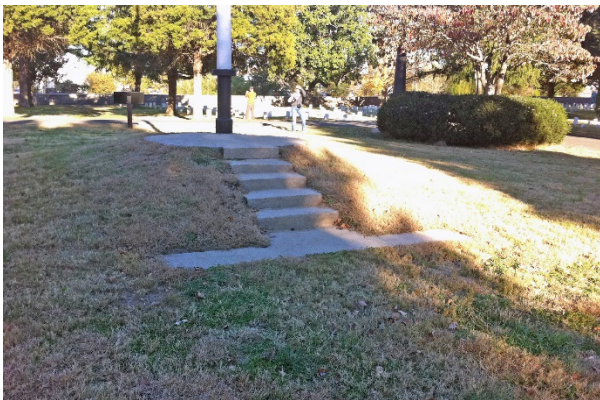
**FIGURE 68.** The flagstaff is located on top of an earthen mound and marks a high point within the burial area of the cemetery. A small concrete stair provides access to the base of the flagstaff mound.

A small concrete stair also leads up the turf mound at the center of Lincoln Square (refer to Figure 68).

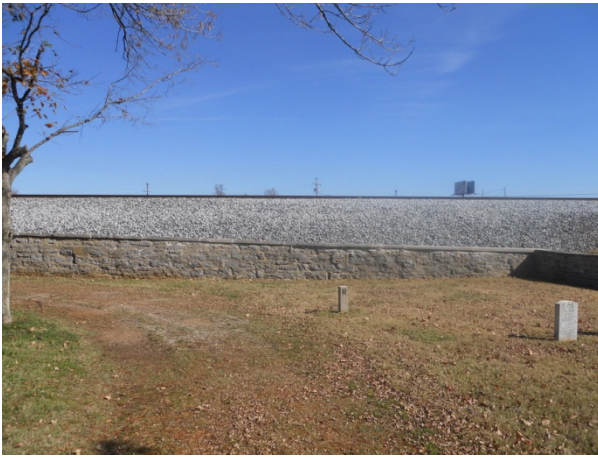
**FIGURE 69.** The railroad bed just outside the north wall of the cemetery has been elevated above historic levels and is now visible from many points inside the cemetery.

The railroad line along the north wall of the cemetery occupies an elevated rail bed set atop ballast that has been built up substantially since the cemetery was first established. The rail bed is now visible from the cemetery (Figure 69).

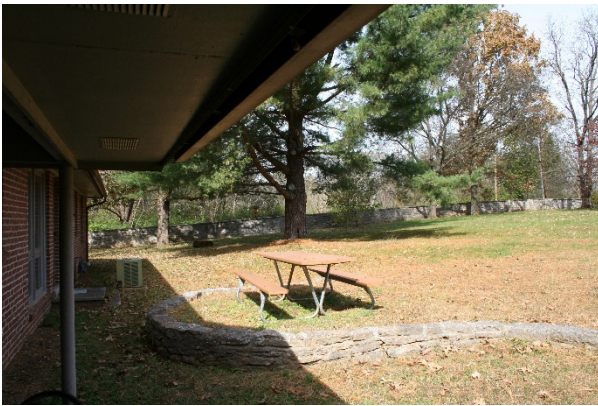
**FIGURE 70.** Stone retaining wall behind Building 6. Source: Stones River National Battlefield, photo by park staff, 2014.

During the 1960s, grading was used to create level areas suitable for the construction of the three housing units and maintenance facilities, as well as the access road and driveways, within the lodge and service area. A low stone retaining wall was constructed near the southernmost of the residences to protect a tree from the grading activities and altered finished grade (Figure 70).

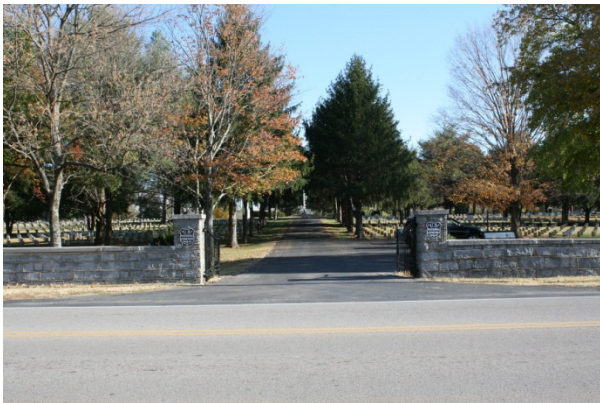
**FIGURE 77.** The main entrance to Stones River National Cemetery is marked by stone piers and wrought iron gates.

The main entrance gate is 16 feet, 8 inches wide, and set approximately at the center of the south side of the perimeter wall (Figure 77). Central Avenue is paved with asphalt and measures 14 feet in width.

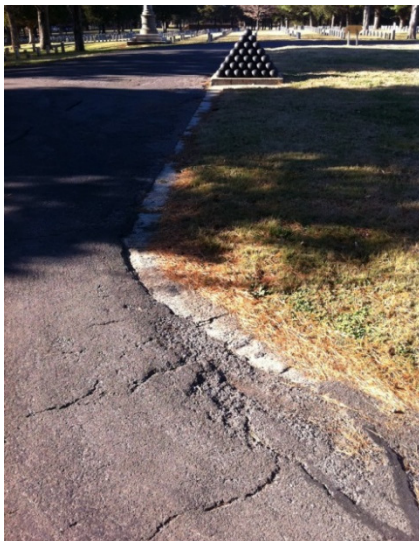
**FIGURE 81.** Concrete curbing along Central Avenue as it loops around Lincoln Square. Also visible is the cracked asphalt pavement of the road.

These paved circulation features within the cemetery are in fair condition, with some cracking of the pavements and wear of surface finishes. The park is working to correct these pavement condition issues.

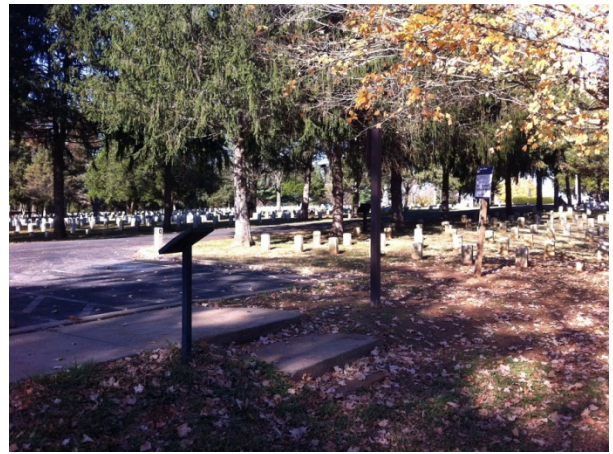
**FIGURE 82.** A small concrete stair edges the sidewalk adjacent to the visitor parking area.

east of the road. The parking area accommodates eleven cars, including one designated universally-accessible space (Figure 80). This parking area was added during the 1960s as part of the Mission 66 program, which also involved the widening of the main entrance to accommodate modern vehicles. Concrete curbing edges the parking area, as well as other sections of the road, such as portions of the margins of the loop road around Lincoln Square (Figure 81). A sidewalk is located along the edge of the parking spaces that leads to a small concrete stair (Figure 82).

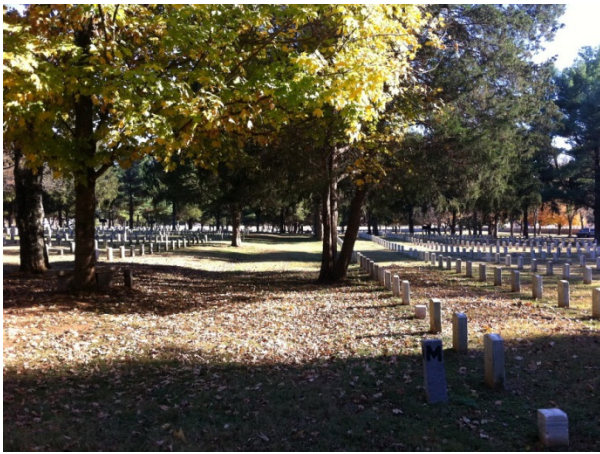
**FIGURE 83.** Eight principal grass avenues radiate from Lincoln Square and are crossed by additional secondary grass avenues that connect the radial system.

Other circulation features include the seven additional grass avenues that radiate outward from Lincoln Square into all corners of the cemetery (Figure 83). The principal avenues are crossed by a series of secondary avenues arranged orthogonally around the central square. The spaces between the avenues form the lettered burial sections of the cemetery. No vehicles, other than those used for maintenance or funerals, are permitted to drive on these avenues, which are grass-surfaced, and thus not universally accessible. The grass avenues are in good condition.

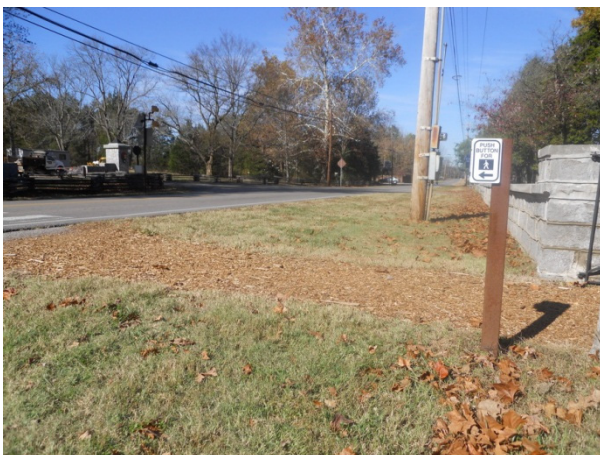
**FIGURE 85.** A push-button pedestrian crossing warning light system is used to support the safety of pedestrians crossing Old Nashville Highway.

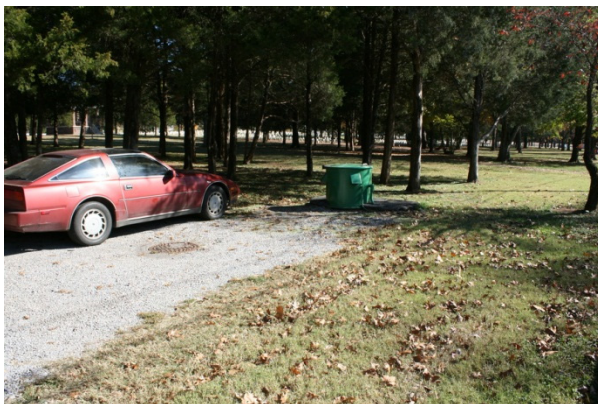
**FIGURE 88.** A gravel access road leads from the maintenance access drive to the sewer pump station, shown with a green cover, located inside the cemetery.

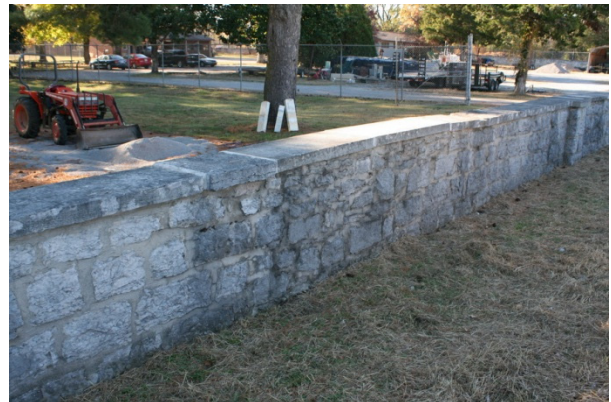
**FIGURE 90.** A pedestrian entrance associated with rail access was closed in 1963 when passenger service was discontinued. It is likely that the variations in stone and mortar in the section of the wall shown here indicate the location of the former entrance.

A former pedestrian gate that once provided entry from the rail line and a depot that was sited nearby was closed in 1963 using limestone similar to the remainder of the wall. The location of the former gate remains visible in the northwestern corner of the cemetery where the use of slightly different capstones and mortar are evident (Figure 90).
