# Stones River National Cemetery

# Cultural Landscape Report

November 2015

Prepared by:  
Wiss, Janney, Elstner Associates, Inc.  
330 Pfingsten Road  
Northbrook, Illinois 60062

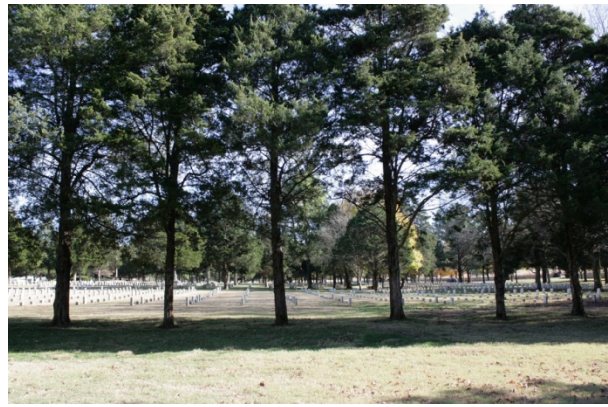
**FIGURE 91.** Eastern red cedars screen the burial area from the rostrum and the rostrum from the housing and maintenance area. However, the trees have been limbed up to facilitate easier mowing, thus limiting their effectiveness as a visual buffer.

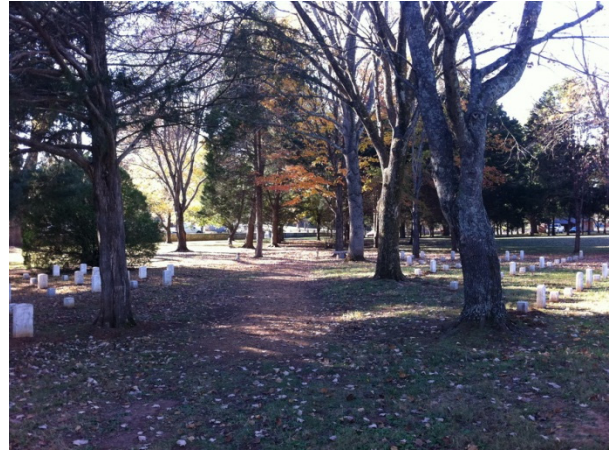
**FIGURE 93.** Dense shade and foot and vehicular traffic make it difficult to maintain turf along some of the grass avenues within the cemetery.

Turf is also used as a groundcover throughout most of the site, although shade and wear and tear due to foot and vehicular traffic inhibits its growth in many areas (Figure 93). Thought to have been originally planted in bluegrass (*Poa pratensis*), and later replanted with fescue (*Festuca arundinacea*), the cemetery currently contains a predominance of Bermuda grass (*Cynodon dactylon*), a non-native invasive species.<sup>130</sup> The floor of the reconstructed rostrum has been planted in fescue.

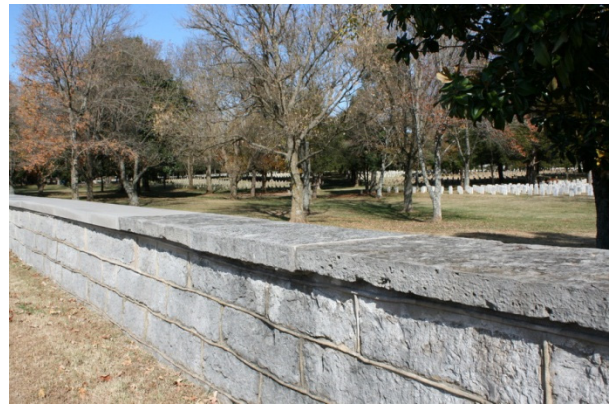
**FIGURE 95.** The limestone perimeter wall completely surrounds Stones River National Cemetery.

**Perimeter Wall.** A limestone masonry wall (LCS ID 090222) surrounds the cemetery, including both the burial ground and lodge and service areas (Figure 95). The wall also forms the project area boundary for the CLR. Based on review of various historic accounts of the cemetery, the wall is thought to have been constructed between 1865 and 1871 of local limestone. A report prepared in 1867 by E. B. Whitman, who after the Civil War became the assistant army quartermaster in charge of national cemeteries, indicates that “the best of stone for the completion of this work [wall construction] can be obtained within one-eighth of a mile of the cemetery.”<sup>131</sup> This report refers to the nearby Ridley limestone deposits along Stones River. Additionally, an October 1865 account from a *New York Times* reporter states that the 111th United States Colored Troops were working in squads to construct the wall using locally quarried limestone.<sup>132</sup>

The exterior of the wall facing Old Nashville Highway is regular ashlar construction with beaded mortar joints. All other portions of the wall are random ashlar construction with flush mortar joints. The large limestone coping stones match the stones in the field of the wall. The wall varies in height, but is generally about 4 feet in height, and is approximately 2 feet 4 inches wide. The outward facing portions of the northern, eastern, and western portions of the wall include regularly spaced buttresses. A drain hole was cut through the base of the wall in the 1980s or 1990s to alleviate flooding within the southwest corner of the cemetery. The wall has required repointing and replacement of stones throughout its history; the most recent repair work was completed in 2009.

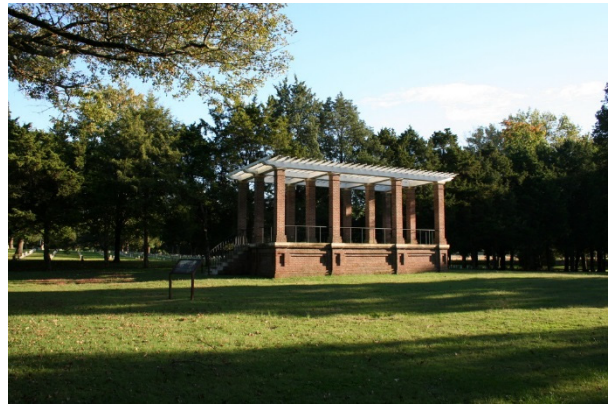
**FIGURE 96.** Overview of the replica rostrum. Source: Stones River National Battlefield, photo by park staff, 2014.

The rostrum is a two-bay-wide by three-bay-long open-air brick structure with a grass-covered raised platform, approximately 36 feet 1 inch long by 19 feet 8 inches wide (Figure 96 through Figure 98). The base of the platform is red brick, set in a running bond pattern inset with geometric decoration differentiating the column bases and spandrel panels.

The platform is accessed by eight stone steps located on the east half of the north and south ends. Both the platform and the steps have a simple black painted steel railing. At the platform level, each bay is delineated by a square brick column, which supports the white painted wood trellis roof. Turf has been planted on the platform. Movable benches have been placed in the space for visitor use, as were present historically.

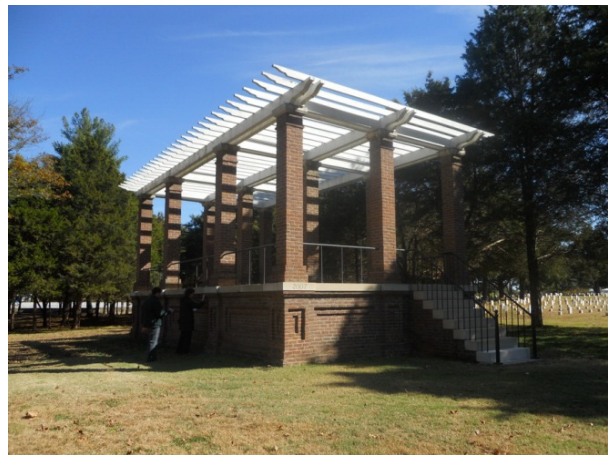
**FIGURE 97.** The original rostrum was demolished in 1941–1942 due to its poor condition. In 2007, the park reconstructed the rostrum based on original designs for the structure.

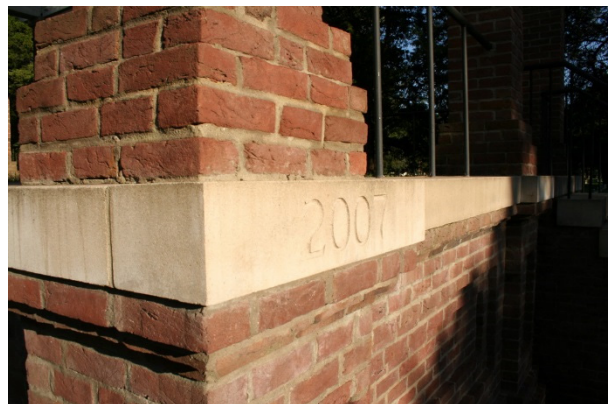
**FIGURE 98.** Cornerstone inscribed with the date of construction of the replica rostrum. Source: Stones River National Battlefield, photo by park staff, 2014.

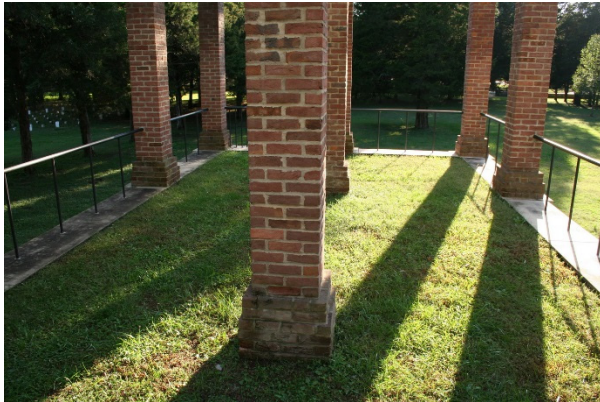
The rostrum is in fair condition. Problems include failing paint coatings and cracked and rotted wood on the wood trellis, and failing paint on the metal railings (despite repeated repainting, according to park staff). The concrete steps are cracked and spalled at railing locations, possibly due to failure of the material in which the railings are set; patch materials and sealant at the railing embedments are cracked and deteriorated. Efflorescence and organic growth on the brick masonry piers and base indicates water movement through the brick, which also exhibits open mortar joints at various locations. The park has also reported problems with the rostrum drainage system (Figure 99 through Figure 105).

**FIGURE 99.** Moisture-related staining at the base of the brick posts. Source: Stones River National Battlefield, photo by park staff, 2014.

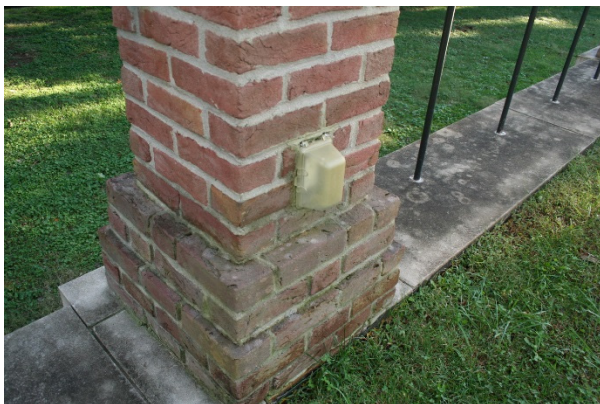
**FIGURE 100.** Detail of moisture-related staining at the base of the brick posts. Source: Stones River National Battlefield, photo by park staff, 2014.

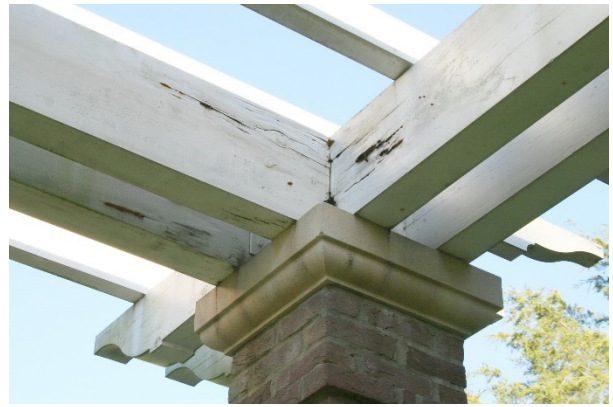
**FIGURE 101.** Deterioration of wood trellis. Source: Stones River National Battlefield, photo by park staff, 2014.

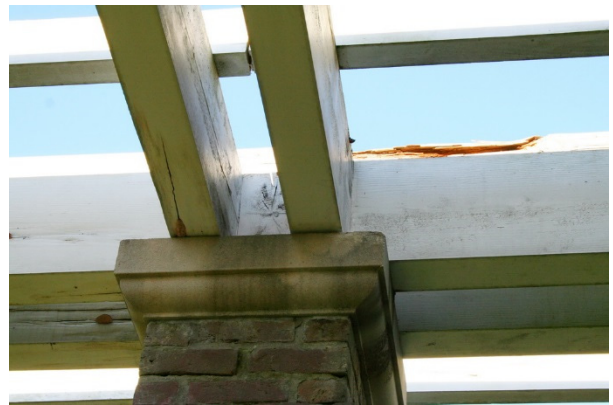
**FIGURE 102.** Splitting and staining of wood trellis. Source: Stones River National Battlefield, photo by park staff, 2014.

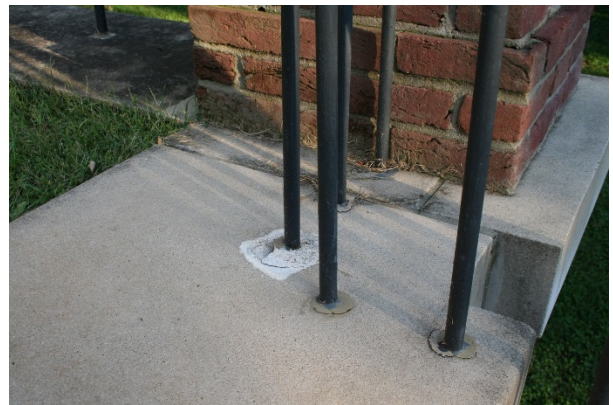
**FIGURE 103.** Previous patching and sealant failure at embedded railing post. Source: Stones River National Battlefield, photo by park staff, 2014.

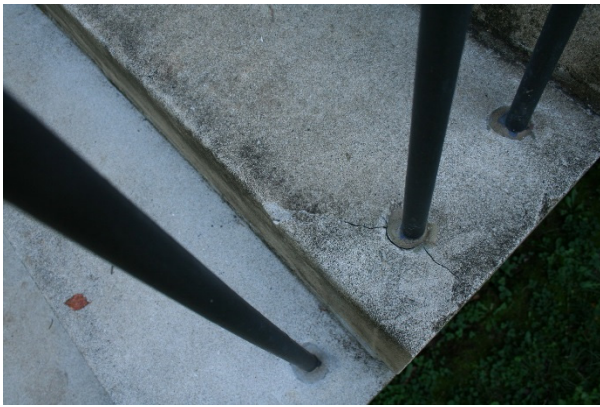
**FIGURE 104.** Cracking of stair tread at embedded railing post. Source: Stones River National Battlefield, photo by park staff, 2014.

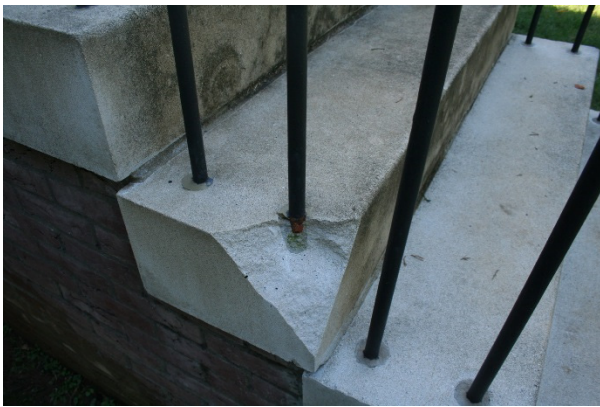
**FIGURE 105.** Spalled cast stone stair tread at embedded railing post. Source: Stones River National Battlefield, photo by park staff, 2014.

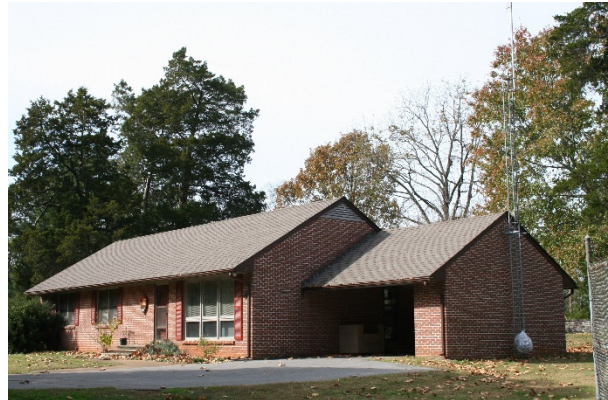
**Staff Residences.** Three brick residences (Buildings 4, 5, and 6 from north to south) were constructed along the western edge of the cemetery within the lodge and service area during the Mission 66 initiative (Figure 106, Figure 107, Figure 108, and Figure 109). These structures, built in 1962–1963, are located along the maintenance drive; Buildings 5 and 6 are used for park housing, while Building 4 is used as office space. Each staff residence is a single story rectangular brick ranch-style building. The red brick is set in a running bond pattern with punched door and window openings. Each window opening has a steel lintel, a brick sill, and red painted decorative shutters. The majority of the windows are two-over-two light double hung windows with aluminum triple-track storm windows. There are also divided light fixed windows. The side-gable roof is covered with brown asphalt shingles and has a single chimney penetration at the center. At the gable

**FIGURE 106.** View of Building 4. Source: Stones River National Battlefield, photo by park staff, 2014.

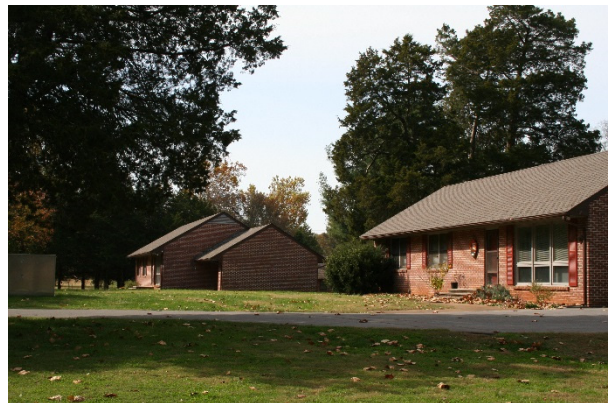
**FIGURE 107.** View looking south of Building 4 (at right) and Building 5 beyond (at left). Source: Stones River National Battlefield, photo by park staff, 2014.

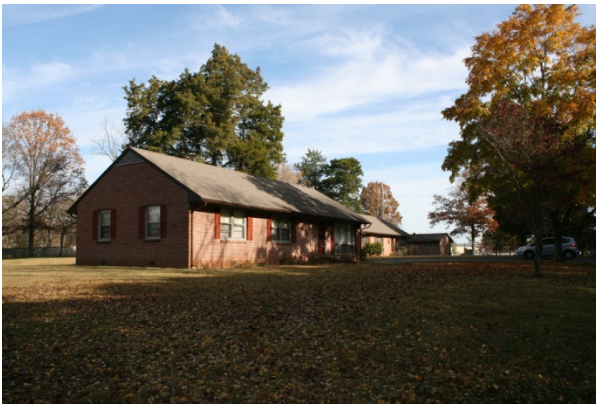
**FIGURE 108.** Building 5 was constructed in the 1960s and is used by park staff for housing. Source: Stones River National Battlefield, photo by park staff, 2014.

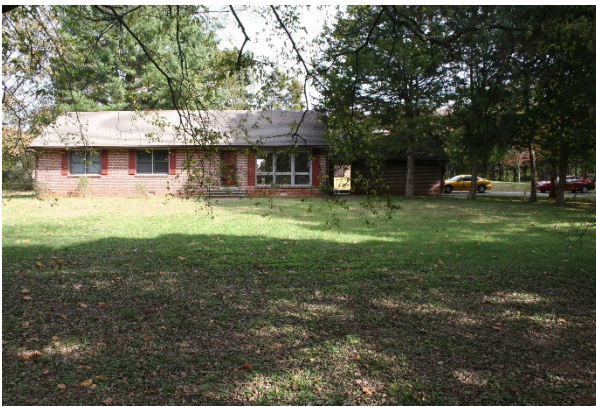
**FIGURE 109.** Front view of Building 6, looking north. Source: Stones River National Battlefield, photo by park staff, 2014.

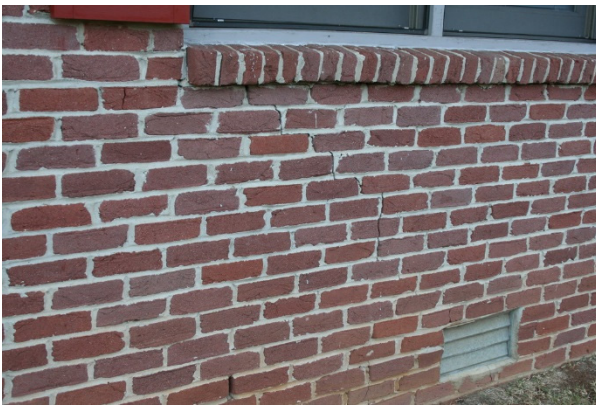
sides, the roof has an overhanging soffit and a wood fascia that supports an extruded aluminum gutter that connects to downspouts which drain at grade. An open carport is connected to each residence. The carport is constructed of brick to match the residence and also has a side-gable asphalt roof. Although these buildings are generally in good condition, Building 6 has experienced fairly serious cracking due to settling of the foundation (Figure 110 and Figure 111).

**FIGURE 110.** Cracked brick masonry, Building 6. Source: Stones River National Battlefield, photo by park staff, 2014.

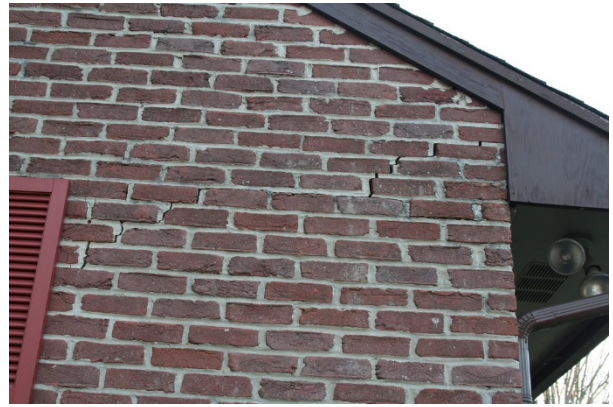
**FIGURE 111.** Cracked brick masonry is evident near the roof of Building 6. Source: Stones River National Battlefield, photo by park staff, 2014.

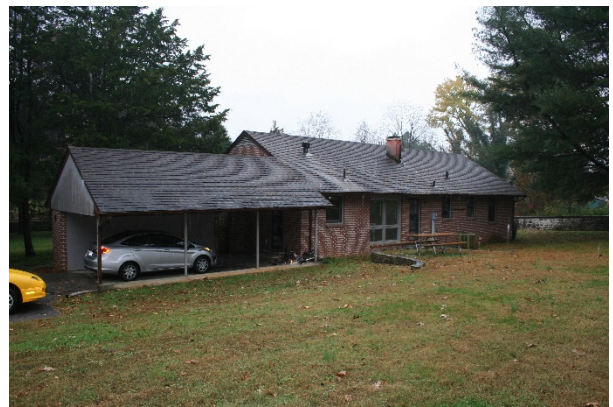
**FIGURE 112.** A low stone retaining wall is located behind Building 6. It was built around a tree that has since been lost. Source: Stones River National Battlefield, photo by park staff, 2014.

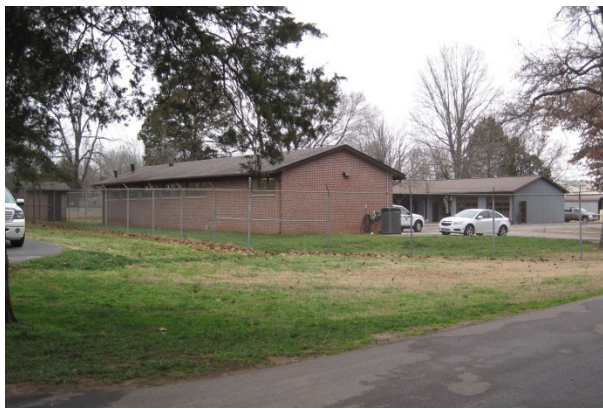
**Maintenance Buildings.** The maintenance area is located north of the housing buildings (Figure 113). The maintenance office and shop is located just inside the chain-link fence and includes office as well as garage space (Figure 114 and Figure 115, and refer to Site History chapter). Originally built in 1962 as part of the Mission 66 program, the maintenance office and shop was renovated in September 2012. The rectangular brick building has seven bays at the front (north) elevation. The first bay includes brick infill and an original pedestrian door. The second bay previously was recessed with a pedestrian door but was altered to include brick infill and a paired

**FIGURE 113.** View of the maintenance area buildings from the south, including the maintenance office and shop at center, the well house at left, and the storage shed and garage at right. Source: Stones River National Battlefield, photo by park staff, 2012.

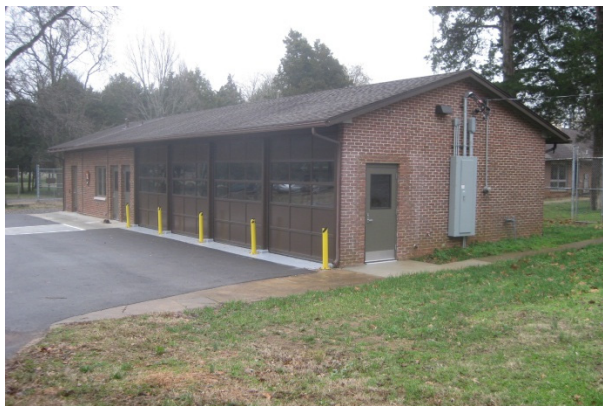
window opening. The next bay was originally an overhead garage door but was altered to include brick infill and two personnel doors. The remaining four bays include new overhead garage doors. The rear (south) elevation includes six window openings with limestone sills, each with a three-part window group. The east and west end walls were originally solid brick, but a new personnel door was created at the west end as part of the September 2012 renovation. The office has a side-gable roof with asphalt shingles. There is an overhanging soffit and a wood fascia supporting an aluminum gutter which connects to downspouts that discharge at grade.

**FIGURE 114.** The maintenance office and shop building, view from the northwest. Source: Stones River National Battlefield, photo by park staff, 2012.

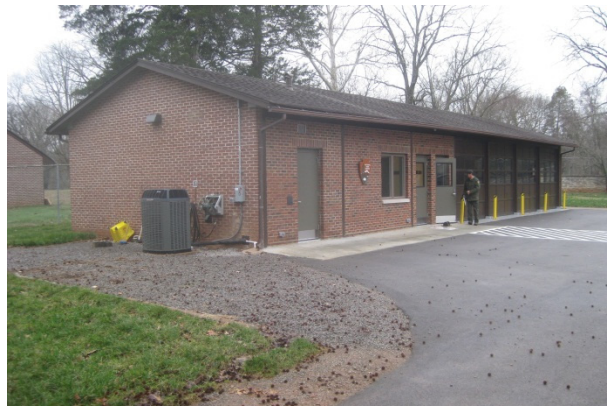
**FIGURE 115.** The maintenance office and shop building, view from the northeast. Source: Stones River National Battlefield, photo by park staff, 2012.

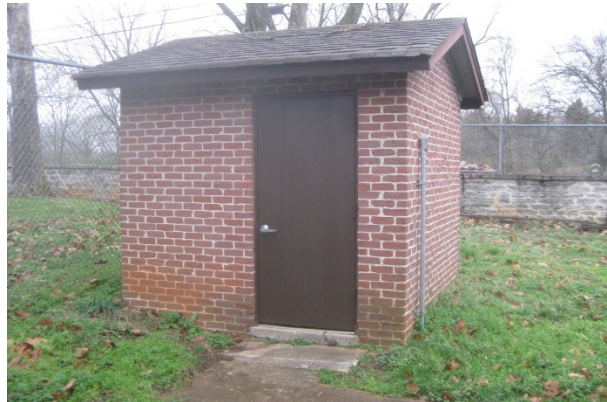
The well house, constructed in 1962 as part of the Mission 66 program, is a small brick structure located behind the shop (Figure 116). The building is a simple rectangular structure with red running bond brick and a side-gable asphalt shingle roof. The structure contains one awning window on its west wall and a single painted steel pedestrian door on its east wall. Although it is generally in good condition, the building exhibits some minor staining on the brick masonry near grade.

**FIGURE 116.** The well house.

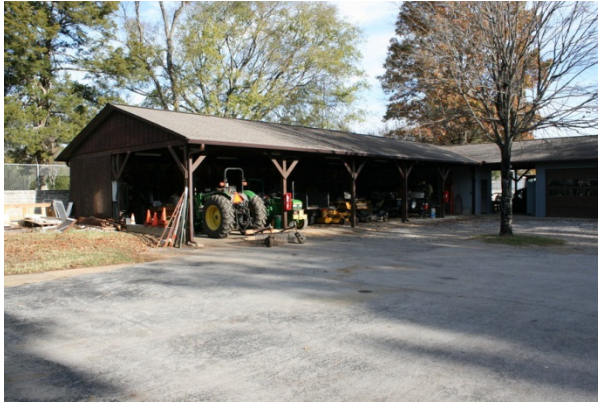
Landscape maintenance equipment is stored in the storage building and garage located near the shop building. The garage is a single-story wood-framed L-shaped structure with five open bays on one side of the L, and three bays at the opposite side. Of the three bays, the first is an open breezeway while the other two include overhead doors. The exterior of the three-bay portion of the building is clad in painted wood board and battens, while the five-bay wing is clad with T-111 plywood. The asphalt shingle covered roof is gable shaped with

aluminum gutters connecting to downspouts that drain at grade (Figure 117).

**FIGURE 117.** The garage is an open structure used to store equipment.

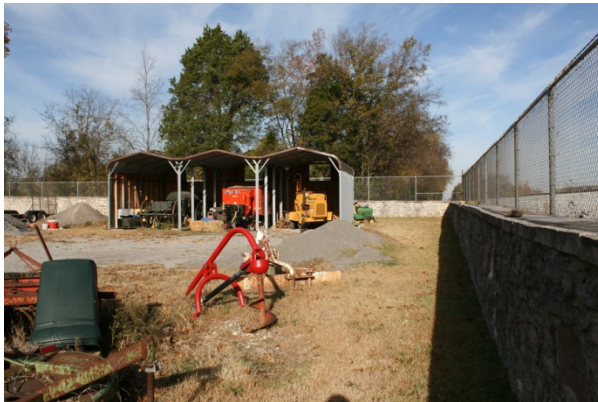
A metal-framed storage shed is located in the maintenance yard. The three-bay prefabricated aluminum storage shed has bays in the longitudinal direction that are open at the front, with T-111 plywood walls on the other elevations (Figure 118).

**FIGURE 118.** The three-bay storage shed in the maintenance yard is also used to store equipment and materials.

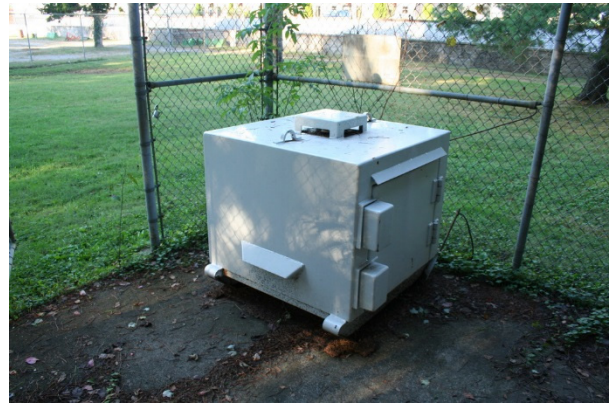
The powder magazine consists of a portable metal box, approximately 3 feet by 3 feet in plan, used to hold black powder for artillery firing demonstrations (Figure 119). The powder magazine is secured within a fenced area and located separately from the rest of the maintenance yard, for safety reasons. The former powder magazine is also located within the fenced area. It is composed of two stacked concrete masonry structures, each with a pre-cast concrete cover (Figure 120).

**FIGURE 119.** The existing powder magazine is a metal box. Source: Stones River National Battlefield, photo by park staff, 2014.

A second chain-link fence, also topped with barbed wire, encloses the powder magazine (refer to Figure 119).

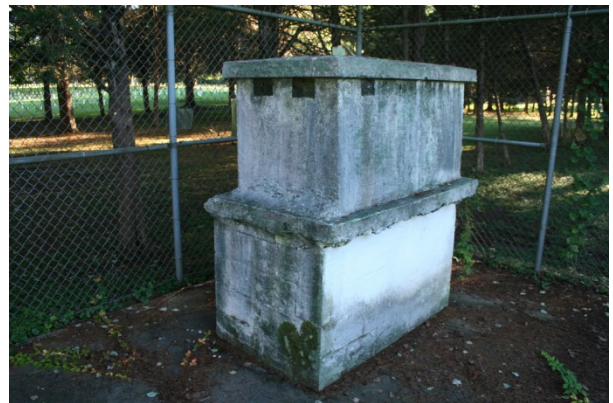
**FIGURE 120.** The former powder magazine is a concrete masonry structure. Source: Stones River National Battlefield, photo by park staff, 2014.

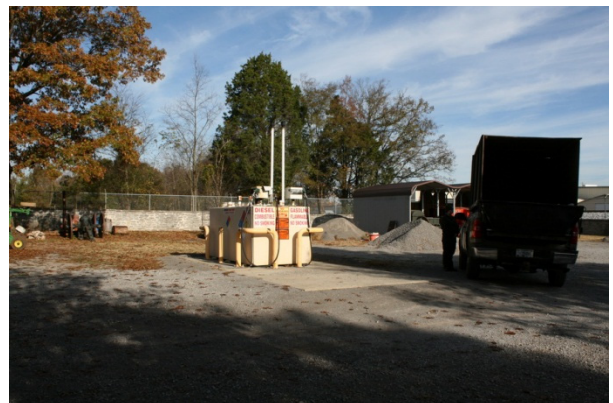
A fuel tank for park vehicle use is located within the maintenance yard. The equipment is located on a concrete pad, is protected by metal bollards (Figure 121).

**FIGURE 121.** The fuel tank located within the maintenance yard.

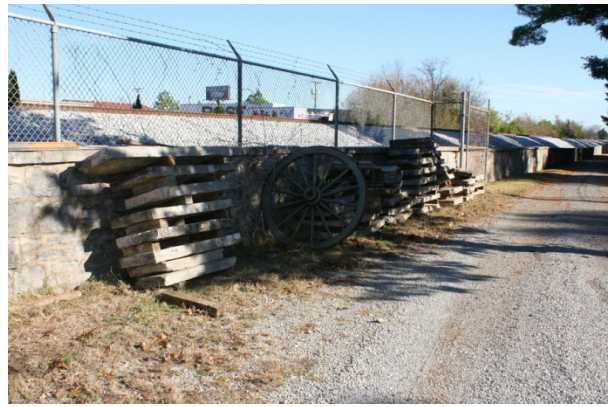
**Fencing.** The maintenance yard is surrounded by chain-link fencing topped with barbed wire. The fence extends beyond the perimeter wall along the northern and western sides of the maintenance yard (Figure 122). There is a gate located within the fence to allow passage into the maintenance yard by park staff. The gate is located at the intersection of the maintenance drive with the fence. A second gate is located in the northeast corner of the fence that provides access to the gravel-paved avenue that follows the north wall interior. There is also a pedestrian gate in the fence near the well house.

**FIGURE 122.** A chain link fence topped with barbed wire surrounds the maintenance yard.

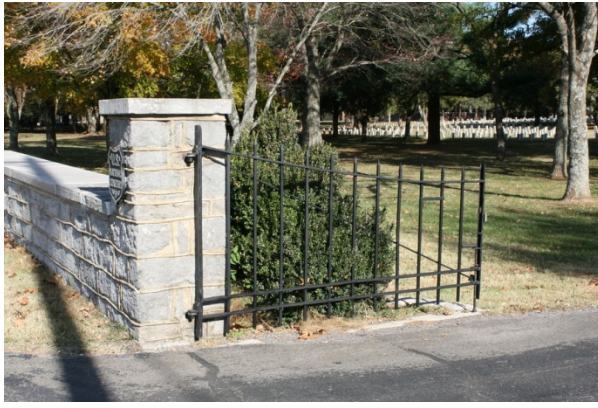
**Gates.** The main entrance gate into the burial grounds is composed of two wrought-iron arms, painted black, made from a frame inset with pickets. Each arm is hung from one of the piers that edge the entrance so that they meet in the middle when closed. In total, the gate is 16 feet 8 inches wide. The piers are each 2 feet 4 inches square in size, 5 feet 5 inches tall, and capped with a flat coping stone. The piers are constructed of native limestone to match the perimeter wall (Figure 123). The gates are composed of three horizontal elements that support a series of vertical pickets with pointed finials. A diagonal cross piece extends from the top left to the bottom right of each gate for added support. The gates are nearly as tall as the piers at the outside edge, but angle downward toward the center where the two panels meet. The pickets similarly descend in height from the pillars toward the center, forming an elliptical curve. Although the main entrance gate is in good condition, it can be difficult to close at times, possibly due to expansion and contraction associated with weather conditions. When the gate is difficult to close, it can scrape the asphalt paving.

**FIGURE 123.** The main entrance gate is double-hung, and composed of wrought iron. Each side swings inward on hinges attached to the stone piers.

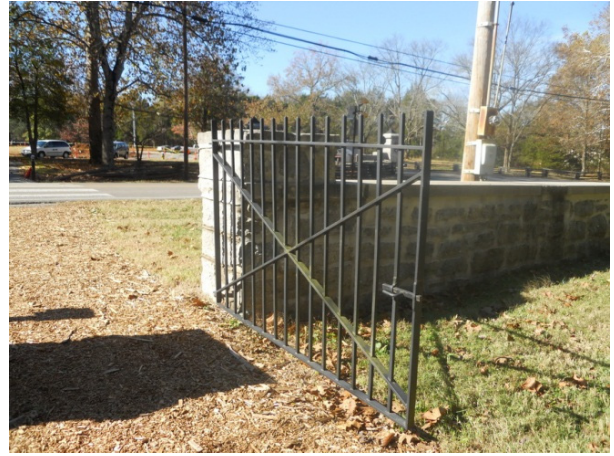
The pedestrian gate into the national cemetery is composed of a single panel, 5 feet 10 inches wide and 4 feet 2 inches tall, made of wrought iron pickets set in an iron frame and painted black (Figure 124). It swings inward on hinges connected to the west pier that marks the opening. A matching pier to the east supports the latch for the gate. The gate includes two horizontal elements and sixteen evenly spaced vertical elements. Additional support is provided by cross-bracing. The pickets of this gate are even in height at 3 feet 11 inches tall.

**FIGURE 124.** A single gate swings open to one side to permit visitors to enter the cemetery's pedestrian entrance along Old Nashville Highway.

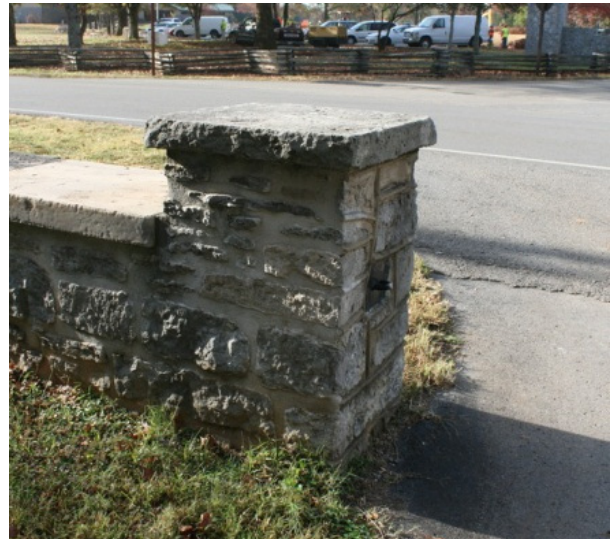
As noted previously, the opening in the perimeter wall at the maintenance access can be secured using a metal pipe concealed within the west pier and wall that slides out to hook to the east pier (Figure 125). The opening is 15 feet 2 inches wide and framed by 3 foot 8 inch tall piers that are 2 feet 4 inches square.

**FIGURE 125.** A sliding metal pole that extends from the west pier of the gate at the maintenance access drive hooks onto the metal loop of the pier as shown to close this road to public access.

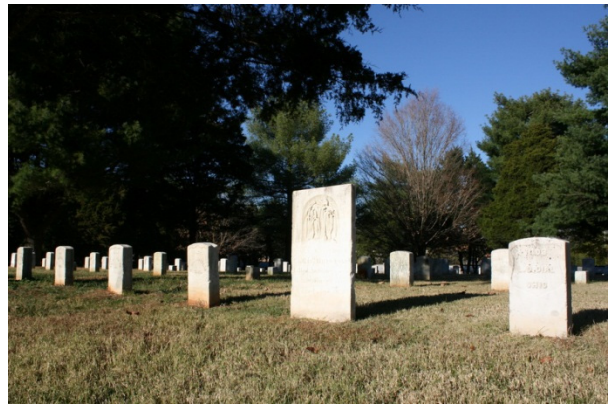
**Grave Markers.** The majority of the grave markers located throughout Stones River National Cemetery are of a standardized design, although they exhibit a range of variations in the thickness, width, and inscriptions of the stone. There are four different categories of grave markers included in Stones River National Cemetery. The majority of the markers are associated with Civil War Union soldiers, although there are two distinct types of markers that indicate whether the grave marks a known or unknown individual (LCS ID 007032). Intermixed among the Civil War markers are unique markers, which were privately

funded and placed by the family members of the deceased soldiers (Figure 126). Most of these are located within sections A through D. The southeastern sections of the cemetery—P through S—contain more recently placed grave markers. These include burials of veterans of the Spanish-American War, World War I, World War II, Korean War, and Vietnam War.

**FIGURE 126.** A variety of grave markers can be found throughout the cemetery. While most are standard marble military issue, some were privately acquired and unique in design.

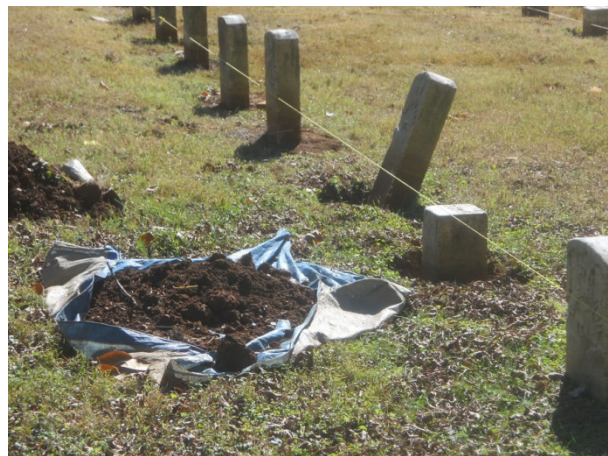
**FIGURE 127.** Grave markers are cleaned, repaired, and reset when necessary in accordance with *Director's Order No. 61: National Cemetery Operations*.

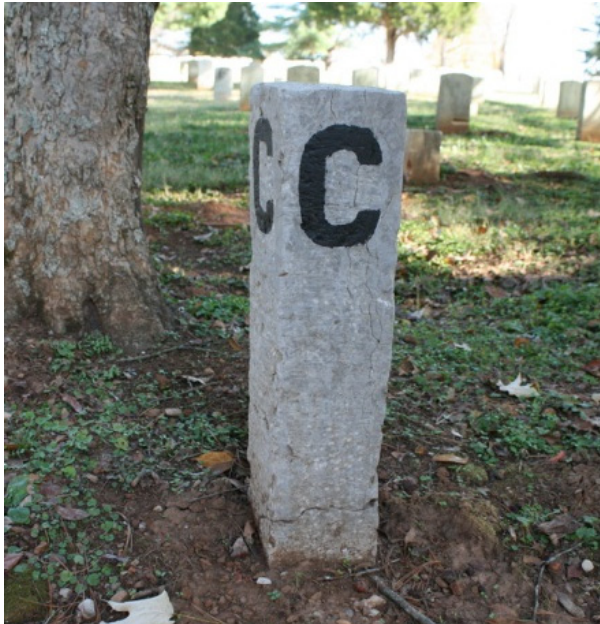
**Section Markers.** The section markers that identify the corners of each cemetery section are square upright features, composed of limestone or precast concrete and inscribed with either a painted or carved letter to identify the adjacent cemetery section. In general, the concrete posts are replacements of older limestone posts and were installed and painted circa 1980. The limestone markers are in good to fair condition as a result of weathering and water damage, and exhibits problems with chipping, cracking, and soiling (Figure 128 and Figure 129).

**FIGURE 128.** Older section markers are made of limestone with inscribed letters painted black.

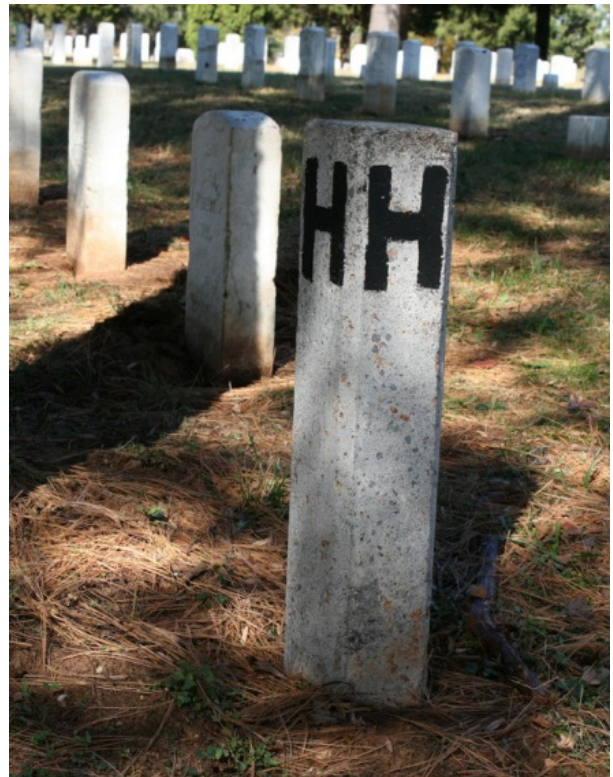
**FIGURE 129.** Newer section markers are precast concrete inscribed with letters painted black.

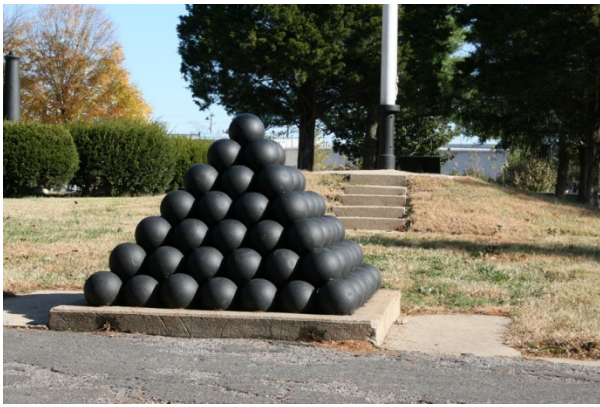
**Cannonball Pyramid.** A monument composed of a pyramid of black painted, 32-pounder cannonballs set on a concrete base is located on axis with Central Avenue within Lincoln Square (LCS ID 090228) (Figure 130). The cannonballs are arranged with seven across each face of the pyramid at the base, rising through seven rows to a single cannonball at the top. The monument does not appear in historic photographs of the area prior to 1964, and is thus believed to have been installed circa 1964, or later in the 1960s. The monument appears to have been installed around the same time that the Bragg Headquarters monument, located south of the cemetery within the park, was replaced, suggesting that it is possible the cannonballs associated with this monument were derived from the Bragg monument. Documentary evidence to confirm this possibility has not been located, however.

**FIGURE 130.** A pyramid of black painted cannonballs is located along the southern edge of Lincoln Square.

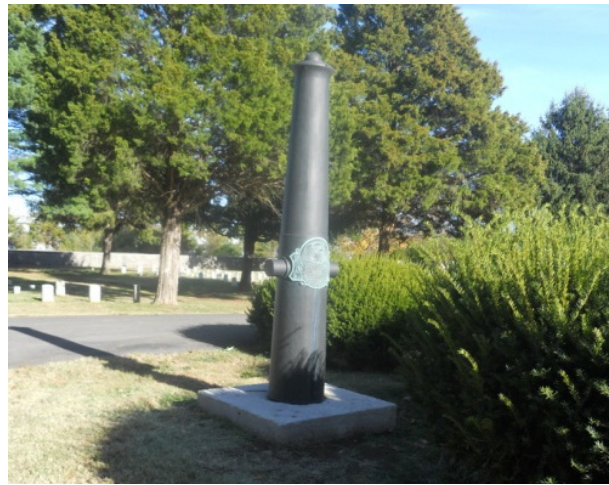
**Cannon Tube Markers.** Two upright black painted 24-pounder cannon tubes set in concrete bases (Figure 131) mark the corners of Lincoln Square. (The List of Classified Structures for the cannon tubes identifies these features as LCS ID 090227 for the cannon tube marker at the east corner of the square and LCS ID 1031310 for the cannon tube marker at the north corner of the square.) These cannon tubes were placed in the cemetery in 1866 to honor the fallen soldiers.<sup>135</sup> The trunions are stamped “McC, W&Co., P.P.F.,” identifying them as having been manufactured at the Fort Pitt Foundry in Pittsburgh, Pennsylvania, operated by McClurg, Wade & Co., probably between 1831 and 1841.

A weathered bronze plaque is mounted on one of the cannon tubes, but is missing two of its four bolts. The plaque provides the establishment date for the cemetery and information regarding interments.

**FIGURE 131.** A pair of upright cannon tubes marks the corners of Lincoln Square. A bronze plaque on one of the cannon tubes provides information about the establishment of the cemetery and its interments.

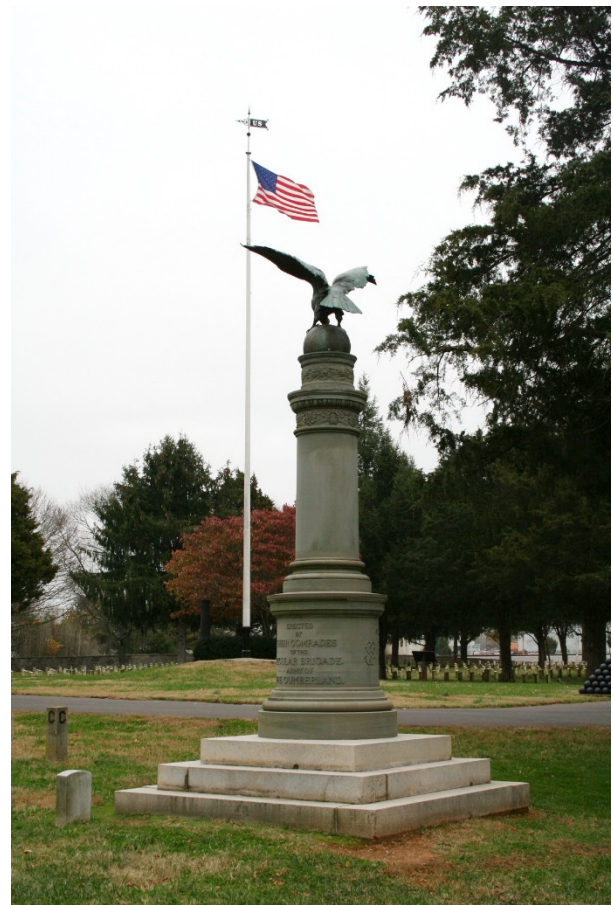
**U.S. Regulars Monument.** The U.S. Regulars Monument (LCS ID 007040) is located in Section C just west of Lincoln Square (Figure 133 and Figure 134). The monument is approximately 15 feet tall and is composed of a sandstone shaft set on a three-tiered stepped granite base. The shaft is topped with a bronze ball and eagle sculpted by Launt Thomson and cast by Bureau Bros of Philadelphia. In the 1880s, Maj. F. L. Guenther, 2nd Artillery, requested a monument be erected to the members of the Regular Brigade of the Army of the Cumberland that were killed at the Battle of Stones River on December 31, 1862. The U.S. Regulars Monument was subsequently erected in 1883 using funds provided by veterans of the brigade.<sup>136</sup> The monument underwent repairs several times to address deterioration and vandalism after attempts (one successful) to steal the bronze eagle from the top. The most recent restoration was completed in 1998.

**FIGURE 134.** The U.S. Regulars Monument with the flagstaff beyond. Source: Stones River National Battlefield Archives, photo by park staff, 2014.

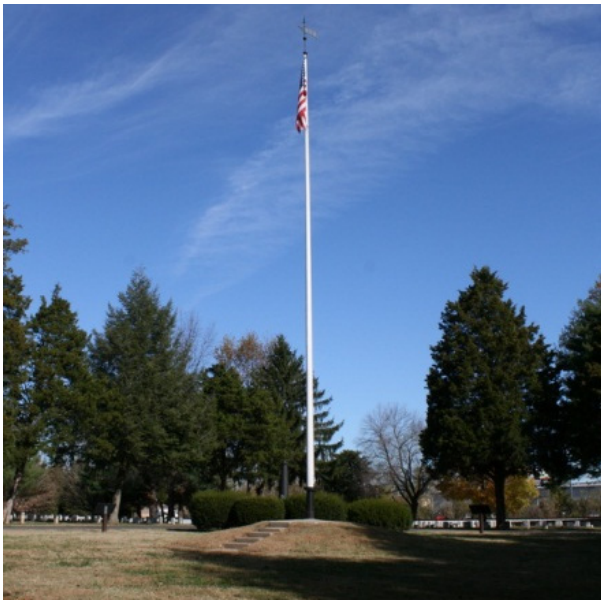
**Flagstaff.** A cast-iron flagstaff topped with a metal weathervane (LCS ID 090226) is located at the center of Lincoln Square. The metal pole is painted white and is set on a black painted base (Figure 135). The banner-style weathervane is composed of metal with a cut-out that says “U.S.” The weathervane was damaged in the late 1990s and repaired in 2007, but one piece is still missing, possibly reflecting previous repairs.<sup>137</sup> The flagstaff is otherwise in good condition.

**FIGURE 135.** The flagstaff is located in the center of Lincoln Square. It is painted white and has a black painted base.

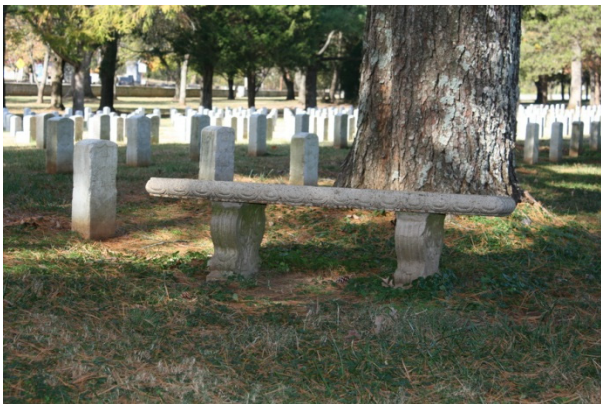
**FIGURE 136.** One of the pre-cast concrete benches located within the cemetery.

**Benches.** Several benches are located throughout the burial ground character area. Some are pre-cast concrete with ornamental designs (Figure 136). The precast concrete benches were in use within the cemetery by 1977, although the date of origin of this feature is not currently known. Others are rustic native limestone slabs set on paired bases (Figure 137). These benches are approximately 50 inches long, 22 inches wide, and 18 inches tall with pillars that are each about 12 inches by 20 inches by 14 inches and support a 4-inch-thick slab. The limestone benches were made out of leftover capstone materials by a Historic Preservation Training Center crew that repointed the cemetery boundary wall in 2009.

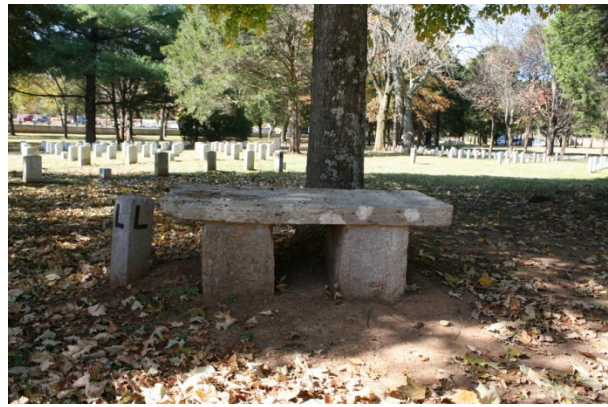
**FIGURE 137.** An example of the limestone slab benches located throughout the cemetery.

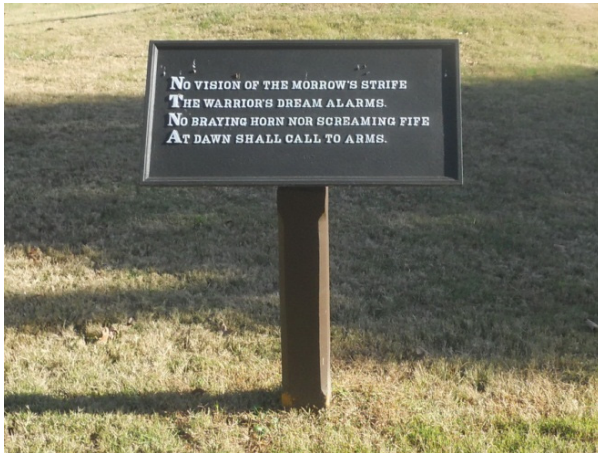
**FIGURE 139.** Seven painted metal plaques set on painted wood posts and displaying the text of “The Bivouac of the Dead” are located along the entrance drive and around Lincoln Square.

**Plaques.** Seven metal plaques displaying lines of “The Bivouac of the Dead,” a poem by Theodore O’Hara, installed in 1882, are located along the entrance road and around Lincoln Square (Figure 139). The plaques (LCS ID 090223), which are painted black with raised lettering painted white, are mounted on wood posts. The original posts were indicated to be cedar, but the existing posts are treated pine, painted brown. These signs were manufactured in 1881 by Rock Island Arsenal and supplied to national cemeteries by the

federal government. The signs and posts are in good condition.

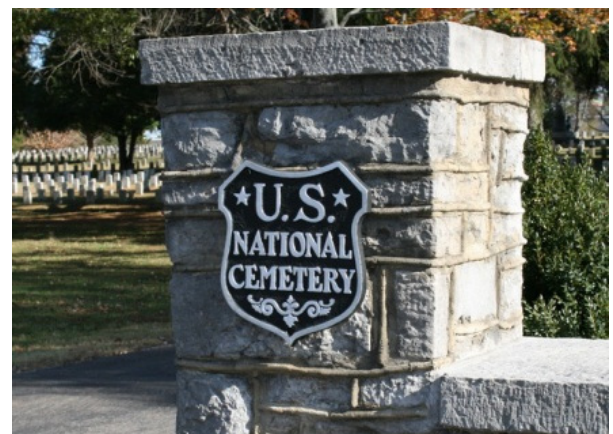
**FIGURE 142.** Painted metal shields are located on the piers that mark the main entrance gate to the cemetery.

A cast metal shield is affixed to each of the main entrance gate columns and identifies the site as a United States national cemetery. These shields are painted black with raised silver-painted lettering, borders, and decorations (Figure 142). There is also a sign indicating the park personnel entrance into the cemetery and a circular metal USGS marker mounted on the top of the limestone perimeter wall along the north side near the location of what had been the railroad entrance to the cemetery (Figure 143 and Figure 144).

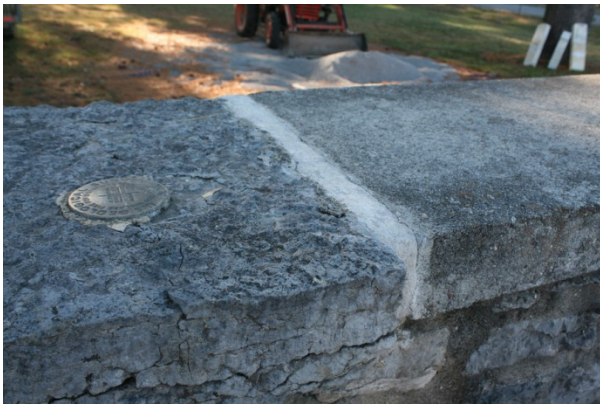
**FIGURE 143.** A small metal USGS medallion is embedded in the limestone perimeter wall near what used to be the pedestrian entrance for visitors arriving by rail. Source: Stones River National Battlefield, photo by park staff, 2014.

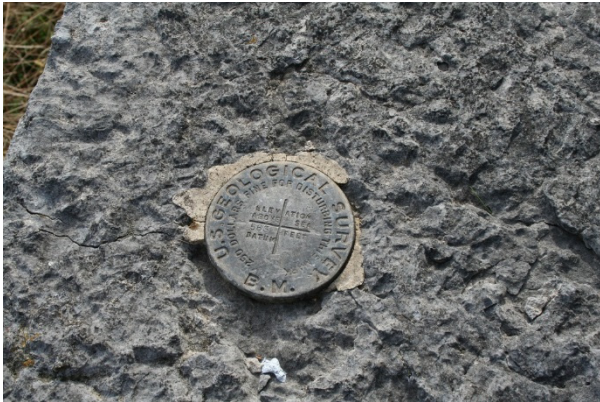
**FIGURE 144.** Detail of the small metal USGS medallion in the limestone perimeter wall. Source: Stones River National Battlefield, photo by park staff, 2014.

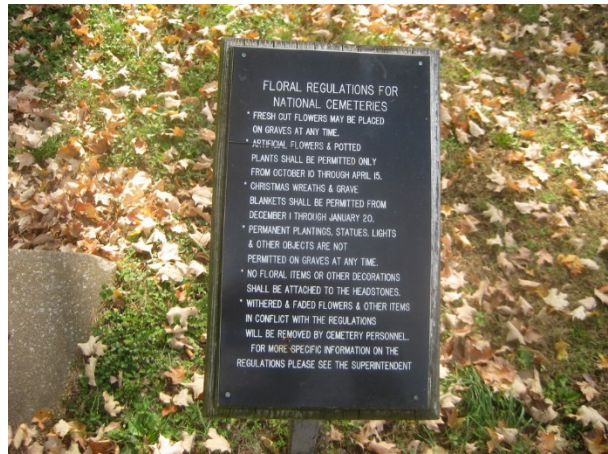
**FIGURE 145.** Floral regulations sign. Source: Stones River National Battlefield, photo by park staff, 2014.

A floral regulations sign is located near the parking lot. This sign is composed of a black plastic board with white lettering, mounted on a wood board and supported by a metal post (Figure 145). The date of installation of this sign is not known. The condition of the sign is judged to be fair.

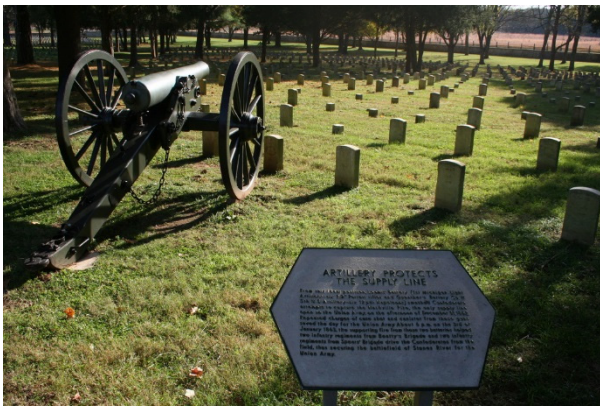
**FIGURE 150.** A cannon and Mission 66 wayside exhibit are located just off Lincoln Square. Source: Stones River National Battlefield, photo by park staff, 2014.

**Cannon.** A Civil War-era cannon set on a reproduction carriage is located on the southern margin of Lincoln Square (Figure 150). The cannon is a 12-pound Napoleon with an original tube set on a reproduction carriage. The cannon was likely placed within the cemetery in association with the Mission 66 wayside exhibit circa 1965–1967. The cannon marks the approximate position of Battery H, 5th U.S. Artillery during the afternoon of December 31, 1862.<sup>139</sup>

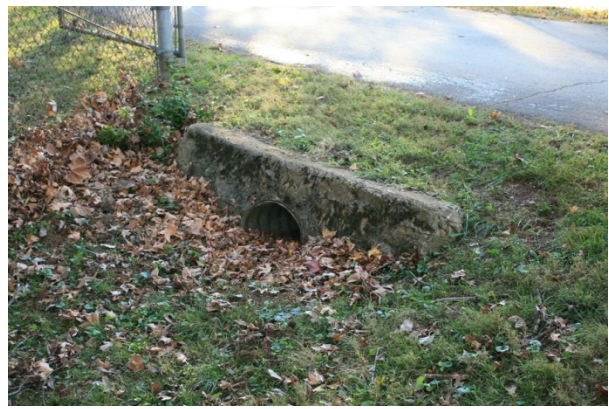
**FIGURE 152.** A stone-faced headwall and culvert runs beneath the maintenance area access drive just inside the chain-link fence that surrounds the maintenance yard.

A fire hydrant is located along the maintenance access road beside the driveway to Building 4 (refer to Figure 64). A stone veneer headwall and culvert is located under the maintenance entrance drive just inside the chain-link fence that marks the boundary of the maintenance yard (Figure 152). There is also a fire department connection box located on the lawn in front of Building 4 within the staff housing area (Figure 153).

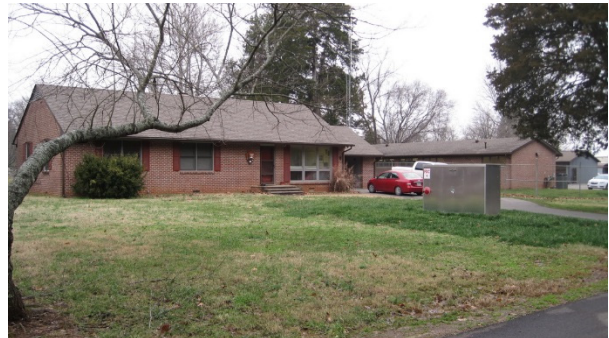
**FIGURE 153.** A fire department connection box is located on the lawn in front of Building 4 within the staff housing area. Source: Stones River National Battlefield, photo by park staff, 2014.

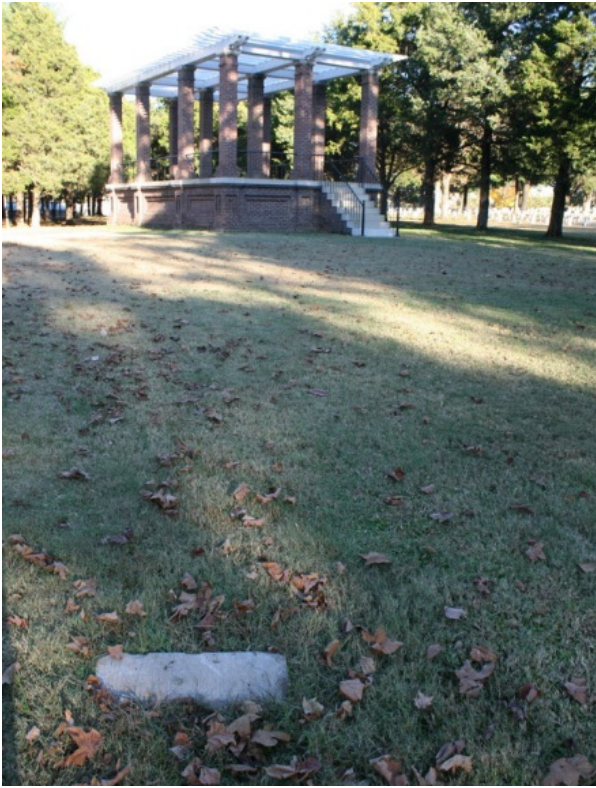
**FIGURE 154.** A concrete storm water outfall is located near the rostrum and is associated with draining the earthen base of the structure.

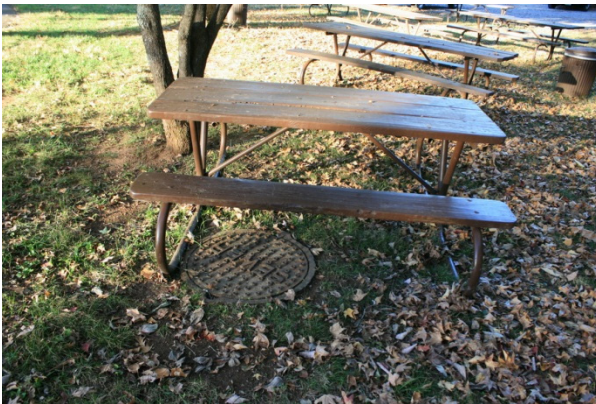
**FIGURE 155.** Manhole and utility box covers are found at various locations through the site, primarily in the lodge and service area.

A concrete storm water outfall that is associated with the rostrum drainage system is located southwest of the rostrum (Figure 154). Manhole and utility box covers indicate the presence of below grade utility infrastructure (Figure 155). Irrigation lines are present within the cemetery.

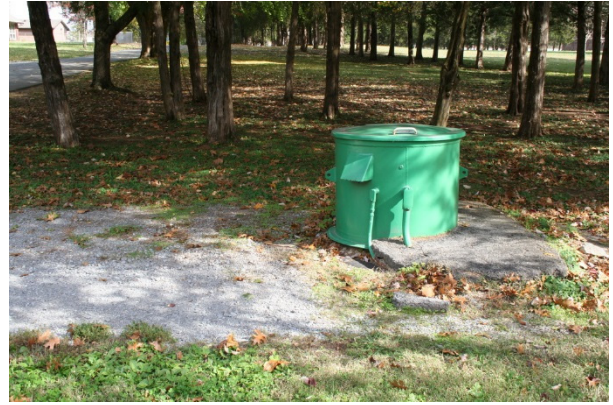
**FIGURE 156.** A sewer pump station is located beside the gravel access road just inside the maintenance entrance off Old Nashville Highway. Source: Stones River National Battlefield, photo by park staff, 2014.

A sewer pump station, protected by a green access hatch, is located beside the gravel access road just inside the maintenance entrance off Old Nashville Highway (Figure 156). Several mailboxes are located at the entrance to the maintenance drive associated with the park staff residences.
