# Stones River National Cemetery

# Cultural Landscape Report

November 2015

Prepared by:  
Wiss, Janney, Elstner Associates, Inc.  
330 Pfingsten Road  
Northbrook, Illinois 60062

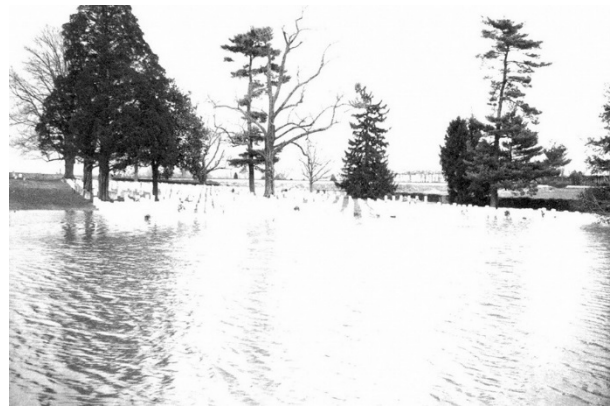
**FIGURE 159.** Flooding in the cemetery, 1972. Source: Stones River National Battlefield Archives, image STRI-ICP-0252.

Flooding continued within the cemetery into the 1970s, particularly in the southeast corner, where water inundated the burials located in Section Q (Figure 159). Cemetery staff cut a 2-foot-deep drainage swale through the lawn panels between Sections M and O and the south boundary wall. The water was directed into large culverts that passed under the Old Nashville Highway to Stones River. The excavated soil was placed over graves in Section Q, raising the elevation of the area by 1 foot.<sup>164</sup>

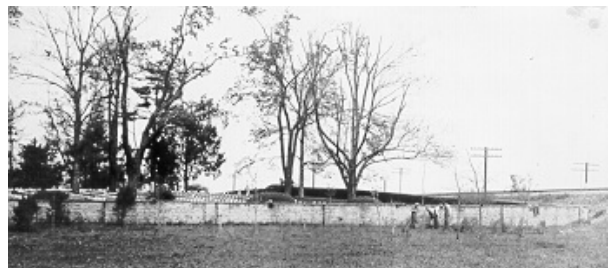
**FIGURE 164.** View of the railroad tracks and the cemetery wall. Source: Stones River National Battlefield, Fraley, image fr.adjfield.

At the time of the establishment of the cemetery, the tracks were much lower than at present and, with the exception of the northwest corner of the cemetery, were concealed behind the cemetery wall well into the twentieth century (Figure 164). Sometime during the twentieth century, the tracks were reset at a higher grade atop ballast to help meet the elevation of a bridge crossing of Stones River. Today, the rail bed is higher than the perimeter wall and the rail line is highly visible from several points within the cemetery, diminishing the integrity of this view slightly.

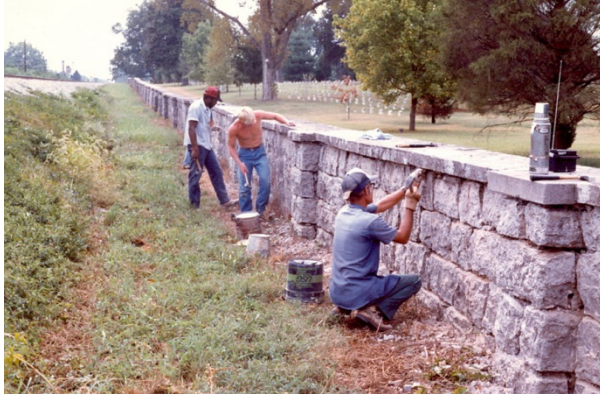
**FIGURE 174.** Repointing the perimeter wall along the railroad, circa 1980s. Source: Stones River National Battlefield Archives, image STRI-4X5P-1307.

**Perimeter Wall.** The cemetery is surrounded by a limestone masonry wall built between 1865 and 1871. The wall has required continual maintenance and repair, including repointing of mortar joints (Figure 174) and occasional reconstruction to address damage due to storms, vehicle accidents, and general deterioration (Figure 175). A drain hole was cut through the base of the wall in the 1980s or 1990s to alleviate flooding within the southwest corner of the cemetery.

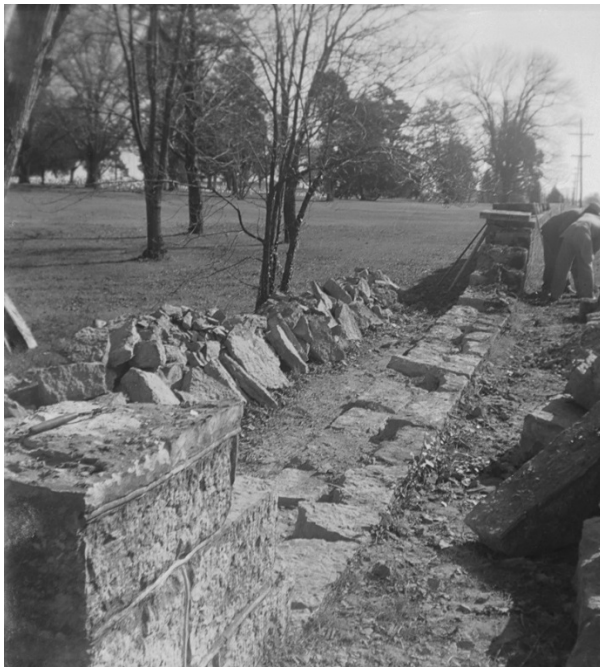
**FIGURE 175.** Reconstruction of a portion of the perimeter wall, circa 1930s. Source: Stones River National Battlefield Archives, image STRI-AN-035b.

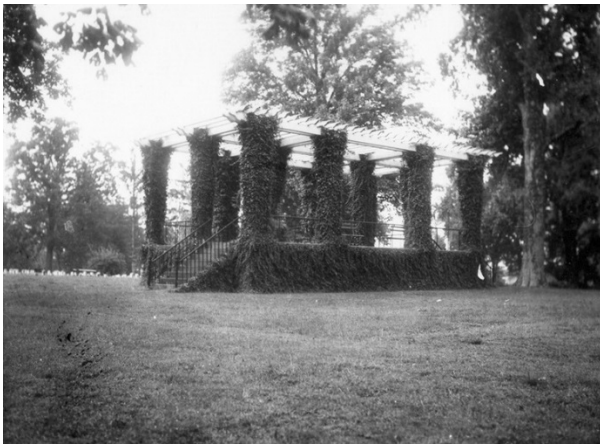
**FIGURE 177.** The rostrum, circa 1930, view looking southeast. Note the location of the stairs on the western half of the structure's north end. Source: Stones River National Battlefield Archives, image STRI-4X5P-1088.

**Rostrum.** A replica of the brick and wood rostrum, originally built in 1882 and demolished in 1941–1942, was built in 2007 based on documentary evidence relating to the original design.<sup>235</sup> Inconsistencies in the replica include the steps on the north and south ends, which are located at the east half, rather than the west half as in the original rostrum, and the use of contemporary construction materials and techniques. Thus the rostrum is not an accurate reconstruction and cannot be assessed as a contributing resource due to the fact that it post-dates the period of significance (Figure 177 and Figure 178).<sup>236</sup>

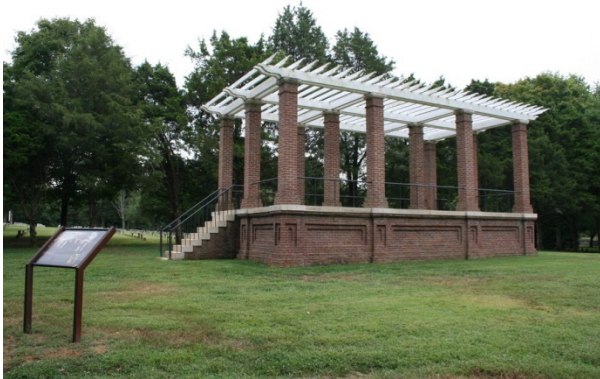
**FIGURE 178.** The reconstructed rostrum, 2010, view looking southeast. Note the position of the stairs on the eastern half of the north end.

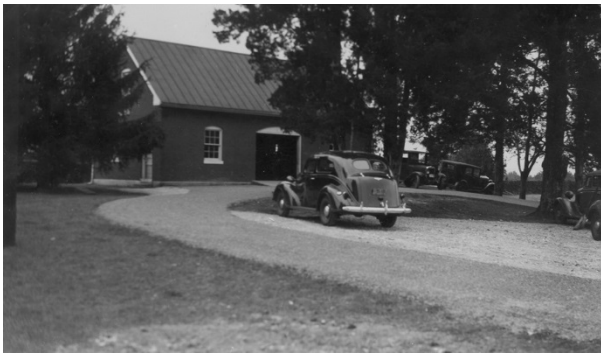
**FIGURE 180.** Circa 1935 view of the brick masonry stable. Source: Stones River National Battlefield Archives, image STRI-ICP-0442.

The original stable was replaced in 1906 by a rectangular gable-roof red-brick structure with six-over-six double hung windows and a double door on the eastern facade (Figure 180).

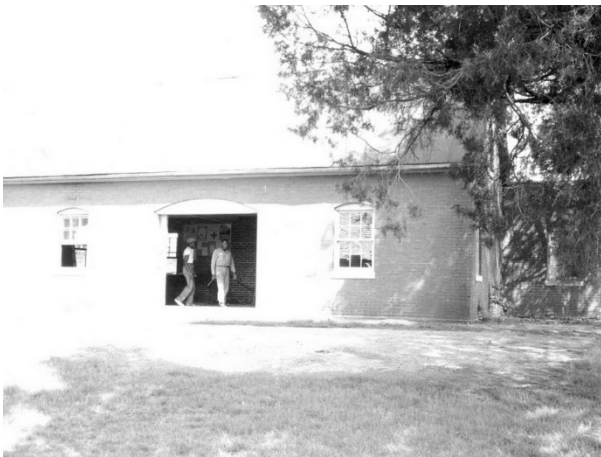
**FIGURE 182.** By the 1950s, the stable was used as a utility and maintenance building. Source: Stones River National Battlefield Archives, image STRI-ICP-0400.

1950s, as shown on National Park Service drawing 2029 dated January 18, 1954, the stable was being used as a utility building (Figure 182). The 1920s lodge and the two outbuildings remained. All of these buildings were demolished to accommodate the planned construction of staff housing during Mission 66.

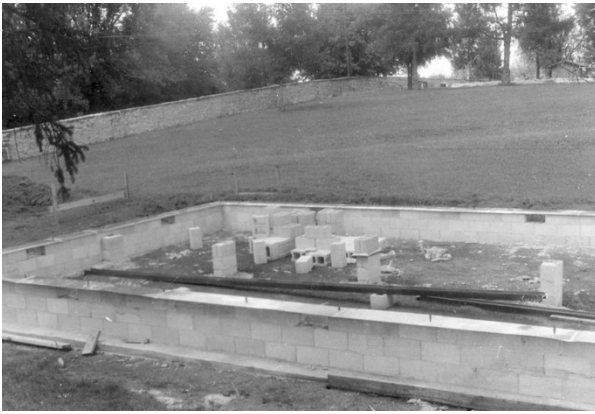
**FIGURE 183.** View of foundation construction for Quarters 6, June 1962. The former site of the stable is beyond, where disturbed earth is visible. The well house is visible at upper right in this view. Source: Stones River National Battlefield Archives, image STRI-ICP-1208.

In 1962, construction began on these new dwellings and an adjacent maintenance complex that included a maintenance shop and well house. Work followed demolition of the earlier stable (Figure 183). Two of the new staff residences were completed in 1962, while the third residence, a

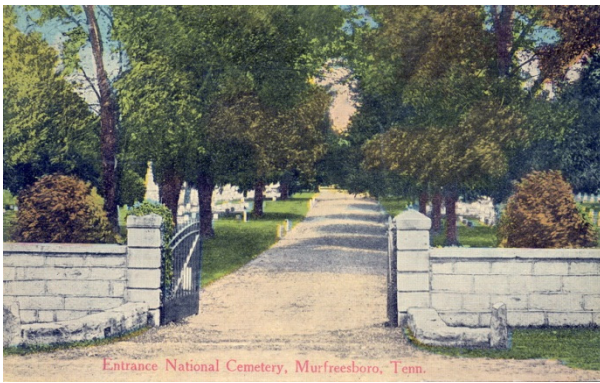
**FIGURE 187.** Postcard view of the main gate, circa 1910, showing rusticated concrete piers constructed in 1896. This view predates the addition of a cast iron plaque to the east pier in 1913. Note raised stone curbs adjacent to the drive. Source: Stones River National Battlefield Archives, image STRI 4735.

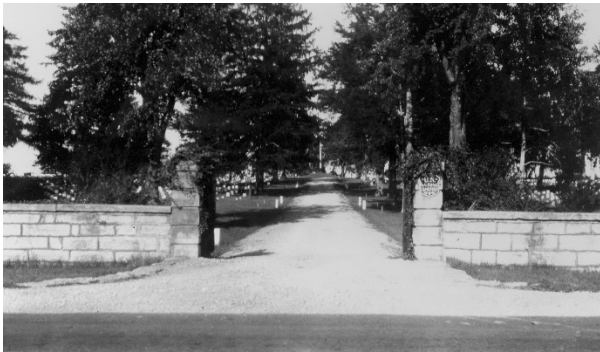
**FIGURE 188.** View of the main entrance gate, circa 1935. Note the cast iron plaque on the east pier. Source: Stones River National Battlefield Archives, image STRI-ICP-0441.

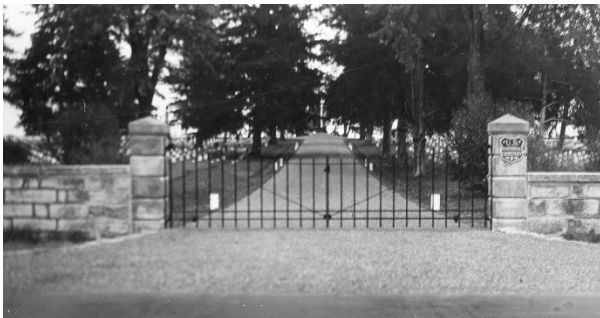
**FIGURE 189.** The completed main entrance gate, circa 1937. Note the freshly repointed joints in the limestone wall adjacent to each pier, indicating the extent of the wall affected by the 1930s work. Source: Stones River National Battlefield Archives, image STRI-ICP-0405.

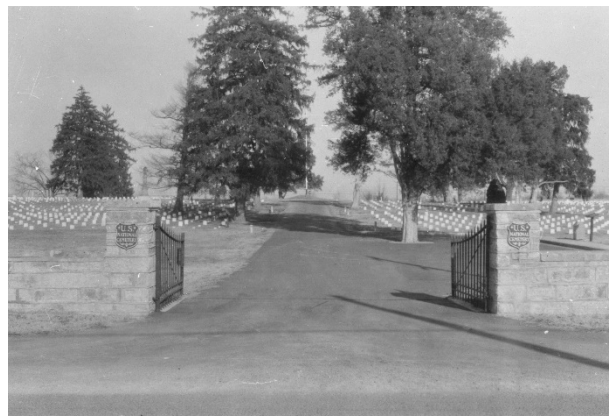
**FIGURE 190.** The reconstructed main entrance gate, circa 1961–1963. The cast metal plaque at the service entrance was moved to the west pier of the main entrance. The 1937 cast iron gates were repaired and reinstalled. Source: Stones River National Battlefield Archives, image STRI-Central Files 516.

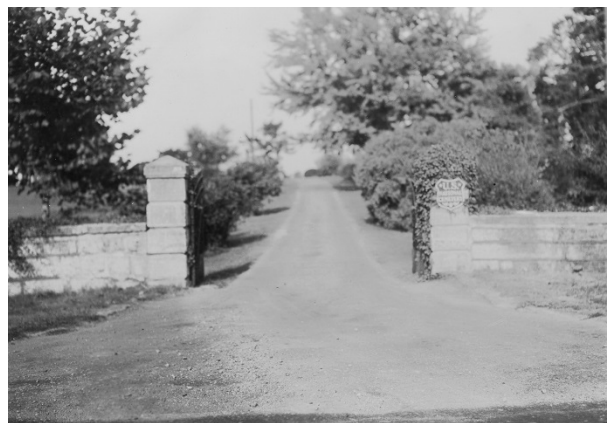
**FIGURE 192.** The gates at the service entrance were cast iron. This view, circa 1934, shows the concrete piers constructed in 1896. Source: Stones River National Battlefield Archives, image STRI-ICP-0439.

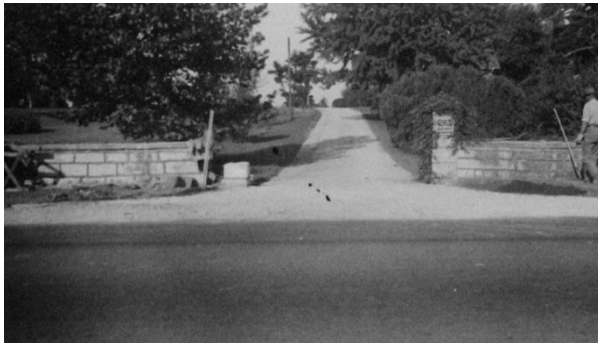
**FIGURE 193.** The service gateway undergoing reconstruction, 1937. Source: National Archives, Record Group 79: Records of the National Park Service, Records of the Branch of Engineering, Final Construction Reports, 1934–1942.

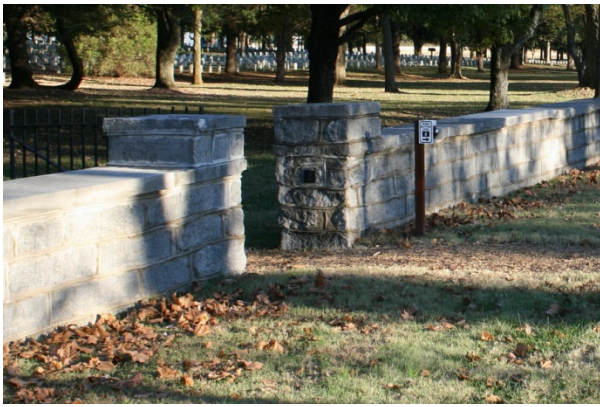
**FIGURE 196.** The reconstructed pedestrian gate, 2010, seen from the opposite angle. The piers as constructed are different from those shown above circa 1930s, with the cap at the top of the wall extending through the pier rather than stopping at the pier face.

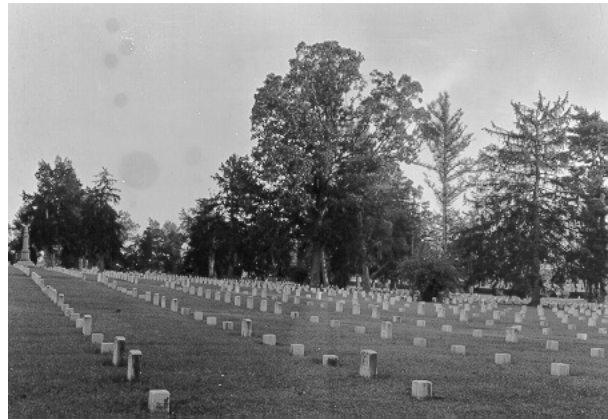
**FIGURE 197.** Grave markers in Section B in Stones River National Cemetery, 1935. Source: Stones River National Battlefield, Fraley, image sectb1935.

**Grave Markers.** When the cemetery was first established, each grave was identified with a wooden headboard, painted white and lettered with the soldier’s name, rank, company, regiment, and date of death.<sup>249</sup> These headboards, however, deteriorated rapidly and by 1870, the superintendent reported that they “all show signs of rot with many of them rotted off at the ground.”<sup>250</sup> In 1873 and 1874, the Quartermaster Department ordered new marble markers to replace the wooden headboards, which were deteriorating. These were installed in 1876.<sup>251</sup> Most of these marble markers survive today (Figure 197 and Figure 198).

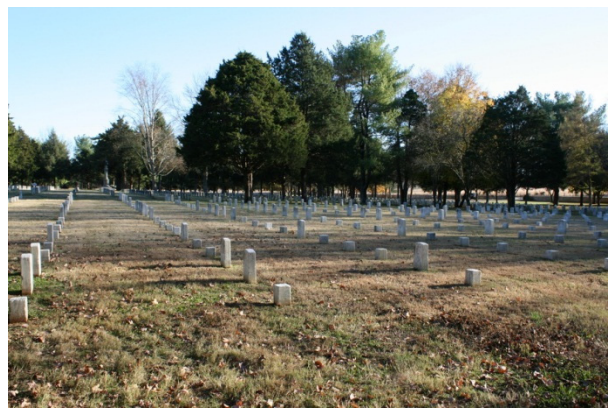
**FIGURE 198.** Grave markers in Section B in Stones River National Cemetery, 2010.

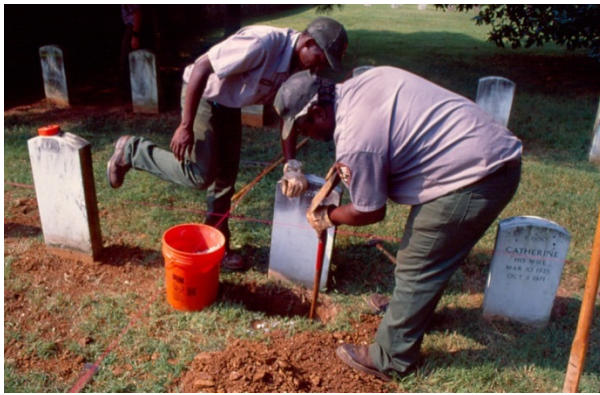
**FIGURE 199.** Resetting grave markers in the cemetery, 2001. Source: Stones River National Battlefield Archives, slides, collection 67, image 67-01-011-0009.

In 1986, a headstone and section marker replacement program was initiated by the park. Because the Department of Veterans Affairs (VA) would only issue modern standard-sized replacement headstones, the park engaged a local stonemason to resize the stones to match the Civil War era proportions.<sup>252</sup> The marker stones are regularly reset, repaired, or replaced as their condition dictates (Figure 199).

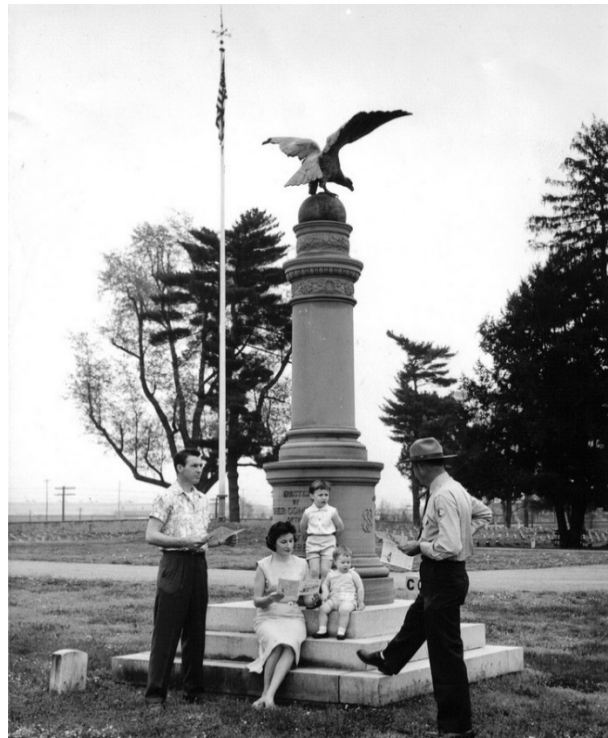
**FIGURE 200.** View of the U.S. Regulars Monument in the 1960s. The future site of the cannonball pyramid monument is the open grass area at right. Source: Stones River National Battlefield Archives, image STRI-4X5-0690.

**Cannonball Pyramid.** A pyramid of cannonballs was added in front of the flagstaff in Lincoln Square circa 1964. Although the exact date of origin is not known, the monument is absent in a photograph from that year (Figure 200), but appears by the 1970s in a planting plan for Lincoln Square and a photograph depicting the completed project (refer to Figure 171 and Figure 172; see also Figure 130 for comparison). The monument may have been constructed of cannonballs associated with the 1931 Bragg Headquarters monument, located south of the cemetery within the park, that were replaced around this time with smaller shot. Documentary evidence to confirm this possibility has not been located, however. The cannonball pyramid appears to date to the period of significance and thus contribute to the significance of the historic cemetery landscape.

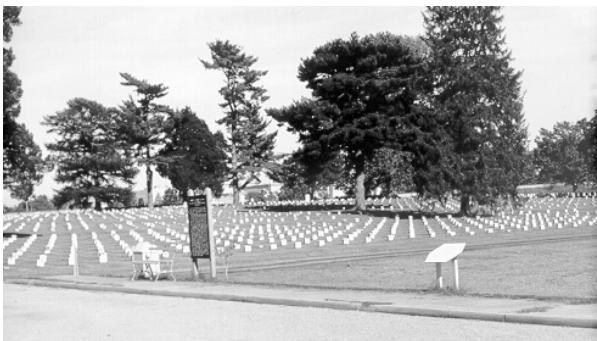
**FIGURE 201.** In the 1960s, the Gettysburg Address plaque was located at the edge of the cemetery parking lot. By 1991, this wayside exhibit had become damaged beyond repair and was moved to curatorial storage. Source: Stones River National Battlefield Archives, image STRI-5X7P-0031.

plaque was removed from the lodge at a later date; it appears in one photograph of the cemetery in the 1960s at the edge of the cemetery parking lot (Figure 201). The plaque was removed from that location sometime between 1975 and 1991 and placed in storage. In curatorial storage today in the museum collection, the plaque is damaged along the top, and is in several pieces.

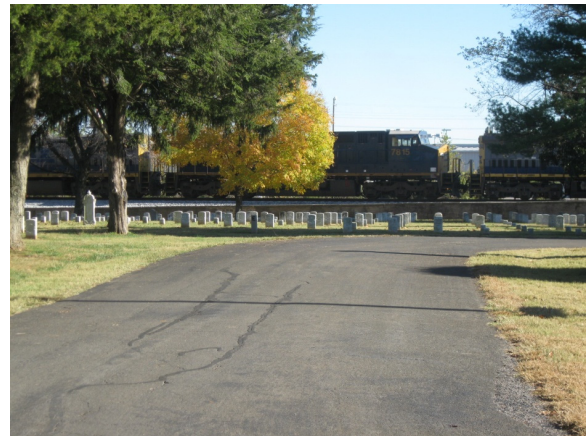
**FIGURE B-2, right.** Asphalt-paved road around the center section of the cemetery.

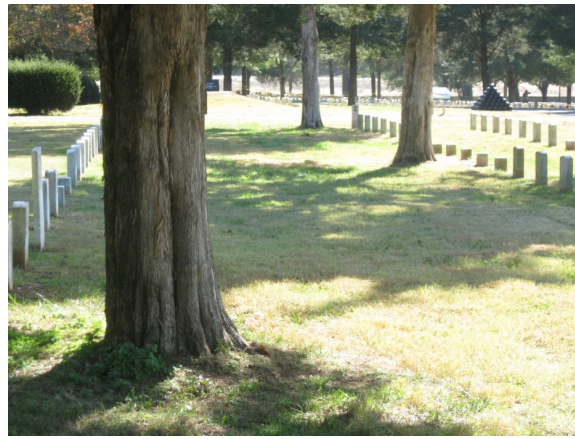
**FIGURE B-4, right.** Grassy path between cemetery sections.

The cemetery encompasses approximately 20 acres of former battlefield ground located north of the visitor center and Old Nashville Highway, and south of the Louisville and Nashville Railroad tracks (Figure B-1). The cemetery landscape includes gently sloped grassy terrain with mature native trees surrounded by a limestone site wall. An asphalt-paved road leads from a parking area inside the site wall, to and around the center section of the cemetery (Figure B-2). A flagpole, cannon ball pyramid, upright cannon, and interpretive signage are located within the center section. West of the center section, a large monument known as the U.S. Regulars Monument is located in Section C (Figure B-3). Grassy pathways radiate from the center of the cemetery and lead through the various burial sections (Figure B-4).

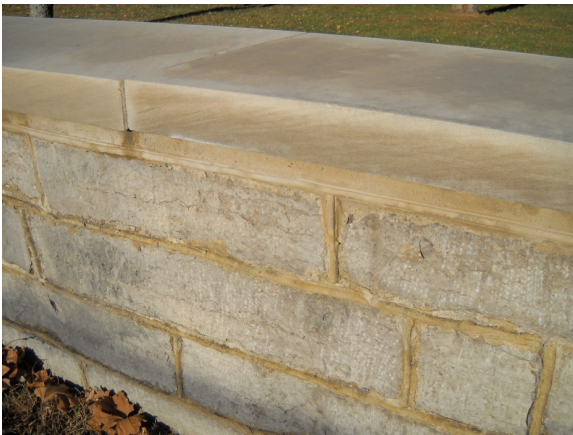
**FIGURE B-5, left.** Ashlar stone with beaded mortar joints at the street-facing portion of the site wall.

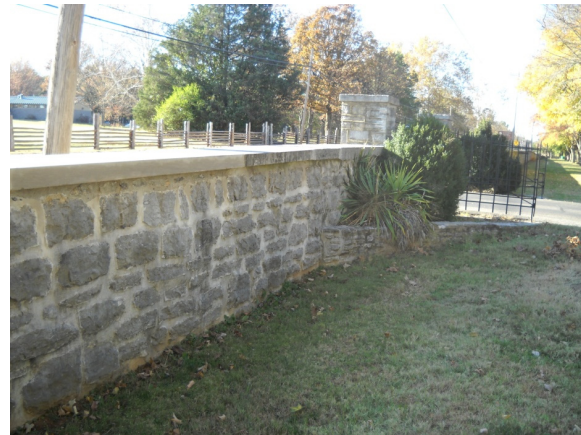
**FIGURE B-6, right.** Interior portion of the site wall, with flush mortar joints and random ashlar construction.

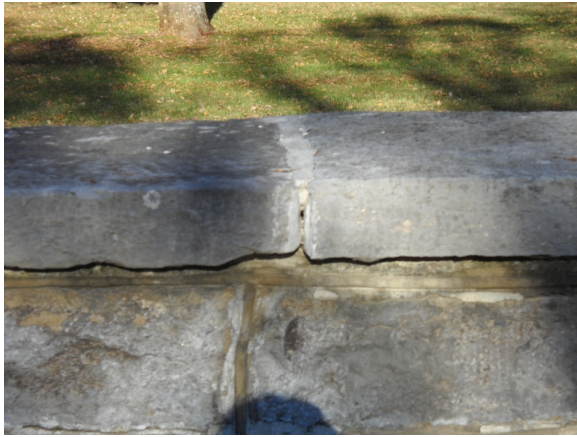
**FIGURE B-7, left.** View of coping stones and wall field stone.

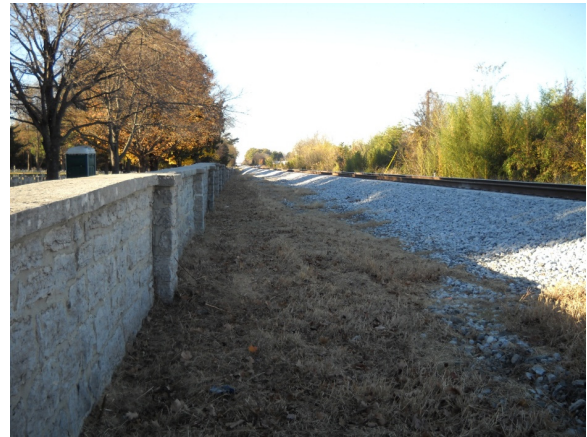
**FIGURE B-8, right.** Buttresses on rear portion of the site wall.

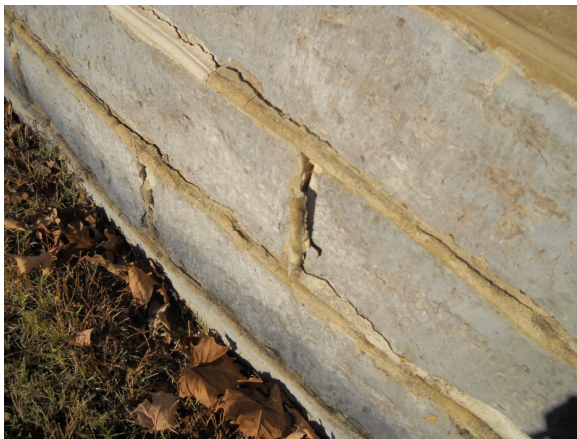
**FIGURE B-9, left.** Failing mortar joints at the street-facing portion of the site wall.

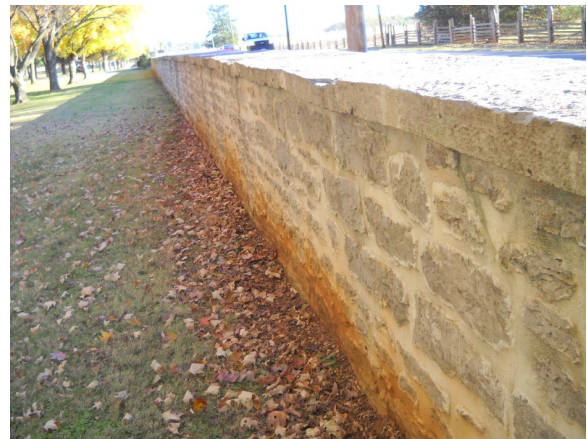
**FIGURE B-10, right.** Soiling at interior of site wall.

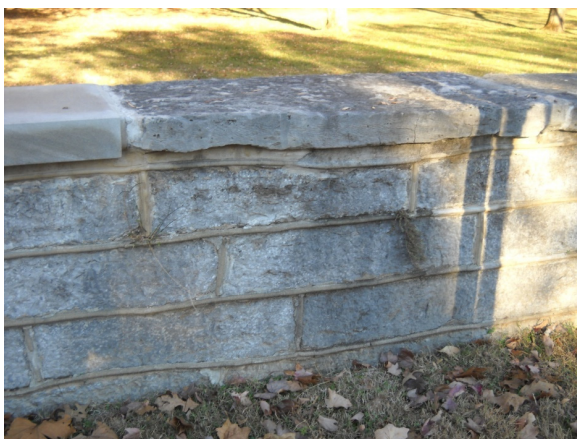
**FIGURE B-11, left.** Plant growth at mortar joints.

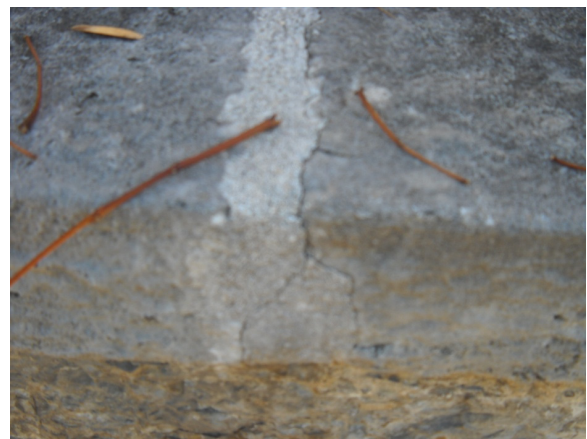
**FIGURE B-12, right.** Bond failure at sealant between coping stones.

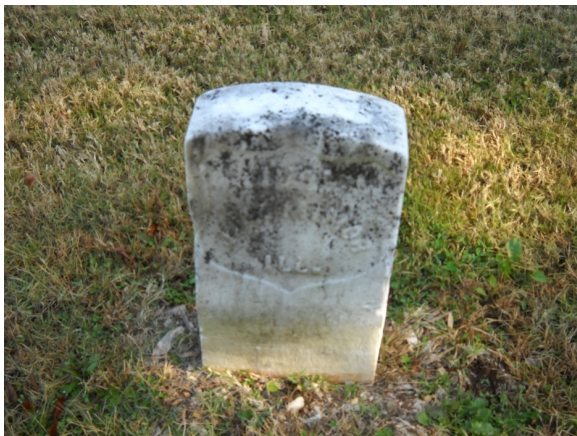
**FIGURE B-25, left.** Erosion and surface wear of inscribed shield and projecting lettering on Civil War era grave marker.

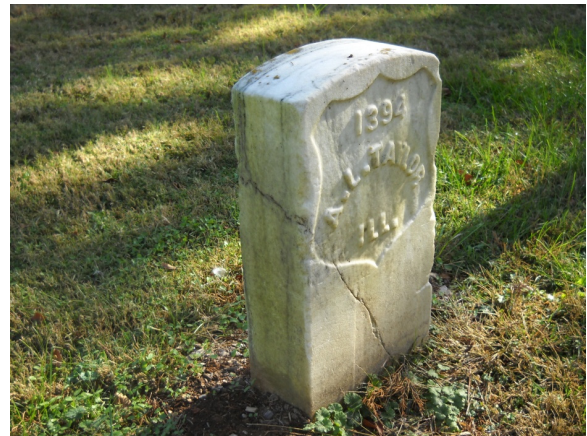
**FIGURE B-26, right.** Vertical/diagonal crack through grave marker.

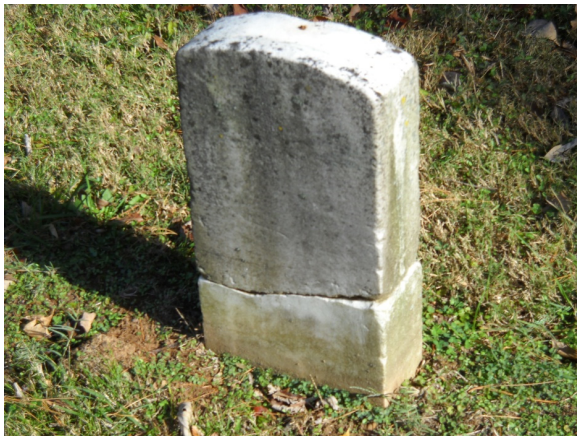
**FIGURE B-27.** Horizontal crack at base of a Civil War era grave marker.

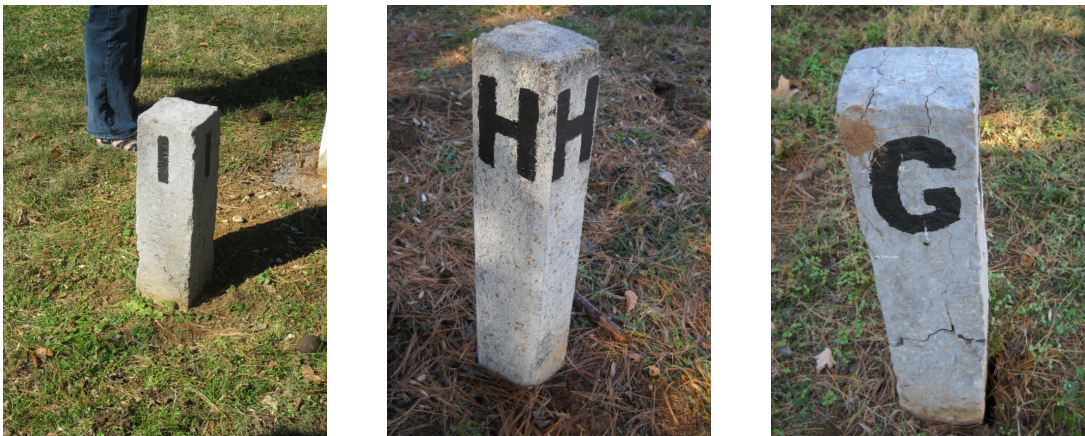
**FIGURE B-28, left.** Example of limestone section marker with chipping at the corners.

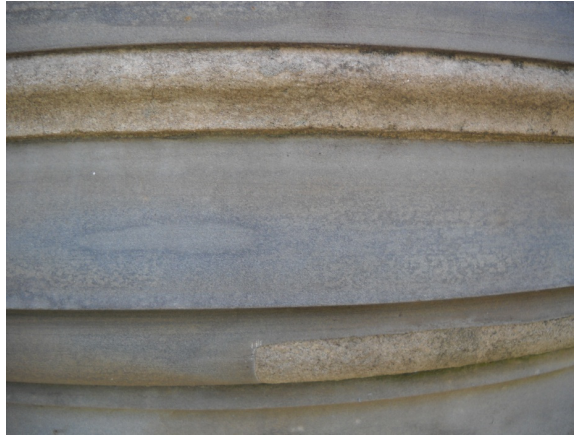
**FIGURE B-32, center.** Discolored previously placed stone patching material at the U.S. Regulars Monument.

The U.S. Regulars Monument was reviewed from grade; close-up inspection was not performed as part of this study. Typical conditions observed on the U.S. Regulars Monument include discoloration of previously placed patch material, slight soiling, and biological growth on the sandstone shaft; slight corrosion of the bronze eagle element; open joints and soiling of the granite steps; and erosion of the ground at the base of the sculpture (Figure B-32 and Figure B-33).

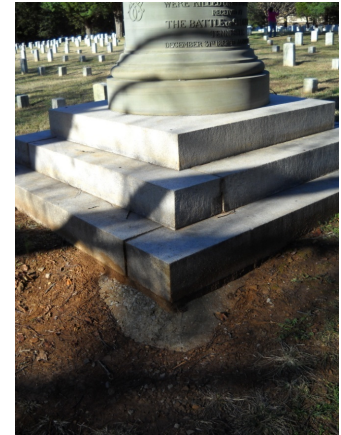
**FIGURE B-33, right.** Soiling, open joints, and grade erosion at the granite steps and base of the U.S. Regulars Monument.

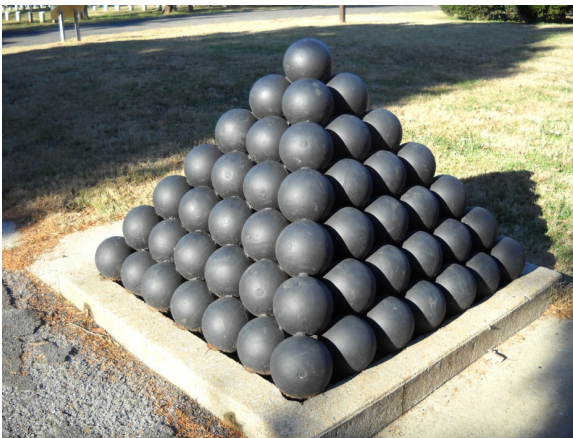
**FIGURE B-36, left.** View of cannonball pyramid.

**Metal Elements.** In addition to interpretive signage, metal commemorative elements located within the cemetery include two upright cannon situated north of the flagpole, a cannon ball pyramid located south of the flagpole, and a cannon located in Section N. All of the metal elements are cast iron coated with black paint (Figure B-36 through Figure B-38).

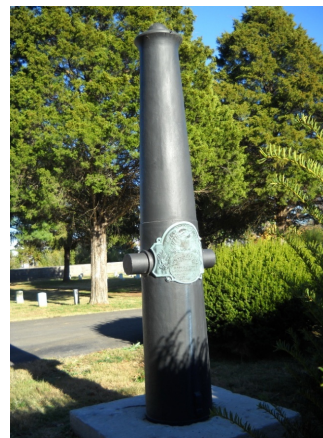
**FIGURE B-37, right.** General view of upright cannon.

Conditions of the upright cannon include open joints at the connection of the cannon and the limestone base, streaking of the coated surface under the bronze plaque on the northernmost cannon, missing fasteners at the bronze plaque, and cracks in the limestone base of the second cannon. In addition, each limestone base includes four anchor locations at each corner, where pyramids consisting of five cannonballs were previously located. Slight surface roughness was observed in the coated surface of some metal elements.

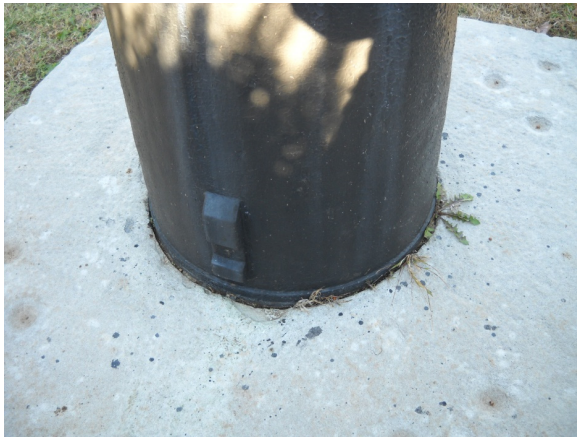
**FIGURE B-38.** Plant growth in open joint at the base of an upright cannon.

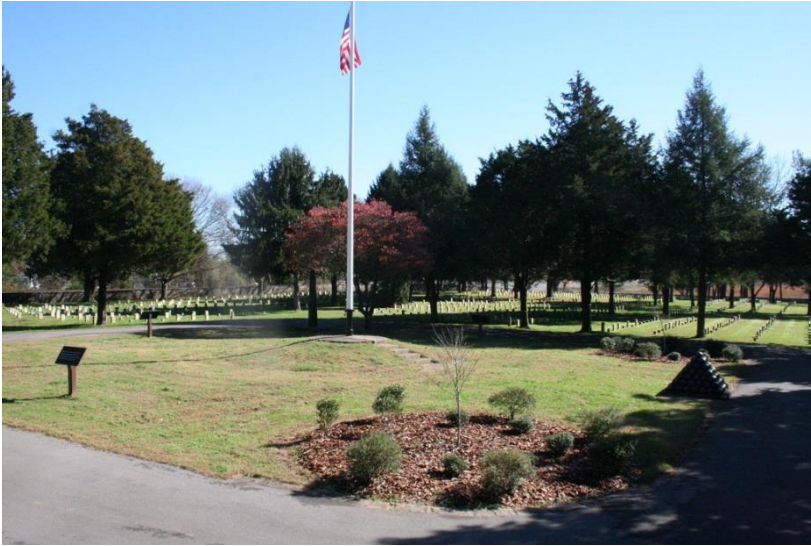
**Figure D-3.** Planting plan and guidelines for new plantings in Lincoln Square, Stones River National Cemetery. Source: Liz Sargent HLA, 2014.

- Use the original layout with replacement plantings that include:
  - Flowering shrubs, which could be timed to bloom during Memorial Day or at other times of year during which events or ceremonies occur
  - Evergreen shrubs
  - Compact forms
  - Low growth habit (2 to 4 feet), to avoid obscuring views of the cannon and other views into and from Lincoln Square
  - Consider rejuvenating the corner plantings of flowering trees (redbud and flowering dogwood) that have declined
  - Consider using only native species
