## Technical Brief 18: Protecting Archeological Sites on Eroding Shorelines: A Hay Bales Approach

Robert M. Thorne, Pickering Environmental Consultants, Inc., Jackson, MS

Published by the DOI Departmental Consulting Archeologist/NPS Archeology Program, National Park Service, Washington, DC, July 2004.

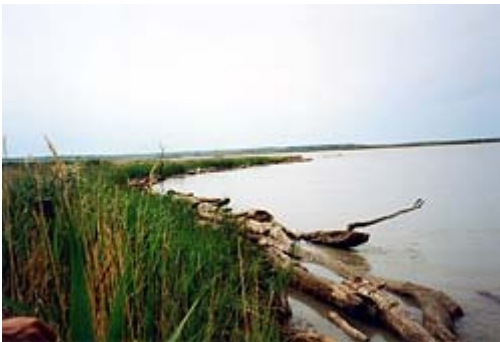
**Figure 1. An Army Corps (WES) stabilization project using logs cabled in place and revegetation planted on bankline. Lake Sharpe, South Dakota, June 1994.**

The revegetation effort at the lake—designed and directed by Hollis Allen—had already proved successful, alone and in combination with driftwood trees (Figure 1). The use of bales, which was untried previously, also proved effective. But the test setting—a relatively well protected bank sloping gently to the water’s edge—was not representative of conditions at Lake Sharpe (Figure 2). The revegetation techniques were common (e.g., Thorne 1990); their efficiency was really never in doubt. The primary purpose was to test the bales in actual conditions.

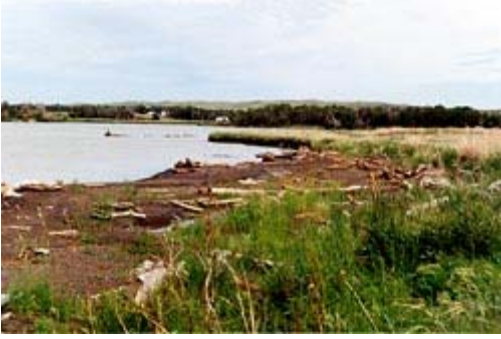
**Figure 2. A beach development zone behind hay bales put in place in 1991.** Lake Sharpe, South Dakota, June, 1994.

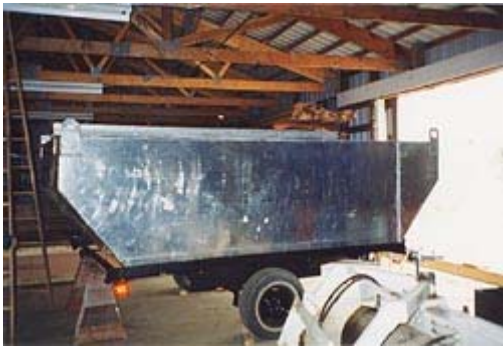
**Figure 5.** An Army Corps "shop built" barge for use with an airboat to place bales. Lake Sharpe, South Dakota, June, 1994.

For the Lake Sharpe project, a barge was designed to place bales in areas not accessible from the bank. This small, light, shallow-draft vessel, which was transported easily by trailer, also could be pushed or towed by boats with small motors (Figure 5). People wading alongside maneuvered it into position; a hydraulic lift dumped the bale in front of the vessel.
