# Case Study 16: Relocating Visitor Facilities Threatened by Erosion, Assateague Island National Seashore, Maryland and Virginia

Contributing Author: Ish Ennis (Assateague Island National Seashore)

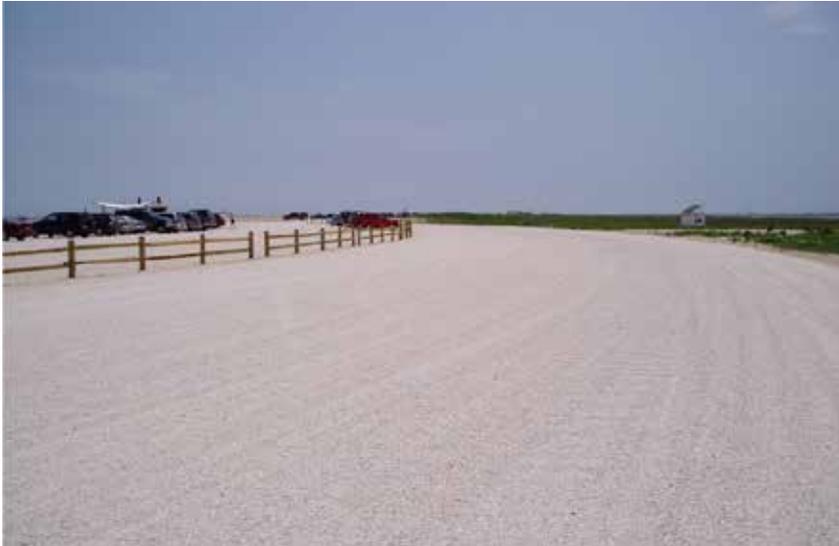
The Virginia visitor parking lot is constructed with native materials including clay and clamshell that can be reused in post-storm repairs. Image credit: Ish Ennis, NPS.

The park has implemented several solutions to improve sustainability. Infrastructure in this area has been replaced with portable substitutes that can be relocated off-island in advance of National Oceanic and Atmospheric Administration (NOAA)-forecasted storms and in response to erosion. The park now constructs roads and parking lots in this area from island-compatible materials, a clay base with clam shell for a road surface, which are dug up and reused when the lot is moved, and which also avoid introduction of foreign debris such as asphalt on post-storm beaches. The surface

requires twice-weekly maintenance and additional clam shells need to be added every year or two. Parking lot repairs have been supported by Emergency Relief for Federally Owned Roads (ERFO) funding and existing park staff.

Due to its ongoing success, the existing portable infrastructure would likely be used in the new location, along with the visitor center, which has been moved twice already. The clay base and clamshell surface might also be used in the new location. The biggest challenge in moving forward with relocation of the recreational beach will likely be opposition by the Town of Chincoteague. Education and outreach programs may help to strengthen the park's efforts.
