## Case Study 6: Eroding Shoreline Threatens Historic Peale Island Cabin, Yellowstone National Park, Wyoming

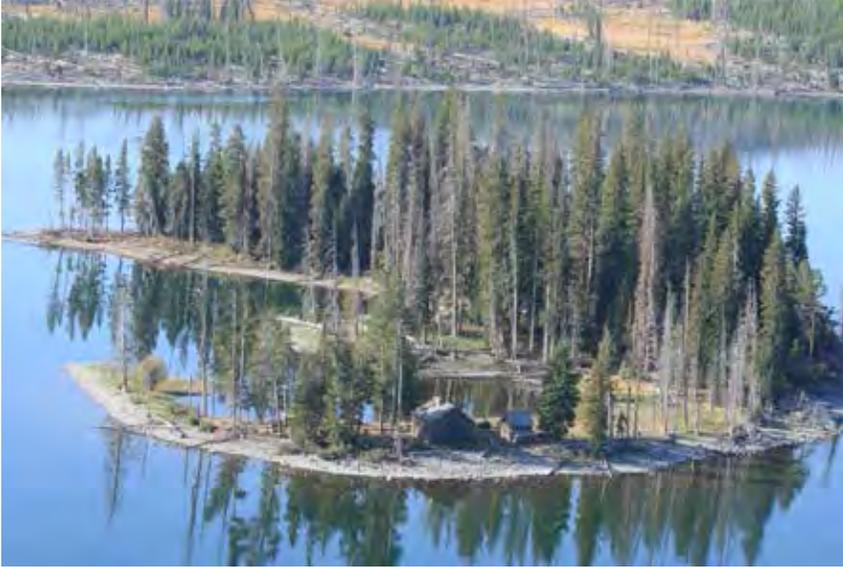
Peale Island Cabin is located on a small spit of land on the northwest corner of Peale Island. Image credit: Yellowstone National Park.

The historic Peale Island Cabin is eligible for listing in the National Register of Historic Places and is used regularly by park staff including backcountry patrols. It is located on a narrow spit on the eroding north end of the island. As of 2013, the shoreline had moved closer than 2 m (6 ft) from the cabin porch, and the number of live trees along the shoreline continued to decrease.
