Exterior Lighting Assessment and Design Recommendations

**Grand Teton National Park**

Respectfully submitted by: Bryan Boulanger

July 26, 2022

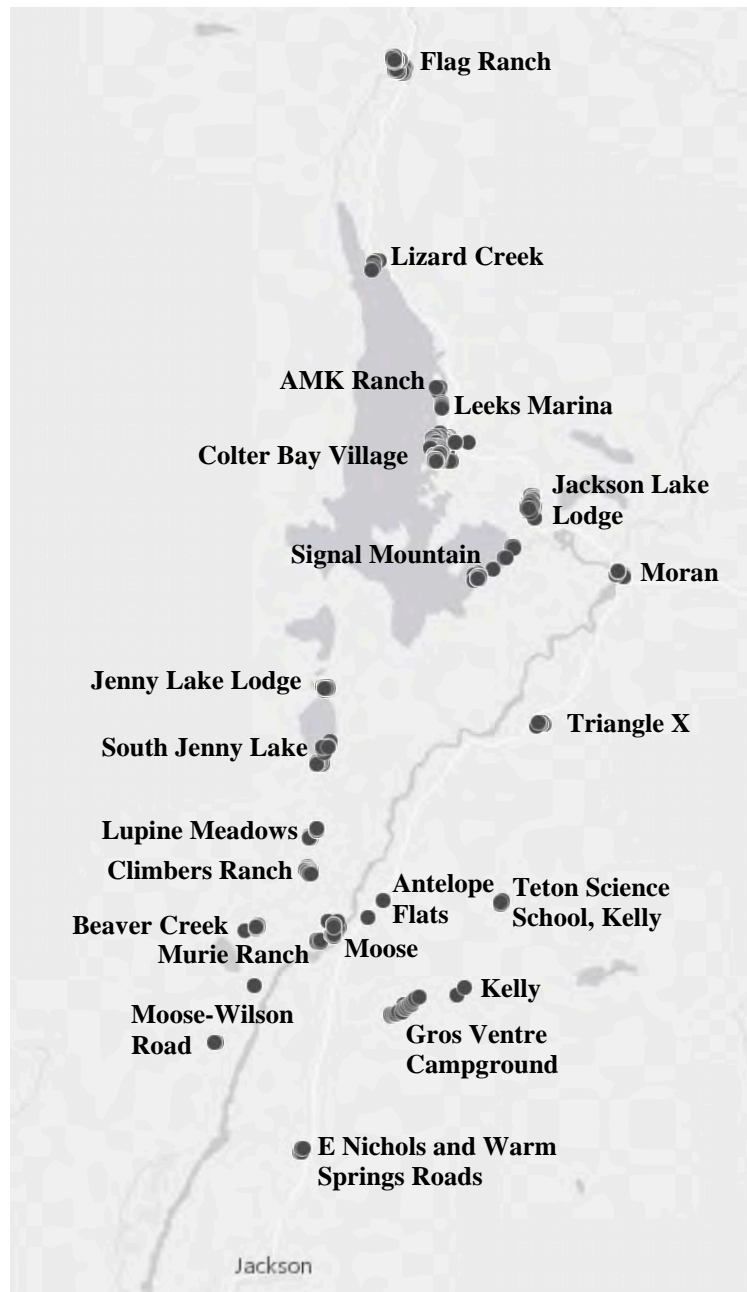
Figure 1 shows a park scale distribution of the 2834 individual fixtures identified and characterized during the inventory. 959 fixtures, accounting for 34% of the exterior artificial lighting within the park, was found to be compliant with IDA's 2018 Dark Sky Park Lighting Guidelines. The breakdown of fixtures (and compliance) by park area is presented in Table 1.

**Figure 1. Generalized locations of fixtures identified within Grand Teton National Park. Dots indicate locations of existing fixtures.**

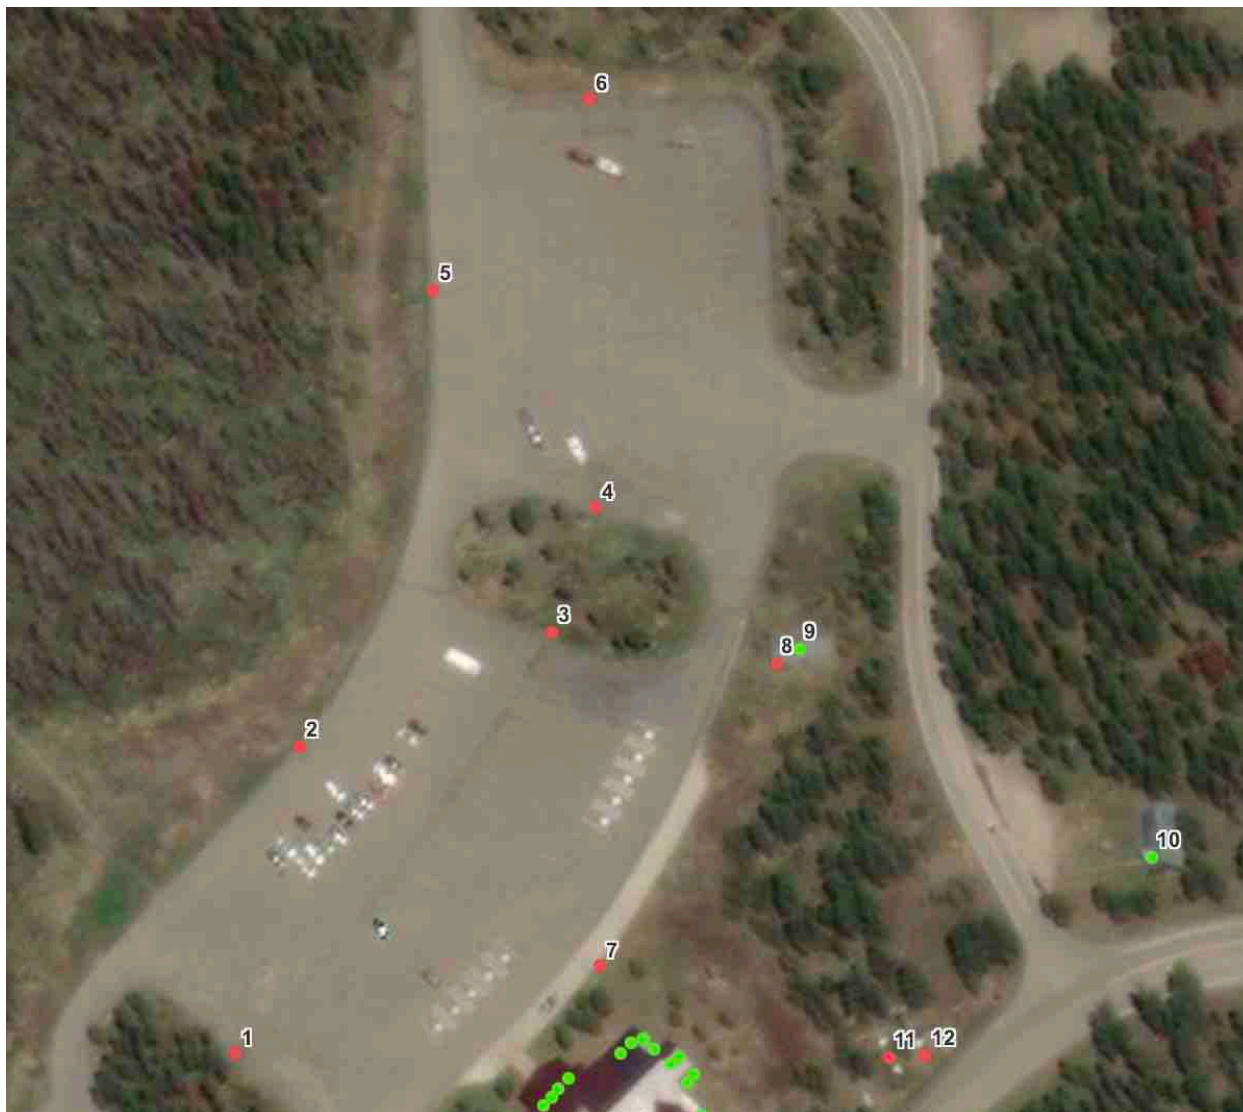
**Figure AI-1. Fixture Locations and Compliance Assessment: Lodge Parking Area.** Dark sky compliant lighting has a green marker and non-compliant lighting has a red marker. Numbers present above the dots indicate the fixture ID number whose characteristics are presented within the tables.

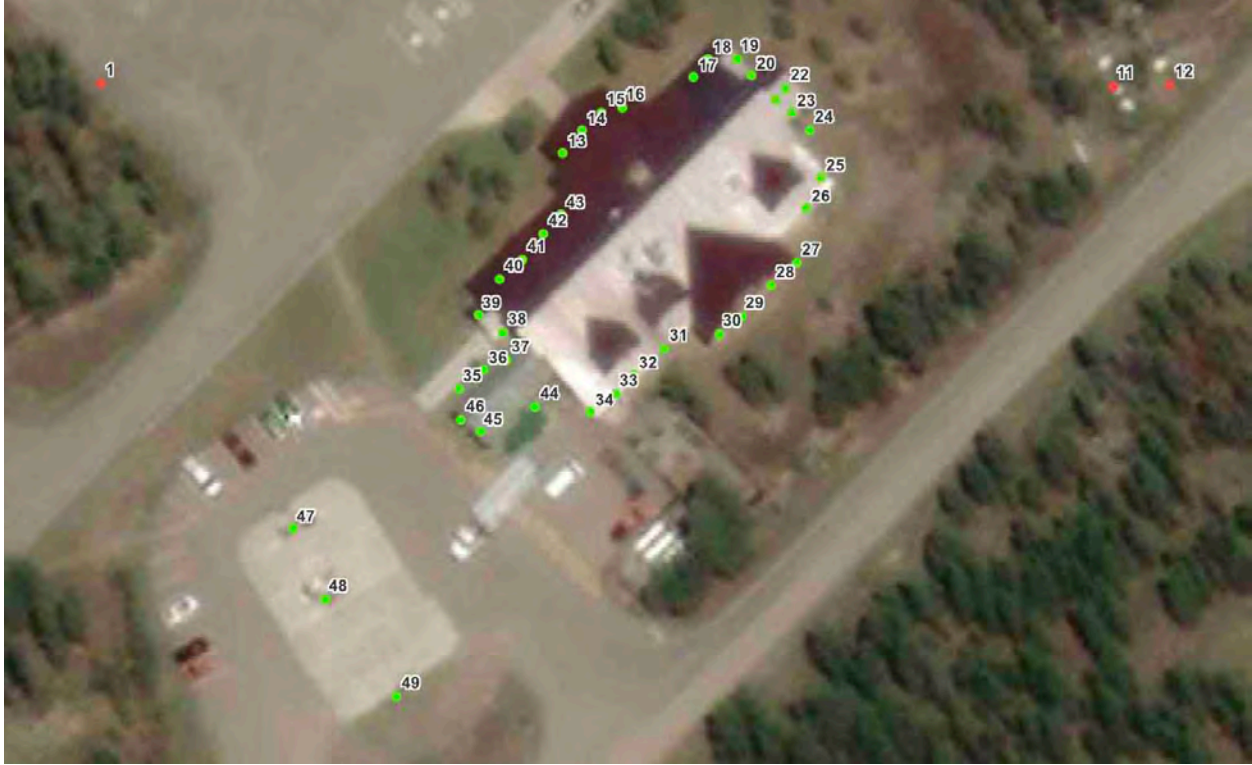
**Figure AI-2. Fixture Locations and Compliance Assessment: Lodge Building.** Dark sky compliant lighting has a green marker and non-compliant lighting has a red marker. Numbers present above the dots indicate the fixture ID number whose characteristics are presented within the tables.

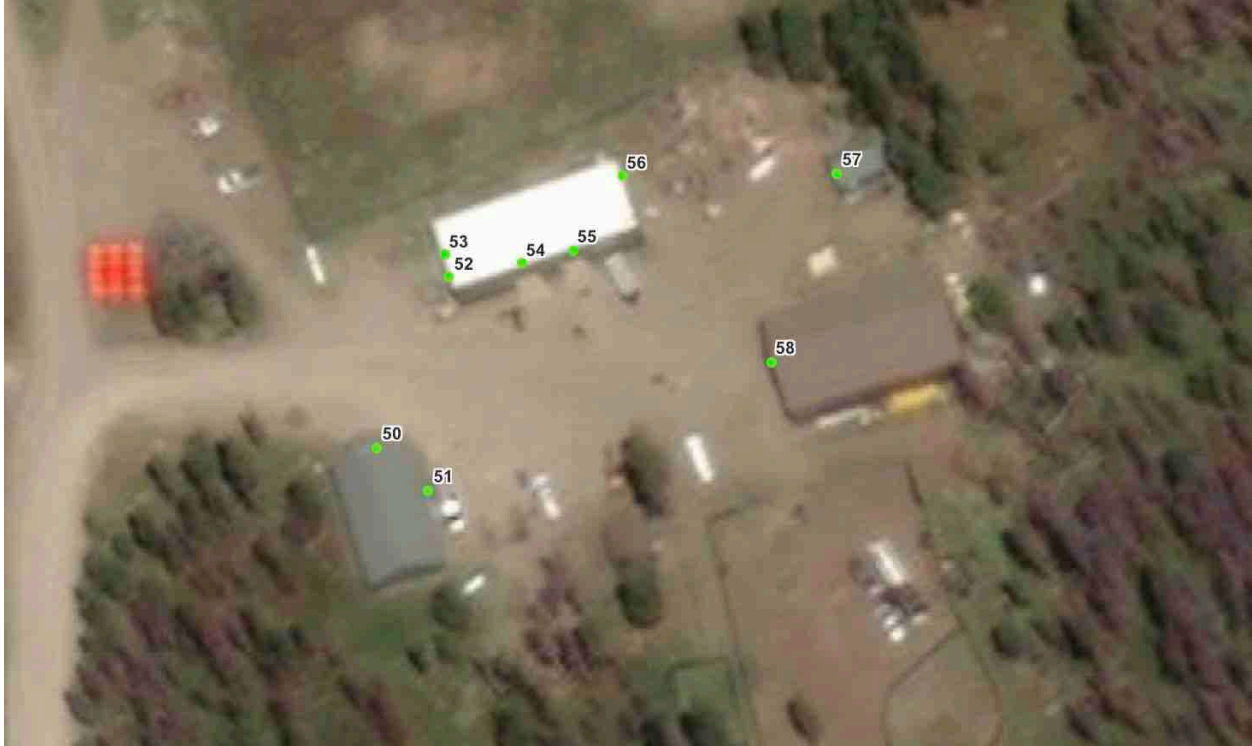
**Figure AI-3. Fixture Locations and Compliance Assessment: Maintenance Area.** Dark sky compliant lighting has a green marker and non-compliant lighting has a red marker. Numbers present above the dots indicate the fixture ID number whose characteristics are presented within the tables.

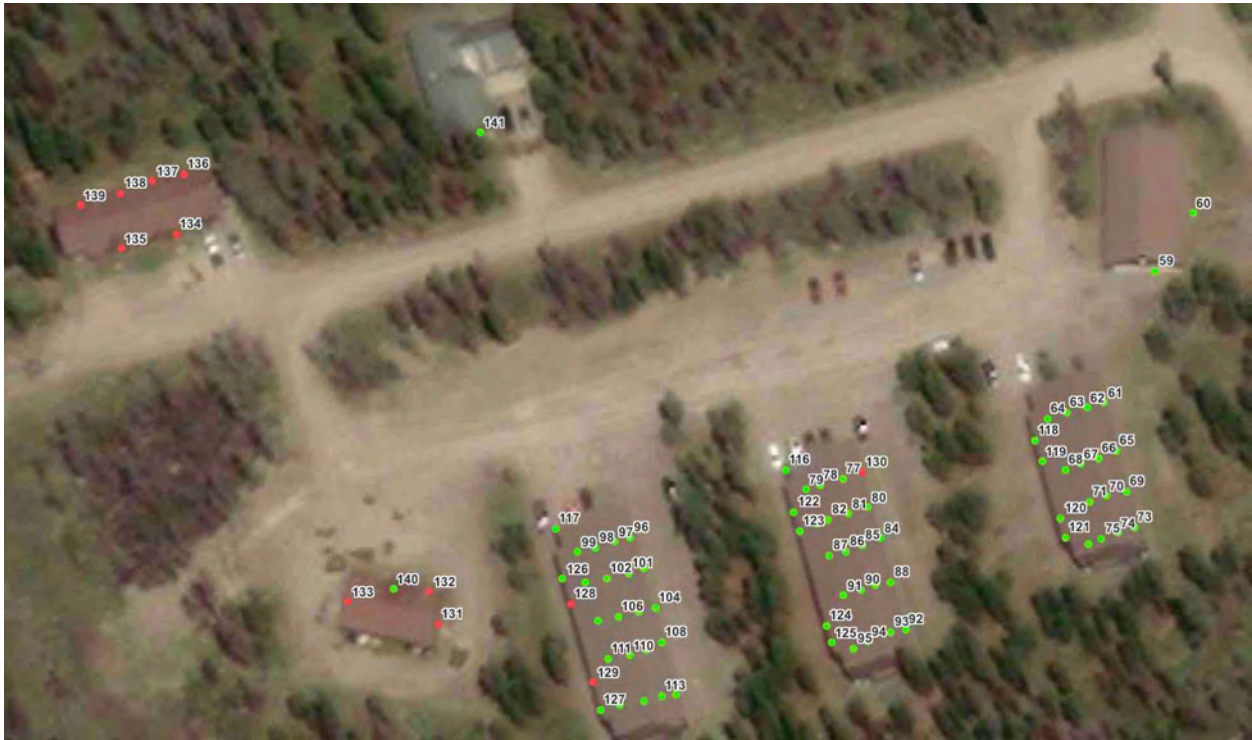
**Figure AI-4. Fixture Locations and Compliance Assessment: Eagle Road Residences.** Dark sky compliant lighting has a green marker and non-compliant lighting has a red marker. Numbers present above the dots indicate the fixture ID number whose characteristics are presented within the tables.

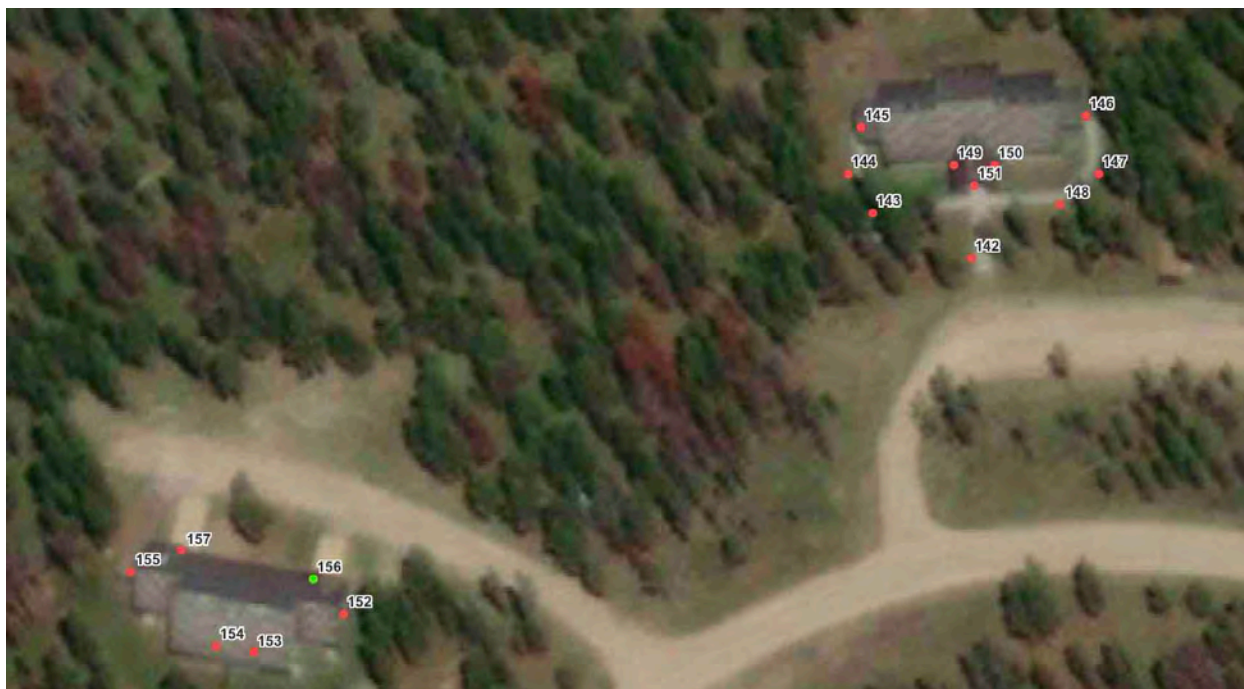
**Figure AI-5. Fixture Locations and Compliance Assessment: Duplex and Quadplex Residences.** Dark sky compliant lighting has a green marker and non-compliant lighting has a red marker. Numbers present above the dots indicate the fixture ID number whose characteristics are presented within the tables.

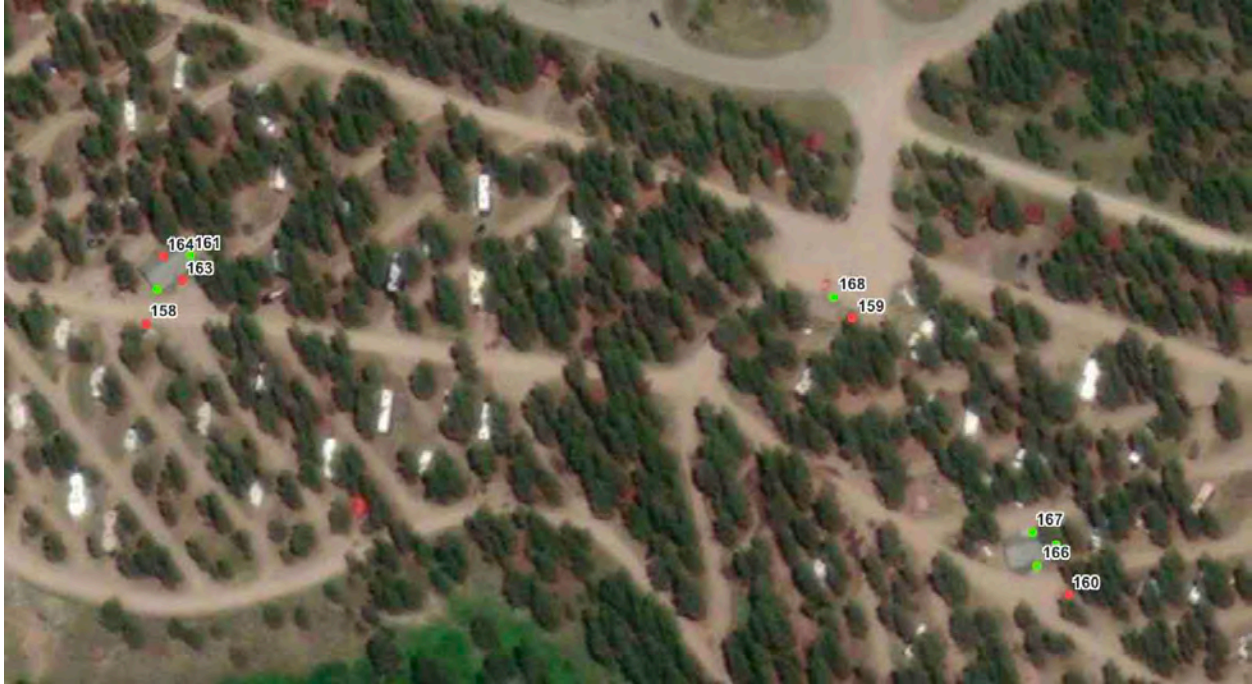
**Figure AI-6. Fixture Locations and Compliance Assessment: Campground.** Dark sky compliant lighting has a green marker and non-compliant lighting has a red marker. Numbers present above the dots indicate the fixture ID number whose characteristics are presented within the tables.

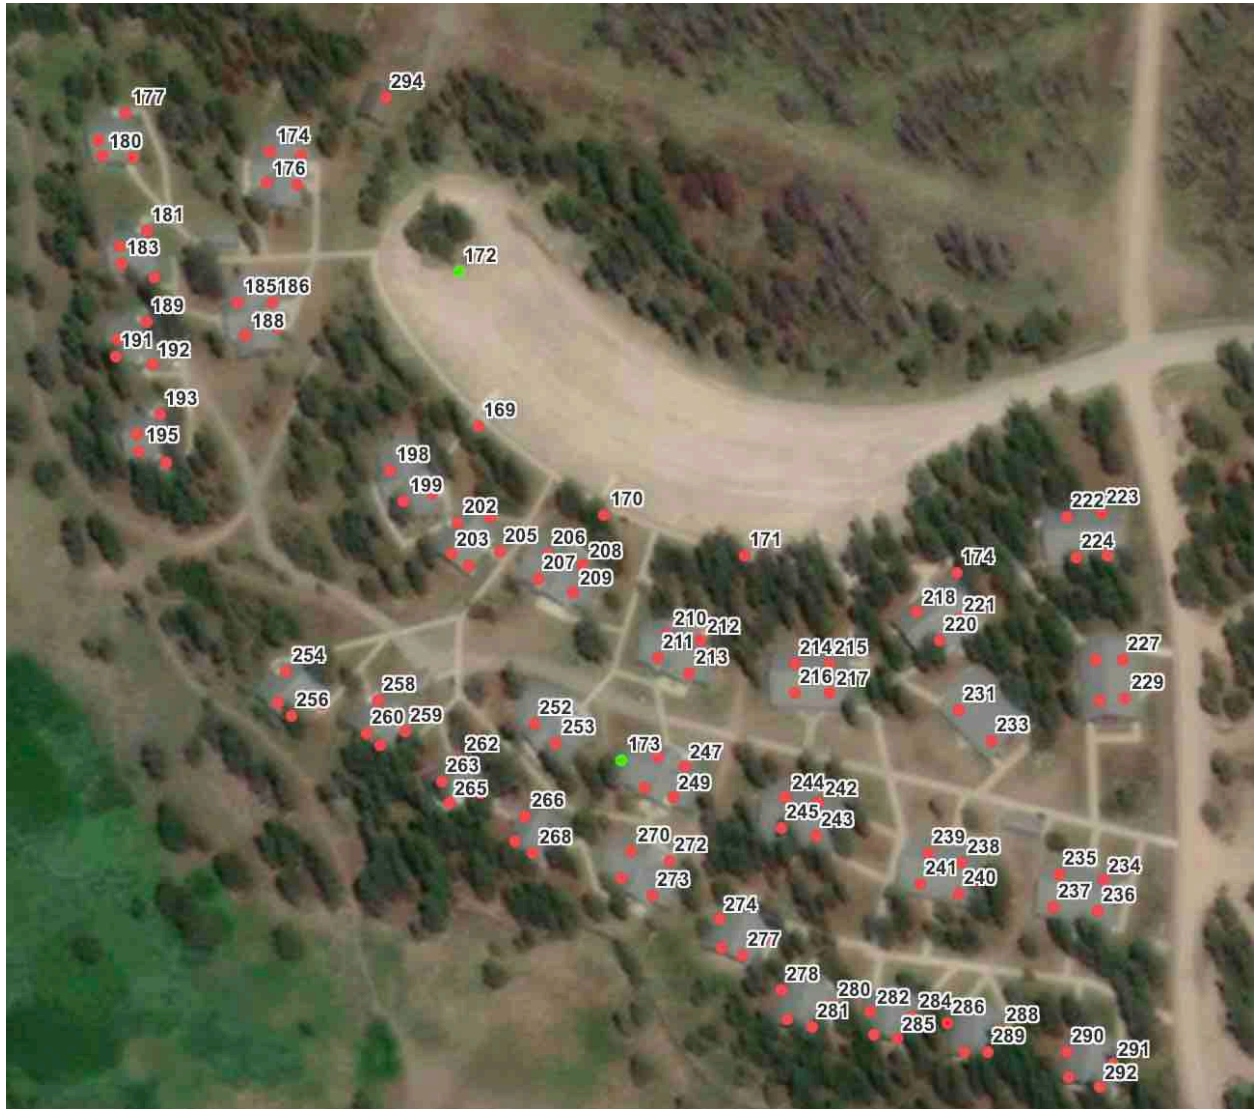
**Figure AI-7. Fixture Locations and Compliance Assessment: Cabin Area.** Dark sky compliant lighting has a green marker and non-compliant lighting has a red marker. Numbers present above the dots indicate the fixture ID number whose characteristics are presented within the tables.

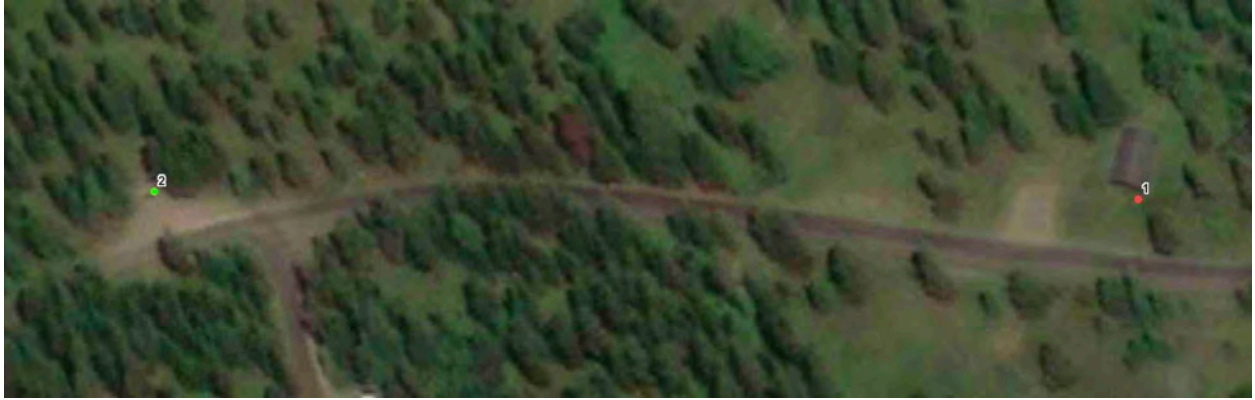
**Figure AII-1. Fixture Locations and Compliance Assessment: Entrance Area Residence and Kiosk.** Dark sky compliant lighting has a green marker and non-compliant lighting has a red marker. Numbers present above the dots indicate the fixture ID number whose characteristics are presented within the tables.

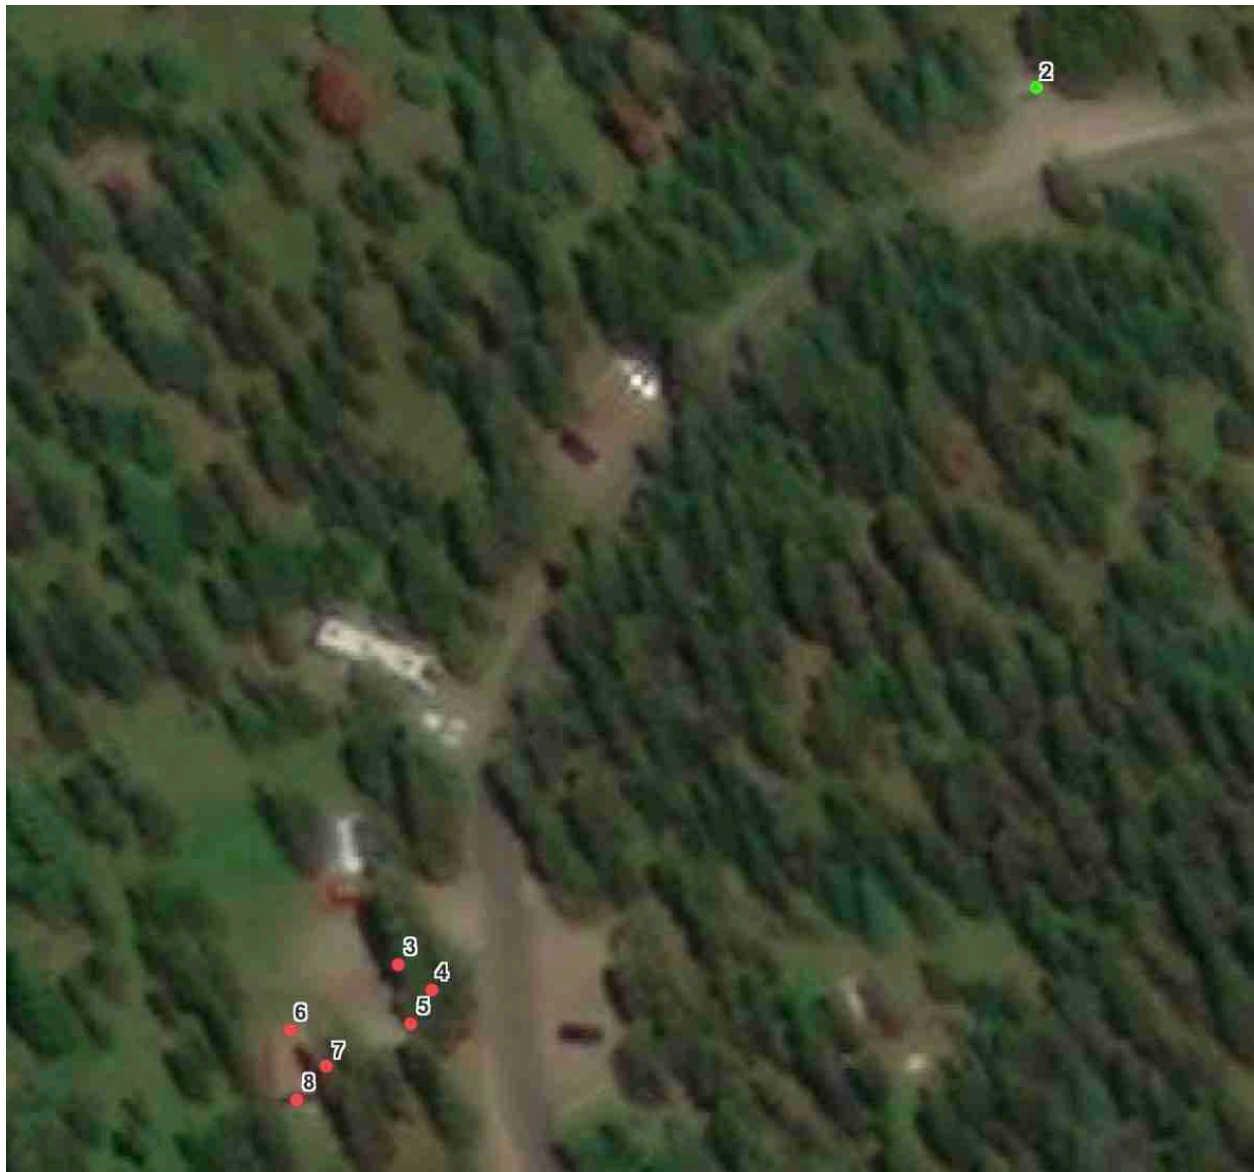
**Figure AII-2. Fixture Locations and Compliance Assessment: Office and Comfort Station 1.** Dark sky compliant lighting has a green marker and non-compliant lighting has a red marker. Numbers present above the dots indicate the fixture ID number whose characteristics are presented within the tables.

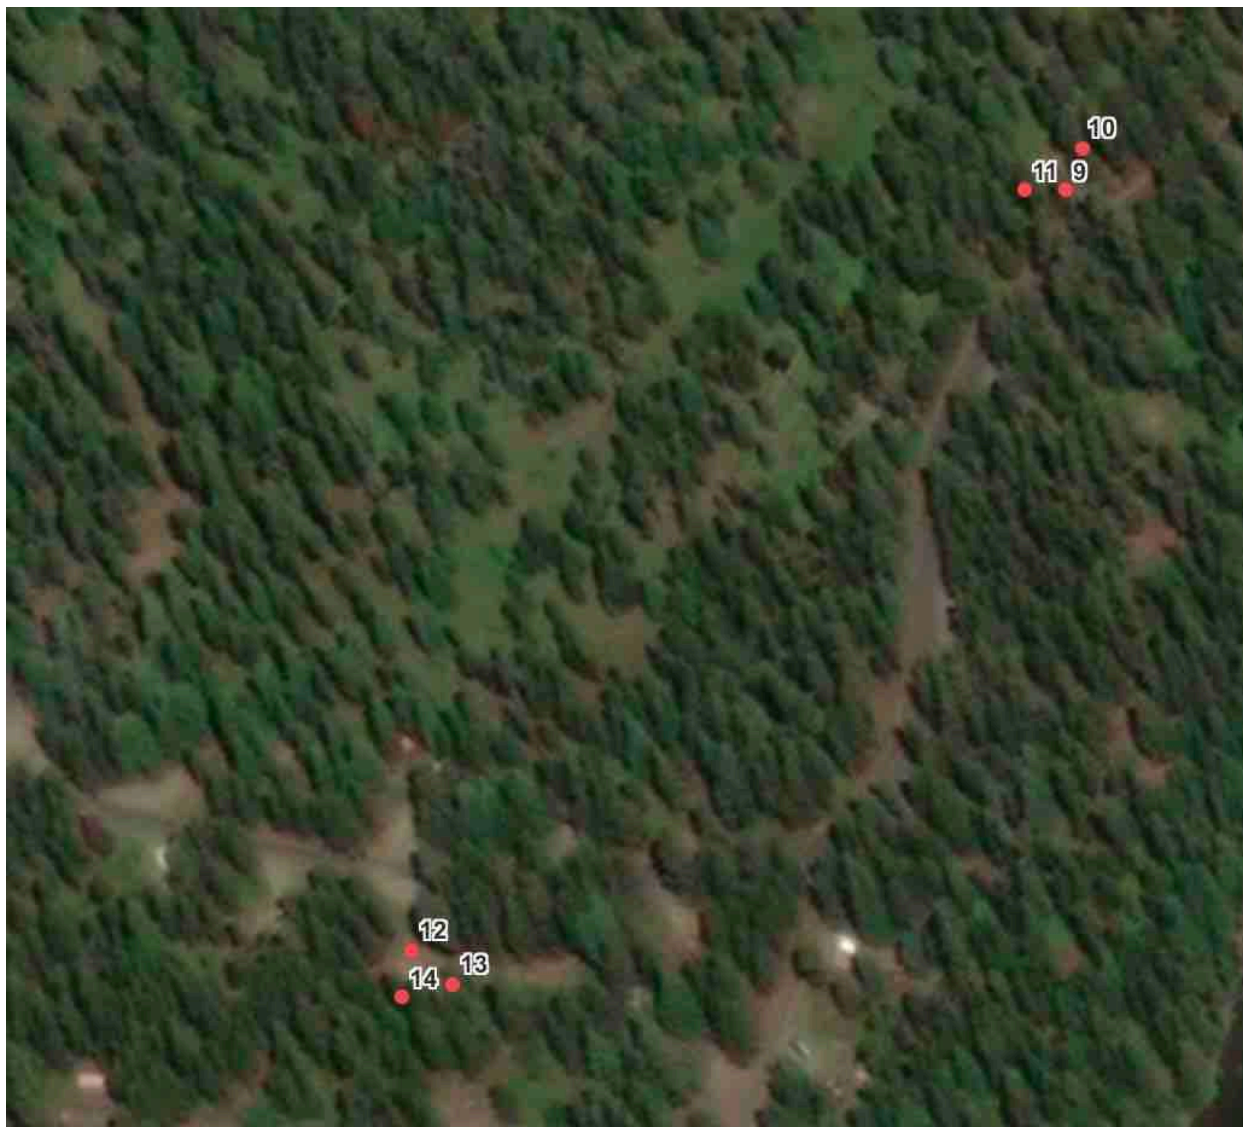
**Figure AII-3. Fixture Locations and Compliance Assessment: Comfort Stations 2 and 3.** Dark sky compliant lighting has a green marker and non-compliant lighting has a red marker. Numbers present above the dots indicate the fixture ID number whose characteristics are presented within the tables.

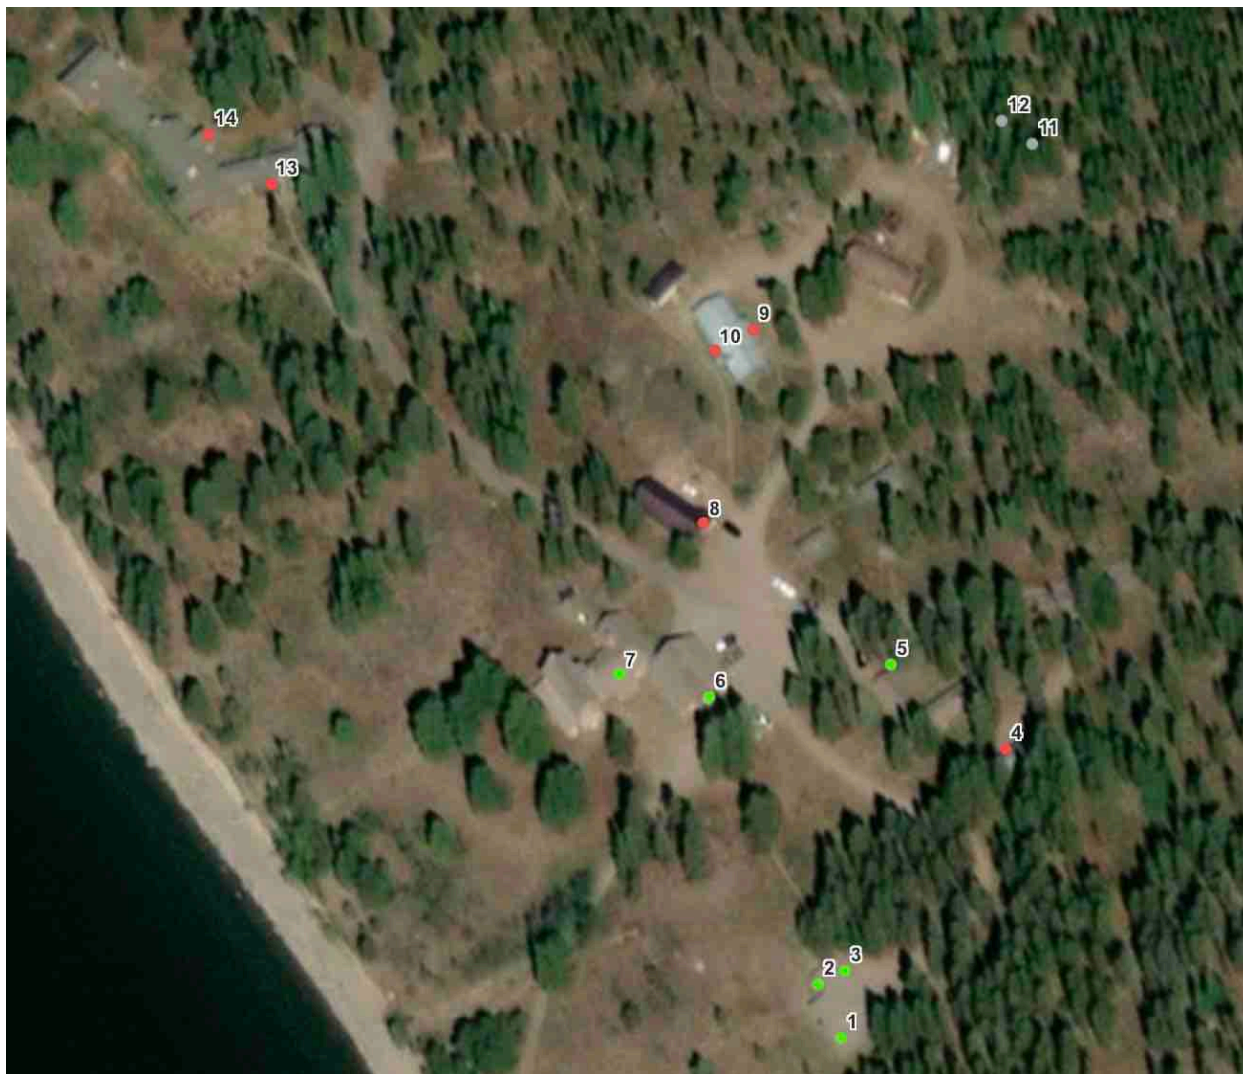
**Figure AIII-1. Fixture Locations and Compliance Assessment: AMK Ranch.** Dark sky compliant lighting has a green marker and non-compliant lighting has a red marker. Numbers present above the dots indicate the fixture ID number whose characteristics are presented within the tables.

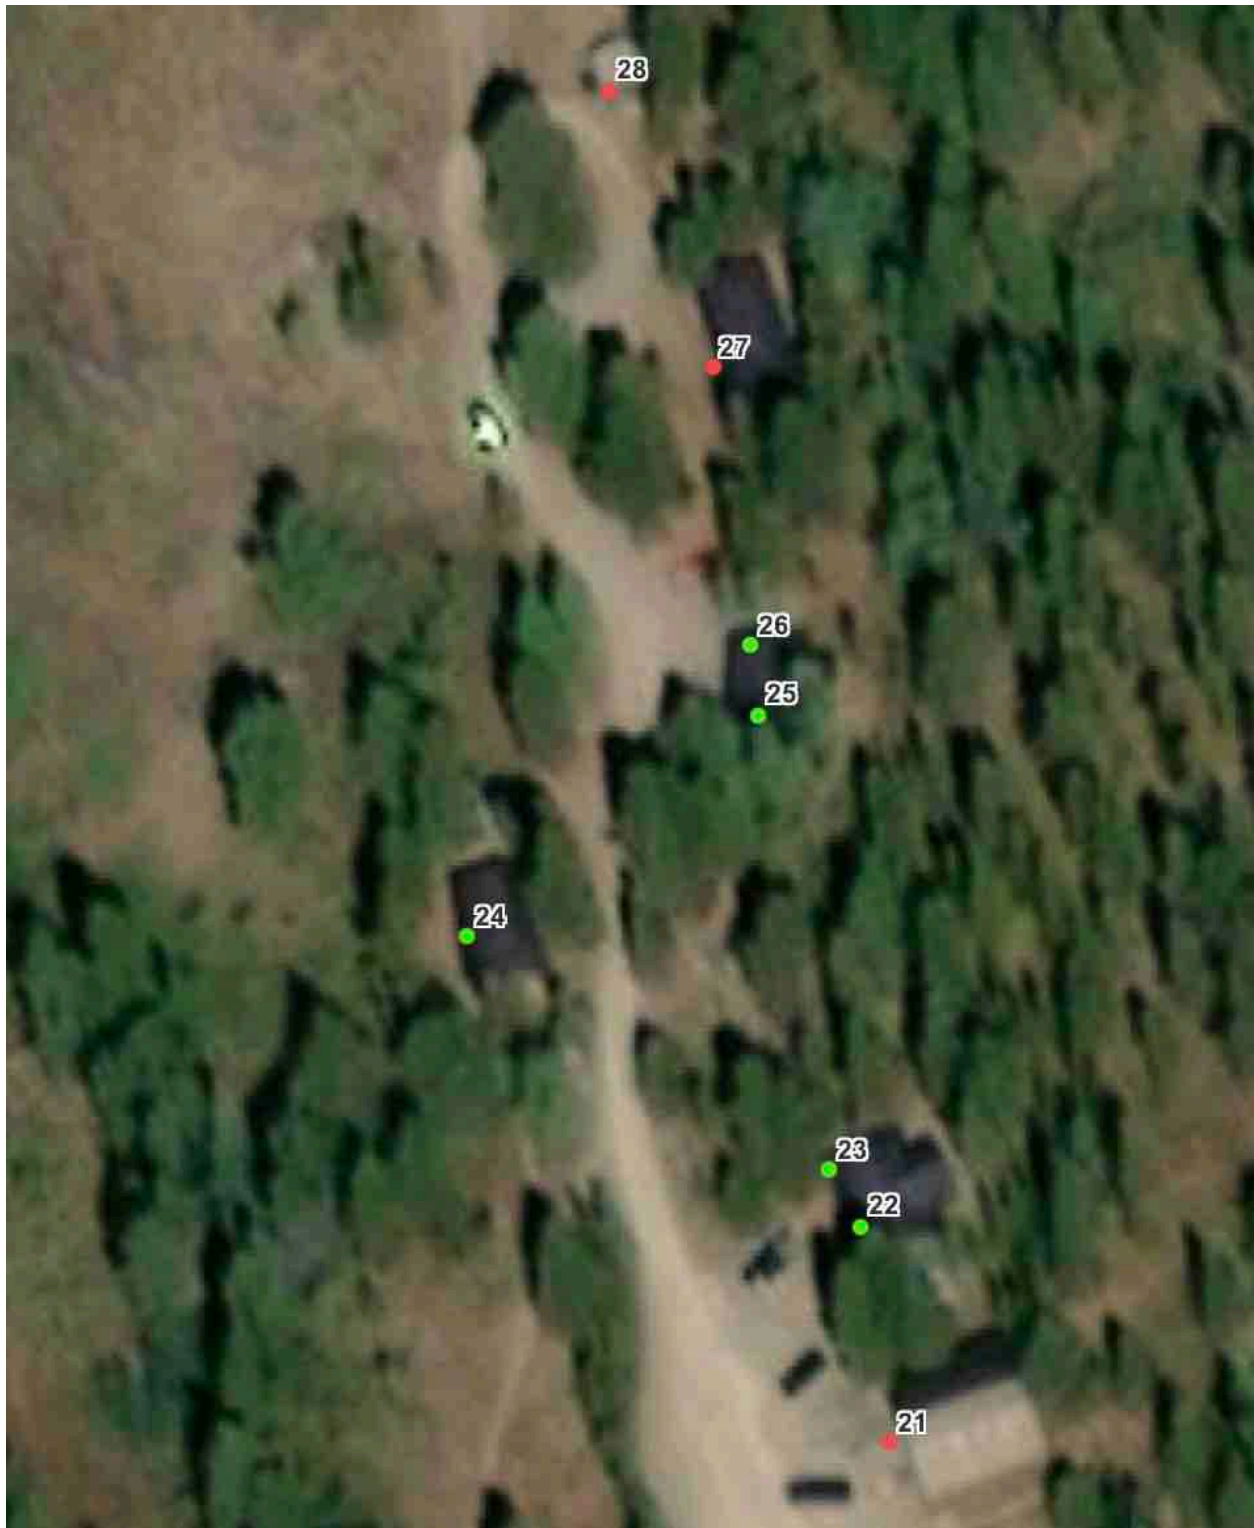
**Figure AIV-1. Fixture Locations and Compliance Assessment: Parking Area.** Dark sky compliant lighting has a green marker and non-compliant lighting has a red marker. Numbers present above the dots indicate the fixture ID number whose characteristics are presented within the tables.

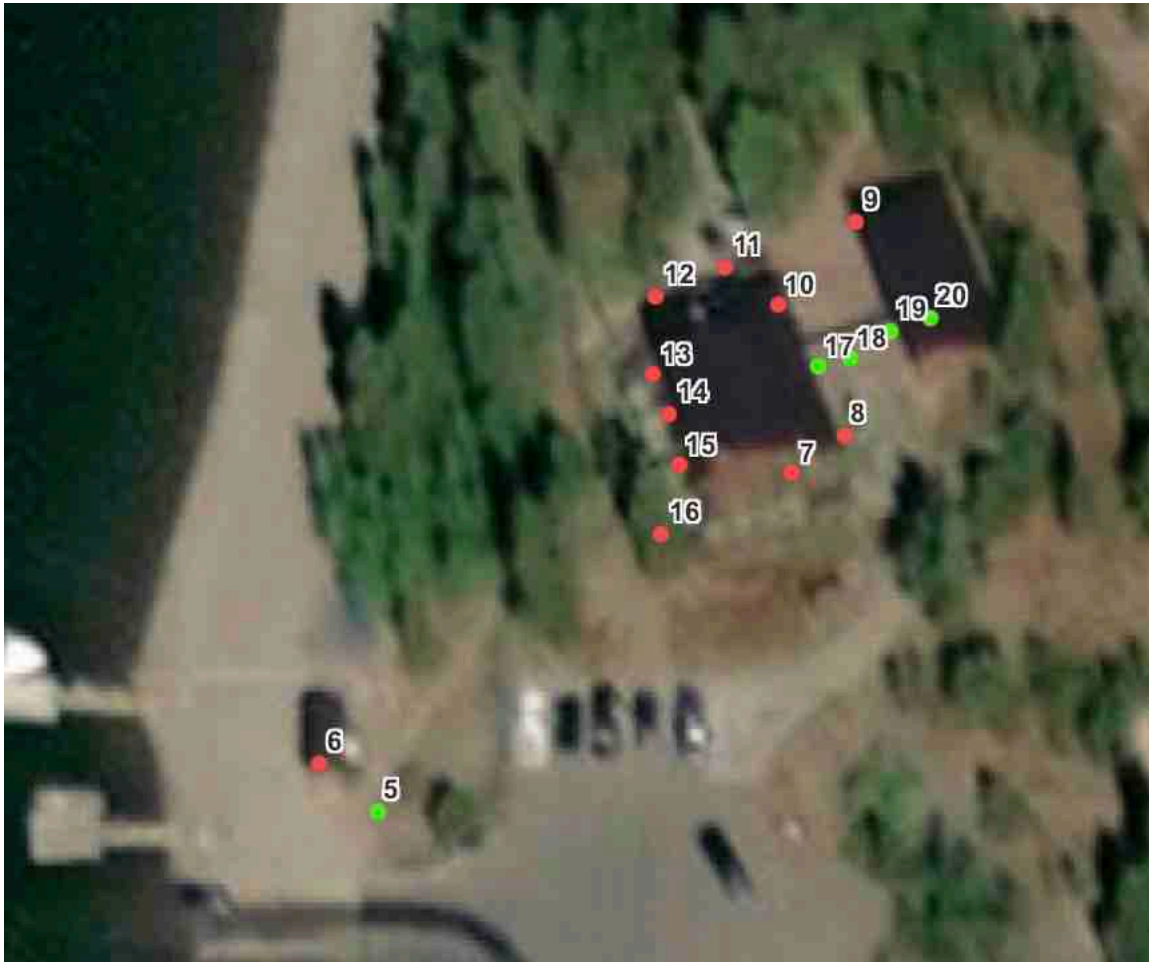
**Figure AIV-2. Fixture Locations and Compliance Assessment: Restaurant Area.** Dark sky compliant lighting has a green marker and non-compliant lighting has a red marker. Numbers present above the dots indicate the fixture ID number whose characteristics are presented within the tables.

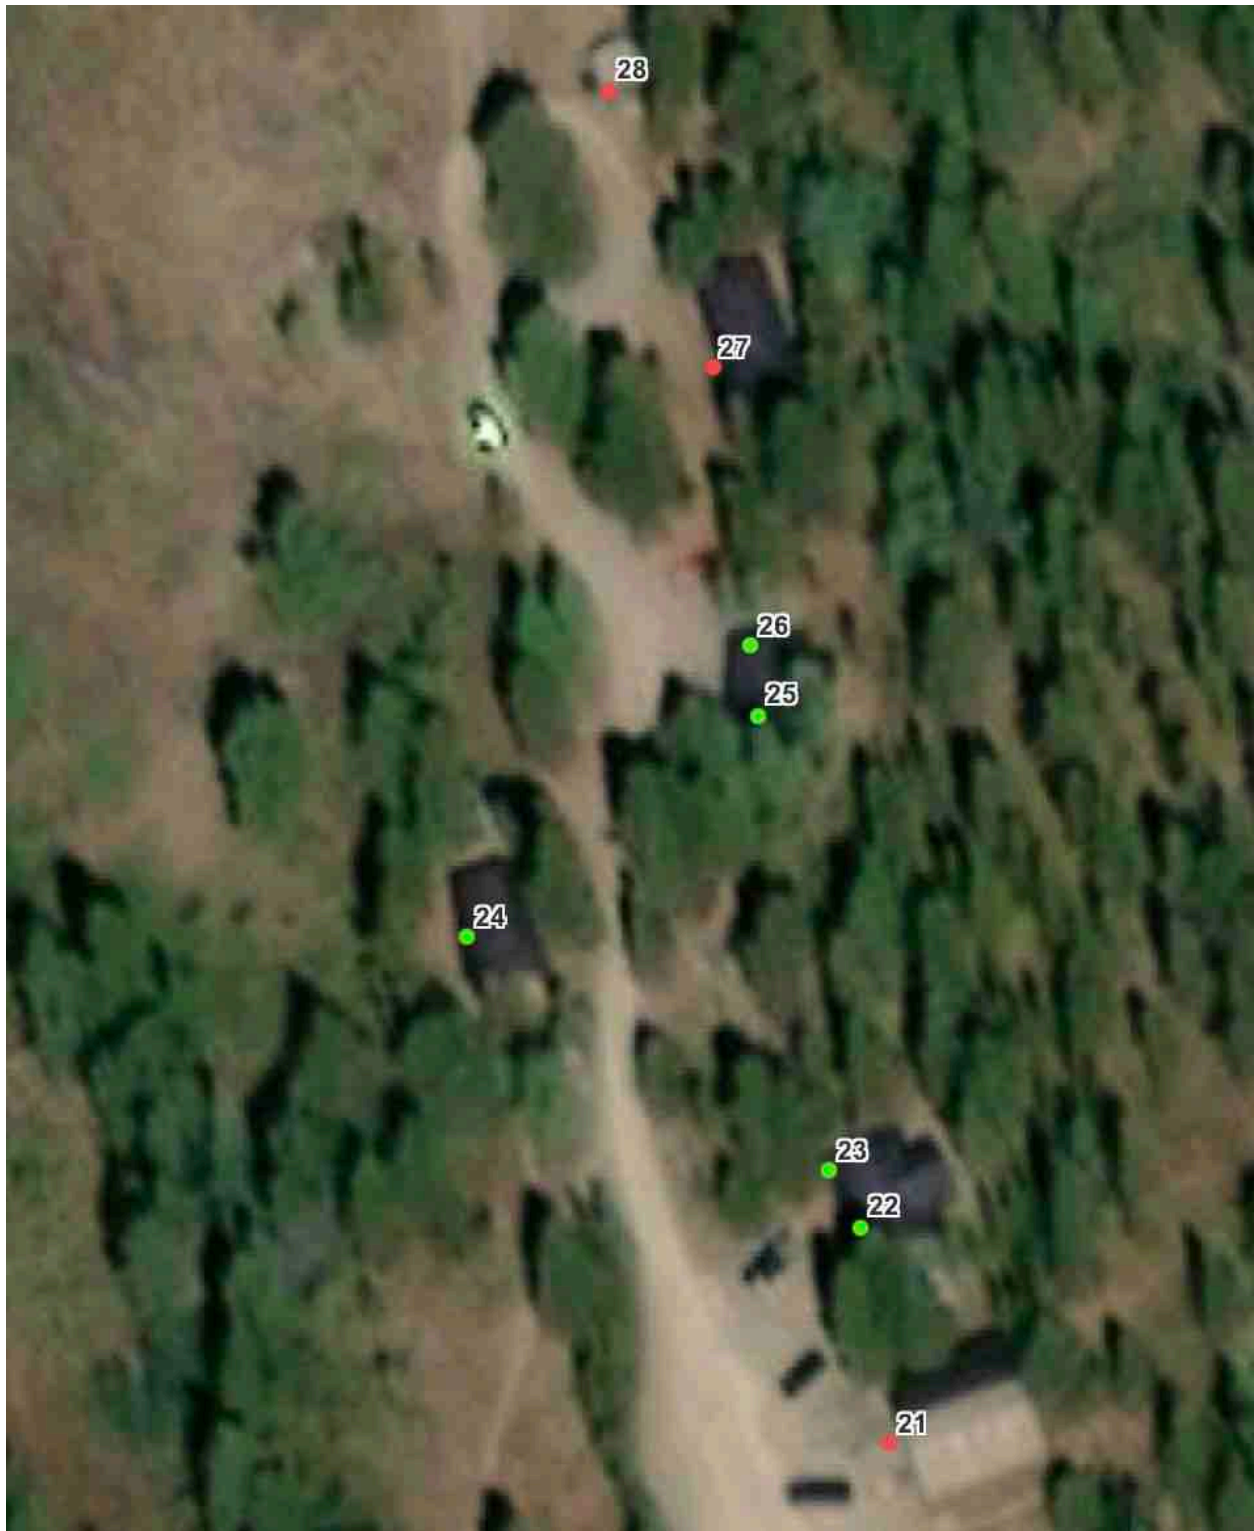
**Figure AIV-3. Fixture Locations and Compliance Assessment: Residential Area.** Dark sky compliant lighting has a green marker and non-compliant lighting has a red marker. Numbers present above the dots indicate the fixture ID number whose characteristics are presented within the tables.

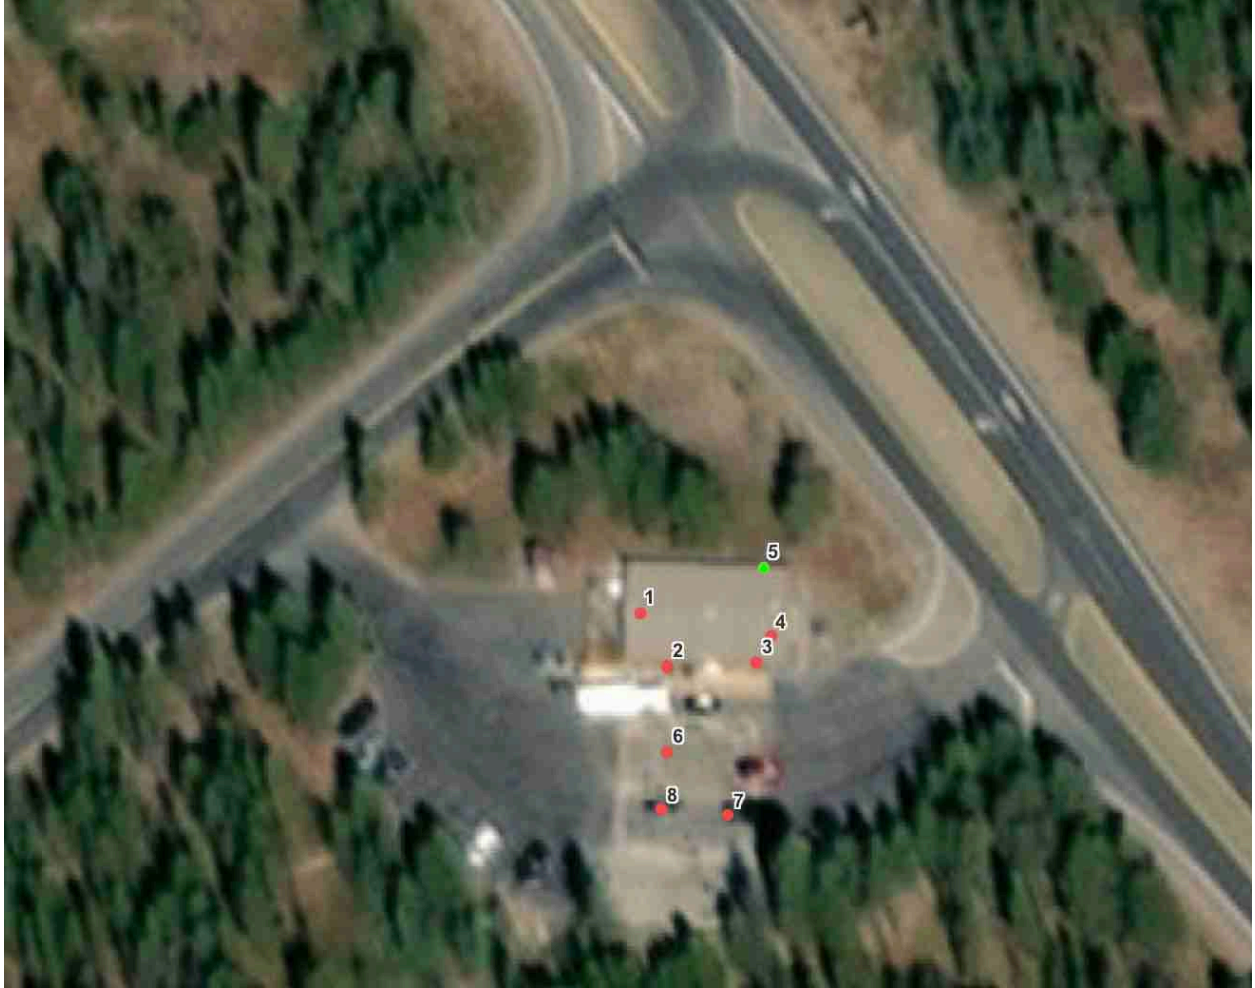
**Figure AV-1. Fixture Locations and Compliance Assessment: Service Station.** Dark sky compliant lighting has a green marker and non-compliant lighting has a red marker. Numbers present above the dots indicate the fixture ID number whose characteristics are presented within the tables.

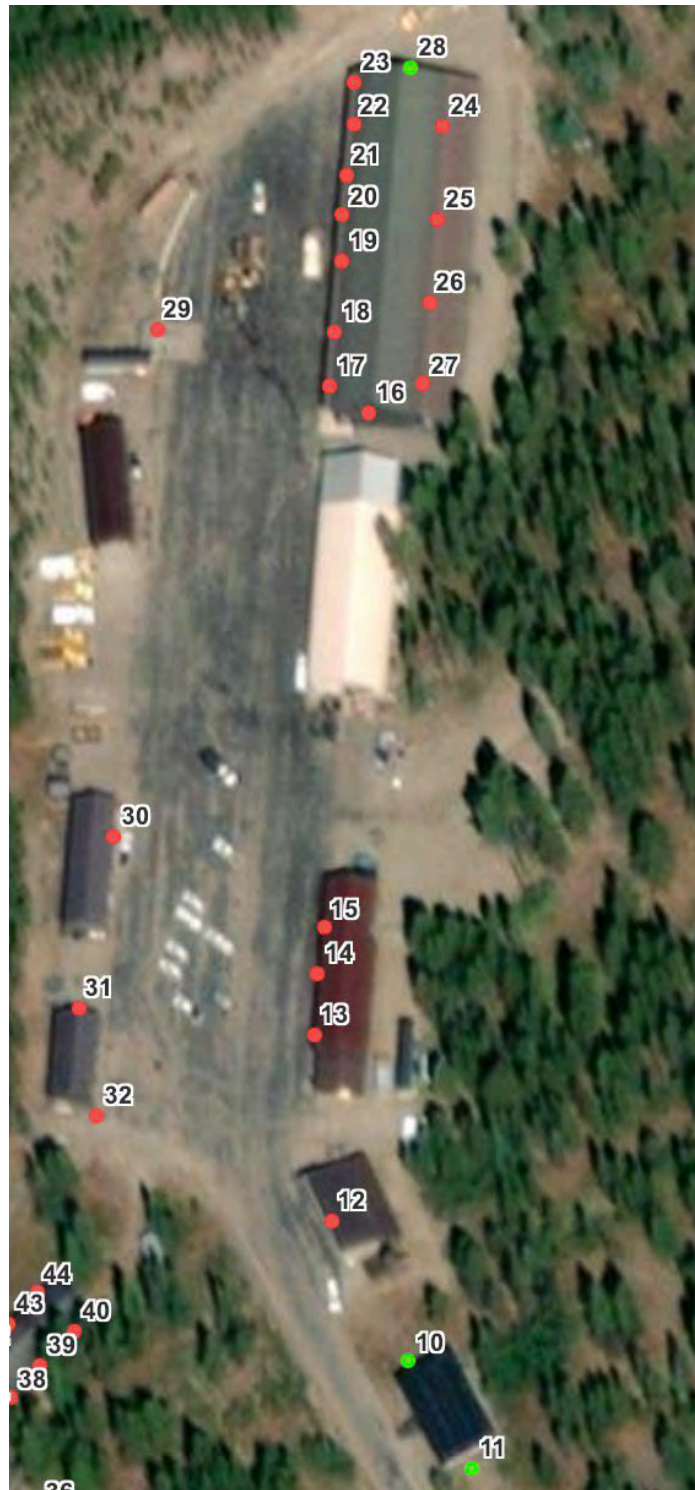
**Figure AV-2. Fixture Locations and Compliance Assessment: Maintenance Area.** Dark sky compliant lighting has a green marker and non-compliant lighting has a red marker. Numbers present above the dots indicate the fixture ID number whose characteristics are presented within the tables.
