Exterior Lighting Assessment and Design Recommendations

**Grand Teton National Park**

Respectfully submitted by: Bryan Boulanger

July 26, 2022

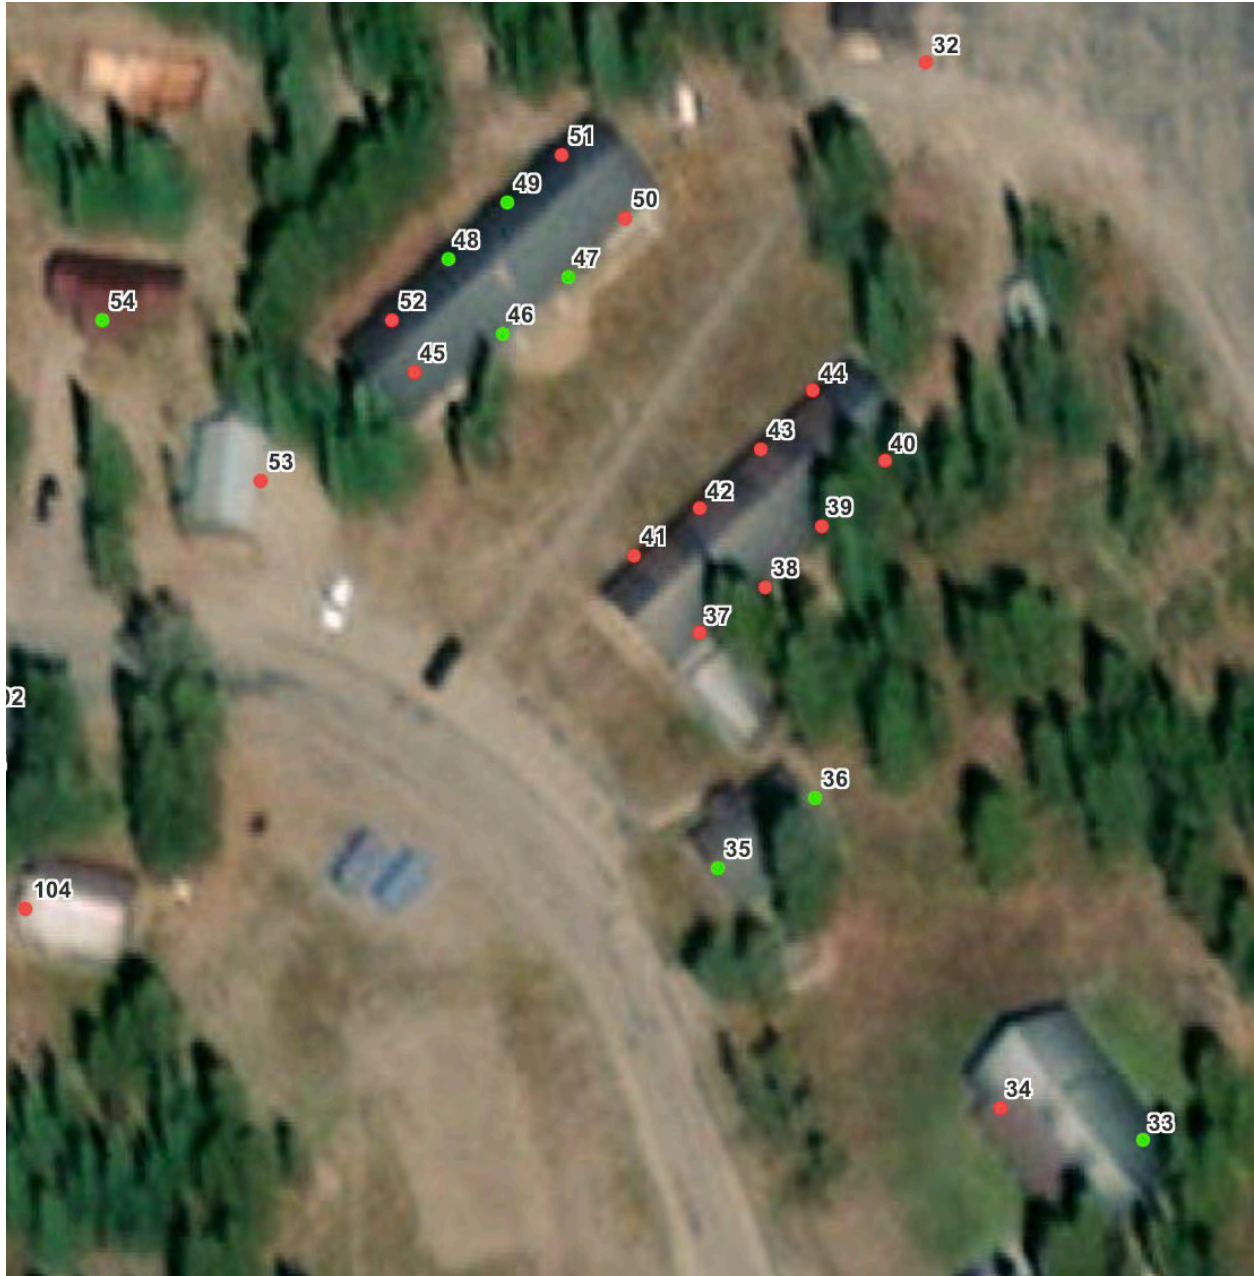
**Figure AV-3. Fixture Locations and Compliance Assessment: 600 – 618 Aspen Loop Residences.** Dark sky compliant lighting has a green marker and non-compliant lighting has a red marker. Numbers present above the dots indicate the fixture ID number whose characteristics are presented within the tables.

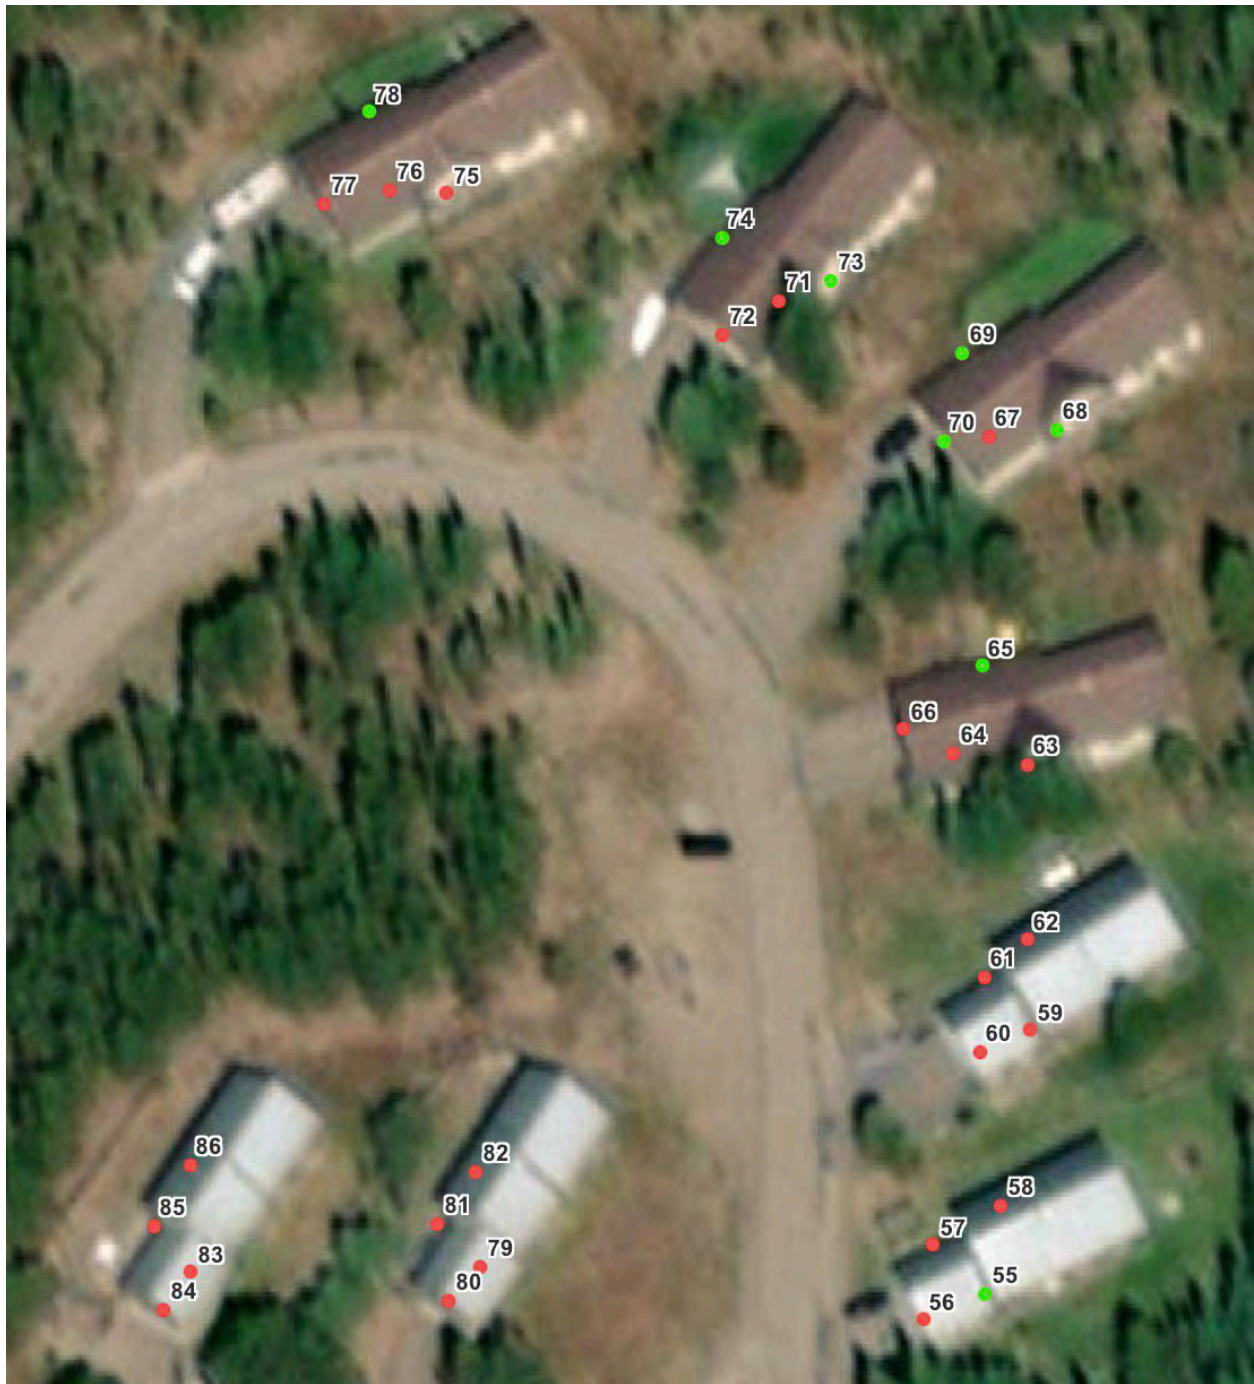
**Figure AV-4. Fixture Locations and Compliance Assessment: 626 – 636, 673, and 675 Aspen Loop Residences.** Dark sky compliant lighting has a green marker and non-compliant lighting has a red marker. Numbers present above the dots indicate the fixture ID number whose characteristics are presented within the tables.

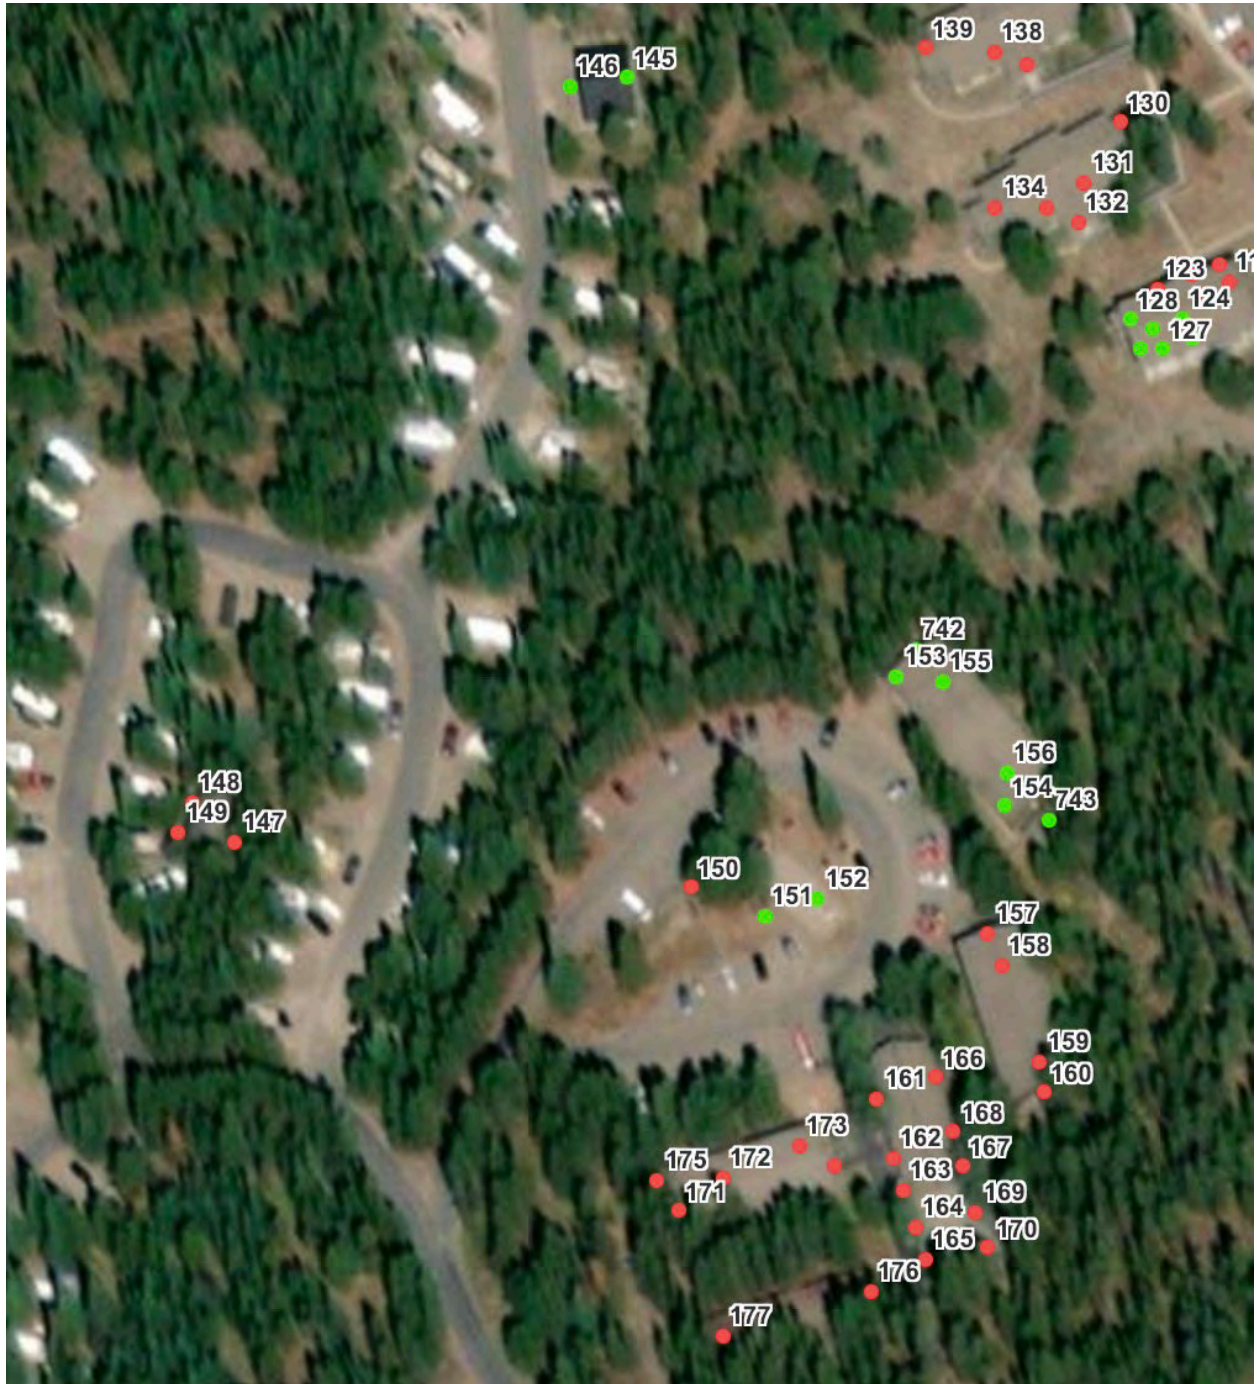
**Figure AV-7. Fixture Locations and Compliance Assessment: Dorm Area.** Dark sky compliant lighting has a green marker and non-compliant lighting has a red marker. Numbers present above the dots indicate the fixture ID number whose characteristics are presented within the tables. *\* Please note fixtures 742 and 743 are included within this fixture. The fixture locations were underneath fixtures 155 and 156 and were not discovered until the end of the Colter Bay data quality check. Therefore, they were named as the last two fixtures within this data set.*

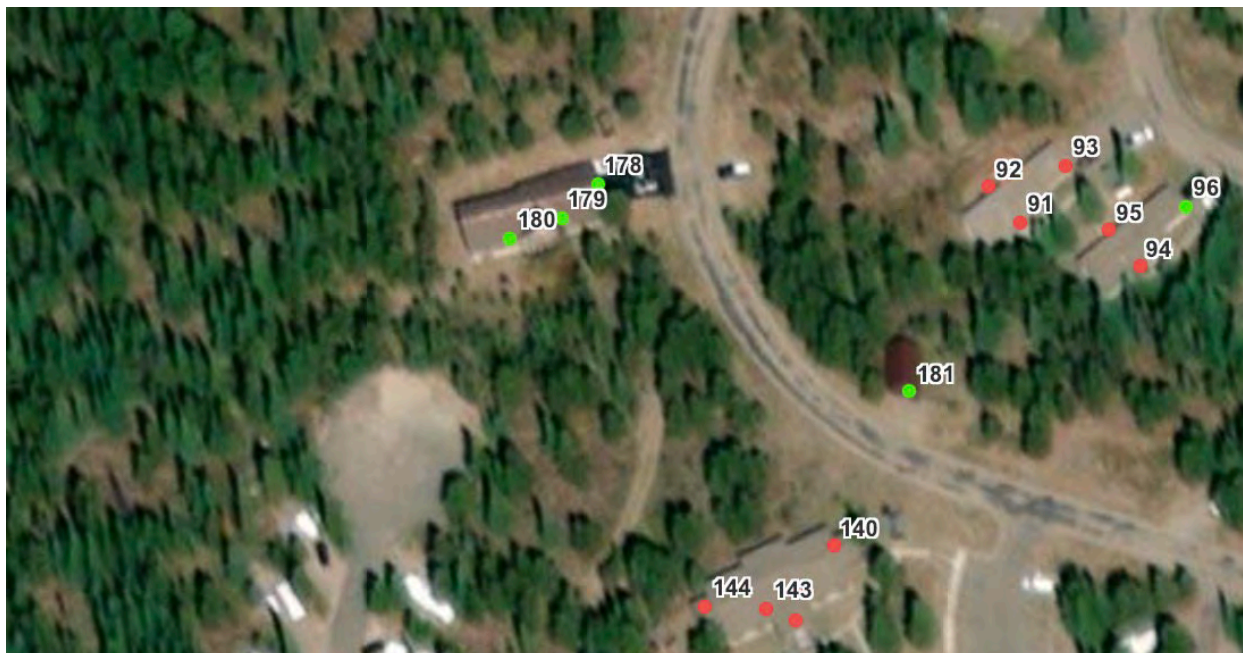
**Figure AV-8. Fixture Locations and Compliance Assessment: 646 and 651 Aspen Loop Residences.** Dark sky compliant lighting has a green marker and non-compliant lighting has a red marker. Numbers present above the dots indicate the fixture ID number whose characteristics are presented within the tables.

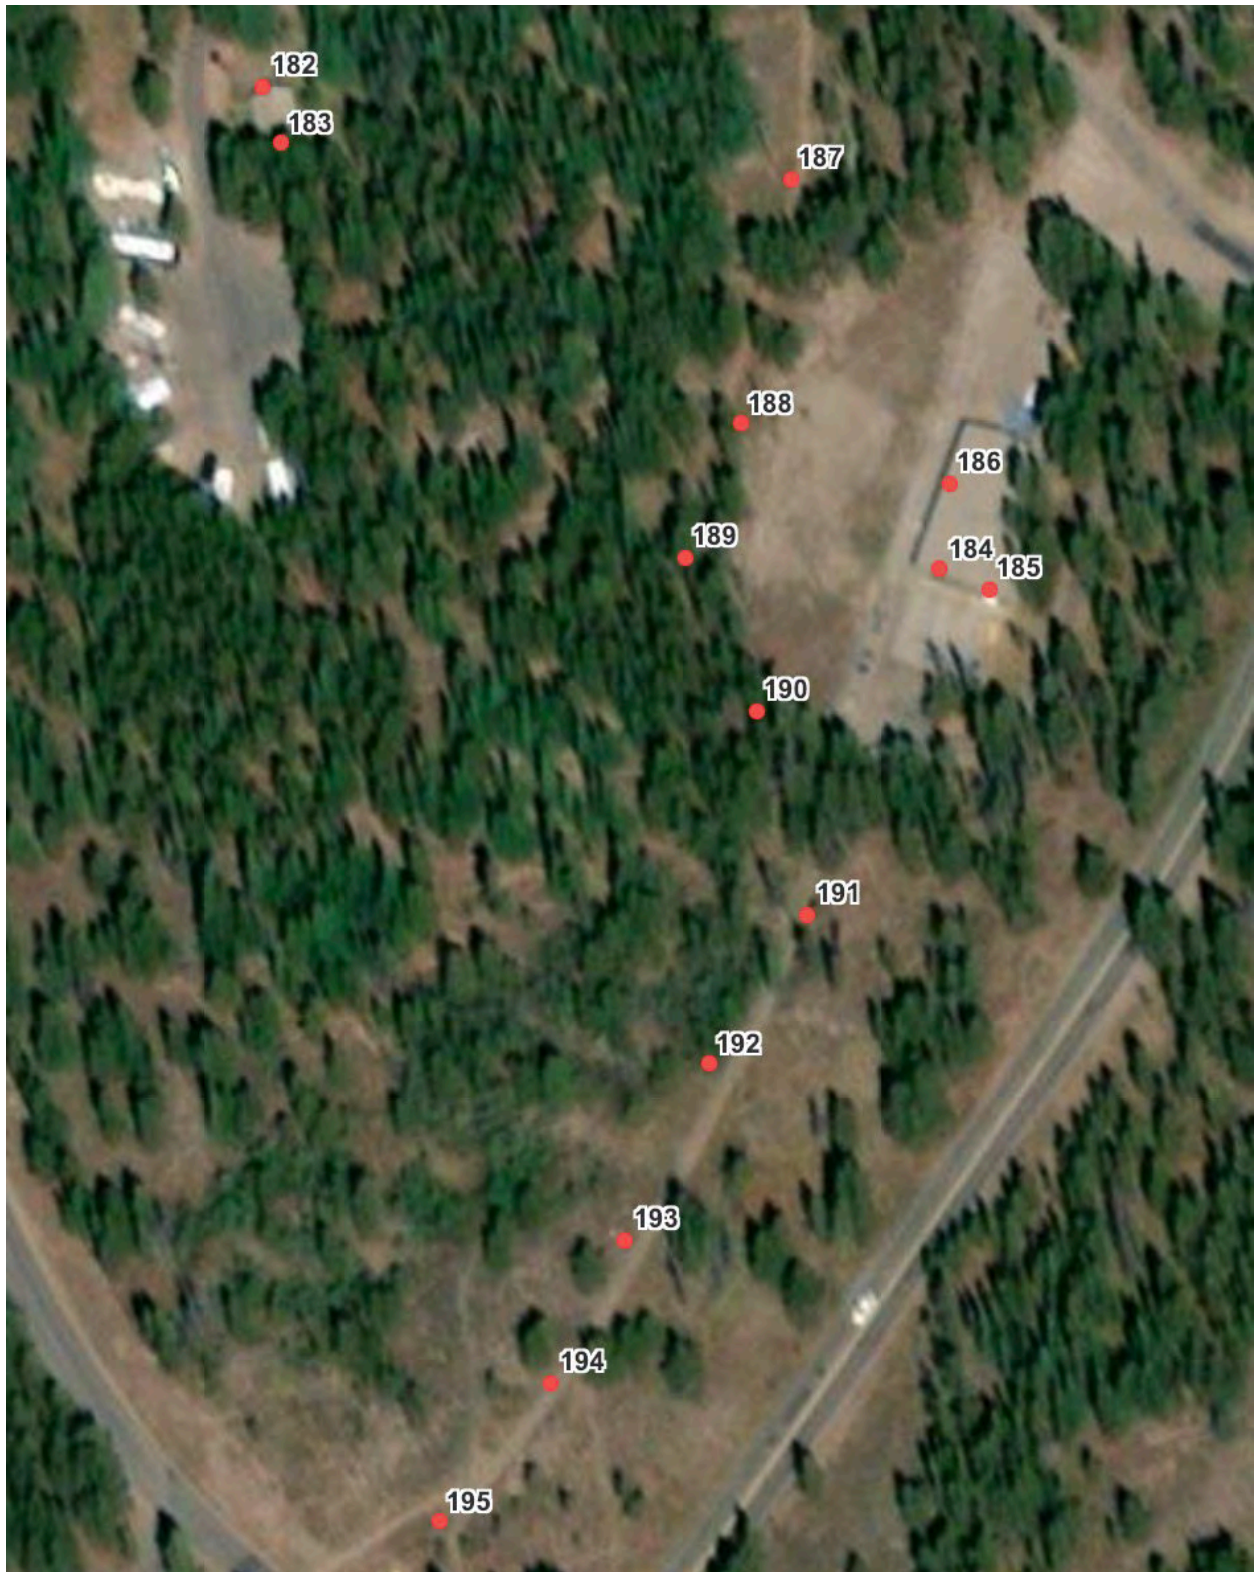
**Figure AV-9. Fixture Locations and Compliance Assessment: Old Service Station and Pathway from Dorms.** Dark sky compliant lighting has a green marker and non-compliant lighting has a red marker. Numbers present above the dots indicate the fixture ID number whose characteristics are presented within the tables.

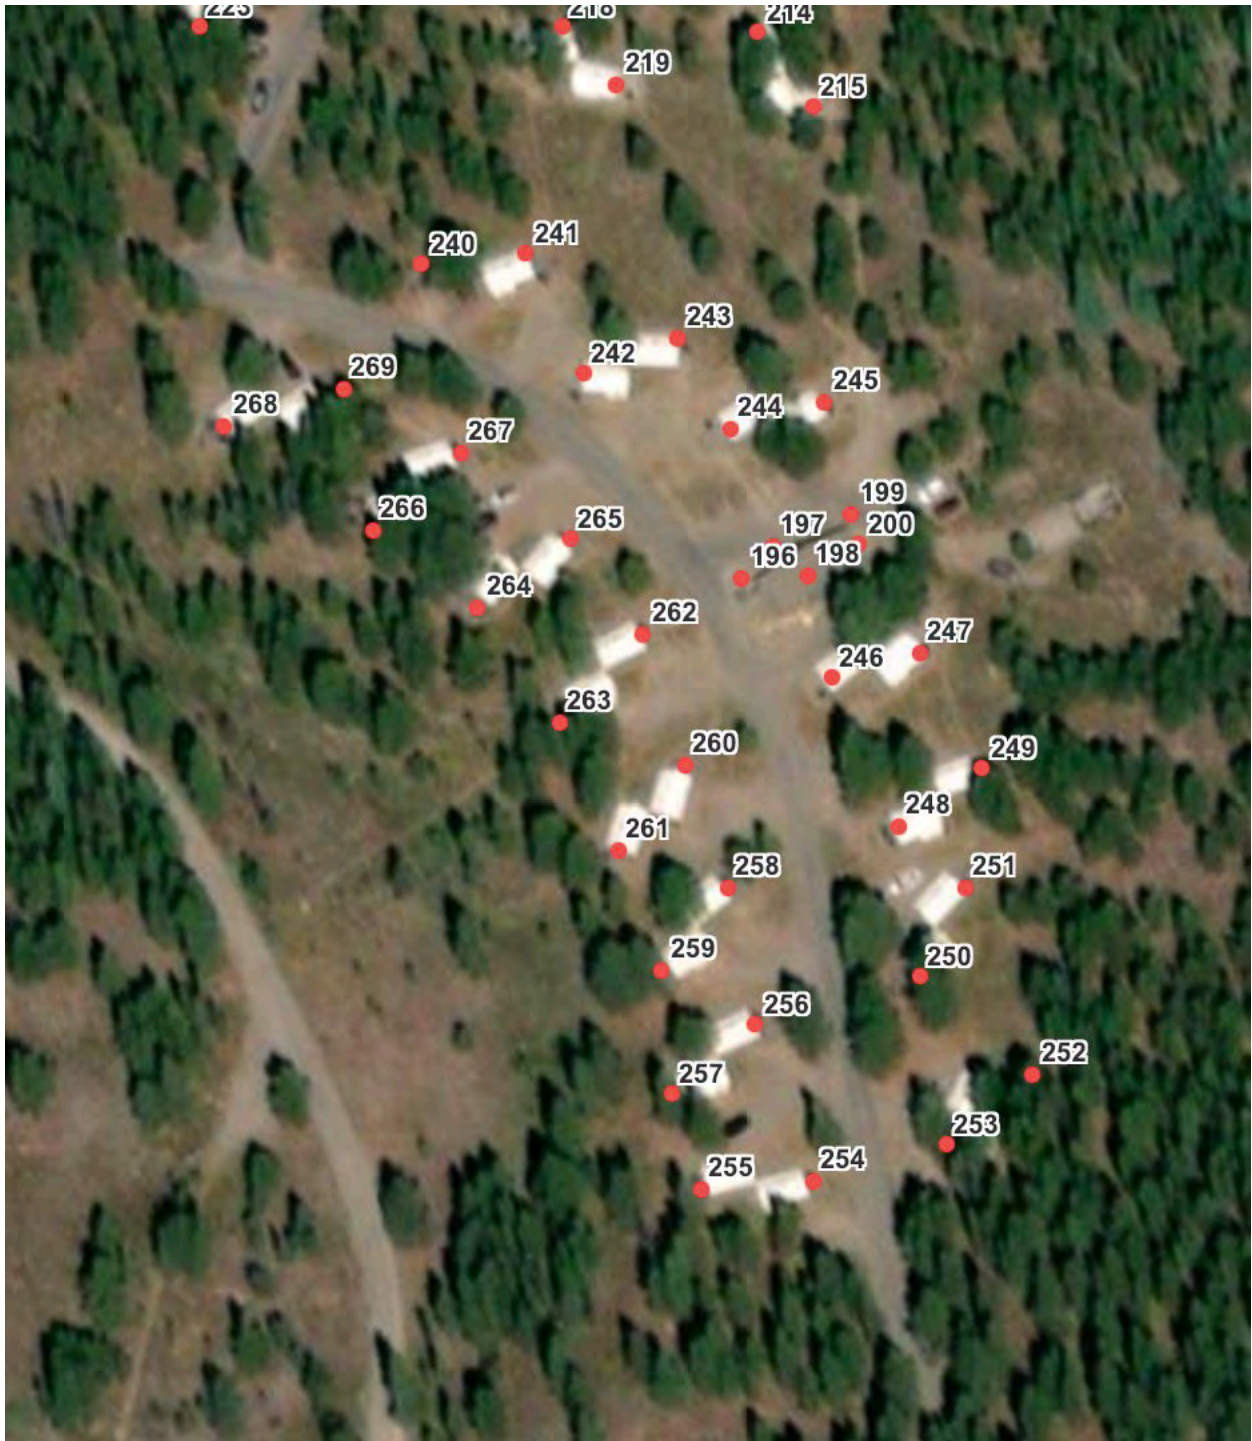
**Figure AV-10. Fixture Locations and Compliance Assessment: Tent Village Office, Restroom and Lower Sites.** Dark sky compliant lighting has a green marker and non-compliant lighting has a red marker. Numbers present above the dots indicate the fixture ID number whose characteristics are presented within the tables.

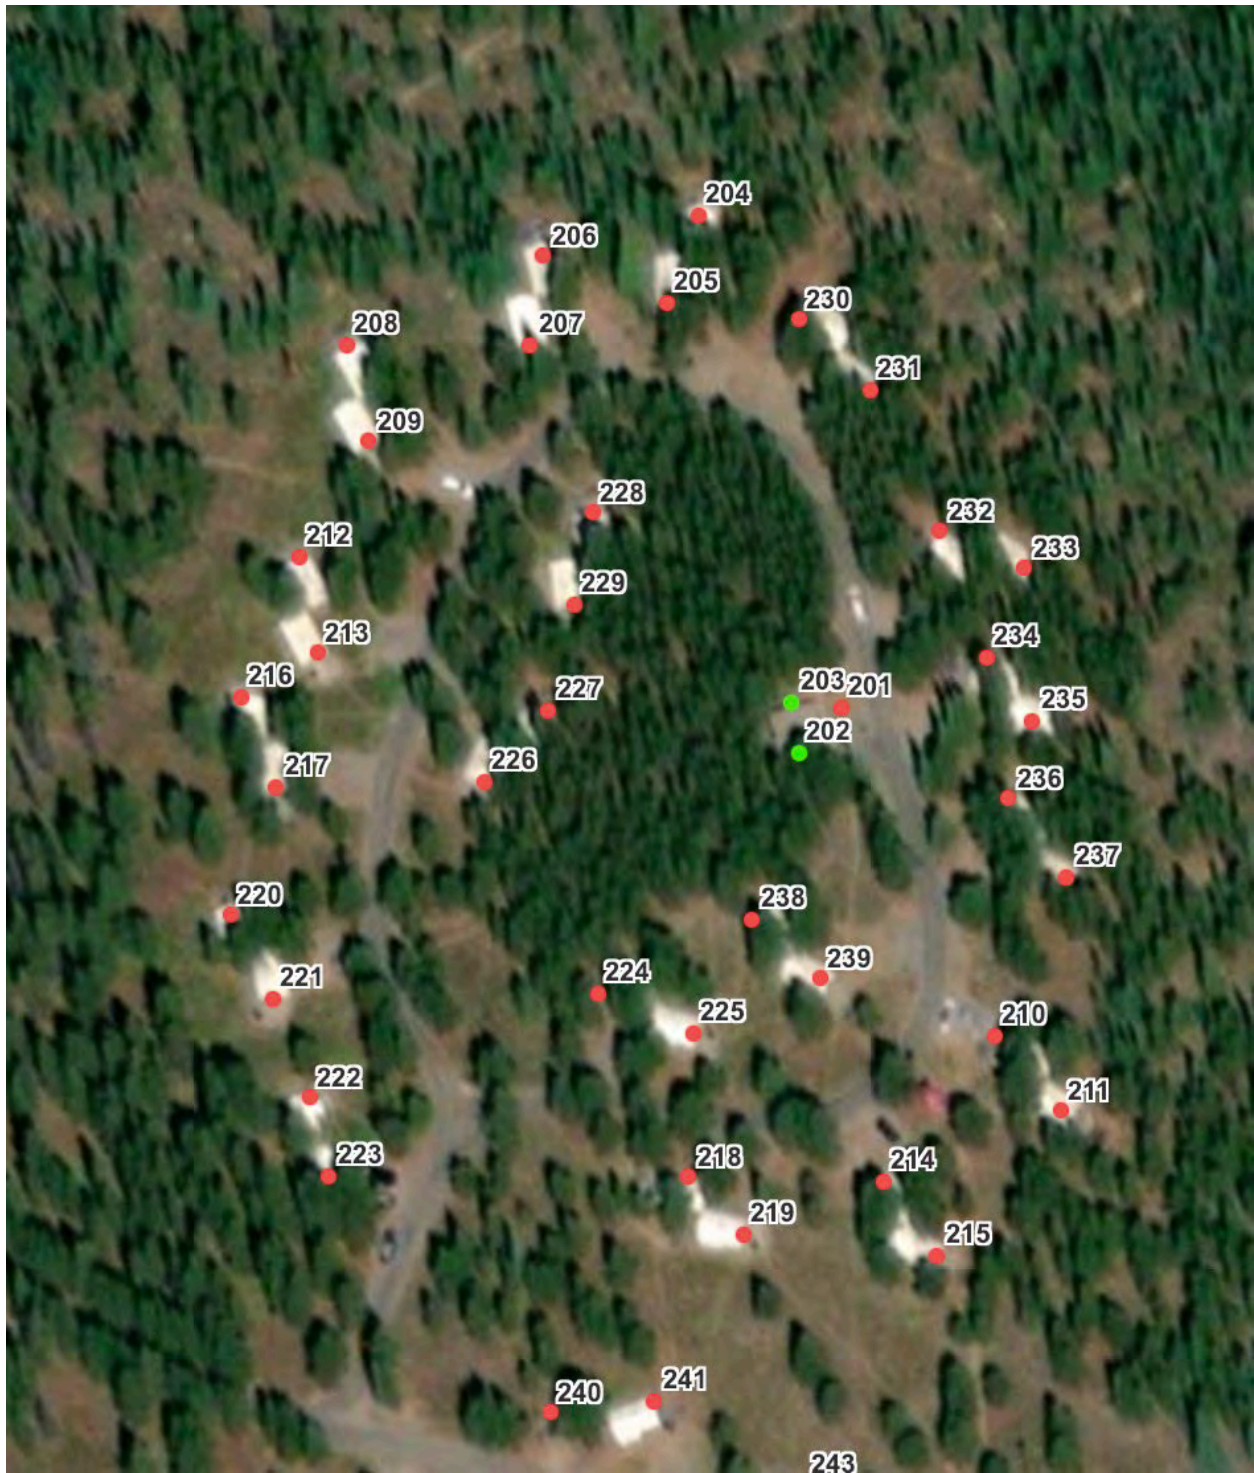
**Figure AV-11. Fixture Locations and Compliance Assessment: Tent Village Upper Sites.** Dark sky compliant lighting has a green marker and non-compliant lighting has a red marker. Numbers present above the dots indicate the fixture ID number whose characteristics are presented within the tables.

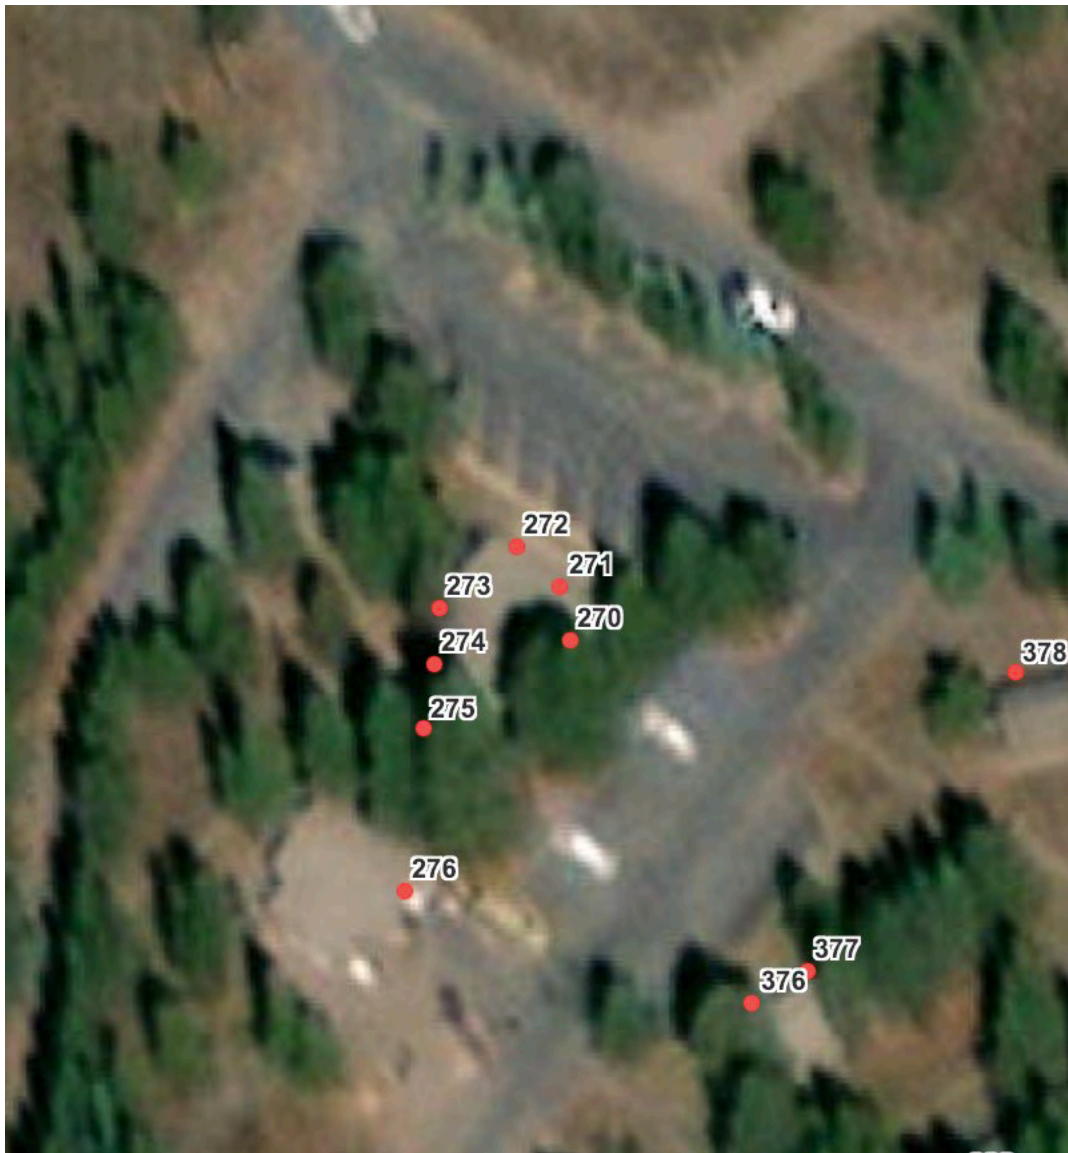
**Figure AV-12. Fixture Locations and Compliance Assessment: Cabin Rental Office.** Dark sky compliant lighting has a green marker and non-compliant lighting has a red marker. Numbers present above the dots indicate the fixture ID number whose characteristics are presented within the tables.

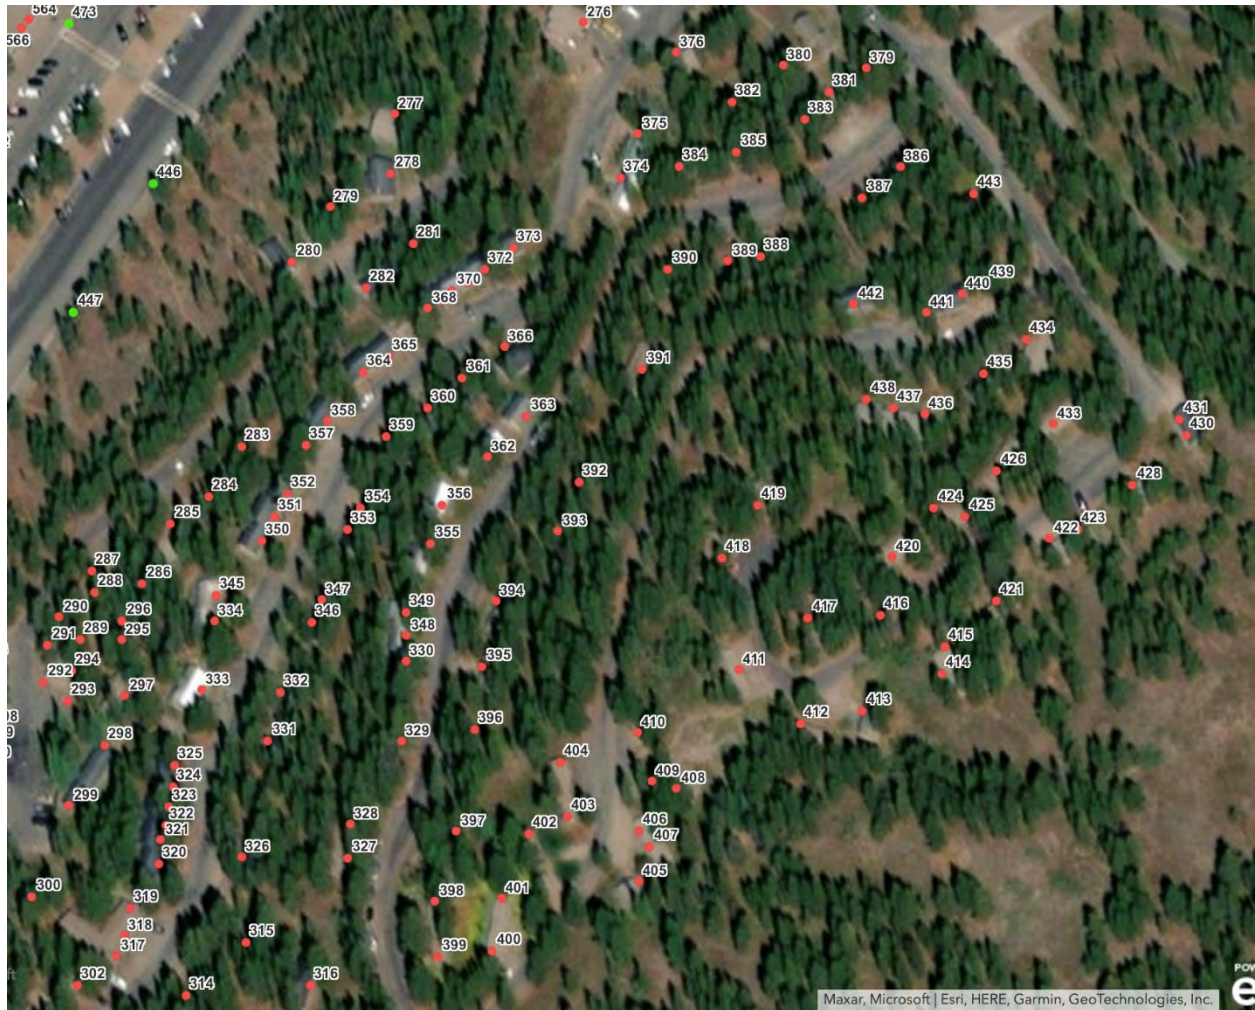
**Figure AV-13. Fixture Locations and Compliance Assessment: Cabins.** Dark sky compliant lighting has a green marker and non-compliant lighting has a red marker. Numbers present above the dots indicate the fixture ID number whose characteristics are presented within the tables.

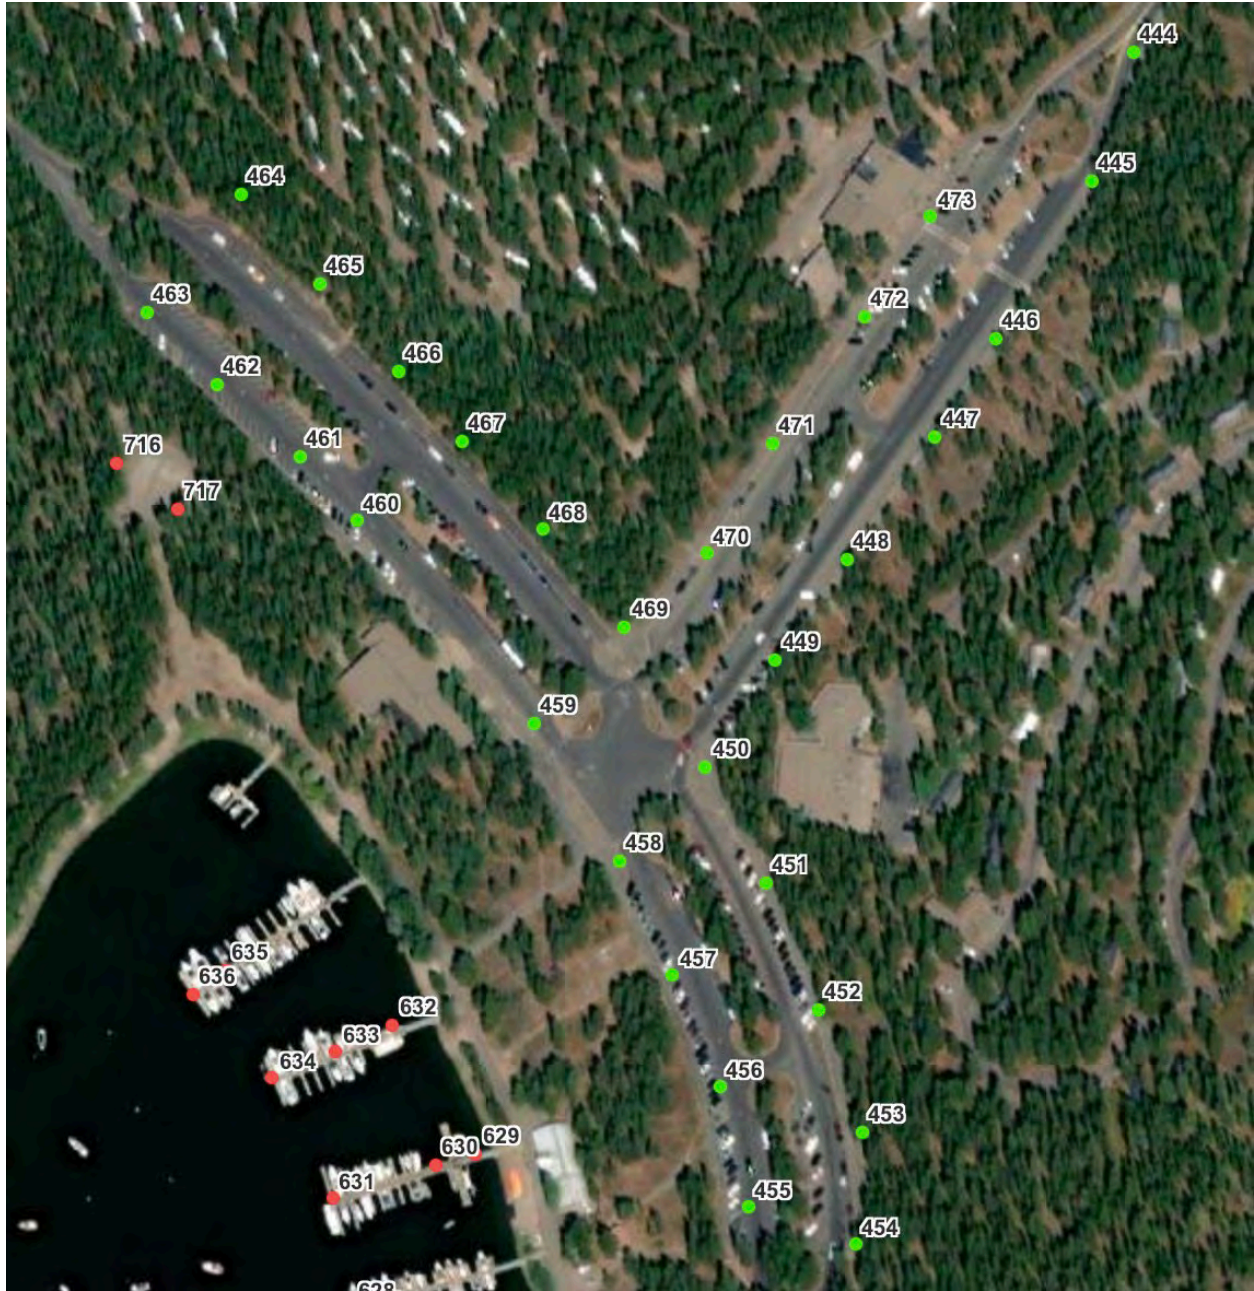
**Figure AV-14. Fixture Locations and Compliance Assessment: Red/White LED Lamp Posts in Parking Lot.** Dark sky compliant lighting has a green marker and non-compliant lighting has a red marker. Numbers present above the dots indicate the fixture ID number whose characteristics are presented within the tables.

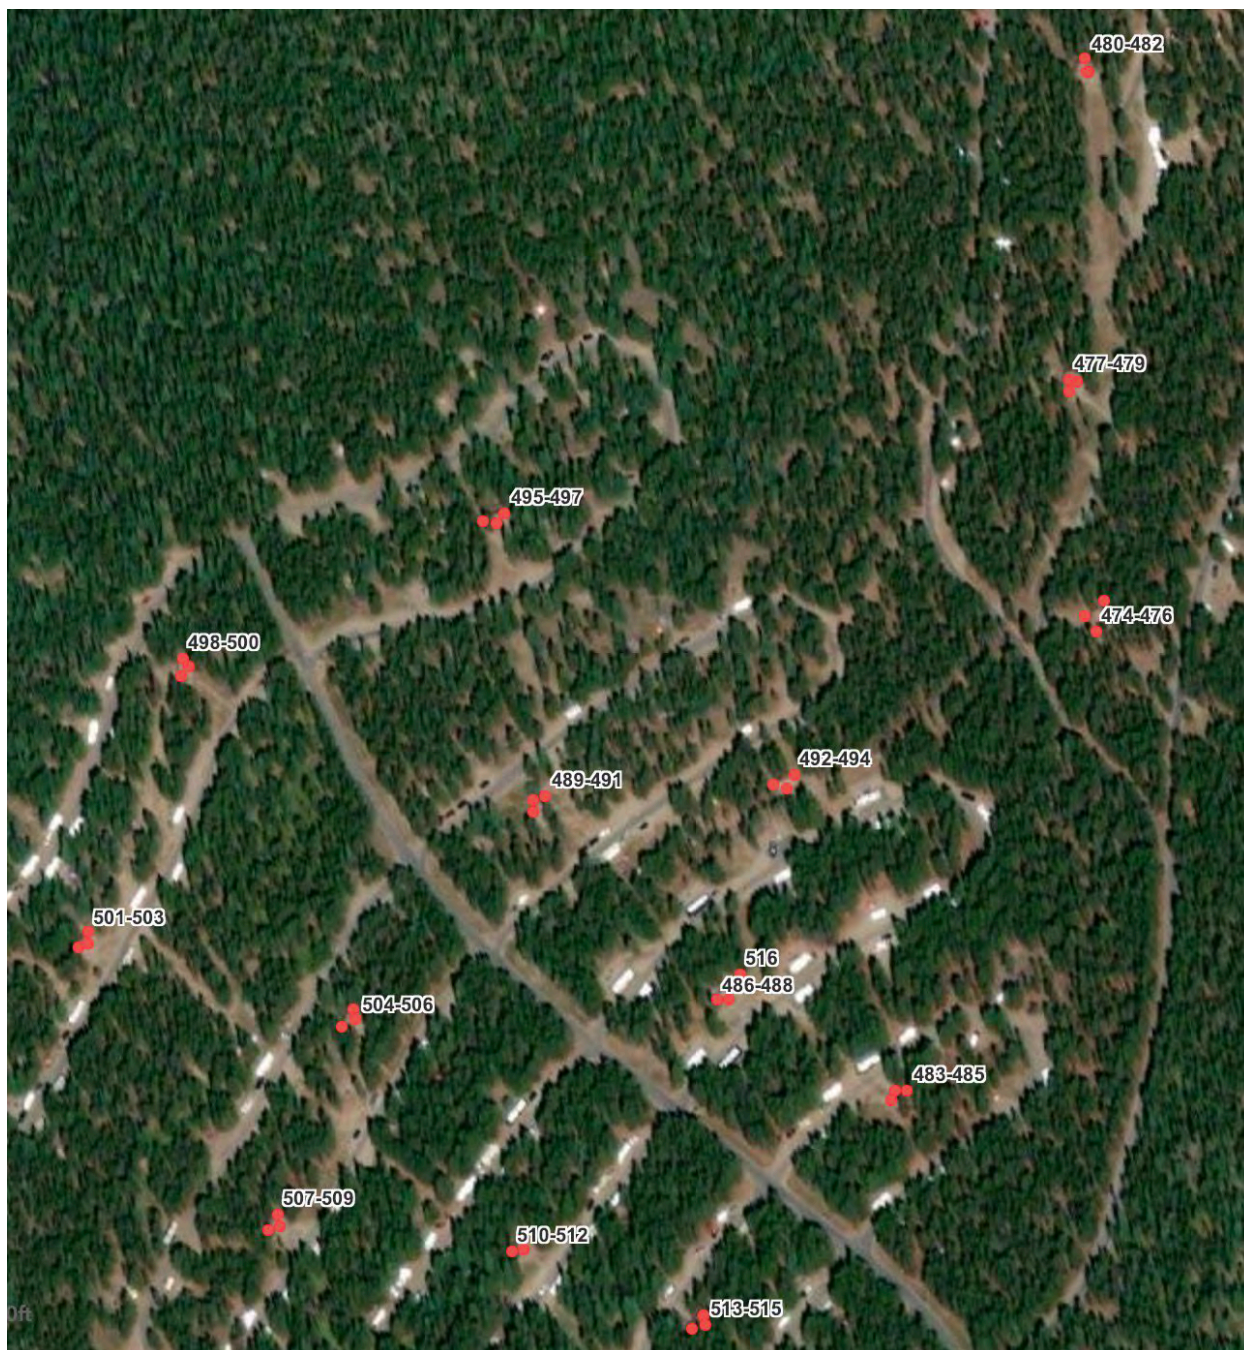
**Figure AV-15. Fixture Locations and Compliance Assessment: Comfort Stations in Campground Group Sites and Loops H, I, J, K, L, M, N, and O.** Dark sky compliant lighting has a green marker and non-compliant lighting has a red marker. Numbers present above the dots indicate the fixture ID number whose characteristics are presented within the tables.

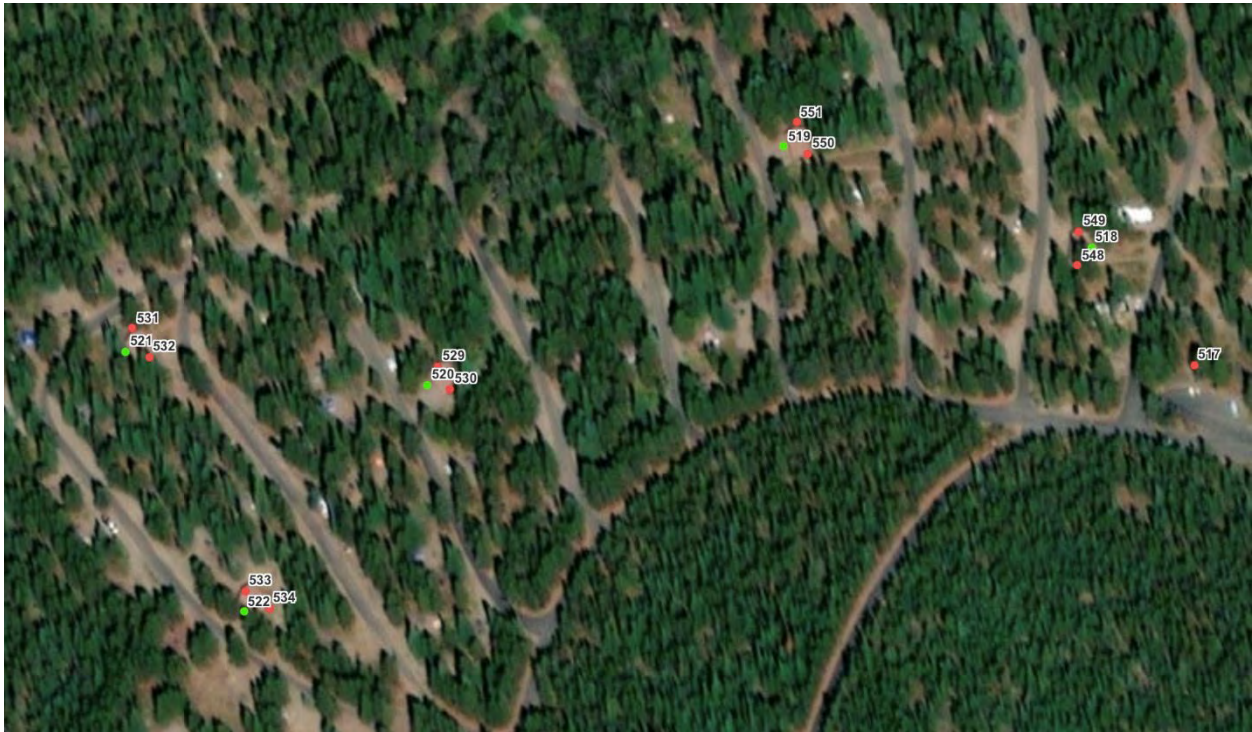
**Figure AV-16. Fixture Locations and Compliance Assessment: Comfort Stations in Campground Loops A-D.** Dark sky compliant lighting has a green marker and non-compliant lighting has a red marker. Numbers present above the dots indicate the fixture ID number whose characteristics are presented within the tables.

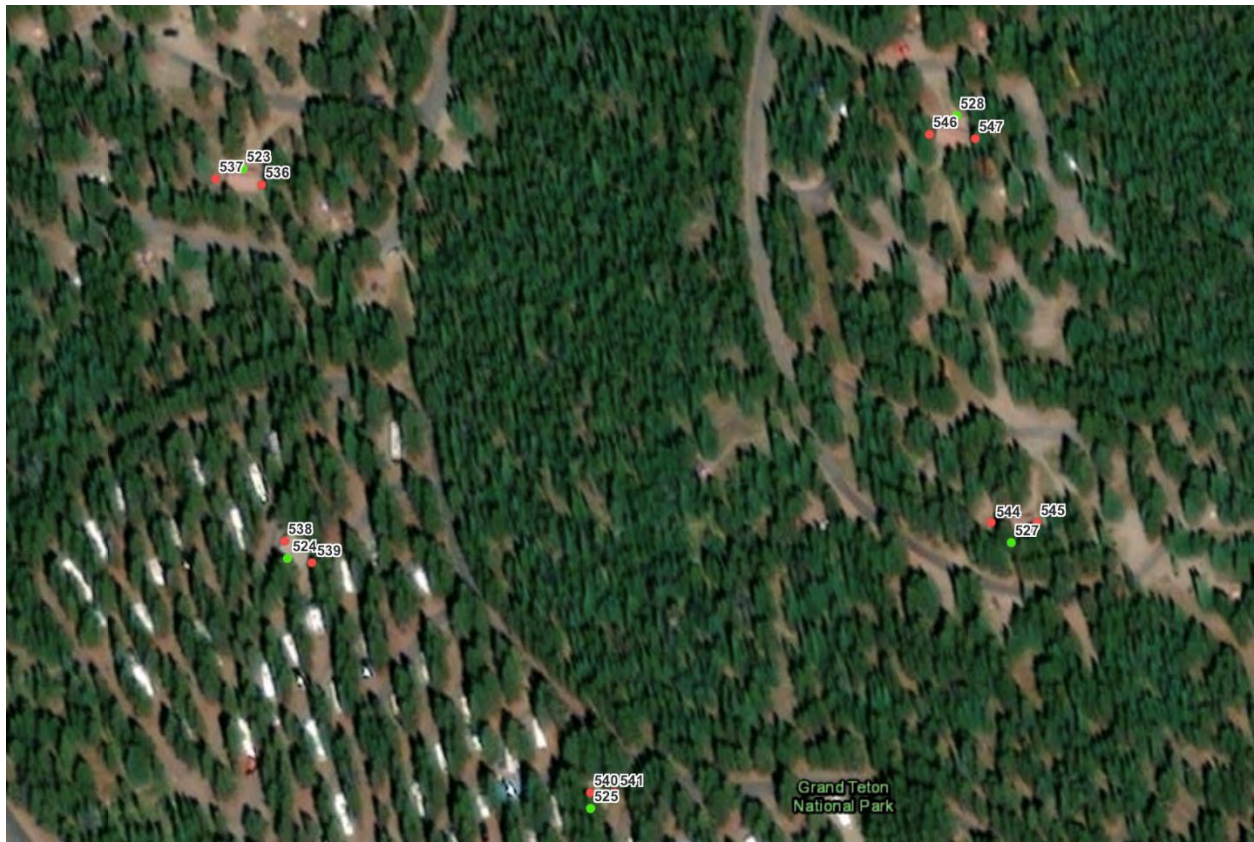
**Figure AV-17. Fixture Locations and Compliance Assessment: Comfort Stations in Campground Loops E-G and in RV Area.** Dark sky compliant lighting has a green marker and non-compliant lighting has a red marker. Numbers present above the dots indicate the fixture ID number whose characteristics are presented within the tables.

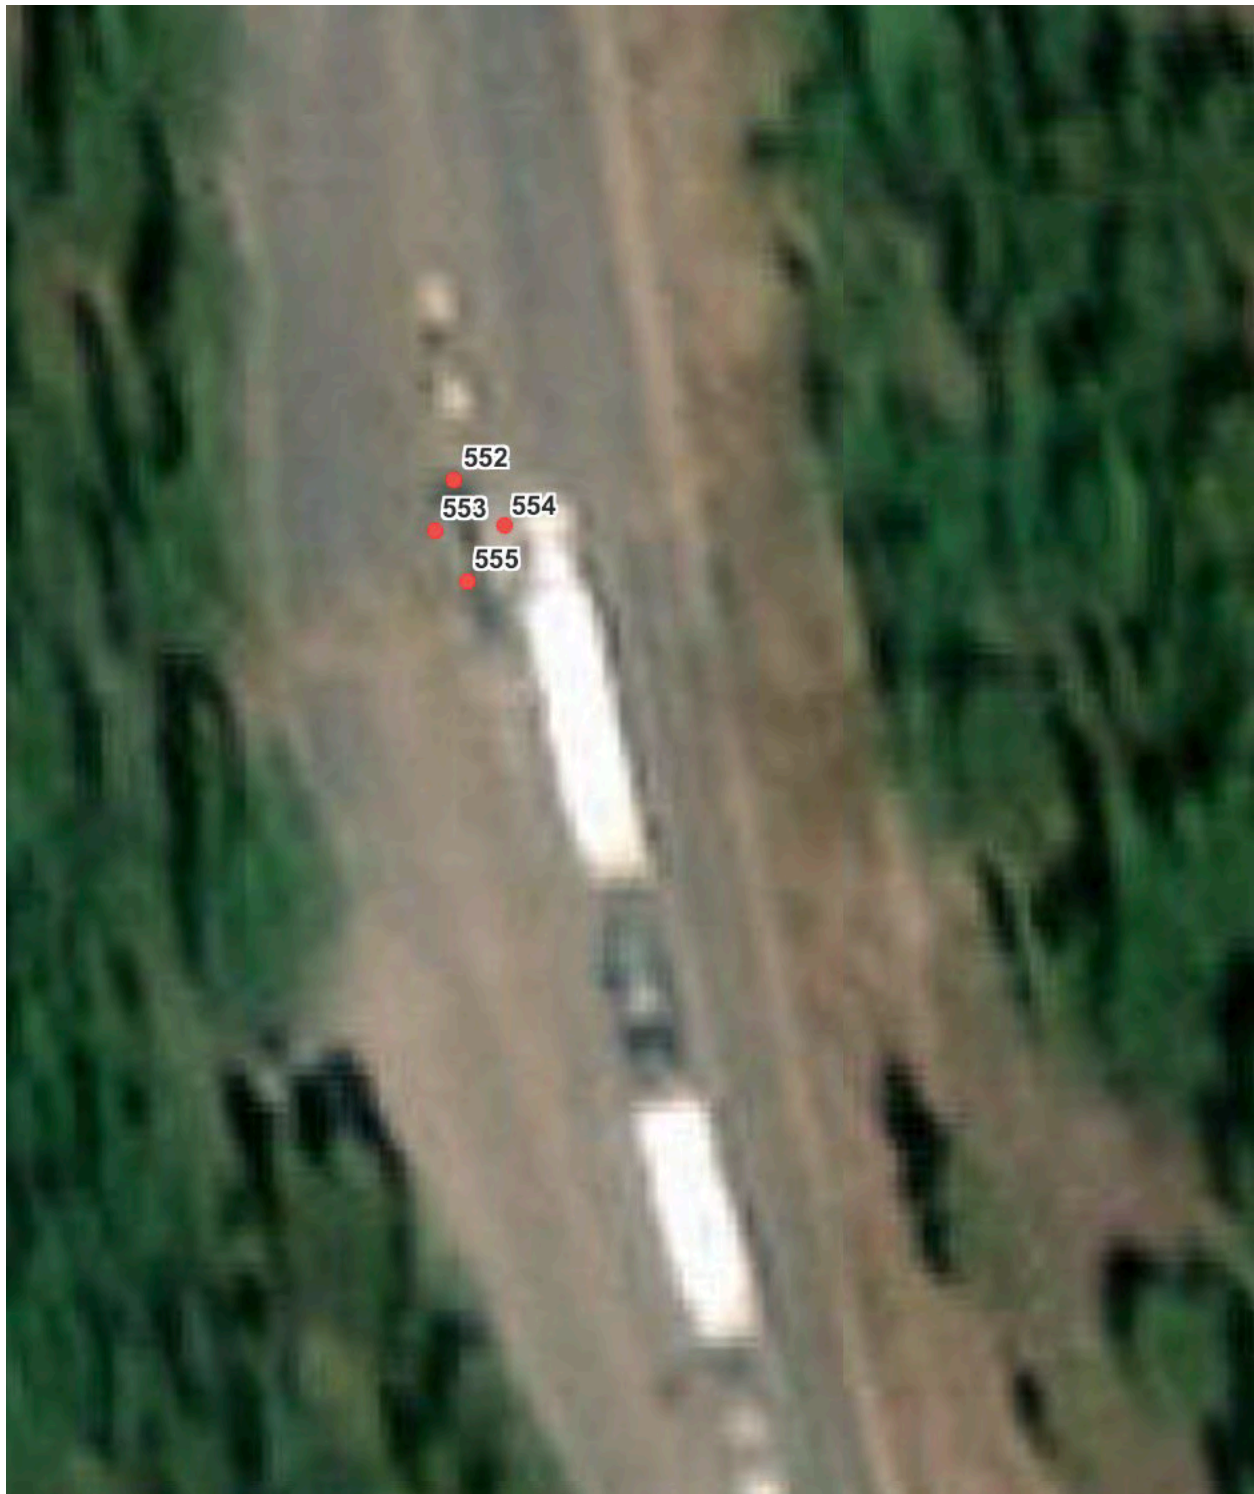
**Figure AV-18. Fixture Locations and Compliance Assessment: Campground Registration Kiosk.** Dark sky compliant lighting has a green marker and non-compliant lighting has a red marker. Numbers present above the dots indicate the fixture ID number whose characteristics are presented within the tables.
