Exterior Lighting Assessment and Design Recommendations

**Grand Teton National Park**

Respectfully submitted by: Bryan Boulanger

July 26, 2022

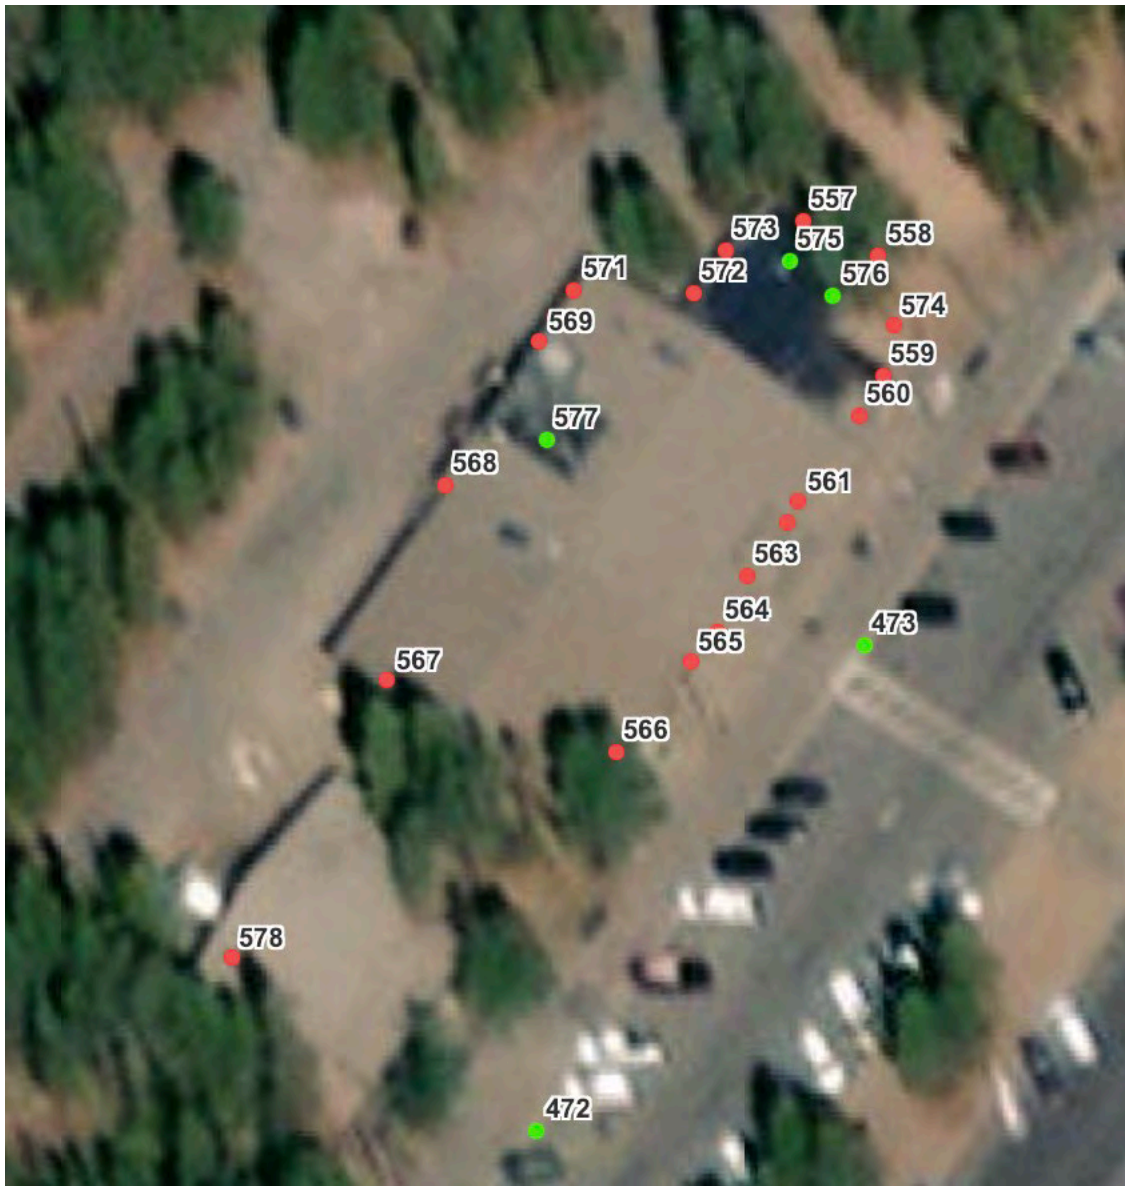
**Figure AV-19. Fixture Locations and Compliance Assessment: Grocery and Gift Shop and Laundry/Showers Building.** Dark sky compliant lighting has a green marker and non-compliant lighting has a red marker. Numbers present above the dots indicate the fixture ID number whose characteristics are presented within the tables.

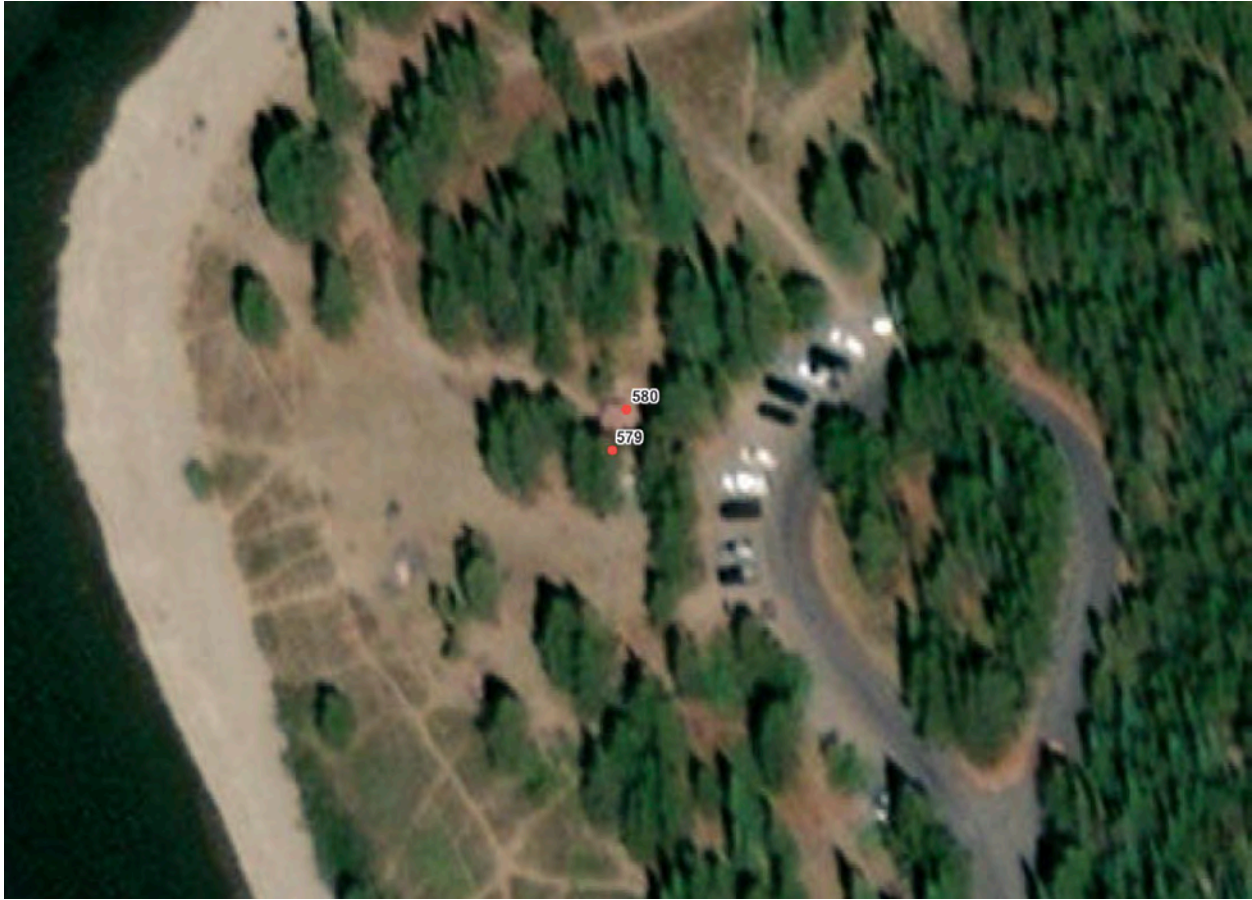
**Figure AV-20. Fixture Locations and Compliance Assessment: Lift/Comfort Station by Beach.** Dark sky compliant lighting has a green marker and non-compliant lighting has a red marker. Numbers present above the dots indicate the fixture ID number whose characteristics are presented within the tables.

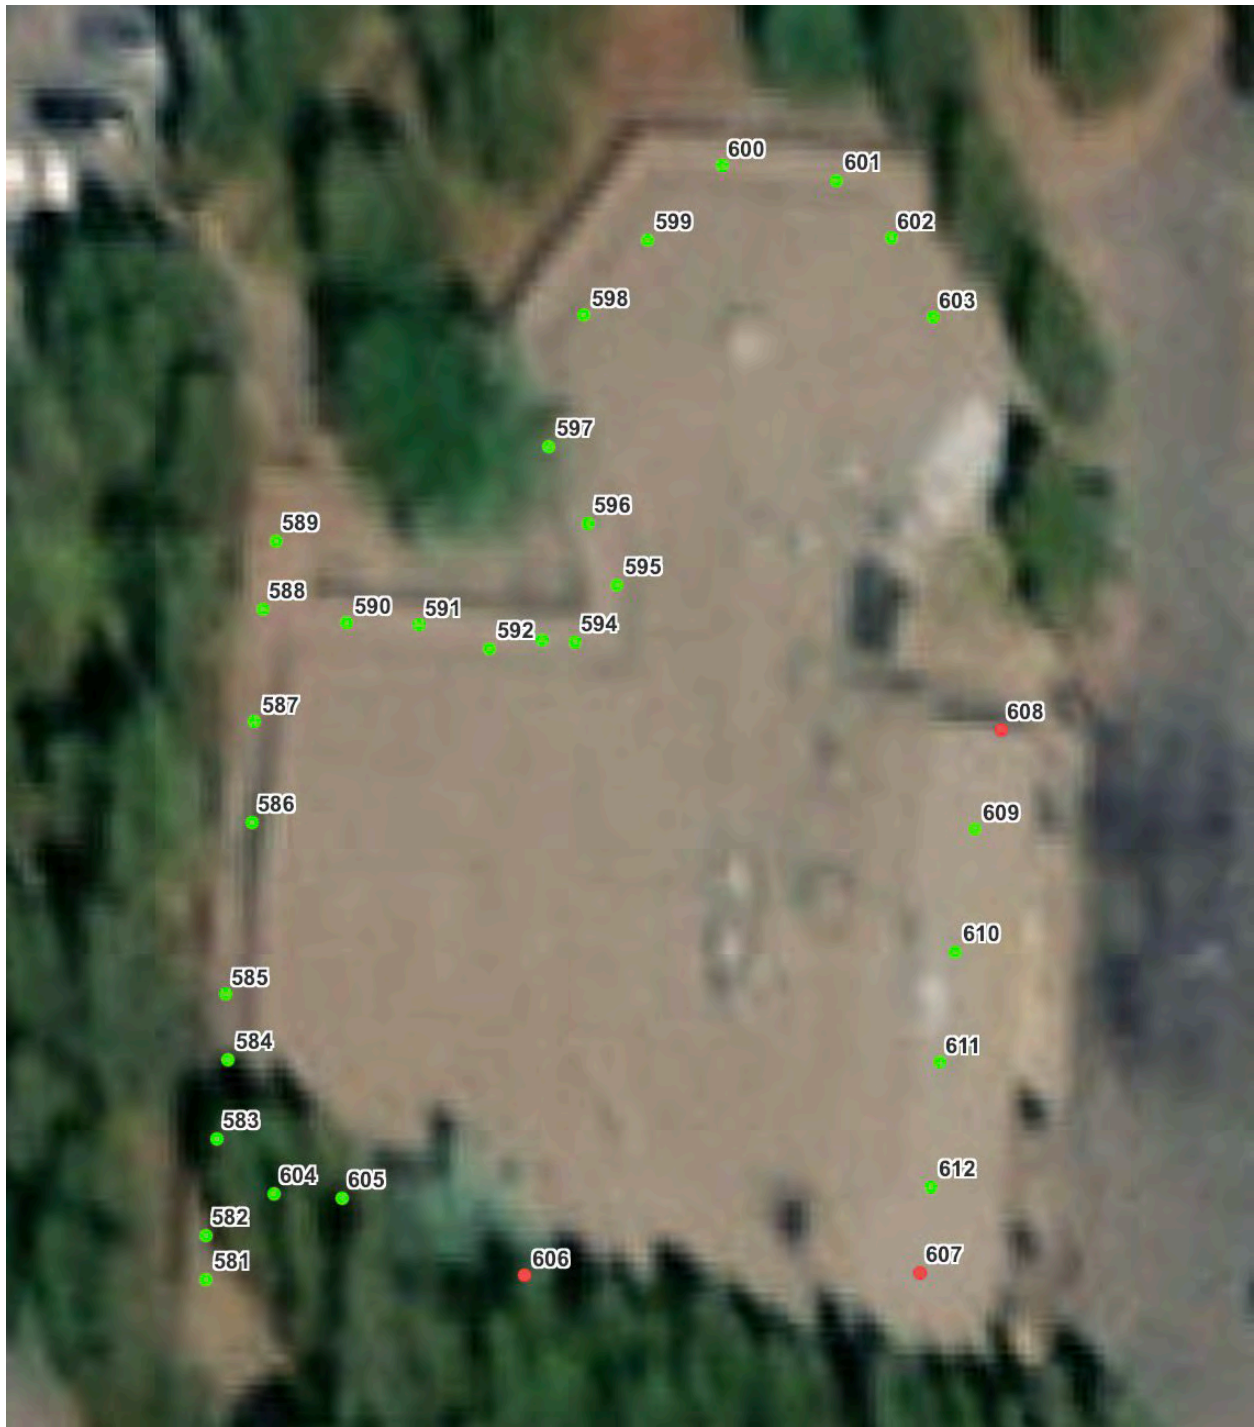
**Figure AV-21. Fixture Locations and Compliance Assessment: Café Court and Chuckwagon Restaurant.** Dark sky compliant lighting has a green marker and non-compliant lighting has a red marker. Numbers present above the dots indicate the fixture ID number whose characteristics are presented within the tables.

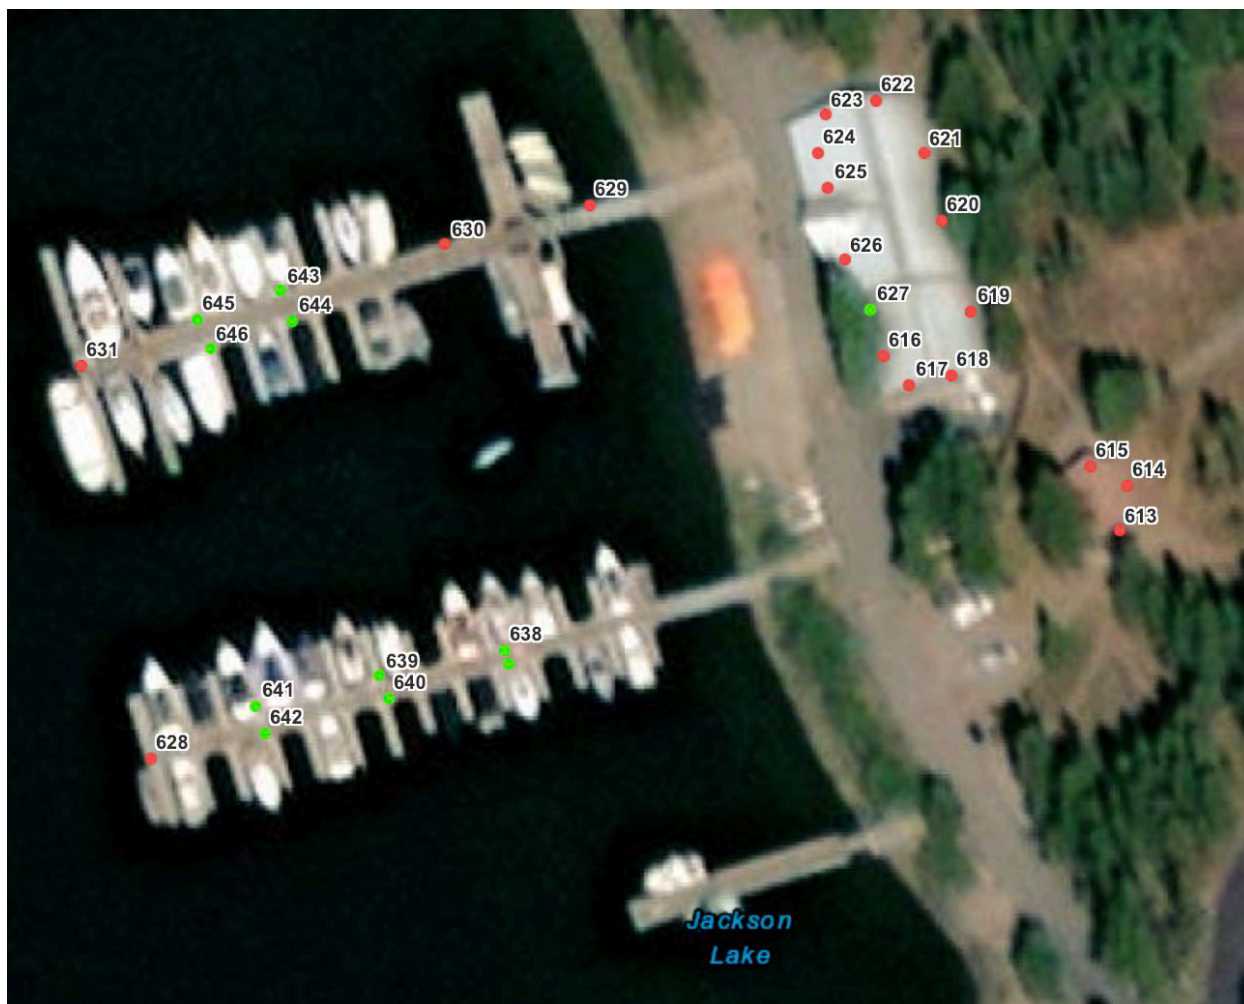
**Figure AV-22. Fixture Locations and Compliance Assessment: Marina Comfort Stations, Bait and Rental Office, and Lower Docks.** Dark sky compliant lighting has a green marker and non-compliant lighting has a red marker. Numbers present above the dots indicate the fixture ID number whose characteristics are presented within the tables.

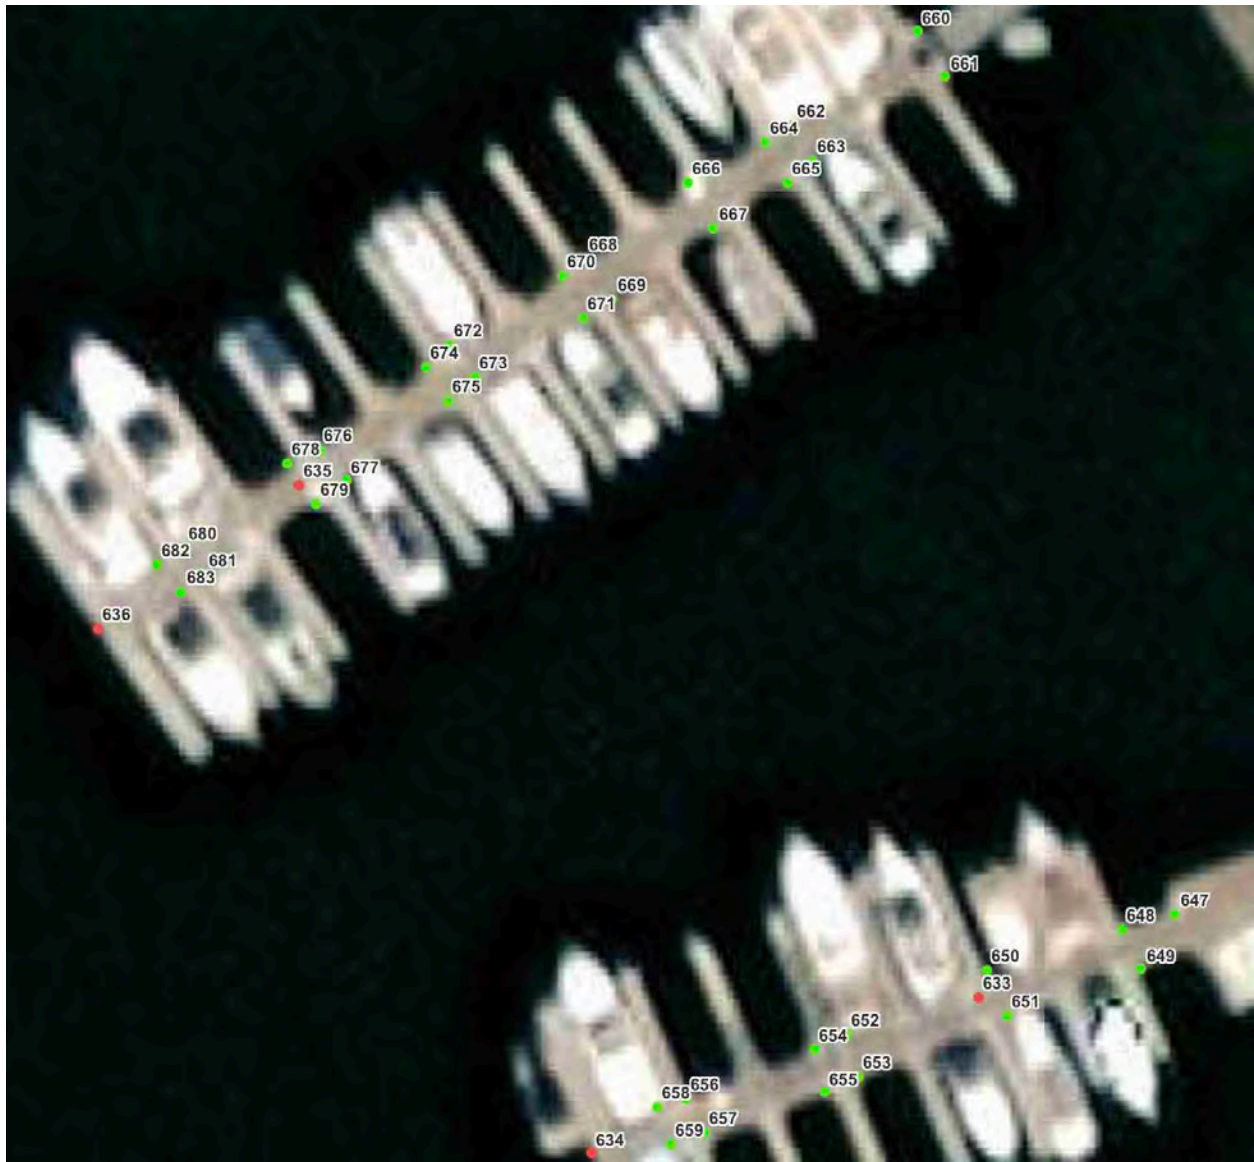
**Figure AV-23. Fixture Locations and Compliance Assessment: Upper Docks.** Dark sky compliant lighting has a green marker and non-compliant lighting has a red marker. Numbers present above the dots indicate the fixture ID number whose characteristics are presented within the tables.

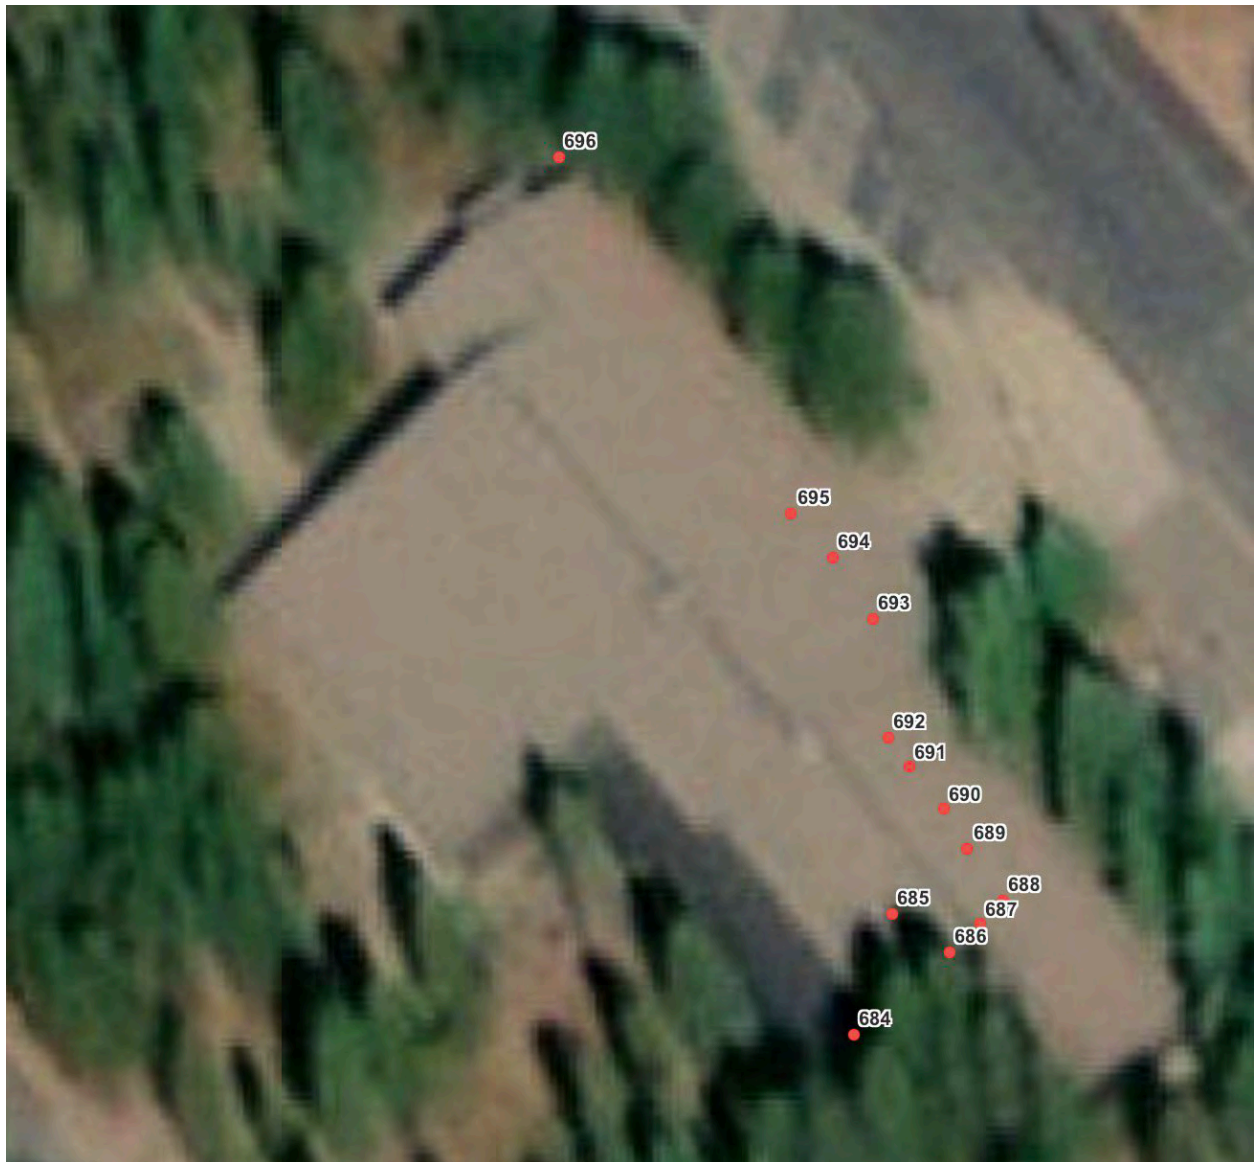
**Figure AV-24. Fixture Locations and Compliance Assessment: Visitor Center.** Dark sky compliant lighting has a green marker and non-compliant lighting has a red marker. Numbers present above the dots indicate the fixture ID number whose characteristics are presented within the tables.

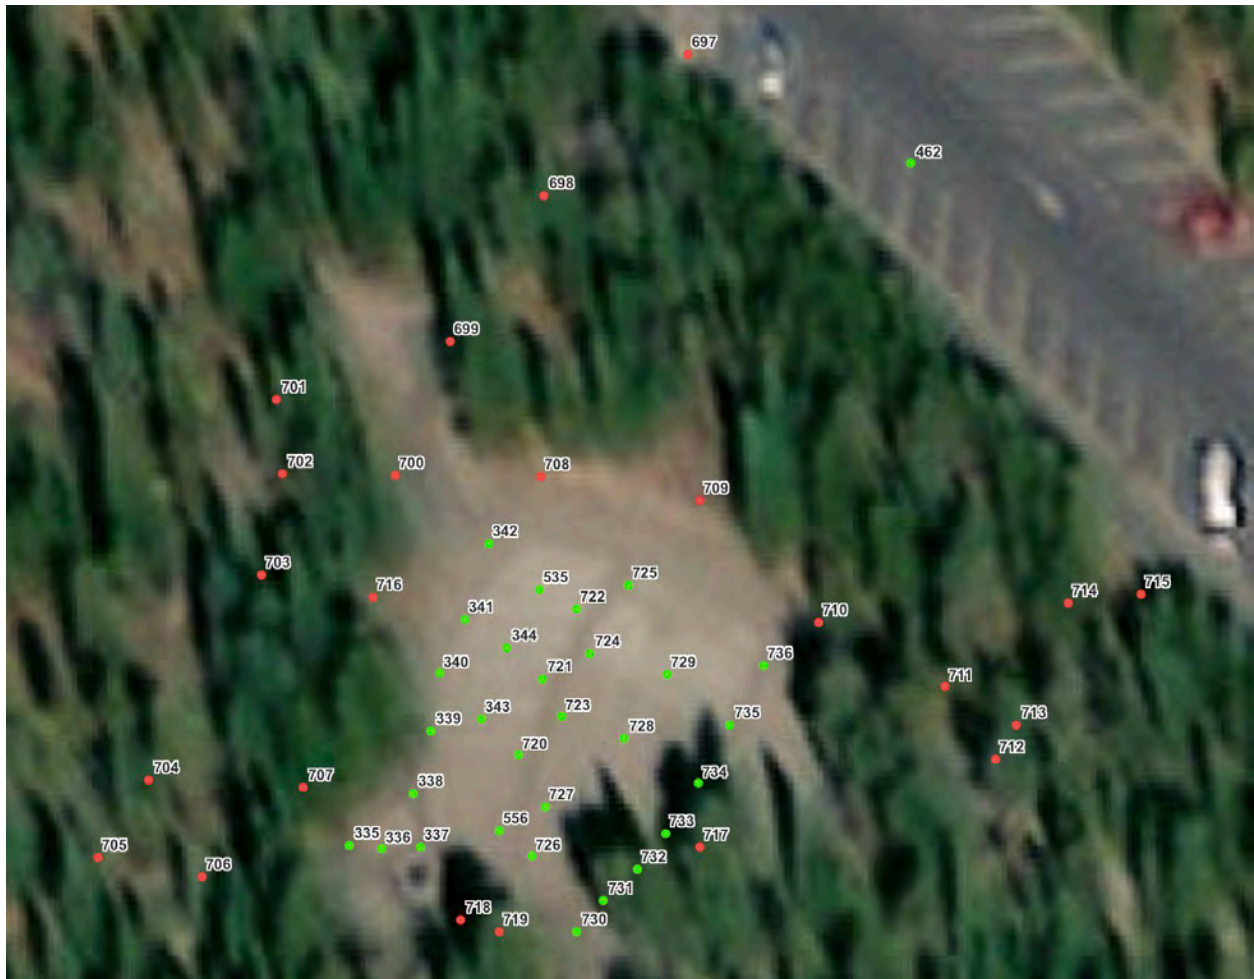
**Figure AV-25. Fixture Locations and Compliance Assessment: Amphitheater.** Dark sky compliant lighting has a green marker and non-compliant lighting has a red marker. Numbers present above the dots indicate the fixture ID number whose characteristics are presented within the tables.

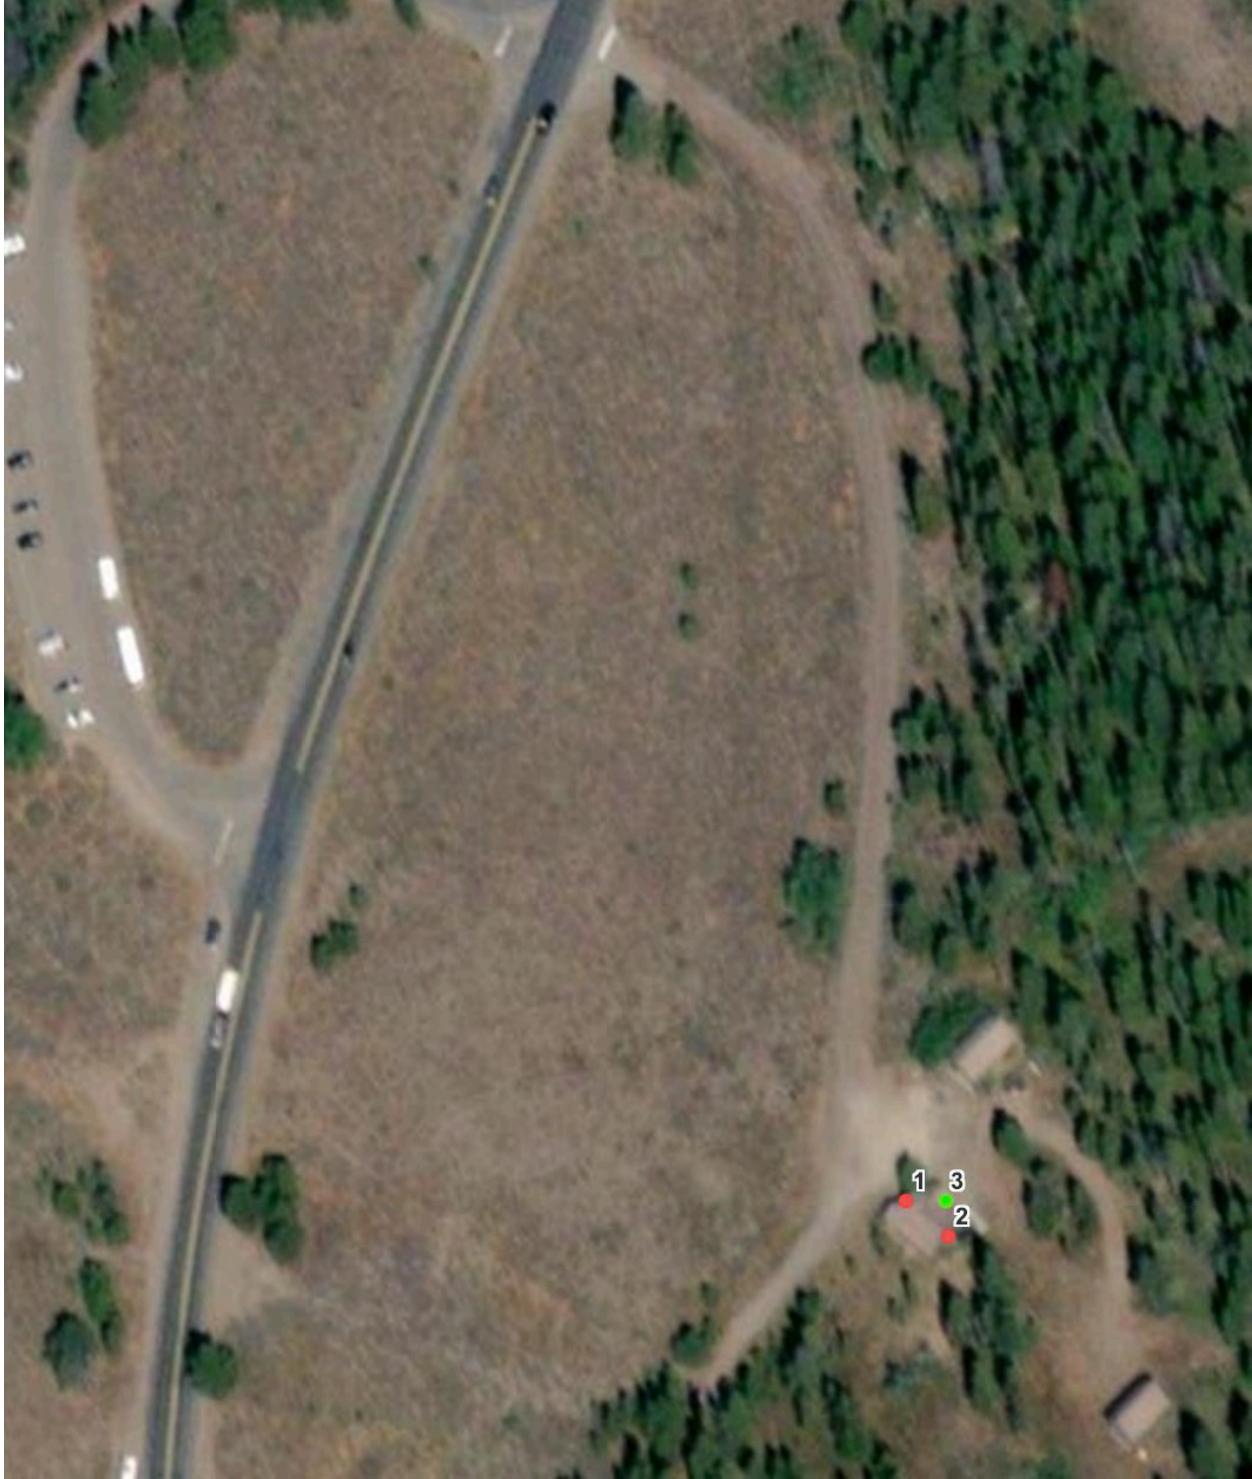
**Figure AVI-1. Fixture Locations and Compliance Assessment: Ranger Station.** Dark sky compliant lighting has a green marker and non-compliant lighting has a red marker. Numbers present above the dots indicate the fixture ID number whose characteristics are presented within the tables.

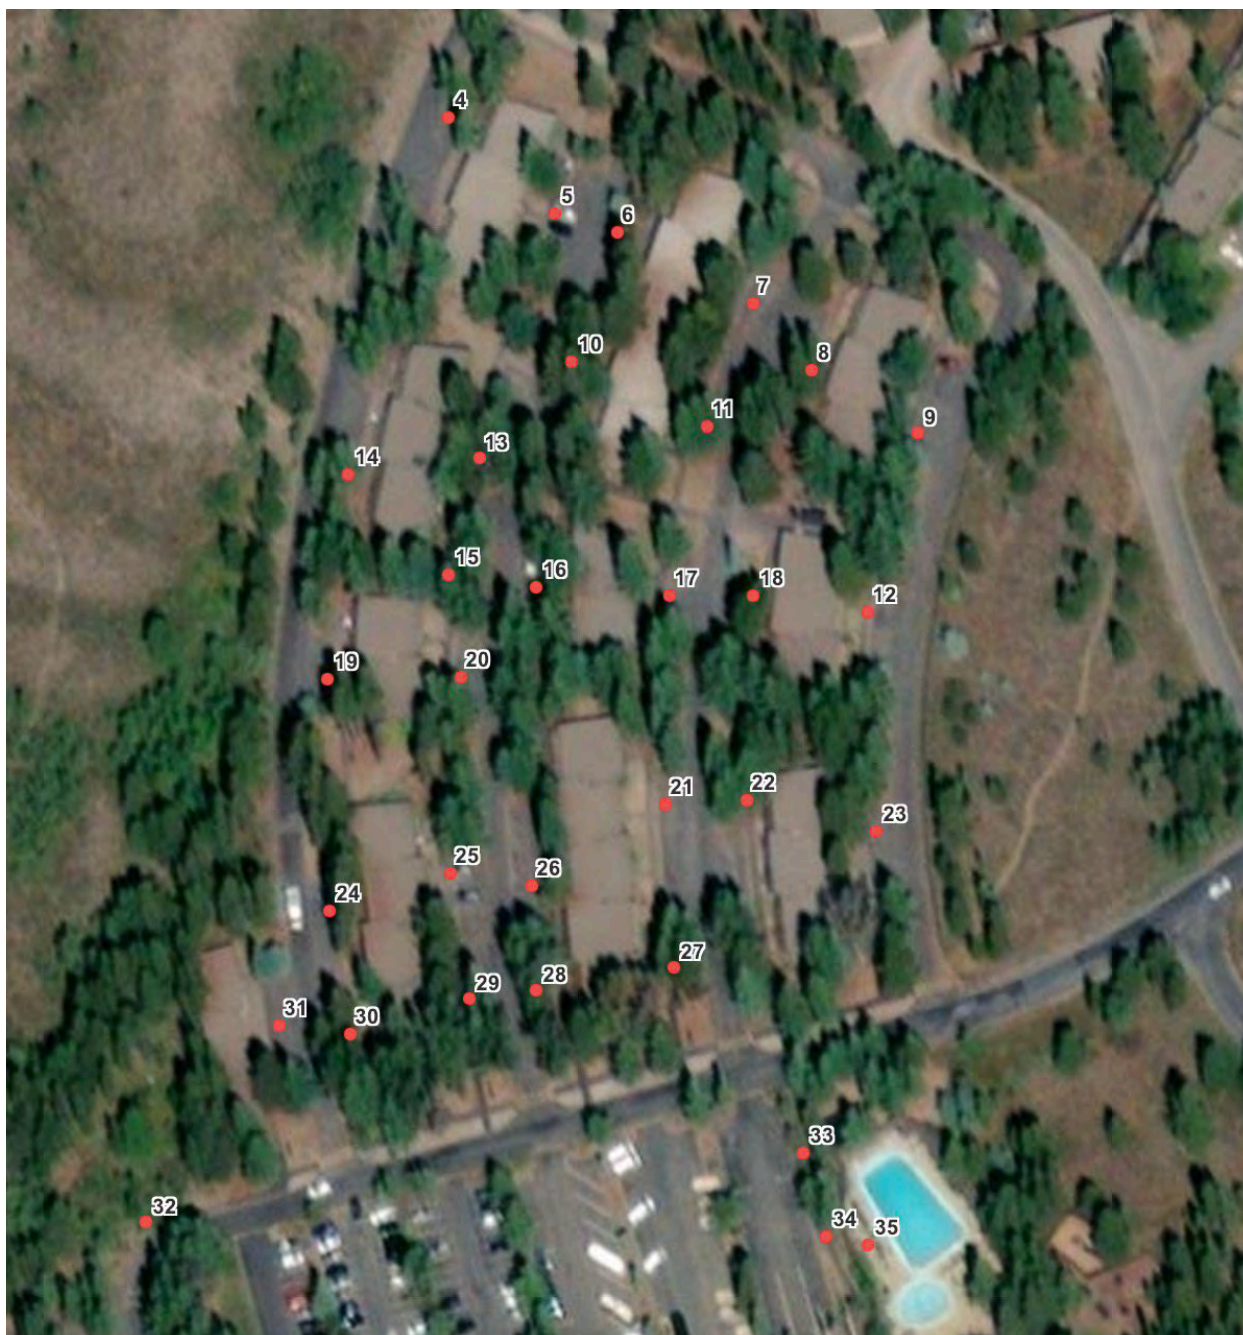
**Figure AVI-2. Fixture Locations and Compliance Assessment: Lodge Area Bollards North of Main Parking Area.** Dark sky compliant lighting has a green marker and non-compliant lighting has a red marker. Numbers present above the dots indicate the fixture ID number whose characteristics are presented within the tables.

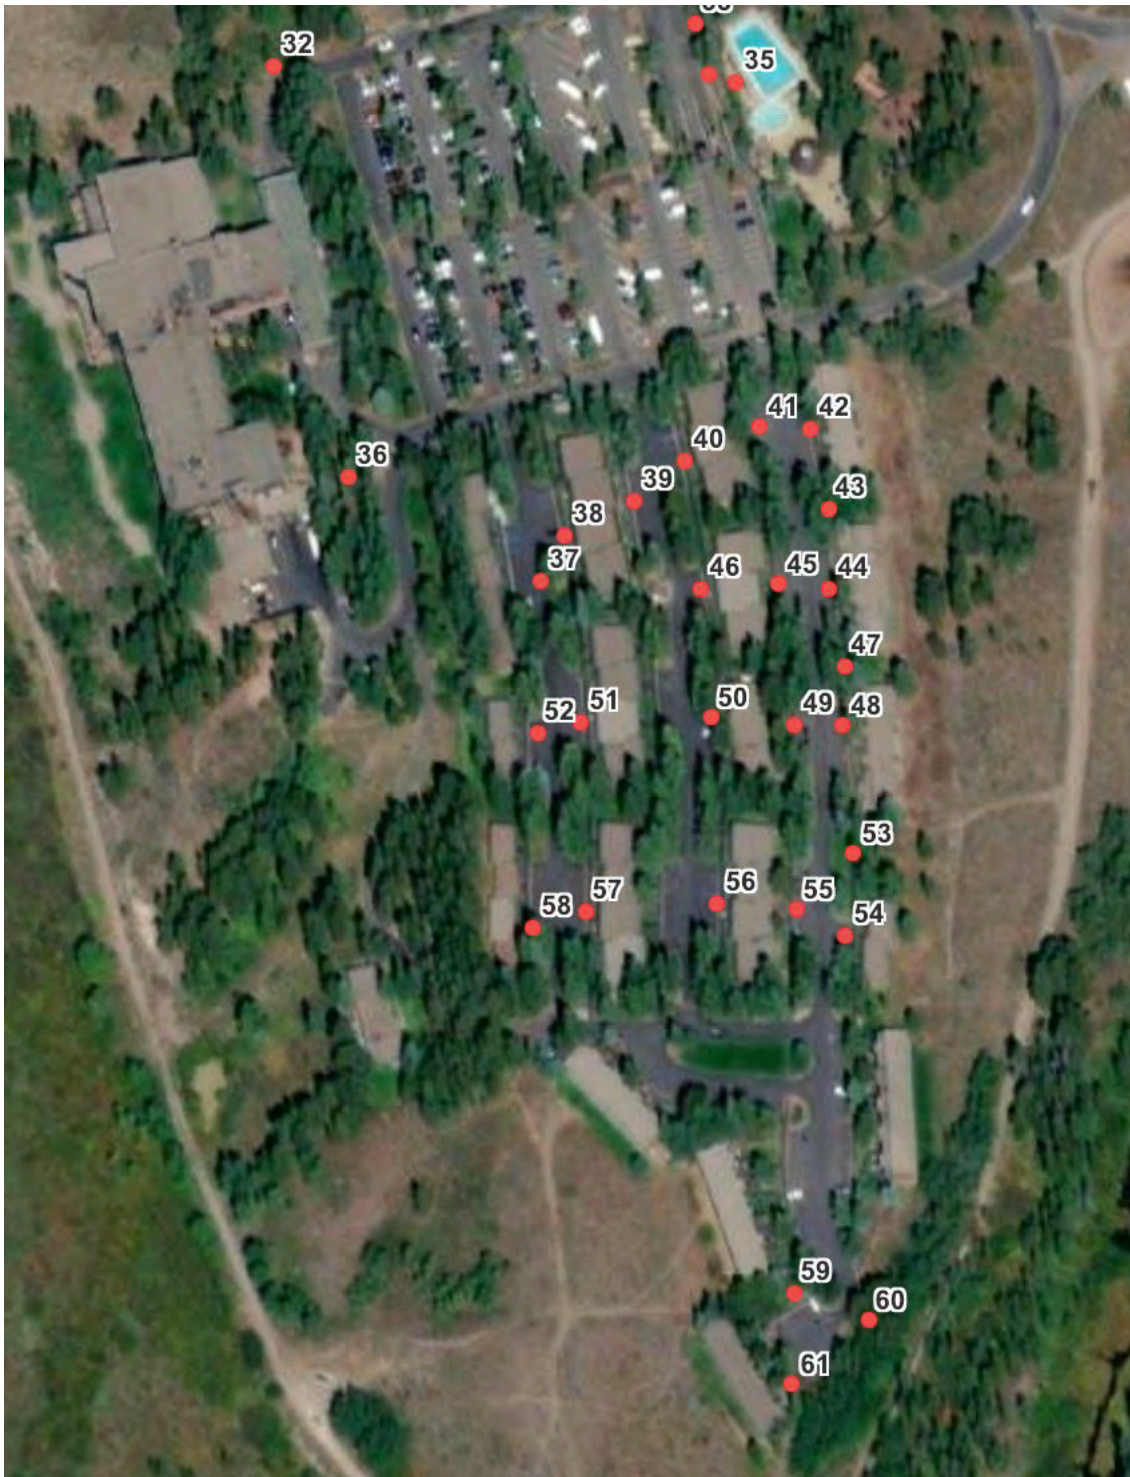
**Figure AVI-3. Fixture Locations and Compliance Assessment: Lodge Area Bollards South of Main Parking Area.** Dark sky compliant lighting has a green marker and non-compliant lighting has a red marker. Numbers present above the dots indicate the fixture ID number whose characteristics are presented within the tables.

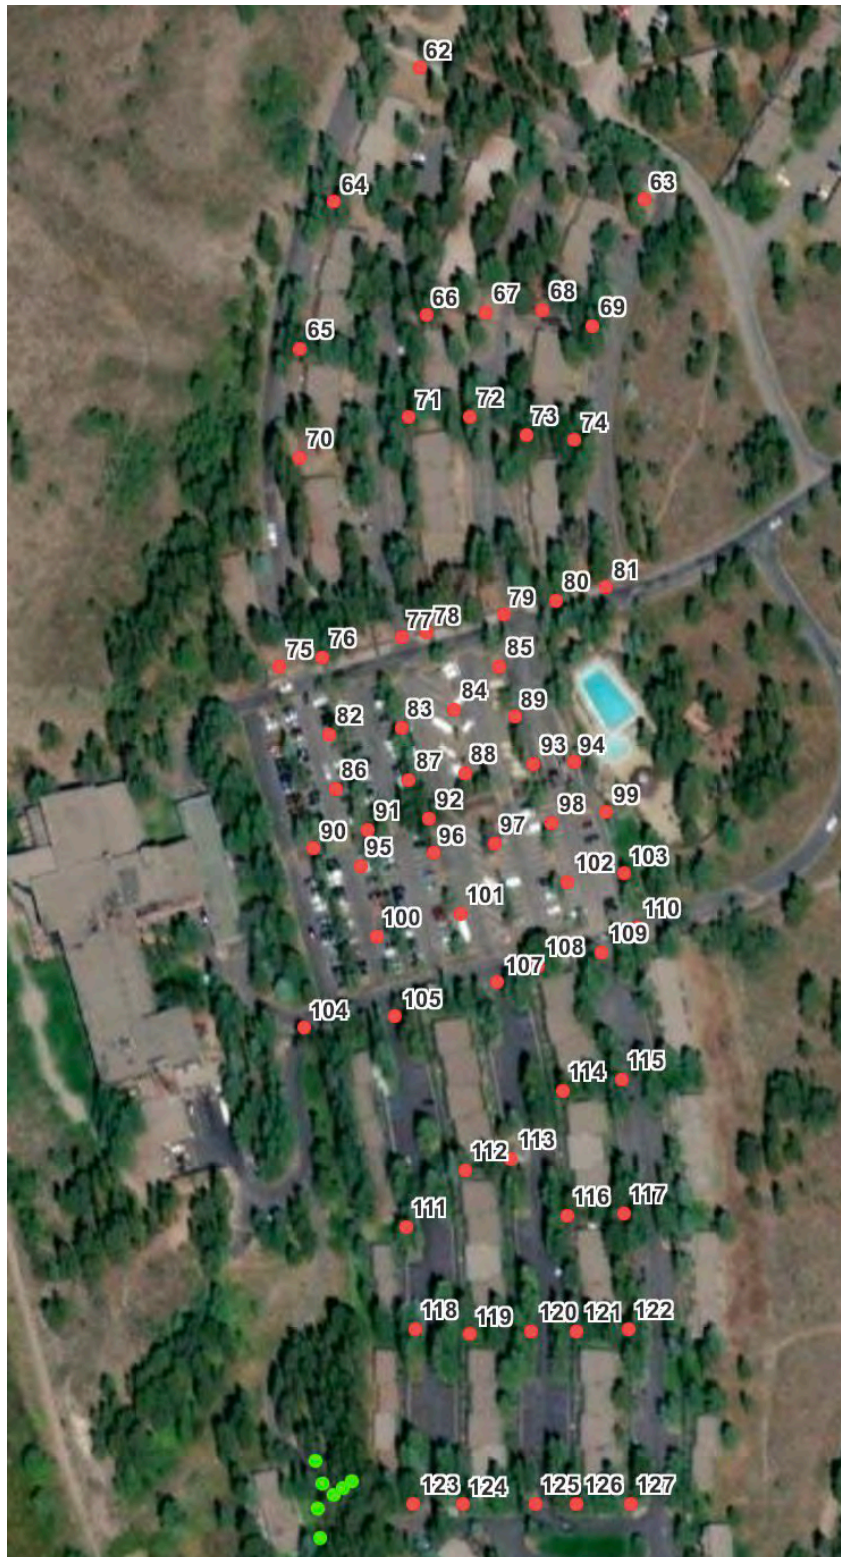
**Figure AVI-4. Fixture Locations and Compliance Assessment: Lodge Area Lamp Posts.** Dark sky compliant lighting has a green marker and non-compliant lighting has a red marker. Numbers present above the dots indicate the fixture ID number whose characteristics are presented within the tables.

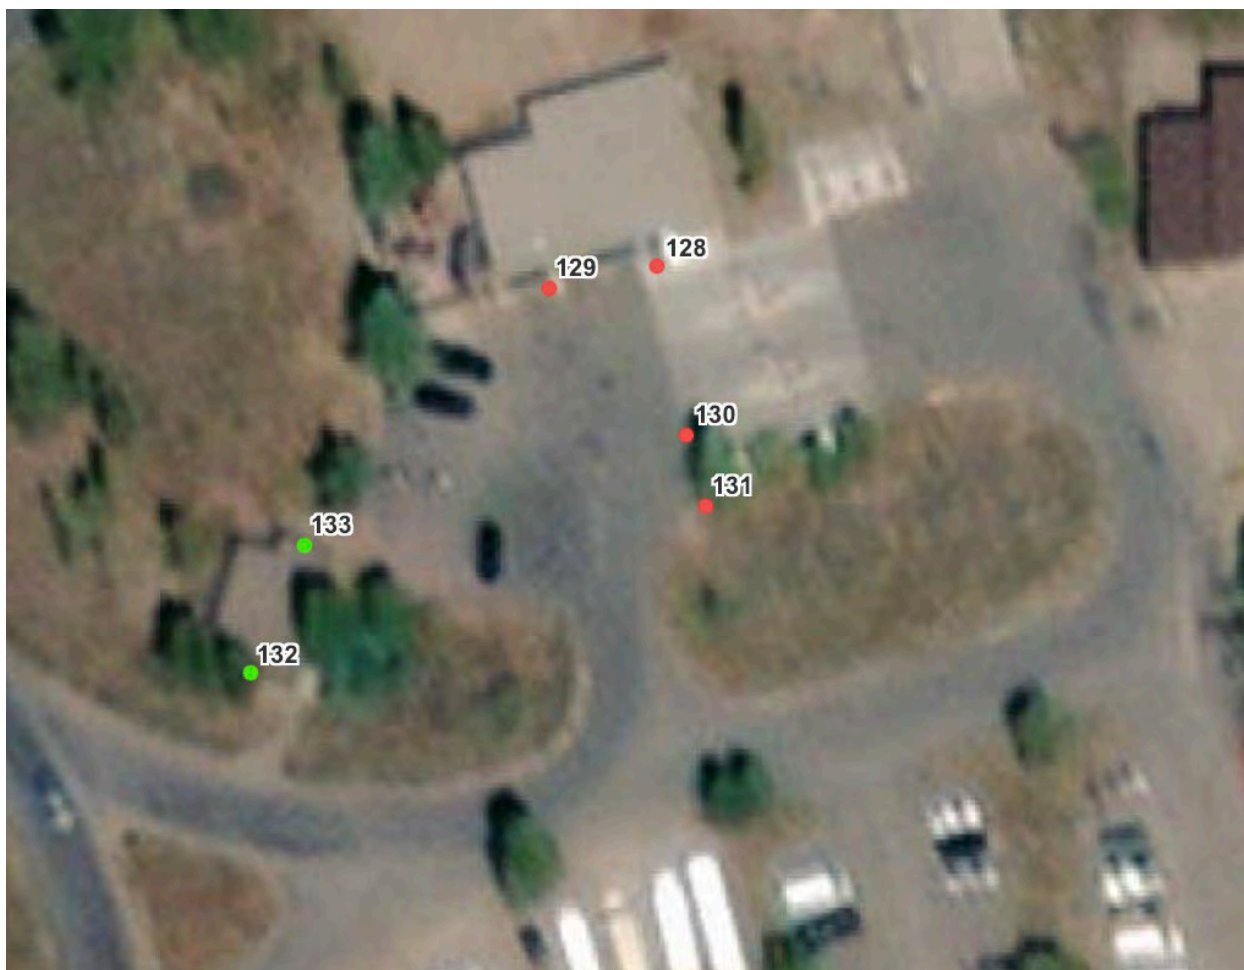
**Figure AVI-5. Fixture Locations and Compliance Assessment: Service Station and Grand Teton Medical Clinic.** Dark sky compliant lighting has a green marker and non-compliant lighting has a red marker. Numbers present above the dots indicate the fixture ID number whose characteristics are presented within the tables.

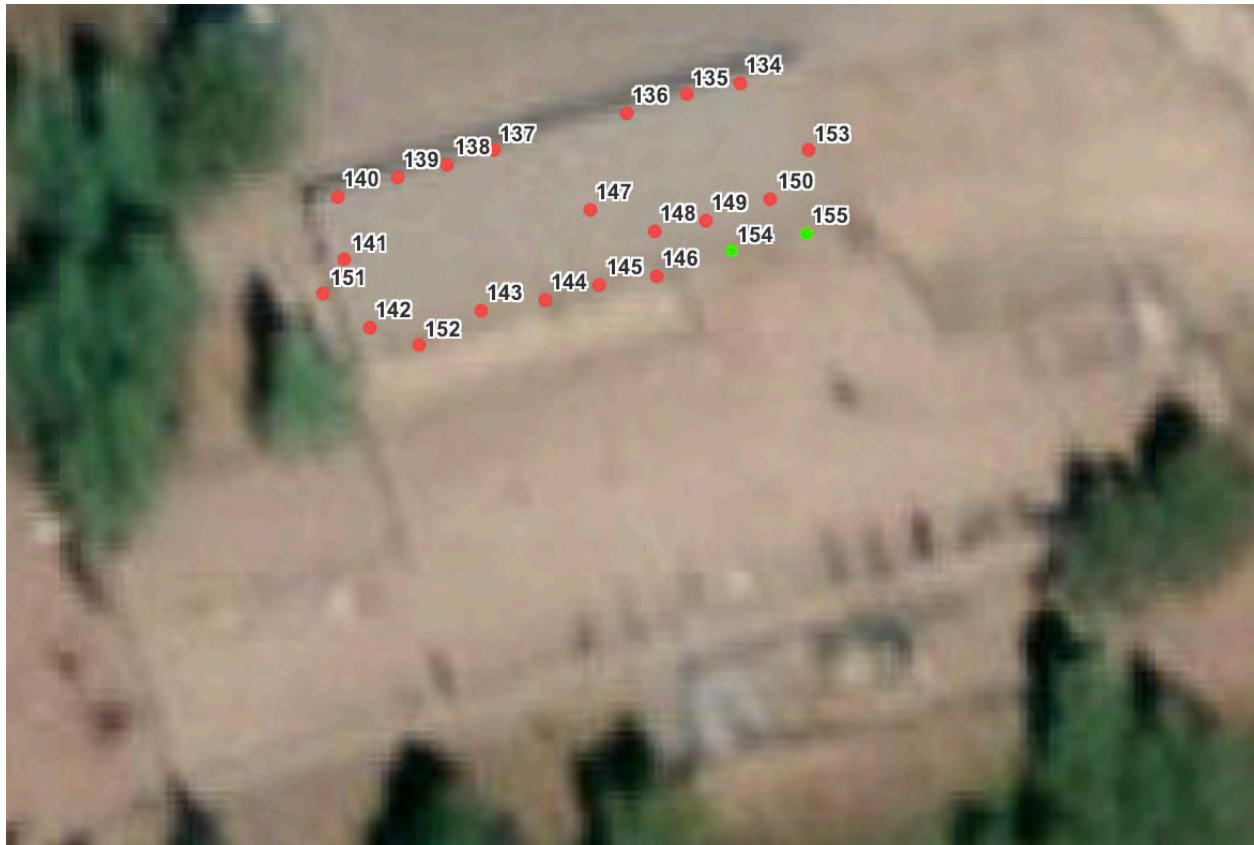
**Figure AVI-6. Fixture Locations and Compliance Assessment: Stable (Corral Offices).** Dark sky compliant lighting has a green marker and non-compliant lighting has a red marker. Numbers present above the dots indicate the fixture ID number whose characteristics are presented within the tables.

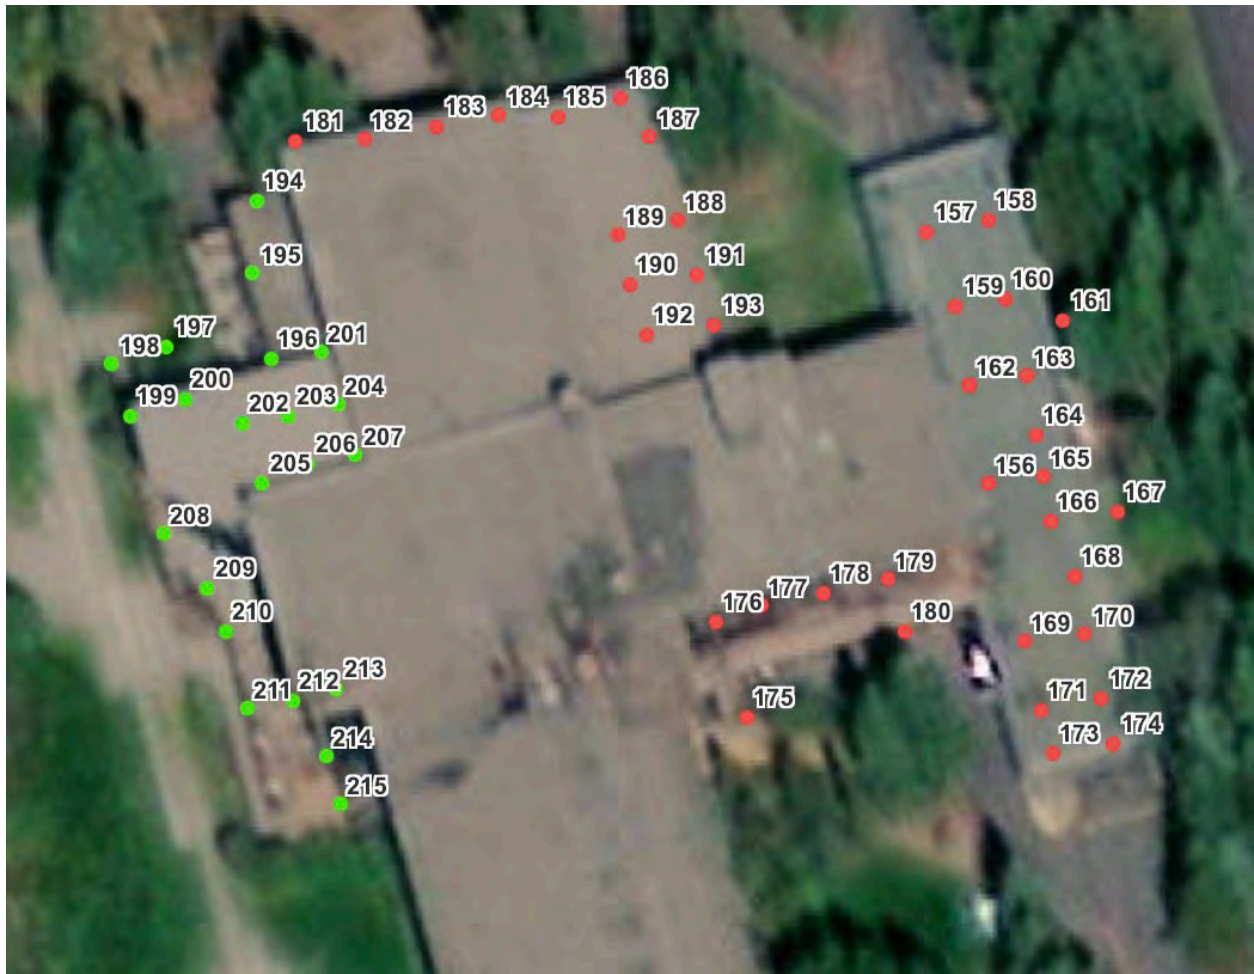
**Figure AVI-7. Fixture Locations and Compliance Assessment: Jackson Lake Lodge (Main Lodge Area).** Dark sky compliant lighting has a green marker and non-compliant lighting has a red marker. Numbers present above the dots indicate the fixture ID number whose characteristics are presented within the tables.

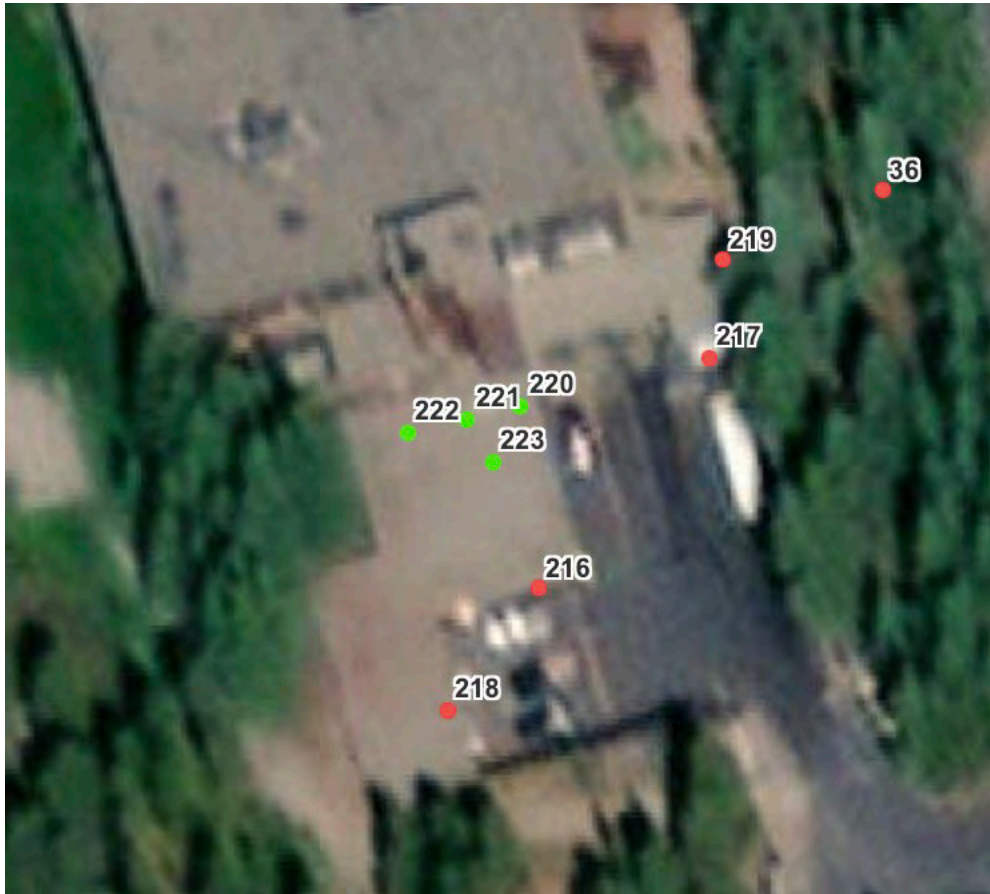
**Figure AVI-8. Fixture Locations and Compliance Assessment: Jackson Lake Lodge (Loading Dock Area).** Dark sky compliant lighting has a green marker and non-compliant lighting has a red marker. Numbers present above the dots indicate the fixture ID number whose characteristics are presented within the tables.

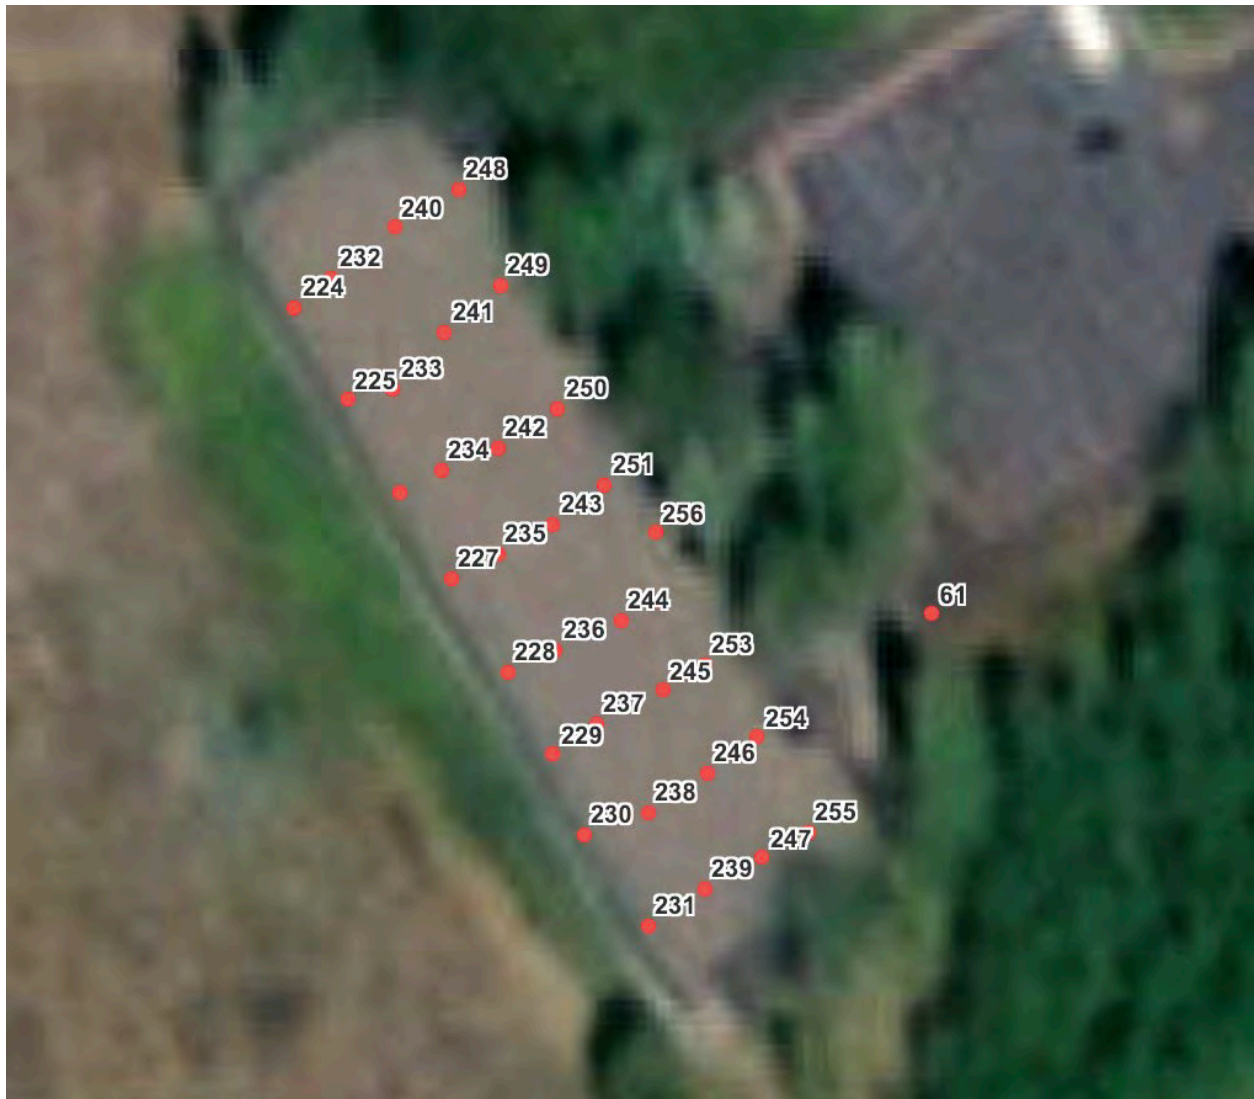
**Figure AVI-9. Fixture Locations and Compliance Assessment: Cabin Rooms 900 - 911.** Dark sky compliant lighting has a green marker and non-compliant lighting has a red marker. Numbers present above the dots indicate the fixture ID number whose characteristics are presented within the tables.
